You're Ref: TP/IP/29221/2021  
Our Ref: CI/TPD21007278/P

**Fatal Accident Investigation Team**

**MECHANICAL INSPECTION REPORT OF MOTOR CAR SJZ 7223Y**

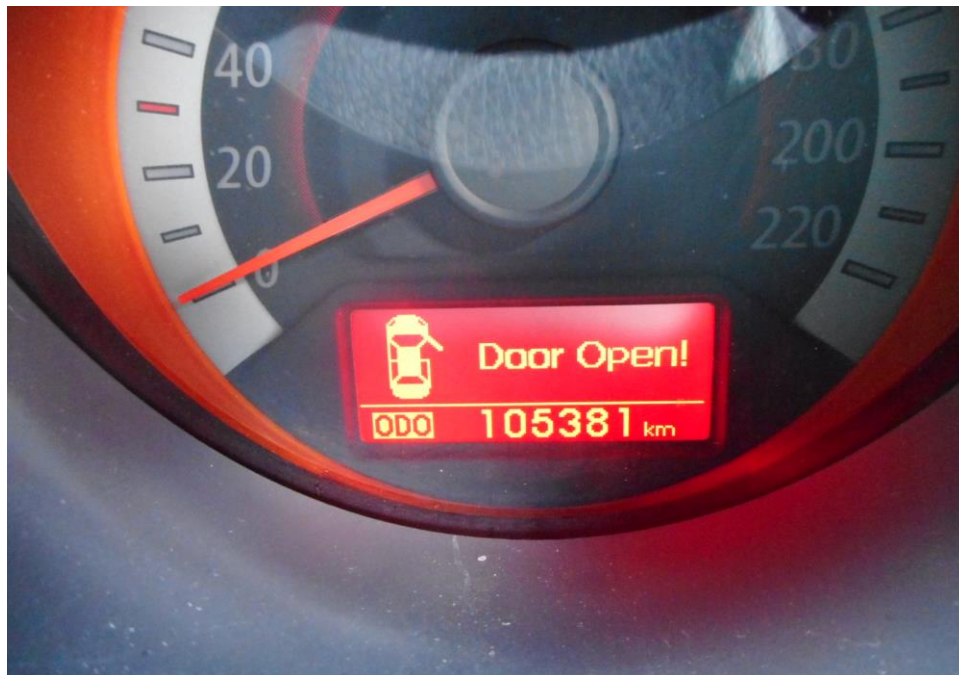
**Photo 1** shows the mileage of the Motor Car at the time of my inspection. The mileage observed was 105,381km.

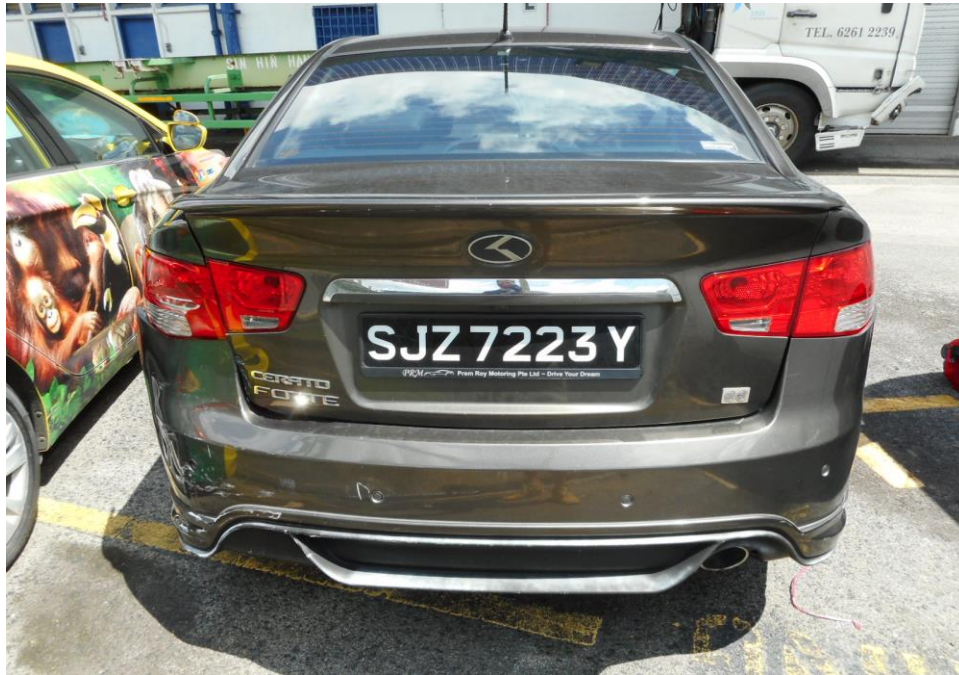
4. The mileage of the Motor Car at the time of my inspection was 105,381km.
5. The Motor Car was observed to have sustained damage at its rear portion. Its rear left brake lamp, rear bonnet and rear bumper was amongst the body parts that were damaged as a result of the accident.

**Photo 2** shows the general view of the Motor Car's rear body at the time of my inspection. The Motor Car rear was observed to have sustained damage at its rear portion. Its rear left brake lamp, rear bonnet and rear bumper was amongst the body parts that were damaged as a result of the accident.

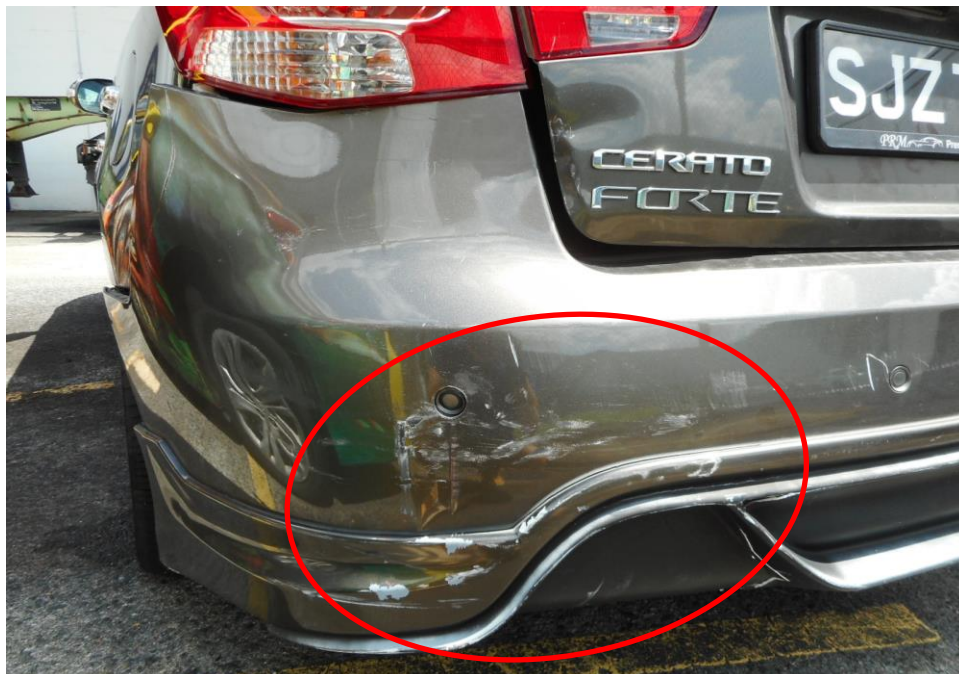
**Photo 3** shows a close up view of the Motor Car's rear body at the time of my inspection. The rear portion of the Motor Car was observed to have sustained damage. Its rear bumper (circled) was the body part that were damaged as a result of the accident.

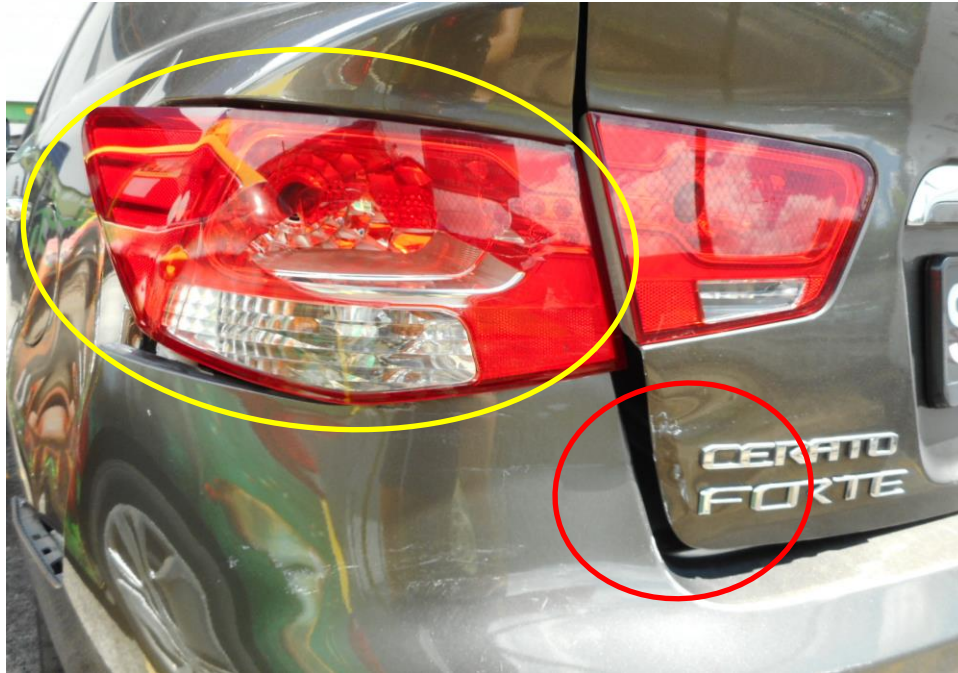
**Photo 4** shows a close up view of the Motor Car's rear body at the time of my inspection. The rear portion of the Motor Car was observed to have sustained damage. Its rear left brake lamp (yellow circle) and rear bonnet (red circle) was the body parts that were damaged as a result of the accident.

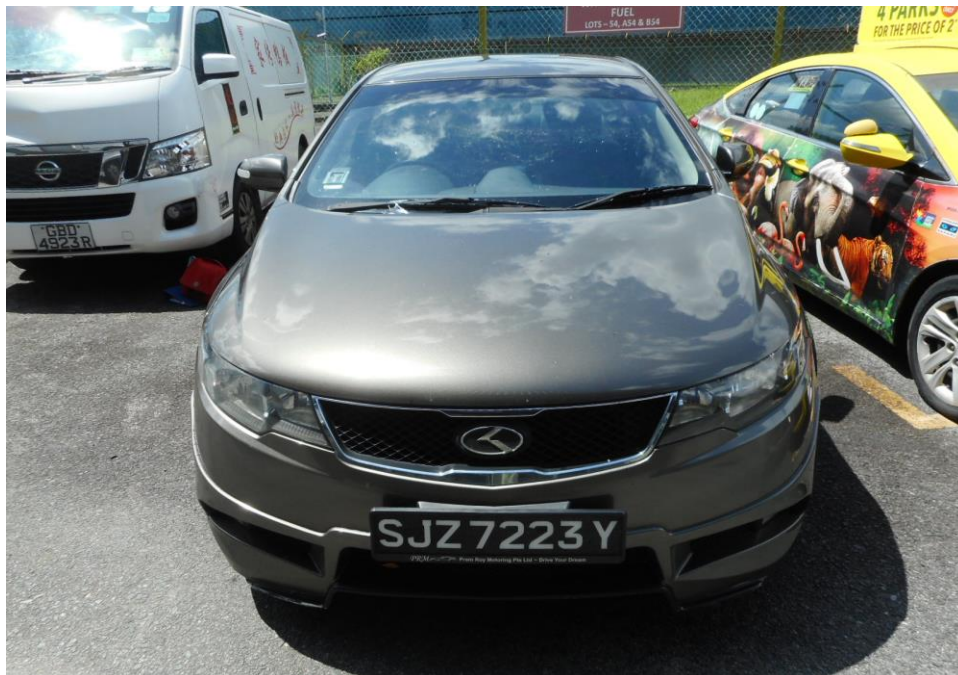
**Photo 5** shows a general view of the Motor Car's front body at the time of my inspection. The front portion of the Motor Car was observed to have sustained damage. Its front left fender was the body part that were damaged as a result of the accident.

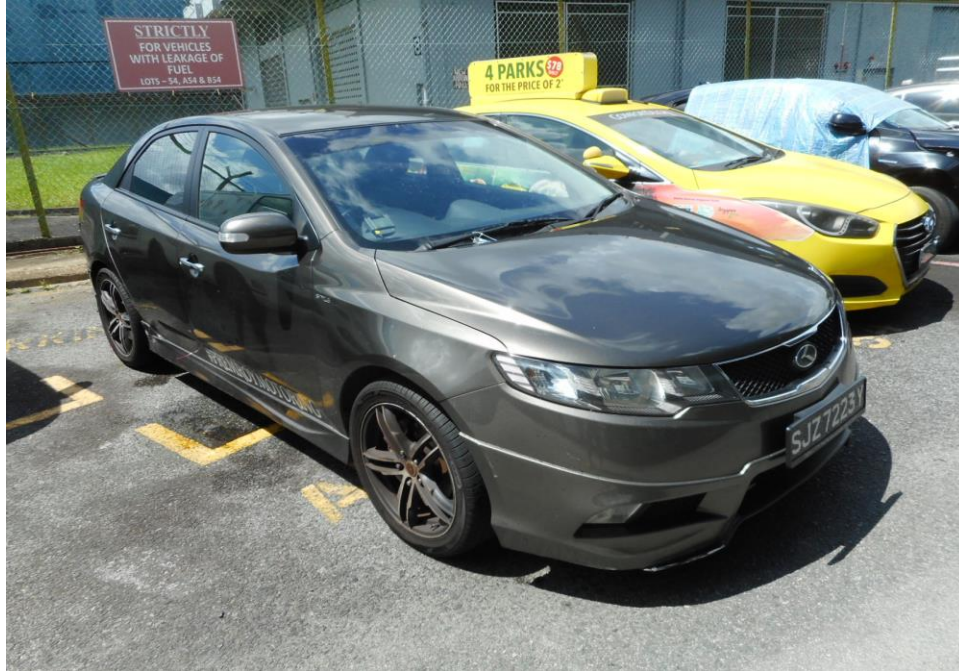
**Photo 6** shows a general view of the Motor Car's right body at the time of my inspection. The right portion of the Motor Car was observed to have been unaffected by the accident.

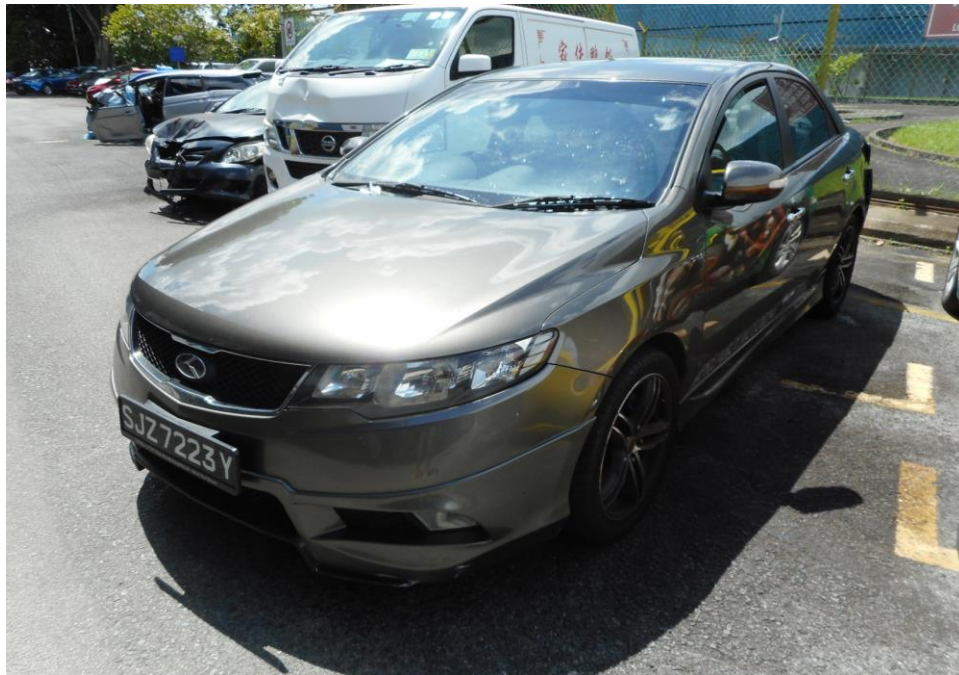
**Photo 7** shows a general view of the Motor Car's left body at the time of my inspection. The left portion of the Motor Car was observed to have been unaffected by the accident.

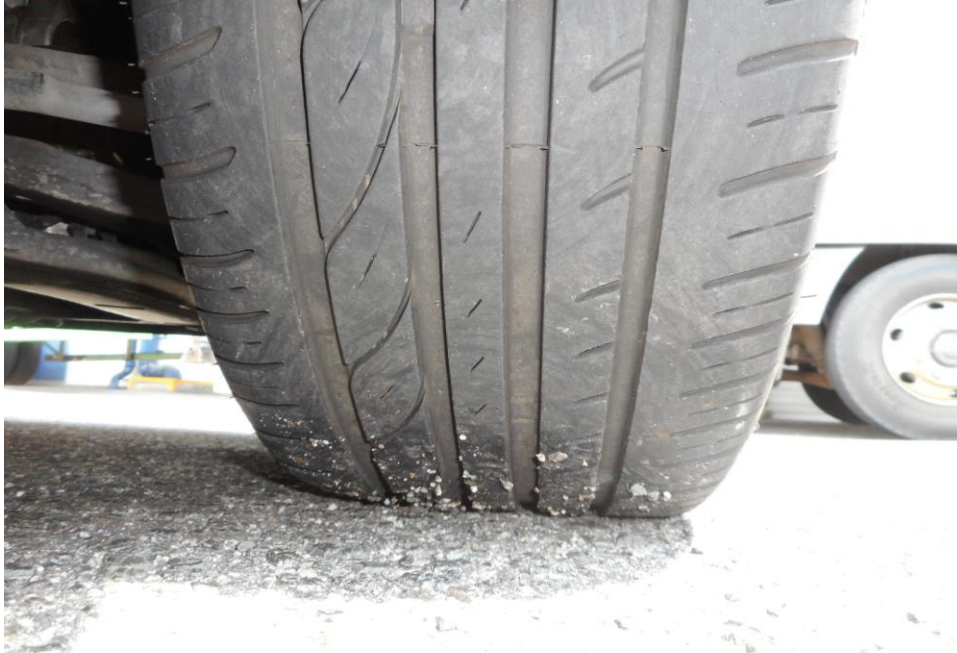
**Photo 8** shows the condition of the front right tyre of the Motor Car, which was observed to be in serviceable condition with remaining tread depth of approximately 4.6mm. The tyre was sufficiently inflated for vehicular operation with no tear, cut or burst mark(s) on the outer and the inner sidewalls as well as across the tread. The 4 tyres of the Motor Car were wrapped around standard steel wheel rims without any damage.

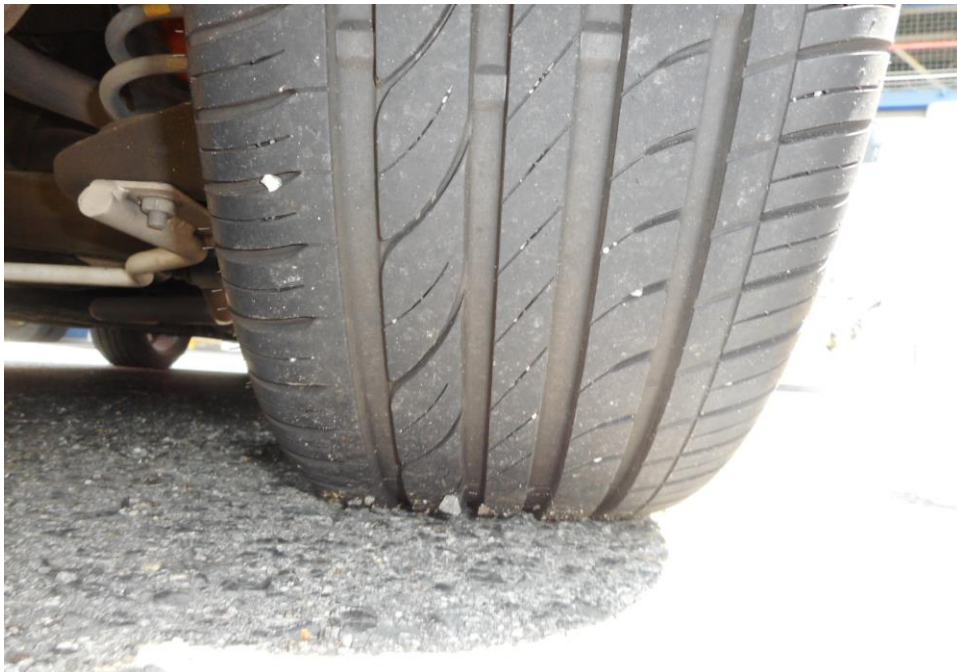
**Photo 9** shows the condition of the rear right tyre of the Motor Car, which was observed to be in serviceable condition with remaining tread depth of approximately 6.1mm. The tyre was also observed to be sufficiently inflated for vehicular operation with no tear, cut or burst mark(s).

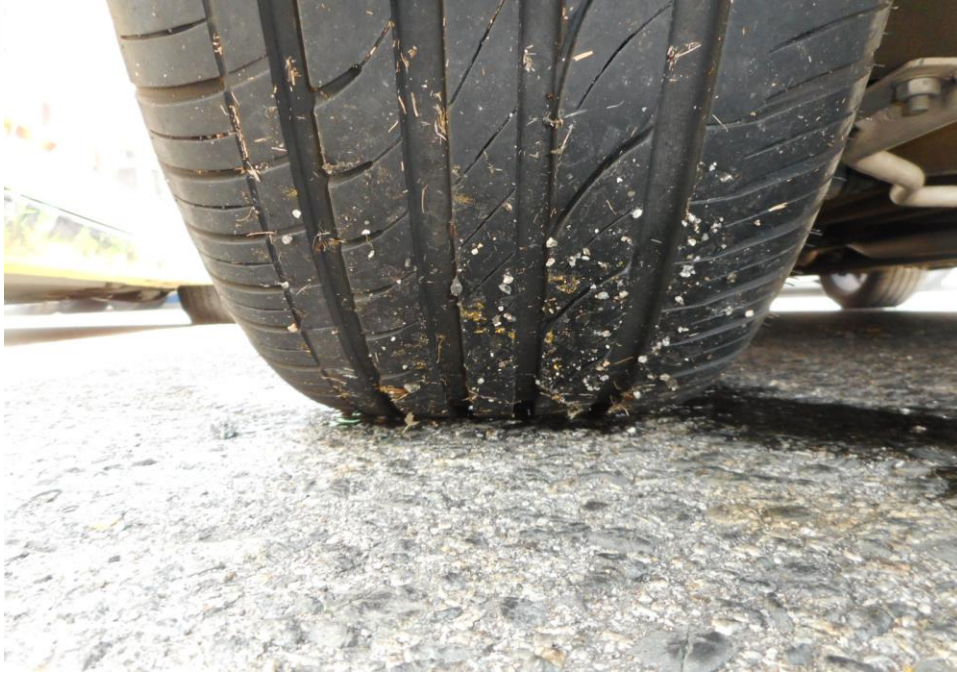
**Photo 10** shows the condition of the rear left tyre of the Motor Car, which was observed to be in serviceable condition with remaining tread depth of approximately 6.1mm. The tyre, which was wrapped around steel wheel rim, was also observed to be sufficiently inflated for vehicular operation. The 4 tyres of the Motor Car were wrapped around standard steel wheel rims.

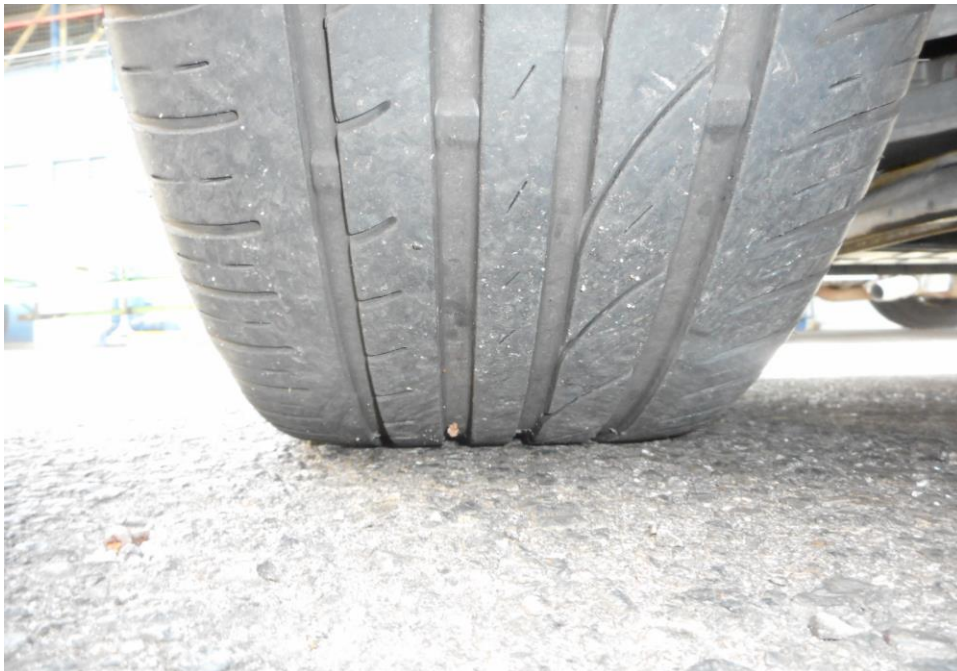
**Photo 11** shows the condition of the front left tyre of the Motor Car, which was observed to be in serviceable condition with remaining tread depth of approximately 4.4mm. There was also no tear, cut or burst mark(s) on the outer and the inner sidewalls as well as across the tread of the Motor Car's 4 tyres.

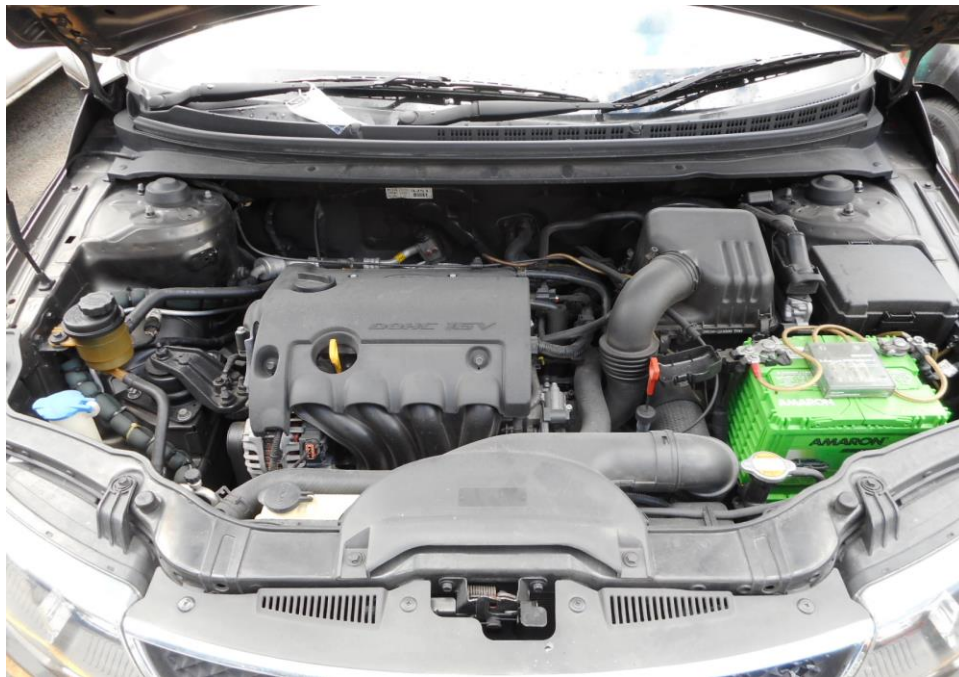
**Photo 12** shows a general view of the Motor Car's engine compartment. The various parts and components inside the engine compartment were unaffected by the accident. There was also no sign(s) or indication(s) of fluid leakage and/or fluid stain within the engine compartment.

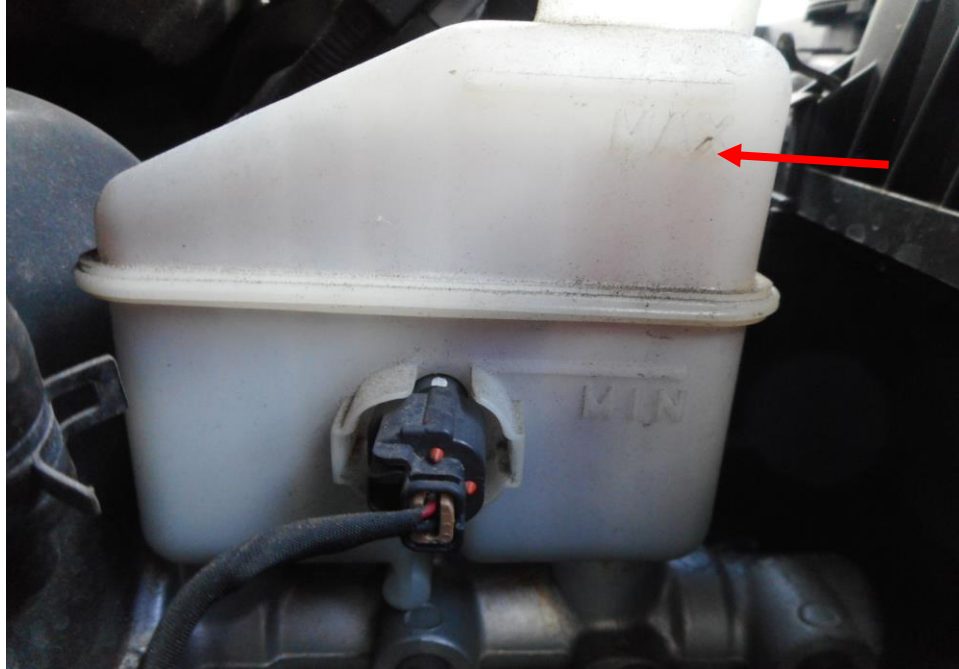
**Photo 13** shows the brake fluid reservoir of the Motor Car at the time of my inspection. The brake fluid was observed to be of sufficient level (arrowed) and without any visible contamination.

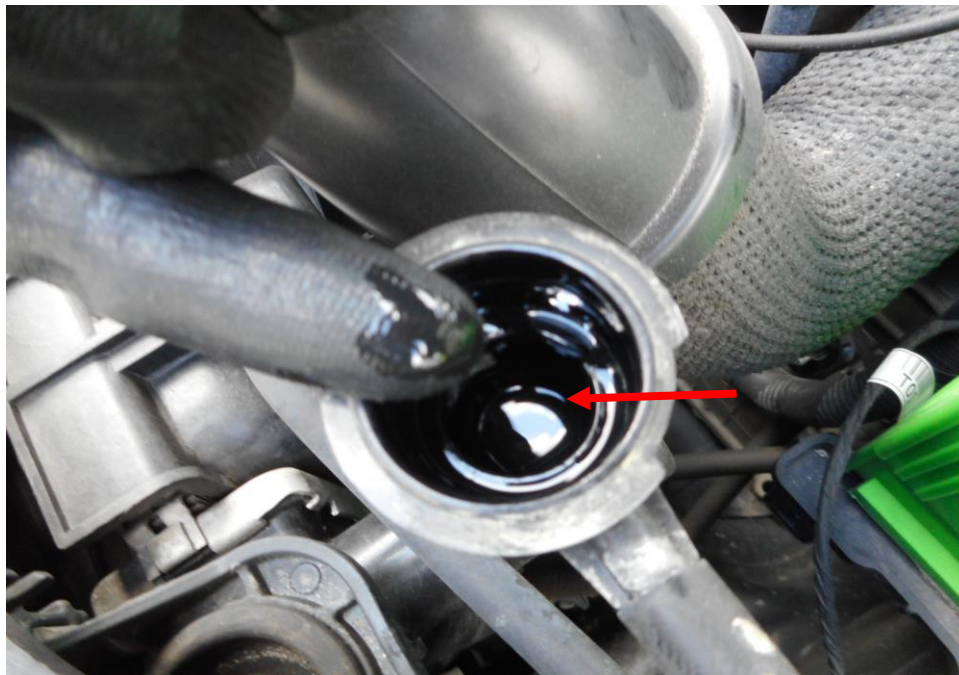
**Photo 14** shows checks being carried out to the engine coolant of the Motor Car at the time of my inspection. The engine coolant was observed to be of sufficient level (arrowed) and without any visible contamination.

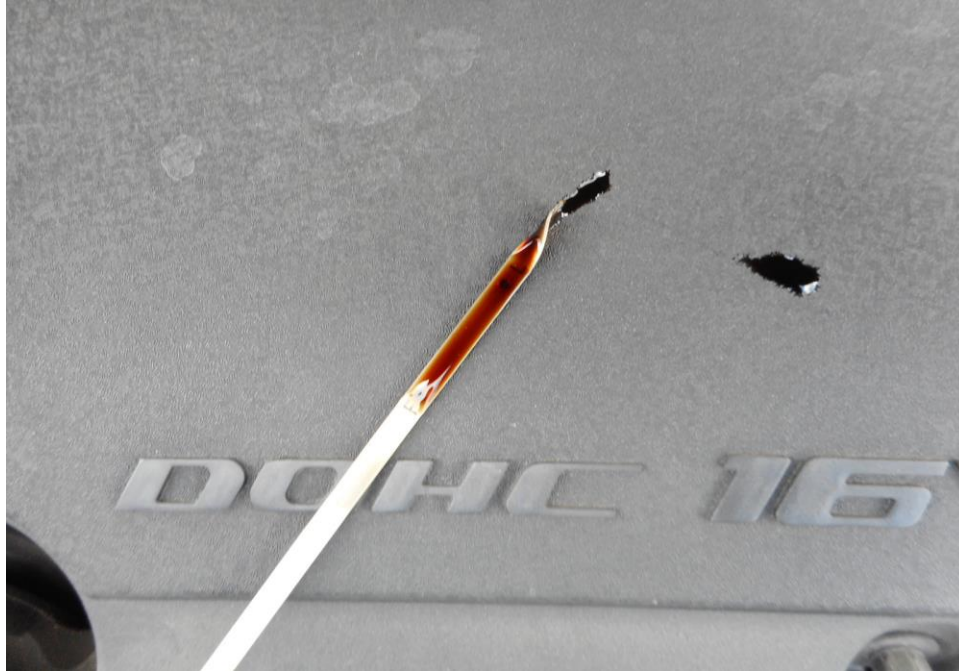
**Photo 15** shows the engine oil dip stick of the Motor Car at the time of my inspection. The engine oil was observed to be of sufficient level and without any visible contamination.

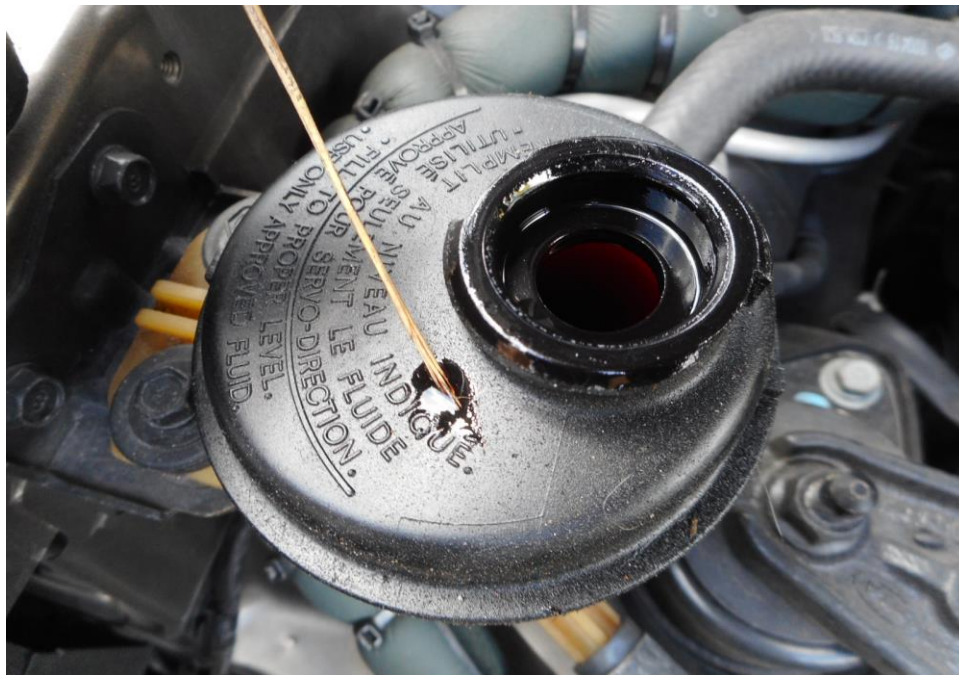
**Photo 16** shows the power steering fluid of the Motor Car at the time of my inspection. The steering fluid was observed to be of sufficient level and without any visible contamination.

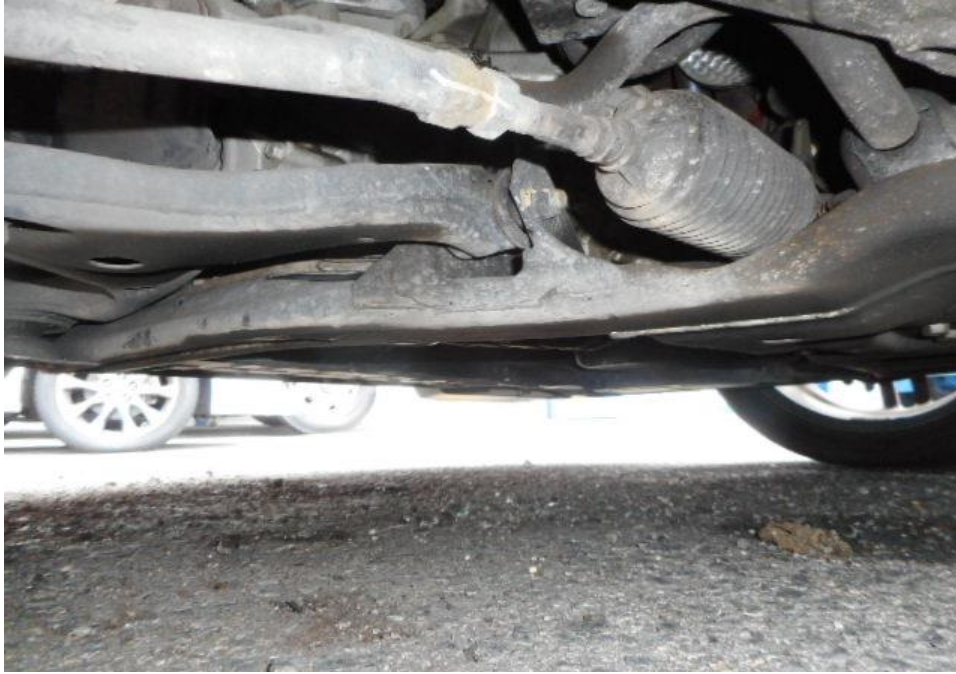
**Photo 17** shows the undercarriage of the Motor Car, at the area where the engine housing and transmission housing are located. I did not find any sign(s) or indication(s) of fluid leak and/or fluid stain(s) on the underside of the Motor Car.

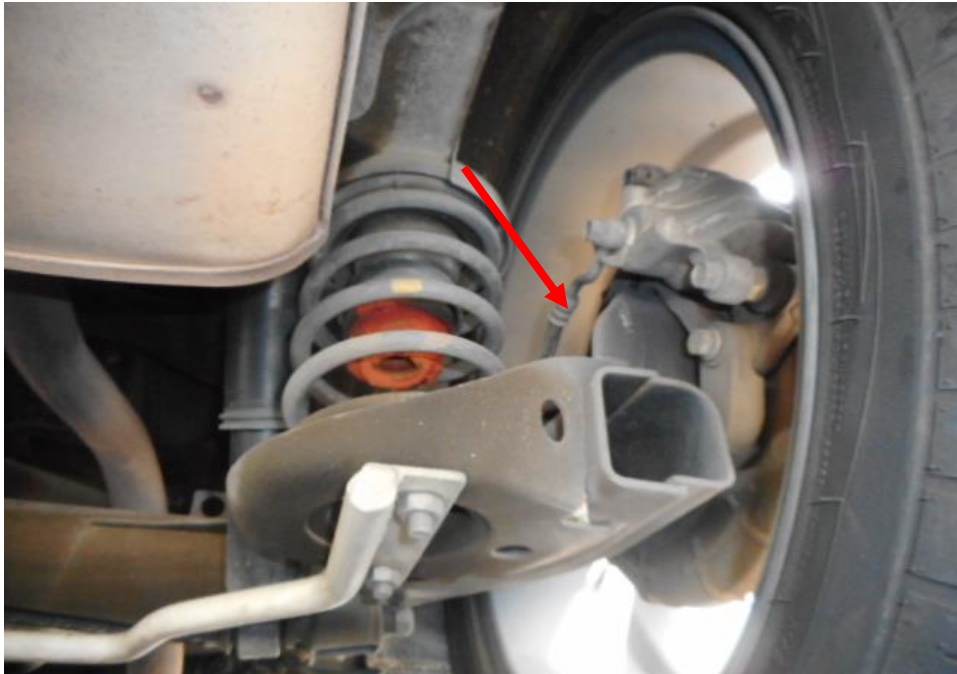
**Photo 18** shows the brake hose/pipe (arrowed) at the rear right wheel of the Motor Car. No leakage of brake fluid was observed. Visual examination of the various components of the braking system like the drum brake, brake booster, brake pedal etc. had revealed all to be intact and without visible damage.

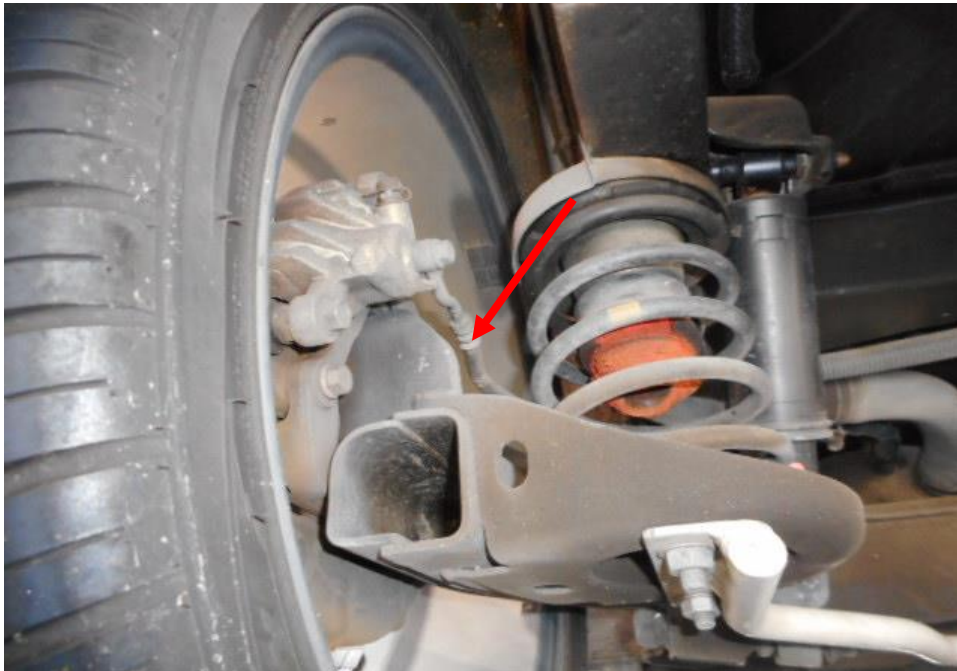
**Photo 19** shows the brake hose/pipe (arrowed) at the rear left wheel of the Motor Car. I did not observe any leakage of brake fluid at the time of my inspection of the Motor Car. Static tests of the Motor Car's braking system had indicated that there was no internal leakage of pressure/vacuum. The undercarriage components of the Motor Car were also all found to be intact and without any visible damage.

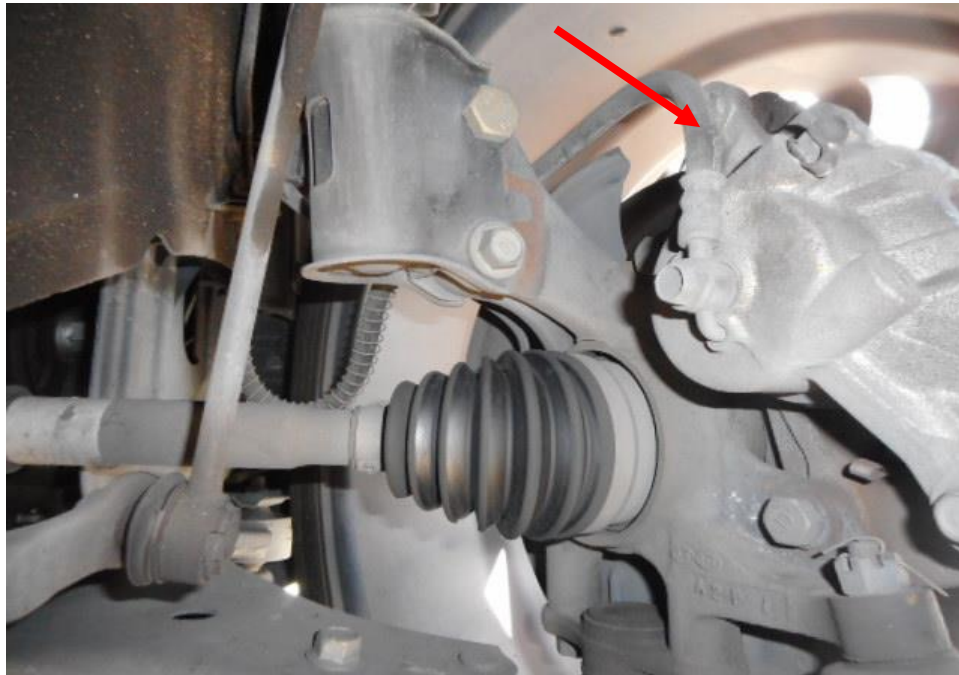
**Photo 20** shows the brake hose/pipe (arrowed) at the front right wheel of the Motor Car. I did not observe any leakage of brake fluid at the time of my inspection of the Motor Car. Static tests of the Motor Car's braking system had indicated that there was no internal leakage of pressure/vacuum. The undercarriage components of the Motor Car were also all found to be intact and without any visible damage.

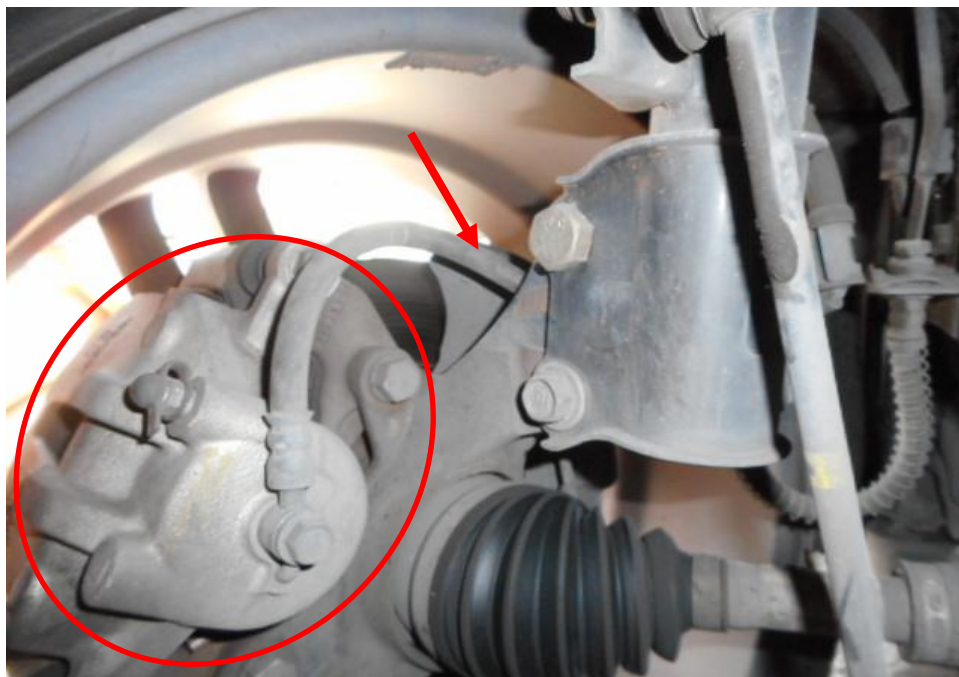
**Photo 21** shows the brake hose/pipe (arrowed) at the front left wheel of the Motor Car. No leakage of brake fluid was observed. Visual examination of the various components of the braking system like the brake caliper (circled), brake booster, brake pedal etc had revealed all to be intact and without visible damage.

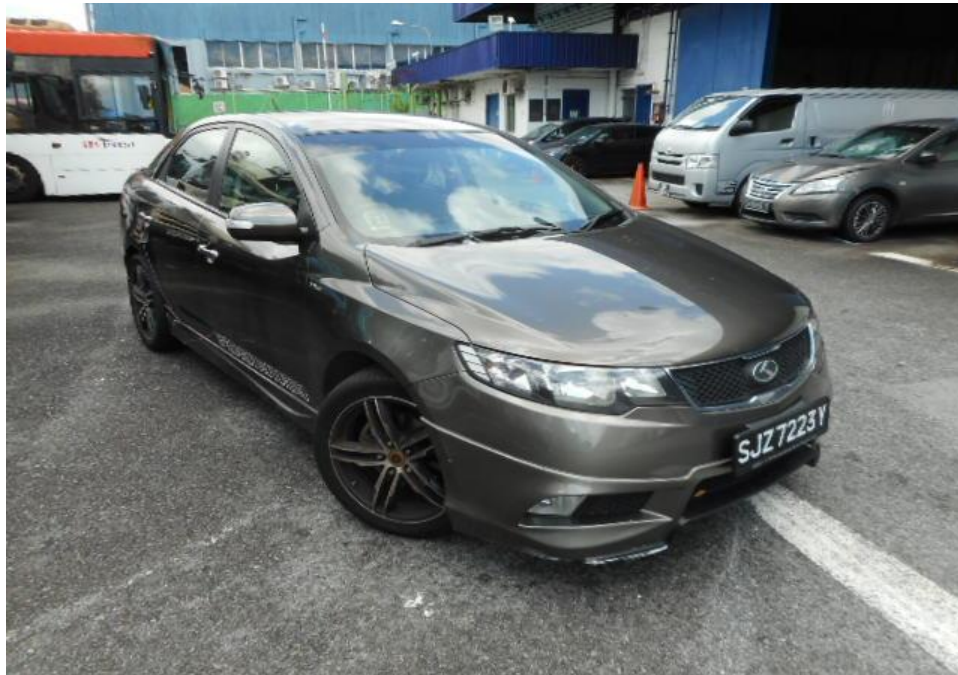
**Photo 22** shows the front right wheel of the Motor Car turned to its full left. During my steering system test, I did not experience any abnormal free play and/or resistance when I had turned the steering wheel towards the left and right. This would suggest that the steering system of the Motor Car was likely to be in serviceable condition at the material time of accident.

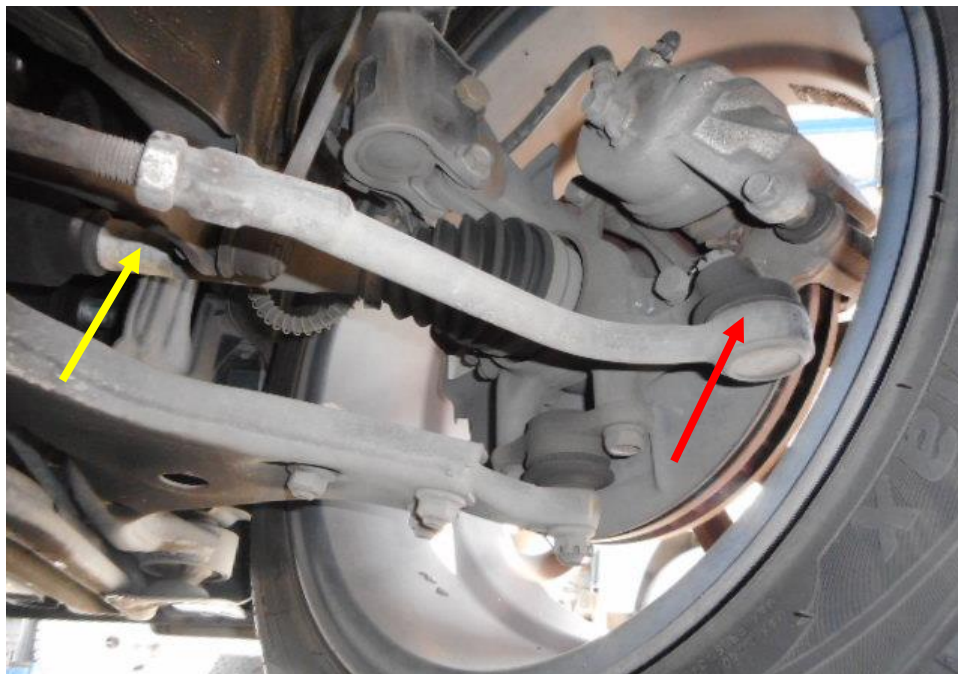
**Photo 23** shows the various undercarriage components at the front right wheel of the Motor Car, in particular the steering tie rod (red arrow) and drive shaft (yellow arrow). The various steering components were all found to be intact, suggesting that the steering system of the Motor Car was likely to be in serviceable condition at the material time of accident. There was also no sign of fluid stain observed on the various undercarriage components at the front right wheel of the Motor Car.

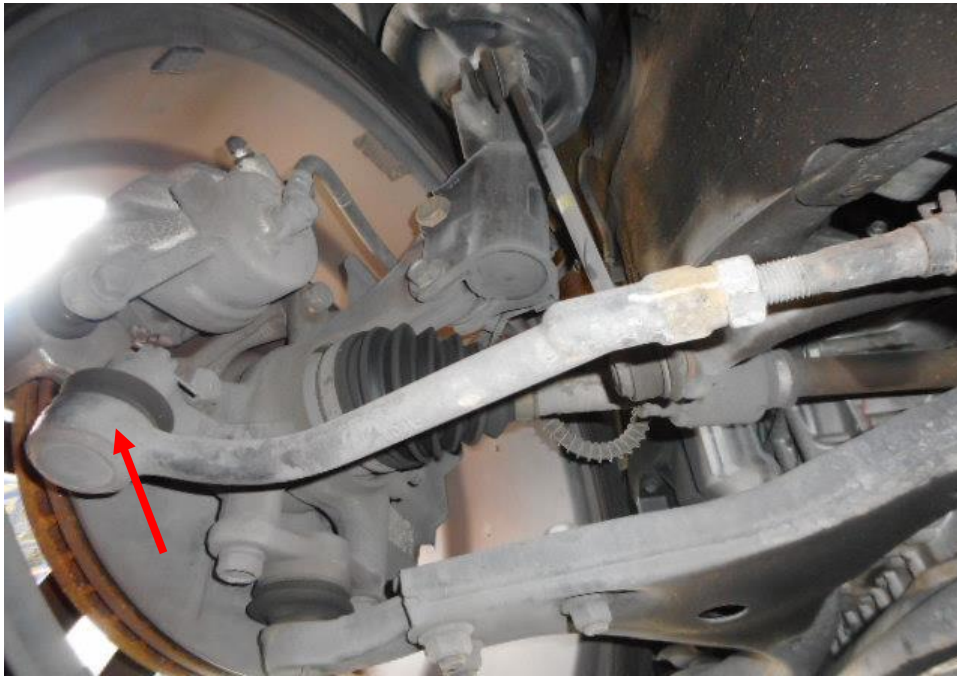
**Photo 24** shows the various undercarriage components at the front left wheel of the Motor Car, which had included the steering tie rod (red arrow). The various undercarriage components of the Motor Car were all found to be intact without any visible damage.

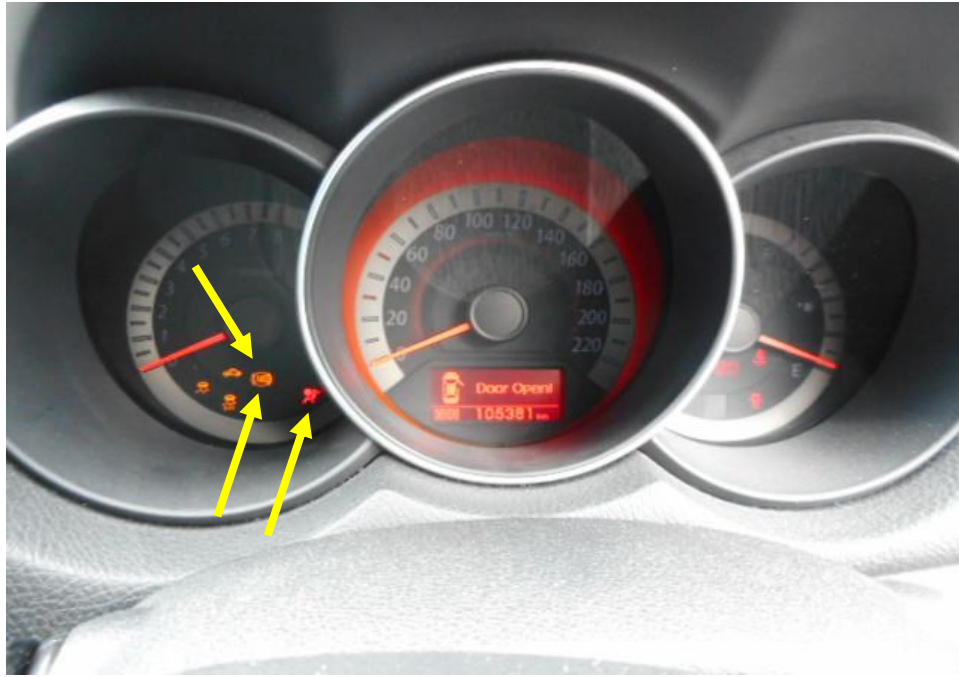
**Photo 25** shows the warning light for Anti-Lock Brake System (ABS), Supplemental Restraint System (SRS) and Traction Control System (TCS) (arrowed) appearing on the instrument panel of the Motor Car during the self-test of its various electronic operating systems when its engine was cranked.

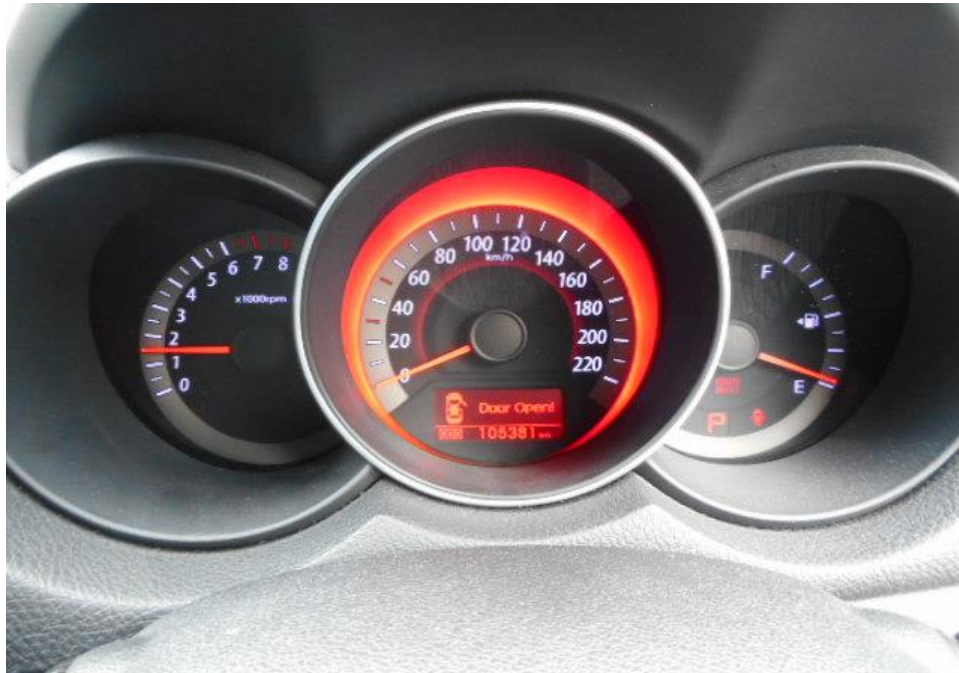
**Photo 26** shows no warning lights illuminated on the instrument panel of the Motor Car after the engine was cranked. This would suggest that there was no abnormality to the electronic operating system of the Motor Car, like the ABS, SRS, TCS and etc.
