## AUTOMOBILE INSPECTION REPORT

Vehicle Inspected: SU -6000-A

## PRE-REPAIR SURVEY REPORT

Assign Date:	25/11/2019	Survey Date:	25/11/2019	Adjustment Date:	16/01/2010
Accident Date:	~ 21/11/2019	TP Policy No:	5111325024	Our Ref:	AVS2019-21674/AT
Place of Survey:	Serve You Motor Service			Your Ref:	MT/1072689-001
	Blk 5033 Ang Mo Kio Ind Park 2 #01-265			Claim Type:	Third Party
	Singapore 569536			Claimant:	Ang Poh Seow

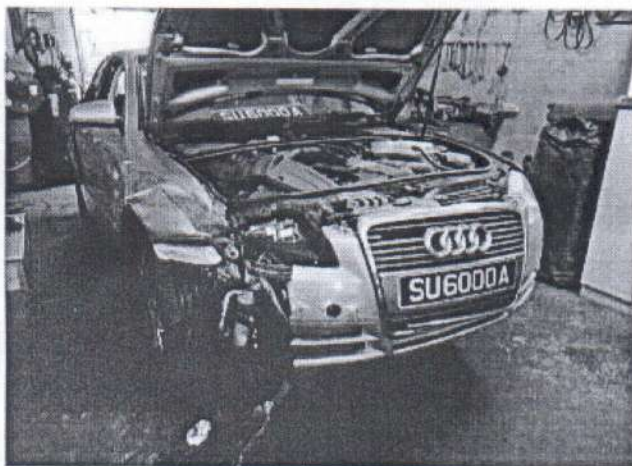
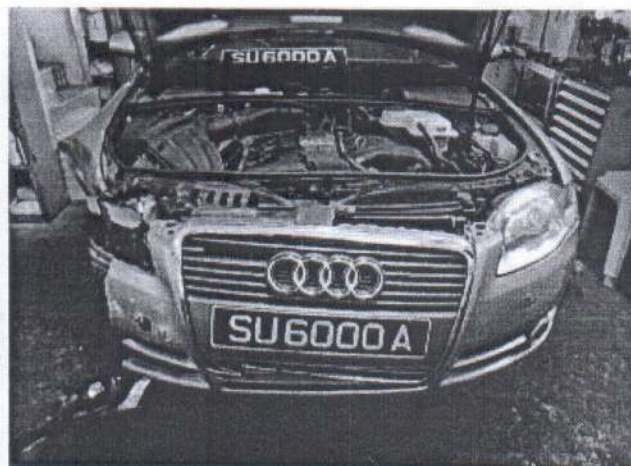
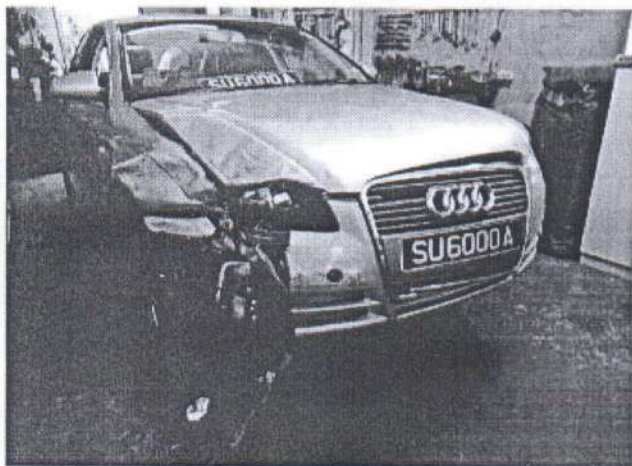
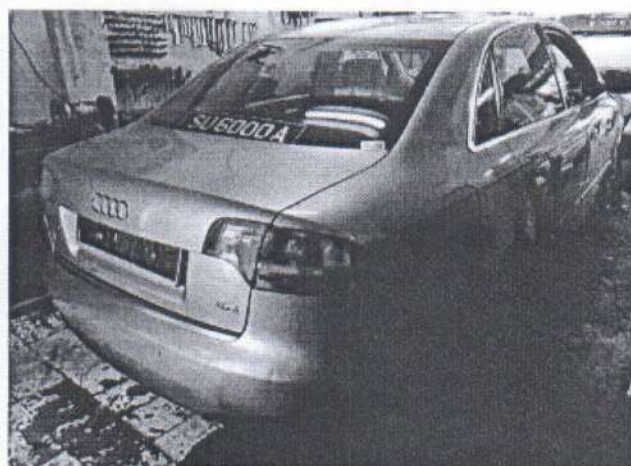
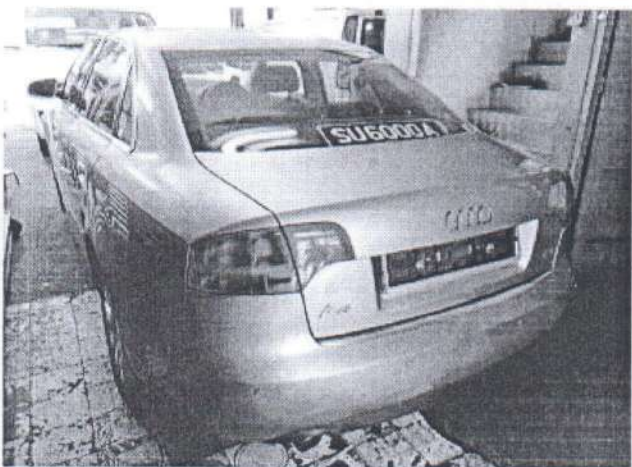
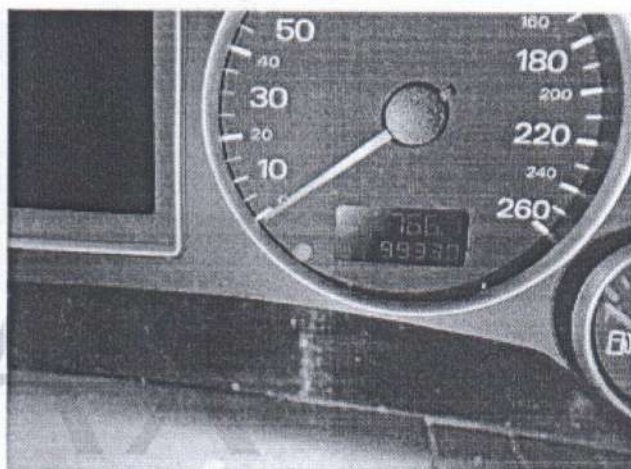
Pre-repair survey - 25/11/2019

The vehicle sustained damage on the front portion.

Our recommended amount for the cost of contract lumpsum repair is S\$11,600.00 with approximately eight (8) working days to complete. However, no finalisation was agreed with the repairer.
