Your Ref: Porsche Marcan
(chassis number WP1ZZZ95ZJLB35298)
Our Ref : CI/TP21007314/D

INSPECTION REPORT OF AN UNREGISTERD PORSCHE MARCAN MOTOR CAR WITH CHASSIS NUMBER WP1ZZZ95ZJLB35298

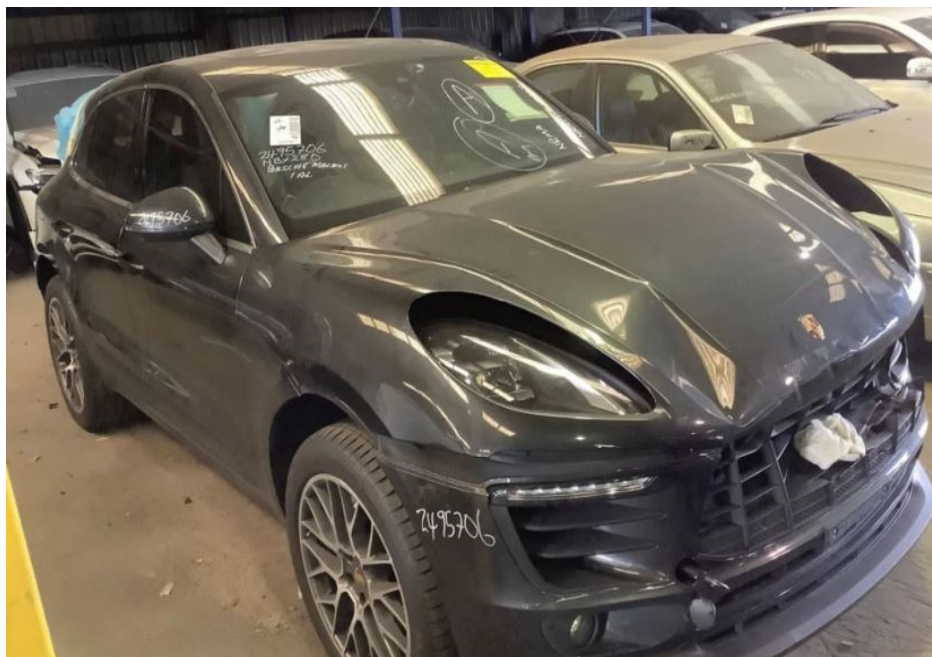
Photo 1 shows the front right body of the Motor Car prior to any repairs being carried out (photograph provided to me). The Motor Car was observed to have sustained damages at its frontal portion. The front bumper, front radiator grille and front bonnet were amongst the parts that were observed to be damaged.

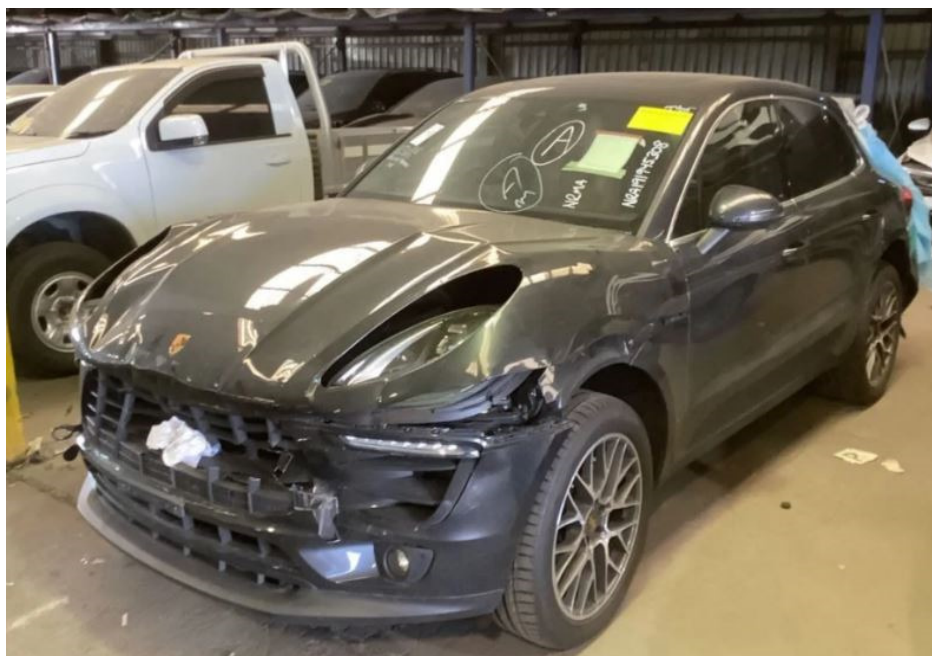
Photo 2 shows the front left body of the Motor Car prior to any repairs being carried out (photograph provided to me). The Motor Car was observed to have sustained damages at its frontal portion. The front bumper, front radiator grille, front left headlamp and front bonnet were amongst the parts that were observed to be damaged. Given the extent of damage seen to the frontal portion, it is likely that the front bumper reinforcement, front support panel, front support panel top garnish and front bonnet lock amongst others, were also damaged.

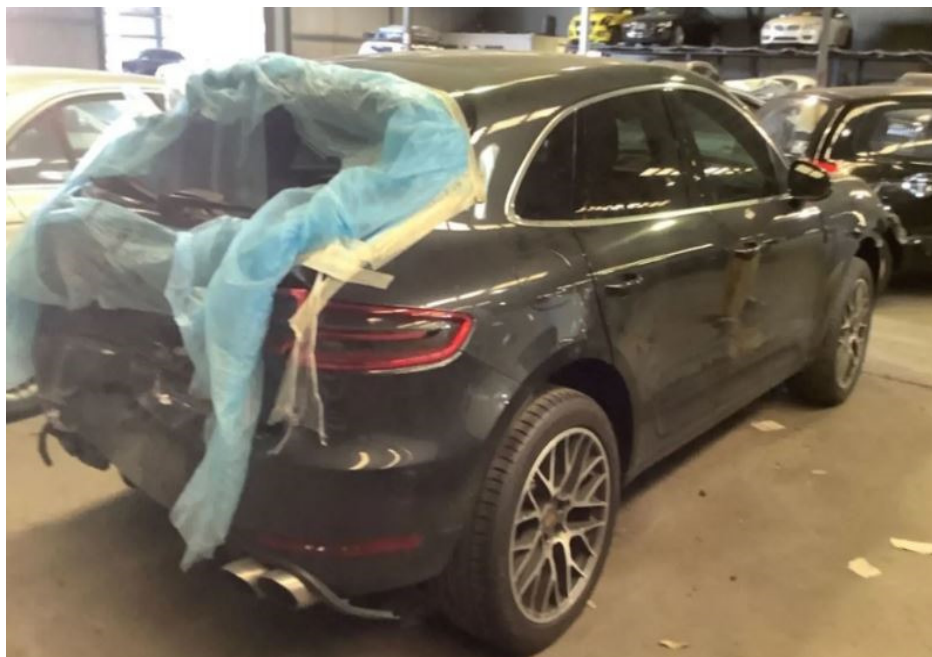
Photo 3 shows the rear right body of the Motor Car prior to any repairs being carried out (photograph provided to me). Apart for the frontal portion, I had also observed damage to the rear portion of the Motor Car. The rear bumper, rear bumper lower garnish, rear tailgate, rear tailgate right side lamp and rear windscreen were amongst the parts that were observed to have been damaged. Given the extent of damage seen to the rear portion, it is likely that the rear bumper reinforcement, rear end panel, rear end panel inner trim, rear tailgate left side lamp and rear tailgate inner trimboard amongst others, were also damaged.

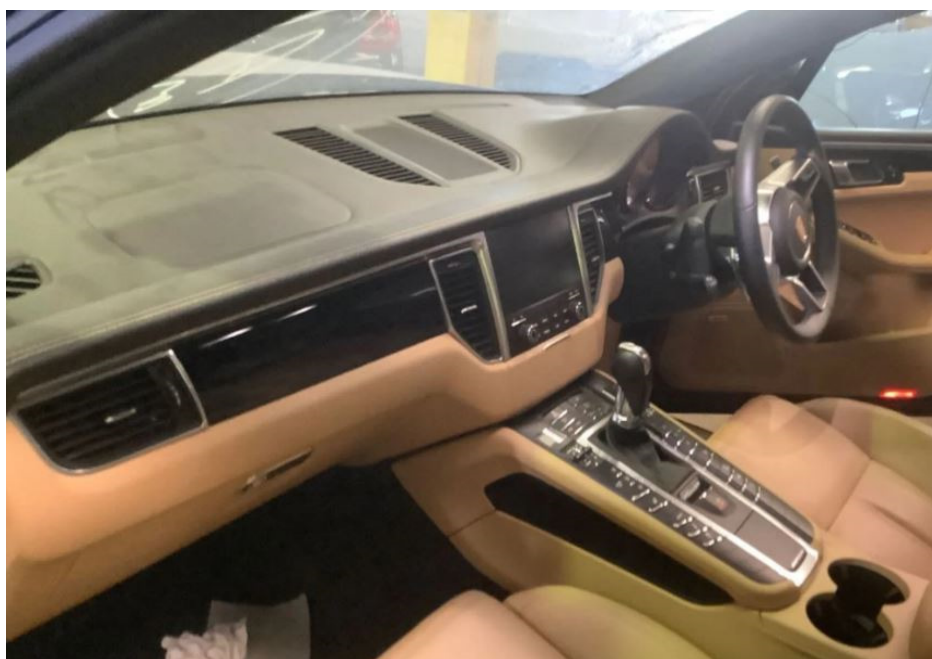
Photo 4 shows the interior compartment of the Motor Car prior to any repairs being carried out (photograph provided to me). The airbags were not deployed as seen from the photographs that were provided to me.

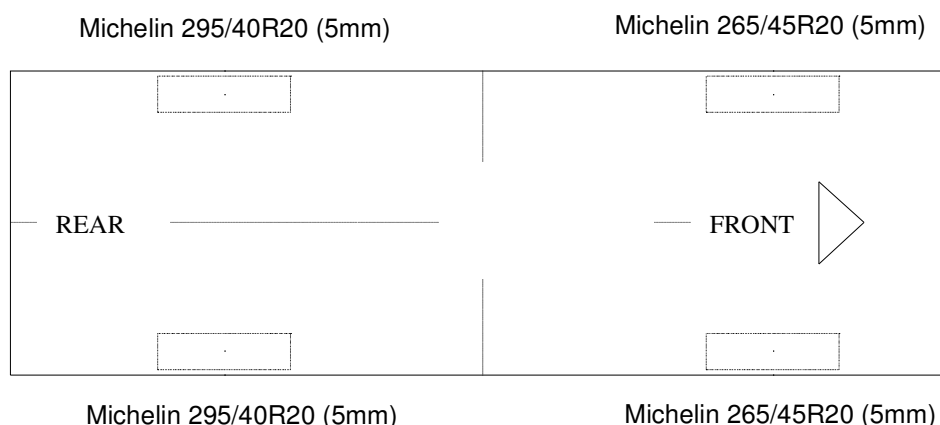
8. It was fitted with 20inch sport wheel rims that were wrapped with tyres that were observed to be of serviceable condition. The tyres were also sufficiently inflated for vehicular operation. The tyre brand, tyre size and approximate remaining tread depth of the 4 tyres of the Motor Car were recorded as follows: -

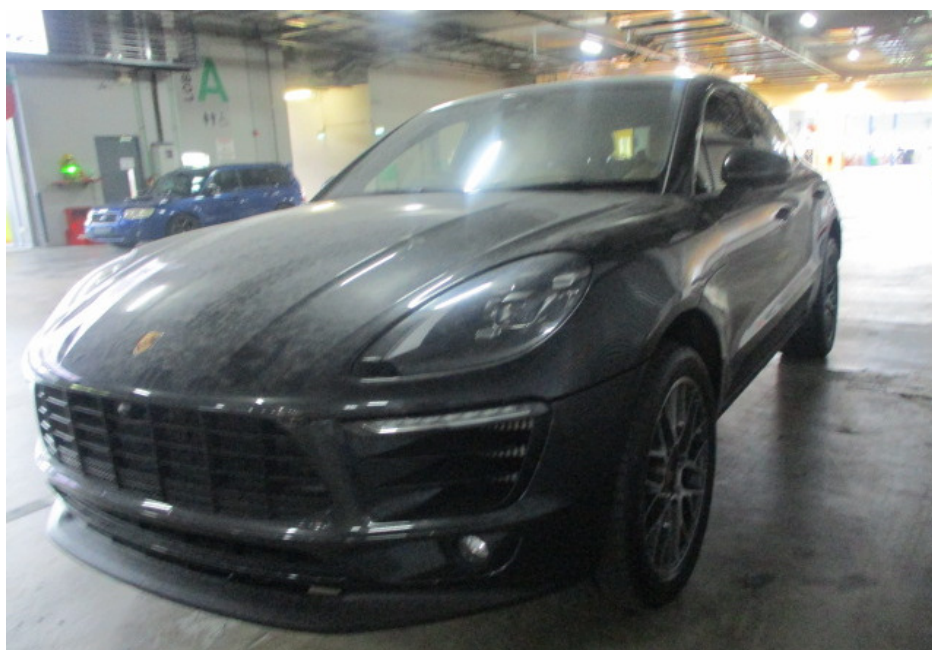
Photo 5 shows a general view of the front left body of the Motor Car at the time of my inspection. The Motor Car was observed to be in a relatively good general condition with no loose exterior fittings observed. The body parts at the frontal portion of the Motor Car were visually examined and it was observed that the repair/restoration works carried out to the damaged area of the Motor Car (refer to photograph 1 & 2 above) were reasonably adequate and in order.

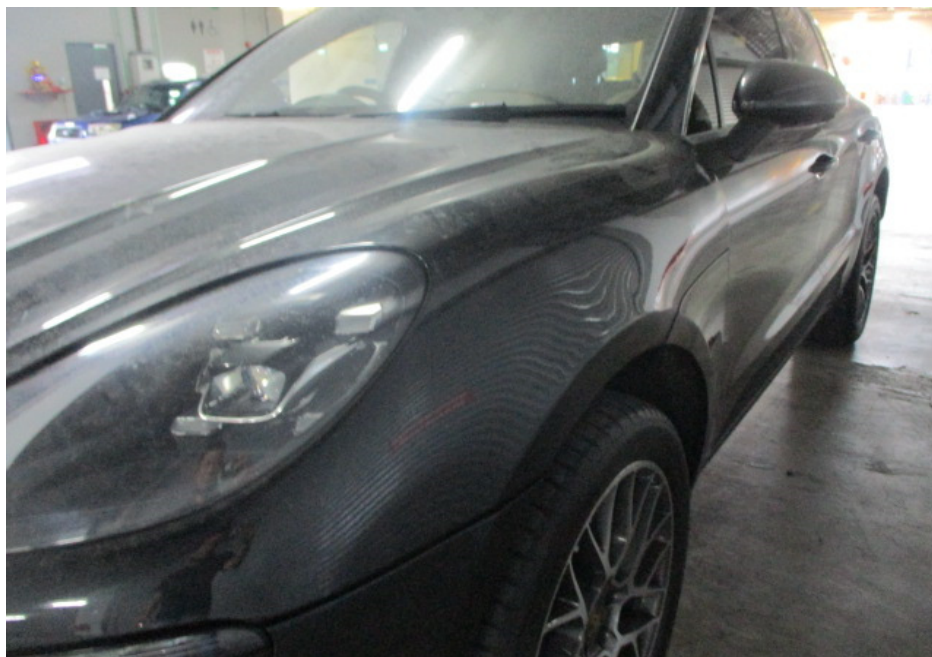
Photo 6 shows a closer view of the Motor Car's front bonnet and front left headlamp. The body parts at the frontal portion of the Motor Car were visually examined and it was observed that the repair/restoration works carried out to the damaged area of the Motor Car (refer to photograph 1 above) were reasonably adequate and in order.

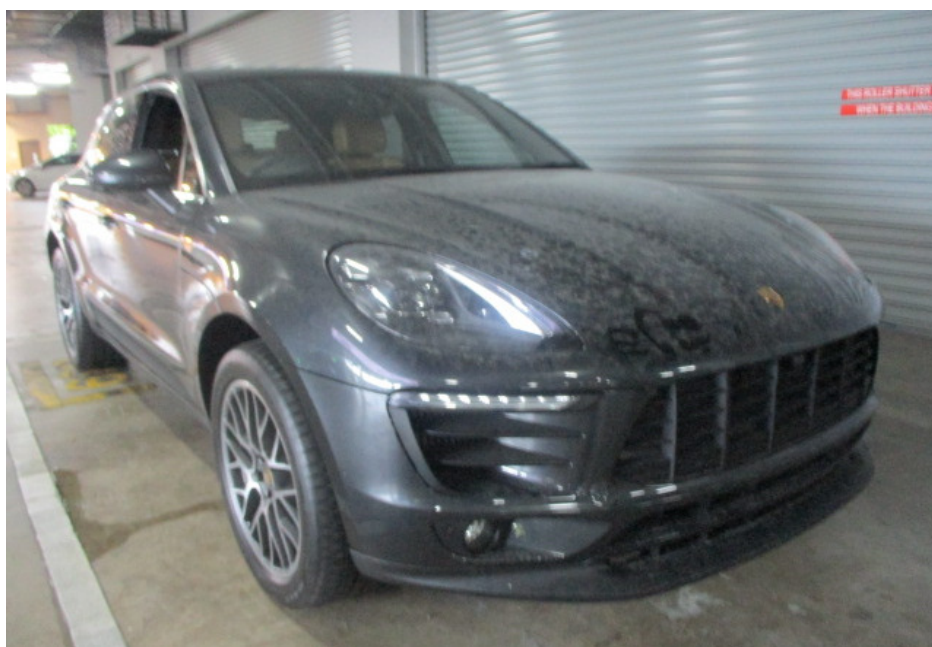
Photo 7 shows a general view of the front right body of the Motor Car at the time of my inspection. The Motor Car was observed to be in a relatively good general condition with no loose exterior fittings observed. The body parts at the frontal portion of the Motor Car were visually examined, and it was observed that the repair/restoration works carried out to the damaged area of the Motor Car (refer to photograph 1 & 2 above) were reasonably adequate and in order.

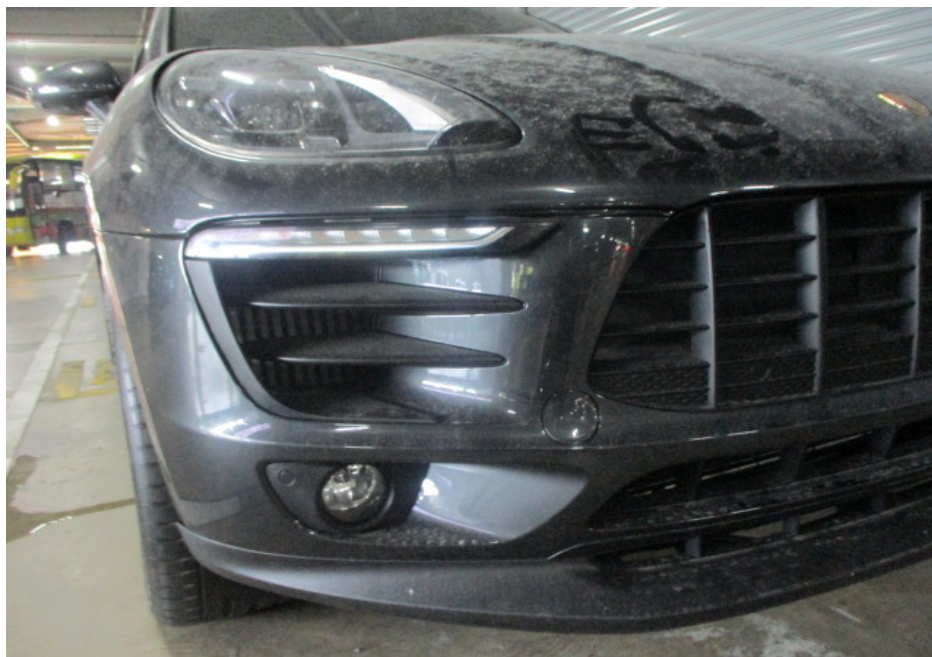
Photo 8 shows a closer view of the Motor Car's front bumper, front bumper right lower grille, front right headlamp, front right day running light, front right fog lamp and front radiator grille. The body parts at the frontal portion of the Motor Car were visually examined and it was observed that the repair/restoration works carried out to the damaged area of the Motor Car (refer to photograph 2 above) were reasonably adequate and in order.

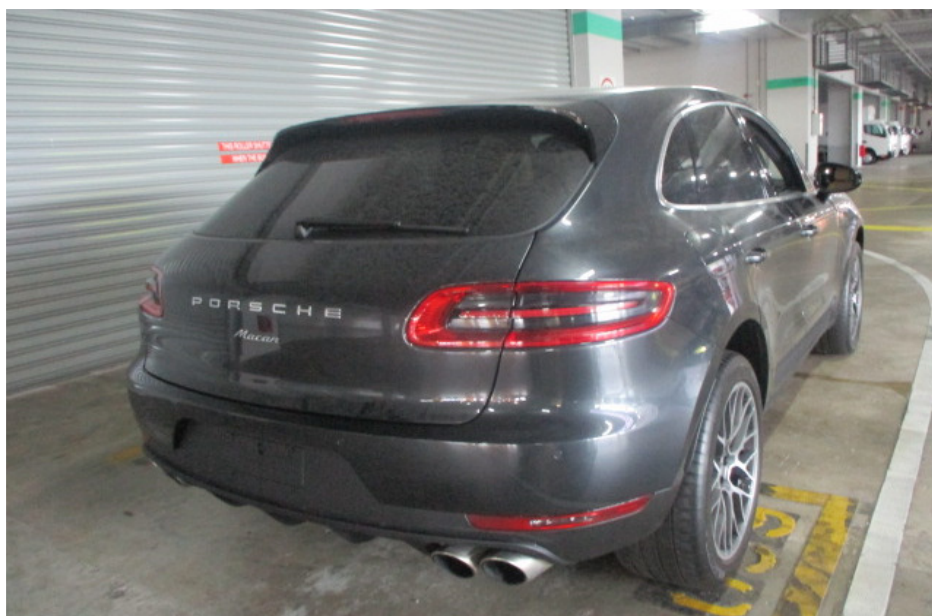
Photo 9 shows a general view of the rear right body of the Motor Car at the time of my inspection. The Motor Car was observed to be in a relatively good general condition with no loose exterior fittings observed. The body parts at the rear portion of the Motor Car were visually examined, and it was observed that the repair/restoration works carried out to the damaged area of the Motor Car (refer to photograph 3 above) were reasonably adequate and in order.

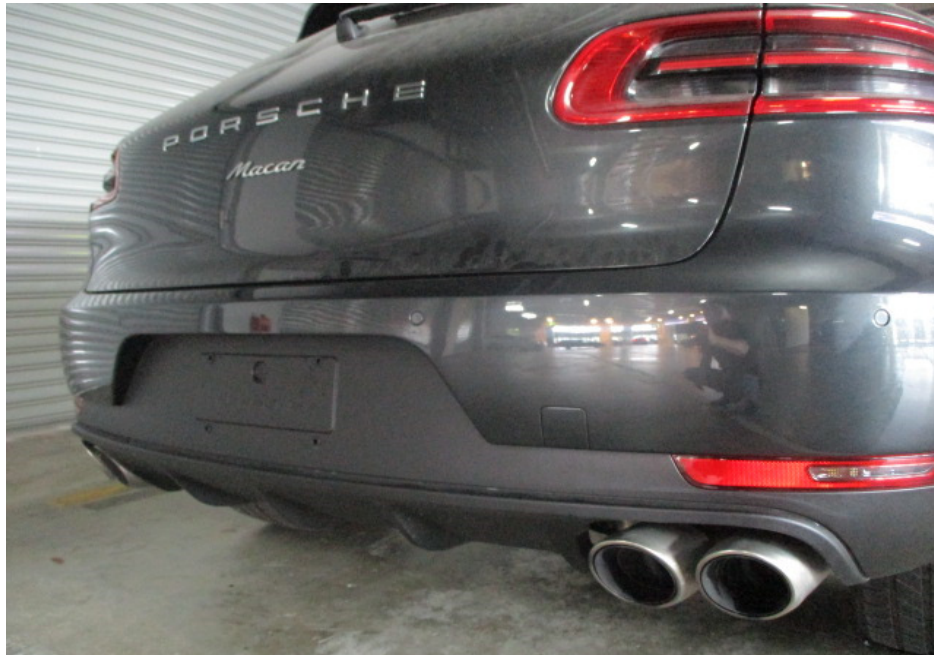
Photo 10 shows a closer view of the Motor Car's rear bumper, rear bumper right reflector, rear bumper lower garnish and rear tailgate. The body parts at the rear portion of the Motor Car were visually examined and it was observed that the repair/restoration works carried out to the damaged area of the Motor Car (refer to photograph 3 above) were reasonably adequate and in order.

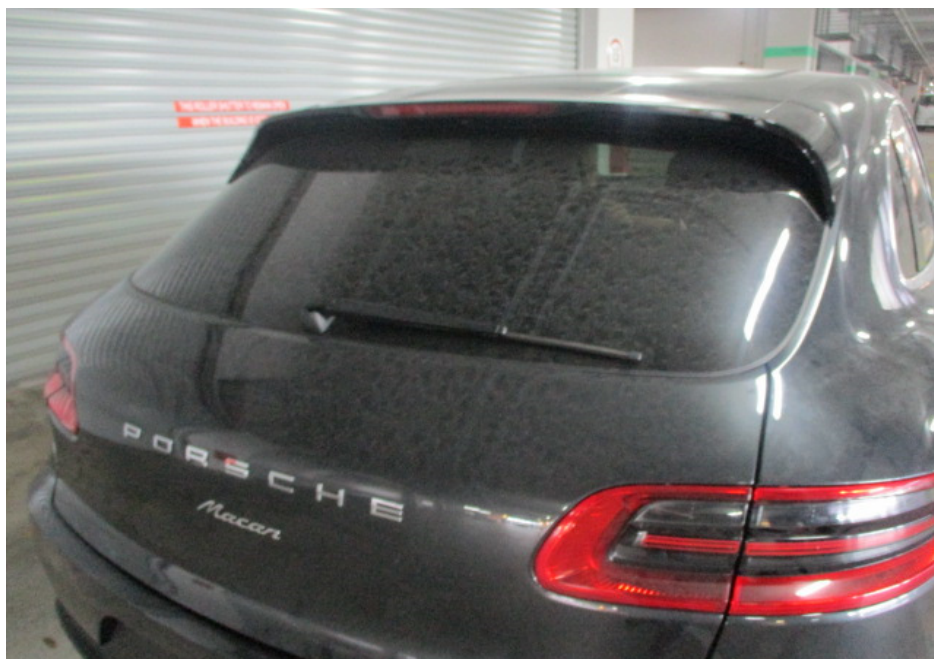
Photo 11 shows a closer view of the Motor Car's rear tailgate, rear tailgate right side lamp, rear right taillamp and rear windscreen. The body parts at the rear portion of the Motor Car were visually examined and it was observed that the repair/restoration works carried out to the damaged area of the Motor Car (refer to photograph 3 above) were reasonably adequate and in order.

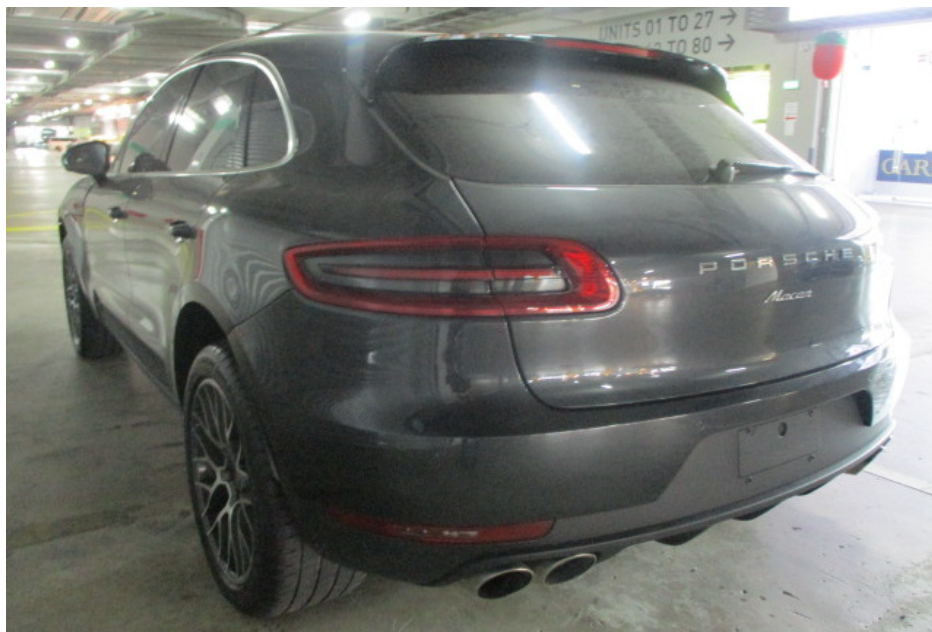
Photo 12 shows a general view of the rear left body of the Motor Car at the time of my inspection. The Motor Car was observed to be in a relatively good general condition with no loose exterior fittings observed. The body parts at the rear portion of the Motor Car were visually examined, and it was observed that the repair/restoration works carried out to the damaged area of the Motor Car (refer to photograph 3 above) were reasonably adequate and in order.

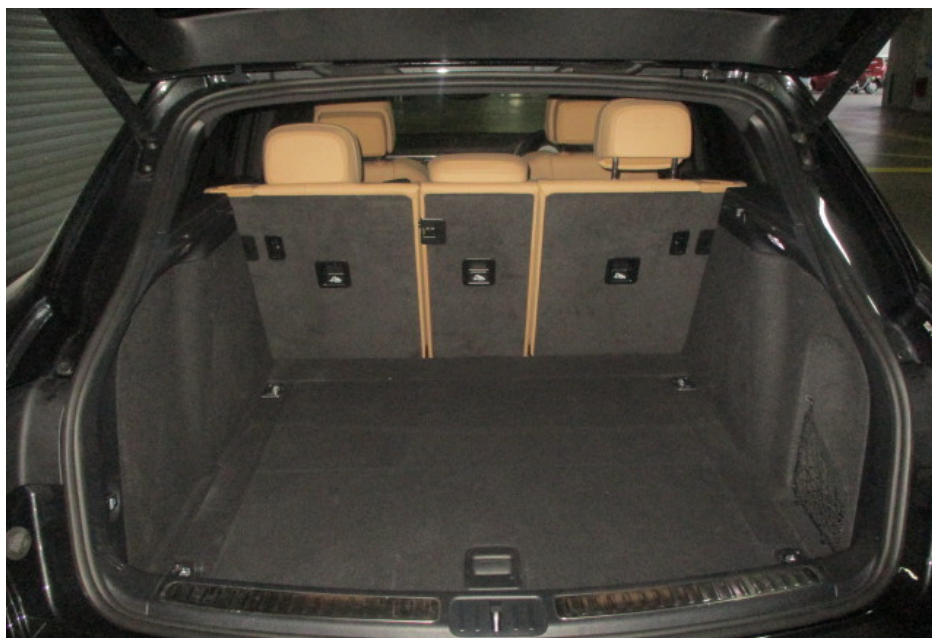
Photo 13 shows a general view of the rear boot compartment of the Motor Car at the time of my inspection. All inner trims, hinges and upholstery etc were observed to be properly fitted. The body parts at the rear portion of the Motor Car were visually examined and the repair/restoration works carried out to the damaged area of the Motor Car (refer to photograph 3 above) were found to be reasonably adequate and in order.

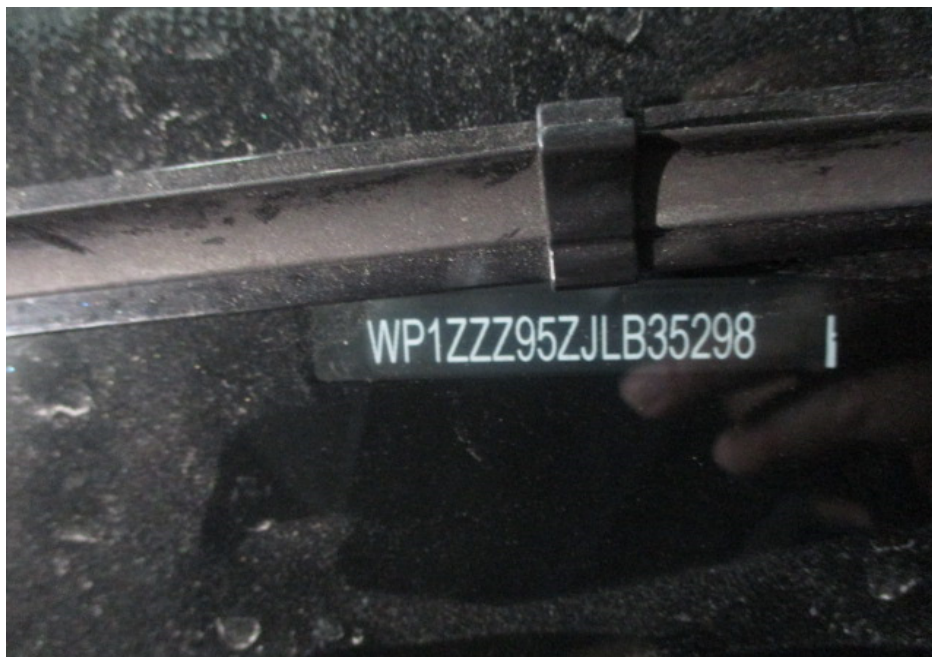
Photo 14 shows the chassis number of the Motor Car. The chassis number recorded was WP1ZZZ95ZJLB35298.

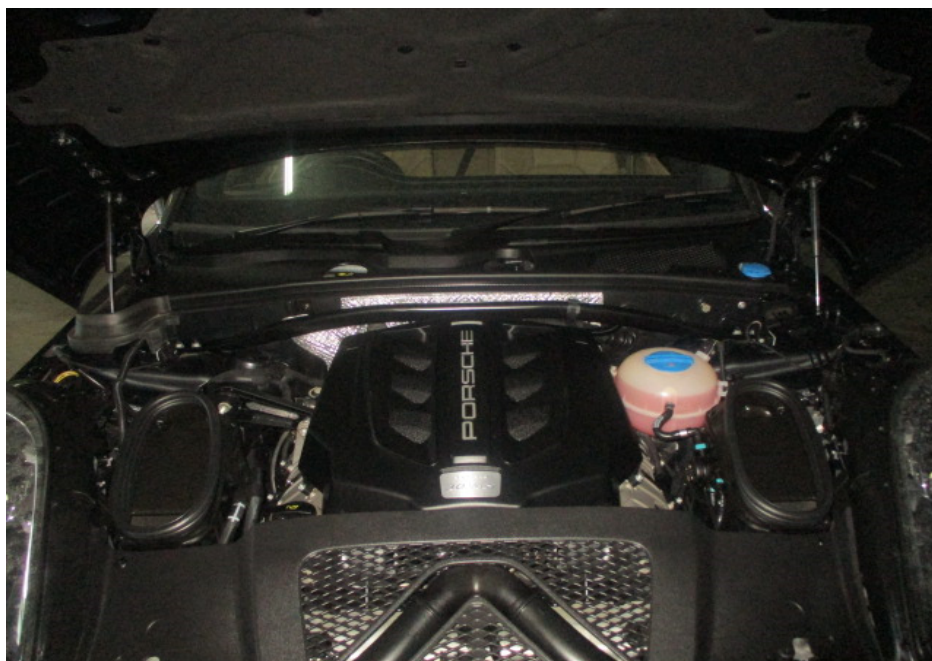
Photo 15 shows a general view of the engine compartment of the Motor Car at the time of my inspection. The various parts and components inside the engine compartment were all observed to be intact and properly fitted. There was also no sign(s) or indication(s) of fluid leak and/or fluid stain found inside the engine compartment.

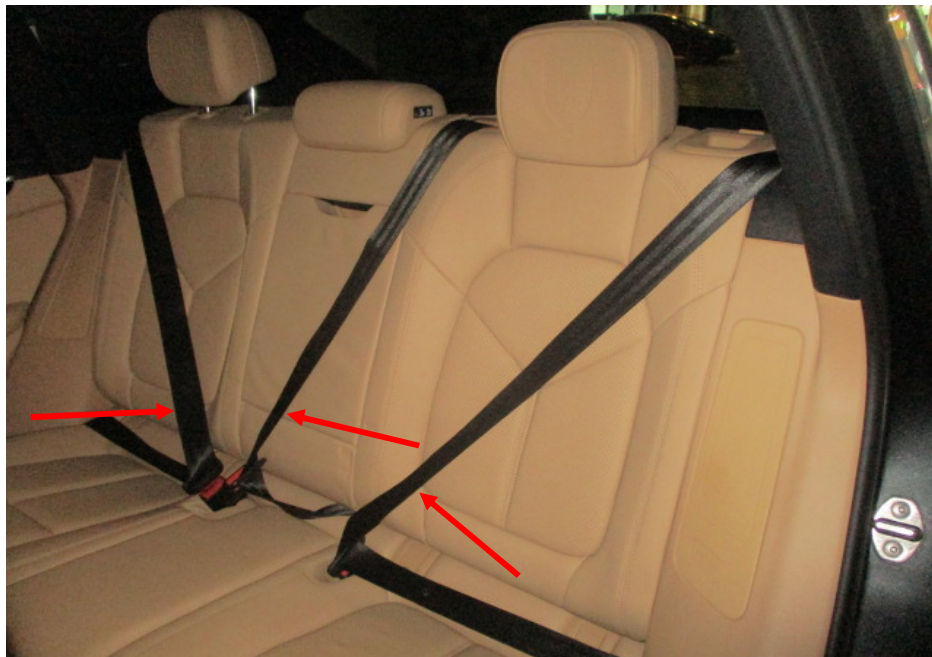
Photo 16 shows the rear seats of the Motor Car. All the seats of the Motor Car were secured via seat rails to the floorboard. They were also fitted with a retractable seat belt reel and a pre-tensioner. The seat belts (arrowed) were tested and were able to be fastened into the respective pre-tensions that were fitted on the side of each individual seat.

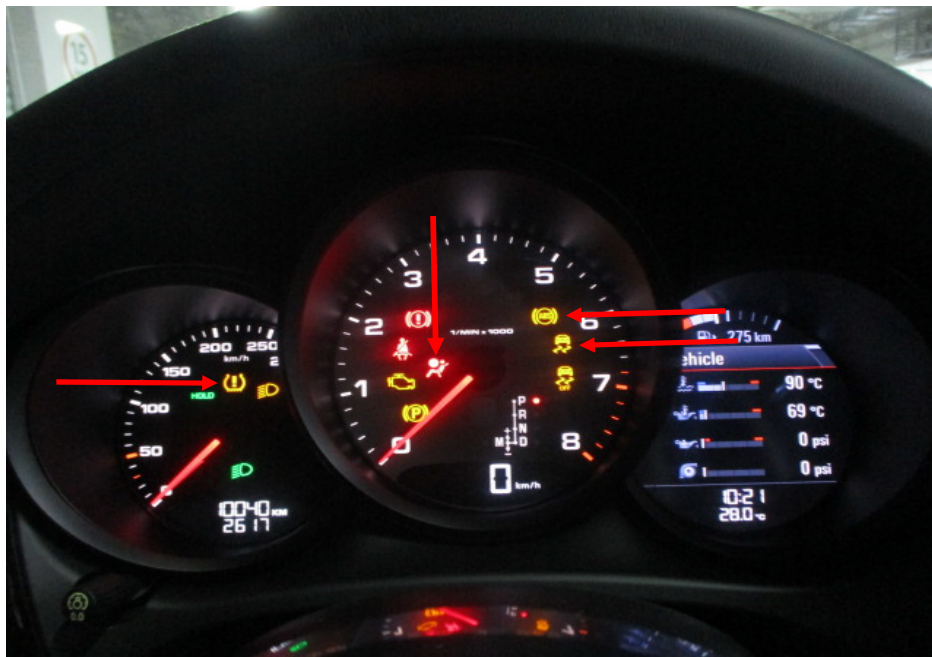
Photo 17 shows the warning lights for the various electronic safety features appearing on the instrument panel of the Motor Car during its self-test when the engine is cranked, in particular the ABS, SRS, TPM and TCS lights (arrowed).

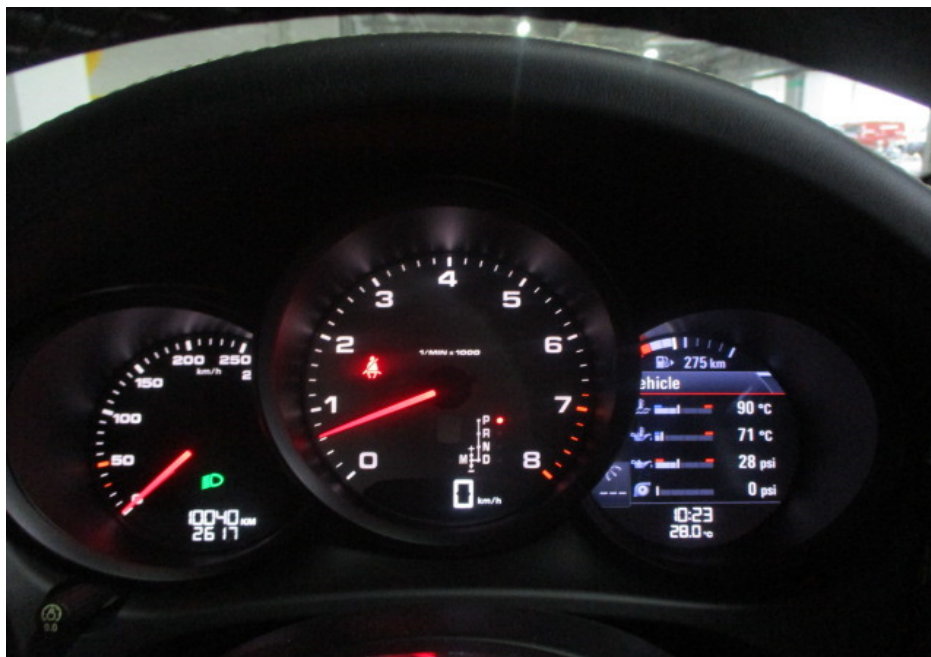
Photo 18 shows the respective warning lights no longer illuminated, indicating that there is no fault detected to the ABS, SRS, TPM and TCS systems of the Motor Car during the self-test. These electronic systems were hence in working condition at the time of my inspection.

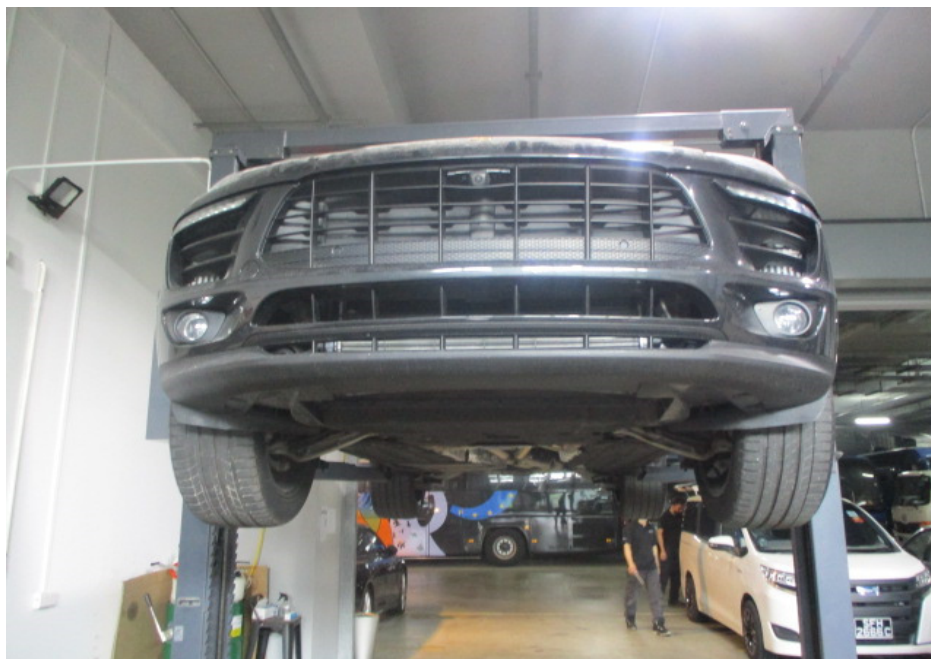
Photo 19 shows the Motor Car hoisted up for checks on its undercarriage. There was no sign(s) or indication(s) of fluid leakage and/or fluid stain(s) on the underside of the Motor Car. The undercarriage components of the Motor Car were also all observed to be intact and secured in an appropriate manner.

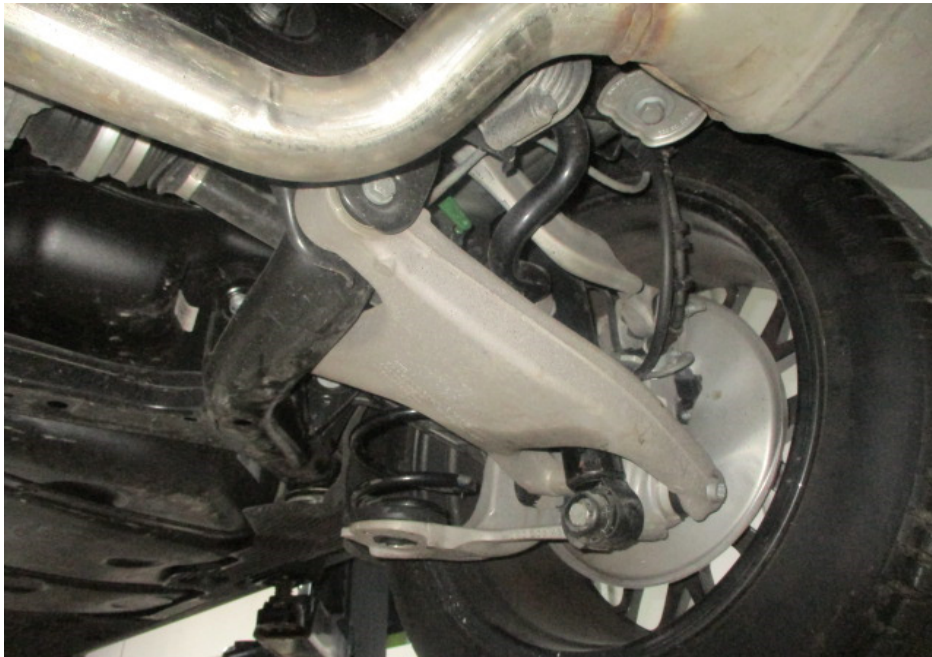
Photo 20 shows a general view of the control arms and linkages at the rear right wheel of the Motor Car. I did not observe any fluid leak and/or fluid stain on the underside of the Motor Car. All the Motor Car's undercarriage components were observed to be intact and secured in an appropriate manner.

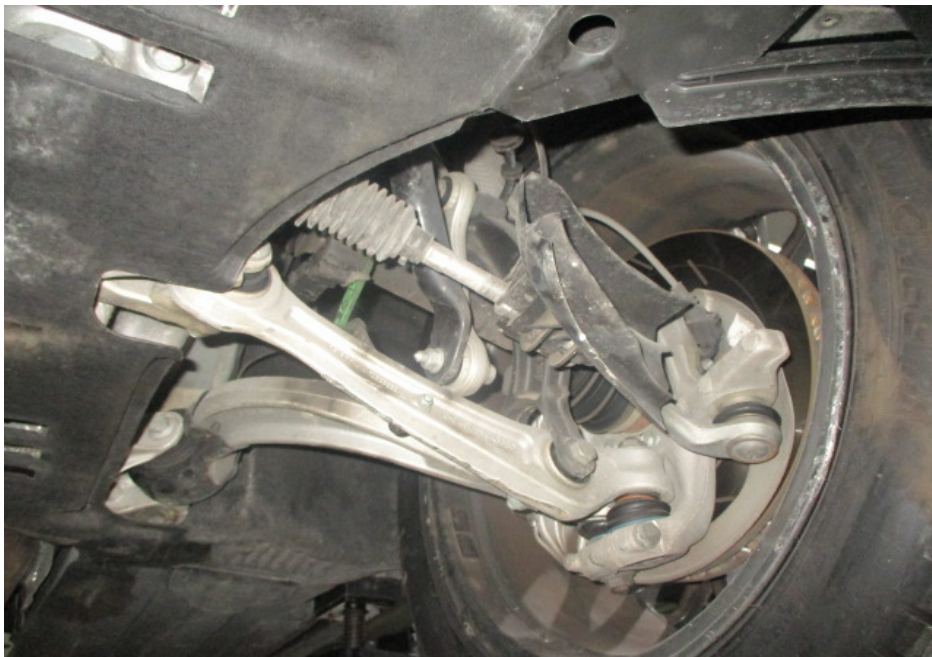
Photo 21 shows the various undercarriage components at the front left wheel of the Motor Car. The mechanical components, control arms and linkages were all found to be intact and secured in an appropriate manner.

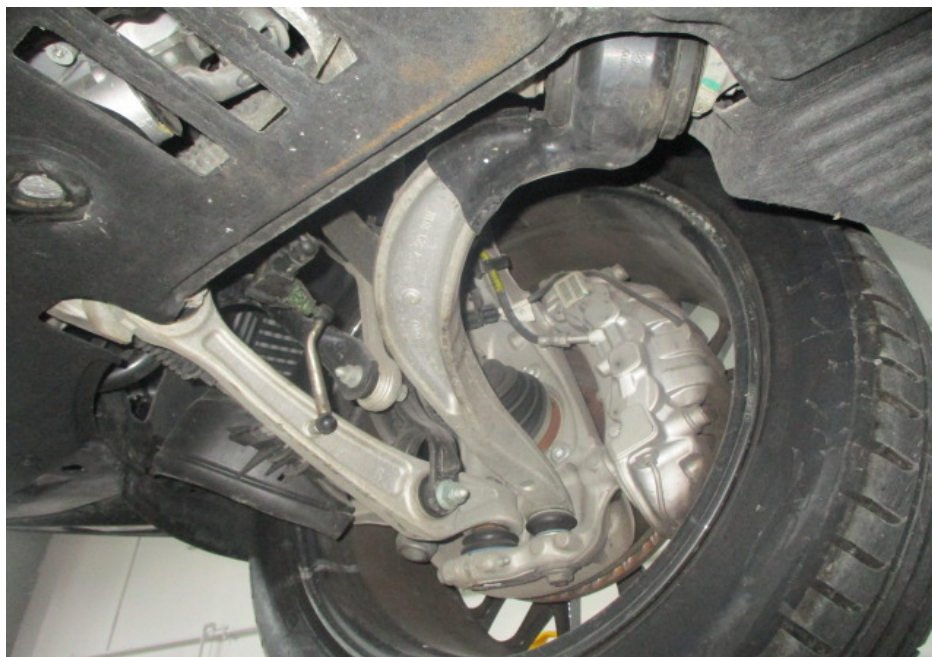
Photo 22 shows the various undercarriage components at the front right wheel of the Motor Car. The mechanical components, control arms and linkages were all found to be intact and secured in an appropriate manner. I also did not observe any fluid leak and/or fluid stain on the underside of the Motor Car.

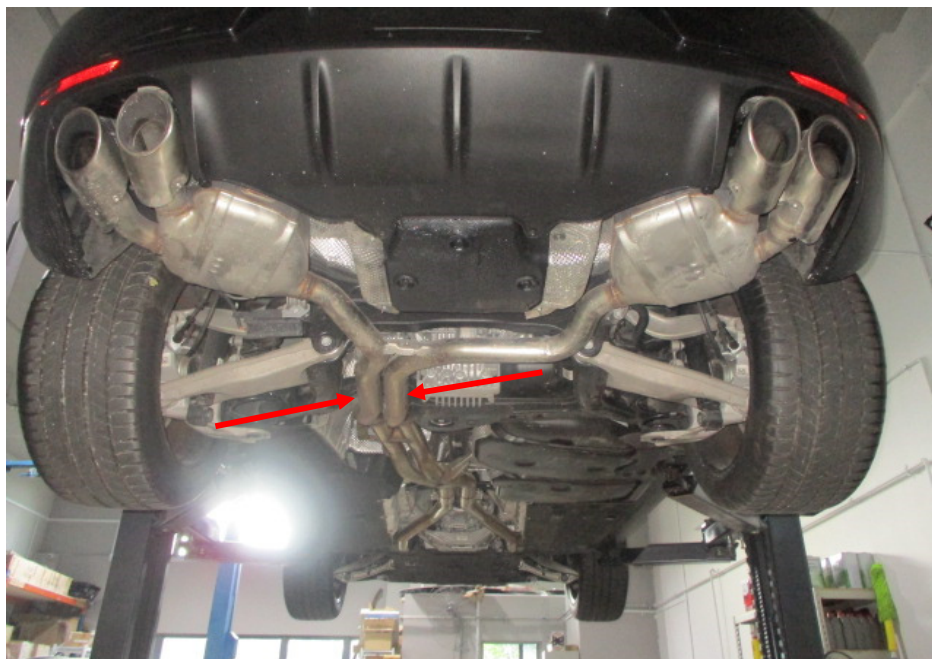
Photo 23 shows a general view of the Motor Car's exhaust system. My examination of the Motor Car's exhaust system revealed no sign(s) or indication(s) of any cut or weld marks along its exhaust pipes (arrowed), on its catalytic converters and on its rear mufflers.

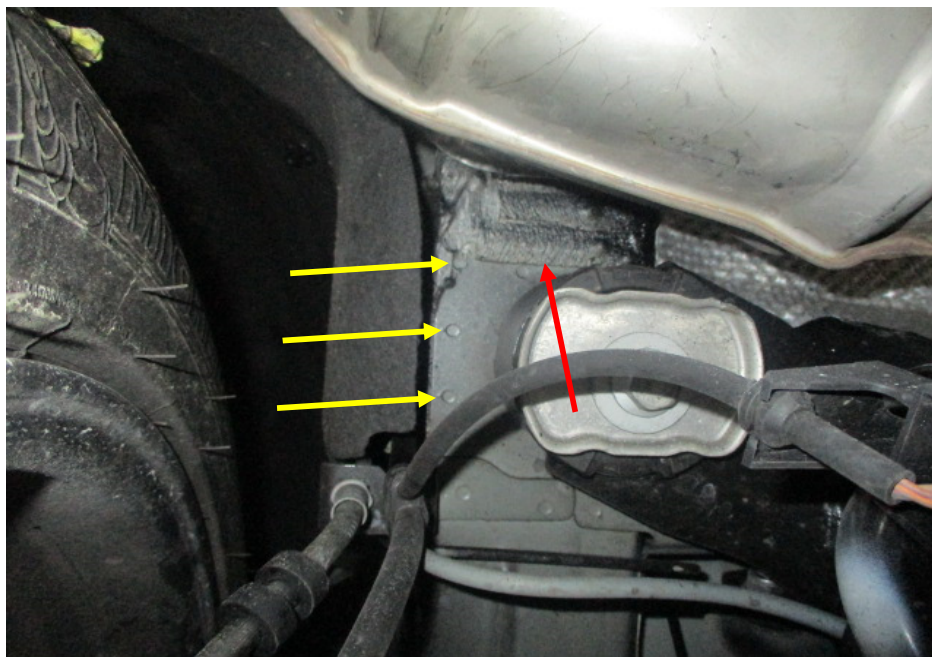
Photo 24 shows the chassis/structural body at the underside rear left of the Motor Car. I did not find any weld marks other than original spot weld marks (yellow arrow) on the chassis/structural body of the Motor Car. The original factory sealant (red arrow) at the joints along the chassis/structural body was untouched, indicating no work was done on the chassis/structural body of the Motor Car and that the chassis/structural body was originally fitted.

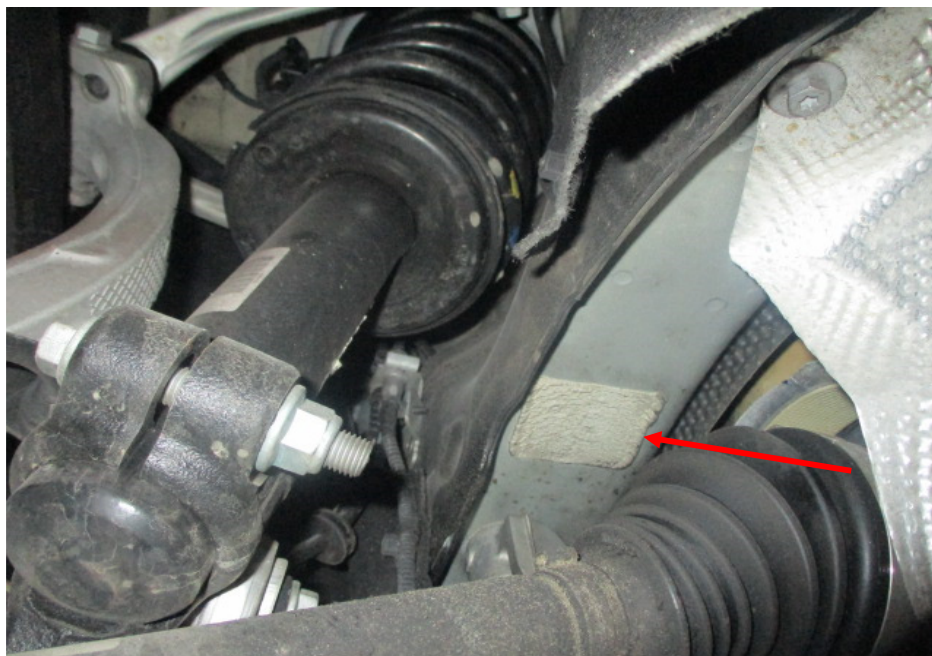
Photo 25 shows the chassis/structural body at the underside front left of the Motor Car. The original factory sealant (arrowed) at the joints along the chassis/structural body was observed to be untouched. In general, I had found no work was carried out on the chassis/structural body of the Motor Car. The chassis/structural body of the Motor Car was originally fitted.

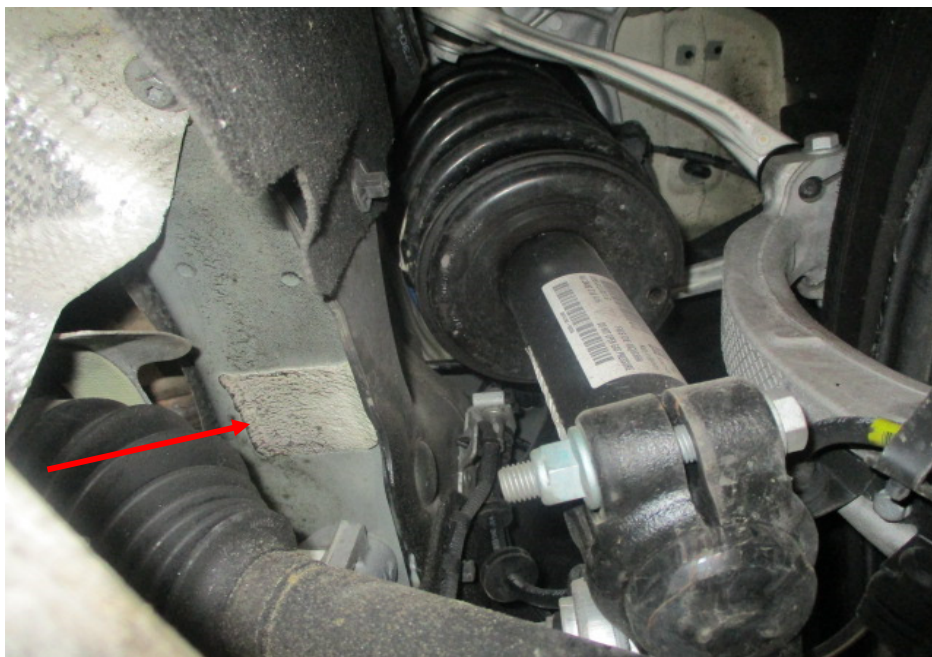
Photo 26 shows the chassis/structural body at the underside front right of the Motor Car. The original factory sealant (arrowed) at the joints along the chassis/structural body was observed to be untouched. In general, I had found no work was carried out on the chassis/structural body of the Motor Car. The chassis/structural body of the Motor Car was originally fitted.

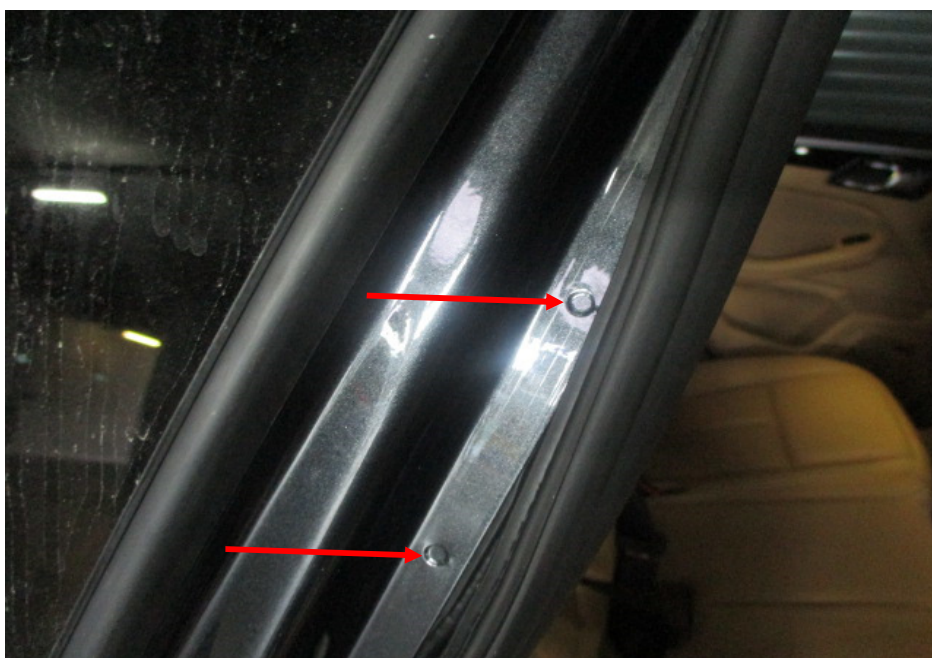
Photo 27 shows the right side "C" pillar of the Motor Car. I did not find any weld marks other than original spot weld marks (arrowed) on the right side "C" pillar of the Motor Car which, indicates that there was no re-welding works carried out. In general, I had found all the non-detachable body panels of the Motor Car to be originally fitted at the time of my inspection.

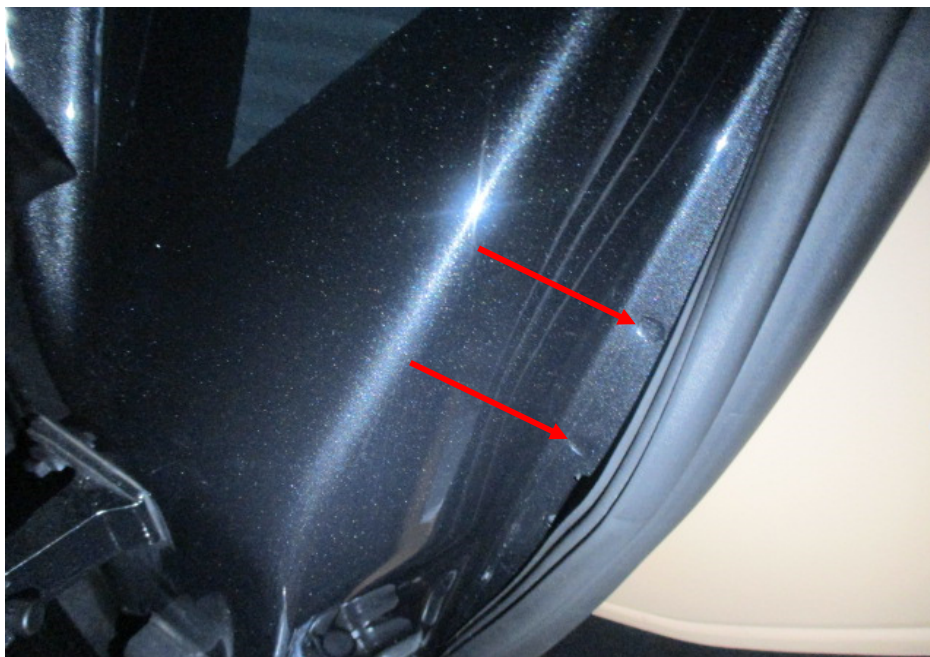
Photo 28 shows the left side "A" pillar of the Motor Car. I did not find any weld marks other than original spot weld marks (arrowed) on the left side "A" pillar of the Motor Car which, indicates that there was no re-welding works carried out. In general, I had found all the non-detachable body panels of the Motor Car to be originally fitted at the time of my inspection.
