Your Ref: SNM21D203738/c01  
Our Ref : CS/CTI21007366/N

12 July 2021

**TECHNICAL INVESTIGATION REPORT OF FIRE INCIDENT INVOLVING THE  
INSURED VEHICLE GX 6151Z ON 3 July 2021**

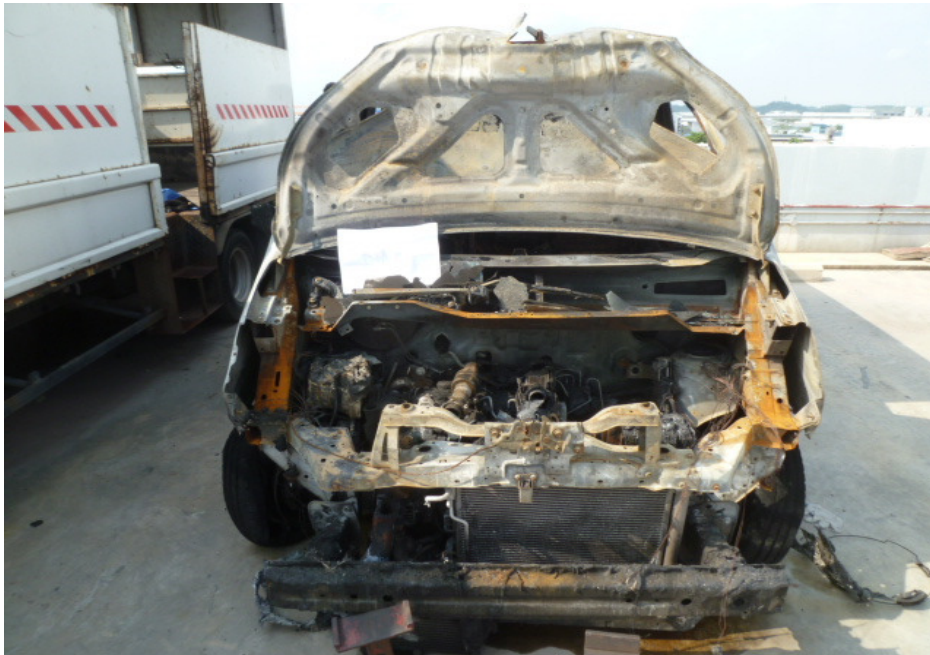
**Photo 1** shows the general view of the frontal portion of the Insured Vehicle at the time of our inspection. The Insured Vehicle was observed to have sustained extensive fire damage all around. Its engine compartment and interior compartment were completely burnt. Rust had accumulated all over the Insured Vehicle as a result of exposure to environmental condition for a period of time.

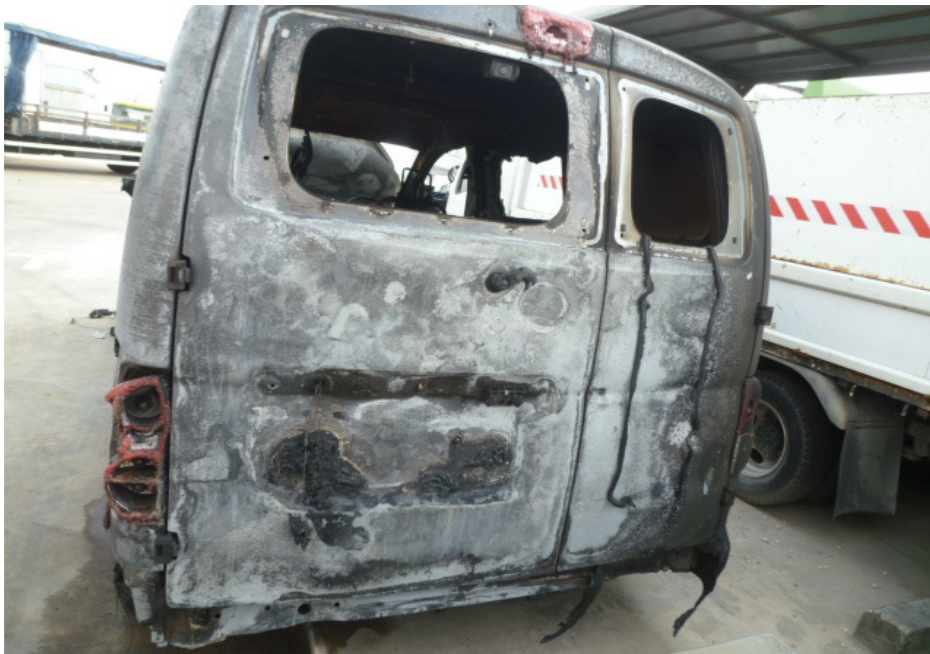
**Photo 2** shows the general view of the rear portion of the Insured Vehicle at the time of our inspection. The Insured Vehicle was observed to have sustained extensive fire damage all around. Rust had accumulated all over the Insured Vehicle as a result of exposure to environmental condition for a period of time.

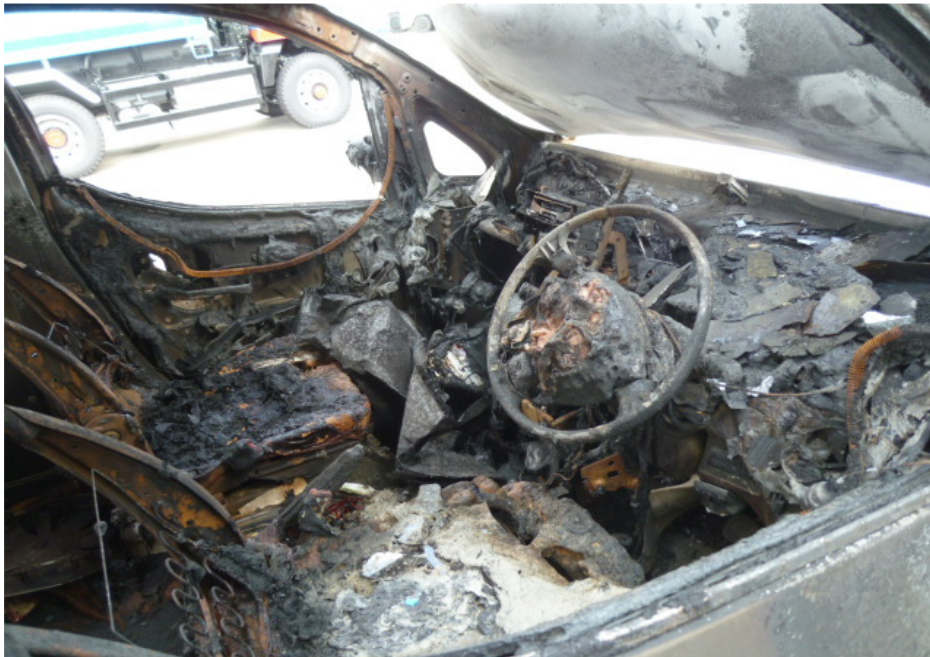
**Photo 3** shows the general view of the interior compartment of the Insured Vehicle at the time of our inspection. Its interior compartment was completely burnt.

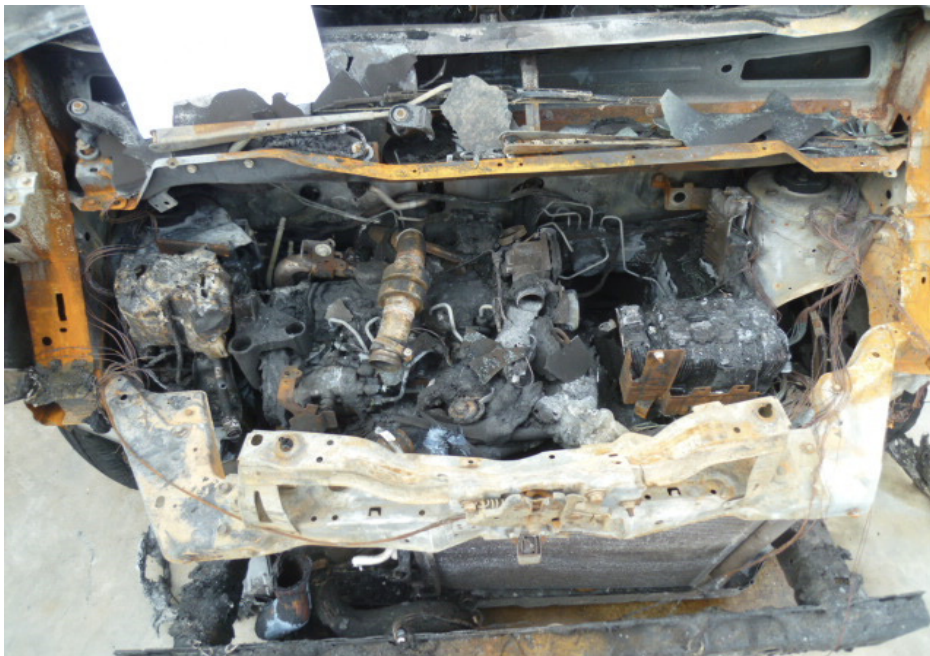
**Photo 4** shows the engine compartment of the Insured Vehicle at the time of our inspection. The entire engine compartment of the Insured Vehicle was observed to be severely burnt. Most of the parts inside the engine compartment were found to be burnt and/or melted as a result of the fire.

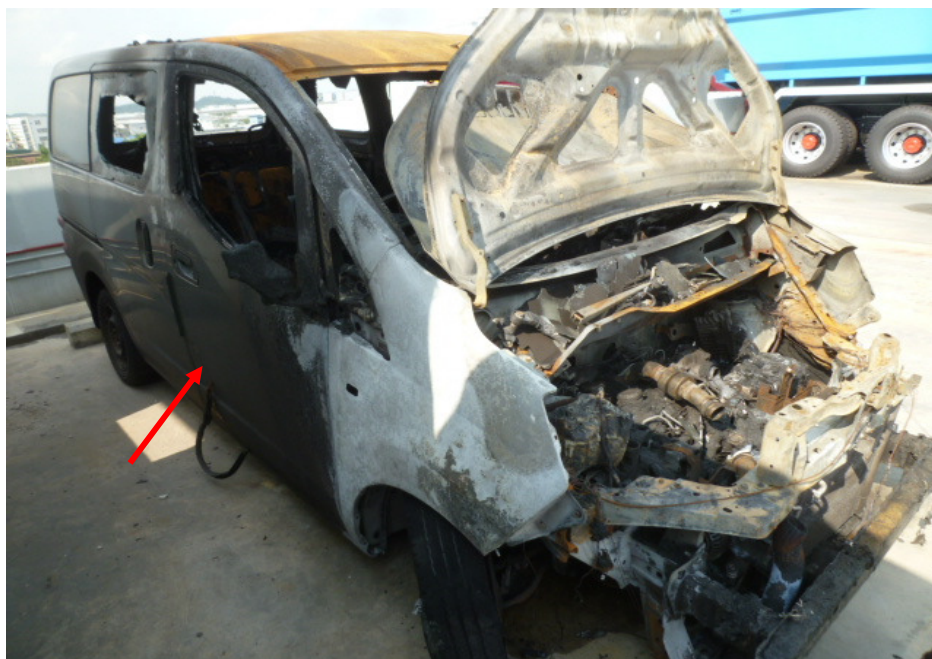
7. For this particular case, the fire appears to have originated within the engine compartment of the Insured Vehicle, somewhere around the left portion of the engine compartment due to the nature of the fire damage which was more extensive at the left portion. This can also be determined from the burn pattern and the high heat intensity burn marks (whitish burn marks) found on the left portion of the bonnet of the Insured Vehicle. The whitish burn marks are a result of exposure to prolonged heat intensity. See photos 7 & 8 below.

**Photo 7** shows the right body of the Insured Vehicle. The nature of the fire damage was less extensive at the right portion (arrowed).

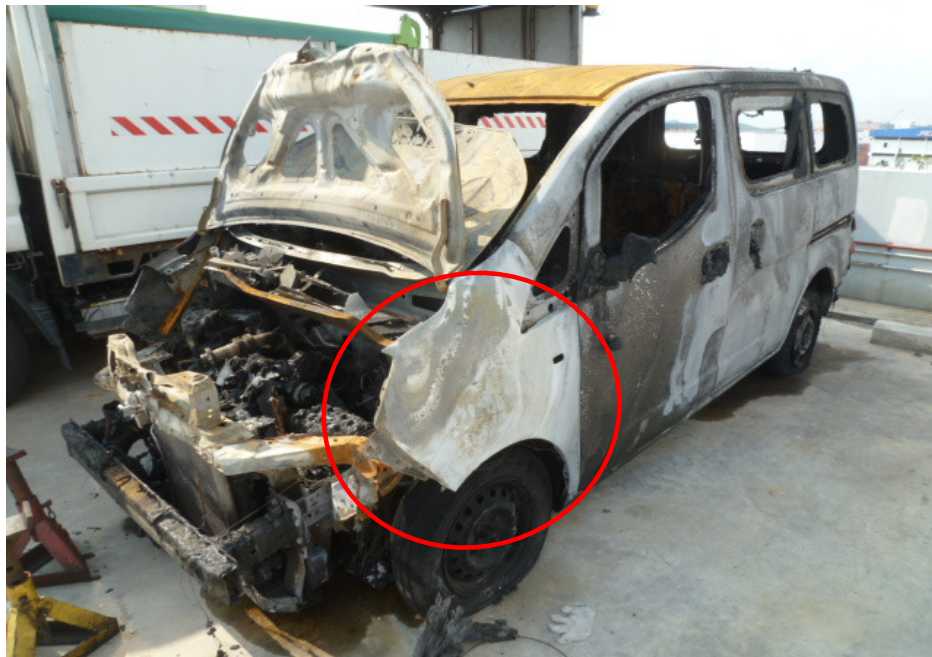
**Photo 19** shows the burn pattern and whitish burn marks that were found on the left front fender of the Insured Vehicle (circled). Such whitish burn marks are a result of exposure to prolonged heat intensity, which may indicate where the fire had started.

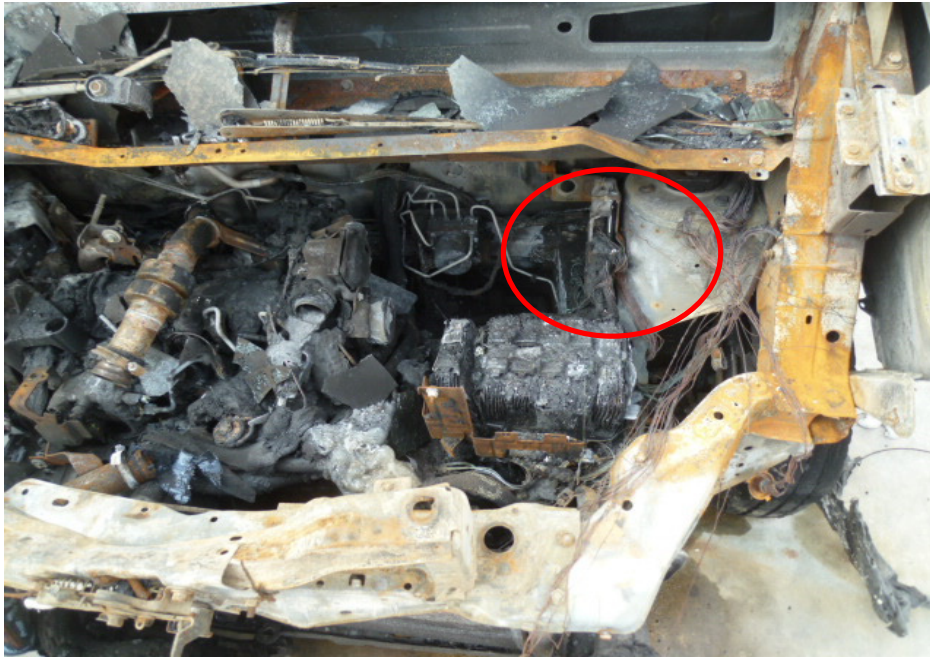
8. Upon closer examination of the left portion of the engine compartment, which was where the fire to the Insured Vehicle had likely started, we had found traces of greenish residue on several stretches of burnt wirings leading from the ECM. The presence of greenish residue indicates internal heating of copper wires, a sign of an electrical short circuit occurring. The greenish residue is normally left behind from oxidation as a result of chemical reaction involving the copper wires. This physical evidence would then appear to suggest that the cause of fire to the Insured Vehicle could have possibly been due to electrical in nature. See photos 9 - 12 below.

**Photo 9** shows the burnt wirings leading from the ECM around the left portion of the engine compartment (circled), which is in the immediate vicinity where the fire to the Insured Vehicle had likely started.

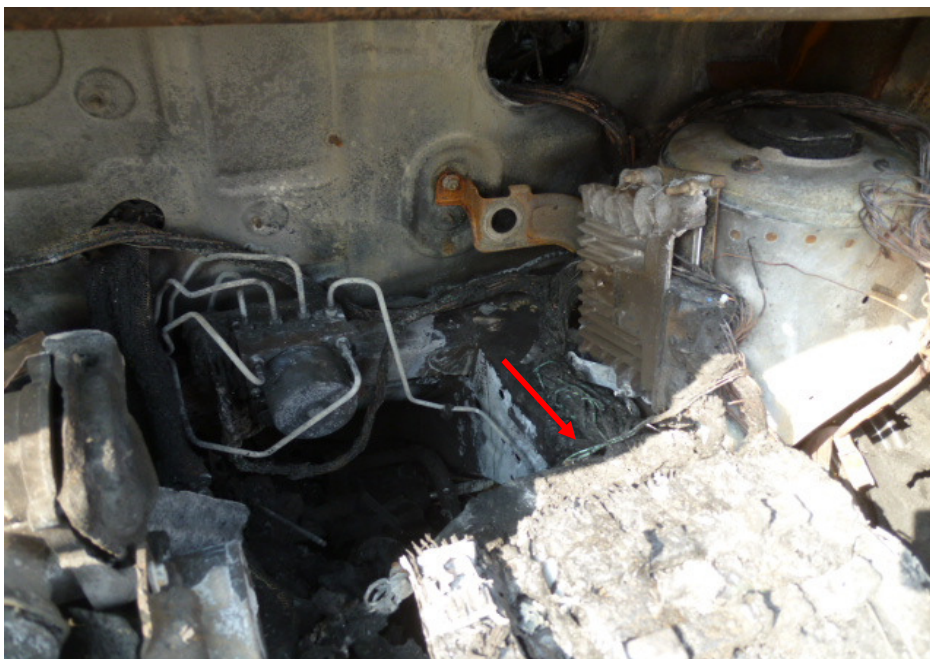
**Photo 10** shows a closer view of the burnt wirings leading from the ECM around the left portion of the engine compartment, which is in the immediate vicinity where the fire to the Insured Vehicle had likely started. We noticed greenish residue on several stretches of burnt wirings (arrowed). The presence of greenish residue indicates internal heating of copper wires, a sign of an electrical short circuit occurring. The greenish residue is normally left behind from oxidation as a result of chemical reaction involving the copper wires.

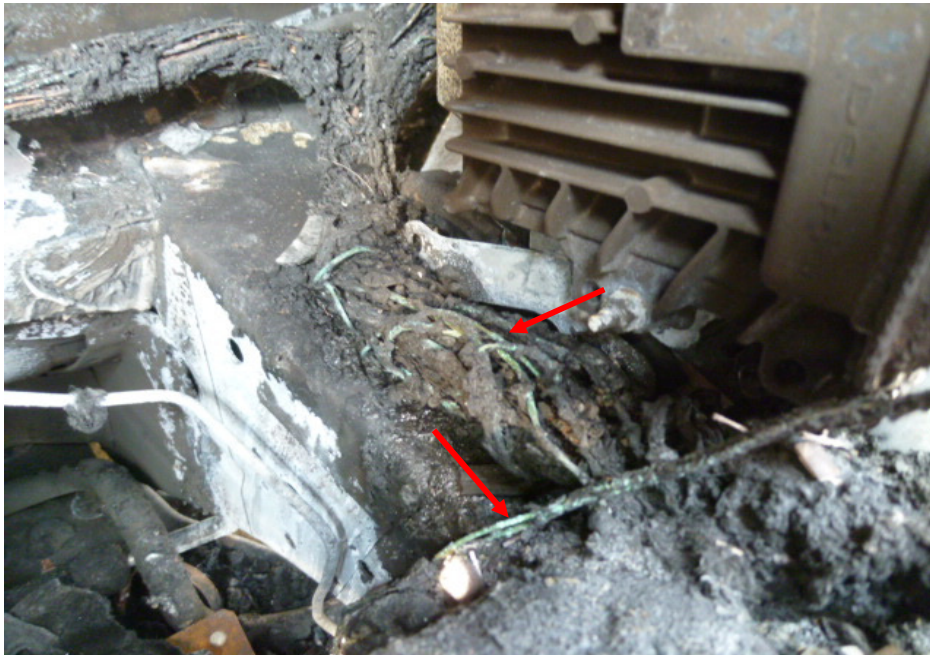
**Photo 11** shows a closer view of the greenish residue found on several stretches of burnt wirings leading from the ECM (red arrows). The presence of such greenish residue suggests occurrence of an electrical short circuit.

25. Having investigated and technically analysed the damages to the Insured Vehicle, we are of the view that the cause of fire to the Insured Vehicle was of electrical in nature. For this particular case, the fire had originated along the wirings inside the engine compartment, leading from the ECM. The wirings were original factory wirings of the Insured Vehicle.

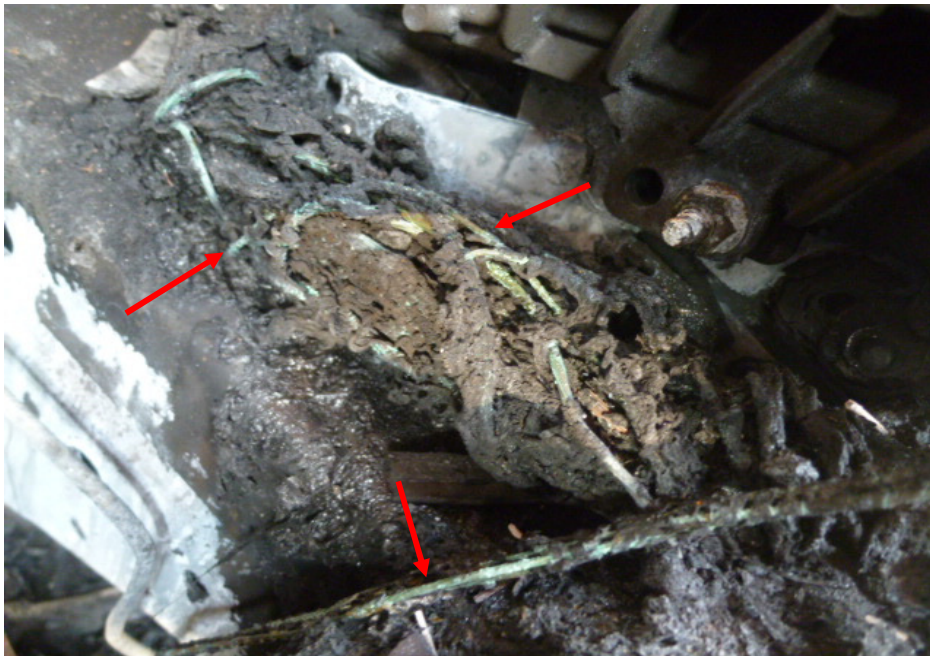
**Photo 12** shows a close up view of the greenish residue found on several stretches of burnt wirings leading from the ECM (red arrows). The presence of such greenish residue suggests occurrence of an electrical short circuit.

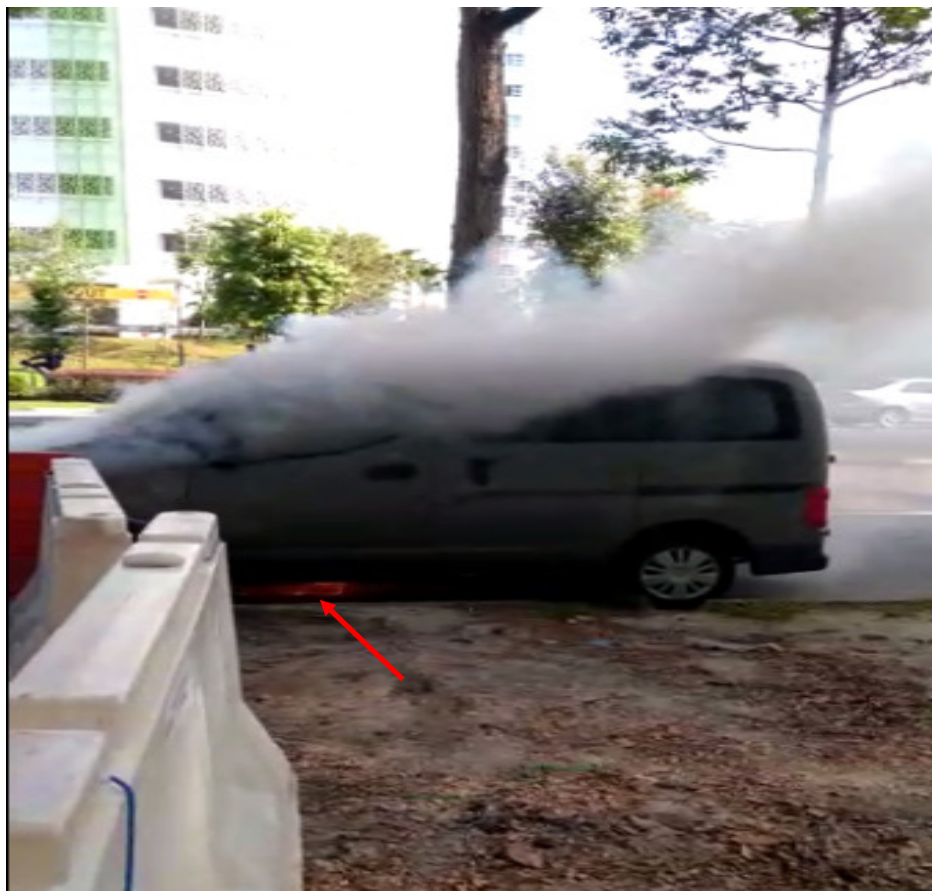
**Photo 13** shows the Insured Vehicle on fire before the arrival of the SCDF. In general, the information that could be gathered from this photograph had corresponded to the events that were related to us by Mr Yong which is the fire had started from the left bottom portion of the Insured Vehicle (arrowed).

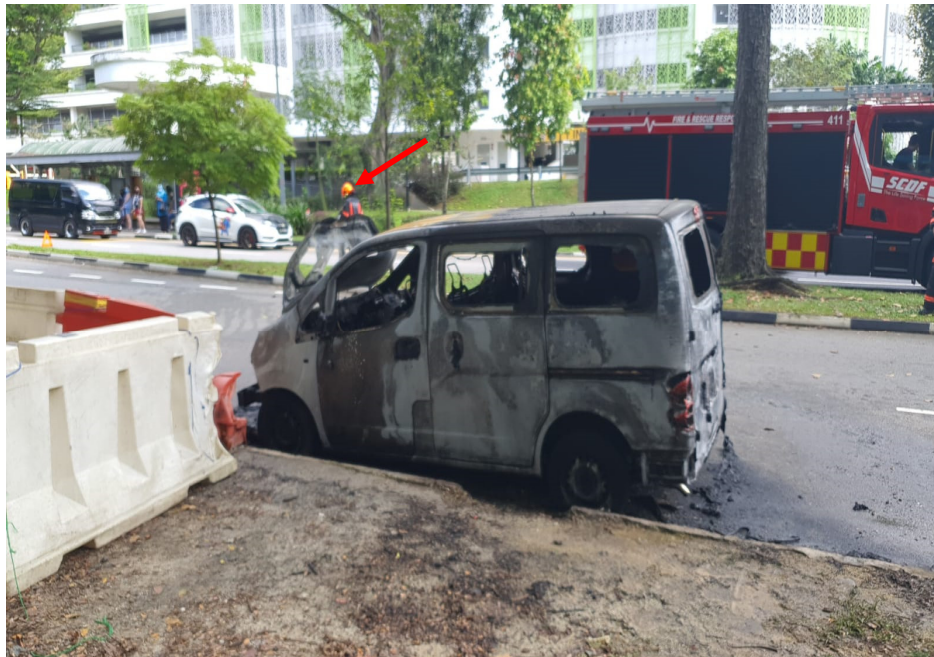
**Photo 14** shows the SCDF having just put out the fire on the Insured Vehicle (arrowed).

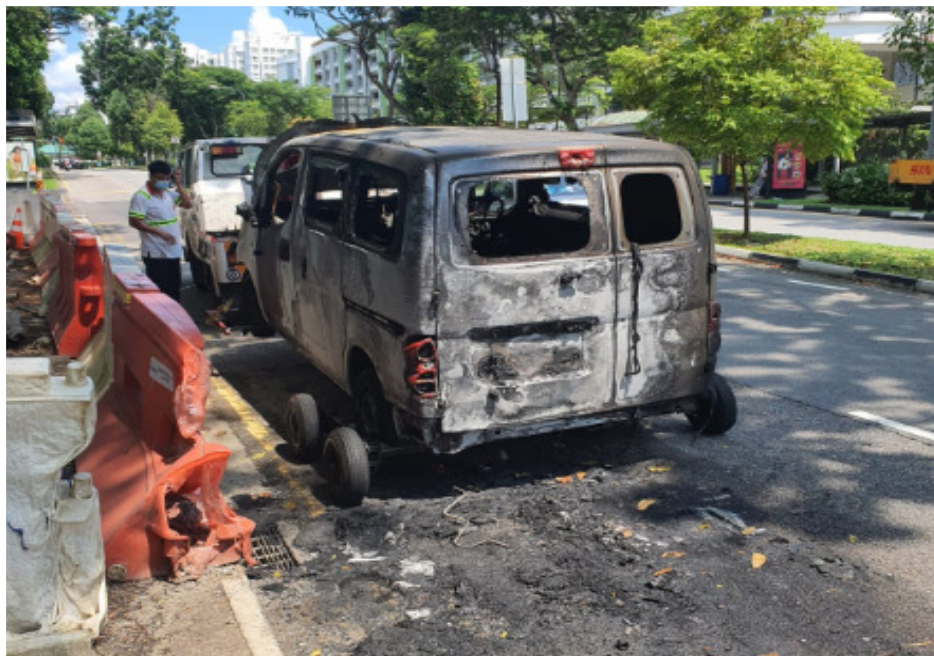
**Photo 15** shows the Insured Vehicle post- incident being prepped to be towed to Goldbell.
