Your Ref: Nissan GTR
(chassis number JN1GANR35U0410183)
Our Ref : CI/TP21007481/D

11 July 2021

**INSPECTION REPORT OF AN UNREGISTERD NISSAN GTR MOTOR CAR
WITH CHASSIS NUMBER JN1GANR35U0410183**

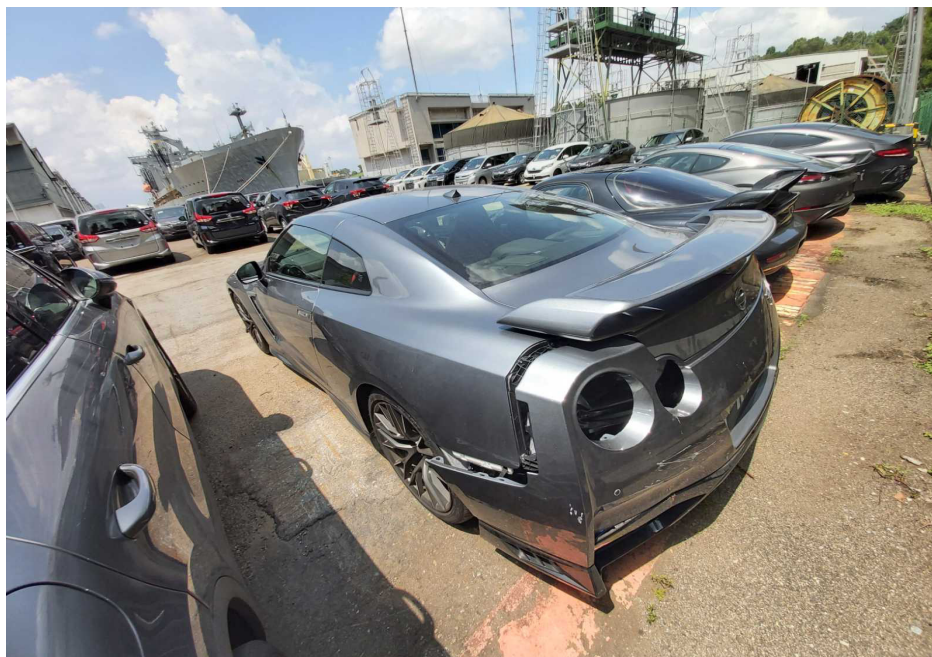
3. The photographs that were provided to me had showed damage to the rear portion of the Motor Car. Body parts observed to be damaged include the rear bumper, rear bumper lower cover, rear bumper lower cover garnish, rear bumper diffuser and rear left taillamp.
4. No physical damage was observed to other areas of the Motor Car. The airbags were not deployed as seen from the photographs that were provided to me. See photo 1 – 4 below.

Photo 1 shows the rear left body of the Motor Car (photograph provided to me). The Motor Car was observed to have sustained damage at its rear portion. From the photographs provided, I had observed damage to rear bumper and rear left taillamp amongst others.

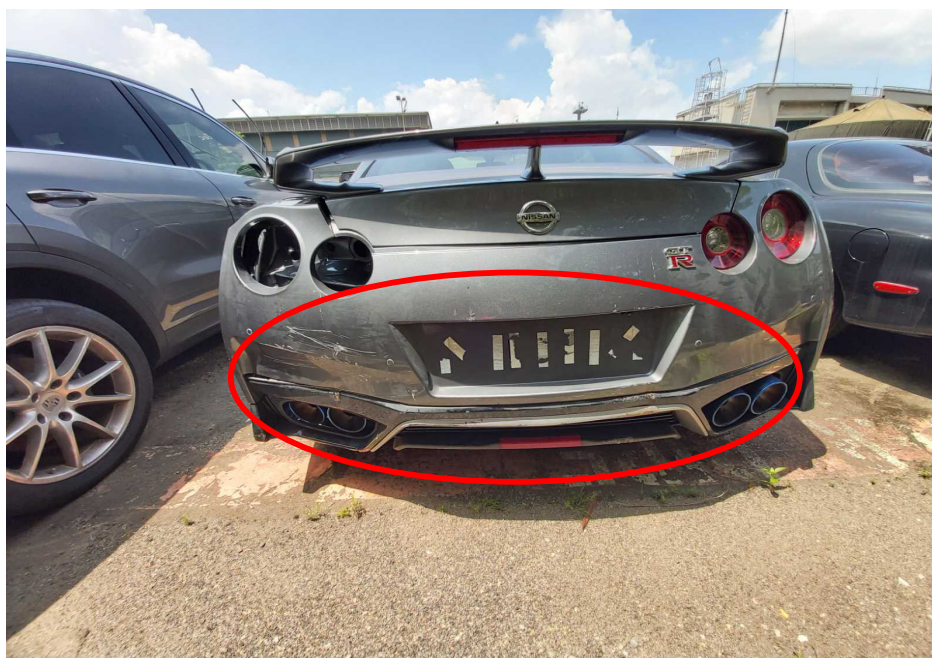
Photo 2 shows the rear body of the Motor Car (photograph provided to me). The Motor Car was observed to have sustained damage at its rear portion (circled). From the photographs provided, I had observed damage to the rear bumper, rear bumper lower cover, rear bumper lower cover garnish, rear bumper diffuser and rear left taillamp.

22. The rear portion of the Motor Car were visually examined, and it was noted that the repair/restoration works carried out to the damaged area of the Motor Car (refer to photograph 1 & 2 above) were reasonably adequate and in order.

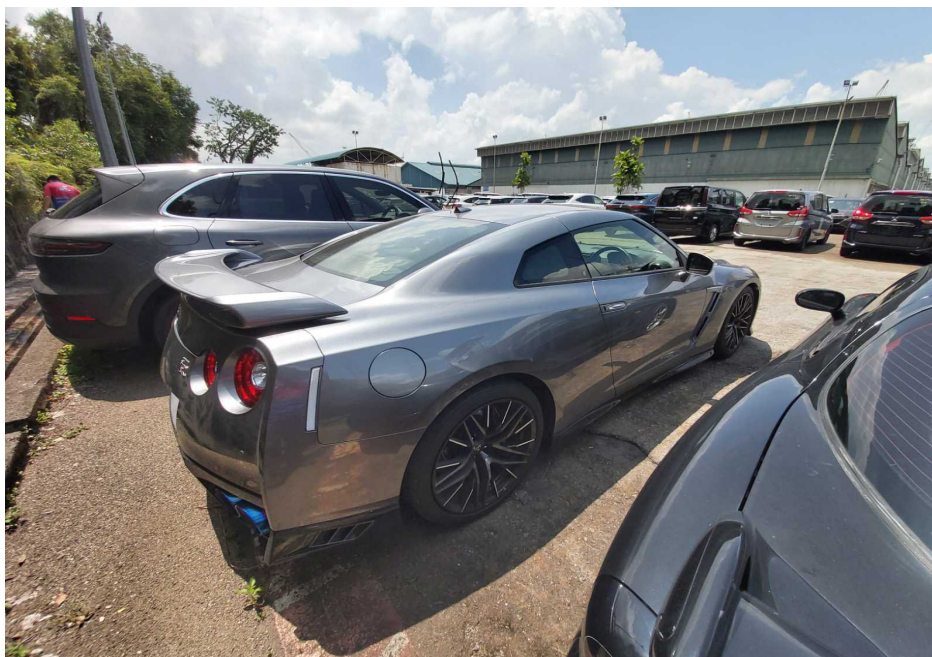
Photo 3 shows the rear right body of the Motor Car (photograph provided to me). Apart for the rear portion, there was no physical damage seen to other areas of the Motor Car. The airbags of the Motor Car were also not deployed as seen from the photographs that were provided to me.

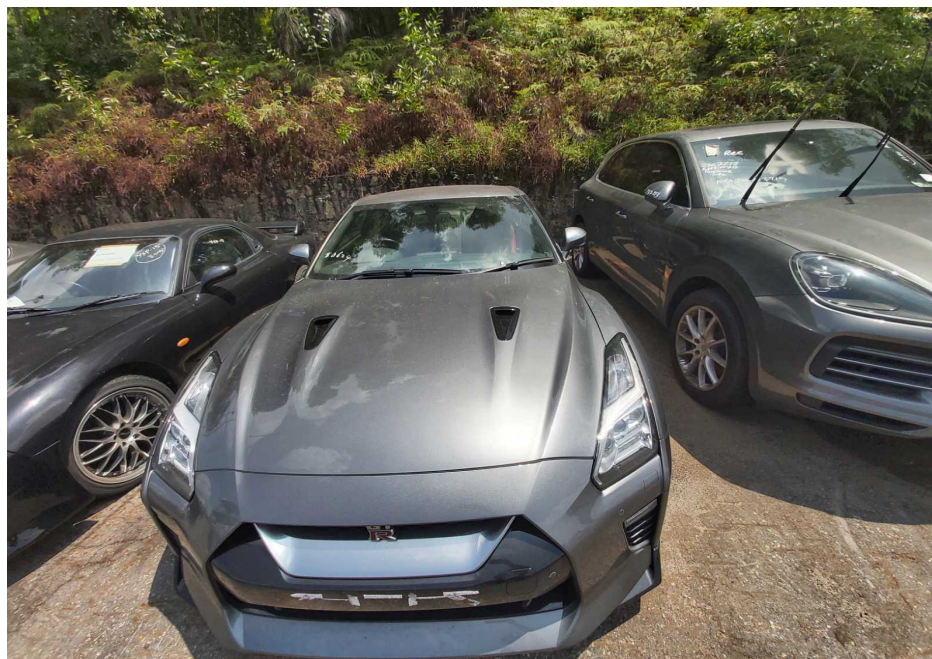
Photo 4 shows the frontal body of the Motor Car (photograph provided to me). Apart for the rear portion, there was no physical damage seen to other areas of the Motor Car. The airbags of the Motor Car were also not deployed as seen from the photographs that were provided to me.

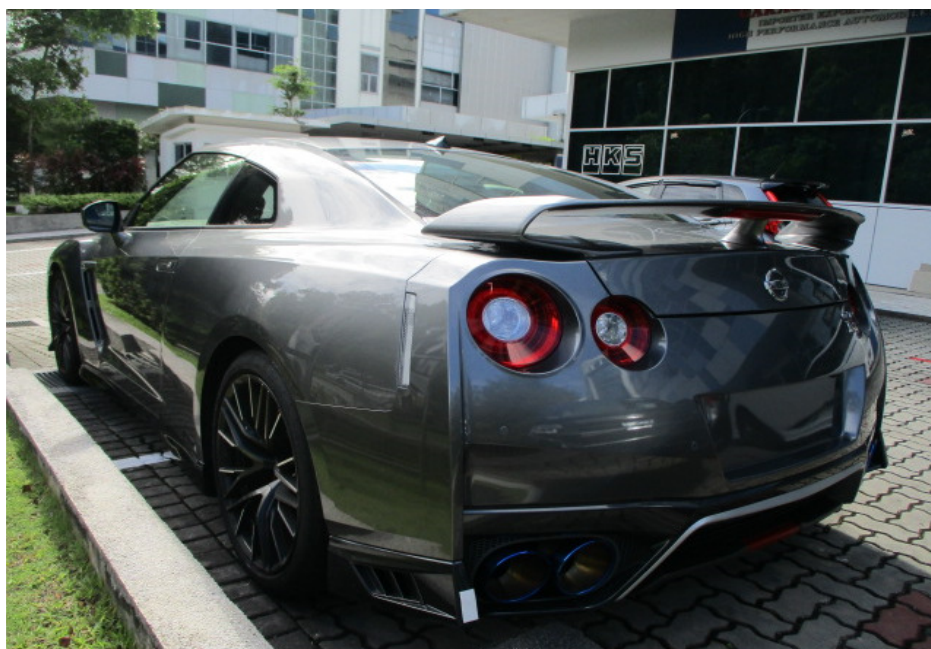
Photo 5 shows a general view of the rear left body of the Motor Car at the time of my inspection. The Motor Car was observed to be in a relatively good general condition with no loose exterior fittings observed. The rear portion of the Motor Car were visually examined, and it was observed that the repair/restoration works carried out to the damaged area of the Motor Car (refer to photograph 1 & 2 above) were reasonably adequate and in order.

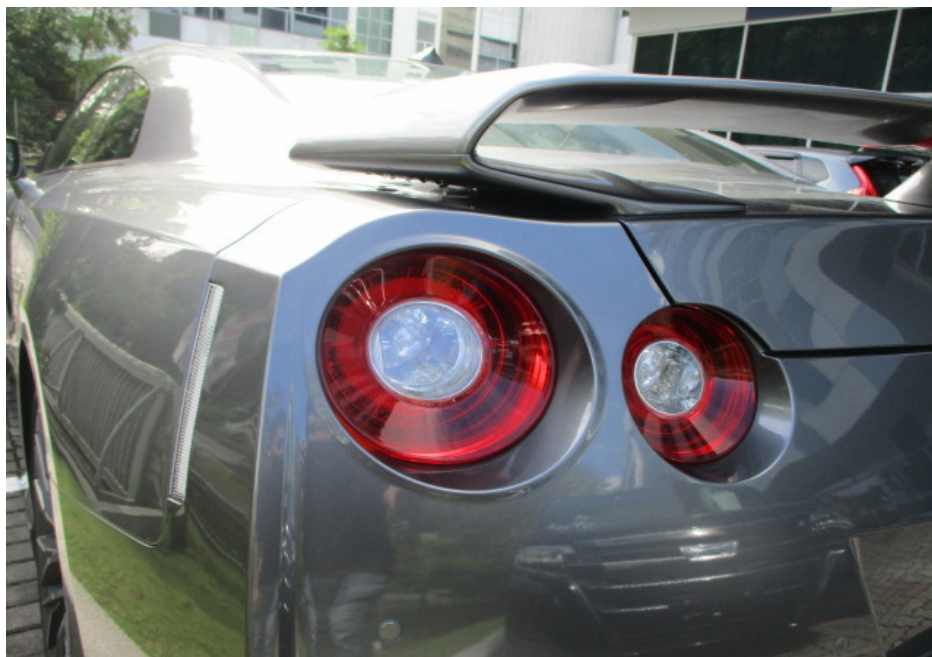
Photo 6 shows a closer view of the Motor Car's rear left taillamp at the time of my inspection. The rear portion of the Motor Car were visually examined, and it was observed that the repair/restoration works carried out to the damaged area of the Motor Car (refer to photograph 1 & 2 above) were reasonably adequate and in order.

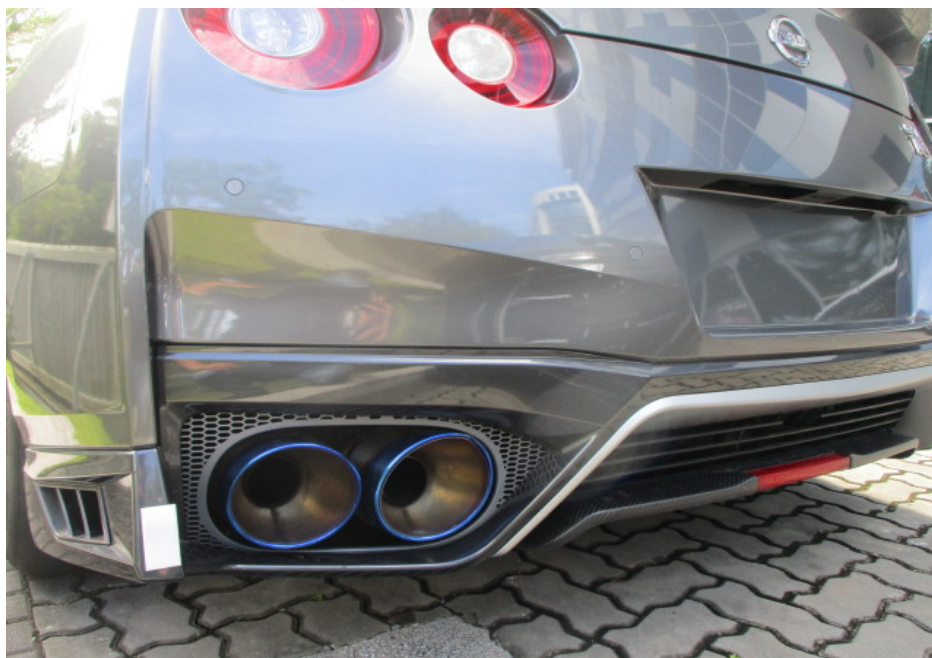
Photo 7 shows a closer view of the Motor Car's rear bumper, rear bumper lower cover, rear bumper lower cover garnish, rear bumper diffuser and rear left taillamp at the time of my inspection. The rear portion of the Motor Car were visually examined, and it was observed that the repair/restoration works carried out to the damaged area of the Motor Car (refer to photograph 1 & 2 above) were reasonably adequate and in order.

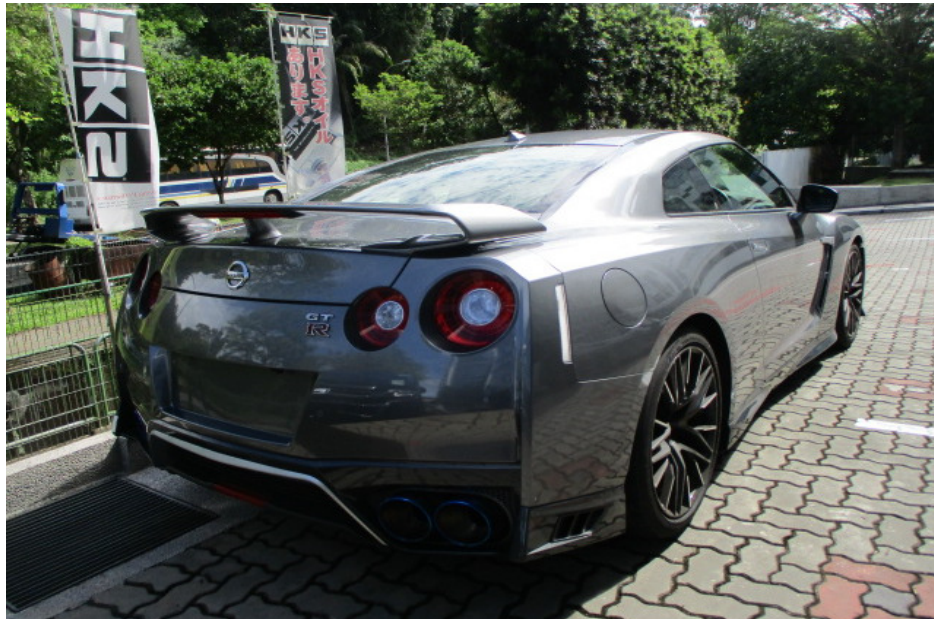
Photo 8 shows a general view of the rear right body of the Motor Car at the time of my inspection. The Motor Car was observed to be in a relatively good general condition with no loose exterior fittings observed. The rear portion of the Motor Car were visually examined, and it was observed that the repair/restoration works carried out to the damaged area of the Motor Car (refer to photograph 1 & 2 above) were reasonably adequate and in order.

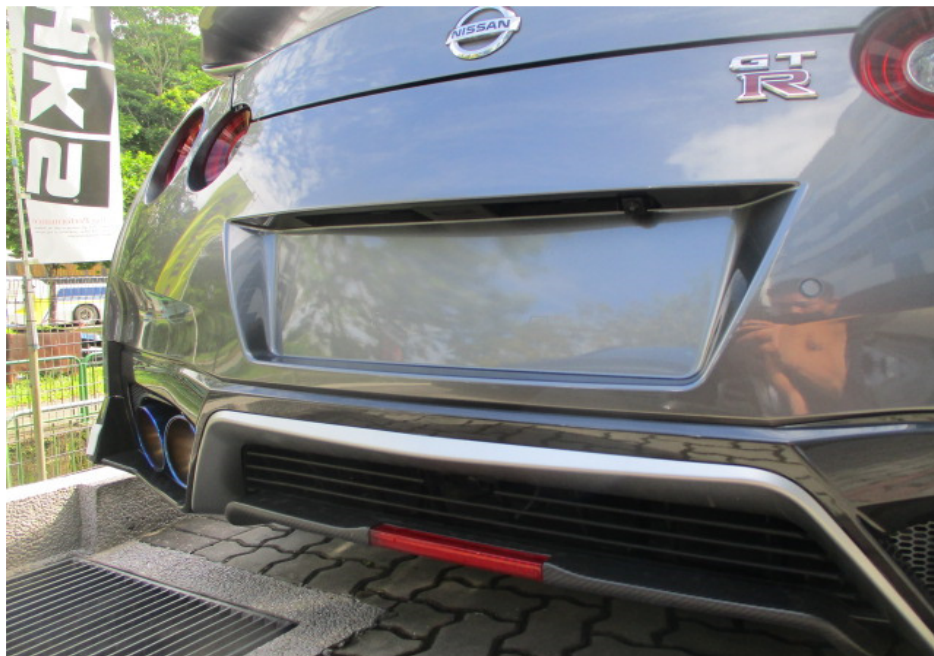
Photo 9 shows a closer view of the Motor Car's rear bumper, rear bumper lower cover, rear bumper lower cover garnish and rear bumper diffuser at the time of my inspection. The rear portion of the Motor Car were visually examined, and it was observed that the repair/restoration works carried out to the damaged area of the Motor Car (refer to photograph 1 & 2 above) were reasonably adequate and in order.

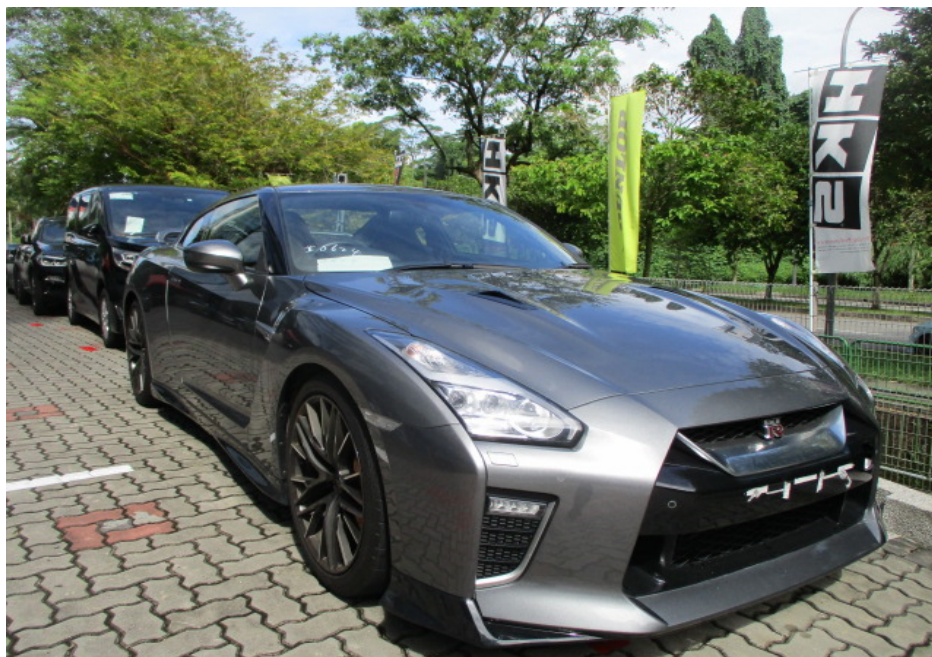
Photo 10 shows a general view of the front right body of the Motor Car at the time of my inspection. The Motor Car was observed to be in a relatively good general condition with no loose exterior fittings observed. The mileage of the Motor Car recorded at the time of my inspection was 264miles.

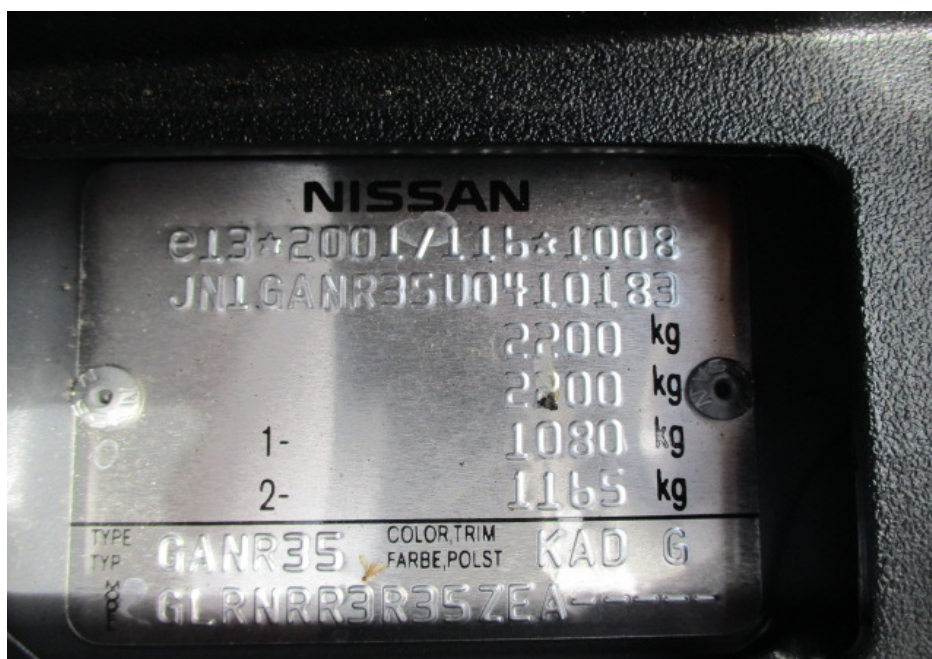
Photo 11 shows the chassis number of the Motor Car. The chassis number recorded was JN1GANR35U0410183.

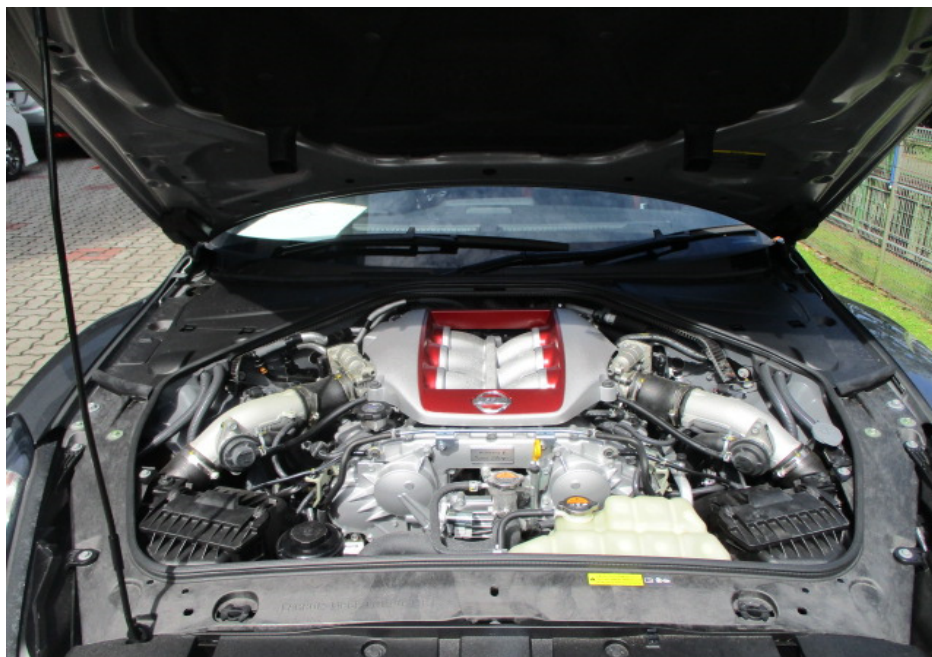
14. My examination of the engine compartment of the Motor Car revealed that the various parts and components inside the engine compartment were all intact and properly fitted. The engine oil, brake fluid and engine coolant were all found to be of sufficient level for operating purposes. Visually, there was also no contamination found to these fluids.

Photo 12 shows a general view of the engine compartment of the Motor Car at the time of my inspection. The various parts and components inside the engine compartment were all observed to be intact and properly fitted. There was also no sign(s) or indication(s) of fluid leak and/or fluid stain found inside the engine compartment.

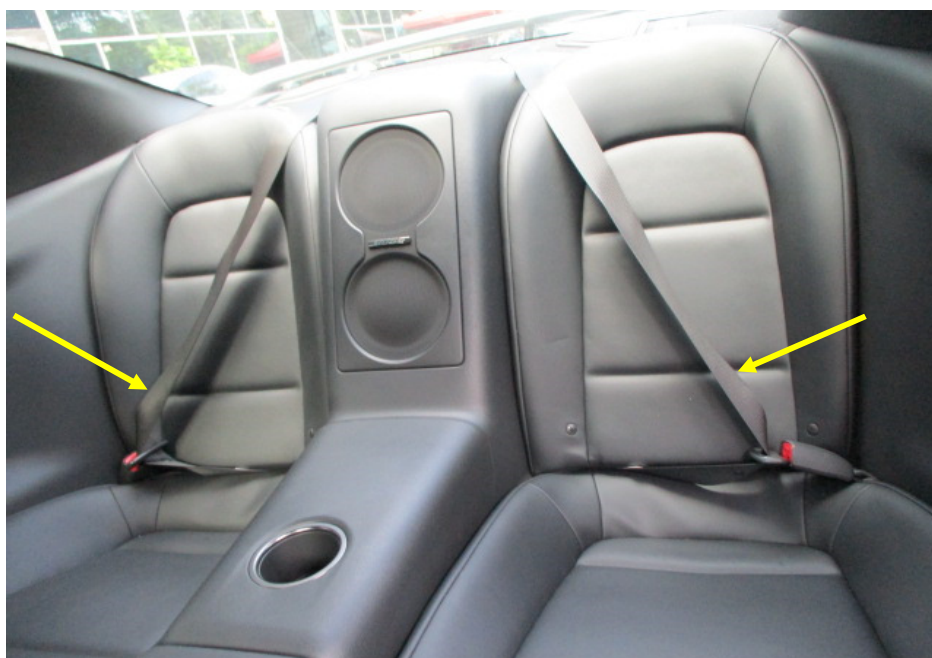
12. The seats of the Motor Car were found to be secured to the floorboard of the Motor Car via seat rails bolted onto the floorboard. Retractable seat belt reels and pre-tensioners were fitted on all seats of the Motor Car. The seat belts were tested and were able to be fastened securely into the respective pre-tensioners that were fixed to the side of all the seats.

Photo 13 shows the rear seats of the Motor Car. All the seats of the Motor Car were secured via seat rails to the floorboard. They were also fitted with a retractable seat belt reel and a pre-tensioner. The seat belts (arrowed) were tested and were able to be fastened into the respective pre-tensions that were fitted on the side of each individual seat.

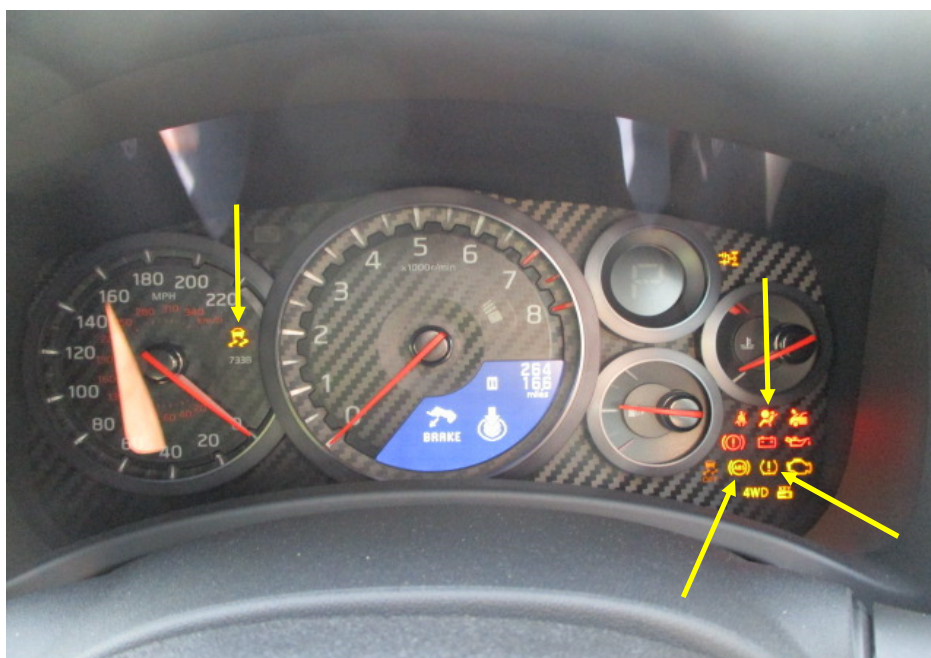
Photo 14 shows the warning lights for the various electronic safety features appearing on the instrument panel of the Motor Car during its self-test when the engine is cranked, in particular the ABS, SRS, TPM and VDC lights (arrowed).

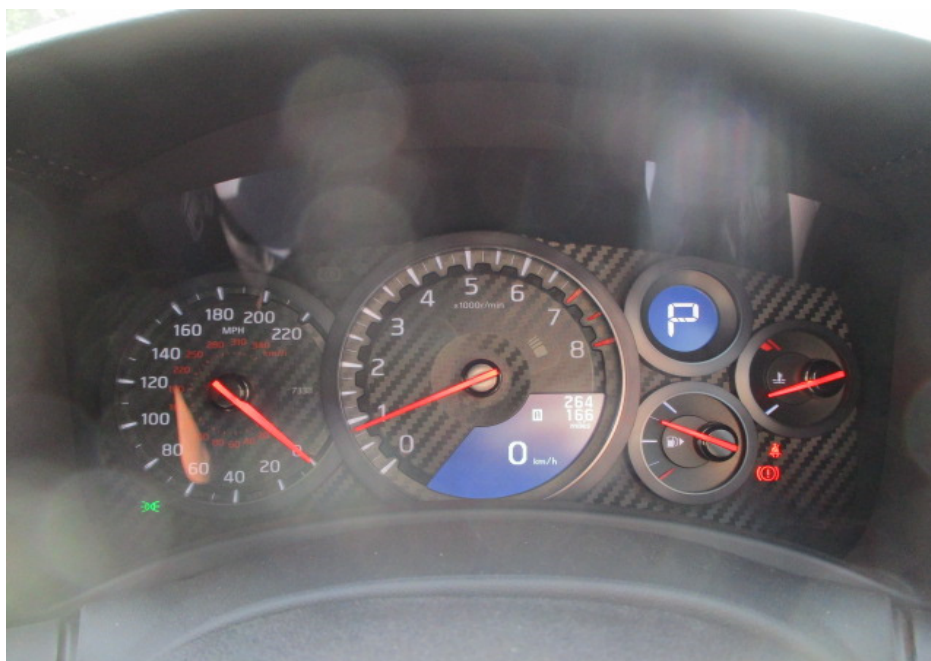
13. The Motor Car's automatic self-test of the functionality of its various electronic safety features like the Anti-Lock Brake System (ABS), Supplemental Restraint System (SRS), Tyre Pressure Monitor (TPM) and Vehicle Dynamic Control (VDC) during cranking of the engine had indicated that these electronic systems were in working condition. This was determined from the respective warning lights disappearing from the instrument panel after the self-test.

Photo 15 shows the respective warning lights no longer illuminated, indicating that there is no fault detected to the ABS, SRS, TPM and VDC systems of the Motor Car during the self-test. These electronic systems were hence in working condition at the time of my inspection.

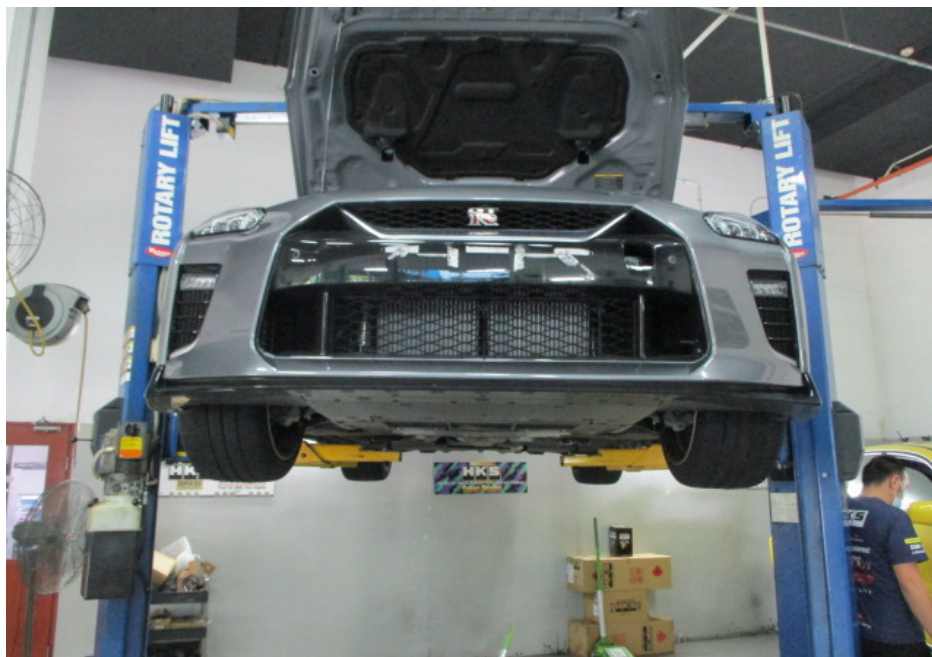
15. My checks on the underside of the Motor Car revealed no sign(s) or indication(s) of fluid leakage and/or fluid stain(s). The engine block and automatic transmission assembly were both secured properly. All undercarriage components of the Motor Car were also observed to be intact and secured in an appropriate manner.

Photo 16 shows the Motor Car hoisted up for checks on its undercarriage. There was no sign(s) or indication(s) of fluid leakage and/or fluid stain(s) on the underside of the Motor Car. The undercarriage components of the Motor Car were also all observed to be intact and secured in an appropriate manner.

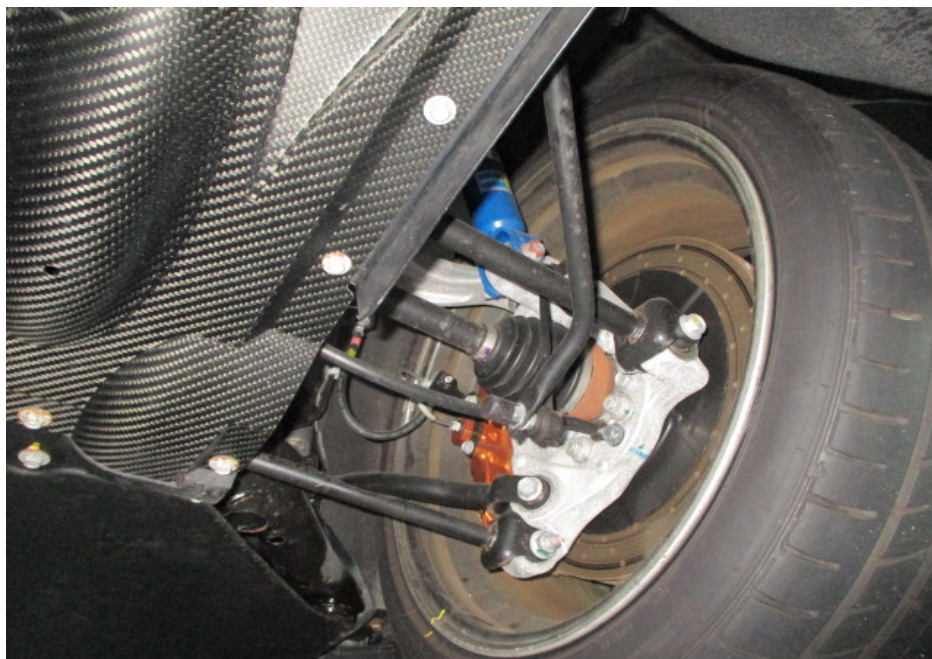
Photo 17 shows a general view of the control arms and linkages at the rear right wheel of the Motor Car. I did not observe any fluid leak and/or fluid stain on the underside of the Motor Car. All of the Motor Car's undercarriage components were observed to be intact and secured in an appropriate manner.

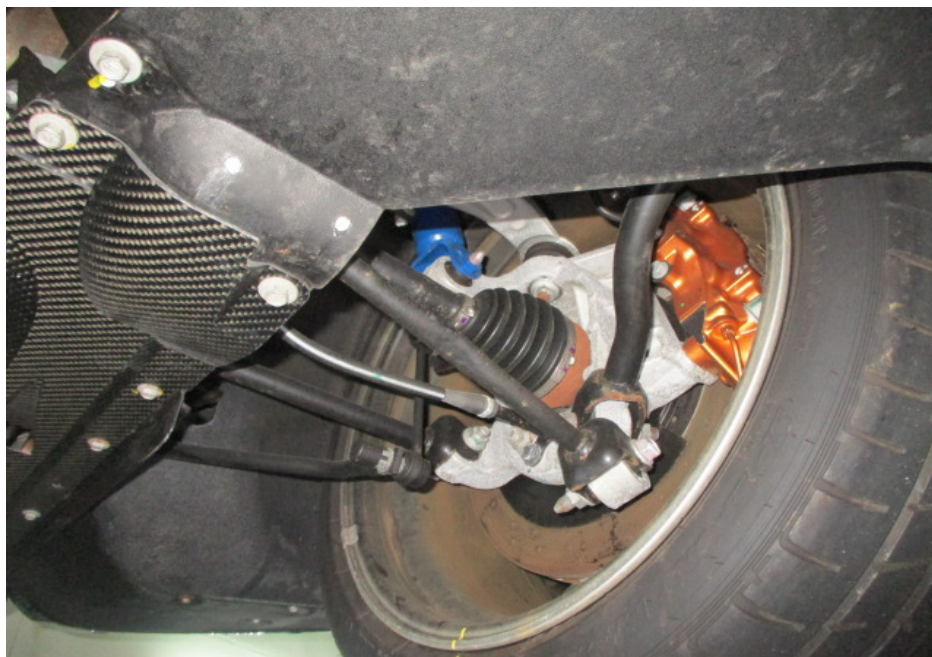
Photo 18 shows the various undercarriage components at the rear left wheel of the Motor Car. The mechanical components, control arms and linkages were all found to be intact and secured in an appropriate manner.

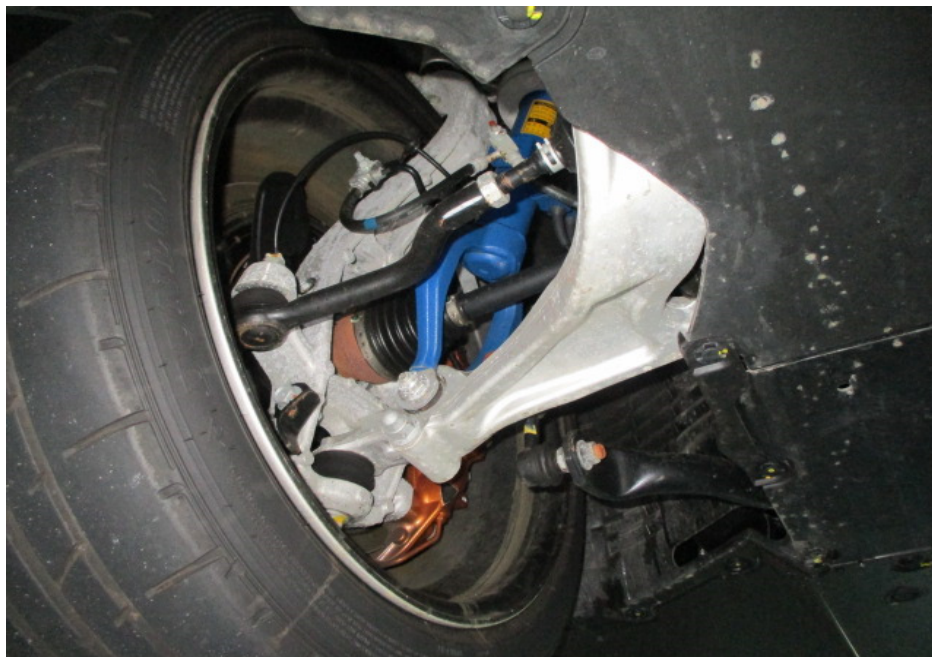
Photo 19 shows the various undercarriage components at the front left wheel of the Motor Car. The mechanical components, control arms and linkages were all found to be intact and secured in an appropriate manner. I also did not observe any fluid leak and/or fluid stain on the underside of the Motor Car.

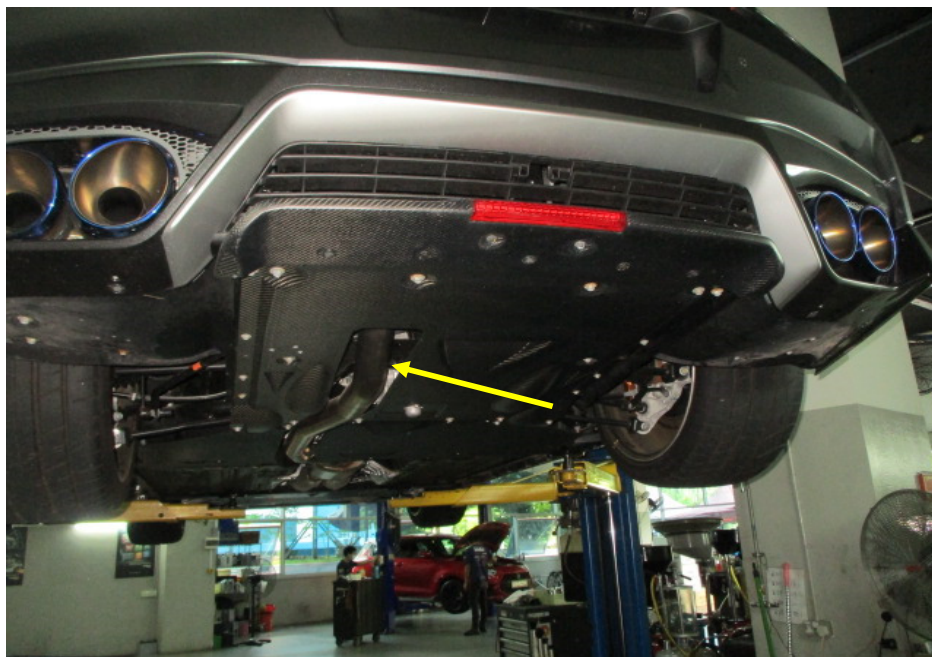
Photo 20 shows a general view of the rear section of the Motor Car's exhaust system. My examination of the Motor Car's exhaust system revealed no sign(s) or indication(s) of any cut or weld marks along its exhaust pipes (arrowed), on its catalytic converters, centre resonator box and its rear mufflers.

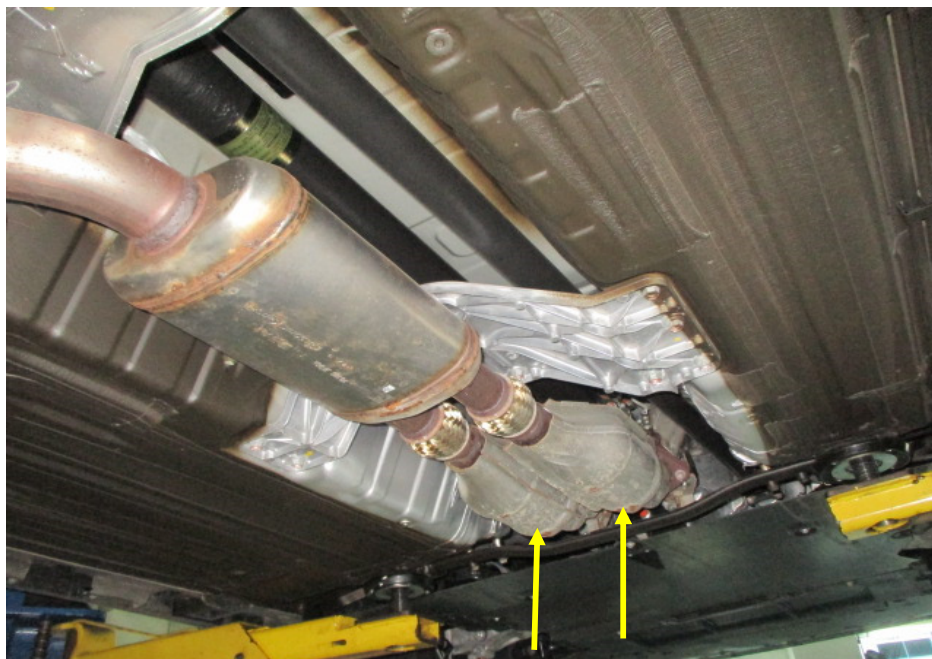
Photo 21 shows the front section of the Motor Car's exhaust system. My examination of the Motor Car's exhaust system revealed no sign(s) or indication(s) of any cut or weld marks along its exhaust pipes, on its catalytic converters (arrowed), centre resonator box and its rear mufflers.

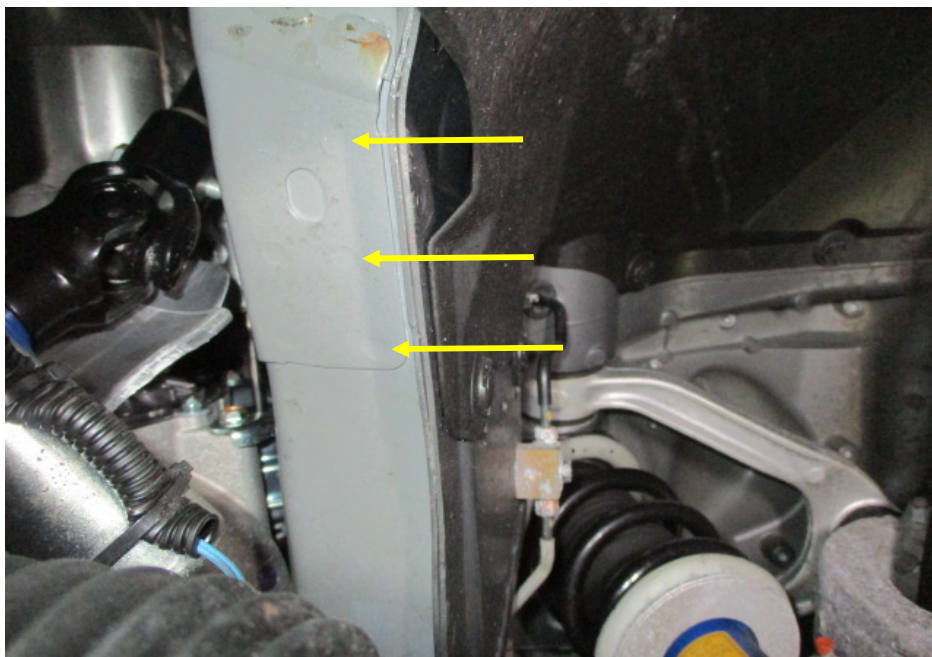
11. Visually, I did not find any weld marks, other than the original spot weld marks, on the chassis/structural body of the Motor Car. The original factory sealant at the joints along the chassis/structural body was also untouched, again indicating that no replacement of the chassis/structural body was carried out; and that the chassis/structural body was originally fitted.

Photo 22 shows the chassis/structural body at the underside front right of the Motor Car. I did not find any weld marks other than original spot weld marks (arrowed) on the chassis/structural body of the Motor Car. The original factory sealant at the joints along the chassis/structural body was untouched, indicating no work was done on the chassis/structural body of the Motor Car and that the chassis/structural body was originally fitted.

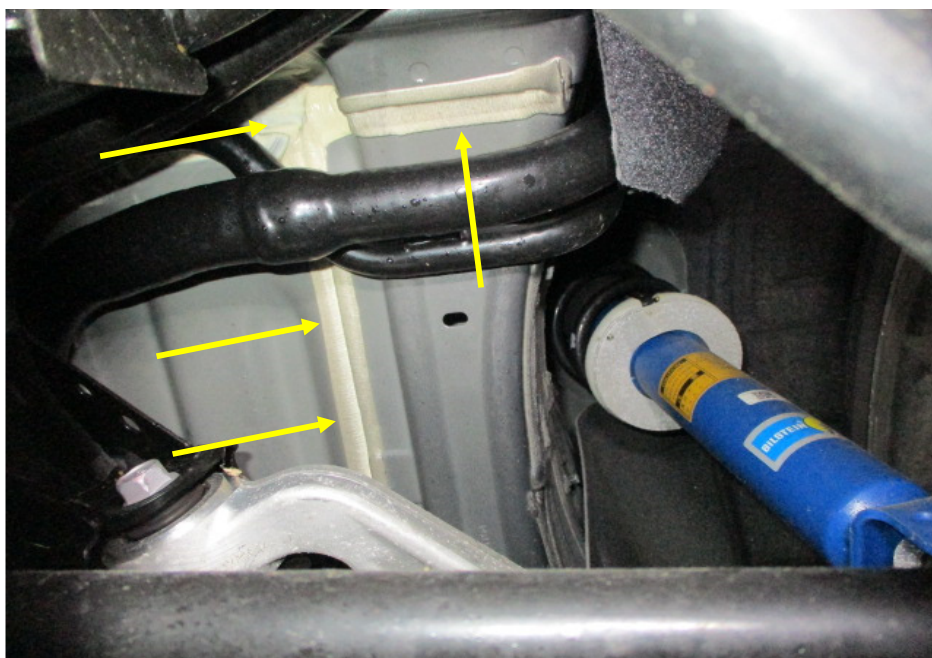
Photo 23 shows the chassis/structural body at the underside rear right of the Motor Car. The original factory sealant (arrowed) at the joints along the chassis/structural body was observed to be untouched. In general, I had found no work was carried out on the chassis/structural body of the Motor Car. The chassis/structural body of the Motor Car was originally fitted.

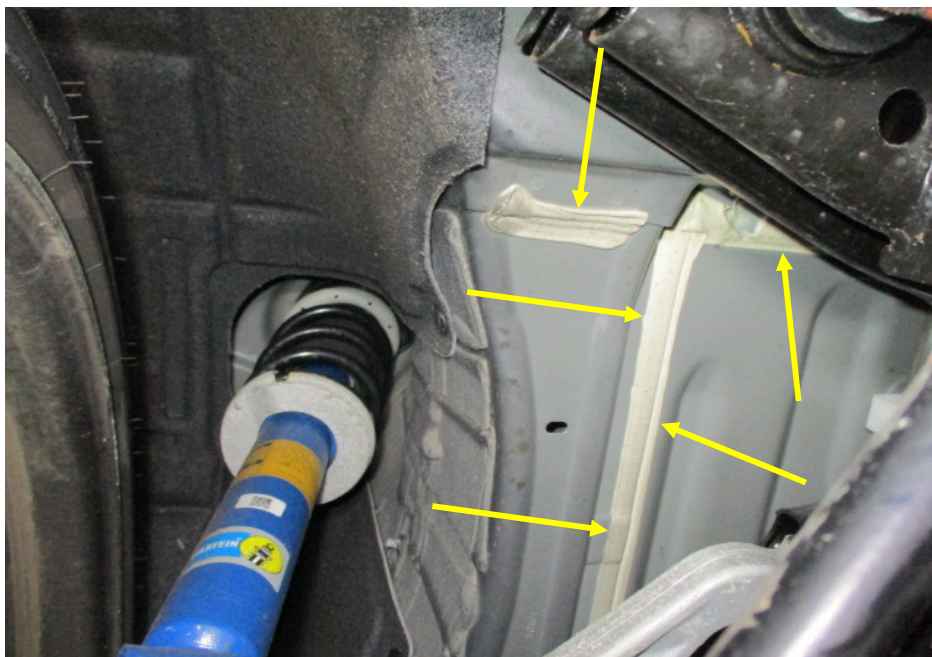
Photo 24 shows the chassis/structural body at the underside rear left of the Motor Car. The original factory sealant (arrowed) at the joints along the chassis/structural body was observed to be untouched. In general, I had found no work was carried out on the chassis/structural body of the Motor Car. The chassis/structural body of the Motor Car was originally fitted.

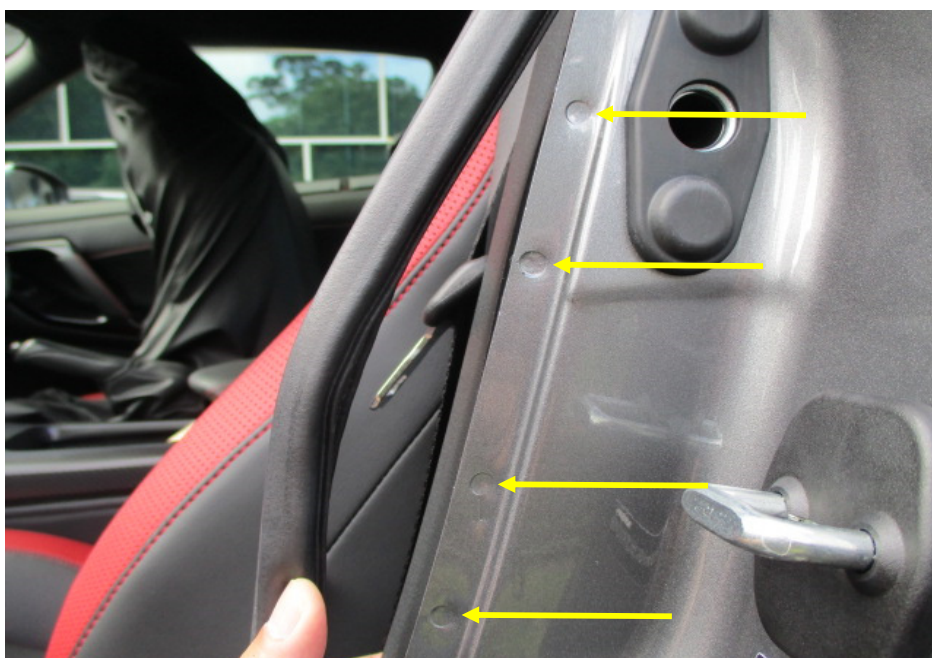
10. Checks on the non-detachable body panels like the rear fenders, floorboard, roof panel, pillars and rocker panels amongst others, revealed that these body panels were spot welded onto the chassis/structural body of the Motor Car. The original factory sealant at the joints of the non-detachable body panels was all untouched indicating no replacement of the non-detachable body panels was carried out; and that these body panels were all originally fitted.

Photo 25 shows the left side rear body panel of the Motor Car. I did not find any weld marks other than original spot weld marks (arrowed) on the left side rear body panel of the Motor Car, which indicates that there was no re-welding works carried out. In general, I had found all the non-detachable body panels of the Motor Car to be originally fitted at the time of my inspection.

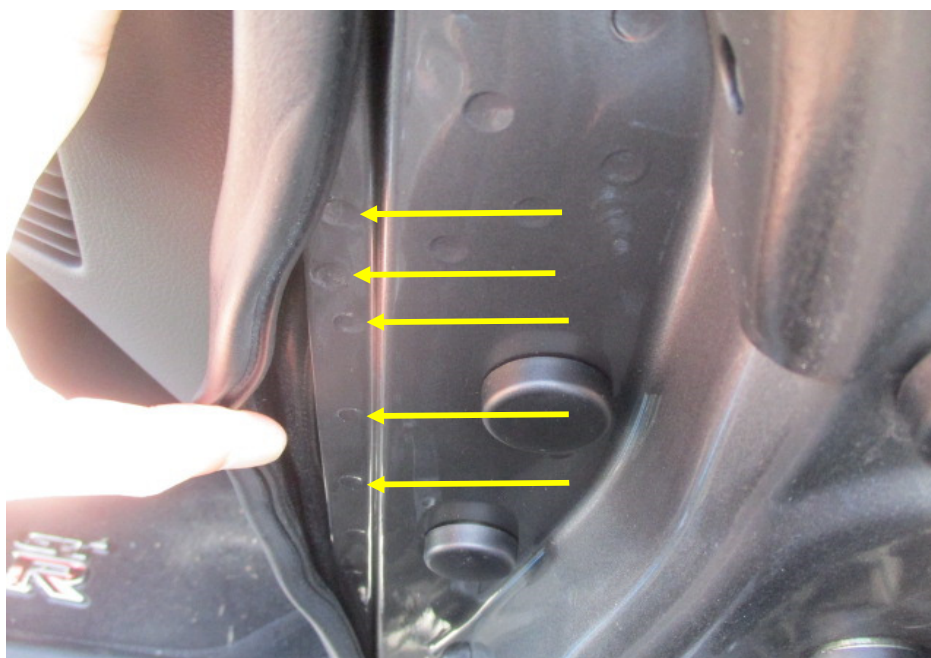
Photo 26 shows the right side "A" pillar of the Motor Car. I did not find any weld marks other than original spot weld marks (arrowed) on the right side "A" pillar of the Motor Car, which indicates that there was no re-welding works carried out. In general, I had found all the non-detachable body panels of the Motor Car to be originally fitted at the time of my inspection.
