Your Ref: Nissan GTR
(chassis number JN1GANR35U0400060)
Our Ref : CI/TP21007482/D

09 July 2021

**INSPECTION REPORT OF AN UNREGISTERD NISSAN GTR MOTOR CAR
WITH CHASSIS NUMBER JN1GANR35U0400060**

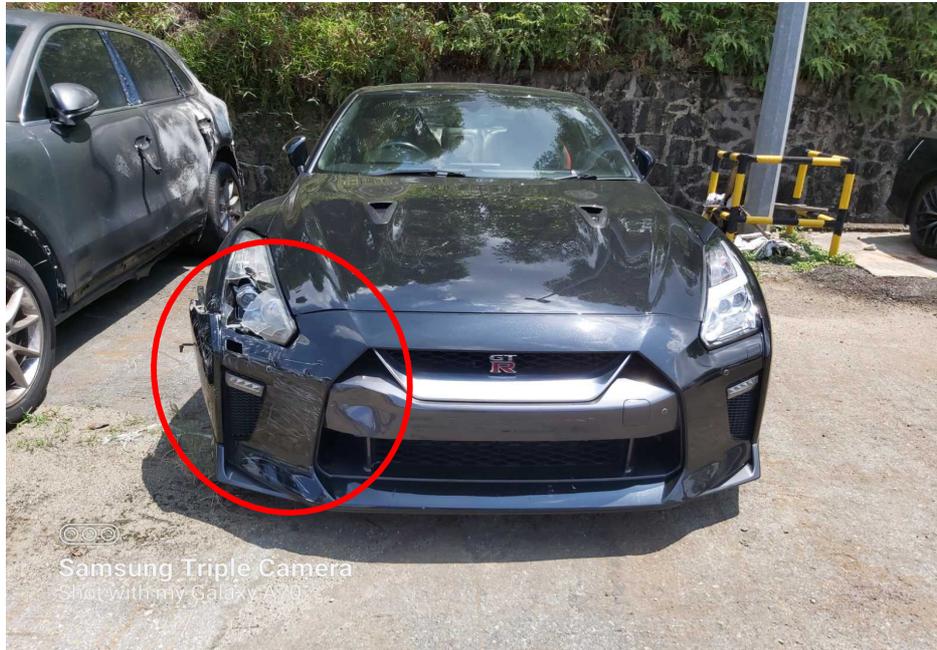
3. The photographs that were provided to me had showed damage to the front right portion of the Motor Car. Body parts observed to be damaged include the front bumper, front bumper centre garnish, front bumper right lower grille, front right day running light, front right headlamp, front right headlamp washer cover, front right signal lamp and front right fender.
4. No physical damage was observed to other areas of the Motor Car. The airbags were not deployed as seen from the photographs that were provided to me. See photo 1 – 4 below.

Photo 1 shows the frontal body of the Motor Car (photograph provided to me). The Motor Car was observed to have sustained damage at its front right portion (circled). From the photographs provided, I had observed damage to front bumper, front bumper centre garnish, front bumper right lower grille, front right headlamp and front right headlamp washer cover amongst others.

22. The front right portion of the Motor Car were visually examined, and it was noted that the repair/restoration works carried out to the damaged area of the Motor Car (refer to photograph 1 & 2 above) were reasonably adequate and in order.

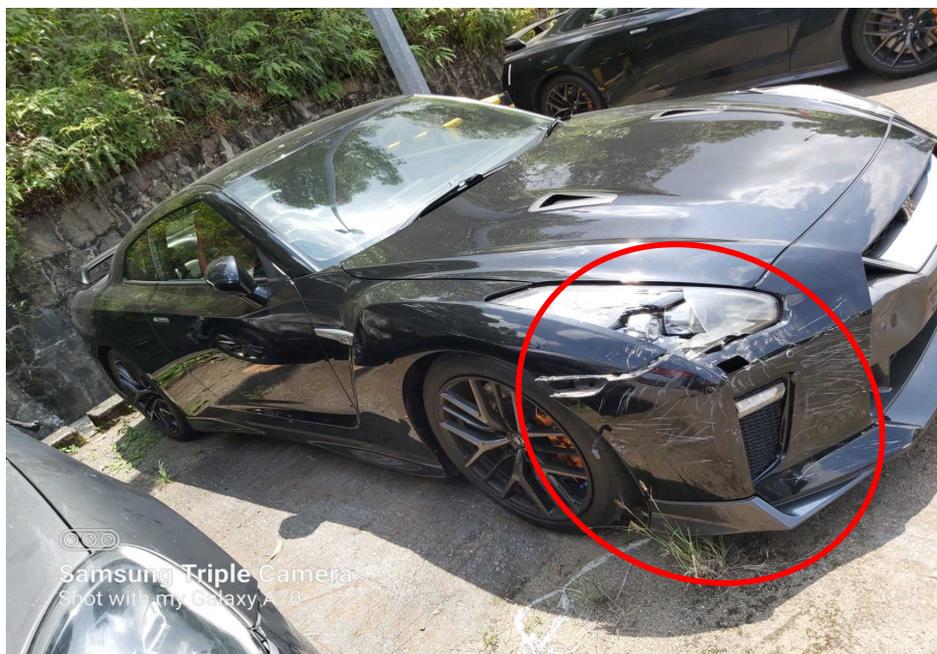
Photo 2 shows the front right body of the Motor Car (photograph provided to me). The Motor Car was observed to have sustained damage at its front right portion (circled). From the photographs provided, I had observed damage to front bumper, front right fender, front right signal lamp, front right headlamp and front right headlamp washer cover amongst others.

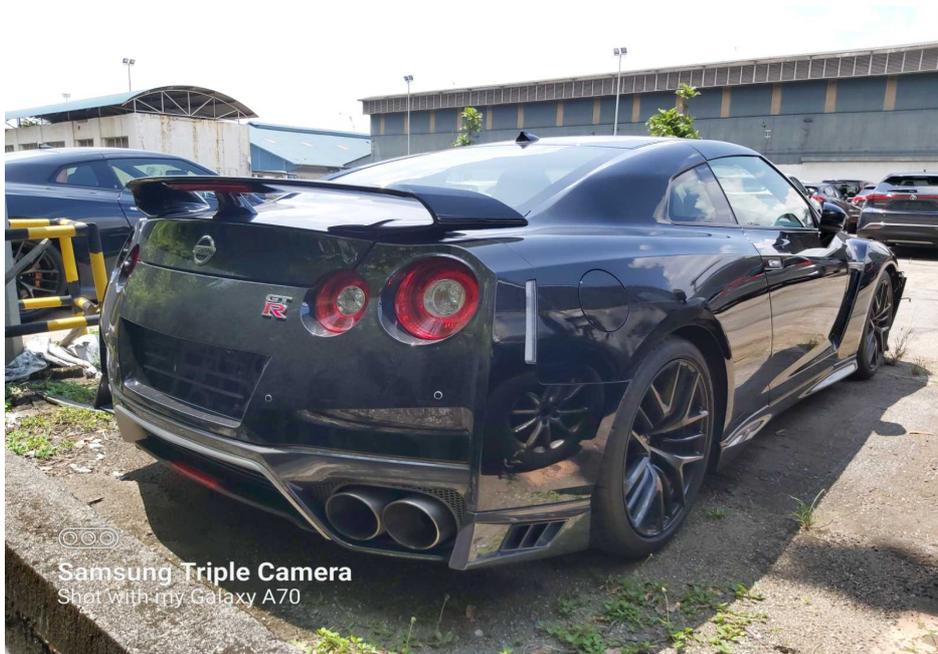
Photo 3 shows the rear right body of the Motor Car (photograph provided to me). Apart for the front right portion, there was no physical damage seen to other areas of the Motor Car. The airbags of the Motor Car were also not deployed as seen from the photographs that were provided to me.

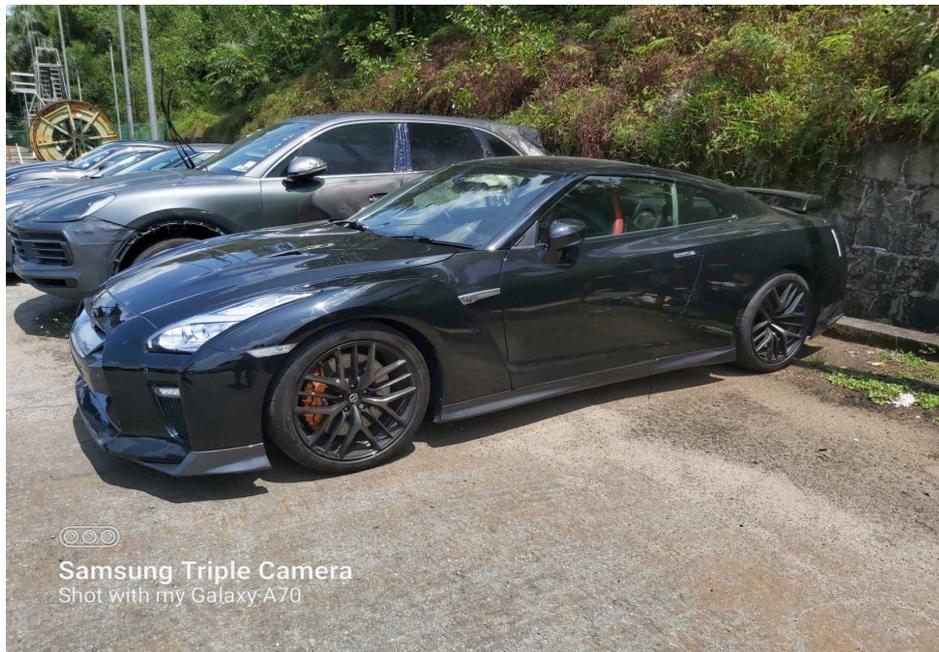
Photo 4 shows the left body of the Motor Car (photograph provided to me). Apart for the front right portion, there was no physical damage seen to other areas of the Motor Car. The airbags of the Motor Car were also not deployed as seen from the photographs that were provided to me.

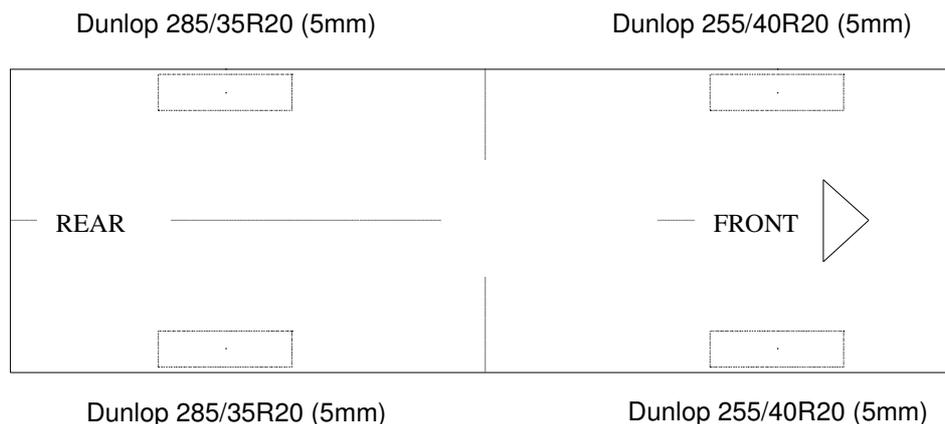
- It was fitted with 20inch sport wheel rims that were wrapped with tyres that were observed to be of serviceable condition. The tyres were also sufficiently inflated for vehicular operation. The tyre brand, tyre size and approximate remaining tread depth of the 4 tyres of the Motor Car were recorded as follows: -

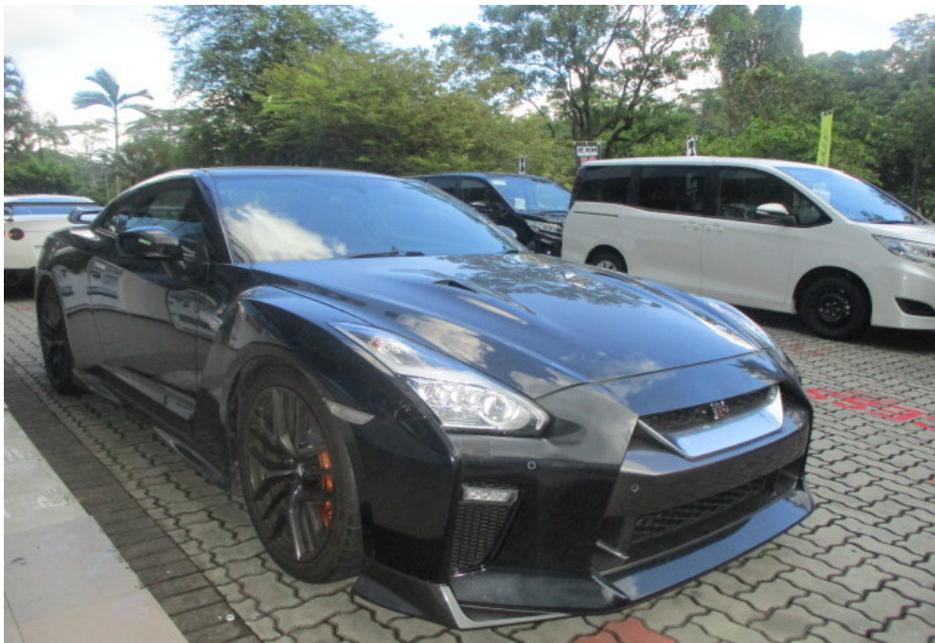
Photo 5 shows a general view of the front right body of the Motor Car at the time of my inspection. The Motor Car was observed to be in a relatively good general condition with no loose exterior fittings observed. The front right portion of the Motor Car were visually examined, and it was observed that the repair/restoration works carried out to the damaged area of the Motor Car (refer to photograph 1 & 2 above) were reasonably adequate and in order.

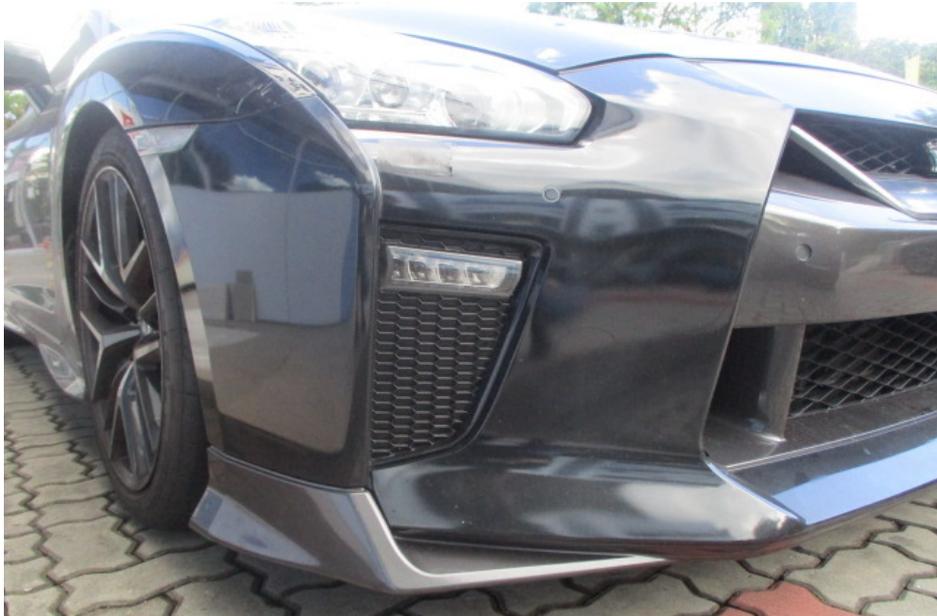
Photo 6 shows a closer view of the Motor Car's front bumper, front bumper centre garnish, front bumper right lower grille, front right day running light and front right headlamp at the time of my inspection. The front right portion of the Motor Car were visually examined, and it was observed that the repair/restoration works carried out to the damaged area of the Motor Car (refer to photograph 1 & 2 above) were reasonably adequate and in order.

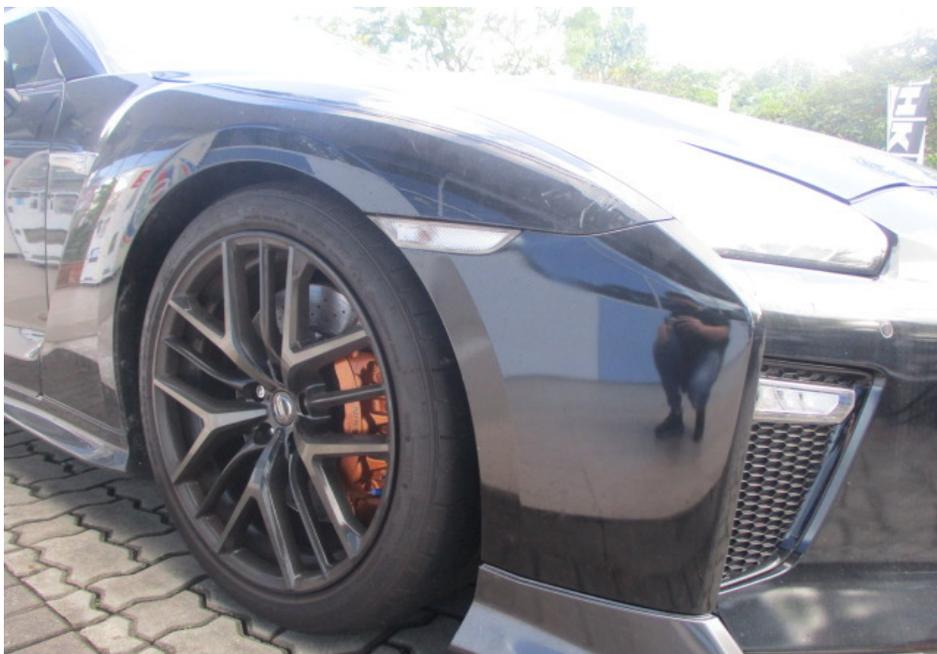
Photo 7 shows a closer view of the Motor Car's front bumper, front bumper right lower grille, front right day running light, front right signal lamp and front right fender. The front right portion of the Motor Car were visually examined, and it was observed that the repair/restoration works carried out to the damaged area of the Motor Car (refer to photograph 1 & 2 above) were reasonably adequate and in order.

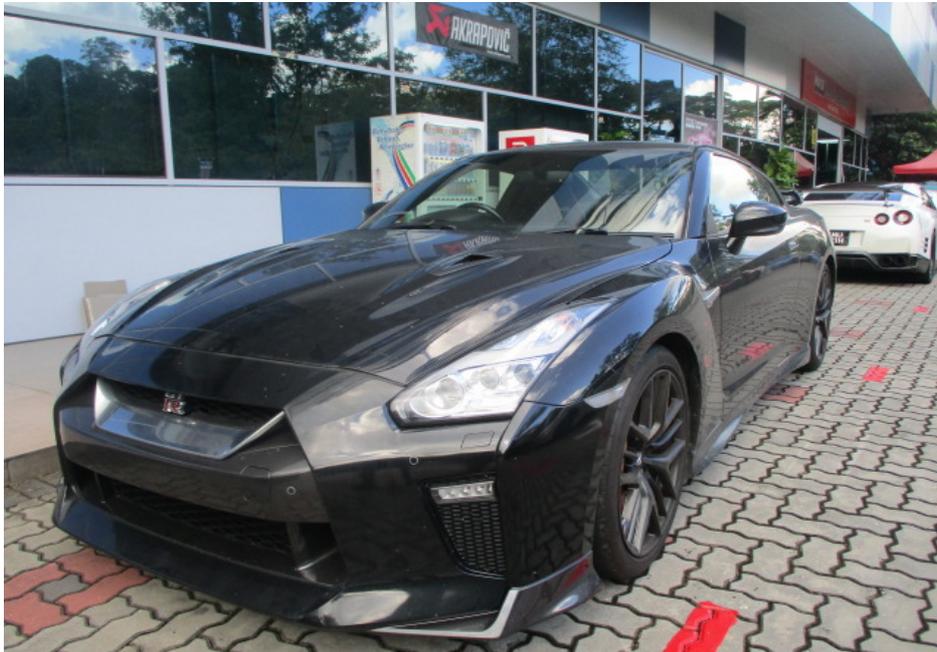
Photo 8 shows a general view of the front left body of the Motor Car at the time of my inspection. The Motor Car was observed to be in a relatively good general condition with no loose exterior fittings observed. The mileage of the Motor Car recorded at the time of my inspection was 23,628miles.

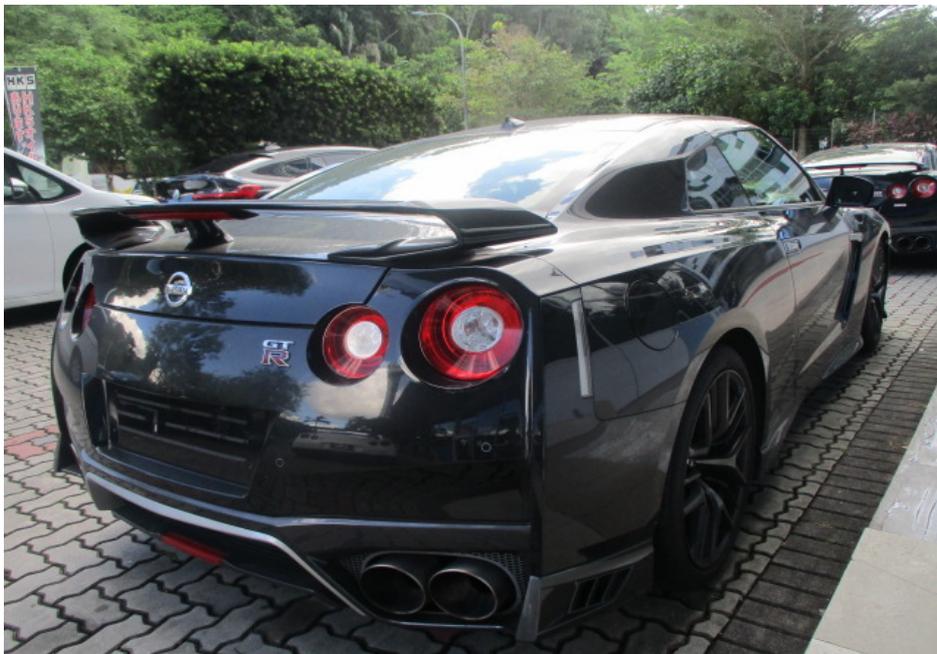
Photo 9 shows a general view of the rear right body of the Motor Car at the time of my inspection. The Motor Car was observed to be in a relatively good general condition with no loose exterior fittings observed. The mileage of the Motor Car recorded at the time of my inspection was 23,628miles.

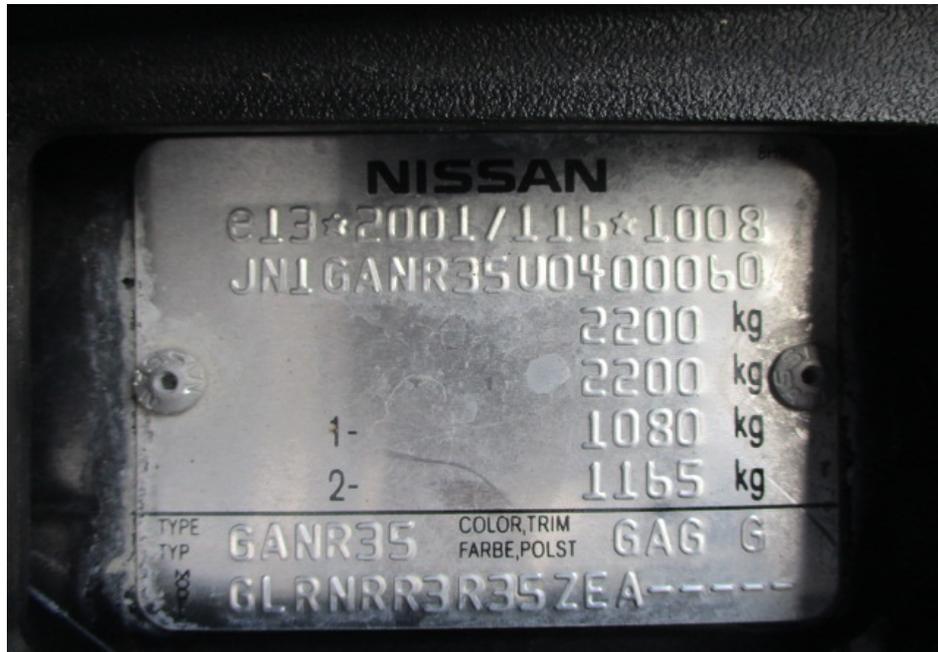
Photo 10 shows the chassis number of the Motor Car. The chassis number recorded was JN1GANR35U0400060.

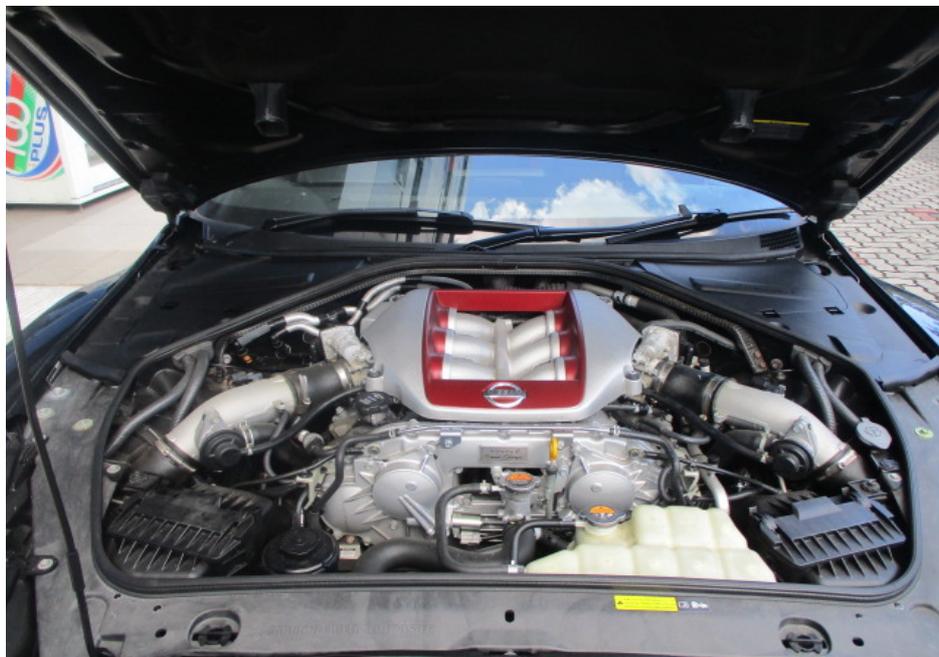
14. My examination of the engine compartment of the Motor Car revealed that the various parts and components inside the engine compartment were all intact and properly fitted. The engine oil, brake fluid and engine coolant were all found to be of sufficient level for operating purposes. Visually, there was also no contamination found to these fluids.

Photo 11 shows a general view of the engine compartment of the Motor Car at the time of my inspection. The various parts and components inside the engine compartment were all observed to be intact and properly fitted. There was also no sign(s) or indication(s) of fluid leak and/or fluid stain found inside the engine compartment.

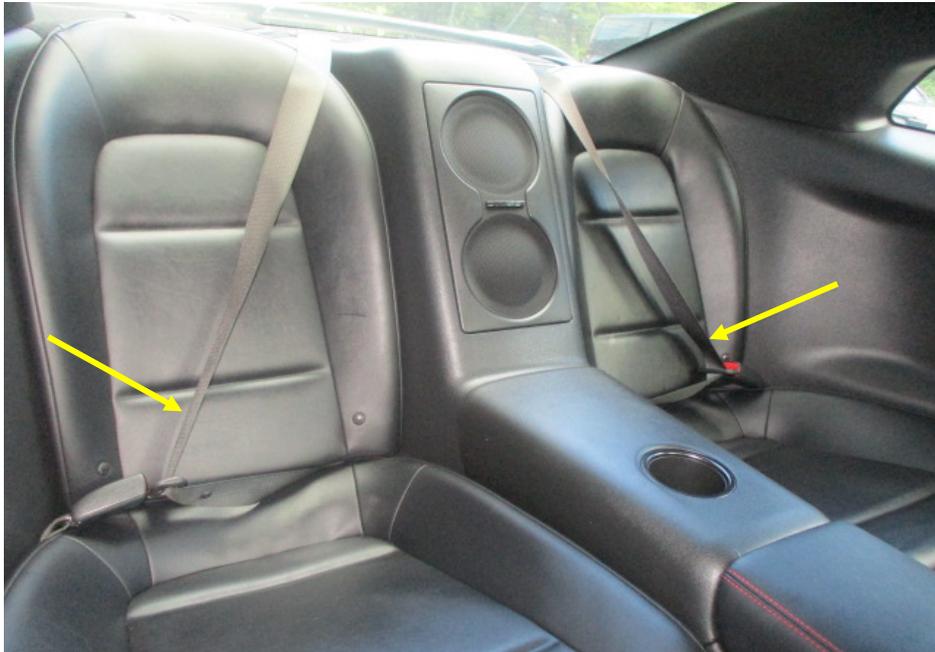
12. The seats of the Motor Car were found to be secured to the floorboard of the Motor Car via seat rails bolted onto the floorboard. Retractable seat belt reels and pre-tensioners were fitted on all seats of the Motor Car. The seat belts were tested and were able to be fastened securely into the respective pre-tensioners that were fixed to the side of all the seats.

Photo 12 shows the rear seats of the Motor Car. All the seats of the Motor Car were secured via seat rails to the floorboard. They were also fitted with a retractable seat belt reel and a pre-tensioner. The seat belts (arrowed) were tested and were able to be fastened into the respective pre-tensions that were fitted on the side of each individual seat.

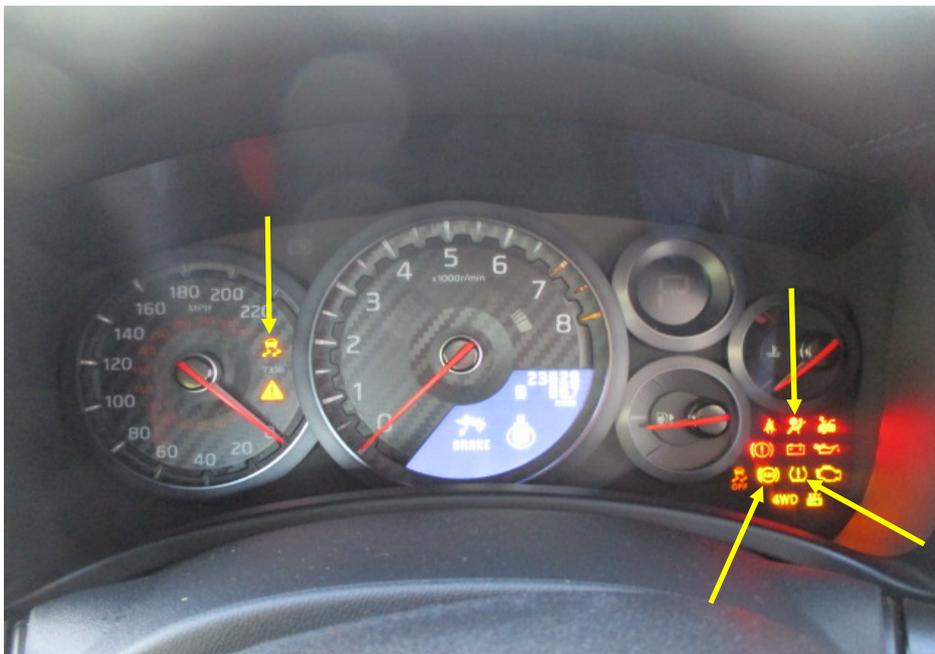
Photo 13 shows the warning lights for the various electronic safety features appearing on the instrument panel of the Motor Car during its self-test when the engine is cranked, in particular the ABS, SRS, TPM and VDC lights (arrowed).

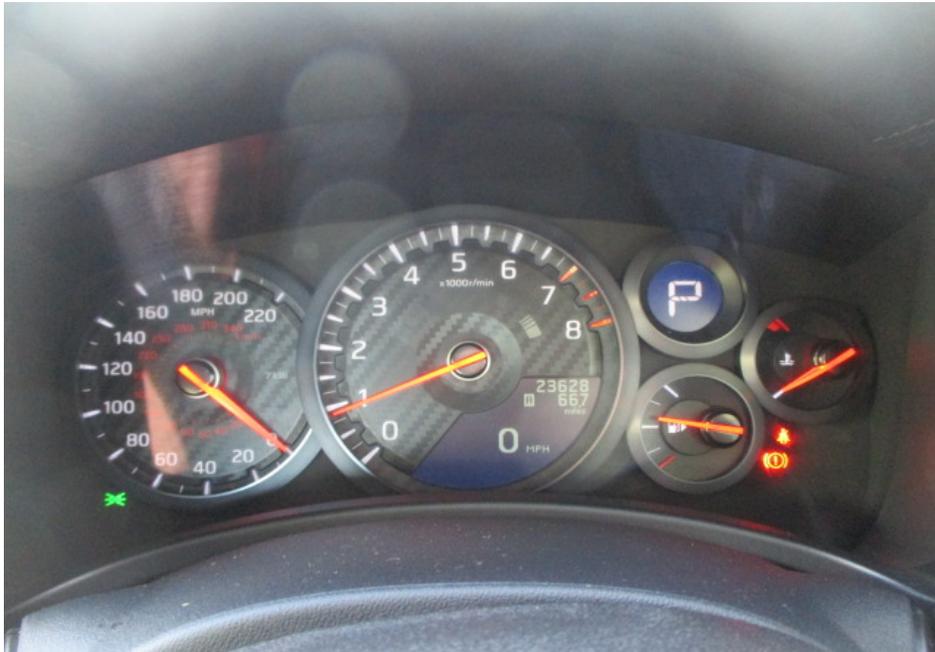
13. The Motor Car's automatic self-test of the functionality of its various electronic safety features like the Anti-Lock Brake System (ABS), Supplemental Restraint System (SRS), Tyre Pressure Monitor (TPM) and Vehicle Dynamic Control (VDC) during cranking of the engine had indicated that these electronic systems were in working condition. This was determined from the respective warning lights disappearing from the instrument panel after the self-test.

Photo 14 shows the respective warning lights no longer illuminated, indicating that there is no fault detected to the ABS, SRS, TPM and VDC systems of the Motor Car during the self-test. These electronic systems were hence in working condition at the time of my inspection.

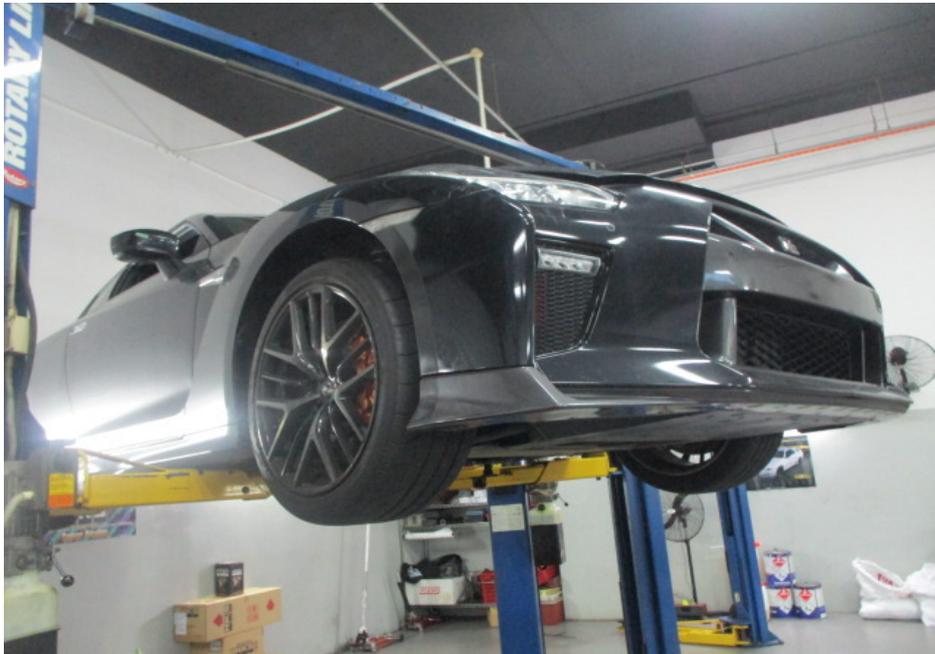
15. My checks on the underside of the Motor Car revealed no sign(s) or indication(s) of fluid leakage and/or fluid stain(s). The engine block and automatic transmission assembly were both secured properly. All undercarriage components of the Motor Car were also observed to be intact and secured in an appropriate manner.

Photo 15 shows the Motor Car hoisted up for checks on its undercarriage. There was no sign(s) or indication(s) of fluid leakage and/or fluid stain(s) on the underside of the Motor Car. The undercarriage components of the Motor Car were also all observed to be intact and secured in an appropriate manner.

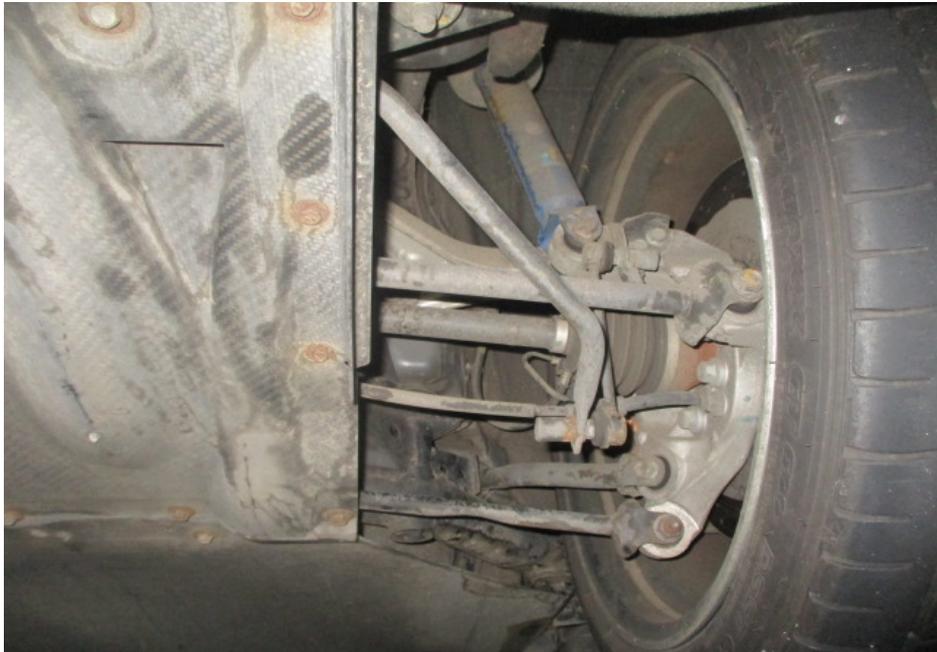
Photo 16 shows a general view of the control arms and linkages at the rear right wheel of the Motor Car. I did not observe any fluid leak and/or fluid stain on the underside of the Motor Car. All of the Motor Car's undercarriage components were observed to be intact and secured in an appropriate manner.

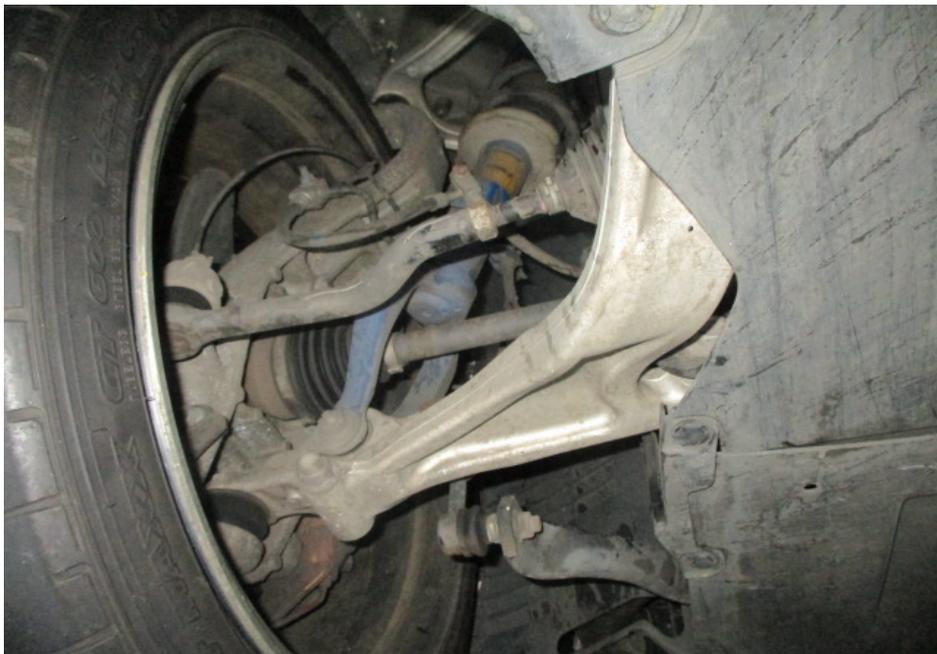
Photo 17 shows the various undercarriage components at the front left wheel of the Motor Car. The mechanical components, control arms and linkages were all found to be intact and secured in an appropriate manner.

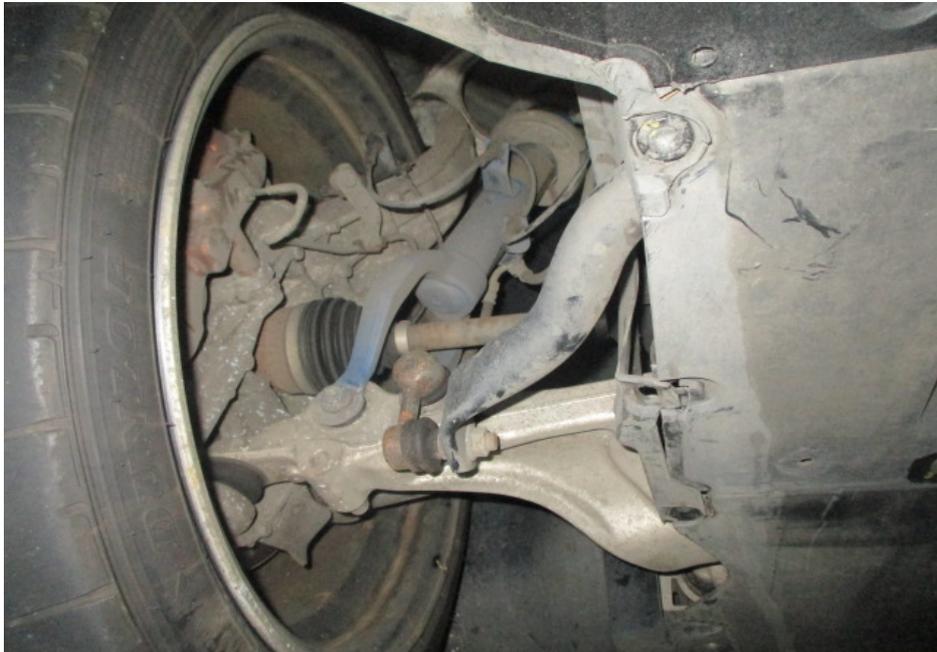
Photo 18 shows the various undercarriage components at the front right wheel of the Motor Car. The mechanical components, control arms and linkages were all found to be intact and secured in an appropriate manner. I also did not observe any fluid leak and/or fluid stain on the underside of the Motor Car.

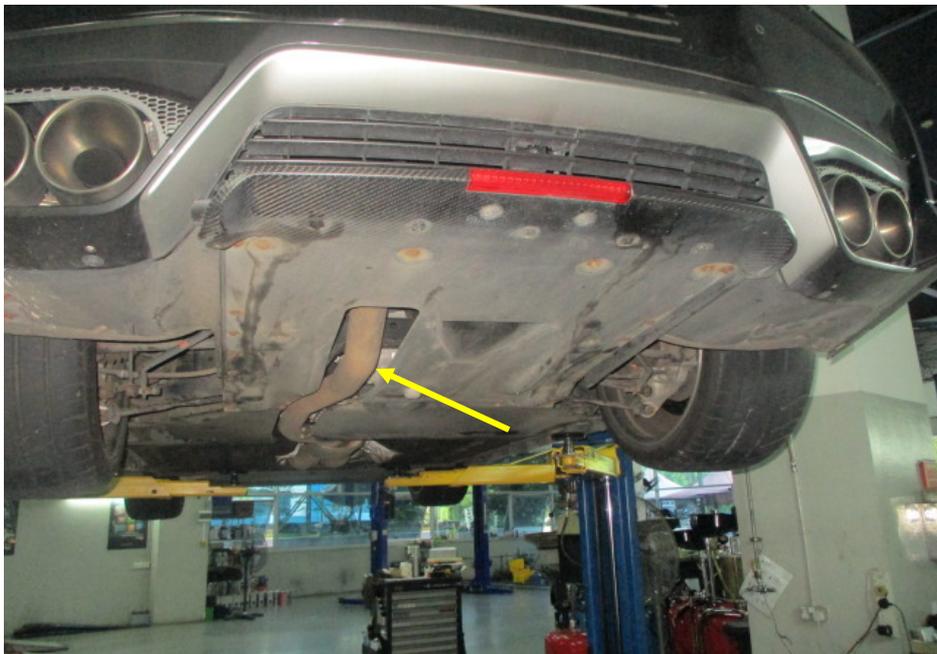
Photo 19 shows a general view of the rear section of the Motor Car's exhaust system. My examination of the Motor Car's exhaust system revealed no sign(s) or indication(s) of any cut or weld marks along its exhaust pipes (arrowed), on its catalytic converters, centre resonator box and its rear mufflers.

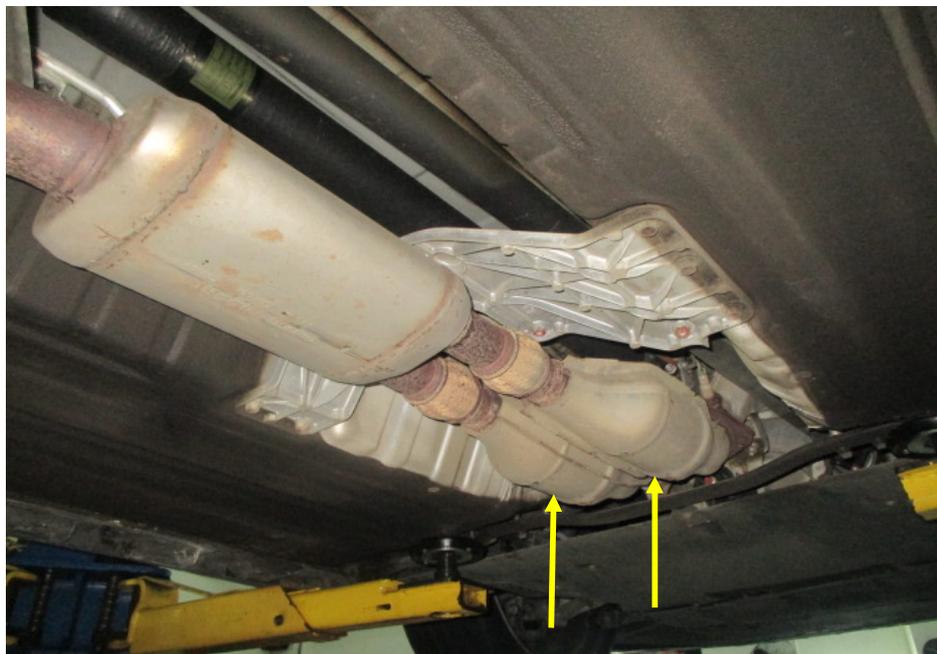
Photo 20 shows the front section of the Motor Car's exhaust system. My examination of the Motor Car's exhaust system revealed no sign(s) or indication(s) of any cut or weld marks along its exhaust pipes, on its catalytic converters (arrowed), centre resonator box and its rear mufflers.

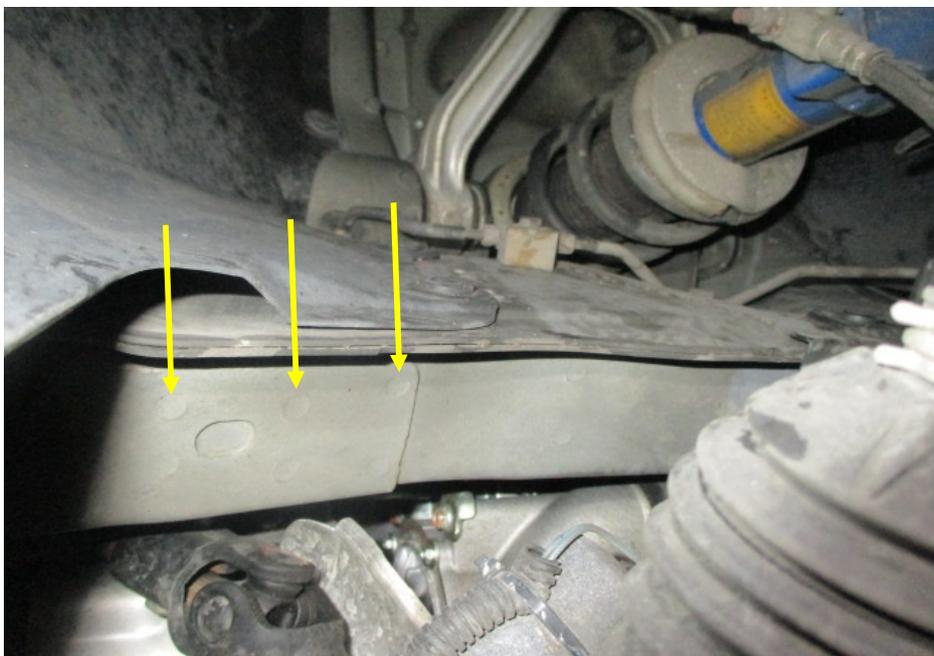
11. Visually, I did not find any weld marks, other than the original spot weld marks, on the chassis/structural body of the Motor Car. The original factory sealant at the joints along the chassis/structural body was also untouched, again indicating that no replacement of the chassis/structural body was carried out; and that the chassis/structural body was originally fitted.

Photo 21 shows the chassis/structural body at the underside front right of the Motor Car. I did not find any weld marks other than original spot weld marks (arrowed) on the chassis/structural body of the Motor Car. The original factory sealant at the joints along the chassis/structural body was untouched, indicating no work was done on the chassis/structural body of the Motor Car and that the chassis/structural body was originally fitted.

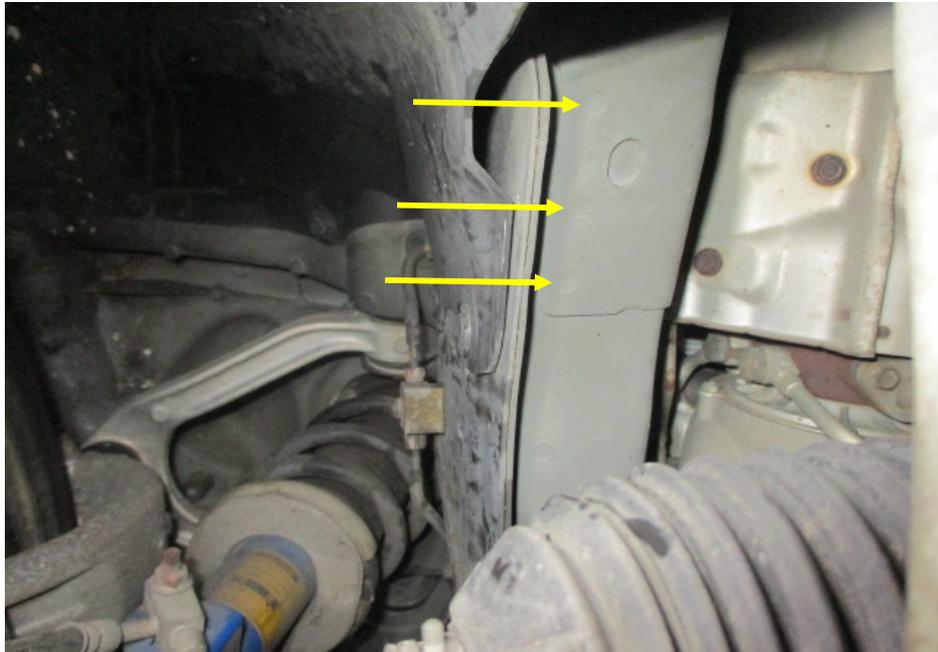
Photo 22 shows the chassis/structural body at the underside front left of the Motor Car. I did not find any weld marks other than original spot weld marks (arrowed) on the chassis/structural body of the Motor Car. The original factory sealant at the joints along the chassis/structural body was untouched, indicating no work was done on the chassis/structural body of the Motor Car and that the chassis/structural body was originally fitted.

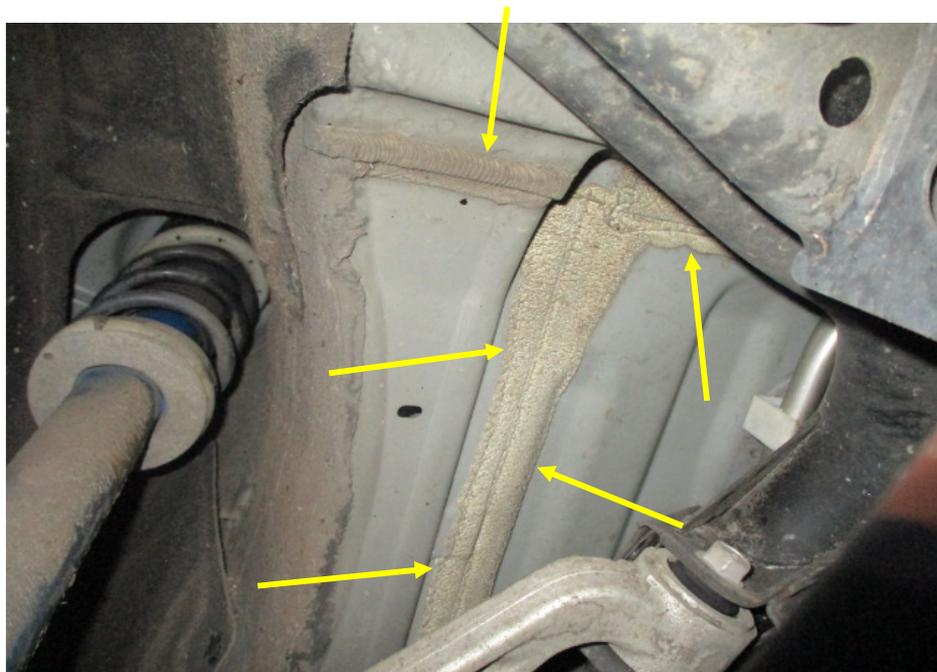
Photo 23 shows the chassis/structural body at the underside rear left of the Motor Car. The original factory sealant (arrowed) at the joints along the chassis/structural body was observed to be untouched. In general, I had found no work was carried out on the chassis/structural body of the Motor Car. The chassis/structural body of the Motor Car was originally fitted.

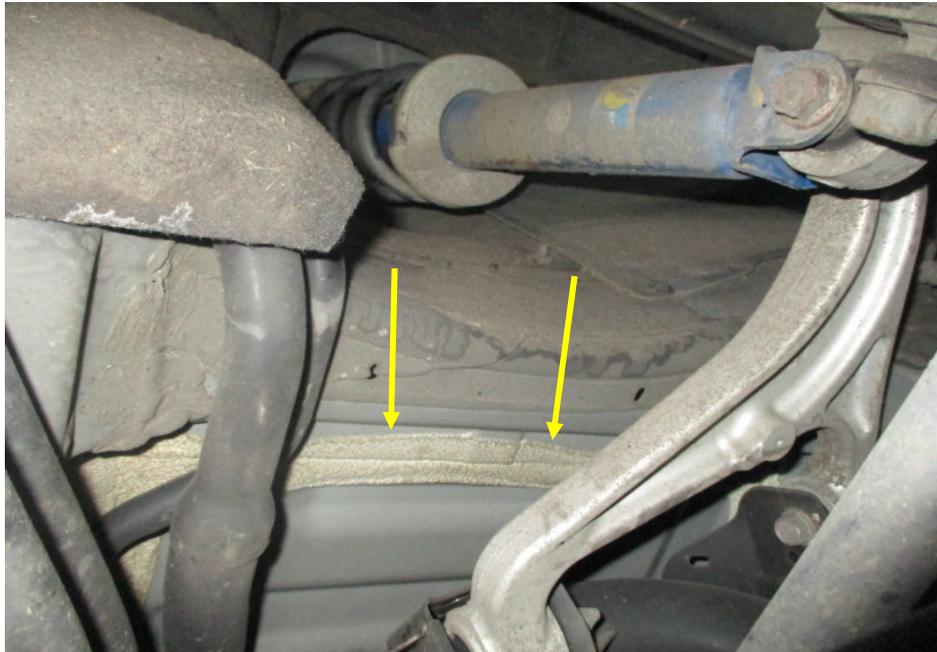
Photo 24 shows the chassis/structural body at the underside rear right of the Motor Car. The original factory sealant (arrowed) at the joints along the chassis/structural body was observed to be untouched. In general, I had found no work was carried out on the chassis/structural body of the Motor Car. The chassis/structural body of the Motor Car was originally fitted.

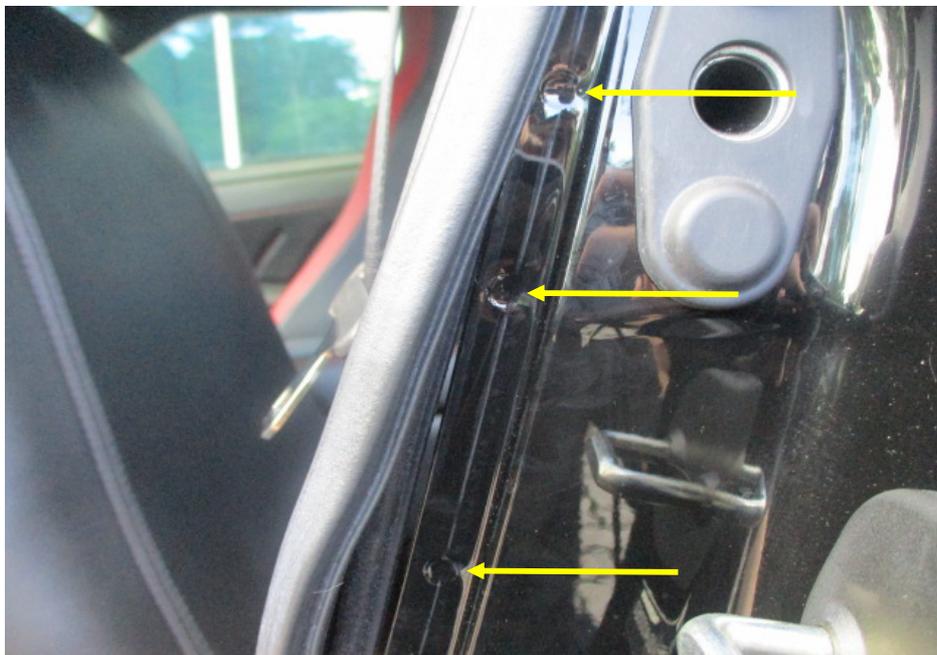
10. Checks on the non-detachable body panels like the rear fenders, floorboard, roof panel, pillars and rocker panels amongst others, revealed that these body panels were spot welded onto the chassis/structural body of the Motor Car. The original factory sealant at the joints of the non-detachable body panels was all untouched indicating no replacement of the non-detachable body panels was carried out; and that these body panels were all originally fitted.

Photo 25 shows the left side rear body panel of the Motor Car. I did not find any weld marks other than original spot weld marks (arrowed) on the left side rear body panel of the Motor Car which, indicates that there was no re-welding works carried out. In general, I had found all the non-detachable body panels of the Motor Car to be originally fitted at the time of my inspection.

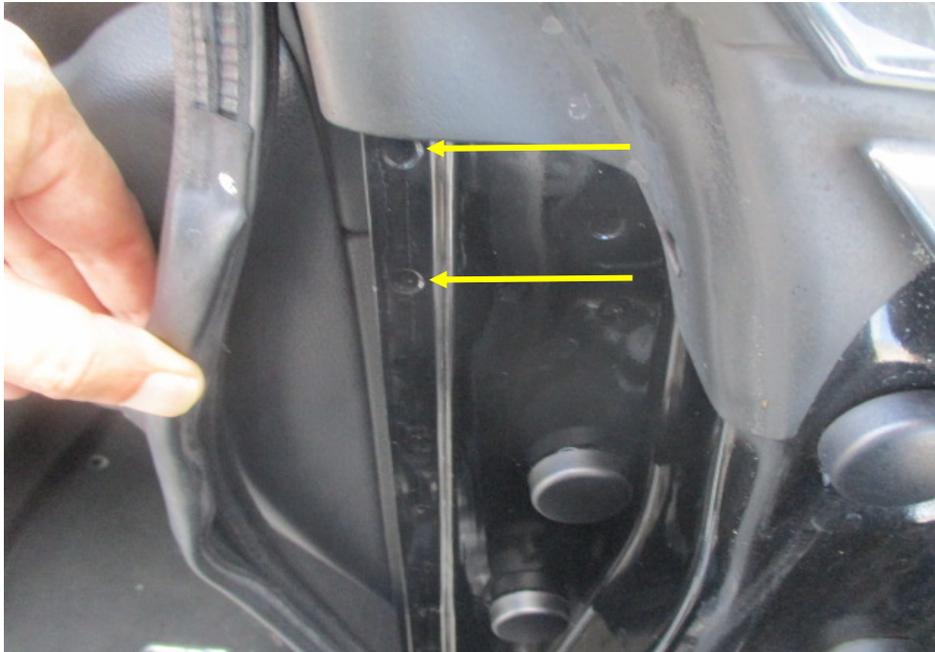
Photo 26 shows the right side “A” pillar of the Motor Car. I did not find any weld marks other than original spot weld marks (arrowed) on the right side “A” pillar of the Motor Car which, indicates that there was no re-welding works carried out. In general, I had found all the non-detachable body panels of the Motor Car to be originally fitted at the time of my inspection.
