### **DAMAGED VEHICLE (SCX 888 T) INSPECTION REPORT (WITHOUT PREJUDICE)**

| Registration No | SCX 888 T | Mileage | 087718 Km |
| Make & Model | MITSUBISHI EVO 9 | Engine No | - |

## ASSESSMENT OF REPAIRS AND SPARE PARTS COSTS FOR VEHICLE NO: SCX 888 T

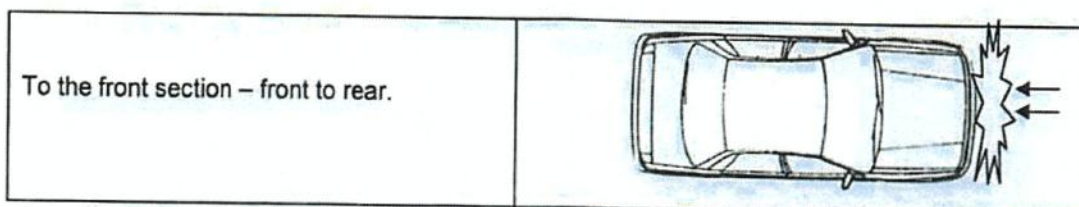
**(E) Point of Impact**

The impact of the collision has damaged the bonnet, front bumper, front bumper lower spoiler, headlamps and etc.

Our adjusted cost of lump sum repair is **\$15,000.00** and an estimated **6** days is required to repair the vehicle. Please refer to the Annex for a detailed account of the cost estimates.
