Date : 10-May-21  
Vehicle number : SCX888T  
Make Model : MITSUBISHI EVO 9  
Accident date : 15-Jan-21  
Reference number : 2101-46

### **DAMAGED VEHICLE (SCX 888 T) INSPECTION REPORT (WITHOUT PREJUDICE)**

## ASSESSMENT OF REPAIRS AND SPARE PARTS COSTS FOR VEHICLE NO: SCX 888 T

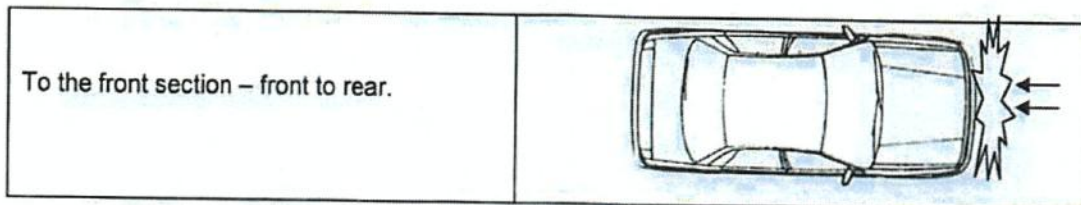
**(E) Point of Impact**

The impact of the collision has damaged the bonnet, front bumper, front bumper lower spoiler, headlamps and etc.

Our adjusted cost of lump sum repair is **\$15,000.00** and an estimated **6** days is required to repair the vehicle. Please refer to the Annex for a detailed account of the cost estimates.
