Our Ref : TP / TWG SCX888T/ 01.15/21
Your Ref :

DAMAGED VEHICLE (SCX 888 T) INSPECTION REPORT (WITHOUT PREJUDICE)

Registration No	SCX 888 T	Mileage	087718 Km
Make & Model	MITSUBISHI EVO 9	Engine No	-
Date of Registration	-	Chassis No.	CT9A0405965
Colour	Purple	Engine Capacity	1,997 c.c.

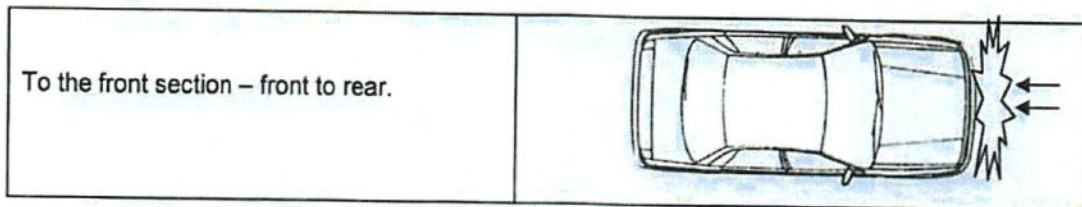
(E) Point of Impact

The impact of the collision has damaged the bonnet, front bumper, front bumper lower spoiler, headlamps and etc.

Our adjusted cost of lump sum repair is **\$15,000.00** and an estimated **6** days is required to repair the vehicle. Please refer to the Annex for a detailed account of the cost estimates.
