## LKK Auto Consultants Pte Ltd

Vehicle No. SLA 4654P  
Insured Veh. SJN 2602H  
Claim No. SNM21D203863/C02  
Policy No. DMPCSNW00022782100  
Accident Date 12/07/2021  
Inspection Date 13/07/2021

## ADJUSTMENT ON REPAIR COST FOR VEHICLE NO. SLA 4654P

PHOTOGRAPHS FOR VEHICLE NO. SLA 4654P

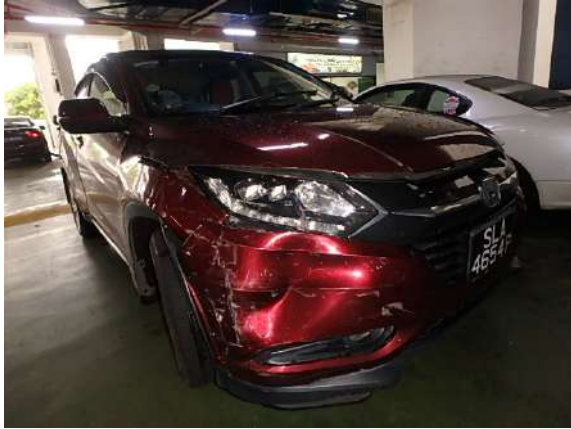
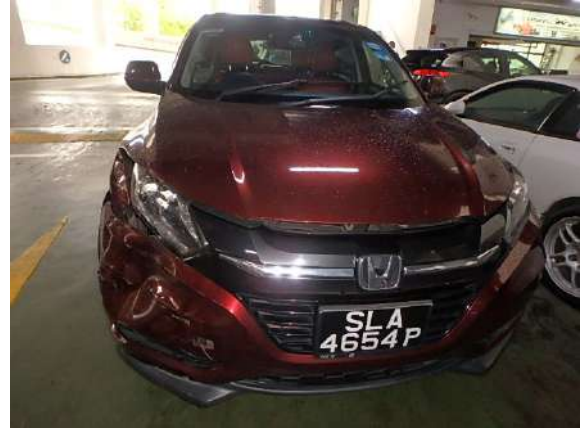
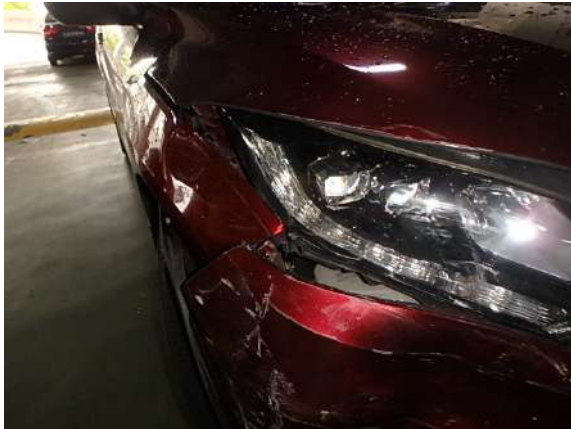
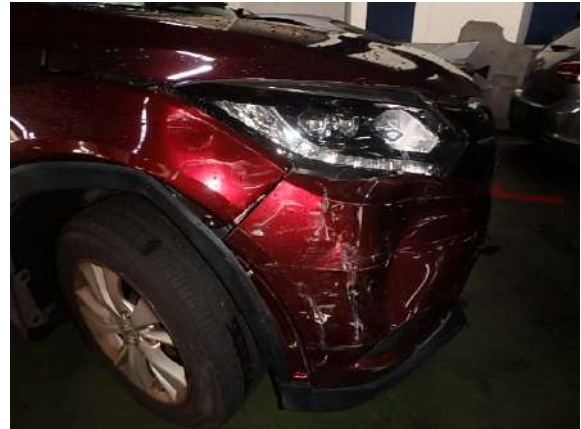
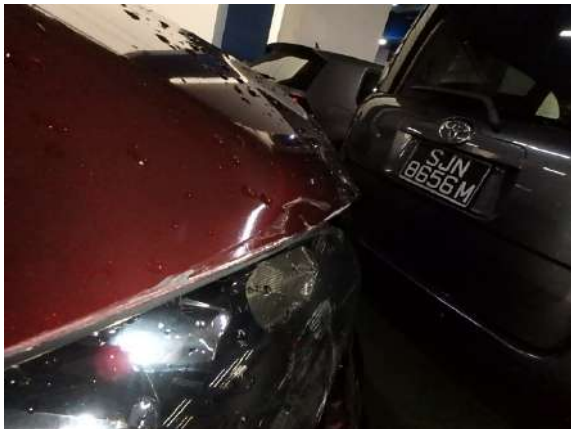
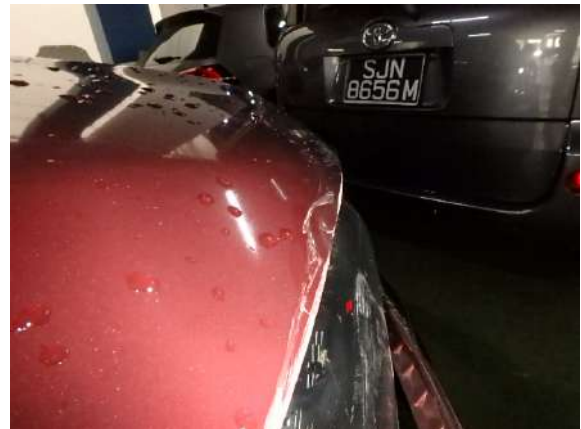
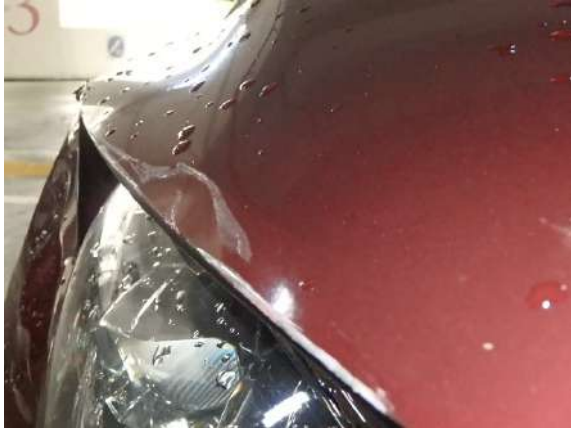
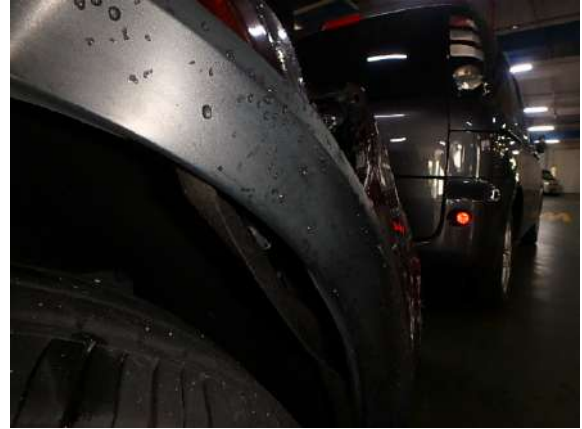
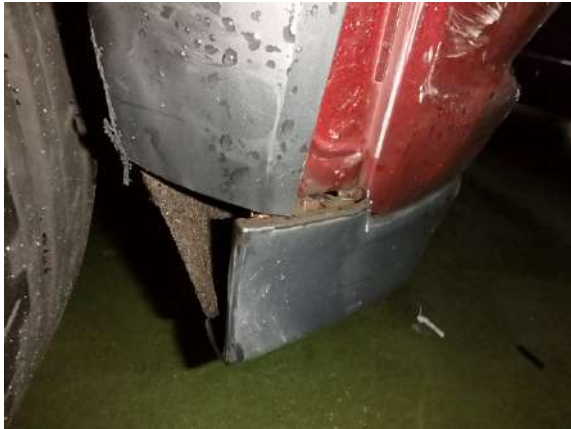
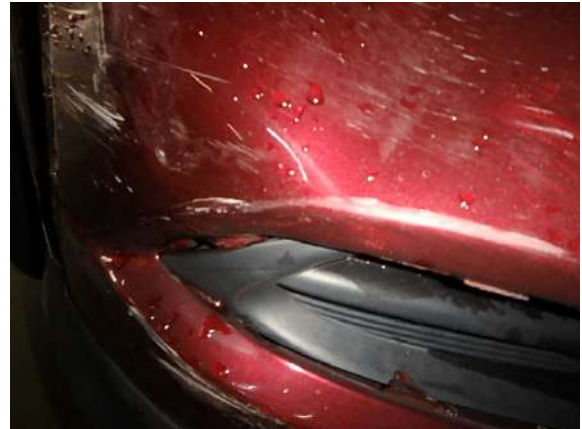
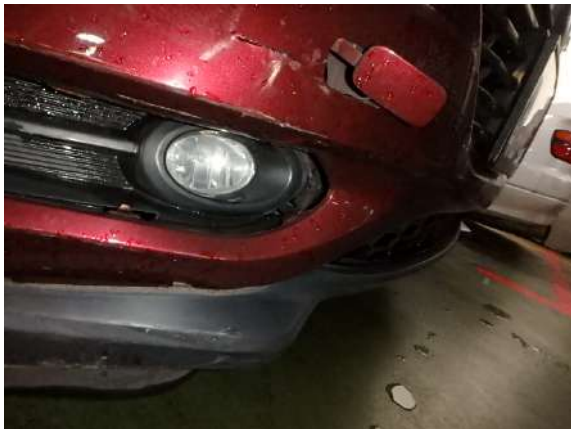
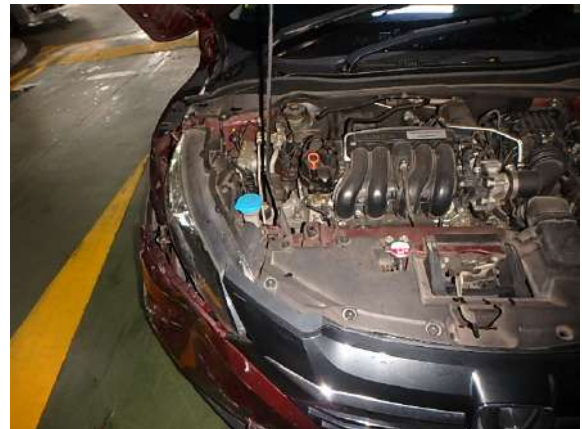
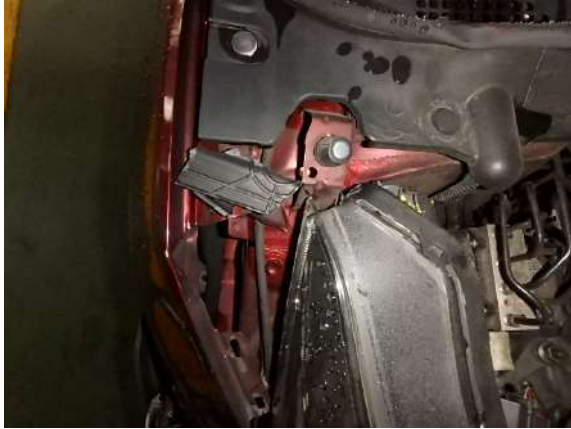
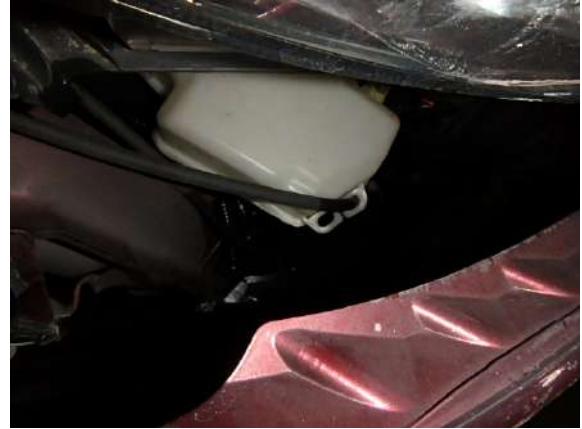
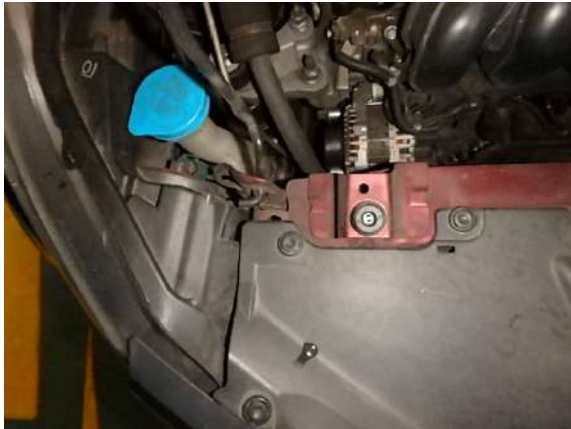
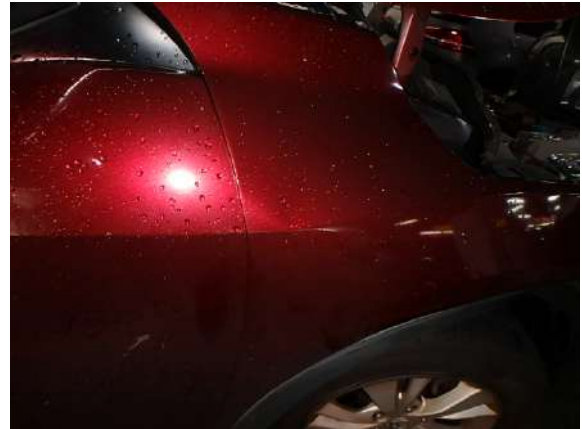
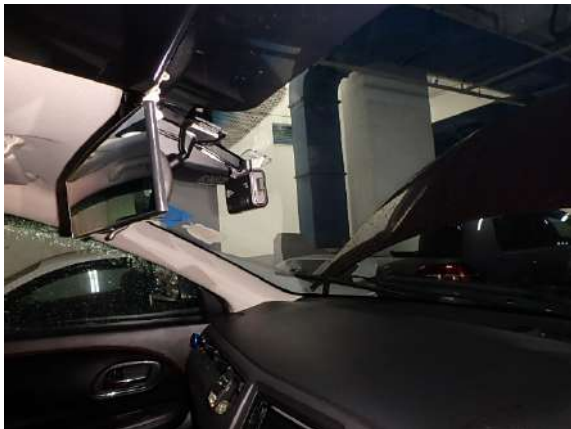
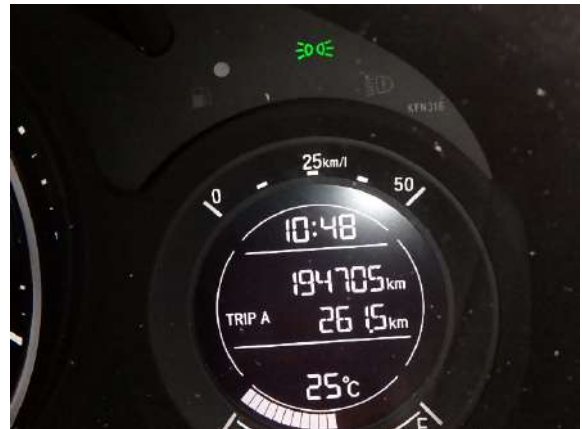
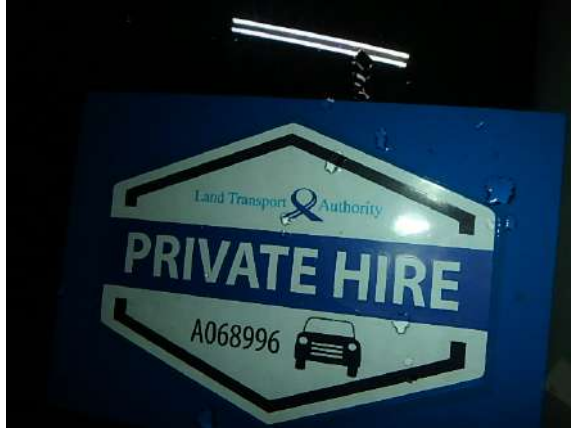
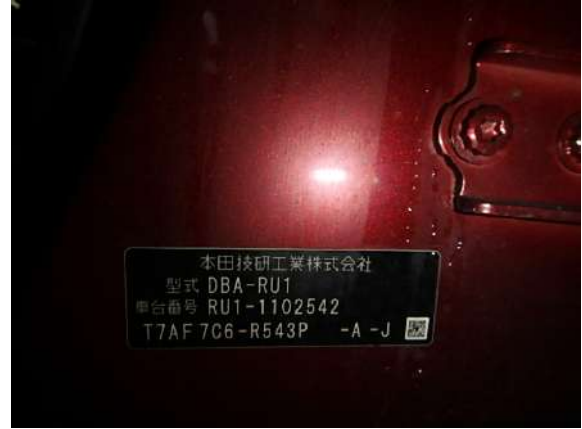
INSPECTION

| Affiliated to Federation Internationale Des Experts En Automobile | | | | |
|---|---|---|---|---|
| | THE VEHICLE SUSTAINED DAMAGES AT THE O/S FRONT PORTION.<br><br>DAMAGES SEE DETAILS. | | | |
