Precise Appraiser Pte Ltd

VEHICLE DAMAGE ASSESSMENT REPORT

Ref No	: 2020/0188	Date of Report	: 16/10/2020
Claim Type	: Third Party	Date of Request	: 21/10/2020
Third party vehicle	: SGL6673Y	Date of Accident	: 15/10/2020
Insured Vehicle	:	Date of Inspection	: 21/10/2020
Your Reference No	: -

Registration Plate No	: SGL6673Y	Engine Modification	: NIL
Model / Make	: Toyota Wish	Pre-accident damage	: NIL
Colour	: Grey	General Condition	: Good
Manufacturing Year	: 2006	General Paint Work	: Good
Engine No	: 1ZZ2665346	Steering	: Serviceable
Engine Capacity	: 1800 cc	Handbrake	: Serviceable
Chassis No	: ZNE100320680	Footbrake	: Serviceable
Odometer No	: 221514		
Transmission	: Auto

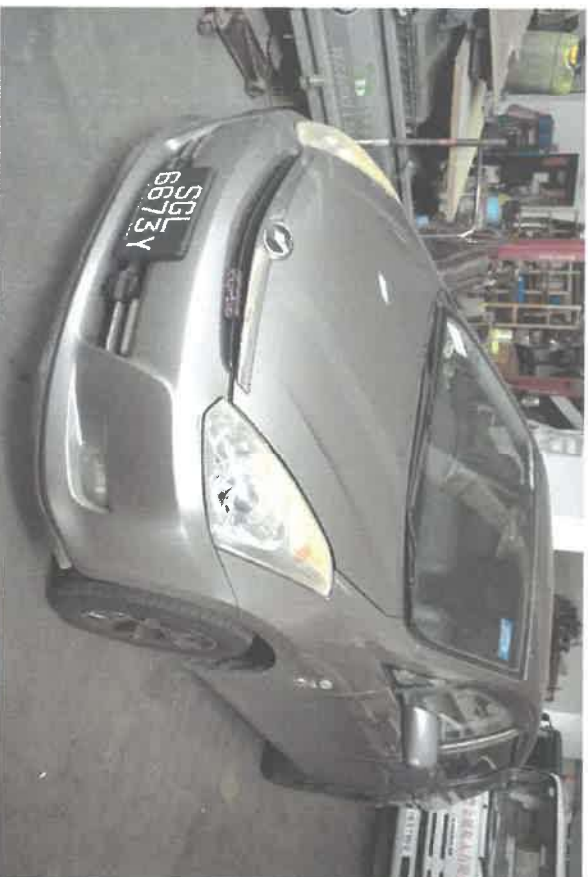
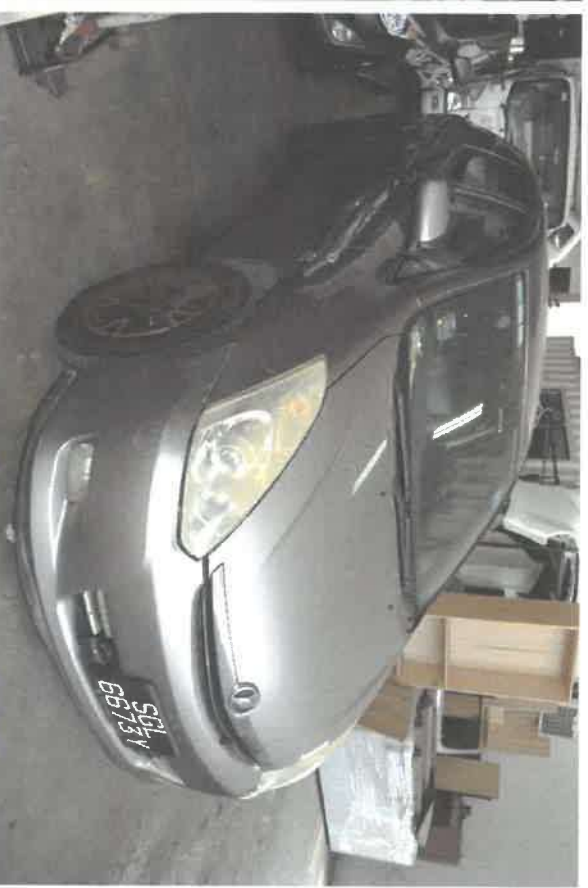
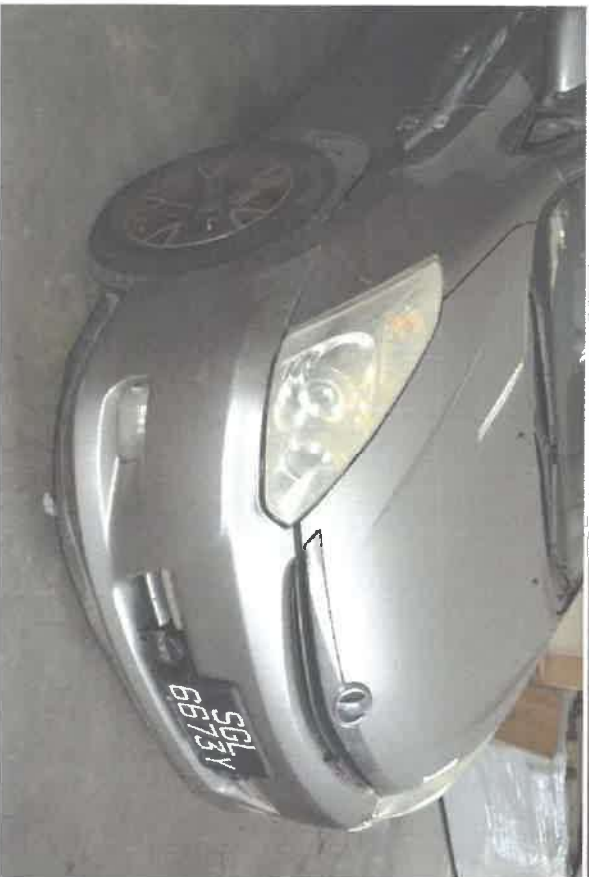
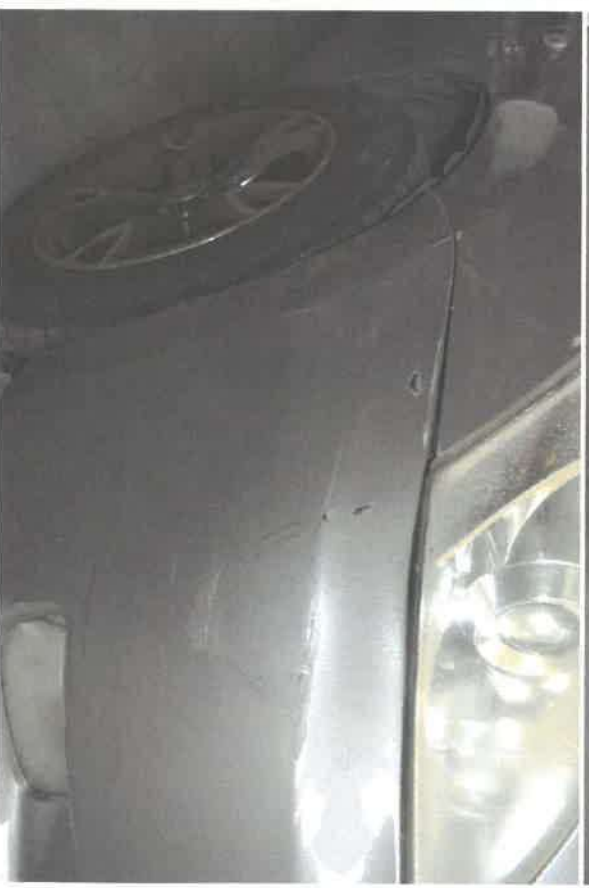
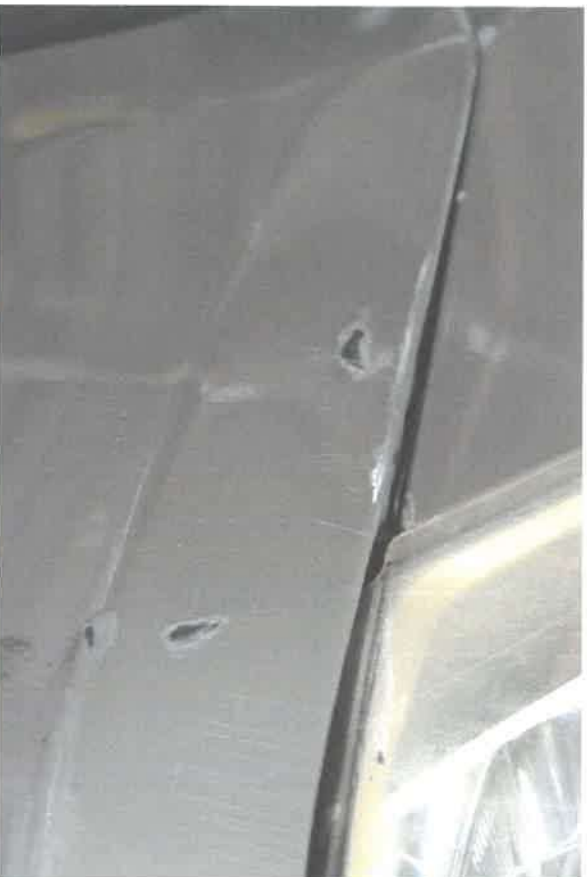
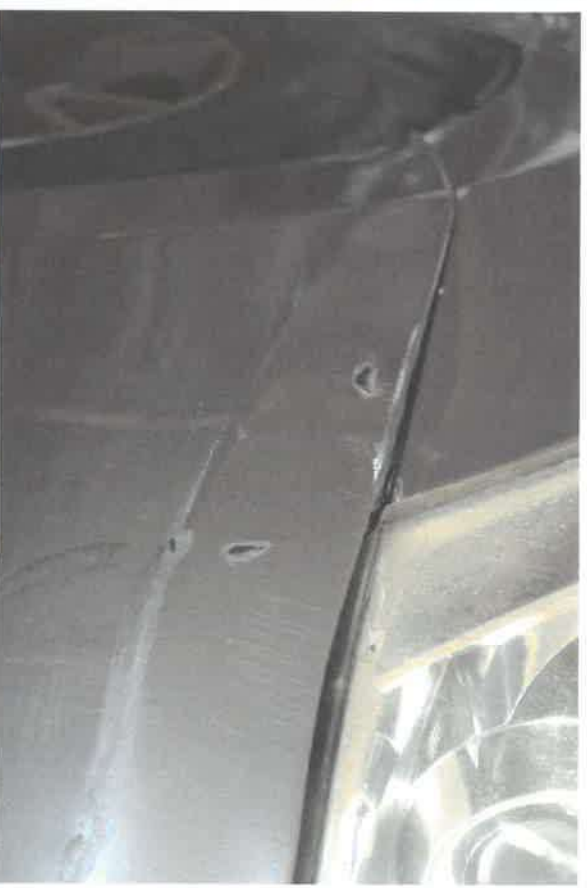
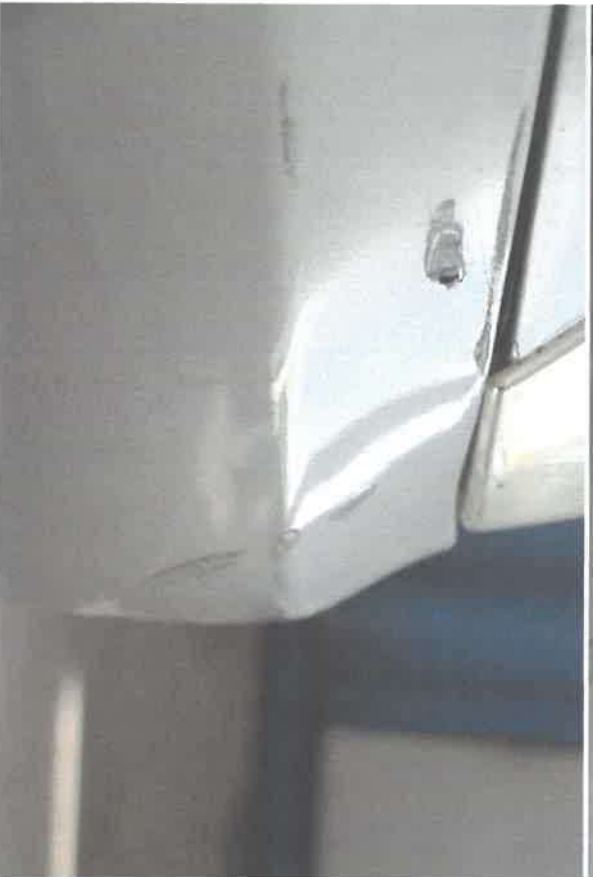
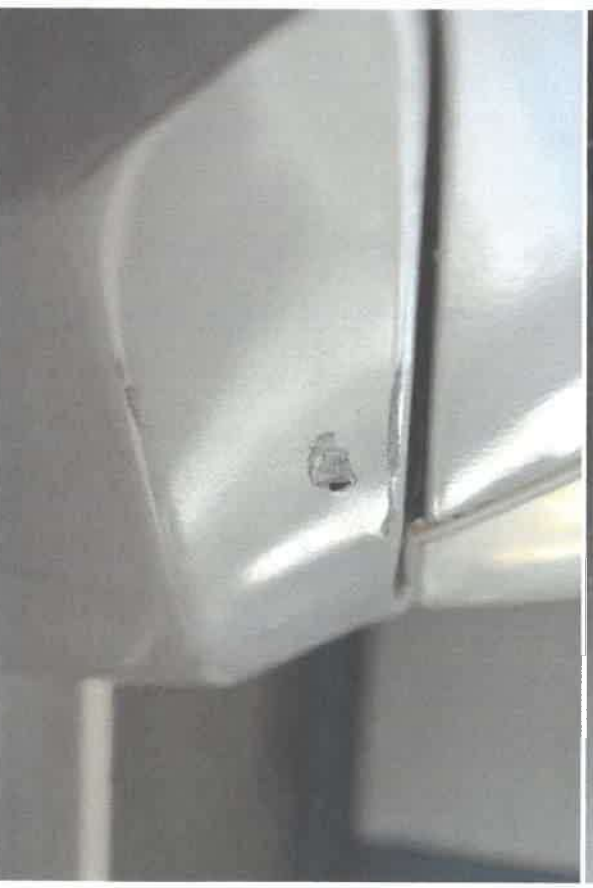
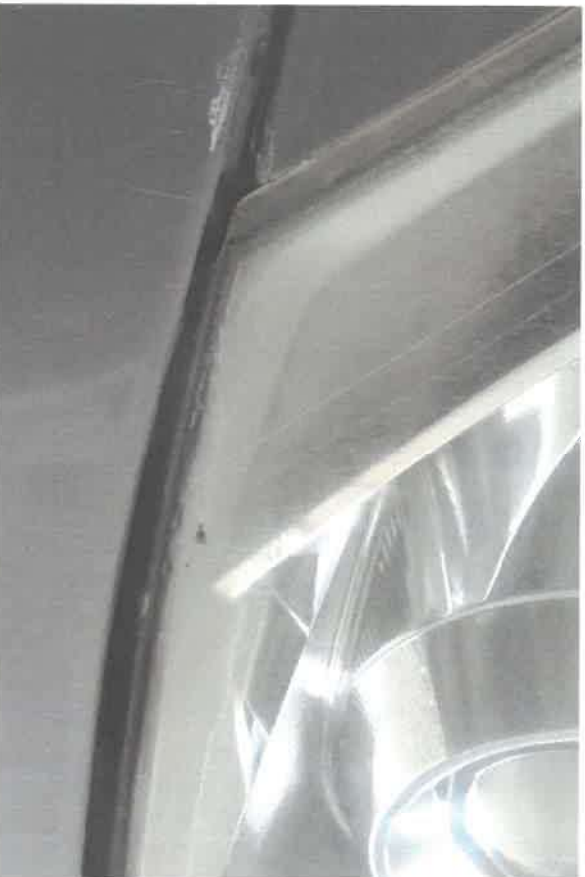
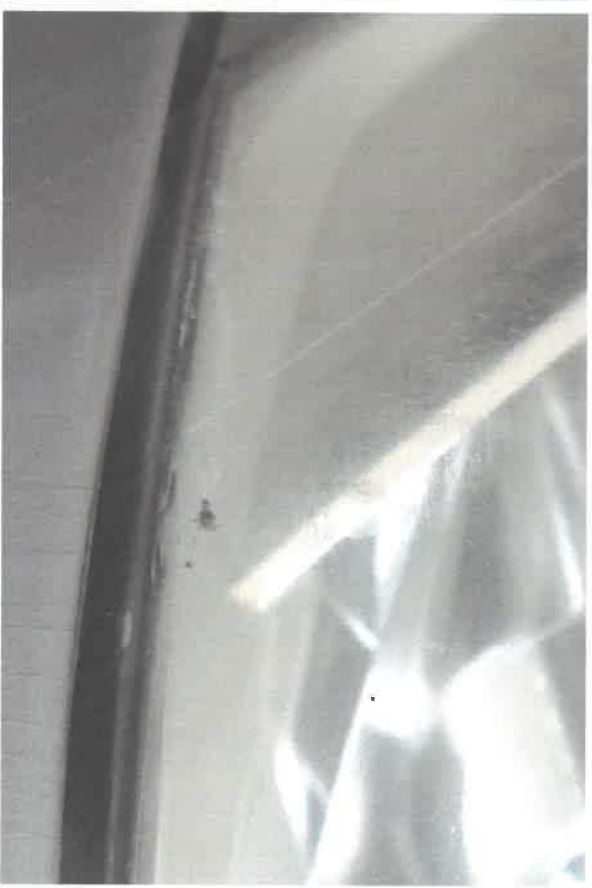
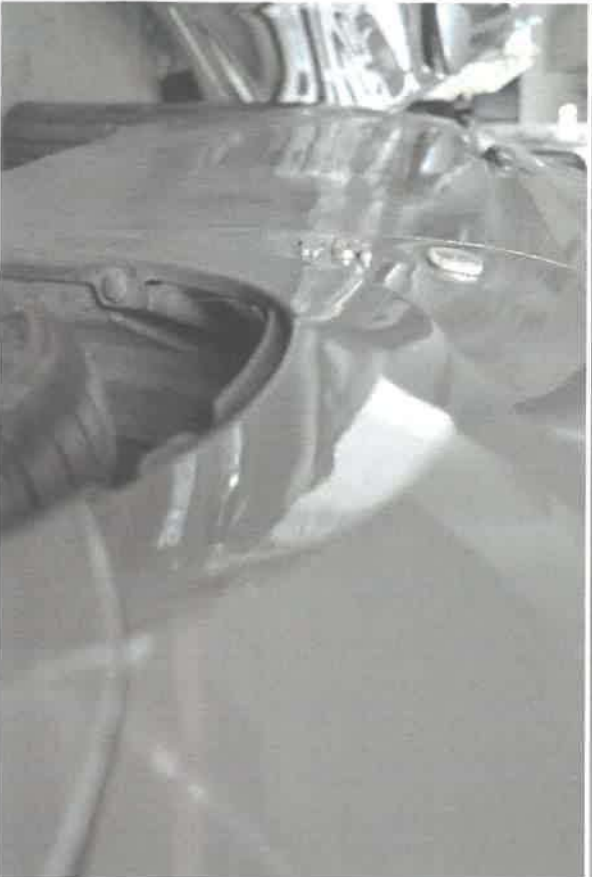
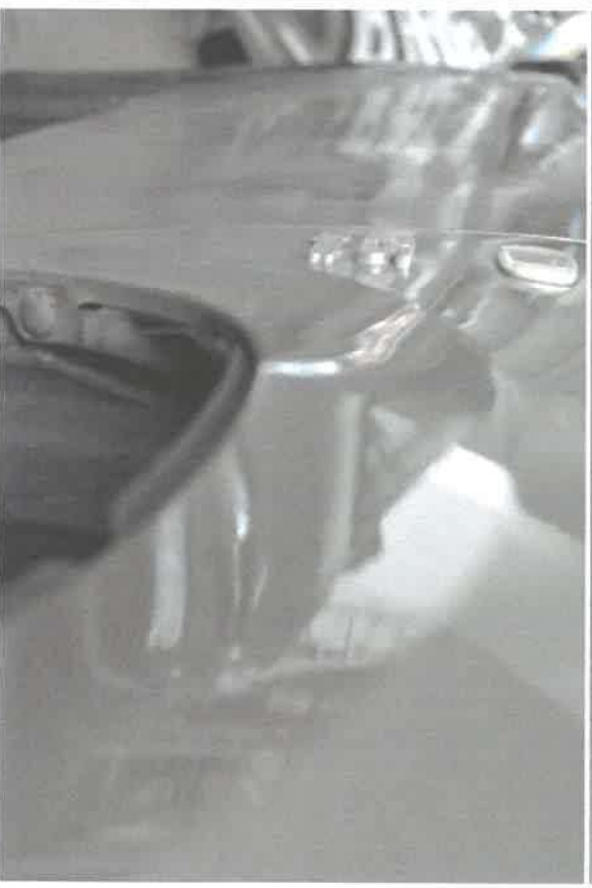
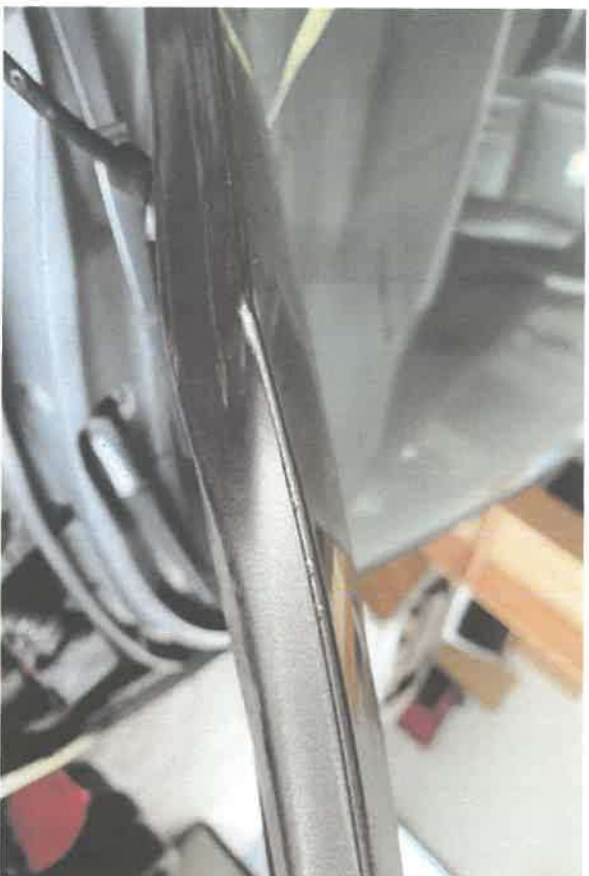
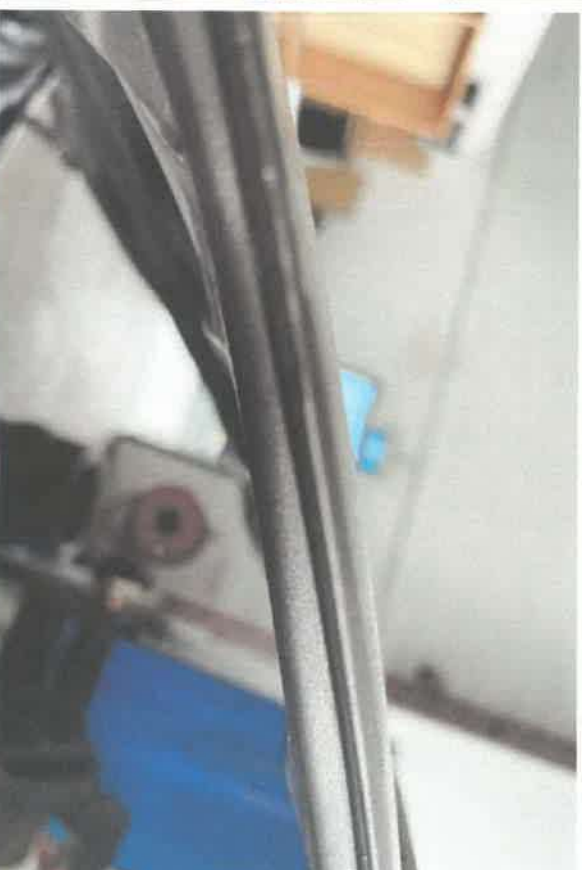
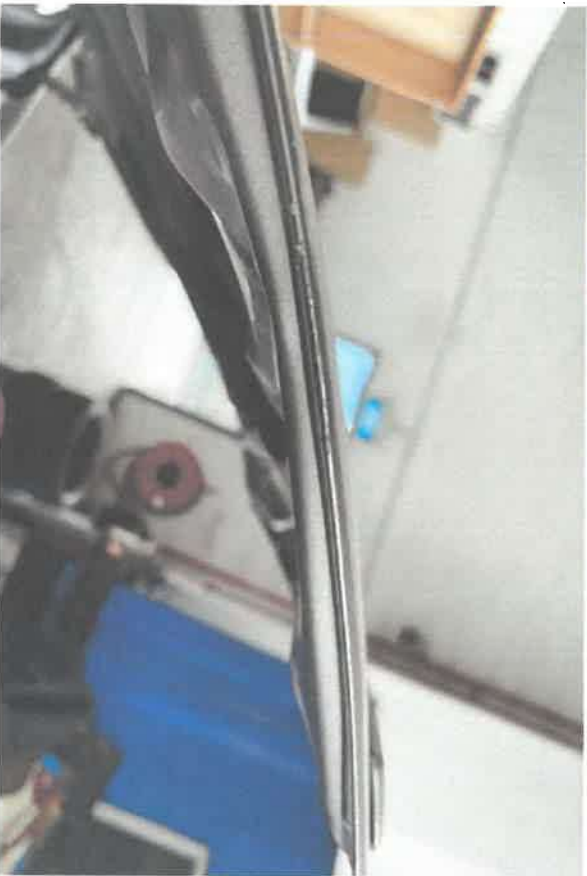
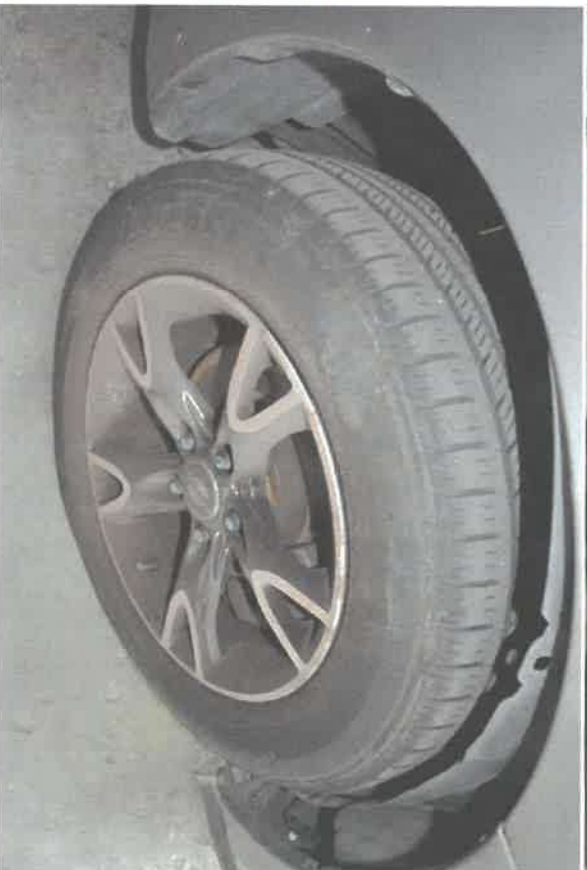
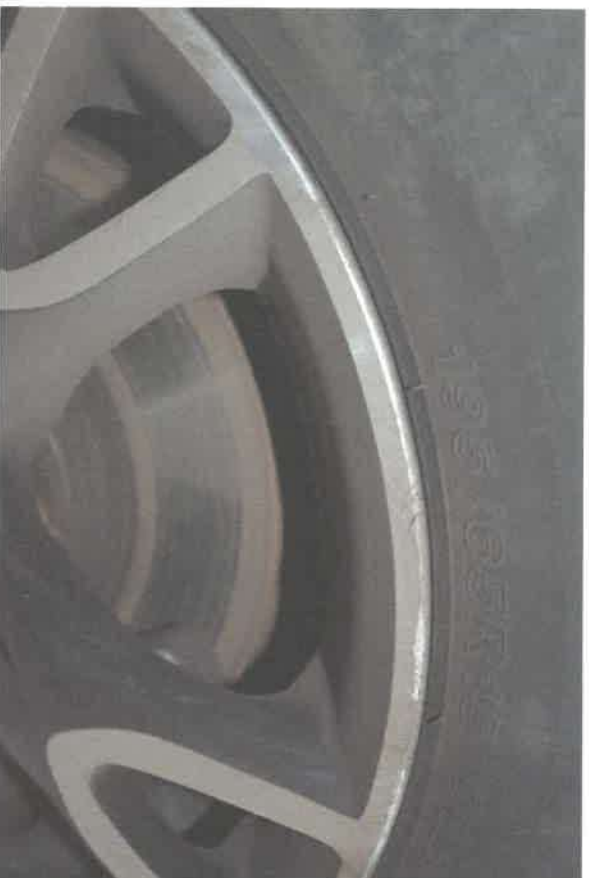
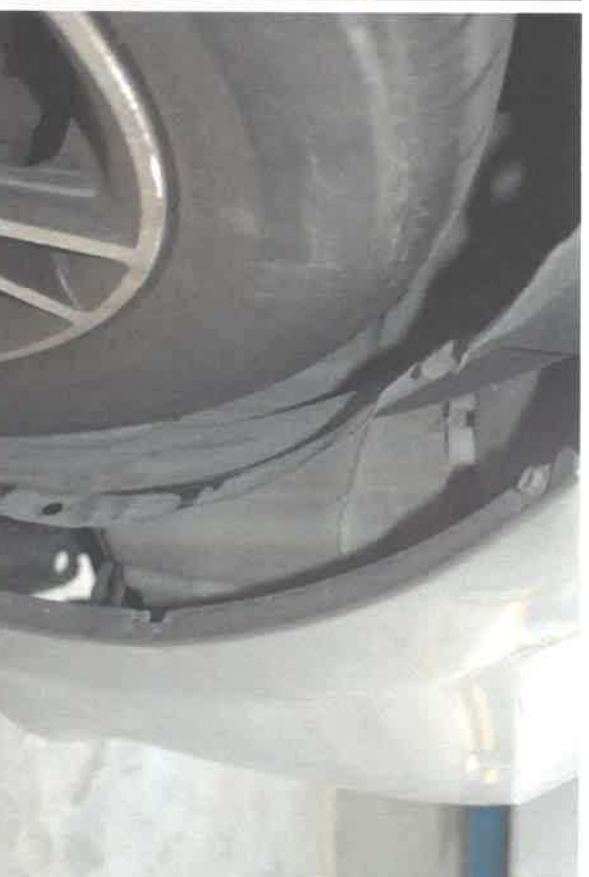
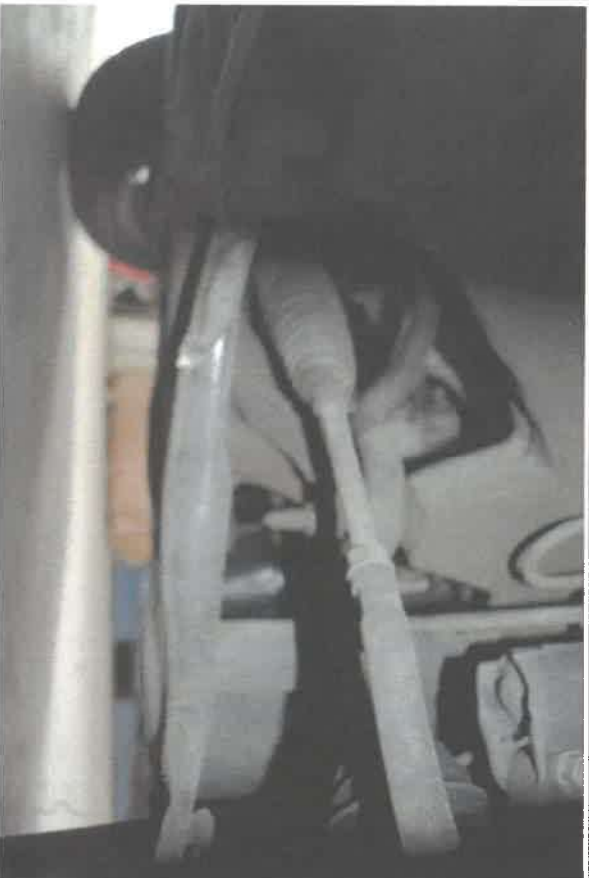
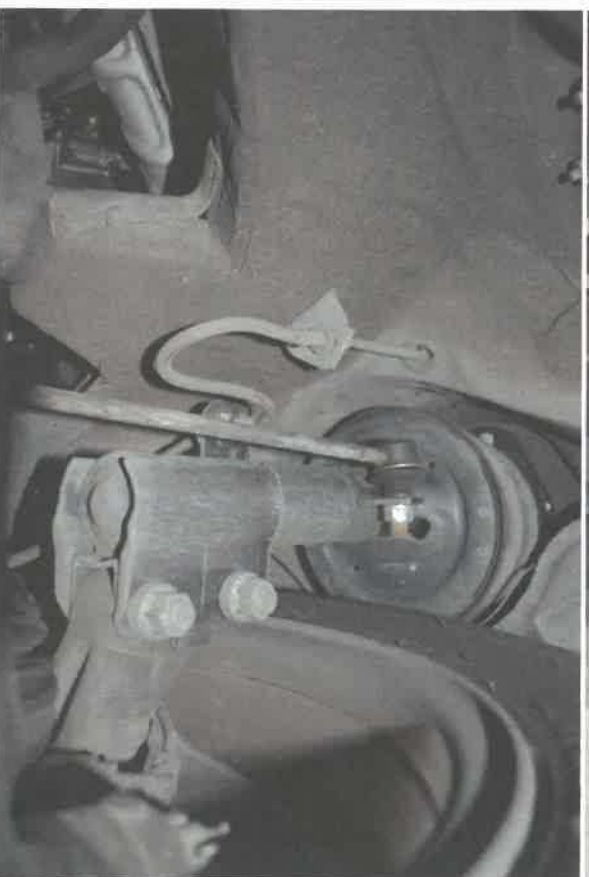
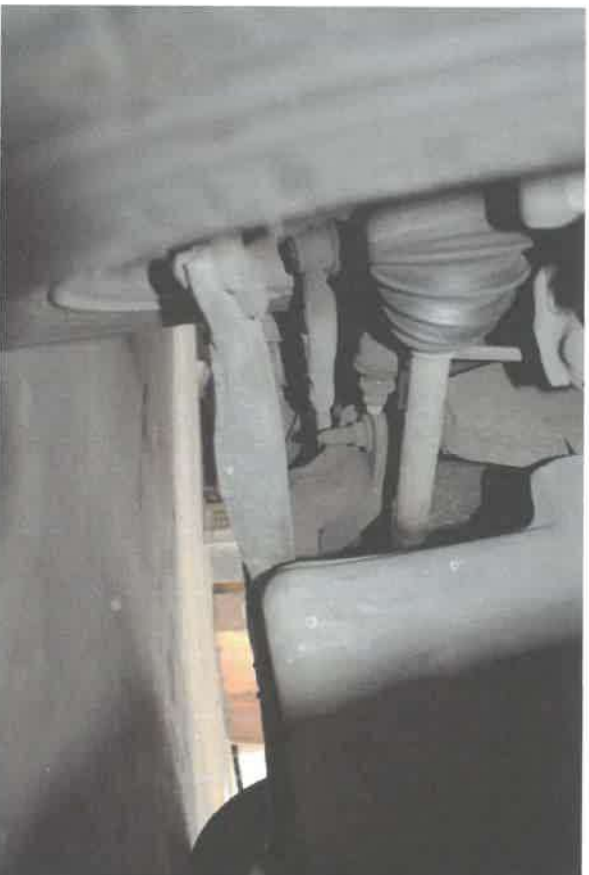
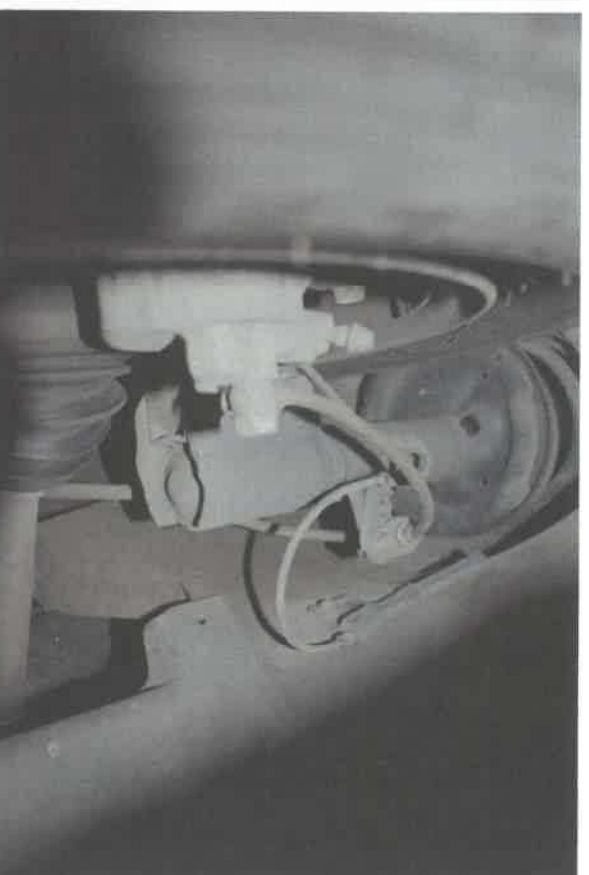
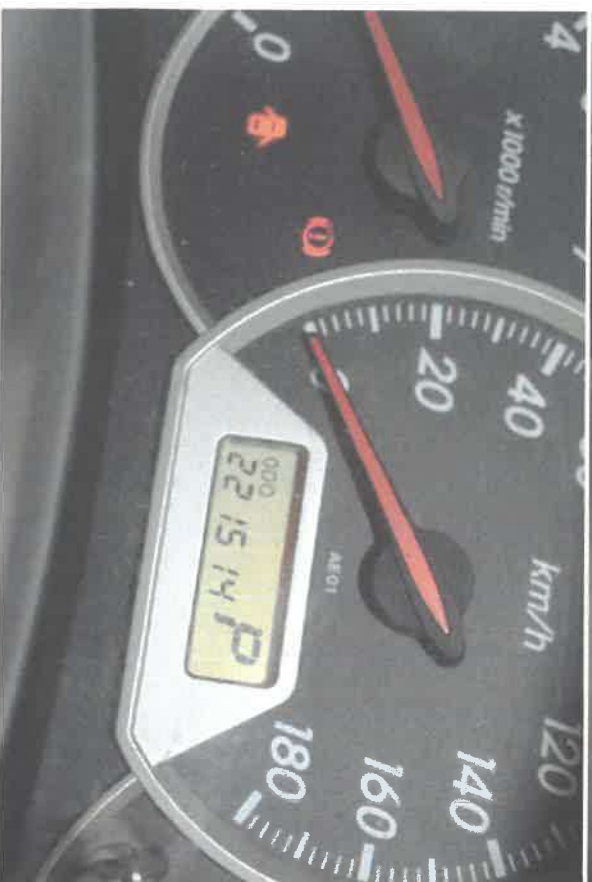
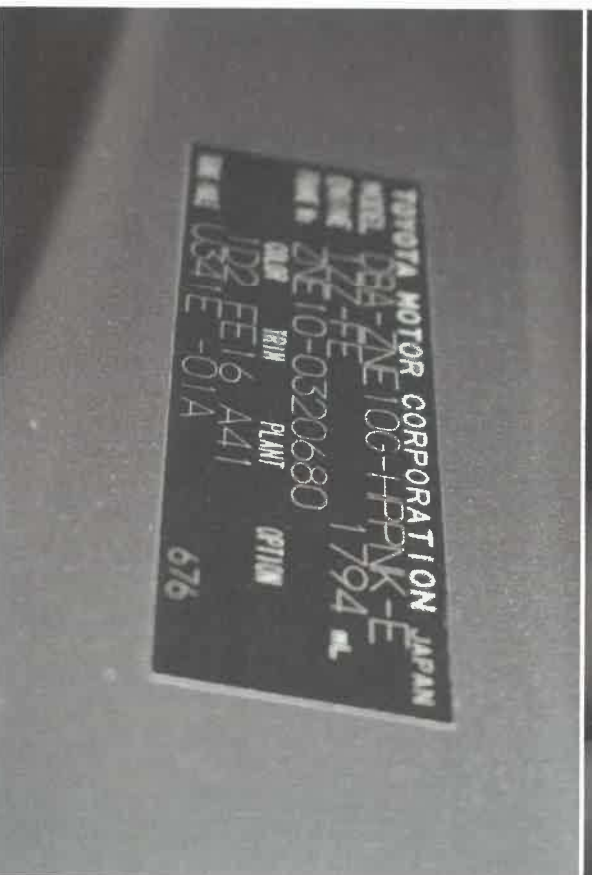
At the time of inspection, this vehicle sustained damages to the **Rh Portion**.

Front bumper holder torn, front rh fender, rh headlamp holder torn, front rh sport rim grazed, front rh undercarriage push in, support panel dented, bonnet scratch etc.
