Your Ref: Porsche Marcan  
(chassis number WP1ZZZ95ZKLB23155)  
Our Ref : CI/TP21007570/D

13 July 2021

**INSPECTION REPORT OF AN UNREGISTERD PORSCHE MARCAN MOTOR CAR WITH CHASSIS NUMBER WP1ZZZ95ZKLB23155**

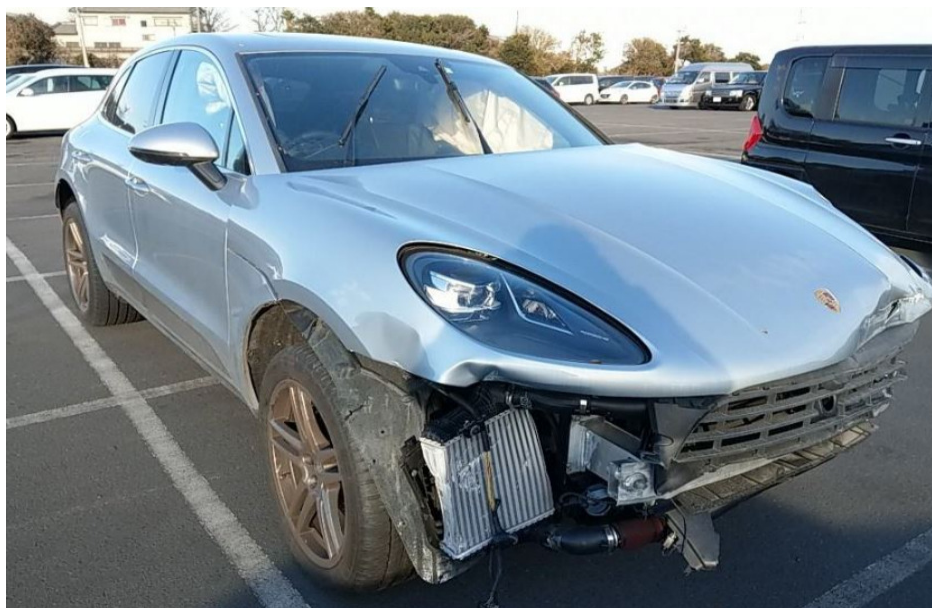
3. The photographs provided to me had showed damage to the frontal portion and rear left portion of the Motor Car. Body parts observed to be damaged at the frontal portion include the front bumper, front bumper left grille, front bumper right grille, front bumper lower cover, front bumper centre lower grille, front bumper left lower grille, front bumper right lower grille, front bumper reinforcement, front radiator grille, front day running lights, front left headlamp, front bonnet, front radar unit, intercoolers, front left fender inner shield, front right fender inner shield and front left wheel rim amongst others.

**Photo 1** shows the front right body of the Motor Car prior to any repairs being carried out (photograph provided to me). The Motor Car was observed to have sustained damages at its frontal portion. The front bumper, front bumper right grille, front bumper centre lower grille, front bumper right lower grille, front bumper reinforcement, front radiator grille, front right day running light, front right intercooler, front bonnet and front right fender inner shield were amongst the body parts that were observed to be damaged.

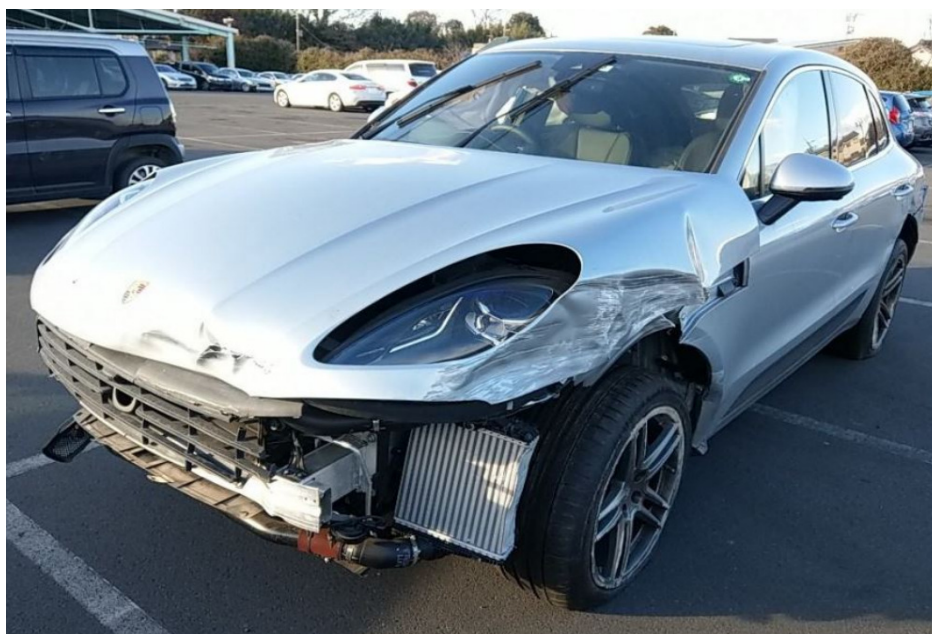
**Photo 2** shows the front left body of the Motor Car prior to any repairs being carried out (photograph provided to me). The Motor Car was observed to have sustained damages at its frontal portion. The front bumper, front bumper left grille, front bumper centre lower grille, front bonnet, front left day running light, front left intercooler, front left headlamp and front left wheel rim were amongst the body parts that were observed to be damaged.

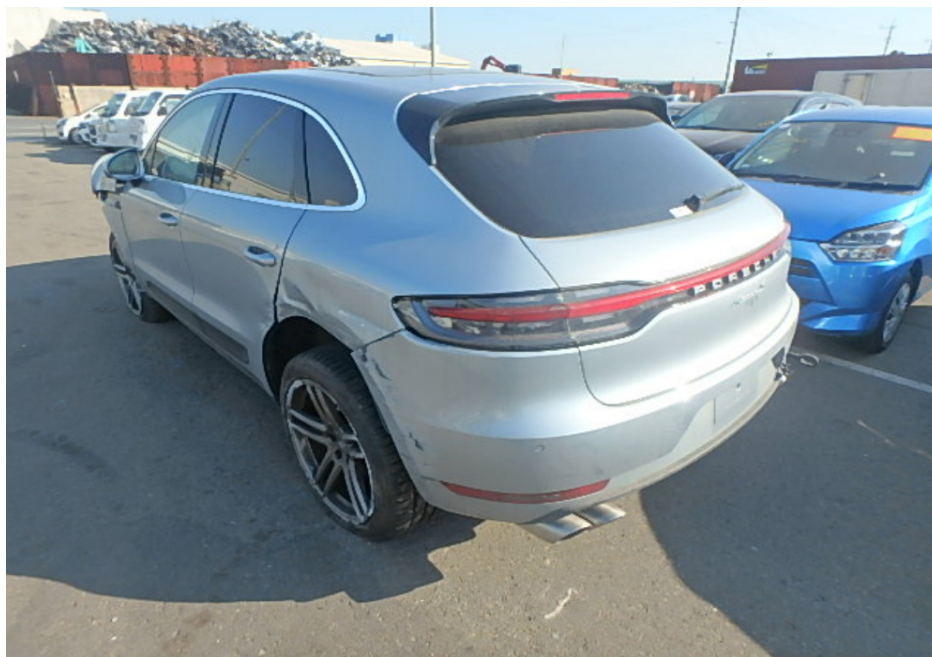
4. With regard to the rear left portion, I had observed damage to the rear bumper, rear left taillamp, rear left fender, rear left door and rear left wheel rim amongst others.

**Photo 3** shows the rear left body of the Motor Car prior to any repairs being carried out (photograph provided to me). Apart for the frontal portion, the Motor Car had also sustained damage at its rear left portion. The rear bumper, rear left taillamp, rear left fender, rear left door and rear left wheel rim were amongst the body parts that were observed to be damaged at the rear left portion.

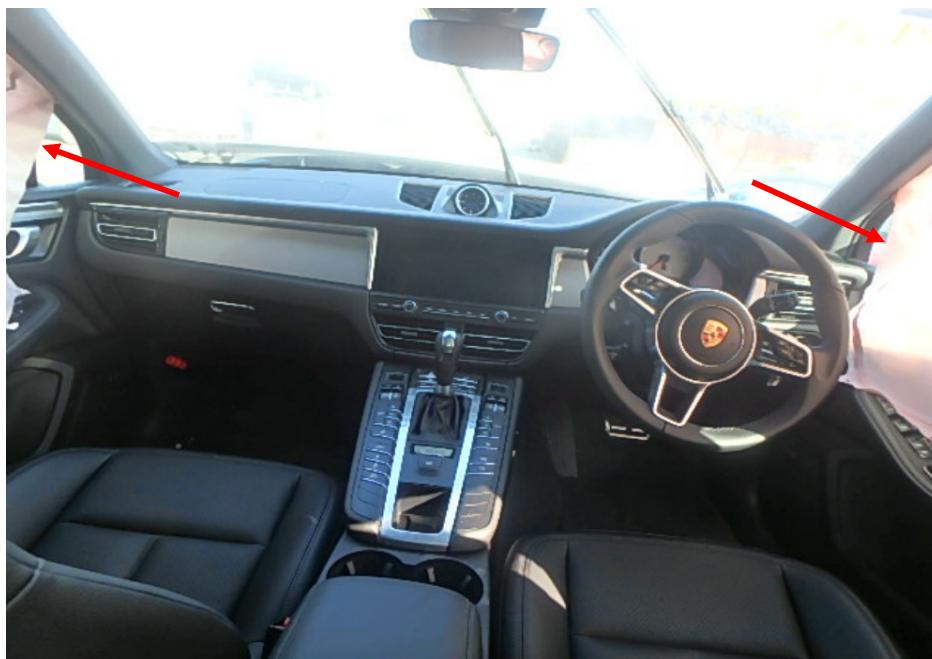
5. The left side curtain airbag and right side curtain airbag of the Motor Car were deployed. See photo 1 – 5 below.

**Photo 4** shows the interior compartment of the Motor Car prior to any repairs being carried out (photograph provided to me). The right side curtain airbag and left side curtain airbag were deployed (arrowed).

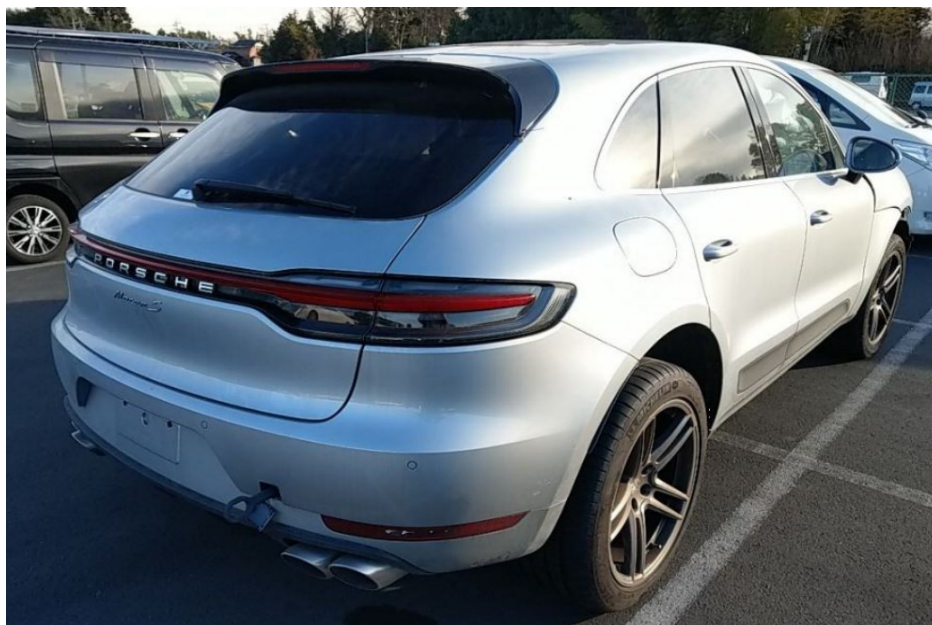
**Photo 5** shows the rear right body of the Motor Car prior to any repairs being carried out (photograph provided to me). The right body of the Motor Car was observed to be without any physical damage.

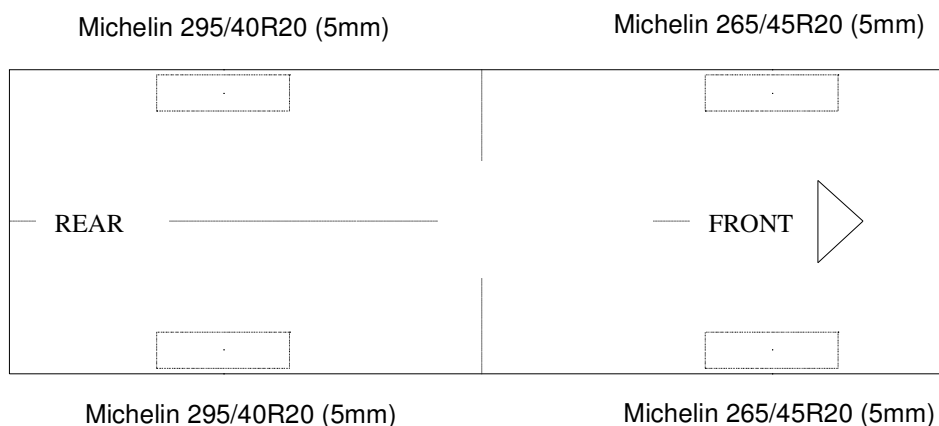
9. It was fitted with 20inch sport wheel rims that were wrapped with tyres that were observed to be of serviceable condition. The tyres were also sufficiently inflated for vehicular operation. The tyre brand, tyre size and approximate remaining tread depth of the 4 tyres of the Motor Car were recorded as follows: -

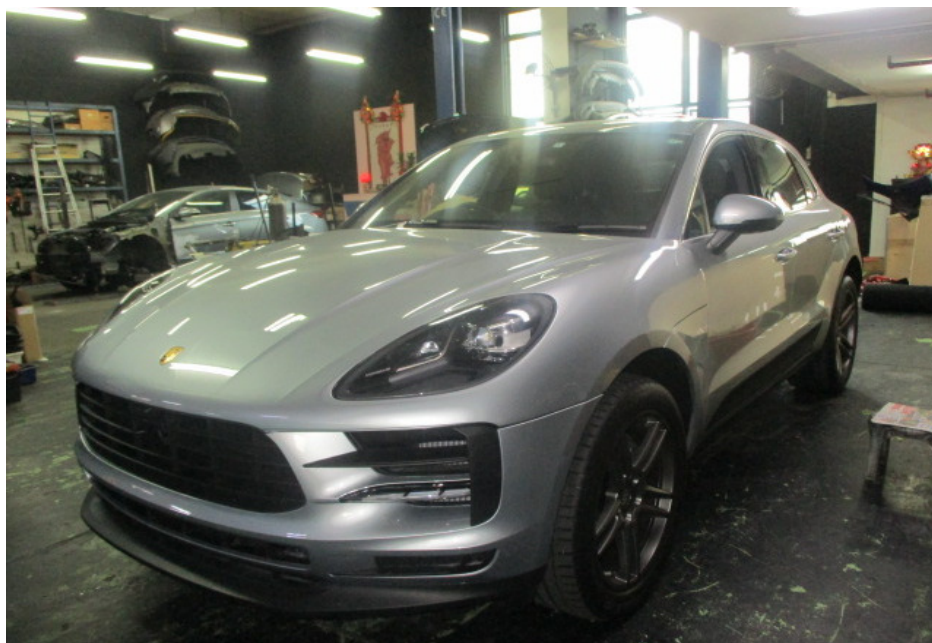
**Photo 6** shows a general view of the front left body of the Motor Car at the time of my inspection. The Motor Car was observed to be in a relatively good general condition with no loose exterior fittings observed. The body parts at the frontal portion of the Motor Car were visually examined and it was observed that the repair/restoration works carried out to the damaged area of the Motor Car (refer to photograph 1 & 2 above) were reasonably adequate and in order.

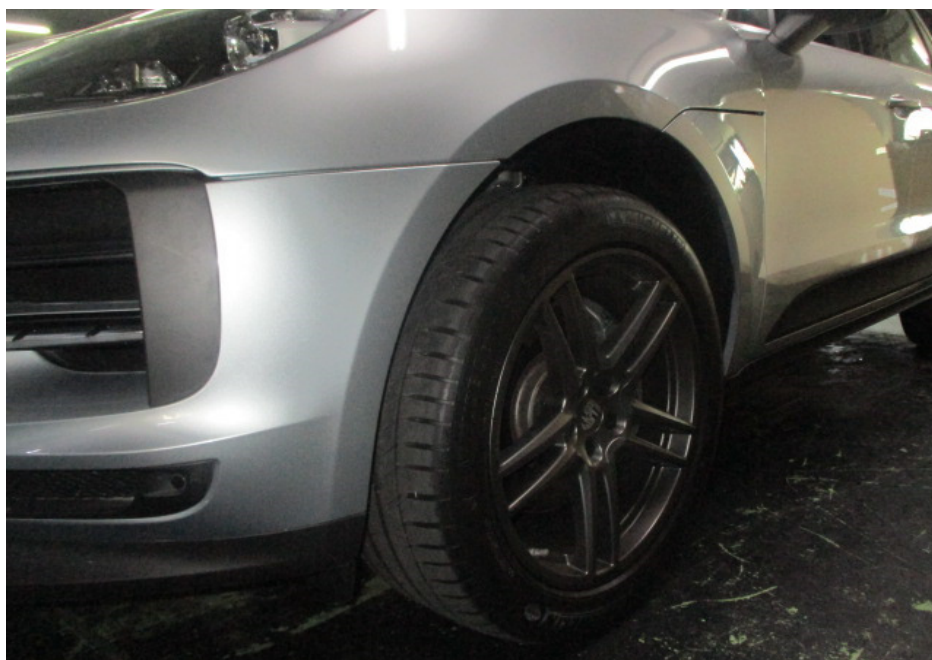
**Photo 7** shows a closer view of the Motor Car's front bumper, front bonnet and front left wheel rim at the time of my inspection. The body parts at the frontal portion of the Motor Car were visually examined and it was observed that the repair/restoration works carried out to the damaged area of the Motor Car (refer to photograph 1 & 2 above) were reasonably adequate and in order.

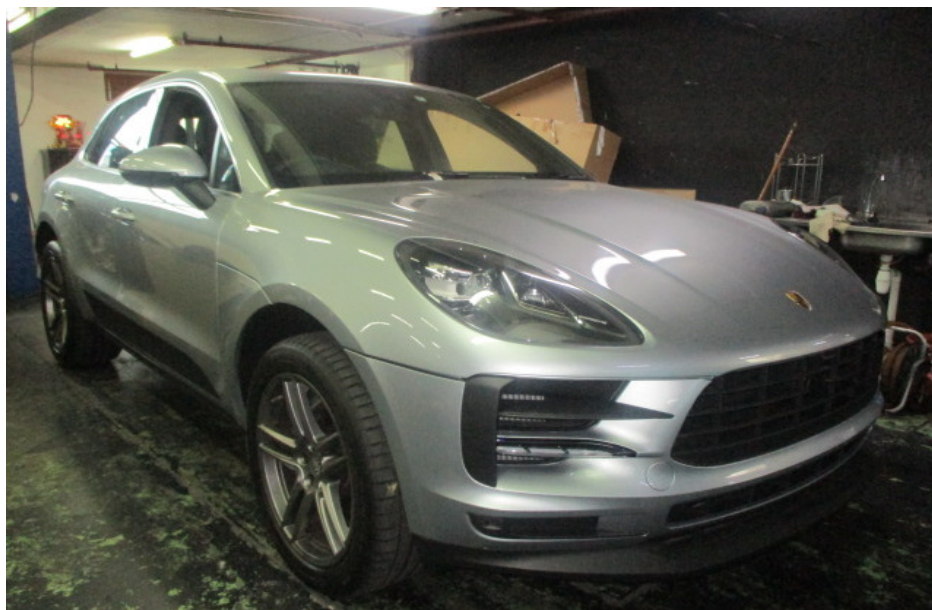
**Photo 8** shows a general view of the front right body of the Motor Car at the time of my inspection. The Motor Car was observed to be in a relatively good general condition with no loose exterior fittings observed. The body parts at the frontal portion of the Motor Car were visually examined, and it was observed that the repair/restoration works carried out to the damaged area of the Motor Car (refer to photograph 1 & 2 above) were reasonably adequate and in order.

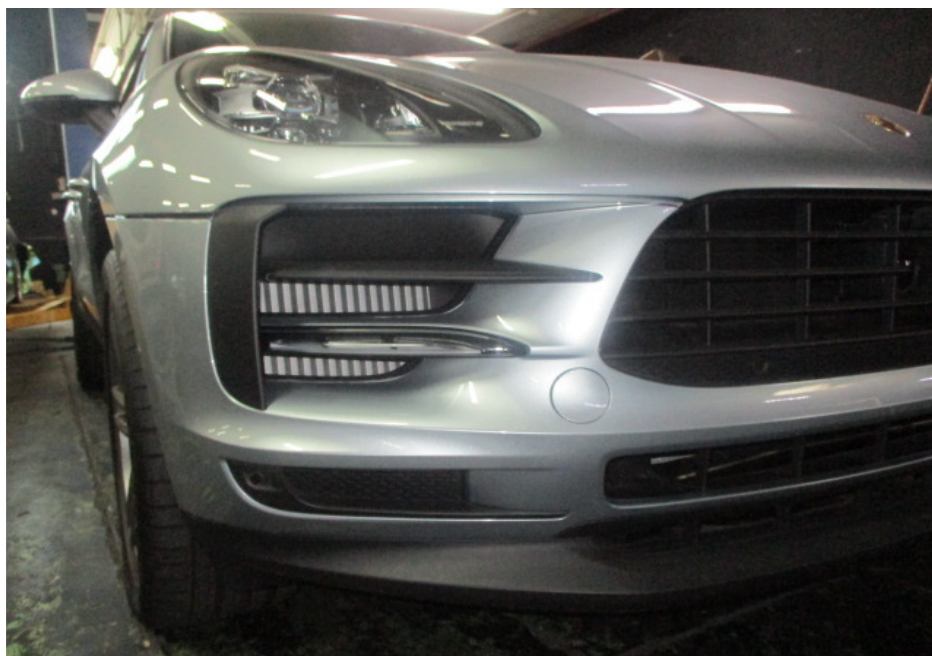
**Photo 9** shows a closer view of the Motor Car's front bumper, front bumper lower cover, front bumper right grille, front bumper right lower grille, front right intercooler and front bonnet. The body parts at the frontal portion of the Motor Car were visually examined and it was observed that the repair/restoration works carried out to the damaged area of the Motor Car (refer to photograph 1 & 2 above) were reasonably adequate and in order.

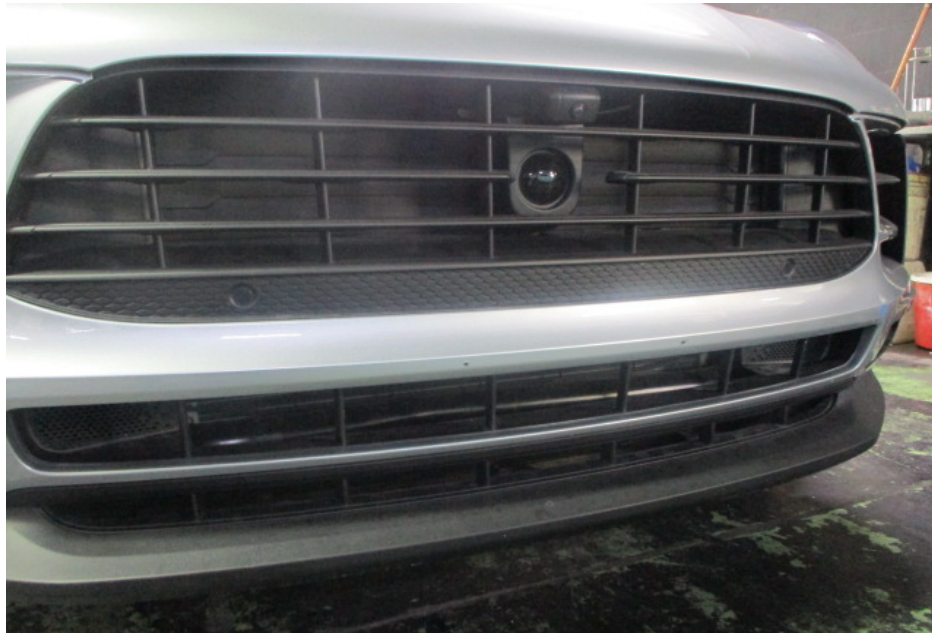
**Photo 10** shows a closer view of the Motor Car's front bumper, front bumper lower cover, front bumper centre lower grille, front radar unit and front radiator grille. The body parts at the frontal portion of the Motor Car were visually examined and it was observed that the repair/restoration works carried out to the damaged area of the Motor Car (refer to photograph 1 & 2 above) were reasonably adequate and in order.

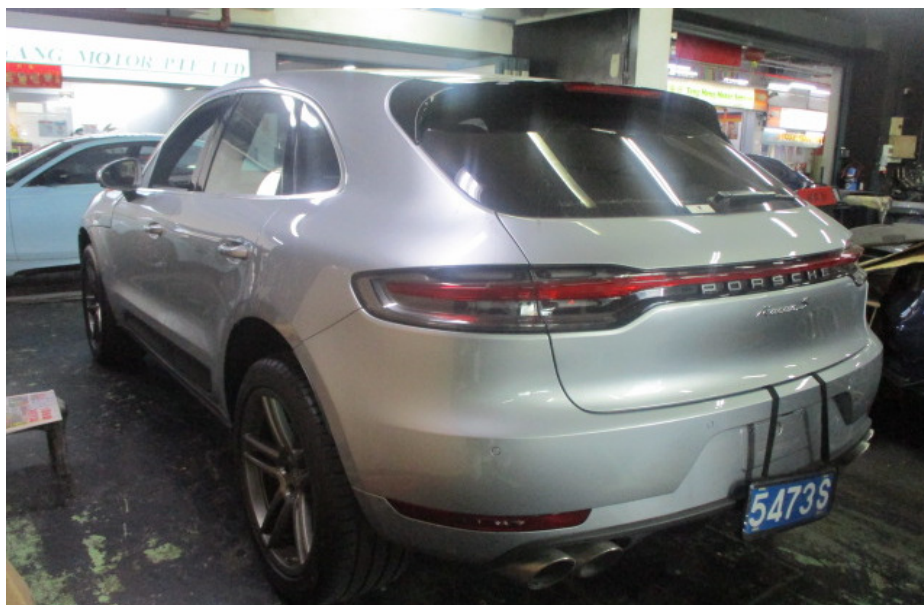
**Photo 11** shows a general view of the rear left body of the Motor Car at the time of my inspection. The Motor Car was observed to be in a relatively good general condition with no loose exterior fittings observed. The body parts at the rear left portion of the Motor Car, like the rear bumper, rear left fender and rear left door amongst others, were visually examined and it was observed that the repair/restoration works carried out to the damaged area of the Motor Car (refer to photograph 3 above) were reasonably adequate and in order.

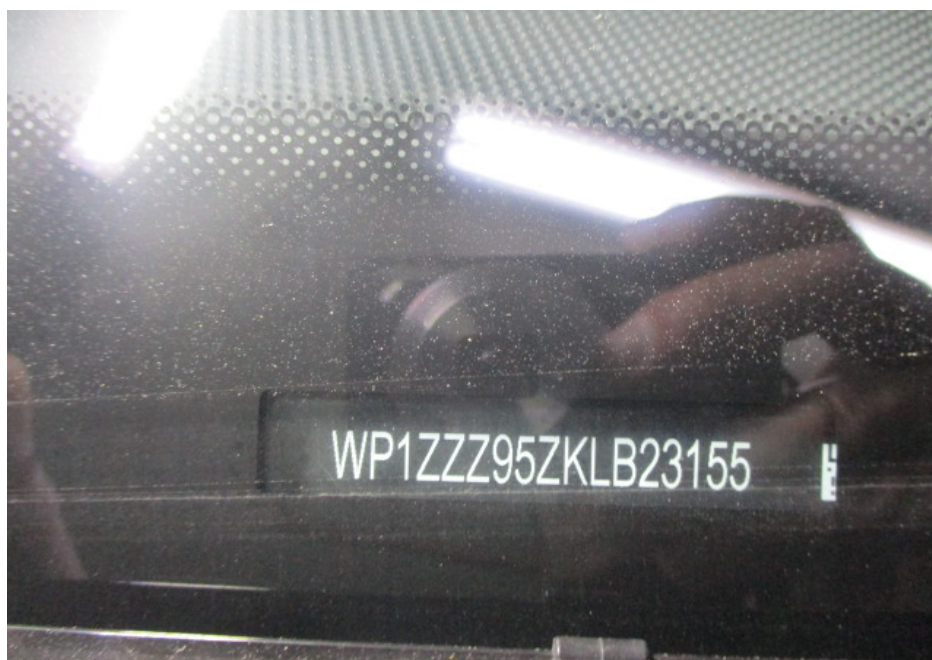
**Photo 12** shows the chassis number of the Motor Car. The chassis number recorded was WP1ZZZ95ZKLB23155.

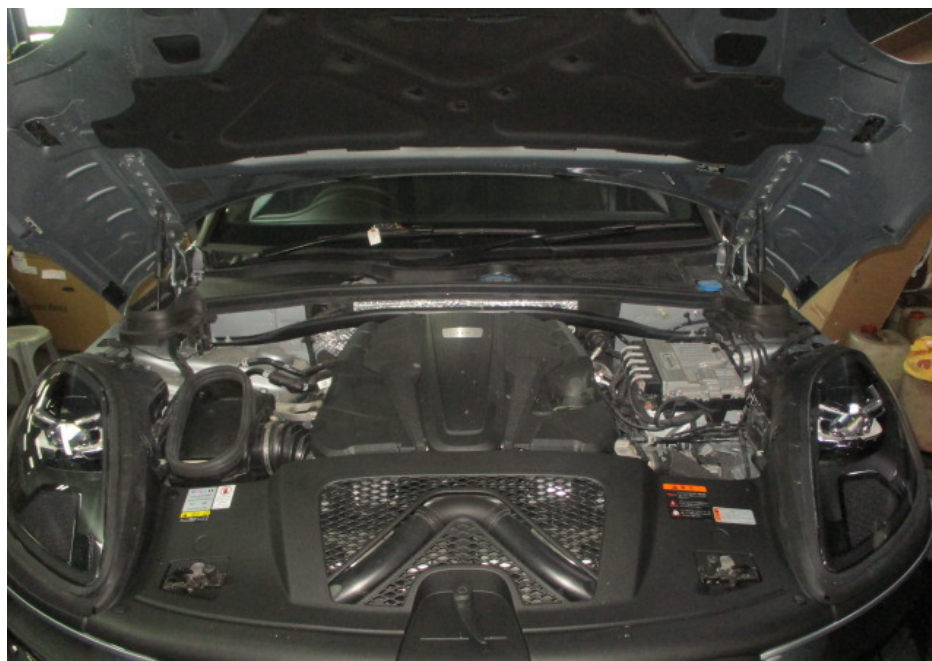
**Photo 13** shows a general view of the engine compartment of the Motor Car at the time of my inspection. The various parts and components inside the engine compartment were all observed to be intact and properly fitted. There was also no sign(s) or indication(s) of fluid leak and/or fluid stain found inside the engine compartment.

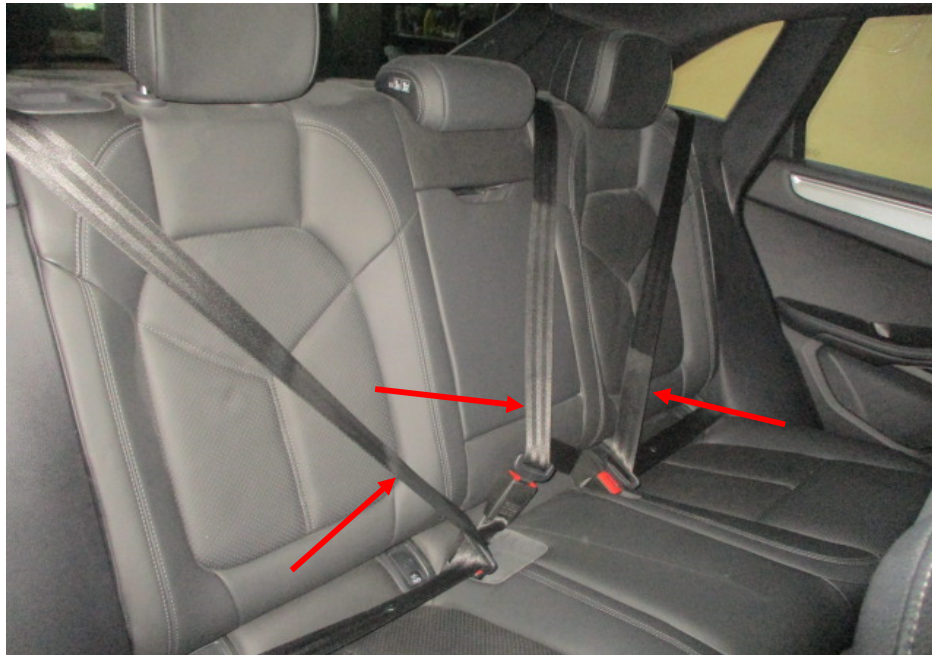
**Photo 14** shows the rear seats of the Motor Car. All the seats of the Motor Car were secured via seat rails to the floorboard. They were also fitted with a retractable seat belt reel and a pre-tensioner. The seat belts (arrowed) were tested and were able to be fastened into the respective pre-tensions that were fitted on the side of each individual seat.

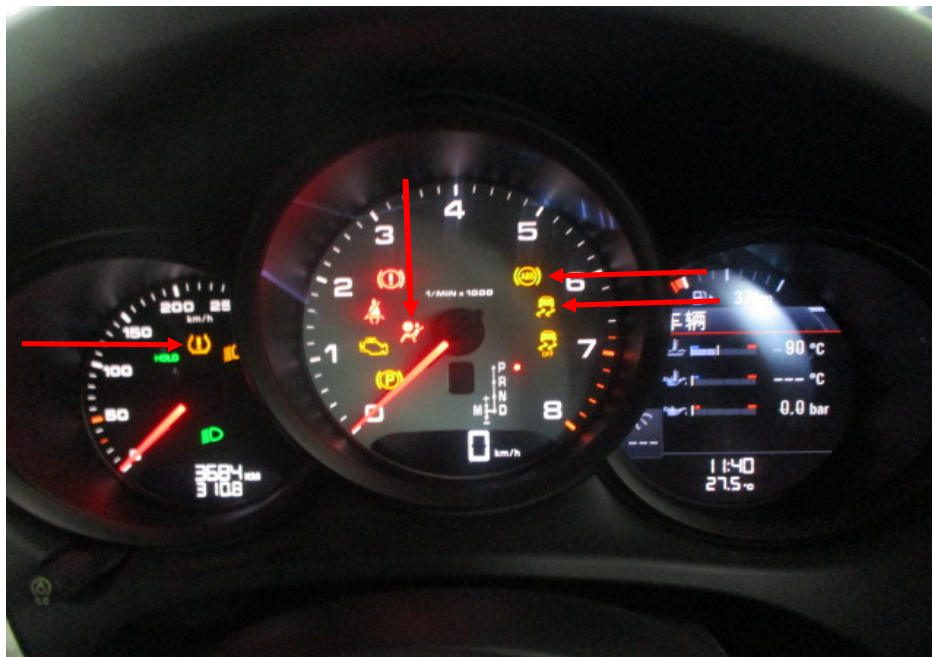
**Photo 15** shows the warning lights for the various electronic safety features appearing on the instrument panel of the Motor Car during its self-test when the engine is cranked, in particular the ABS, SRS, TPM and TCS lights (arrowed).

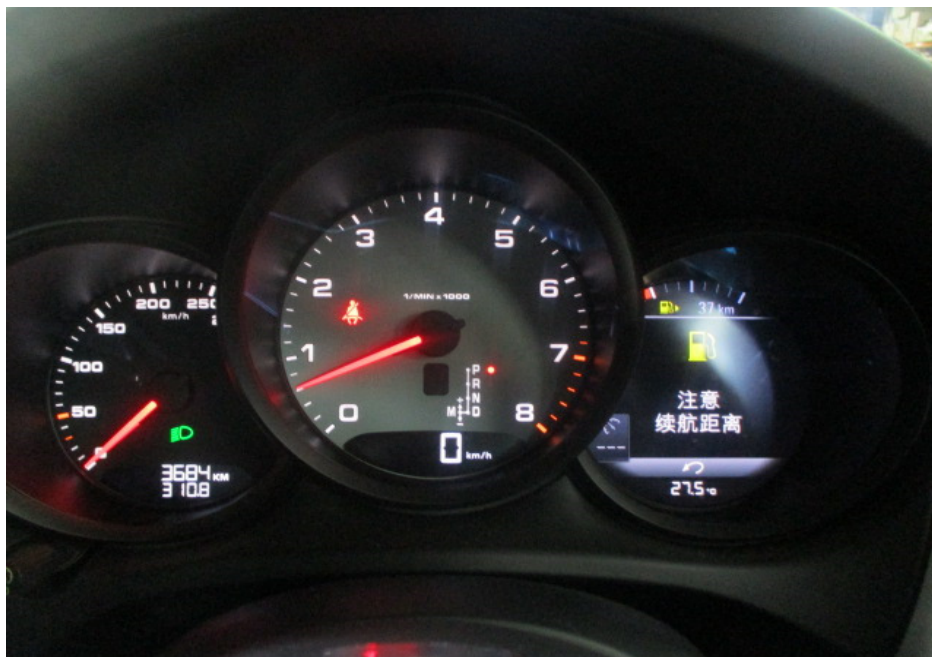
**Photo 16** shows the respective warning lights no longer illuminated, indicating that there is no fault detected to the ABS, SRS, TPM and TCS systems of the Motor Car during the self-test. These electronic systems were hence in working condition at the time of my inspection.

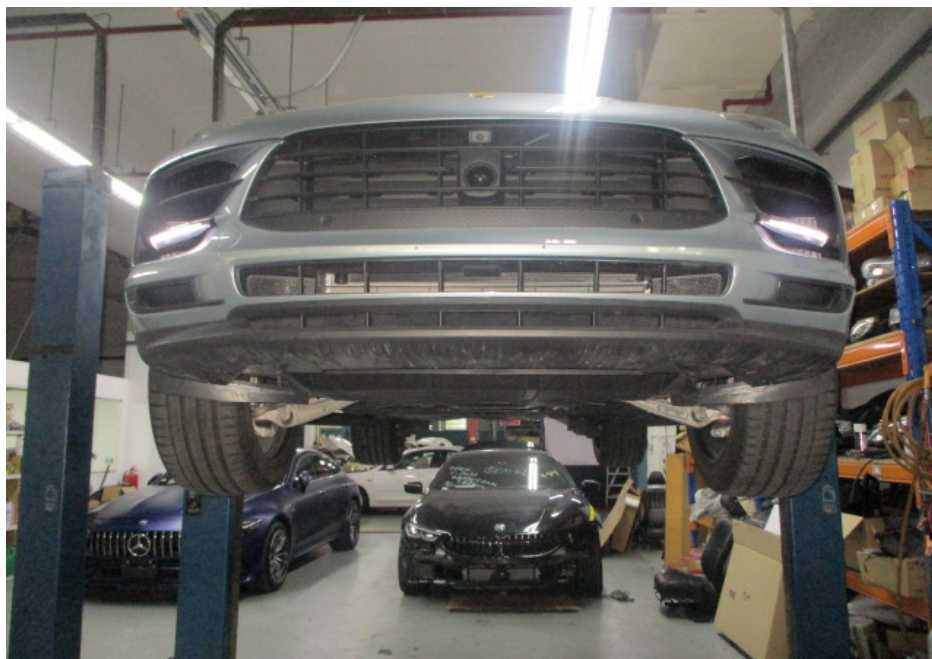
**Photo 17** shows the Motor Car hoisted up for checks on its undercarriage. There was no sign(s) or indication(s) of fluid leakage and/or fluid stain(s) on the underside of the Motor Car. The undercarriage components of the Motor Car were also all observed to be intact and secured in an appropriate manner.

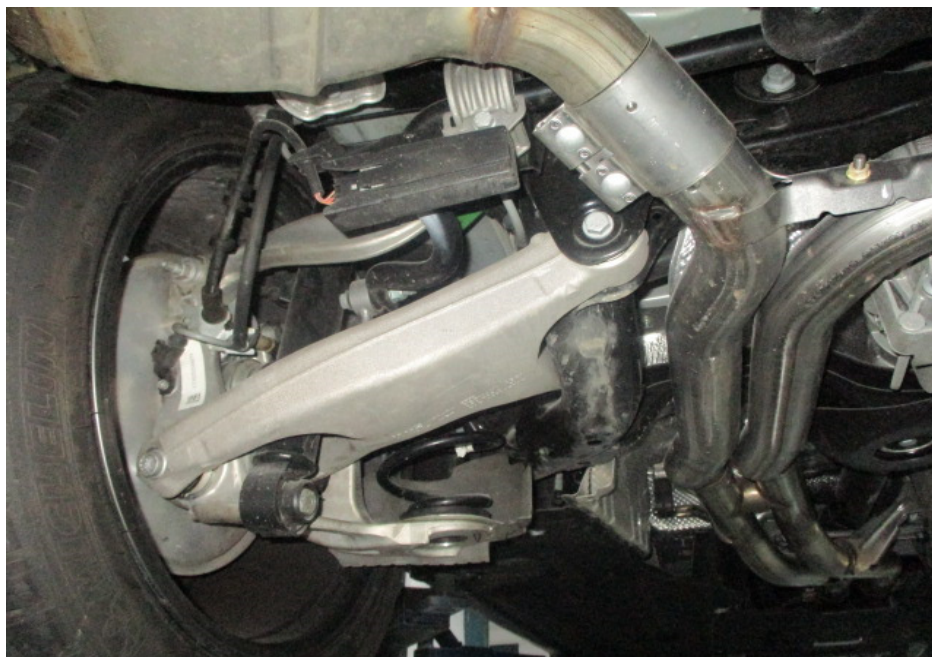
**Photo 18** shows a general view of the control arms and linkages at the rear left wheel of the Motor Car. I did not observe any fluid leak and/or fluid stain on the underside of the Motor Car. All the Motor Car's undercarriage components were observed to be intact and secured in an appropriate manner.

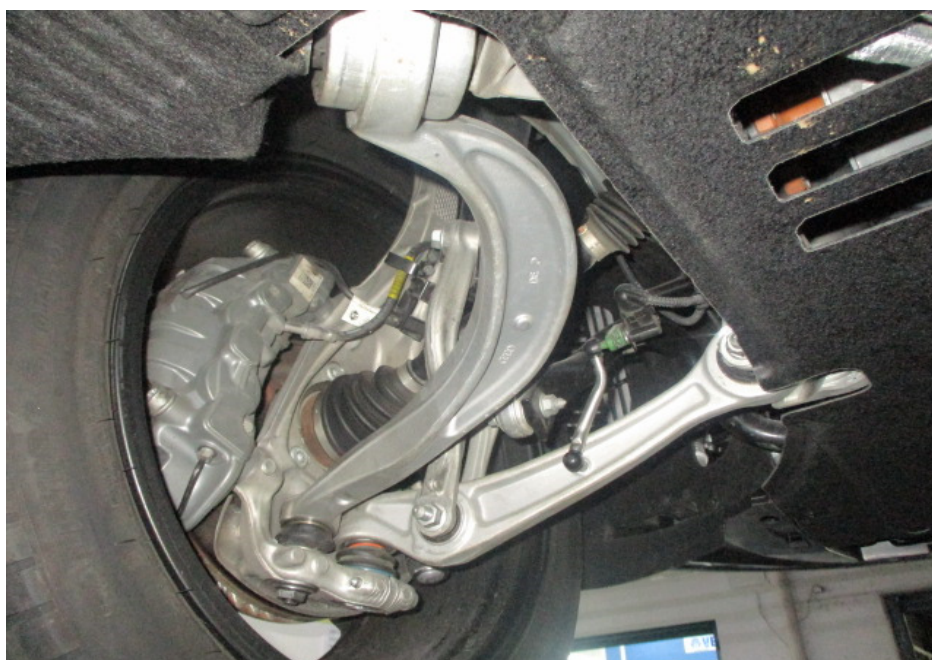
**Photo 19** shows the various undercarriage components at the front left wheel of the Motor Car. The mechanical components, control arms and linkages were all found to be intact and secured in an appropriate manner.

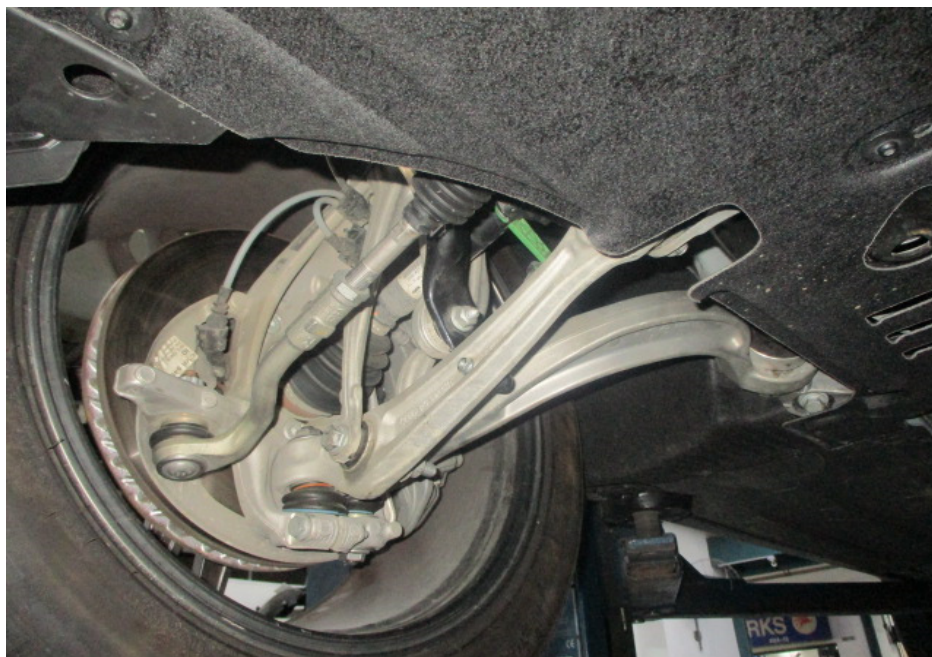
**Photo 20** shows the various undercarriage components at the front right wheel of the Motor Car. The mechanical components, control arms and linkages were all found to be intact and secured in an appropriate manner. I also did not observe any fluid leak and/or fluid stain on the underside of the Motor Car.

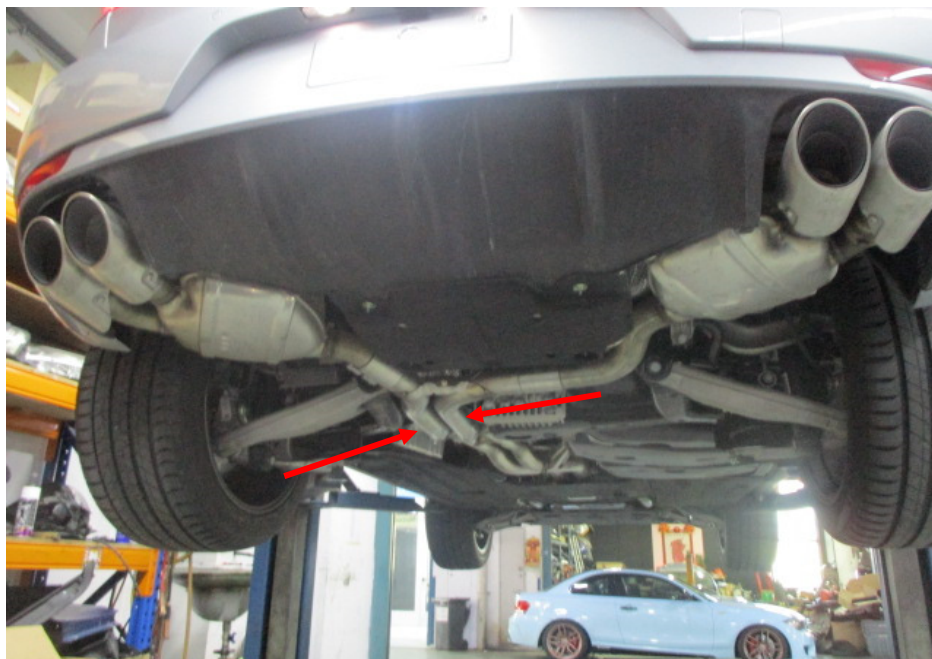
**Photo 21** shows a general view of the Motor Car's exhaust system. My examination of the Motor Car's exhaust system revealed no sign(s) or indication(s) of any cut or weld marks along its exhaust pipes (arrowed), on its catalytic converters and on its rear mufflers.

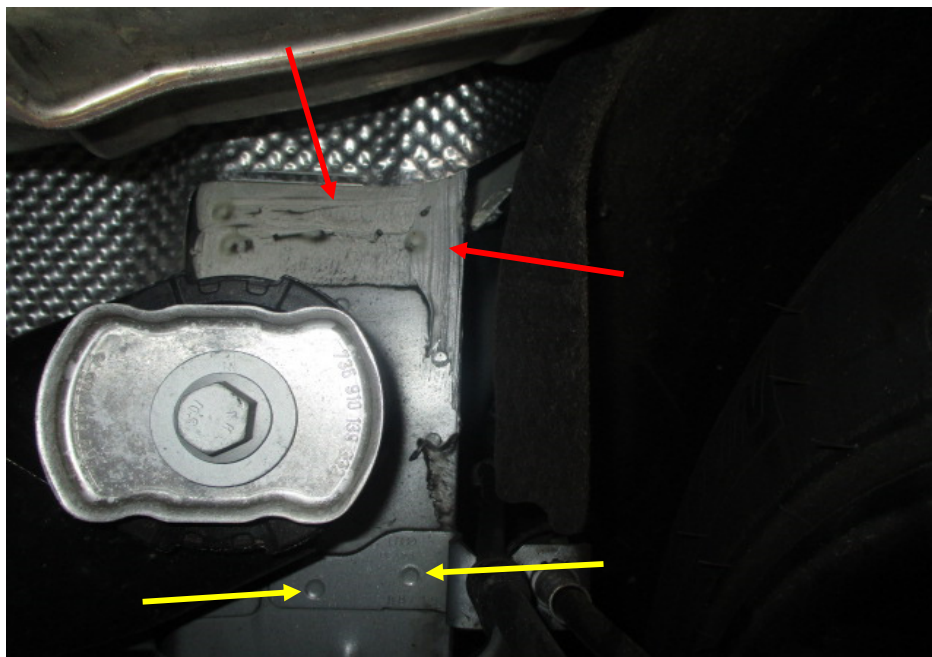
**Photo 22** shows the chassis/structural body at the underside rear right of the Motor Car. I did not find any weld marks other than original spot weld marks (yellow arrow) on the chassis/structural body of the Motor Car. The original factory sealant (red arrow) at the joints along the chassis/structural body was untouched, indicating no work was done on the chassis/structural body of the Motor Car and that the chassis/structural body was originally fitted.

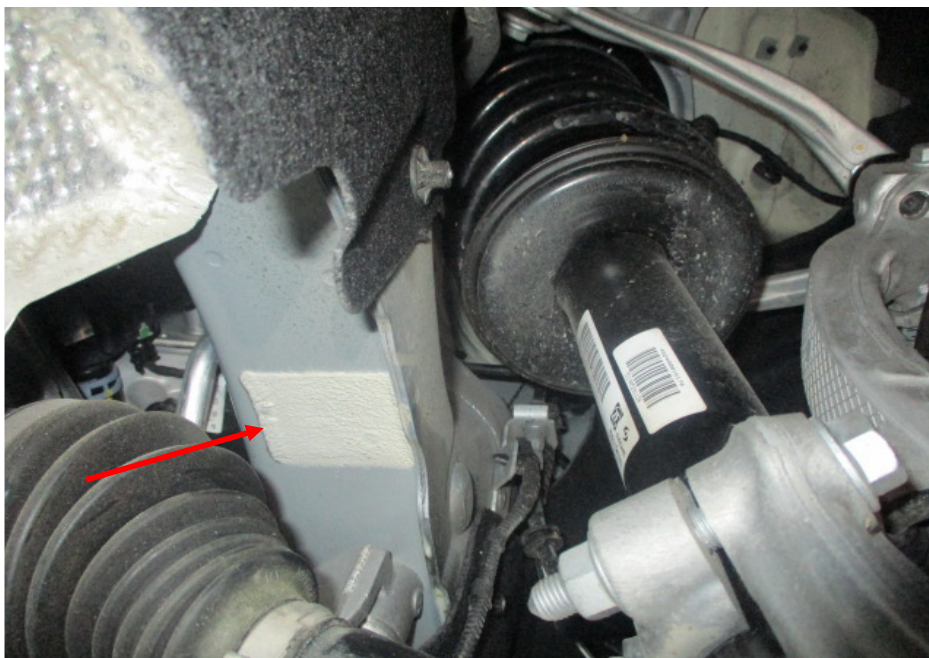
**Photo 23** shows the chassis/structural body at the underside front right of the Motor Car. The original factory sealant (arrowed) at the joints along the chassis/structural body was observed to be untouched. In general, I had found no work was carried out on the chassis/structural body of the Motor Car. The chassis/structural body of the Motor Car was originally fitted.

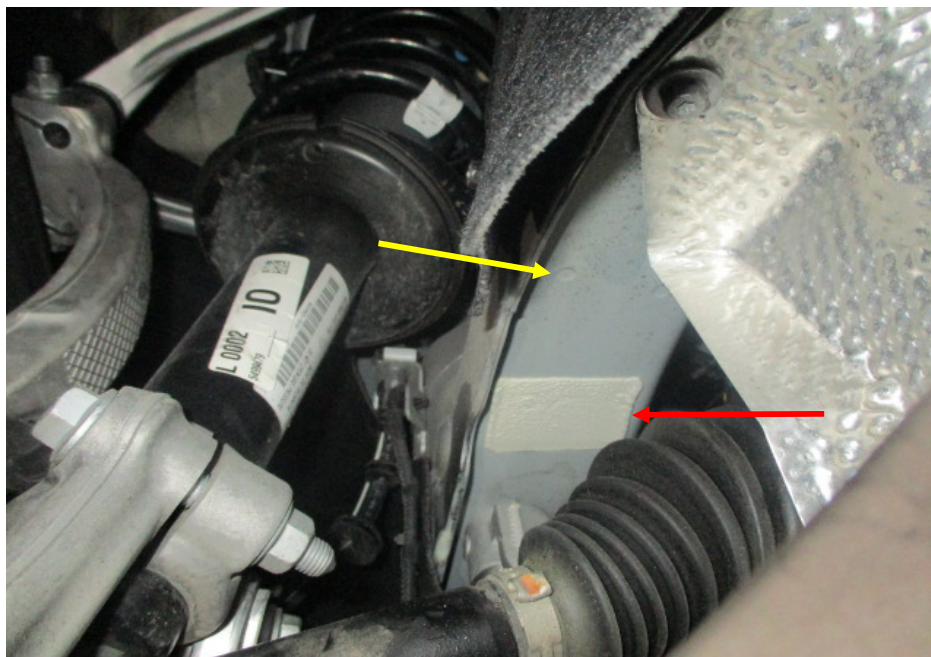
**Photo 24** shows the chassis/structural body at the underside front left of the Motor Car. I did not find any weld marks other than original spot weld marks (yellow arrow) on the chassis/structural body of the Motor Car. The original factory sealant (red arrow) at the joints along the chassis/structural body was untouched, indicating no work was done on the chassis/structural body of the Motor Car and that the chassis/structural body was originally fitted.

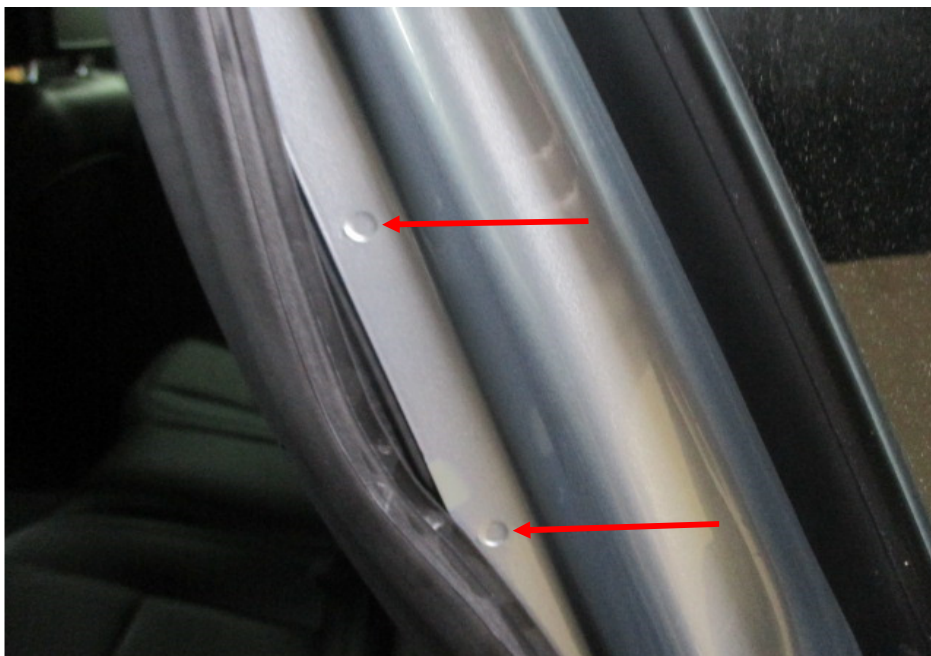
**Photo 25** shows the left side "C" pillar of the Motor Car. I did not find any weld marks other than original spot weld marks (arrowed) on the left side "C" pillar of the Motor Car which, indicates that there was no re-welding works carried out. In general, I had found all the non-detachable body panels of the Motor Car to be originally fitted at the time of my inspection.

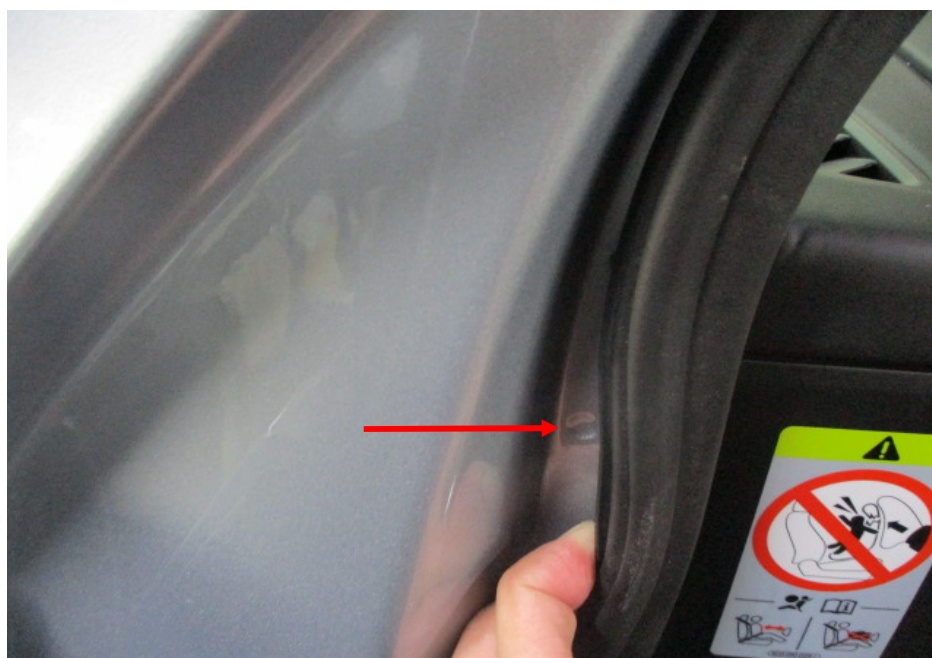
**Photo 26** shows the left side "A" pillar of the Motor Car. I did not find any weld marks other than original spot weld marks (arrowed) on the left side "A" pillar of the Motor Car which, indicates that there was no re-welding works carried out. In general, I had found all the non-detachable body panels of the Motor Car to be originally fitted at the time of my inspection.
