Your Ref: BMW 220i Coupe  
(chassis number WBA2H520207F47452)  
Our Ref : CI/TP21007685/D

**INSPECTION REPORT OF AN UNREGISTERD BMW 220i MOTOR CAR WITH CHASSIS NUMBER WBA2H520207F47452**

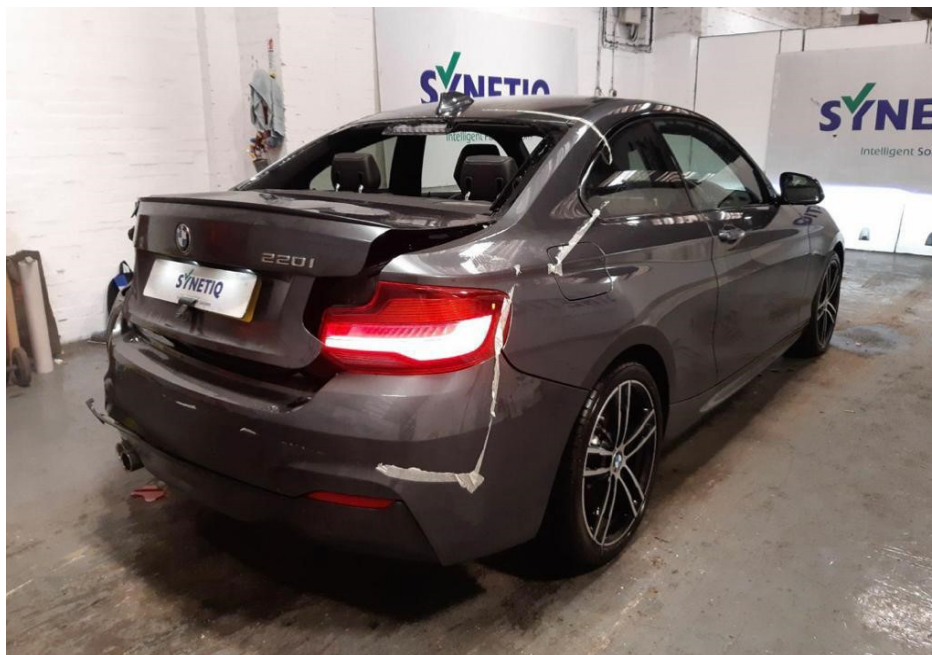
3. The photographs provided to me had showed damage to the Motor Car's rear left portion. Body parts observed to have been damaged include the rear bumper, rear bumper lower cover, rear bumper left reflector, rear bootlid, rear left taillamp, rear left body panel and rear windscreen amongst others.
4. No physical damage was observed to other areas of the Motor Car. The airbags of the Motor Car were also not deployed as seen from the photographs that were provided to me. See photo 1 – 3 below.

**Photo 1** shows the rear right body of the Motor Car (photograph provided to me). The Motor Car was observed to have sustained damage at its rear left portion. The rear bumper, rear bumper lower cover, rear bumper left reflector, rear bootlid, rear left taillamp, rear left body panel and rear windscreen were amongst the body parts that were observed to have been damaged.

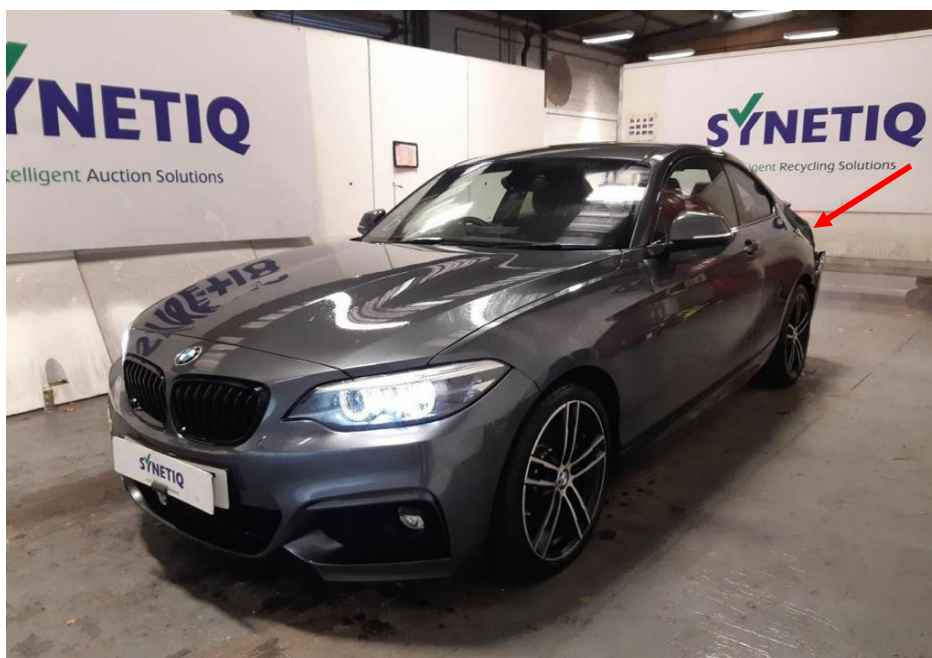
**Photo 2** shows the front left body of the Motor Car (photograph provided to me). The Motor Car was observed to have sustained damage at its rear left portion (arrowed). The rear bumper, rear bumper lower cover, rear bumper left reflector, rear bootlid, rear left taillamp, rear left body panel and rear windscreen were amongst the body parts that were observed to have been damaged.

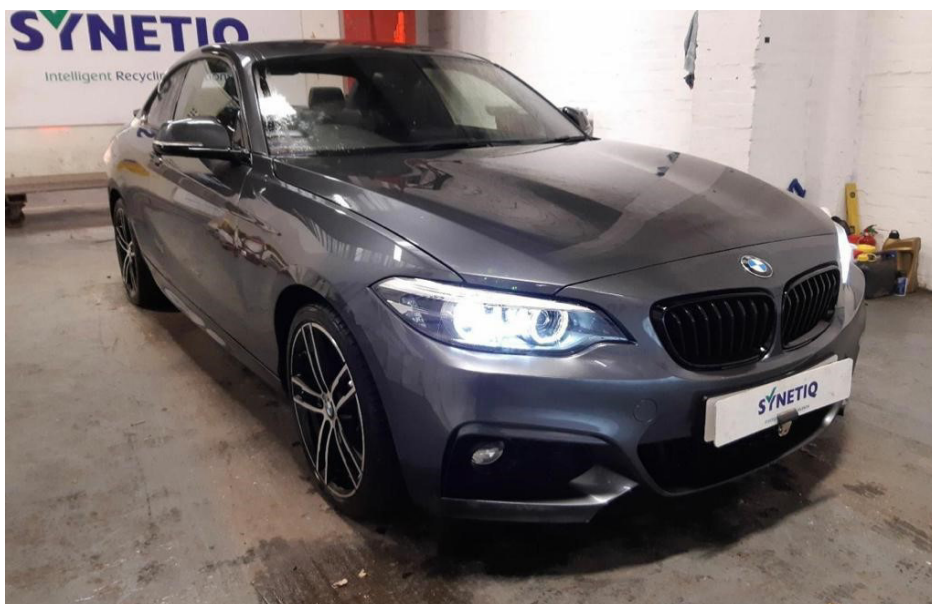
**Photo 3** shows the front right body of the Motor Car (photograph provided to me). Apart for the rear left portion, there was no physical damage seen to other areas of the Motor Car. The airbags were also not deployed as seen from the photographs that were provided to me.

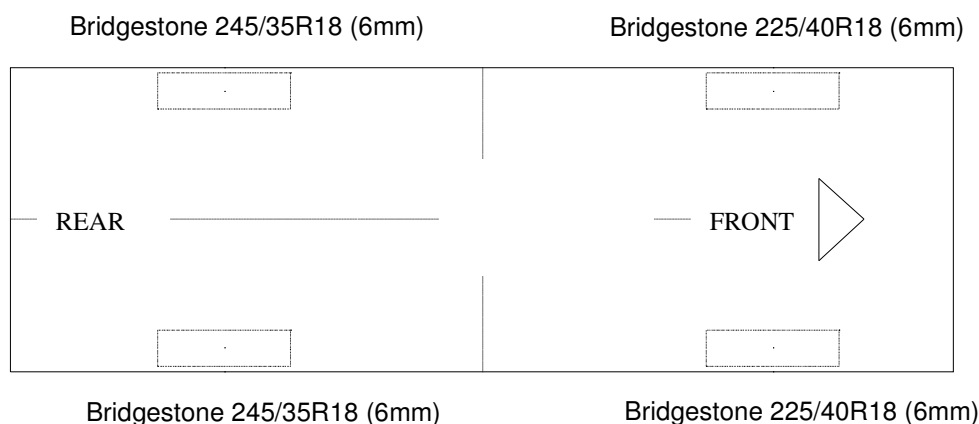
8. It was fitted with 18inch sport wheel rims that were wrapped with tyres that were observed to be of serviceable condition. The tyres were also sufficiently inflated for vehicular operation. The tyre brand, tyre size and approximate remaining tread depth of the 4 tyres of the Motor Car were recorded as follows: -

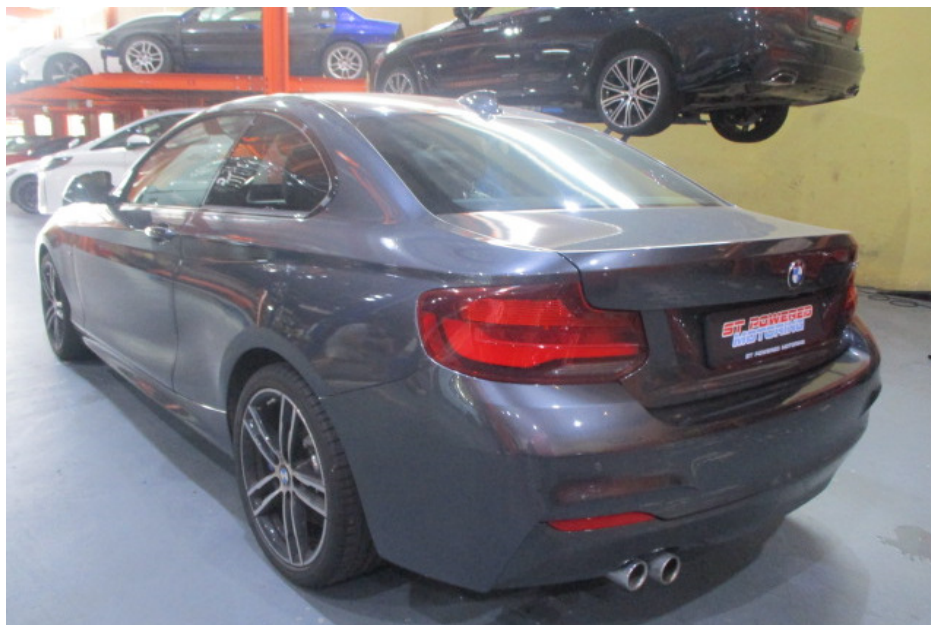
**Photo 4** shows a general view of the rear left body of the Motor Car at the time of my inspection. The Motor Car was observed to be in a relatively good general condition with no loose exterior fittings observed. The body parts at the rear left portion of the Motor Car were visually examined and it was observed that the repair/restoration works carried out to the damaged area of the Motor Car (refer to photograph 1 & 2 above) were reasonably adequate and in order.

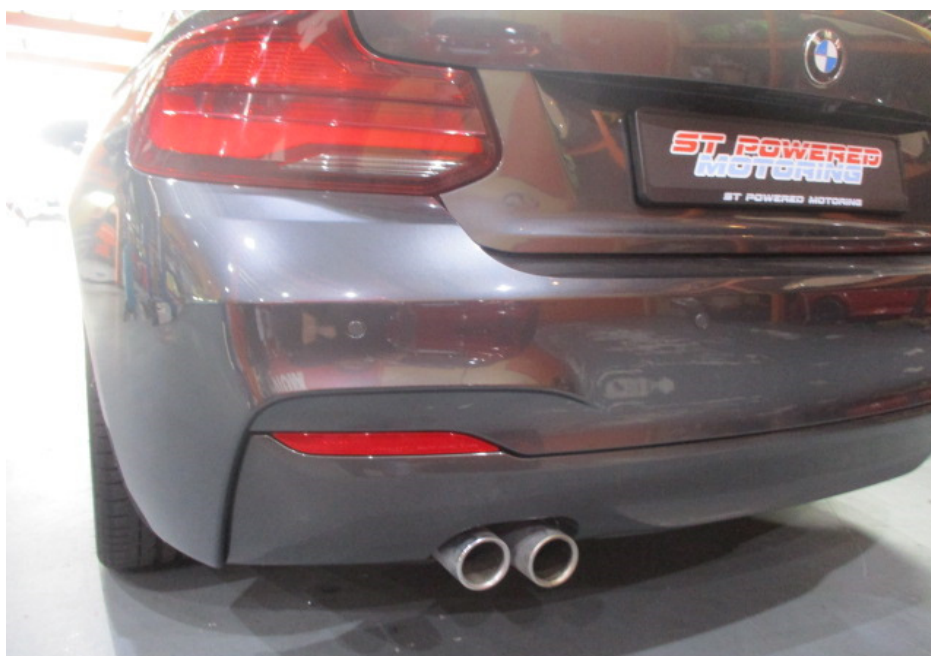
**Photo 5** shows a closer view of the Motor Car's rear bumper, rear bumper lower cover, rear bumper left reflector and rear left taillamp at the time of my inspection. The body parts at the rear left portion of the Motor Car were visually examined and it was observed that the repair/restoration works carried out to the damaged area of the Motor Car (refer to photograph 1 & 2 above) were reasonably adequate and in order.

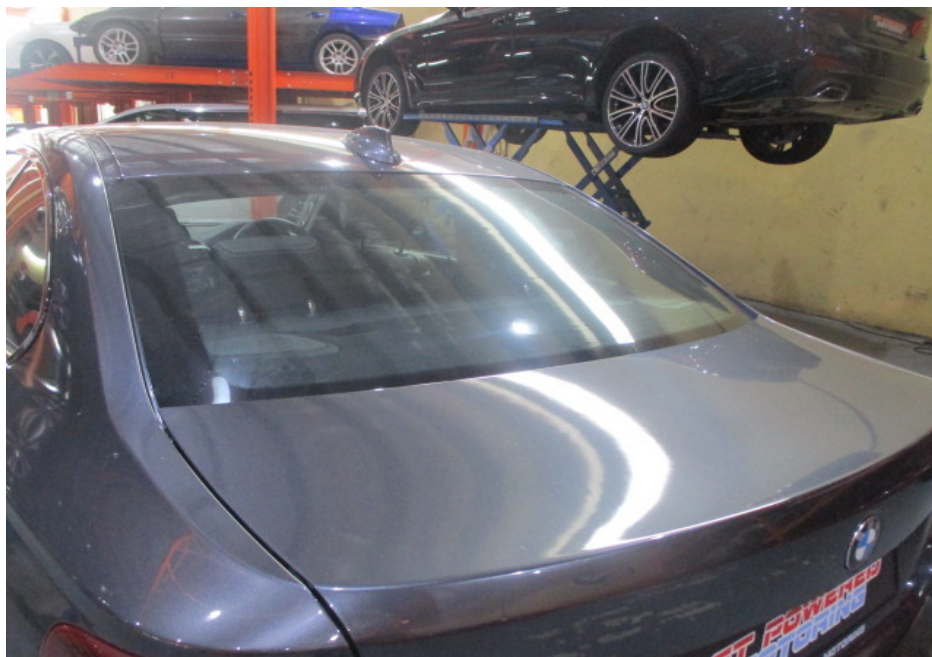
**Photo 6** shows a closer view of the Motor Car's rear windscreen, rear bootlid and rear left body panel at the time of my inspection. The body parts at the rear left portion of the Motor Car were visually examined and it was observed that the repair/restoration works carried out to the damaged area of the Motor Car (refer to photograph 1 & 2 above) were reasonably adequate and in order.

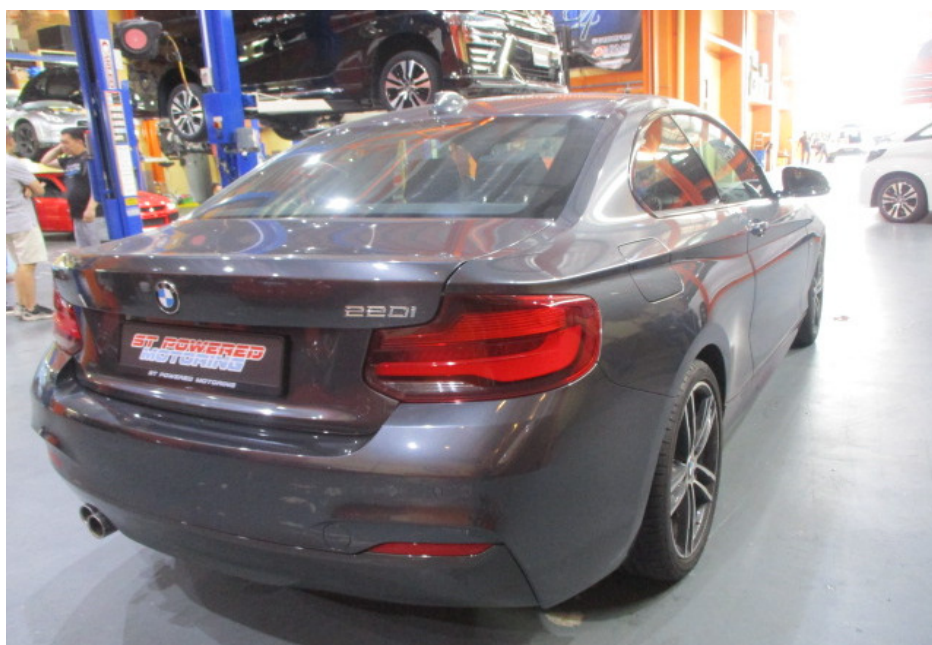
**Photo 7** shows a general view of the rear right body of the Motor Car at the time of my inspection. The Motor Car was observed to be in a relatively good general condition with no loose exterior fittings observed. The body parts at the rear left portion of the Motor Car were visually examined and it was observed that the repair/restoration works carried out to the damaged area of the Motor Car (refer to photograph 1 & 2 above) were reasonably adequate and in order.

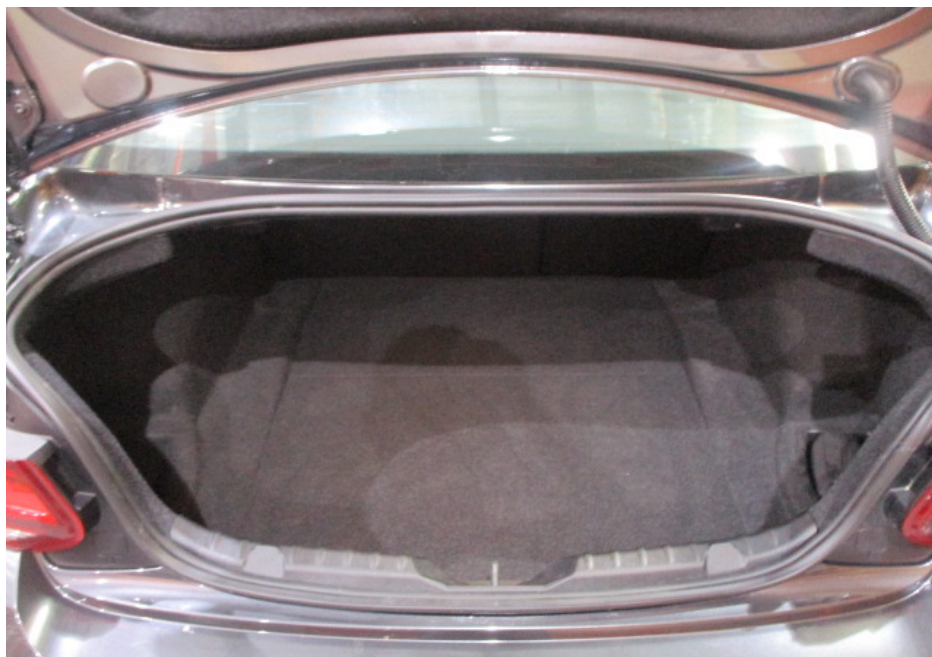
**Photo 8** shows a general view of the Motor Car's rear boot compartment at the time of my inspection. All inner trims, hinges and upholstery etc were observed to be properly fitted. The body parts at the rear left portion of the Motor Car were visually examined and the repair/restoration works carried out to the damaged area of the Motor Car (refer to photograph 1 & 2 above) were found to be reasonably adequate and in order.

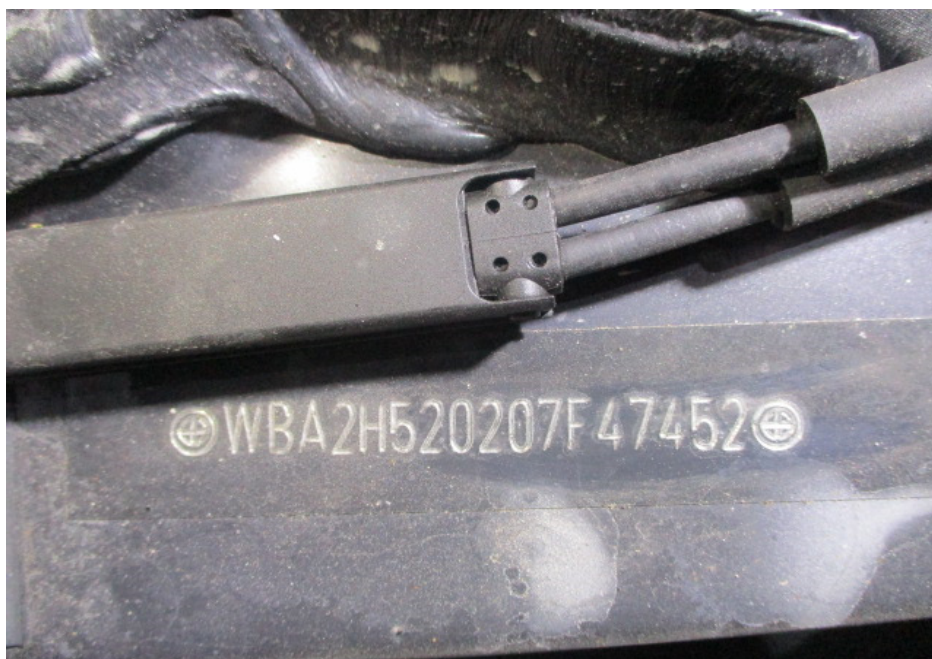
**Photo 9** shows the chassis number of the Motor Car. The chassis number recorded was WBA2H520207F47452.

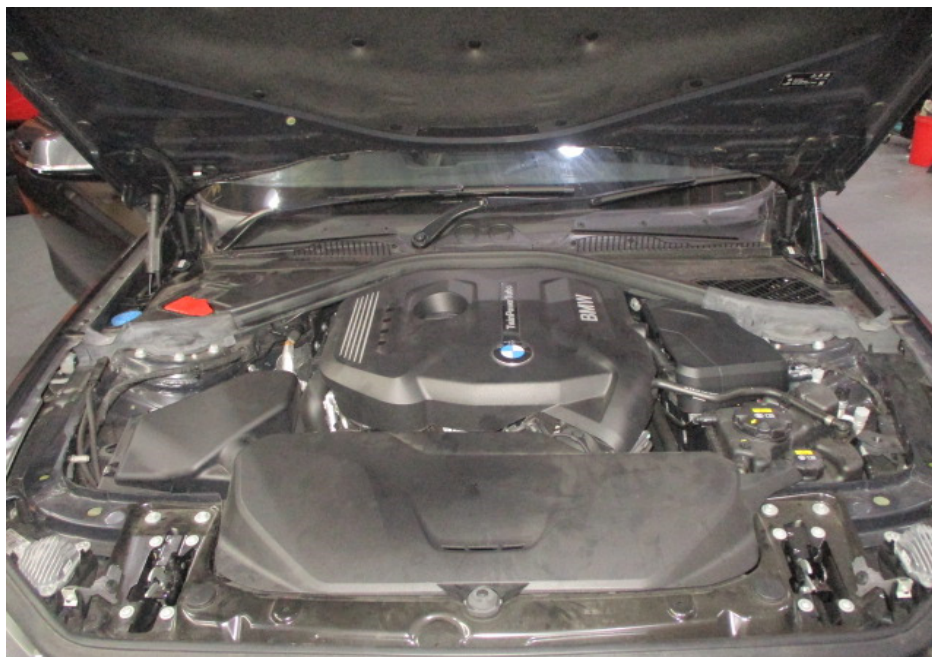
**Photo 10** shows a general view of the Motor Car's engine compartment at the time of my inspection. The various parts and components inside the engine compartment were all observed to be intact and properly fitted. There was also no sign(s) or indication(s) of fluid leak and/or fluid stain found within the engine compartment.

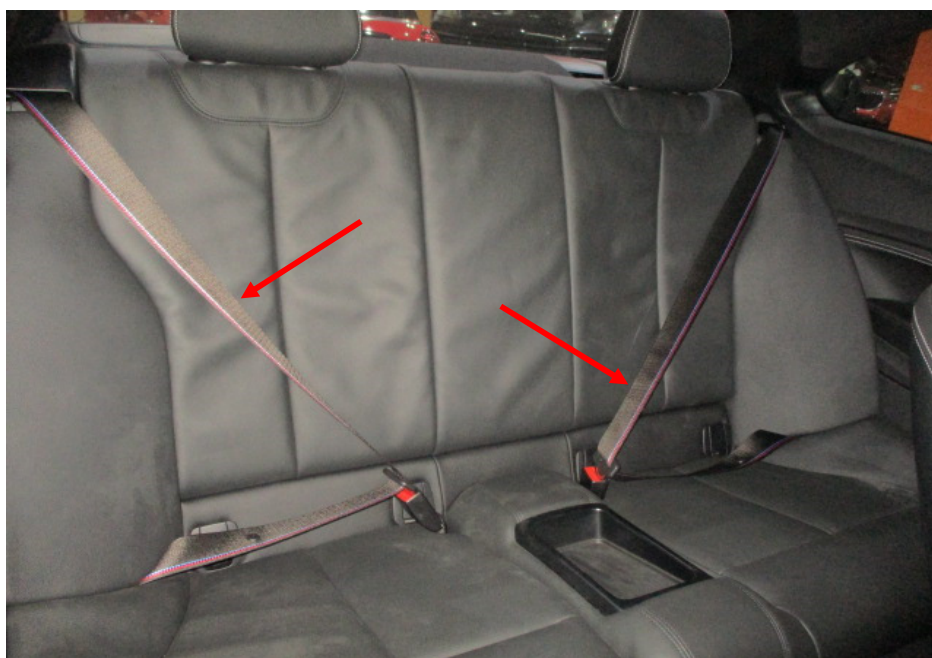
**Photo 11** shows the rear seats of the Motor Car. All the seats of the Motor Car were secured via seat rails to the floorboard. They were also fitted with a retractable seat belt reel and a pre-tensioner. The seat belts (arrowed) were tested and were able to be fastened into the respective pre-tensions that were fitted on the side of each individual seat.

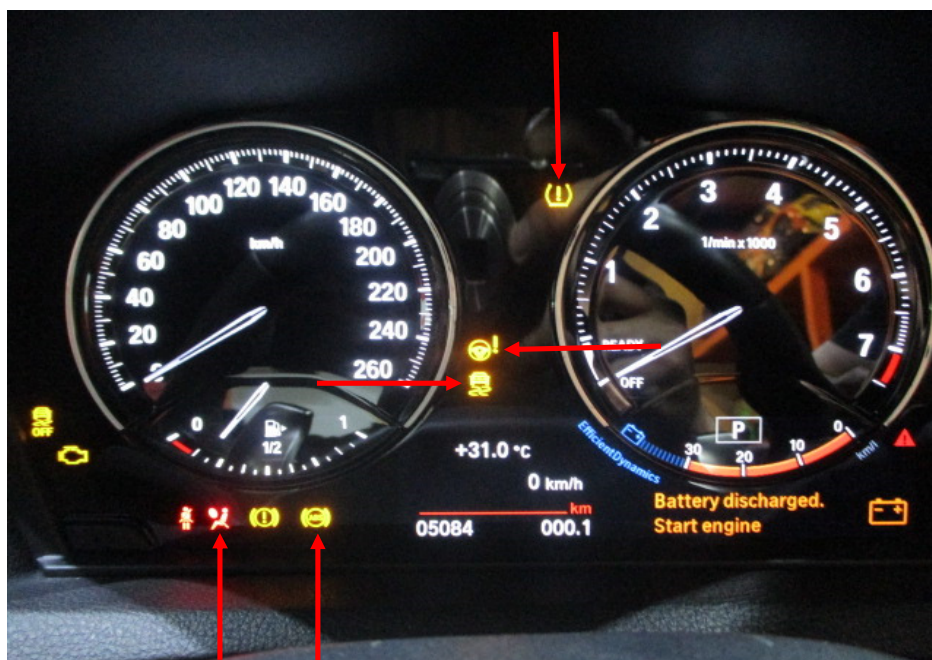
**Photo 12** shows the warning lights for the various electronic safety features appearing on the instrument panel of the Motor Car during its self-test when the engine is cranked, in particular the ABS, SRS, IAS, TPM and DSC lights (arrowed).

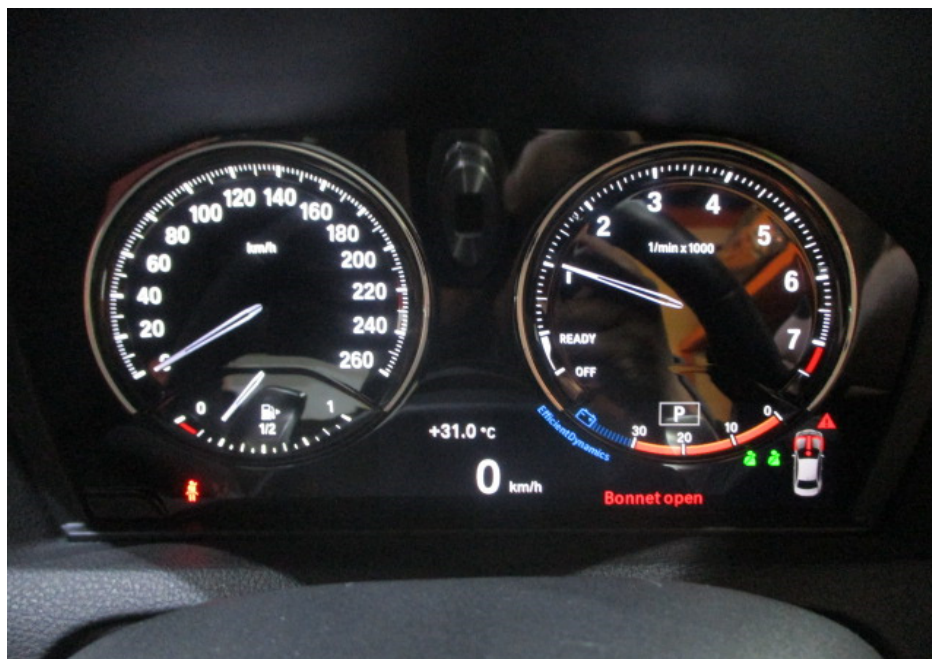
**Photo 13** shows the respective warning lights no longer illuminated, indicating that there is no fault detected to the ABS, SRS, IAS, TPM and DSC systems of the Motor Car during the self-test. These electronic systems were hence in working condition at the time of my inspection.

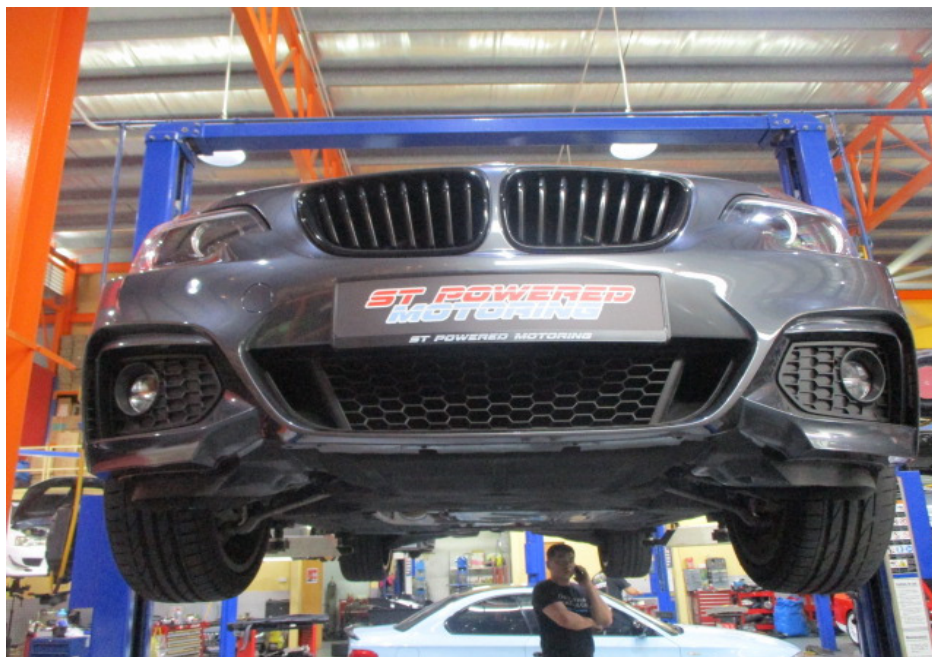
**Photo 14** shows the Motor Car hoisted up for checks on its undercarriage. There was no sign(s) or indication(s) of fluid leakage and/or fluid stain(s) on the underside of the Motor Car. The undercarriage components of the Motor Car were also all observed to be intact and secured in an appropriate manner.

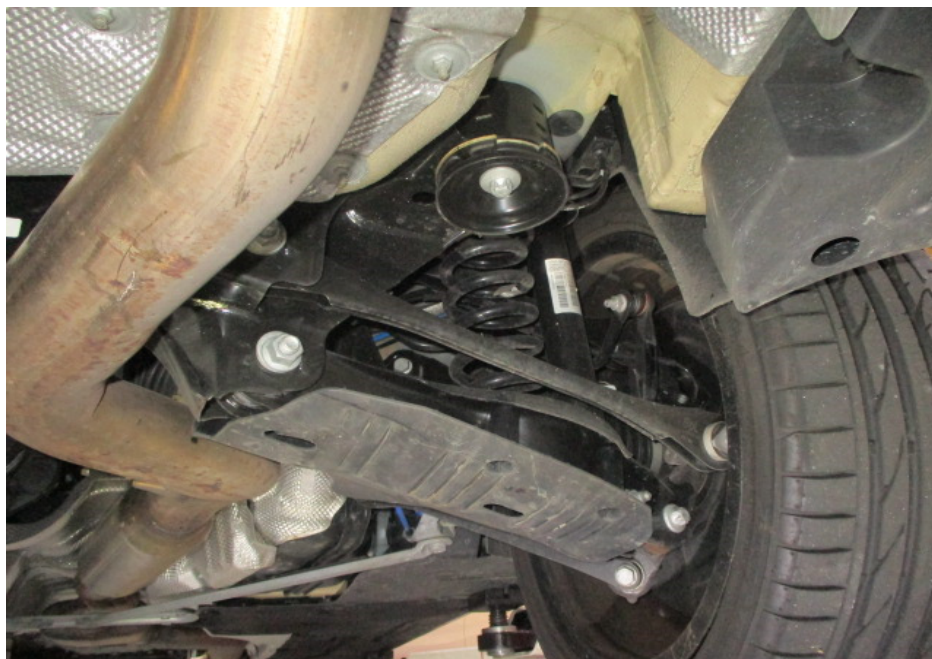
**Photo 15** shows a general view of the control arms and linkages at the rear right wheel of the Motor Car. I did not observe any fluid leak and/or fluid stain on the underside of the Motor Car. All of the Motor Car's undercarriage components were observed to be intact and secured in an appropriate manner.

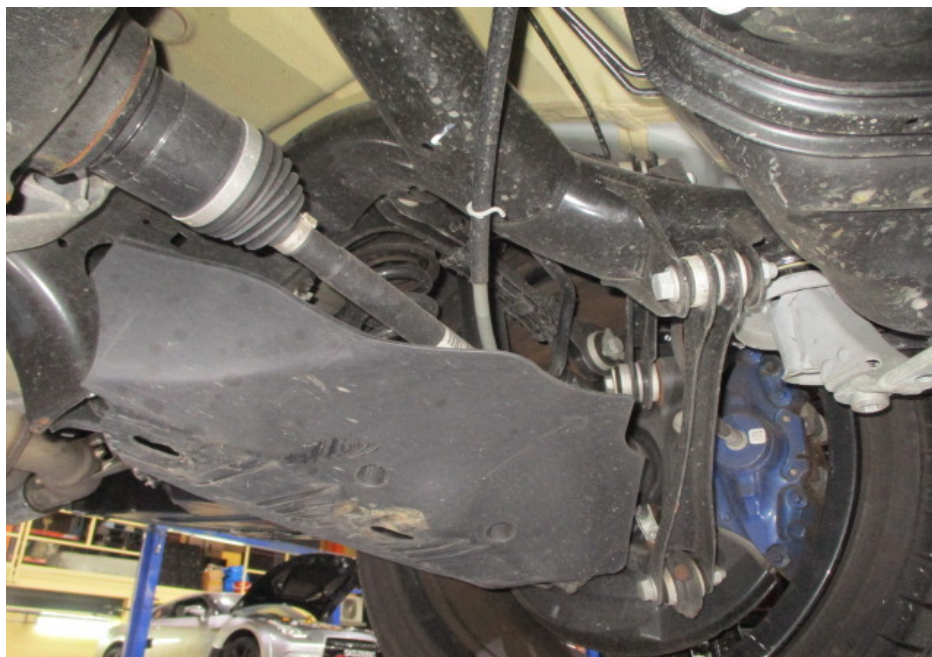
**Photo 16** shows the various undercarriage components at the rear left wheel of the Motor Car. The mechanical components, control arms and linkages were all found to be intact and secured in an appropriate manner.

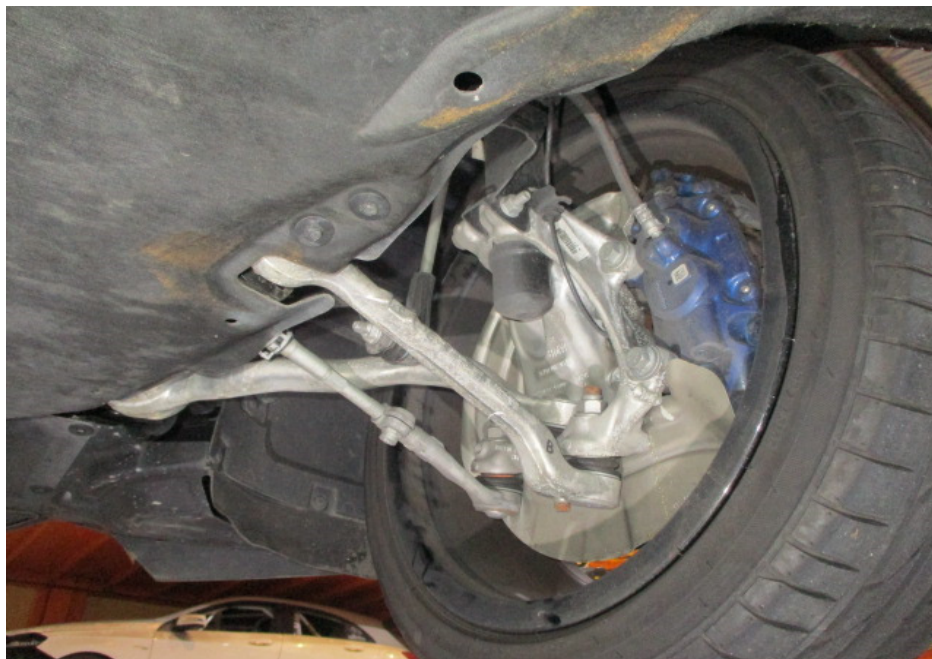
**Photo 17** shows the various undercarriage components at the front right wheel of the Motor Car. The mechanical components, control arms and linkages were all found to be intact and secured in an appropriate manner. I also did not observe any fluid leak and/or fluid stain on the underside of the Motor Car.

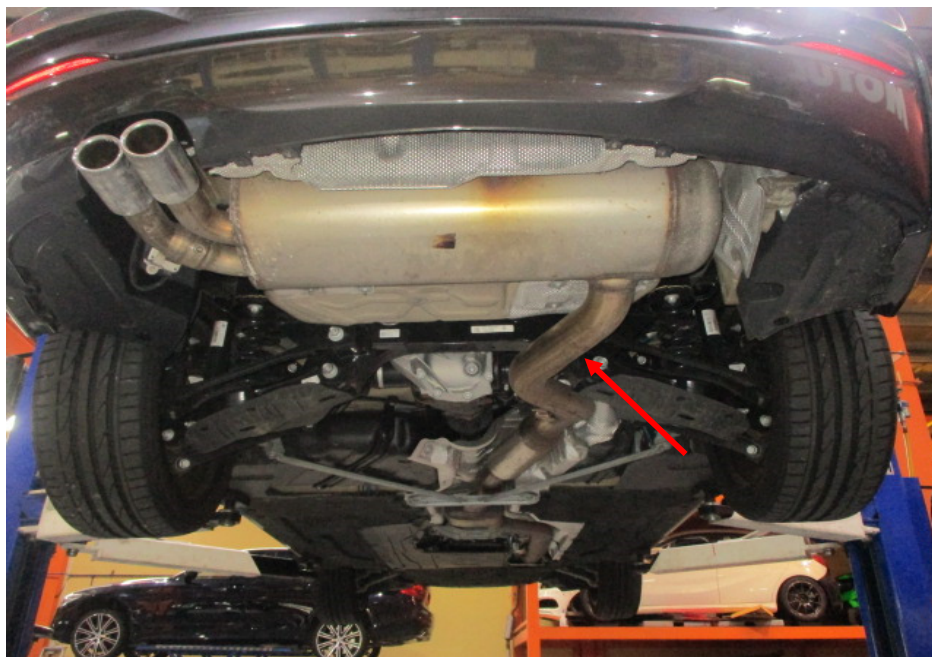
**Photo 18** shows a general view of the Motor Car's exhaust system (rear section). My examination of the Motor Car's exhaust system revealed no sign(s) or indication(s) of any cut or weld marks along its exhaust pipes (arrowed), centre resonator boxes, rear muffler and on its catalytic converter.

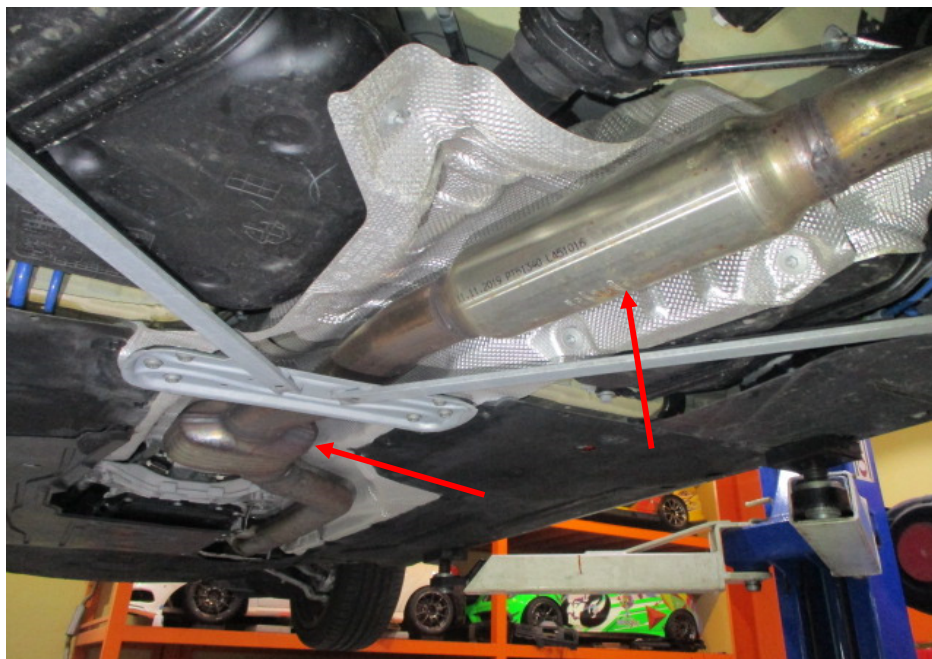
**Photo 19** shows a general view of the Motor Car's exhaust system (front section). My examination of the Motor Car's exhaust system revealed no sign(s) or indication(s) of any cut or weld marks along its exhaust pipes, centre resonator boxes (arrowed), rear muffler and on its catalytic converter.

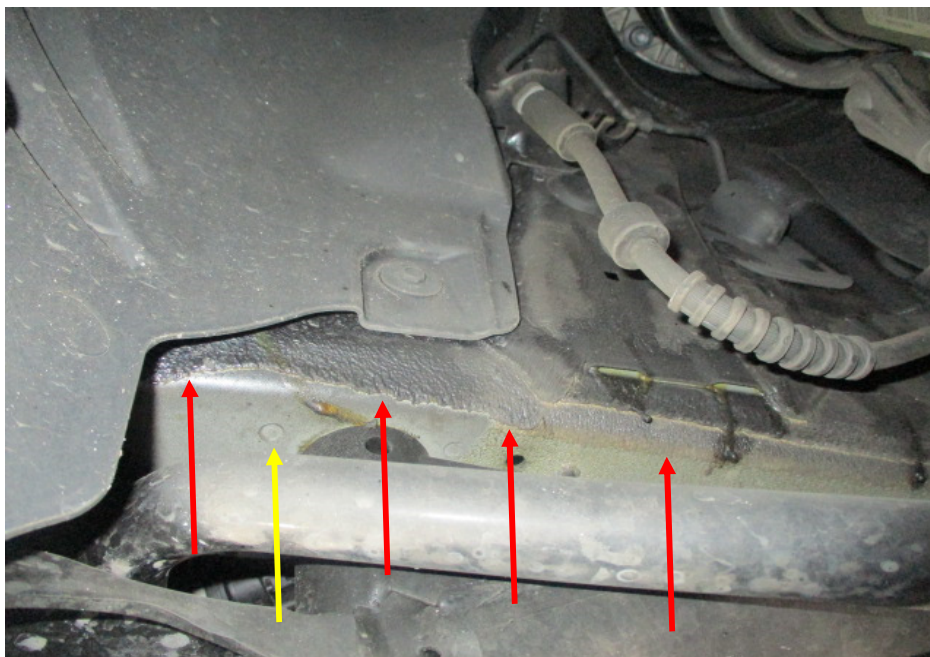
**Photo 20** shows the chassis/structural body at the underside front left of the Motor Car. I did not find any weld marks other than original spot weld marks (yellow arrow) on the chassis/structural body of the Motor Car. The original factory sealant (red arrow) at the joints along the chassis/structural body was untouched, indicating no work was done on the chassis/structural body of the Motor Car and that the chassis/structural body was originally fitted.

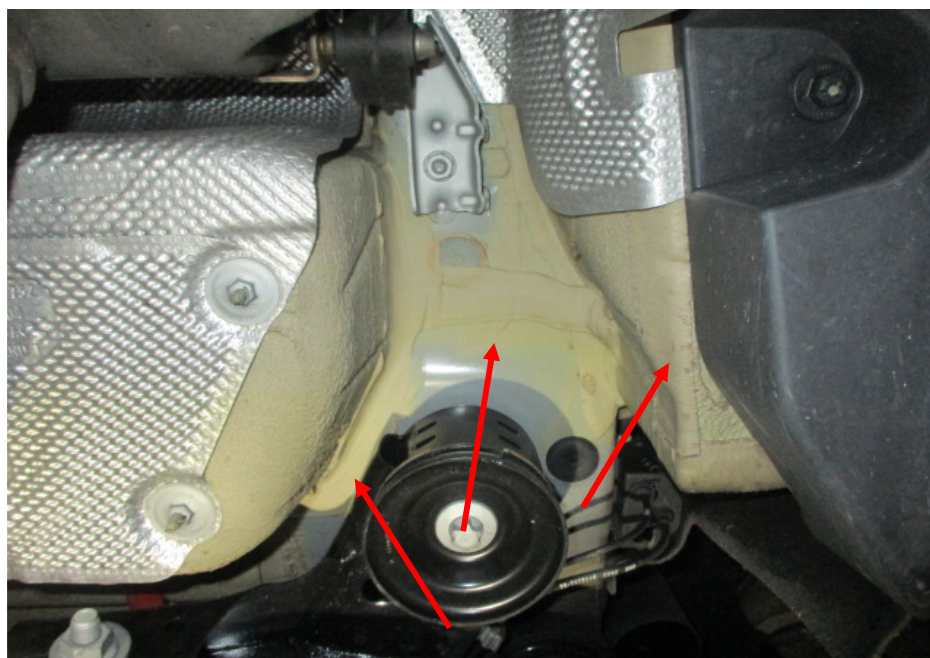
**Photo 21** shows the chassis/structural body at the underside rear right of the Motor Car. The original factory sealant (arrowed) at the joints along the chassis/structural body was observed to be untouched. In general, I had found no work was carried out on the chassis/structural body of the Motor Car. The chassis/structural body of the Motor Car was originally fitted.

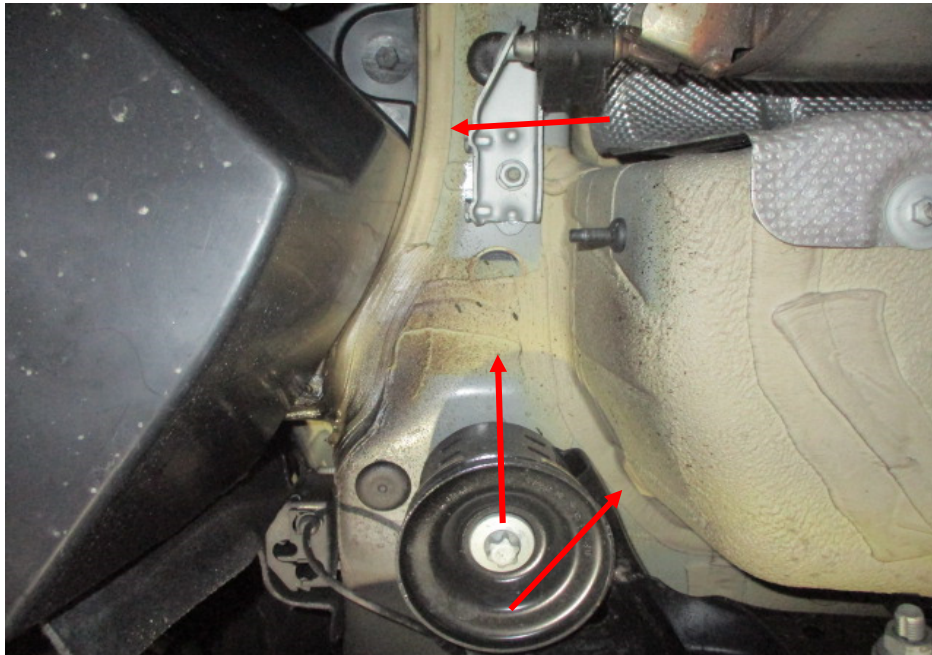
**Photo 22** shows the chassis/structural body at the underside rear left of the Motor Car. The original factory sealant (arrowed) at the joints along the chassis/structural body was observed to be untouched. In general, I had found no work was carried out on the chassis/structural body of the Motor Car. The chassis/structural body of the Motor Car was originally fitted.

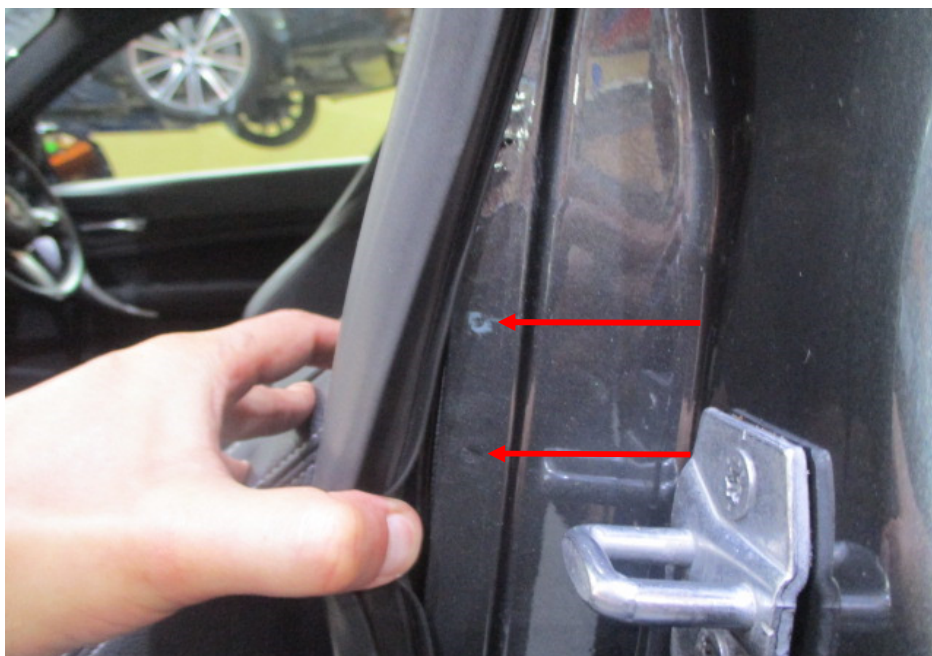
**Photo 23** shows the left rear body panel of the Motor Car. I did not find any weld marks other than original spot weld marks (arrowed) on the left rear body panel of the Motor Car which, indicates that there was no re-welding works carried out. In general, I had found all the non-detachable body panels of the Motor Car to be originally fitted at the time of my inspection.

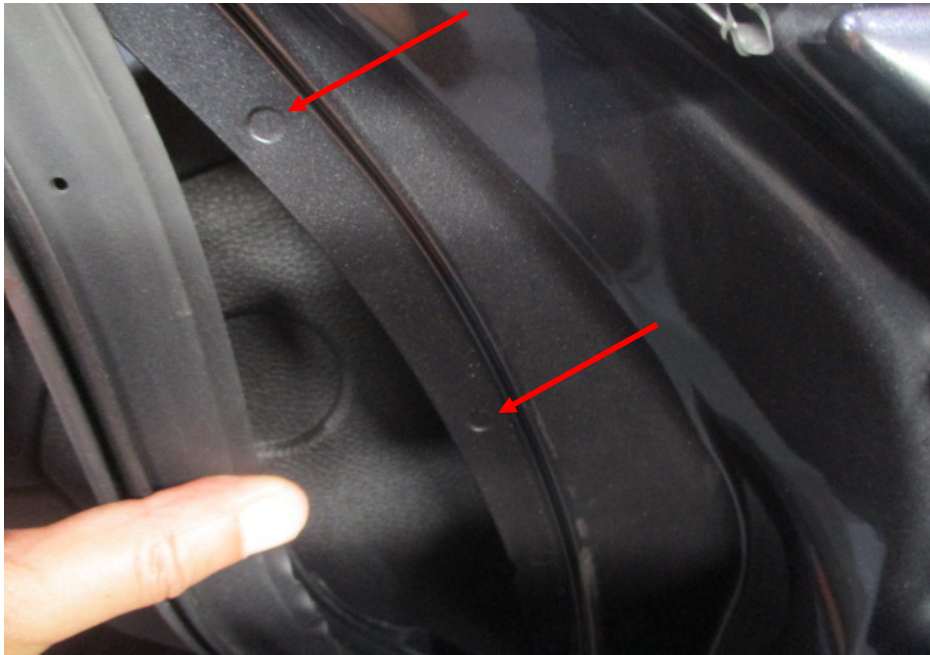
**Photo 24** shows the right side "A" pillar of the Motor Car. I did not find any weld marks other than original spot weld marks (arrowed) on the right side "A" pillar of the Motor Car which, indicates that there was no re-welding works carried out. In general, I had found all the non-detachable body panels of the Motor Car to be originally fitted at the time of my inspection.
