Your Ref: Mercedes Benz C43 Coupe  
(chassis number WDD2053642F966810)

16 July 2021

Our Ref : CI/TP21007686/D

**INSPECTION REPORT OF AN UNREGISTERD MERCEDES BENZ C43  
COUPE MOTOR CAR WITH CHASSIS NUMBER WDD2053642F966810**

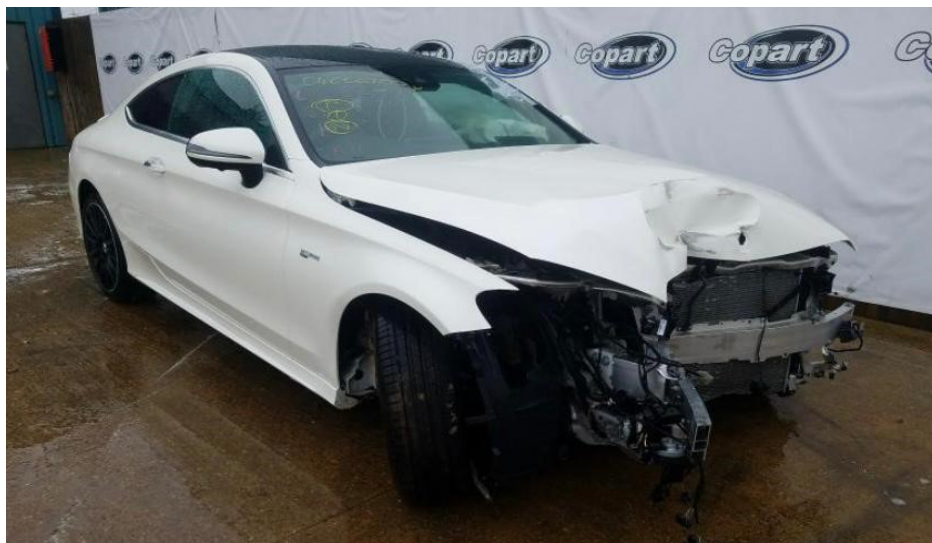
3. The photographs provided to me had showed damage at the frontal portion of the Motor Car. Body parts observed to be damaged include the front bumper and all its related parts and attachments, front bumper reinforcement, front radiator grille, front headlamps, front left headlamp top panel, front right headlamp top panel, front bonnet, front bonnet lock, front bonnet hinges, front top panel centre, front support panel, aircon condenser, radiator, front left fender, front left fender inner shield and front right fender inner shield amongst others.
4. The orientation of the front right wheel and front left wheel, as seen from the photographs, indicates to me that the front undercarriage parts were also damaged. The front left passenger airbag of the Motor Car was deployed. See photo 1 – 4 below.

**Photo 1** shows the front right body of the Motor Car (photograph provided to me). The Motor Car was observed to have sustained damage at its frontal portion. The front bumper and all its related parts and attachments, front bonnet, front right headlamp and front bumper reinforcement were amongst the body parts that were observed to have been damaged. The front right wheel and front left wheel (refer to photograph 2 below) were orientated in different directions, which suggests to me that the front undercarriage parts of the Motor Car were also damaged.

22. The body parts and undercarriage parts at the frontal portion of the Motor Car were visually examined and it was noted that the repair/restoration works carried out to the damaged area of the Motor Car (refer to photograph 1 & 2 above) were reasonably adequate and in order.

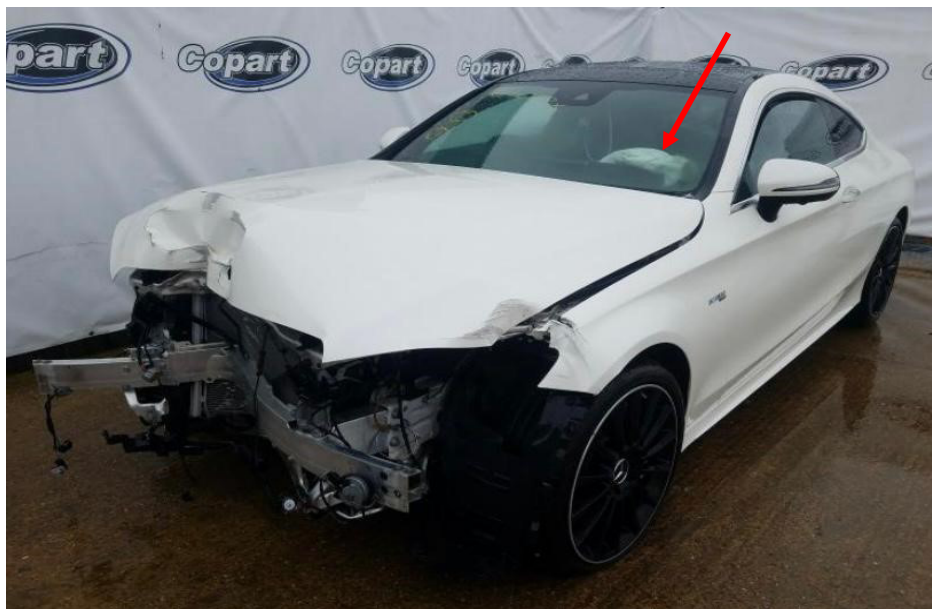
**Photo 2** shows the front left body of the Motor Car (photograph provided to me). The Motor Car was observed to have sustained damage at its frontal portion. The front bumper and all its related parts and attachments, front left headlamp, aircon condenser, radiator and front left fender were amongst the body parts that were observed to have been damaged. The front right wheel (refer to photograph 1 above) and front left wheel were orientated in different directions, which suggests to me that the front undercarriage parts of the Motor Car were also damaged. The front left passenger airbag (arrowed) was observed to be deployed.

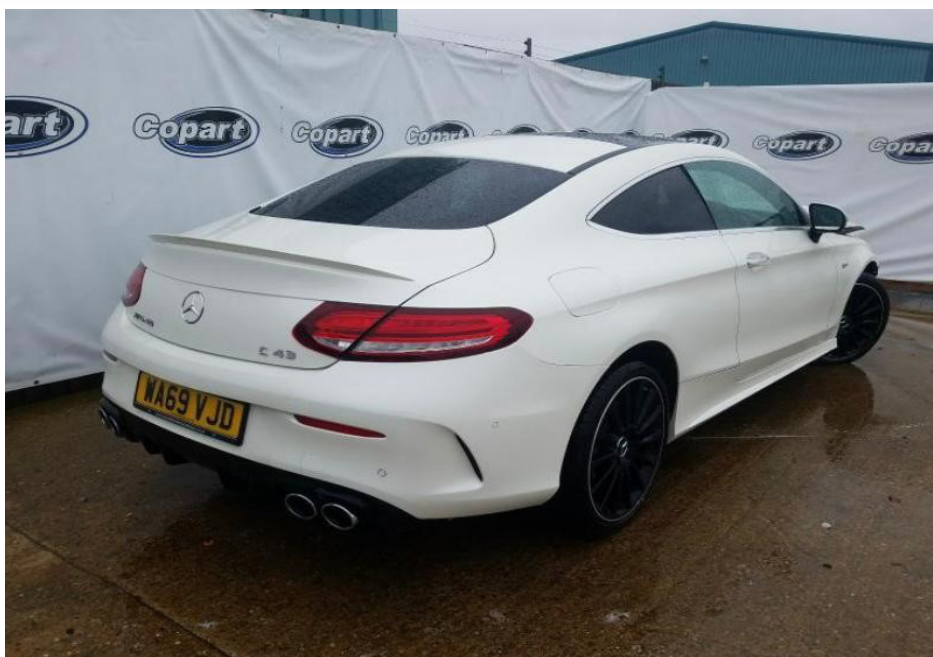
**Photo 3** shows the rear right body of the Motor Car (photograph provided to me). Apart for the frontal portion, there was no physical damage seen to other areas of the Motor Car.

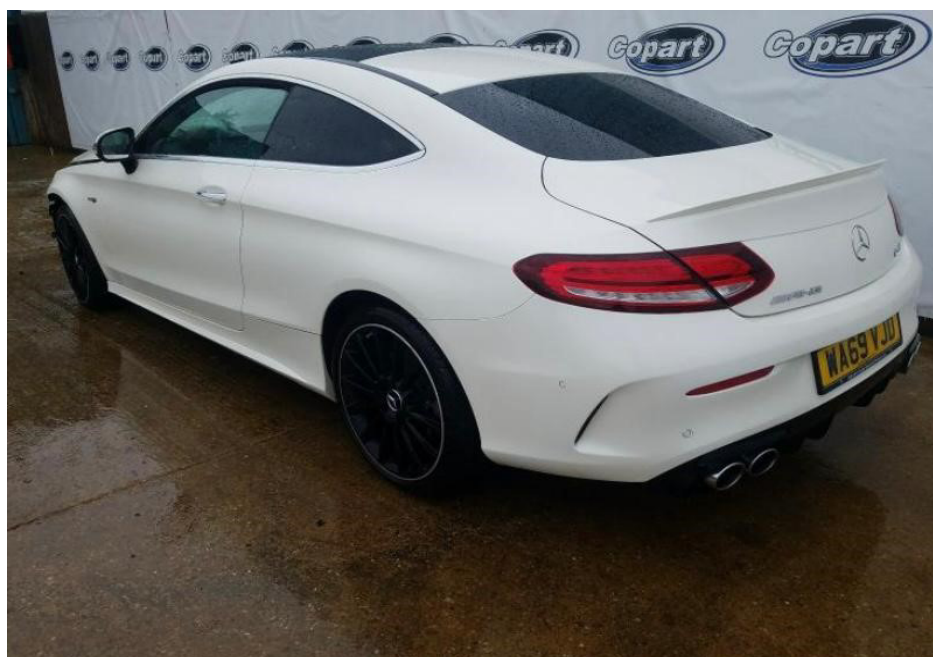
**Photo 4** shows the rear left body of the Motor Car (photograph provided to me). Apart for the frontal portion, there was no physical damage seen to other areas of the Motor Car.

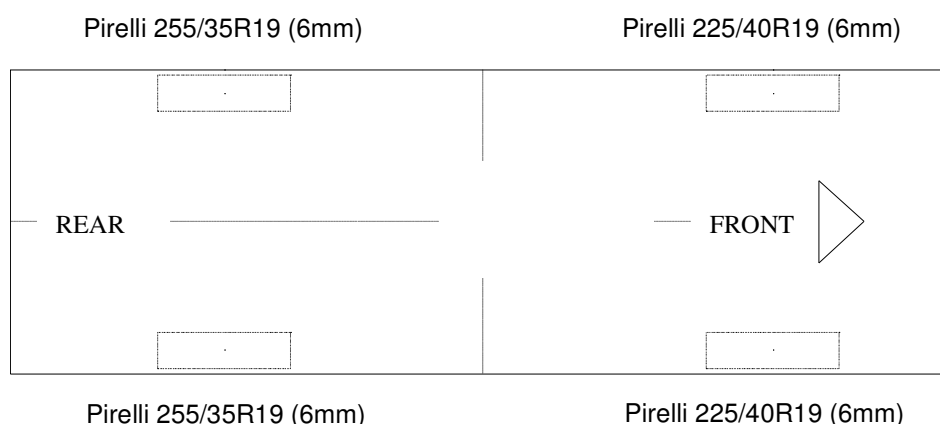
8. It was fitted with 19inch sport wheel rims that were wrapped with tyres that were observed to be of serviceable condition. The tyres were also sufficiently inflated for vehicular operation. The tyre brand, tyre size and approximate remaining tread depth of the 4 tyres of the Motor Car were recorded as follows: -

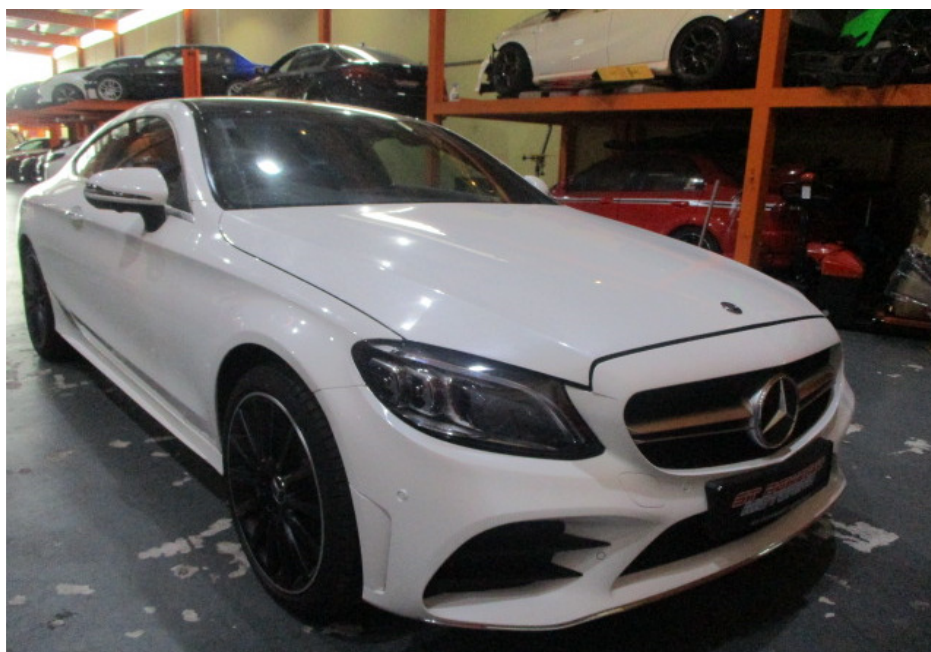
**Photo 5** shows a general view of the front right body of the Motor Car at the time of my inspection. The Motor Car was observed to be in a relatively good general condition with no loose exterior fittings observed. The body parts at the frontal portion of the Motor Car were visually examined and it was observed that the repair/restoration works carried out to the damaged area of the Motor Car (refer to photograph 1 & 2 above) were reasonably adequate and in order.

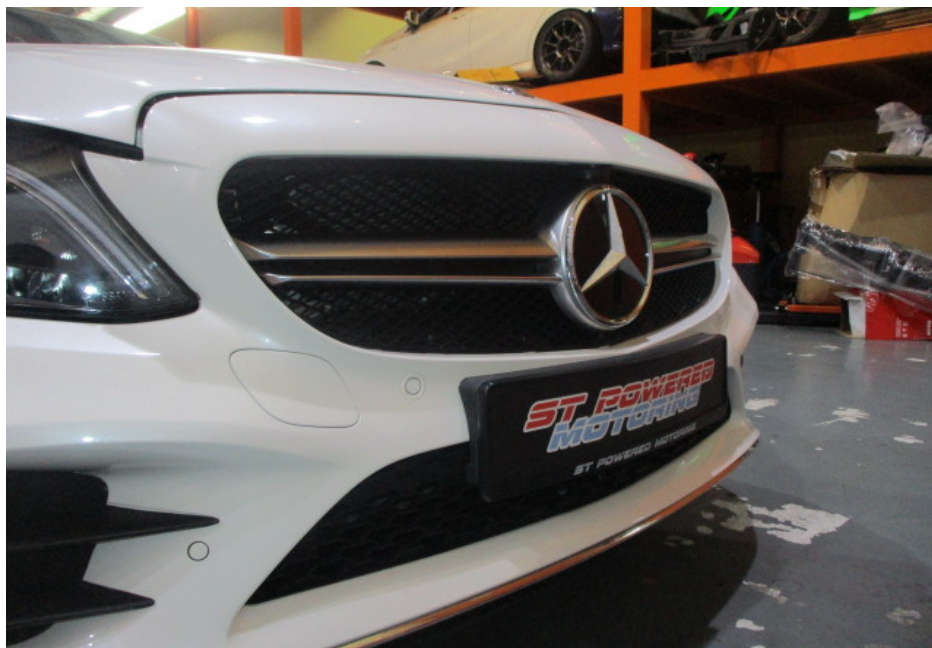
**Photo 6** shows a closer view of the Motor Car's front bumper, front bumper centre lower grille and front radiator grille at the time of my inspection. The body parts at the frontal portion of the Motor Car were visually examined and it was observed that the repair/restoration works carried out to the damaged area of the Motor Car (refer to photograph 1 & 2 above) were reasonably adequate and in order.

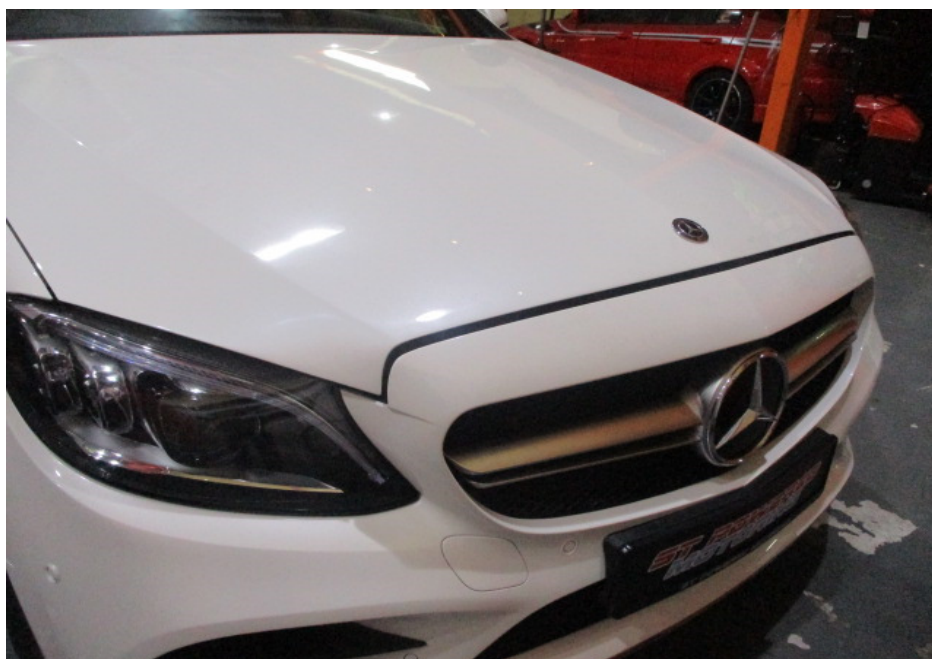
**Photo 7** shows a closer view of the Motor Car's front bumper, front right headlamp and front bonnet at the time of my inspection. The body parts at the frontal portion of the Motor Car were visually examined and it was observed that the repair/restoration works carried out to the damaged area of the Motor Car (refer to photograph 1 & 2 above) were reasonably adequate and in order.

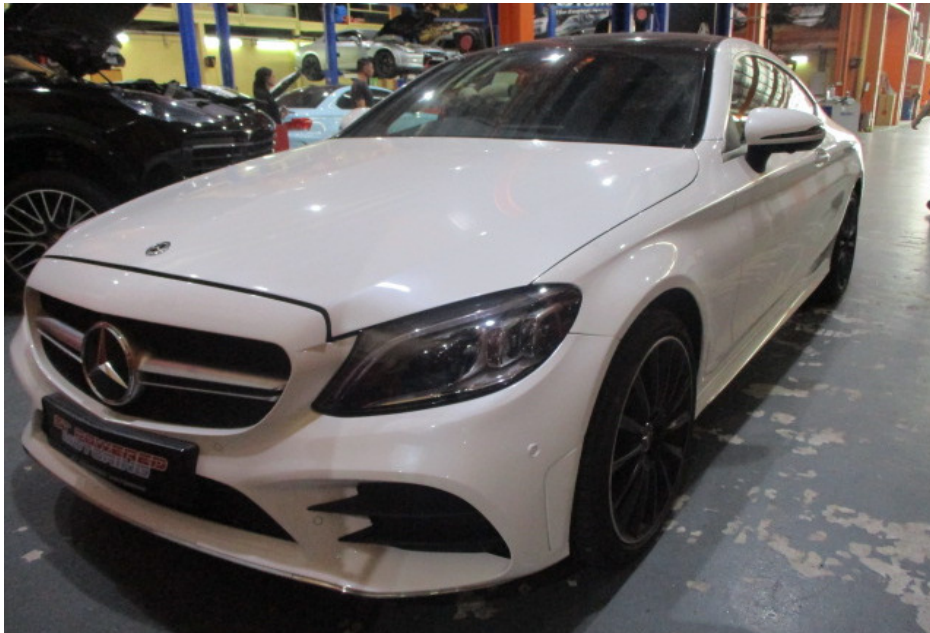
**Photo 8** shows a general view of the front left body of the Motor Car at the time of my inspection. The Motor Car was observed to be in a relatively good general condition with no loose exterior fittings observed. The body parts at the frontal portion of the Motor Car were visually examined and it was observed that the repair/restoration works carried out to the damaged area of the Motor Car (refer to photograph 1 & 2 above) were reasonably adequate and in order.

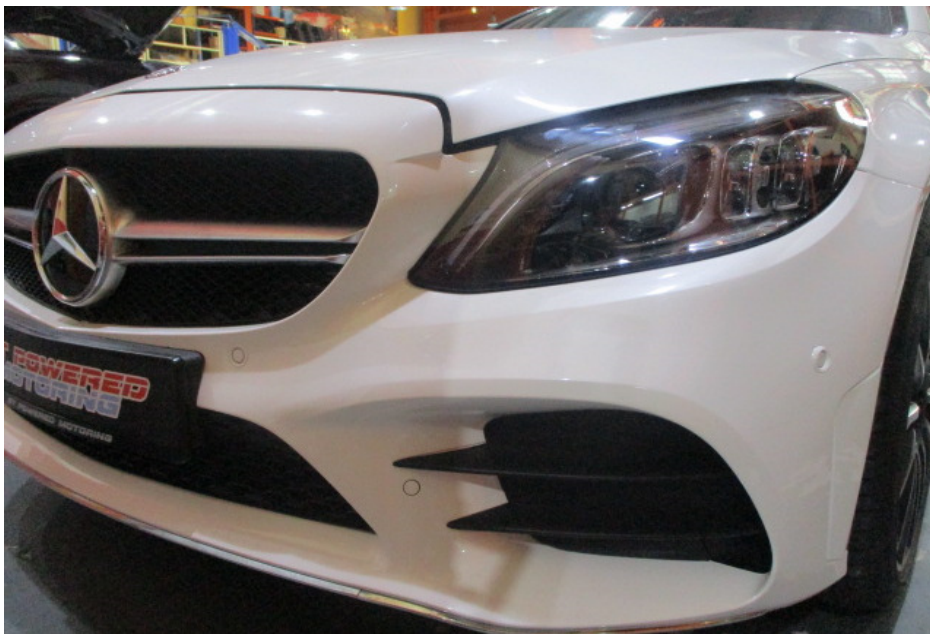
**Photo 9** shows a closer view of the Motor Car's front bumper, front bumper left lower grille, front radiator grille and front left headlamp at the time of my inspection. The body parts at the frontal portion of the Motor Car were visually examined and it was observed that the repair/restoration works carried out to the damaged area of the Motor Car (refer to photograph 1 & 2 above) were reasonably adequate and in order.

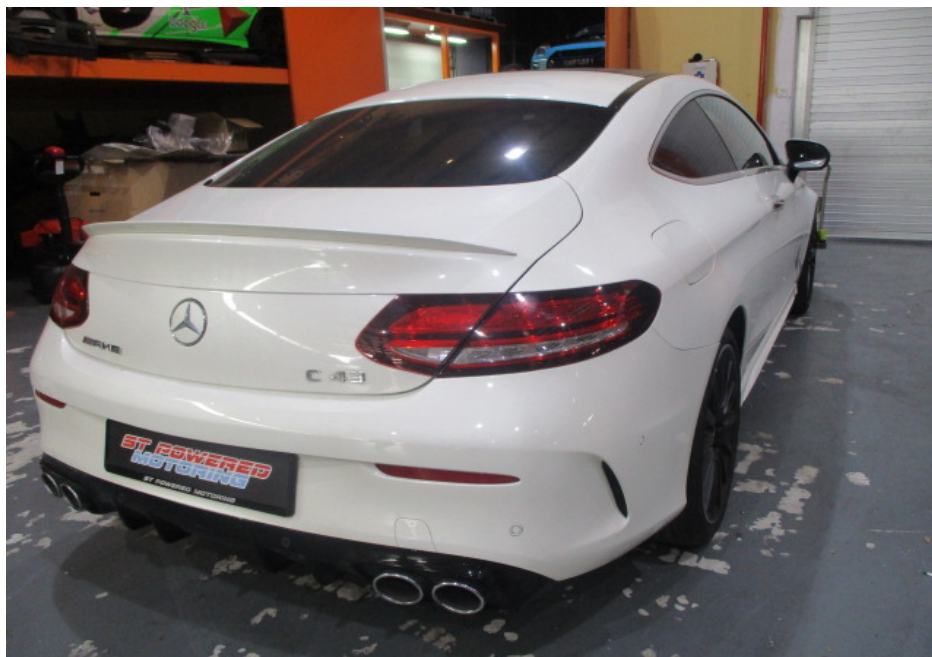
**Photo 10** shows a general view of the rear right body of the Motor Car at the time of my inspection. The Motor Car was observed to be in a relatively good general condition with no loose exterior fittings observed. The mileage of the Motor Car recorded at the time of my inspection was 5,563km.

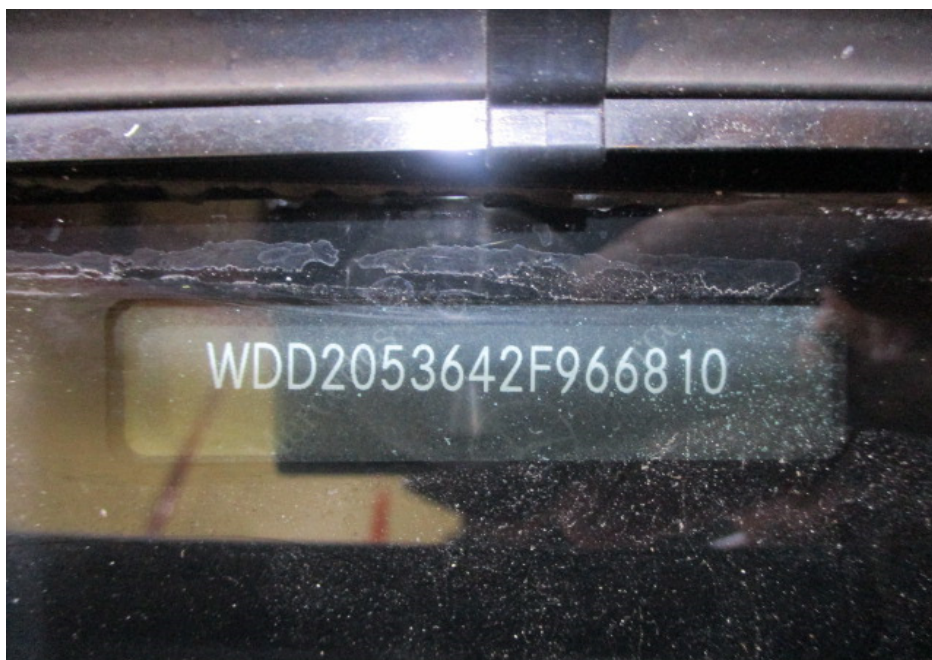
**Photo 11** shows the chassis number of the Motor Car. The chassis number recorded was WDD2053642F966810.

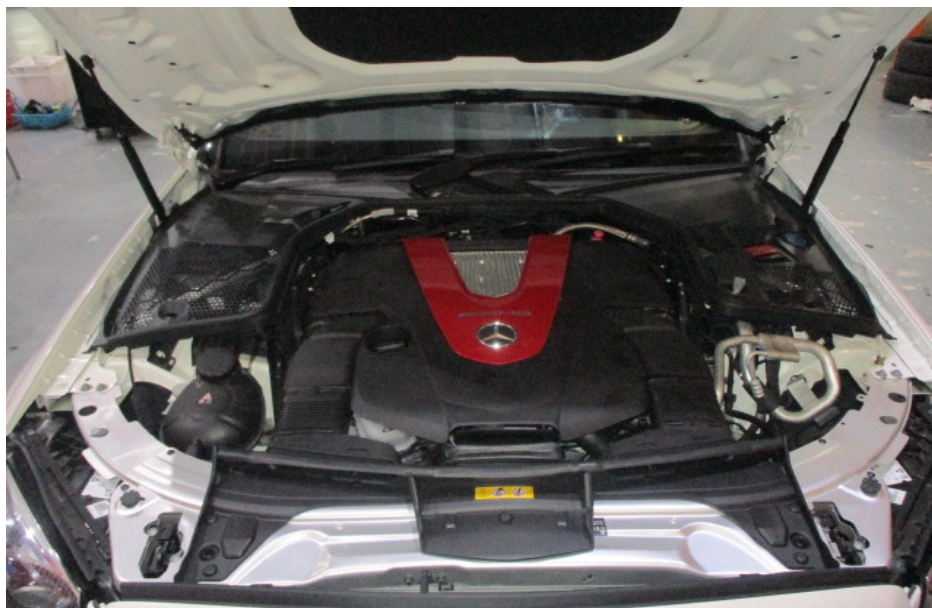
**Photo 12** shows a general view of the Motor Car's engine compartment at the time of my inspection. The various parts and components inside the engine compartment were all observed to be intact and properly fitted. There was also no sign(s) or indication(s) of fluid leak and/or fluid stain found inside the engine compartment. The repair/restoration works carried out to the various parts within the engine compartment like the front headlamp top panels, front top panel centre, front top air guide, front support panel, aircon condenser and radiator amongst others, were reasonably adequate and in order.

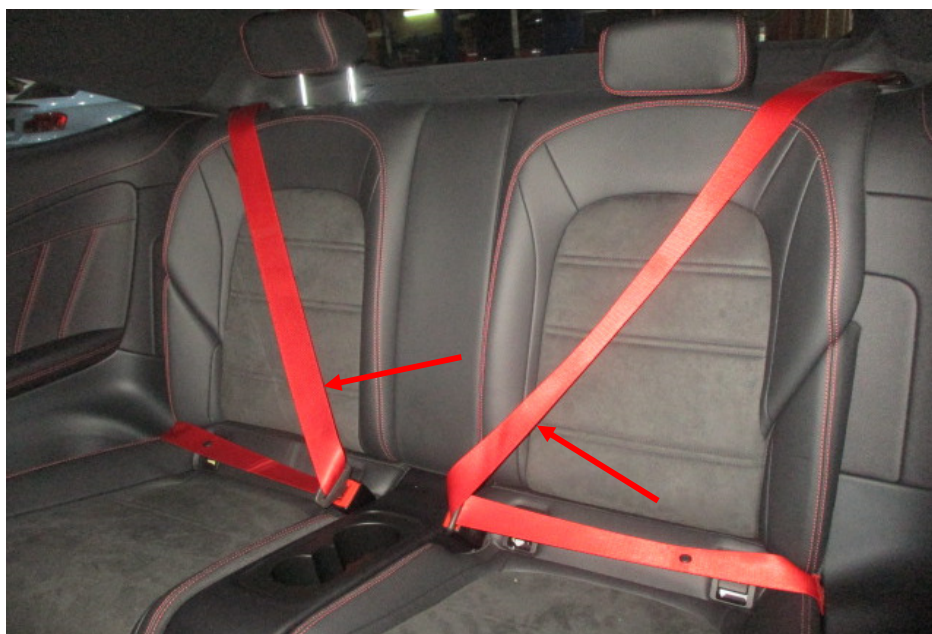
**Photo 13** shows the rear seats of the Motor Car. All the seats of the Motor Car were secured via seat rails to the floorboard. They were also fitted with a retractable seat belt reel and a pre-tensioner. The seat belts (arrowed) were tested and were able to be fastened into the respective pre-tensions that were fitted on the side of each individual seat.

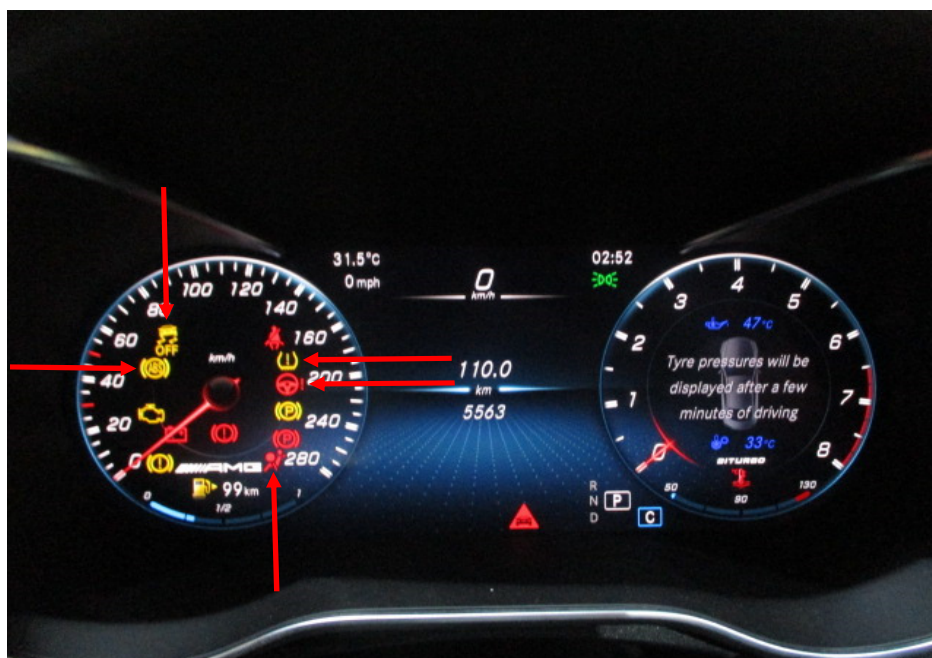
**Photo 14** shows the warning lights for the various electronic safety features appearing on the instrument panel of the Motor Car during its self-test when the engine is cranked, in particular the ABS, SRS, EPS, TPM and TCS lights (arrowed).

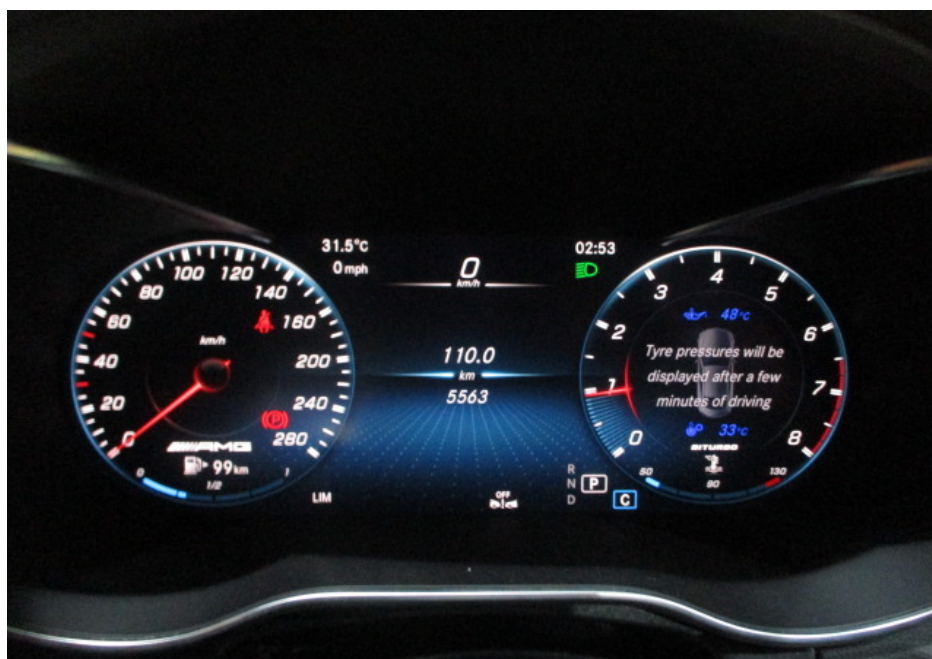
**Photo 15** shows the respective warning lights no longer illuminated, indicating that there is no fault detected to the ABS, SRS, EPS, TPM and TCS systems of the Motor Car during the self-test. These electronic systems were hence in working condition at the time of my inspection.

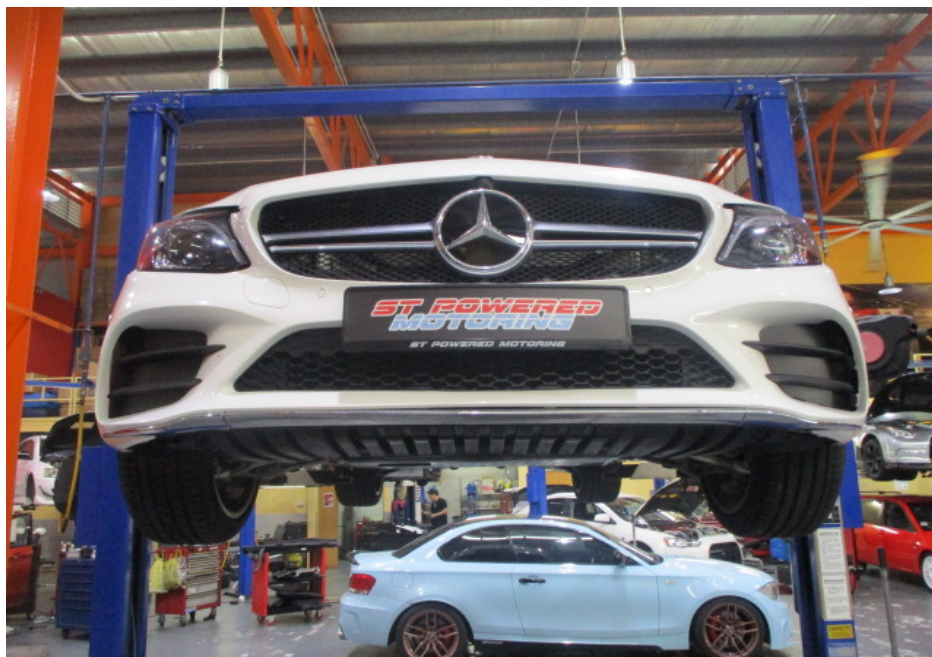
**Photo 16** shows the Motor Car hoisted up for checks on its undercarriage. There was no sign(s) or indication(s) of fluid leakage and/or fluid stain(s) on the underside of the Motor Car. The undercarriage components of the Motor Car were also all observed to be intact and secured in an appropriate manner.

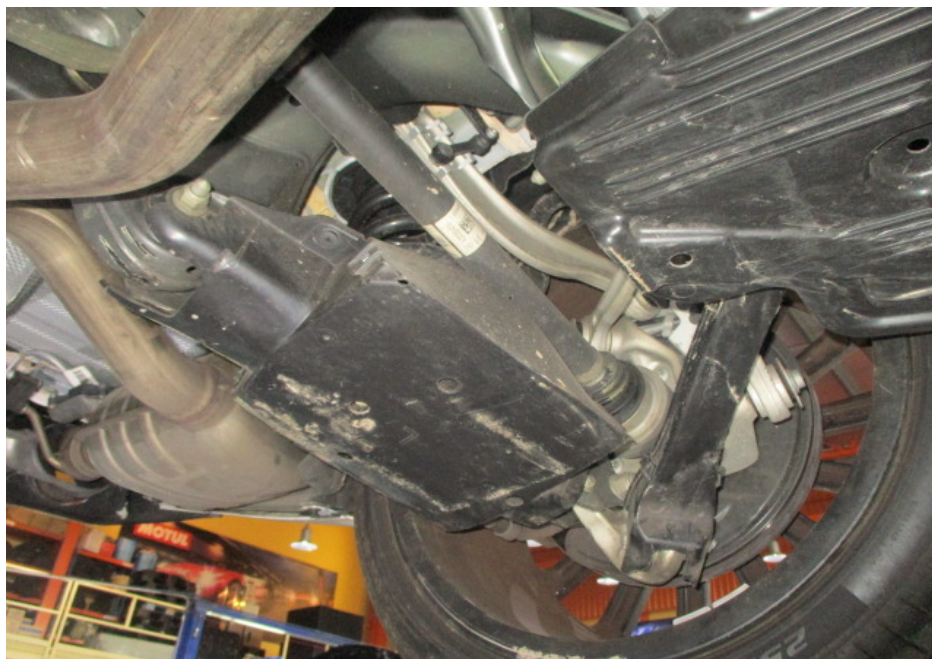
**Photo 17** shows a general view of the control arms and linkages at the rear left wheel of the Motor Car. I did not observe any fluid leak and/or fluid stain on the underside of the Motor Car. All of the Motor Car's undercarriage components were observed to be intact and secured in an appropriate manner.

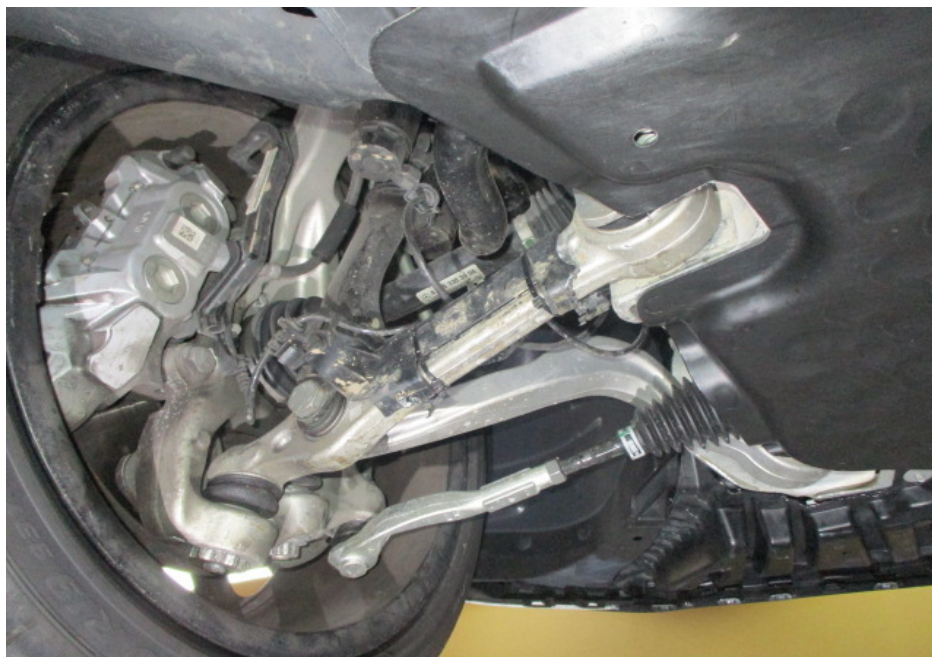
**Photo 18** shows the various undercarriage components at the front left wheel of the Motor Car. The mechanical components, control arms and linkages were all found to be intact and secured in an appropriate manner.

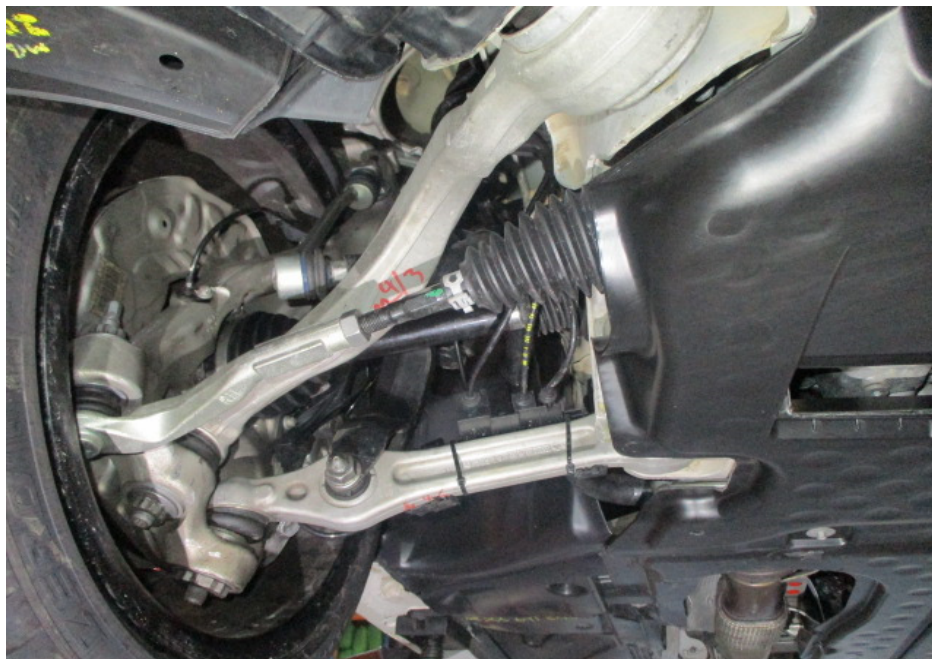
**Photo 19** shows the various undercarriage components at the front right wheel of the Motor Car. The mechanical components, control arms and linkages were all found to be intact and secured in an appropriate manner. I also did not observe any fluid leak and/or fluid stain on the underside of the Motor Car.

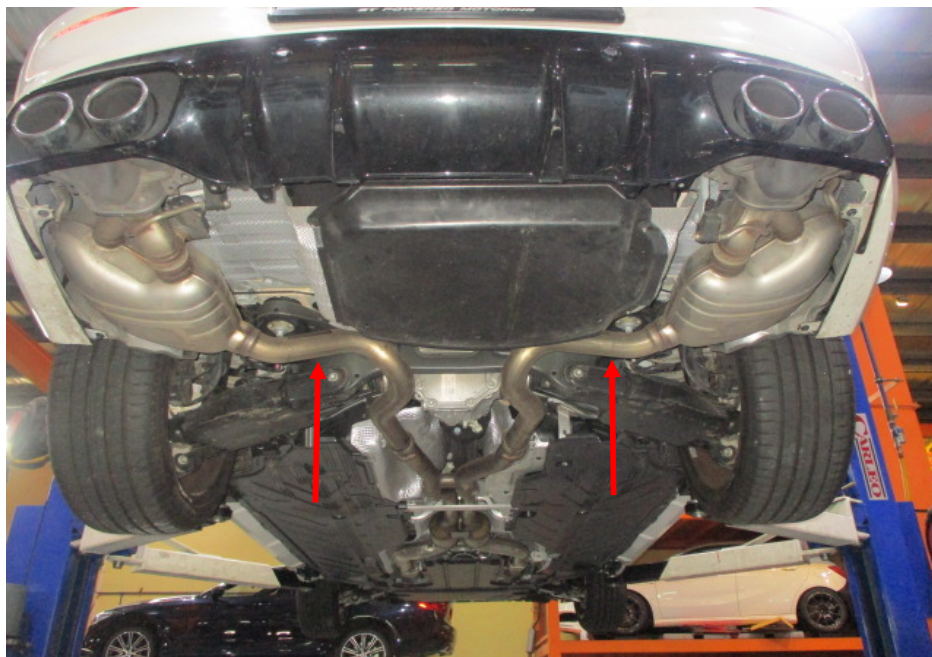
**Photo 20** shows a general view of the Motor Car's exhaust system (rear section). My examination of the Motor Car's exhaust system revealed no sign(s) or indication(s) of any cut or weld marks along its exhaust pipes (arrowed), on its centre resonator boxes, catalytic converters and on its rear mufflers.

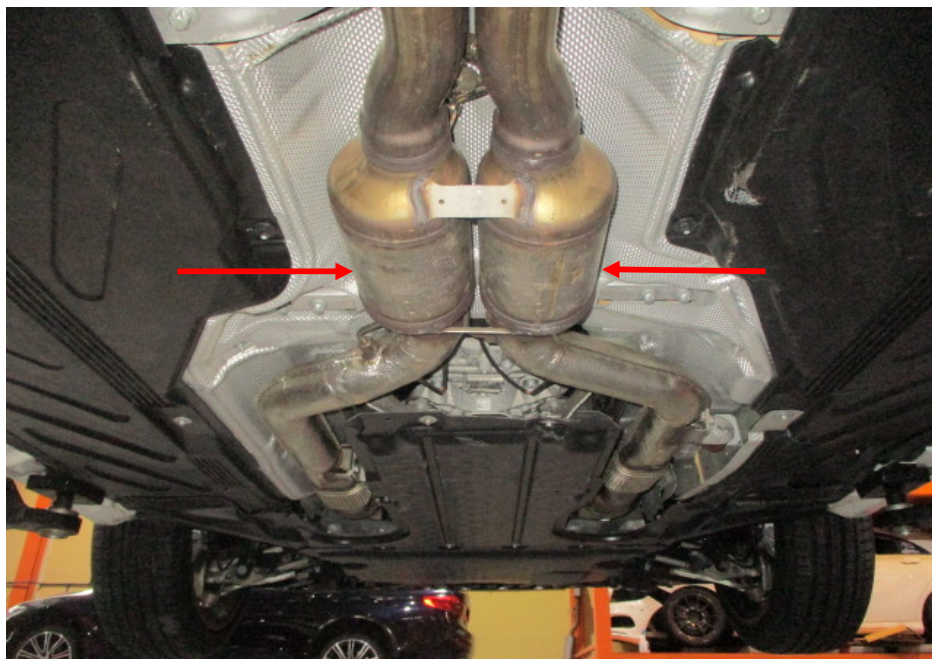
**Photo 21** shows a general view of the Motor Car's exhaust system (front section). My examination of the Motor Car's exhaust system revealed no sign(s) or indication(s) of any cut or weld marks along its exhaust pipes, on its centre resonator boxes (arrowed), catalytic converters and on its rear mufflers.

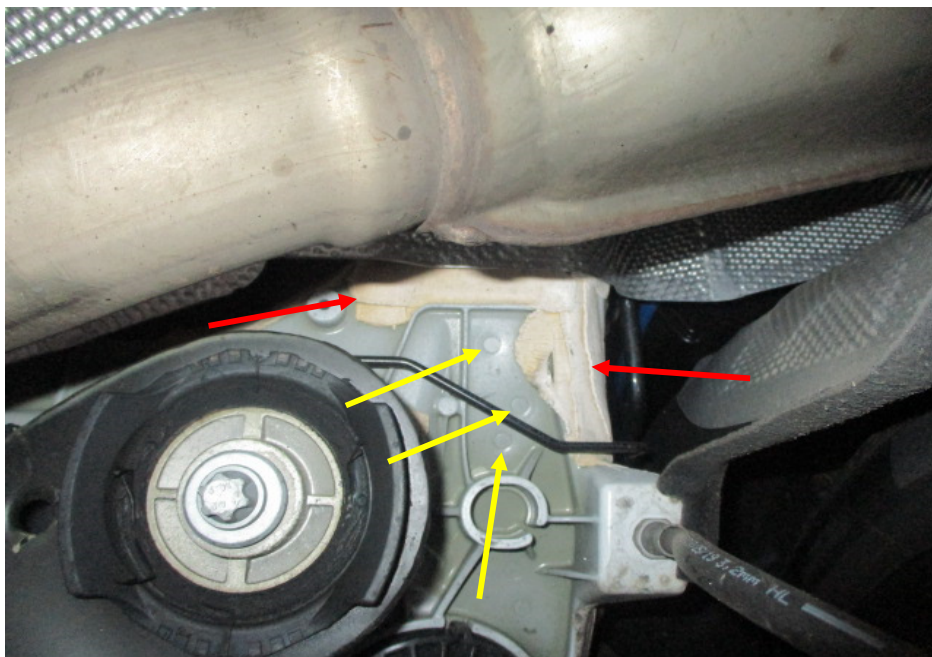
**Photo 22** shows the chassis/structural body at the underside rear right of the Motor Car. I did not find any weld marks other than original spot weld marks (yellow arrow) on the chassis/structural body of the Motor Car. The original factory sealant (red arrow) at the joints along the chassis/structural body was untouched, indicating no work was done on the chassis/structural body of the Motor Car and that the chassis/structural body was originally fitted.

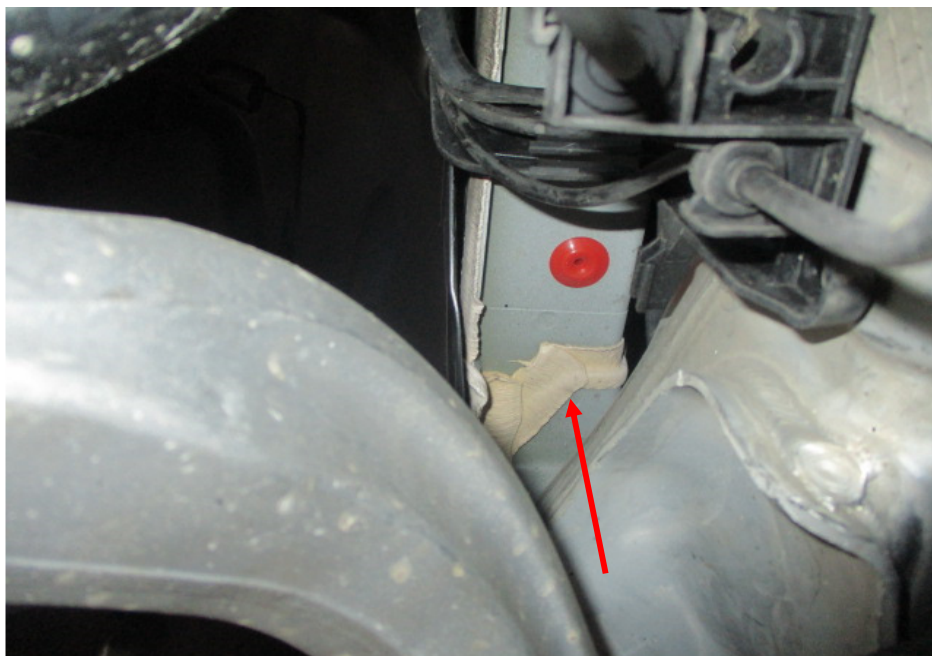
**Photo 23** shows the chassis/structural body at the underside front left of the Motor Car. The original factory sealant (arrowed) at the joints along the chassis/structural body was observed to be untouched. In general, I had found no work was carried out on the chassis/structural body of the Motor Car. The chassis/structural body of the Motor Car was originally fitted.

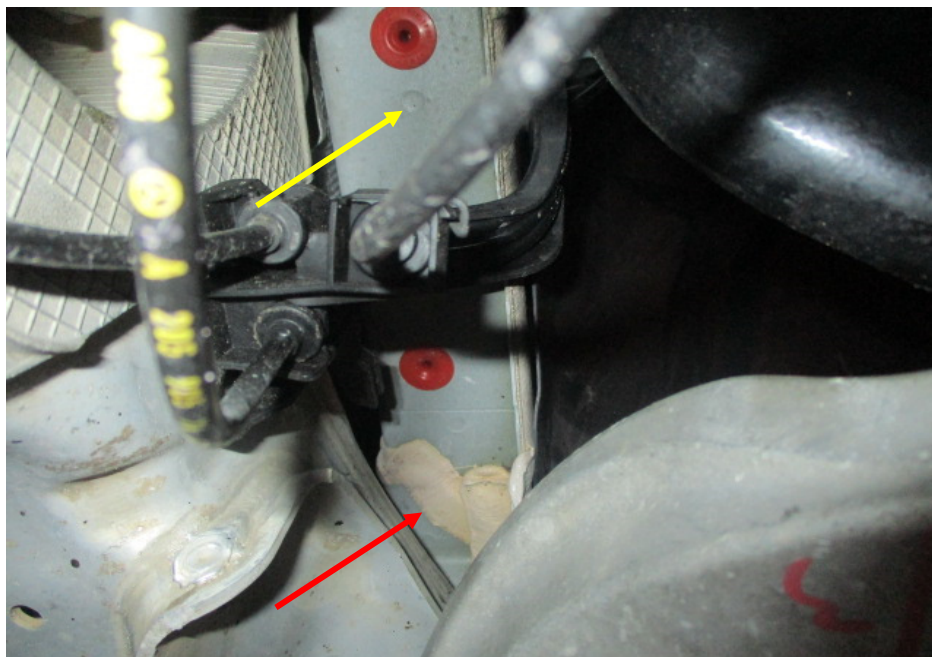
**Photo 24** shows the chassis/structural body at the underside front right of the Motor Car. I did not find any weld marks other than original spot weld marks (yellow arrow) on the chassis/structural body of the Motor Car. The original factory sealant (red arrow) at the joints along the chassis/structural body was untouched, indicating no work was done on the chassis/structural body of the Motor Car and that the chassis/structural body was originally fitted.

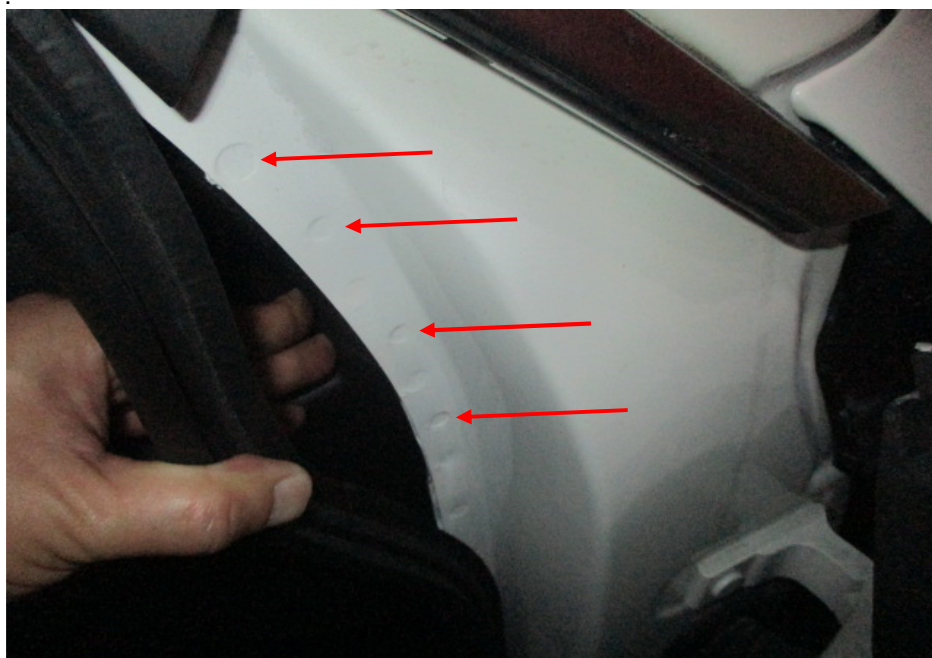
**Photo 25** shows the right side "A" pillar of the Motor Car. I did not find any weld marks other than original spot weld marks (arrowed) on the right side "A" pillar of the Motor Car which, indicates that there was no re-welding works carried out. In general, I had found all the non-detachable body panels of the Motor Car to be originally fitted at the time of my inspection.

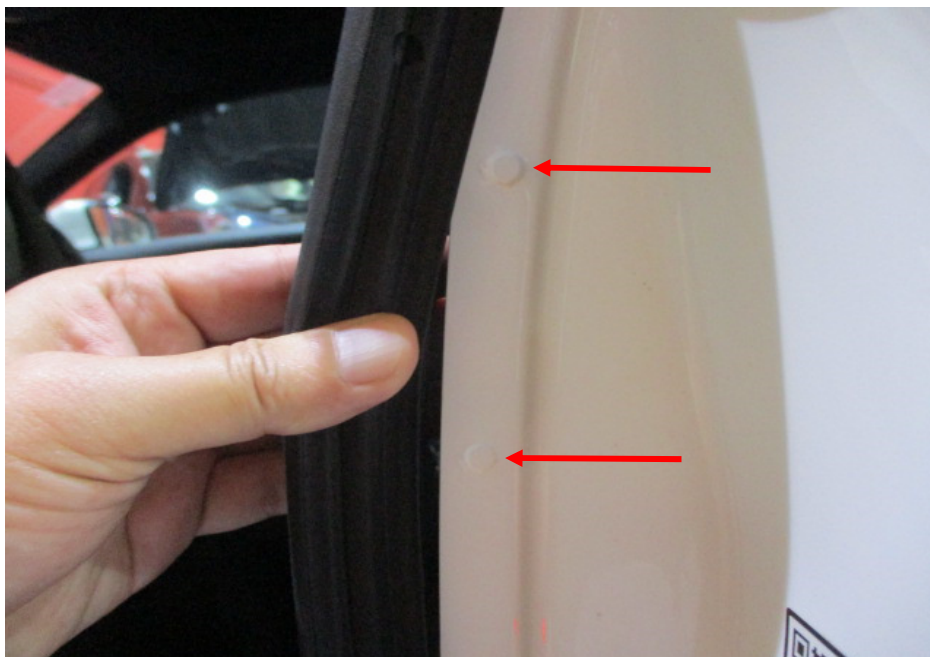
**Photo 26** shows the left rear body panel of the Motor Car. I did not find any weld marks other than original spot weld marks (arrowed) on the left rear body panel of the Motor Car which, indicates that there was no re-welding works carried out. In general, I had found all the non-detachable body panels of the Motor Car to be originally fitted at the time of my inspection.
