Your Ref: BMW M4 Coupe  
(chassis number WBS4Y92060AG10471)  
Our Ref : CI/TP21007733/D

18 July 2021

**Regent Express Pte Ltd**

**INSPECTION REPORT OF AN UNREGISTERD BMW M4 COUPE MOTOR CAR WITH CHASSIS NUMBER WBS4Y92060AG10471**

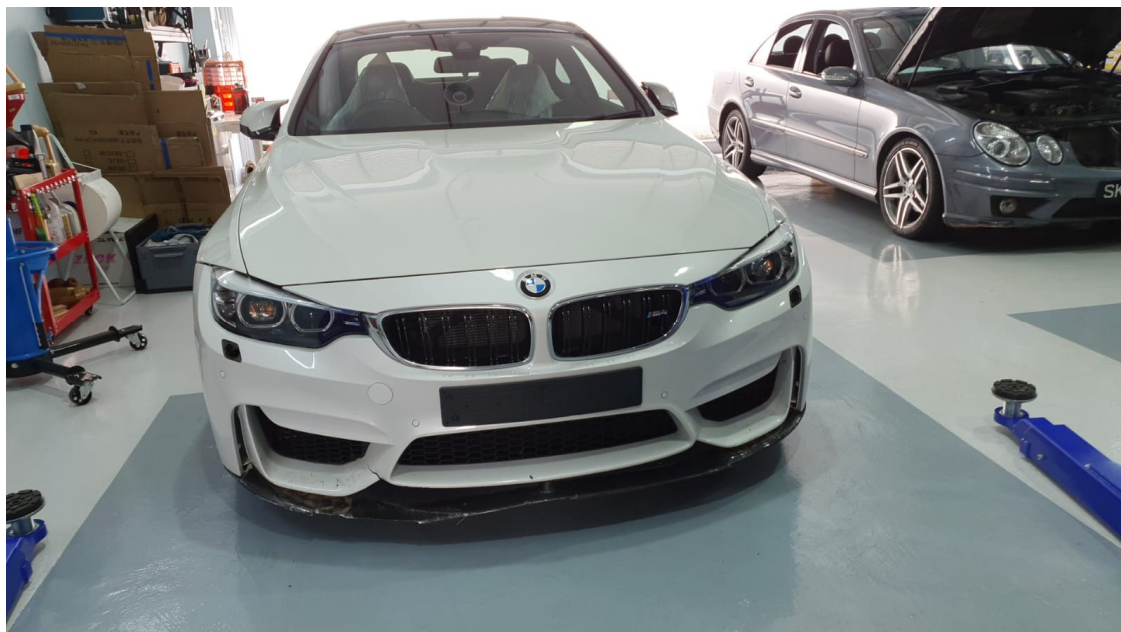
3. The photographs provided to me had showed damage to the frontal portion of the Motor Car. Body parts observed to be damaged were the front bumper and front bumper lower lip. The front left headlamp washer cover and front right headlamp washer cover were both observed to be missing.
4. No physical damage was observed to other areas of the Motor Car. The airbags were not deployed as seen from the photographs that were provided to me. See photo 1 – 5 below.

**Photo 1** shows the frontal body of the Motor Car (photograph provided to me). The photographs provided to me had showed damage to the frontal portion of the Motor Car. Body parts observed to be damaged were the front bumper and front bumper lower lip. The front left headlamp washer cover and front right headlamp washer cover were both observed to be missing.

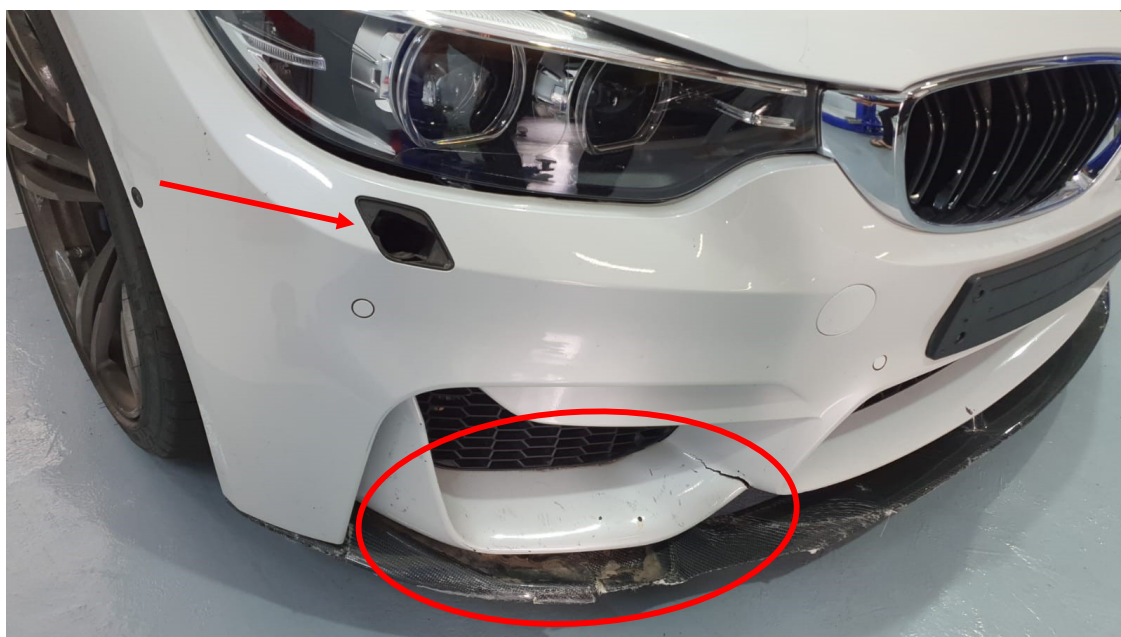
**Photo 2** shows a closer view of the damage to the front bumper and front bumper lower lip of the Motor Car (photograph provided to me). The front right headlamp washer cover (arrowed) was also observed to be missing.

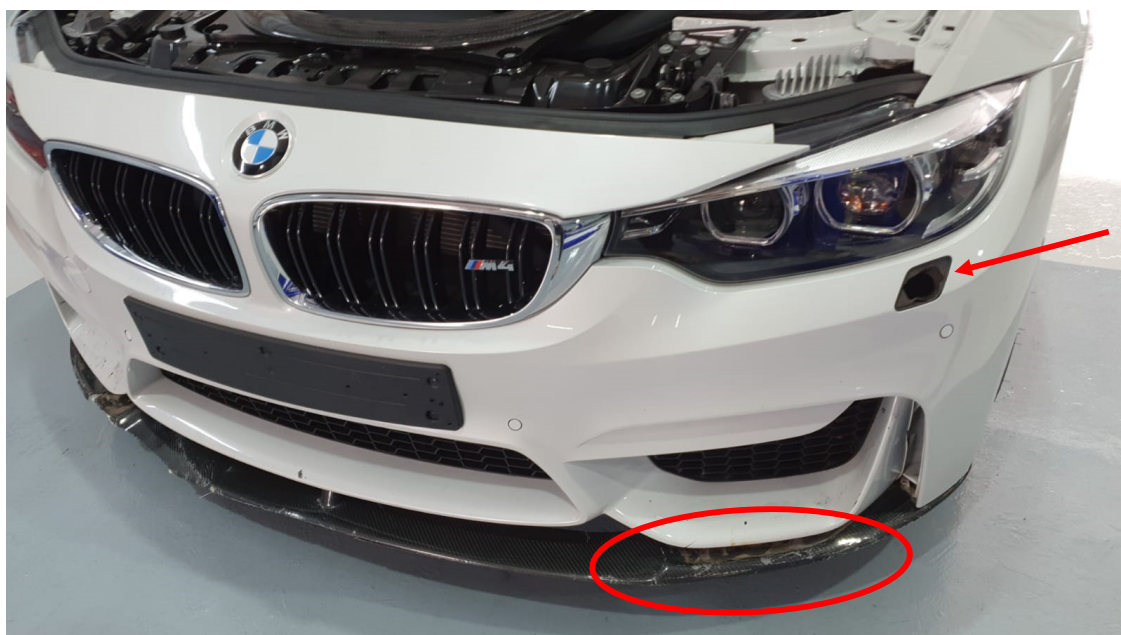
**Photo 3** shows a closer view of the damage to the front bumper and front bumper lower lip of the Motor Car (photograph provided to me). The front left headlamp washer cover (arrowed) was also observed to be missing.

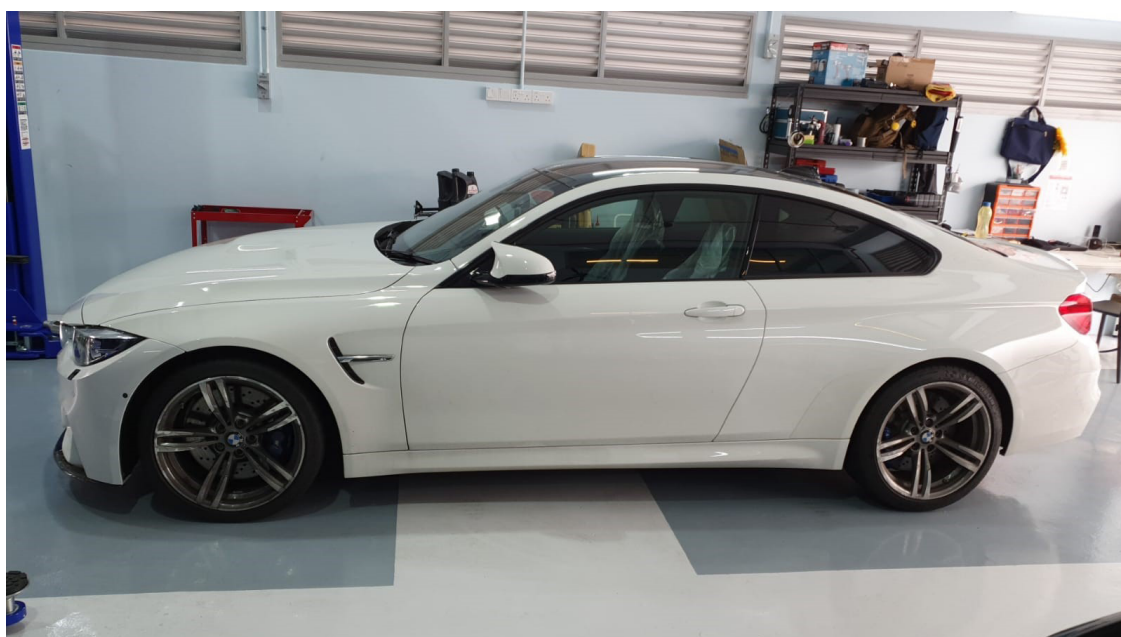
**Photo 4** shows the left body of the Motor Car (photograph provided to me). Apart from the frontal portion, there was no physical damage seen to other areas of the Motor Car. The airbags of the Motor Car were also not deployed as seen from the photographs that were provided to me.

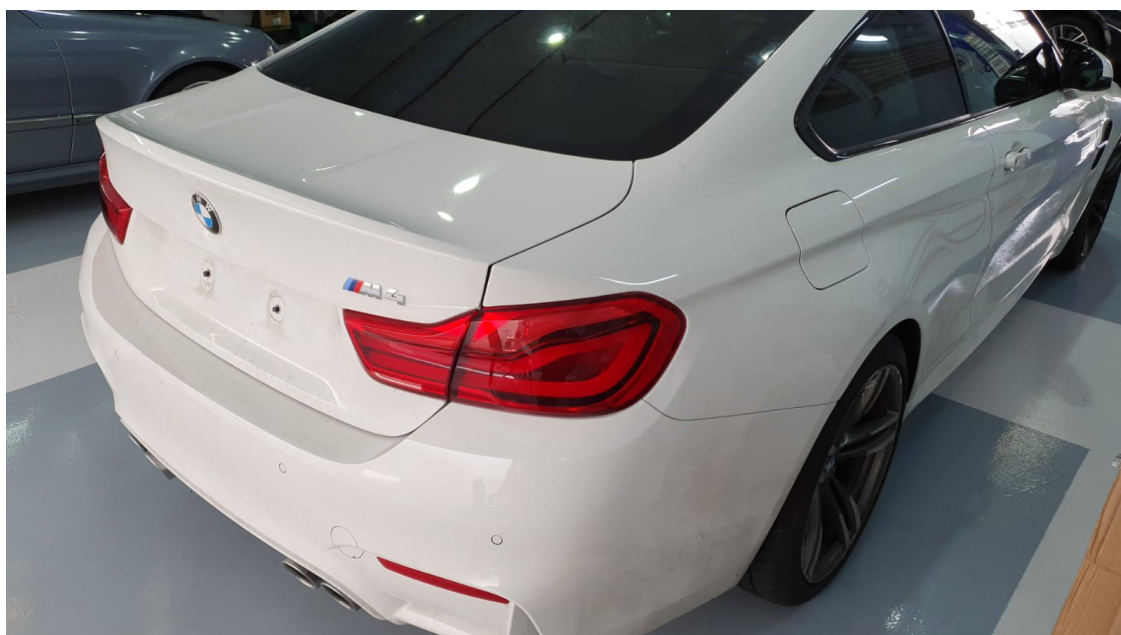
**Photo 5** shows the rear right body of the Motor Car (photograph provided to me). Apart for the frontal portion, there was no physical damage seen to other areas of the Motor Car.

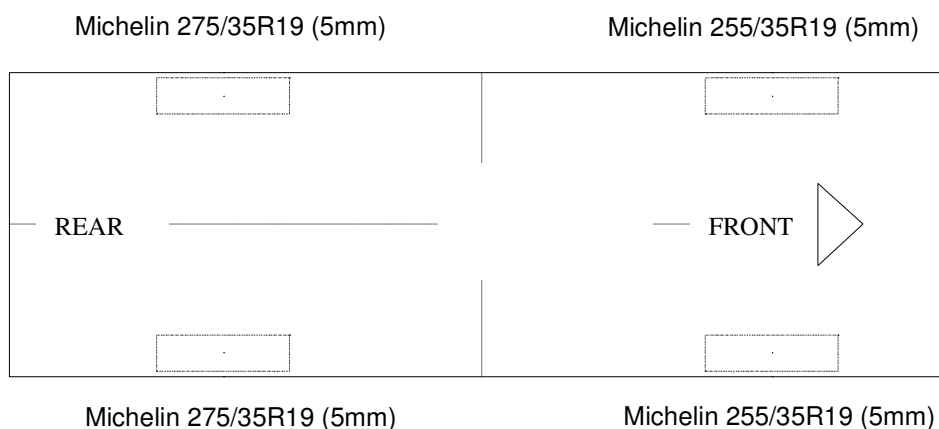
8. It was fitted with 19inch sport wheel rims that were wrapped with tyres that were observed to be of serviceable condition. The tyres were also sufficiently inflated for vehicular operation. The tyre brand, tyre size and approximate remaining tread depth of the 4 tyres of the Motor Car were recorded as follows: -

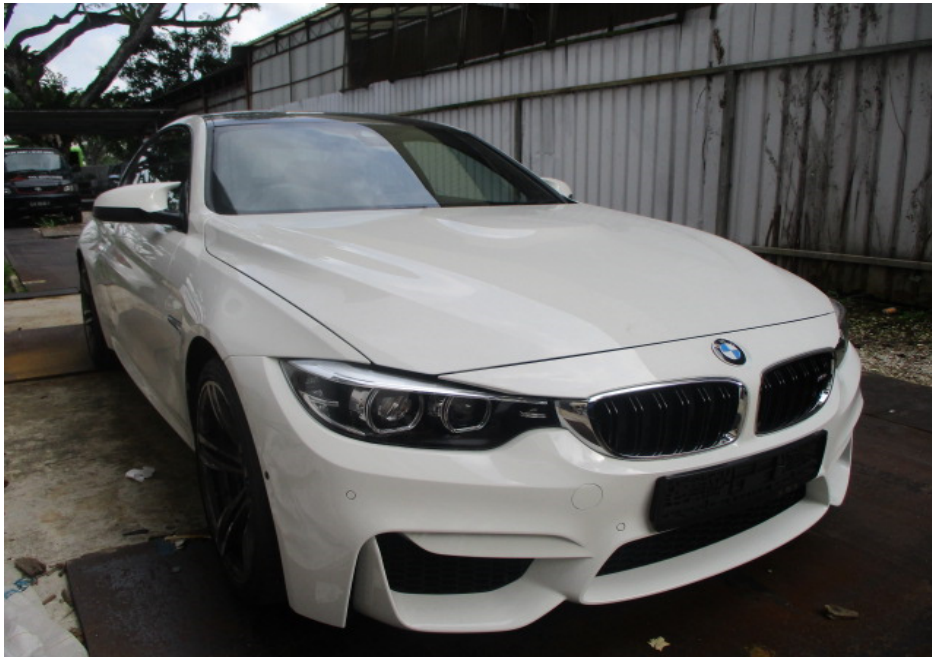
22. The frontal portion of the Motor Car were visually examined, and it was noted that the repair/restoration works carried out to the damaged area of the Motor Car (refer to photograph 1 - 3 above) were reasonably adequate and in order.

**Photo 6** shows a general view of the front right body of the Motor Car at the time of my inspection. The Motor Car was observed to be in a relatively good general condition with no loose exterior fittings observed. The frontal portion of the Motor Car were visually examined, and it was observed that the repair/restoration works carried out to the damaged area of the Motor Car (refer to photograph 1 - 3 above) were reasonably adequate and in order.

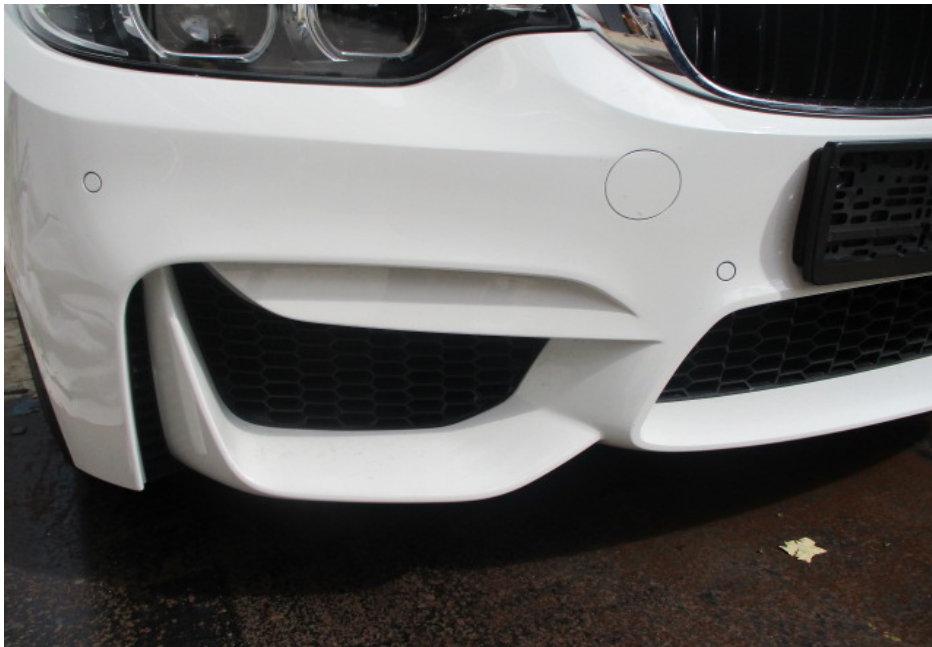
**Photo 7** shows a closer view of the Motor Car's front bumper at the time of my inspection. The frontal portion of the Motor Car were visually examined, and it was observed that the repair/restoration works carried out to the damaged area of the Motor Car (refer to photograph 1 - 3 above) were reasonably adequate and in order.

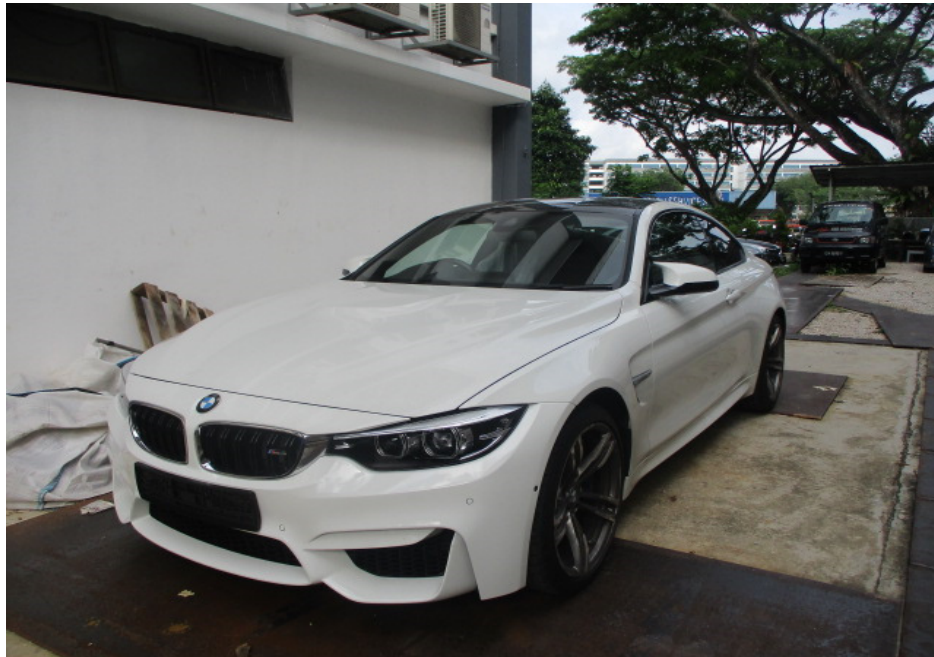
**Photo 8** shows a general view of the front left body of the Motor Car at the time of my inspection. The Motor Car was observed to be in a relatively good general condition with no loose exterior fittings observed. The frontal portion of the Motor Car were visually examined, and it was observed that the repair/restoration works carried out to the damaged area of the Motor Car (refer to photograph 1 - 3 above) were reasonably adequate and in order.

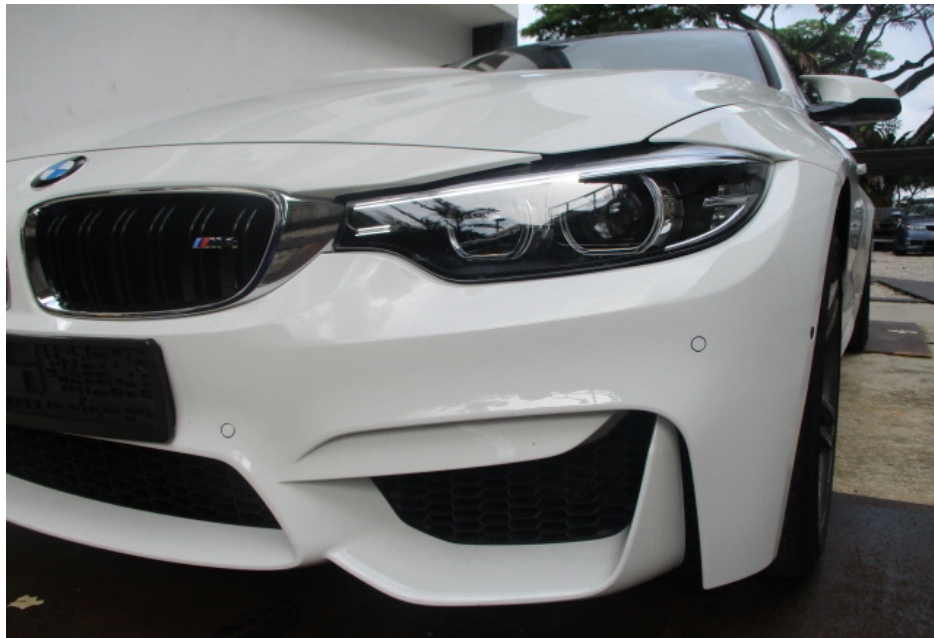
**Photo 9** shows a closer view of the Motor Car's front bumper at the time of my inspection. The frontal portion of the Motor Car were visually examined, and it was observed that the repair/restoration works carried out to the damaged area of the Motor Car (refer to photograph 1 - 3 above) were reasonably adequate and in order.

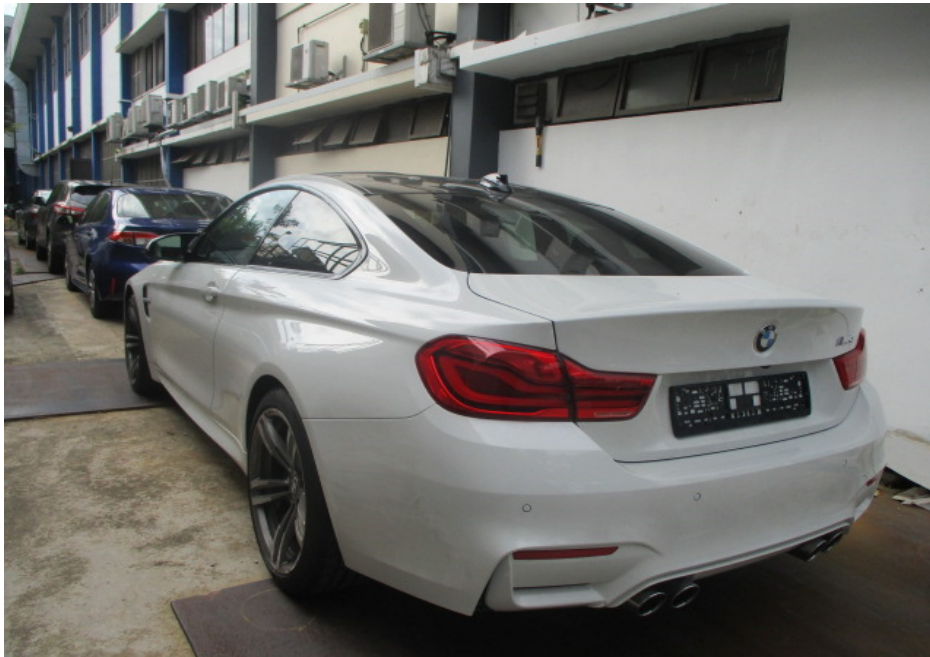
**Photo 10** shows a general view of the rear left body of the Motor Car at the time of my inspection. The Motor Car was observed to be in a relatively good general condition with no loose exterior fittings observed. The mileage of the Motor Car recorded at the time of my inspection was 10,113km.

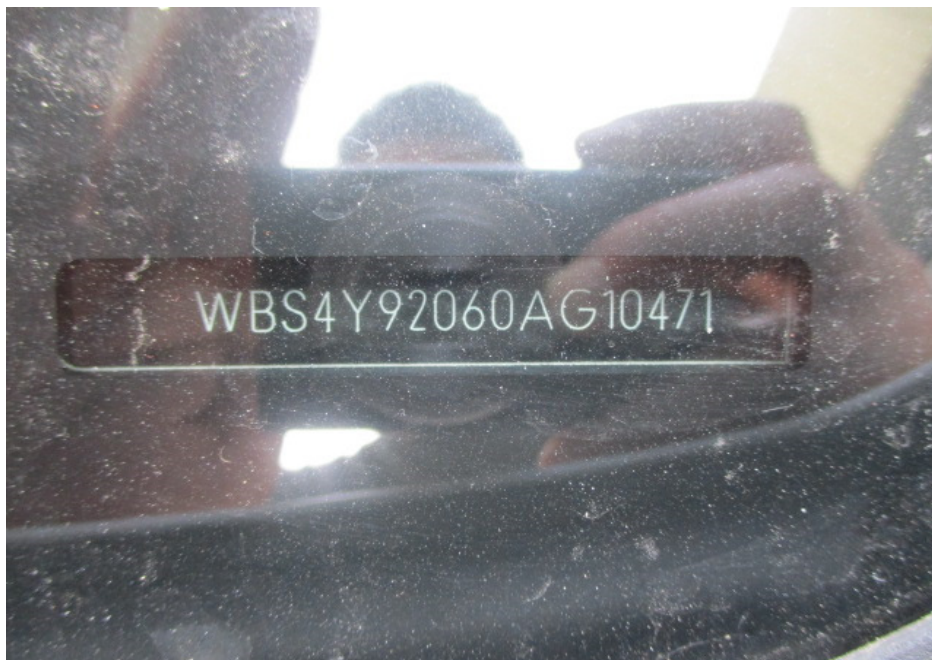
**Photo 11** shows the chassis number of the Motor Car. The chassis number recorded was WBS4Y92060AG10471.

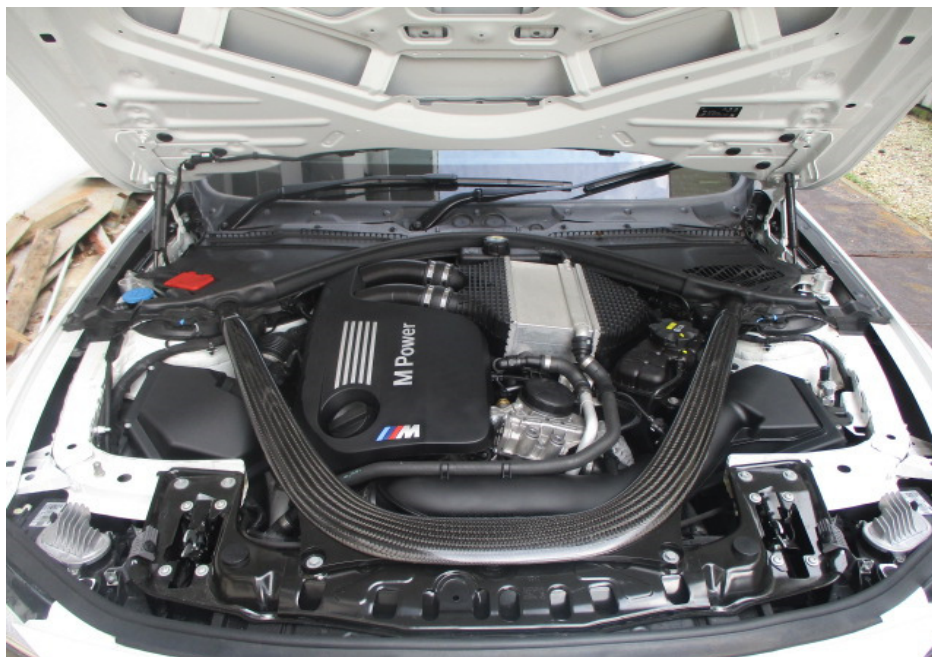
**Photo 12** shows a general view of the engine compartment of the Motor Car at the time of my inspection. The various parts and components inside the engine compartment were all observed to be intact and properly fitted. There was also no sign(s) or indication(s) of fluid leak and/or fluid stain found inside the engine compartment.

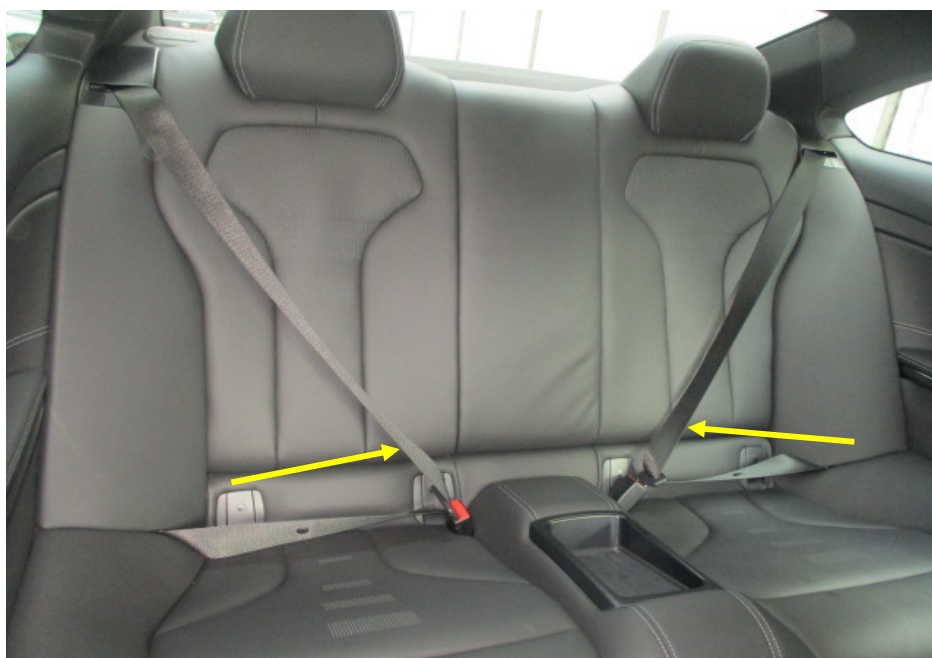
**Photo 13** shows the rear seats of the Motor Car. All the seats of the Motor Car were secured via seat rails to the floorboard. They were also fitted with a retractable seat belt reel and a pre-tensioner. The seat belts (arrowed) were tested and were able to be fastened into the respective pre-tensions that were fitted on the side of each individual seat.

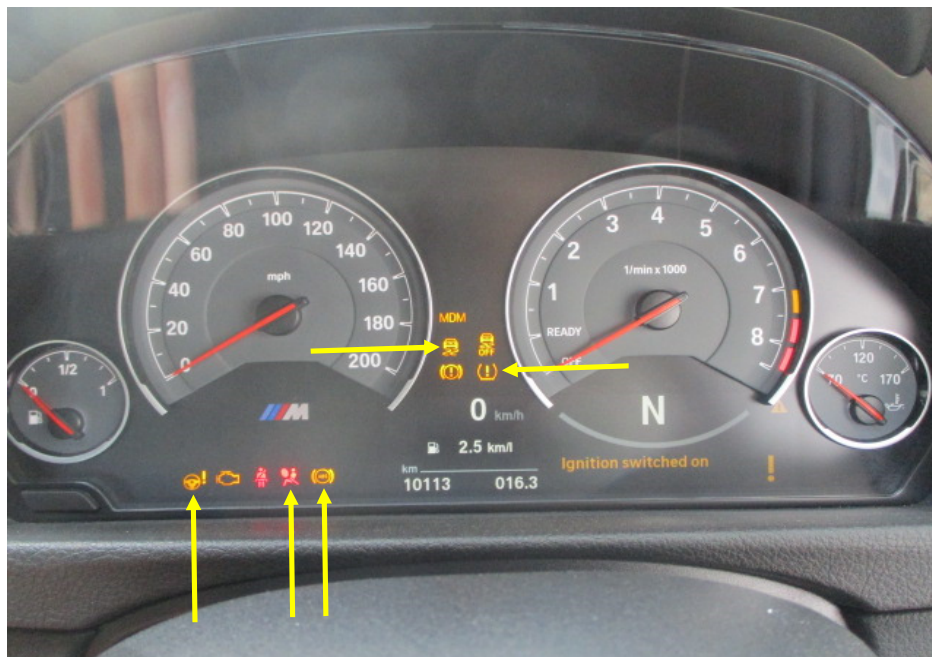
**Photo 14** shows the warning lights for the various electronic safety features appearing on the instrument panel of the Motor Car during its self-test when the engine is cranked, in particular the ABS, SRS, IAS, TPM and DSC lights (arrowed).

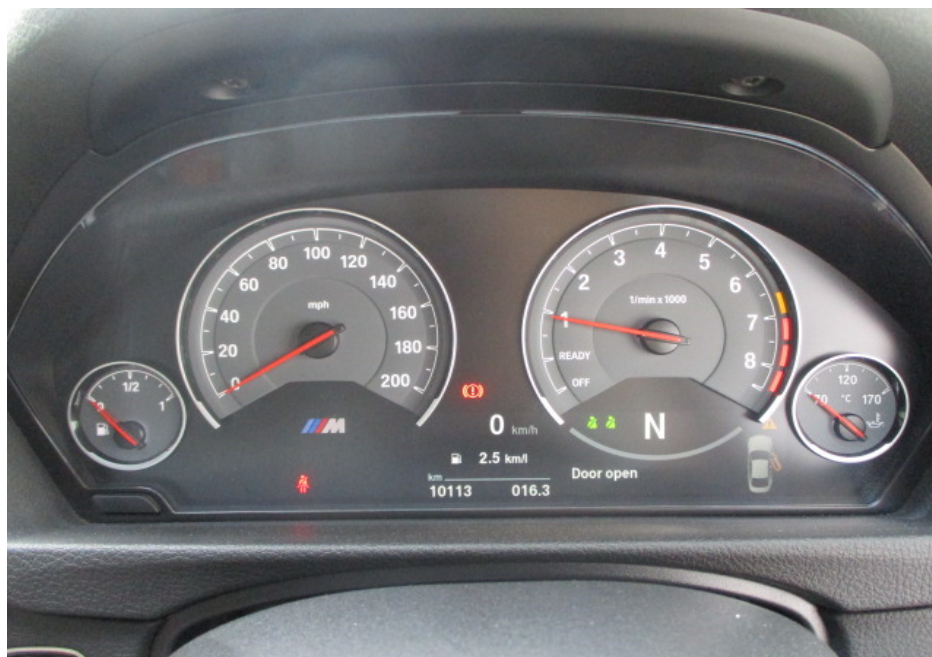
**Photo 15** shows the respective warning lights no longer illuminated, indicating that there is no fault detected to the ABS, SRS, IAS, TPM and DSC systems of the Motor Car during the self-test. These electronic systems were hence in working condition at the time of my inspection.

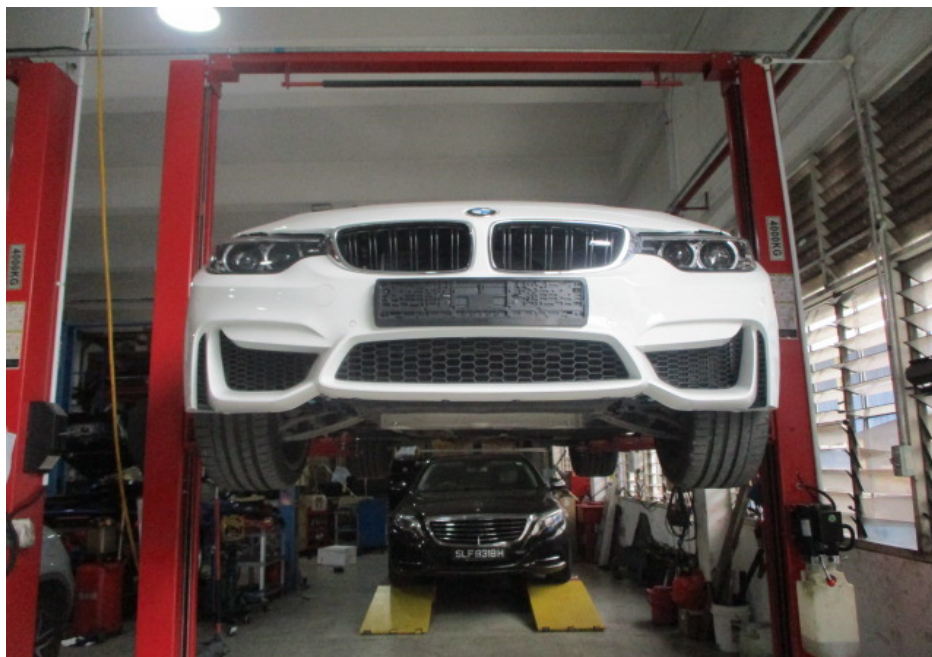
**Photo 16** shows the Motor Car hoisted up for checks on its undercarriage. There was no sign(s) or indication(s) of fluid leakage and/or fluid stain(s) on the underside of the Motor Car. The undercarriage components of the Motor Car were also all observed to be intact and secured in an appropriate manner.

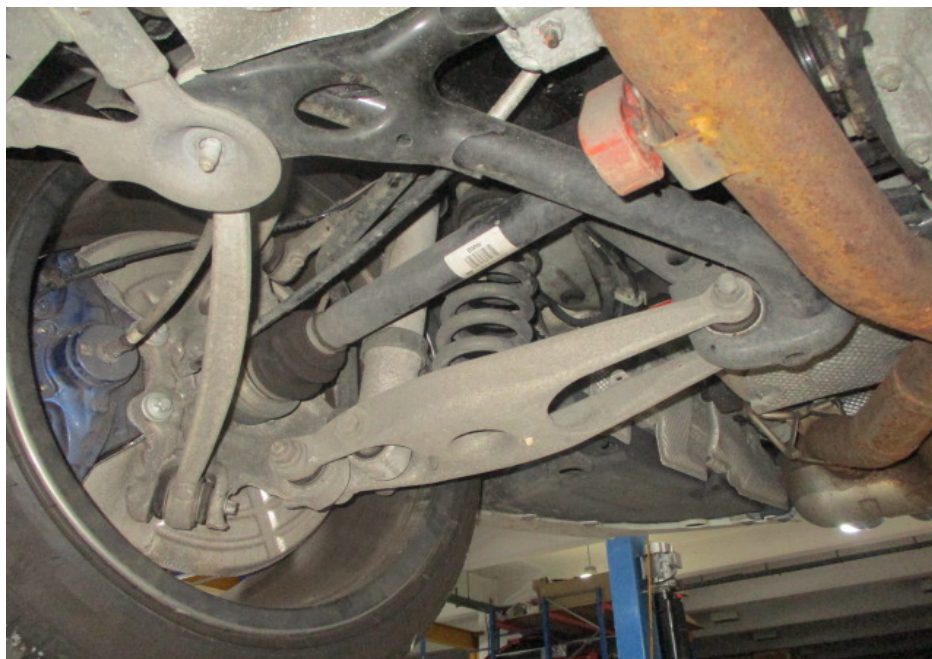
**Photo 17** shows a general view of the control arms and linkages at the rear right wheel of the Motor Car. I did not observe any fluid leak and/or fluid stain on the underside of the Motor Car. All of the Motor Car's undercarriage components were observed to be intact and secured in an appropriate manner.

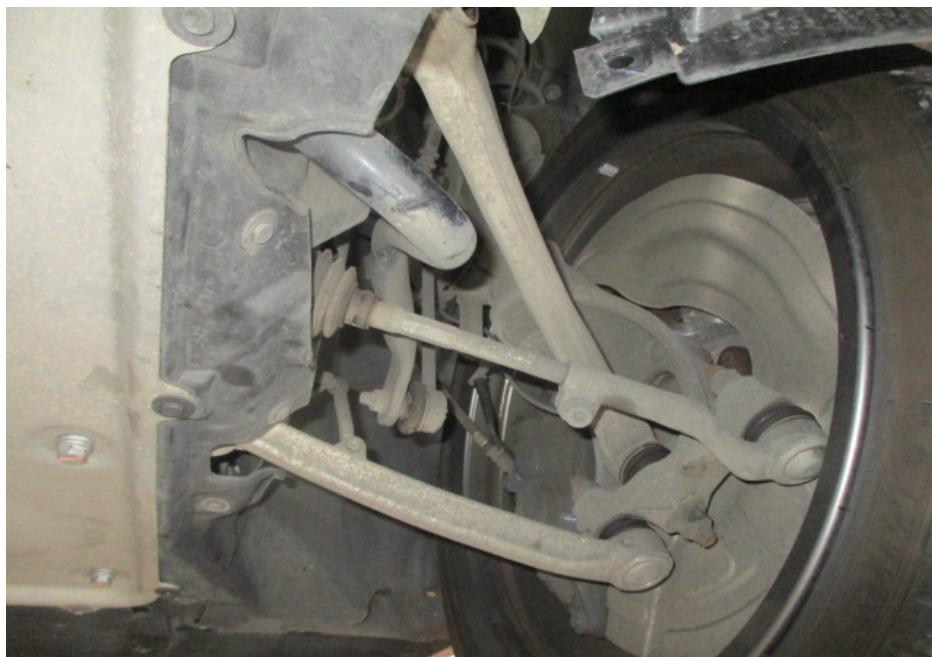
**Photo 18** shows the various undercarriage components at the front left wheel of the Motor Car. The mechanical components, control arms and linkages were all found to be intact and secured in an appropriate manner.

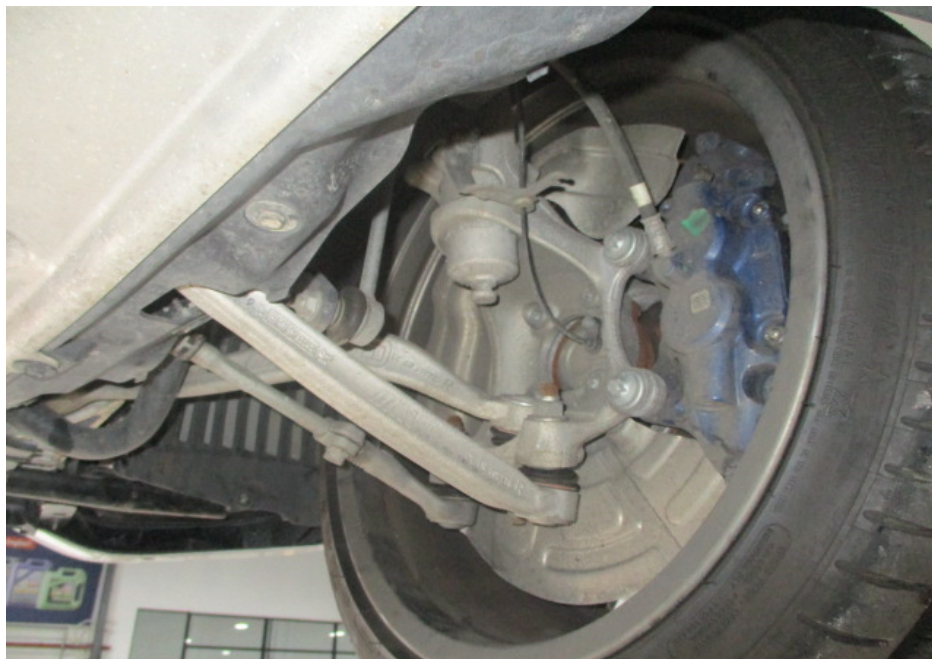
**Photo 19** shows the various undercarriage components at the front right wheel of the Motor Car. The mechanical components, control arms and linkages were all found to be intact and secured in an appropriate manner. I also did not observe any fluid leak and/or fluid stain on the underside of the Motor Car.

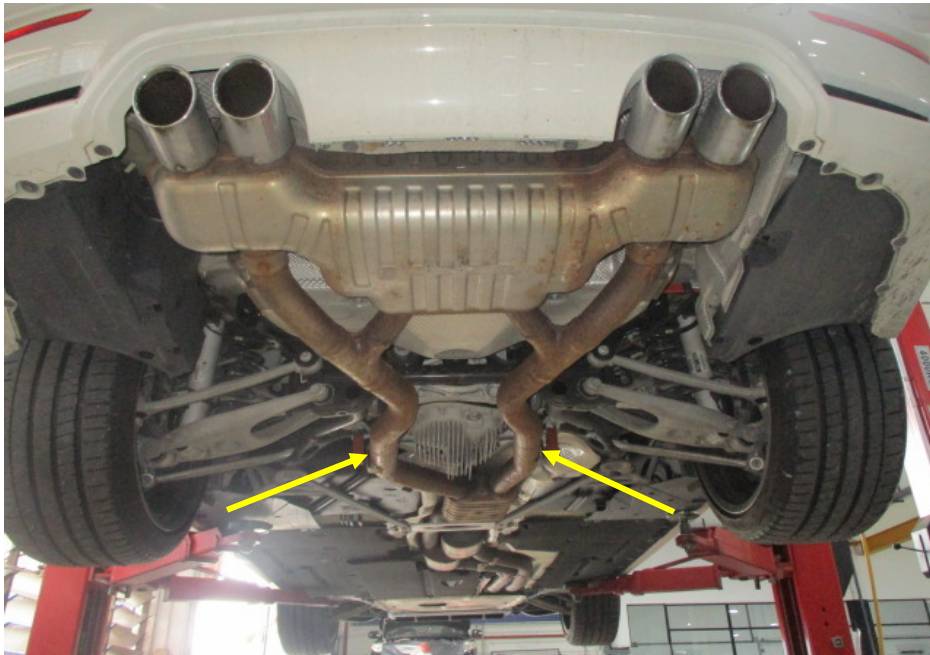
**Photo 20** shows a general view of the rear section of the Motor Car's exhaust system. My examination of the Motor Car's exhaust system revealed no sign(s) or indication(s) of any cut or weld marks along its exhaust pipes (arrowed), on its catalytic converters, centre resonator boxes and on its rear mufflers.

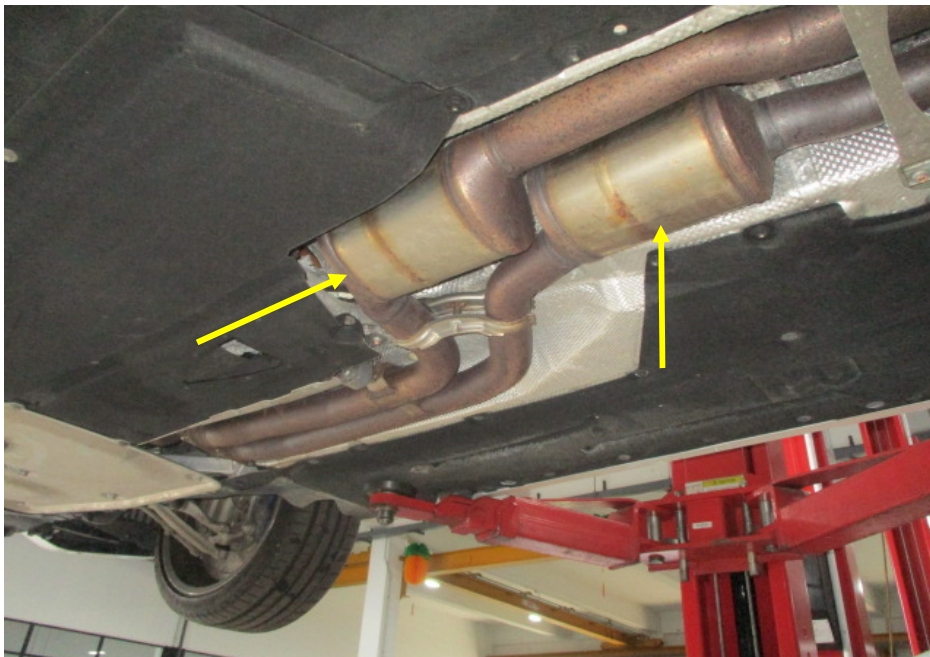
**Photo 21** shows the front section of the Motor Car's exhaust system. My examination of the Motor Car's exhaust system revealed no sign(s) or indication(s) of any cut or weld marks along its exhaust pipes, on its catalytic converters, centre resonator boxes (arrowed) and on its rear mufflers.

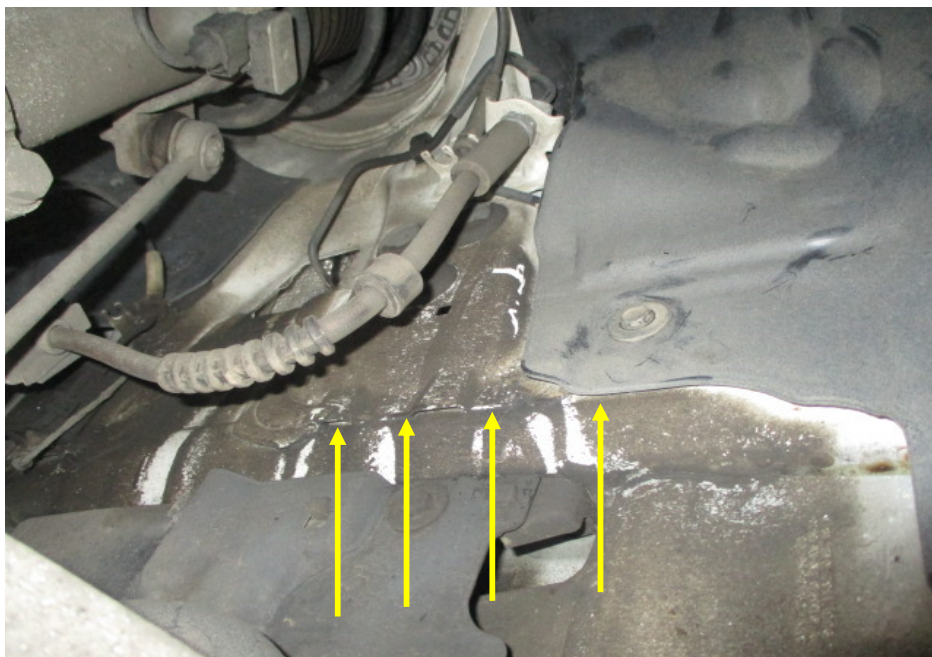
**Photo 22** shows the chassis/structural body at the underside front right of the Motor Car. I did not find any weld marks other than original spot weld marks on the chassis/structural body of the Motor Car. The original factory sealant (arrowed) at the joints along the chassis/structural body was untouched, indicating no work was done on the chassis/structural body of the Motor Car and that the chassis/structural body was originally fitted.

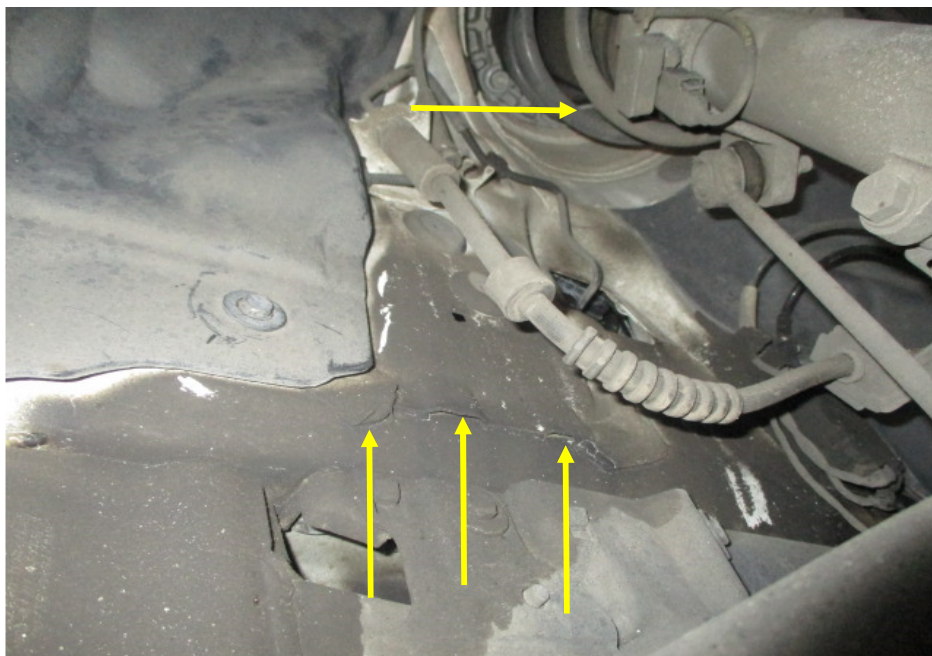
**Photo 23** shows the chassis/structural body at the underside front left of the Motor Car. The original factory sealant (arrowed) at the joints along the chassis/structural body was observed to be untouched. In general, I had found no work was carried out on the chassis/structural body of the Motor Car. The chassis/structural body of the Motor Car was originally fitted.

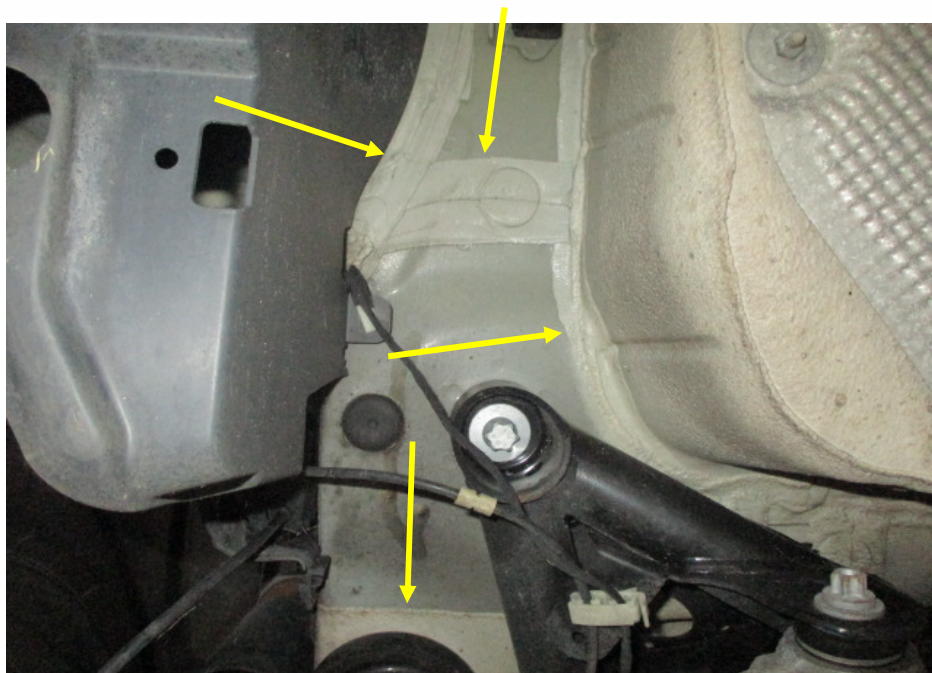
**Photo 24** shows the chassis/structural body at the underside rear left of the Motor Car. The original factory sealant (arrowed) at the joints along the chassis/structural body was observed to be untouched. In general, I had found no work was carried out on the chassis/structural body of the Motor Car. The chassis/structural body of the Motor Car was originally fitted.

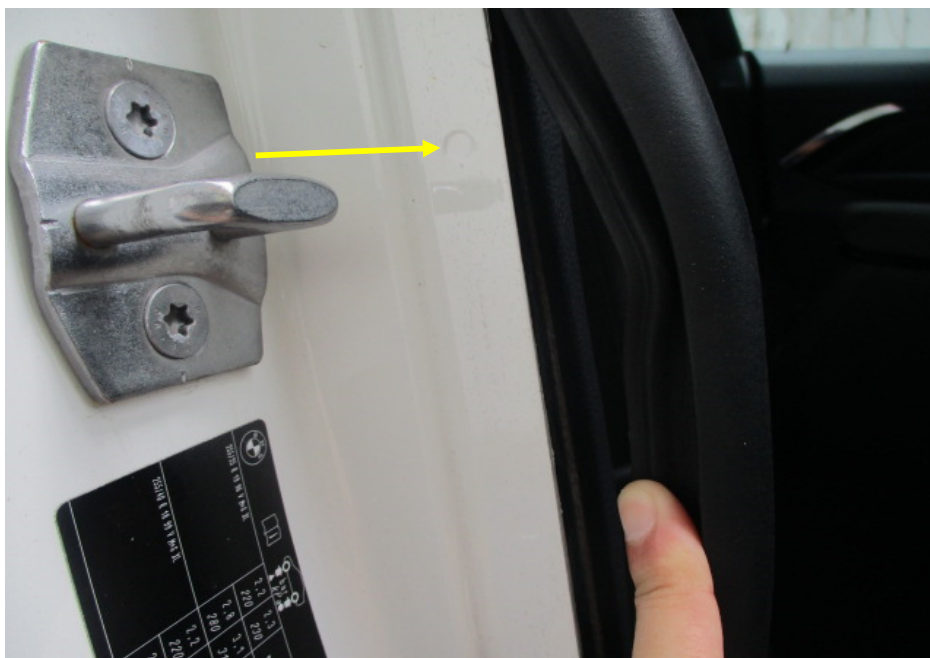
**Photo 25** shows the right side rear body panel of the Motor Car. I did not find any weld marks other than original spot weld marks (arrowed) on the right side rear body panel of the Motor Car, which indicates that there was no re-welding works carried out. In general, I had found all the non-detachable body panels of the Motor Car to be originally fitted at the time of my inspection.

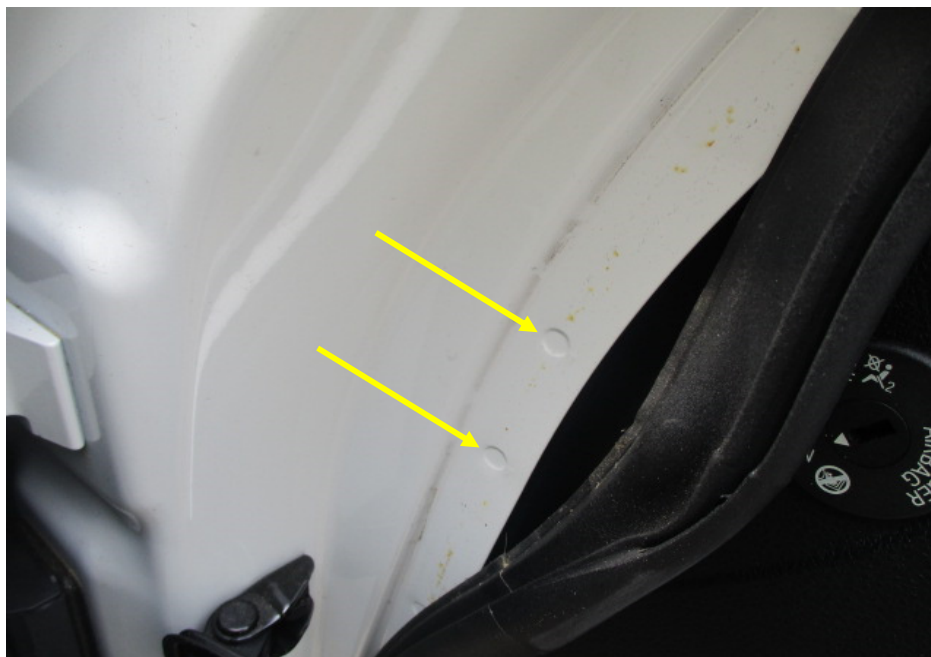
**Photo 26** shows the left side "A" pillar of the Motor Car. I did not find any weld marks other than original spot weld marks (arrowed) on the left side "A" pillar of the Motor Car, which indicates that there was no re-welding works carried out. In general, I had found all the non-detachable body panels of the Motor Car to be originally fitted at the time of my inspection.
