You're Ref: TP/IP/26771/2021  
Our Ref: CI/TPD21007779/P

**Fatal Accident Investigation Team**

**MECHANICAL INSPECTION REPORT OF MOTOR CAR SGQ 1900Z**

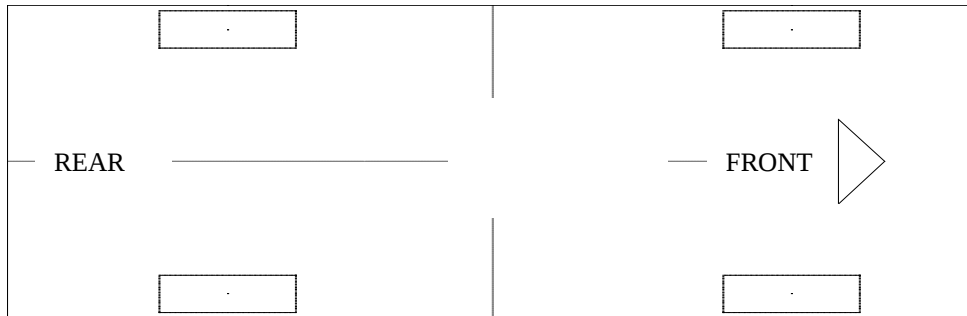
6. The condition of the Motor Car's 4 tyres was observed to be in serviceable condition. I did not find any tear, cut or burst mark(s) on the outer and the inner sidewalls as well as across the tread of the 4 tyres. The 4 tyres were also observed to be sufficiently inflated for vehicular operation. The tyre brand, tyre size and remaining tread depth of the 4 tyres were recorded as follows:-

Yokohama 205/50R15 (5.9mm)

Yokohama 205/50R15 (6.1mm)

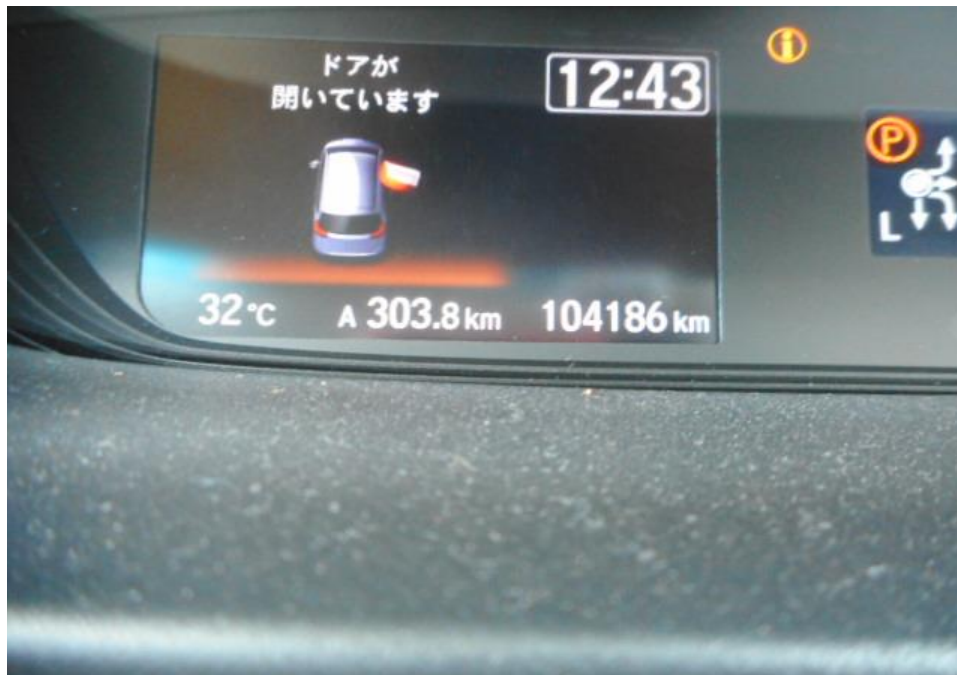
**Photo 1** shows the mileage of the Motor Car at the time of my inspection. The mileage observed was 104,186km.

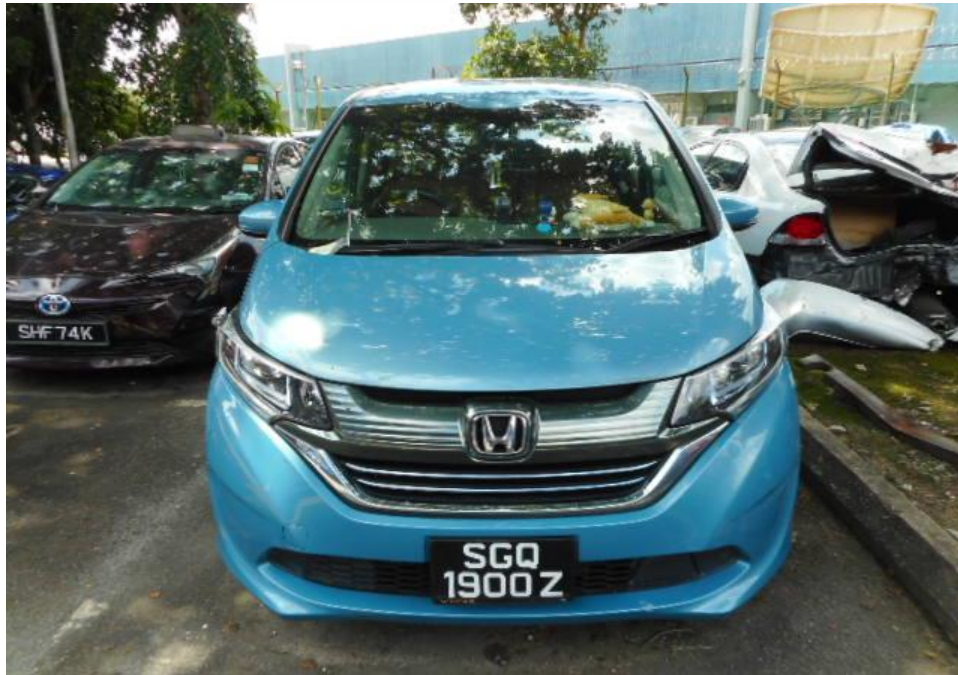
4. The mileage of the Motor Car at the time of my inspection was 104,186km.
5. The Motor Car was observed to have sustained damage at its front portion. Its front grille was the body part that were damaged as a result of the accident.

**Photo 2** shows a general view of the Motor Car's front body at the time of my inspection. The front portion of the Motor Car was observed to have sustained damage. Its front grille was the body part that were damaged as a result of the accident.

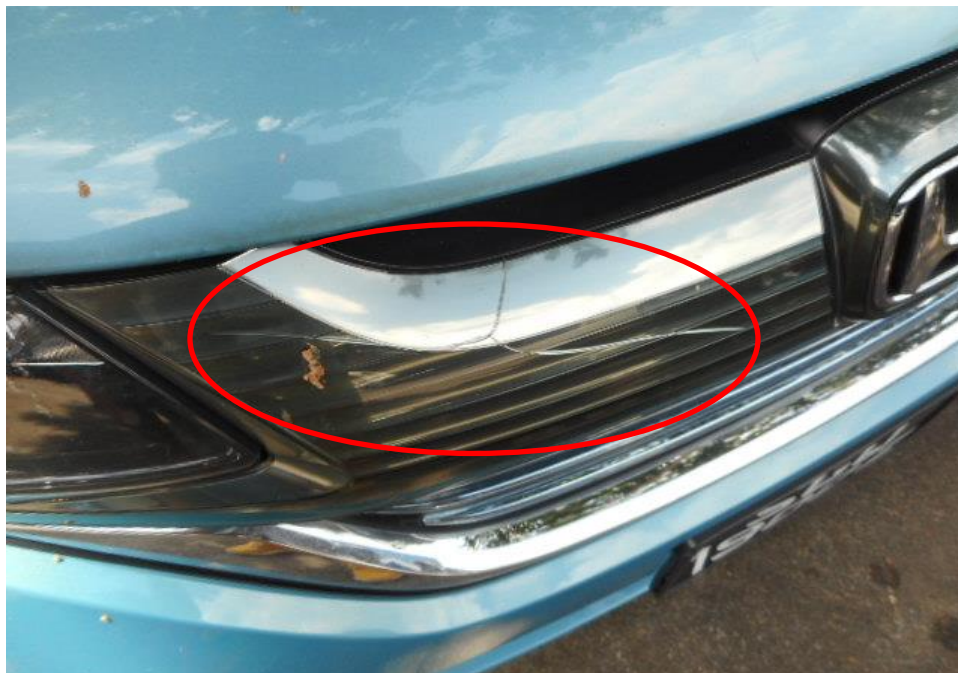
**Photo 3** shows a close up view of the Motor Car's front body at the time of my inspection. The front portion of the Motor Car was observed to have sustained damage. Its front grille (circled) was the body part that were damaged as a result of the accident.

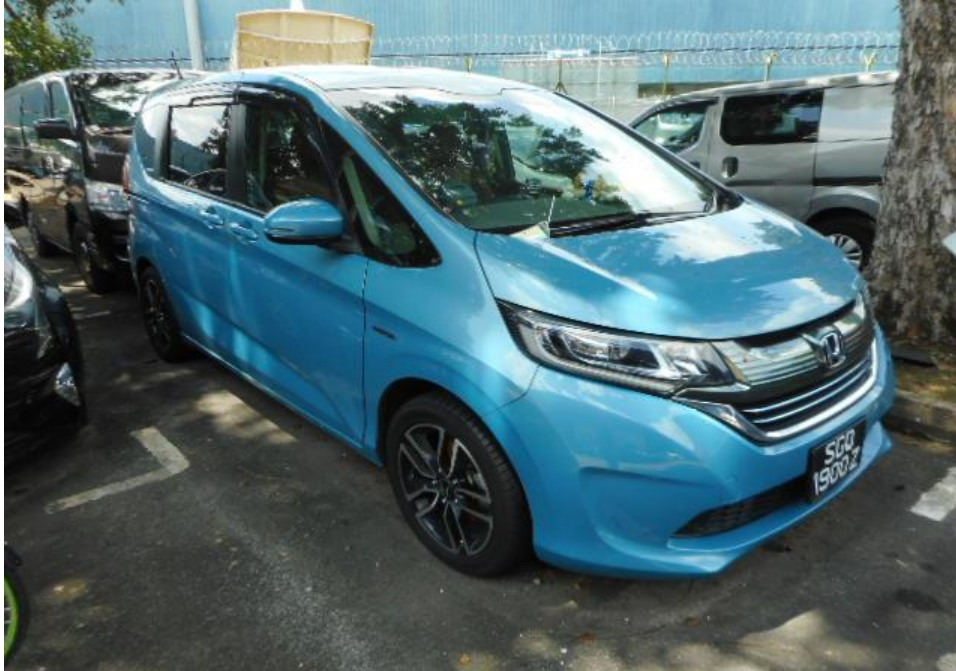
**Photo 4** shows a general view of the Motor Car's right body at the time of my inspection. The right portion of the Motor Car was observed to have been unaffected by the accident.

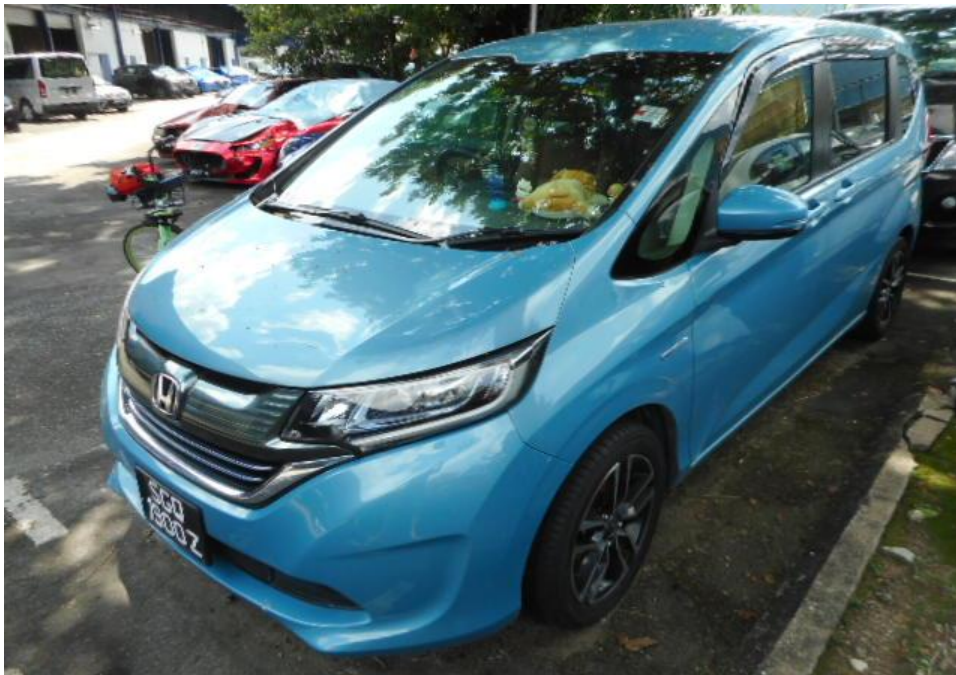
**Photo 5** shows a general view of the Motor Car's left body at the time of my inspection. The left portion of the Motor Car was observed to have been unaffected by the accident.

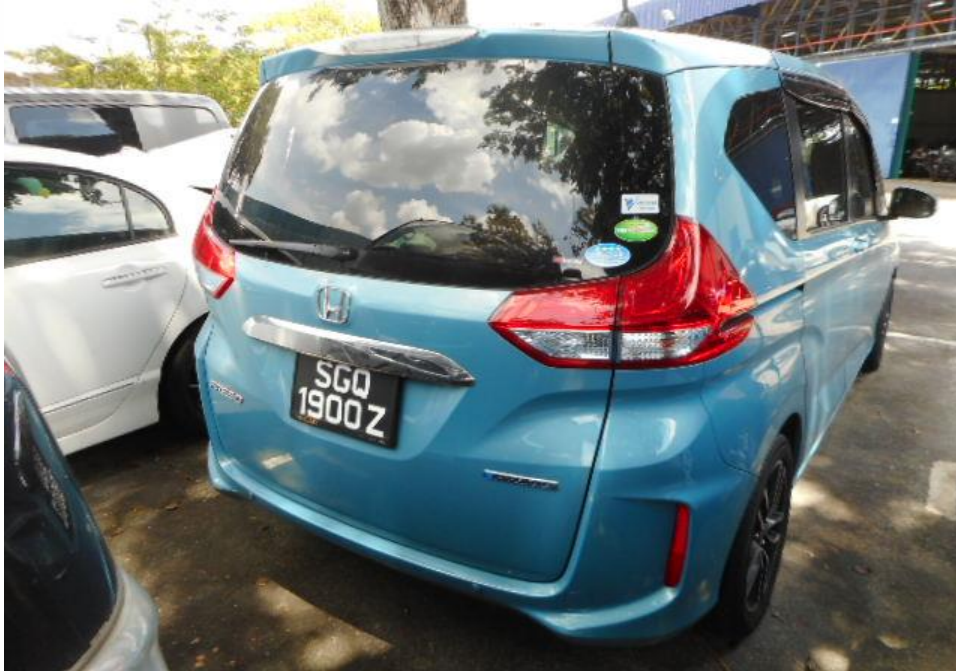
**Photo 6** shows the general view of the Motor Car's rear body at the time of my inspection. The Motor Car rear was observed to be unaffected by the accident.

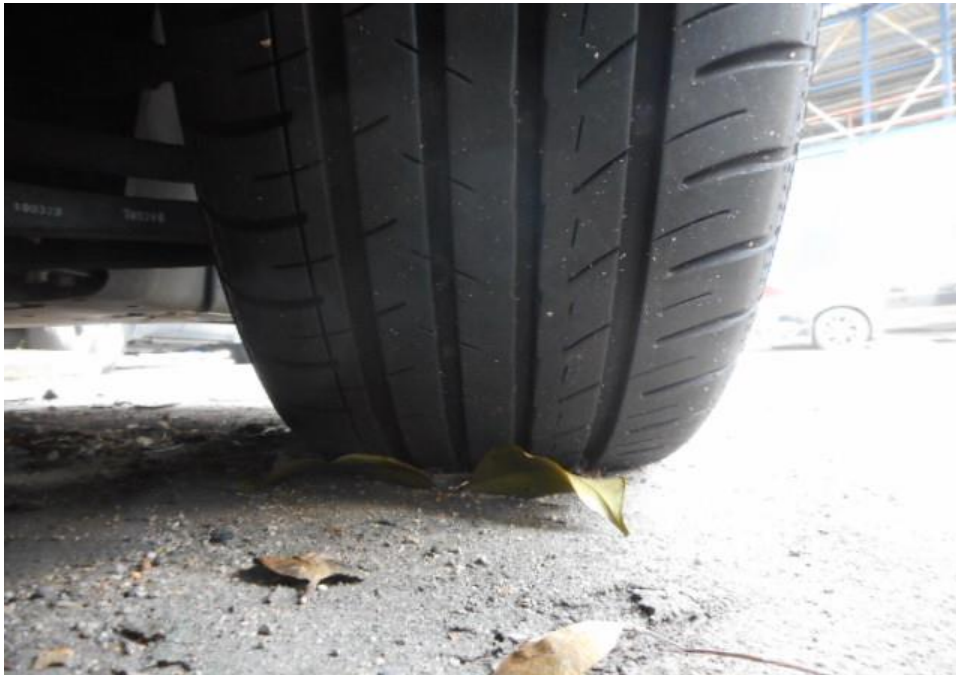
**Photo 7** shows the condition of the front right tyre of the Motor Car, which was observed to be in serviceable condition with remaining tread depth of approximately 6.1mm. The tyre was sufficiently inflated for vehicular operation with no tear, cut or burst mark(s) on the outer and the inner sidewalls as well as across the tread. The 4 tyres of the Motor Car were wrapped around standard steel wheel rims without any damage.

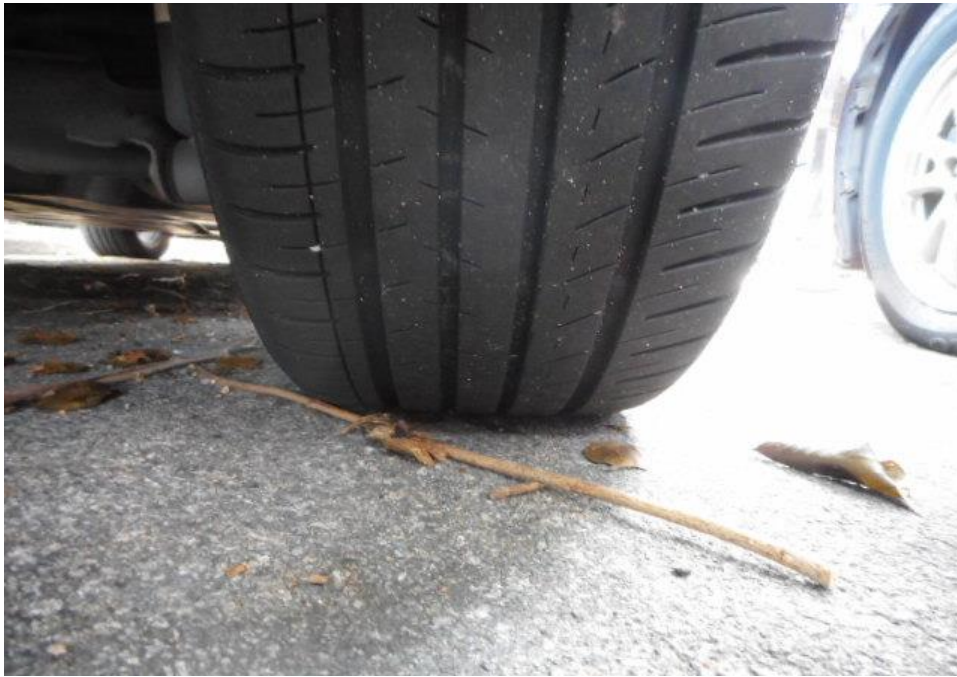
**Photo 8** shows the condition of the rear right tyre of the Motor Car, which was observed to be in serviceable condition with remaining tread depth of approximately 5.9mm. The tyre was also observed to be sufficiently inflated for vehicular operation with no tear, cut or burst mark(s).

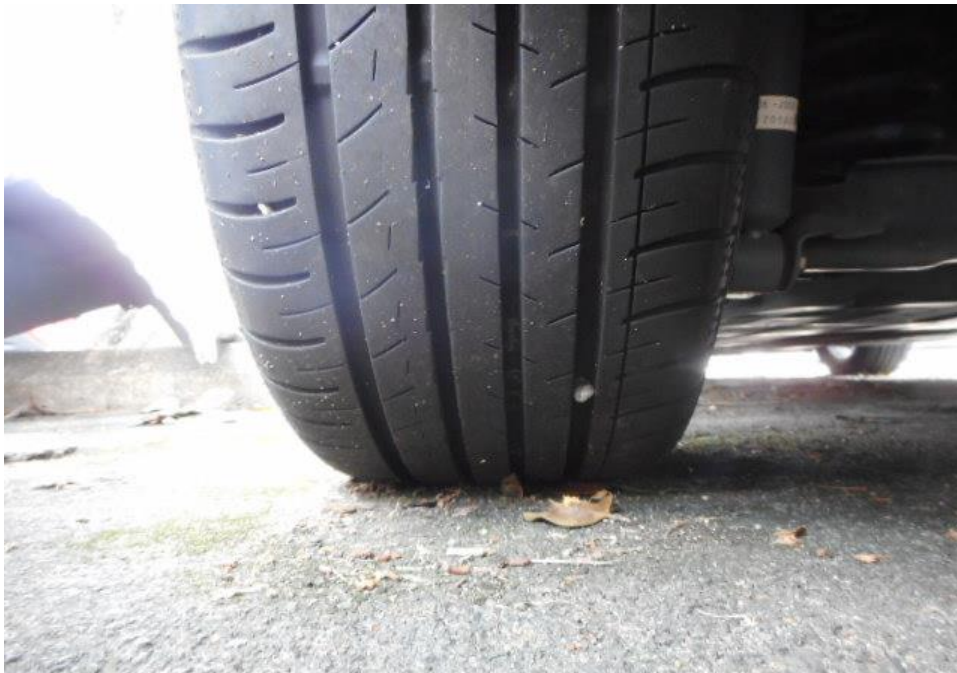
**Photo 9** shows the condition of the rear left tyre of the Motor Car, which was observed to be in serviceable condition with remaining tread depth of approximately 5.9mm. The tyre, which was wrapped around steel wheel rim, was also observed to be sufficiently inflated for vehicular operation. The 4 tyres of the Motor Car were wrapped around standard steel wheel rims.

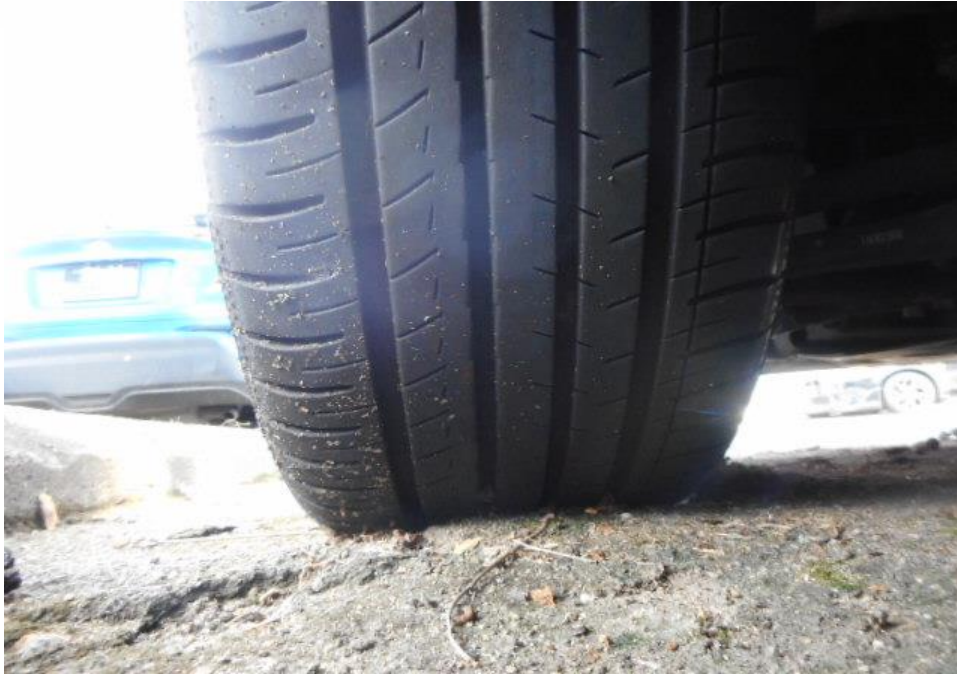
**Photo 10** shows the condition of the front left tyre of the Motor Car, which was observed to be in serviceable condition with remaining tread depth of approximately 5.9mm. There was also no tear, cut or burst mark(s) on the outer and the inner sidewalls as well as across the tread of the Motor Car's 4 tyres.

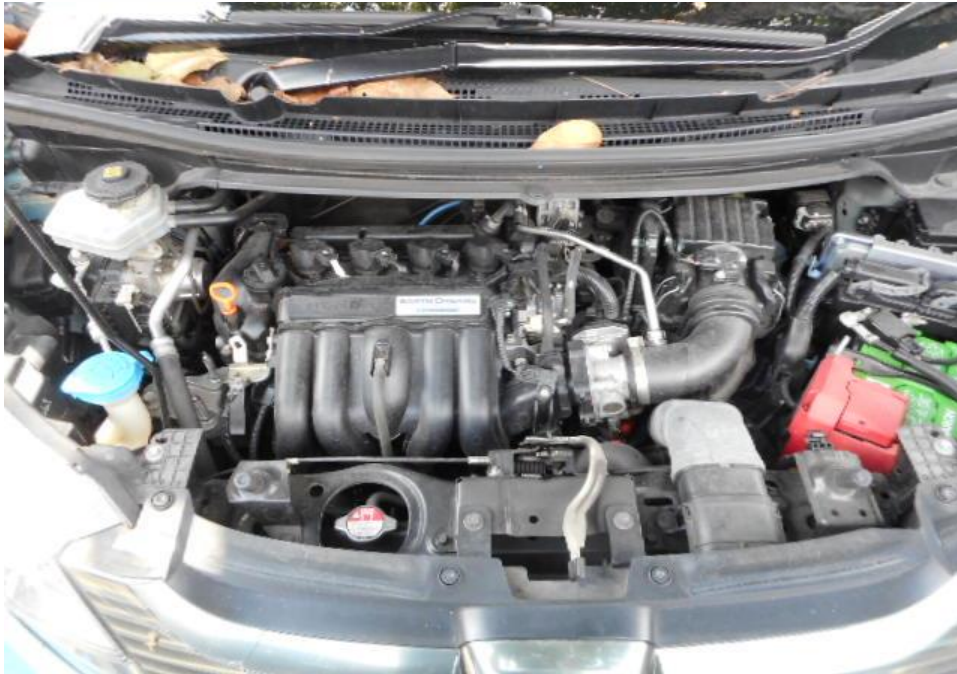
**Photo 11** shows a general view of the Motor Car's engine compartment. The various parts and components inside the engine compartment were unaffected by the accident. There was also no sign(s) or indication(s) of fluid leakage and/or fluid stain within the engine compartment.

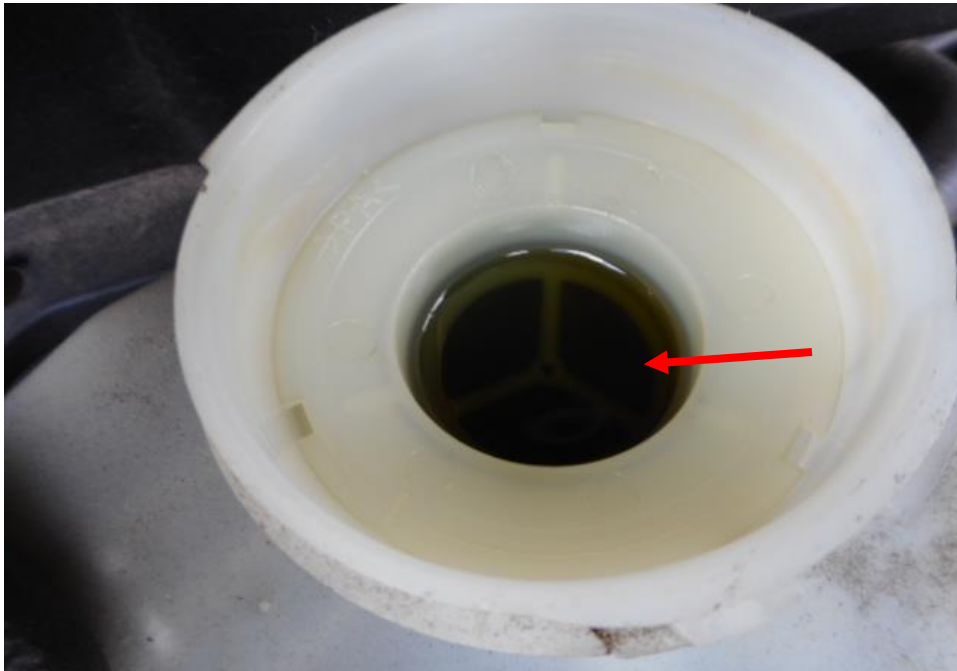
**Photo 12** shows the brake fluid reservoir of the Motor Car at the time of my inspection. The brake fluid was observed to be of sufficient level (arrowed) and without any visible contamination.

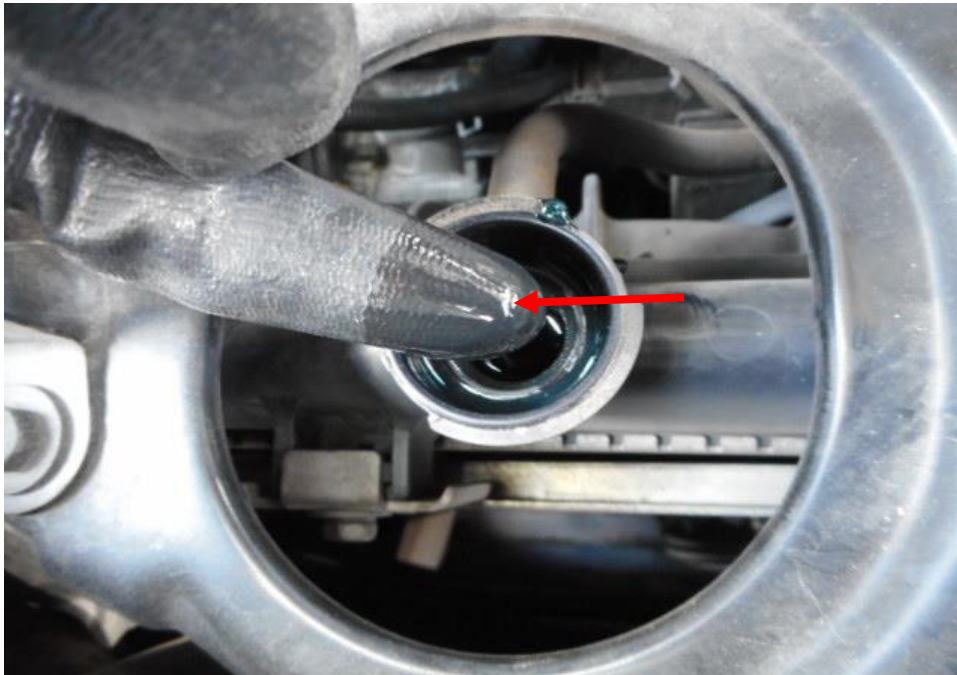
**Photo 13** shows checks being carried out to the engine coolant of the Motor Car at the time of my inspection. The engine coolant was observed to be of sufficient level (arrowed) and without any visible contamination.

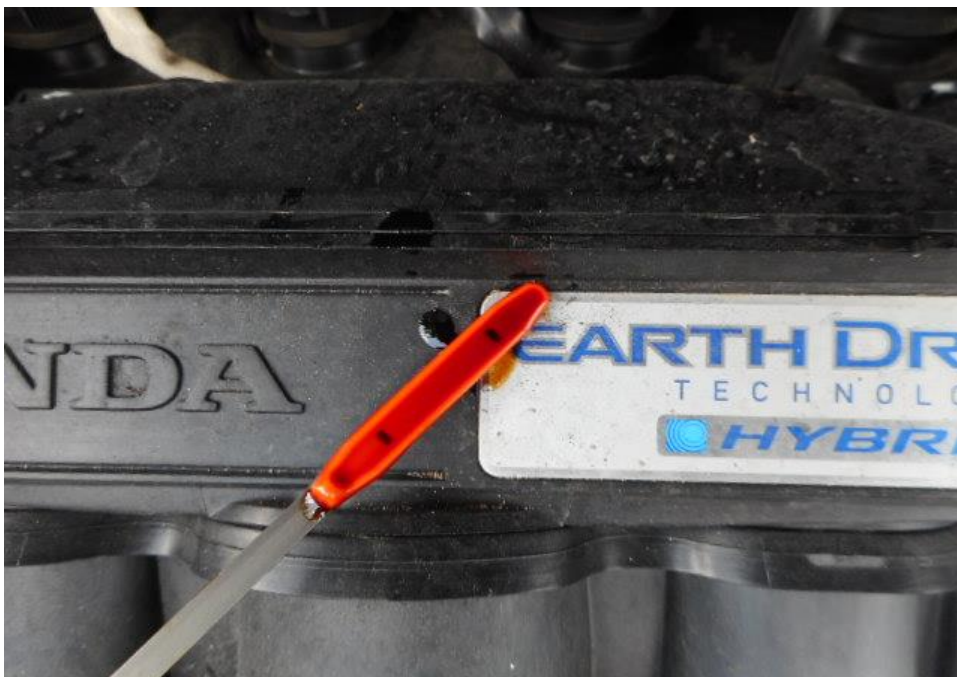
**Photo 14** shows the engine oil dipstick of the Motor Car at the time of my inspection. The engine oil was observed to be of sufficient level and without any visible contamination.

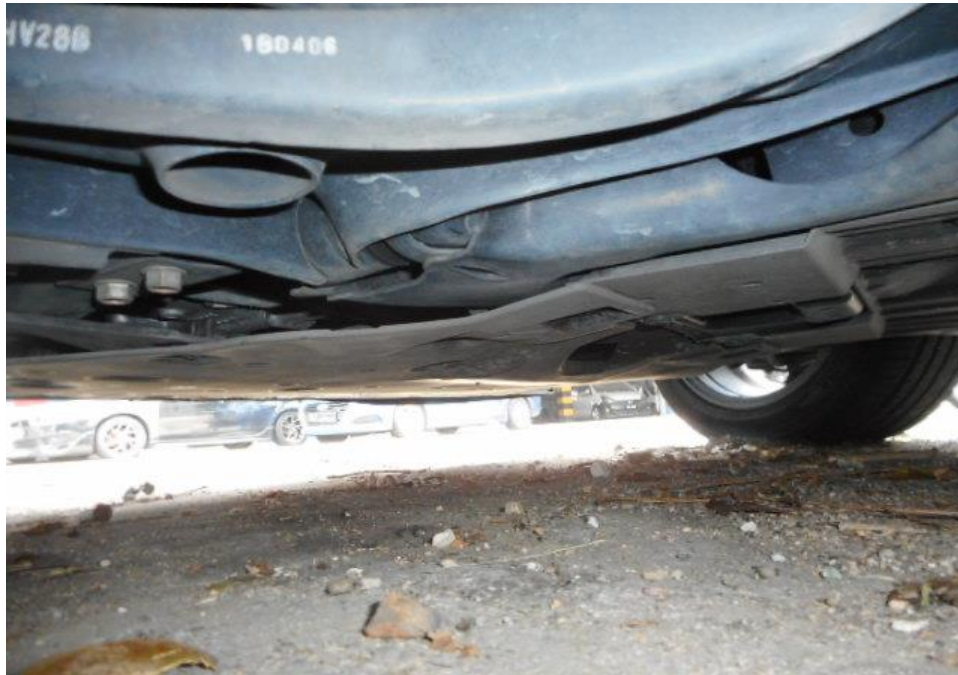
**Photo 15** shows the undercarriage of the Motor Car, at the area where the engine housing and transmission housing are located. I did not find any sign(s) or indication(s) of fluid leak and/or fluid stain(s) on the underside of the Motor Car.

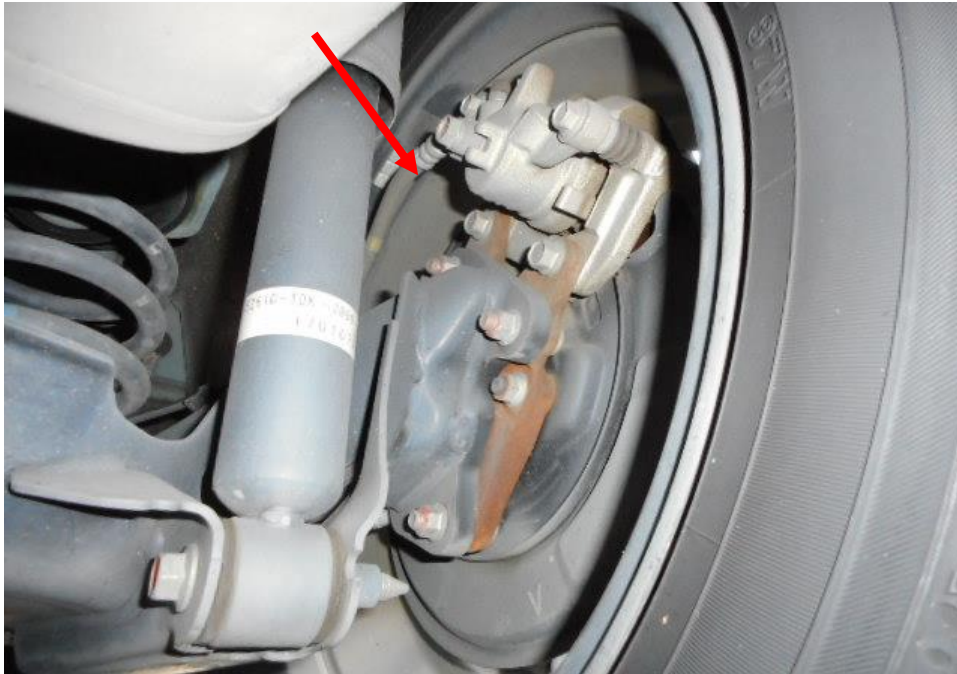
**Photo 16** shows the brake hose/pipe (arrowed) at the rear right wheel of the Motor Car. No leakage of brake fluid was observed. Visual examination of the various components of the braking system like the drum brake, brake booster, brake pedal etc. had revealed all to be intact and without visible damage.

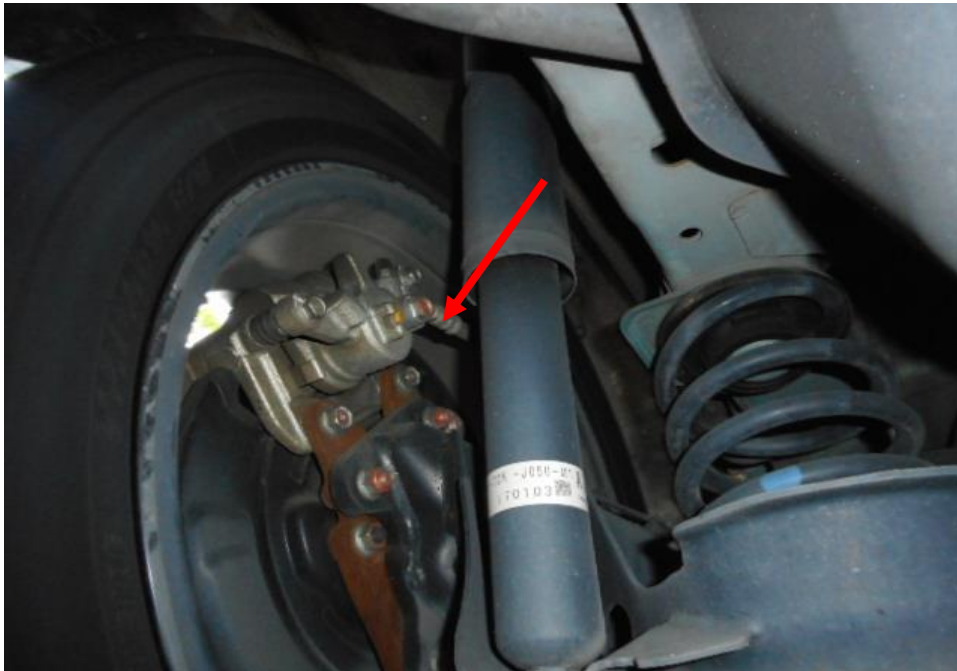
**Photo 17** shows the brake hose/pipe (arrowed) at the rear left wheel of the Motor Car. I did not observe any leakage of brake fluid at the time of my inspection of the Motor Car. Static tests of the Motor Car's braking system had indicated that there was no internal leakage of pressure/vacuum. The undercarriage components of the Motor Car were also all found to be intact and without any visible damage.

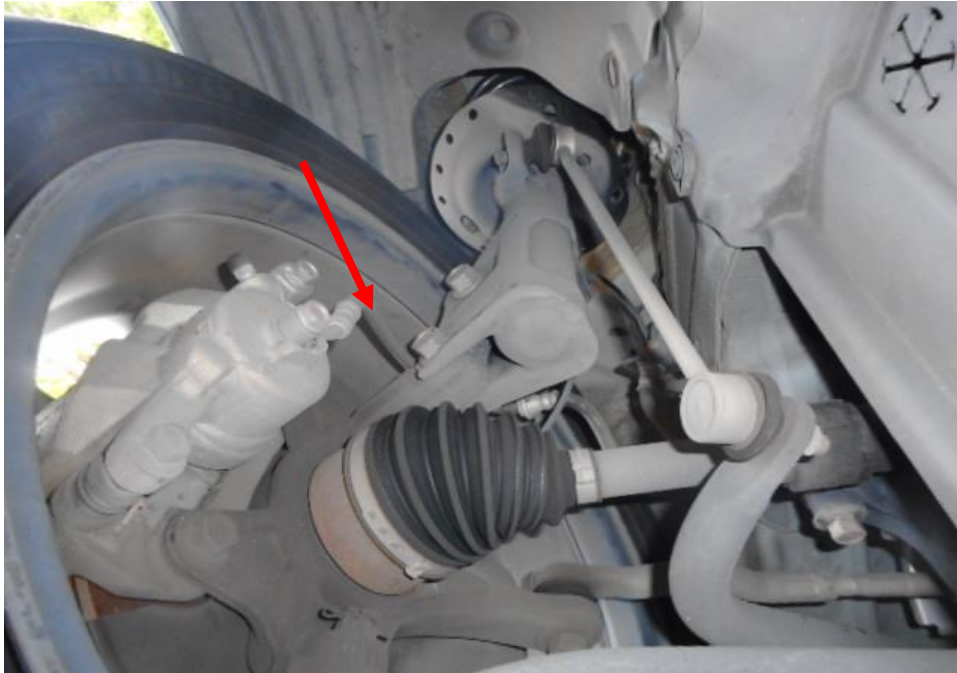
**Photo 18** shows the brake hose/pipe (arrowed) at the front right wheel of the Motor Car. I did not observe any leakage of brake fluid at the time of my inspection of the Motor Car. Static tests of the Motor Car's braking system had indicated that there was no internal leakage of pressure/vacuum. The undercarriage components of the Motor Car were also all found to be intact and without any visible damage.

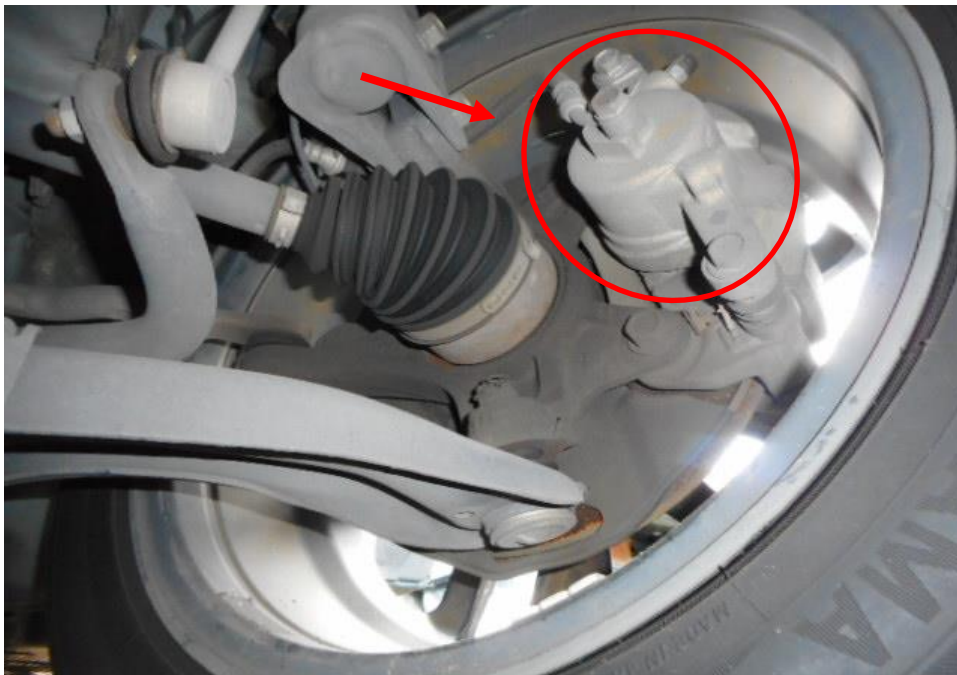
**Photo 19** shows the brake hose/pipe (arrowed) at the front left wheel of the Motor Car. No leakage of brake fluid was observed. Visual examination of the various components of the braking system like the brake caliper (circled), brake booster, brake pedal etc had revealed all to be intact and without visible damage.

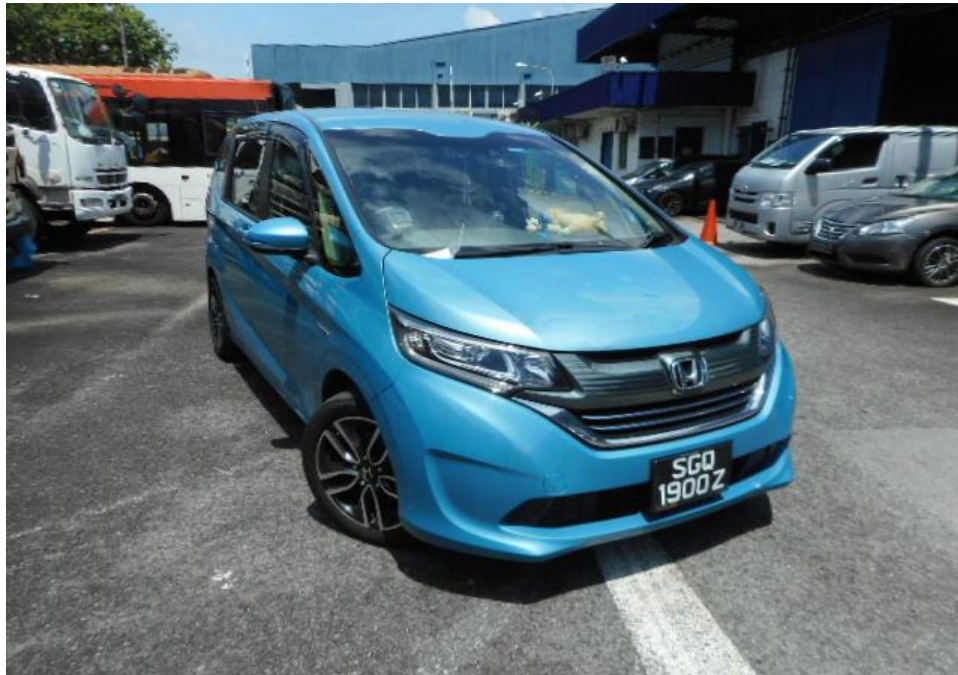
**Photo 20** shows the front right wheel of the Motor Car turned to its full left. During my steering system test, I did not experience any abnormal free play and/or resistance when I had turned the steering wheel towards the left and right. This would suggest that the steering system of the Motor Car was likely to be in serviceable condition at the material time of accident.

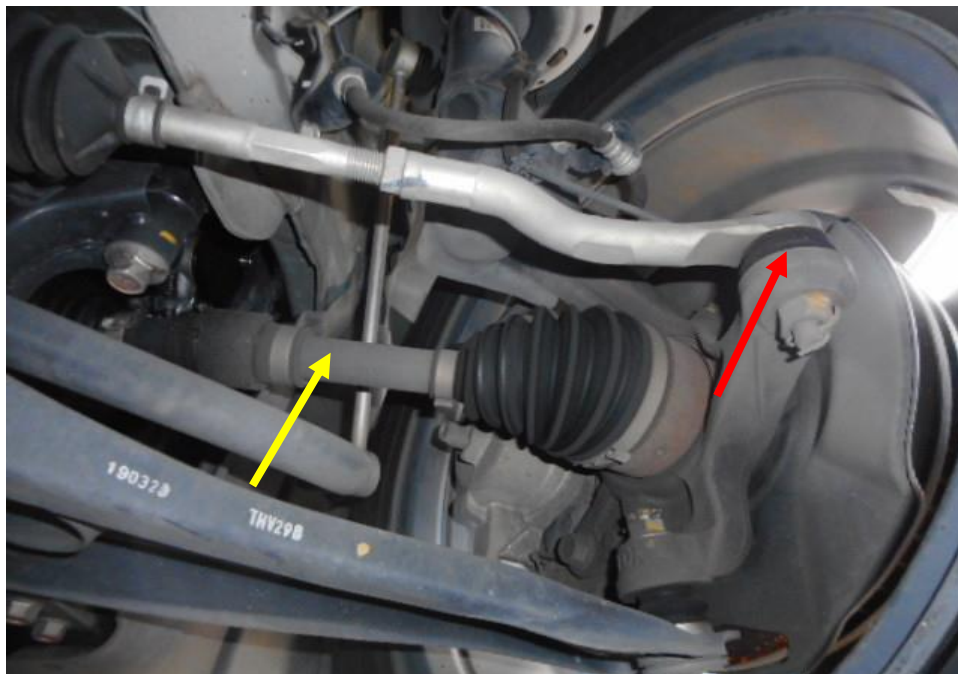
**Photo 21** shows the various undercarriage components at the front right wheel of the Motor Car, in particular the steering tie rod (red arrow) and drive shaft (yellow arrow). The various steering components were all found to be intact, suggesting that the steering system of the Motor Car was likely to be in serviceable condition at the material time of accident. There was also no sign of fluid stain observed on the various undercarriage components at the front right wheel of the Motor Car.

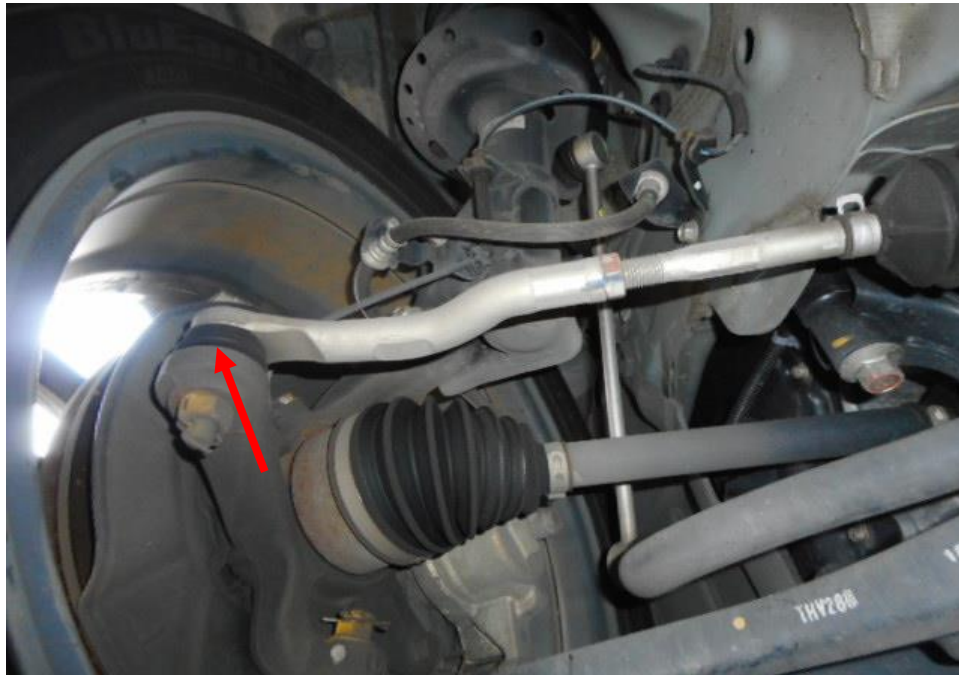
**Photo 22** shows the various undercarriage components at the front left wheel of the Motor Car, which had included the steering tie rod (red arrow). The various undercarriage components of the Motor Car were all found to be intact without any visible damage.

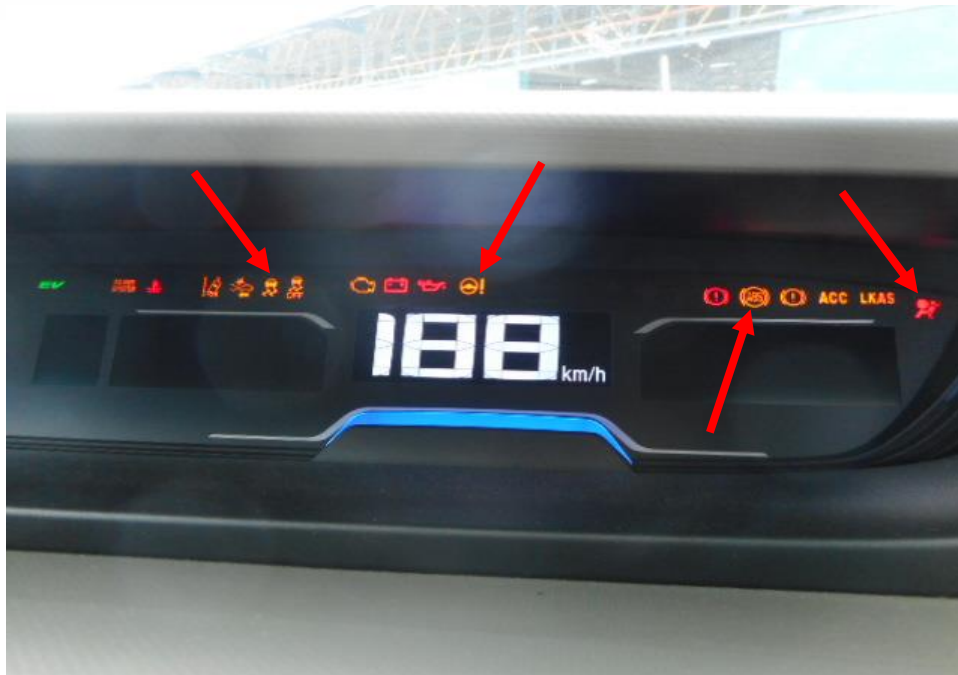
**Photo 23** shows the warning light for Anti-Lock Brake System (ABS), Electric Power Steering System (EPS), Traction Control System (TCS) and Supplemental Restraint System (SRS) (arrowed) appearing on the instrument panel of the Motor Car during the self-test of its various electronic operating systems when its engine was cranked.

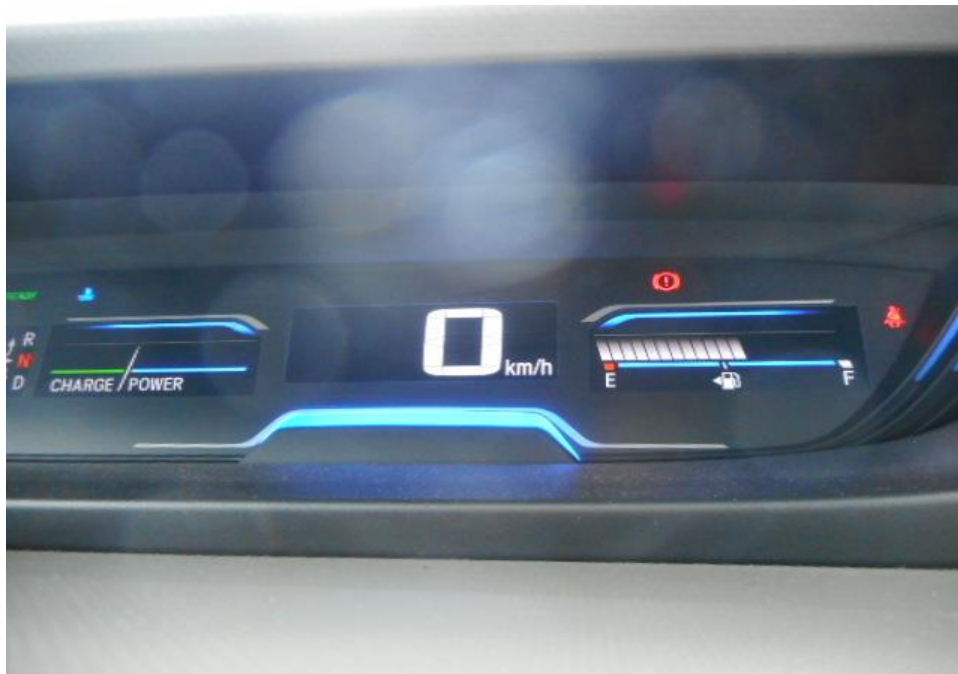
**Photo 24** shows no warning lights illuminated on the instrument panel of the Motor Car after the engine was cranked. This would suggest that there was no abnormality to the electronic operating system of the Motor Car, like the ABS, EPS, TCS and SRS etc.
