Your Ref: TP/IP/13043/2021
Our Ref : CI/TPD21007781/P

22nd July 2021

Fatal Accident Investigation Team

MECHANICAL INSPECTION REPORT OF MINI BUS PC 6160B

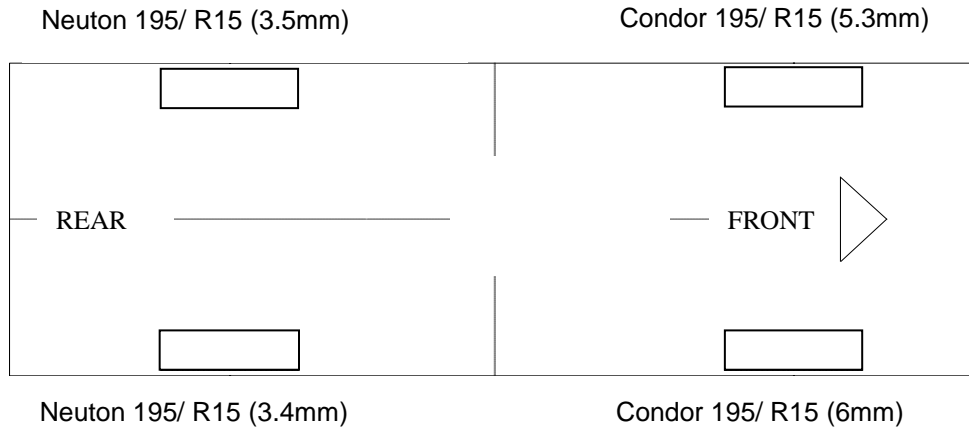
6. The 4 tyres of the Mini Bus were observed to be in serviceable condition and sufficiently inflated for vehicular operation. I did not find any tear, cut or burst mark(s) on the outer and the inner sidewalls as well as across the tread of the 4 tyres. The tyre brand, tyre size and remaining tread depth of the 4 tyres of the Mini Bus were recorded as follows:-

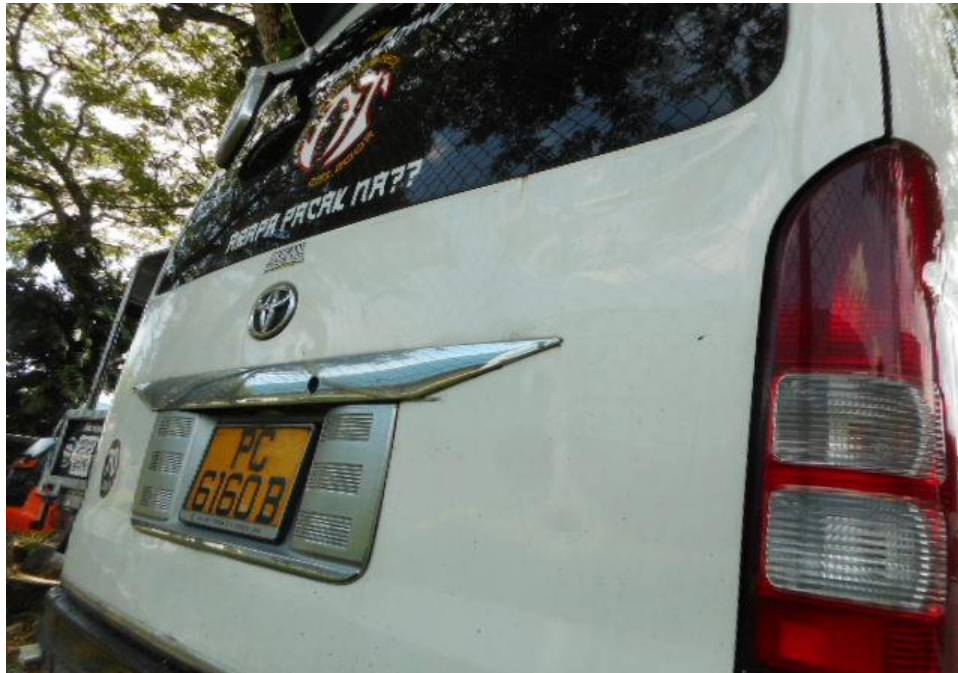
Photo 1 shows general view of the Mini Bus's rear portion at the time of my inspection. The Mini Bus rear portion was observed to be intact and unaffected by the accident.

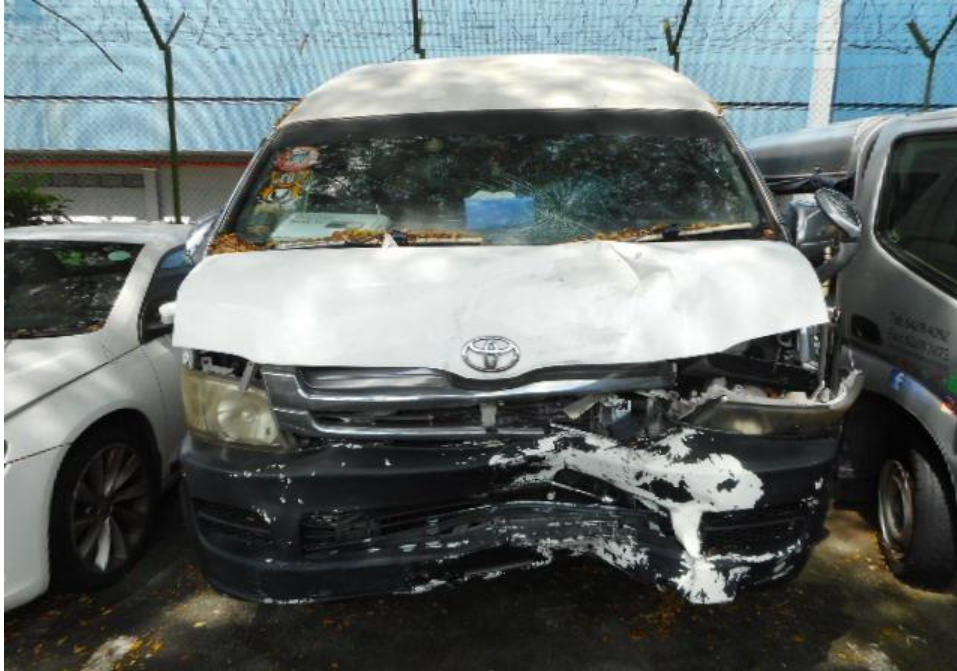
4. The mileage of the Mini Bus at the time of my inspection was not recorded as the engine was unable to be jumpstarted up despite multiple attempts in jumpstarting it.
5. The Mini Bus appeared to have sustained damage at its front portion. Its front windscreen, front body panel, front bumper, front left headlamp and engine components were damage at the time of my inspection as result of the accident.

Photo 2 shows a general view of the Mini Bus's frontal portion at the time of my inspection. The Mini Bus front portion was observed to have sustained damage at its front windscreen, front body panel, front bumper, front left headlamp and engine components were damage at the time of my inspection as result of the accident.

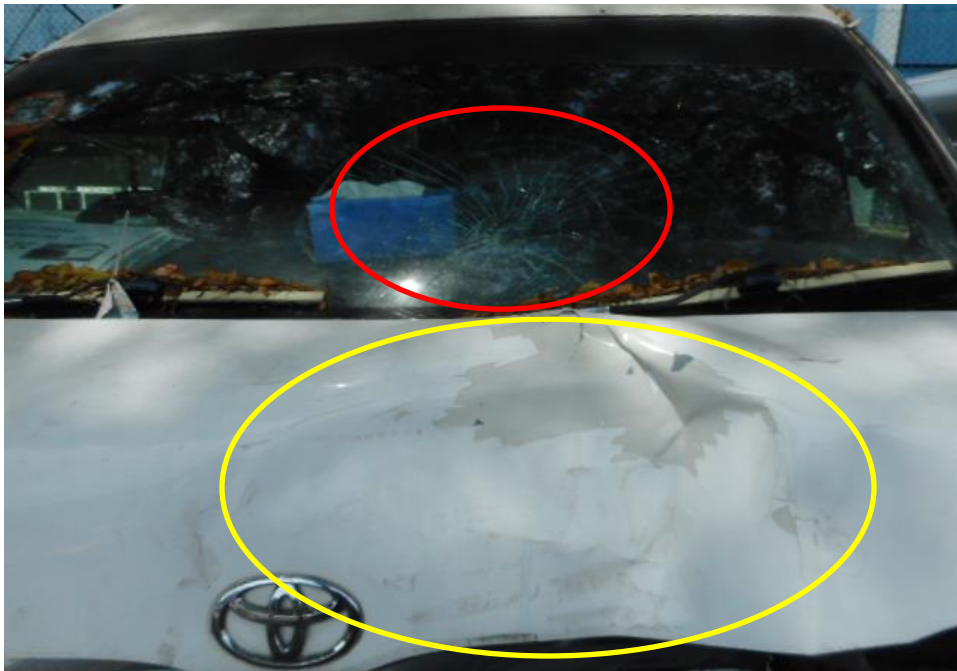
Photo 3 shows a close up view of the Mini Bus's frontal portion at the time of my inspection. The Mini Bus front portion was observed to have sustained damage at its front windscreen (red circle) and front body panel (yellow circle) at the time of my inspection as result of the accident.

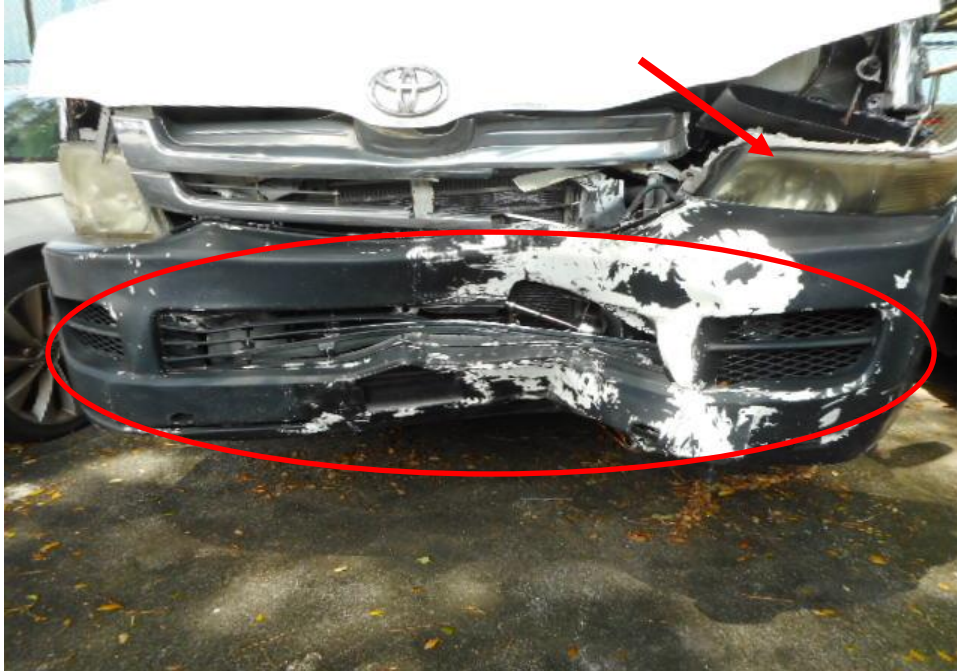
Photo 4 shows a close up view of the Mini Bus's frontal portion at the time of my inspection. The Mini Bus front portion was observed to have sustained damage at its front bumper (circled) and front left headlamp (arrowed) at the time of my inspection as result of the accident.

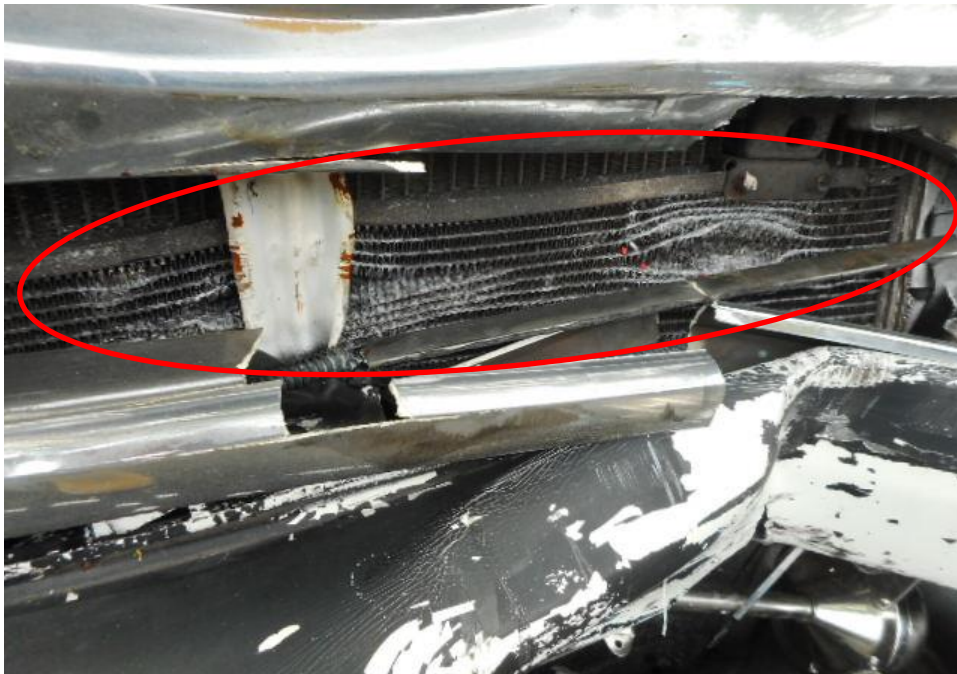
Photo 5 shows a close up view of the Mini Bus's frontal portion at the time of my inspection. The Mini Bus front portion was observed to have sustained damage at its front engine radiator (circled) at the time of my inspection as result of the accident.

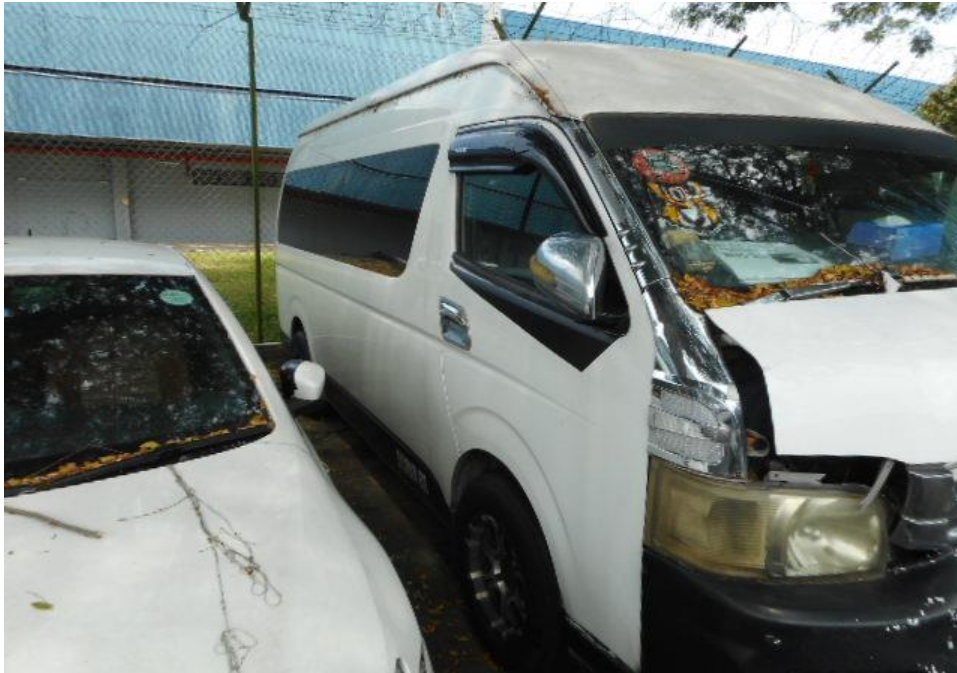
Photo 6 shows general view of the Mini Bus's right portion at the time of my inspection. The Mini Bus was observed to be intact and unaffected by the accident.

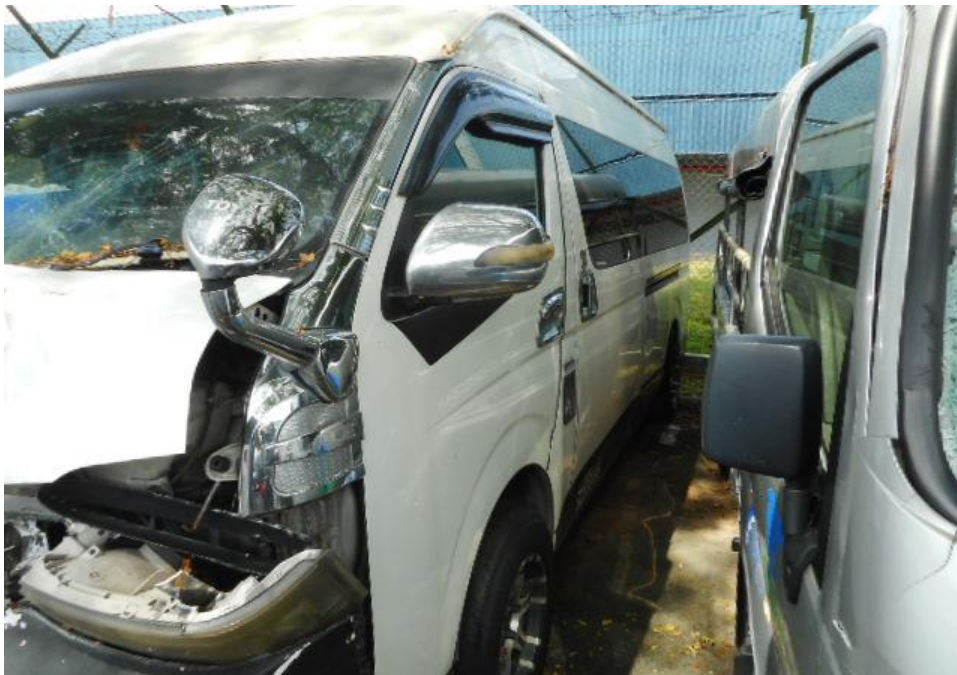
Photo 7 shows a general view of the left body of the Mini Bus at the time of my inspection. The Mini Bus was observed to be intact and unaffected by the accident.

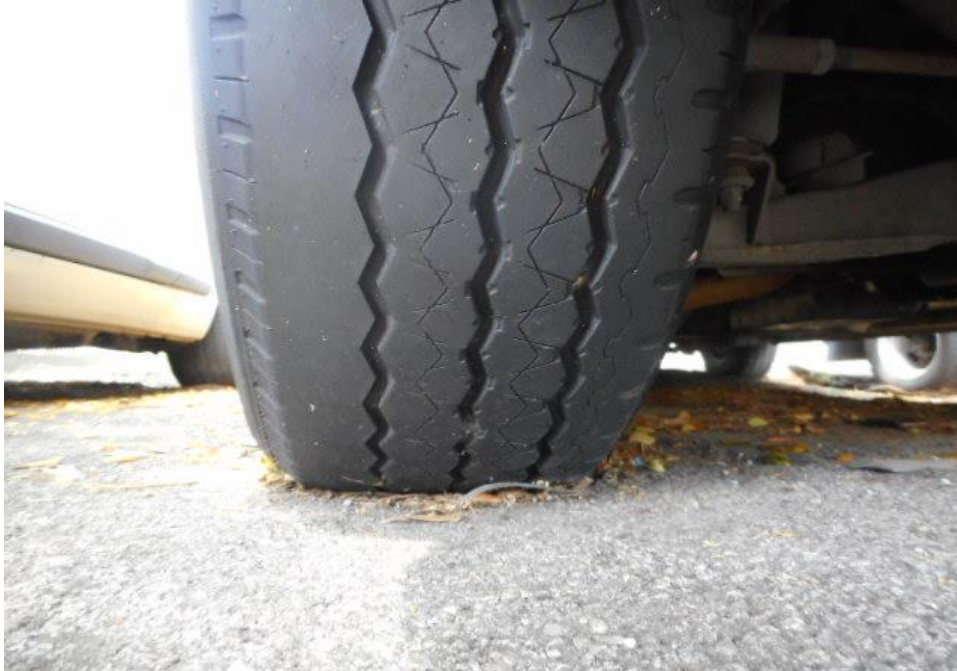
Photo 8 shows the condition of the front right tyre of the Mini Bus, which was observed to be in serviceable condition with remaining tread depth of approximately 6mm. The tyre, which was wrapped around standard steel wheel rim, was also observed to be sufficiently inflated for vehicular operation. There was no tear, cut or burst mark(s) on the outer and the inner sidewalls as well as across the tread of the 4 tyres that were fitted on the Mini Bus.

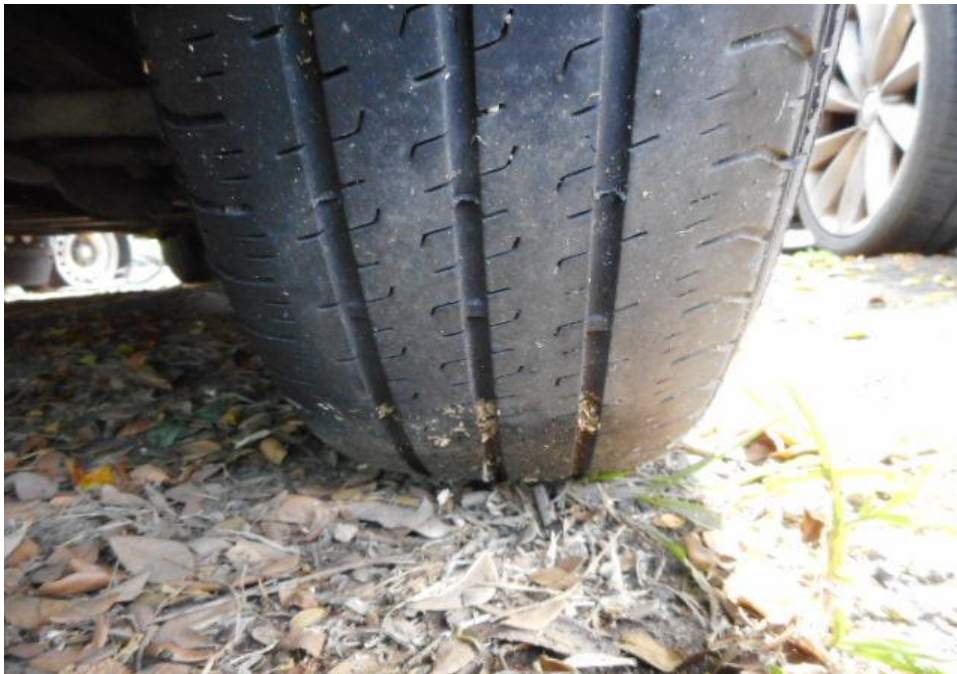
Photo 9 shows the condition of the rear right tyre of the Mini Bus, which was observed to be in serviceable condition with remaining tread depth of approximately 3.4mm. The tyre, which was wrapped around standard steel wheel rim, it was observed to be sufficiently inflated for vehicular operation.

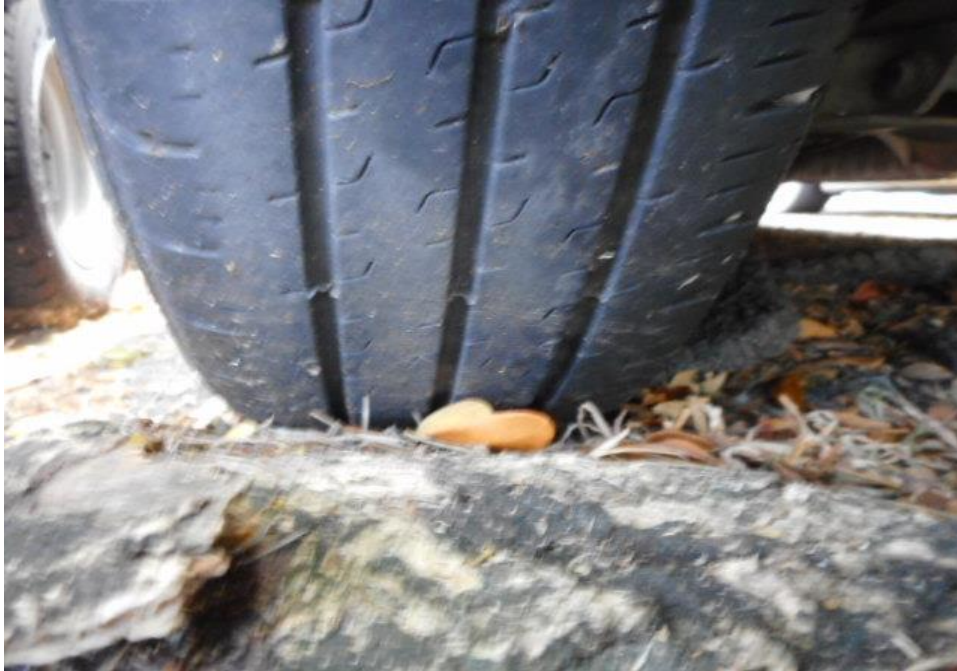
Photo 10 shows the condition of the rear left tyres of the Mini Bus, which was observed to be in serviceable condition with remaining tread depth of approximately 3.5mm. The tyres, which were wrapped around standard steel wheel rim, were also observed to be sufficiently inflated for vehicular operation. There was also no damage found on all 4 steel wheel rims of the Mini Bus.

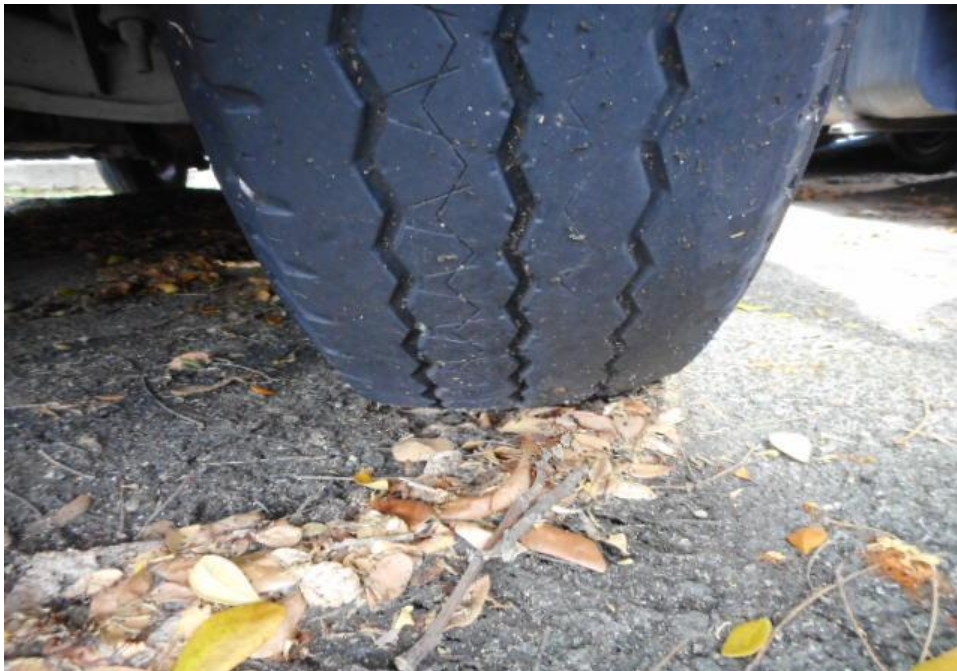
Photo 11 shows the condition of the rear right tyres of the Mini Bus, which were observed to be in serviceable condition with remaining, tread depth of approximately 5.3mm. There was also no tear, cut or burst mark(s) on the outer and the inner sidewalls as well as across the tread of the 4 tyres that were fitted on the Mini Bus.

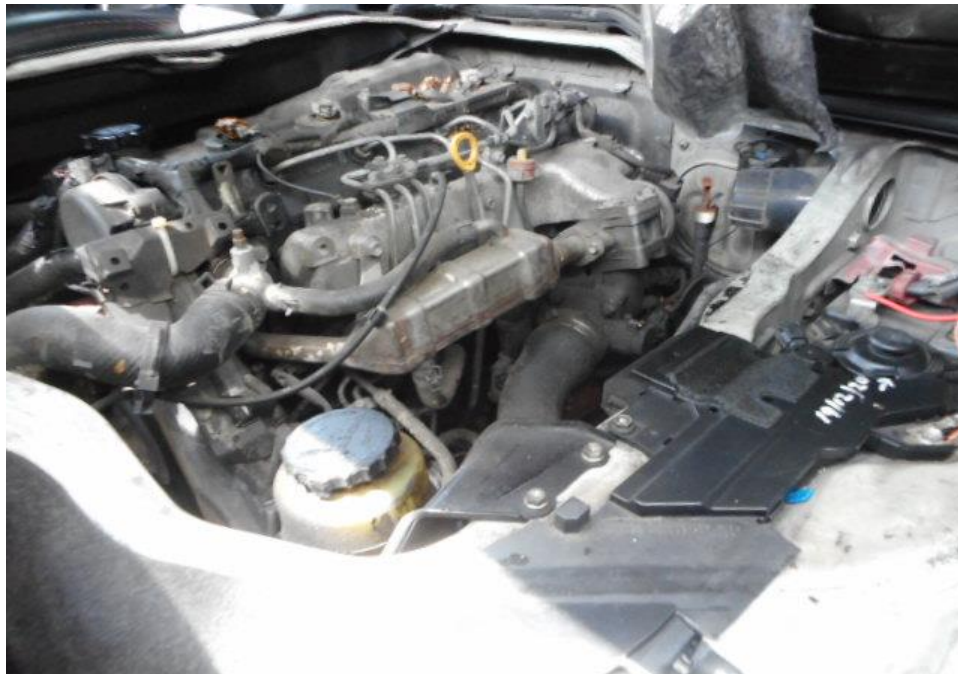
8. Upon examination of the Mini Bus's engine compartment, I had observed all the parts and components inside the engine compartment to be intact and unaffected by the accident. The brake fluid, power steering fluid and engine oil were all found to be of sufficient level for operating purposes. Visually, there was also no contamination found to these fluids. However, the engine coolant was observed to be insufficient due to the damaged to the radiator that caused a leakage of engine coolant as a result of the accident.

Photo 12 shows a general view of the Mini Bus's engine compartment, which was accessed by lifting the front cabin of the Mini Bus. The various parts and components inside the engine compartment were unaffected by the accident. There was also no sign(s) or indication(s) of fresh fluid leakage and/or fluid stain within the engine compartment

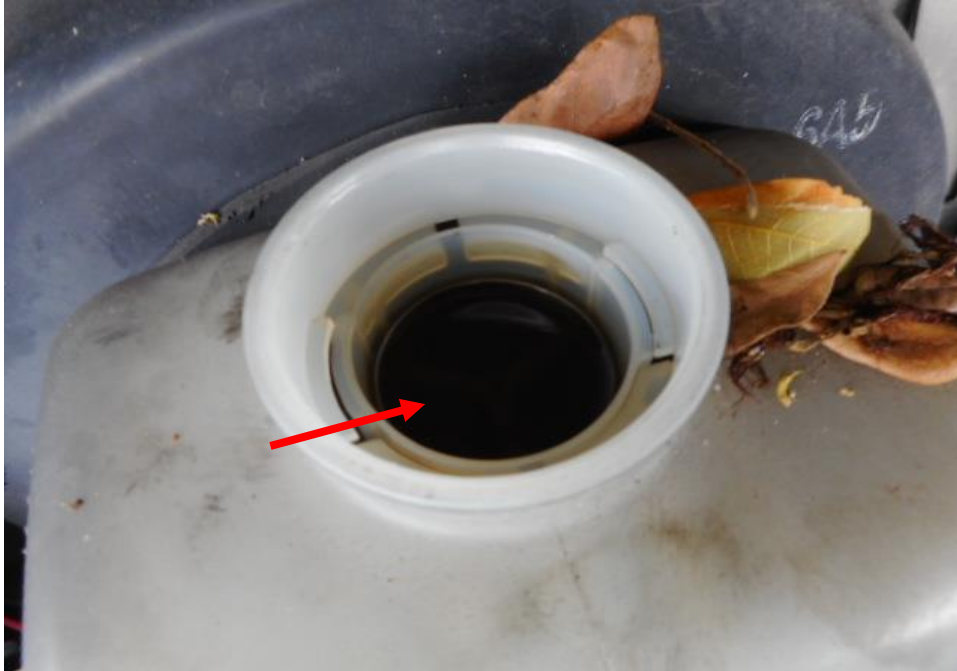
Photo 13 shows the brake fluid reservoir of the Mini Bus at the time of my inspection. The brake fluid was observed to be of sufficient level (arrowed) and without any visible contamination.

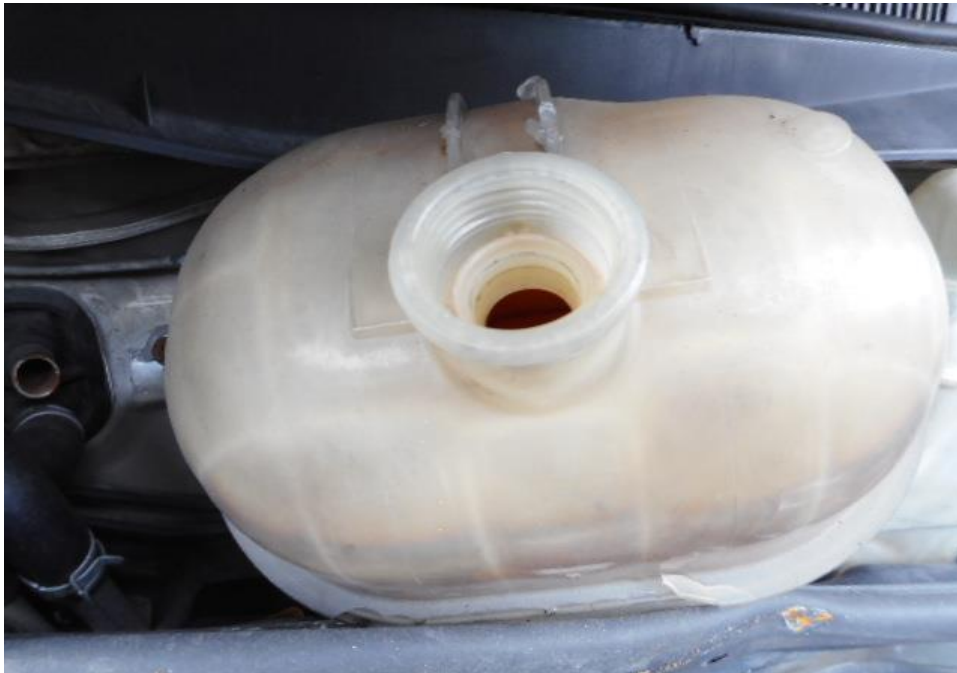
Photo 14 shows the engine coolant reservoir of the Mini Bus at the time of my inspection. The engine coolant was observed to be insufficient level as the damaged sustained from the accident had caused a leakage of engine coolant from the radiator.

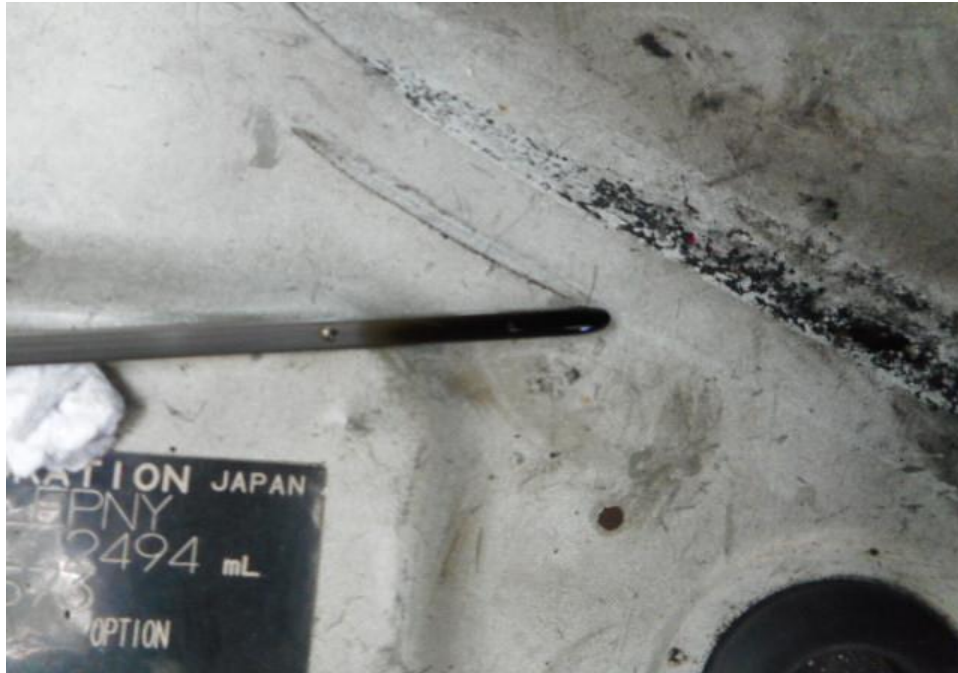
Photo 15 shows the engine oil dip stick of the Mini Bus at the time of my inspection. The engine oil was observed to be of sufficient level and without any visible contamination.

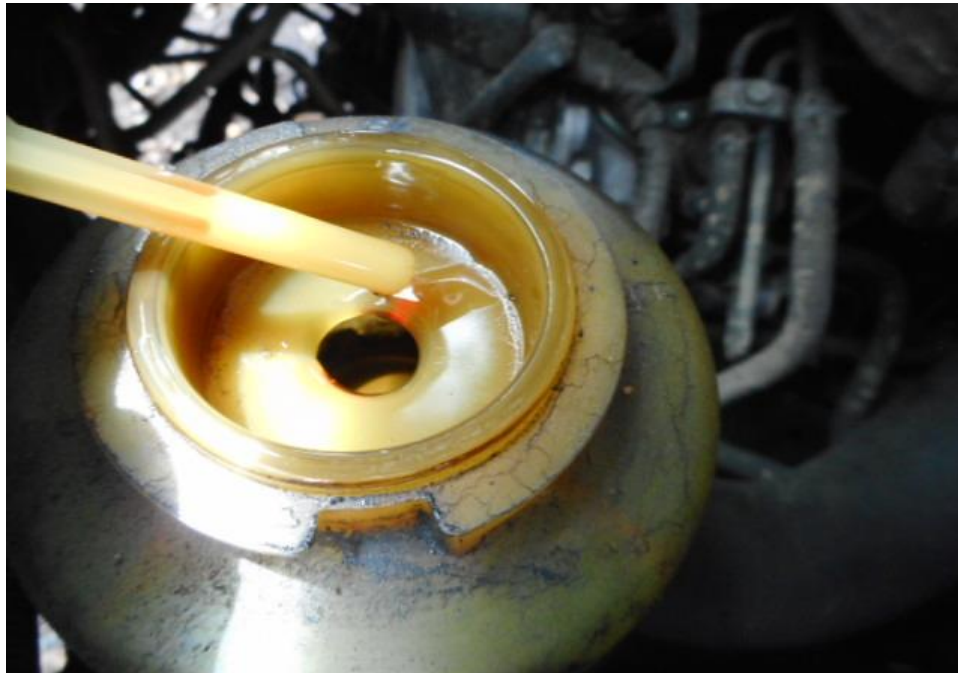
Photo 16 shows the power steering fluid reservoir of the Mini Bus at the time of my inspection. The power steering fluid was observed to be of sufficient level and without any visible contamination.

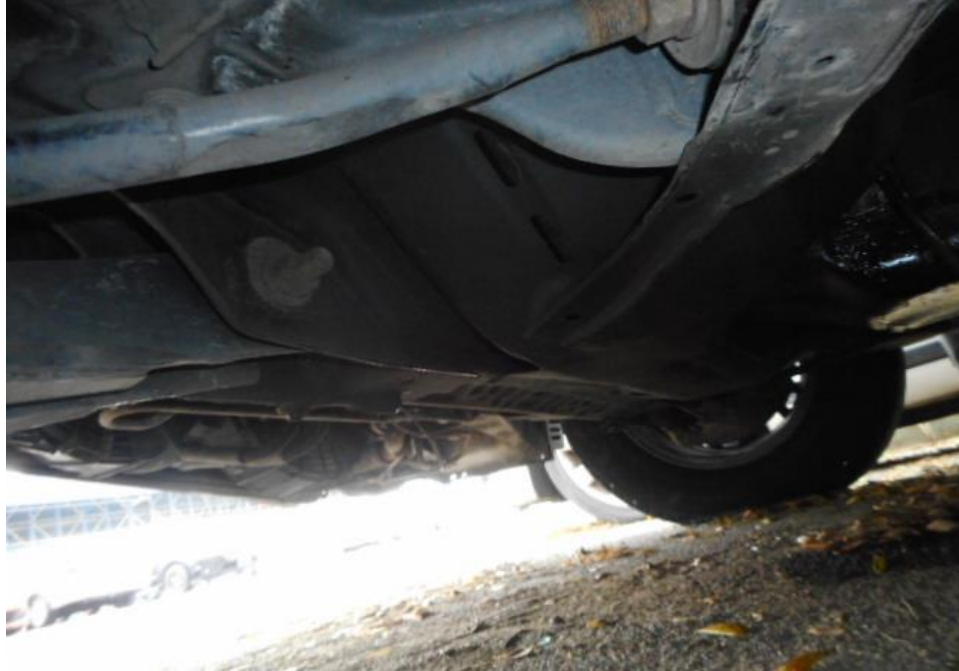
Photo 17 shows the undercarriage of the Mini Bus, at the area where the engine housing and transmission housing are located. I did not find any sign(s) or indication(s) of fluid leak and/or fluid stain(s) on the underside of the Mini Bus.

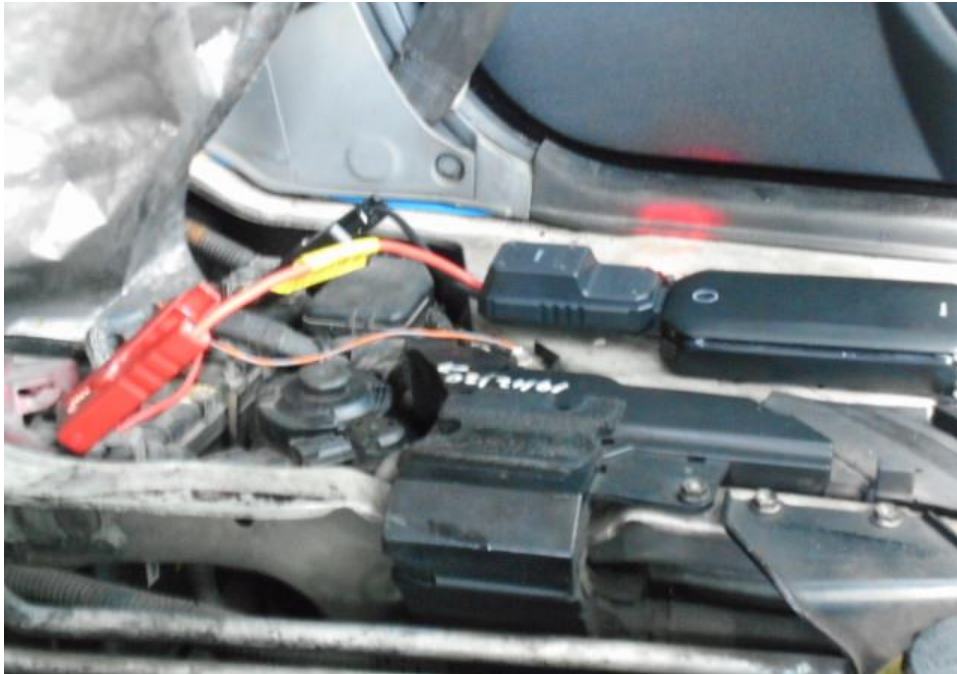
Photo 18 shows the jumpstarting process of the Mini Bus's engine. The engine of the Mini Bus was unable to be jumpstarted up despite multiple attempts in starting it.

16. For this particular case, I was unable to determine whether there was any possible mechanical failure to the Mini Bus that may have contributed to the accident. Its engine not able to be started up had prevented me from carrying out any operational test(s) and/or static test(s) to its engine system, transmission system, steering system and suspension system.

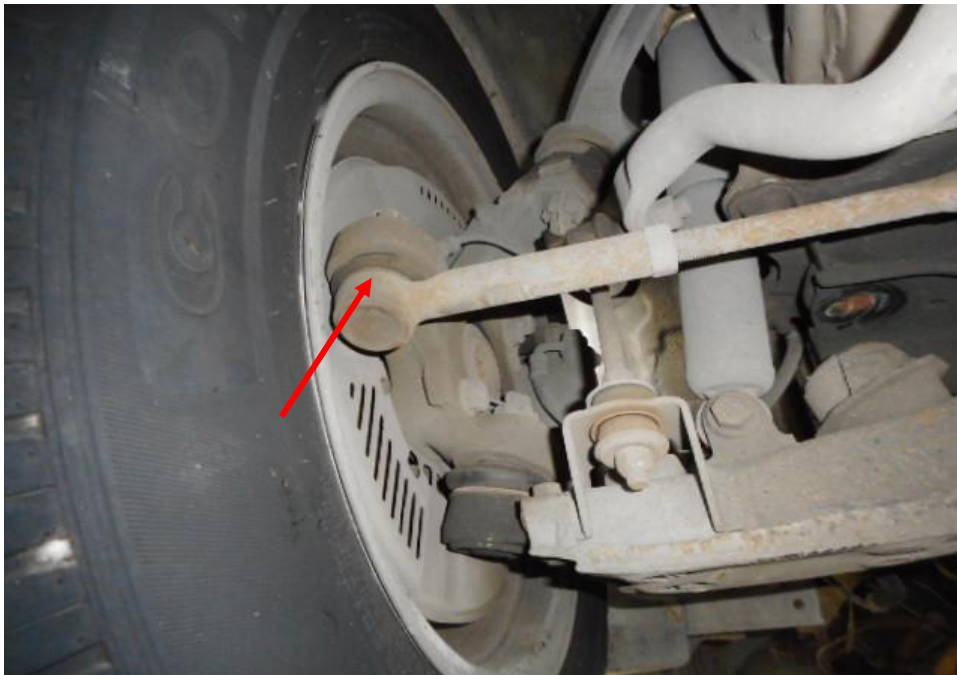
Photo 19 shows the various undercarriage components at the front right wheel of the Mini Bus, in particular the steering tie rod end (arrowed). The various steering components were all found to be intact, suggesting that the steering system of the Mini Bus was likely to be in serviceable condition at the material time of accident. There was also no sign of fluid stain(s) observed on the various undercarriage components.

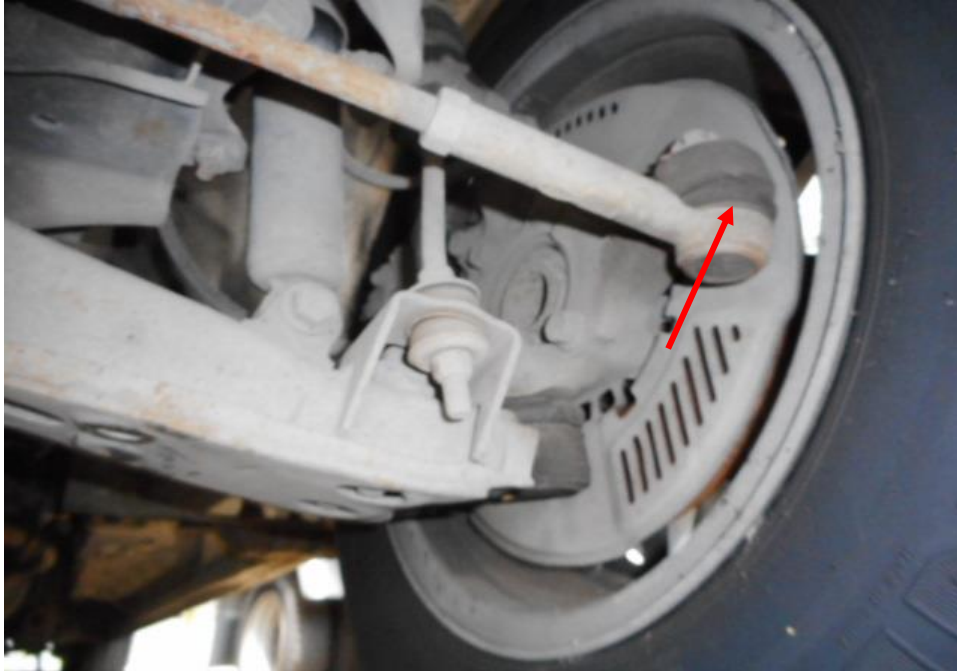
Photo 20 shows the various undercarriage components at the front left wheel of the Mini Bus, in particular the steering tie rod end (arrowed). The various undercarriage components of the Mini Bus were all found to be intact without any visible damage. There was also no sign of fluid stain(s) observed on the various undercarriage components.

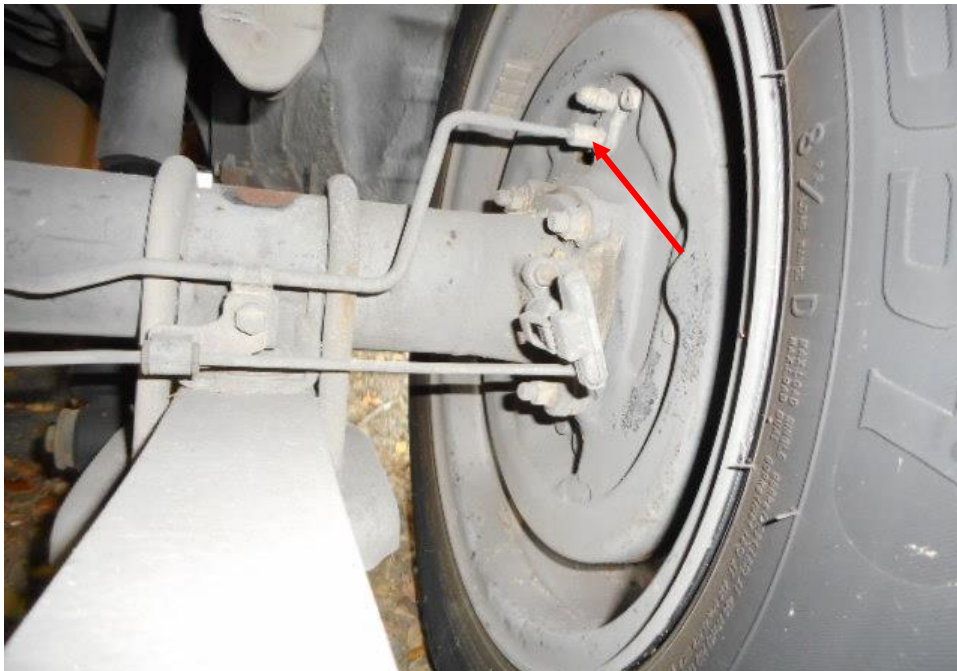
Photo 21 shows the brake pipe (arrowed) at the rear right wheel of the Mini Bus. I did not observe any leakage of brake fluid at the time of my inspection of the Mini Bus. My static tests of the Mini Bus's braking system, along with my visual examination of the various mechanical components in the braking system, had indicated that there was no internal leakage of pressure/vacuum. Hence the braking system of the Mini Bus was likely to be in serviceable condition at the material time of accident.

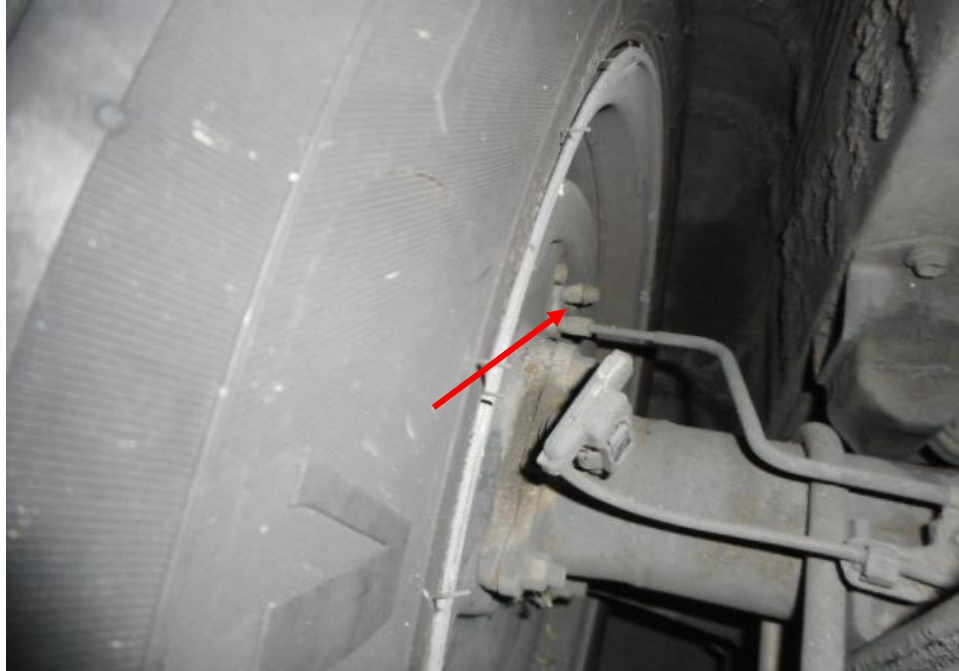
Photo 22 shows the brake pipe (arrowed) at the rear left wheel of the Mini Bus. I did not observe any leakage of brake fluid at the time of my inspection of the Mini Bus. My static tests of the Mini Bus's braking system, along with my visual examination of the various mechanical components in the braking system had indicated that there was no internal leakage of pressure/vacuum. Hence the braking system of the Mini Bus was likely to be in serviceable condition at the material time of accident.

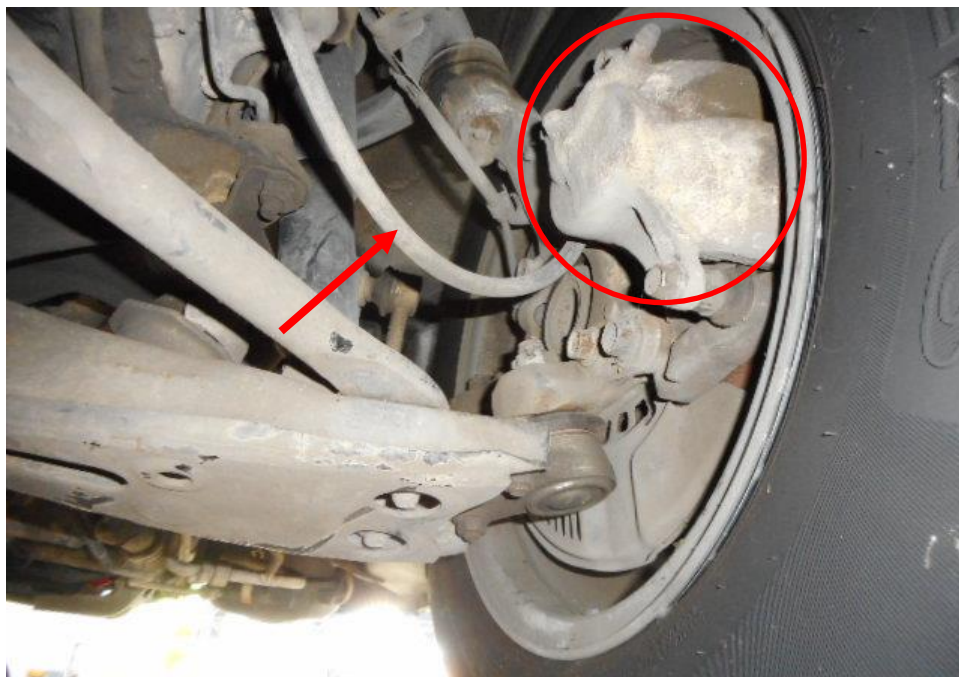
Photo 23 shows the brake hose/pipe (arrowed) at the front right wheel of the Mini Bus. No leakage of brake fluid was observed. Visual examination of the various components of the braking system like the brake caliper (circled), brake booster, brake pedal etc had revealed all to be intact and without visible damage at the time of accident. There was also no sign of fluid stain(s) observed on the various undercarriage components.

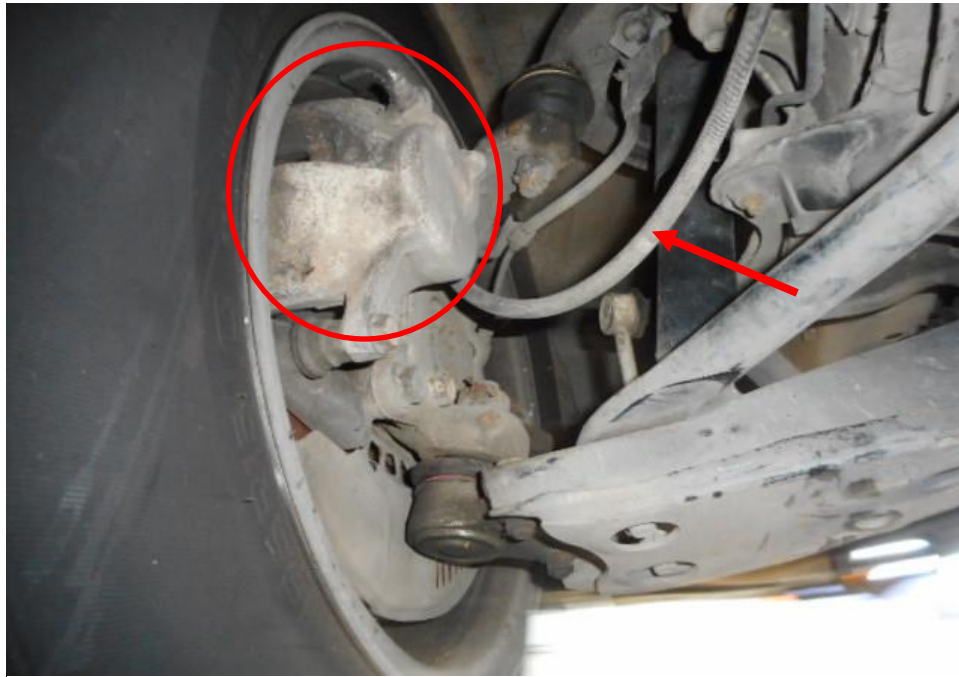
Photo 24 shows the brake hose/pipe (arrowed) at the front left wheel of the Mini Bus. No leakage of brake fluid was observed. Visual examination of the various components of the braking system like the brake caliper (circled), brake booster, brake pedal etc had revealed all to be intact and without visible damage at the time of accident. There was also no sign of fluid stain(s) observed on the various undercarriage components.
