You're Ref: TP/IP/15883/2021
Our Ref: CI/TPD21007782/P

Fatal Accident Investigation Team

MECHANICAL INSPECTION REPORT OF MOTOR TAXI SHD 3618H

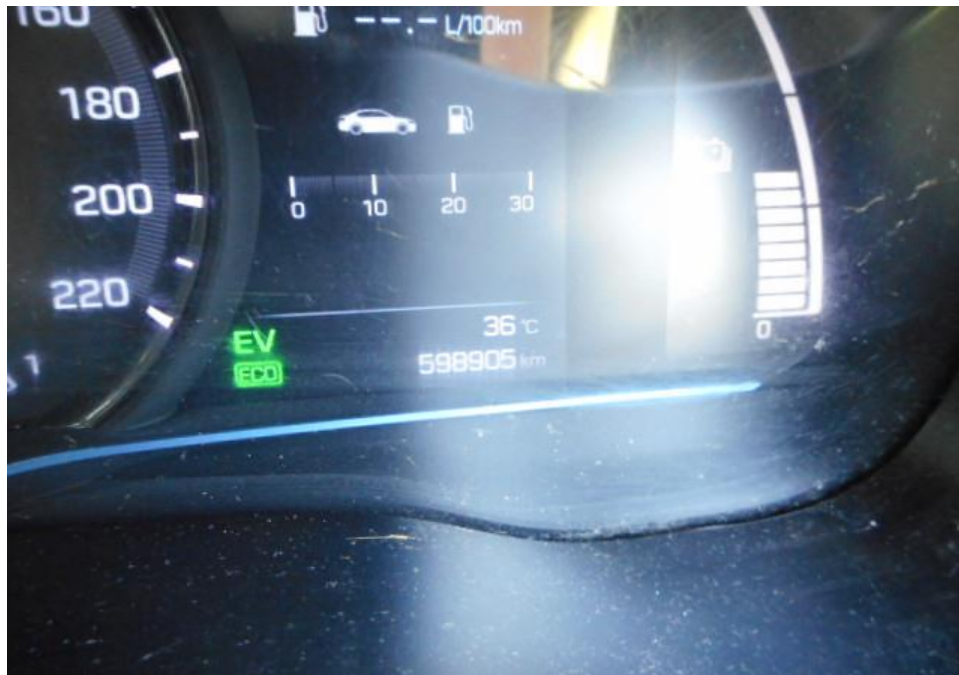
4. The mileage of the Motor Taxi at the time of my inspection was 598,905 km.
5. The Motor Taxi was observed to have sustained damage at its front portion. Its front windscreen, front bonnet, front bumper and front left headlamp was the body parts that were damaged as a result of the accident.

Photo 1 shows the mileage of the Motor Taxi at the time of my inspection. The mileage observed was 598,905km.

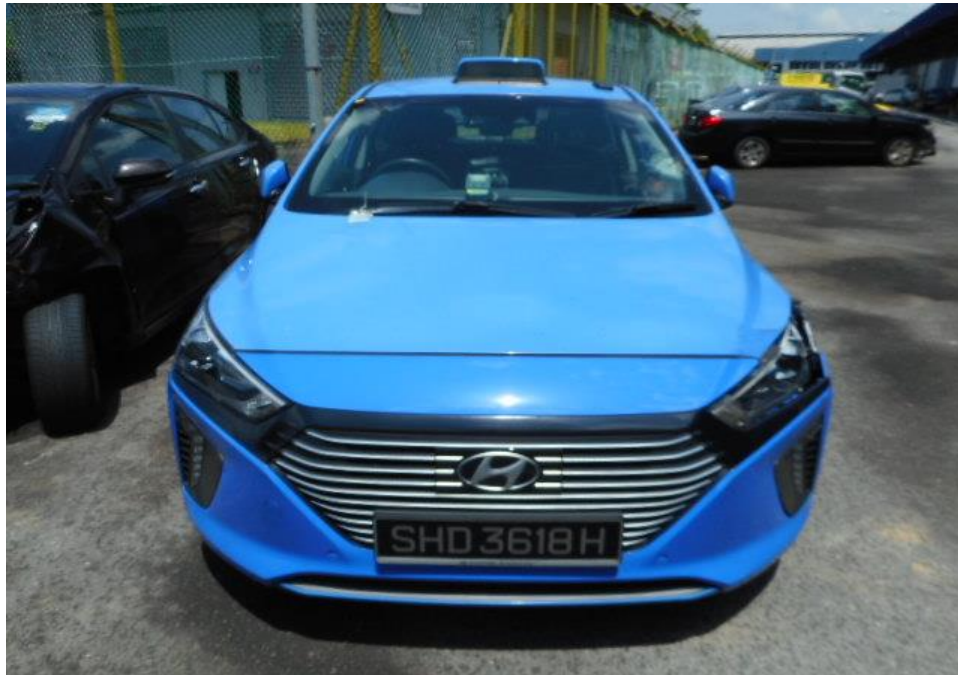
Photo 2 shows a general view of the Motor Taxi's front body at the time of my inspection. The front portion of the Motor Taxi was observed to have sustained damage. Its front windscreen, front bonnet, front bumper and front left headlamp was the body parts that were damaged as a result of the accident.

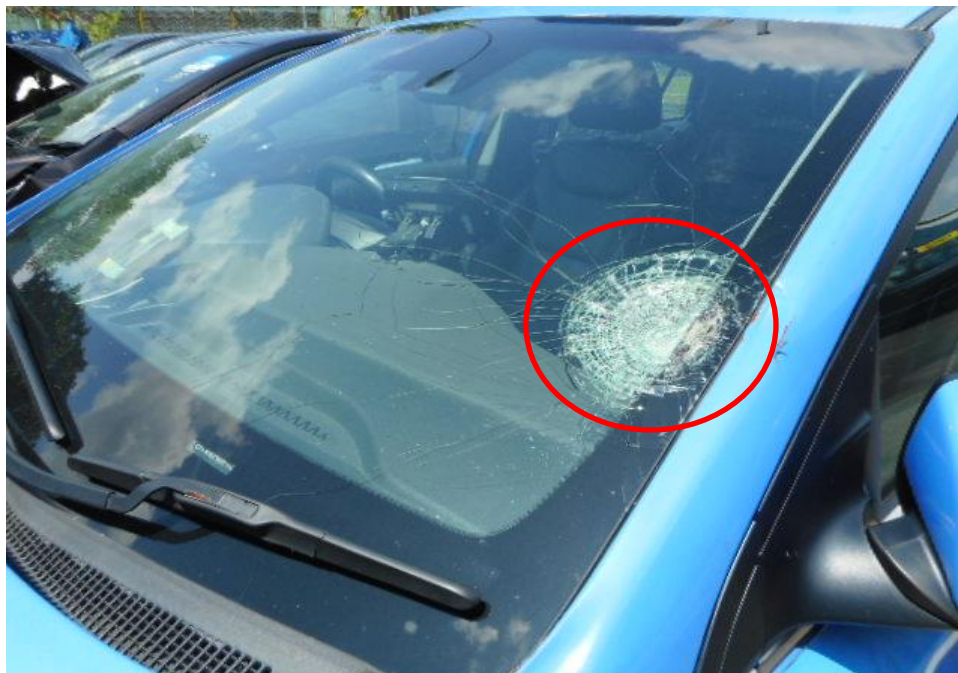
Photo 3 shows a close up view of the Motor Taxi's front body at the time of my inspection. The front portion of the Motor Taxi was observed to have sustained damage. Its front windscreen (circled) was the body part that were damaged as a result of the accident.

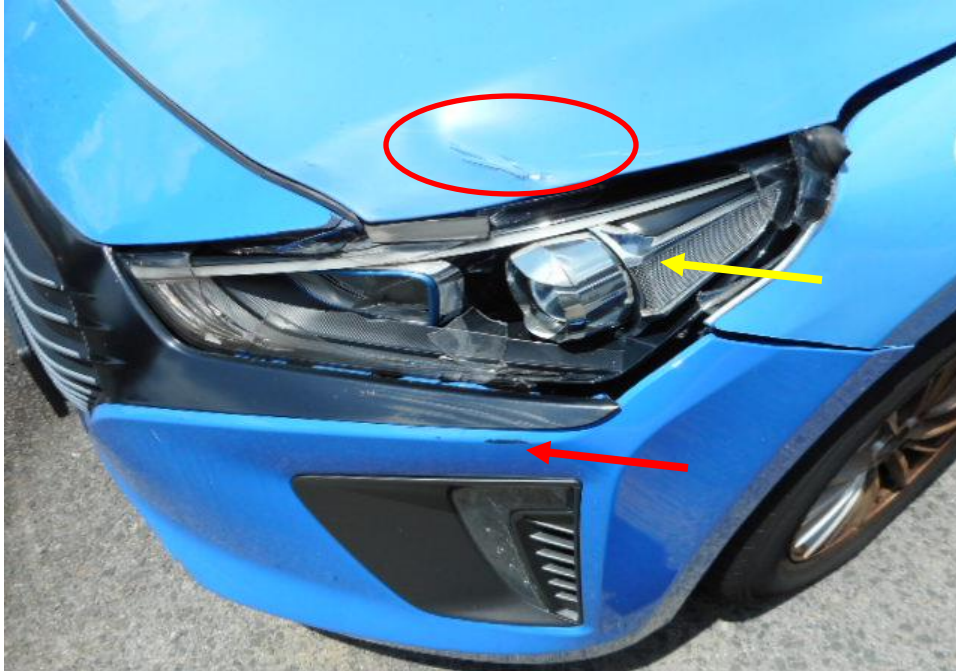
Photo 4 shows a close up view of the Motor Taxi's front body at the time of my inspection. The front portion of the Motor Taxi was observed to have sustained damage. Its front bonnet (circled), front bumper (red arrow) and front left headlamp (yellow arrow) was the body parts that were damaged as a result of the accident.

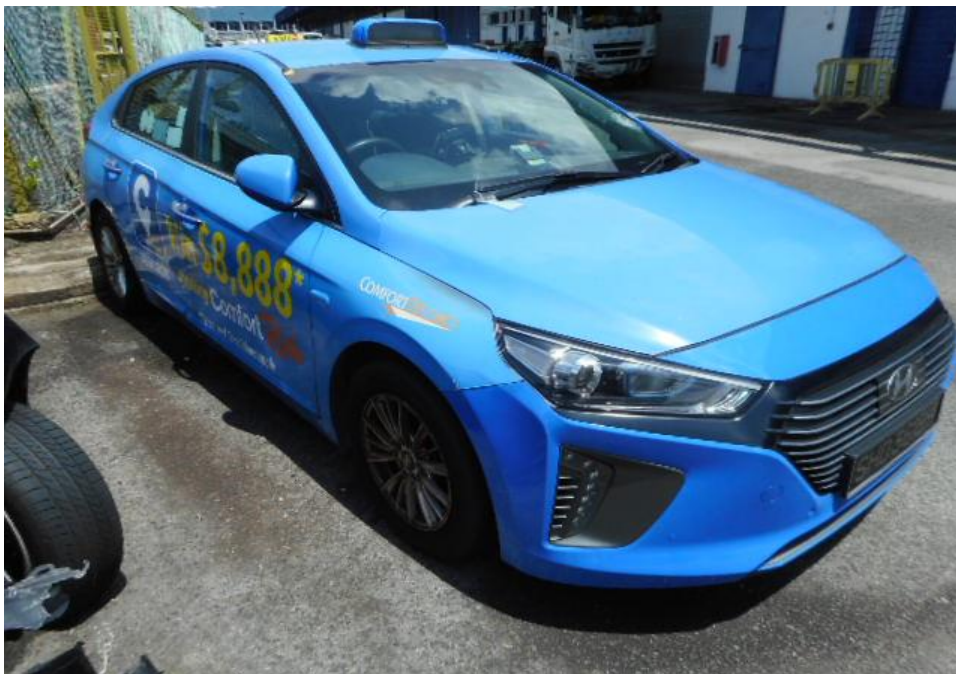
Photo 5 shows a general view of the Motor Taxi's right body at the time of my inspection. The right portion of the Motor Taxi was observed to have been unaffected by the accident.

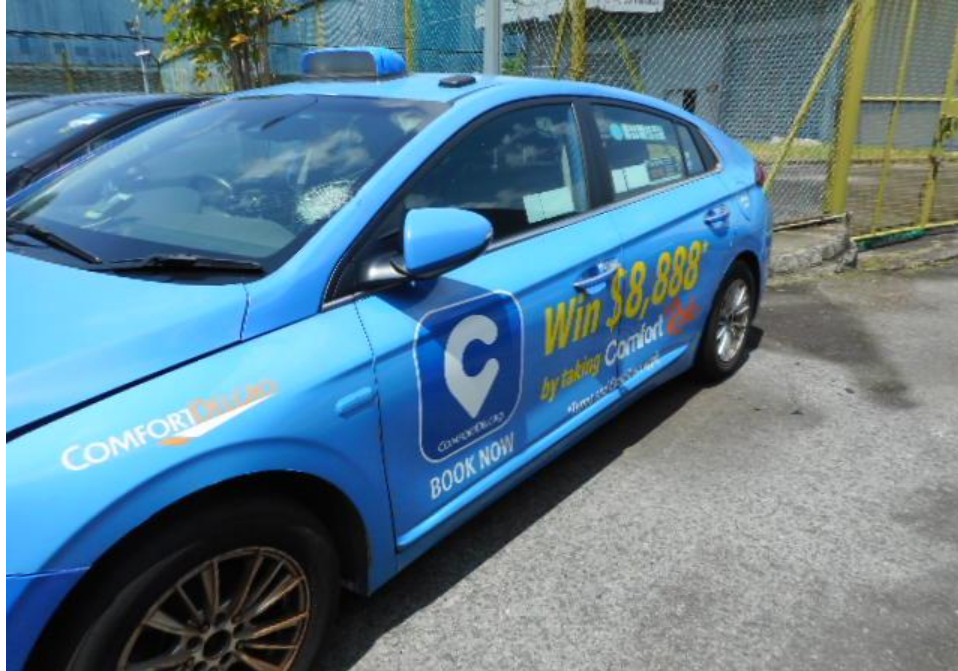
Photo 6 shows a general view of the Motor Taxi's left body at the time of my inspection. The left portion of the Motor Taxi was observed to have been unaffected by the accident.

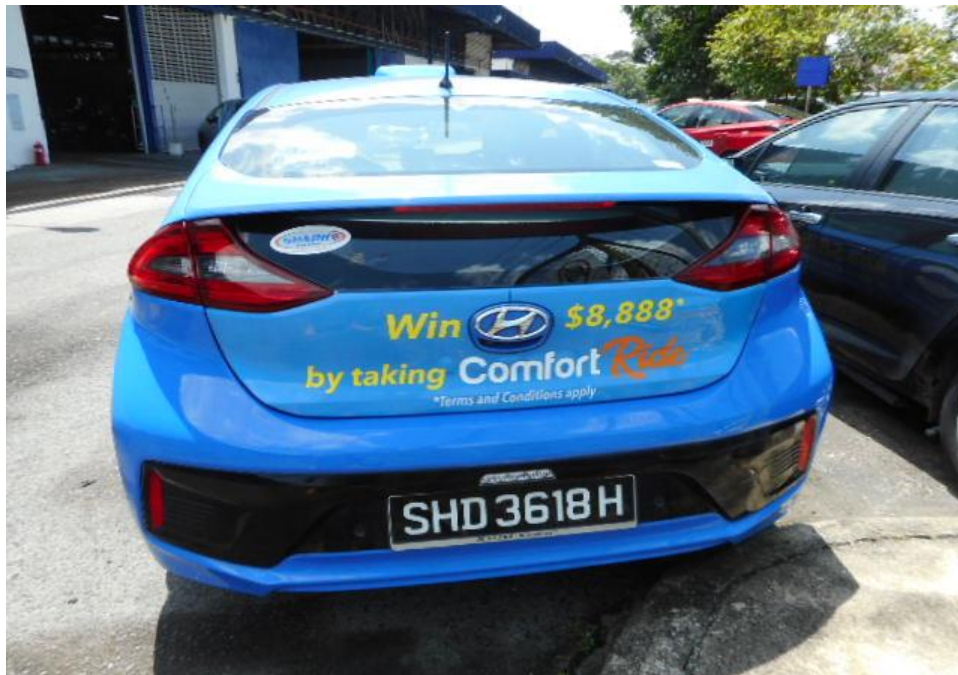
Photo 7 shows the general view of the Motor Taxi's rear body at the time of my inspection. The Motor Taxi rear was observed to be unaffected by the accident.

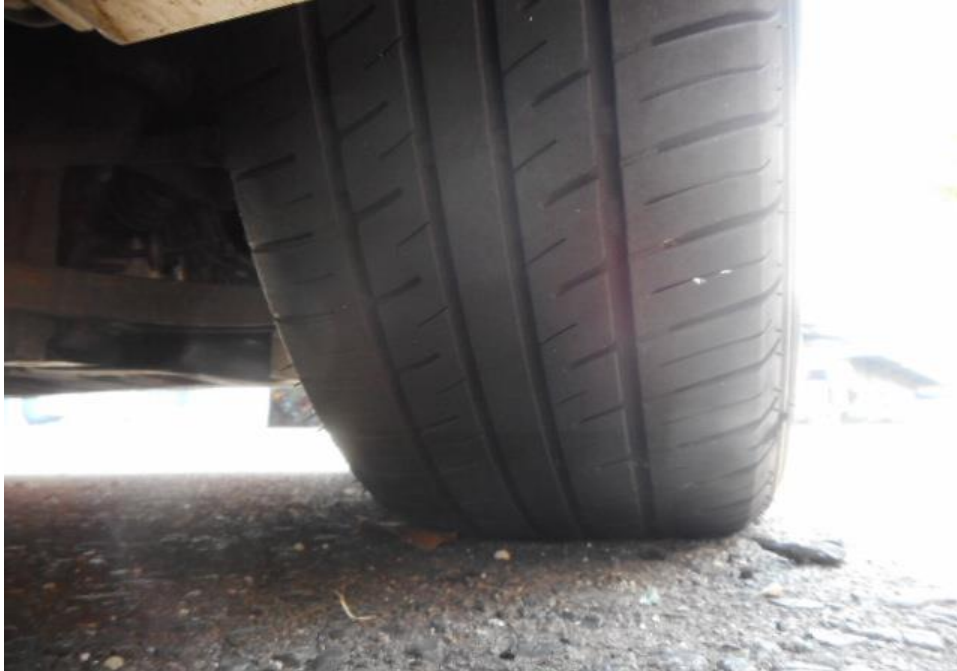
Photo 8 shows the condition of the front right tyre of the Motor Taxi, which was observed to be in serviceable condition with remaining tread depth of approximately 3.8mm. The tyre was sufficiently inflated for vehicular operation with no tear, cut or burst mark(s) on the outer and the inner sidewalls as well as across the tread. The 4 tyres of the Motor Taxi were wrapped around standard steel wheel rims without any damage.

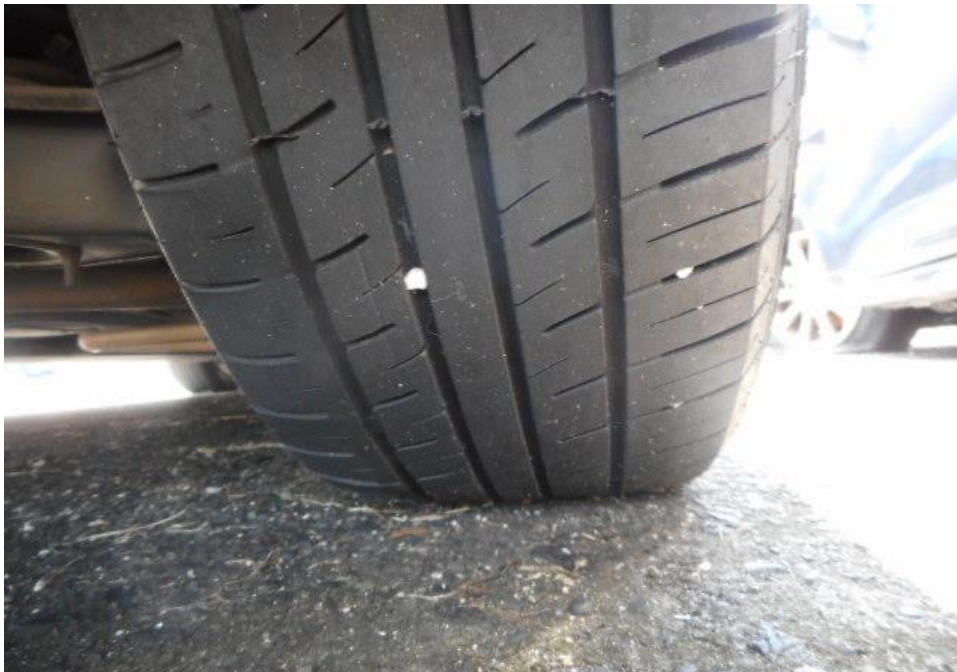
Photo 9 shows the condition of the rear right tyre of the Motor Taxi, which was observed to be in serviceable condition with remaining tread depth of approximately 4.8mm. The tyre was also observed to be sufficiently inflated for vehicular operation with no tear, cut or burst mark(s).

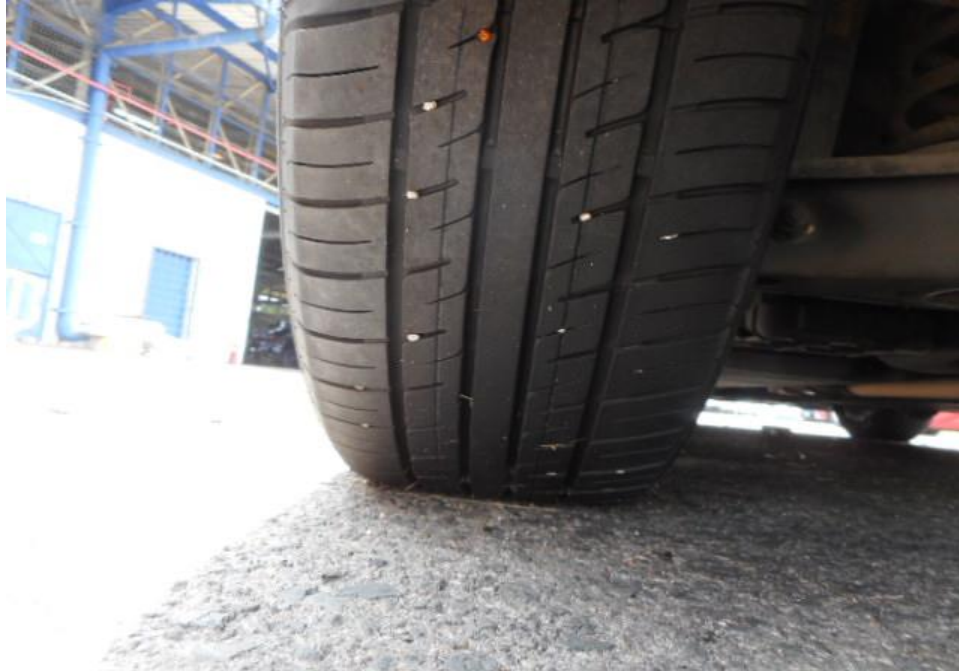
Photo 10 shows the condition of the rear left tyre of the Motor Taxi, which was observed to be in serviceable condition with remaining tread depth of approximately 5mm. The tyre, which was wrapped around steel wheel rim, was also observed to be sufficiently inflated for vehicular operation. The 4 tyres of the Motor Taxi were wrapped around standard steel wheel rims.

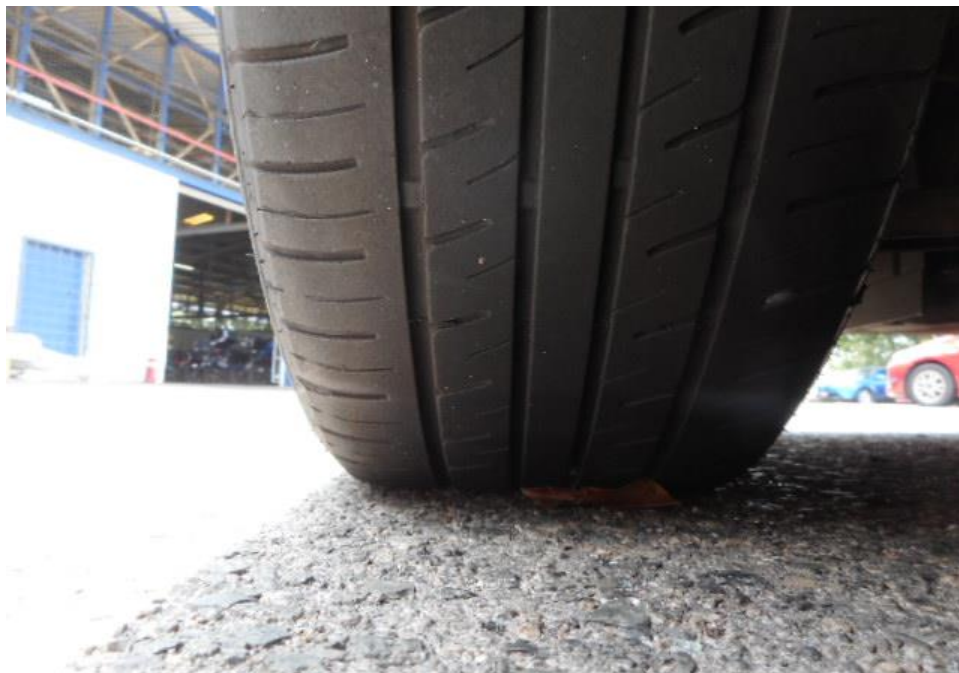
Photo 11 shows the condition of the front left tyre of the Motor Taxi, which was observed to be in serviceable condition with remaining tread depth of approximately 3.2mm. There was also no tear, cut or burst mark(s) on the outer and the inner sidewalls as well as across the tread of the Motor Taxi's 4 tyres.

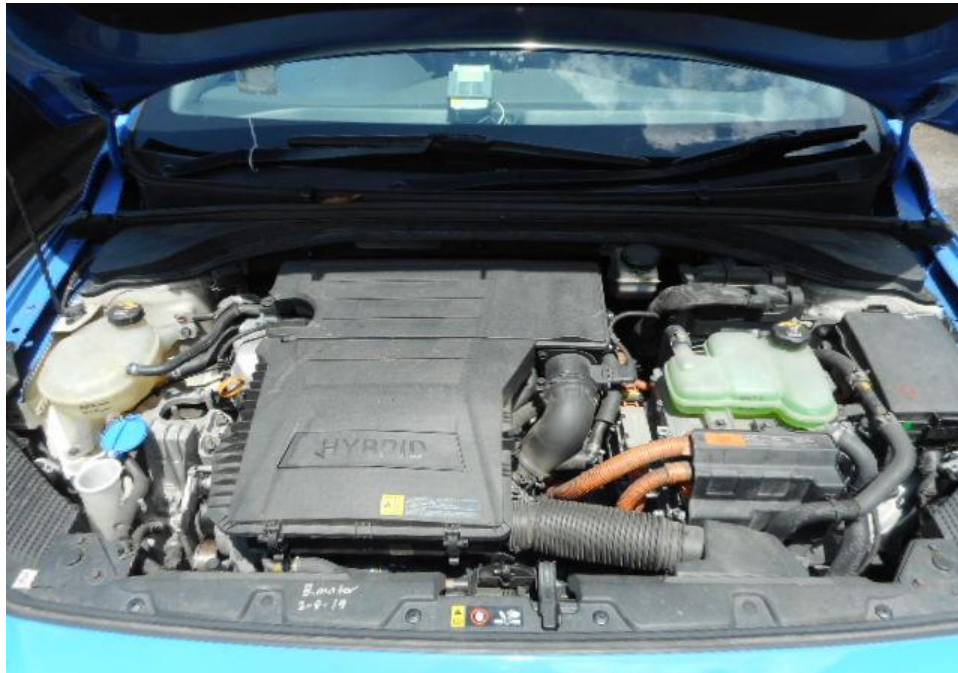
Photo 12 shows a general view of the Motor Taxi's engine compartment. The various parts and components inside the engine compartment were unaffected by the accident. There was also no sign(s) or indication(s) of fluid leakage and/or fluid stain within the engine compartment.

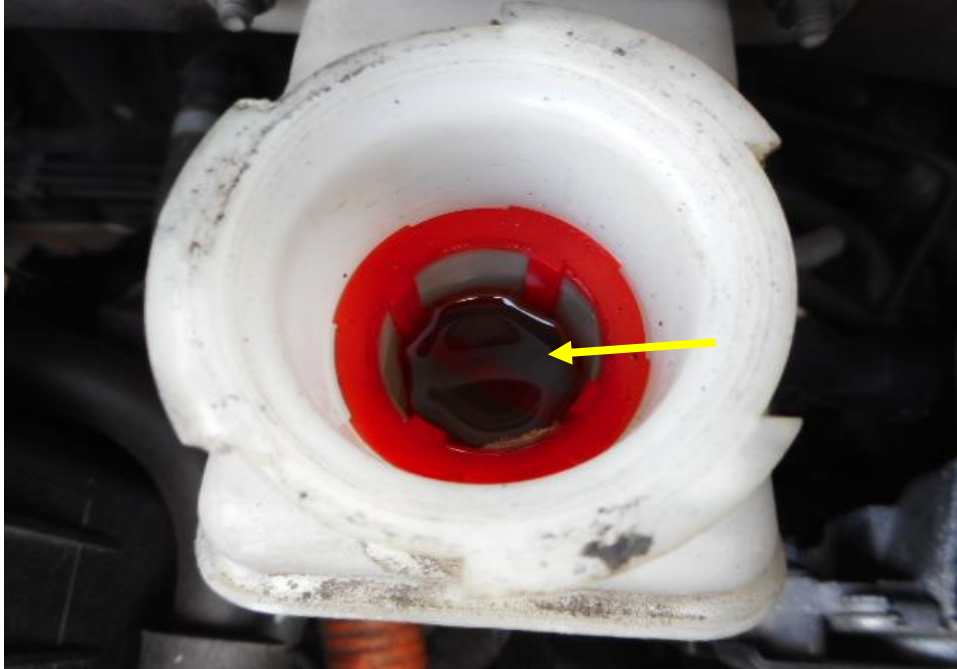
Photo 13 shows the brake fluid reservoir of the Motor Taxi at the time of my inspection. The brake fluid was observed to be of sufficient level (arrowed) and without any visible contamination.

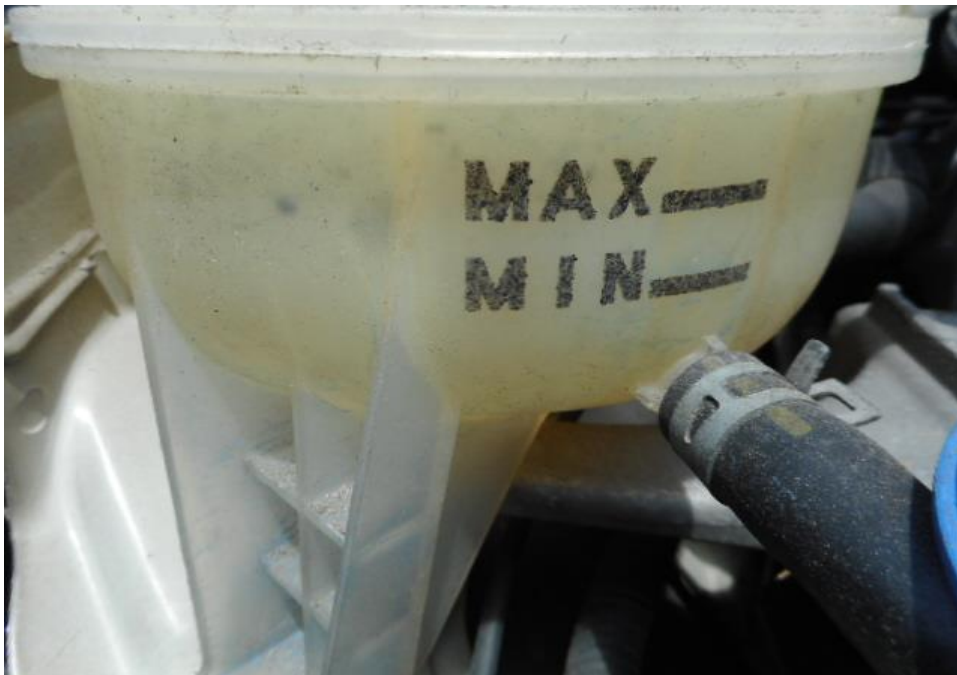
Photo 14 shows checks being carried out to the engine coolant of the Motor Taxi at the time of my inspection. The engine coolant was observed to be of insufficient level.

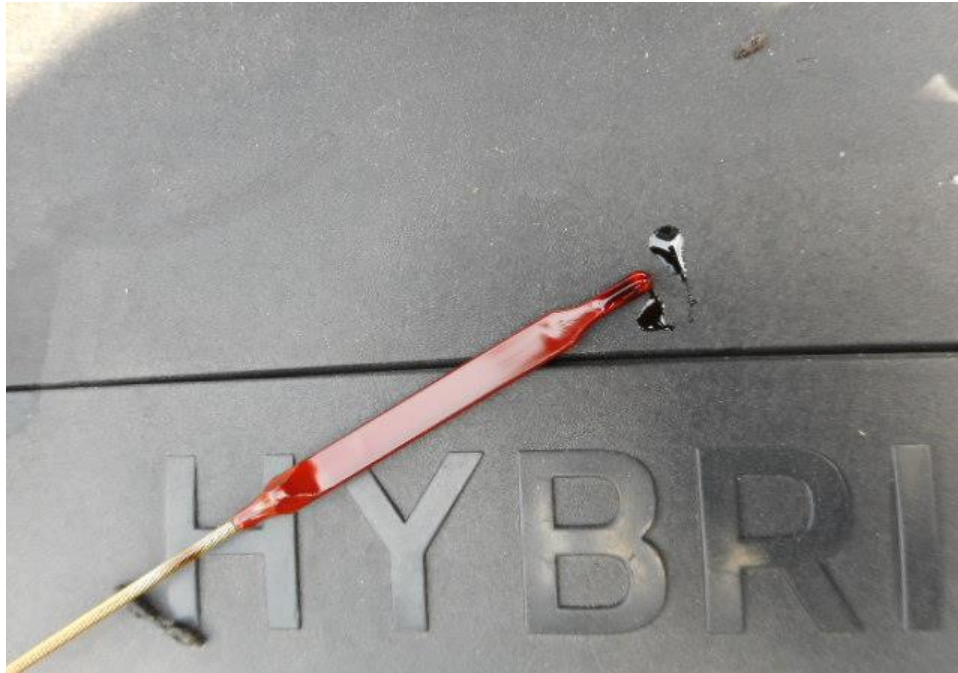
Photo 15 shows the engine oil dipstick of the Motor Taxi at the time of my inspection. The engine oil was observed to be of sufficient level and without any visible contamination.

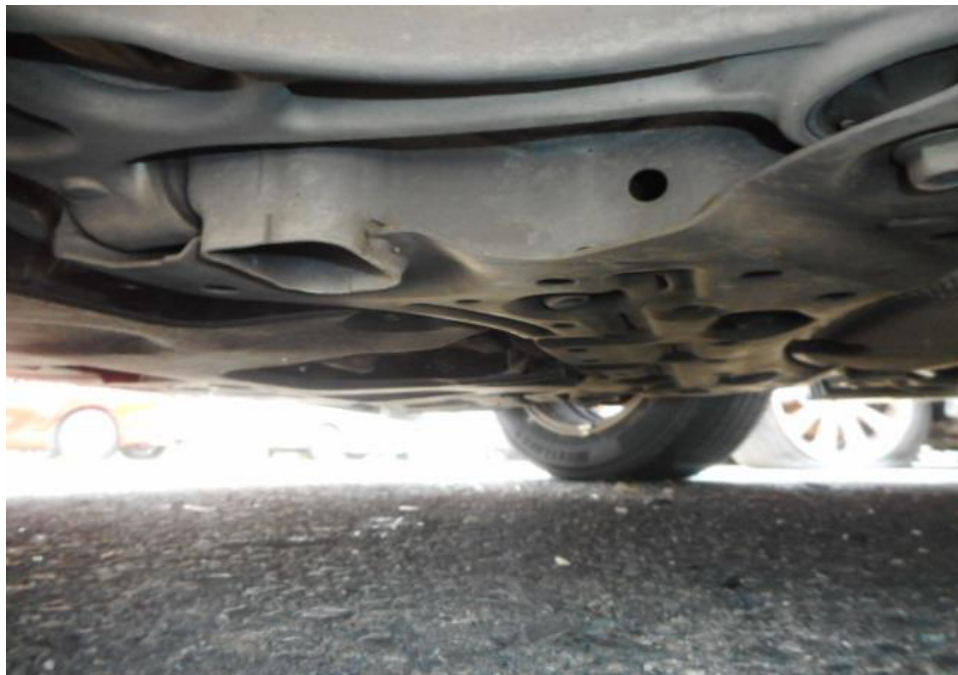
Photo 16 shows the undercarriage of the Motor Taxi, at the area where the engine housing and transmission housing are located. I did not find any sign(s) or indication(s) of fluid leak and/or fluid stain(s) on the underside of the Motor Taxi.

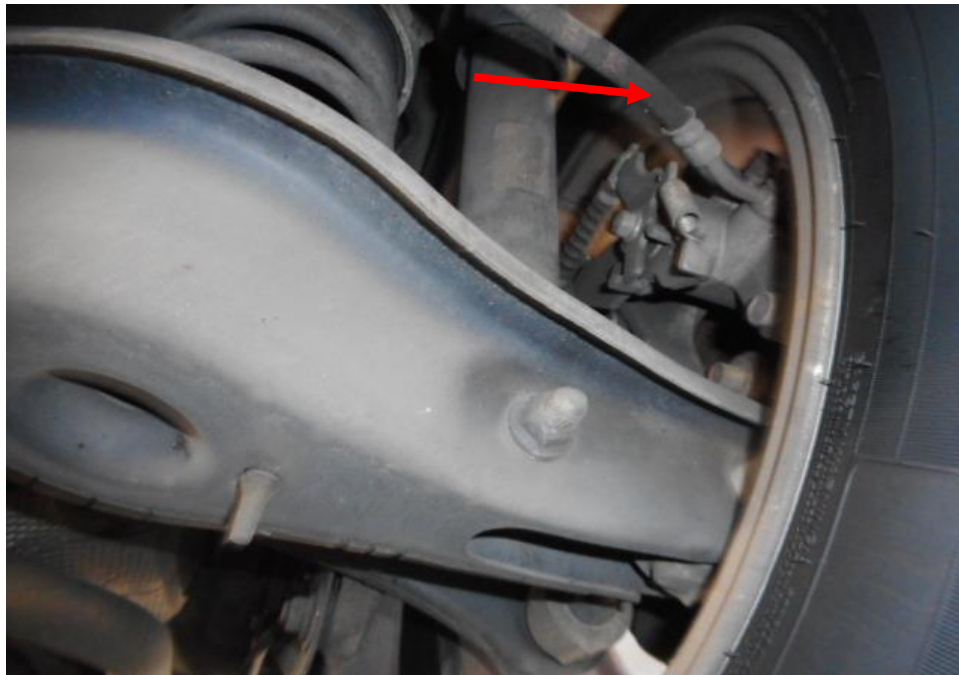
Photo 17 shows the brake hose/pipe (arrowed) at the rear right wheel of the Motor Taxi. No leakage of brake fluid was observed. Visual examination of the various components of the braking system like the drum brake, brake booster, brake pedal etc. had revealed all to be intact and without visible damage.

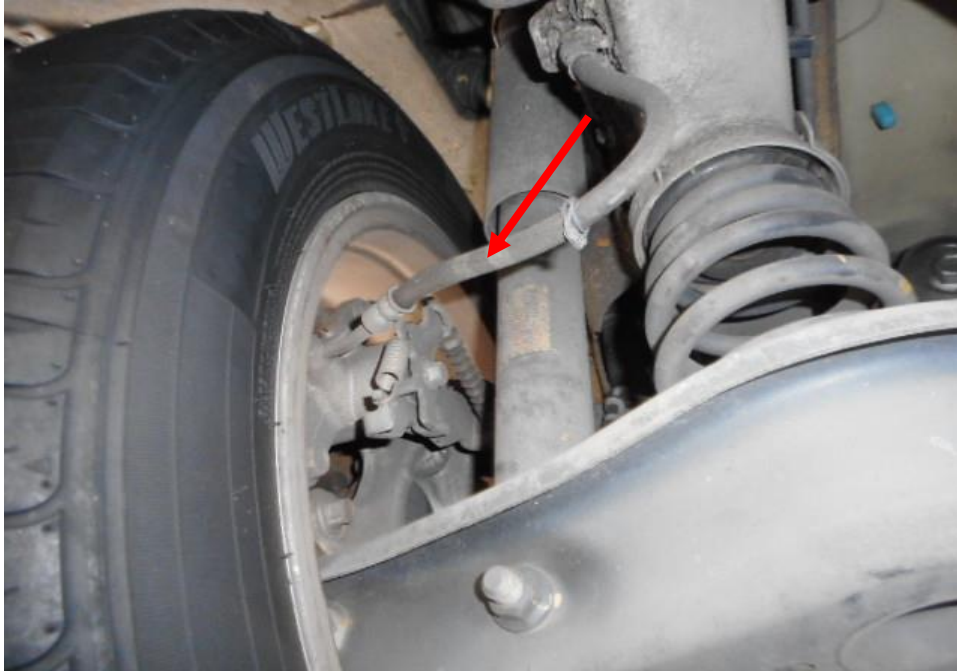
Photo 18 shows the brake hose/pipe (arrowed) at the rear left wheel of the Motor Taxi. I did not observe any leakage of brake fluid at the time of my inspection of the Motor Taxi. Static tests of the Motor Taxi's braking system had indicated that there was no internal leakage of pressure/vacuum. The undercarriage components of the Motor Taxi were also all found to be intact and without any visible damage.

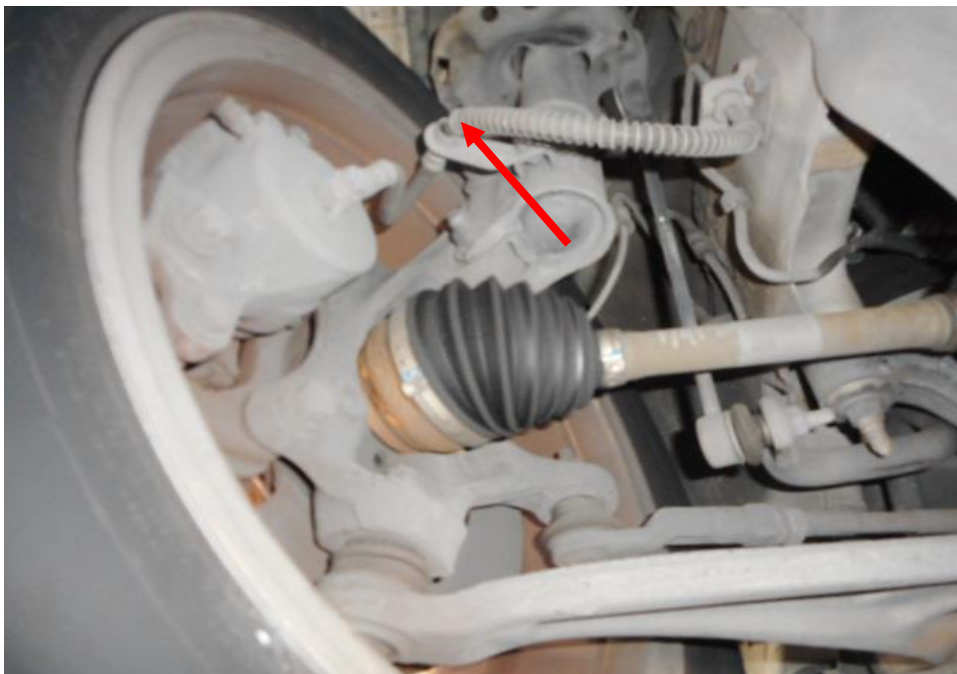
Photo 19 shows the brake hose/pipe (arrowed) at the front right wheel of the Motor Taxi. I did not observe any leakage of brake fluid at the time of my inspection of the Motor Taxi. Static tests of the Motor Taxi's braking system had indicated that there was no internal leakage of pressure/vacuum. The undercarriage components of the Motor Taxi were also all found to be intact and without any visible damage.

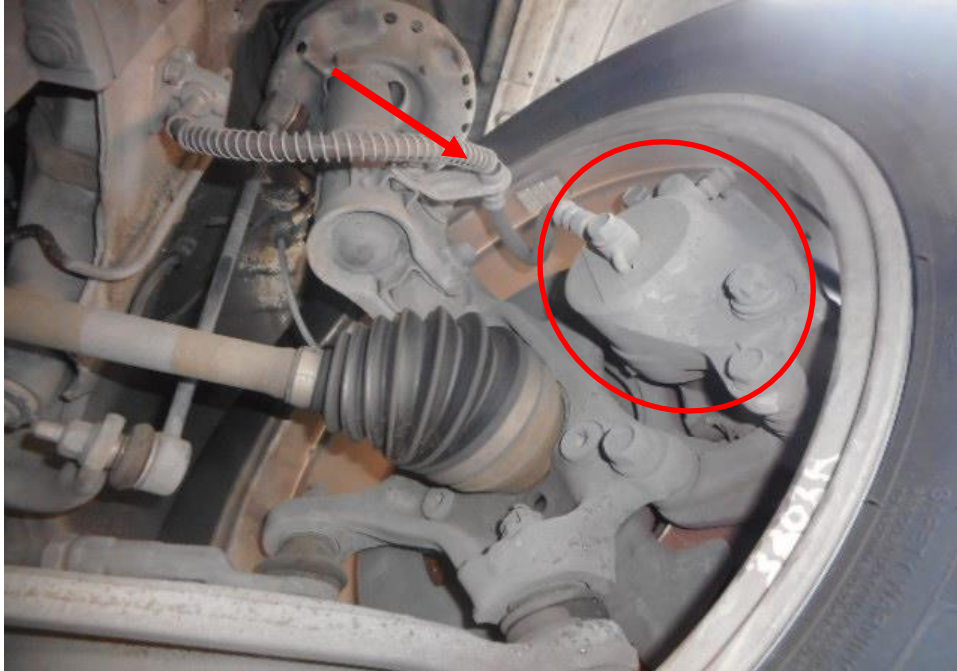
Photo 20 shows the brake hose/pipe (arrowed) at the front left wheel of the Motor Taxi. No leakage of brake fluid was observed. Visual examination of the various components of the braking system like the brake caliper (circled), brake booster, brake pedal etc had revealed all to be intact and without visible damage.

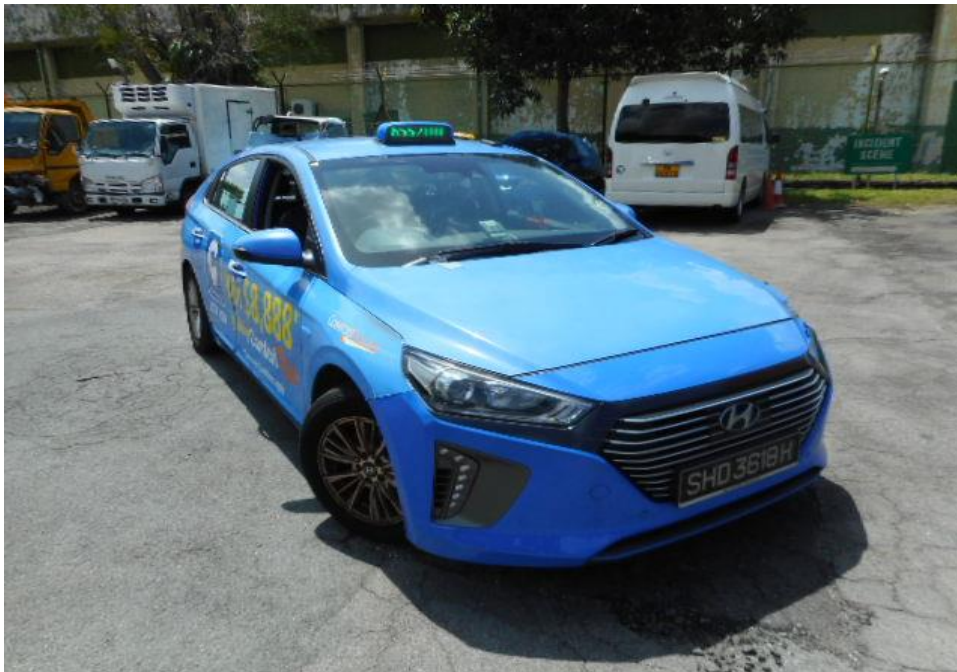
Photo 21 shows the front right wheel of the Motor Taxi turned to its full left. During my steering system test, I did not experience any abnormal free play and/or resistance when I had turned the steering wheel towards the left and right. This would suggest that the steering system of the Motor Taxi was likely to be in serviceable condition at the material time of accident.

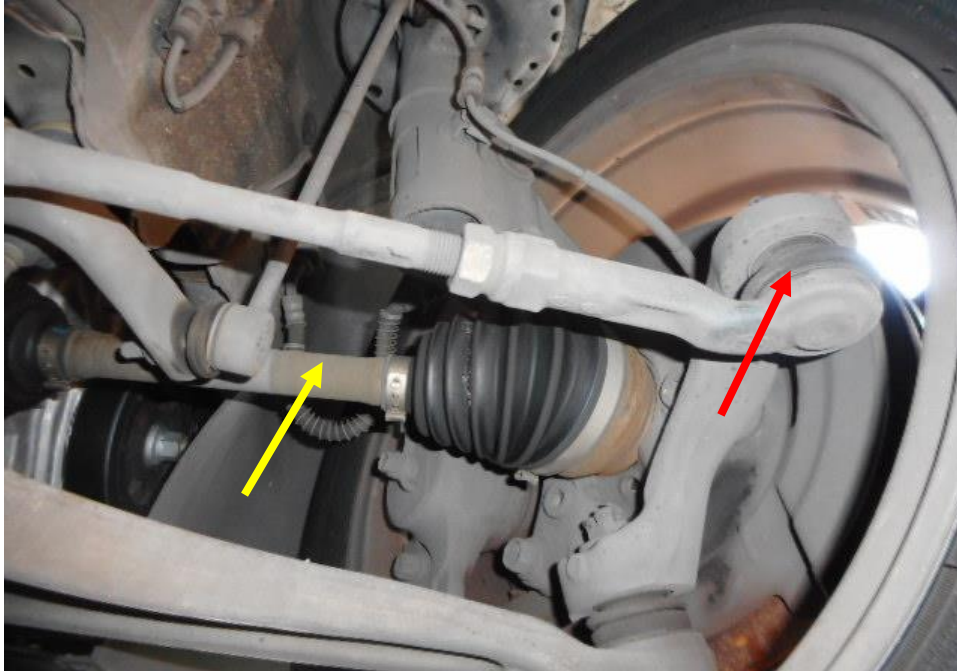
Photo 22 shows the various undercarriage components at the front right wheel of the Motor Taxi, in particular the steering tie rod (red arrow) and drive shaft (yellow arrow). The various steering components were all found to be intact, suggesting that the steering system of the Motor Taxi was likely to be in serviceable condition at the material time of accident. There was also no sign of fluid stain observed on the various undercarriage components at the front right wheel of the Motor Taxi.

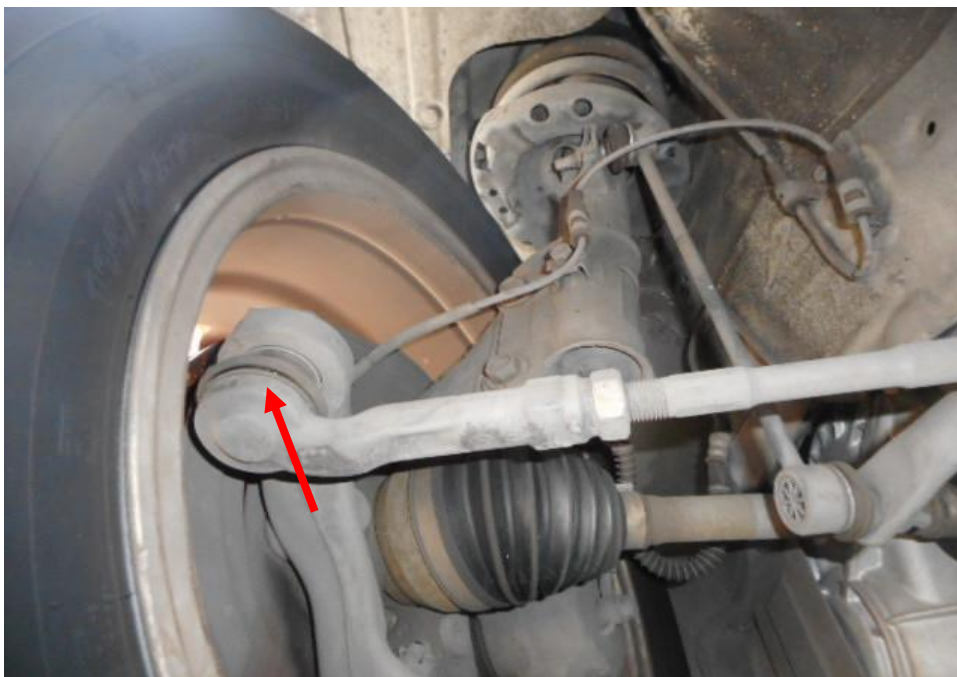
Photo 23 shows the various undercarriage components at the front left wheel of the Motor Taxi, which had included the steering tie rod (red arrow). The various undercarriage components of the Motor Taxi were all found to be intact without any visible damage.

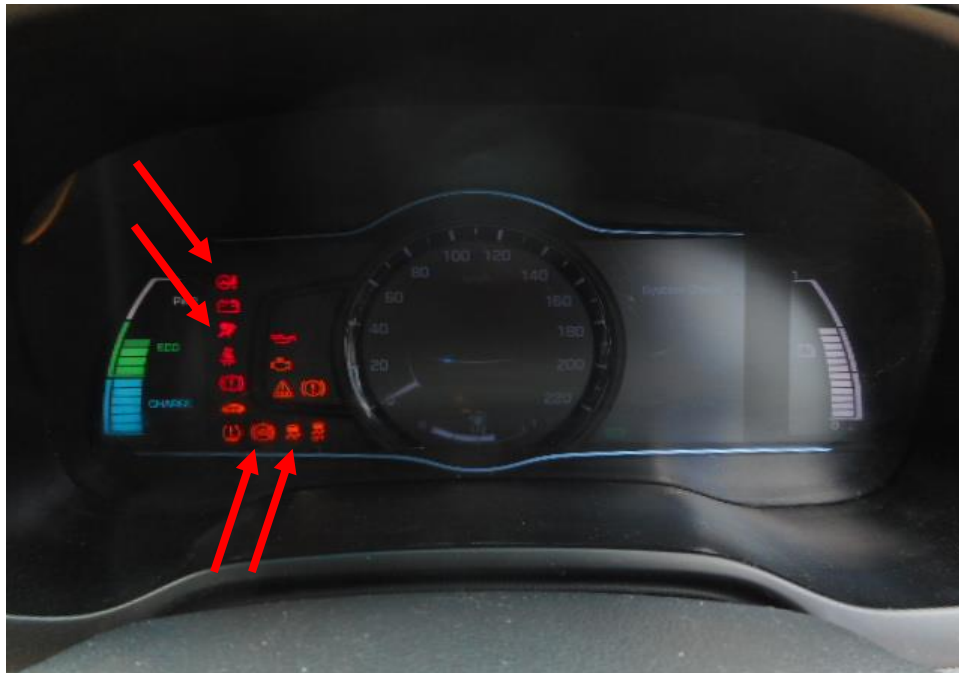
Photo 24 shows the warning light for Anti-Lock Brake System (ABS), Electric Power Steering System (EPS), Traction Control System (TCS) and Supplemental Restraint System (SRS) (arrowed) appearing on the instrument panel of the Motor Taxi during the self-test of its various electronic operating systems when its engine was cranked.

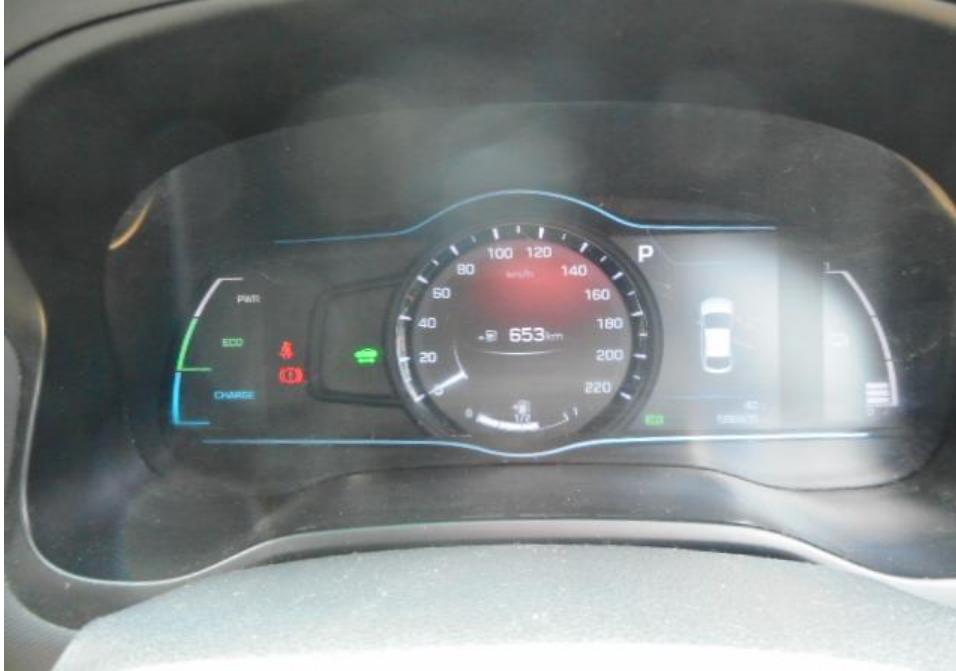
Photo 25 shows no warning lights illuminated on the instrument panel of the Motor Taxi after the engine was cranked. This would suggest that there was no abnormality to the electronic operating system of the Motor Taxi, like the ABS, EPS, TCS and SRS etc.
