Your Ref: TP/IP/14569/2021  
Our Ref : CI/TPD21007783/P

**Fatal Accident Investigation Team**

**MECHANICAL INSPECTION REPORT OF BUS PA 8825P**

1. I refer to your request on 19<sup>th</sup> July 2021 to conduct a physical inspection of a Bus bearing registration number PA 8825P (herein referred to as "**Bus**"), which was involved in a road traffic accident on 22<sup>nd</sup> March 2021
2. The objective of this inspection is to determine if there was any possible mechanical failure to the Bus that may have contributed to the accident.
3. Following the request, I had carried out a physical inspection of the Bus on 27<sup>th</sup> September 2021 at the premises of Traffic Police vehicle pound, 517 Airport Road Singapore 539942. I now set out below my observations and comments with respect to this inspection.

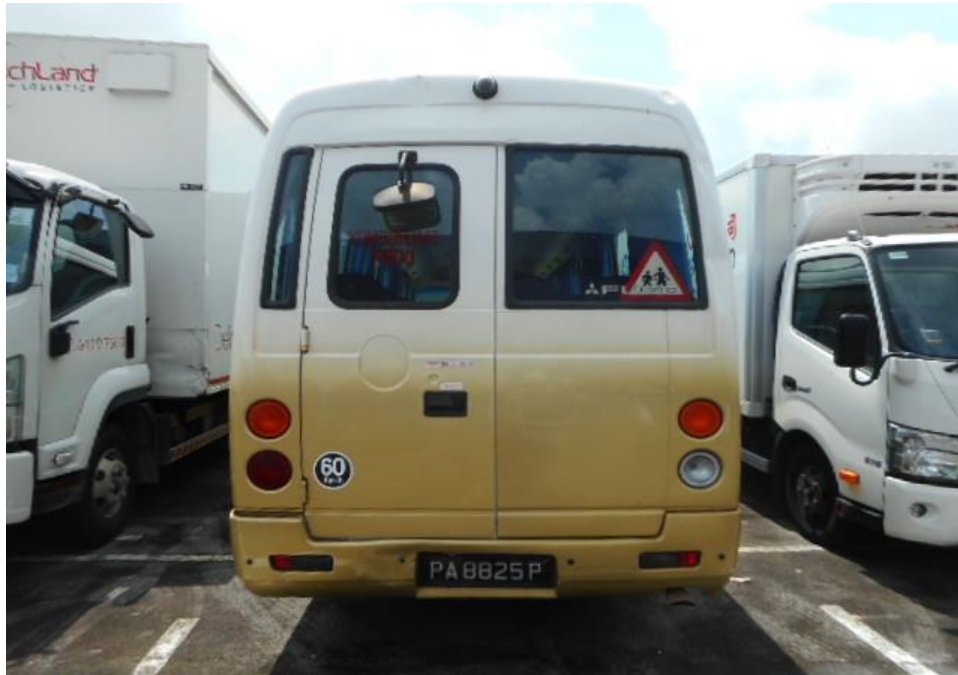
4. The mileage of the Bus at the time of my inspection was not recorded at the time of my inspection. As the engine was unable to be jumpstarted up despite multiple attempts in jumpstarting it.
5. The Bus appeared to have sustained damage at its rear portion. Its rear bumper were damage at the time of my inspection as result of the accident.

**Photo 1** shows a general view of the Bus's rear portion at the time of my inspection. The Bus rear portion was observed to have sustained damage at its rear bumper at the time of my inspection as result of the accident.

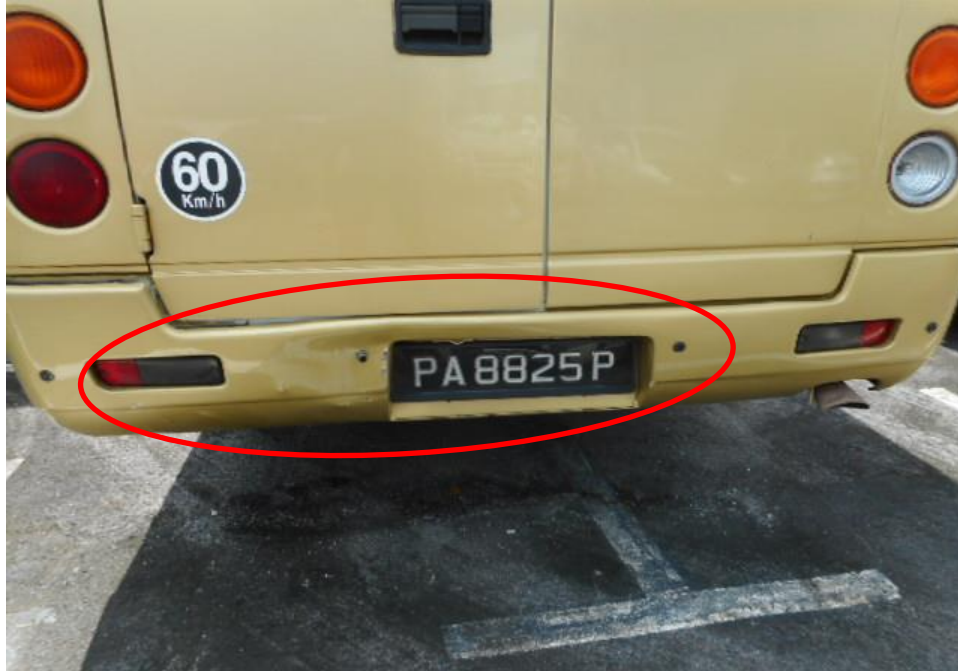
**Photo 2** shows a close up view of the Bus's rear portion at the time of my inspection. The Bus rear portion was observed to have sustained damage at its rear bumper (circled) at the time of my inspection as result of the accident.

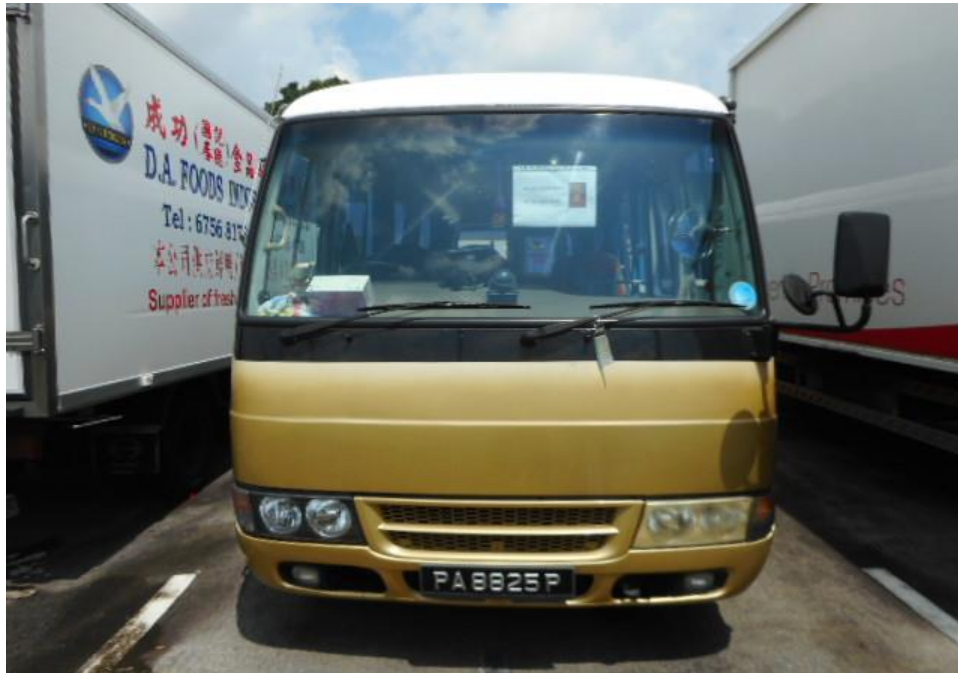
**Photo 3** shows general view of the Bus's front portion at the time of my inspection. The Bus rear portion was observed to be intact and unaffected by the accident.

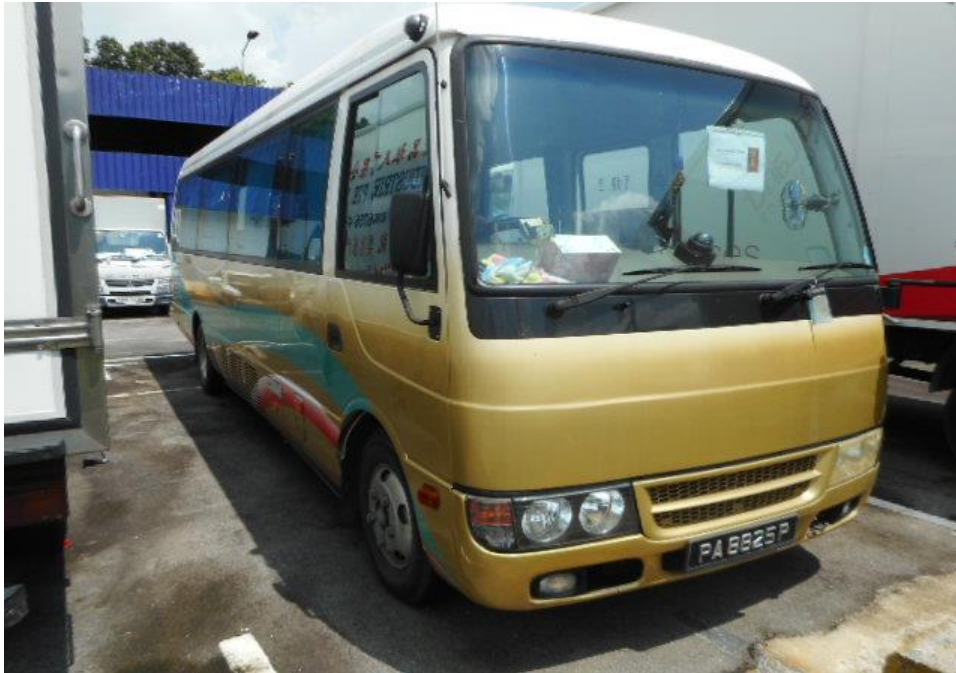
**Photo 4** shows general view of the Bus's right portion at the time of my inspection. The Bus was observed to be intact and unaffected by the accident.

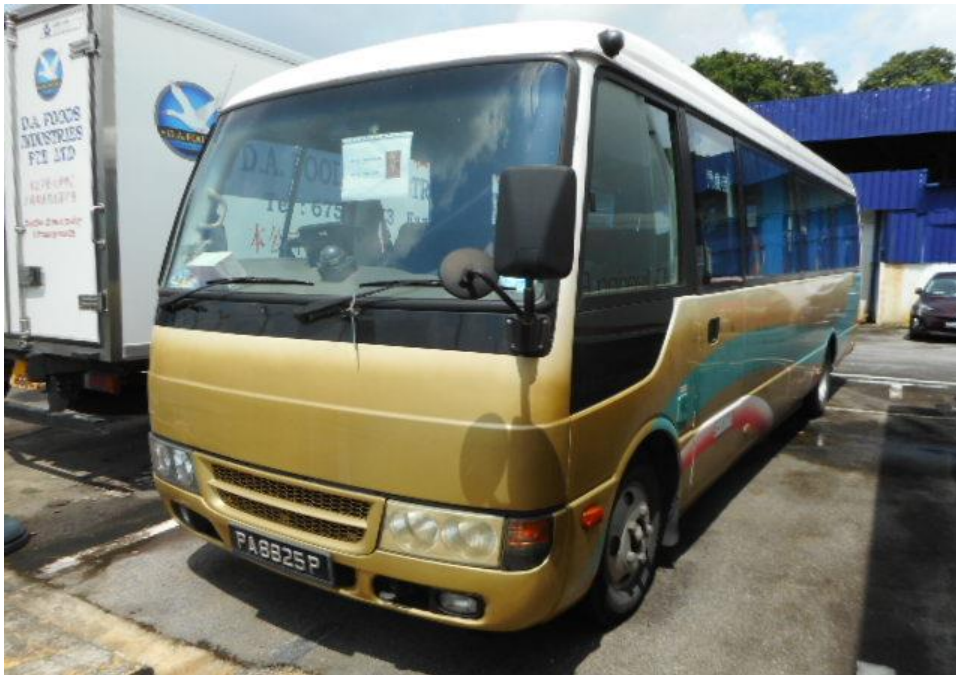
**Photo 5** shows a general view of the left body of the Bus at the time of my inspection. The Bus was observed to be intact and unaffected by the accident.

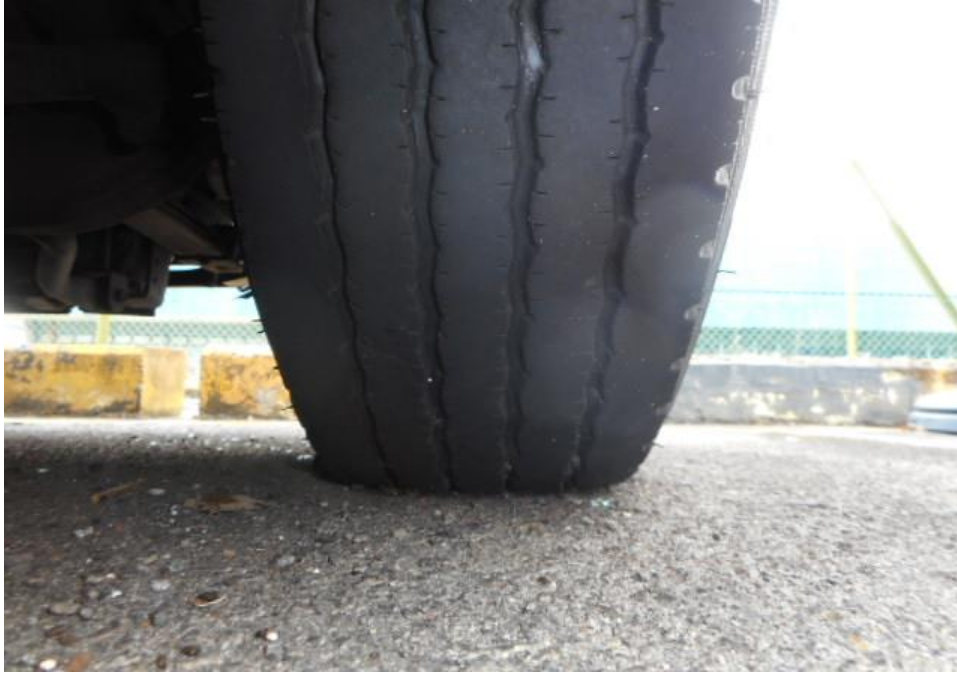
**Photo 6** shows the condition of the front right tyre of the Bus, which was observed to be in serviceable condition with remaining tread depth of approximately 6mm. The tyre, which was wrapped around standard steel wheel rim, was also observed to be sufficiently inflated for vehicular operation. There was no tear, cut or burst mark(s) on the outer and the inner sidewalls as well as across the tread of the 6 tyres that were fitted on the Bus.

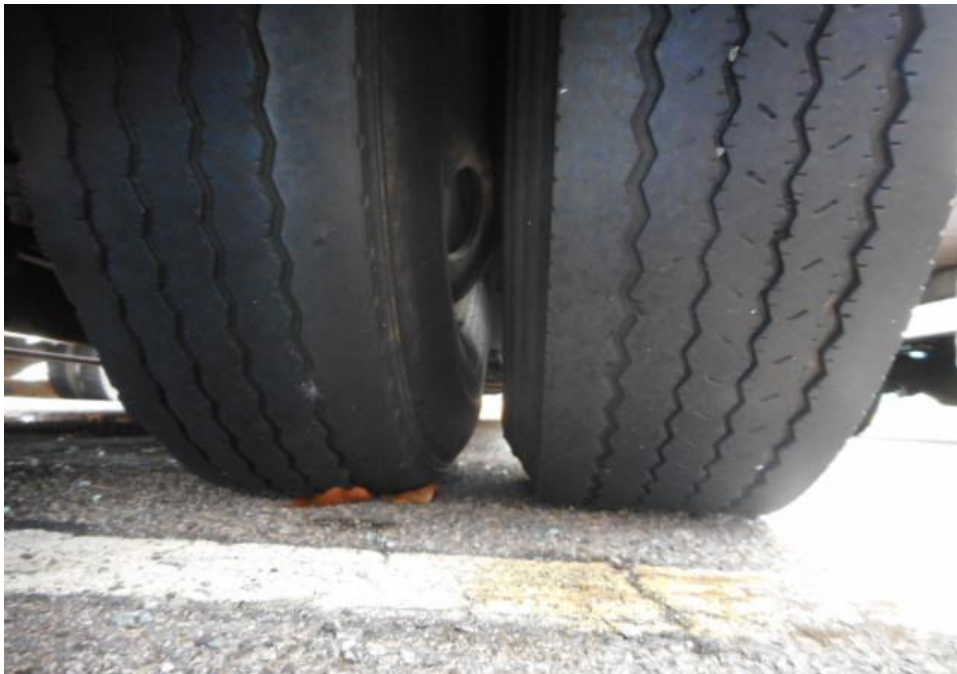
**Photo 7** shows the condition of the rear right tyre of the Bus, which was observed to be in serviceable condition with remaining tread depth of approximately 2.5mm. The tyre, which was wrapped around standard steel wheel rim, it was observed to be sufficiently inflated for vehicular operation.

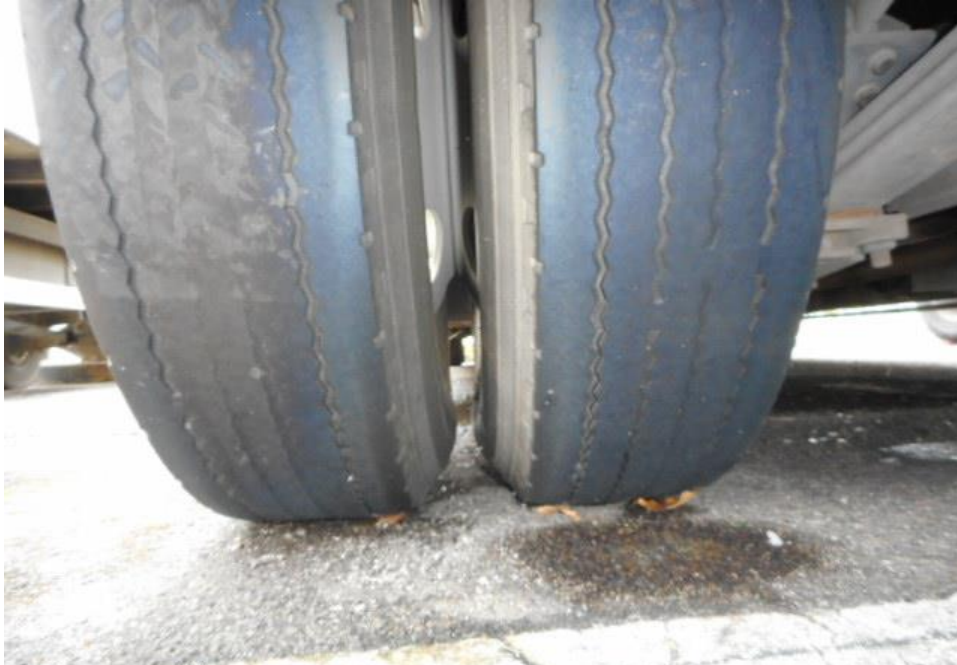
**Photo 8** shows the condition of the rear left tyres of the Bus, which was observed to be in serviceable condition with remaining tread depth of approximately 1.9mm. The tyres, which were wrapped around standard steel wheel rim, were also observed to be sufficiently inflated for vehicular operation. There was also no damage found on all 6 steel wheel rims of the Bus.

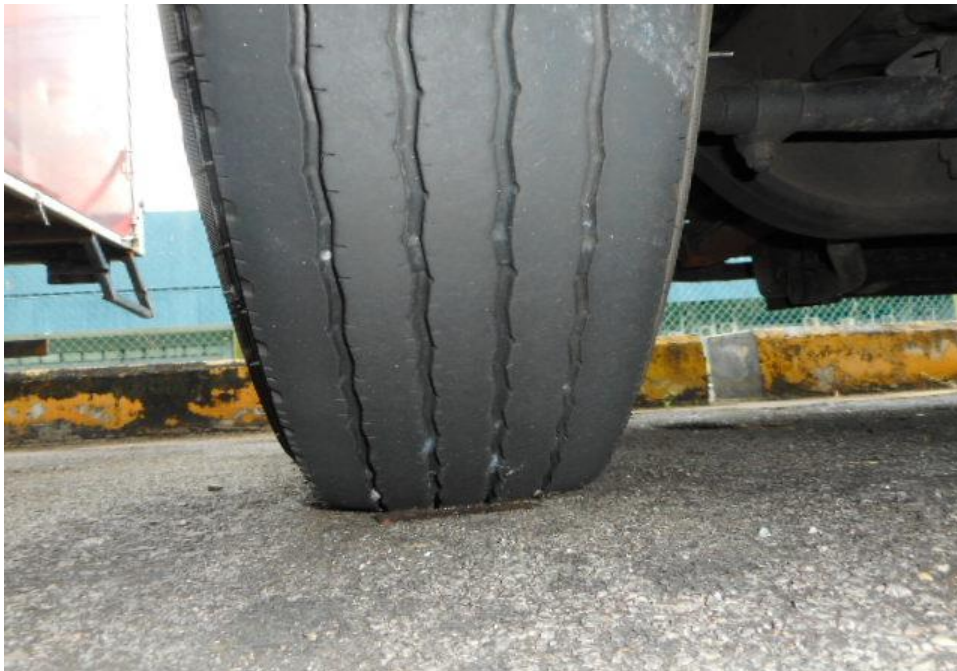
**Photo 9** shows the condition of the rear right tyres of the Bus, which were observed to be in serviceable condition with remaining, tread depth of approximately 4.6mm. There was also no tear, cut or burst mark(s) on the outer and the inner sidewalls as well as across the tread of the 6 tyres that were fitted on the Bus.

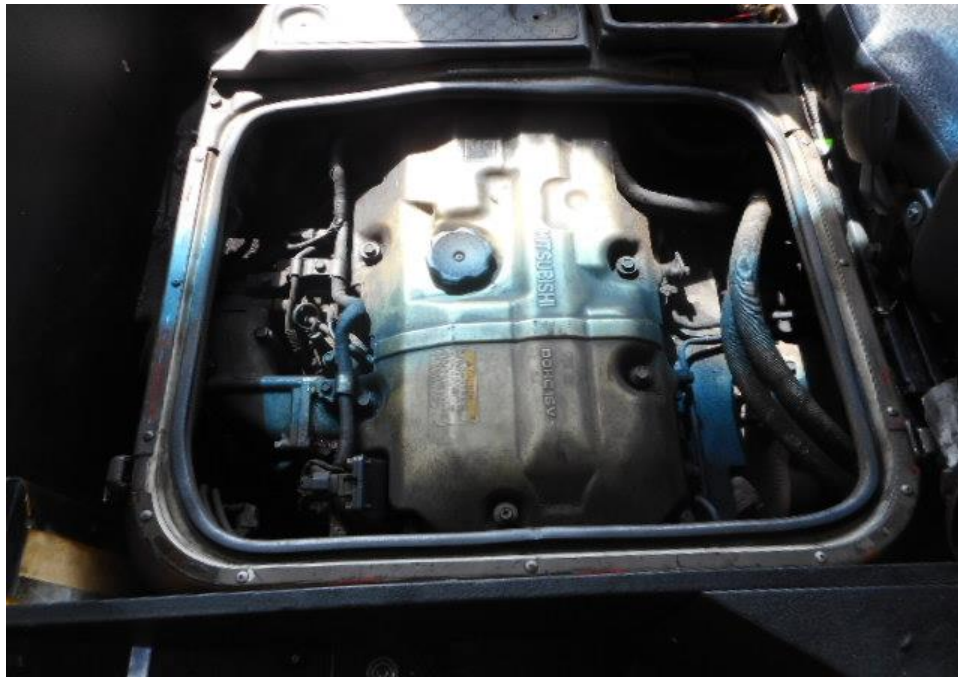
**Photo 10** shows a general view of the Bus's engine compartment, which was accessed by lifting the front cabin of the Bus. The various parts and components inside the engine compartment were unaffected by the accident. There was also no sign(s) or indication(s) of fresh fluid leakage and/or fluid stain within the engine compartment

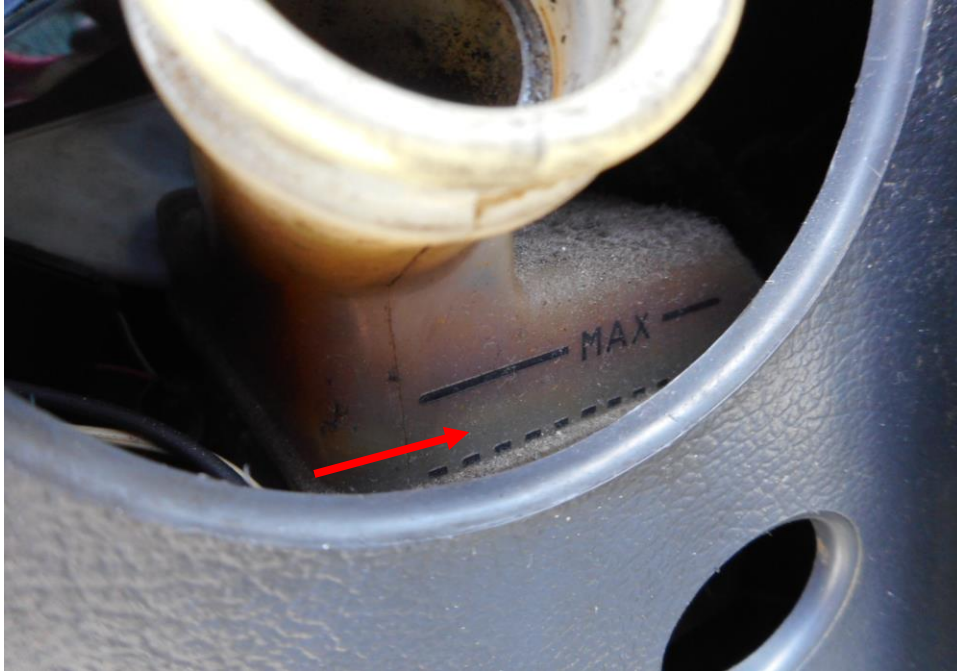
**Photo 11** shows the brake fluid reservoir of the Bus at the time of my inspection. The brake fluid was observed to be of sufficient level (arrowed) and without any visible contamination.

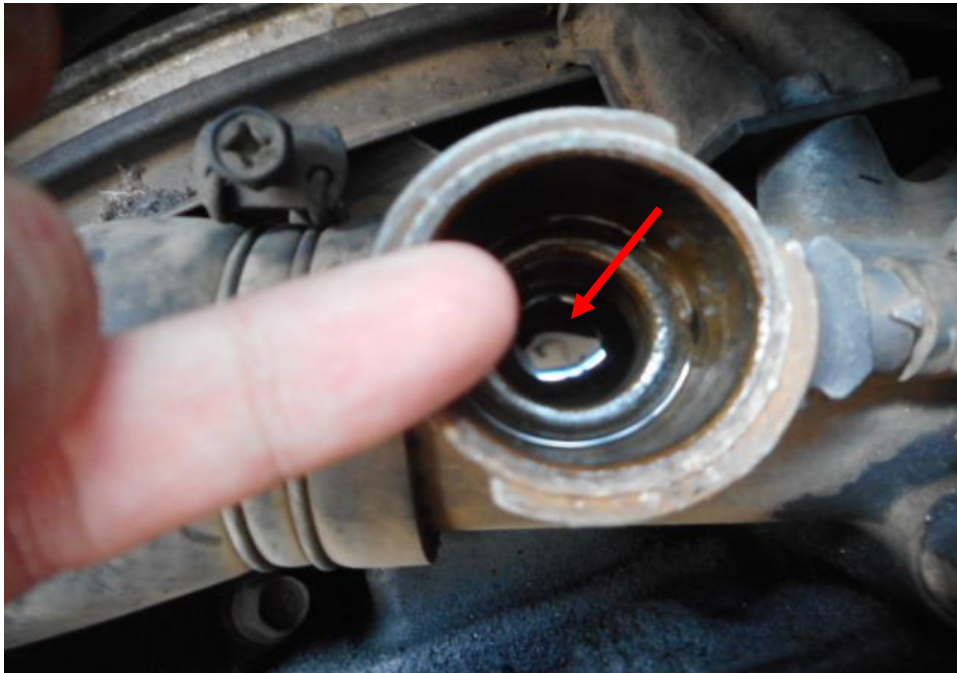
**Photo 12** shows the engine coolant reservoir of the Bus at the time of my inspection. The engine coolant was observed to be of sufficient level (arrowed) and without any visible contamination.

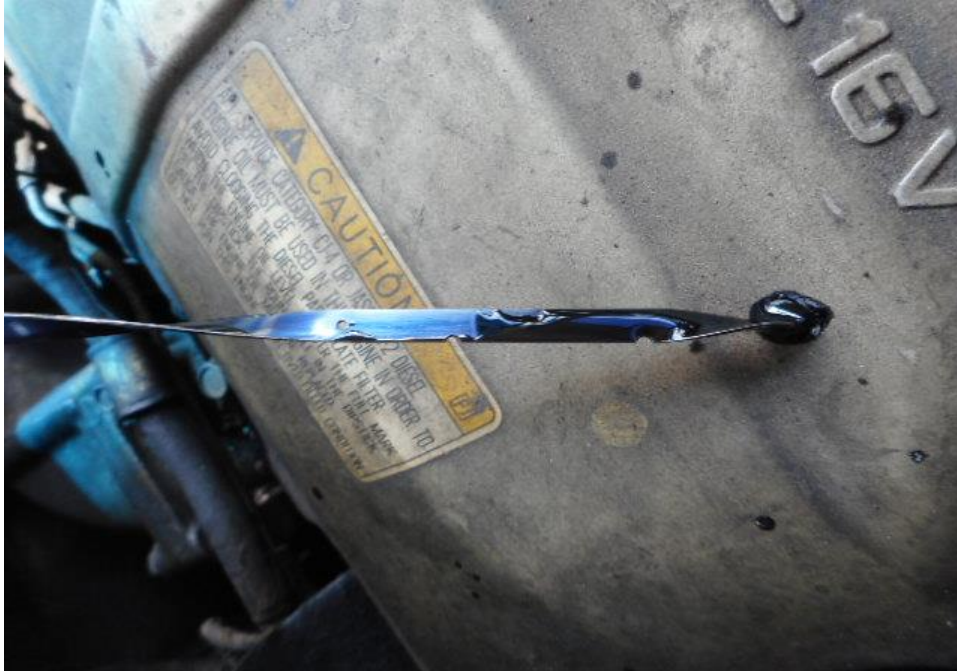
**Photo 13** shows the engine oil dip stick of the Bus at the time of my inspection. The engine oil was observed to be of sufficient level and without any visible contamination.

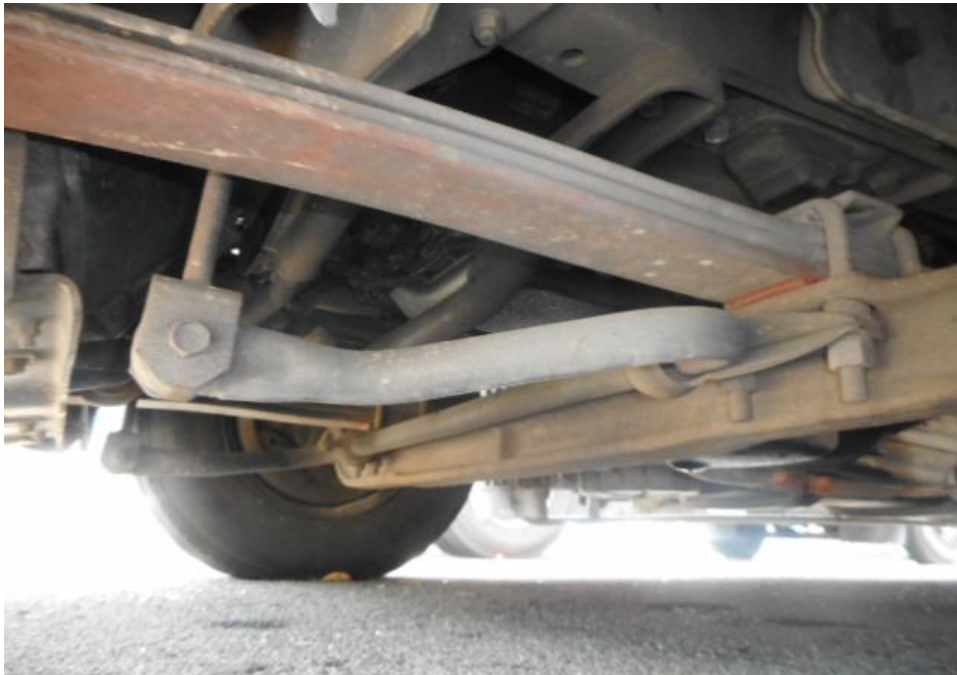
**Photo 14** shows the undercarriage of the Bus, at the area where the engine housing and transmission housing are located. I did not find any sign(s) or indication(s) of fluid leak and/or fluid stain(s) on the underside of the Bus.

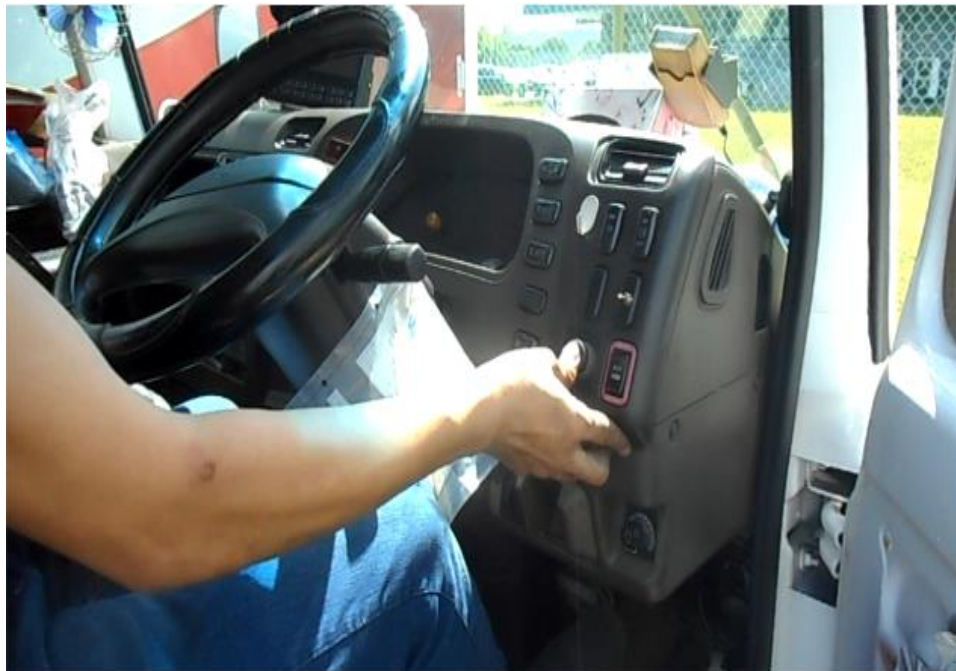
**Photo 15** shows the jumpstarting process of the Bus's engine. The engine of the Bus was unable to be jumpstarted up despite multiple attempts in starting it.

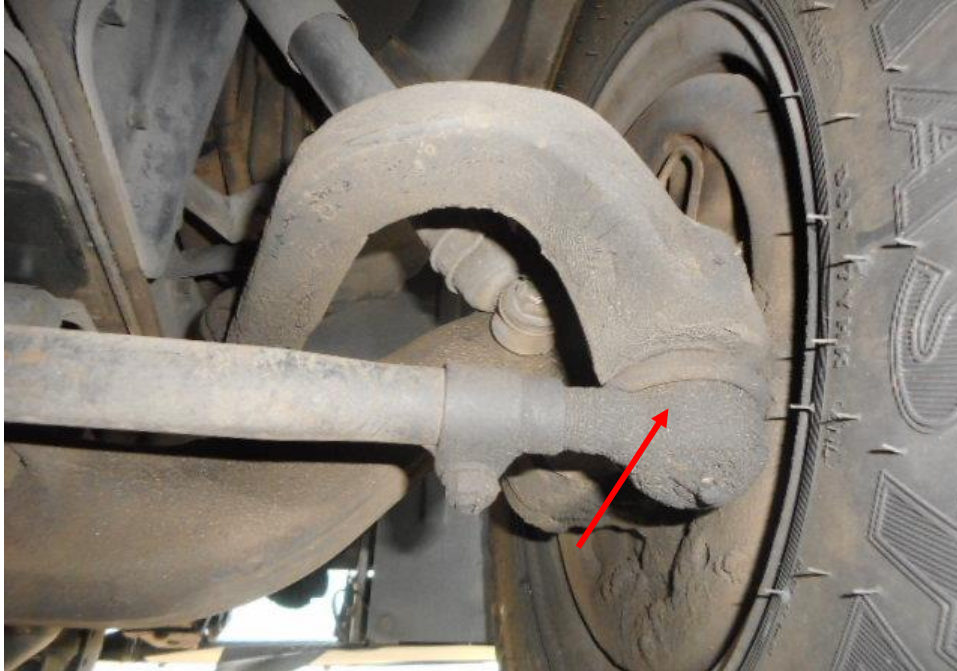
**Photo 16** shows the various undercarriage components at the front right wheel of the Bus, in particular the steering tie rod end (arrowed). The various steering components were all found to be intact, suggesting that the steering system of the Bus was likely to be in serviceable condition at the material time of accident. There was also no sign of fluid stain(s) observed on the various undercarriage components.

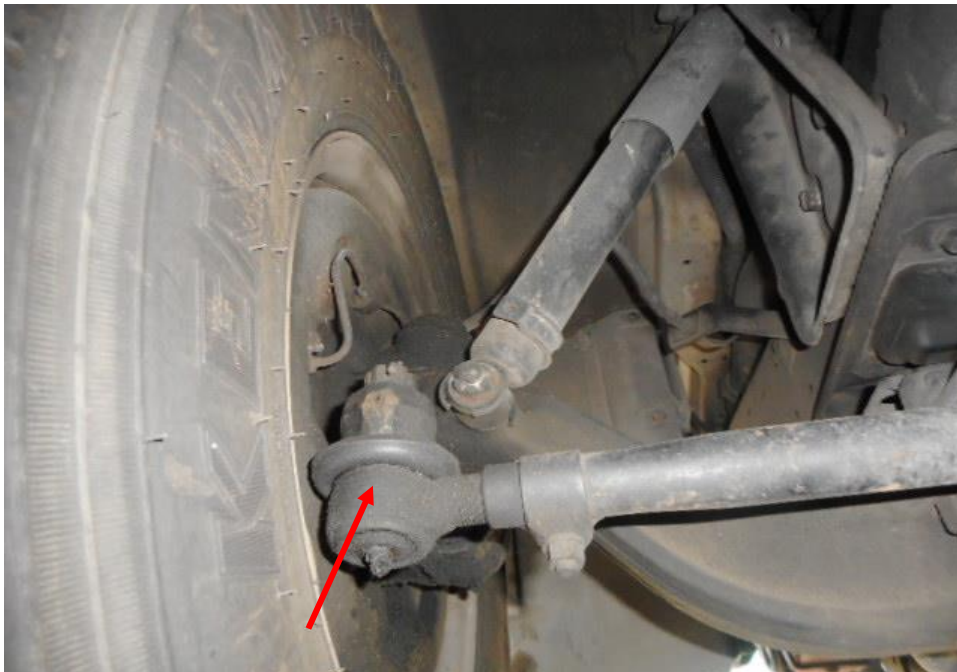
**Photo 17** shows the various undercarriage components at the front left wheel of the Bus, in particular the steering tie rod end (arrowed). The various undercarriage components of the Bus were all found to be intact without any visible damage. There was also no sign of fluid stain(s) observed on the various undercarriage components.

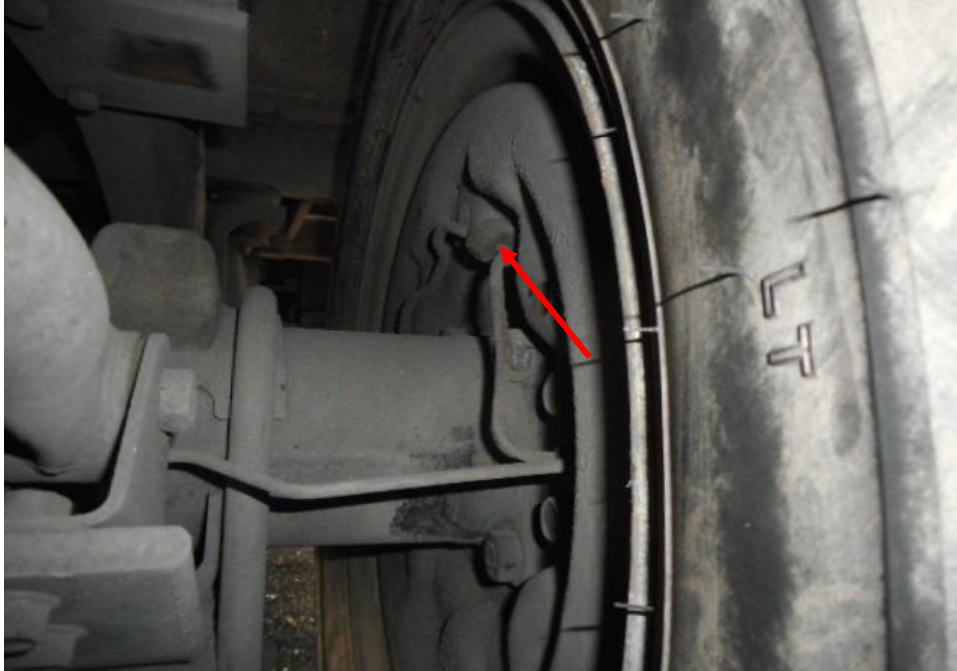
**Photo 18** shows the brake pipe (arrowed) at the rear right wheel of the Bus. I did not observe any leakage of brake fluid at the time of my inspection of the Bus. My static tests of the Bus's braking system, along with my visual examination of the various mechanical components in the braking system, had indicated that there was no internal leakage of pressure/vacuum. Hence the braking system of the Bus was likely to be in serviceable condition at the material time of accident.

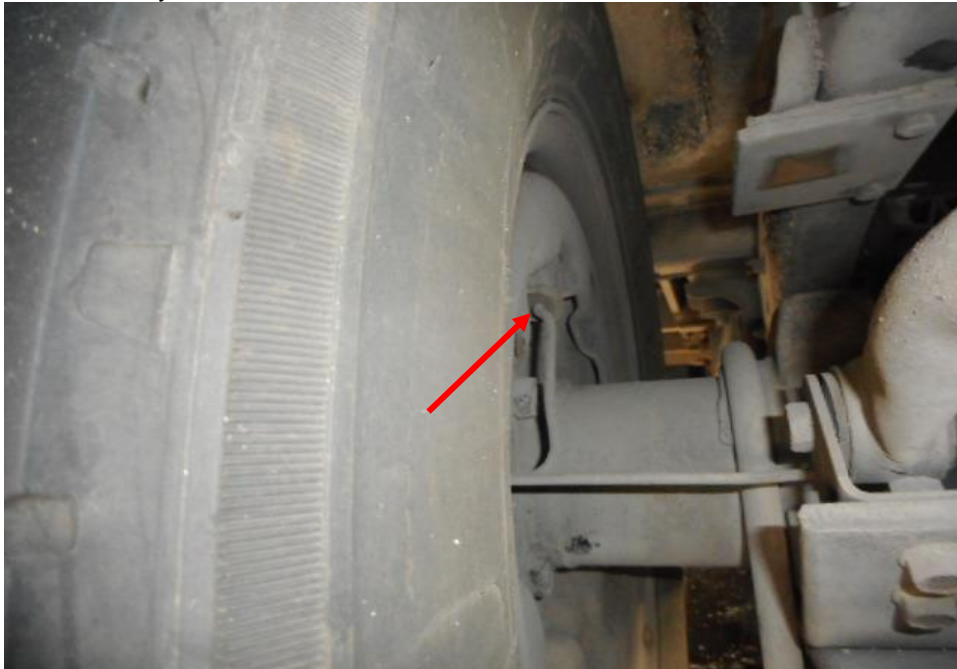
**Photo 19** shows the brake pipe (arrowed) at the rear left wheel of the Bus. I did not observe any leakage of brake fluid at the time of my inspection of the Bus. My static tests of the Bus's braking system, along with my visual examination of the various mechanical components in the braking system had indicated that there was no internal leakage of pressure/vacuum. Hence the braking system of the Bus was likely to be in serviceable condition at the material time of accident.

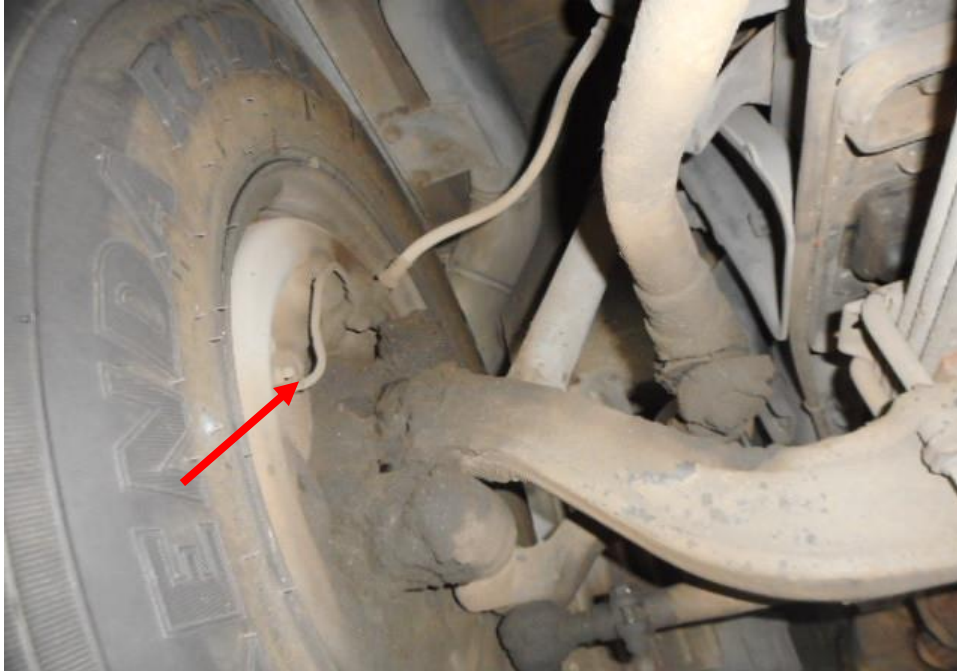
**Photo 20** shows the brake hose/pipe (arrowed) at the front right wheel of the Bus. No leakage of brake fluid was observed. Visual examination of the various components of the braking system like the brake drum, brake booster, brake pedal etc had revealed all to be intact and without visible damage at the time of accident. There was also no sign of fluid stain(s) observed on the various undercarriage components.

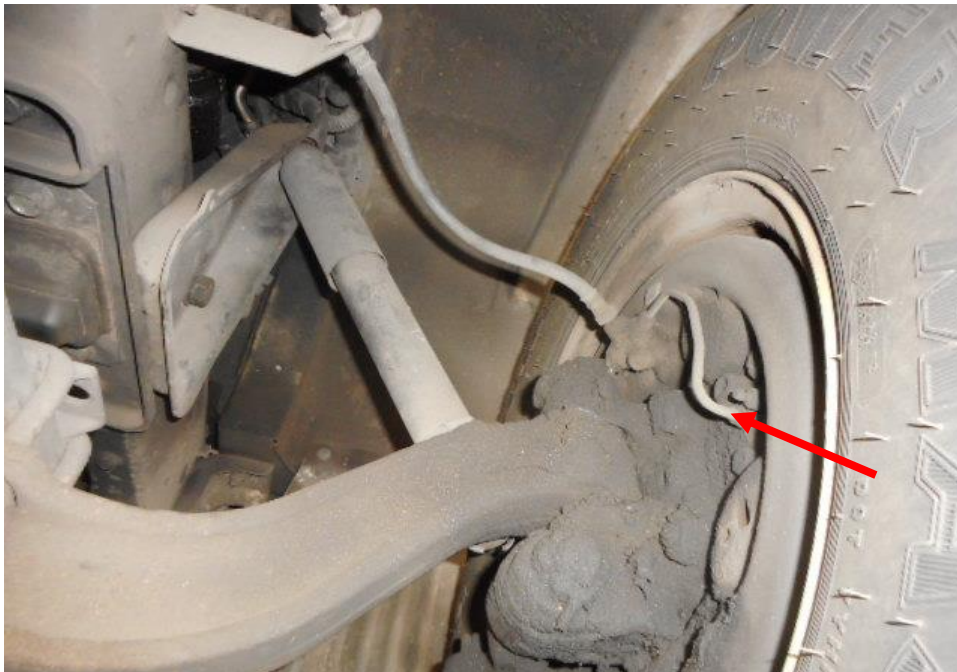
**Photo 21** shows the brake hose/pipe (arrowed) at the front left wheel of the Bus. No leakage of brake fluid was observed. Visual examination of the various components of the braking system like the brake drum, brake booster, brake pedal etc had revealed all to be intact and without visible damage at the time of accident. There was also no sign of fluid stain(s) observed on the various undercarriage components.
