**Fatal Accident Investigation Team**

**MECHANICAL INSPECTION REPORT OF MOTOR CAR SMG 4474Z**

1. I refer to your request on 19<sup>th</sup> July 2021 to conduct a physical inspection of a Motor Car bearing registration number SMG 4474Z (herein referred to as "**Motor Car**"), which was involved in a road traffic accident on 22<sup>nd</sup> March 2021.
2. The objective of the inspection is to determine if there was any possible mechanical failure to the Motor Car that may have contributed to the accident.
3. Following the request, I had carried out a physical inspection of the Motor Car on 20<sup>th</sup> September 2021 at the premises of Traffic Police vehicle pound, 517 Airport Road Singapore 539942. I now set out below my observations and comments with respect to this inspection.

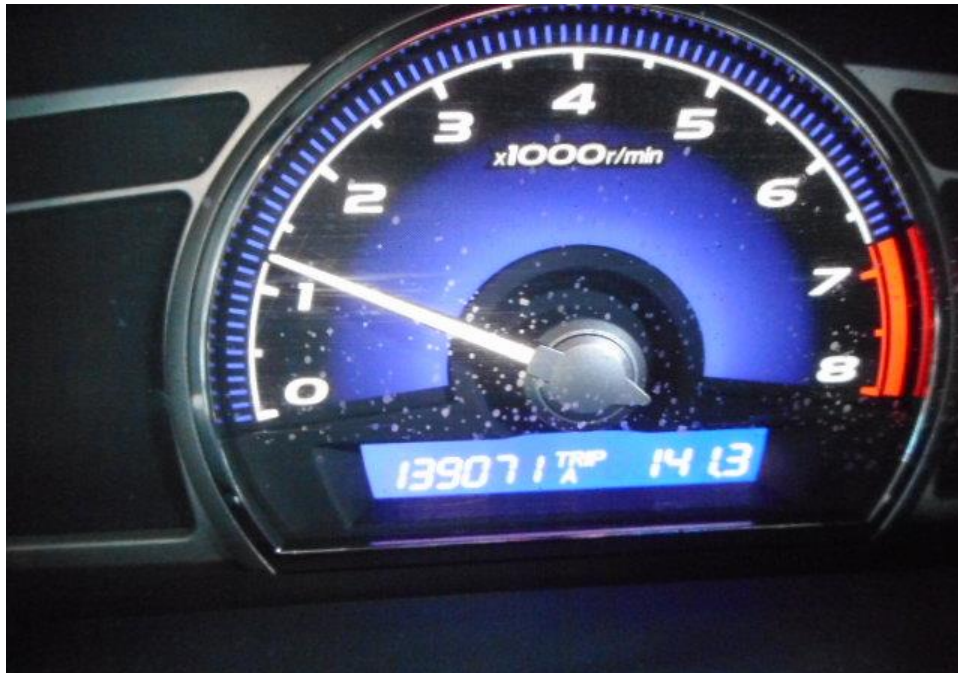
4. The mileage of the Motor Car at the time of my inspection was 139,071km.
5. The Motor Car was observed to have sustained damage at its front and rear portion. Its front bumper, front number plate, rear bonnet, rear number plate, rear bumper and rear exhaust pipe was the body parts that were damaged as a result of the accident.

**Photo 1** shows the mileage of the Motor Car at the time of my inspection. The mileage observed was 139,071km.

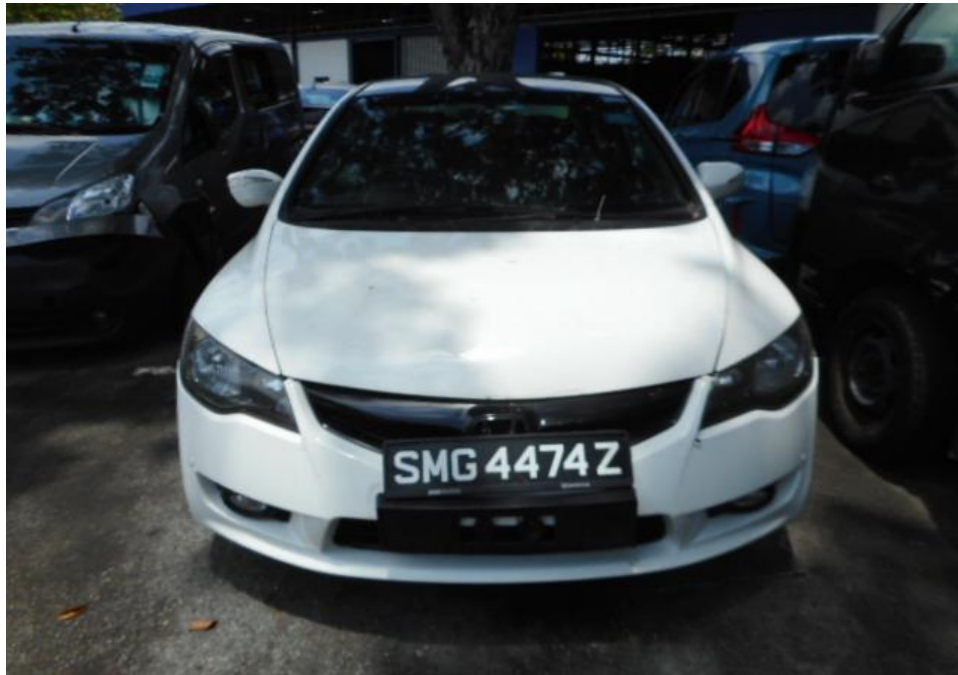
**Photo 2** shows a general view of the Motor Car's front body at the time of my inspection. The front and rear portion. Its front bumper, front number plate, rear bonnet, rear number plate, rear bumper and rear exhaust pipe was the body parts that were damaged as a result of the accident.

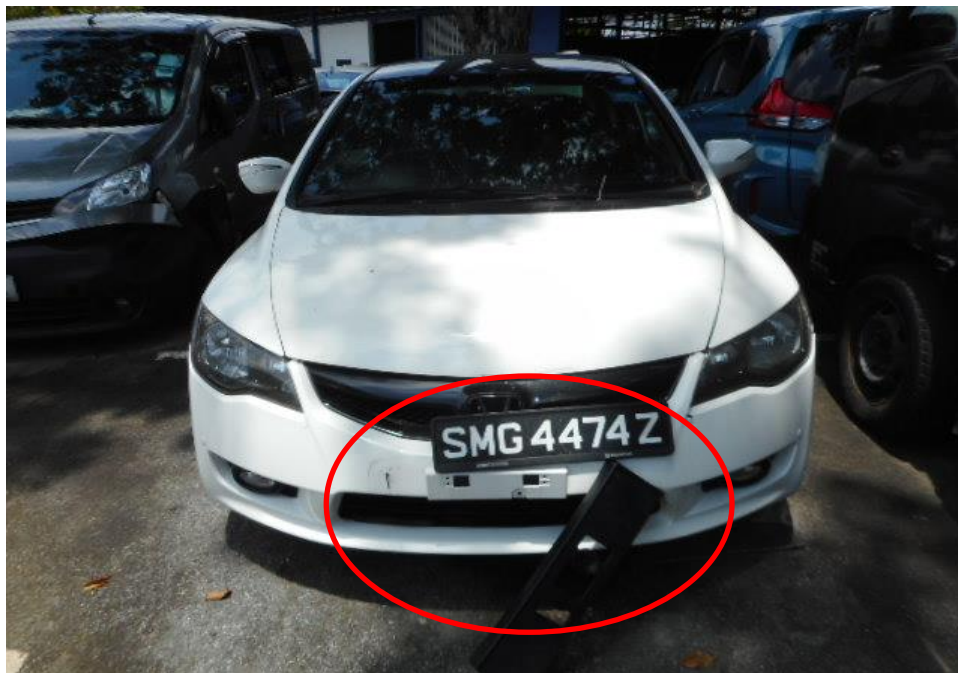
**Photo 3** shows a close up view of the Motor Car's front body at the time of my inspection. The front portion of the Motor Car was observed to have sustained damage. Its front bumper and front number plate (circled) was the body parts that were damaged as a result of the accident.

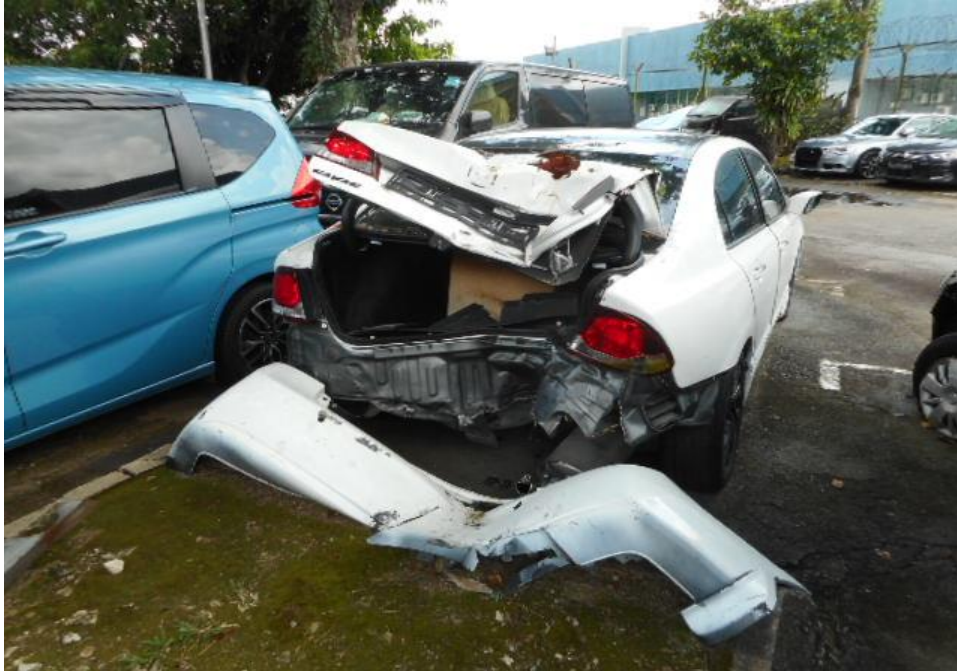
**Photo 4** shows a general view of the Motor Car's front body at the time of my inspection. The front and rear portion. Its front bumper, front number plate, rear bonnet, rear bumper and rear exhaust pipe was the body parts that were damaged as a result of the accident.

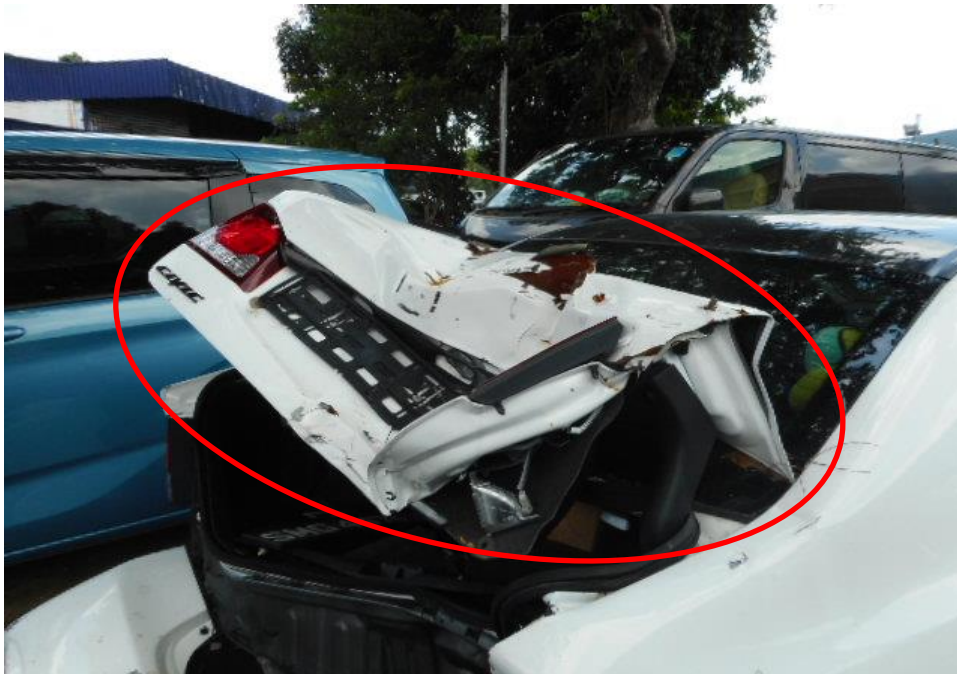
**Photo 5** shows a close up view of the Motor Car's rear body at the time of my inspection. The rear portion of the Motor Car was observed to have sustained damage. Its rear bonnet and rear number plate (circled) was the body parts that were damaged as a result of the accident.

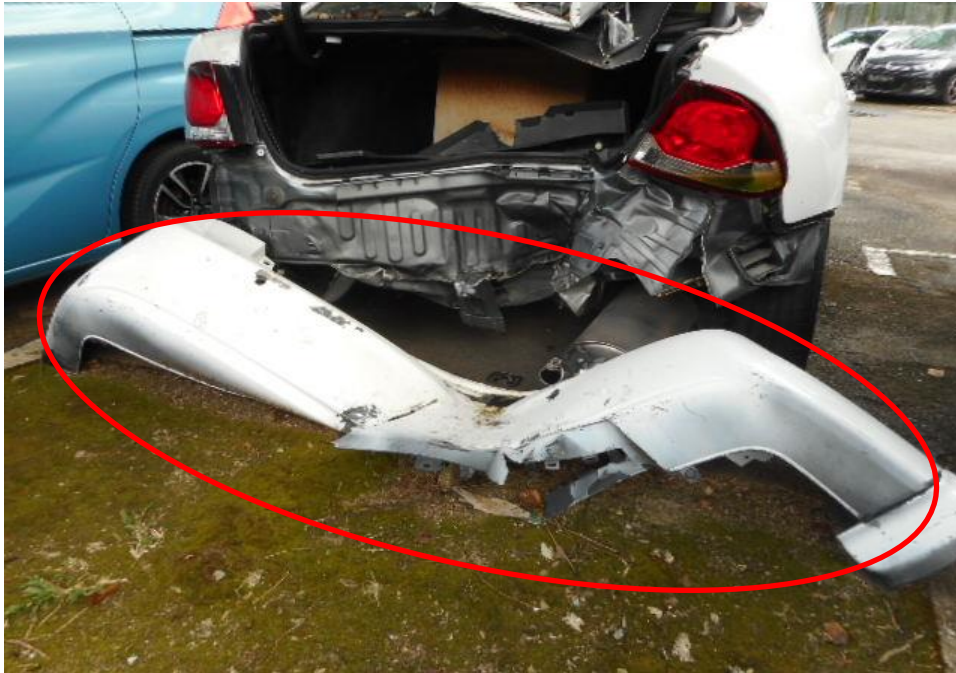
**Photo 6** shows a close up view of the Motor Car's rear body at the time of my inspection. The rear portion of the Motor Car was observed to have sustained damage. Its rear bonnet and rear number plate (circled) was the body parts that were damaged as a result of the accident

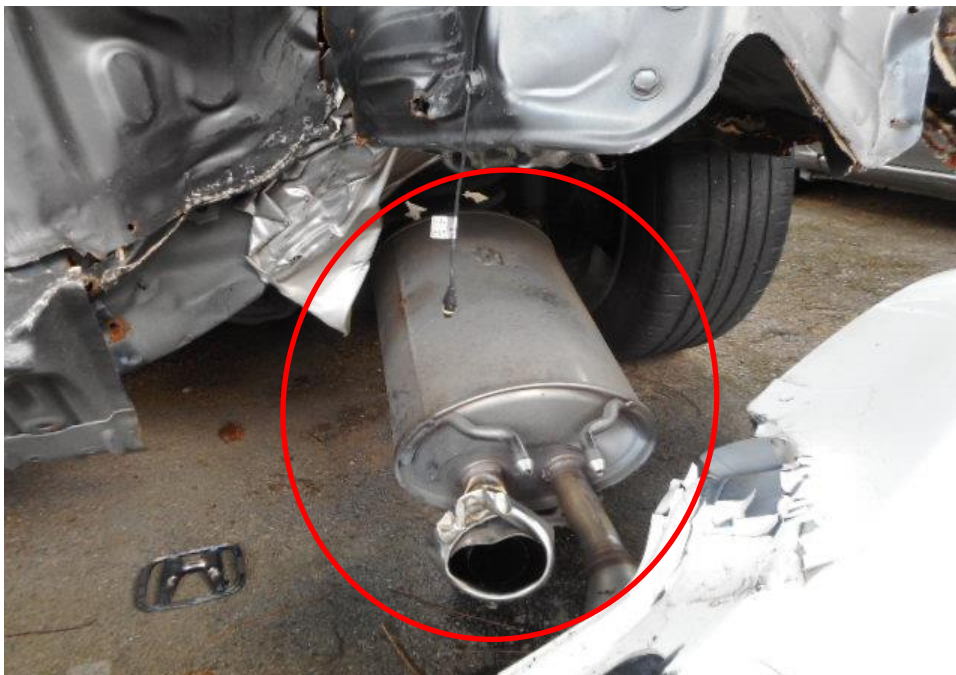
**Photo 7** shows a close up view of the Motor Car's rear body at the time of my inspection. The rear portion of the Motor Car was observed to have sustained damage. Its rear exhaust pipe (circled) was the body parts that were damaged as a result of the accident

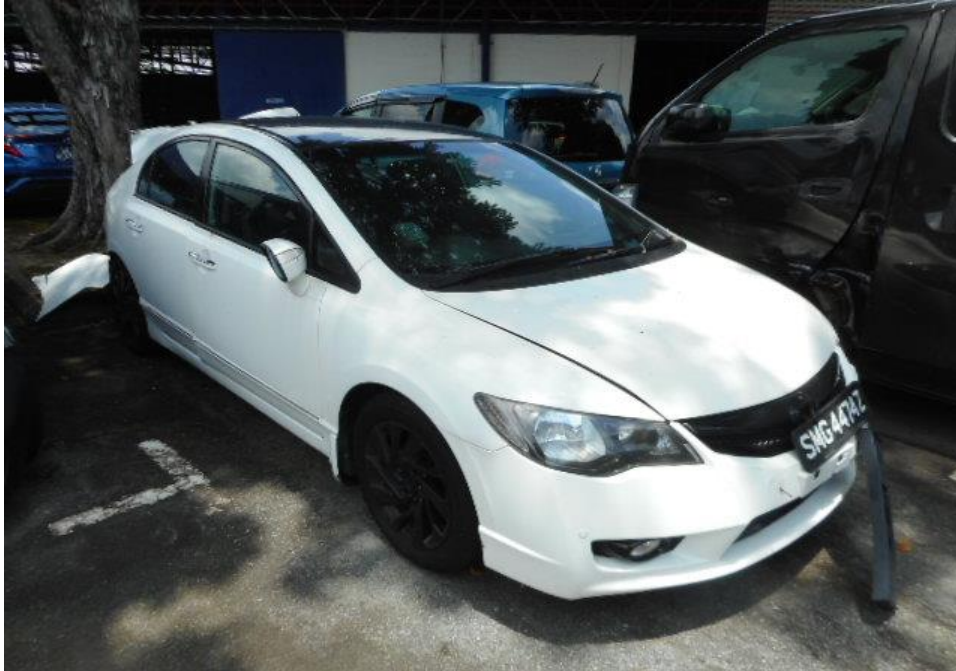
**Photo 8** shows a general view of the Motor Car's right body at the time of my inspection. The right portion of the Motor Car was observed to have been unaffected by the accident.

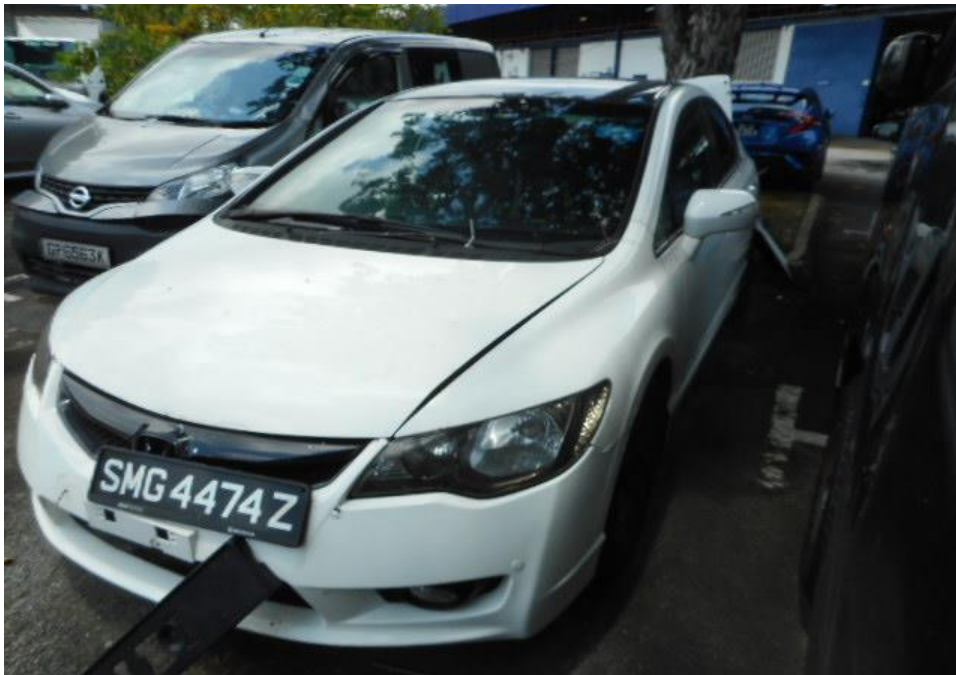
**Photo 9** shows a general view of the Motor Car's left body at the time of my inspection. The left portion of the Motor Car was observed to have been unaffected by the accident.

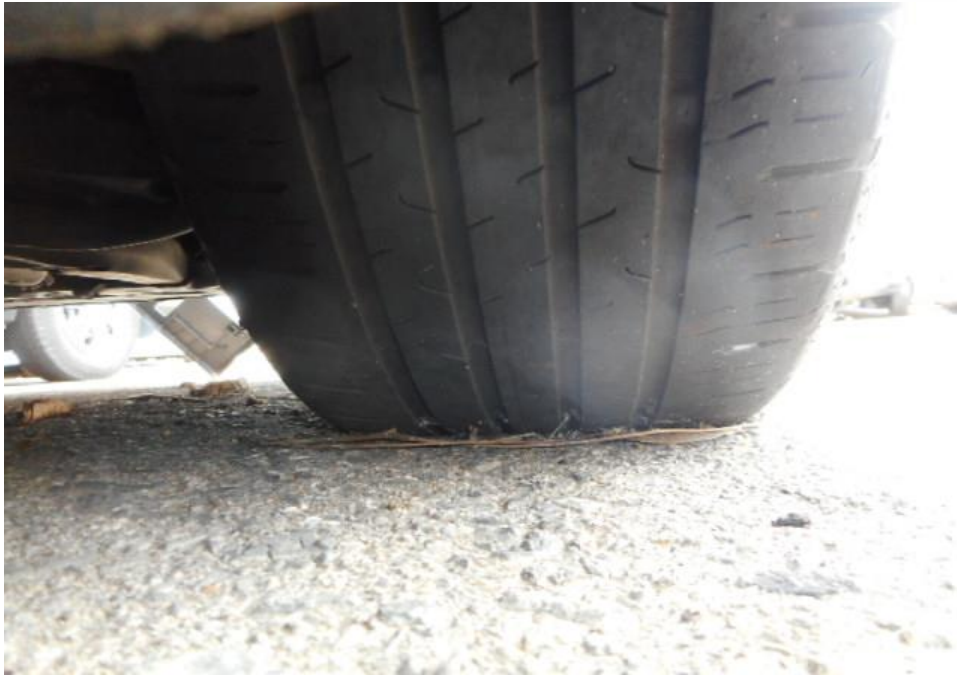
**Photo 10** shows the condition of the front right tyre of the Motor Car, which was observed to be in serviceable condition with remaining tread depth of approximately 3.4mm. The tyre was sufficiently inflated for vehicular operation with no tear, cut or burst mark(s) on the outer and the inner sidewalls as well as across the tread. The 4 tyres of the Motor Car were wrapped around standard steel wheel rims without any damage.

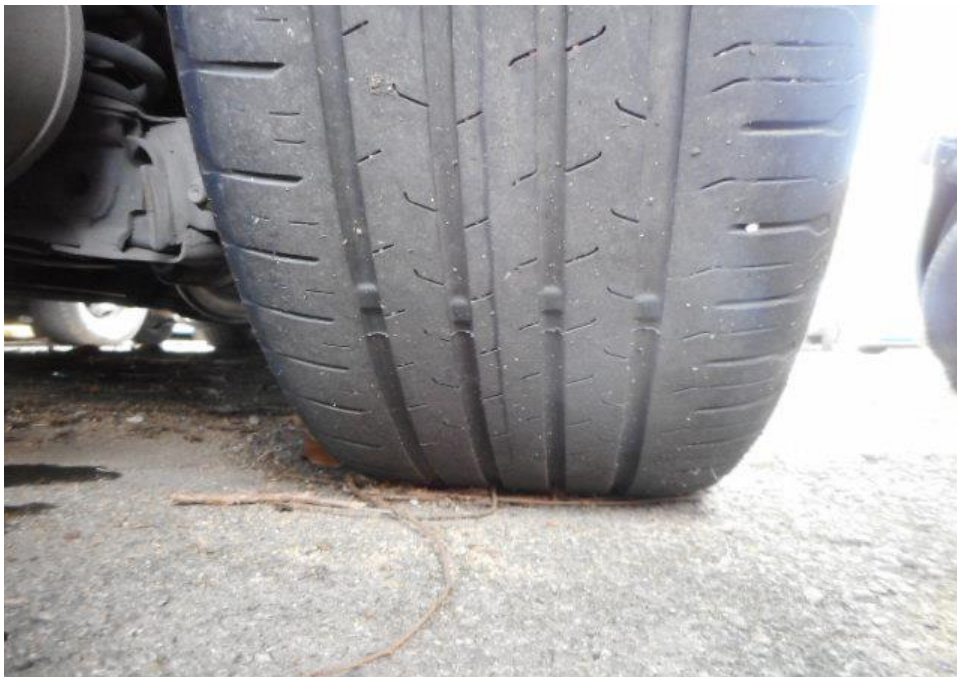
**Photo 11** shows the condition of the rear right tyre of the Motor Car, which was observed to be in serviceable condition with remaining tread depth of approximately 3.5mm. The tyre was also observed to be sufficiently inflated for vehicular operation with no tear, cut or burst mark(s).

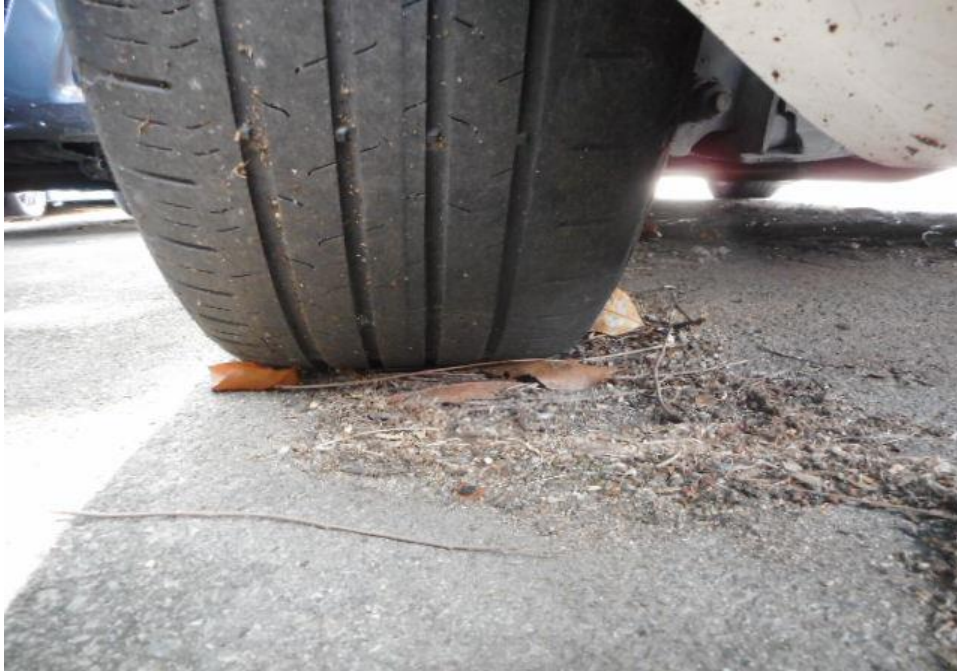
**Photo 12** shows the condition of the rear left tyre of the Motor Car, which was observed to be in serviceable condition with remaining tread depth of approximately 2.9mm. The tyre, which was wrapped around steel wheel rim, was also observed to be sufficiently inflated for vehicular operation. The 4 tyres of the Motor Car were wrapped around standard steel wheel rims.

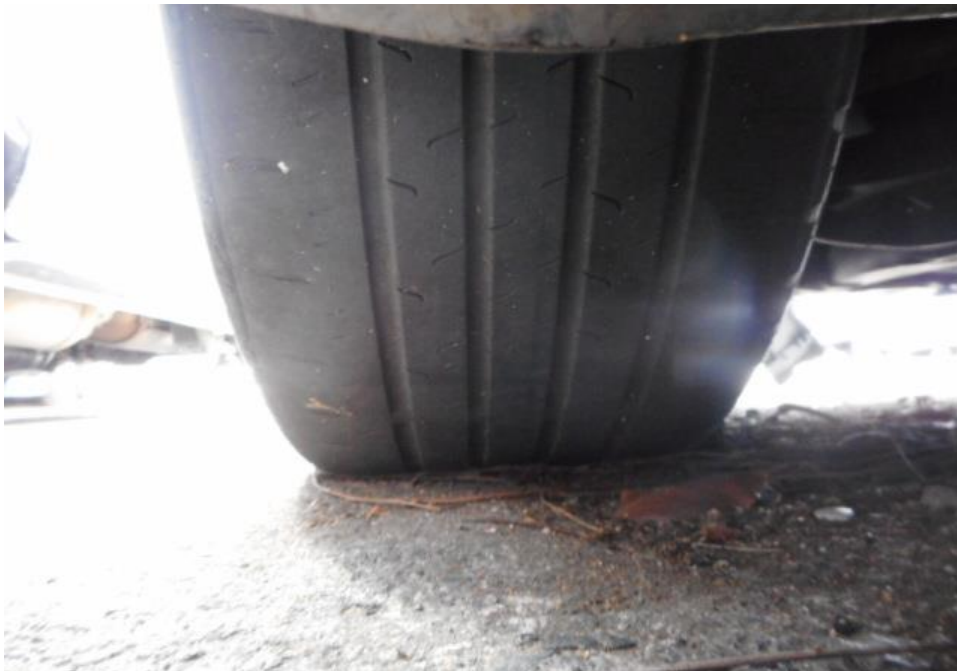
**Photo 13** shows the condition of the front left tyre of the Motor Car, which was observed to be in serviceable condition with remaining tread depth of approximately 2.5mm. There was also no tear, cut or burst mark(s) on the outer and the inner sidewalls as well as across the tread of the Motor Car's 4 tyres.

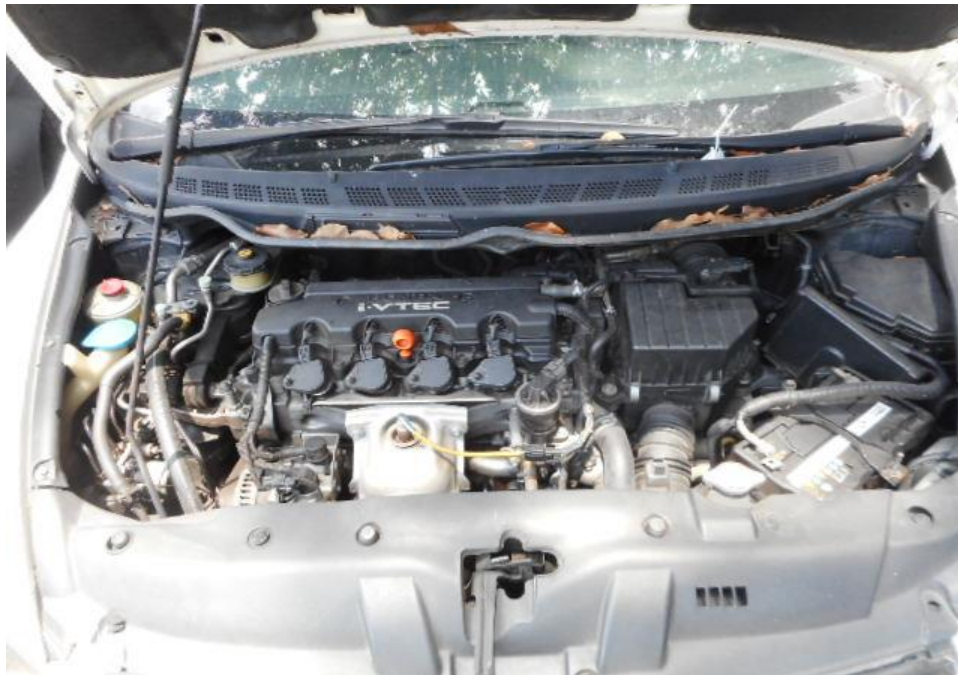
**Photo 14** shows a general view of the Motor Car's engine compartment. The various parts and components inside the engine compartment were unaffected by the accident. There was also no sign(s) or indication(s) of fluid leakage and/or fluid stain within the engine compartment.

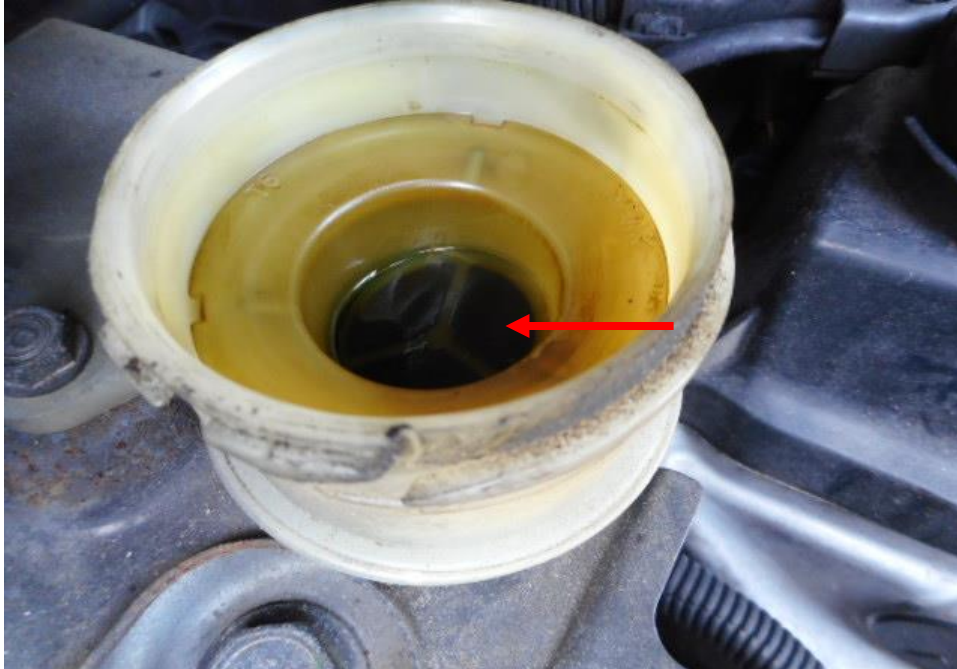
**Photo 15** shows the brake fluid reservoir of the Motor Car at the time of my inspection. The brake fluid was observed to be of sufficient level (arrowed) and without any visible contamination.

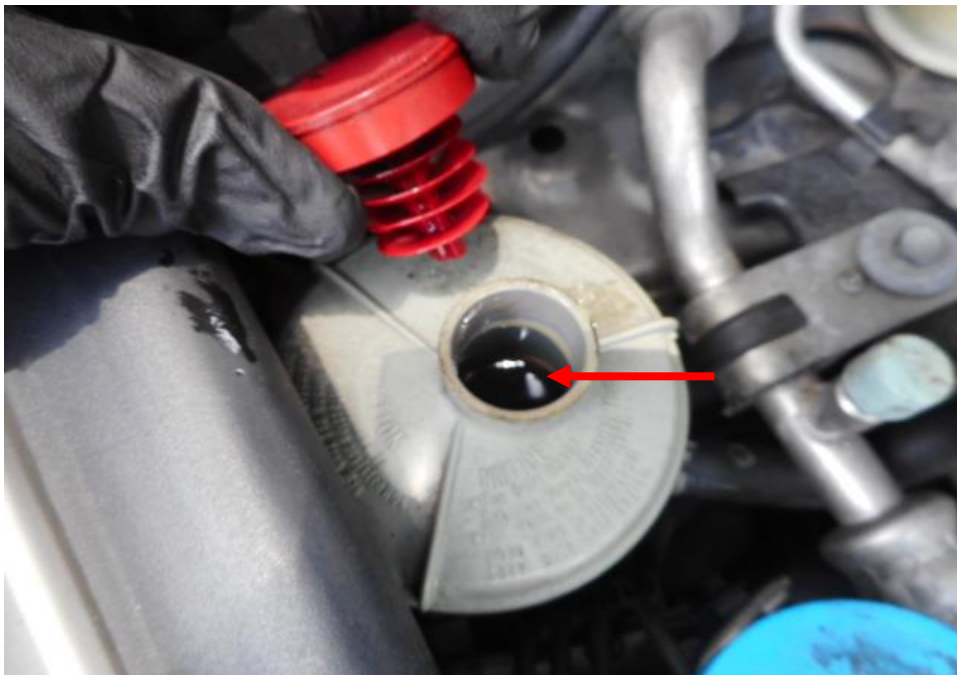
**Photo 16** shows the power steering fluid reservoir of the Motor Car at the time of my inspection. The steering fluid was observed to be of sufficient level (arrowed) and without any visible contamination.

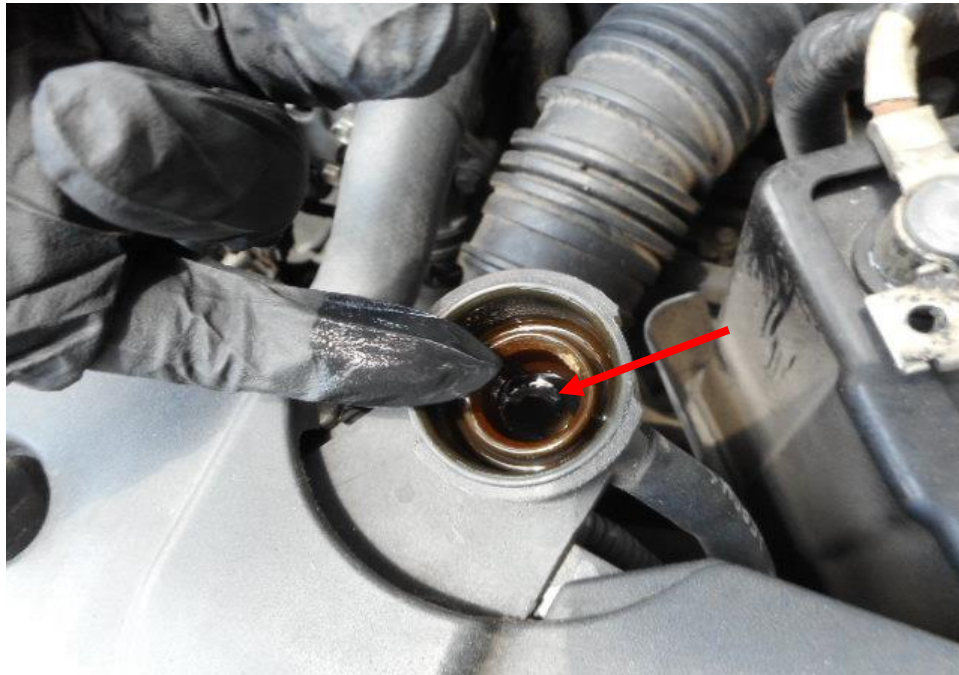
**Photo 17** shows checks being carried out to the engine coolant of the Motor Car at the time of my inspection. The engine coolant was observed to be of sufficient level (arrowed) and without any visible contamination.

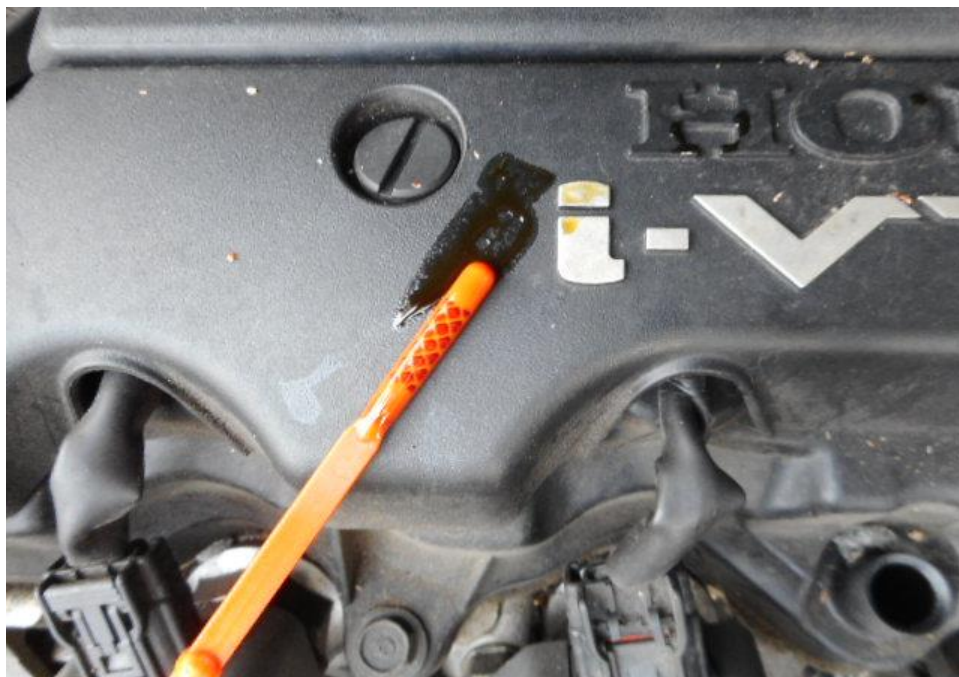
**Photo 18** shows the engine oil dipstick of the Motor Car at the time of my inspection. The engine oil was observed to be of sufficient level and without any visible contamination.

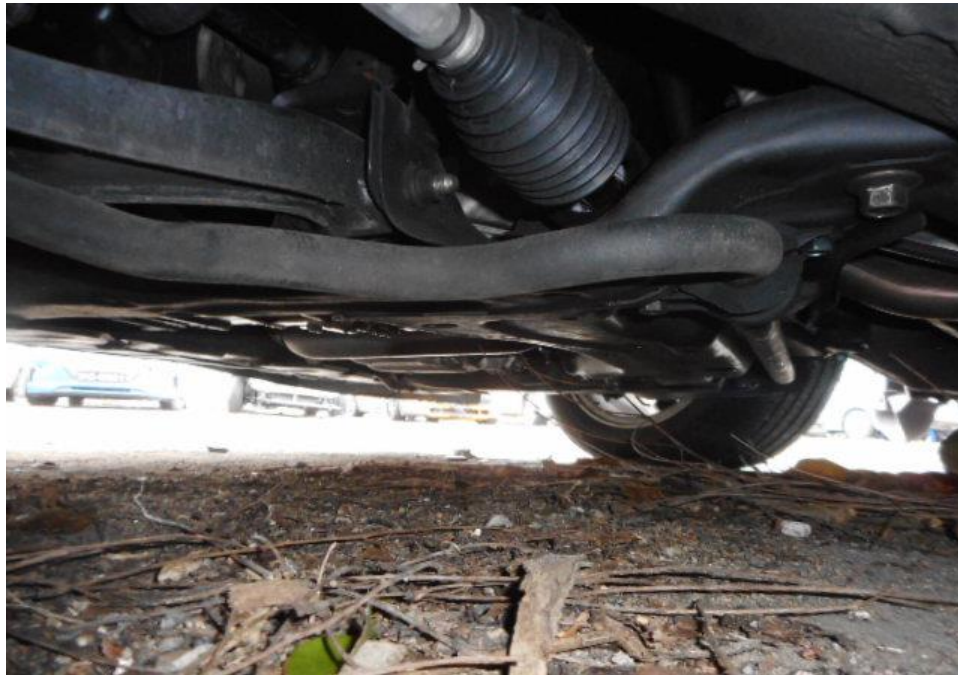
**Photo 19** shows the undercarriage of the Motor Car, at the area where the engine housing and transmission housing are located. I did not find any sign(s) or indication(s) of fluid leak and/or fluid stain(s) on the underside of the Motor Car.

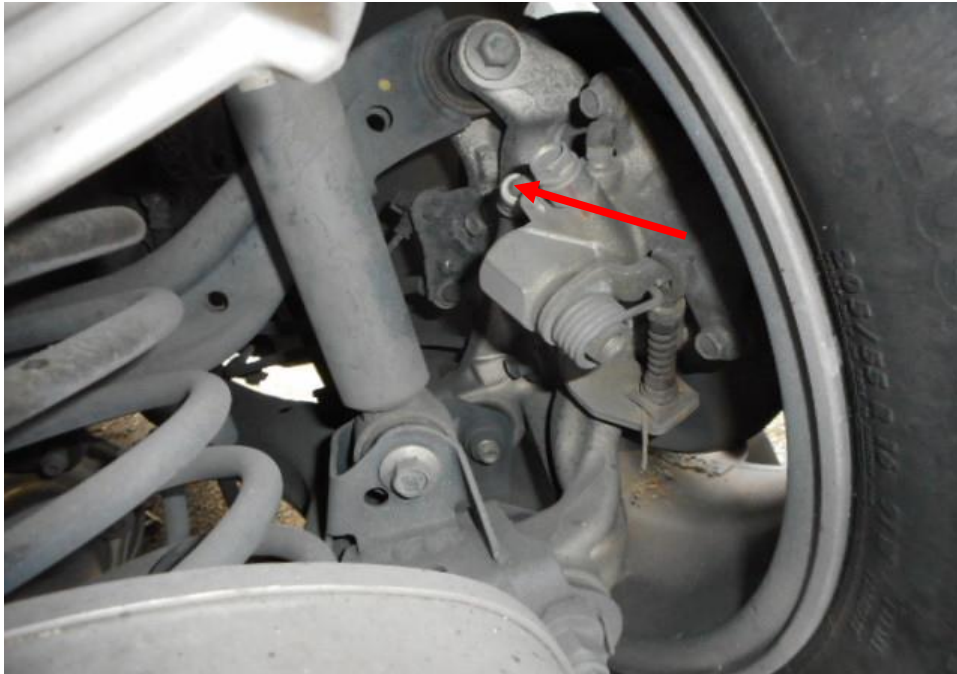
**Photo 20** shows the brake hose/pipe (arrowed) at the rear right wheel of the Motor Car. No leakage of brake fluid was observed. Visual examination of the various components of the braking system like the drum brake, brake booster, brake pedal etc. had revealed all to be intact and without visible damage.

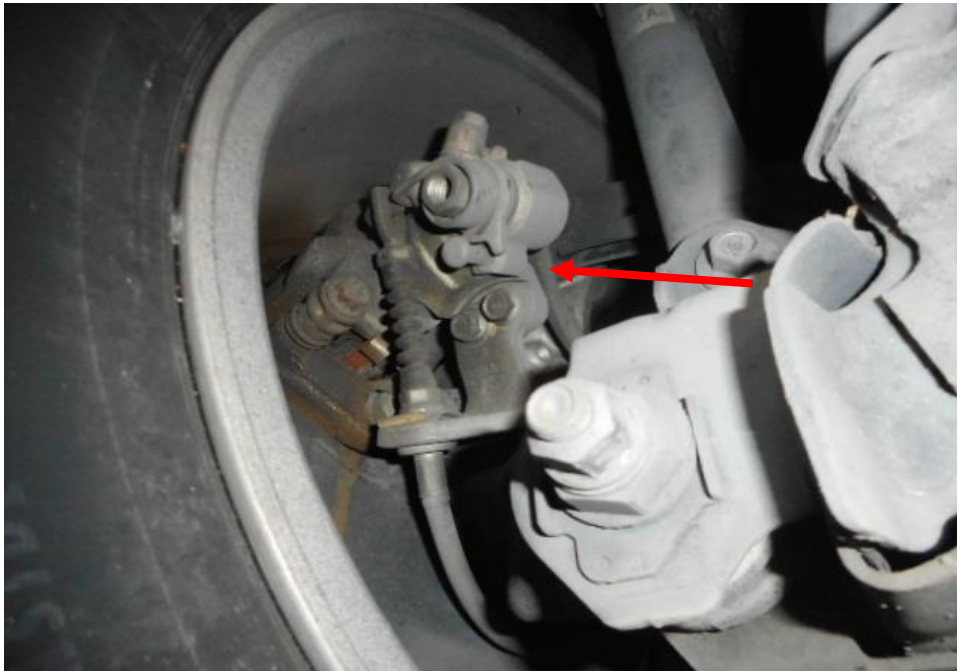
**Photo 21** shows the brake hose/pipe (arrowed) at the rear left wheel of the Motor Car. I did not observe any leakage of brake fluid at the time of my inspection of the Motor Car. Static tests of the Motor Car's braking system had indicated that there was no internal leakage of pressure/vacuum. The undercarriage components of the Motor Car were also all found to be intact and without any visible damage.

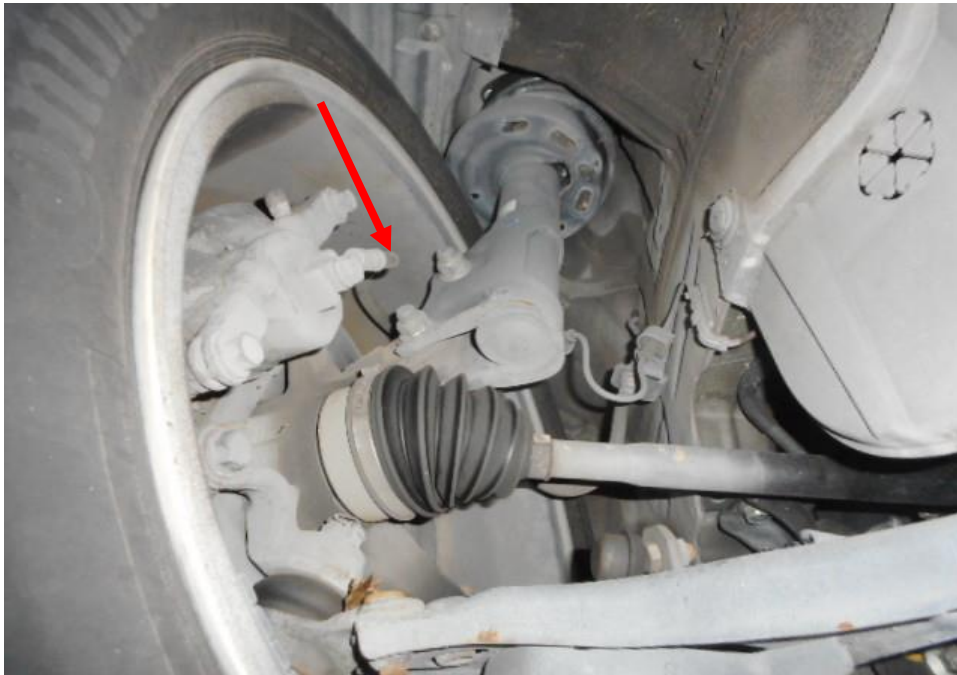
**Photo 22** shows the brake hose/pipe (arrowed) at the front right wheel of the Motor Car. I did not observe any leakage of brake fluid at the time of my inspection of the Motor Car. Static tests of the Motor Car's braking system had indicated that there was no internal leakage of pressure/vacuum. The undercarriage components of the Motor Car were also all found to be intact and without any visible damage.

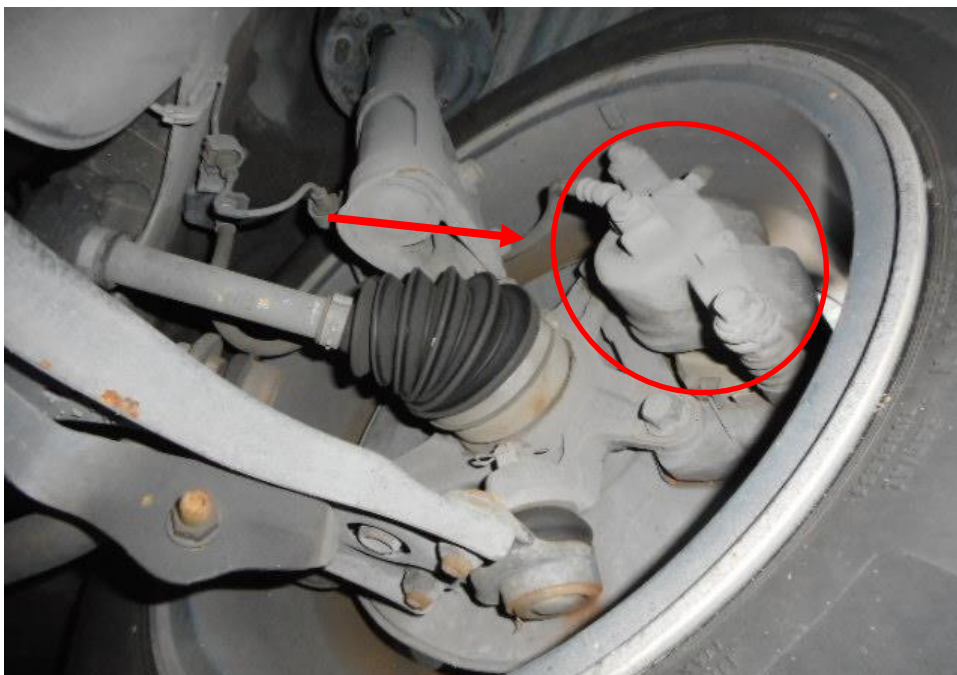
**Photo 23** shows the brake hose/pipe (arrowed) at the front left wheel of the Motor Car. No leakage of brake fluid was observed. Visual examination of the various components of the braking system like the brake caliper (circled), brake booster, brake pedal etc had revealed all to be intact and without visible damage.

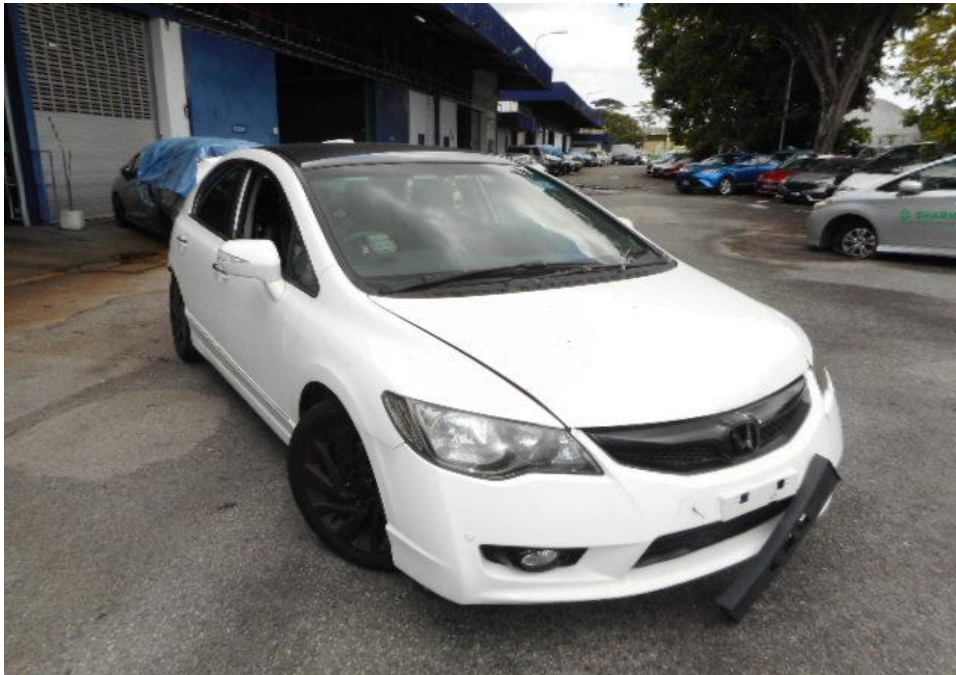
**Photo 24** shows the front right wheel of the Motor Car turned to its full left. During my steering system test, I did not experience any abnormal free play and/or resistance when I had turned the steering wheel towards the left and right. This would suggest that the steering system of the Motor Car was likely to be in serviceable condition at the material time of accident.

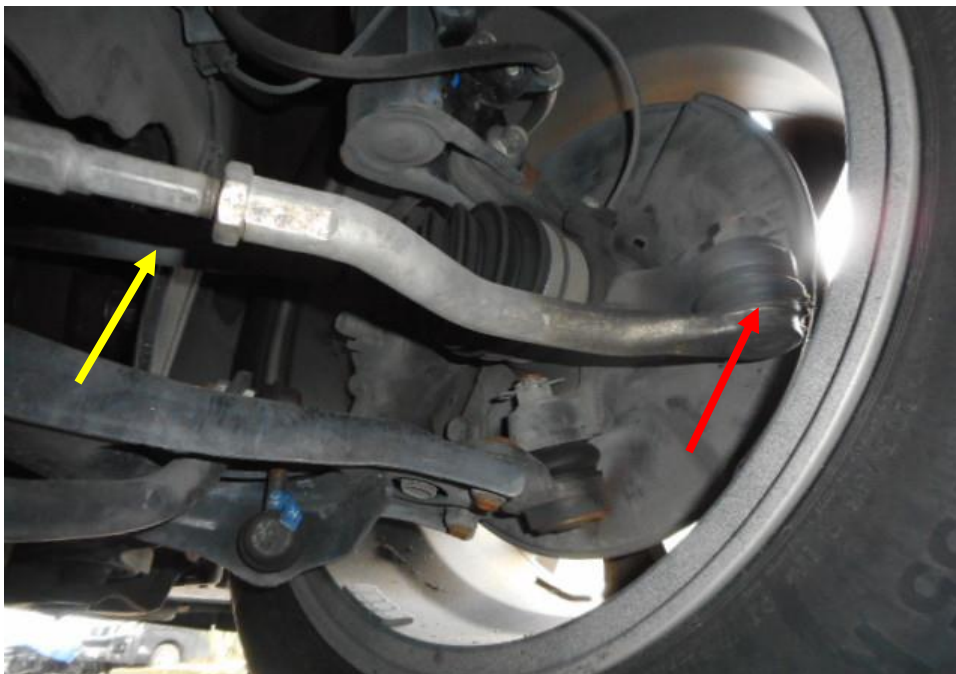
**Photo 25** shows the various undercarriage components at the front right wheel of the Motor Car, in particular the steering tie rod (red arrow) and drive shaft (yellow arrow). The various steering components were all found to be intact, suggesting that the steering system of the Motor Car was likely to be in serviceable condition at the material time of accident. There was also no sign of fluid stain observed on the various undercarriage components at the front right wheel of the Motor Car.

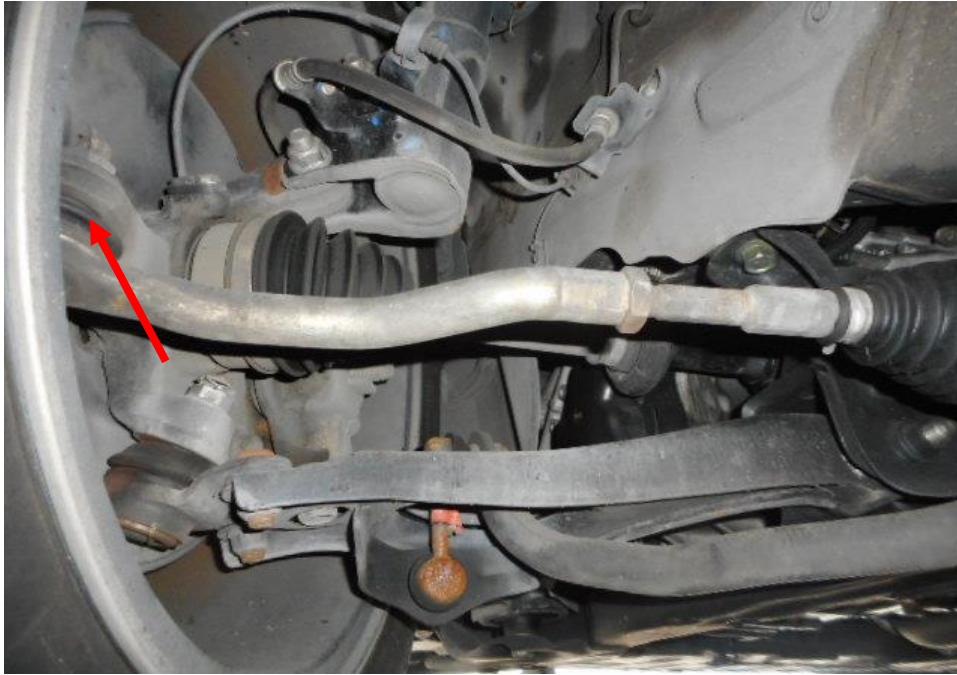
**Photo 26** shows the various undercarriage components at the front left wheel of the Motor Car, which had included the steering tie rod (red arrow). The various undercarriage components of the Motor Car were all found to be intact without any visible damage.

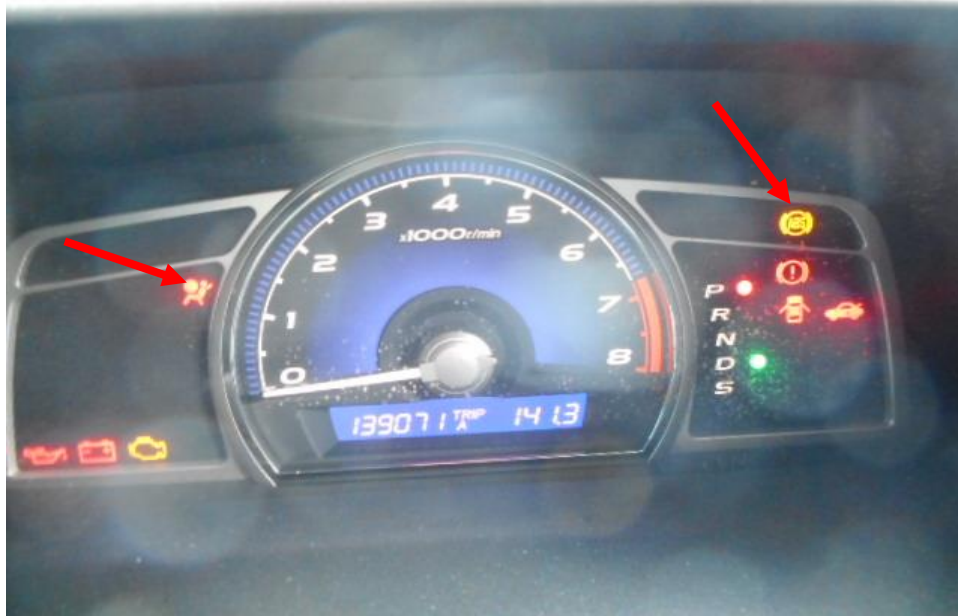
**Photo 27** shows the warning light for Anti-Lock Brake System (ABS), and Supplemental Restraint System (SRS) (arrowed) appearing on the instrument panel of the Motor Car during the self-test of its various electronic operating systems when its engine was cranked.

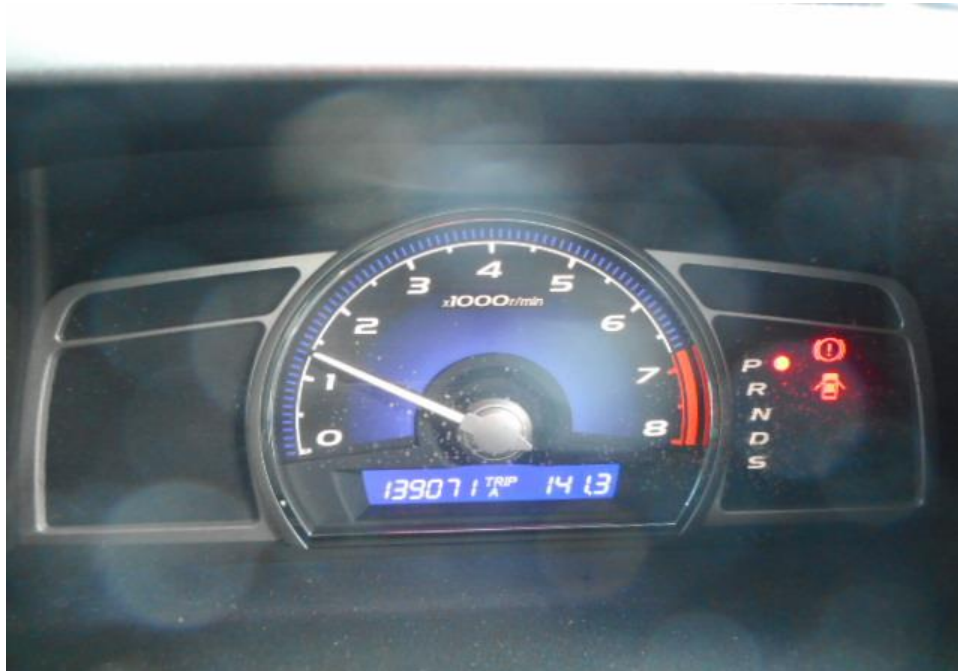
**Photo 28** shows no warning lights illuminated on the instrument panel of the Motor Car after the engine was cranked. This would suggest that there was no abnormality to the electronic operating system of the Motor Car, like the ABS, and SRS etc.
