Your Ref: TP/IP/32987/2021
Our Ref : CI/TPD21007785/P

Fatal Accident Investigation Team

MECHANICAL INSPECTION REPORT OF POLICE MOTOR CAR QX 295M

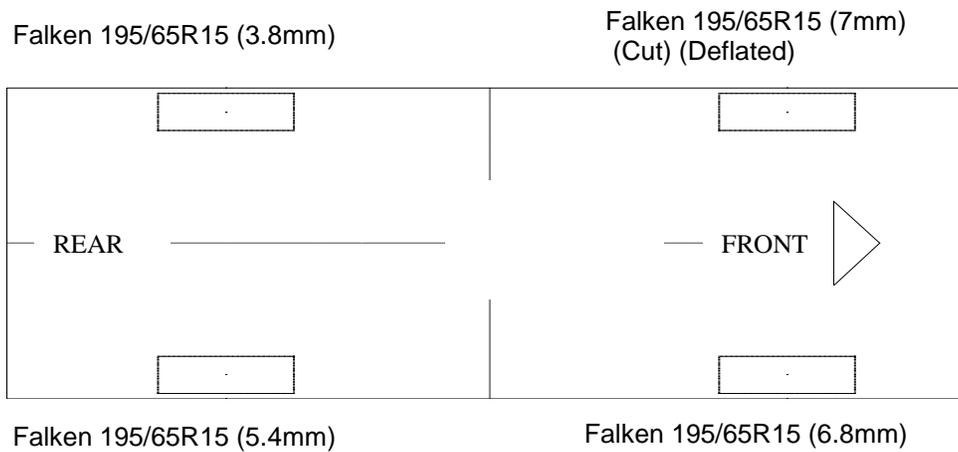
6. The condition of the Police Motor Car's front left tyre was observed to be in damaged as a result of the accident. However, the other 3 tyres was observed to be in serviceable condition. I did not find any tear, cut or burst mark(s) on the outer and the inner sidewalls as well as across the tread of the 3 tyres. The 3 tyres were also observed to be sufficiently inflated for vehicular operation. The tyre brand, tyre size and remaining tread depth of the 4 tyres were recorded as follows:-

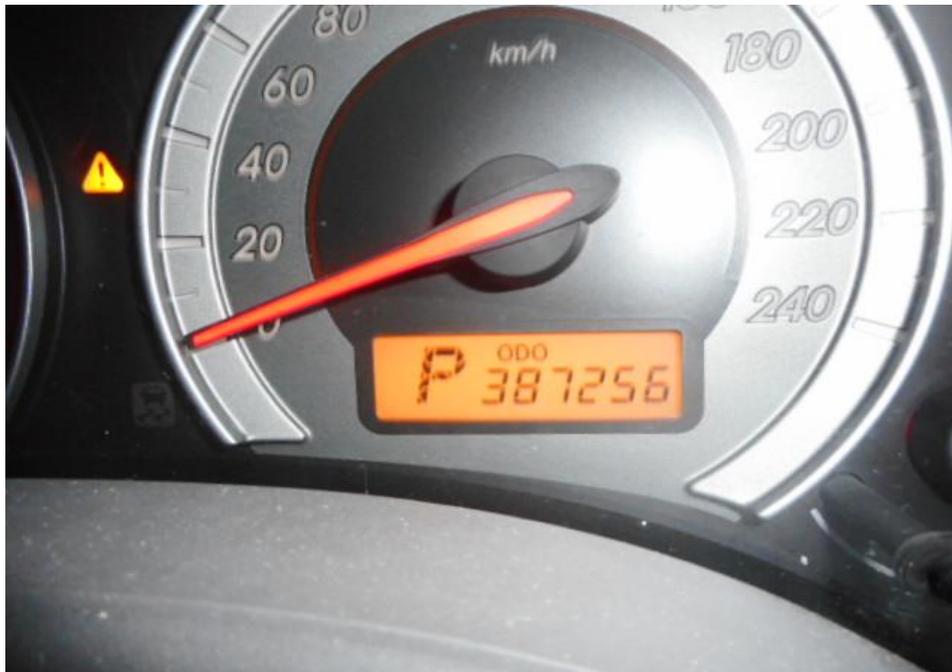
Photo 1 shows the mileage of the Police Motor Car at the time of my inspection. The mileage observed was 387,256km.

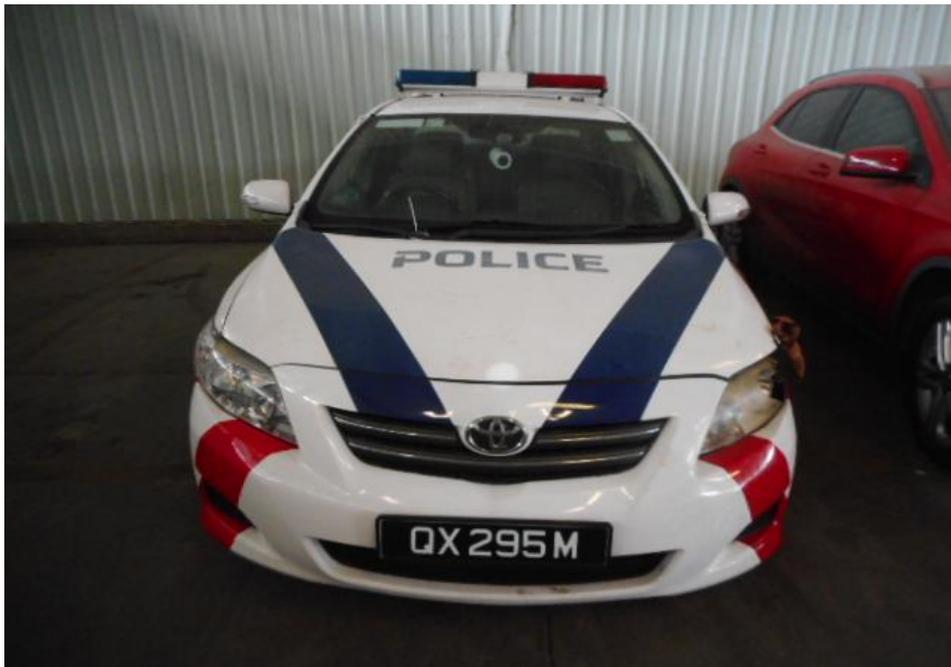
4. The mileage of the Police Motor Car at the time of my inspection was 387,256km.
5. The Police Motor Car was observed to have sustained damage at its front, left and rear portion. Its front bumper, front left headlamp, front left fender, left door panels and rear bumper were amongst the body parts that were damaged as a result of the accident.

Photo 2 shows a general view of the Police Motor Car's front body at the time of my inspection. The Police Motor Car was observed to have sustained damage at its front, left and rear portion. Its front bumper, front left headlamp, front left fender, left door panels and rear bumper were amongst the body parts that were damaged as a result of the accident.

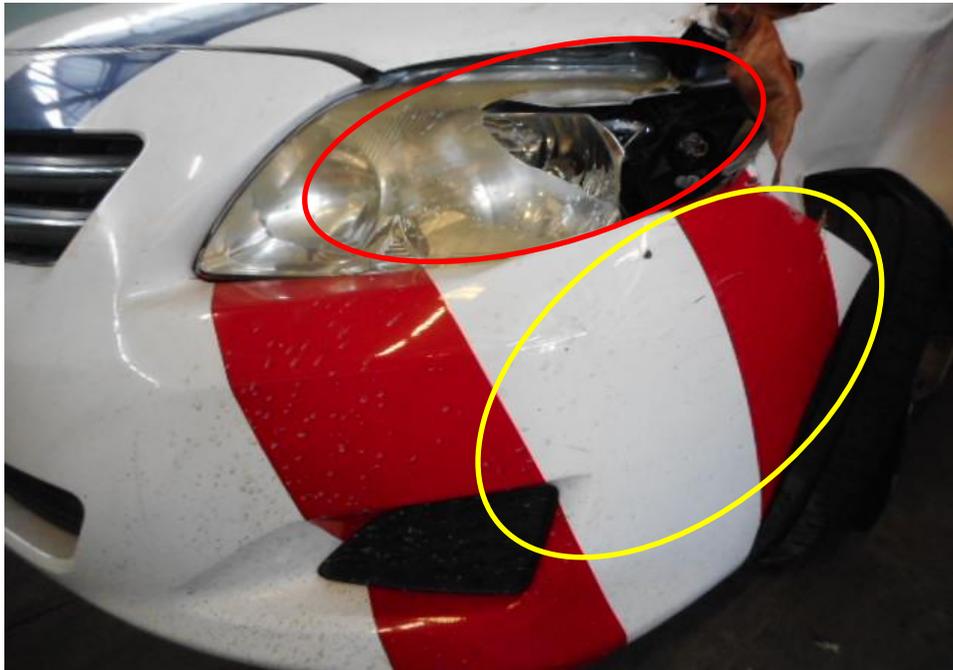
Photo 3 shows the close up view of the Police Motor Car's front body at the time of my inspection. The Police Motor Car was observed to have sustained damage at its front portion. Its front bumper (yellow circle) and front left headlamp (red circle) were amongst the body parts that were damaged as a result of the accident.

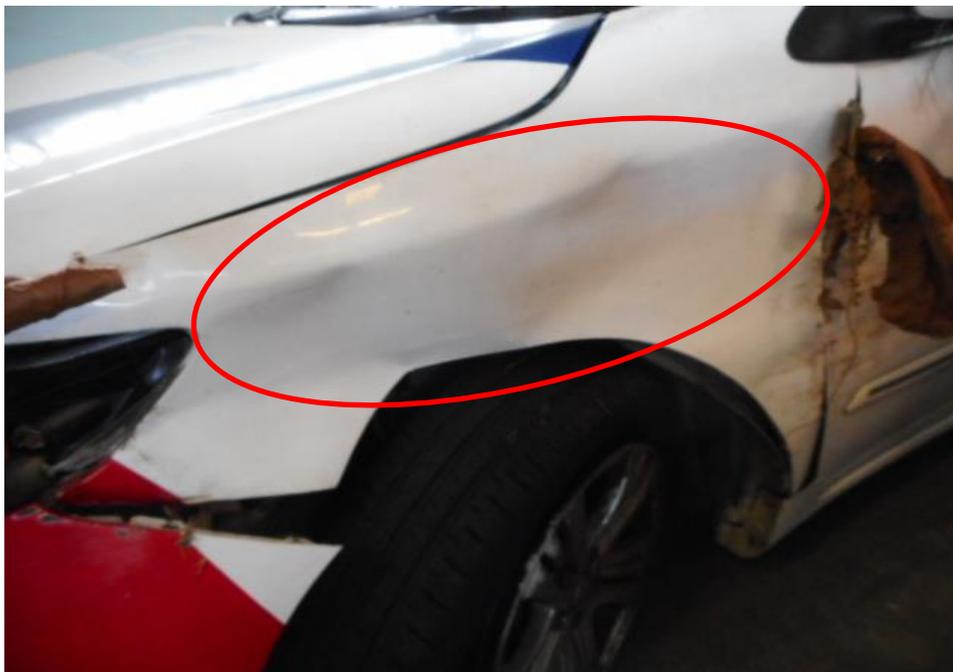
Photo 4 shows the close up view of the Police Motor Car's front body at the time of my inspection. The Police Motor Car was observed to have sustained damage at its front portion. Its front left fender (circled) were amongst the body parts that were damaged as a result of the accident.

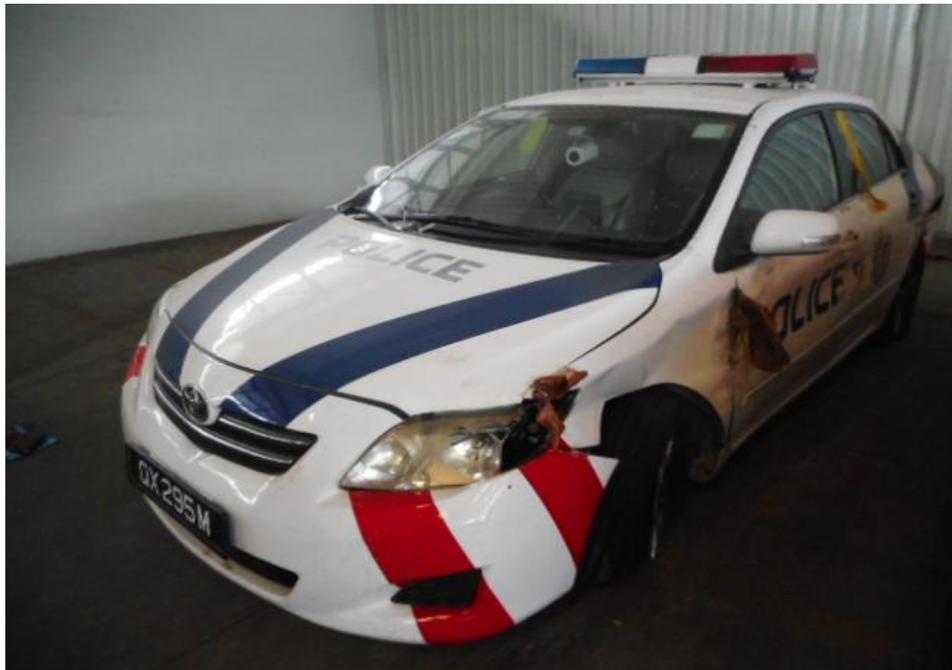
Photo 5 shows a general view of the Police Motor Car's left body at the time of my inspection. The Police Motor Car was observed to have sustained damage at its left portion. Its right side skirts were amongst the body parts that were damaged as a result of the accident.

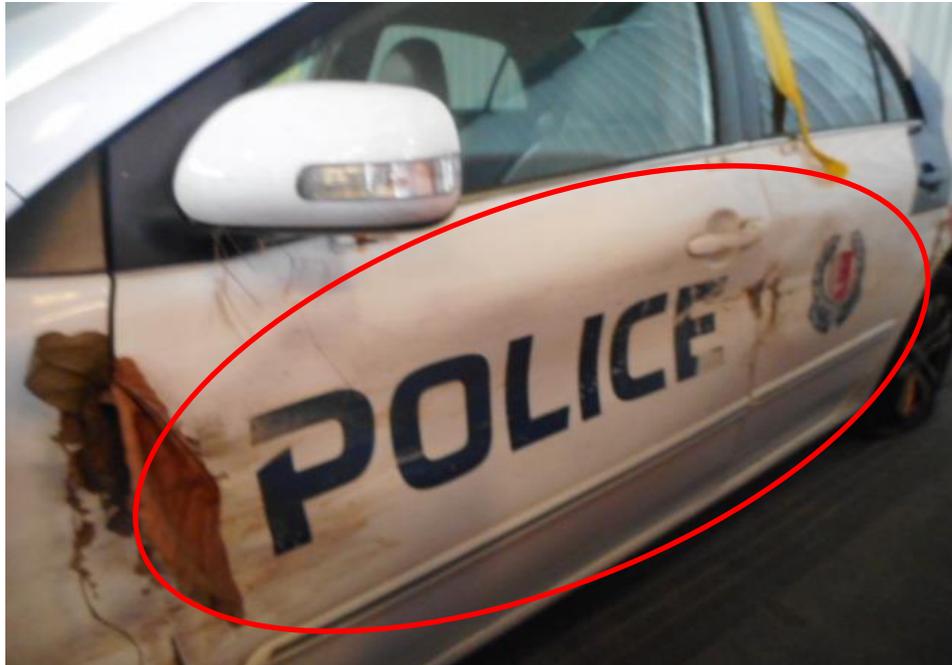
Photo 6 shows a close up view of the Police Motor Car's left body at the time of my inspection. The Police Motor Car was observed to have sustained damage at its left portion. Its left door panels (circled) were amongst the body parts that were damaged as a result of the accident.

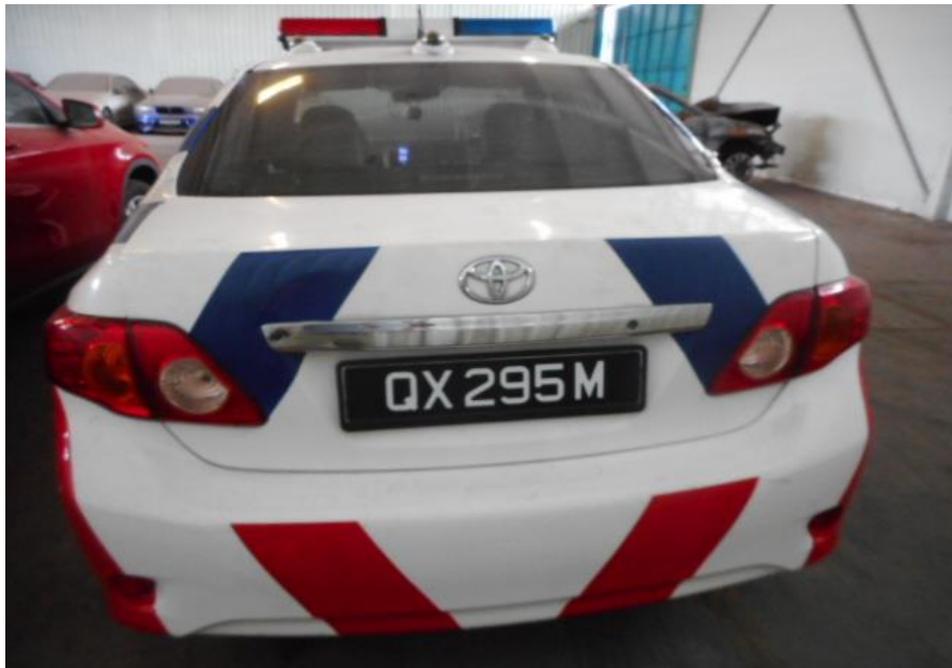
Photo 8 shows the general view of the Police Motor Car's rear body at the time of my inspection. The Police Motor Car was observed to have sustained damage at its rear portion. Its rear bumper were amongst the body parts that were damaged as a result of the accident.

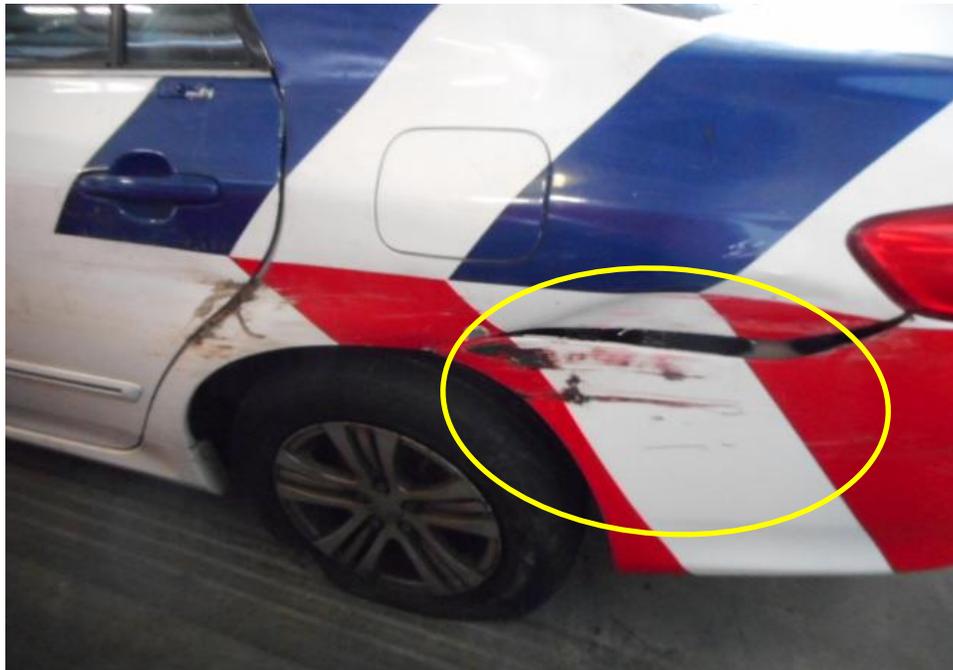
Photo 9 shows a close up view of the Police Motor Car's left body at the time of my inspection. The Police Motor Car was observed to have sustained damage at its rear portion. Its rear bumper (circled) were amongst the body parts that were damaged as a result of the accident.

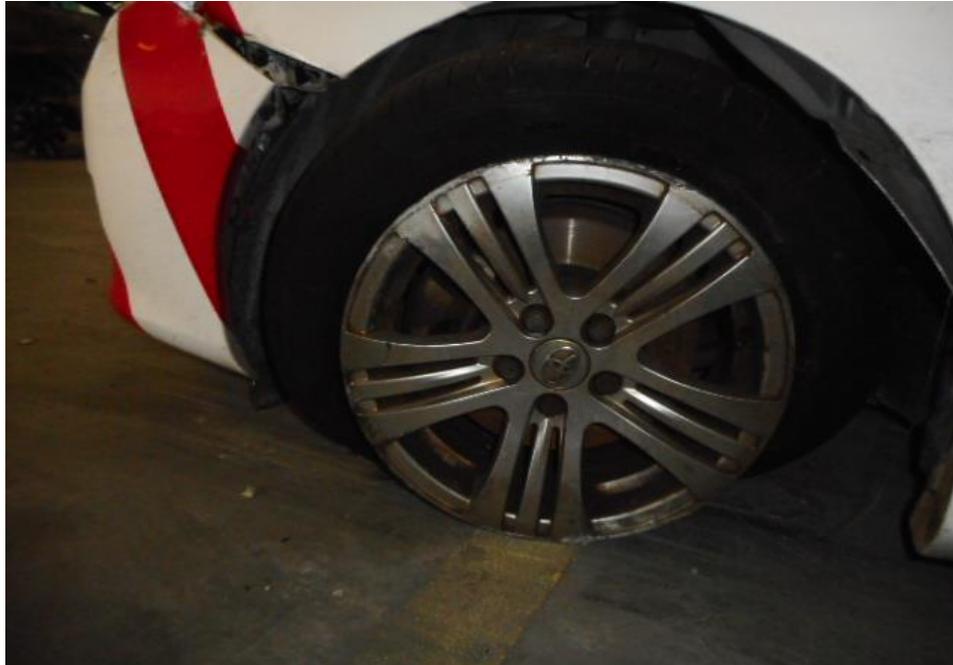
Photo 10 shows the condition of the front left tyre of the Police Motor Car, which was observed to be unserviceable condition with remaining tread depth of approximately 7mm. The tyre was observed with cut mark(s) on the outer sidewalls and there was damage observed on the wheel rims as a result of the accident.

19. The front left tyre and wheel rim of the Police Motor Car were found to be damaged as a result of the accident. However, the other 3 tyres were found to be serviceable condition as I did not find any tear, cut or burst mark(s) on the outer and the inner sidewalls as well as across the tread of the 3 tyres. The 4 tyres were also observed with remaining tread depth of approximately 3.8mm to 7mm.

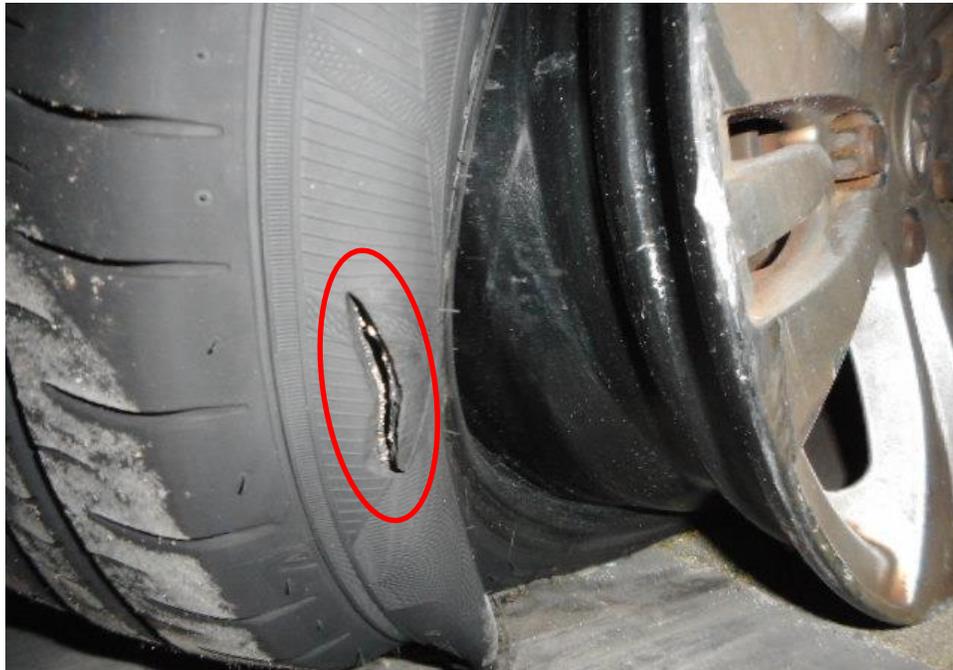
Photo 11 shows the close up view of the condition of the front left tyre of the Police Motor Car, which was observed to be unserviceable condition. The tyre was observed with cut mark(s) on the outer sidewalls and there was damage observed on the wheel rims (circled) as a result of the accident.

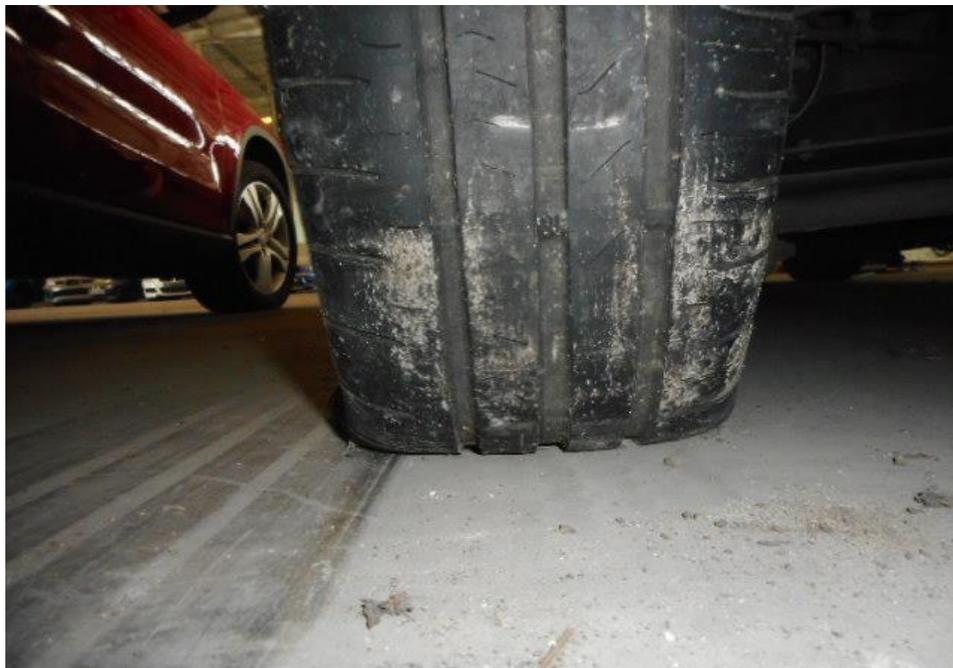
Photo 12 shows the condition of the rear left tyre of the Police Motor Car, which was observed to be in serviceable condition with remaining tread depth of approximately 3.8mm. The tyre was observed with cut marks and wheel rim damage as a result of the accident, however it was observed to be sufficiently inflated for vehicular operation

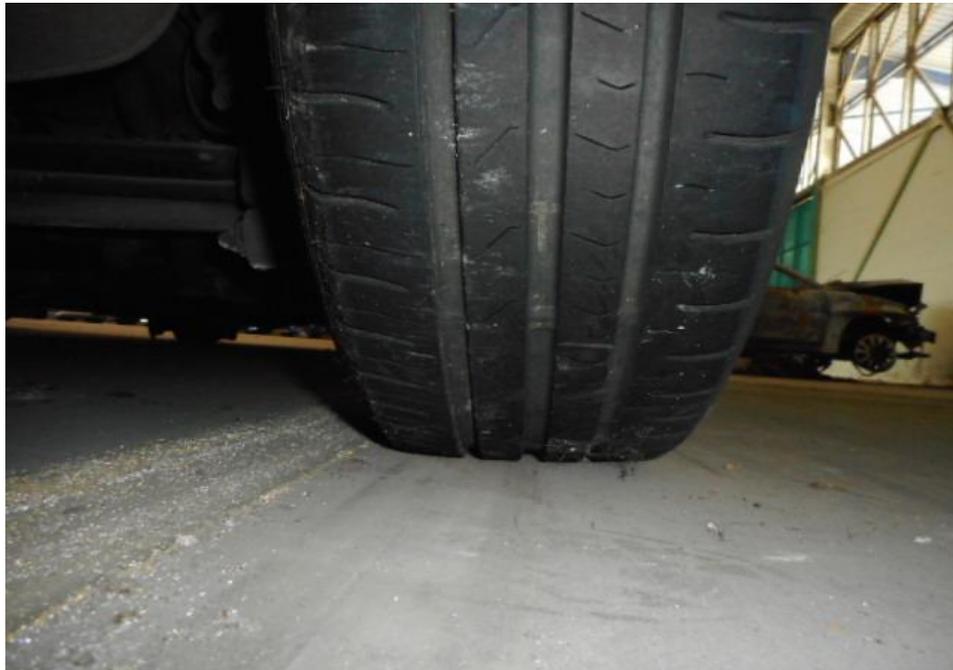
Photo 13 shows the condition of the rear right tyre of the Police Motor Car, which was observed to be in serviceable condition with remaining tread depth of approximately 3.8mm. The tyre was observed with cut marks and wheel rim damage as a result of the accident, however it was observed to be sufficiently inflated for vehicular operation

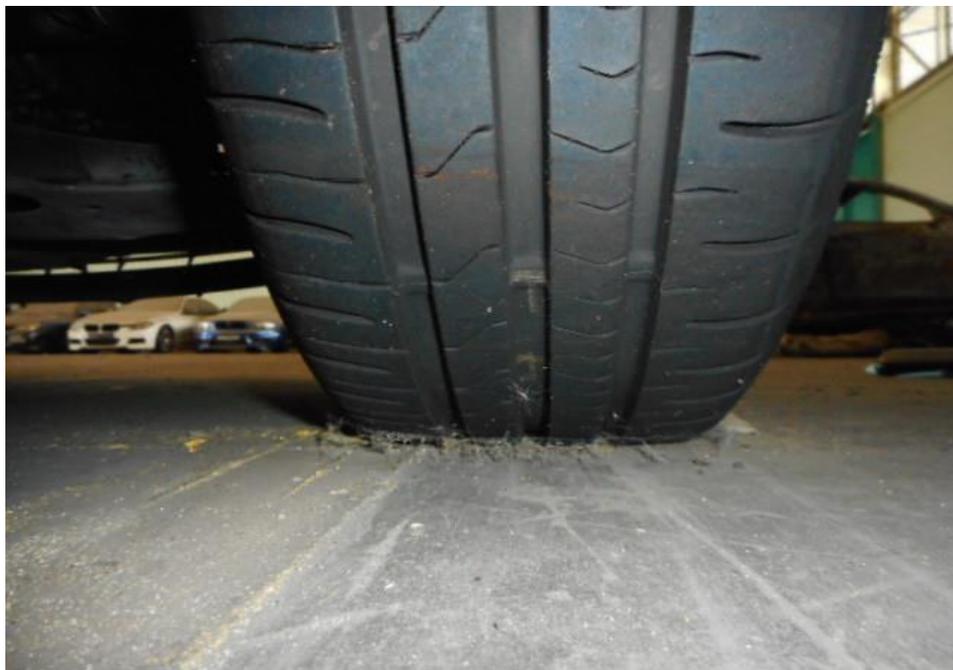
Photo 14 shows the condition of the front right tyre of the Police Motor Car, which was observed to be in serviceable condition with remaining tread depth of approximately 6.8mm. The tyre was observed with cut marks and wheel rim damage as a result of the accident, however it was observed to be sufficiently inflated for vehicular operation

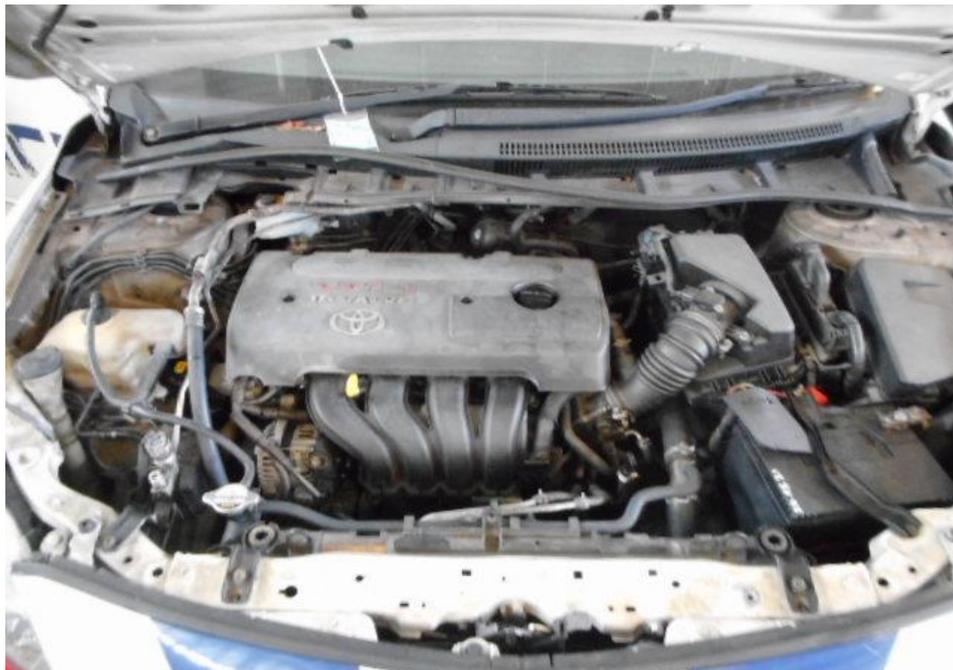
Photo 15 shows a general view of the Police Motor Car's engine compartment. The various parts and components inside the engine compartment were unaffected by the accident. There was also no sign(s) or indication(s) of fluid leakage and/or fluid stain within the engine compartment.

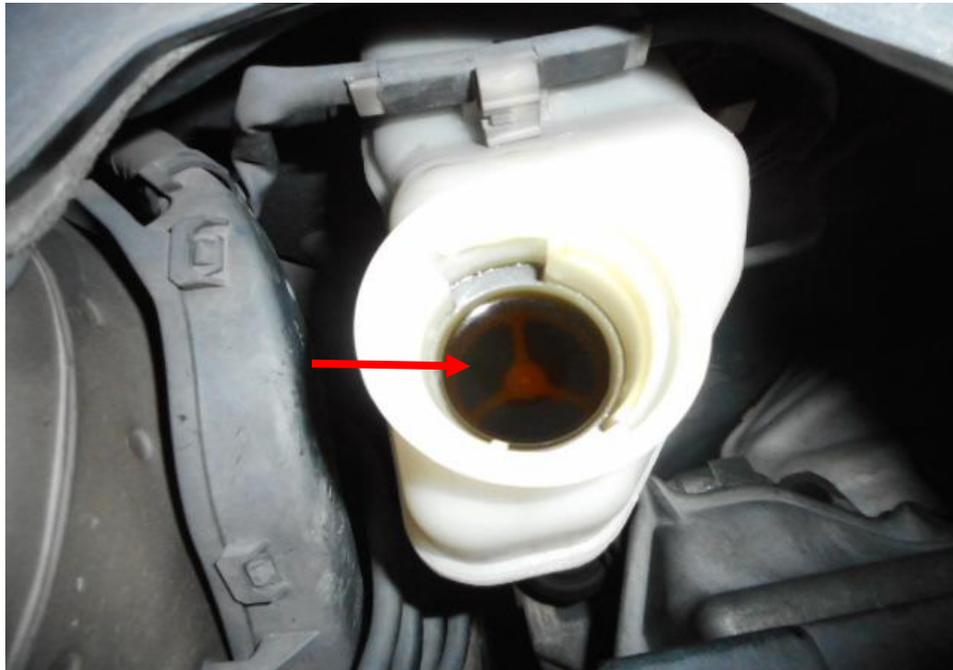
Photo 16 shows the brake fluid reservoir of the Police Motor Car at the time of my inspection. The brake fluid was observed to be of sufficient level (arrowed) and without any visible contamination.

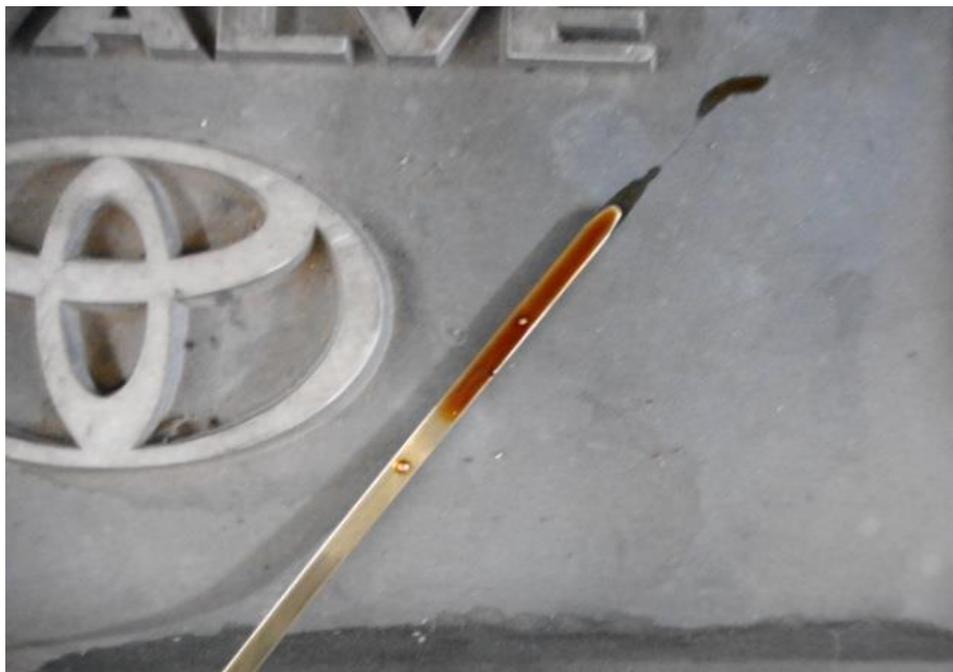
Photo 17 shows the engine oil dip stick of the Police Motor Car at the time of my inspection. The engine oil was observed to be of sufficient level and without any visible contamination.

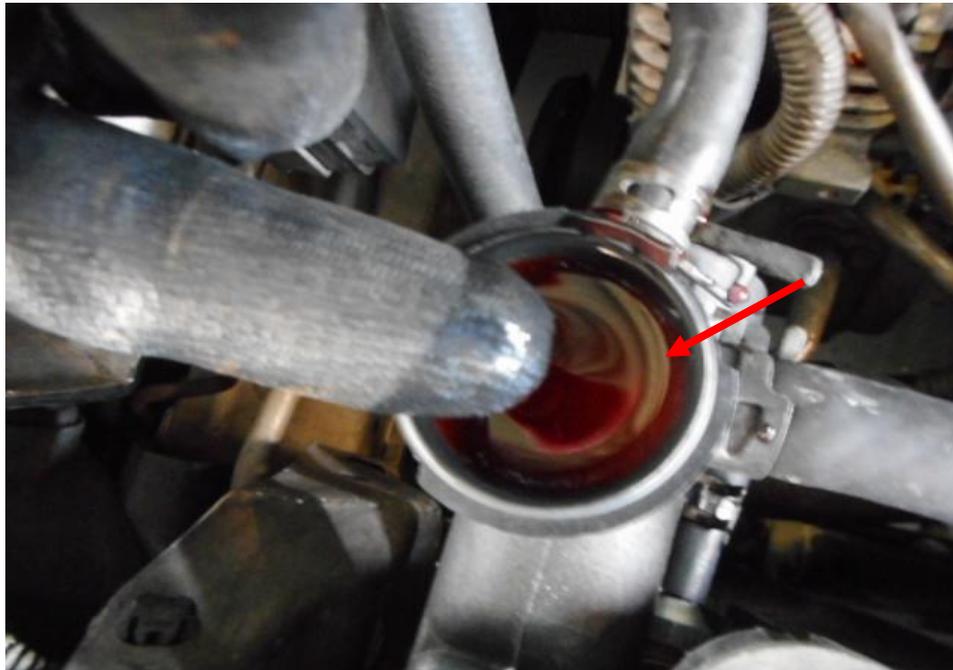
Photo 18 shows checks being carried out to the engine coolant of the Police Motor Car at the time of my inspection. The engine coolant was observed to be of sufficient level (arrowed) and without any visible contamination.

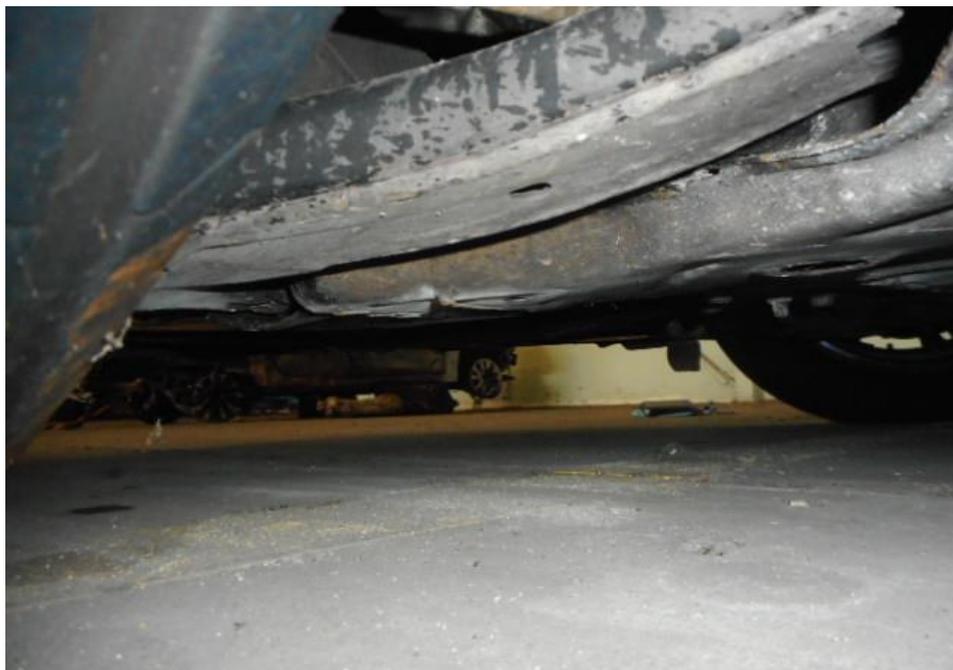
Photo 19 shows the undercarriage of the Police Motor Car, at the area where the engine housing and transmission housing are located. I did not find any sign(s) or indication(s) of fluid leak and/or fluid stain(s) on the underside of the Police Motor Car.

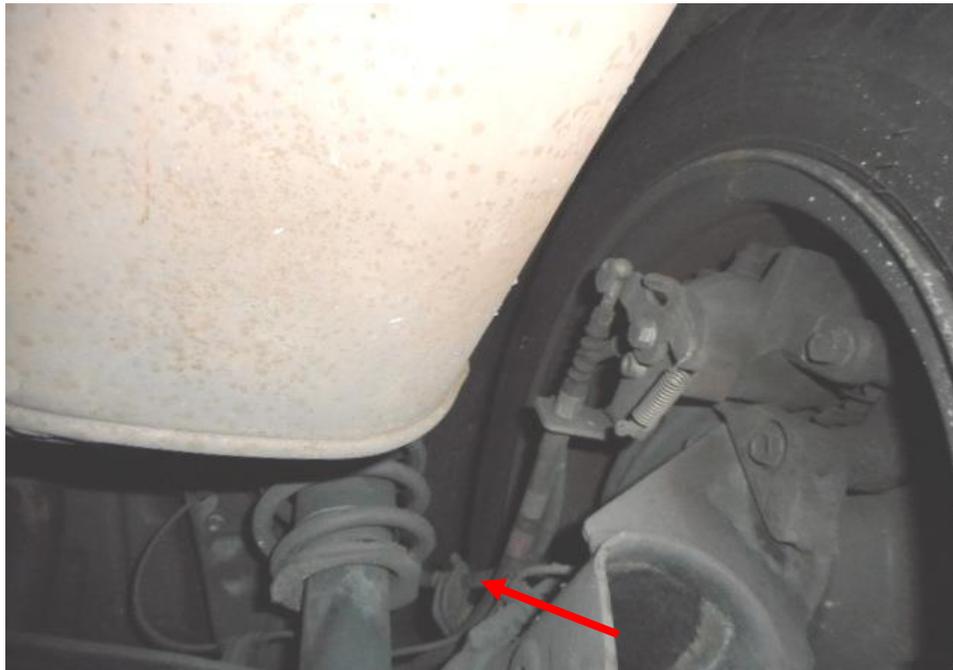
Photo 20 shows the brake hose/pipe (arrowed) at the rear right wheel of the Police Motor Car. No leakage of brake fluid was observed. Visual examination of the various components of the braking system like the drum brake, brake booster, brake pedal etc. had revealed all to be intact and without visible damage.

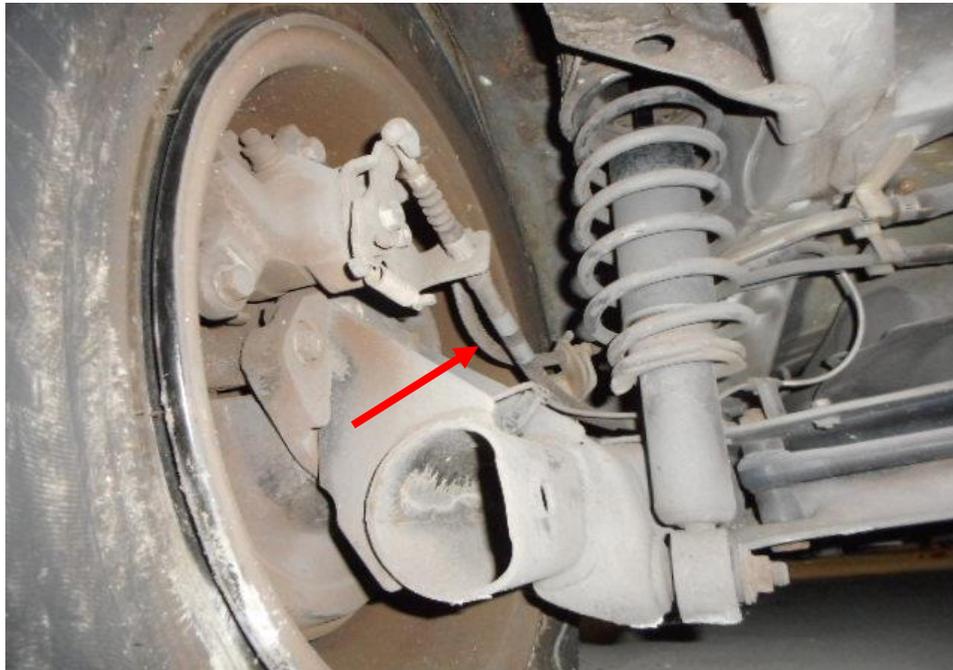
Photo 21 shows the brake hose/pipe (arrowed) at the rear left wheel of the Police Motor Car. I did not observe any leakage of brake fluid at the time of my inspection of the Police Motor Car. Static tests of the Police Motor Car's braking system had indicated that there was no internal leakage of pressure/vacuum. The undercarriage components of the Police Motor Car were also all found to be intact and without any visible damage.

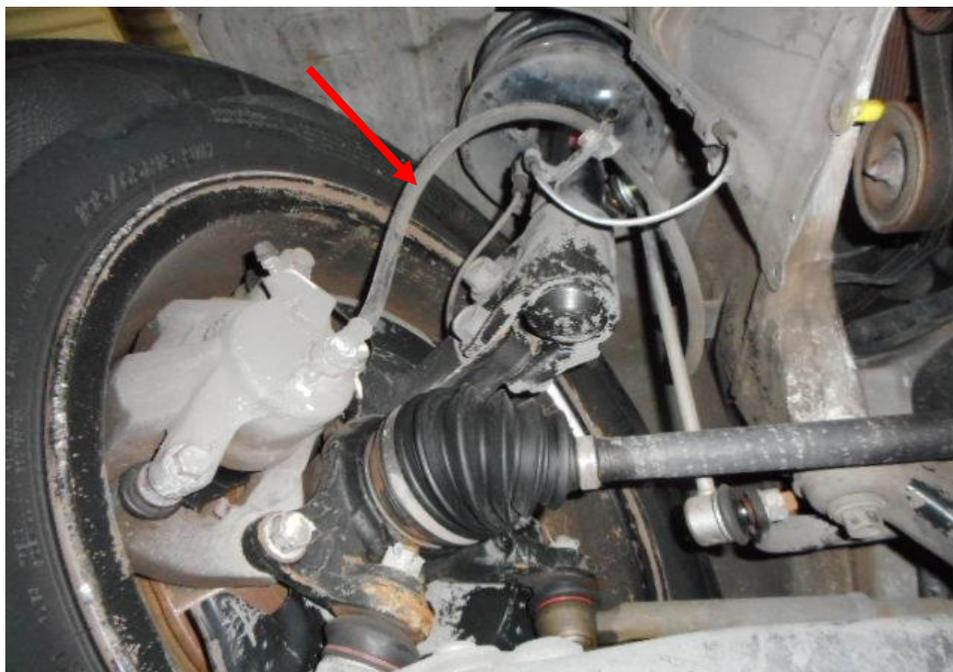
Photo 22 shows the brake hose/pipe (arrowed) at the front right wheel of the Police Motor Car. I did not observe any leakage of brake fluid at the time of my inspection of the Police Motor Car. Static tests of the Police Motor Car's braking system had indicated that there was no internal leakage of pressure/vacuum. The undercarriage components of the Police Motor Car were also all found to be intact and without any visible damage.

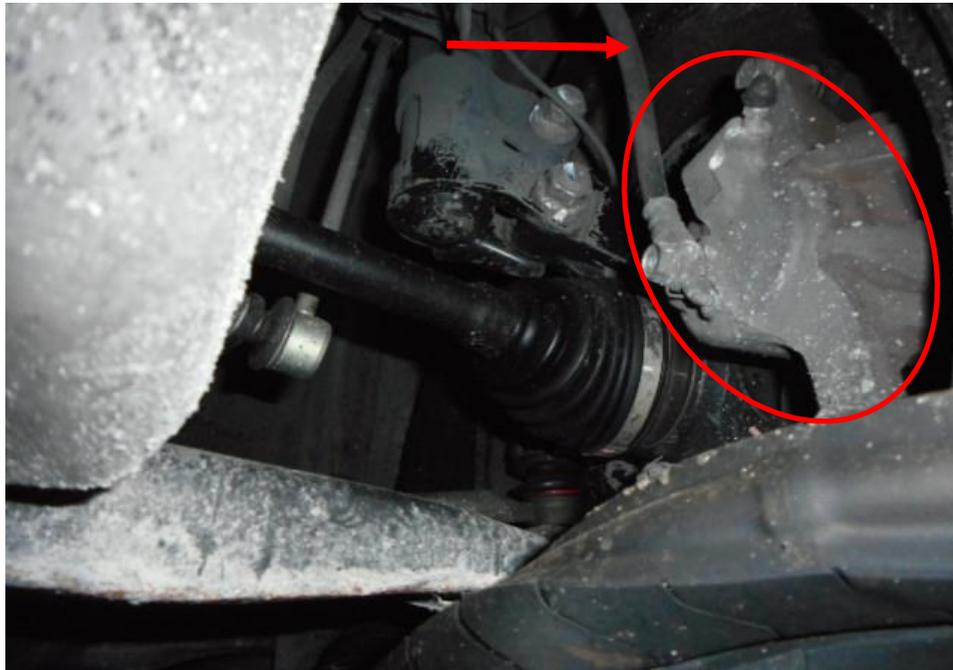
Photo 23 shows the brake hose/pipe (arrowed) at the front left wheel of the Police Motor Car. No leakage of brake fluid was observed. Visual examination of the various components of the braking system like the brake caliper (circled), brake booster, brake pedal etc had revealed all to be intact and without visible damage.

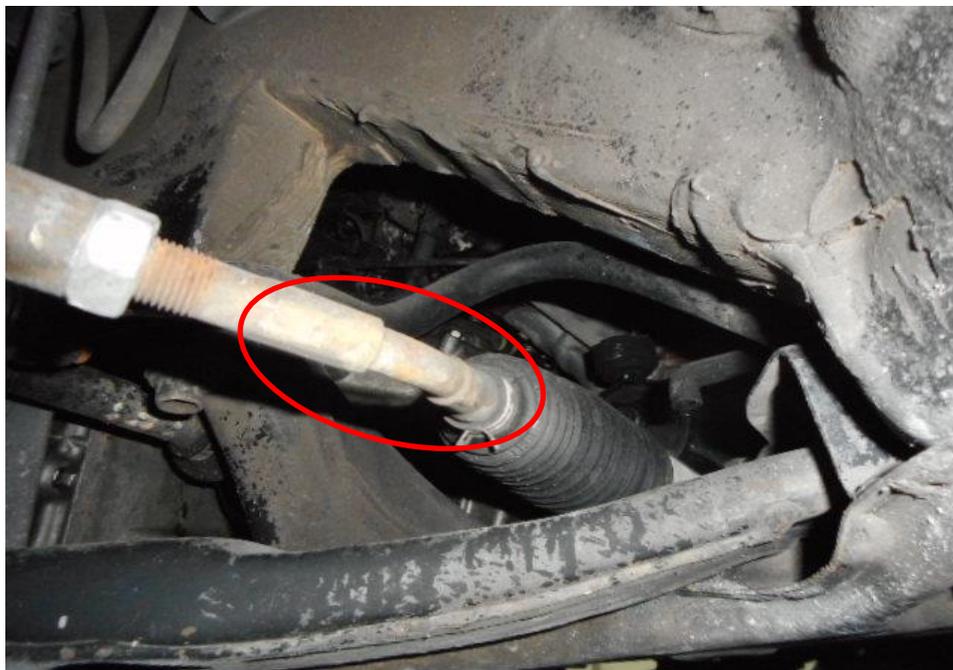
13. Static test on the steering system of the Police Motor Car was conducted and revealed abnormality as we observed that the front left tie rod was bent as a result of the accident. However, my visual examination of the other various steering components which had included the steering rack and pinion, the right tie rod ends and ball joints revealed that these components were all generally in good condition. See photo 20 - 25 below.

Photo 24 shows the various undercarriage components at the front left wheel of the Police Motor Car, in particular the steering tie rod (arrowed). The various steering components were all found to be bent as a result of the accident.

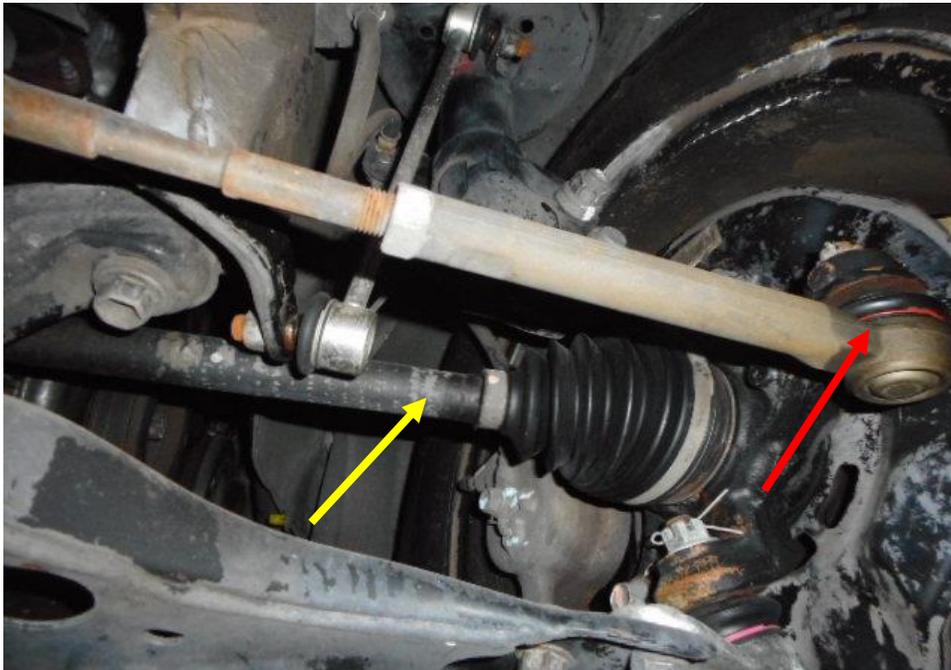
Photo 25 shows the various undercarriage components at the front right wheel of the Police Motor Car, in particular the steering tie rod (red arrow) and driveshaft (yellow arrow). The various steering components were all found to be intact, suggesting that the steering system of the Police Motor Car was likely to be in serviceable condition at the material time of accident. There was also no sign of fluid stain observed on the various undercarriage components at the front right wheel of the Police Motor Car.

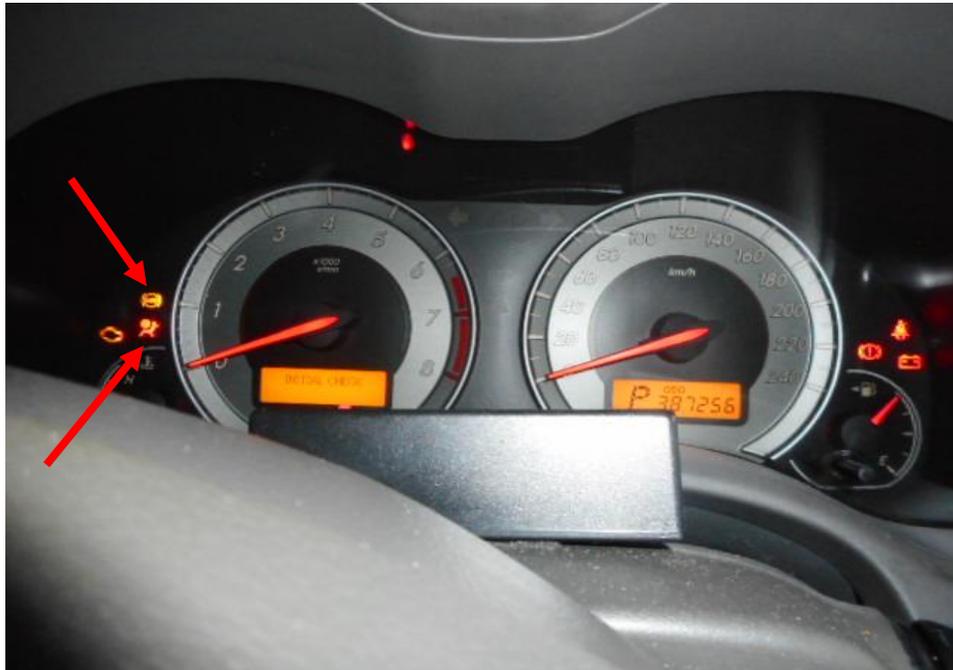
Photo 26 shows the warning light for Anti-Lock Brake System (ABS), Supplemental Restraint System (SRS) (arrowed) appearing on the instrument panel of the Police Motor Car during the self-test of its various electronic operating systems when its engine was cranked.

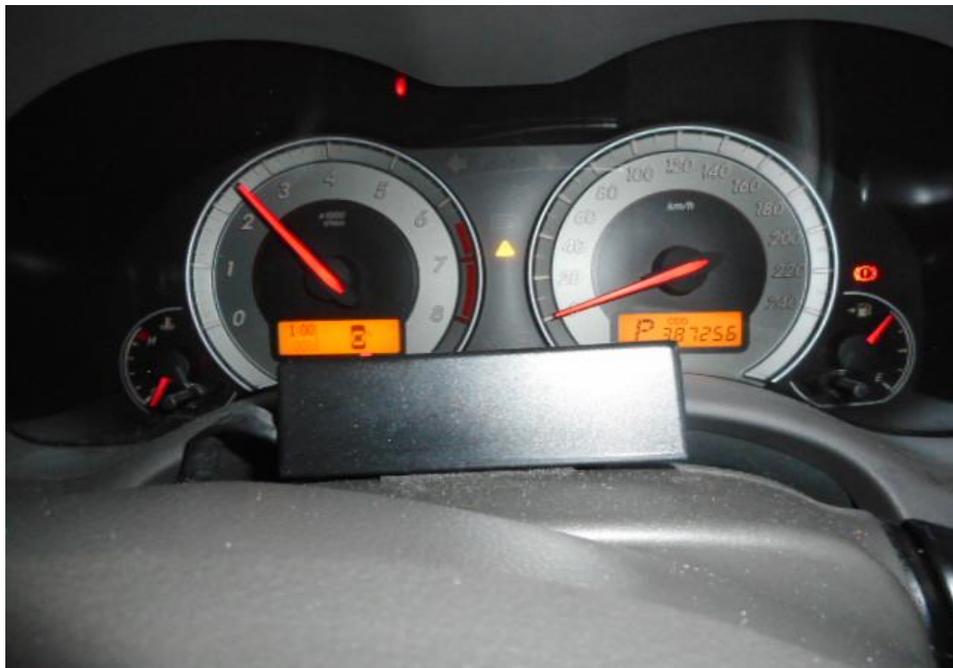
Photo 27 shows no warning lights illuminated on the instrument panel of the Police Motor Car after the engine was cranked. This would suggest that there was no abnormality to the electronic operating system of the Police Motor Car, like the ABS, SRS and etc.
