Your Ref: TP/IP/33077/2021  
Our Ref : CI/TPD21007788/P

### **MECHANICAL INSPECTION REPORT OF MOTOR BUS SBS 6329P**

1. I refer to your request on 19<sup>th</sup> July 2021 to conduct a physical inspection of a Motor Bus bearing registration number SBS 6329P (herein referred to as "**Motor Bus**"), which was involved in a road traffic accident on 11<sup>th</sup> July 2021.
2. The objective of this inspection is to determine if there was any possible mechanical failure to the Motor Bus that may have contributed to the accident.
3. Following the request, I had carried out a physical inspection of the Motor Bus on 2<sup>nd</sup> August 2021 at the premises of Traffic Police vehicle pound, 517 Airport Road Singapore 539942. I now set out below my observations and comments with respect to this inspection.

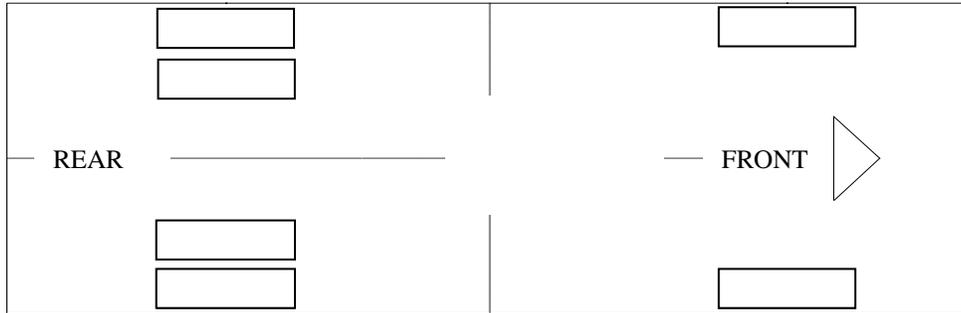
6. The 2 front tyres and 4 rear tyres of the Motor Bus were observed to be in serviceable condition and sufficiently inflated for vehicular operation. I did not find any tear, cut or burst mark(s) on the outer and the inner sidewalls as well as across the tread of the 6 tyres. The tyre brand, tyre size and remaining tread depth of the 6 tyres of the Motor Bus were recorded as follows:-

Michelin 275/70R22.5 (7.6mm)

Michelin 275/70R22.5 (7.8mm)

Michelin 275/70R22.5 (7.9mm)

Michelin 275/70R22.5 (7.2mm)

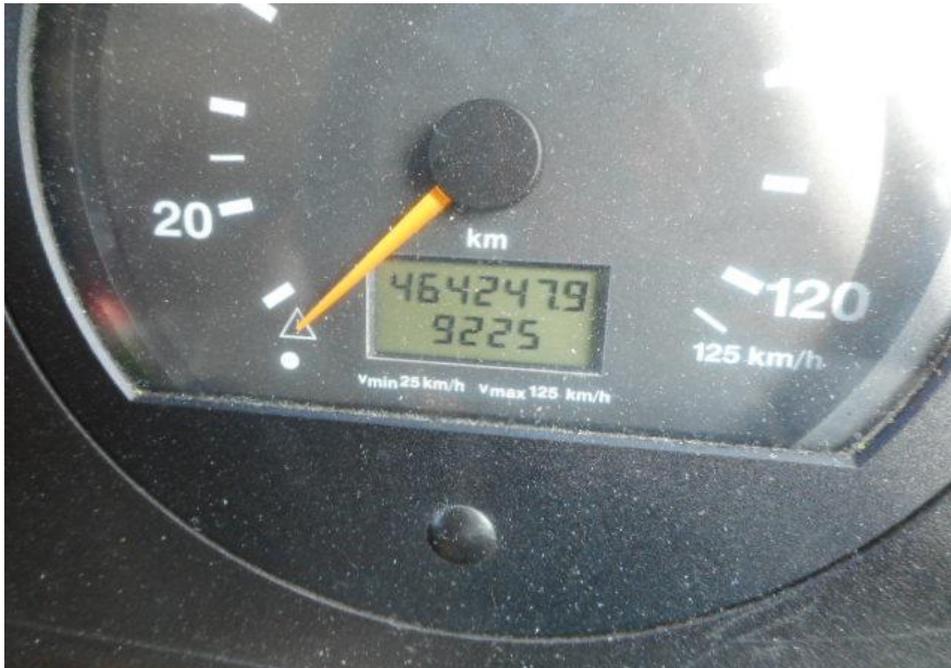
**Photo 1** shows a general view of the instrument cluster of the Motor Bus at the time of my inspection. The mileage of the Motor Bus was 464,247km

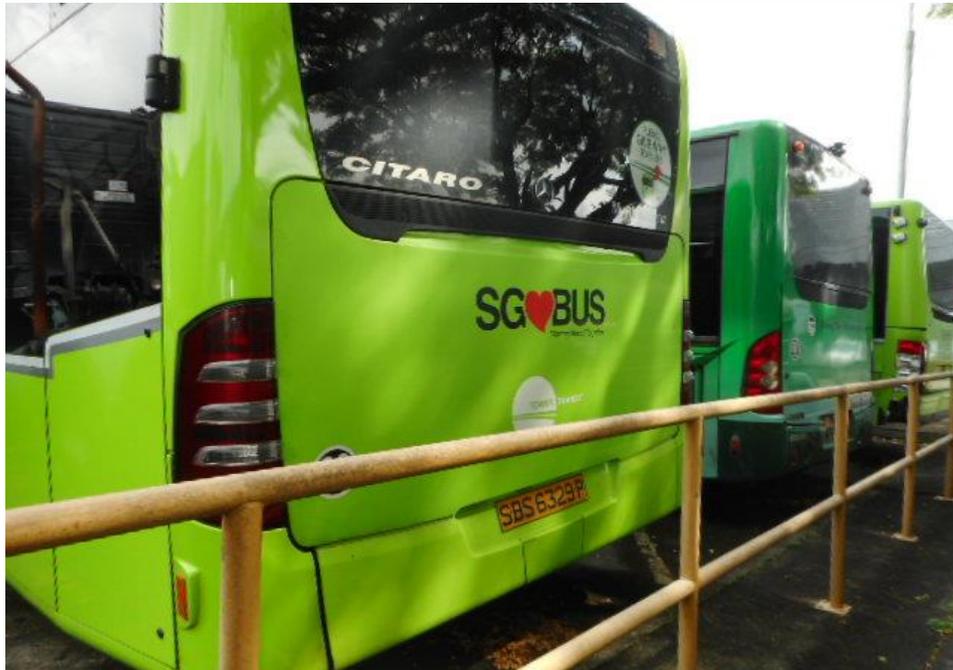
**Photo 2** shows a general view of the Motor Bus's rear body at the time of my inspection. The Motor Bus was observed to be intact and unaffected to by the accident.

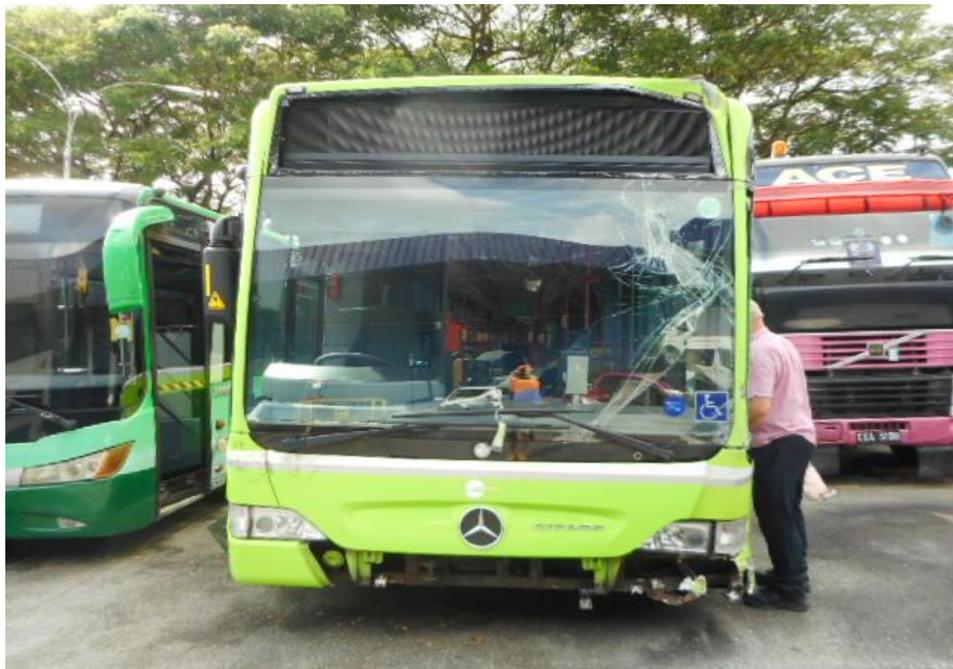
4. The mileage of the Motor Bus at the time of my inspection was 464,247km.
5. The Motor Bus was observed to sustained damage at its front and left portion. Its front windscreen, front body panel, front bumper and its front left door were damage at the time of my inspection as a result of the accident.

**Photo 3** shows a general view of the front body of the Motor Bus at the time of my inspection. The Motor Bus was observed to sustained damage at its front portion. Its front windscreen, front body panel, front bumper and its front left door were damage at the time of my inspection as a result of the accident.

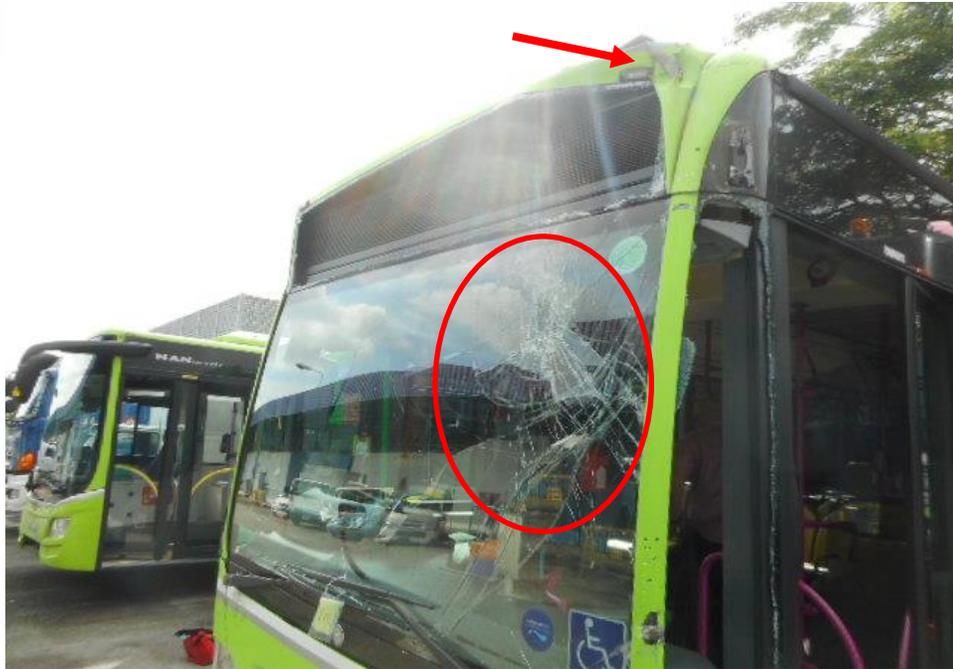
**Photo 4** shows a close up view of the front body of the Motor Bus at the time of my inspection. The Motor Bus was observed to sustained damage at its front portion. Its front windscreen (red circle) and front body panel (arrowed) were damage at the time of my inspection as a result of the accident.

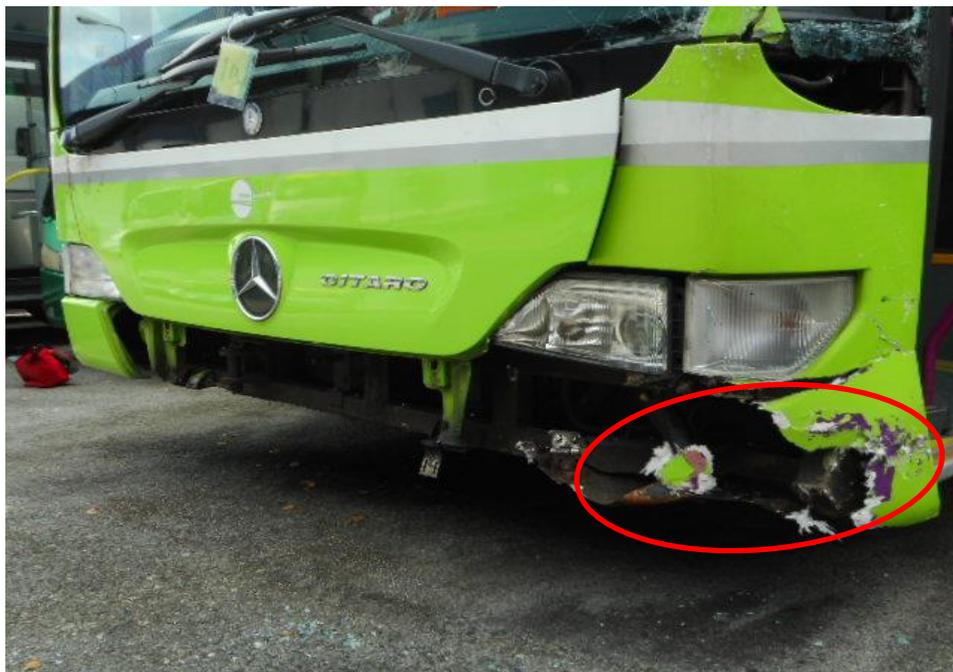
**Photo 5** shows a close up view of the front body of the Motor Bus at the time of my inspection. The Motor Bus was observed to sustained damage at its front portion. Its front bumper (circled) were damage at the time of my inspection as a result of the accident.

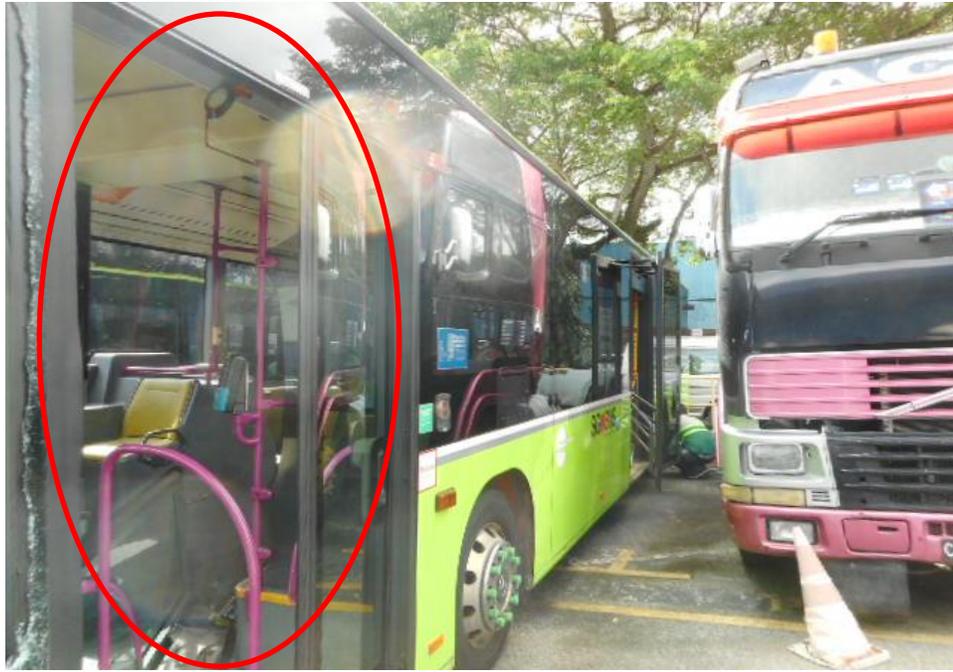
**Photo 6** shows a general view of the left body of the Motor Bus at the time of my inspection. The Motor Bus was observed to sustained damage at its left portion. Its front left door (circled) were damage at the time of my inspection as a result of the accident.

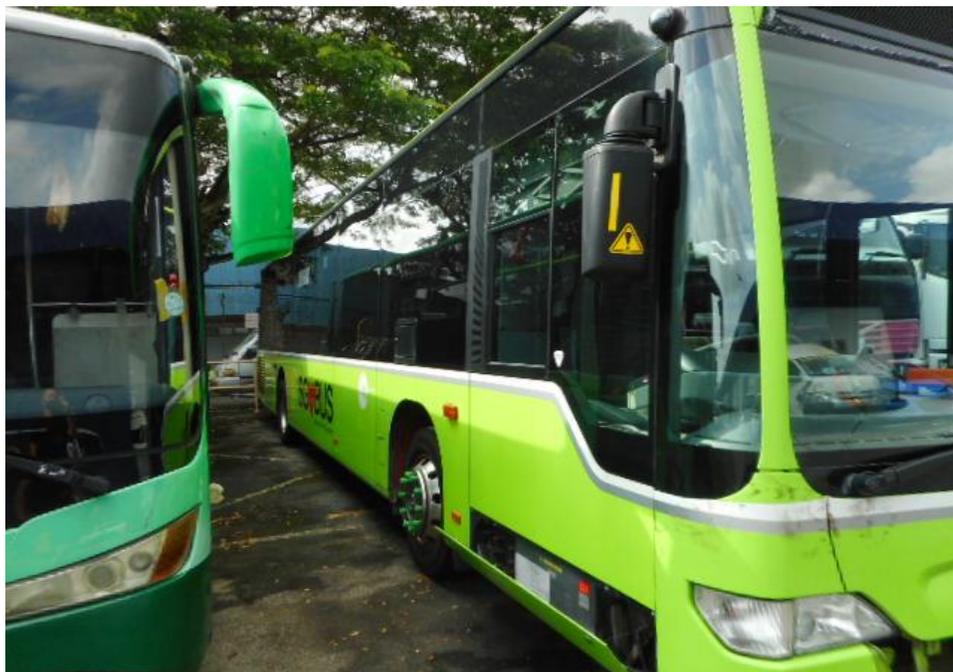
**Photo 7** shows a general view of the right body of the Motor Bus at the time of my inspection. The Motor Bus was observed to be intact and unaffected by the accident.

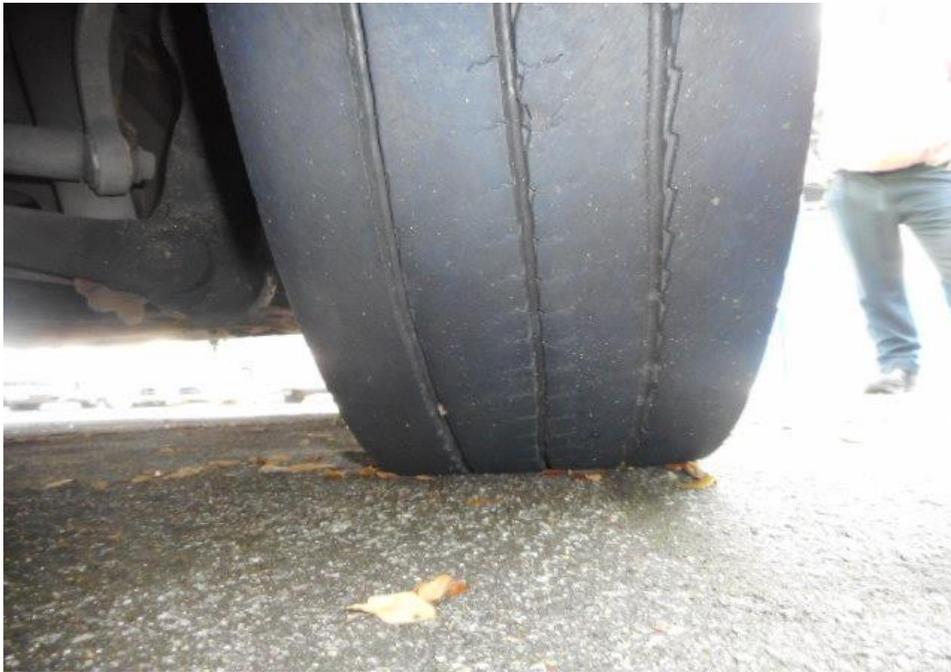
**Photo 8** shows the condition of the front right tyre of the Motor Bus, which was observed to be in serviceable condition with remaining tread depth of approximately 7.2mm. The tyre, which was wrapped around standard steel wheel rim, was also observed to be sufficiently inflated for vehicular operation. There was no tear, cut or burst mark(s) on the outer and the inner sidewalls as well as across the tread of the 6 tyres that were fitted on the Motor Bus.

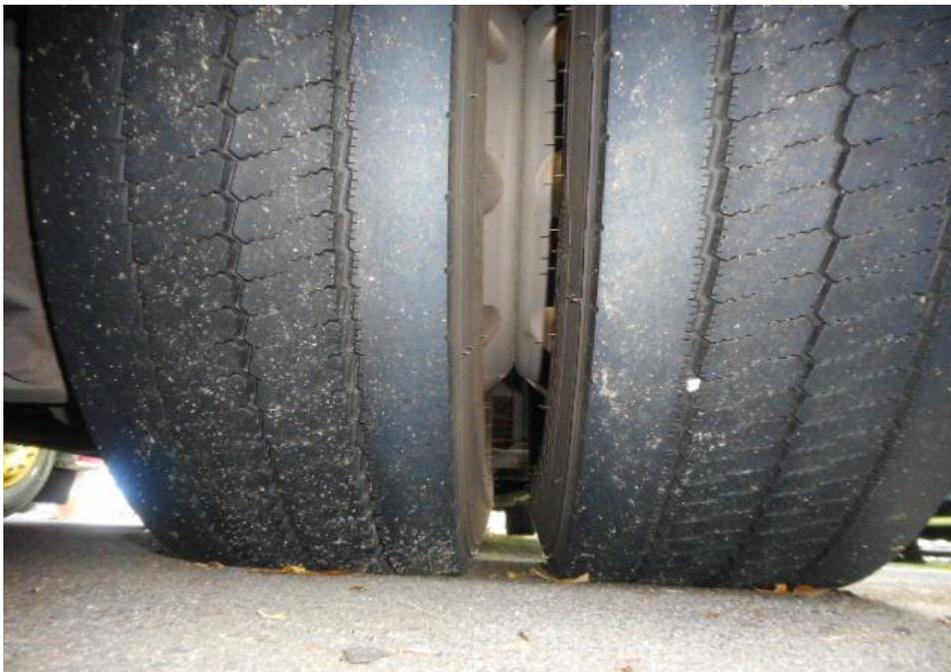
**Photo 9** shows the condition of the rear right tyre of the Motor Bus, which was observed to be in serviceable condition with remaining tread depth of approximately 7.9mm. The tyre, which was wrapped around standard steel wheel rim, was also observed to be sufficiently inflated for vehicular operation.

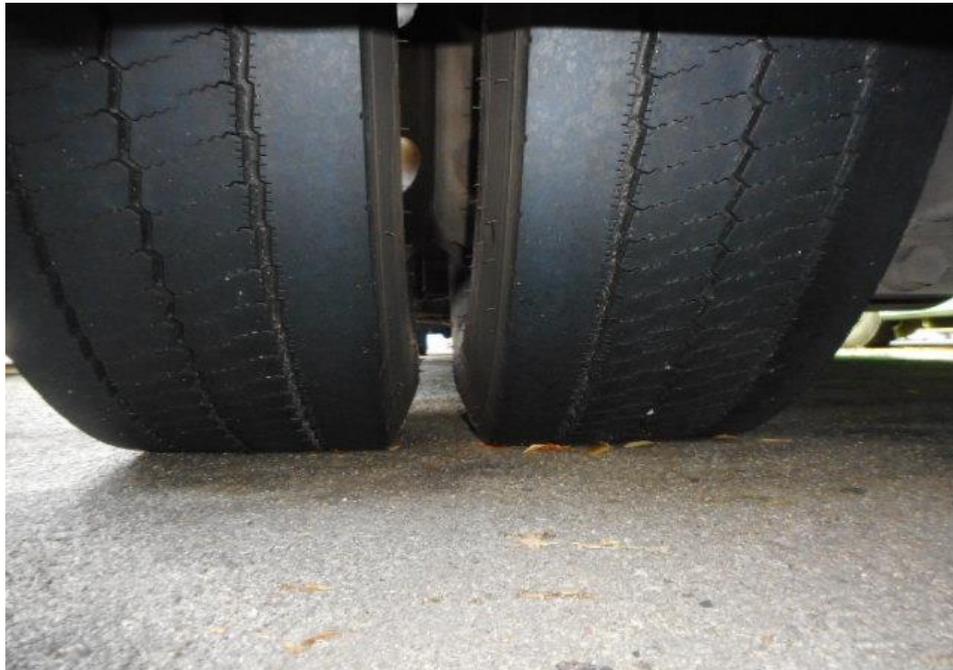
**Photo 10** shows the condition of the rear left tyres of the Motor Bus, which was observed to be in serviceable condition with remaining tread depth of approximately 7.6mm. The tyres, which were wrapped around standard steel wheel rim, were also observed to be sufficiently inflated for vehicular operation. There was also no damage found on all 6 steel wheel rims of the Motor Bus.

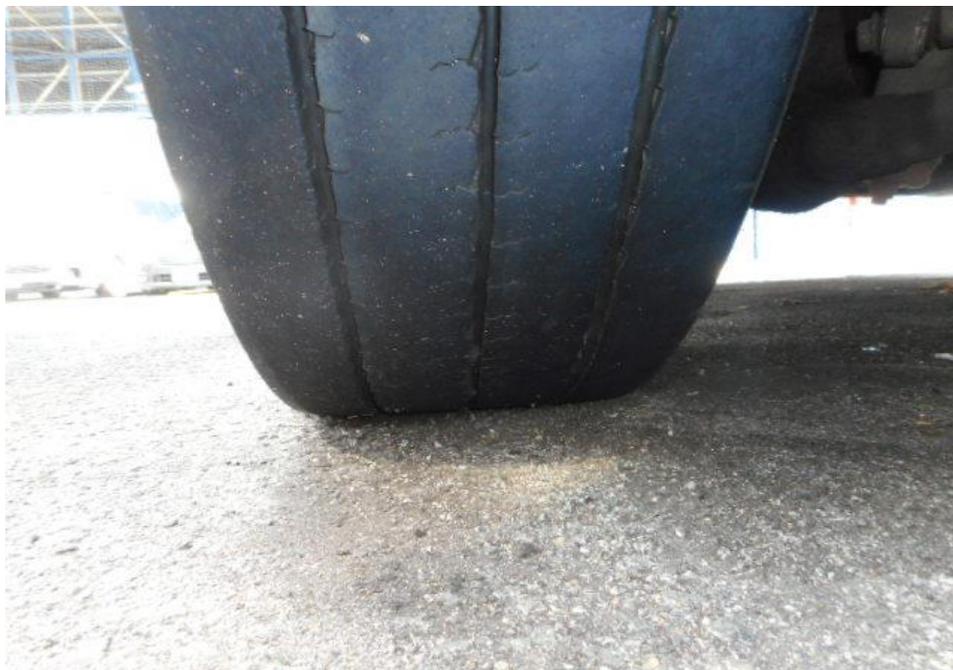
**Photo 11** shows the condition of the front left tyres of the Motor Bus, which were observed to be in serviceable condition with remaining tread depth of approximately 7.8mm. There was also no tear, cut or burst mark(s) on the outer and the inner sidewalls as well as across the tread of the 6 tyres that were fitted on the Motor Bus.

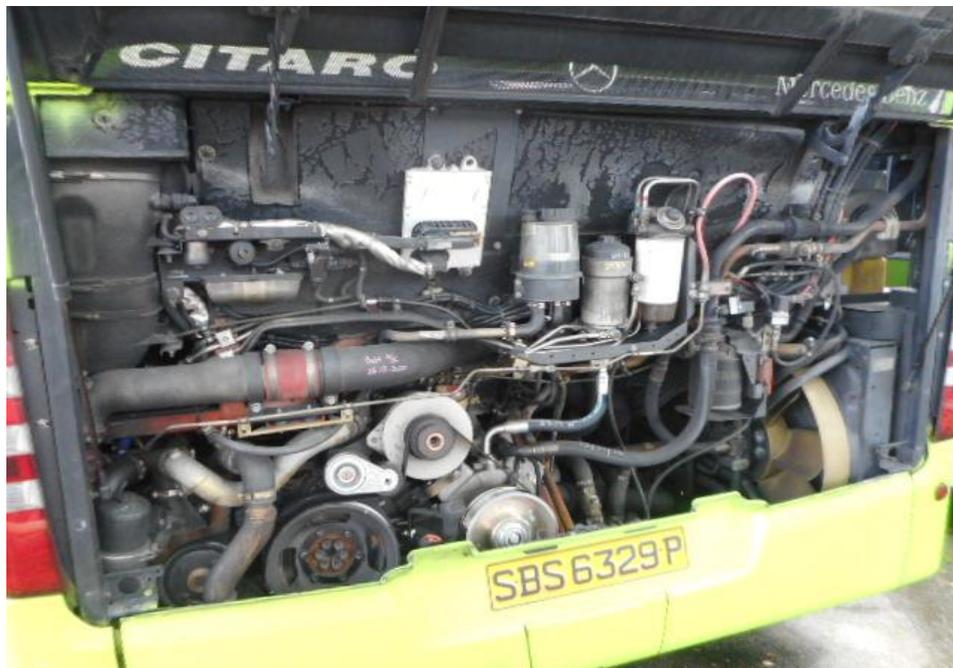
**Photo 12** shows a general view of the Motor Bus's engine compartment, which was accessed by lifting the rear of the Motor Bus. The various parts and components inside the engine compartment were unaffected by the accident. There was also no sign(s) or indication(s) of fresh fluid leakage and/or fluid stain within the engine compartment

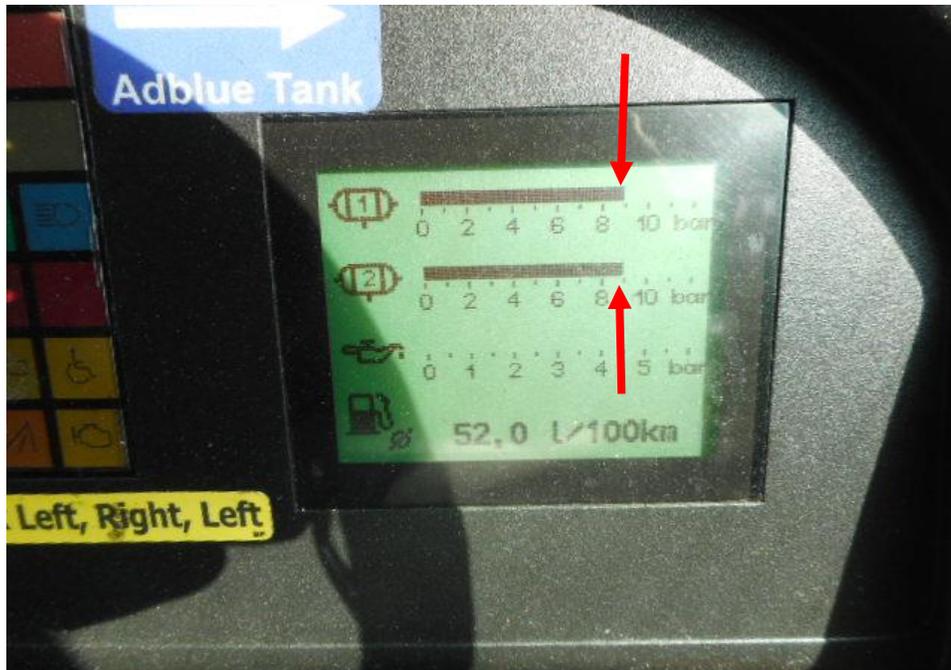
**Photo 13** shows the air in the air brake cylinder of the Motor Bus at the time of my inspection. The air in the cylinder was observed to be of sufficient level & serviceable at the time of the accident.

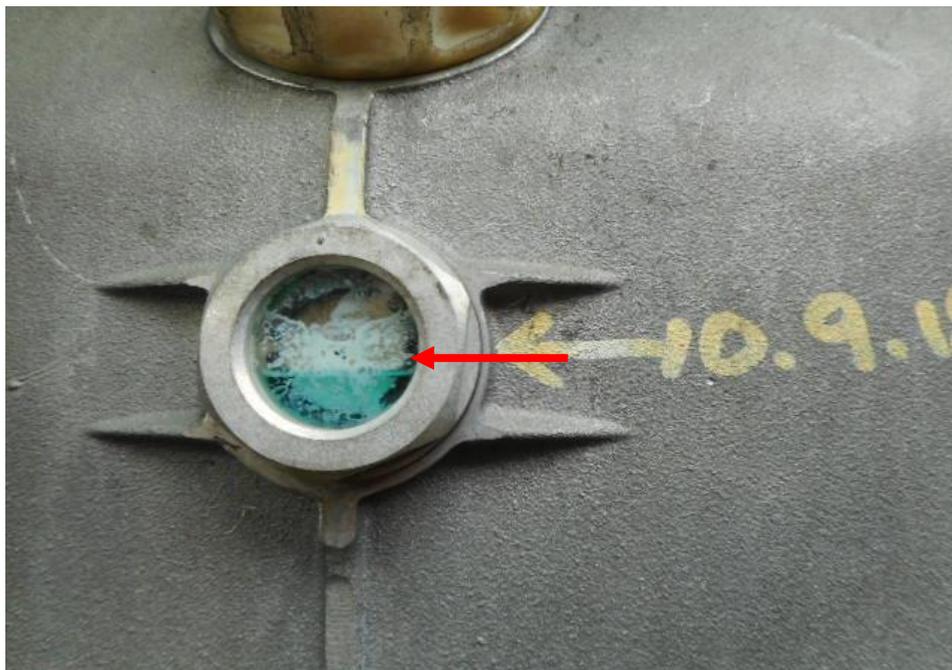
**Photo 14** shows the engine coolant reservoir of the Motor Bus at the time of my inspection. The engine coolant was observed to be of sufficient level (arrowed) and without any visible contamination.

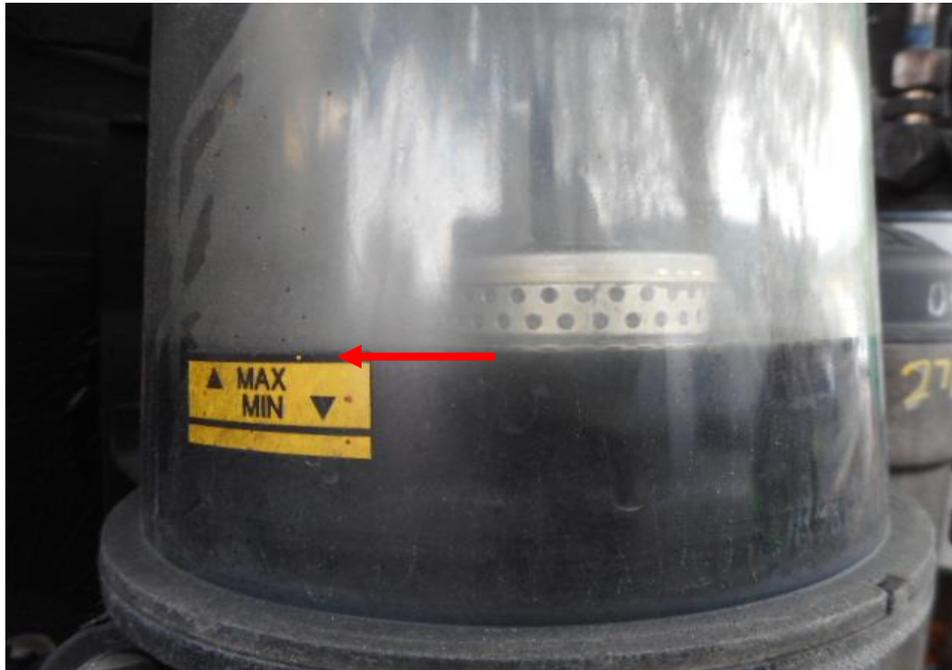
**Photo 15** shows the power steering fluid reservoir of the Motor Bus at the time of my inspection. The power steering fluid was observed to be of sufficient level and without any visible contamination.

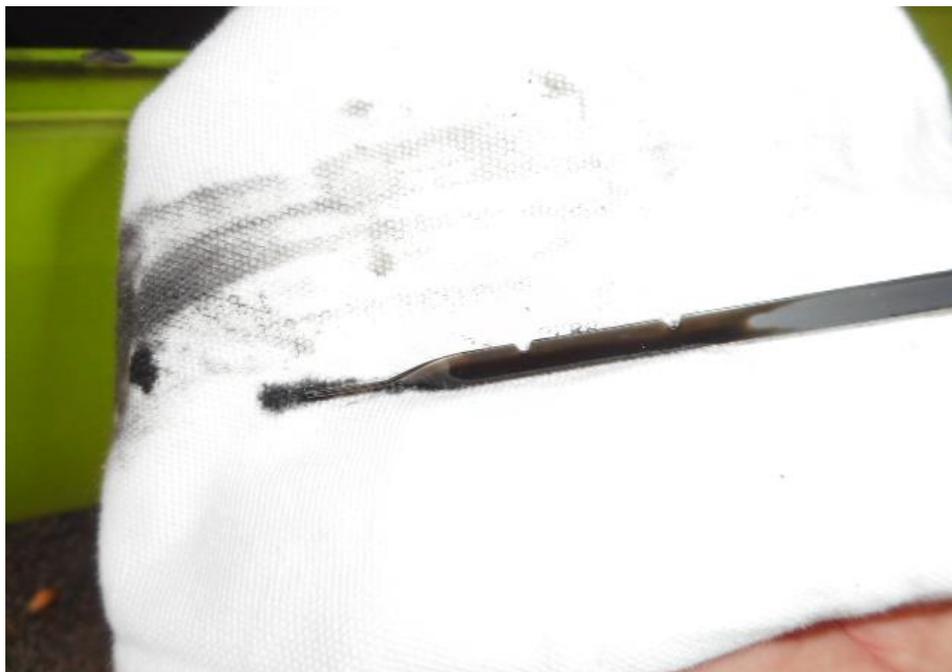
**Photo 16** shows the engine oil dip stick system of the Motor Bus at the time of my inspection. The engine oil was observed to be sufficient for operation and without any visible contamination.

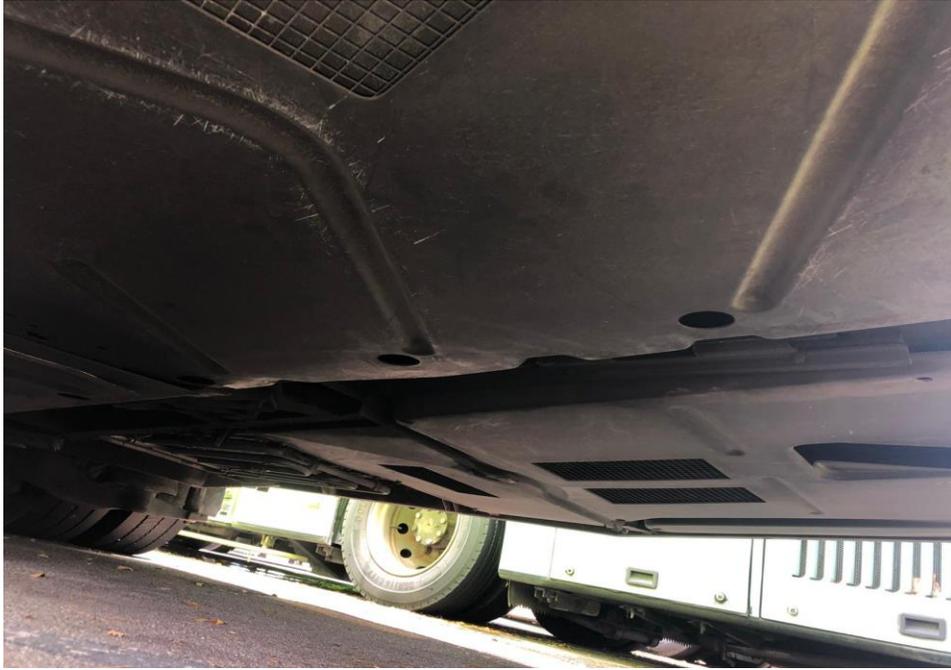
**Photo 17** shows the undercarriage of the Motor Bus, at the area where the engine housing and transmission housing are located. I did not find any sign(s) or indication(s) of fluid leak and/or fluid stain(s) on the underside of the Motor Bus.

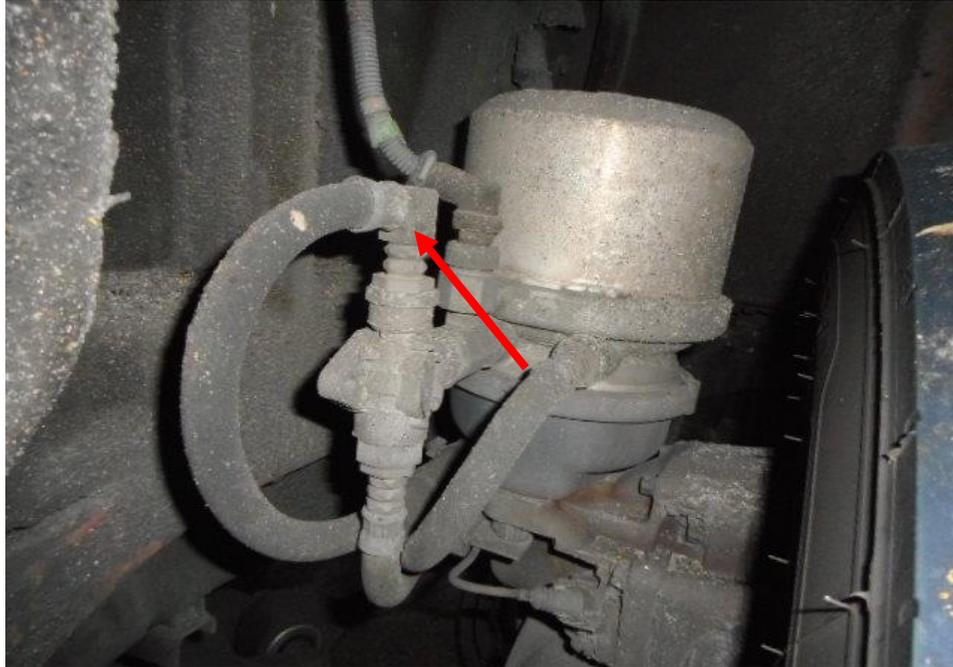
**Photo 18** shows the brake pipe (arrowed) at the rear right wheel of the Motor Bus. I did not observe any leakage of brake fluid at the time of my inspection of the Motor Bus. My static tests of the Motor Bus's braking system, along with my visual examination of the various mechanical components in the braking system, had indicated that there was no internal leakage of pressure/vacuum. Hence the braking system of the Motor Bus was likely to be in serviceable condition at the material time of accident.

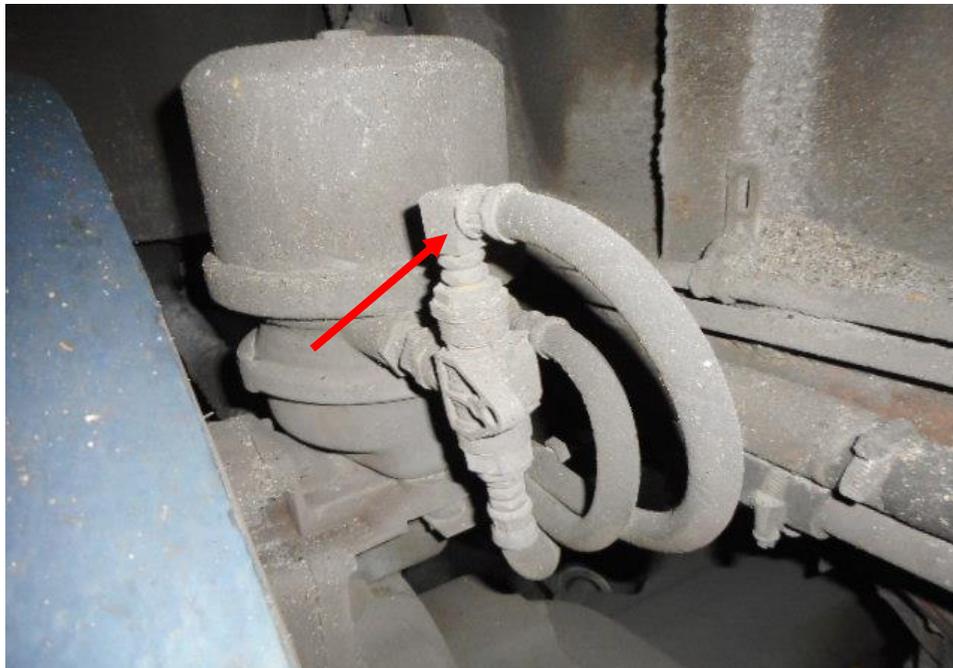
**Photo 19** shows the brake pipe (arrowed) at the rear left wheel of the Motor Bus. I did not observe any leakage of brake fluid at the time of my inspection of the Motor Bus. My static tests of the Motor Bus's braking system, along with my visual examination of the various mechanical components in the braking system, had indicated that there was no internal leakage of pressure/vacuum. Hence the braking system of the Motor Bus was likely to be in serviceable condition at the material time of accident.

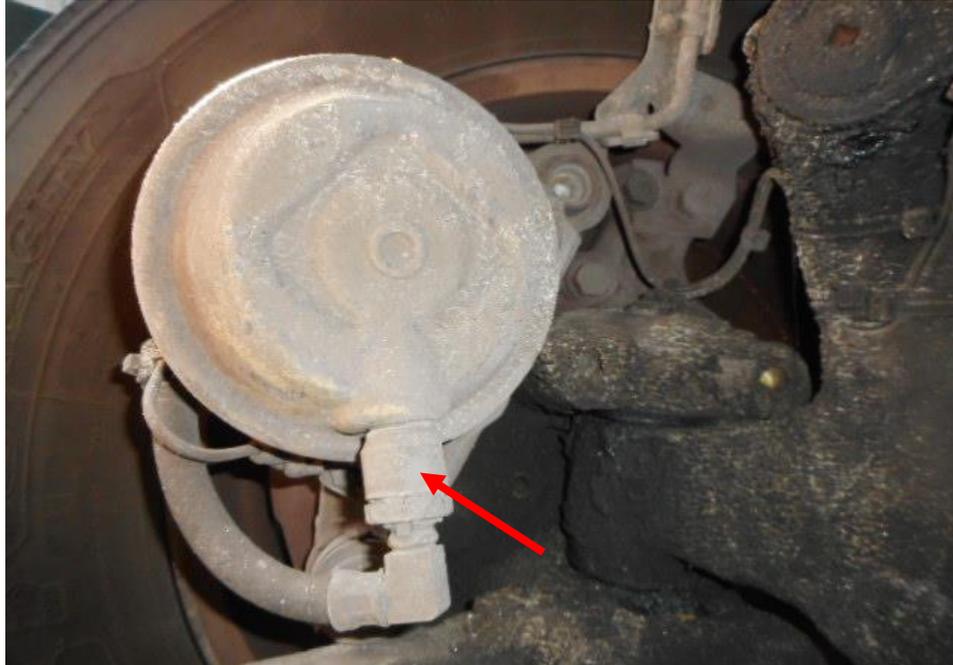
**Photo 20** shows the brake pipe (arrowed) at the front right wheel of the Motor Bus. I did not observe any leakage of brake fluid at the time of my inspection of the Motor Bus. My static tests of the Motor Bus's braking system, along with my visual examination of the various mechanical components in the braking system, had indicated that there was no internal leakage of pressure/vacuum. Hence the braking system of the Motor Bus was likely to be in serviceable condition at the material time of accident.

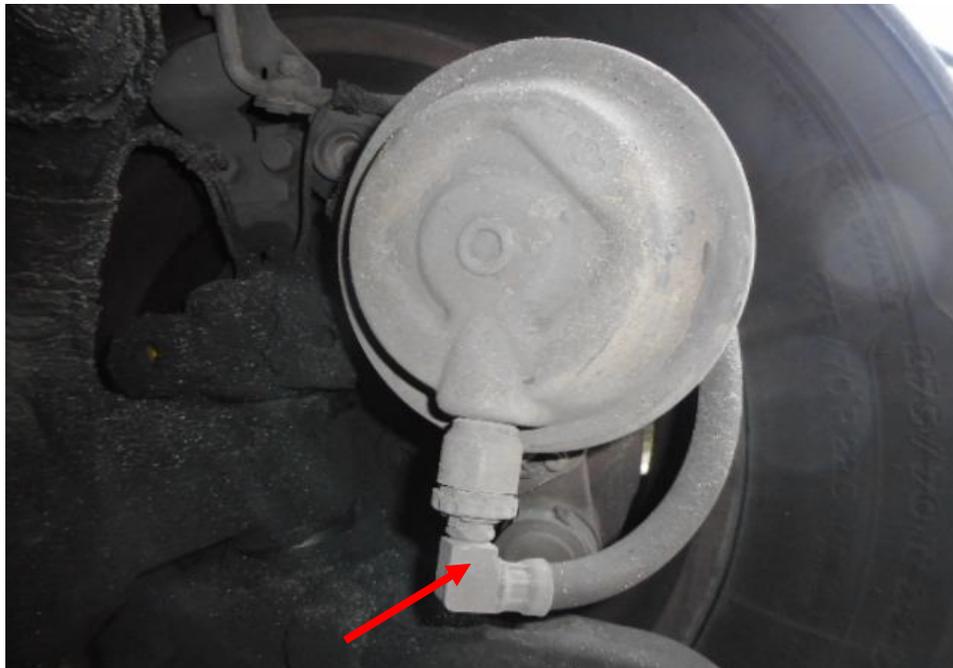
**Photo 21** shows the brake pipe (arrowed) at the front left wheel of the Motor Bus. I did not observe any leakage of brake fluid at the time of my inspection of the Motor Bus. My static tests of the Motor Bus's braking system, along with my visual examination of the various mechanical components in the braking system had indicated that there was no internal leakage of pressure/vacuum. Hence the braking system of the Motor Bus was likely to be in serviceable condition at the material time of accident.

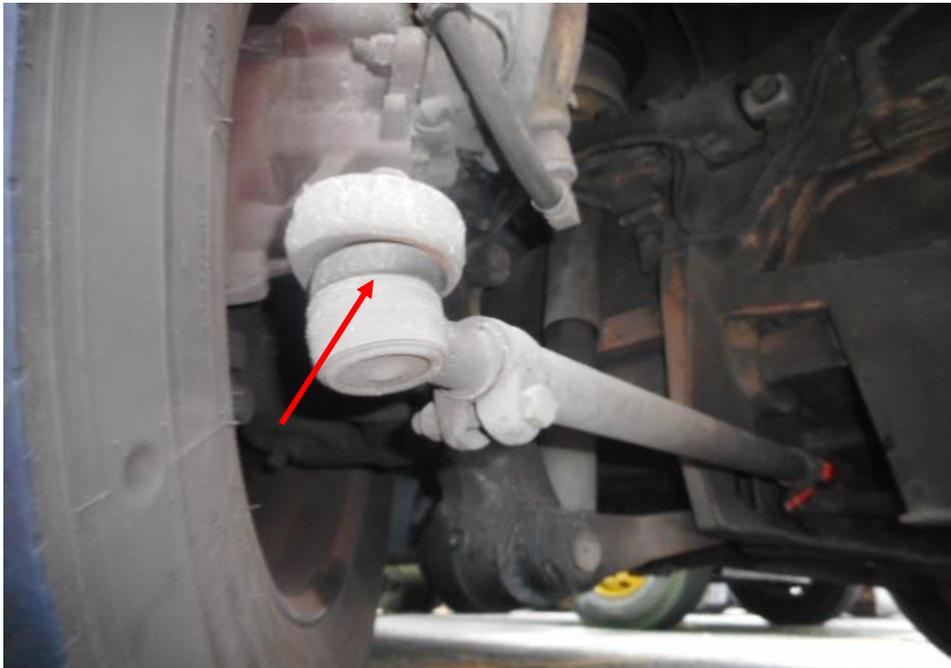
**Photo 22** shows the various undercarriage components at the front right wheel of the Motor Bus, in particular the steering tie rod end (arrowed). The various steering components were all found to be intact, suggesting that the steering system of the Motor Bus was likely to be in serviceable condition at the material time of accident. There was also no sign of fluid stain(s) observed on the various undercarriage components.

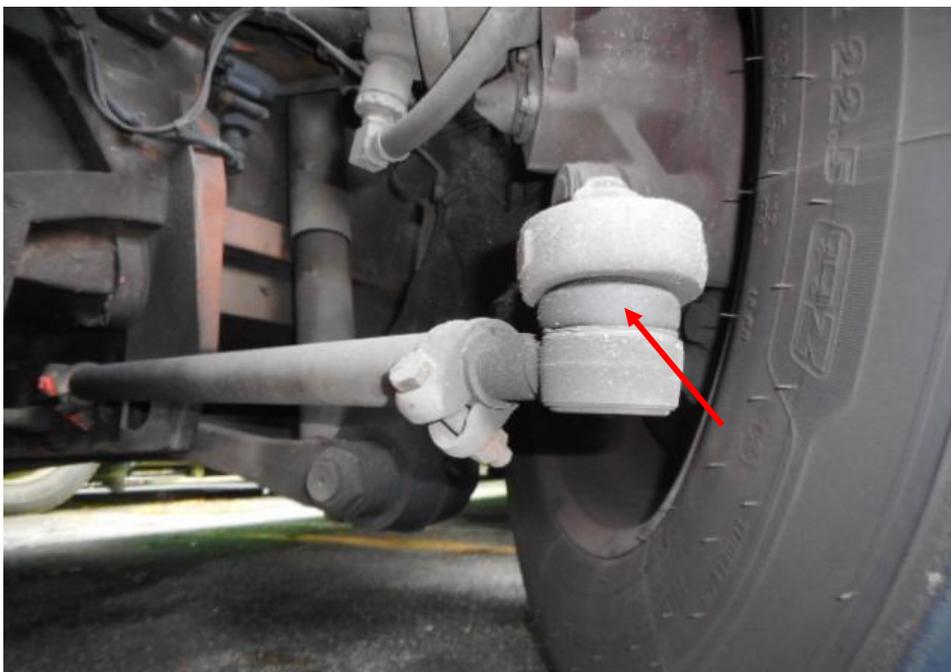
**Photo 23** shows the various undercarriage components at the front left wheel of the Motor Bus, in particular the steering tie rod end (arrowed). The various undercarriage components of the Motor Bus were all found to be intact without any visible damage. There was also no sign of fluid stain(s) observed on the various undercarriage components.

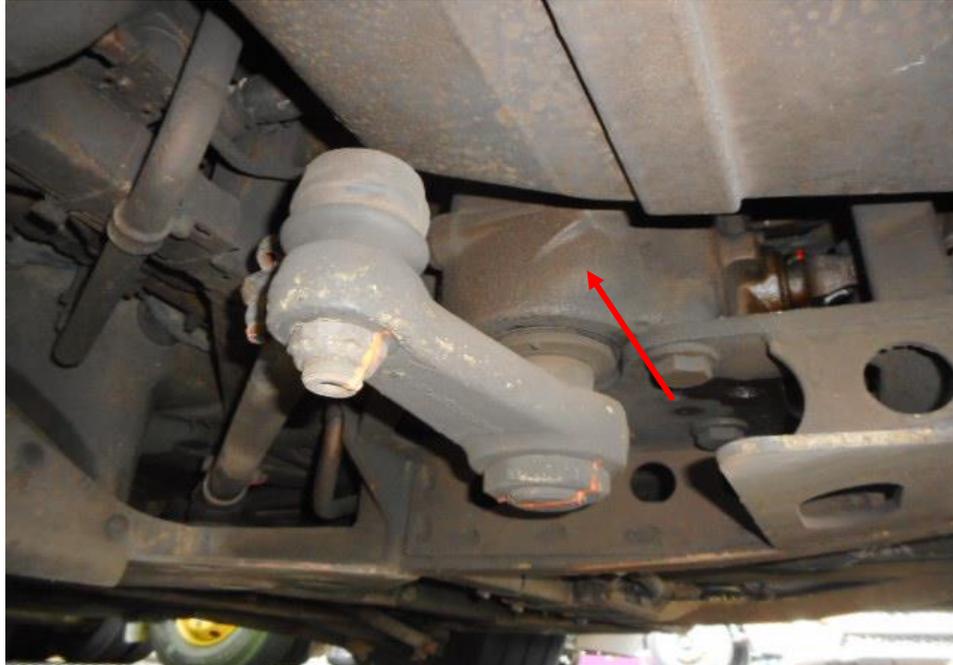
**Photo 24** shows the steering box component (arrowed) at the undercarriage of the Motor Bus was found to be intact without any visible damage. There was also no sign of fluid stain(s) observed on the various undercarriage components.

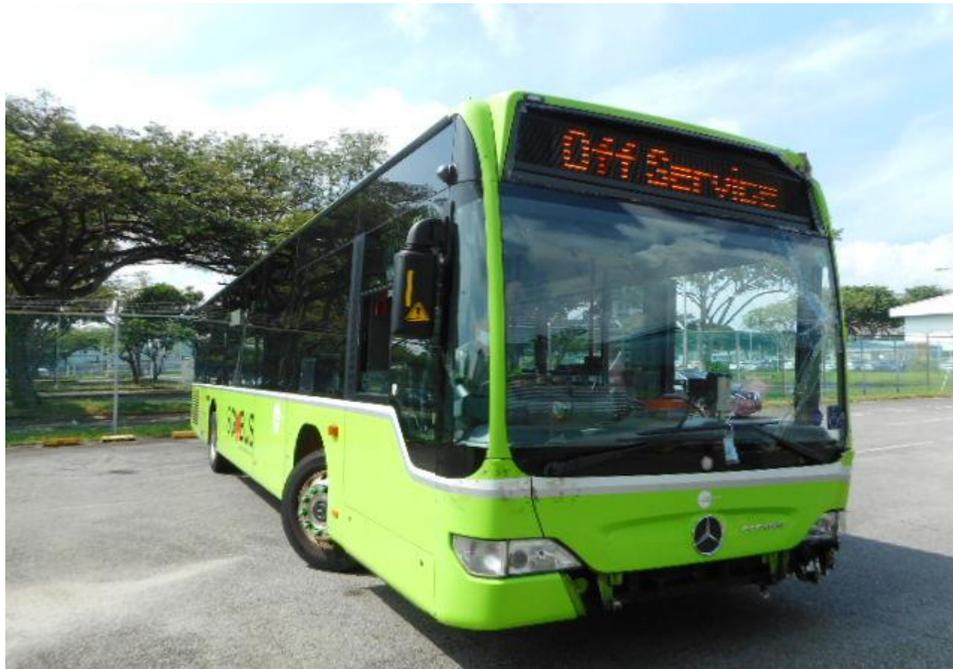
**Photo 25** shows the front right wheel of the Motor Bus turned to its full left. During my steering system test, I did not experience any abnormal free play and/or resistance when I had turned the steering wheel towards full left and full right. This would suggest that the steering system of the Motor Bus was likely to be in serviceable condition at the material time of accident.
