Our Reference : KAAS/TA/6162/6649/TP/01.21  
Date : 12 February 2021

## VEHICLE APPRAISAL REPORT

Registration No.	: SMF 6649D	Chassis Frame No.	: WDD2040412A258168
Make / Model	: Mercedes Benz C200 Kompressor	Engine No. ( Logcard )	: 27195031184574
Year of Manufacture/Reg	: 2009	Odometer Reading	: 197,913 KM
Colour	: Black		
Class / Type	: Saloon

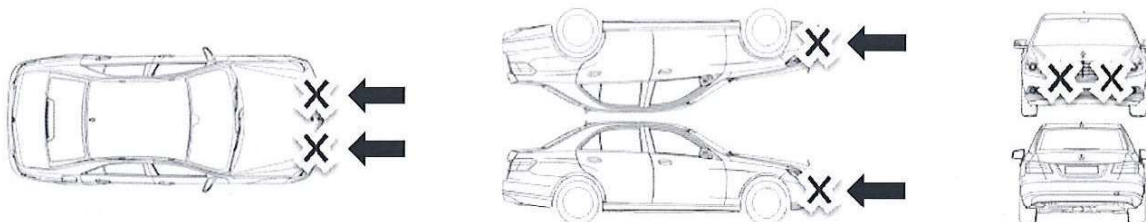
Damages sustained were consistent with the subject vehicle being involved in a collision with another vehicle and the impact was delivered **Squarely to the Front** portion of the vehicle.

The general area of damages is at the **Front portion**  
( Please refer to the parts list and photographs as attached for more information )
