Your Ref: Mercedes Benz CLA 45  
(chassis number WDD1183542N067892)  
Our Ref : CI/TP21007932/D

26 July 2021

**INSPECTION REPORT OF AN UNREGISTERD MERCEDES BENZ CLA 45  
MOTOR CAR WITH CHASSIS NUMBER WDD1183542N067892**

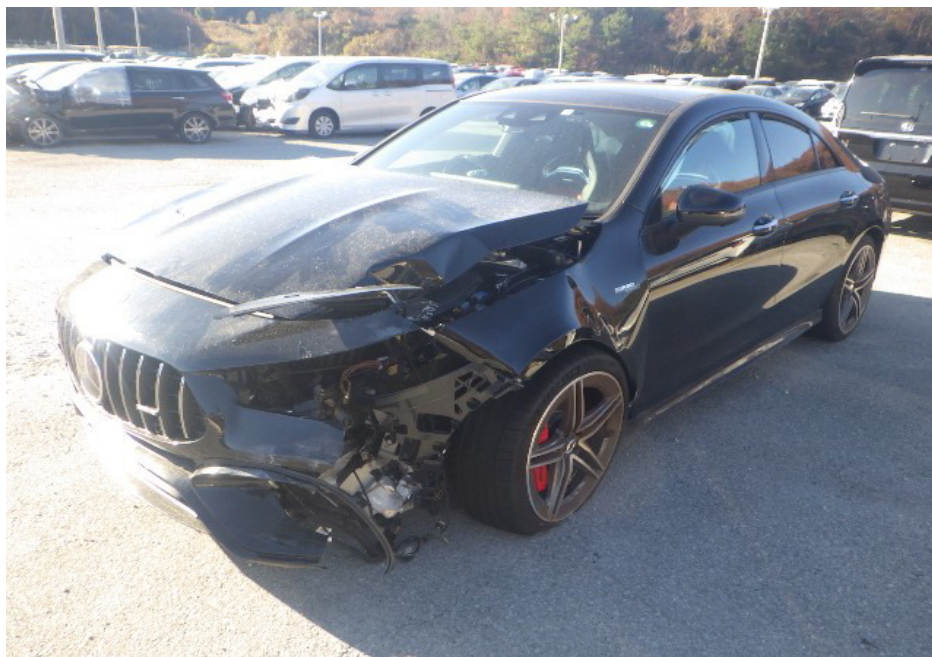
**Photo 1** shows the front left body of the Motor Car (photograph provided to me). The Motor Car was observed to have sustained damages at its front left portion. Body parts damaged include the front bumper, front bumper left bracket, front bumper left lower grille, front left headlamp, front left fender and front left fender inner shield amongst others.

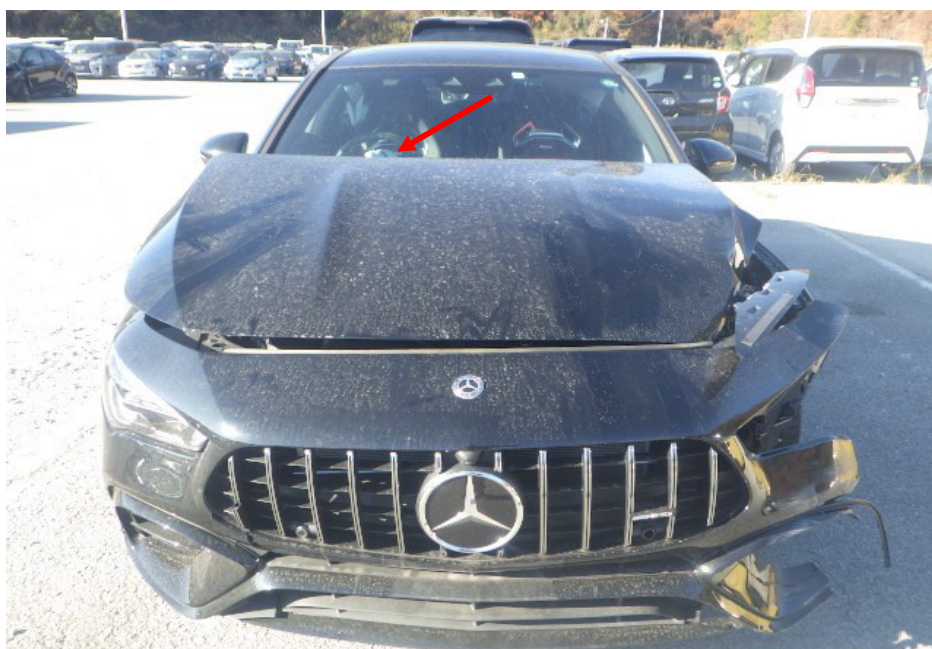
**Photo 2** shows the frontal body of the Motor Car (photograph provided to me). The Motor Car was observed to have sustained damages at its front left portion. Body parts damaged include the front bumper, front bumper centre lower grille, front left headlamp and front bonnet amongst others. The driver's airbag (arrowed) was observed to be deployed.

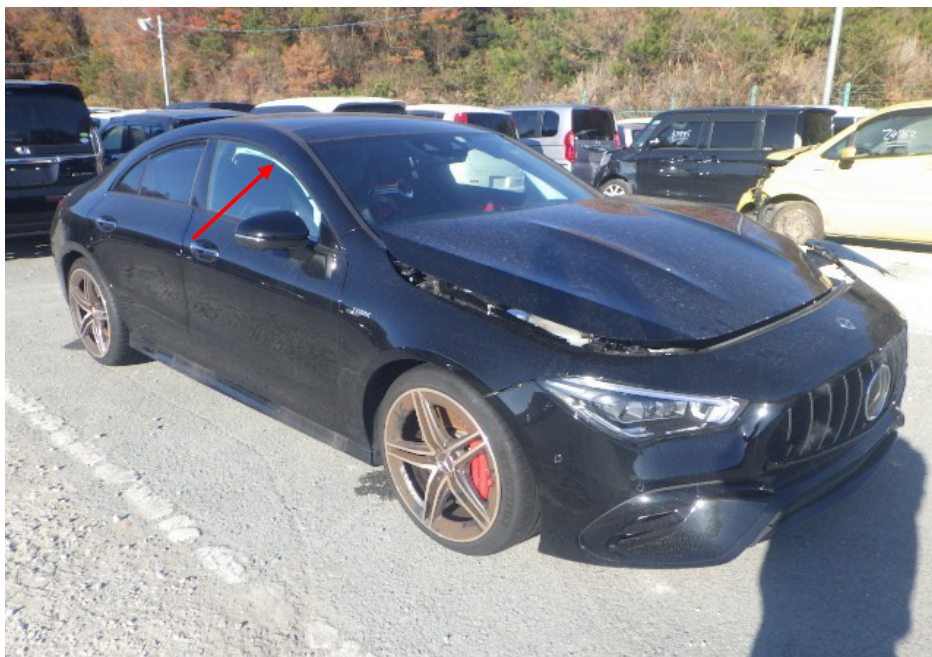
**Photo 3** shows the front right body of the Motor Car (photograph provided to me). Apart for the front left portion, there was no physical damage seen to other areas of the Motor Car. I had however observed that the right curtain airbag (arrowed) was activated.

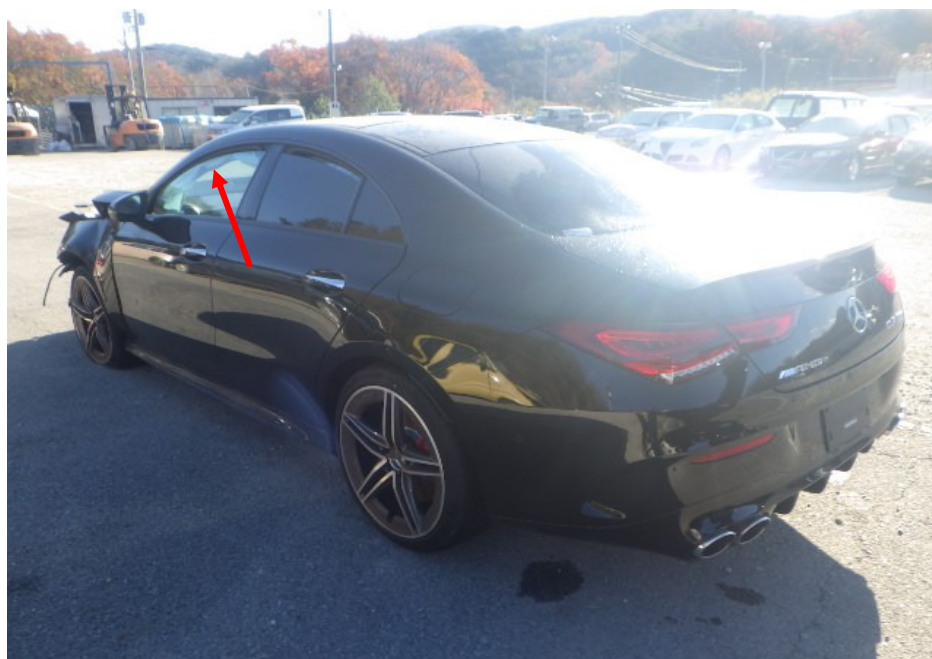
**Photo 4** shows the rear left body of the Motor Car (photograph provided to me). Apart for the front left portion, there was no physical damage seen to other areas of the Motor Car. I had however observed that the left curtain airbag (arrowed) was activated.

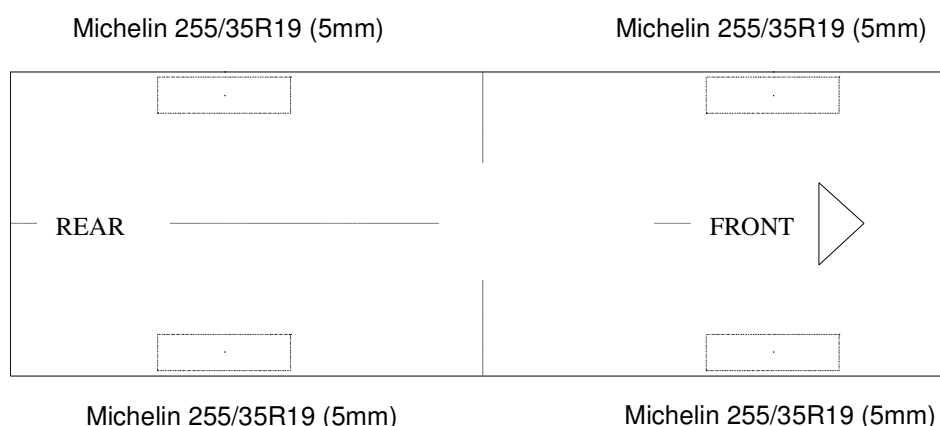
8. It was fitted with 19inch sport wheel rims that were wrapped with tyres that were observed to be of serviceable condition. The tyres were also sufficiently inflated for vehicular operation. The tyre brand, tyre size and approximate remaining tread depth of the 4 tyres of the Motor Car were recorded as follows: -

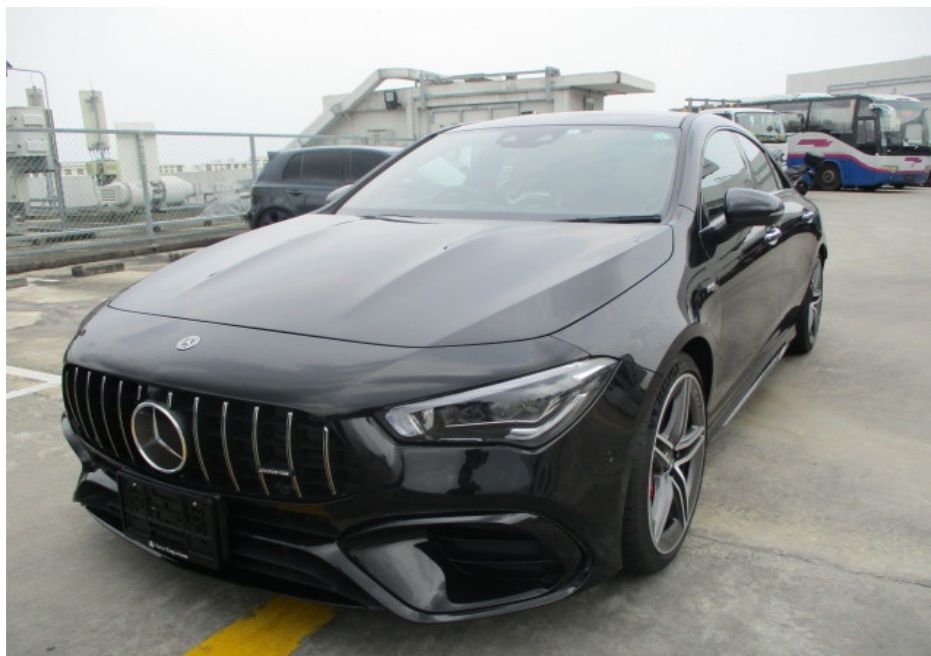
**Photo 5** shows a general view of the front left body of the Motor Car at the time of my inspection. The Motor Car was observed to be in a relatively good general condition with no loose exterior fittings observed. The body parts at the front left of the Motor Car were visually examined and it was observed that the repair/restoration works carried out to the damaged area of the Motor Car (refer to photograph 1 & 2 above) were reasonably adequate and in order.

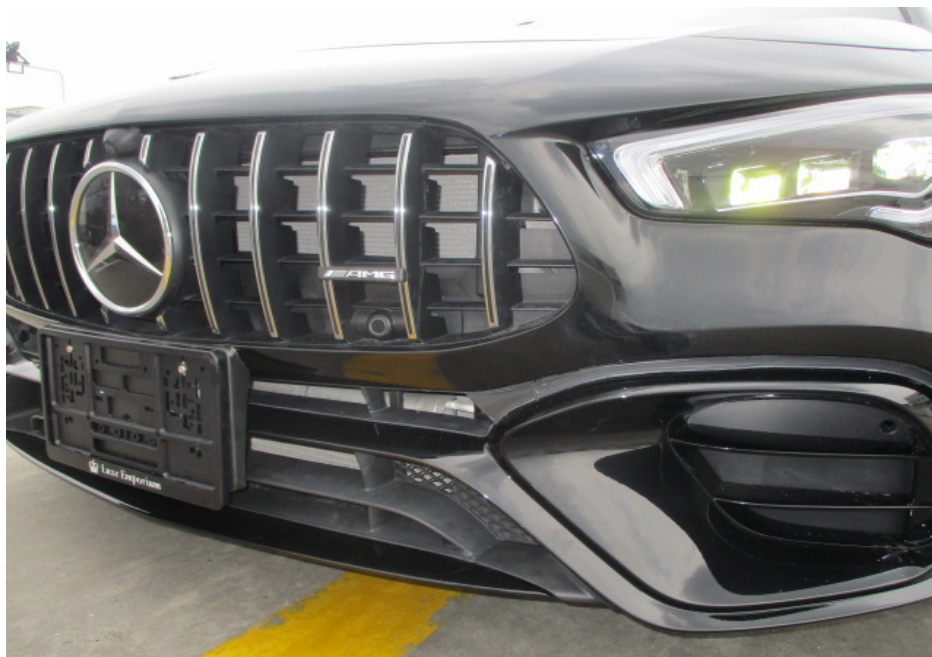
**Photo 6** shows a closer view of the front bumper, front bumper centre lower grille, front bumper left lower grille and front left headlamp of the Motor Car. The body parts at the front left portion of the Motor Car were visually examined and it was observed that the repair/restoration works carried out to the damaged area of the Motor Car (refer to photograph 1 & 2 above) were reasonably adequate and in order.

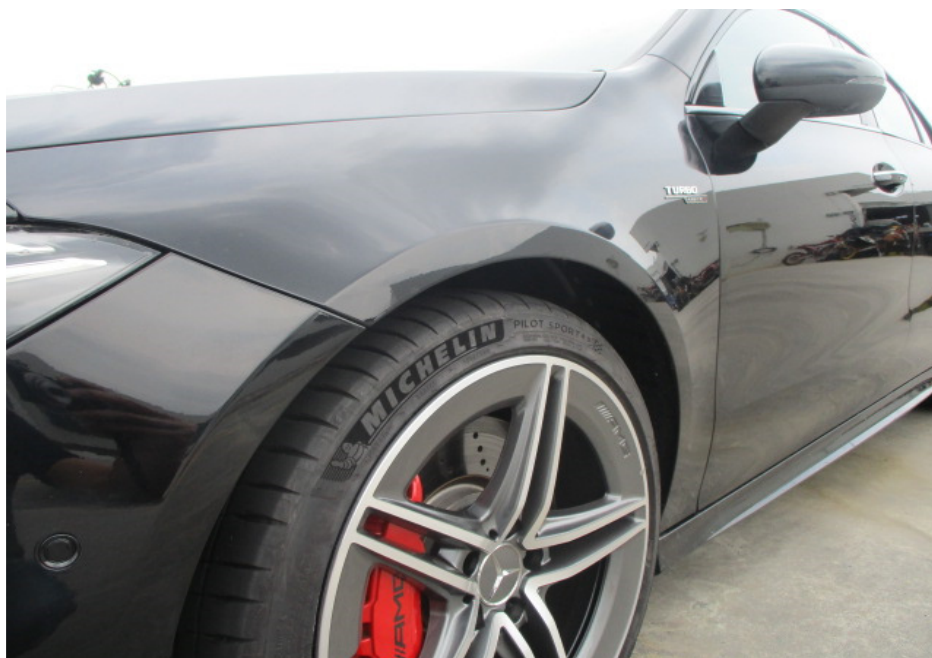
**Photo 7** shows a closer view of the front bumper and front left fender of the Motor Car. The body parts at the front left portion of the Motor Car were visually examined and it was observed that the repair/restoration works carried out to the damaged area of the Motor Car (refer to photograph 1 & 2 above) were reasonably adequate and in order.

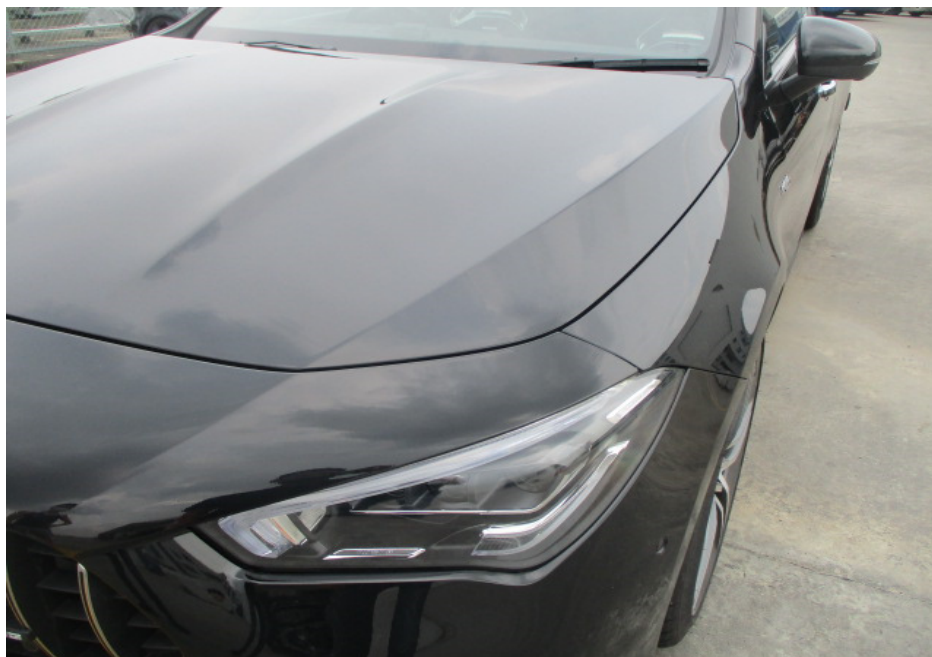
**Photo 8** shows a closer view of the front bonnet and front left headlamp of the Motor Car. The body parts at the front left portion of the Motor Car were visually examined and it was observed that the repair/restoration works carried out to the damaged area of the Motor Car (refer to photograph 1 & 2 above) were reasonably adequate and in order.

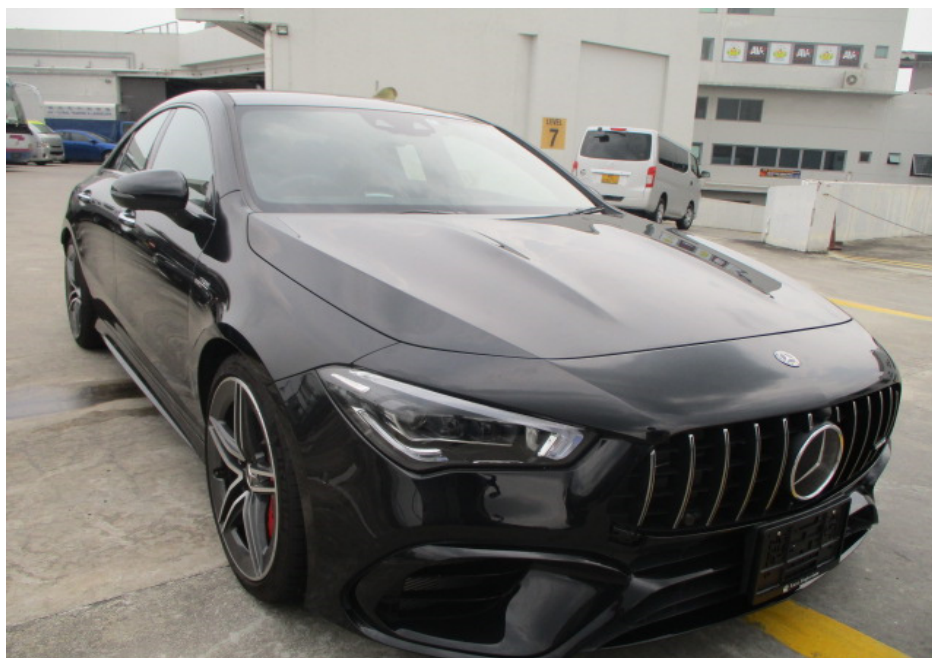
**Photo 9** shows a general view of the front right body of the Motor Car at the time of my inspection. The Motor Car was observed to be in a relatively good general condition with no loose exterior fittings observed. The body parts at the front left of the Motor Car were visually examined and it was observed that the repair/restoration works carried out to the damaged area of the Motor Car (refer to photograph 1 & 2 above) were reasonably adequate and in order.

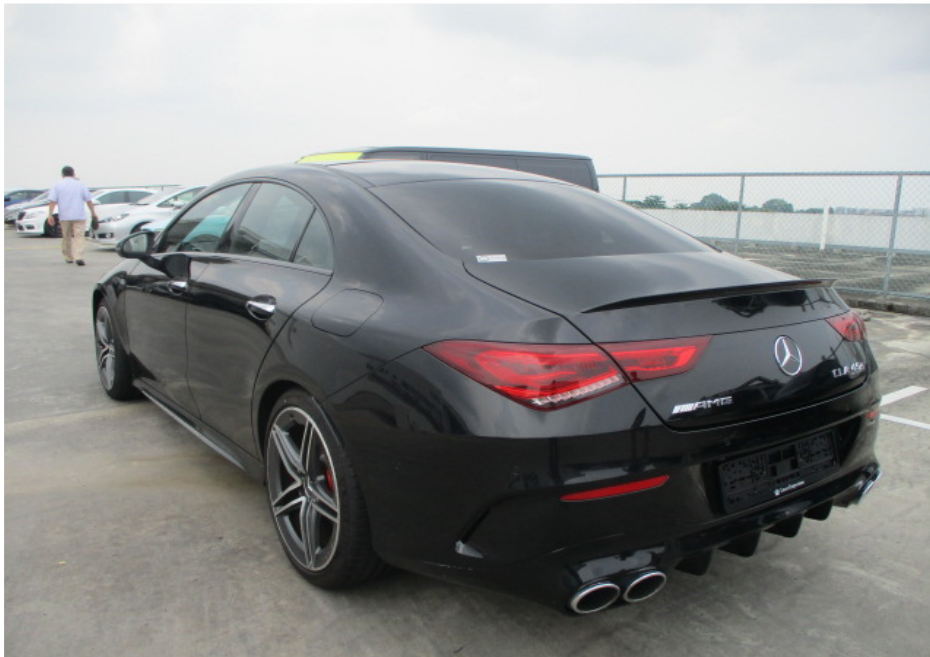
**Photo 10** shows a general view of the rear left body of the Motor Car at the time of my inspection. The Motor Car was observed to be in a relatively good general condition with no loose exterior fittings observed. The mileage of the Motor Car recorded at the time of my inspection was 1,732km.

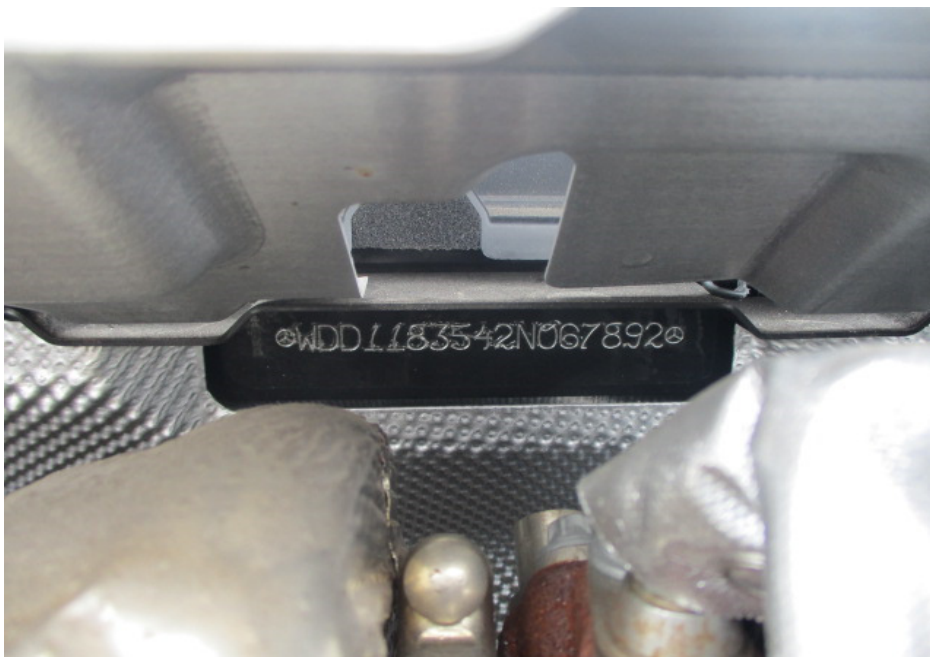
**Photo 11** shows the chassis number of the Motor Car. The chassis number recorded was WDD1183542N067892.

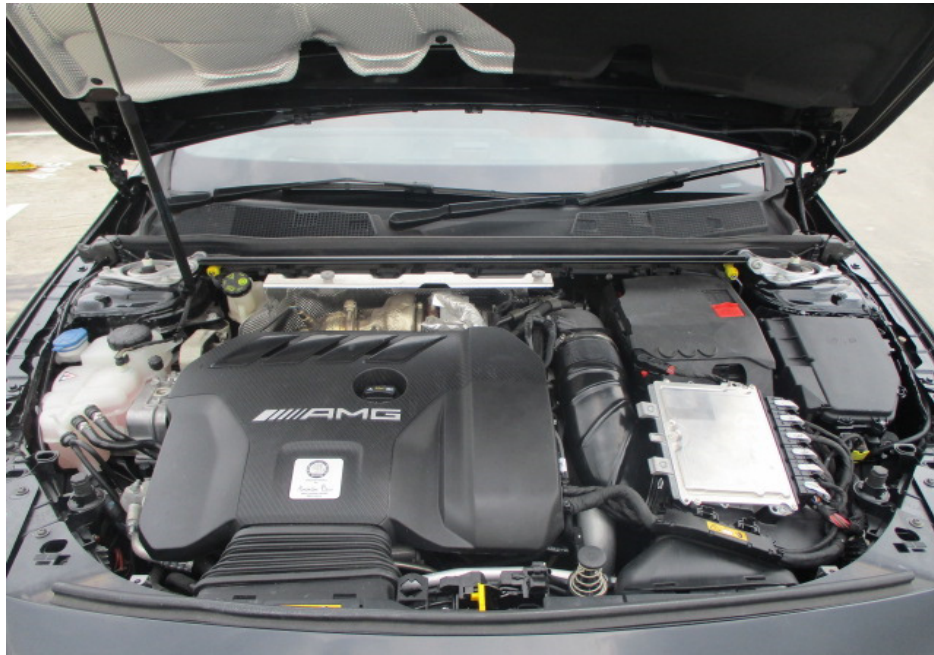
**Photo 12** shows a general view of the engine compartment of the Motor Car at the time of my inspection. The various parts and components inside the engine compartment were all observed to be intact and properly fitted. There was also no sign(s) or indication(s) of fluid leak and/or fluid stain found inside the engine compartment.

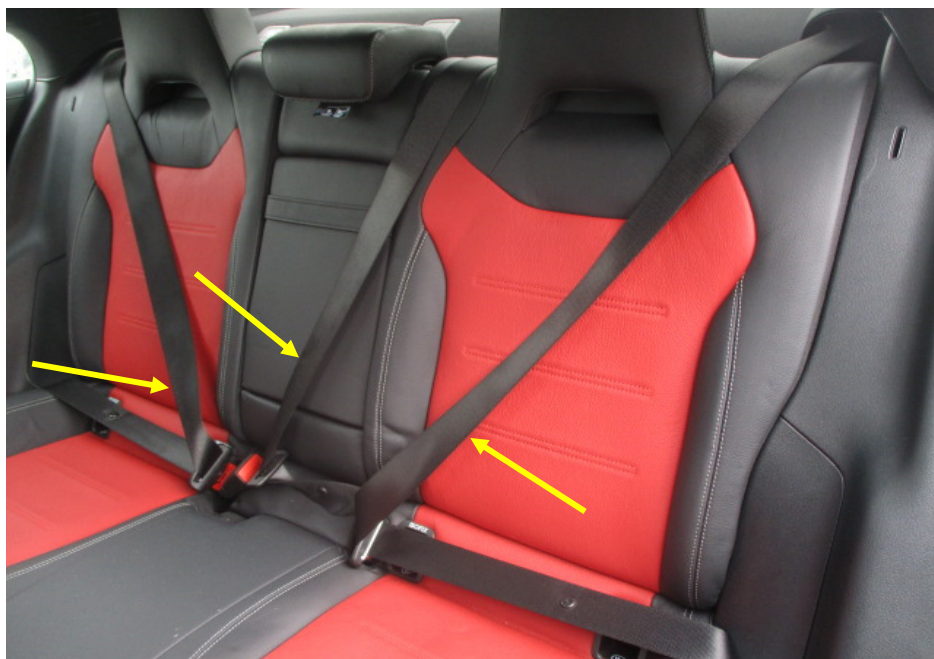
**Photo 13** shows the rear seats of the Motor Car. All the seats of the Motor Car were secured via seat rails to the floorboard. They were also fitted with a retractable seat belt reel and a pre-tensioner. The seat belts (arrowed) were tested and were able to be fastened into the respective pre-tensions that were fitted on the side of each individual seat.

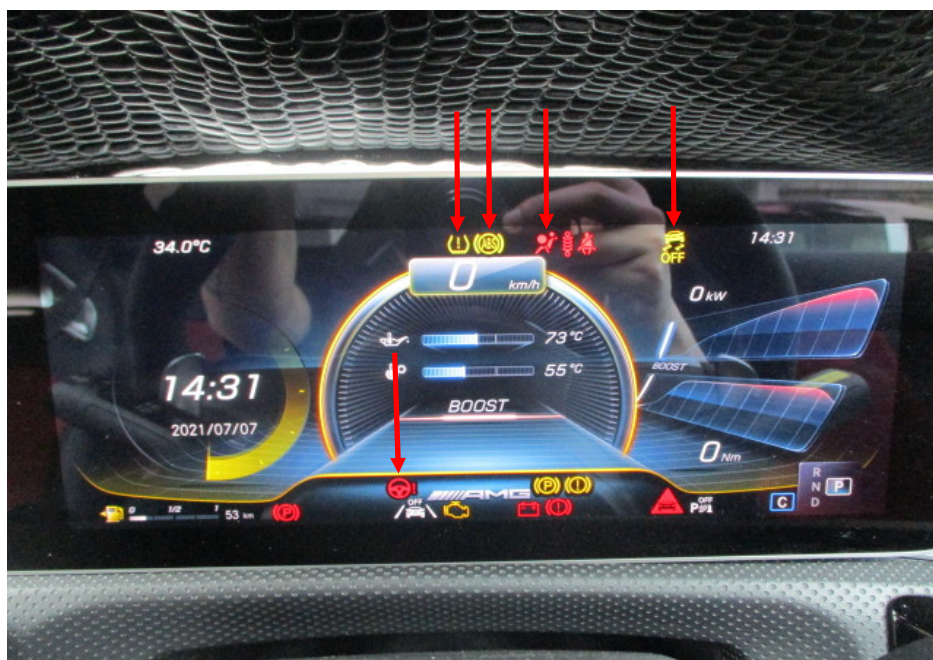
**Photo 14** shows the warning lights for the various electronic safety features appearing on the instrument panel of the Motor Car during its self-test when the engine is cranked, in particular the ABS, SRS, EPS, TPM and TCS lights (arrowed).

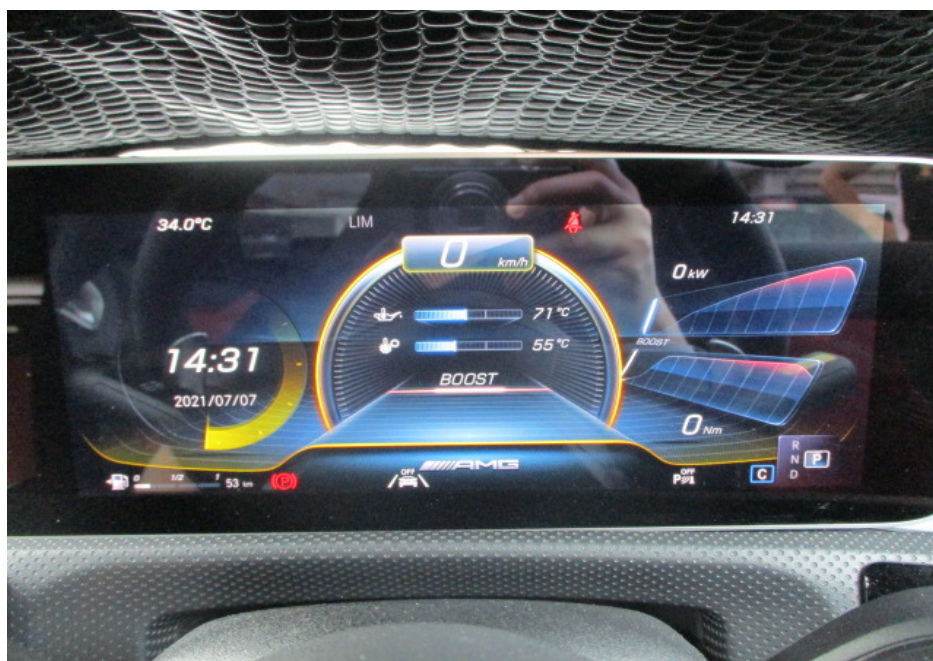
**Photo 15** shows the respective warning lights no longer illuminated, indicating that there is no fault detected to the ABS, SRS, EPS, TPM and TCS systems of the Motor Car during the self-test. These electronic systems were hence in working condition at the time of my inspection.

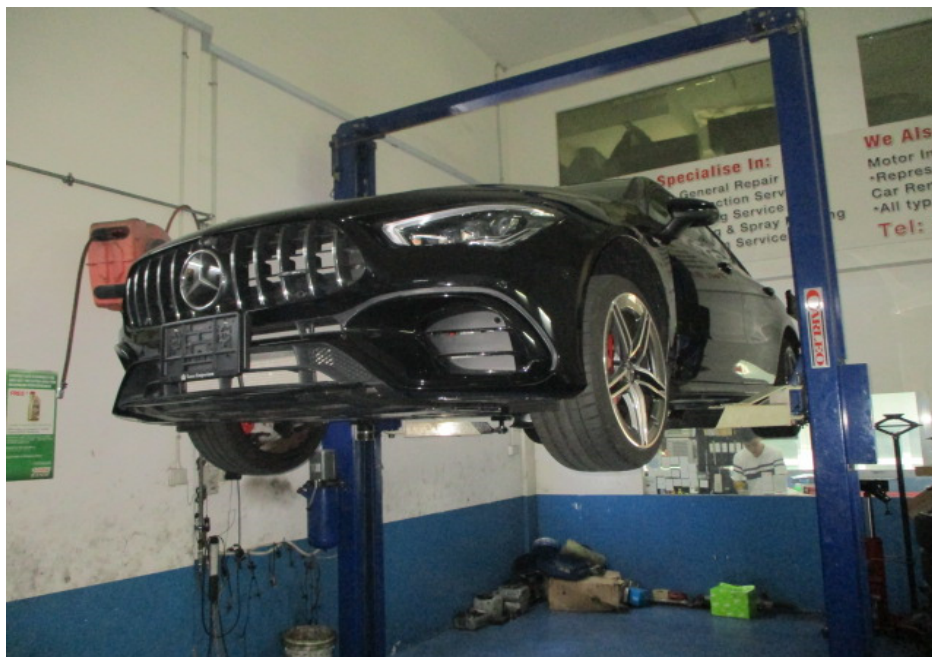
**Photo 16** shows the Motor Car hoisted up for checks on its undercarriage. There was no sign(s) or indication(s) of fluid leakage and/or fluid stain(s) on the underside of the Motor Car. The undercarriage components of the Motor Car were also all observed to be intact and secured in an appropriate manner.

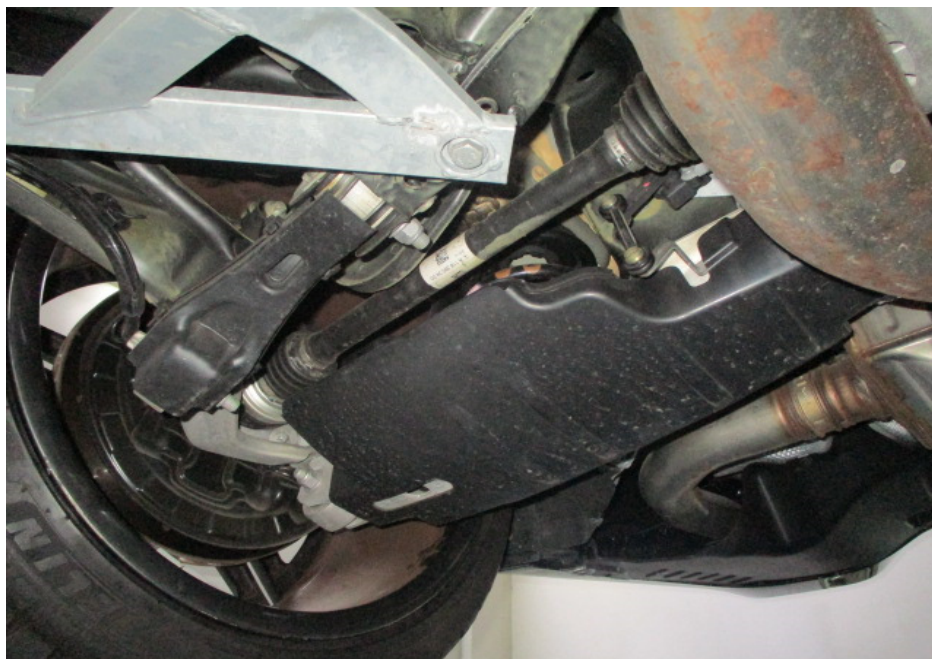
**Photo 17** shows a general view of the control arms and linkages at the rear right wheel of the Motor Car. I did not observe any fluid leak and/or fluid stain on the underside of the Motor Car. All of the Motor Car's undercarriage components were observed to be intact and secured in an appropriate manner.

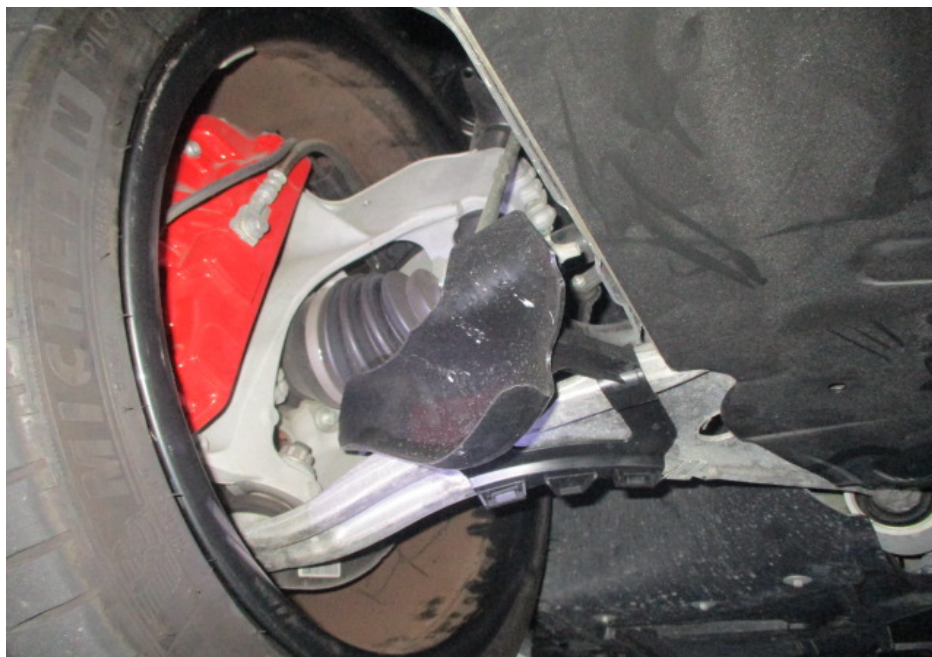
**Photo 18** shows the various undercarriage components at the front right wheel of the Motor Car. The mechanical components, control arms and linkages were all found to be intact and secured in an appropriate manner.

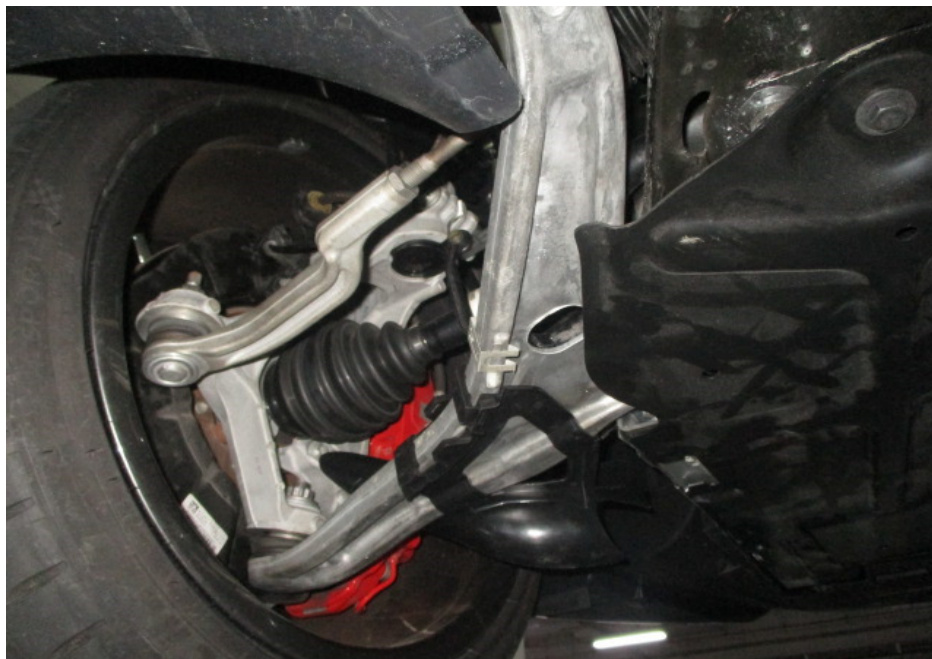
**Photo 19** shows the various undercarriage components at the front left wheel of the Motor Car. The mechanical components, control arms and linkages were all found to be intact and secured in an appropriate manner. I also did not observe any fluid leak and/or fluid stain on the underside of the Motor Car.

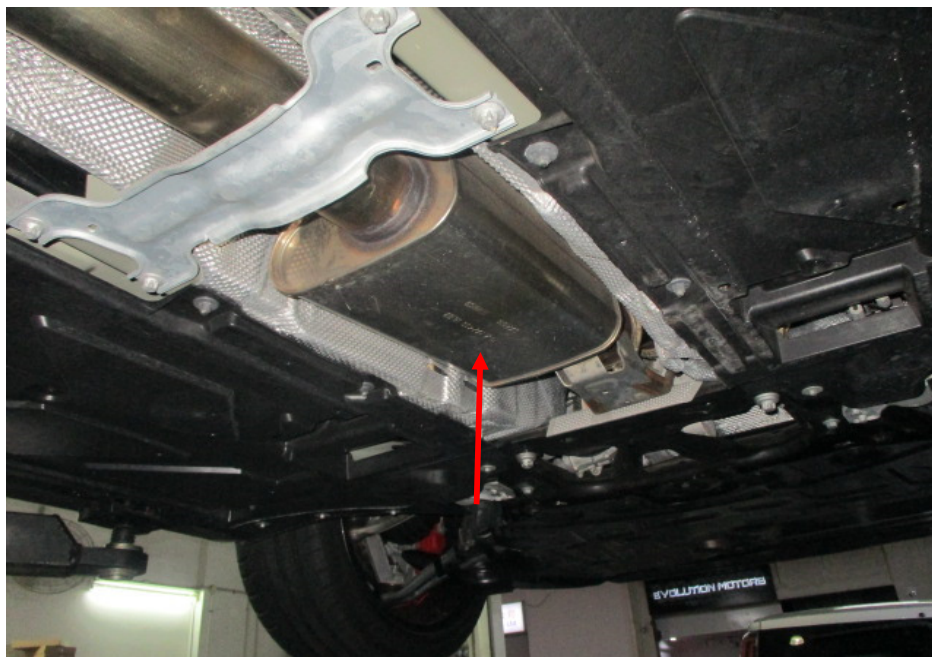
**Photo 20** shows the front section of the Motor Car's exhaust system. My examination of the Motor Car's exhaust system revealed no sign(s) or indication(s) of any cut or weld marks along its exhaust pipes, on its catalytic converter, centre resonator box (arrowed) and on its rear muffler.

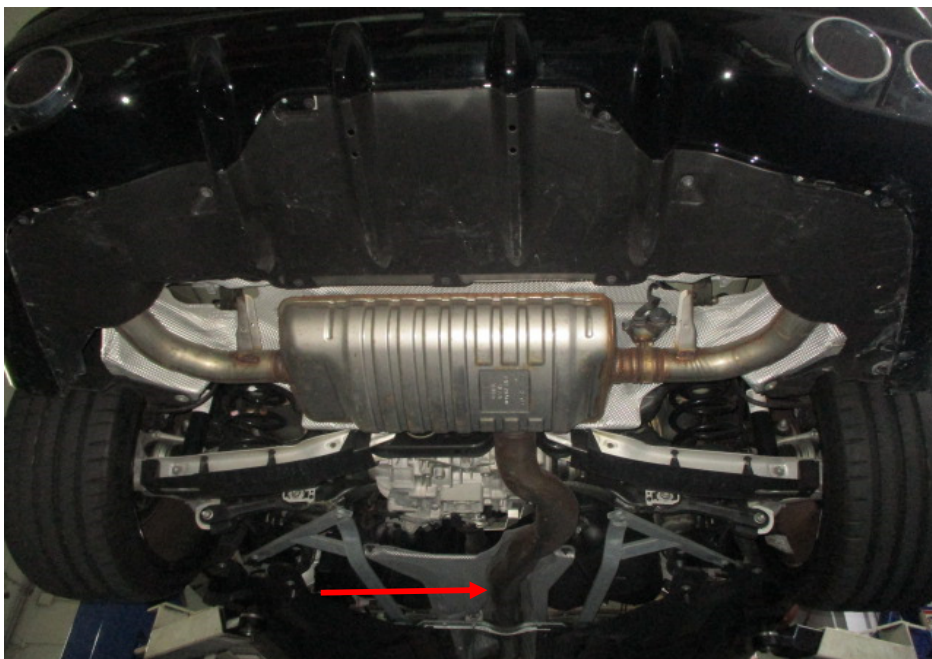
**Photo 21** shows the rear section of the Motor Car's exhaust system. My examination of the Motor Car's exhaust system revealed no sign(s) or indication(s) of any cut or weld marks along its exhaust pipes (arrowed), on its catalytic converter, centre resonator box and on its rear muffler.

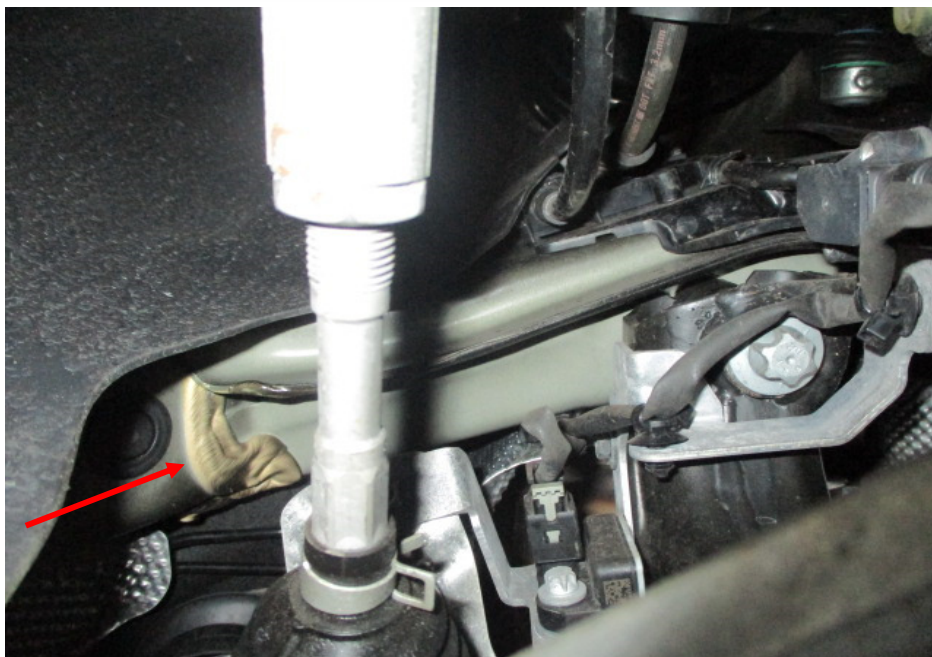
**Photo 22** shows the chassis/structural body at the underside front right of the Motor Car. The original factory sealant (arrowed) at the joints along the chassis/structural body was observed to be untouched. In general, I had found no work was carried out on the chassis/structural body of the Motor Car. The chassis/structural body of the Motor Car was originally fitted.

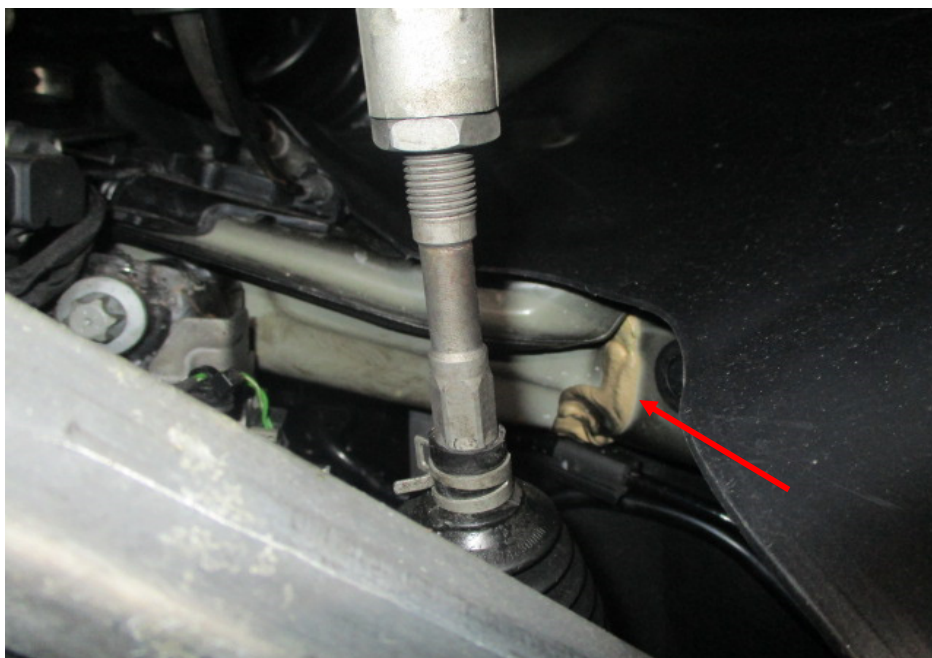
**Photo 23** shows the chassis/structural body at the underside front left of the Motor Car. I did not find any weld marks other than original spot weld marks on the chassis/structural body of the Motor Car. The original factory sealant (arrowed) at the joints along the chassis/structural body was untouched, indicating no work was done on the chassis/structural body of the Motor Car and that the chassis/structural body was originally fitted.

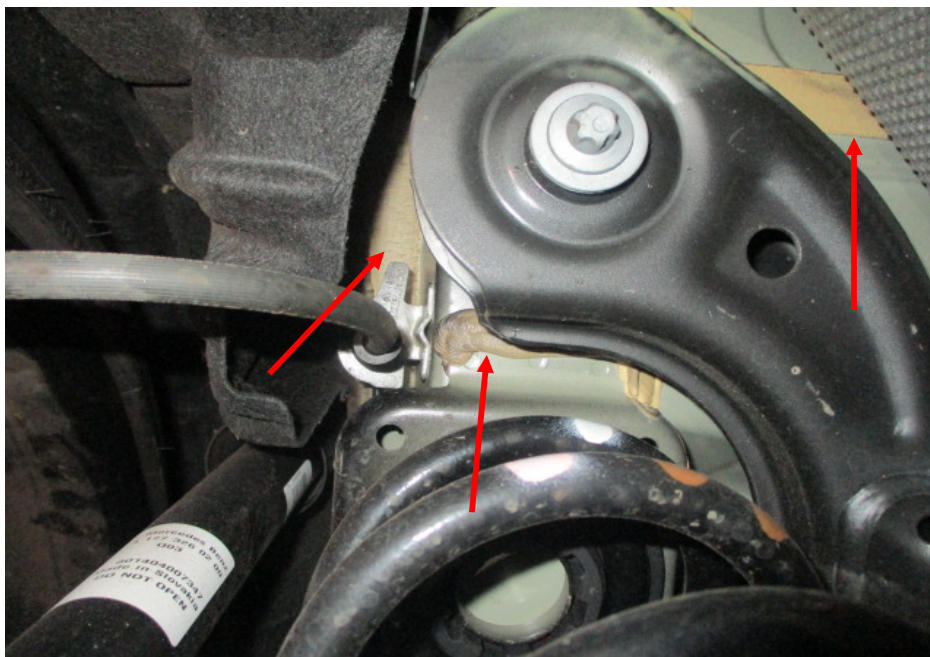
**Photo 24** shows the chassis/structural body at the underside rear left of the Motor Car. The original factory sealant (arrowed) at the joints along the chassis/structural body was observed to be untouched. In general, I had found no work was carried out on the chassis/structural body of the Motor Car. The chassis/structural body of the Motor Car was originally fitted.

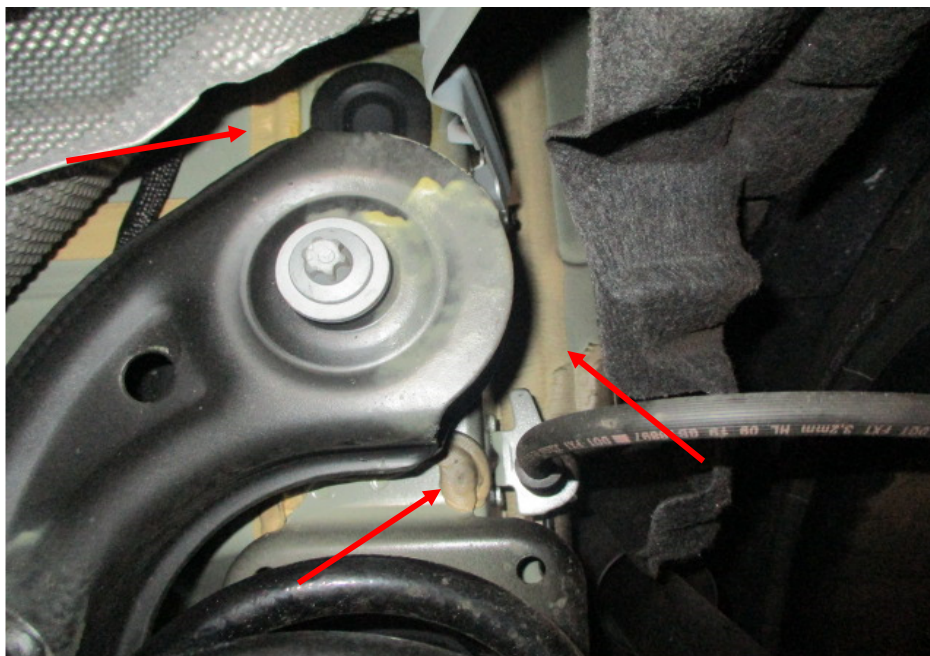
**Photo 25** shows the chassis/structural body at the underside rear right of the Motor Car. The original factory sealant (arrowed) at the joints along the chassis/structural body was observed to be untouched. In general, I had found no work was carried out on the chassis/structural body of the Motor Car. The chassis/structural body of the Motor Car was originally fitted.

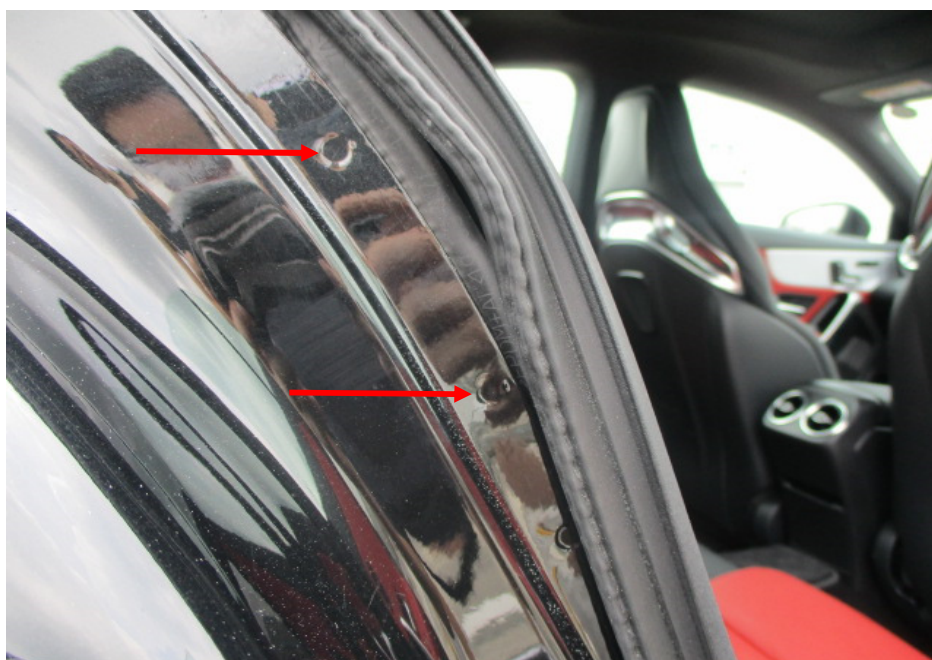
**Photo 26** shows the right side "C" pillar of the Motor Car. I did not find any weld marks other than original spot weld marks (arrowed) on the right side "C" pillar of the Motor Car which, indicates that there was no re-welding works carried out. In general, I had found all the non-detachable body panels of the Motor Car to be originally fitted at the time of my inspection.
