Auto  
Consultants  
Pte Ltd

Your Ref: MC/MC 18210/2019  
Our Ref : CI/LAW21007981/D

**Incident Involving Motor Cars SLL 5469T And SKP 9800J  
On 25 September 2018 Along China Street Turning Into  
Church Street**

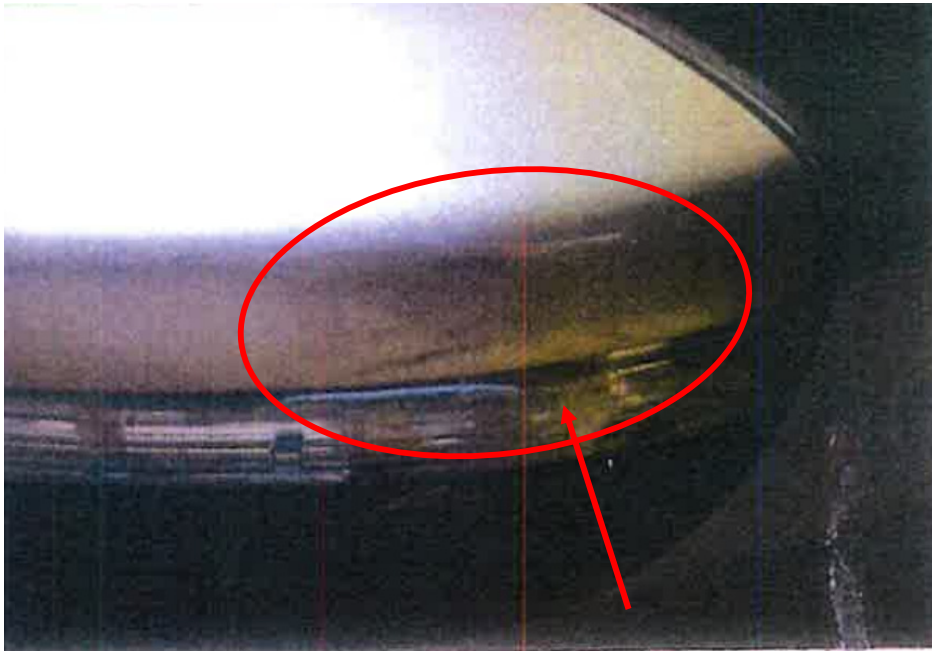
17. The Vehicle Damage Inspection Report of PMC dated 11 March 2018 had showed damage along the side body of PMC, at its front left portion. Photographs taken at the time of inspection by M/s JP Knights Adjusters & Surveyors on 01 October 2018 had showed damage to PMC's left wing mirror, front left wheel rim, front left fender, front left headlamp and left side of the front bumper. See photo 1 – 7 below.

**Photo 1** shows a close up view of the damage to the left wing mirror of PMC. Scratch/grazed marks (circled) were observed on the outer cover at the side surface area of the left wing mirror. Its signal lamp also appears to be cracked (arrowed). Refer to photograph 2 below for a general view of PMC showing its side profile.

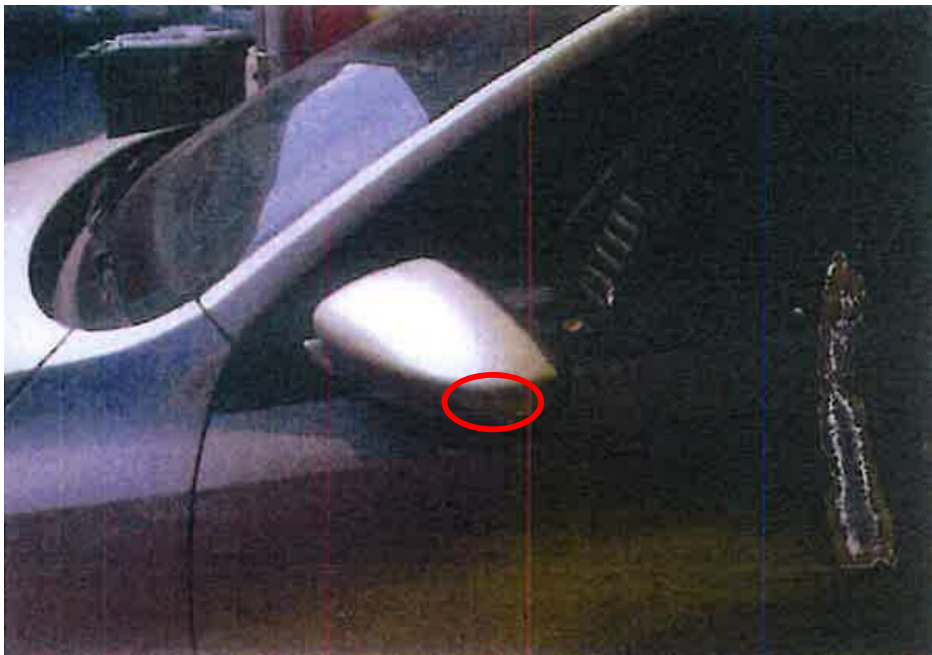
**Photo 2** shows a side profile of PMC. Following the contours of the left wing mirror, the scratch/grazed marks seen on outer cover of the left wing mirror (shown in photograph 1 above) was at the side surface area of the left wing mirror (circled).

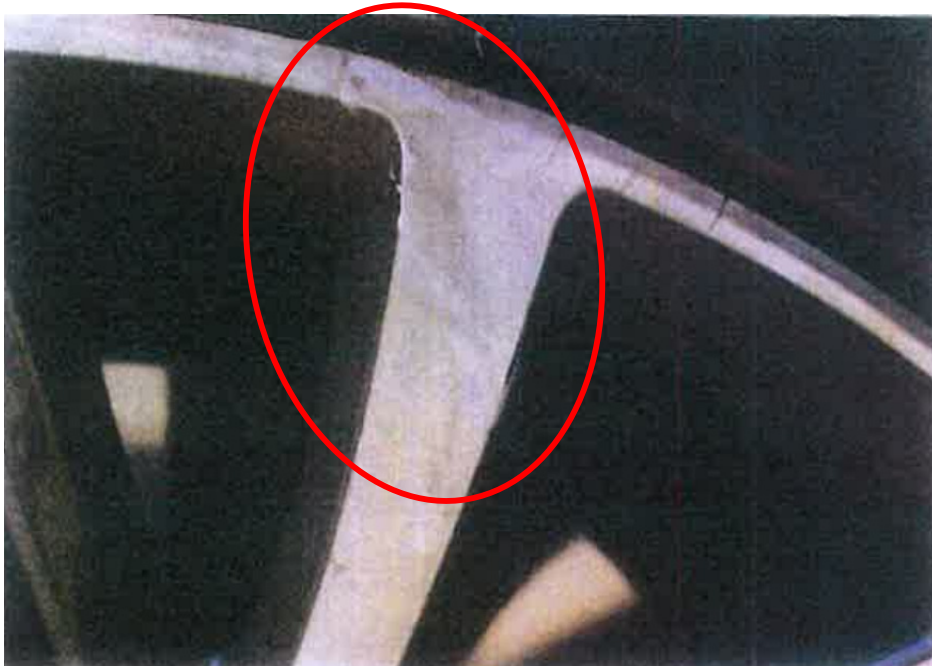
**Photo 3** shows a close up view of the damage to the front left wheel rim of PMC. What appear to be black coloured marks were seen on the outer spoke of the front left wheel rim (circled).

25. The damage to the front left wheel rim and front bumper of PMC, and damage to the front right wheel rim of DMC were not considered as their respective height above ground level at the material time of incident could not be establish given that wheels will rotate. Any measurements carried out will not represent the actual height above ground level of the damage.

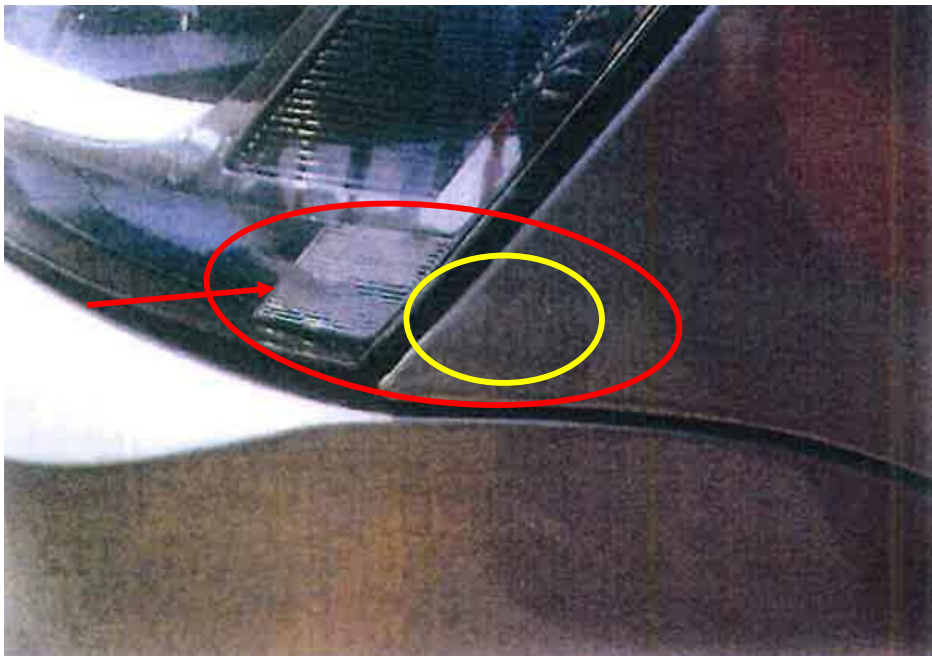
**Photo 4** shows the damage (red circle) to the front left fender and front left headlamp of PMC. Marks of grazing nature were seen to the front left fender (yellow circle) and front left headlamp (red arrow). Collectively, the grazed marks on the front left fender and front left headlamp were a result of a single motion/contact.

- a) the height above ground level of the damage at PMC's front left headlamp and front left fender was approximately 61cm above ground level. The height above ground level of the damage at DMC's front right fender was approximately also 61cm. The height above ground level of the damaged front left headlamp and front left fender of PMC had corresponded to the height above ground level of the damage at DMC's front right fender. Height measurements indicate that there was contact between PMC and DMC at the material time, and also confirms that the grazed marks seen on the front right fender of DMC at the incident location was a damage arising from this incident. See photo 18 & 19 below.

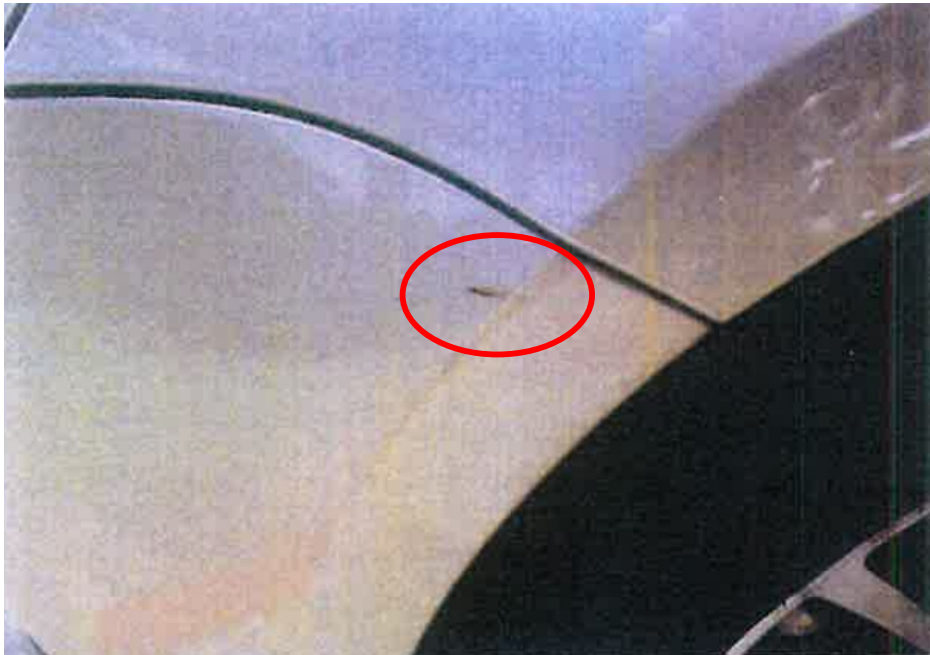
**Photo 5** shows a close up view of a black coloured mark (circled) seen on the left side of PMC's front bumper.

26. In addition, the damage profile of the black coloured marks seen on the left side of PMC's front bumper and also on the left lower corner of PMC's front bumper (refer to photograph 5 & 6 above) appears to indicate that the marks were likely to be from tyre rubbing hence these damages were also not considered in my height measurements for similar reasons of rotation as it would not be possible to determine which area (location) of a tyre sidewall had caused these damages.

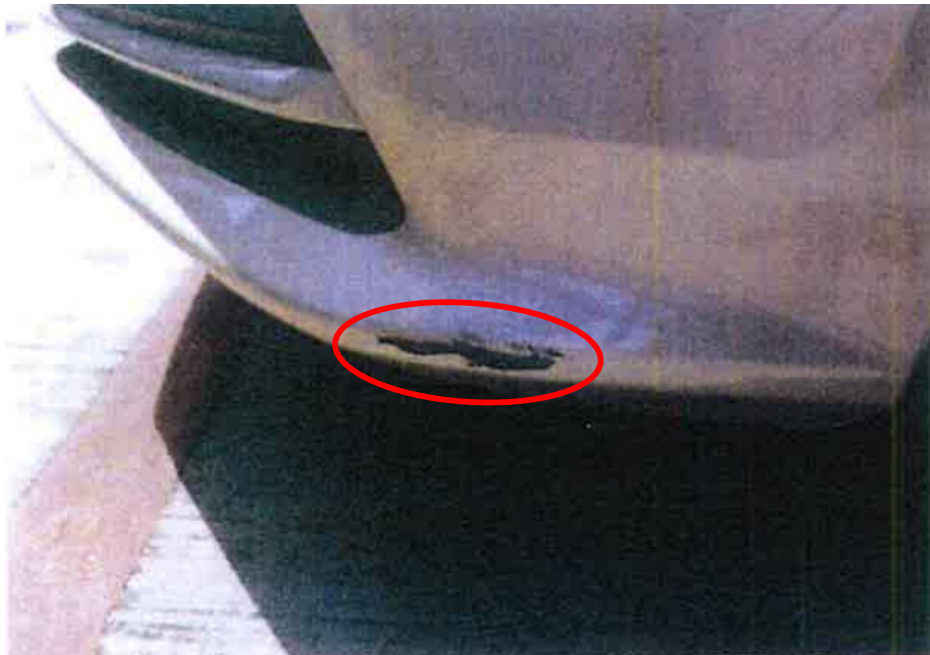
**Photo 6** shows the damage to left side lower area of PMC's front bumper. Black coloured marks that appear to be of grazing nature (circled) were seen on the left lower corner of the front bumper. Refer to photograph 7 below for a general view of PMC showing its left side front profile.

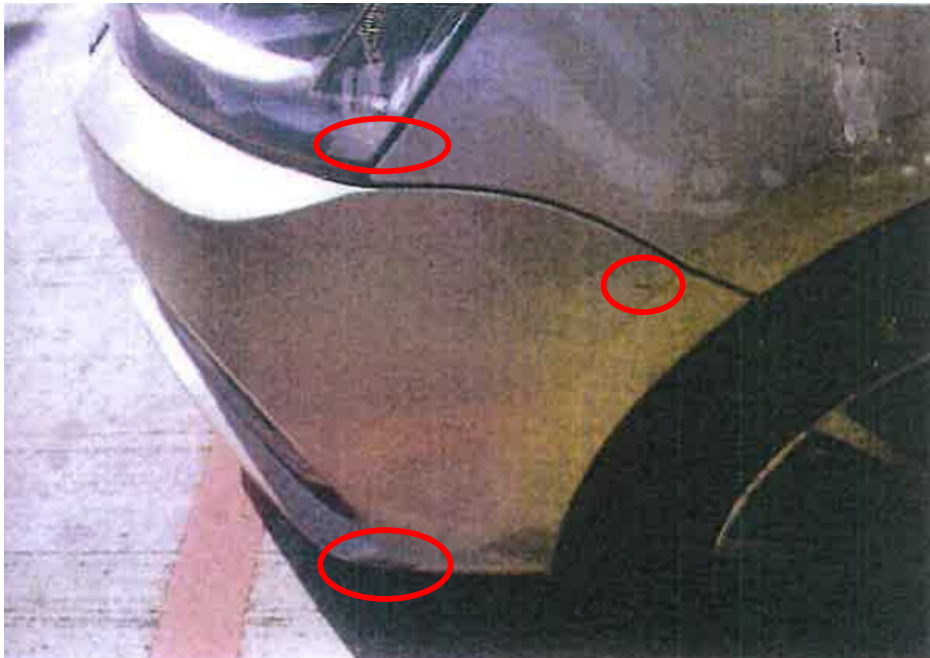
**Photo 7** shows the left side front profile of PMC. The damage to the front left fender, front left headlamp and front bumper (shown in photograph 4 to 6 above) were along the side body of PMC (circled).

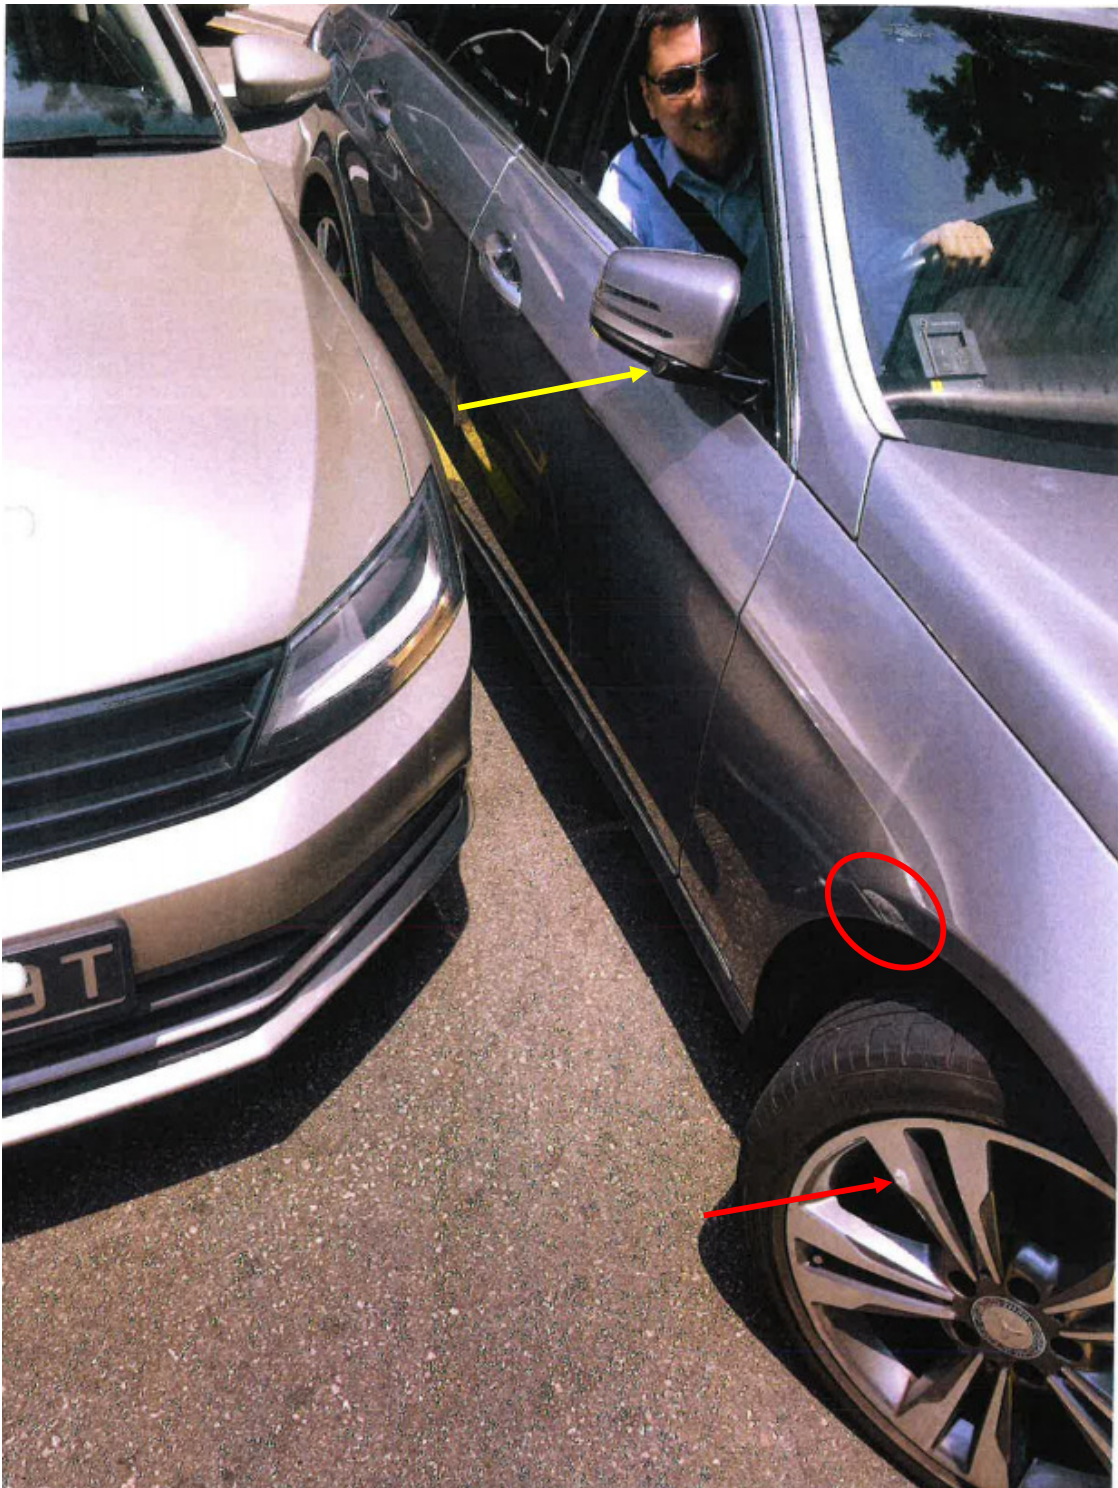
19. Basing on the photographs that were taken at the incident location and contained in PAEIC, it was observed that the front right wheel rim of DMC had sustained scratches on its outer spoke. What appears to be marks of grazing nature was also observed on the front right fender. DMC's right wing mirror was further seen to be shifted inwards. See photo 8 below.

**Photo 8** shows DMC at the incident location. Basing on the photographs contained in DAEIC, it was observed that the front right wheel rim of DMC had sustained scratches on its outer spoke (red arrow). What appears to be marks of grazing nature was also observed on the front right fender (red circle). DMC's right wing mirror was further seen to be shifted inwards (yellow arrow). Note that these damages were along the side body of DMC.

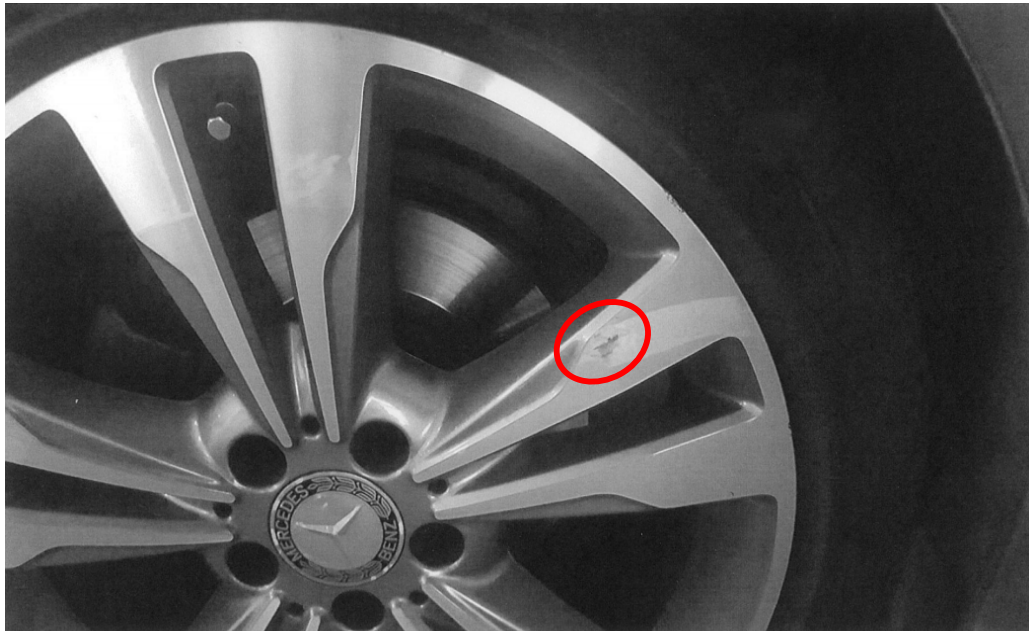
**Photo 9** shows the front right wheel rim of DMC (photograph taken on 01 October 2018 or thereabouts). Upon my comparison with the set of photographs that were taken at the incident location, I had observed scratch marks on the same area of the outer spoke of the front right wheel rim. Refer to red arrow in photograph 8 above.

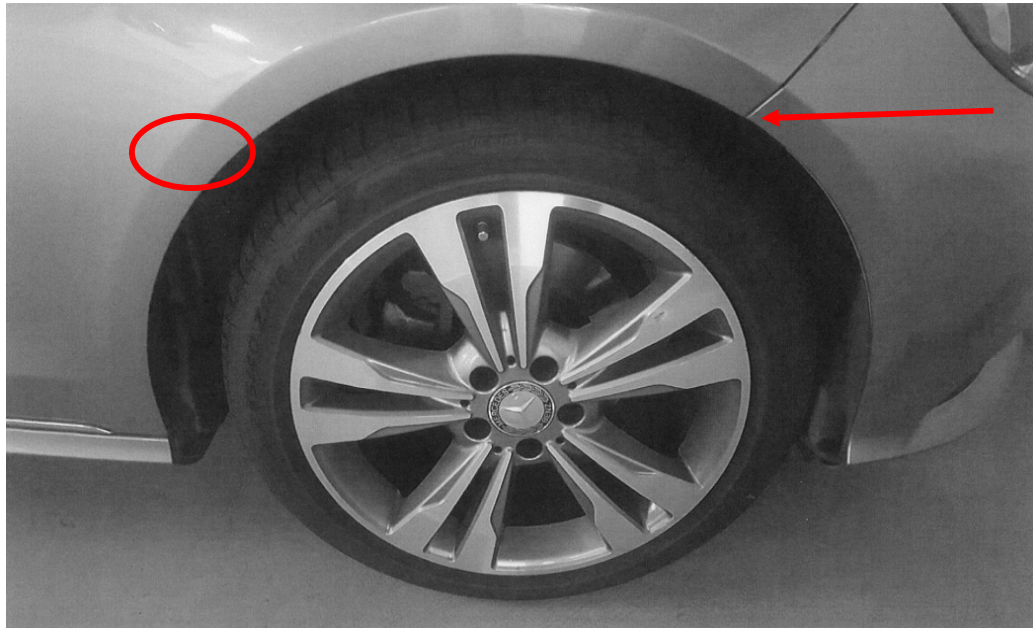
**Photo 10** shows a general view of the front right wheel rim and front right fender of DMC (photograph taken on 01 October 2018 or thereabouts). The grazed marks on the front right fender of DMC that were seen in the set of photographs taken at the incident location (refer to red circle in photograph 8 above) were not seen on the same area of the front right fender (circled). This area was determined by taking reference from the edge of DMC's front bumper as highlighted by the red arrow (refer to the set of photographs taken at the incident location that were contained in PAEIC).

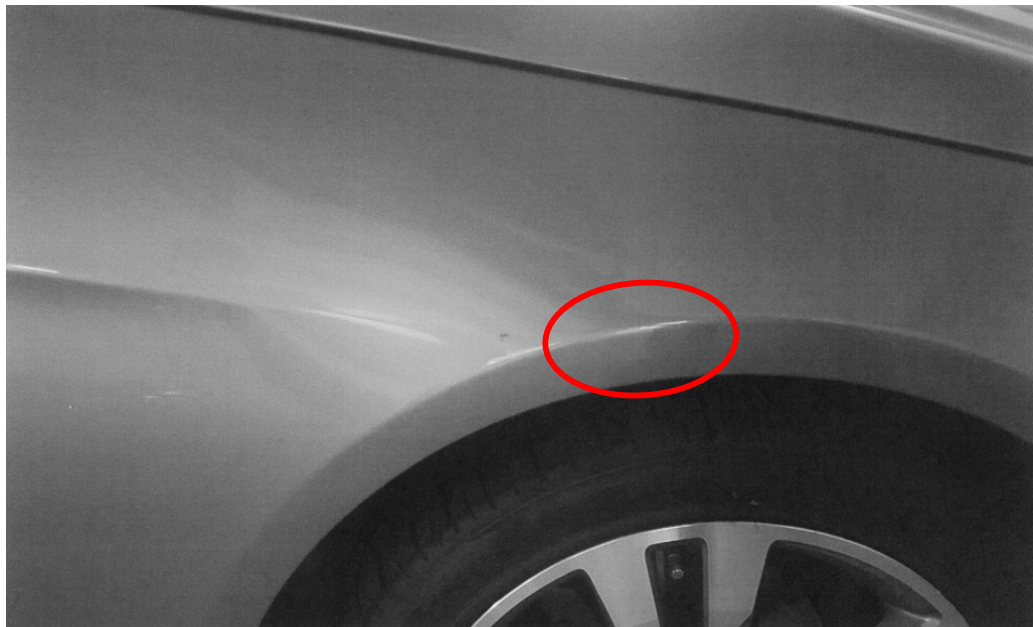
**Photo 11** shows the distortion (circled) on the front right fender of DMC that I had observed from the set of photographs that were taken on 01 October 2018 or thereabouts. The distorted area was noted to be near the grazed marks that were seen on the front right fender of DMC at the incident location (refer to red circle in photograph 8 above).

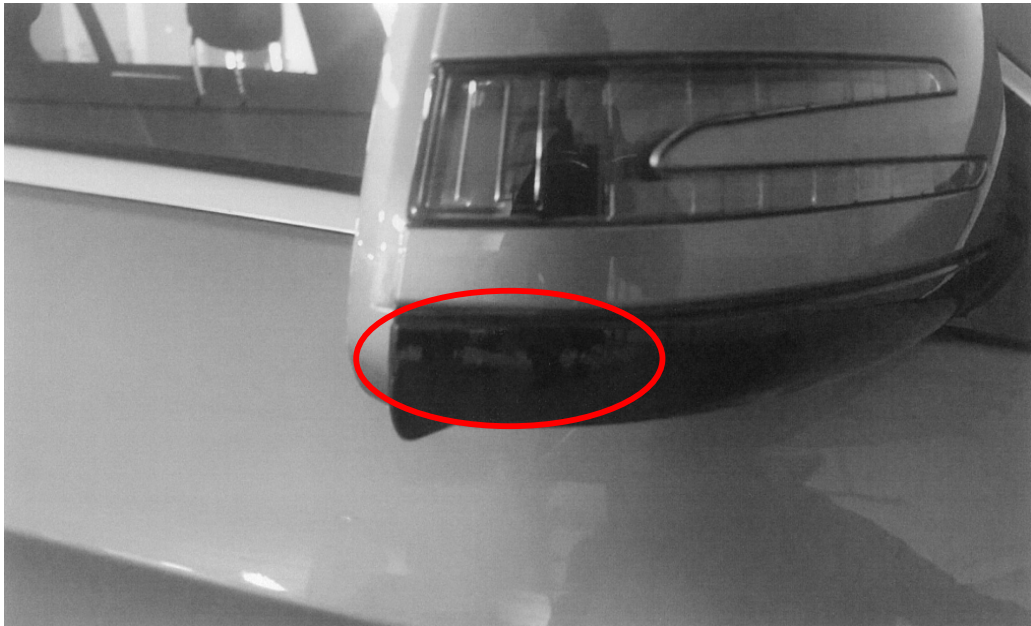
**Photo 12** shows a close up view of DMC's right wing mirror (photograph taken on 01 October 2018 or thereabouts). Scratch/grazed marks (circled) were observed on the outer cover at the side surface area of the right wing mirror (refer to photograph 13 below for a general view of DMC showing its side profile). Note that the right wing mirror was seen to be shifted inwards in the photographs that were taken at the incident location. Refer to yellow arrow in photograph 8 above.

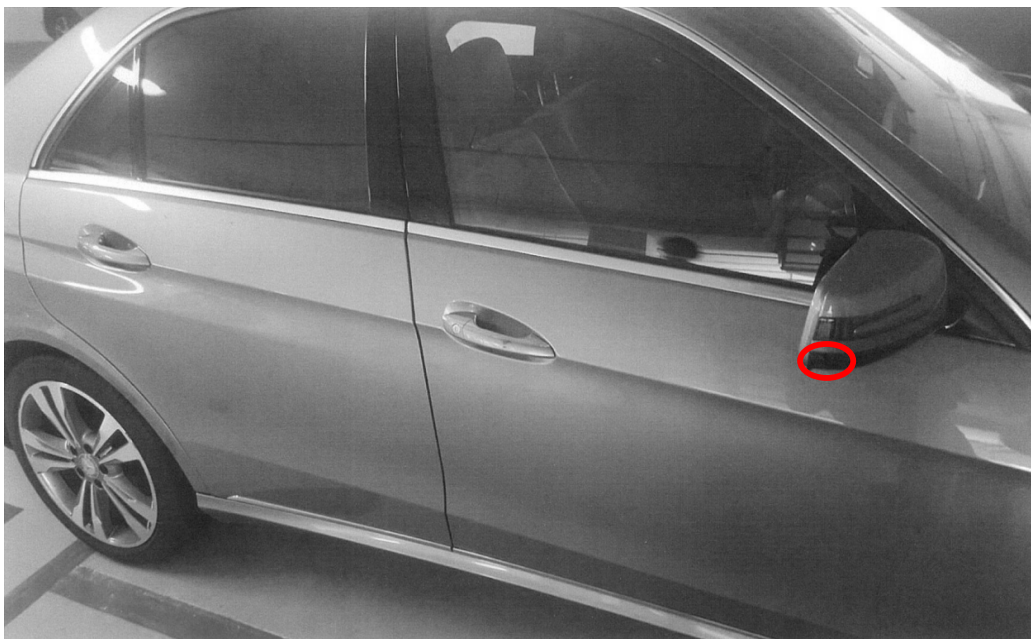
**Photo 13** shows a side profile of DMC. Following the contours of the right wing mirror, the scratch/grazed marks seen on outer cover of the right wing mirror (shown in photograph 12 above) was at the side surface area of DMC's right wing mirror (circled).

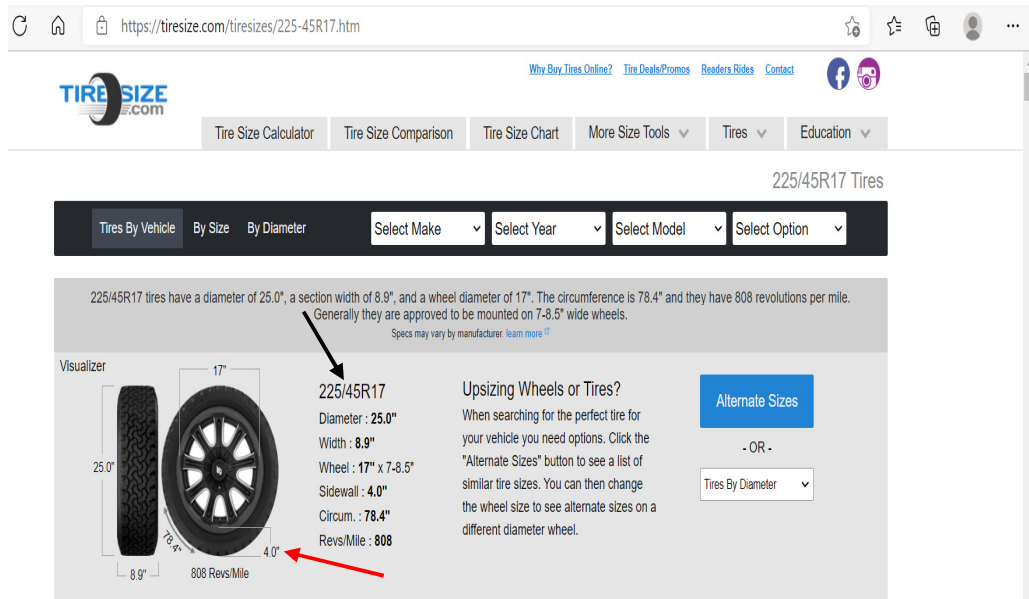
**Photo 14** shows measurements of a 17inch rim with 225/45 tyre size fitted (black arrow). This was the size of the tyre fitted on PMC as indicated in The Vehicle Damage Inspection Report of PMC. Note that the tyre sidewall height is 4.0inch (red arrow).

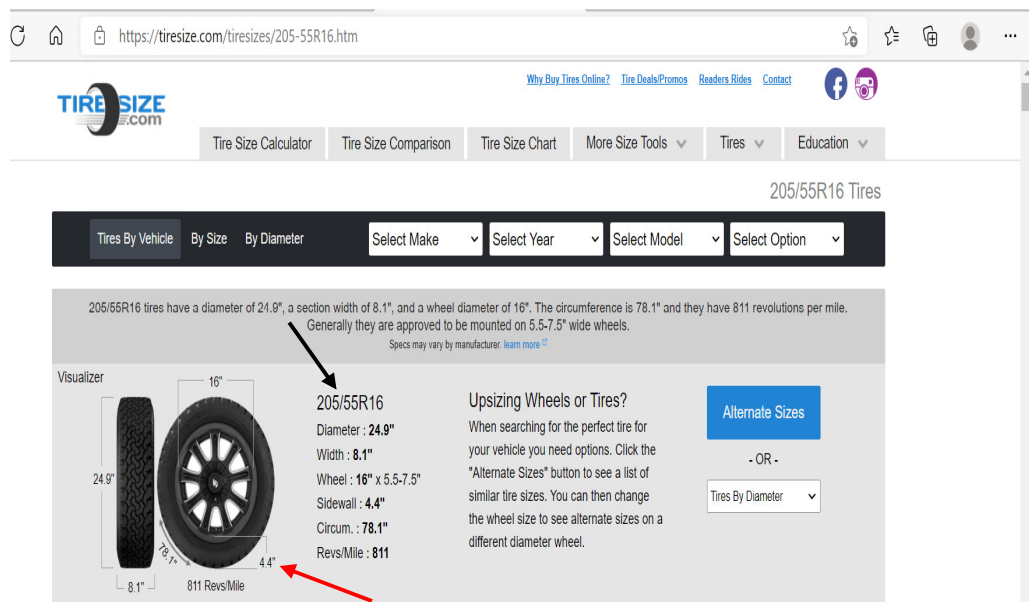
**Photo 15** shows measurements of a 16inch rim with 205/55 tyre size fitted (black arrow). This was the size of the tyre fitted on the similar make and model vehicle that was used for the height measurements. Note that the tyre sidewall height is 4.4inch (red arrow). Taking the difference of 0.4inch per sidewall for a tyre that is on a vertical axis, the height measurements obtained from the similar make and model vehicle would have to be reduce by 0.8inch in order for a comparison that is more reflective of the height above ground level of PMC's body parts.

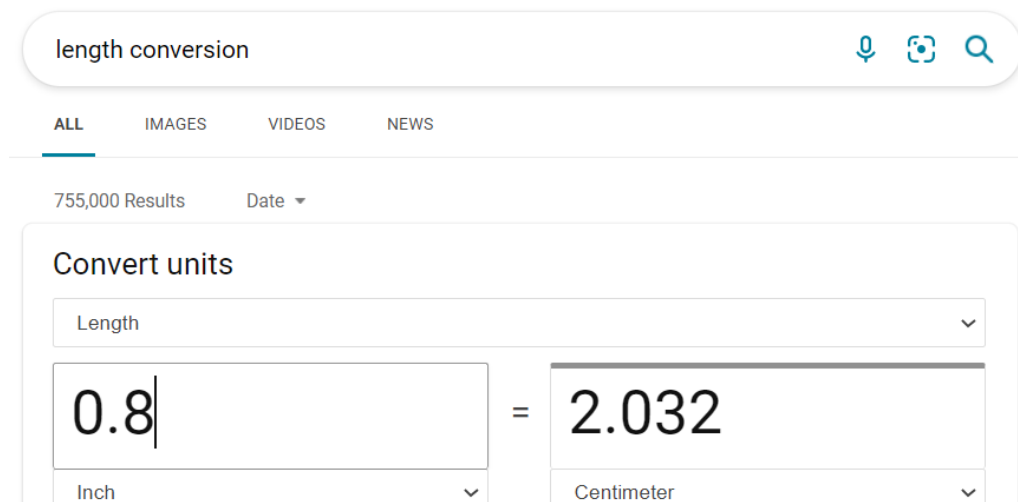
**Photo 16** shows length conversion from inch to centimetre. For the purpose of this report, the height measurements obtained from the similar make and model vehicle were all reduced by 2cm to compensate for the height difference between the tyres for 17inch rim and 16inch rim.

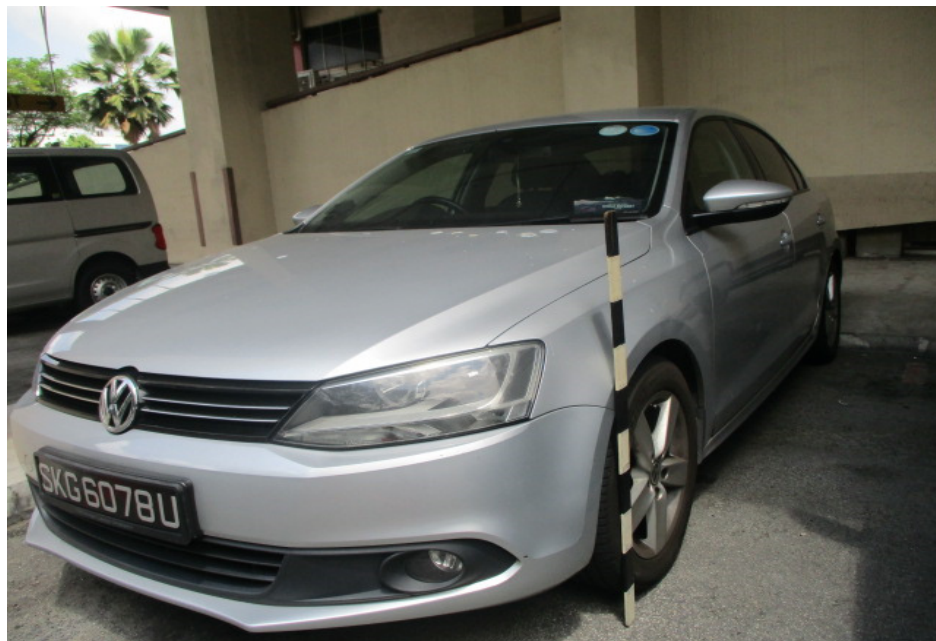
**Photo 17** shows height measurement being carried out to a similar make and model vehicle as PMC, in particular to the height above ground level of the damage at the front left headlamp, front left fender and left wing mirror of PMC.

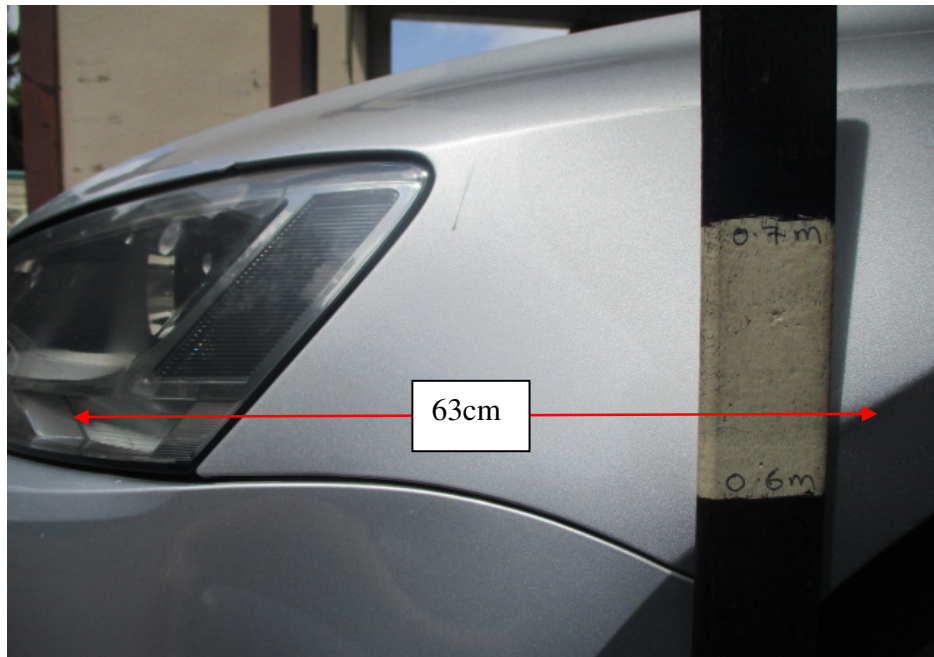
**Photo 18** shows height measurement being carried out on a similar make and model vehicle as PMC. The damage at the front left fender and front left handlamp of PMC (shown in photograph 4 above) was approximately 61cm above ground level after taking into consideration the 2cm compensation for the height difference between the tyres for 17inch rim and 16inch rim.

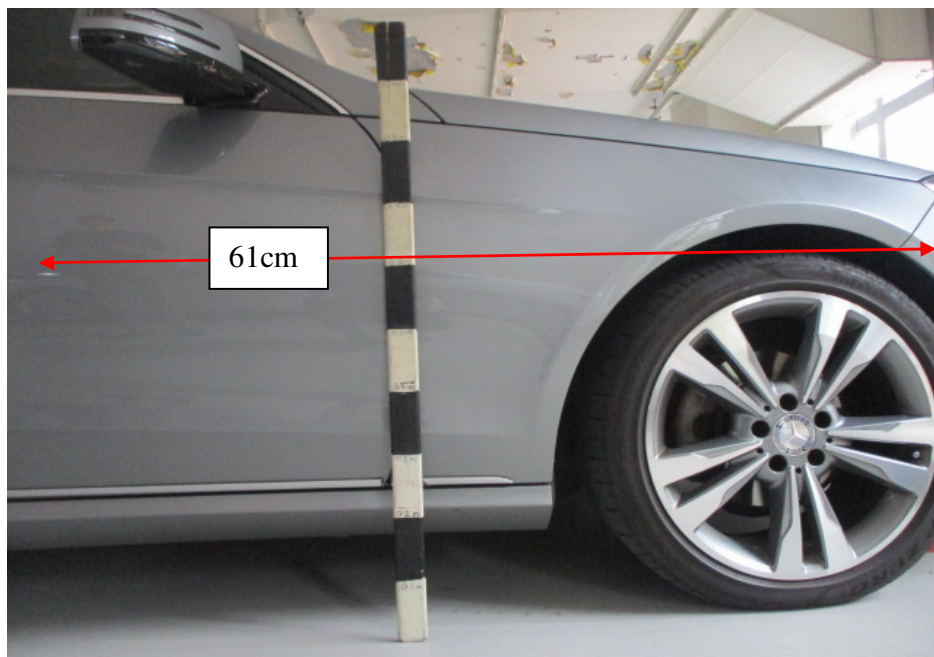
**Photo 19** shows height measurement being carried out on DMC, in particular to the height above ground level of the damage at the front right fender and right wing mirror of DMC. The damage at the front right fender of DMC (refer to red circle in photograph 8 above) was approximately 61cm above ground level.

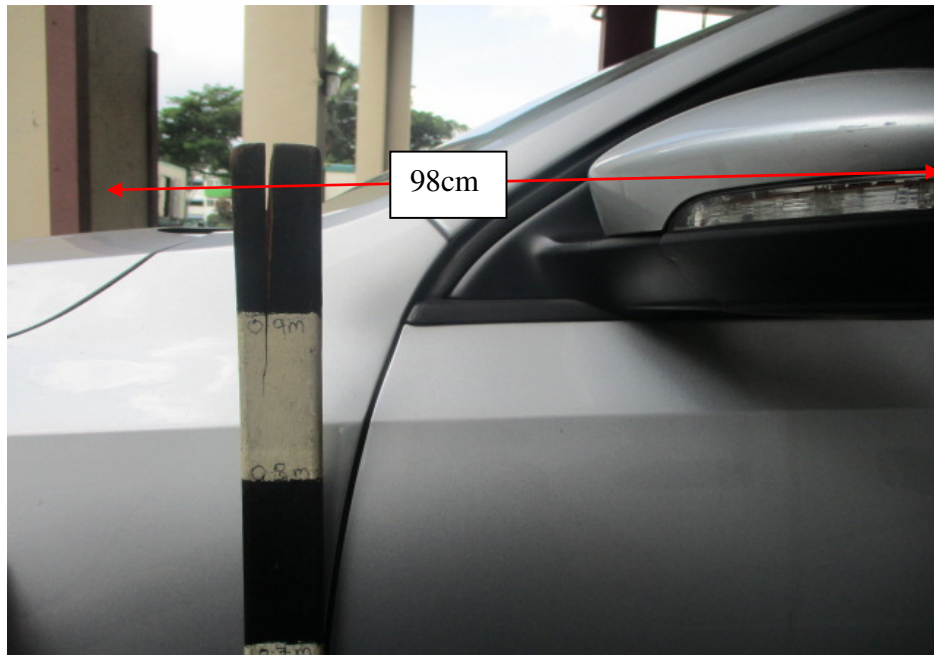
- b) the height above ground level of the damage at PMC's left wing mirror was approximately 96cm above ground level. The height above ground level of the damage at DMC's right wing mirror was approximately 92cm. The height above ground level of the aforesaid damaged body parts of PMC and DMC is relatively similar (the difference of 4cm can be considered to be within a reasonable tolerance level that could have been attributed by factors like tyre pressure, braking action, road elevation amongst others). Again, the height measurements had indicated that there was contact between PMC and DMC at the material time. See photo 20 & 21 below.

**Photo 20** shows height measurement being carried out on a similar make and model vehicle as PMC. The damage at the left wing mirror of PMC (shown in photograph 1 above) was approximately 96cm above ground level after taking into consideration the 2cm compensation for the height difference between the tyres for 17inch rim and 16inch rim.

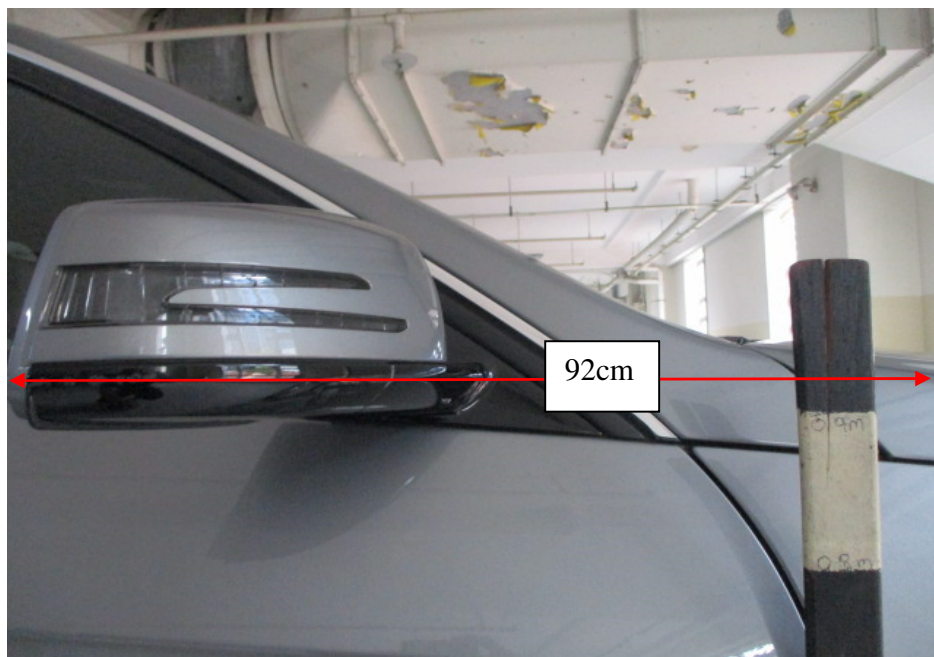
**Photo 21** shows height measurement being carried out on DMC. The damage at the right wing mirror of DMC (shown in photograph 12 above) was approximately 92cm above ground level.

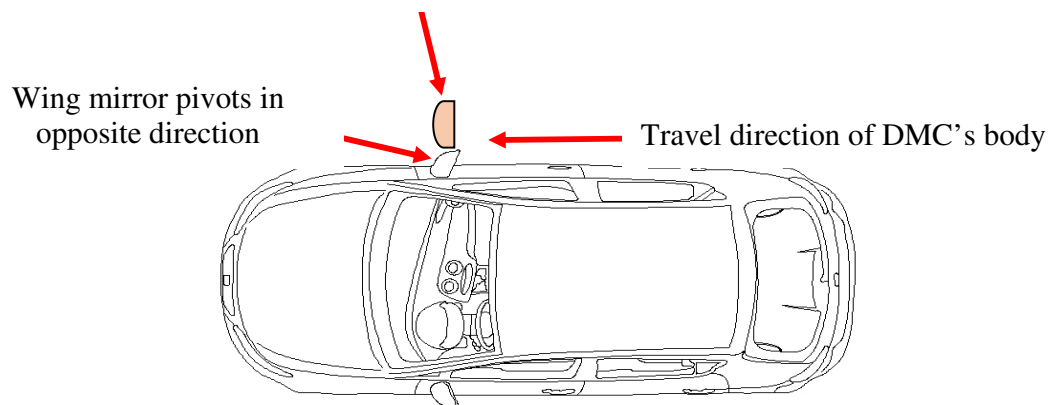
30. To further explain, the cause of the right wing mirror shifting inwards was due to the forward movement of DMC's body when its right wing mirror came into contact with the left wing mirror of PMC whilst it (PMC) was stationary. Simply put, upon contact, the right wing mirror pivots inwards, which is in a direction that is opposite from DMC's travelling direction. See below for a simple illustration.

A non-moving obstruction to the travel direction of DMC  
(wing mirror of PMC whilst stationary)

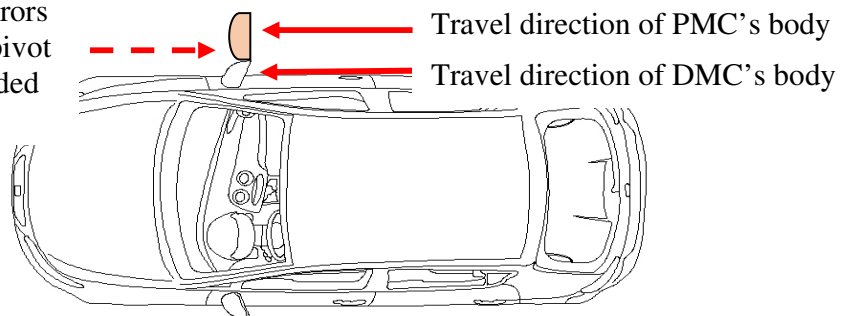
32. In this scenario, the same directional movement of PMC and DMC, regardless of actual respective turning angle at the time of contact, would in all likelihood result in both wing mirrors remaining in its normal unfolded position as there is no opposite direction force acting on both wing mirrors at the time of contact. This also takes into consideration that the contact between both PMC and DMC wing mirrors was at their respective side surfaces, which I had earlier commented and shown in photograph 1 and photograph 12 above. See below for a simple illustration.

No opposite direction forces acting on the wing mirrors to cause either one to pivot from its normal unfolded position
