Your Ref: TP/IP/26771/2021
Our Ref : CI/TPD21008003/N

Traffic Police Department
Singapore Police Force
10 Ubi Avenue 3
Singapore 408865

MECHANICAL INSPECTION REPORT OF MOTORCYCLE JQR 8144

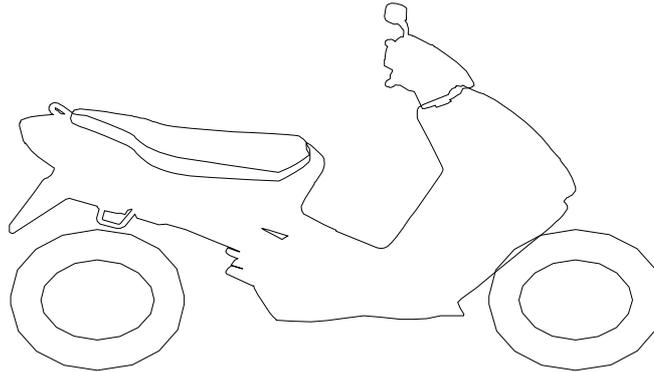
7. However the rear tyre was observed to be bald. The tyre brand, tyre size and remaining tread depth of the 2 tyres of the Motorcycle were recorded as follows:-

Pirelli 80/90 R17 (0mm)

Pirelli 70/90 R17 (3mm)

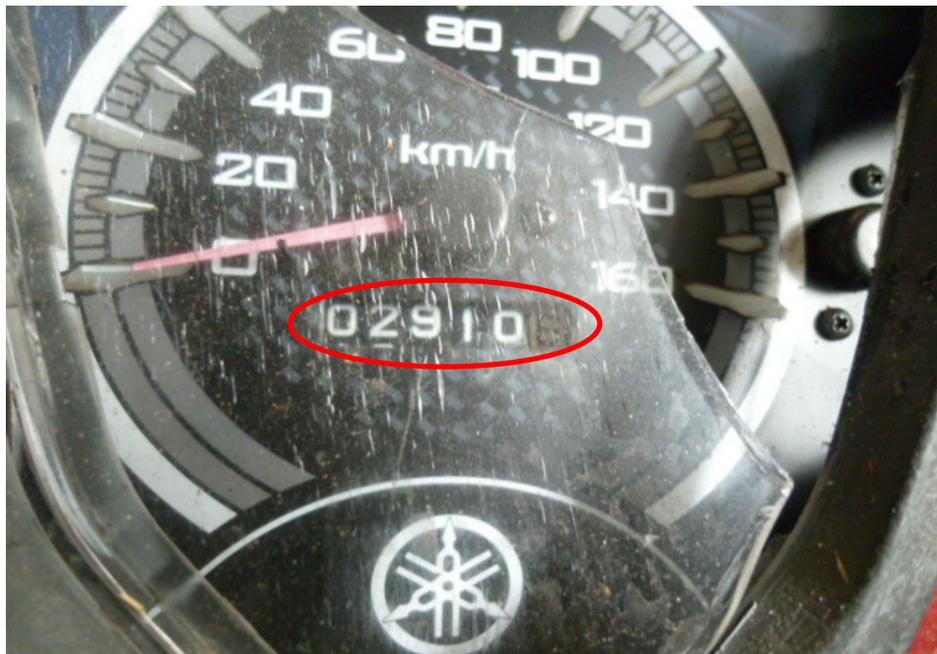
Photo 1 shows the speedometer gauge of the Motorcycle where the mileage recorded at the time of our inspection was 2, 910km (circled).

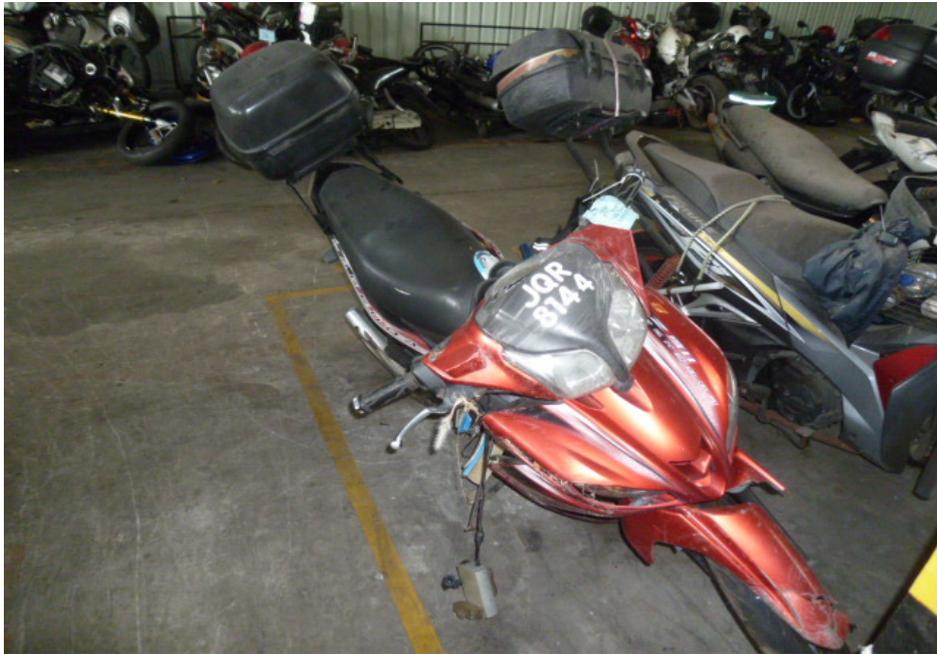
Photo 2 shows a general view of the frontal portion of the Motorcycle at the time of our inspection. The Motorcycle had sustained damages all around.

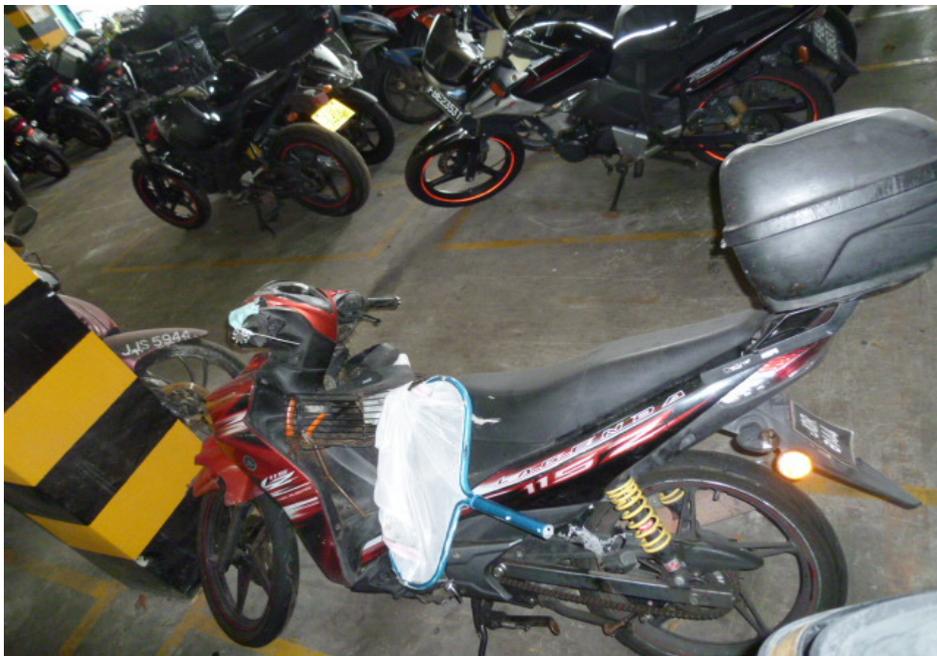
Photo 3 shows a general view of the left body of the Motorcycle at the time of our inspection. The Motorcycle had sustained damages all around.

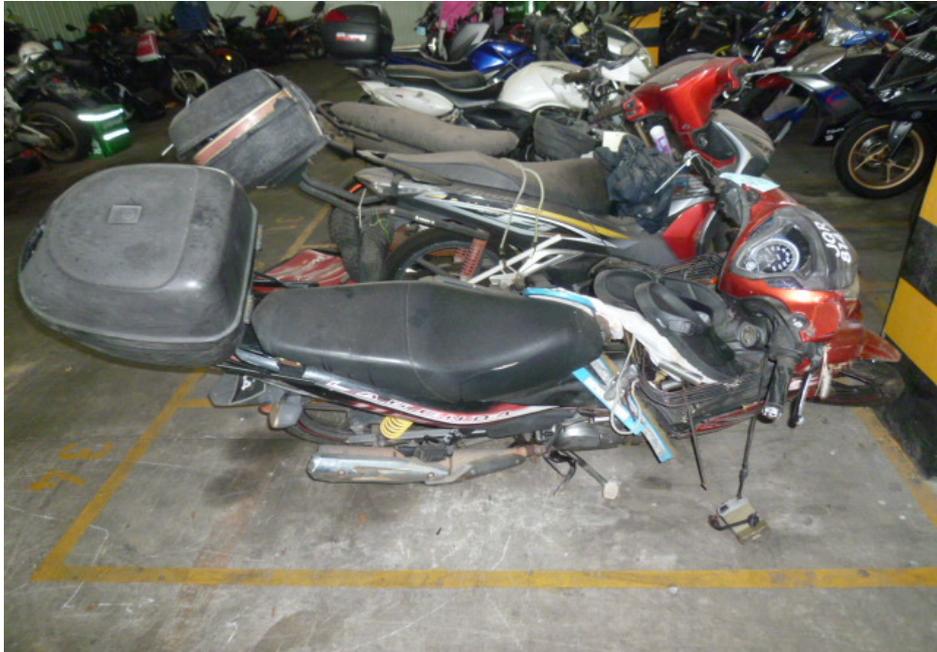
Photo 4 shows a general view of the right body of the Motorcycle at the time of our inspection. The Motorcycle had sustained damages all around. Body parts that were found to have been damaged include its headlight assembly, front cowling, front fork assembly, front mudguard, front basket, side cowlings, front brake lever, rear side covers, rear brake pedal, right front footrest, gear shift pedal, exhaust muffler and exhaust muffler heat shield, amongst others.

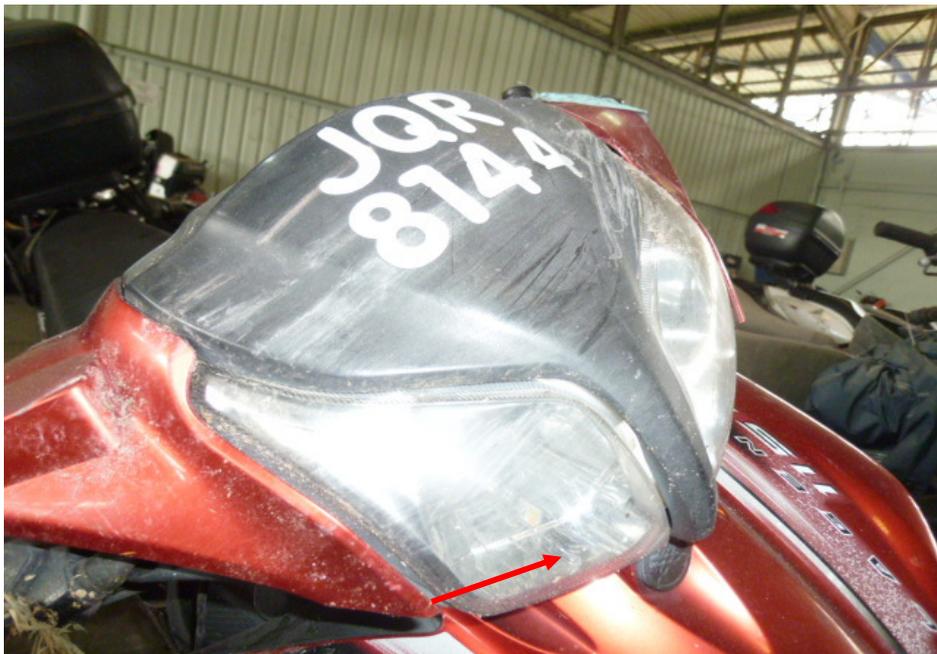
Photo 5 shows a closer view of the grazed headlight assembly of the Motorcycle as a result of the accident (arrowed).

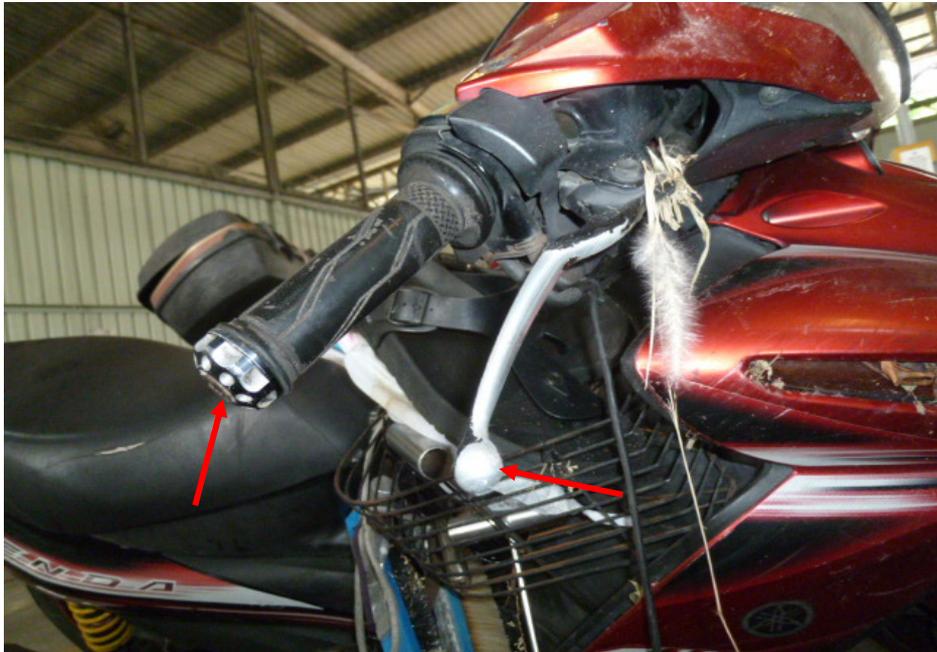
Photo 6 shows a closer view of the front brake lever and left handlebar end of the Motorcycle (arrowed). These parts were amongst the body parts of the Motorcycle which were damaged as a result of the accident.

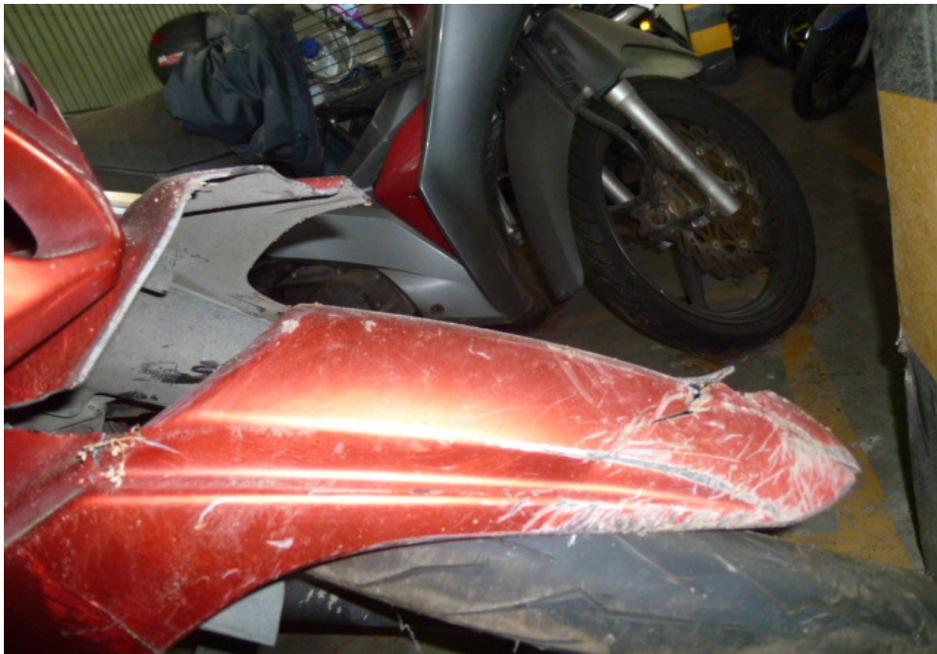
Photo 7 shows a closer view of the front mudguard, which was amongst the body parts of the Motorcycle that had sustained damage as a result of the accident.

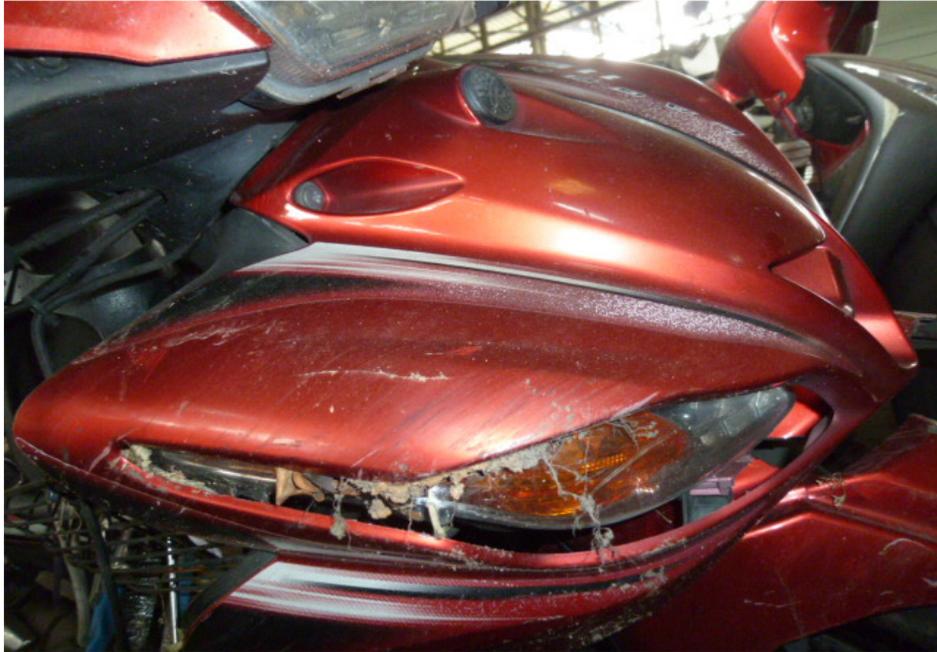
Photo 8 shows a closer view of the front cowling which was amongst the body parts at the front body of the Motorcycle that had sustained damages as a result of the accident.

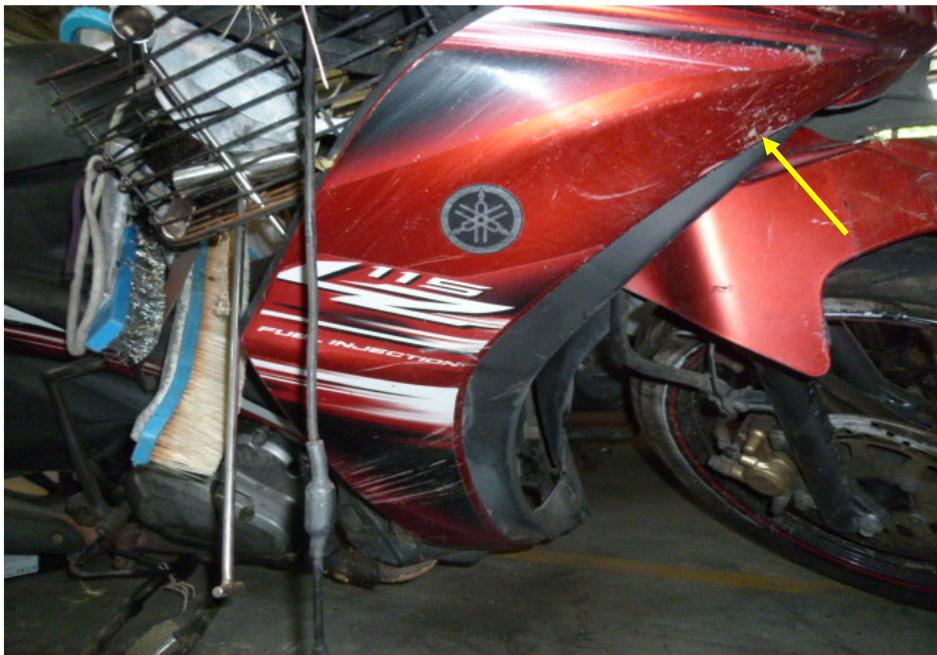
Photo 9 shows a closer view of the right cowling which was amongst the body parts at the front body of the Motorcycle that had sustained damages as a result of the accident.

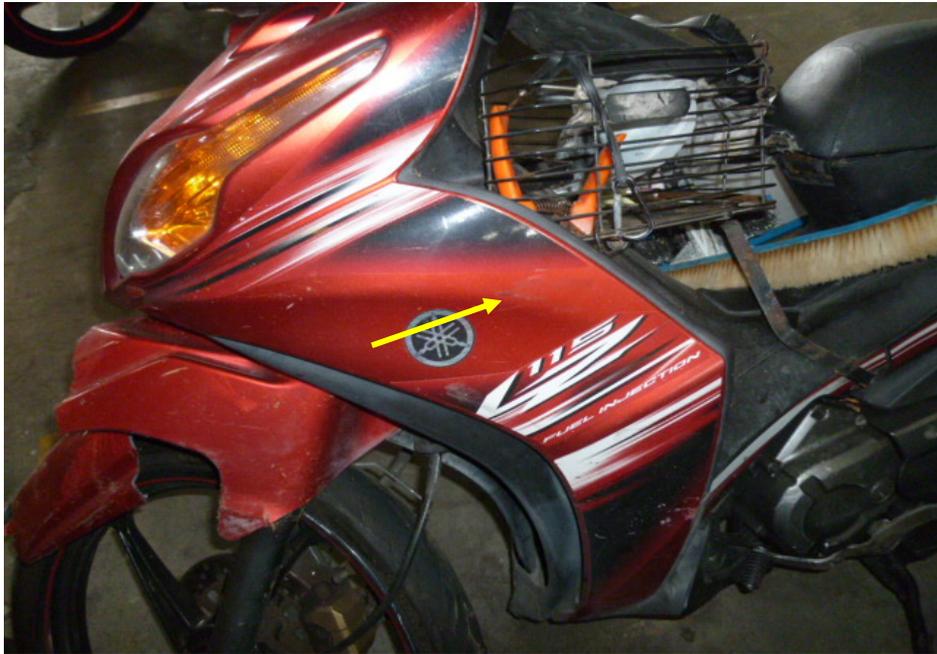
Photo 10 shows a closer view of the grazed left cowling which was amongst the body parts at the front body of the Motorcycle that had sustained damages as a result of the accident (arrowed).

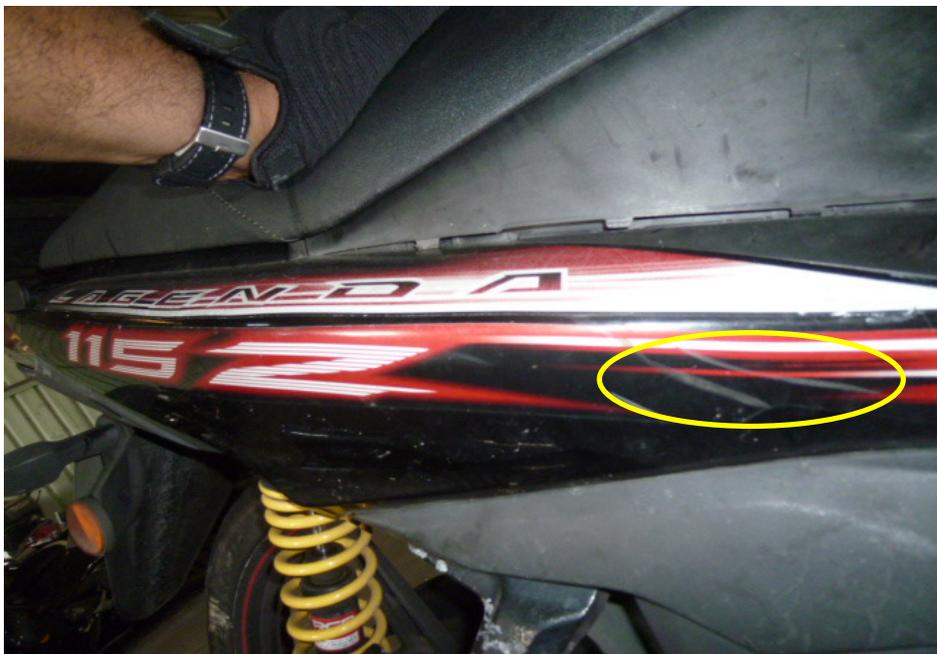
Photo 11 shows a closer view of the right rear side cover which was amongst the body parts of the Motorcycle that had sustained damages of grazing nature as a result of the accident (circled).

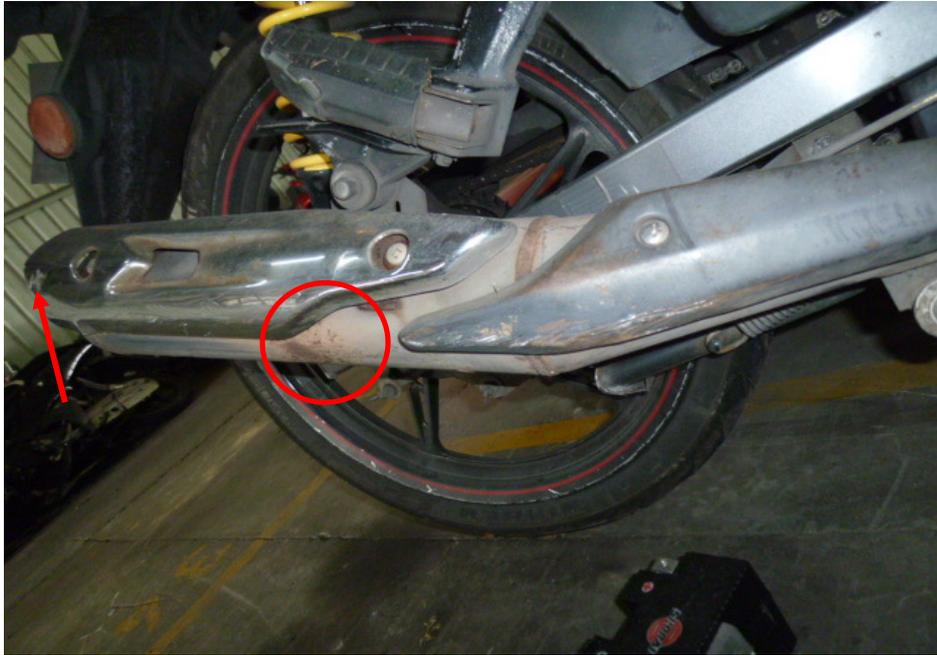
Photo 12 shows a closer view of the grazed exhaust muffer (circled) and dented exhaust muffer heat shield (arrowed) which were amongst the body parts of the Motorcycle that had sustained damage as a result of the accident.

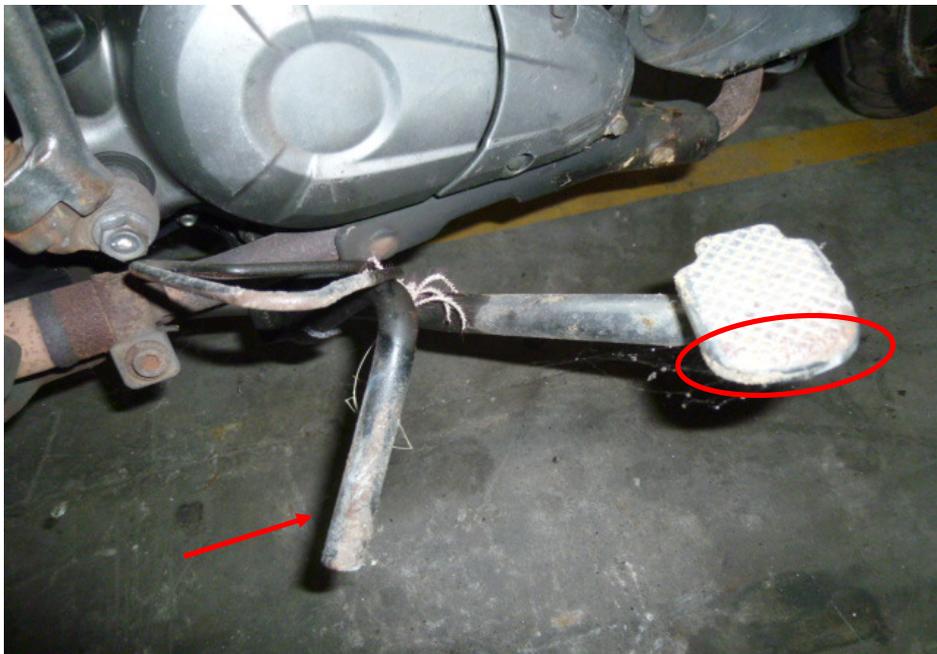
Photo 13 shows a closer view of the rear brake pedal (circled) and right front footrest (arrowed) which were amongst the body parts of the Motorcycle that had sustained damage as a result of the accident.

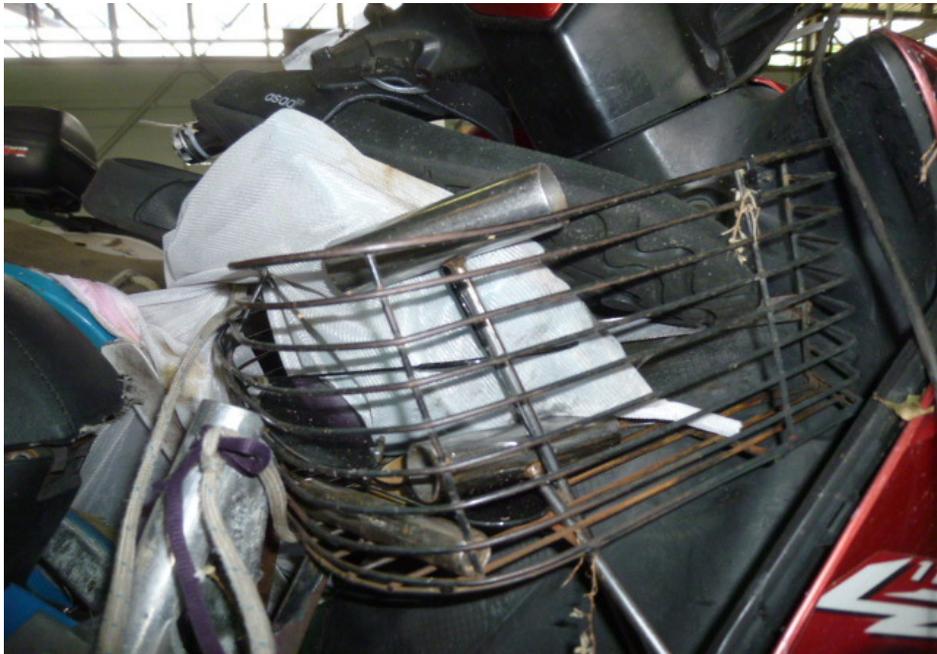
Photo 14 shows the broken front basket of the Motorcycle at the time of our inspection.

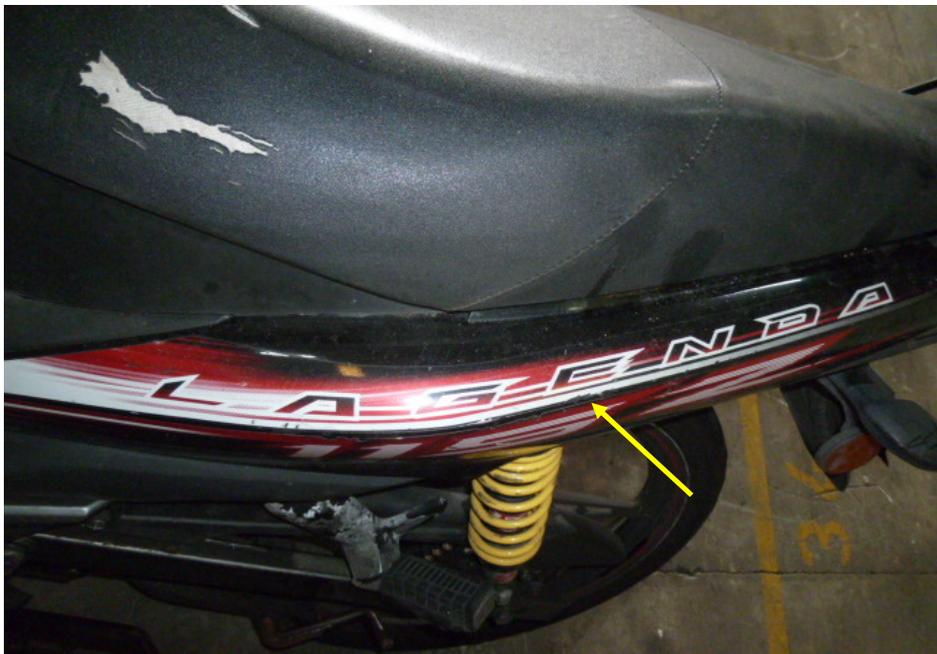
Photo 15 shows a closer view of the left rear side cover which was amongst the body parts of the Motorcycle that had sustained damages of grazing nature as a result of the accident (arrowed).

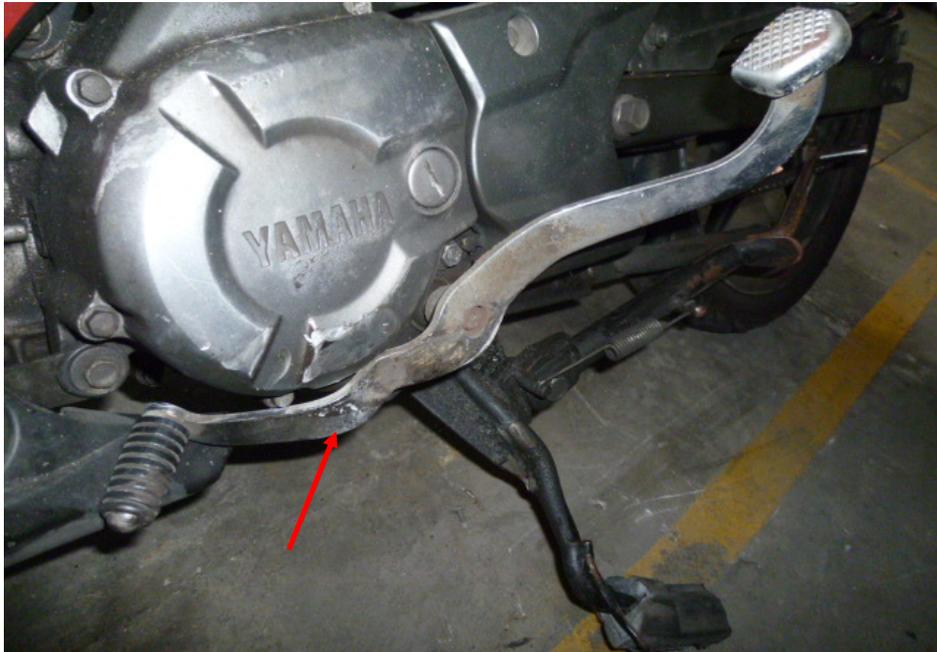
Photo 16 shows a closer view of the bent gear shift pedal of the Motorcycle as a result of the accident (arrowed).

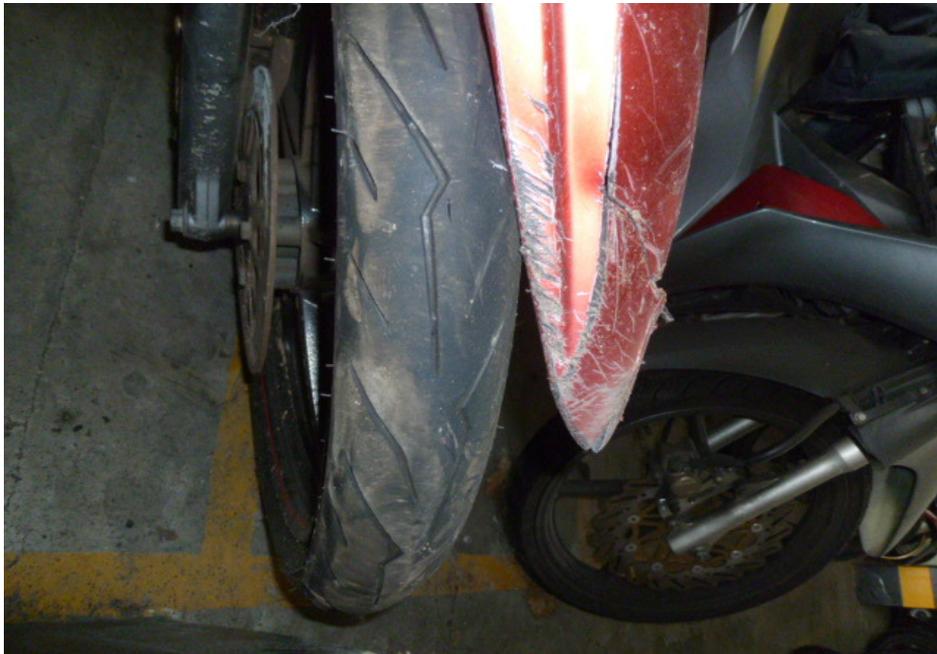
Photo 17 shows the front tyre of the Motorcycle at the time of our inspection. The front tyre was observed to be in serviceable condition with remaining tread depth of approximately 3mm. The pattern of the tread was also clearly visible. There was no tear, burst mark(s) and/or punctured hole(s) on the sidewalls as well as across the tread of the front tyre.

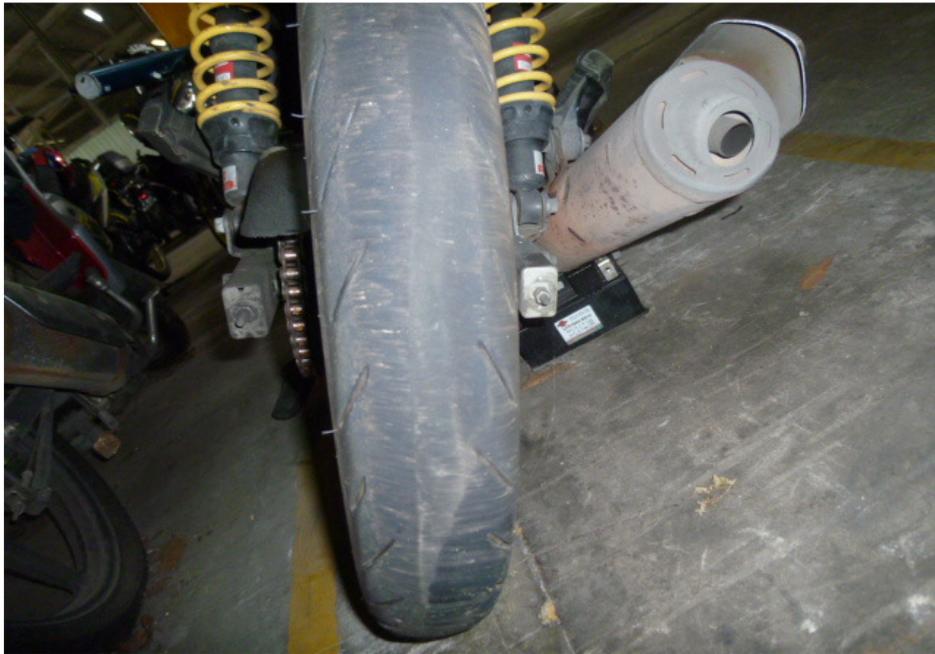
Photo 18 shows the condition of the Motorcycle's rear tyre. The rear tyre was observed to be bald. The tyre was also observed to be sufficiently inflated for vehicular operation. We did not observe any tear, burst mark(s) and/or punctured hole(s) on the sidewalls as well as across the tread of the rear tyre.

16. The front tyre of the Motorcycle was found to be in serviceable condition. There was no tear, cut or burst mark(s) on the outer and the inner sidewalls as well as across the tread of the 2 tyres. The 2 tyres were sufficiently inflated for vehicular operation. The front tyre had remaining tread depth of approximately 3mm. The rear tyre of the Motorcycle was observed to be bald.

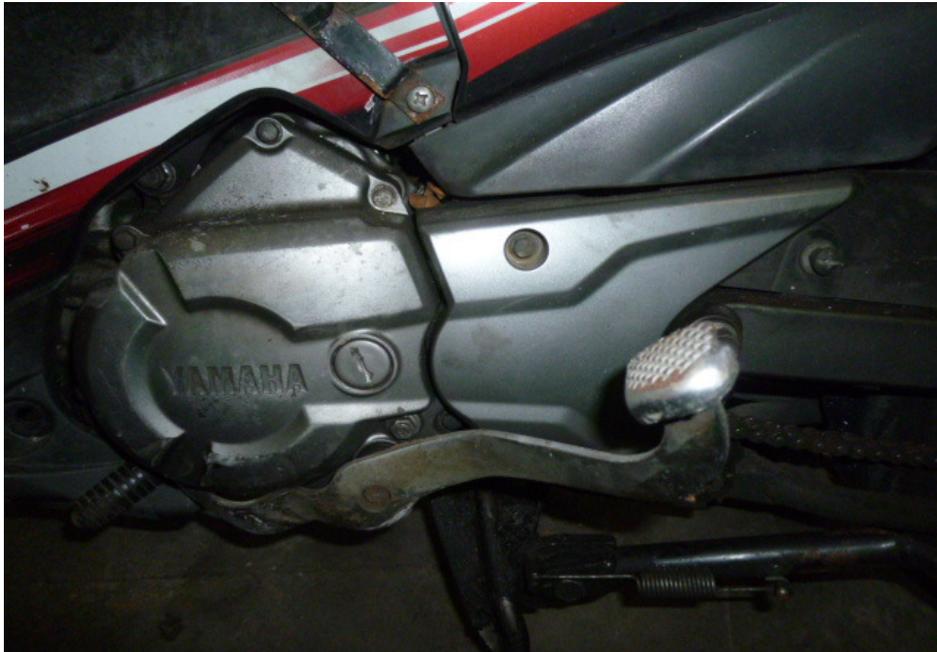
Photo 19 shows the left side of the engine of the Motorcycle at the time of our inspection. The various engine related parts and components were found to be intact with no visible damage. There was also no sign(s) or indication(s) of fluid leak observed around the left engine area of the Motorcycle.

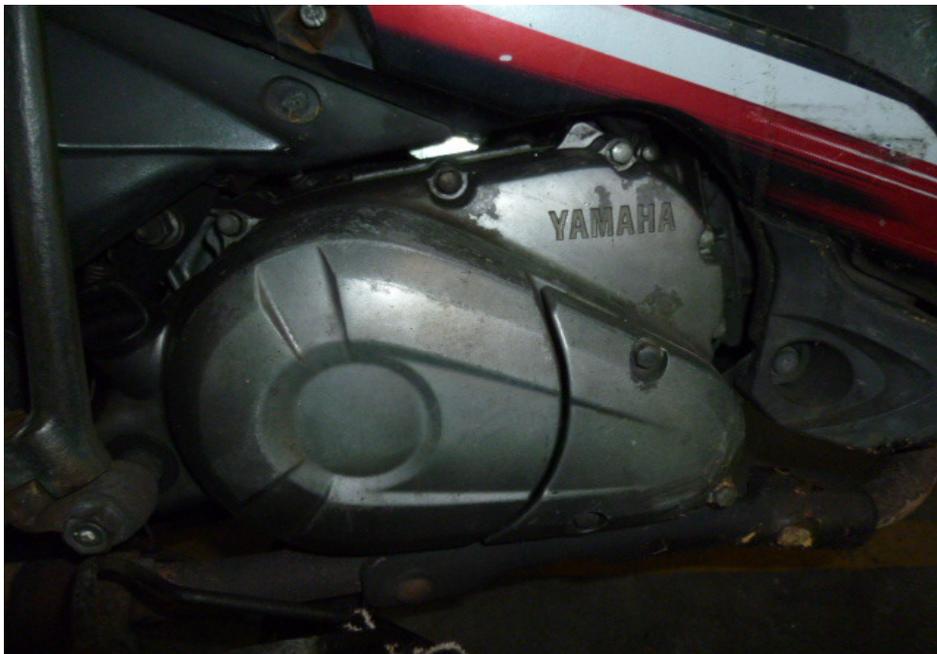
Photo 20 shows the right side of the engine of the Motorcycle at the time of our inspection. The various engine related parts and components were found to be intact with no visible damage. There was also no sign(s) or indication(s) of fluid leak observed around the right engine area of the Motorcycle.

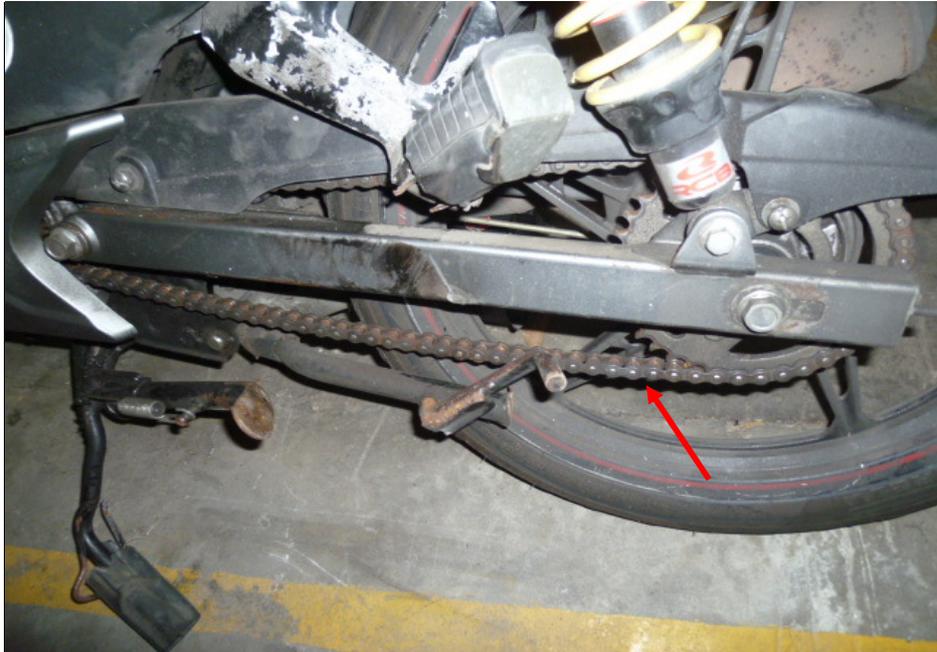
Photo 21 shows the gear chain (arrowed) of the Motorcycle, which was observed to be intact with no misalignment. It was also adequately lubricated for operating purposes. The gear chain rotates the rear wheel of the Motorcycle.

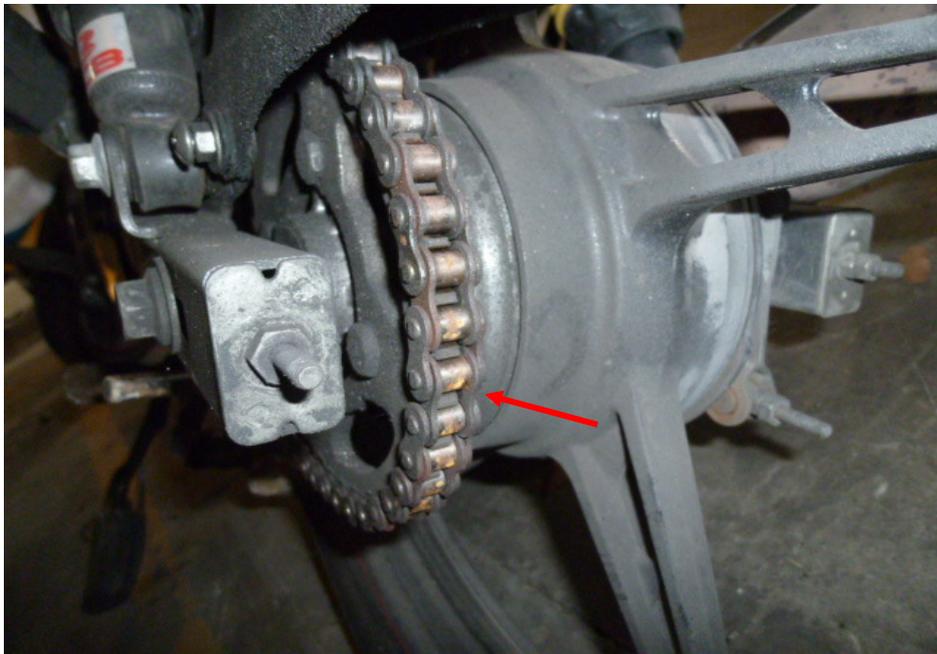
Photo 22 shows the closer view of the gear chain (arrowed) of the Motorcycle, which was observed to be intact with no misalignment. It was also adequately lubricated for operating purposes.

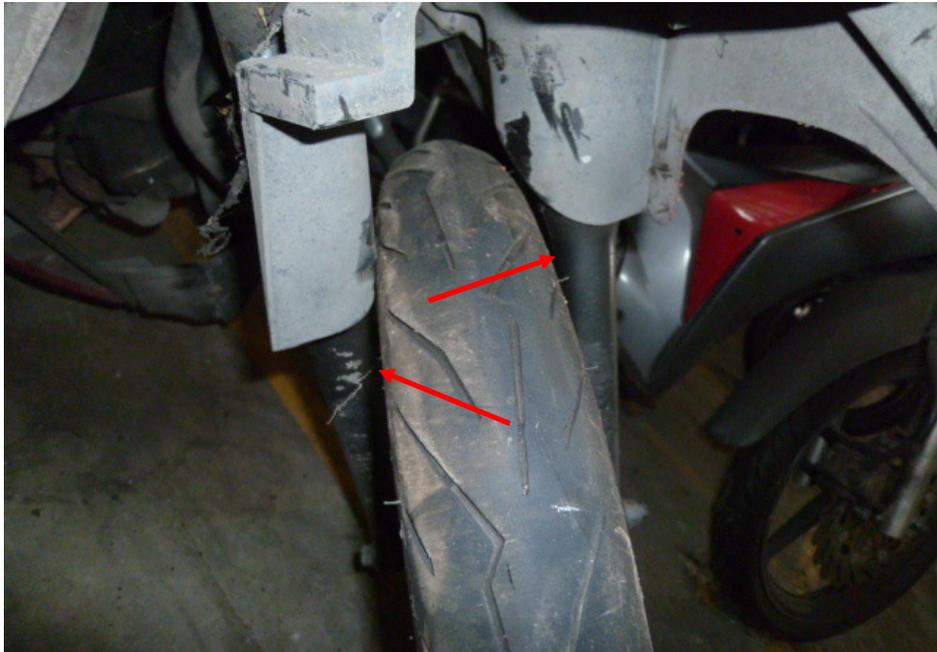
11. For this case, we were not able to conduct any test(s) on the steering system of the Motorcycle due to the damage of its front forks. The front forks were found to be bent as a result of the accident.

Photo 23 shows the front forks of the Motorcycle. The front forks (arrowed) were observed to be bent as a result of the accident. We were hence not able to conduct any tests on the steering system of the Motorcycle.

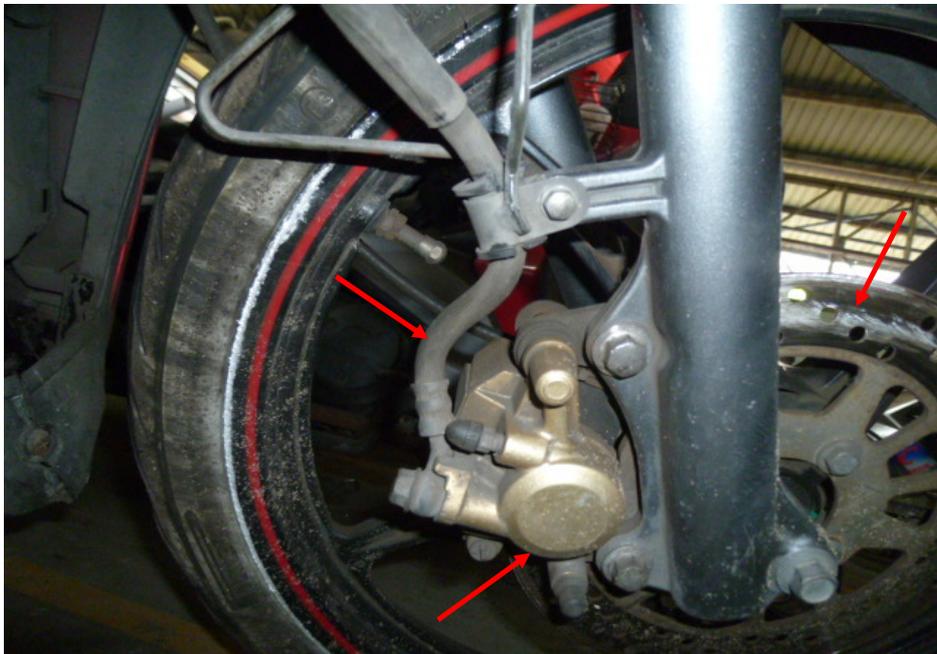
Photo 24 shows a close up view of the front brake caliper, front brake disc and front brake hose (arrowed) of the Motorcycle, which are all part of the components in the hydraulic front brake system of the Motorcycle. Our visual checks of these various components had revealed all to be intact with no visible damage. No leakage of brake fluid was also observed.

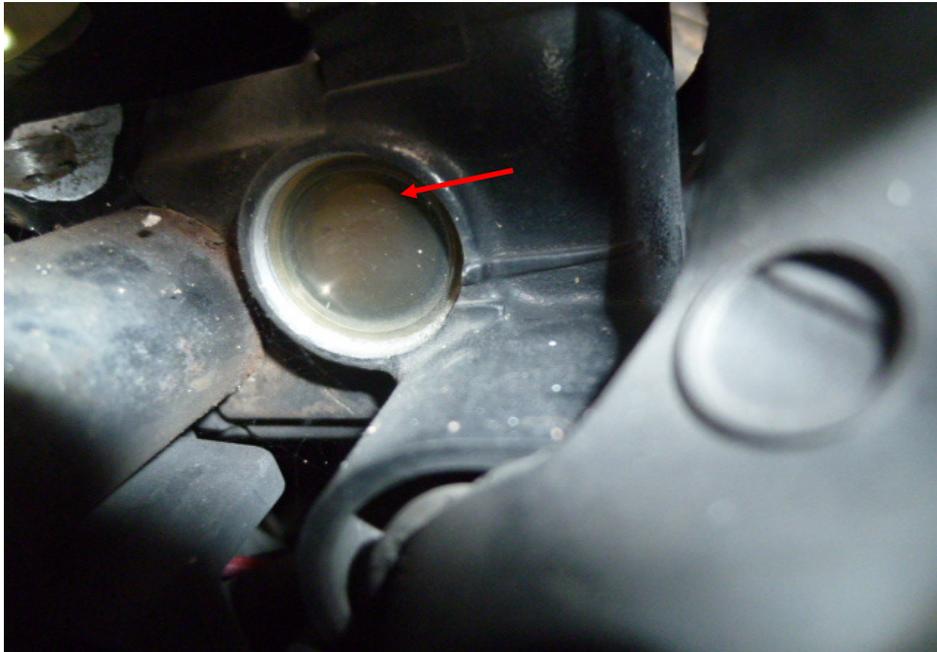
Photo 25 shows the brake fluid reservoir for the front brake of the Motorcycle. The brake fluid was observed to be of sufficient level (arrowed) and without contamination for operational purposes.

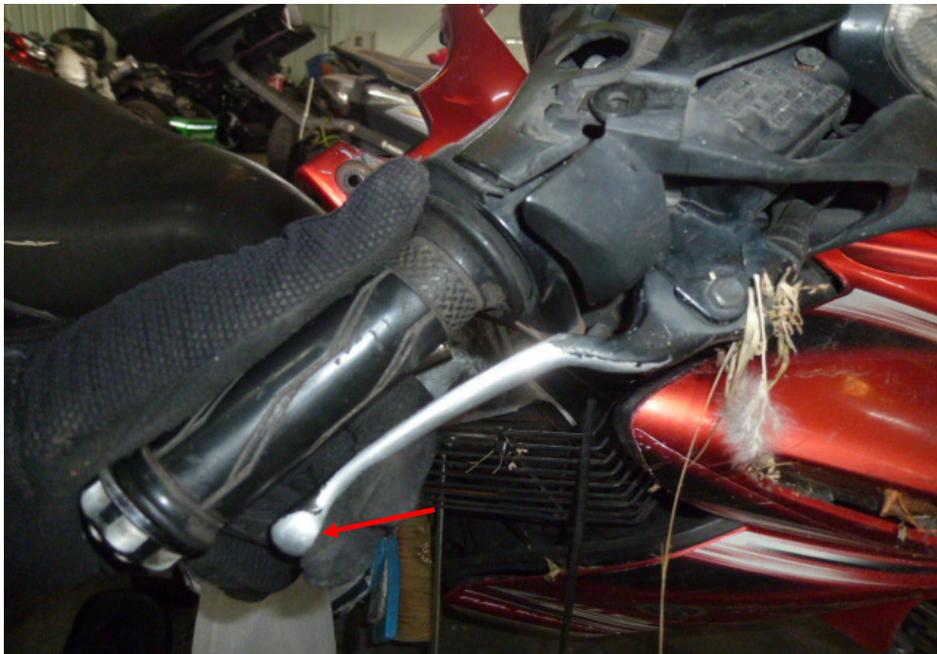
Photo 26 shows the front brake lever being depressed. There was some resistance felt (spongy like feel) upon pressing the front brake lever (arrowed). This would indicate that there is no leakage of pressure/vacuum in the brake system.

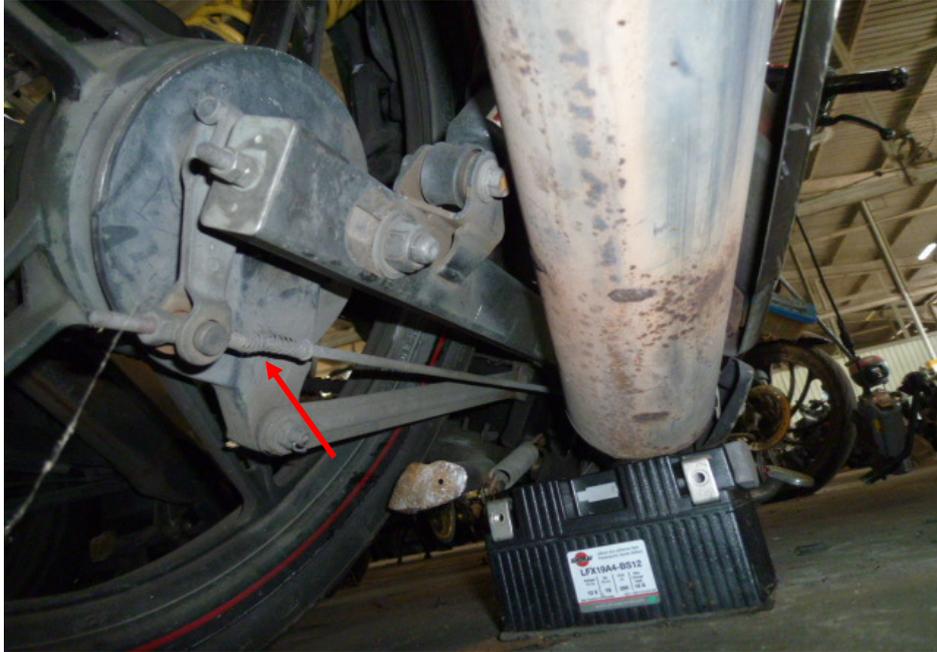
Photo 27 shows the rear wheel of the Motorcycle. The type of brake system for the rear wheel was of a mechanical type, controlled by the brake foot pedal of the Motorcycle. Our checks of the cable (arrowed), spring and drum which are all part of the components in the rear brake system of the Motorcycle reveal all to be intact and without damage.
