Your Ref: TP/IP/28149/2021  
Our Ref : CI/TPD21008004/N

**Fatal Accident Investigation Team**

**INSPECTION REPORT OF MOTORCYCLE FBQ 6529P**

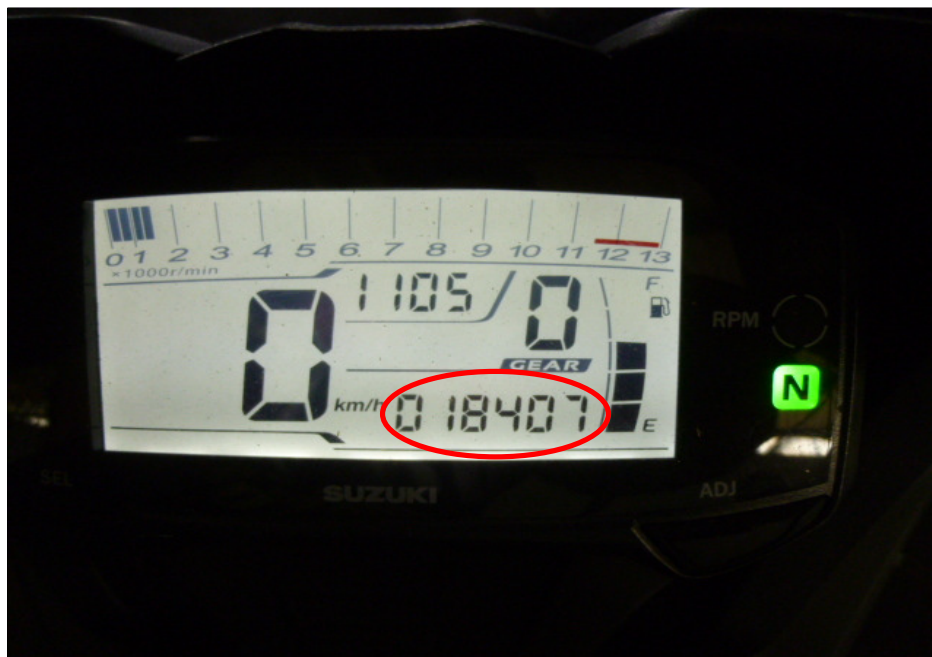
**Photo 1** shows the speedometer gauge of the Motorcycle. The mileage of the Motorcycle at the time of our inspection was 18, 407km (circled).

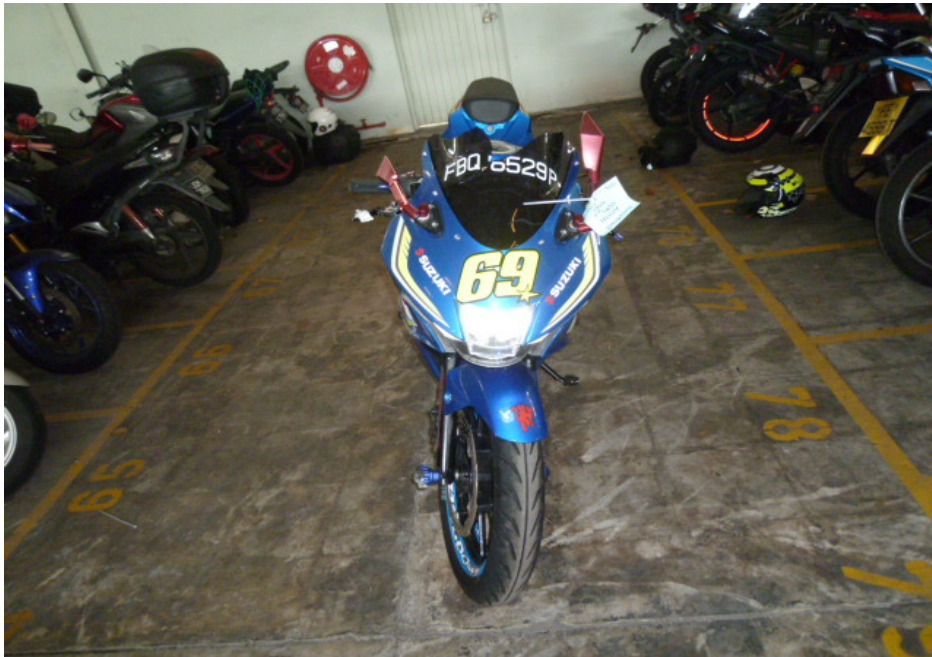
**Photo 2** shows a general view of the frontal portion of the Motorcycle at the time of our inspection. The Motorcycle was observed to have sustained damages all around.

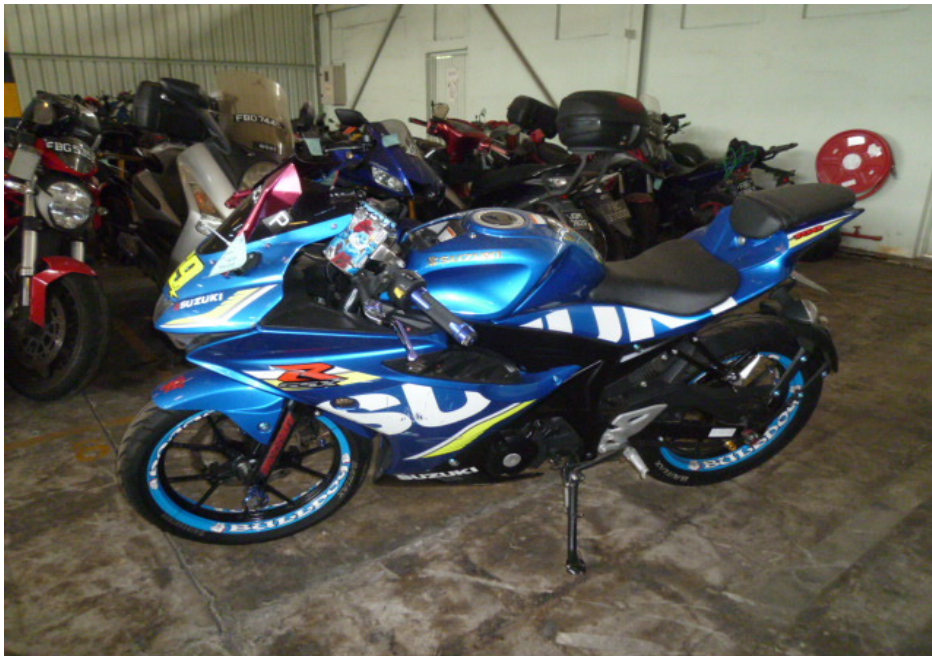
**Photo 3** shows a general view of the left body of the Motorcycle at the time of our inspection. The Motorcycle was observed to have sustained damages all around.

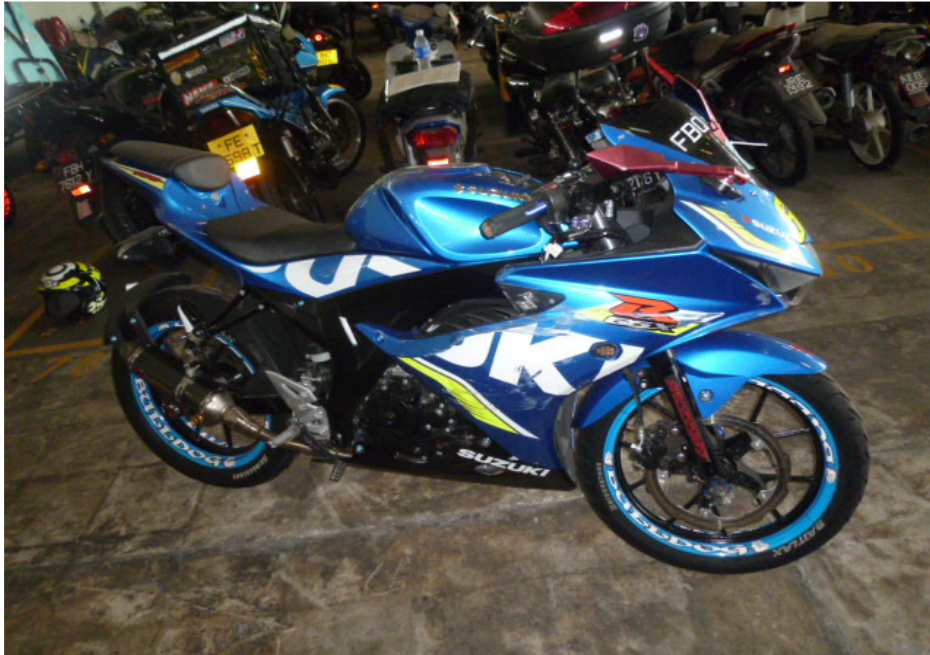
4. The mileage of the Motorcycle at the time of our inspection was 18, 407km.
5. The Motorcycle was observed to have sustained damages all around. The body parts that were found to have been damaged include its windshield, front cowling, front brake lever, right handlebar end, side cowlings, right side mirror, rear brake pedal, right front footrest, right pillion footpeg, right rear side cover, and exhaust muffler, amongst others.

**Photo 4** shows a general view of the right body of the Motorcycle at the time of our inspection. The Motorcycle was observed to have sustained damages all around. The body parts that were found to have been damaged include its windshield, front cowl, front brake lever, right handlebar end, side cowlings, right side mirror, rear brake pedal, right front footrest, right pillion footpeg, right rear side cover, and exhaust muffler, amongst others.

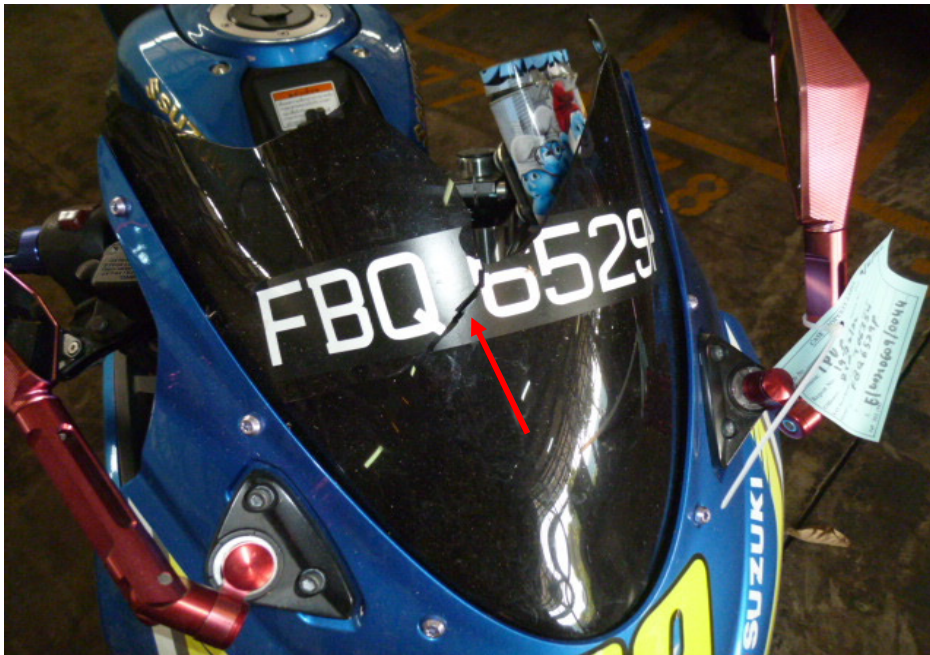
**Photo 5** shows a closer view of the windshield (arrowed) which was amongst the body parts of the Motorcycle that had sustained damage as a result of the accident.

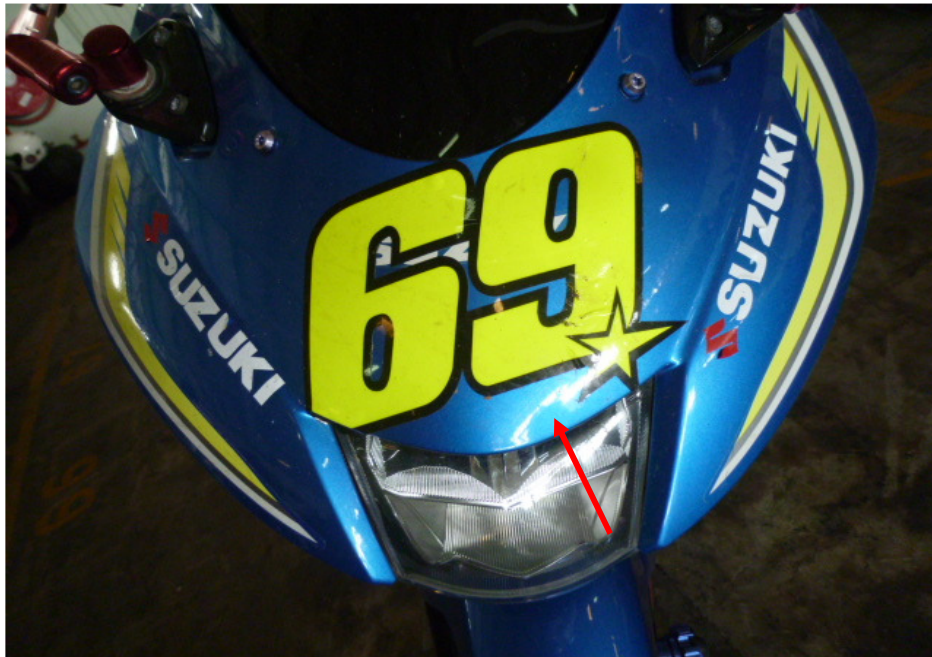
**Photo 6** shows the front cowling (arrowed), which were amongst the body parts of the Motorcycle that had sustained damage as a result of the accident.

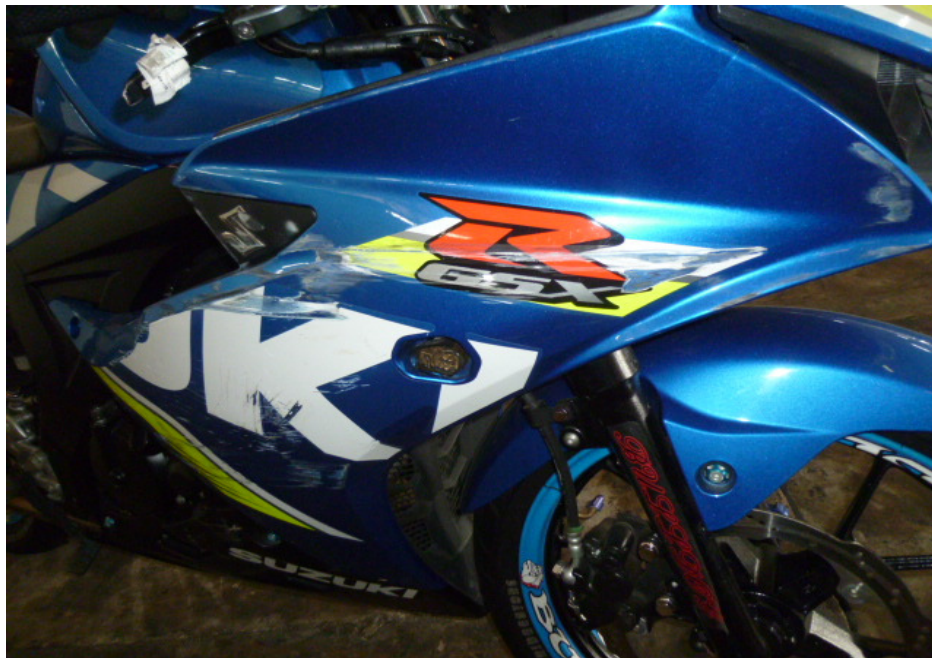
**Photo 7** shows a closer view of the right cowling which was amongst the body parts of the Motorcycle that had sustained damage as a result of the accident.

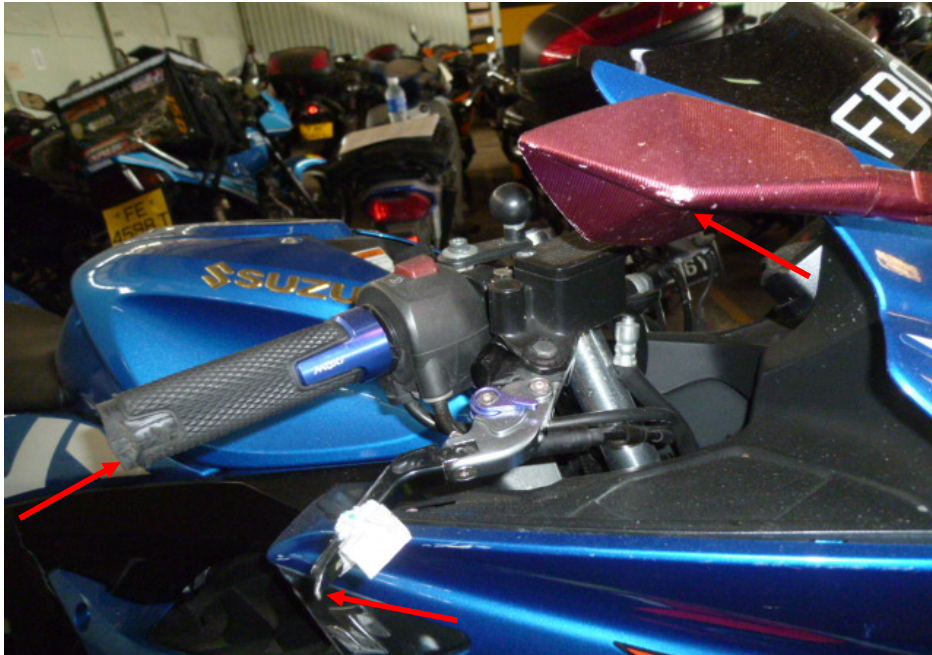
**Photo 8** shows the right handlebar end, front brake lever and right side mirror (arrowed), which were amongst the body parts of the Motorcycle that had sustained damage as a result of the accident.

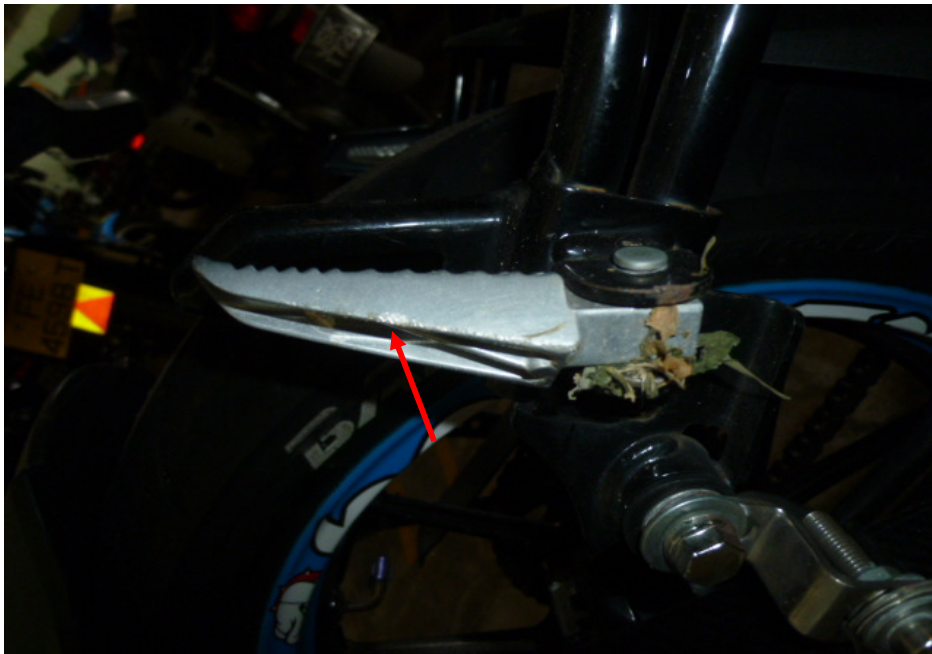
**Photo 9** shows a closer view of the right pillion footpeg which was amongst the body parts of the Motorcycle that had sustained damage as a result of the accident (arrowed).

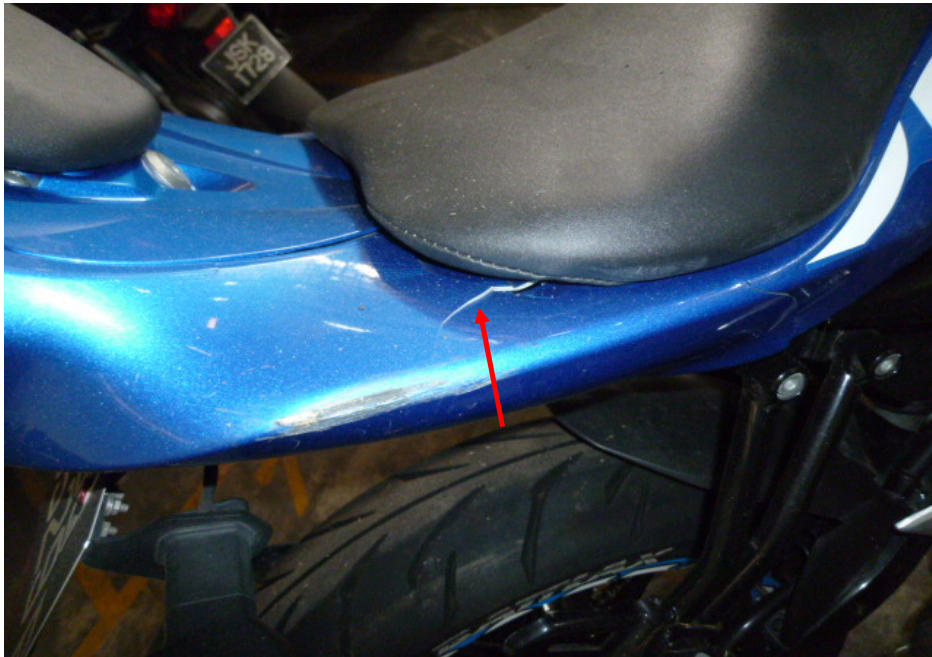
**Photo 10** shows a closer view of the cracked right rear side cover of the Motorcycle as a result of the accident (arrowed).

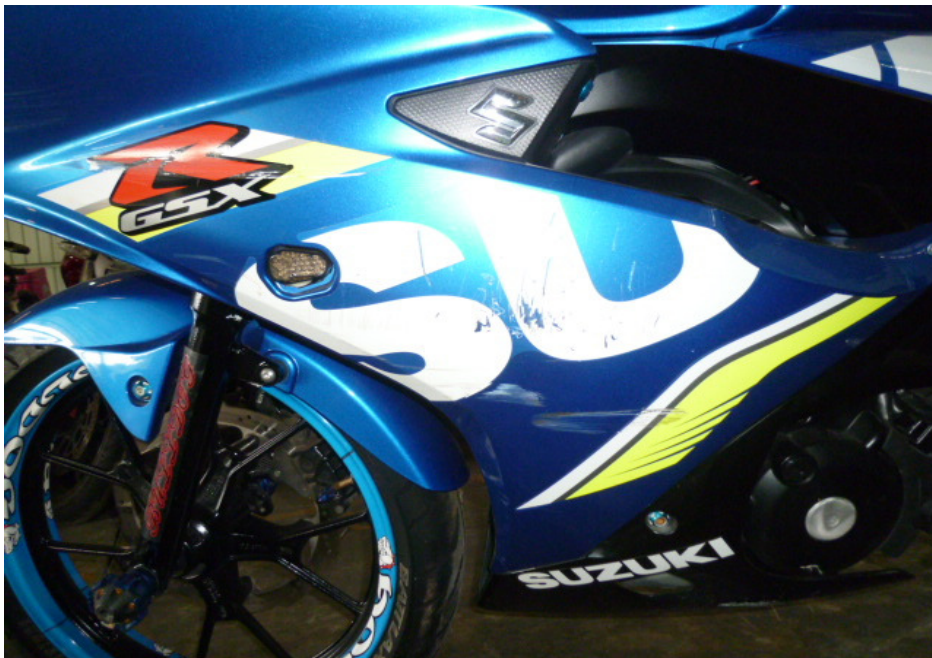
**Photo 11** shows a closer view of the left cowling which was amongst the body parts of the Motorcycle that had sustained damages of grazing nature as a result of the accident.

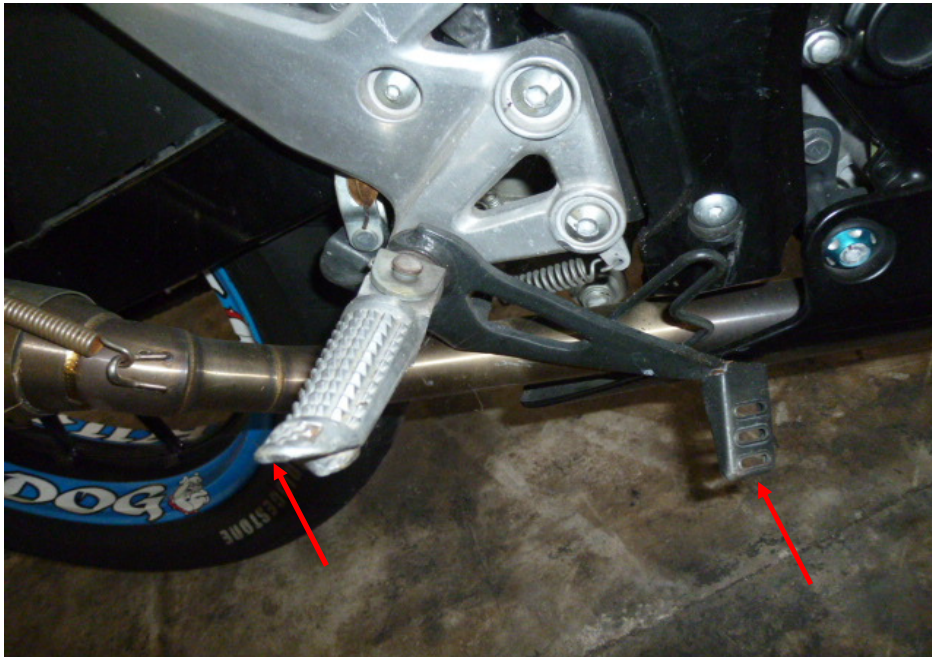
**Photo 12** shows the rear brake pedal and right front footrest of the Motorcycle that had sustained damage as a result of the accident (arrowed).

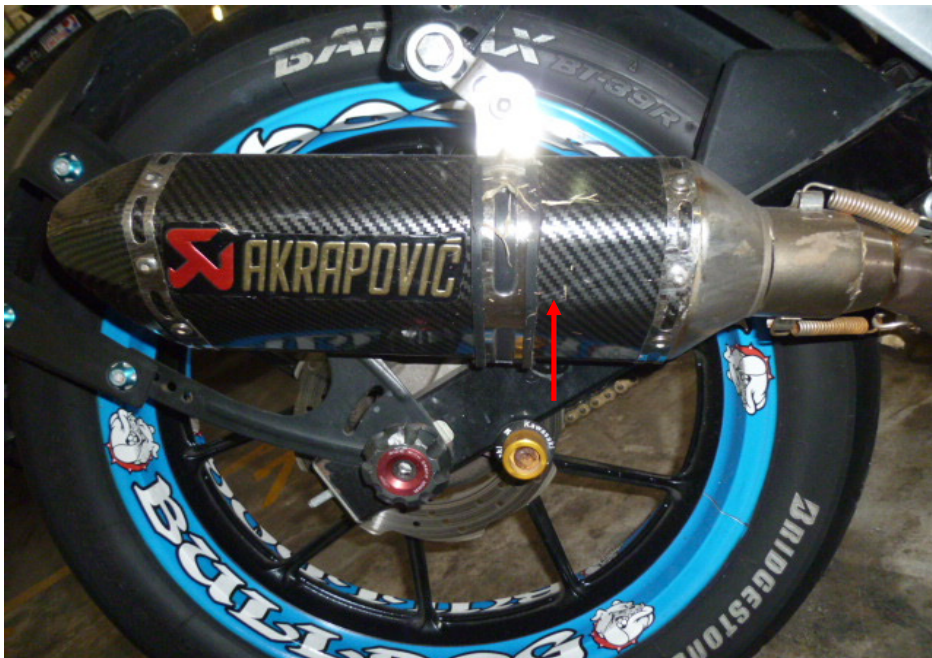
**Photo 13** shows the grazed exhaust muffler of the Motorcycle as a result of the accident (arrowed).

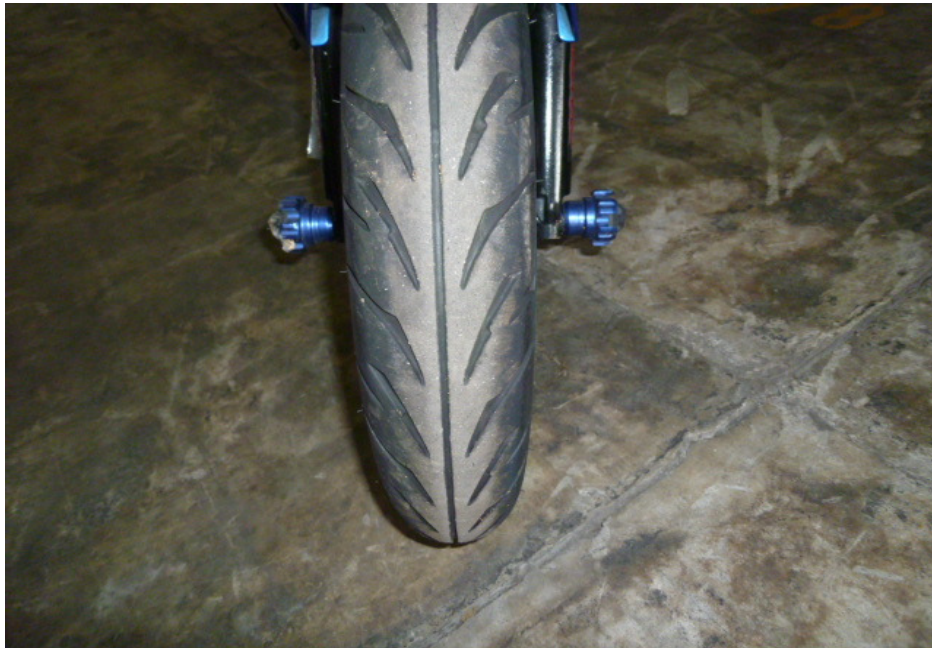
**Photo 14** shows the front tyre of the Motorcycle at the time of our inspection. The front tyre was observed to be in serviceable condition with remaining tread depth of approximately 3mm. The pattern of the tread was also clearly visible. There was no tear, burst mark(s) and/or punctured hole(s) on the sidewalls as well as across the tread of the front tyre.

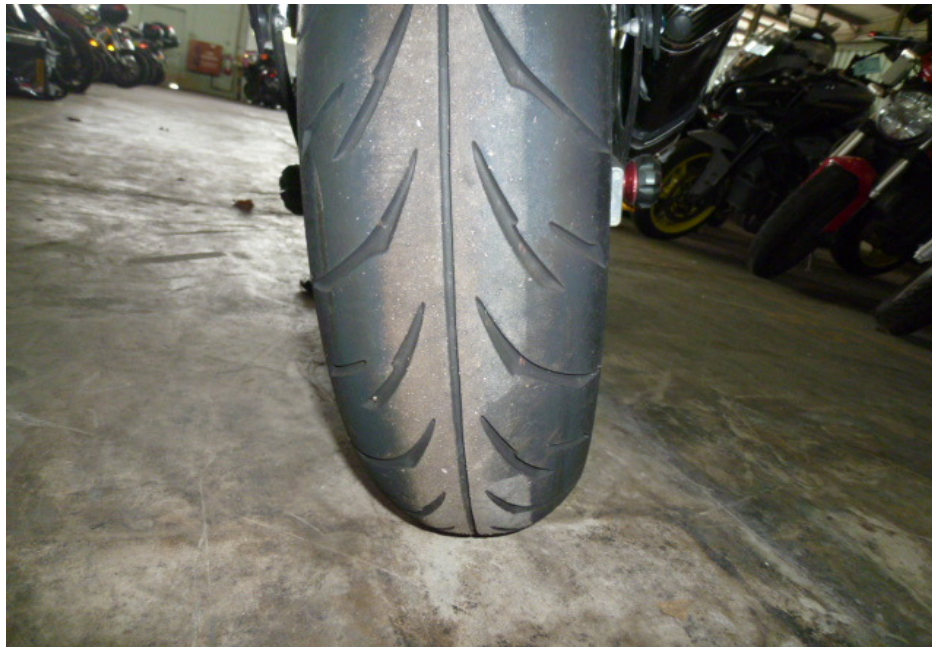
**Photo 15** shows the condition of the Motorcycle's rear tyre. The rear tyre was observed to be in serviceable condition with remaining tread depth of approximately 3mm. The tyre was also observed to be sufficiently inflated for vehicular operation. We did not observe any tear, burst mark(s) and/or punctured hole(s) on the sidewalls as well as across the tread of the rear tyre.

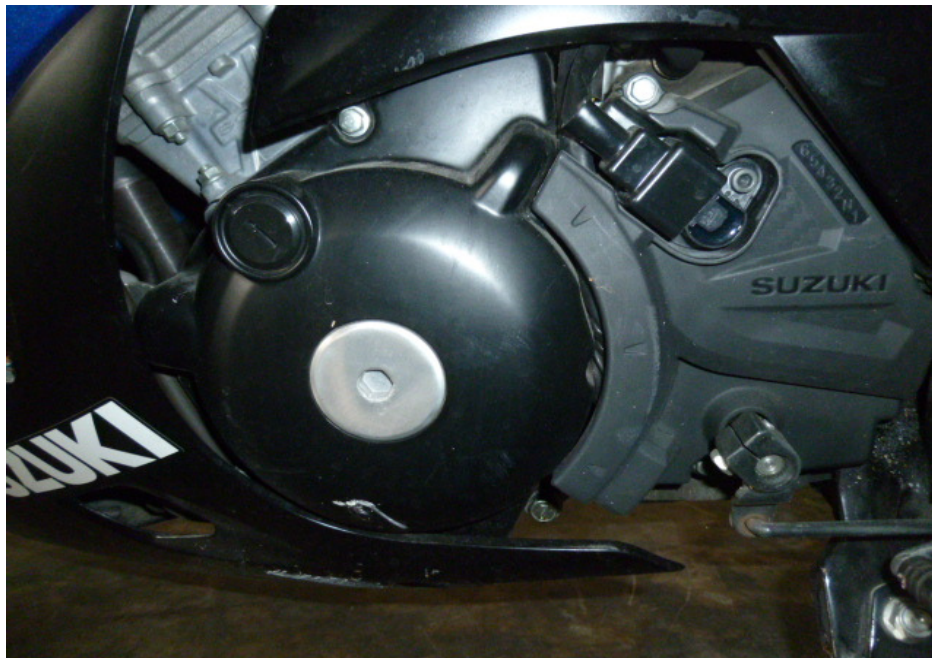
**Photo 16** shows the left side of the engine of the Motorcycle at the time of our inspection. The various engine related parts and components were found to be intact with no visible damage. There was also no sign(s) or indication(s) of fluid leak observed around the left engine area of the Motorcycle.

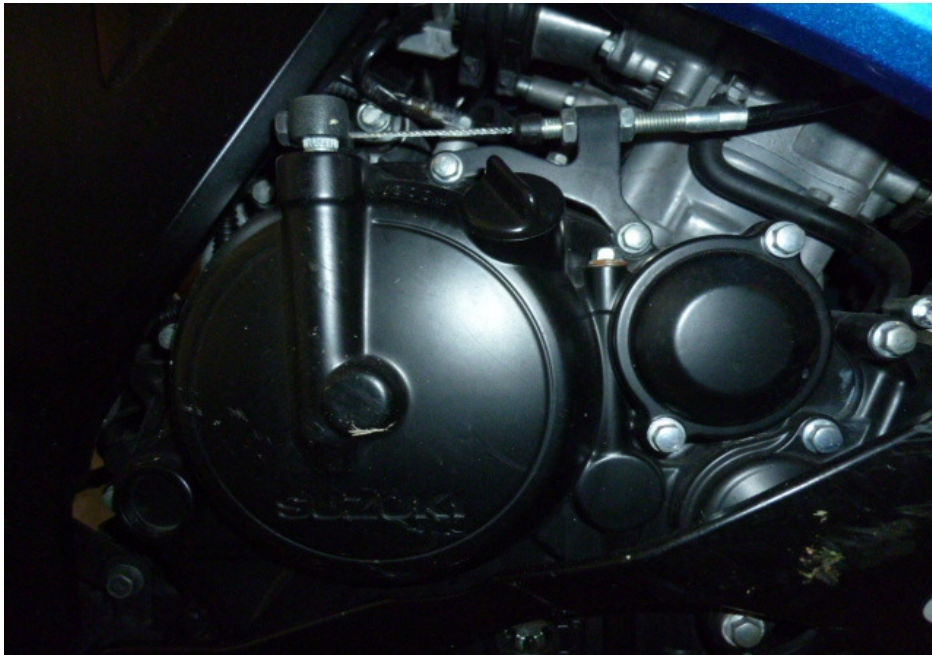
**Photo 17** shows the right side of the engine of the Motorcycle at the time of our inspection. The various engine related parts and components were found to be intact with no visible damage. There was also no sign(s) or indication(s) of fluid leak observed around the right engine area of the Motorcycle.

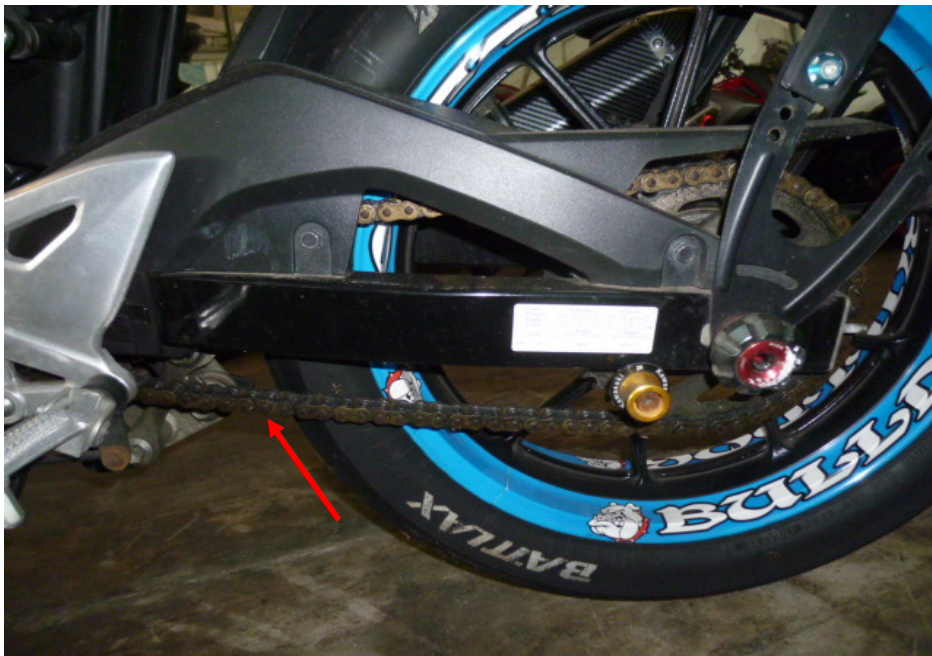
**Photo 18** shows the general view of the gear train (arrowed) of the Motorcycle, which was observed to be intact with no misalignment. It was also adequately lubricated for operating purposes.

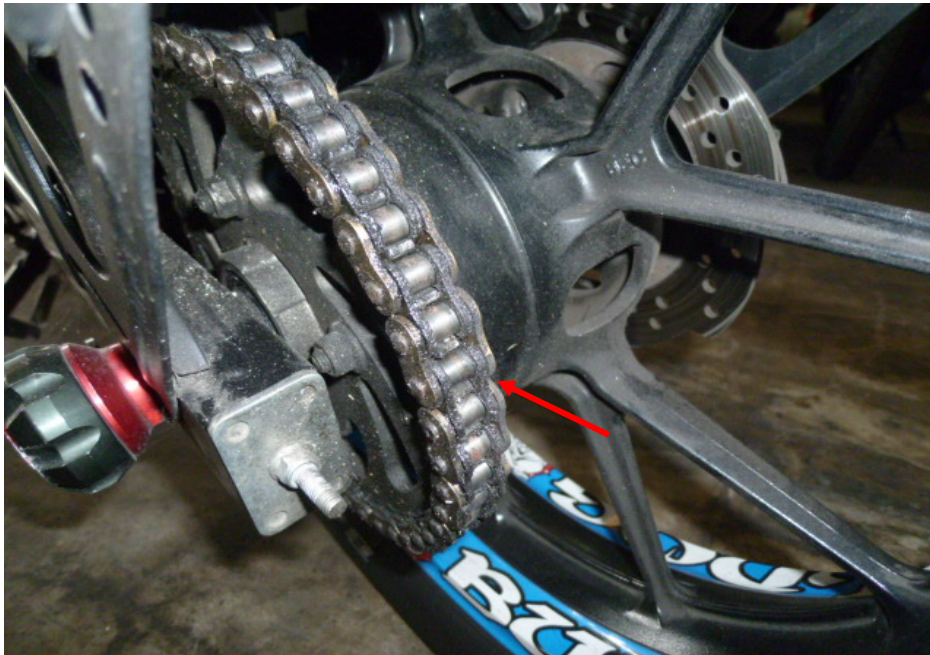
**Photo 19** shows a closer view of the gear train (arrowed) of the Motorcycle, which was observed to be intact with no misalignment. It was also adequately lubricated for operating purposes.

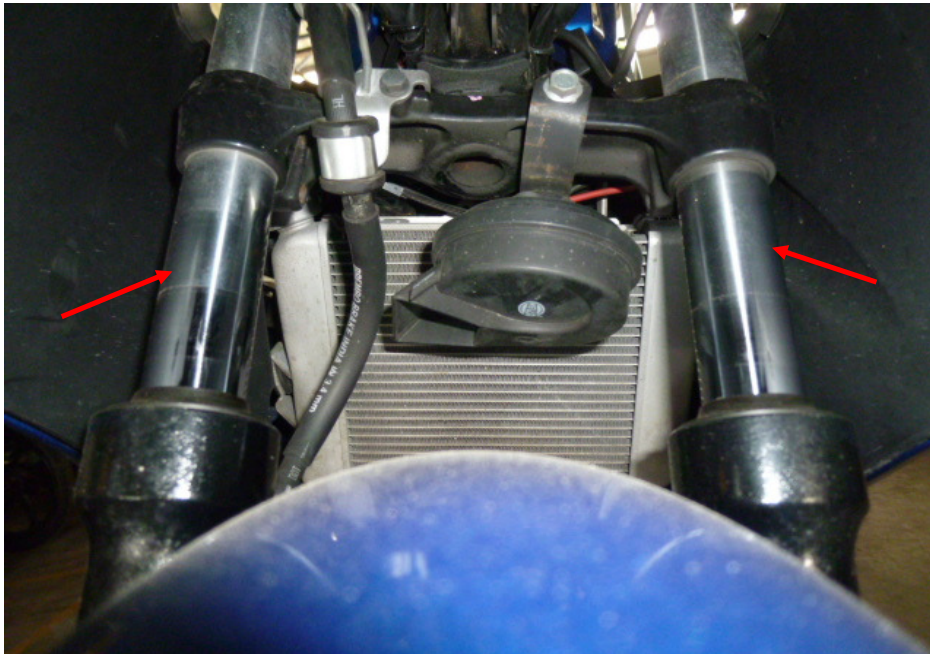
**Photo 20** shows the front fork (arrowed) of the Motorcycle. The front fork and fork bracket of the Motorcycle were both found to be intact and undamaged. Turning the Motorcycle's handle bar towards the left and right did not produce any abnormal free play. The steering system of the Motorcycle was in serviceable condition at the time of our inspection.

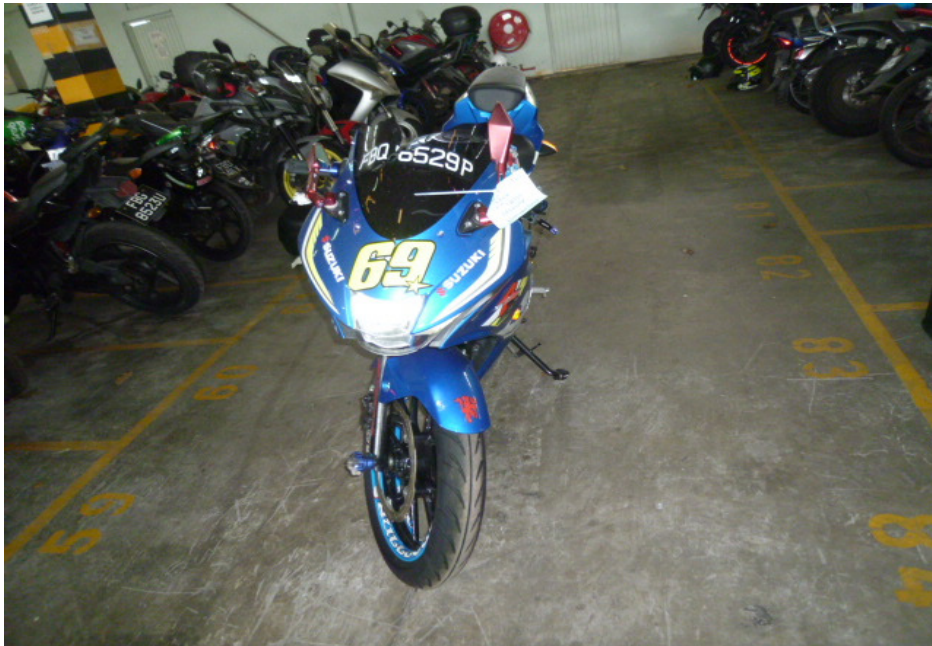
**Photo 21** shows the front wheel of the Motorcycle turned towards its full left. Turning the Motorcycle's handle bar towards the left did not produce any abnormal free play and/or resistance. This would indicate that the steering system of the Motorcycle was in serviceable condition at the time of our inspection.

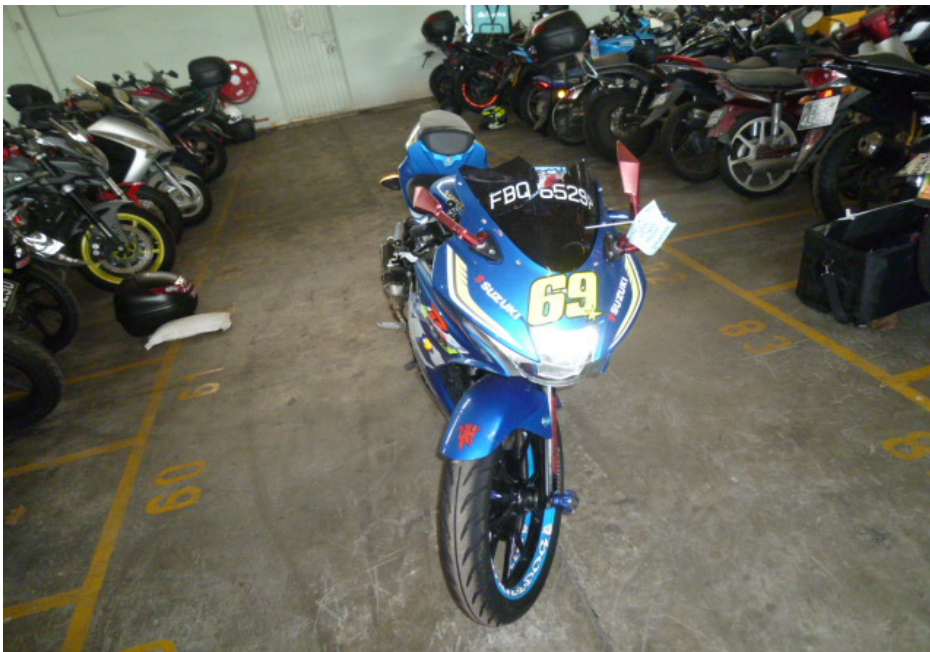
**Photo 22** shows the front wheel of the Motorcycle turned towards its full right. Turning the Motorcycle's handle bar towards the right did not produce any abnormal free play and/or resistance. This would indicate that the steering system of the Motorcycle was in serviceable condition at the time of our inspection.

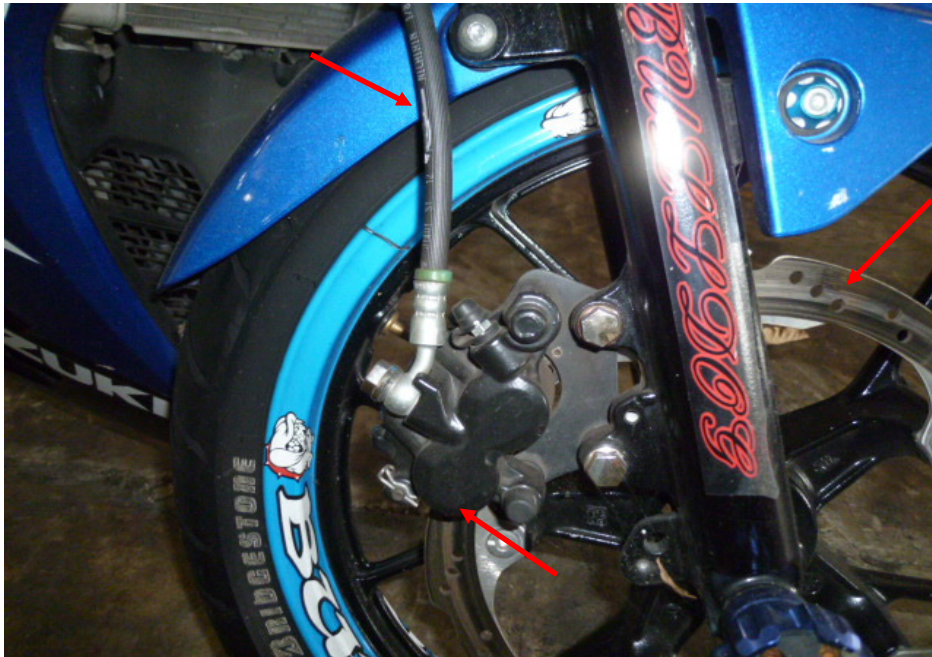
**Photo 23** shows a close up view of the front brake caliper, front brake disc and front brake hose (arrowed) of the Motorcycle, which are all part of the components in the hydraulic front brake system of the Motorcycle. Our visual checks of these various components had revealed all to be intact with no visible damage. No leakage of brake fluid was also observed.

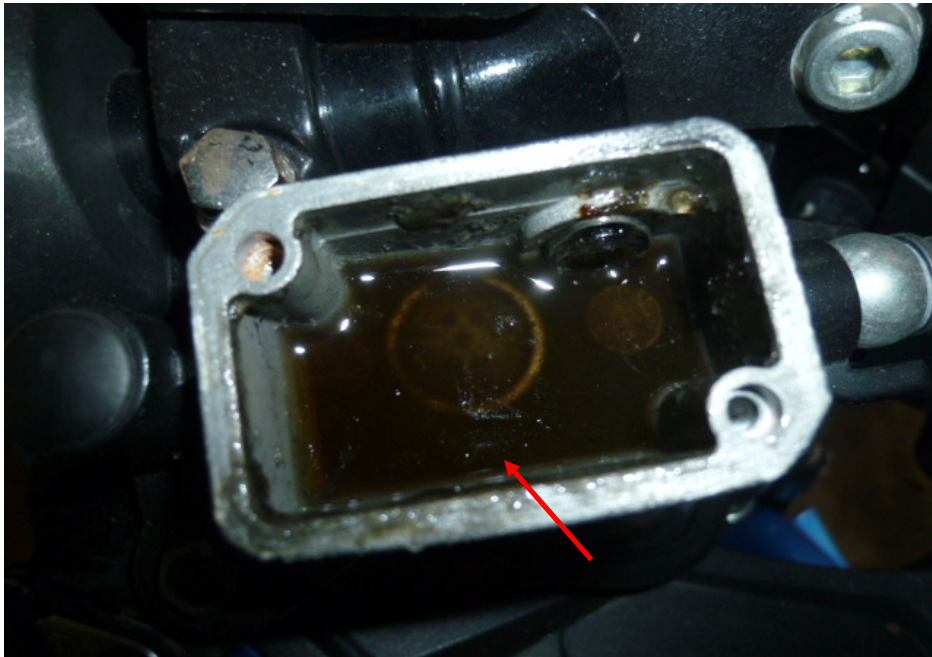
14. The brake fluid for the rear brake was found to be of sufficient level for operational purposes and without any contamination. The brake fluid for the front brake was also found to be of sufficient level for operational purposes. However it was observed to be slightly contaminated.

**Photo 24** shows the brake fluid reservoir for the front brake of the Motorcycle. The brake fluid was found to be of sufficient level for operating purposes. However the brake fluid was observed to be slightly contaminated (arrowed).

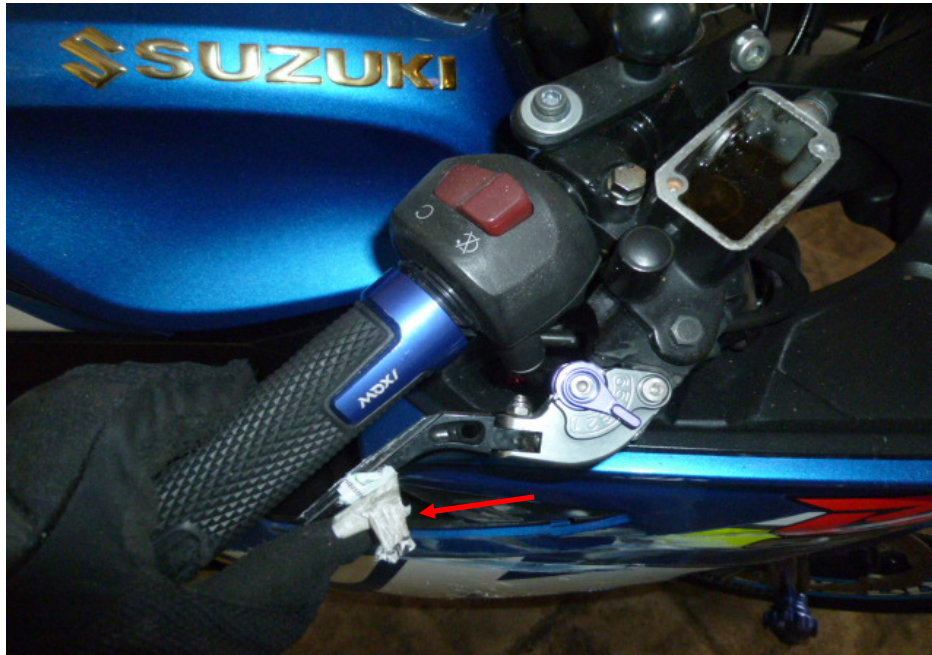
15. Static brake tests conducted on the Motorcycle had appear to indicate that the braking system of the Motorcycle was in serviceable condition. There was some resistance felt (spongy like feel) upon pressing the brake lever and upon stepping on the brake pedal. This would indicate that there was no leakage of pressure/vacuum in the brake system.

**Photo 25** shows the front brake lever being depressed. There was some resistance felt (spongy like feel) upon pressing the front brake lever (arrowed). This would indicate that there is no leakage of pressure/vacuum in the brake system.

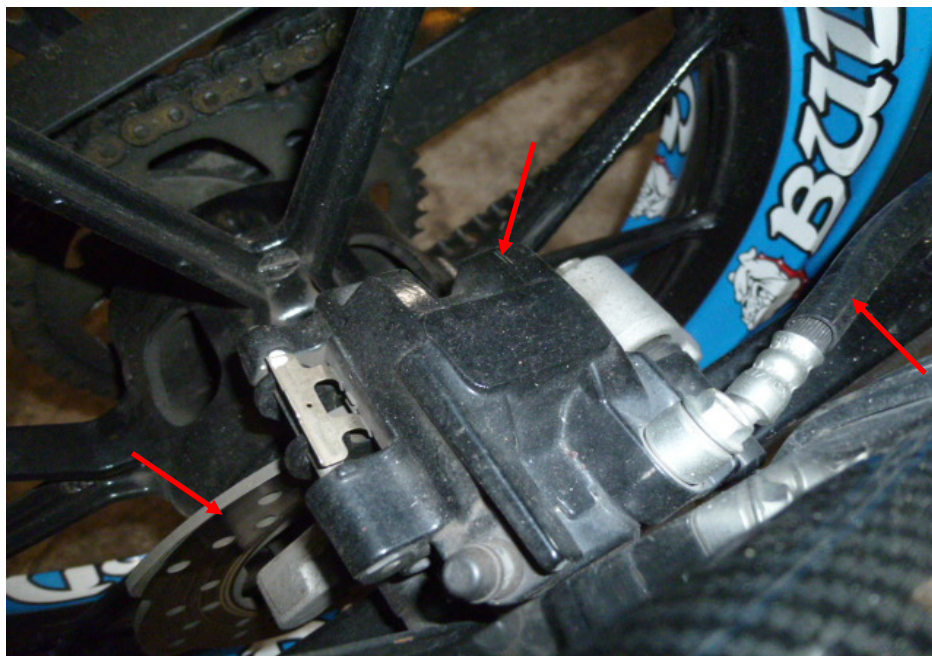
**Photo 26** shows a close up view of the rear brake caliper, rear brake disc and rear brake hose (arrowed) of the Motorcycle, which are all part of the components in the hydraulic rear brake system of the Motorcycle. Our visual checks of these various components had revealed all to be intact with no visible damage. No leakage of brake fluid was also observed.
