Your Ref: TP/IP/22175/2021  
Our Ref :CI/TPD21008006/N

4 August 2021

**Fatal Accident Investigation Team**

**INSPECTION REPORT OF BICYCLE (BLACK AND RED) - TRAFFIC POLICE  
POUND REPORT NO. 1560/21**

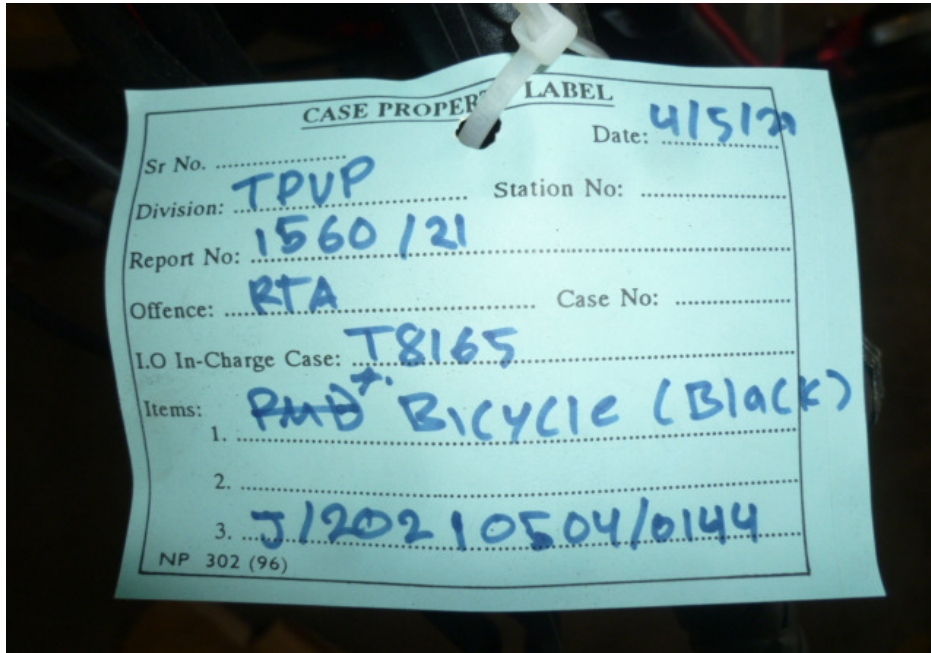
**Photo 1** shows the identification of the Bicycle with reference to Traffic Police Pound Report No. 1560/21.

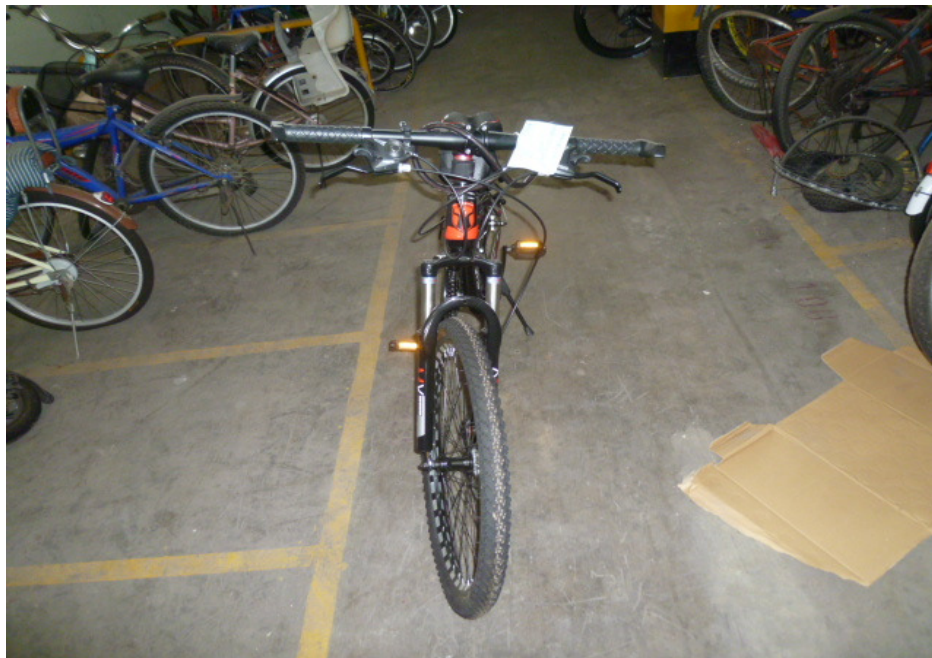
**Photo 2** shows the frontal portion of the Bicycle at time of our inspection. The Bicycle had sustained damages at its left body.

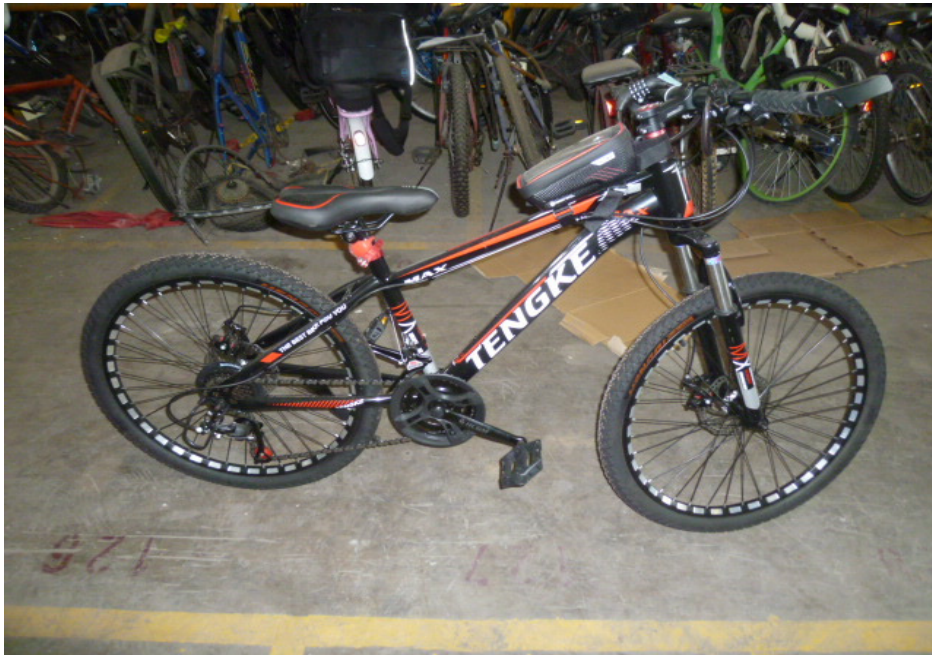
**Photo 3** shows the right body of the Bicycle at time of our inspection. The Bicycle had sustained damages at its left body.

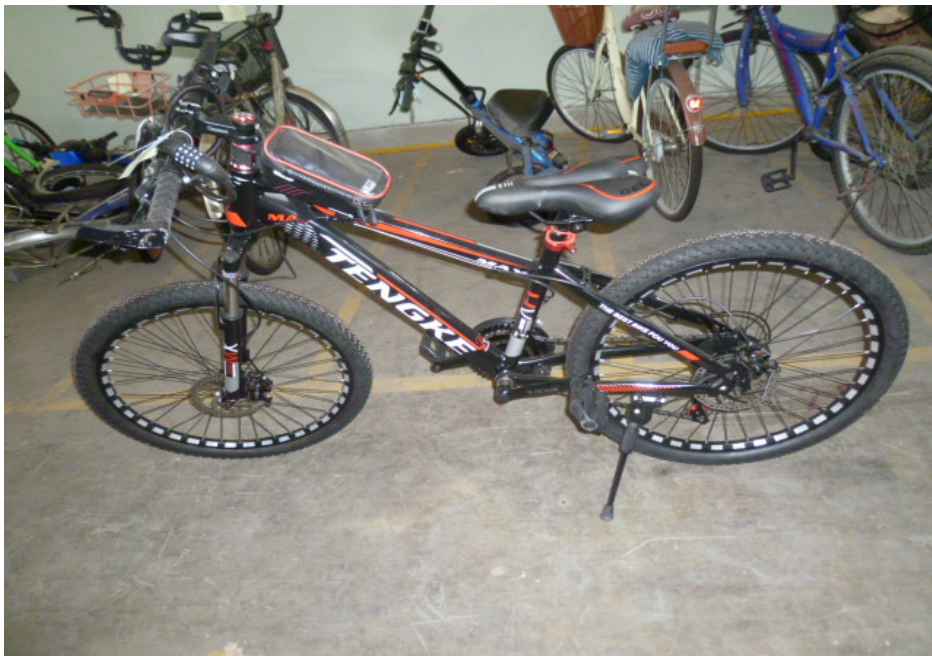
4. The Bicycle was observed to have sustained damages at its left body. The body parts that were found to have been damaged include its left hand brake lever guard, left fork stem, left pedal, seat and rear brake caliper nut, amongst others as a result of the accident. See photos 1 – 10 below.

**Photo 4** shows the left body of the Bicycle at time of our inspection. The Bicycle had sustained damages at its left body. The body parts that were found to have been damaged include its left hand brake lever guard, left fork stem, left pedal, seat and rear brake caliper nut, amongst others as a result of the accident.

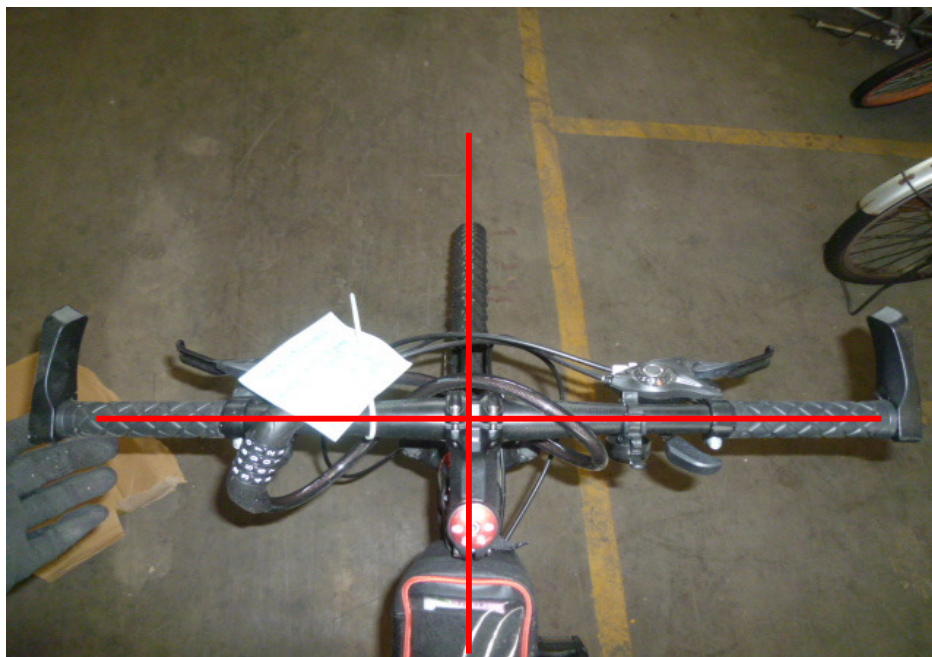
**Photo 5** shows the frontal portion of the Bicycle (top view) at the time of our inspection. There was no misalignment of the handle bar & front tyre observed.

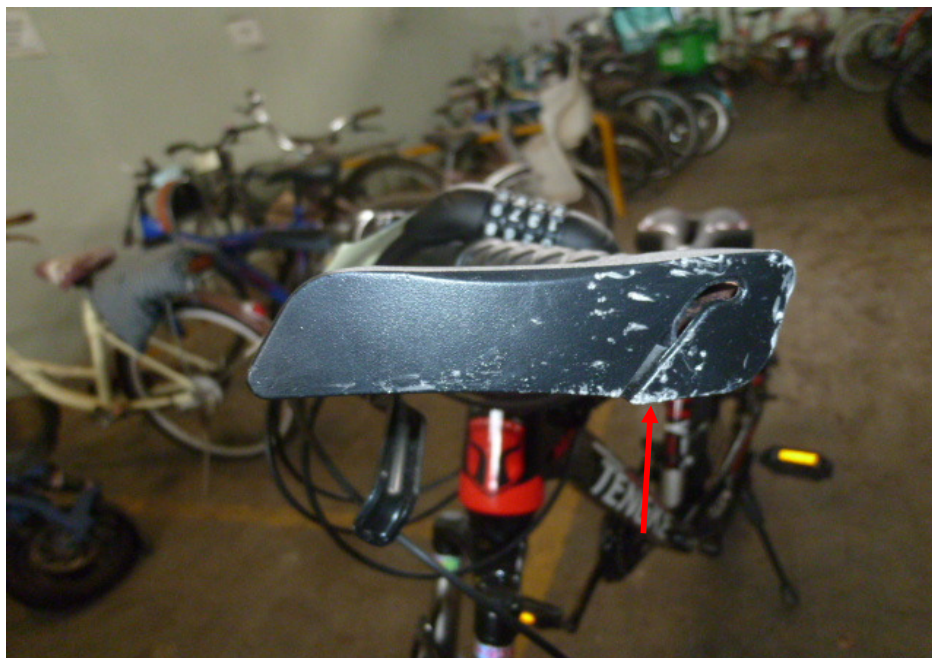
**Photo 6** shows the damaged left hand brake lever guard (arrowed) of the Bicycle at the time of our inspection.

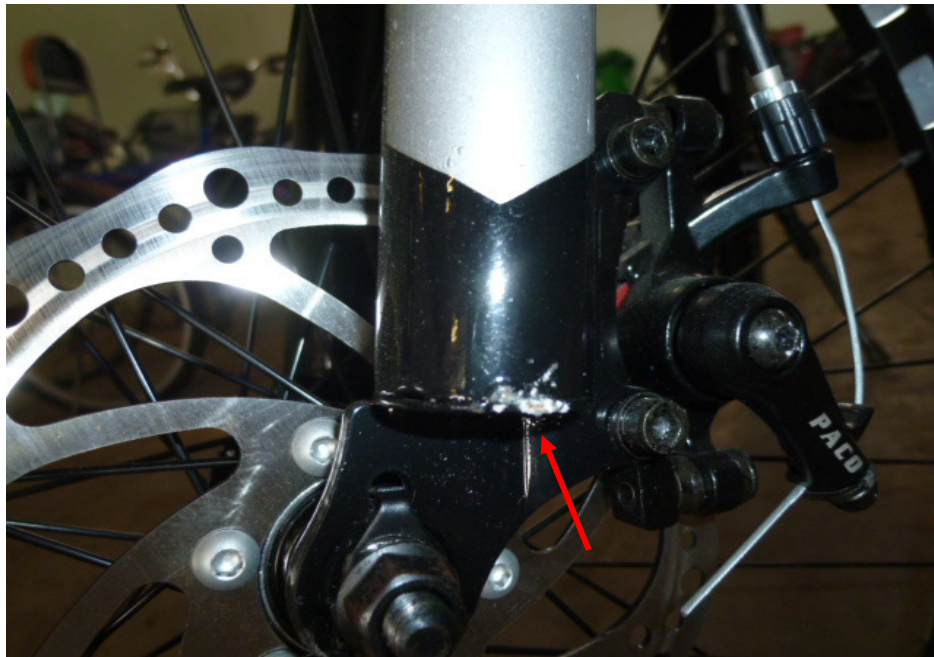
**Photo 7** shows the damages of grazing nature on the left fork stem (arrowed) of the Bicycle at the time of our inspection.

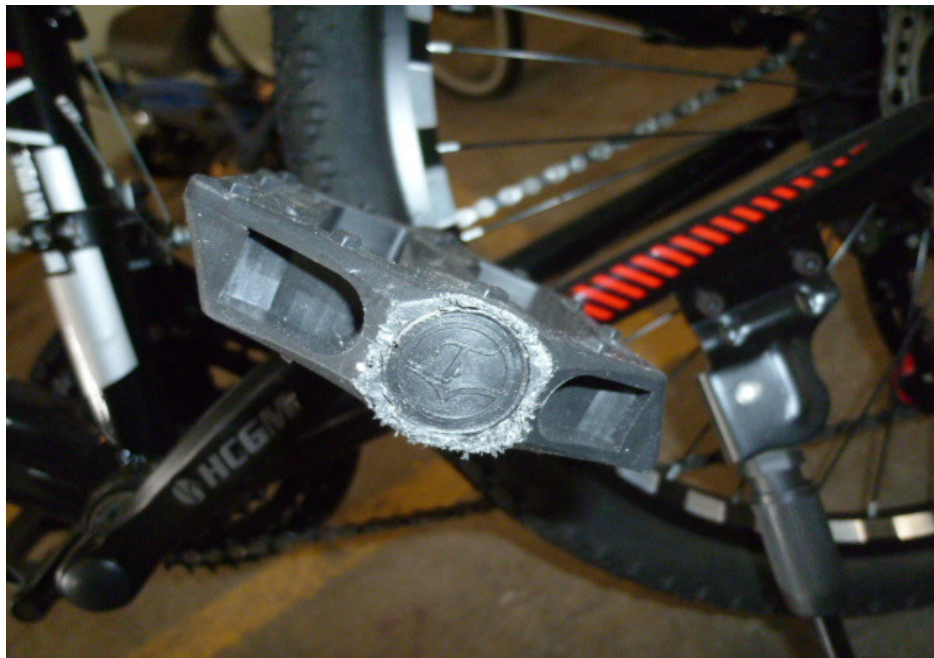
**Photo 8** shows the damages of grazing nature on the left pedal of the Bicycle at the time of our inspection.

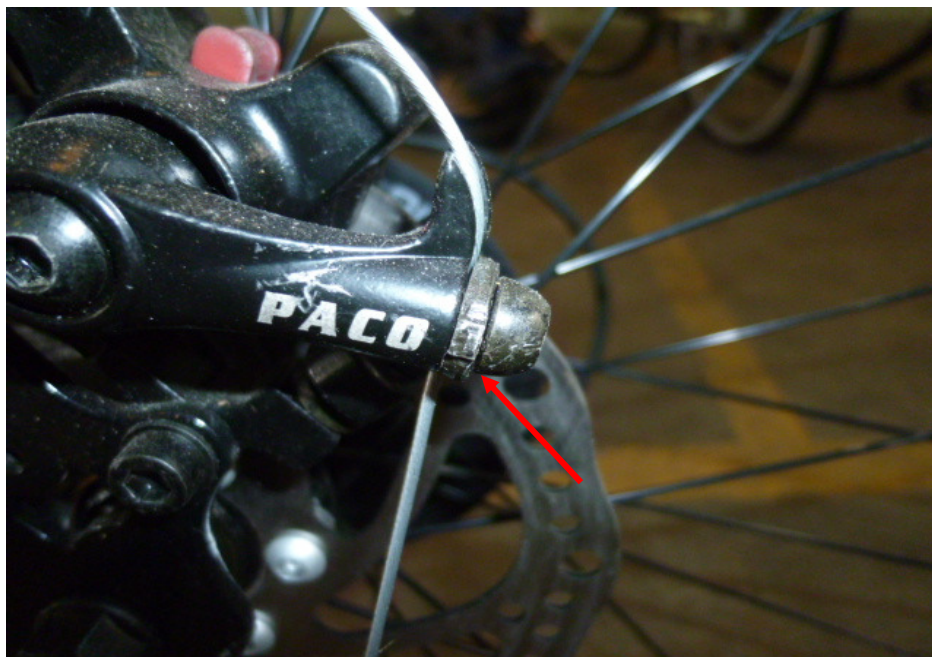
**Photo 9** shows the damages of grazing nature on the rear brake caliper nut of the Bicycle at the time of our inspection (arrowed).

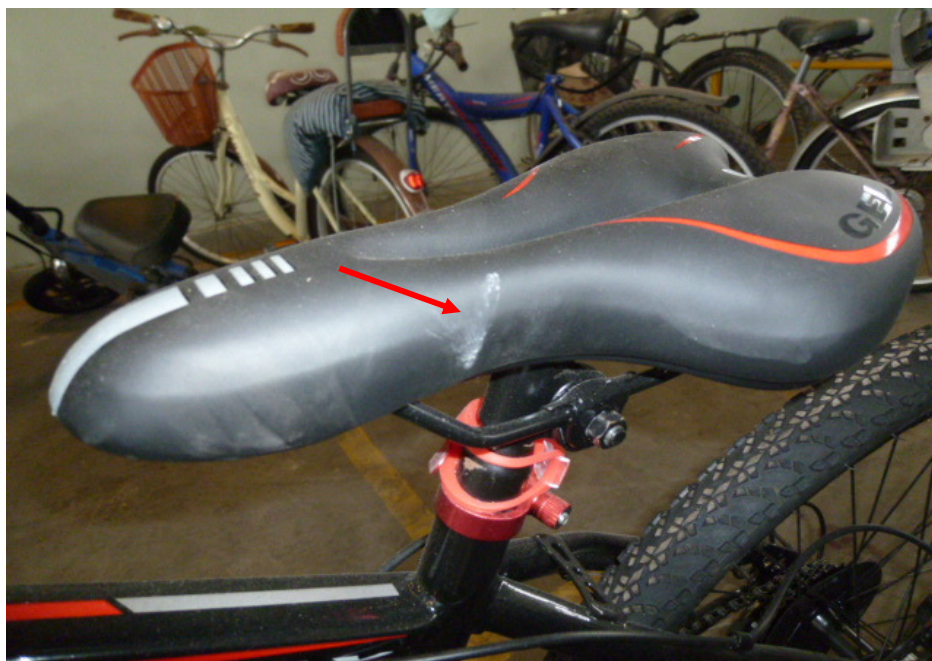
**Photo 10** shows a close-up view of the damaged seat (arrowed) of the Bicycle as a result of the accident.

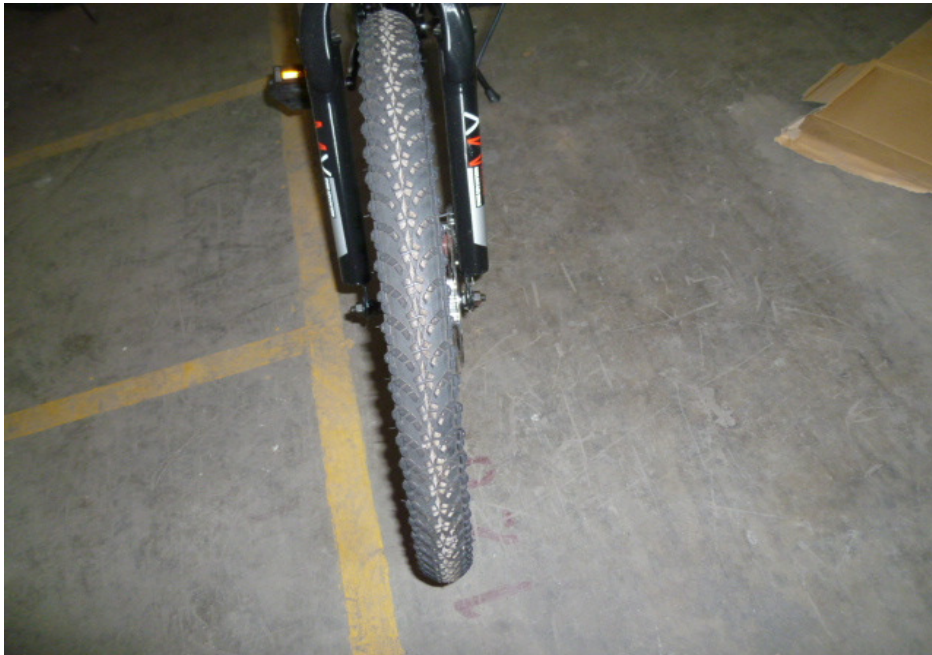
5. The condition of the Bicycle's front & rear tyres was observed to be in serviceable condition. The tread pattern of the 2 tyres was clearly visible. We did not observe any tear, burst mark(s) and/or punctured hole(s) on the sidewalls as well as across the tread of the 2 tyres. Both tyres were observed to be deflated at the time of our inspection. The tyre brand, tyre size and remaining tread depth of the 2 tyres were recorded as follows:-

**Photo 11** shows the front tyre of the Bicycle. The pattern of the tread was clearly visible. There was no tear, burst mark(s) and/or punctured hole(s) on the sidewalls as well as across the tread of the front tyre. However the front tyre was observed to be deflated.

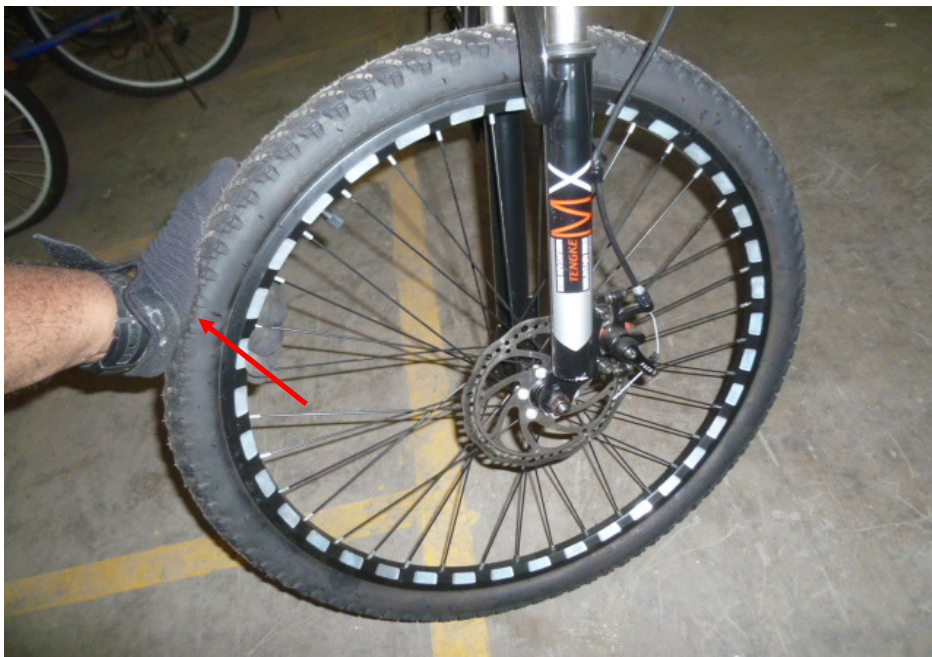
**Photo 12** shows the deflated front tyre of the Bicycle (arrowed).

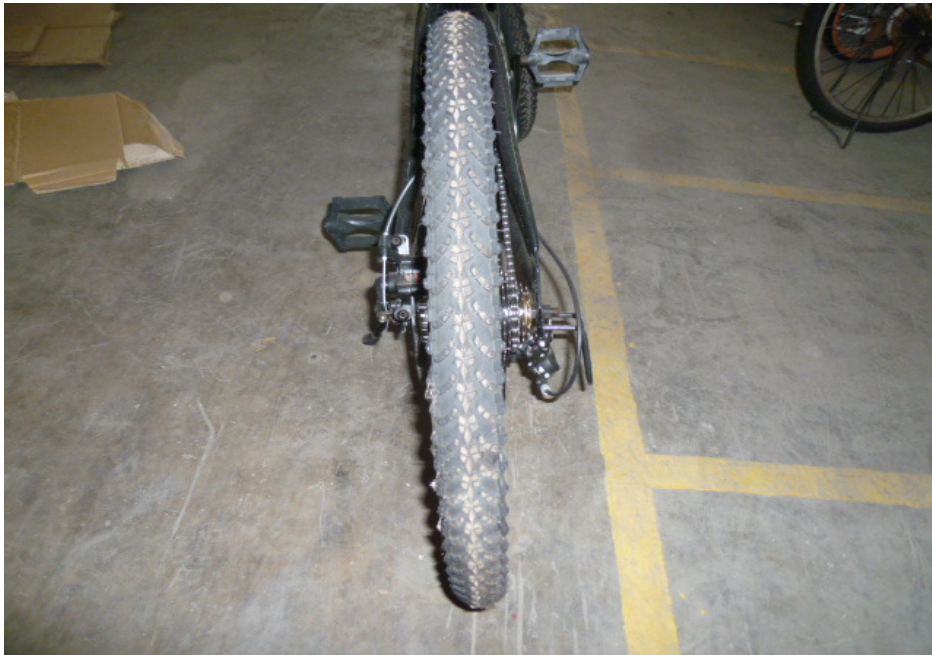
**Photo 13** shows the rear tyre of the Bicycle. The pattern of the tread was clearly visible. There was no tear, burst mark(s) and/or punctured hole(s) on the sidewalls as well as across the tread of the front tyre. However the rear tyre was observed to be deflated.

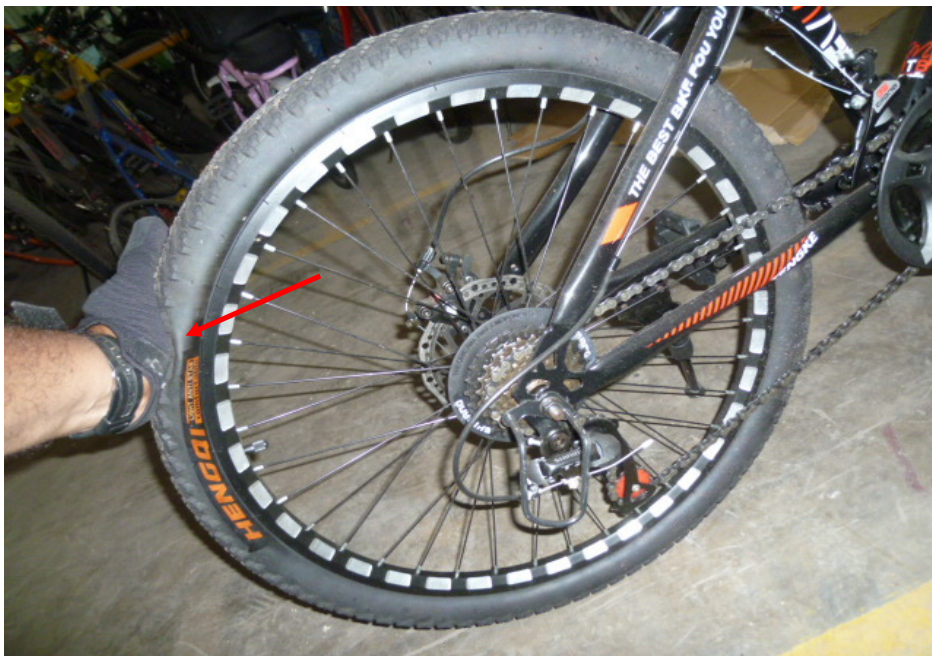
**Photo 14** shows the deflated rear tyre of the Bicycle (arrowed).

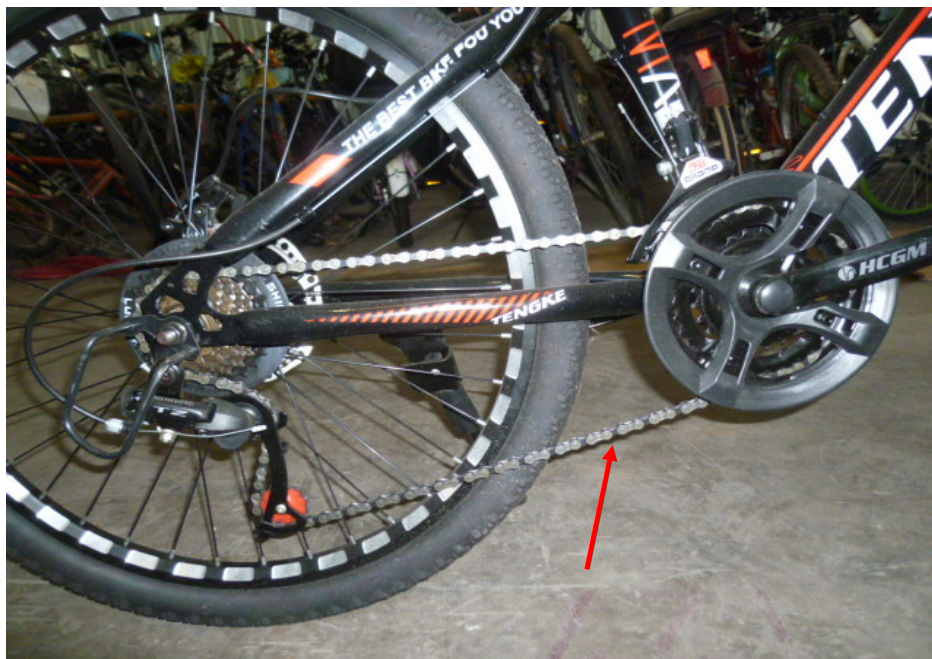
7. The gear train of the Bicycle was found to be intact without any misalignment. It was also adequately lubricated for operating purposes. See photos 15 & 16 below.

**Photo 15** shows the general view of the gear train of the Bicycle, which was observed to be intact with no misalignment (arrowed). It was also adequately lubricated for operating purposes.

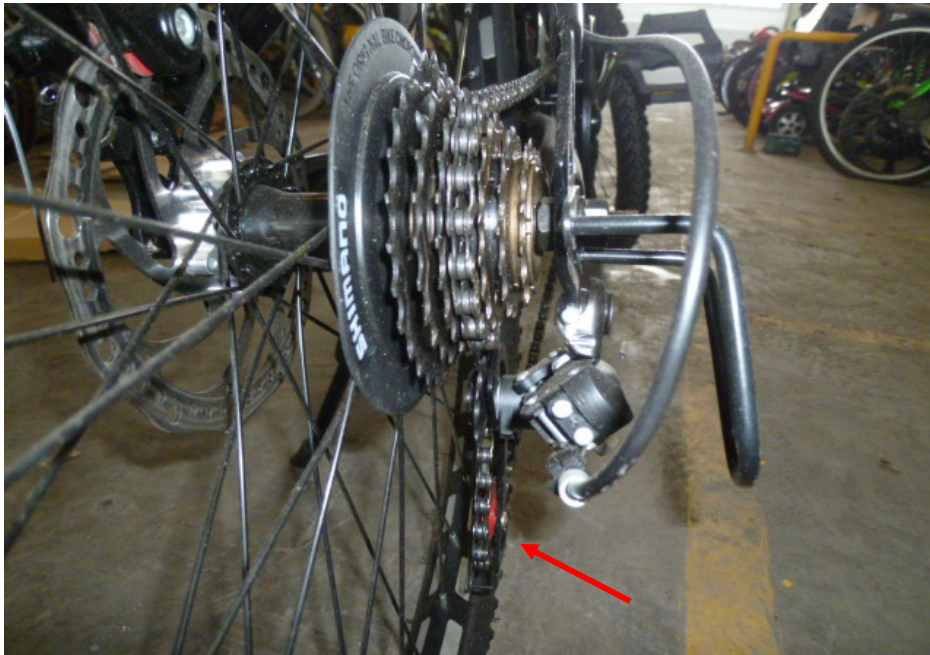
**Photo 16** shows a closer view of the gear train of the Bicycle, which was observed to be intact with no misalignment (arrowed). It was also adequately lubricated for operating purposes.

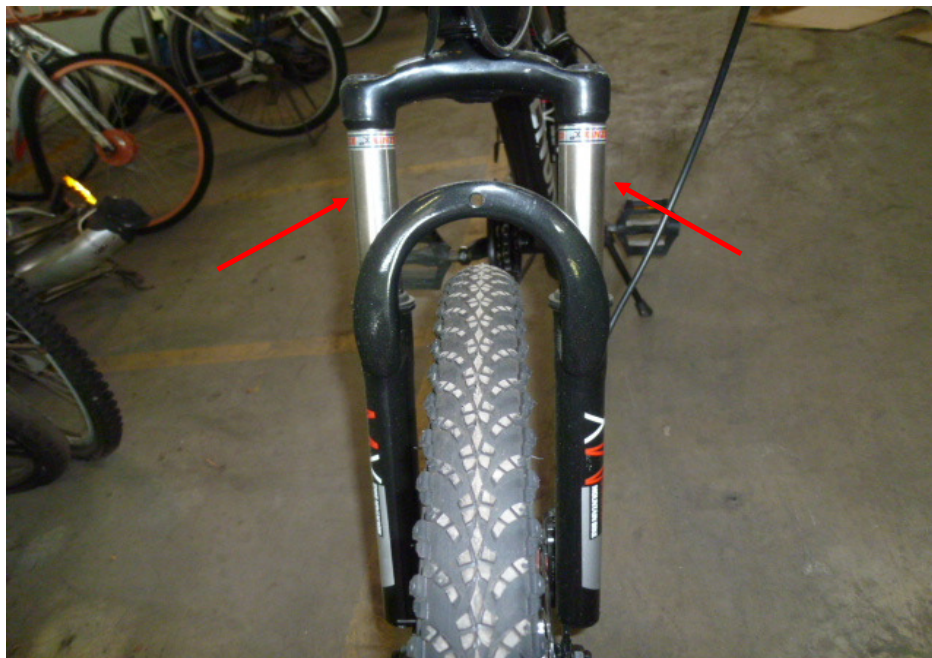
8. Our checks on the various steering components of the Bicycle revealed that its steering system was in serviceable condition. Its front fork assembly was found to be intact and undamaged. Turning the handle bar towards the left and right did not produce any abnormal free play and/or resistance.

**Photo 17** shows the front fork assembly (arrowed) of the Bicycle. The front forks and fork bracket of the Bicycle were both found to be intact and undamaged. Turning the Bicycle's handle bar towards the left and right did not produce any abnormal free play. The steering system of the Bicycle was in serviceable condition at the time of our inspection.

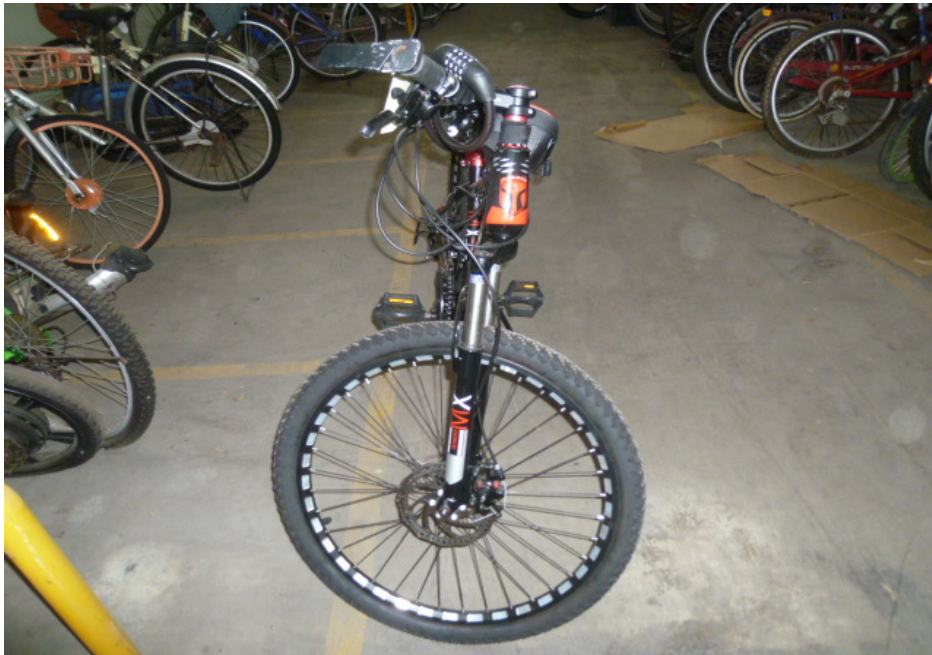
**Photo 18** shows the front wheel of the Bicycle turned towards its full right. Turning the Bicycle's handle bar towards the right did not produce any abnormal free play and/or resistance. This would indicate that the steering system of the Bicycle was in serviceable condition at the time of our inspection.

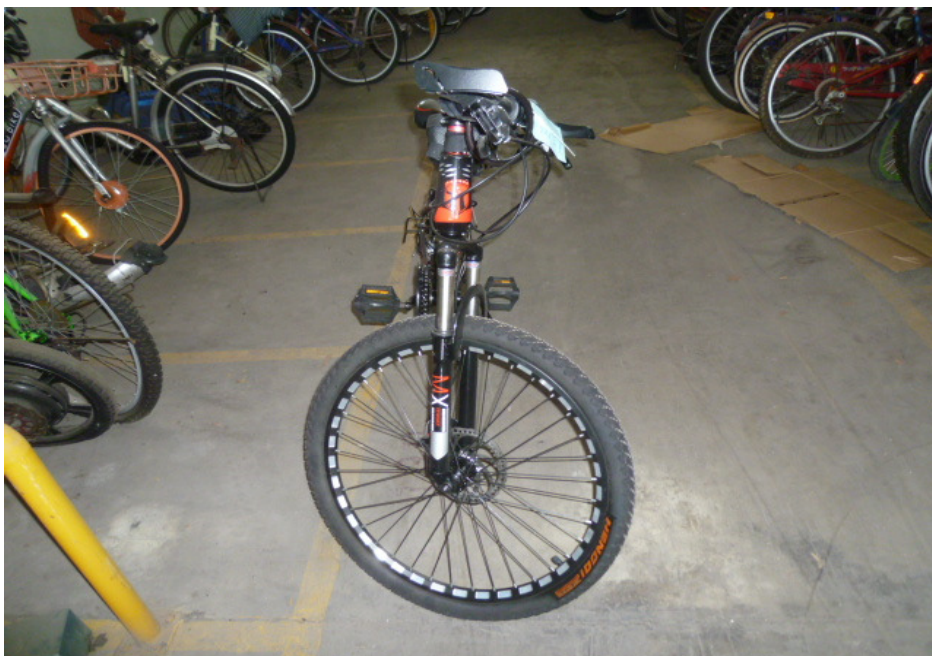
**Photo 19** shows the front wheel of the Bicycle turned towards its full left. Turning the Bicycle's handle bar towards the left did not produce any abnormal free play and/or resistance. This would indicate that the steering system of the Bicycle was in serviceable condition at the time of our inspection.

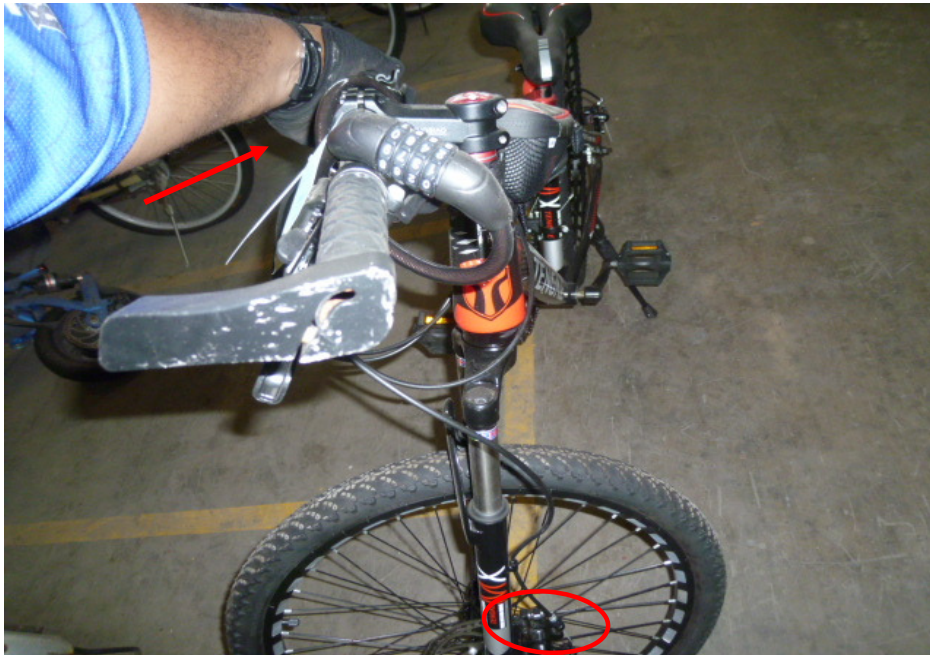
10. A static brake test was conducted on the front brake of the Bicycle. There was some resistance felt upon pressing the right hand brake lever. This was further confirmed by looking at the front brake pads while we pressed the right hand brake lever. It shows that the front brake pads responded to the gripping action. The front brake pads pressed against the front brake disc. This had appeared to indicate that the front brake of the Bicycle was in serviceable condition.

**Photo 20** shows a static brake test conducted on the Bicycle's front brake. There was some resistance felt upon pressing the right hand brake lever (arrowed). It also shows that the front brake pads responded to the gripping action (circled) after depressing the right hand brake lever.

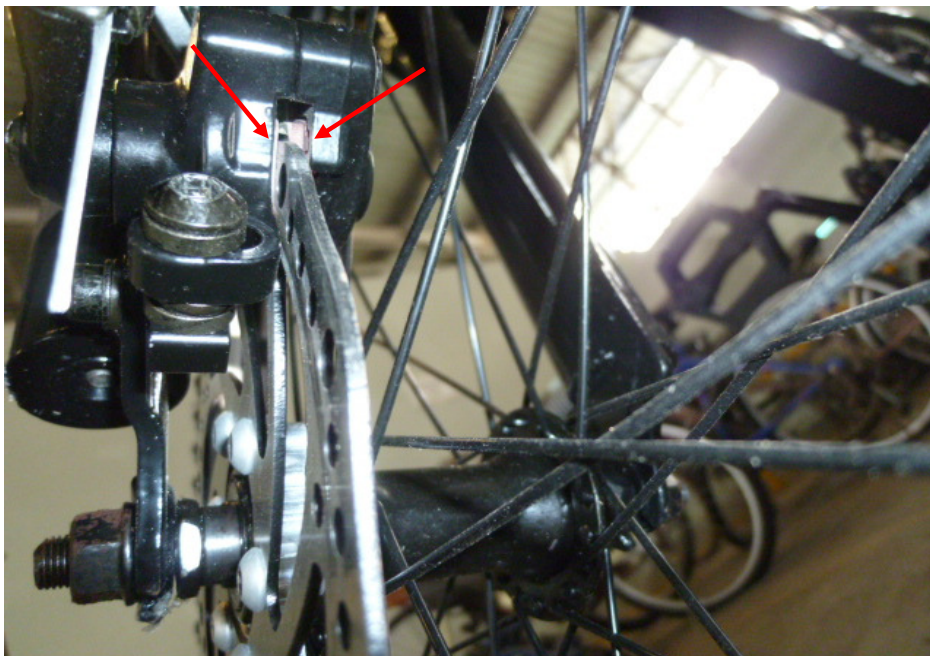
**Photo 21** shows a close up view of the front brake pads responding to the gripping action. The front brake pads pressed against the front brake disc (arrowed) upon depressing the right hand brake lever. This had appeared to indicate that the front brake of the Bicycle was in serviceable condition.

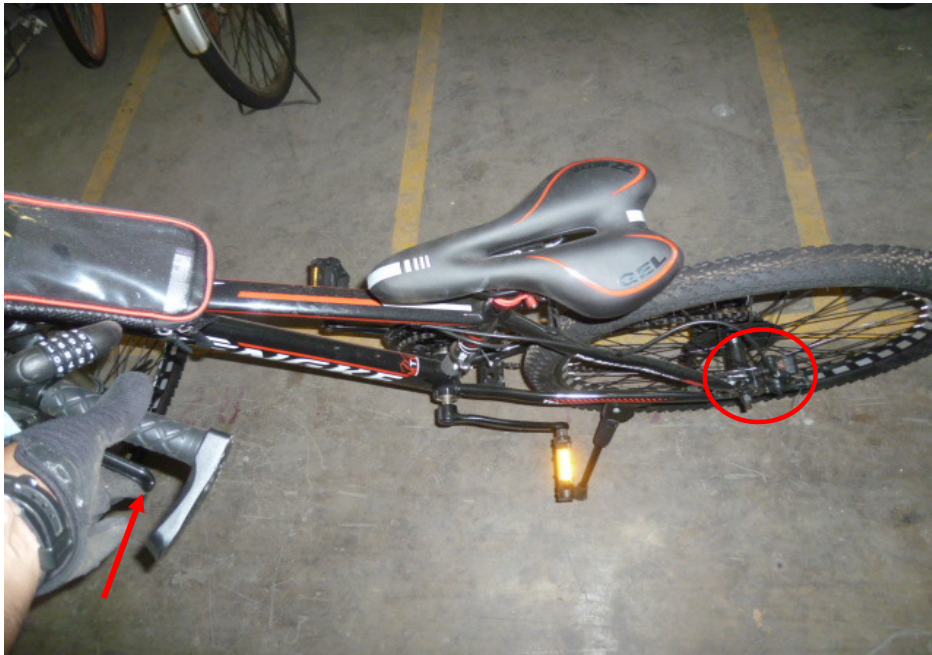
11. A static brake test was conducted on the rear brake of the Bicycle. There was some resistance felt upon pressing the left hand brake lever. This was further confirmed by looking at the rear brake pads while we pressed the left hand brake lever. It shows that the rear brake pads responded to the gripping action. The rear brake pads pressed against the rear brake disc. This had appeared to indicate that the rear brake of the Bicycle was in serviceable condition.

**Photo 22** shows a static brake test conducted on the Bicycle's rear brake. There was some resistance felt upon pressing the left hand brake lever (arrowed). It also shows that the rear brake pads responded to the gripping action (circled) after depressing the left hand brake lever.

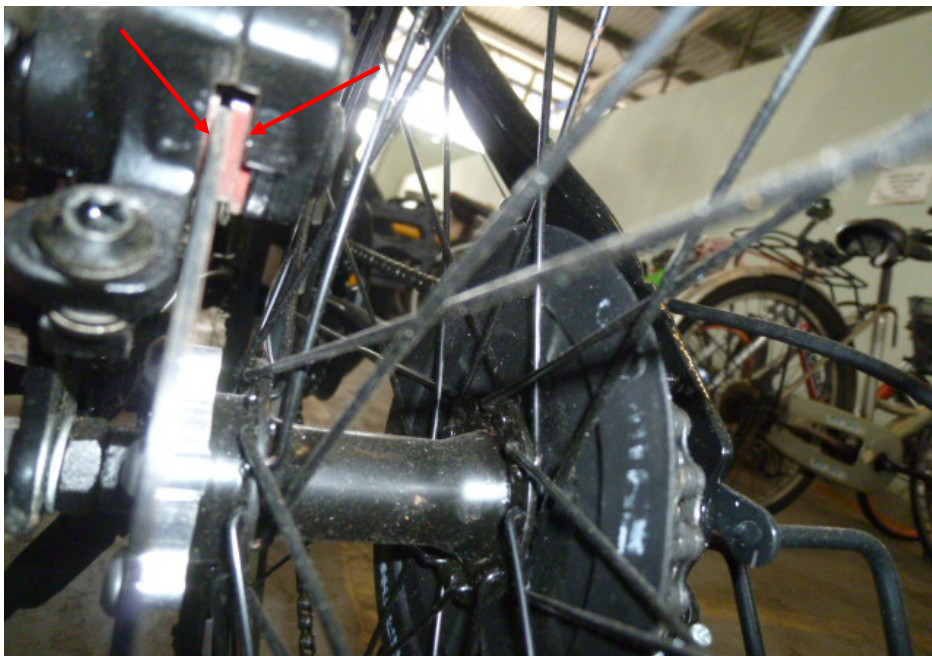
**Photo 23** shows a close up view of the rear brake pads responding to the gripping action. The rear brake pads pressed against the rear brake disc (arrowed) upon depressing the left hand brake lever. This had appeared to indicate that the rear brake of the Bicycle was in serviceable condition.
