Your Ref: TP/IP/27321/2021
Our Ref : CI/TPD21008007/N

Fatal Accident Investigation Team

MECHANICAL INSPECTION REPORT OF MOTORCYCLE FBD 9918Z

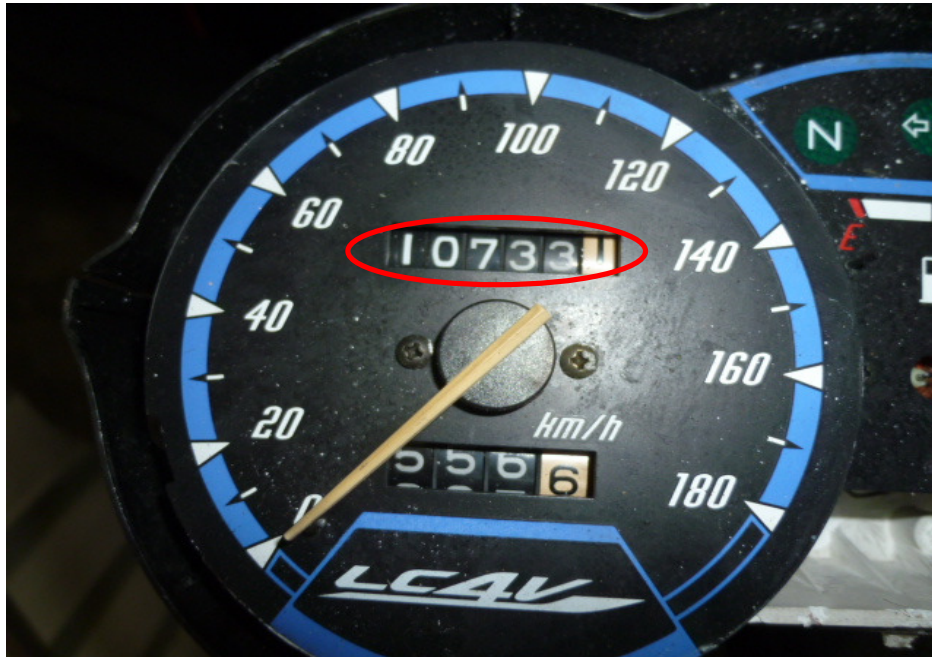
Photo 1 shows the speedometer gauge of the Motorcycle. The mileage of the Motorcycle at the time of our inspection was 10, 733km (circled).

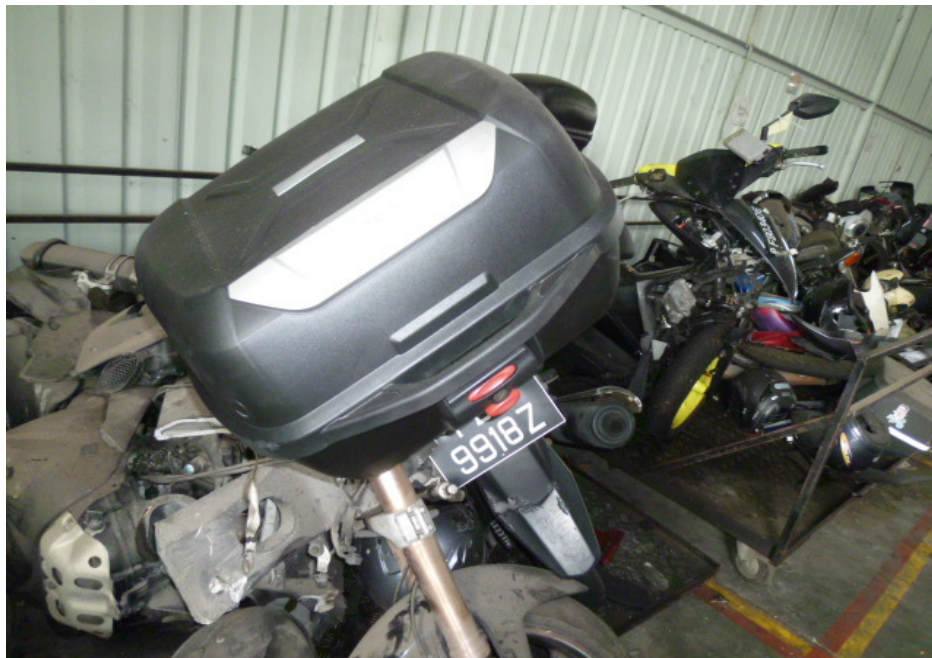
Photo 2 shows a general view of the rear portion of the Motorcycle at the time of our inspection. The Motorcycle had sustained damages all around.

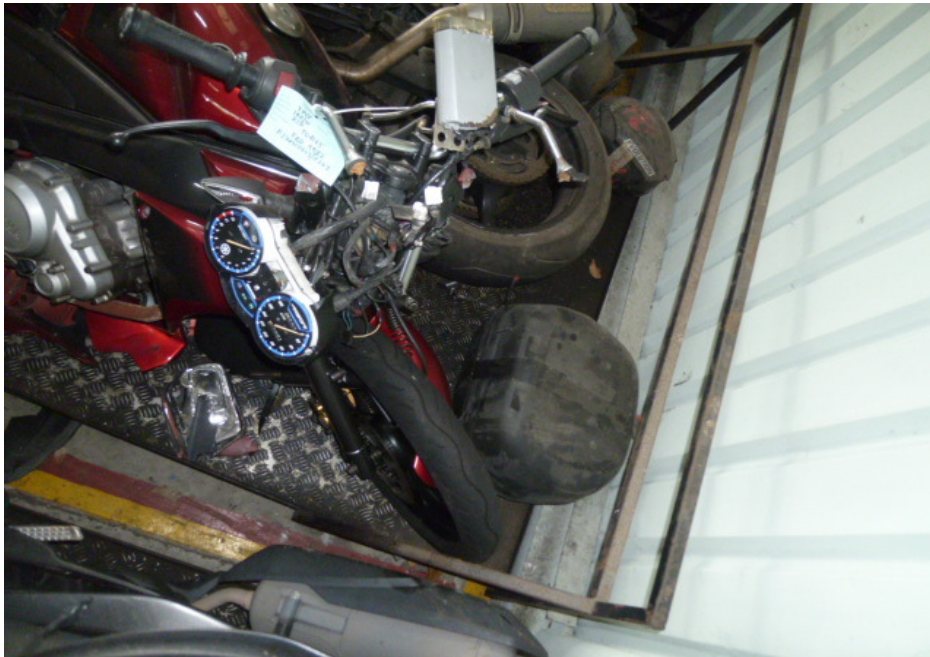
Photo 3 shows a general view of the frontal portion of the Motorcycle at the time of our inspection. The Motorcycle had sustained damages all around.

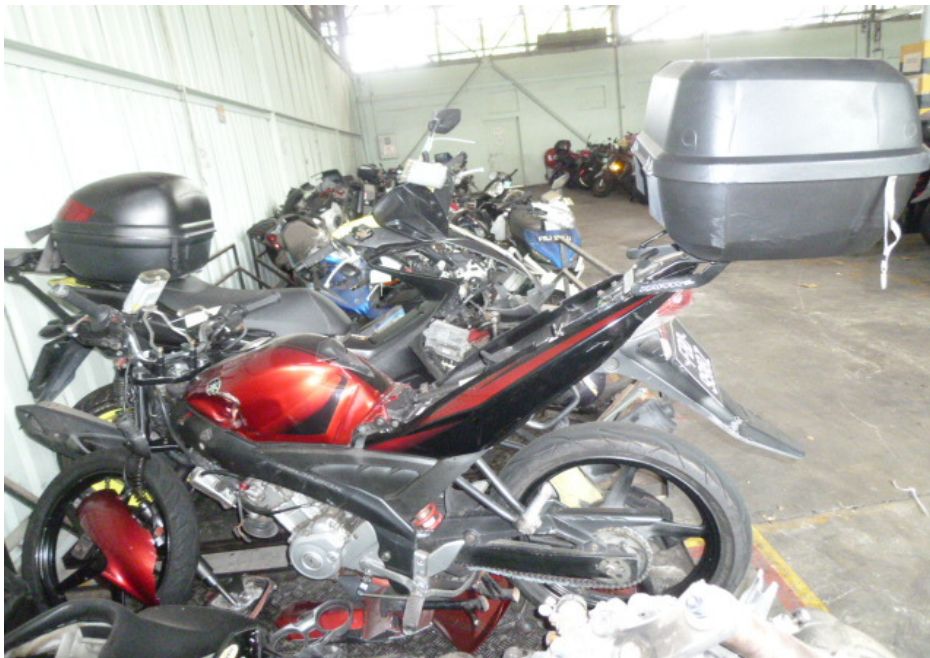
Photo 4 shows a general view of the left body of the Motorcycle at the time of our inspection. The Motorcycle had sustained damages all around. Body parts that were found to have been damaged include its headlight assembly, speedometer gauge, front fork assembly, front mudguard, right front signal lamp, right handlebar end, right side mirror, front brake lever, petrol tank, radiator, left rear side cover, rear brake pedal, gear shift pedal, left front footrest, top box and rear mudguard, amongst others.

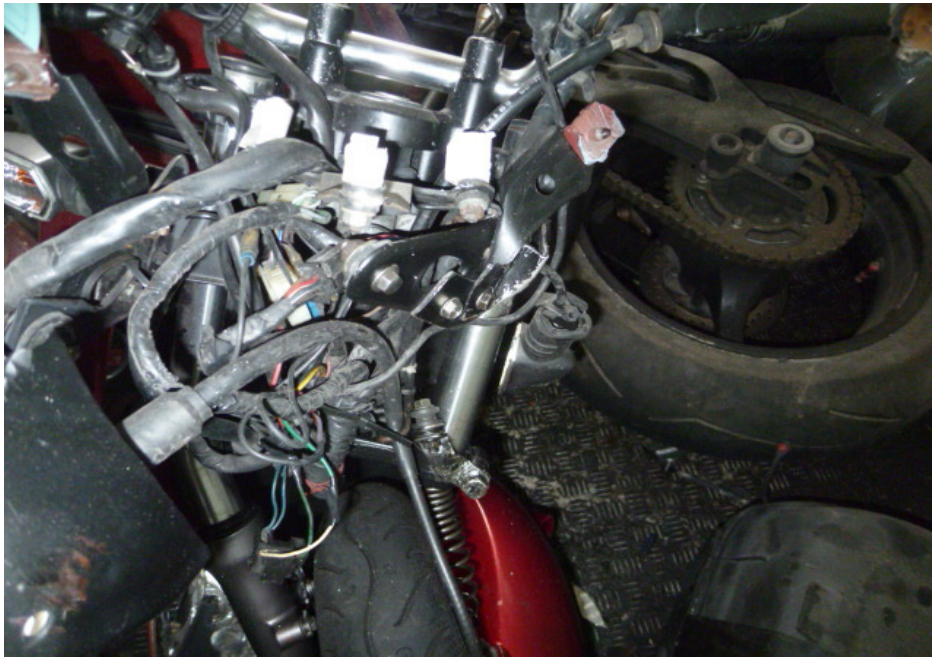
Photo 5 shows a closer view of the headlight assembly which was amongst the body parts at the front body of the Motorcycle that had sustained damage as a result of the accident.

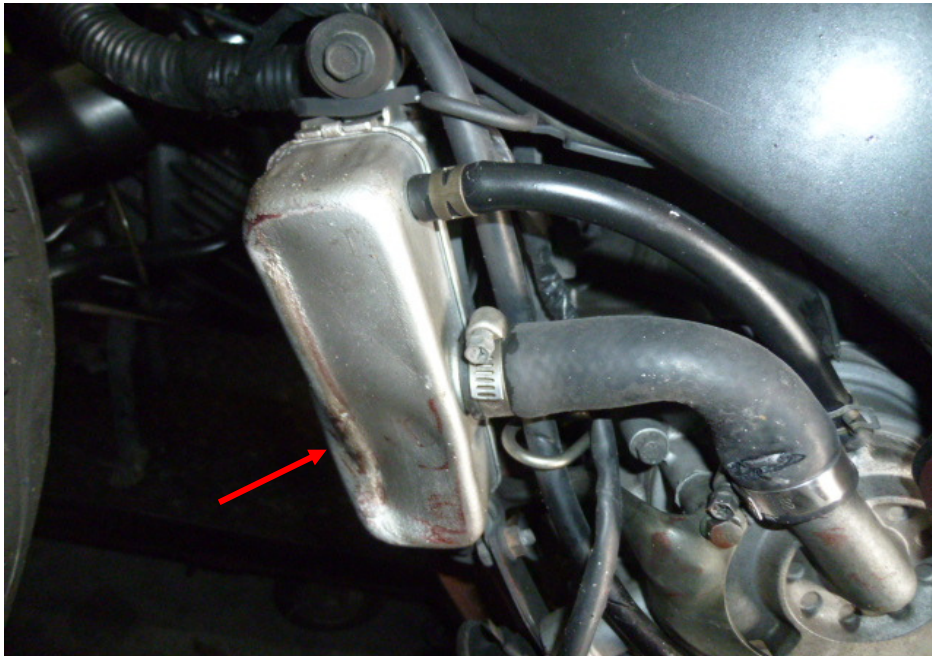
Photo 6 shows a closer view of the radiator which was amongst the body parts at the front body of the Motorcycle that had sustained damage as a result of the accident (arrowed).

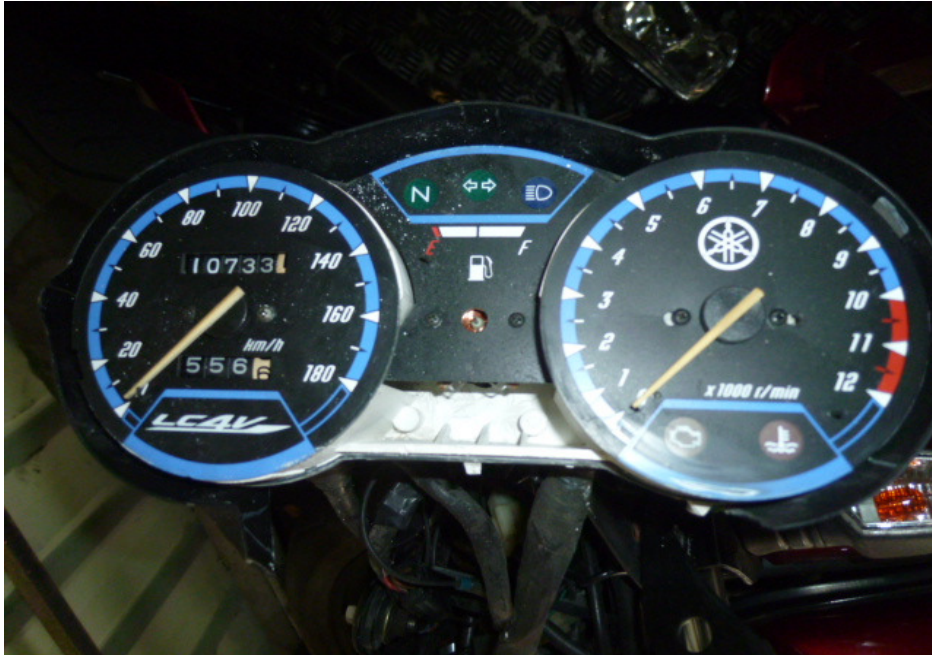
Photo 7 shows a closer view of the speedometer gauge which was amongst the body parts at the front body of the Motorcycle that had sustained damage as a result of the accident.

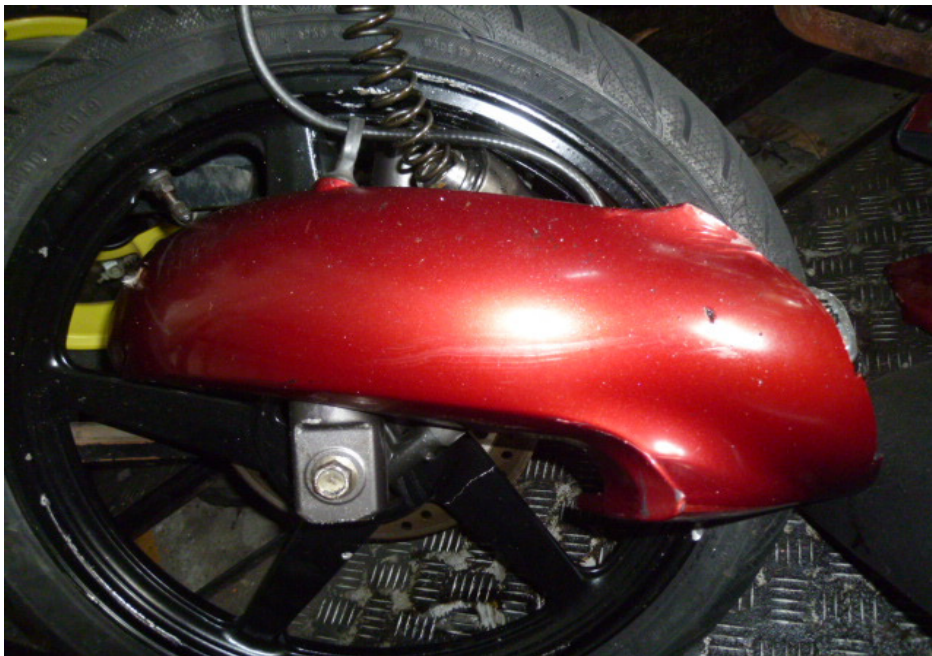
Photo 8 shows a closer view of the front mudguard which was amongst the body parts at the front body of the Motorcycle that had sustained damage as a result of the accident.

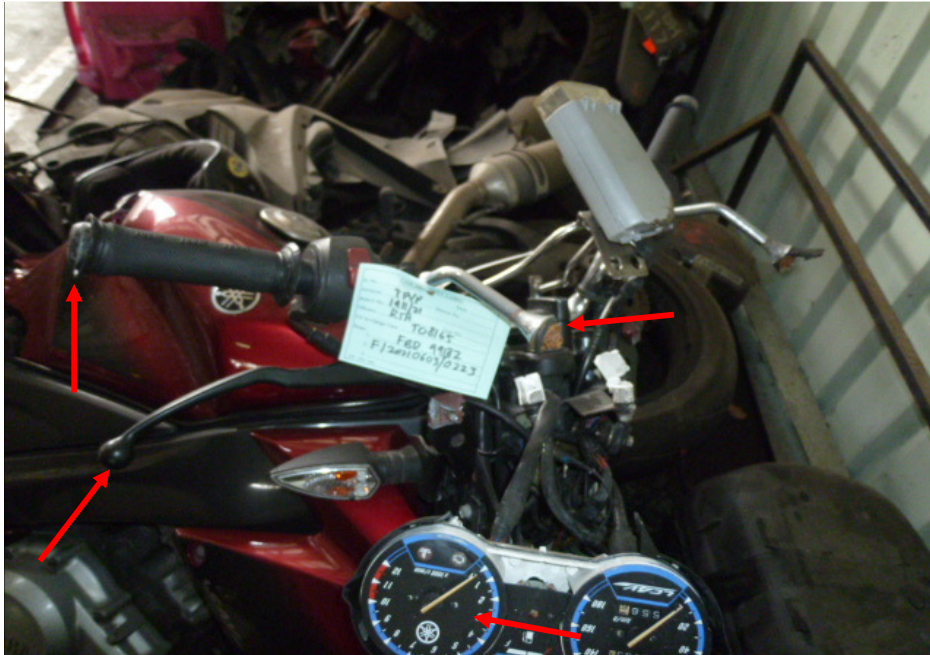
Photo 9 shows a closer view of the right side mirror, front brake lever and right handlebar end of the Motorcycle (arrowed). These parts were amongst the body parts of the Motorcycle which were damaged as a result of the accident.

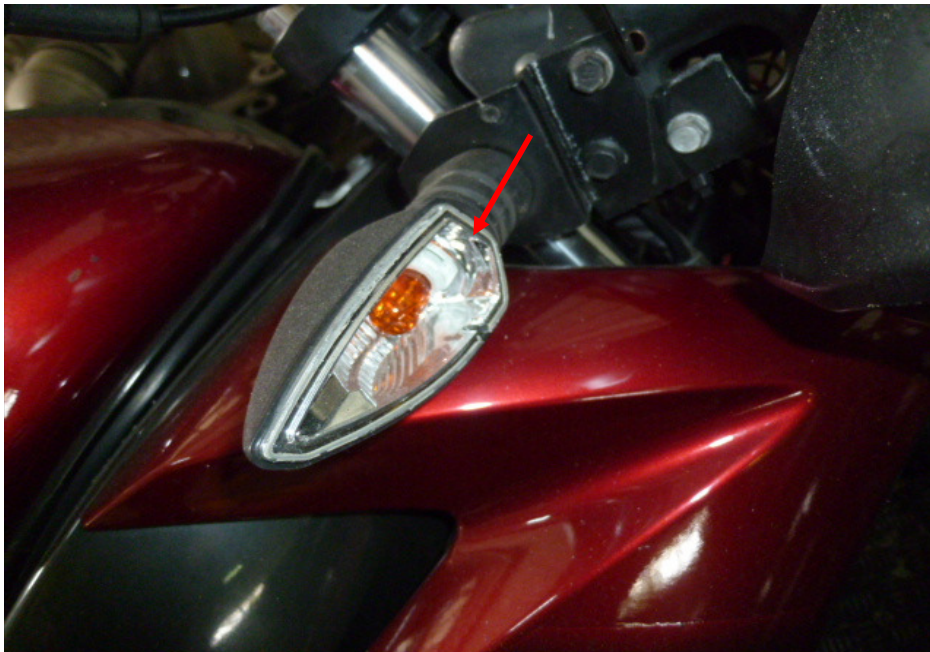
Photo 10 shows a closer view of the cracked right front signal lamp which was amongst the body parts of the Motorcycle that had sustained damage as a result of the accident (arrowed).

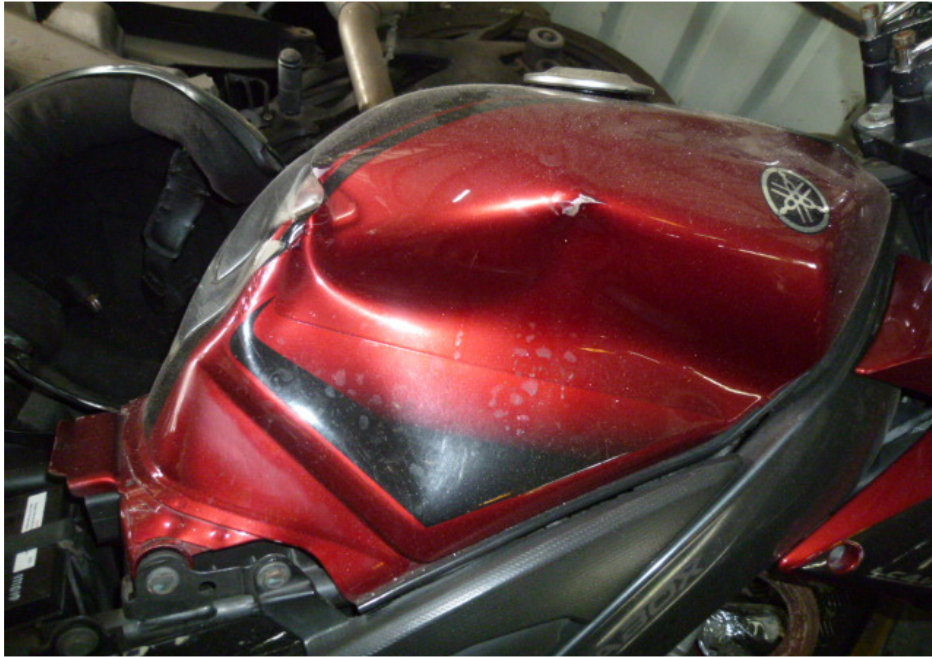
Photo 11 shows a closer view of the dented petrol tank of the Motorcycle as a result of the accident.

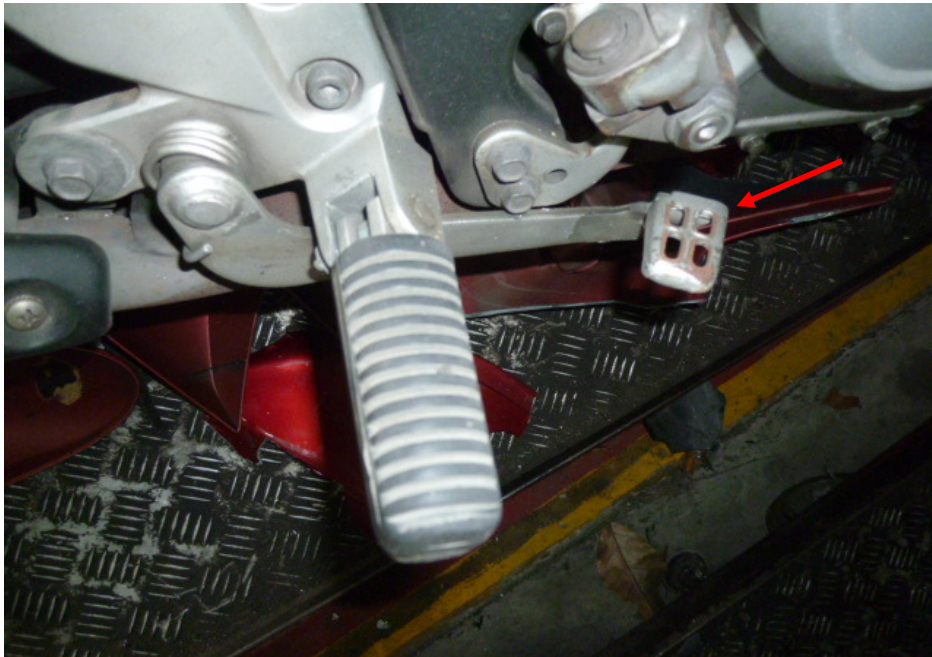
Photo 12 shows a closer view of the bent rear brake pedal of the Motorcycle that as a result of the accident (arrowed).

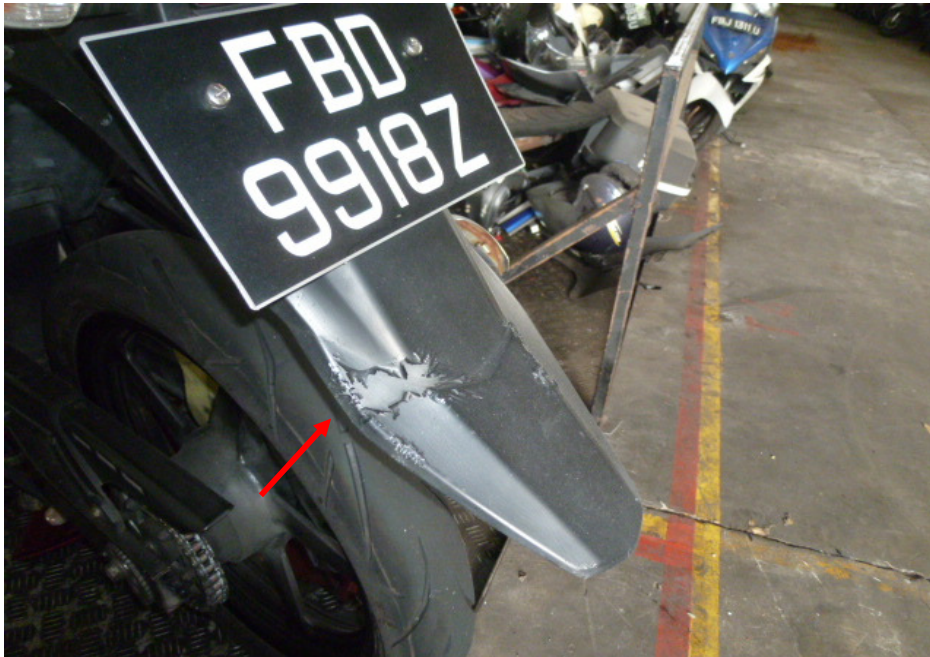
Photo 13 shows a closer view of the deformed rear mudguard of the Motorcycle as a result of the accident (arrowed).

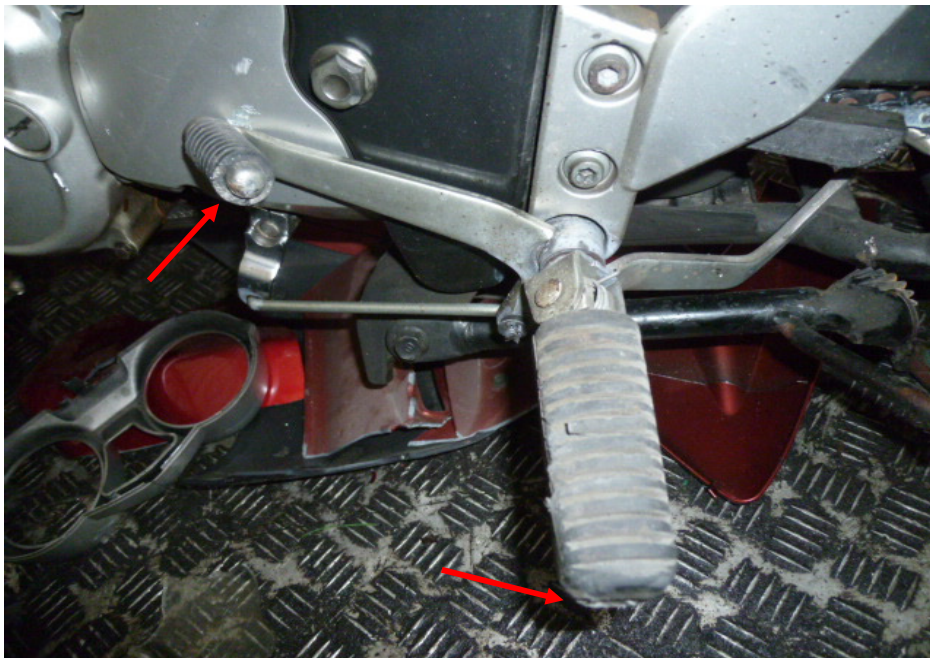
Photo 14 shows a closer view of the gear shift pedal and left front footrest which were amongst the body parts of the Motorcycle that had sustained damage as a result of the accident (arrowed).

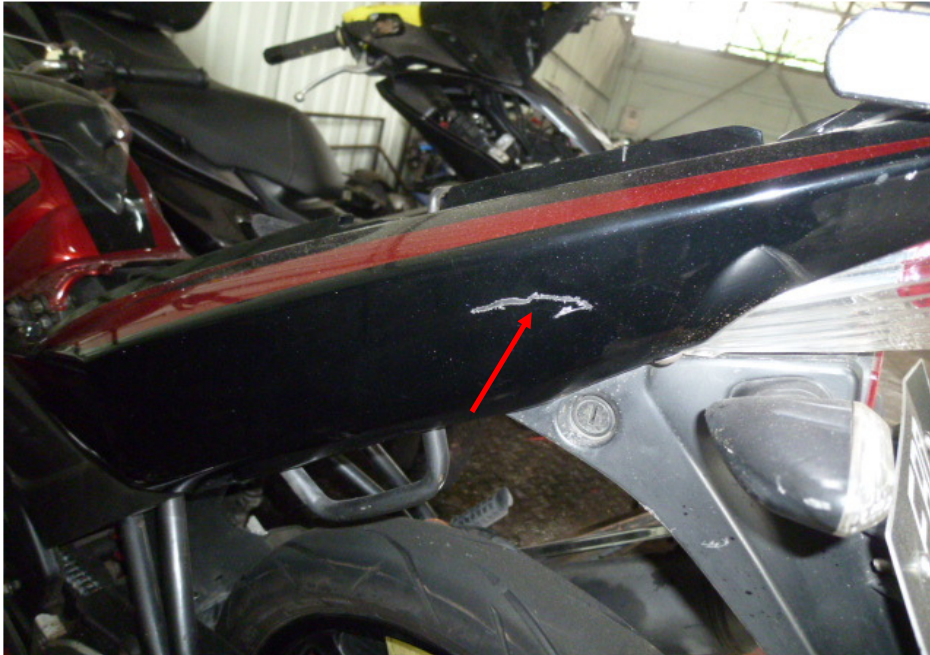
Photo 15 shows the grazed left rear side cover (arrowed) the Motorcycle damage as a result of the accident.

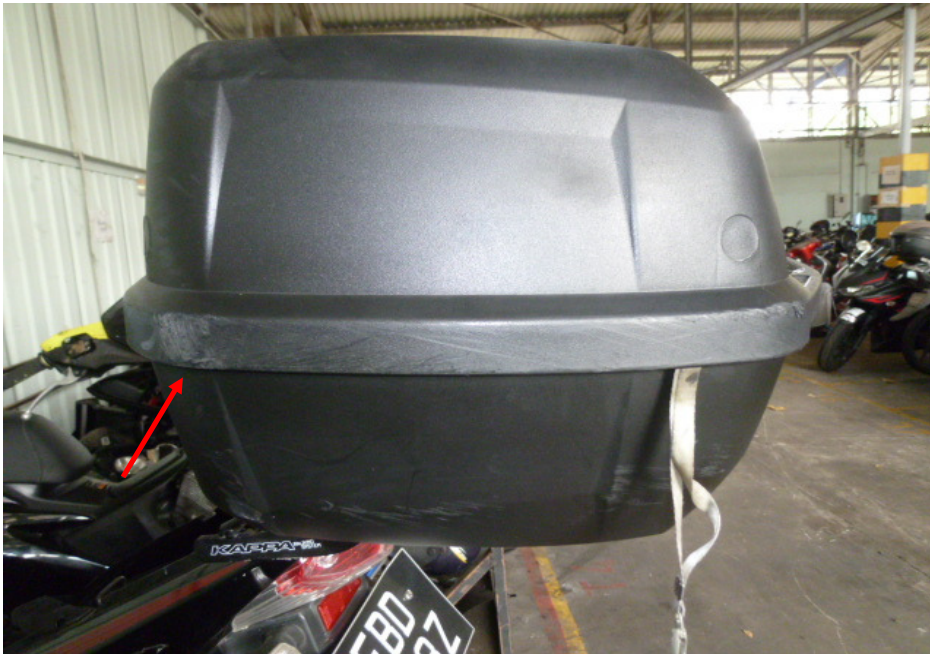
Photo 16 shows the top box of the Motorcycle which had sustained damage as a result of the accident (arrowed).

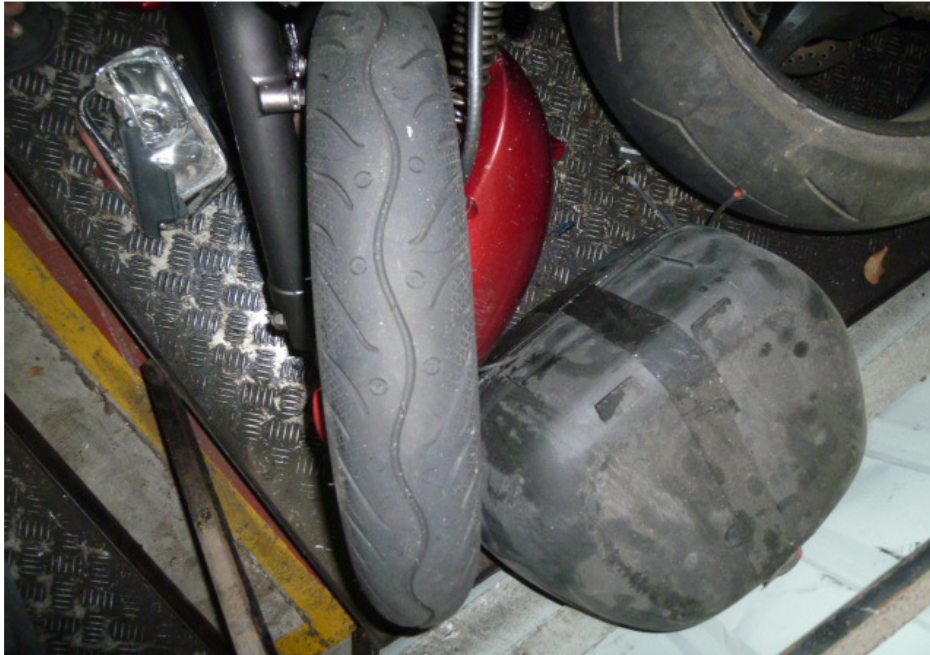
Photo 17 shows the front tyre of the Motorcycle at the time of our inspection. The front tyre was observed to be in serviceable condition with remaining tread depth of approximately 3mm. The pattern of the tread was also clearly visible. There was no tear, burst mark(s) and/or punctured hole(s) on the sidewalls as well as across the tread of the front tyre.

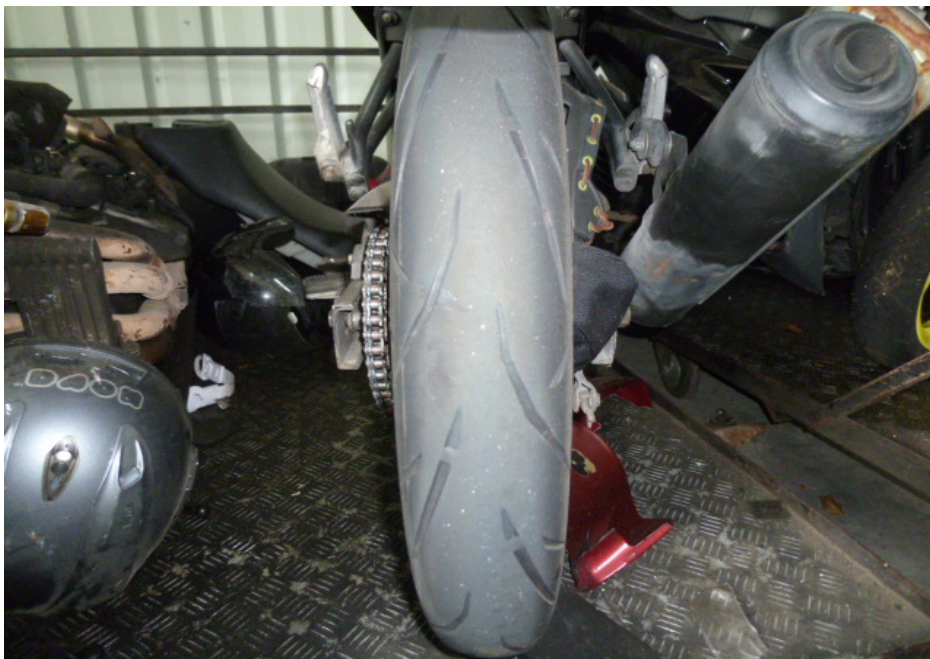
Photo 18 shows the condition of the Motorcycle's rear tyre. The pattern of the tread was clearly visible with remaining tread depth of approximately 3mm. We did not observe any tear, burst mark(s) and/or punctured hole(s) on the sidewalls as well as across the tread of the rear tyre.

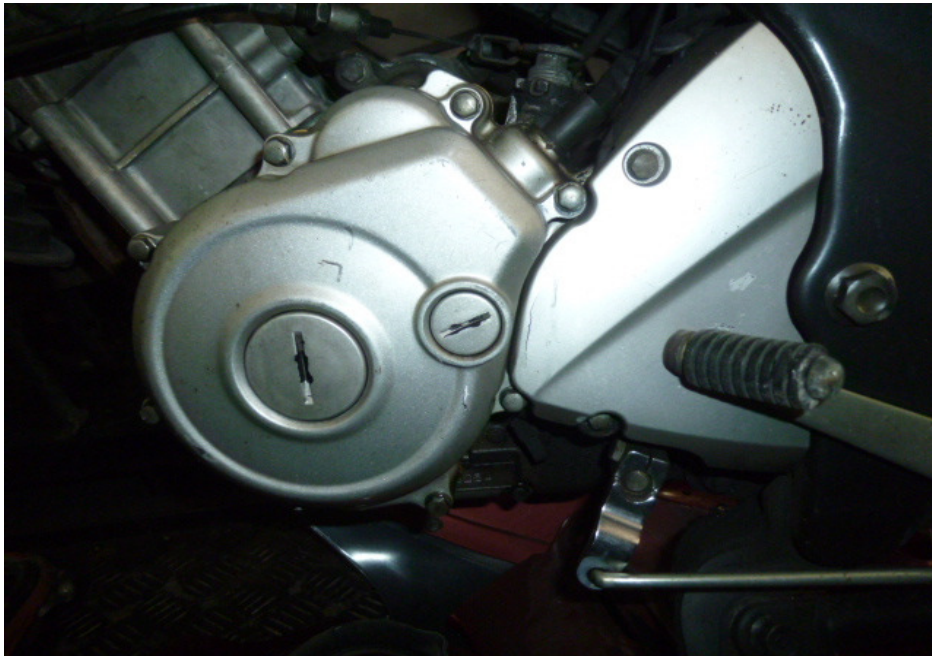
Photo 19 shows the left side of the engine of the Motorcycle at the time of our inspection. The various engine related parts and components were found to be intact with no visible damage. There was also no sign(s) or indication(s) of fluid leak observed around the left engine area of the Motorcycle.

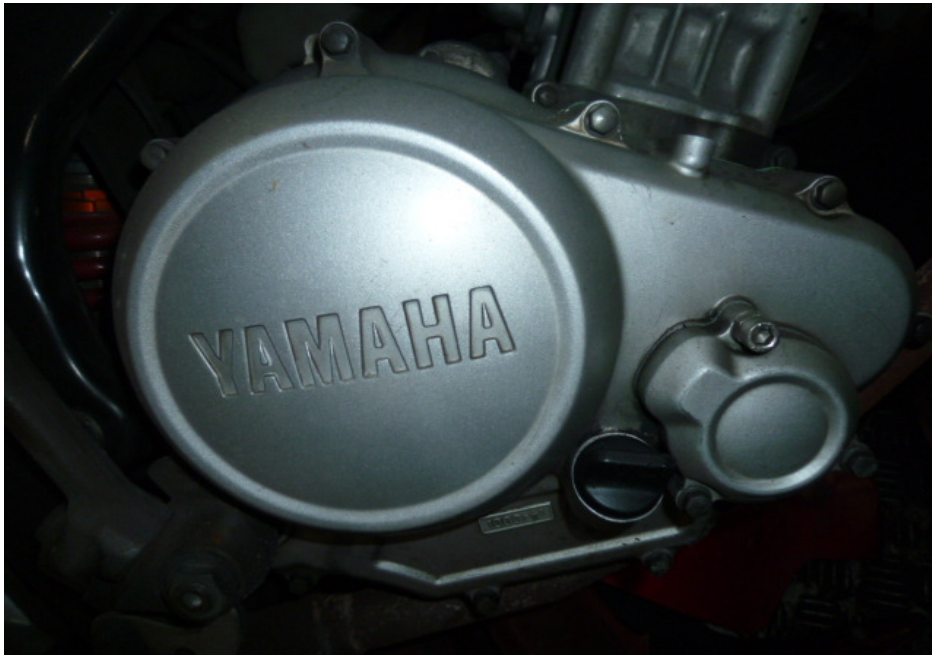
Photo 20 shows the right side of the engine of the Motorcycle at the time of our inspection. The various engine related parts and components were found to be intact with no visible damage. There was also no sign(s) or indication(s) of fluid leak observed around the right engine area of the Motorcycle.

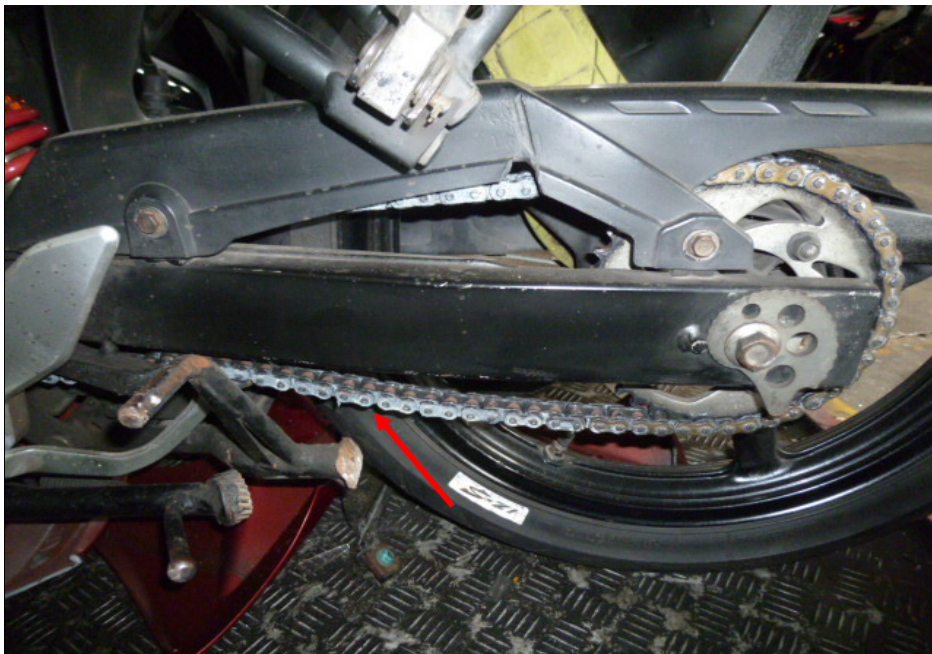
Photo 21 shows the gear chain (arrowed) of the Motorcycle, which was observed to be intact with no misalignment. It was also adequately lubricated for operating purposes. The gear chain rotates the rear wheel of the Motorcycle.

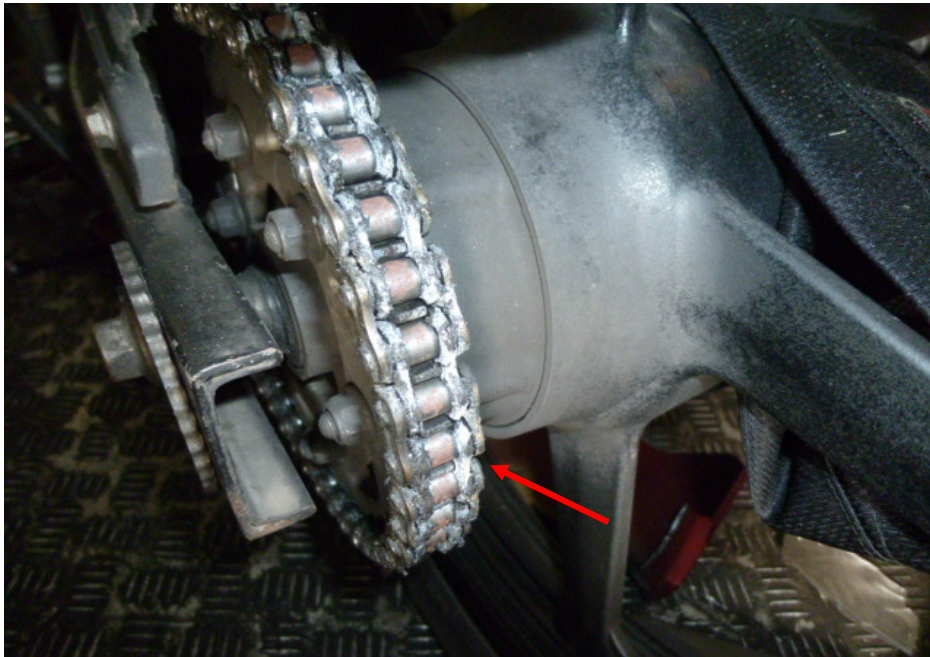
Photo 22 shows the closer view of the gear chain (arrowed) of the Motorcycle, which was observed to be intact with no misalignment. It was also adequately lubricated for operating purposes.

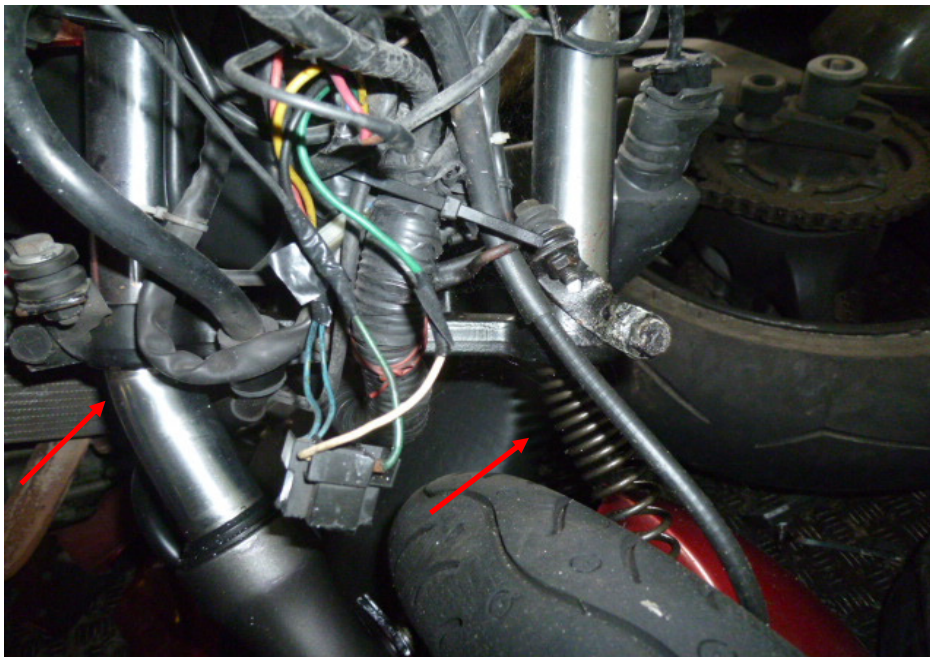
11. For this case, we were not able to conduct any test(s) on the steering system of the Motorcycle due to the damage of its fork assembly. The front forks were found to be bent inwards and dislodged as a result of the accident.

Photo 23 shows the front fork assembly of the Motorcycle. The front forks were observed to be bent inwards and dislodged as a result of the accident (arrowed). We were hence not able to conduct any tests on the steering system of the Motorcycle.

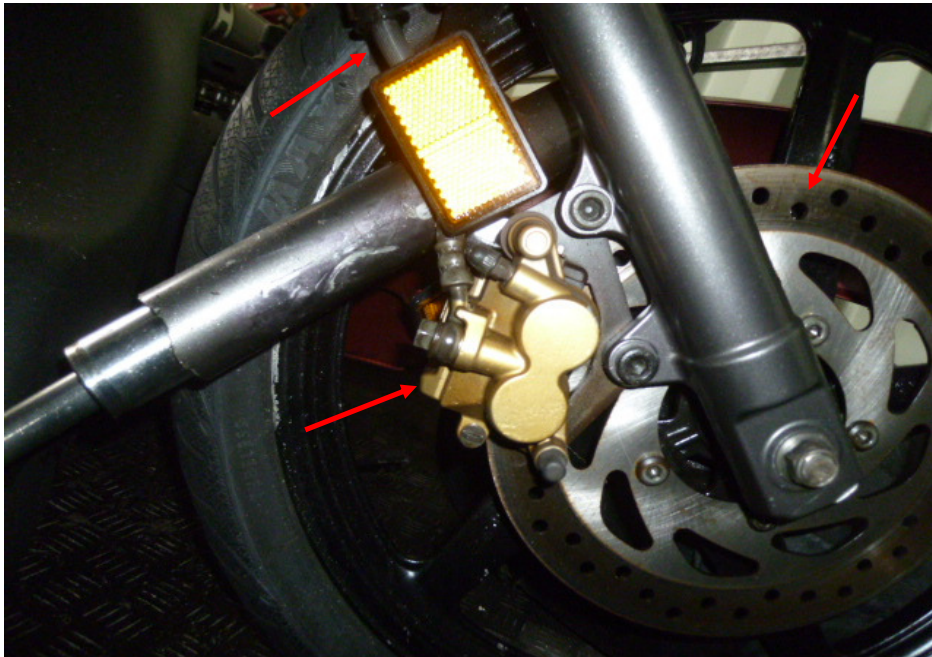
Photo 24 shows a close up view of the front brake caliper, front brake disc and front brake hose (arrowed) of the Motorcycle, which are all part of the components in the hydraulic front brake system of the Motorcycle. Our visual checks of these various components had revealed all to be intact with no visible damage. No leakage of brake fluid was also observed.

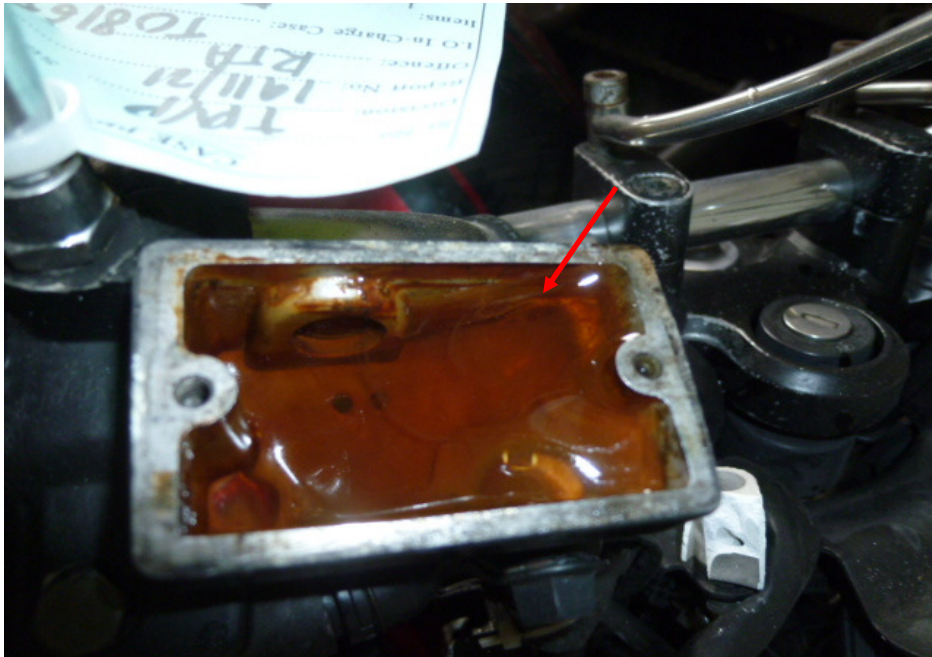
Photo 25 shows the brake fluid reservoir for the front brake of the Motorcycle. The brake fluid was found to be of sufficient level for operating purposes. However the brake fluid was found to be slightly contaminated (arrowed).

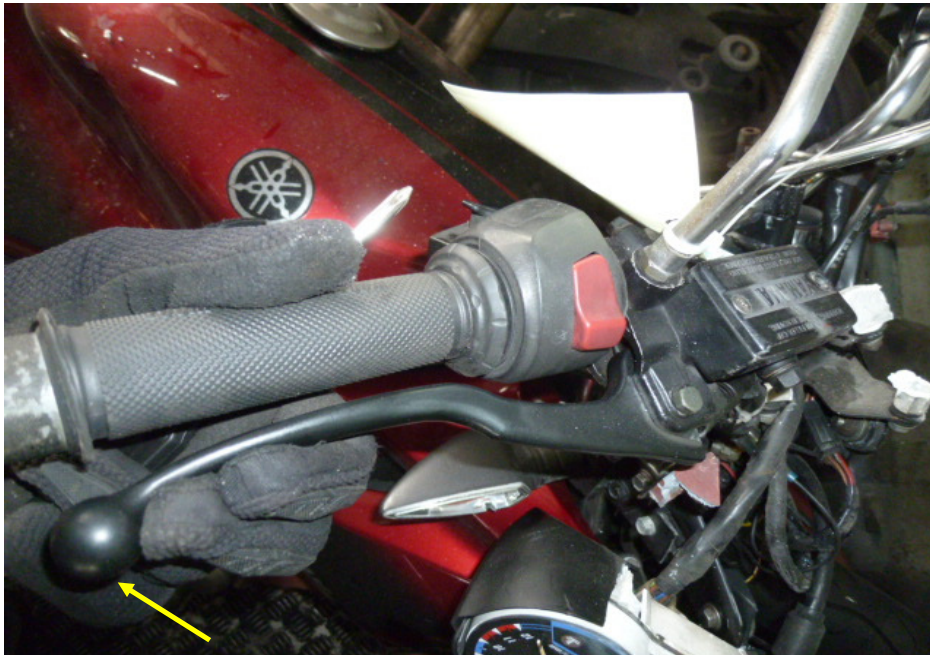
13. Static brake tests conducted on the Motorcycle had appeared to indicate that the front brake system of the Motorcycle was in serviceable condition. There was some resistance felt (spongy like feel) upon pressing the front brake lever. This would indicate that there's no leakage of pressure/vacuum in the front brake system.
14. For this case, we were not able to carry out any operational tests to the steering system and braking system of the Motorcycle due to the damage of its front forks, which had rendered the Motorcycle immobile for the operational tests. We were not able to push the Motorcycle manually forward and backward, simulating movement of the Motorcycle, for the operational tests. See photos 23 – 27 below.

Photo 26 shows the front brake lever being depressed. There was some resistance felt (spongy like feel) upon pressing the front brake lever (arrowed). This would indicate that there is no leakage of pressure/vacuum in the brake system.

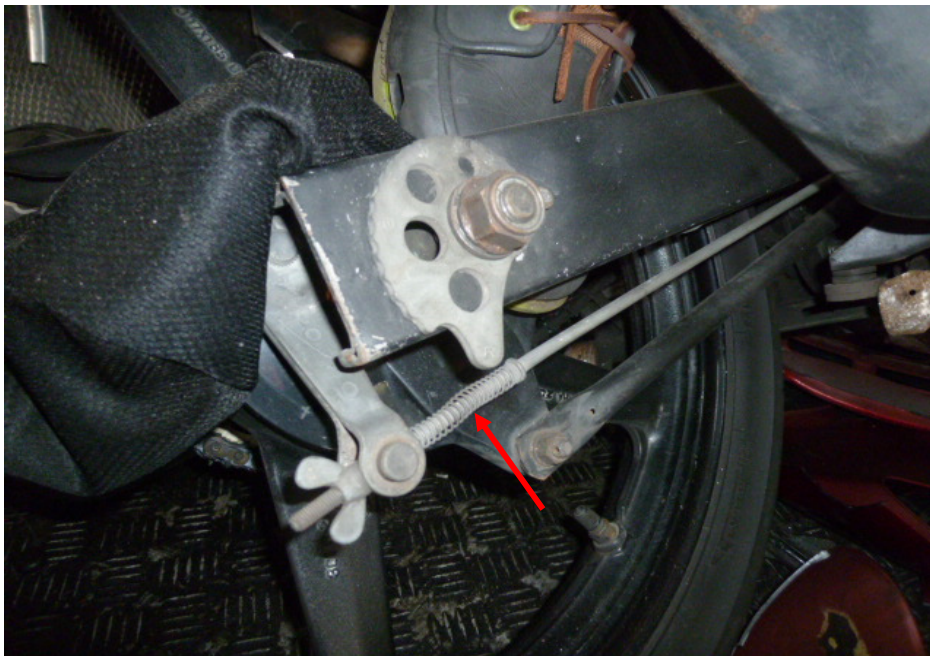
Photo 27 shows the rear wheel of the Motorcycle. The type of brake system for the rear wheel was of a mechanical type, controlled by the brake foot pedal of the Motorcycle. Our checks of the cable (arrowed), spring and drum which are all part of the components in the rear brake system of the Motorcycle reveal all to be intact and without damage.
