Your Ref: TP/IP/23985/2021
Our Ref : CI/TPD21008008/N

Fatal Accident Investigation Team

INSPECTION REPORT OF MOTORCYCLE FBN 9371Y

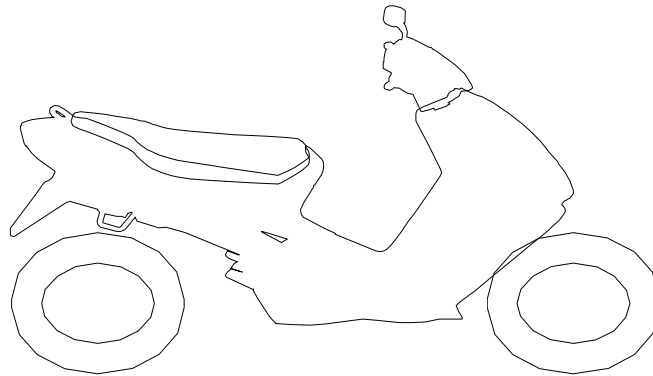
7. However the tyre was observed to be deflated at the time of our inspection. The tyre brand, tyre size and remaining tread depth of the 2 tyres were recorded as follows:-

IRC 140/70 - 17 (3mm)
(Deflated)

IRC 100/80 - 17 (3mm)

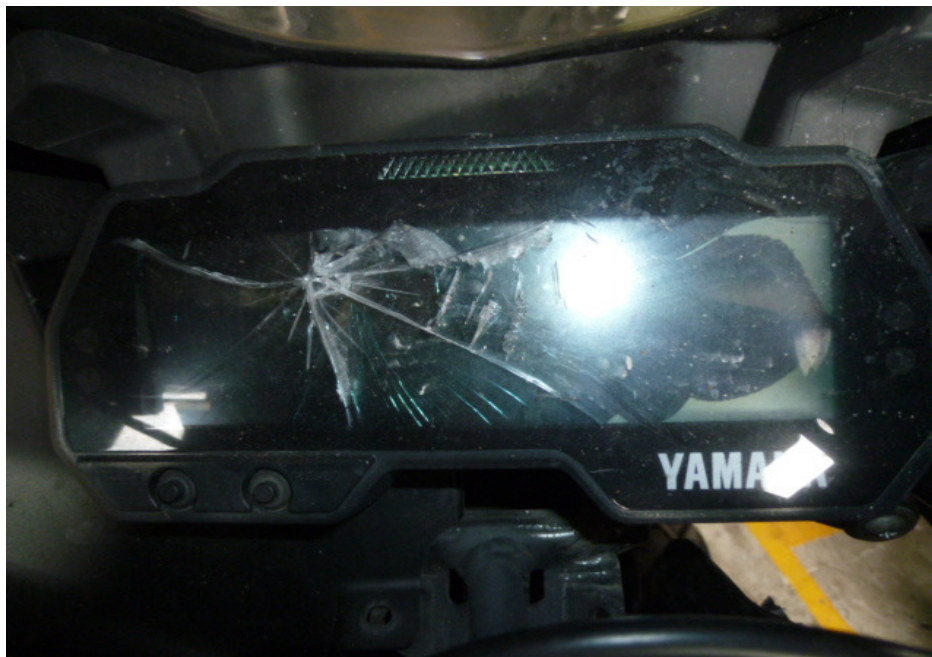
4. The mileage of the Motorcycle could not be recorded at the time of our inspection due to a damaged speedometer gauge.
5. The Motorcycle was observed to have sustained damages all around. The body parts that were found to have been damaged include its head cowling, front mudguard, clutch lever, right cowling, right side mirror, rear brake pedal, right rear side cover and exhaust muffler heat shield, amongst others.

Photo 1 shows the damaged speedometer gauge of the Motorcycle as a result of the accident. Hence, we were unable to record the mileage of the Motorcycle at the time of our inspection.

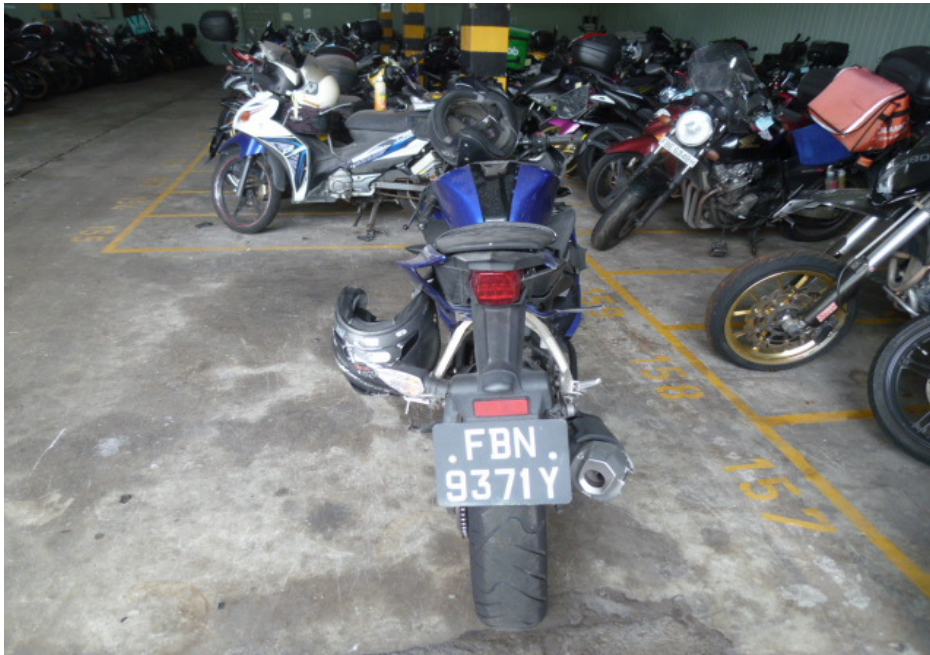
Photo 2 shows a general view of the rear portion of the Motorcycle at the time of our inspection. The Motorcycle was observed to have sustained damages all around.

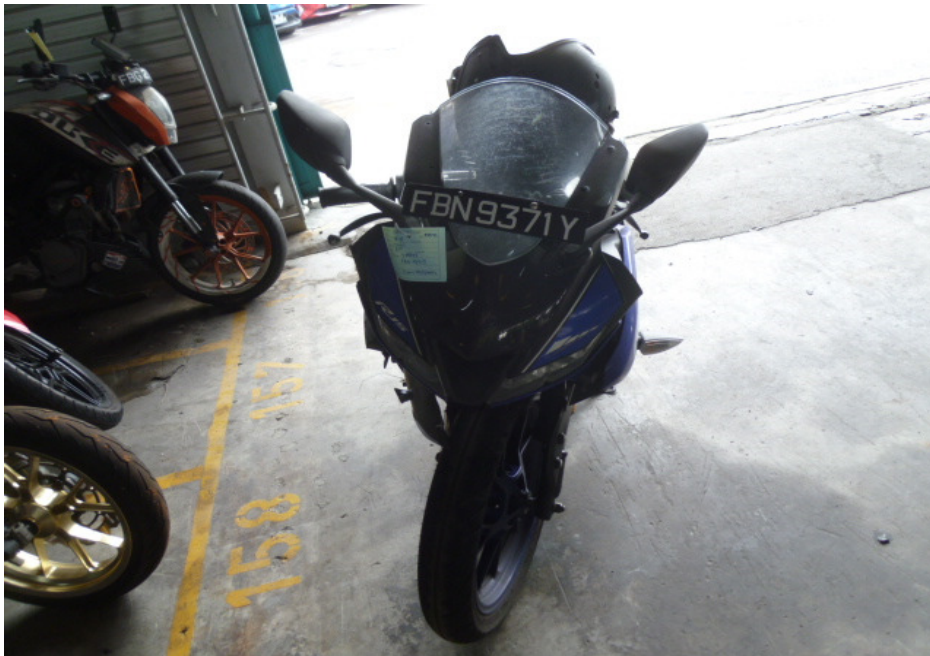
Photo 3 shows a general view of the frontal portion of the Motorcycle at the time of our inspection. The Motorcycle was observed to have sustained damages all around.

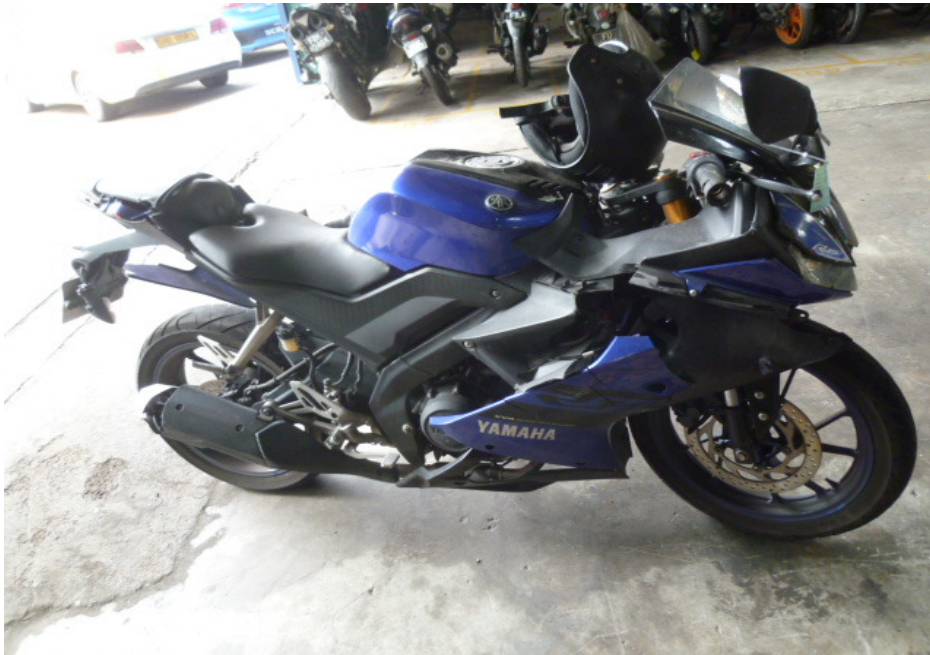
Photo 4 shows a general view of the right body of the Motorcycle at the time of our inspection. The Motorcycle was observed to have sustained damages all around. Amongst the body parts that were found to have been damaged include its head cowl, front mudguard, clutch lever, right cowl, right side mirror, rear brake pedal, right rear side cover and exhaust muffler heat shield, amongst others.

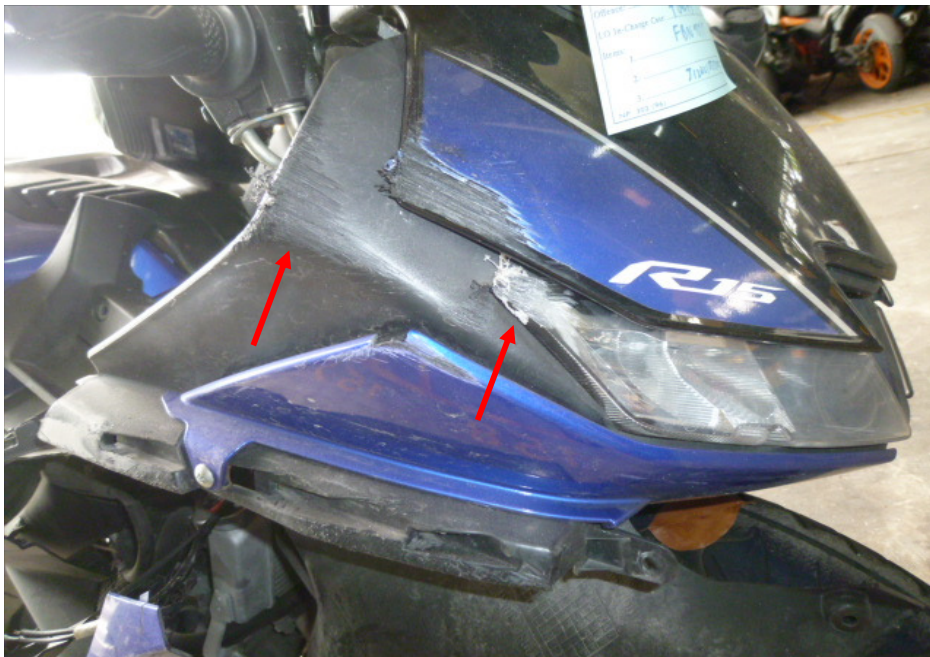
Photo 5 shows a closer view of the grazed head cowl and headlight assembly of the Motorcycle as a result of the accident (arrowed).

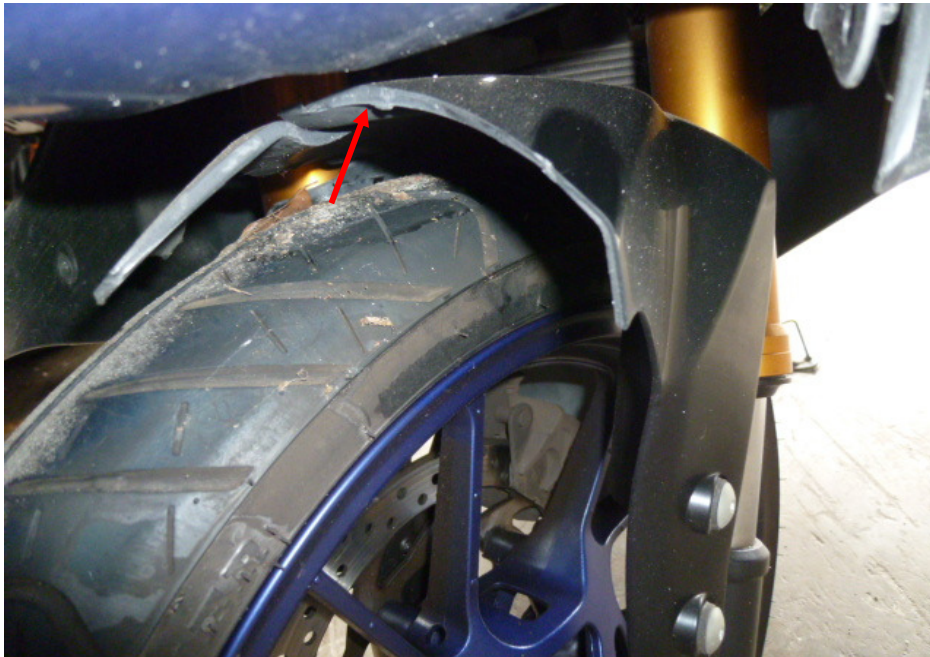
Photo 6 shows a closer view of the front mudguard (arrowed) which was amongst the body parts at the front body of the Motorcycle that had sustained damage as a result of the accident.

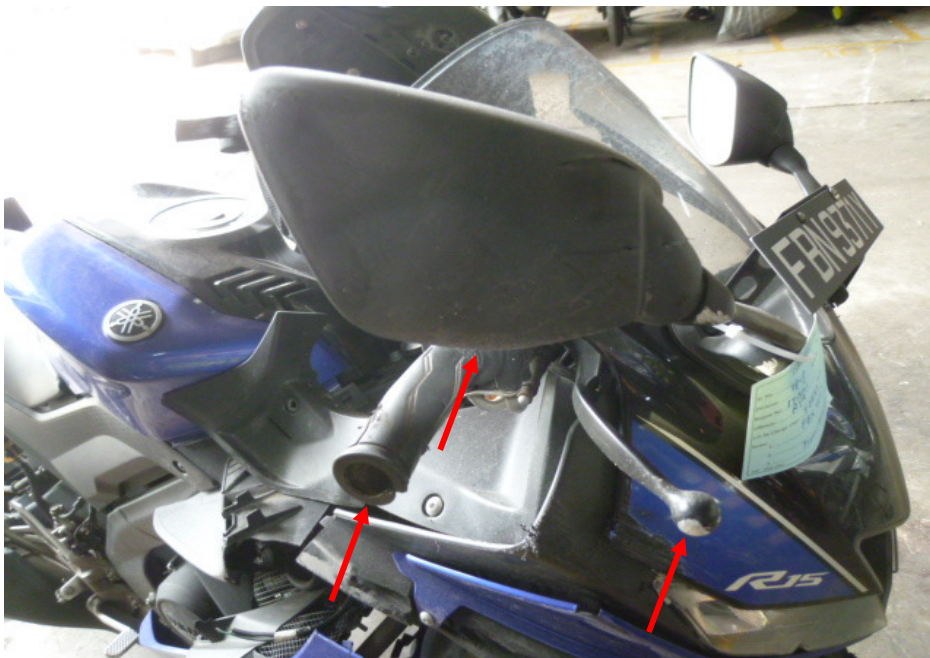
Photo 7 shows a closer view of the right handlebar grip, right side mirror and front brake lever which was amongst the body parts of the Motorcycle that had sustained damage as a result of the accident (arrowed).

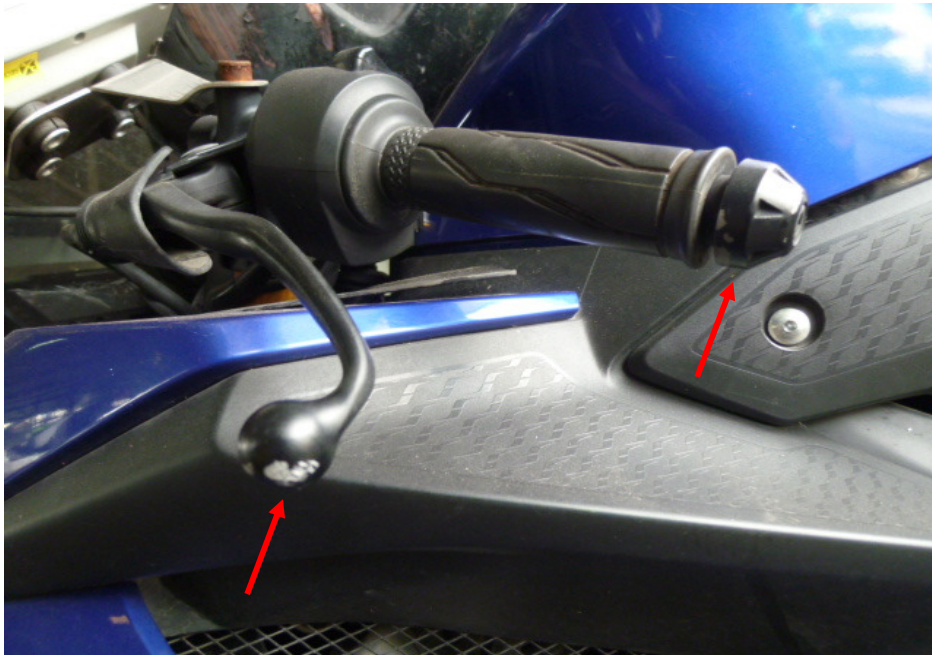
Photo 8 shows a closer view of the grazed left handlebar and bent clutch lever of the Motorcycle as a result of the accident (arrowed).

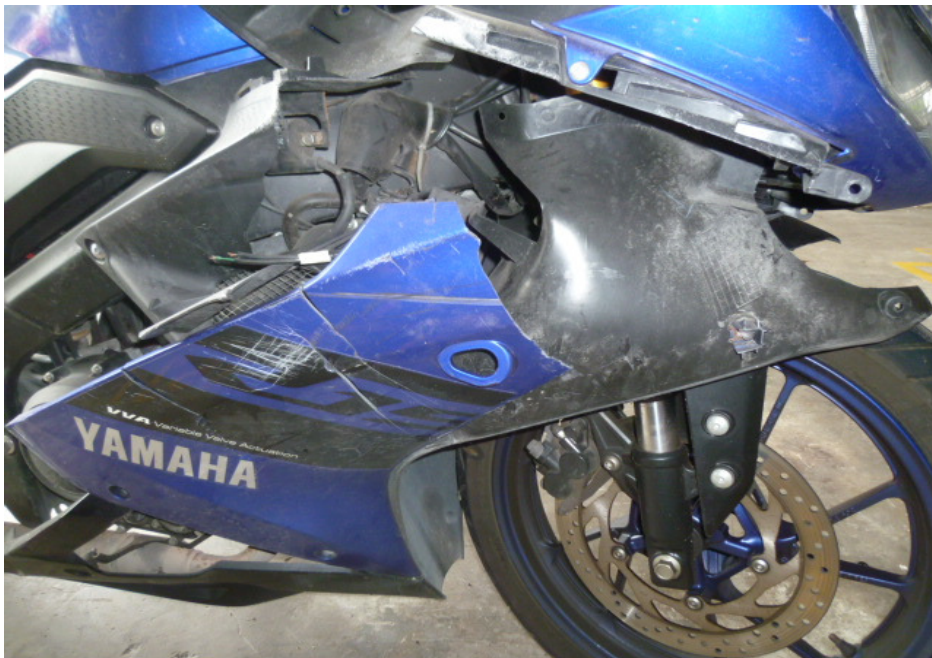
Photo 9 shows a closer view of the cracked right cowling of the Motorcycle as a result of the accident.

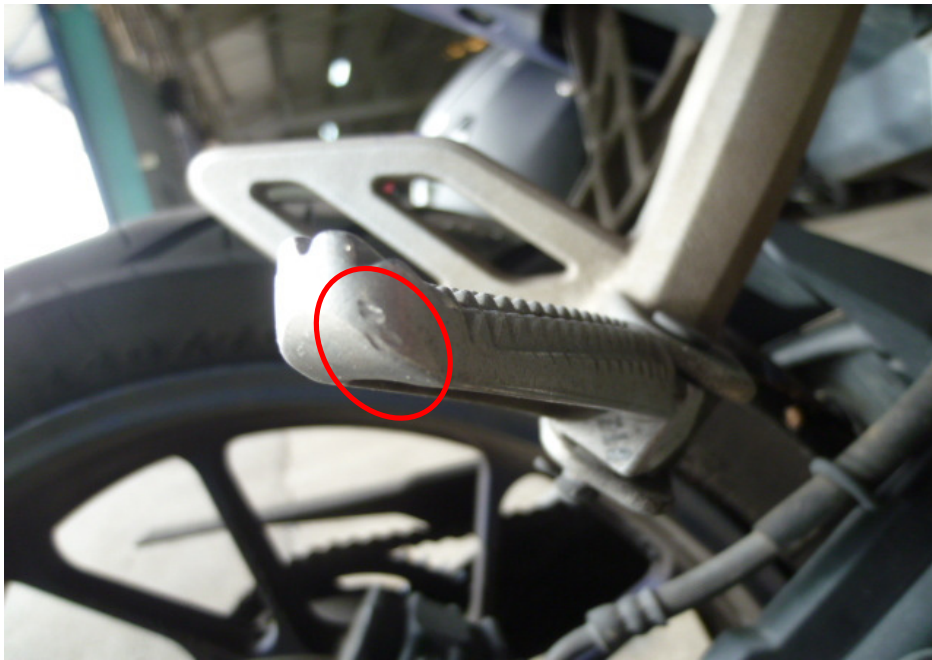
Photo 10 shows a closer view of the left pillion foot peg (circled) which was amongst the body parts of the Motorcycle that had sustained damage as a result of the accident.

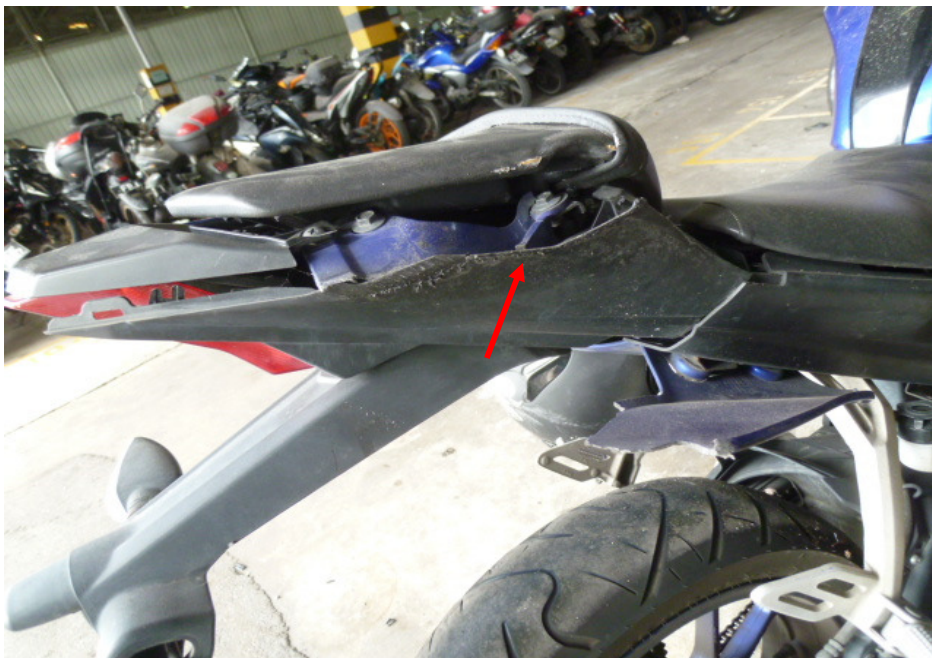
Photo 11 shows the cracked right rear side cover of the Motorcycle as a result of the accident (arrowed).

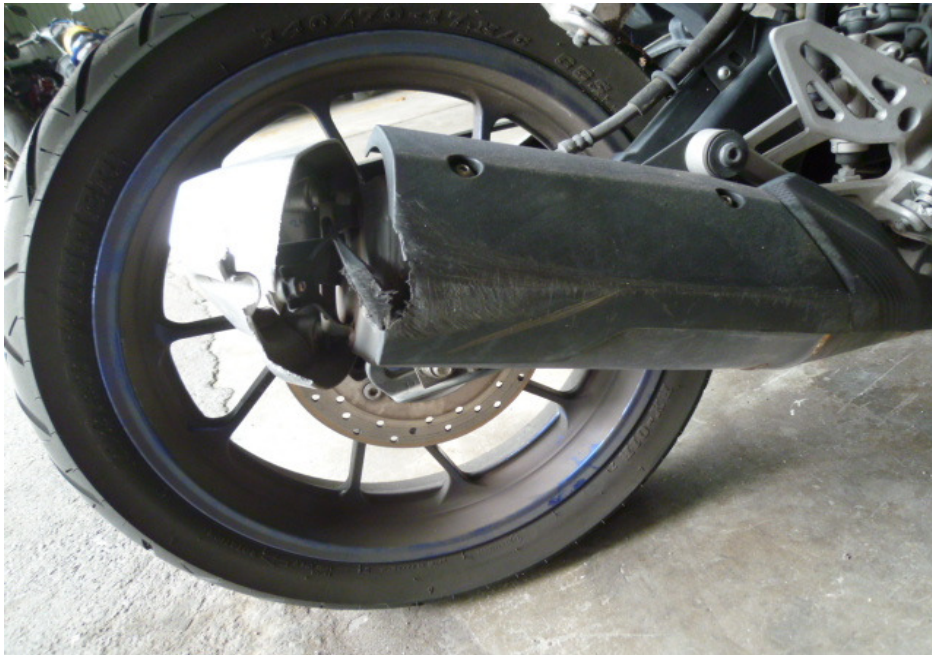
Photo 12 shows a closer view of the cracked exhaust muffler heat shield of the Motorcycle as a result of the accident.

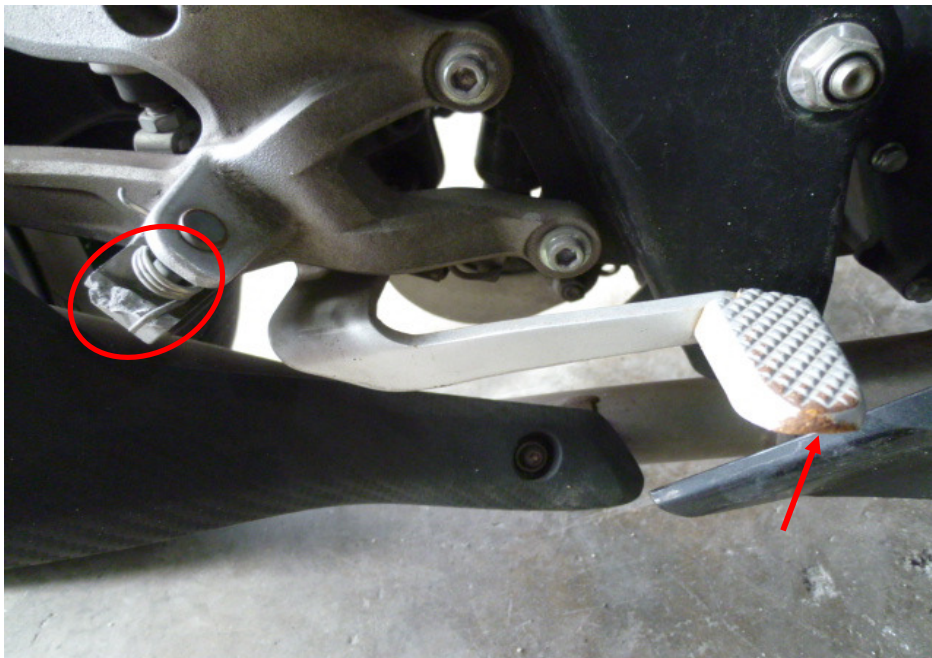
Photo 13 shows the broken right front footrest (circled) and grazed rear brake pedal (arrowed) of the Motorcycle as a result of the accident.

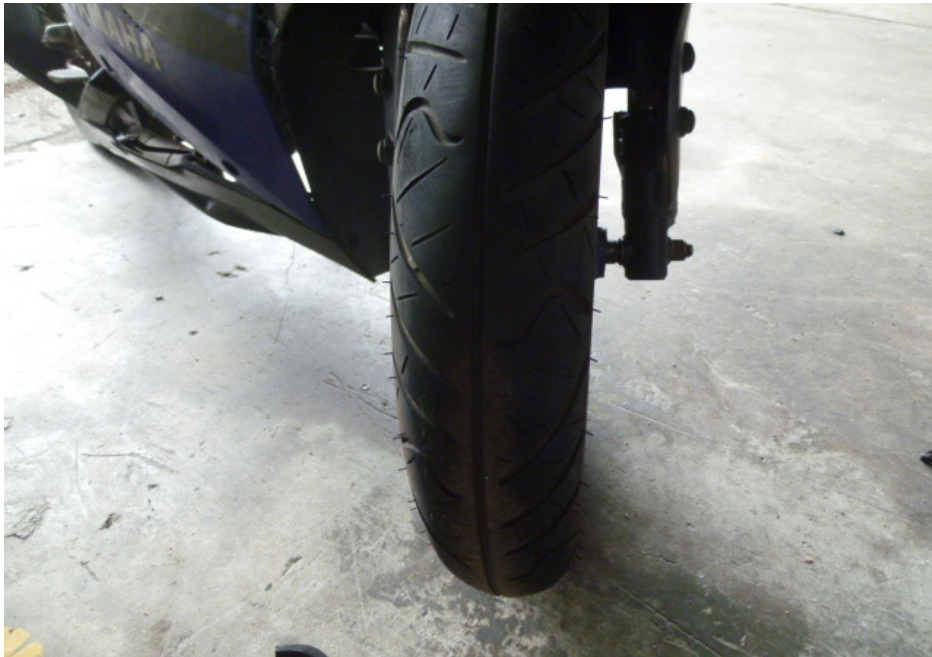
Photo 14 shows the condition of the Motorcycle's front tyre. The front tyre was observed to be in serviceable condition with remaining tread depth of approximately 3mm. There was no tear, burst mark(s) and/or punctured hole(s) on the sidewalls as well as across the tread of the front tyre.

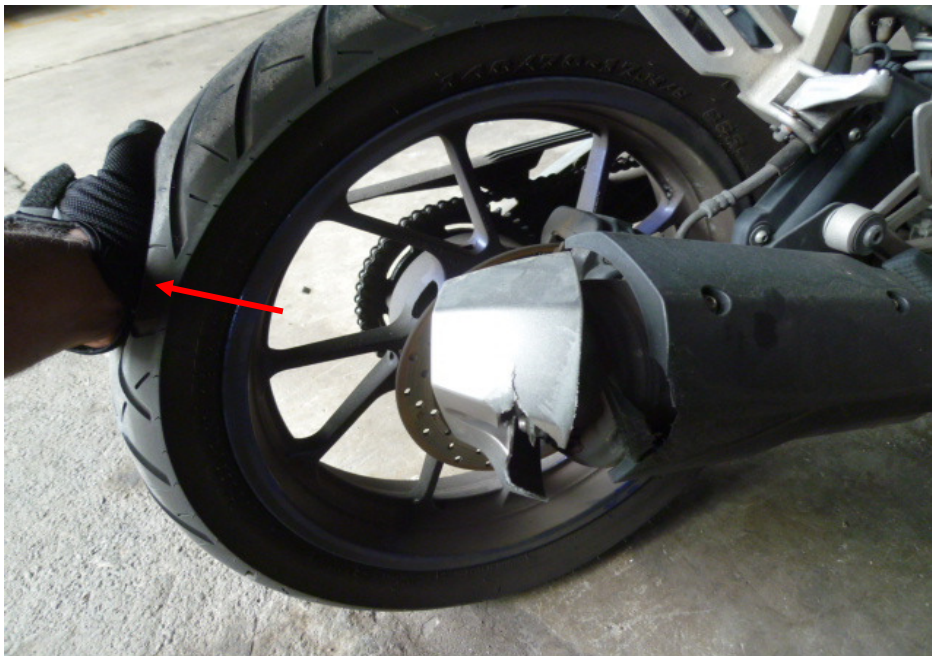
Photo 15 shows the condition of the Motorcycle's rear tyre. The rear tyre was observed to be in serviceable condition with remaining tread depth of approximately 3mm. We did not observe any tear, burst mark(s) and/or punctured hole(s) on the sidewalls as well as across the tread of the rear tyre. However the tyre was also observed to be deflated (arrowed).

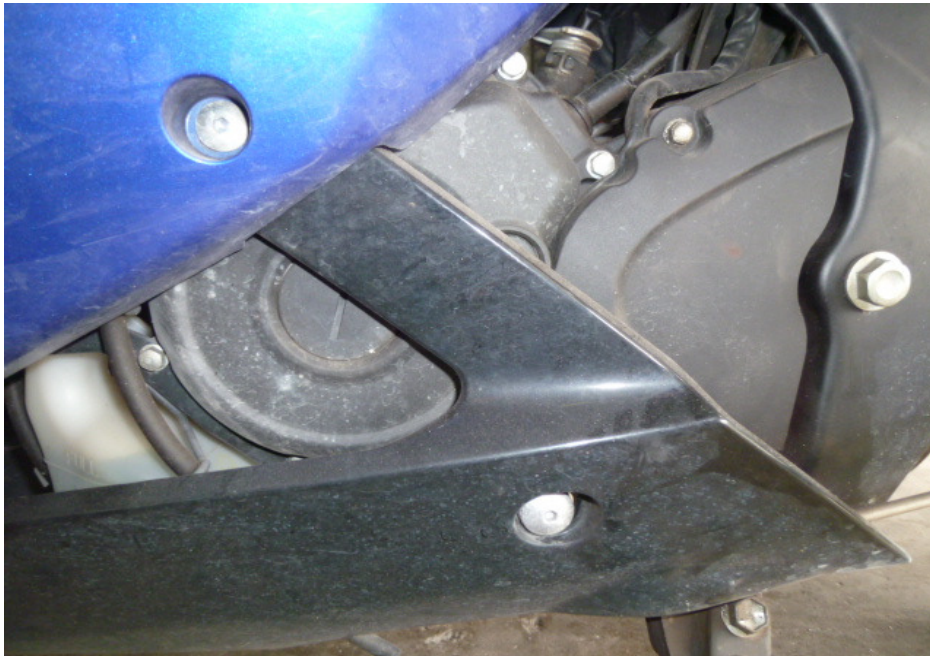
Photo 16 shows the left side of the engine of the Motorcycle at the time of our inspection. The various engine related parts and components were found to be intact with no visible damage. There was also no sign(s) or indication(s) of fluid leak observed around the left engine area of the Motorcycle.

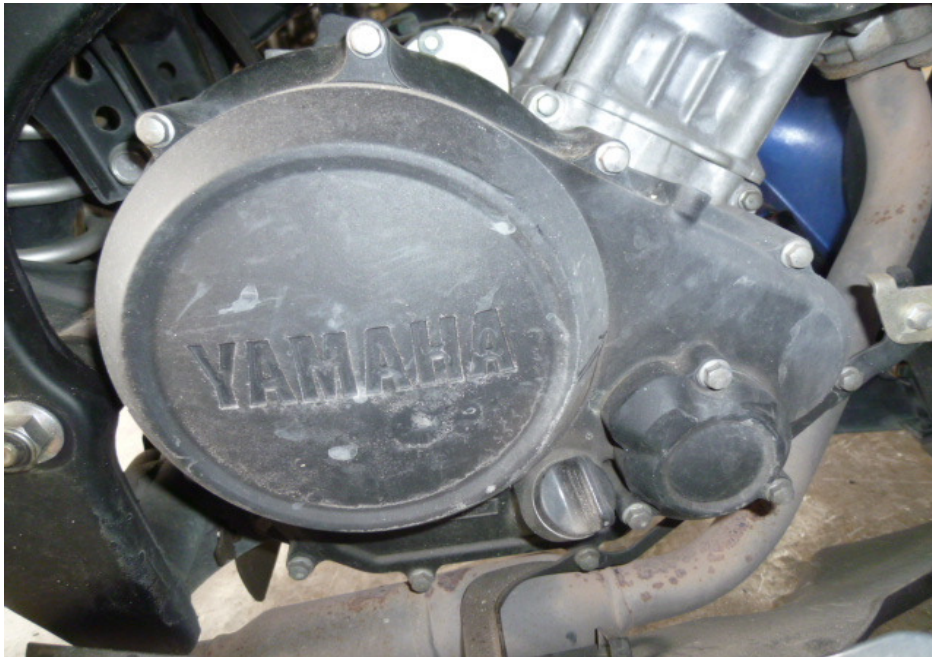
Photo 17 shows the right side of the engine of the Motorcycle at the time of our inspection. The various engine related parts and components were found to be intact with no visible damage. There was also no sign(s) or indication(s) of fluid leak observed around the right engine area of the Motorcycle.

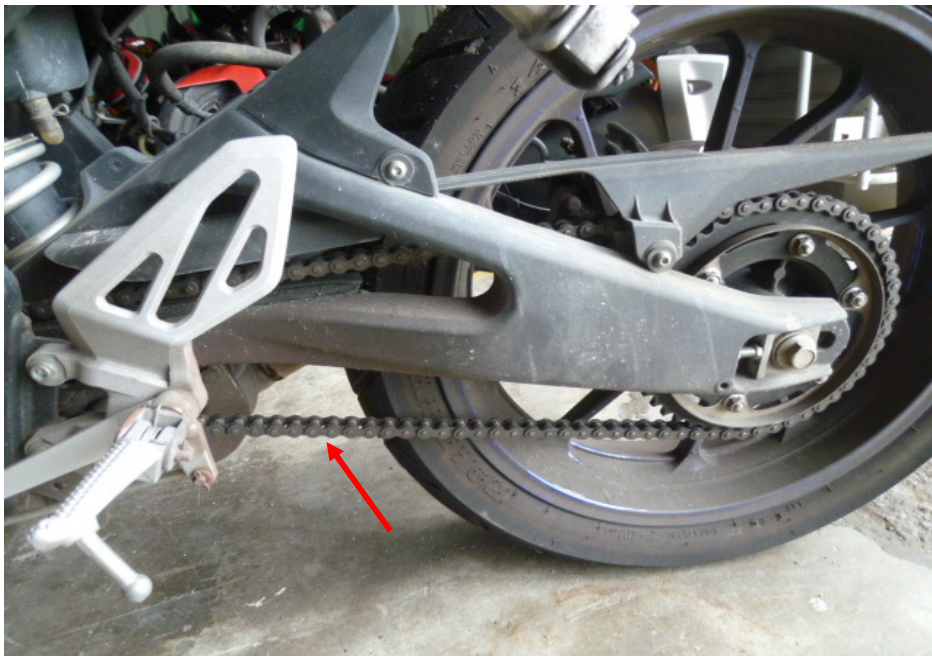
Photo 18 shows the general view of the gear train (arrowed) of the Motorcycle, which was observed to be intact with no misalignment. It was also adequately lubricated for operating purposes.

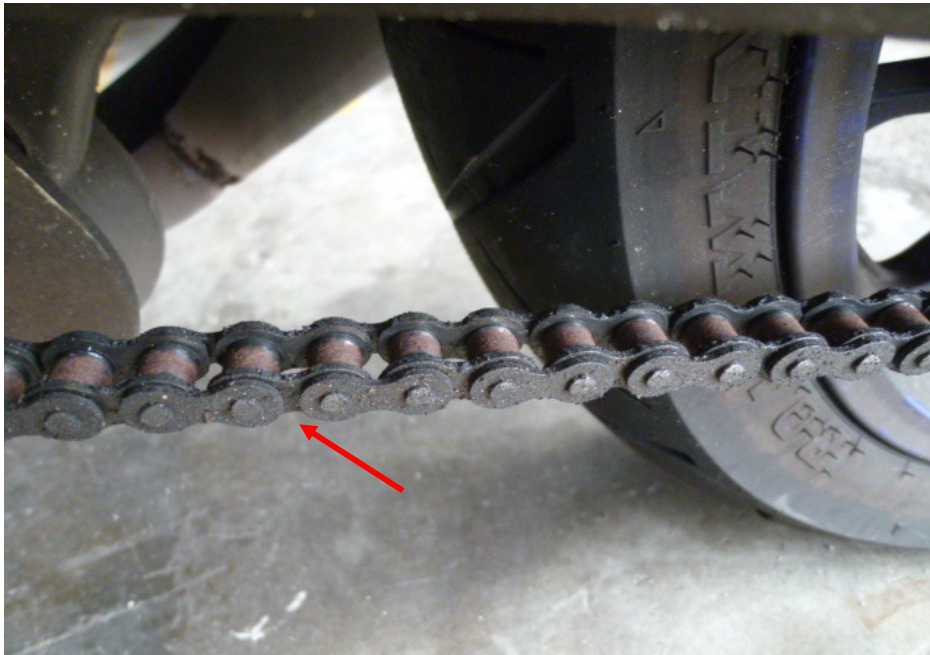
Photo 19 shows a closer view of the gear train (arrowed) of the Motorcycle, which was observed to be intact with no misalignment. It was also adequately lubricated for operating purposes.

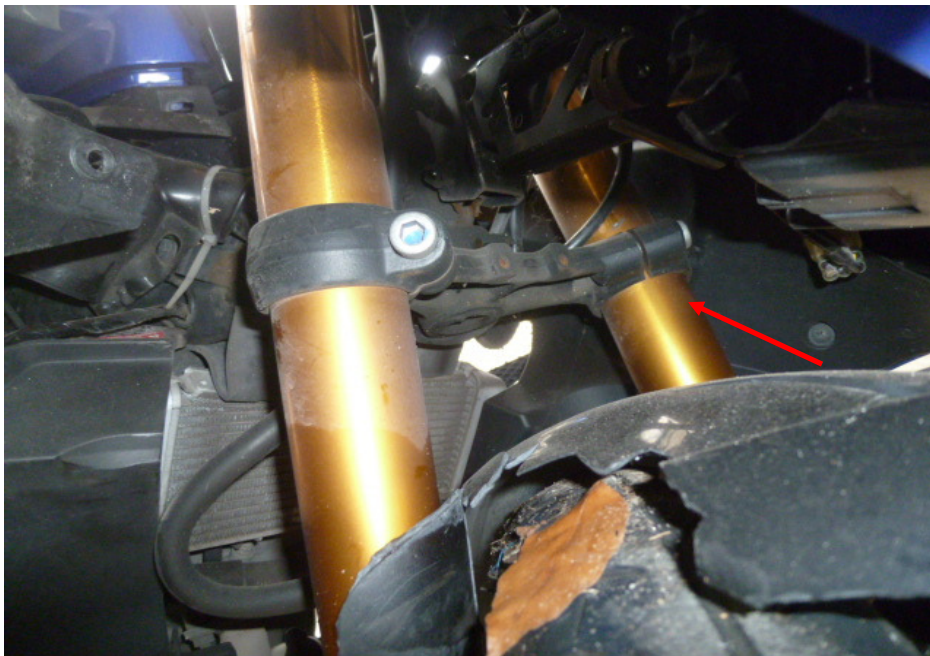
11. For this case, we were not able to conduct any test(s) on the steering system of the Motorcycle due to the damage to its fork assembly. The left front fork was observed to be bent as a result of the accident. Hence we were unable to turn the handle bar towards the left or right.

Photo 20 shows the front forks of the Motorcycle. The left front fork was observed to be bent (arrowed) as a result of the accident. Hence we were unable to turn the handle bar towards the left or right.

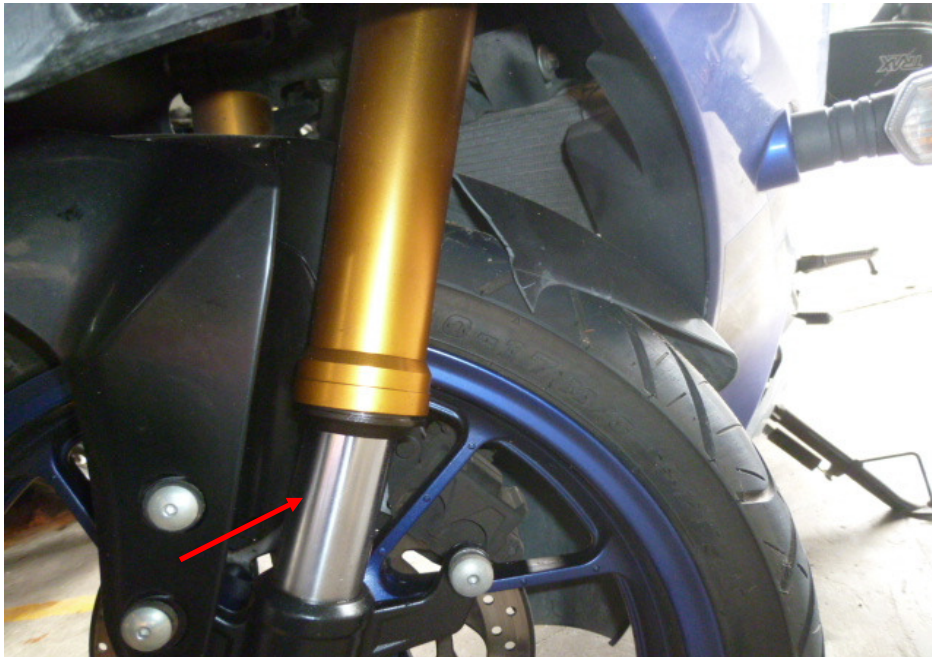
Photo 21 shows a closer view of the bent left front fork of the Motorcycle as a result of the accident (arrowed). Hence we were not able to conduct any test(s) on the steering system of the Motorcycle

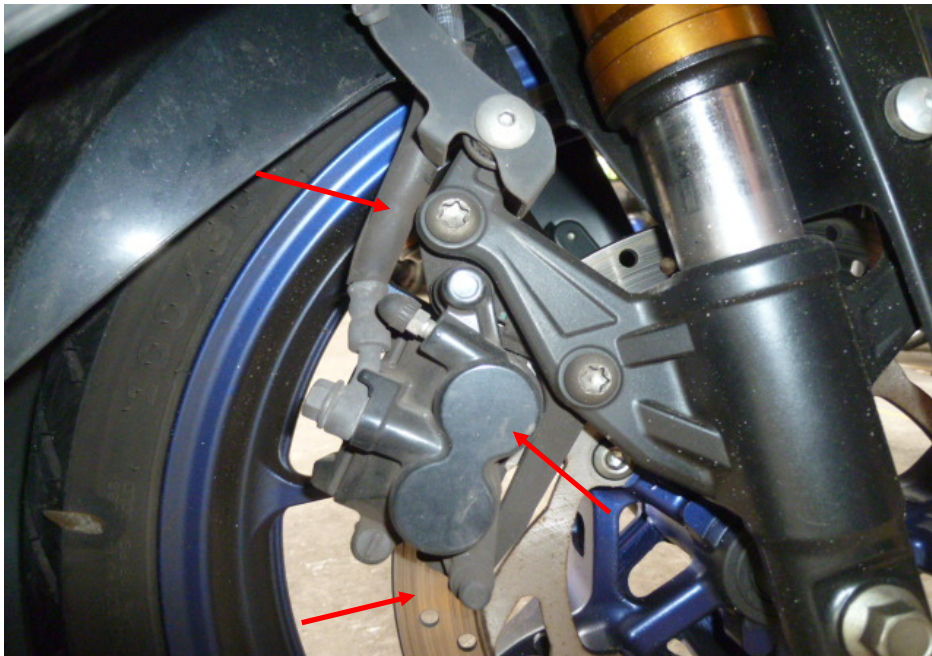
Photo 22 shows a close up view of the front brake caliper, front brake disc and front brake hose (arrowed) of the Motorcycle, which are all part of the components in the hydraulic front brake system of the Motorcycle. Our visual checks of these various components had revealed all to be intact with no visible damage. No leakage of brake fluid was also observed.

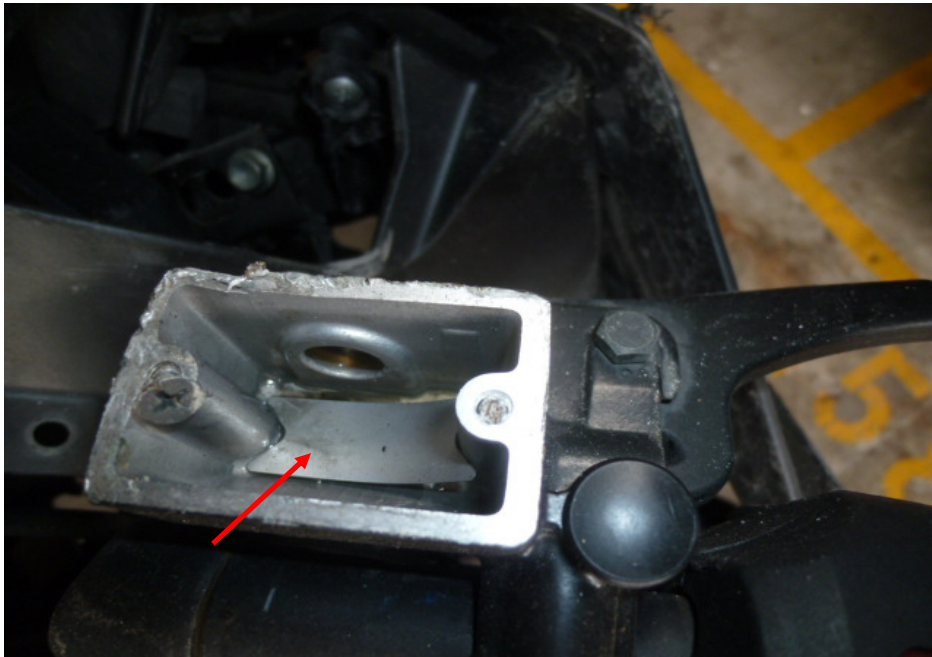
14. However the front brake reservoir cover was observed to be missing as a result of the accident. The front brake reservoir was also found to be empty.

Photo 23 shows the front brake reservoir of the Motorcycle. The front brake reservoir cover was missing as a result of the accident. The front brake reservoir was also found to be empty (arrowed).

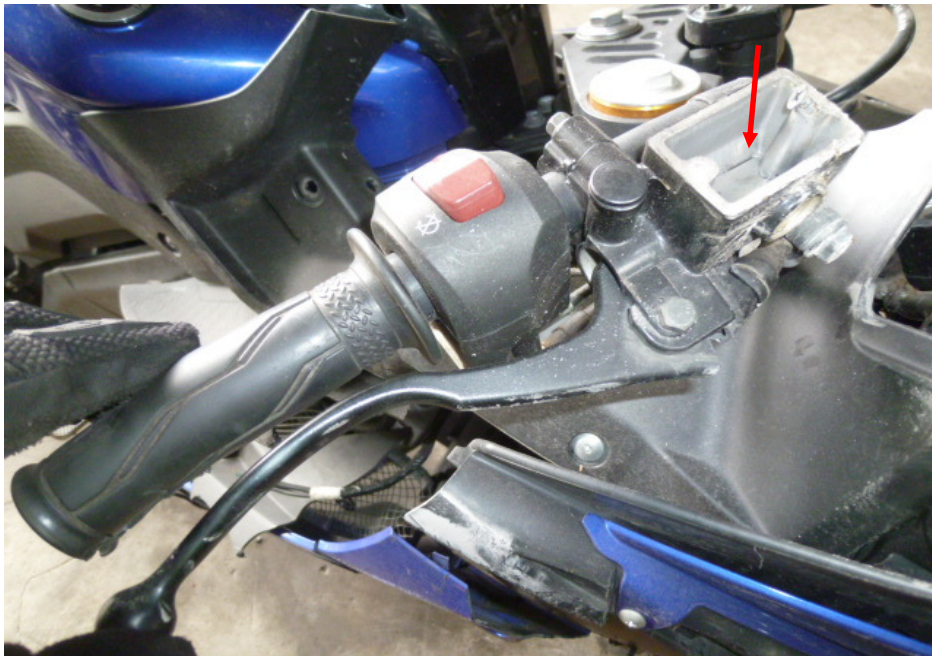
15. Static brake tests could not be conducted on the front brake of the Motorcycle due to the empty front brake reservoir. Hence we were unable to indicate if there was any leakage of pressure/vacuum in the front brake system.

Photo 24 shows the front brake lever being depressed. The front brake reservoir cover was observed to be missing as a result of the accident. The front brake reservoir was also found to be empty (arrowed). Hence we were unable to indicate if there was any leakage of pressure/vacuum in the front brake system of the Motorcycle.

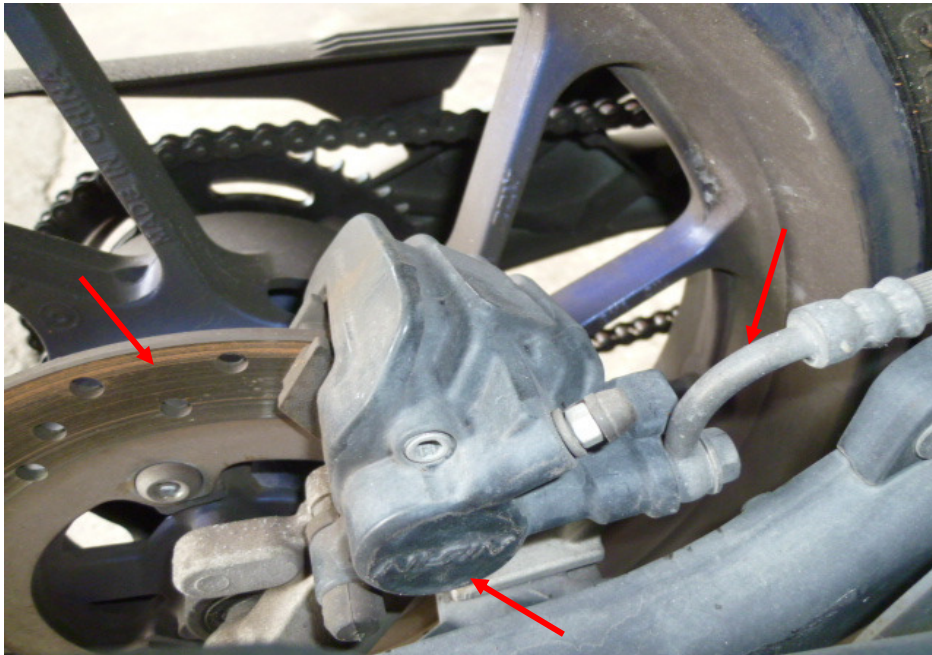
Photo 25 shows a close up view of the rear brake caliper, rear brake disc and rear brake hose (arrowed) of the Motorcycle, which are all part of the components in the hydraulic rear brake system of the Motorcycle. Our visual checks of these various components had revealed all to be intact with no visible damage. No leakage of brake fluid was also observed.

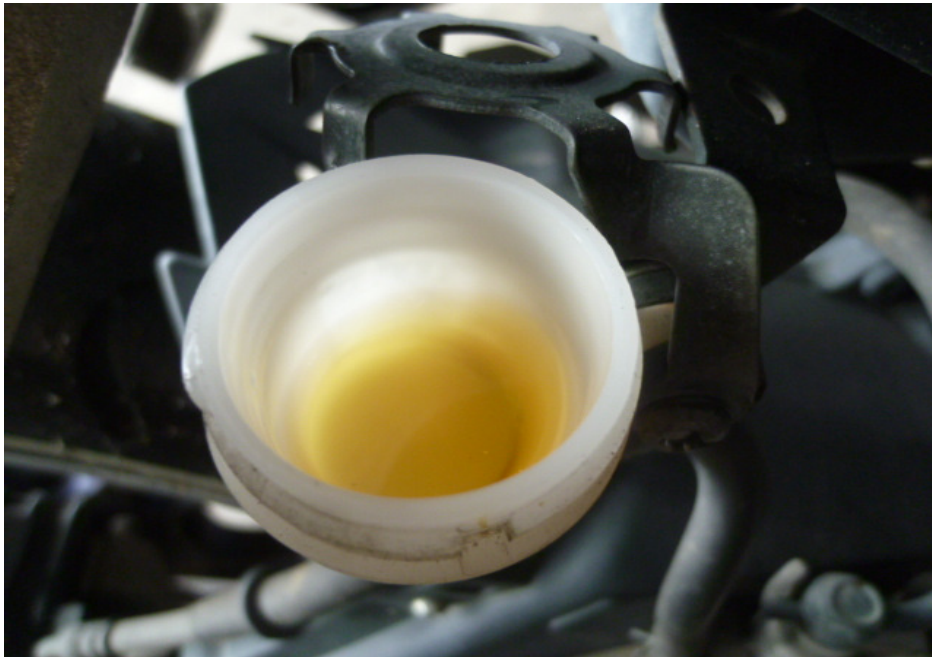
Photo 26 shows the brake fluid reservoir for the rear brake of the Motorcycle. The brake fluid was observed to be of sufficient level for operational purposes and without contamination.
