Your Ref: TP/IP/24779/2021  
Our Ref : CI/TPD21008009/N

4 August 2021

**Fatal Accident Investigation Team**

**INSPECTION REPORT OF MOTORCYCLE FBA 994C**

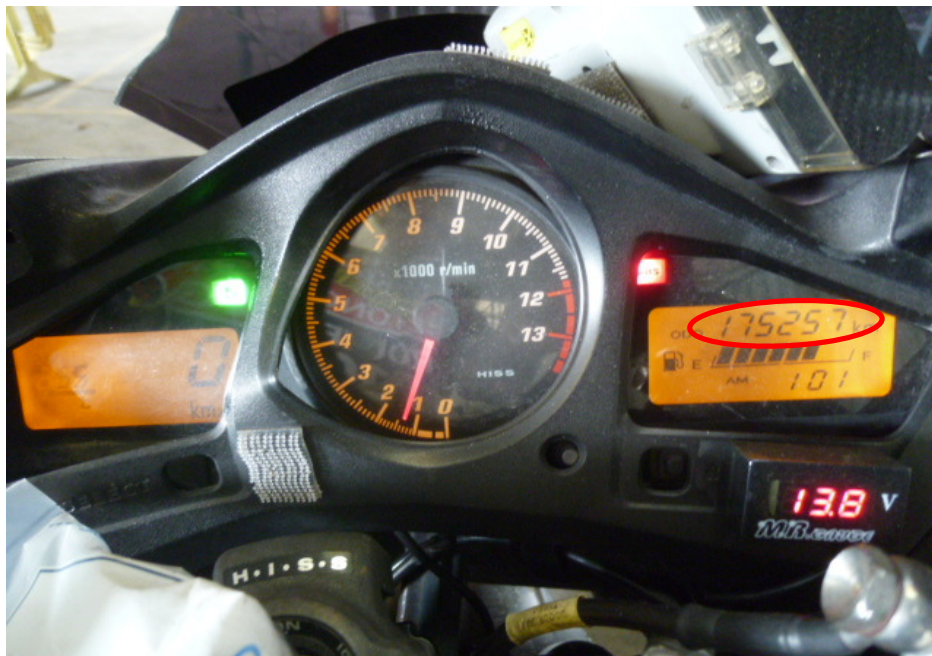
**Photo 1** shows the speedometer gauge of the Motorcycle where the mileage recorded at the time of our inspection was 175, 257km (circled).

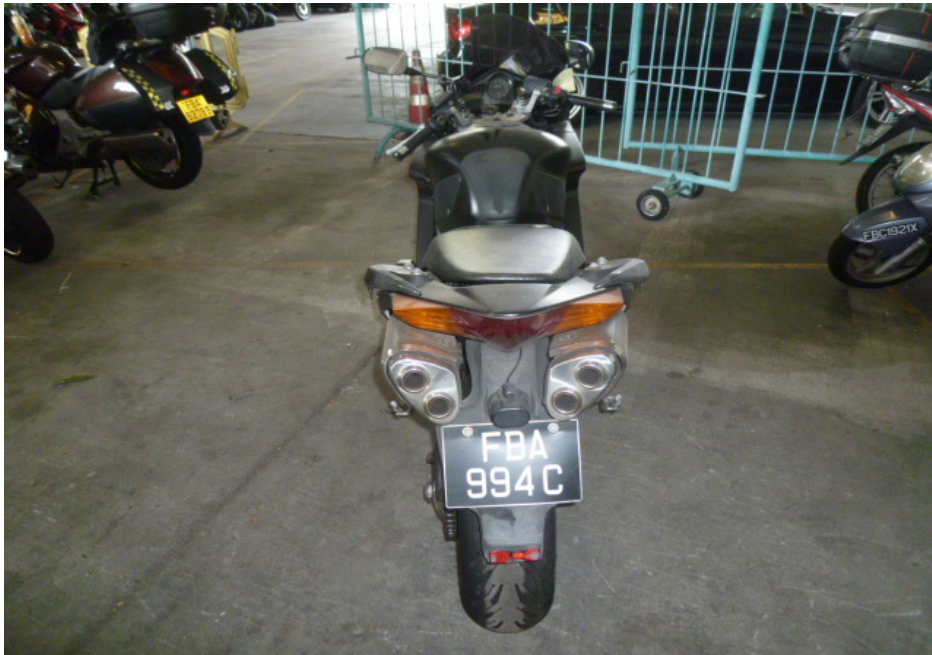
**Photo 2** shows a general view of the rear portion of the Motorcycle at the time of our inspection. The Motorcycle was observed to have sustained damages at its frontal portion and left body.

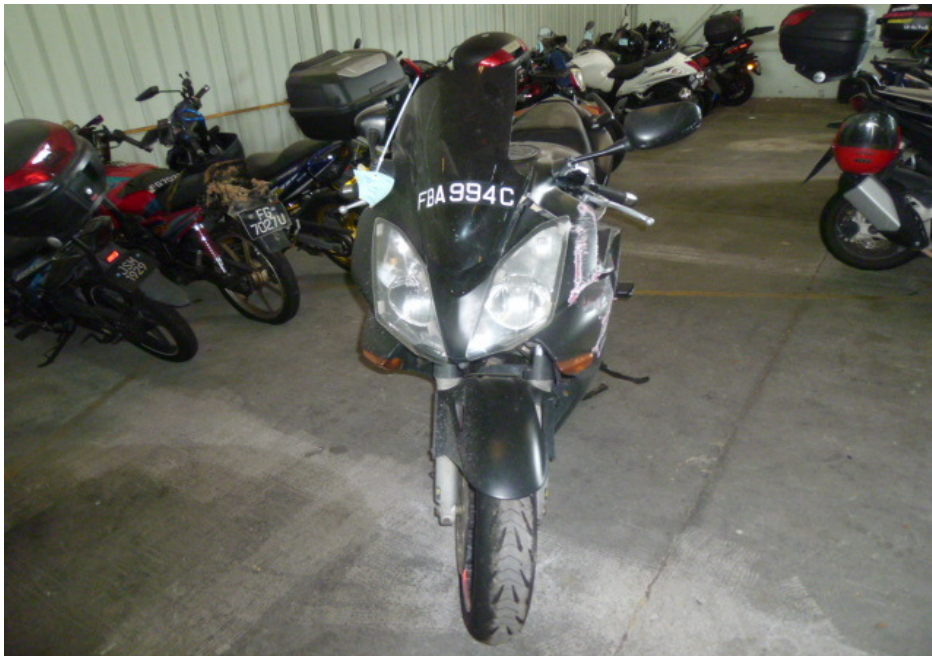
**Photo 3** shows a general view of the frontal portion of the Motorcycle at the time of our inspection. The Motorcycle was observed to have sustained damages at its frontal portion and left body.

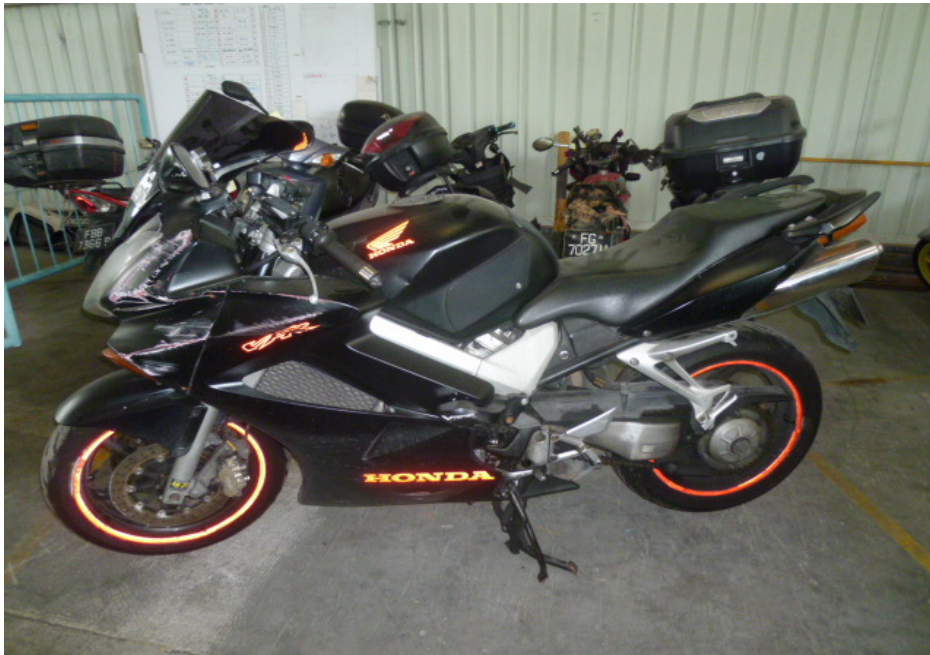
4. The mileage of the Motorcycle at the time of our inspection was 175, 257km.
5. The Motorcycle was observed to have sustained damages at its frontal portion and left body. The body parts that were found to have been damaged include its windshield, head cowling, left cowling, left frame slider, left handlebar end, left side mirror, gear shift pedal, left front footrest, left pillion foot peg, left rear side cover and left pillion grab rail, amongst others.

**Photo 4** shows a general view of the left body of the Motorcycle at the time of our inspection. The Motorcycle was observed to have sustained at its frontal portion and left body. The body parts that were found to have been damaged include its windshield, head cowl, left cowl, left frame slider, left handlebar end, left side mirror, gear shift pedal, left front footrest, left pillion foot peg, left rear side cover and left pillion grab rail, amongst others.

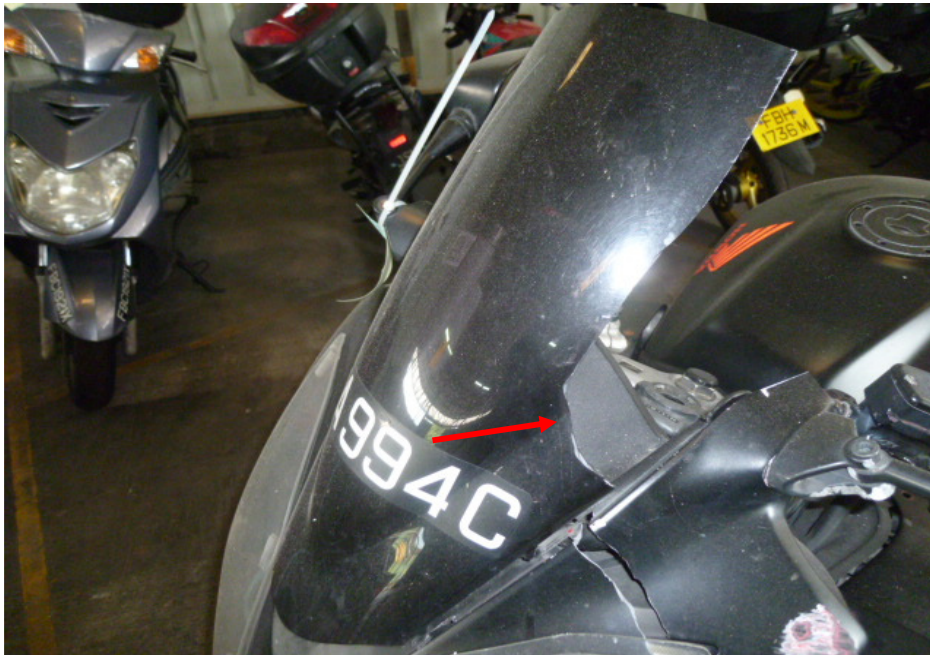
**Photo 5** shows a close up view of the cracked windshield which was amongst the body parts of the Motorcycle that had sustained damage as a result of the accident (arrowed).

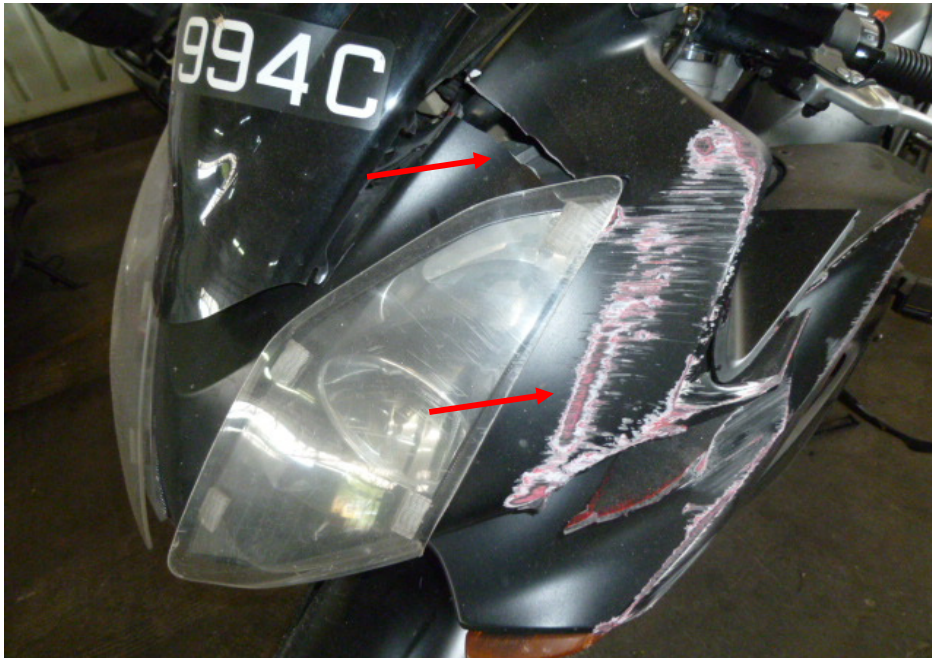
**Photo 6** shows a closer view of the cracked and grazed head cowling which was amongst the body parts at the front body of the Motorcycle that had sustained damage as a result of the accident (arrowed).

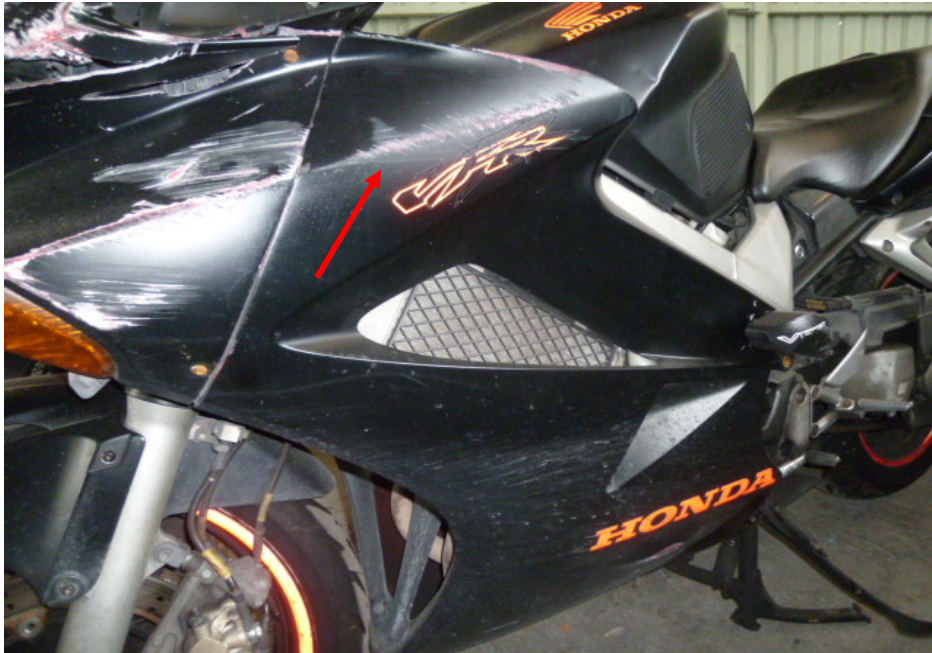
**Photo 7** shows a closer view of the left cowling of the Motorcycle that had sustained damages of grazing nature as a result of the accident (arrowed).

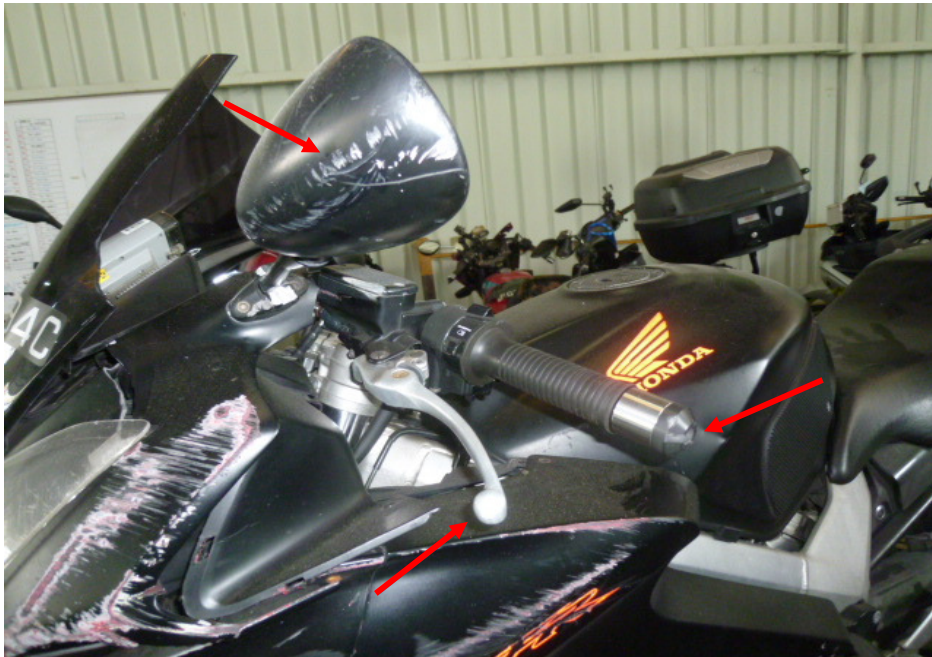
**Photo 8** shows a closer view of the clutch lever, left handlebar end and left side mirror (arrowed) which were amongst the body parts of the Motorcycle that had sustained damage as a result of the accident.

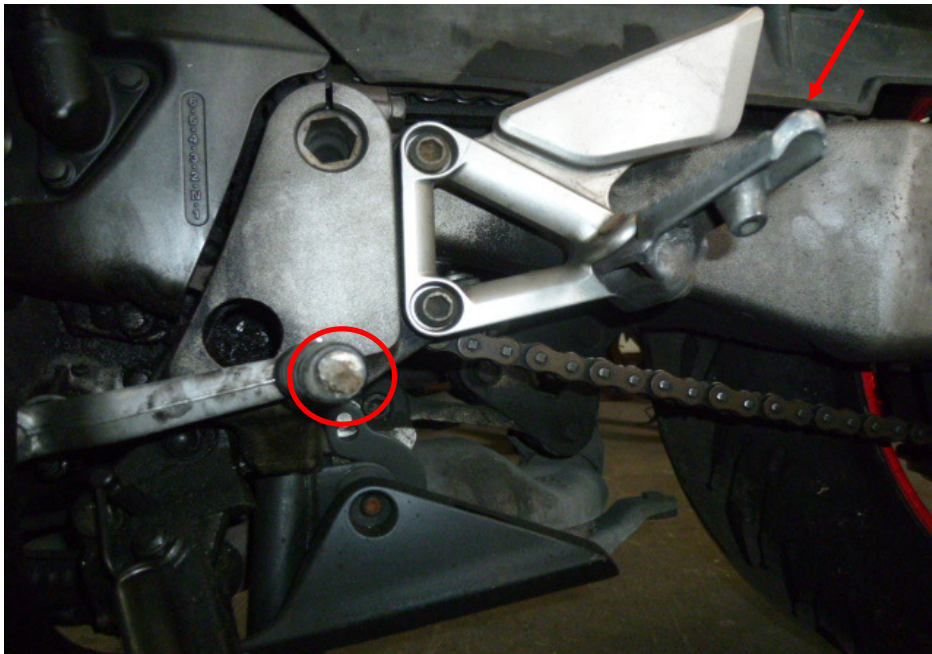
**Photo 9** shows a closer view of the gear shift pedal (circled) and left front footrest (arrowed) which were amongst the body parts of the Motorcycle that had sustained damage as a result of the accident.

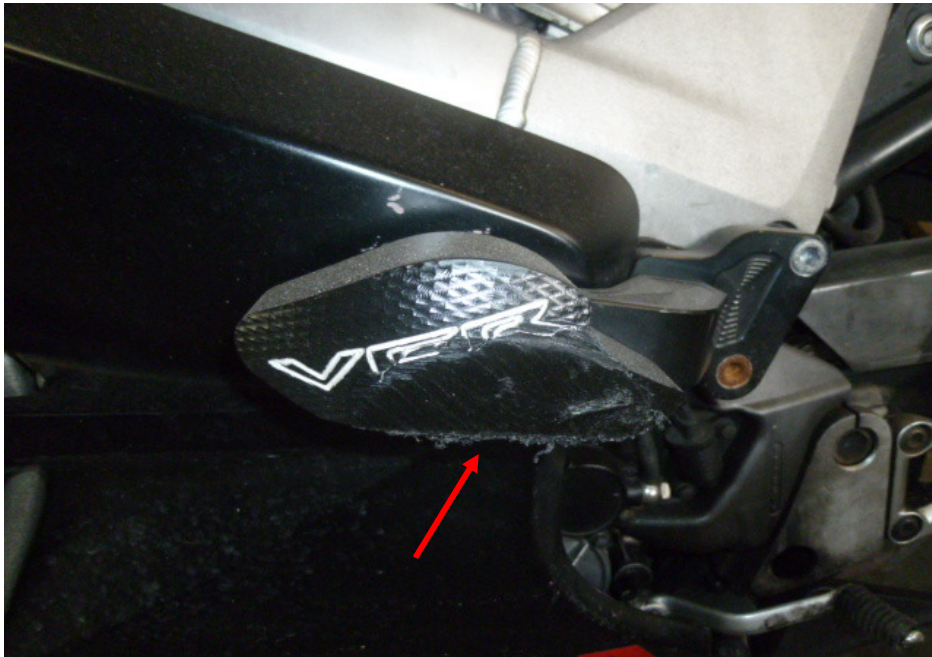
**Photo 10** shows a closer view of the left frame slider which was amongst the body parts of the Motorcycle that had sustained damages of grazing nature as a result of the accident (arrowed).

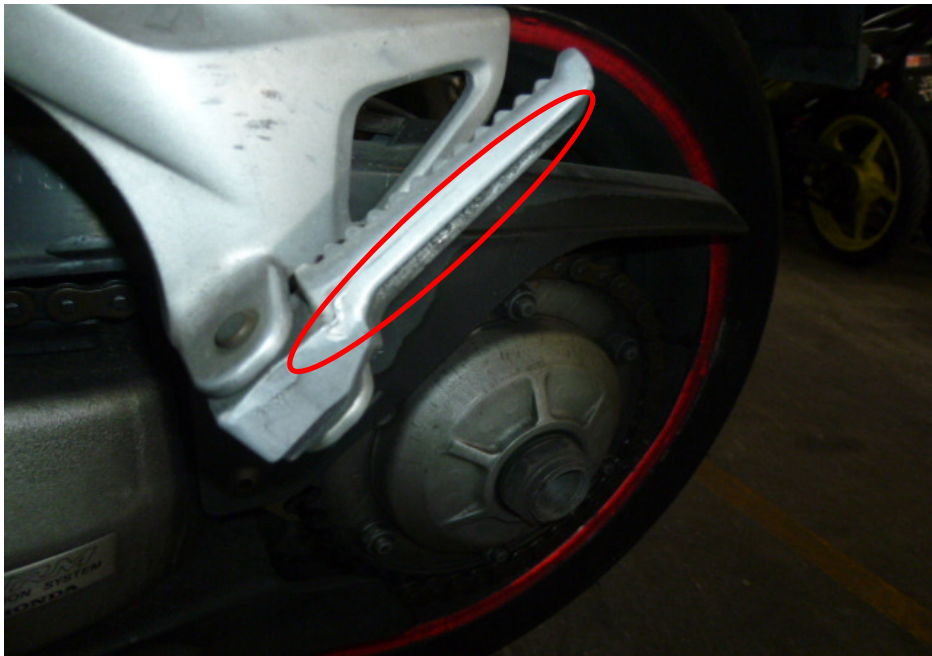
**Photo 11** shows a closer view of the left pillion foot peg which was amongst the body parts of the Motorcycle that had sustained damages of grazing nature as a result of the accident (circled).

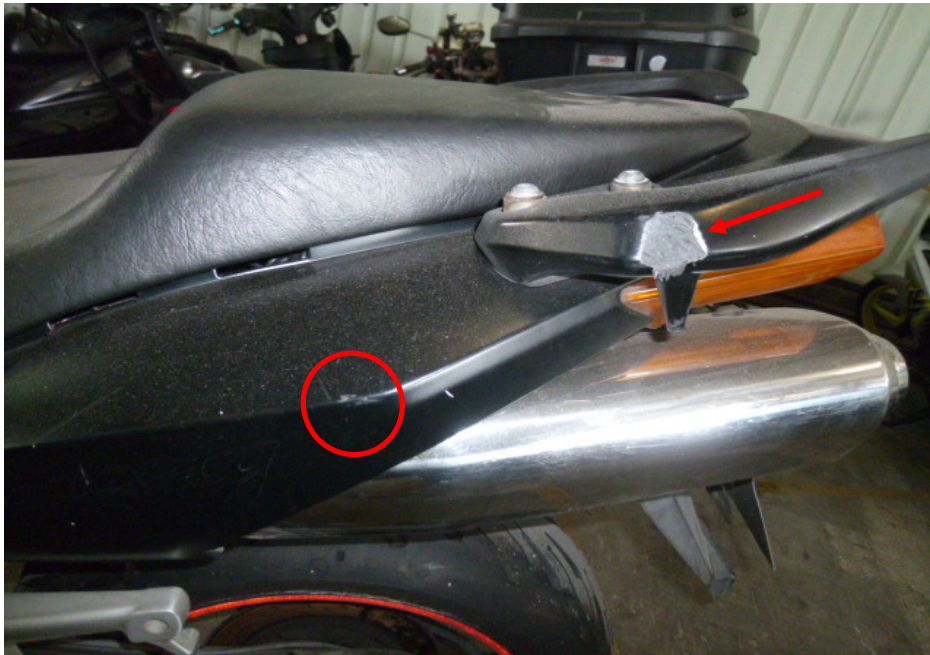
**Photo 12** shows a closer view of the grazed left rear side cover (circled) and left pillion grab rail (arrowed) of the Motorcycle as a result of the accident.

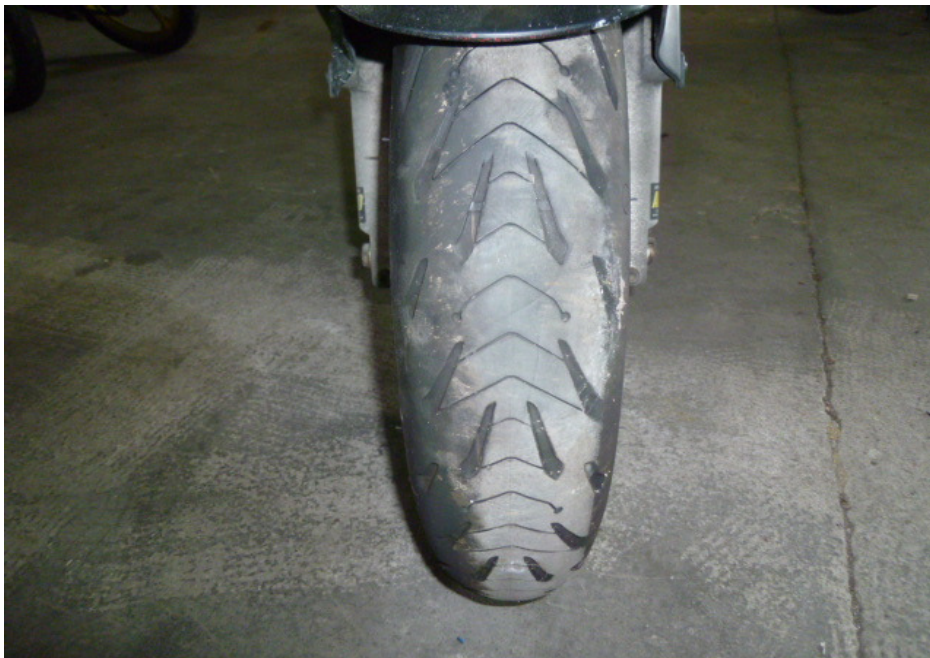
**Photo 13** shows the condition of the Motorcycle's front tyre. The front tyre was observed to be in serviceable condition with remaining tread depth of approximately 3mm. There was no tear, burst mark(s) and/or punctured hole(s) on the sidewalls as well as across the tread of the front tyre.

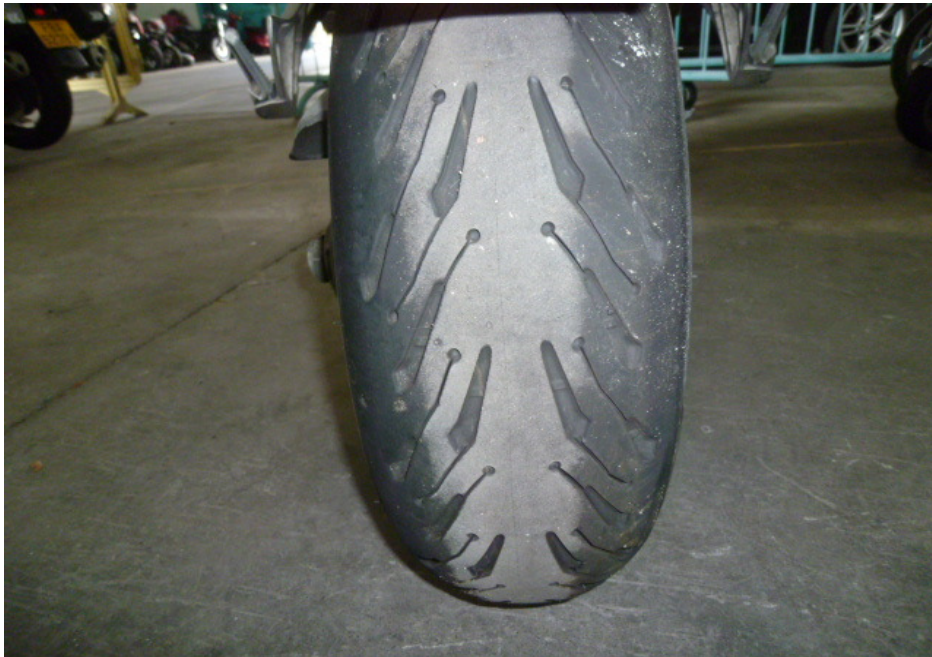
**Photo 14** shows the condition of the Motorcycle's rear tyre. The rear tyre was observed to be in serviceable condition with remaining tread depth of approximately 4mm. The tyre was also observed to be sufficiently inflated for vehicular operation. We did not observe any tear, burst mark(s) and/or punctured hole(s) on the sidewalls as well as across the tread of the rear tyre.

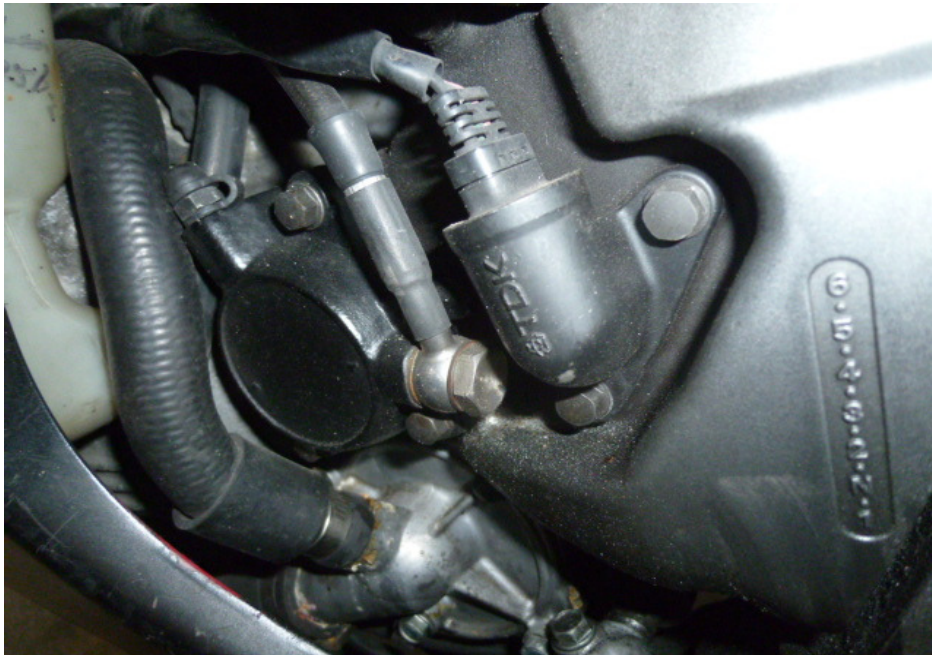
**Photo 15** shows the left side of the engine of the Motorcycle at the time of our inspection. The various engine related parts and components were found to be intact with no visible damage. There was also no sign(s) or indication(s) of fluid leak observed around the left engine area of the Motorcycle.

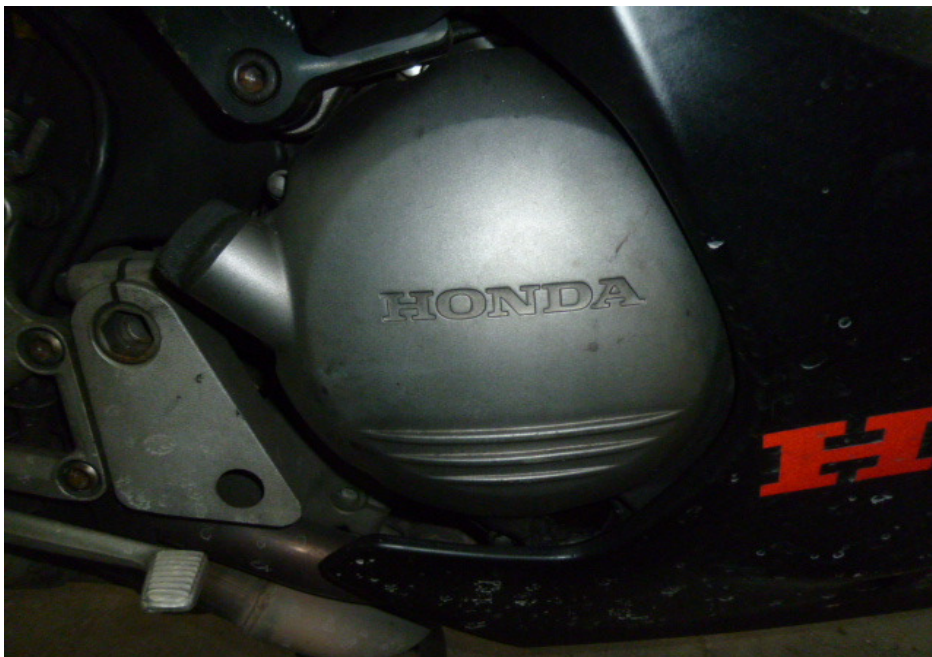
**Photo 16** shows the right side of the engine of the Motorcycle at the time of our inspection. The various engine related parts and components were found to be intact with no visible damage. There was also no sign(s) or indication(s) of fluid leak observed around the right engine area of the Motorcycle.

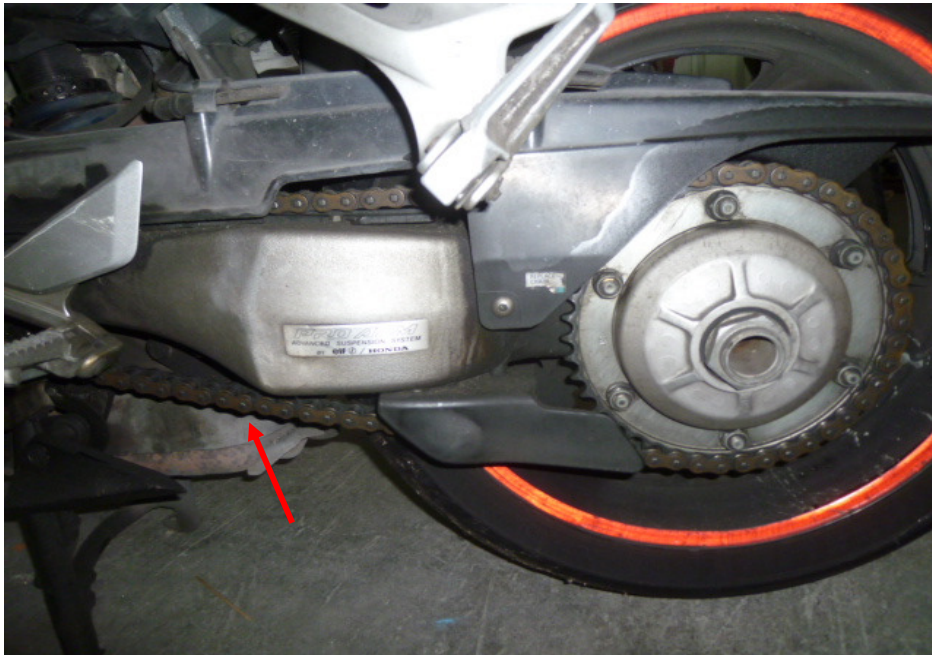
**Photo 17** shows the general view of the gear train (arrowed) of the Motorcycle, which was observed to be intact with no misalignment. It was also adequately lubricated for operating purposes.

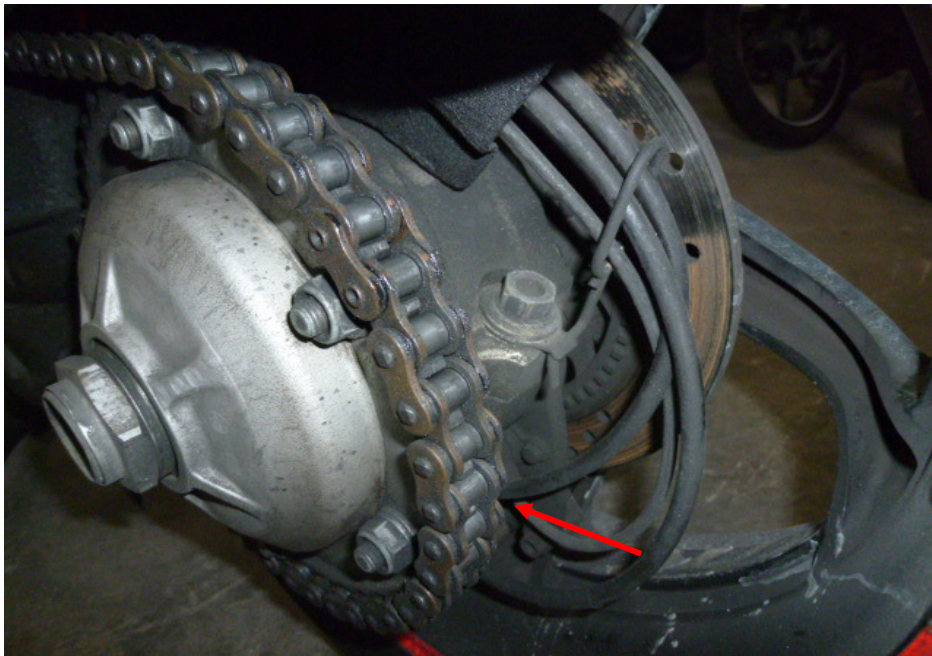
**Photo 18** shows a closer view of the gear train (arrowed) of the Motorcycle, which was observed to be intact with no misalignment. It was also adequately lubricated for operating purposes.

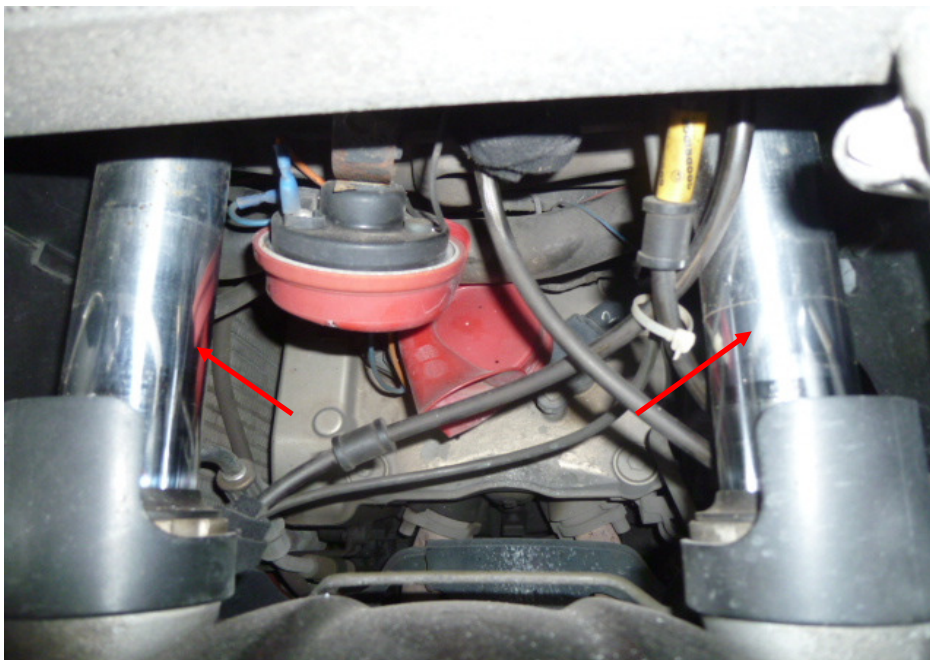
**Photo 19** shows the front forks (arrowed) of the Motorcycle. The front fork and fork bracket of the Motorcycle were both found to be intact and undamaged. Turning the Motorcycle's handle bar towards the left and right did not produce any abnormal free play and/or resistance. The steering system of the Motorcycle was in serviceable condition at the time of our inspection.

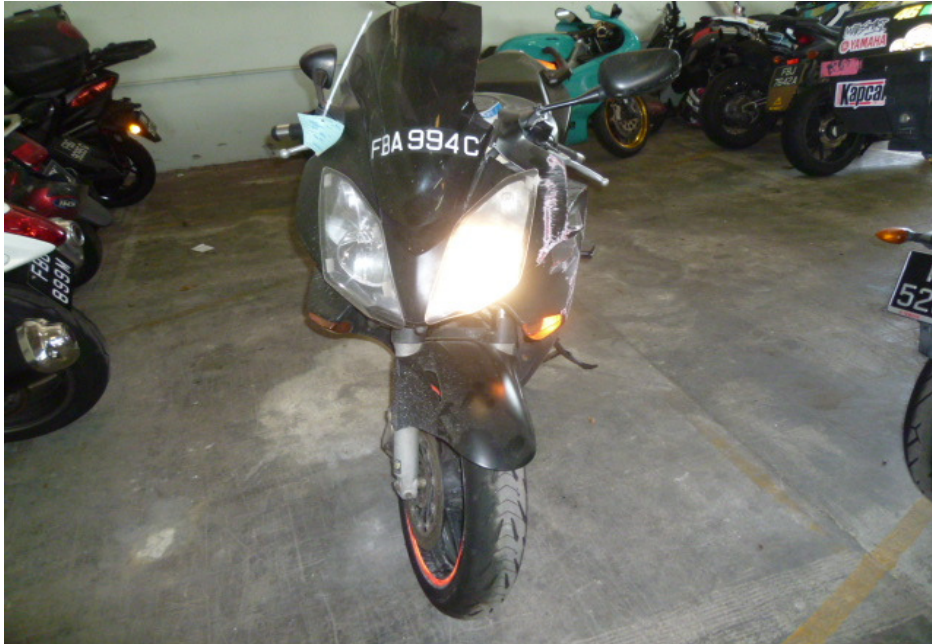
**Photo 20** shows the front wheel of the Motorcycle turned towards its full left. Turning the Motorcycle's handle bar towards the left and right did not produce any abnormal free play and/or resistance. This would indicate that the steering system of the Motorcycle was in serviceable condition at the time of our inspection.

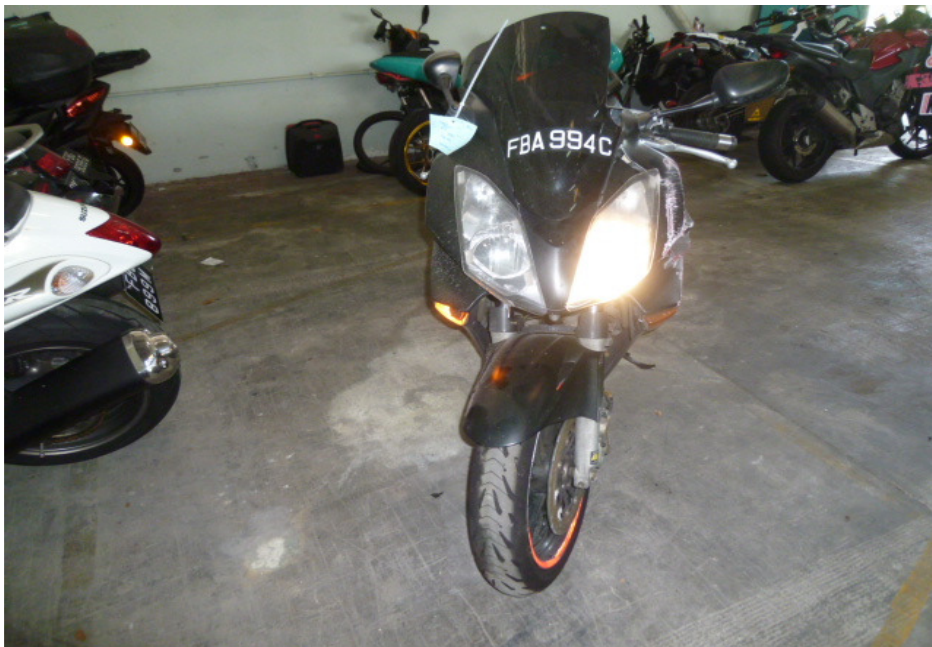
**Photo 21** shows the front wheel of the Motorcycle turned towards its full right. Turning the Motorcycle's handle bar towards the left and right did not produce any abnormal free play and/or resistance. This would indicate that the steering system of the Motorcycle was in serviceable condition at the time of our inspection.

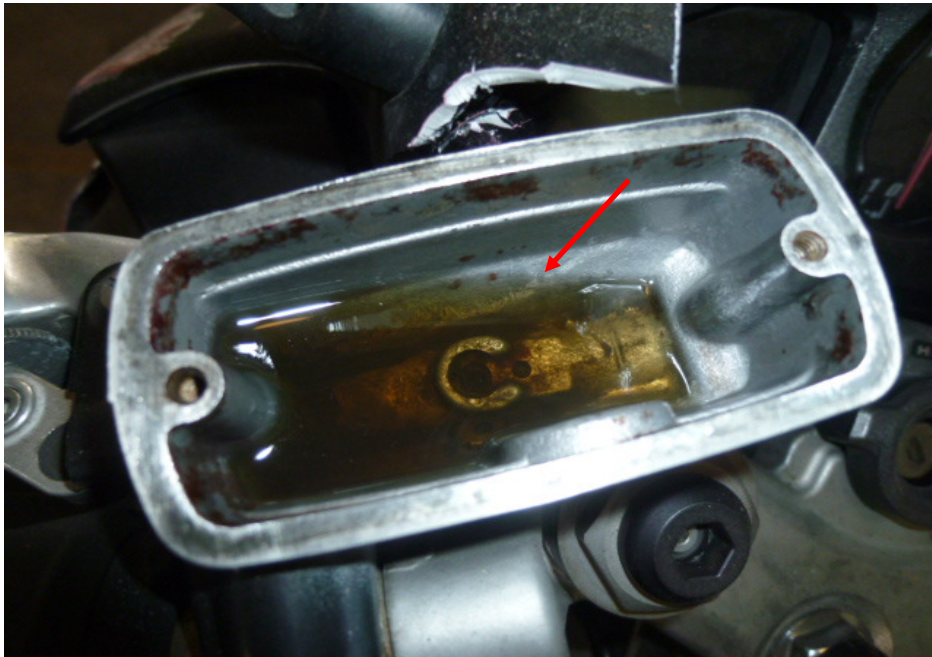
13. Our visual examination of the various components in the Motorcycle's hydraulic clutch system like the clutch lever and clutch hoses revealed all to be intact and without damage. There was also no leakage of clutch fluid observed along the clutch hose. This was from the respective clutch fluid reservoir at the left handlebar of the Motorcycle. However the clutch fluid was found to be of insufficient level for operating purposes. It was also found to be slightly contaminated.

**Photo 24** shows the hydraulic clutch fluid reservoir for the hydraulic clutch system of the Motorcycle. The hydraulic clutch fluid was observed to be of insufficient level for operational purposes. It was also found to be slightly contaminated (arrowed).

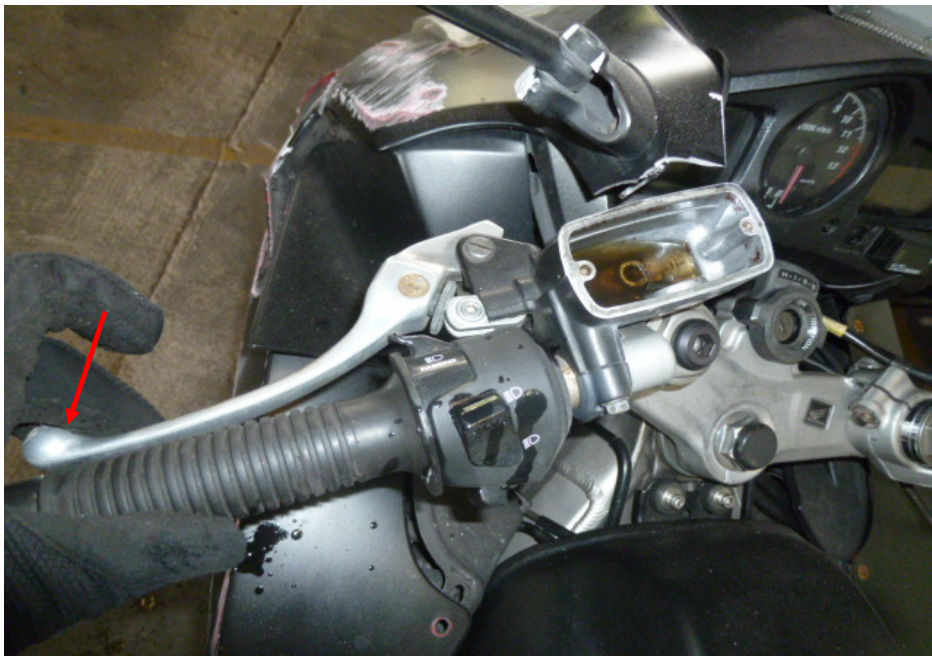
14. Static tests conducted on the clutch of the Motorcycle had appear to indicate that the hydraulic clutch system of the Motorcycle was in serviceable condition. There was some resistance felt (spongy like feel) upon pressing the clutch lever. This would indicate that there was no leakage of pressure/vacuum in the hydraulic clutch system.

**Photo 25** shows the clutch lever being depressed. There was some resistance felt (spongy like feel) upon pressing the clutch lever (arrowed). This would indicate that there is no leakage of pressure/vacuum in the hydraulic clutch system.

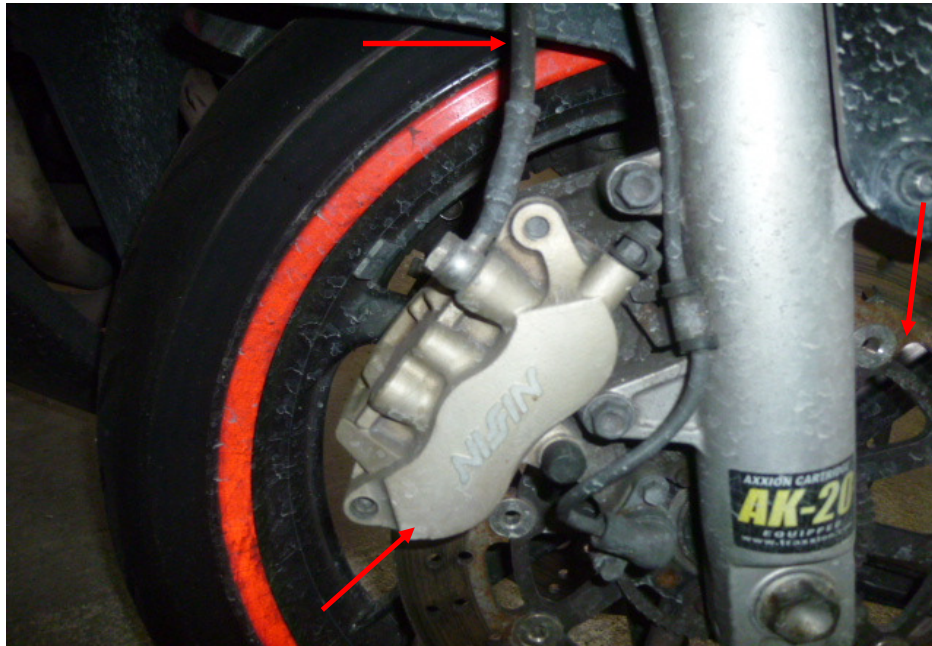
**Photo 22** shows a close up view of the front brake caliper, front brake disc and front brake hose (arrowed) at the right side of the Motorcycle's front wheel, which are all part of the components in the hydraulic front brake system of the Motorcycle. Our visual checks of these various components had revealed all to be intact with no visible damage. No leakage of brake fluid was also observed.

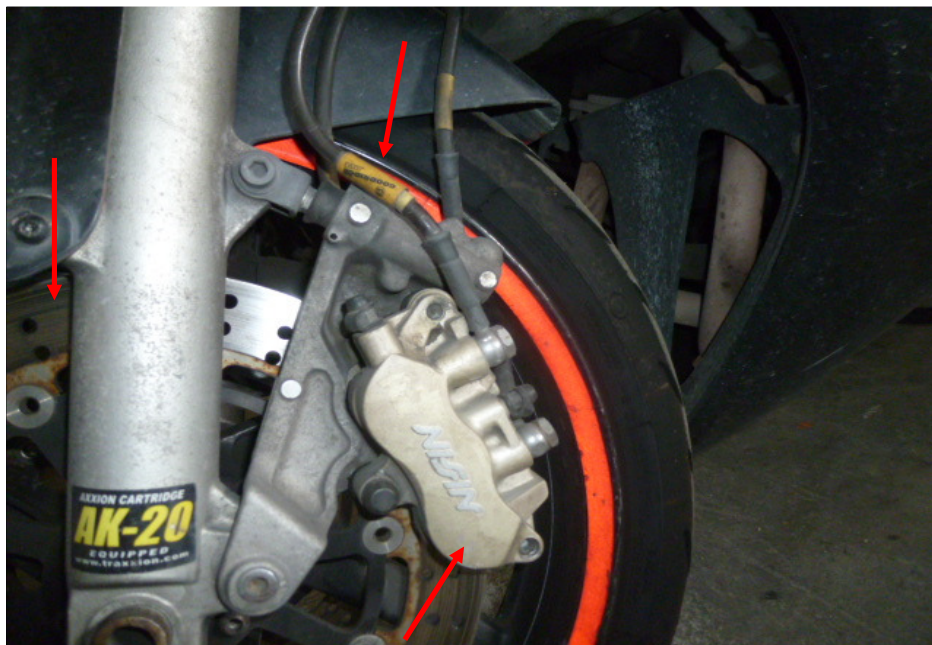
**Photo 23** shows a close up view of the front brake caliper, front brake disc and front brake hose (arrowed) at the left side of the Motorcycle's front wheel, which are all part of the components in the hydraulic front brake system of the Motorcycle. Our visual checks of these various components had revealed all to be intact with no visible damage. No leakage of brake fluid was also observed.

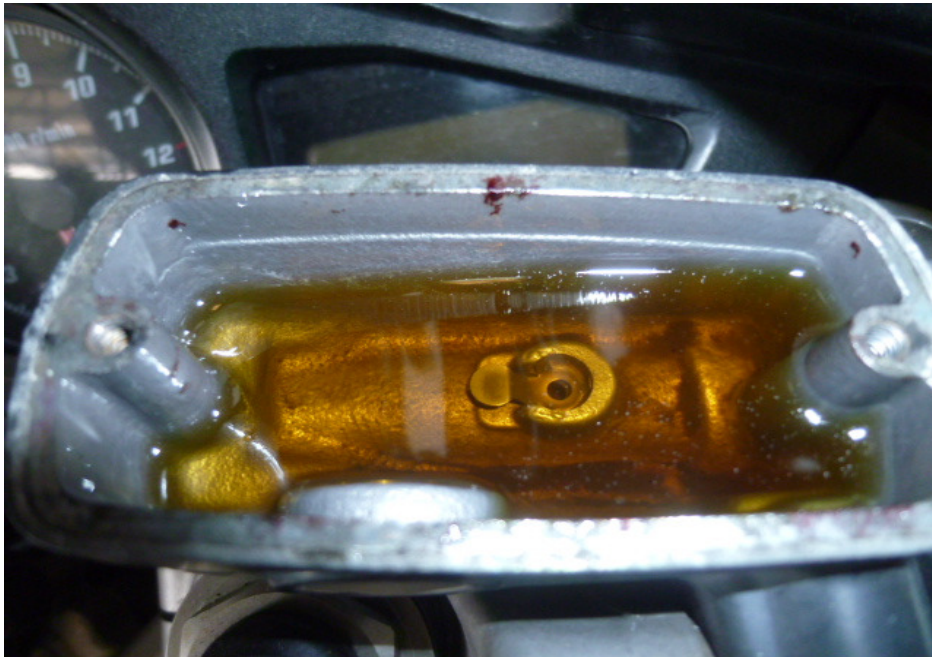
**Photo 24** shows the brake fluid reservoir for the front brake of the Motorcycle. The brake fluid was observed to be of sufficient level for operational purposes and without contamination.

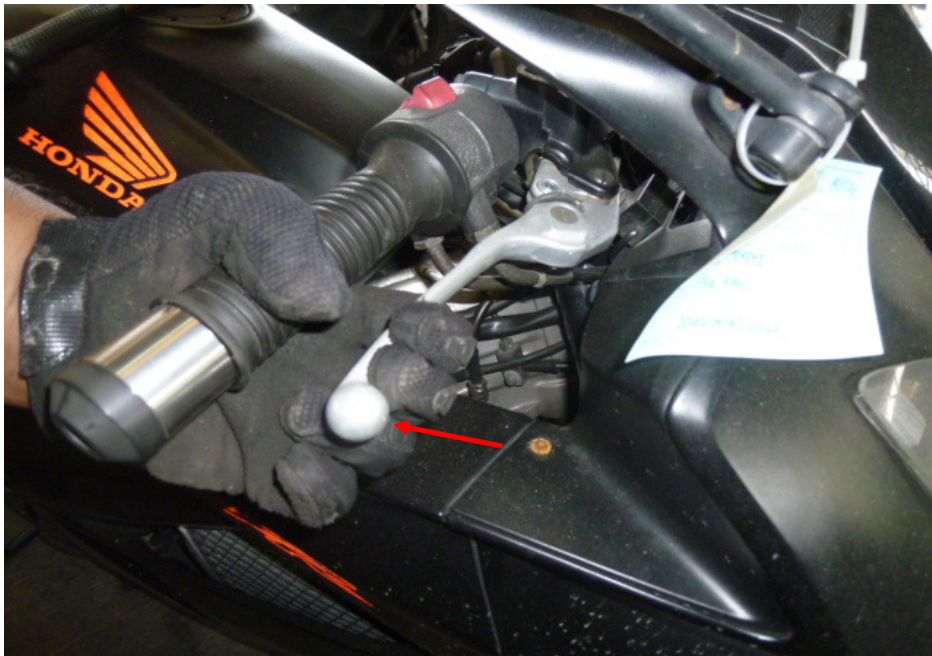
**Photo 25** shows the front brake lever being depressed. There was some resistance felt (spongy like feel) upon pressing the front brake lever (arrowed). This would indicate that there is no leakage of pressure/vacuum in the brake system.

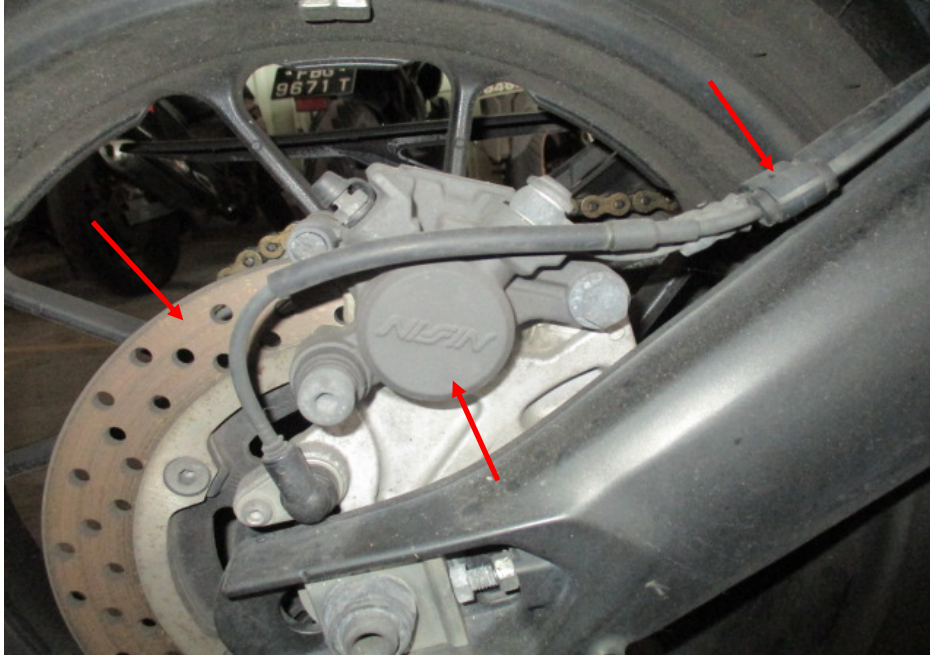
**Photo 26** shows a close up view of the rear brake caliper, rear brake disc and rear brake hose (arrowed) of the Motorcycle, which are all part of the components in the hydraulic rear brake system of the Motorcycle. Our visual checks of these various components had revealed all to be intact with no visible damage. No leakage of brake fluid was also observed.

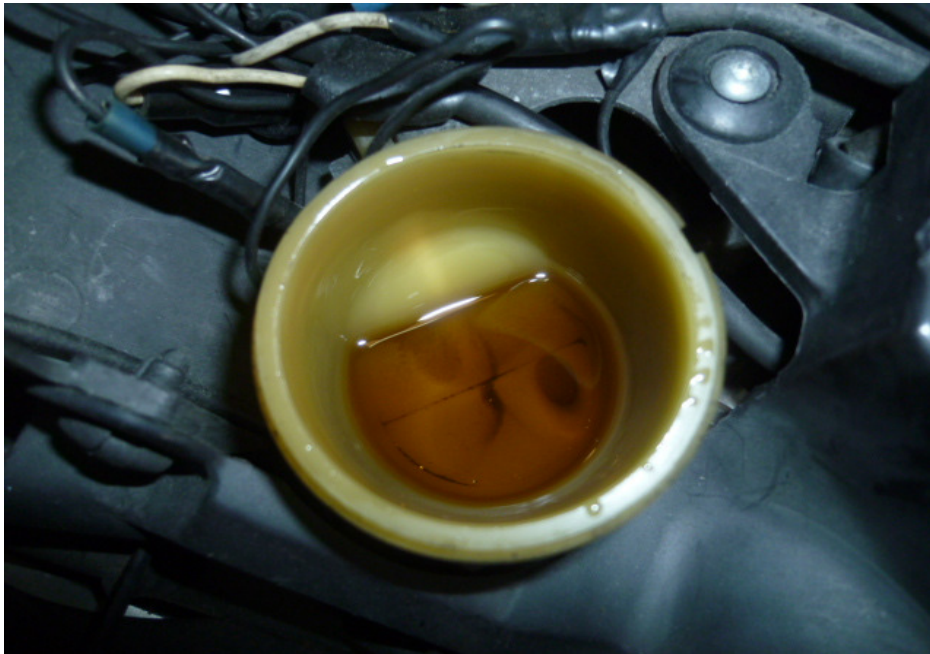
**Photo 24** shows the brake fluid reservoir for the rear brake of the Motorcycle. The brake fluid was observed to be of sufficient level for operational purposes and without contamination.
