Your Ref: TP/IP/26557/2021
Our Ref : CI/TPD21008010/N

Fatal Accident Investigation Team

**INSPECTION REPORT OF BICYCLE (BLACK) - TRAFFIC POLICE POUND
REPORT NO. 1873/21**

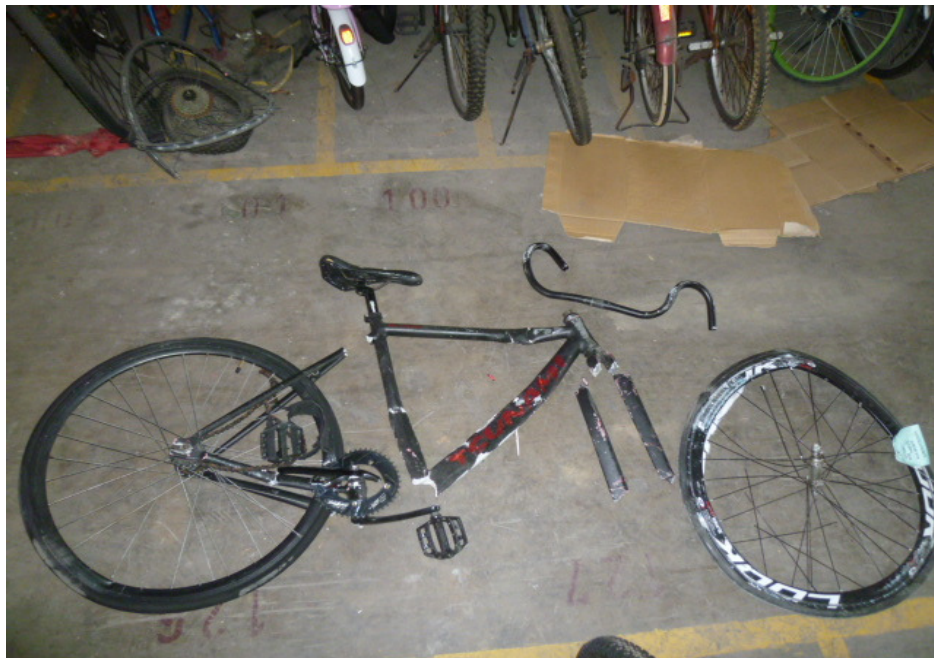
Photo 2 shows the right body of the Bicycle at the time of our inspection. The Bicycle had sustained damages all around. The body parts that were found to have been damaged include its front fork assembly, handlebar, frame, seat and pedals, amongst others as a result of the accident.

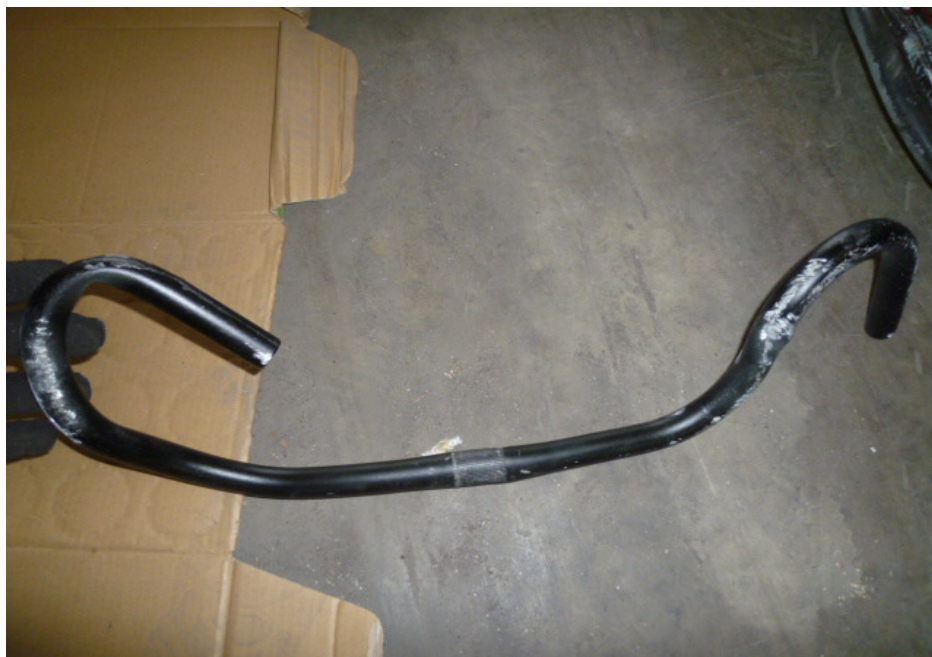
Photo 3 shows the deformed handlebar of the Bicycle at the time of our inspection.

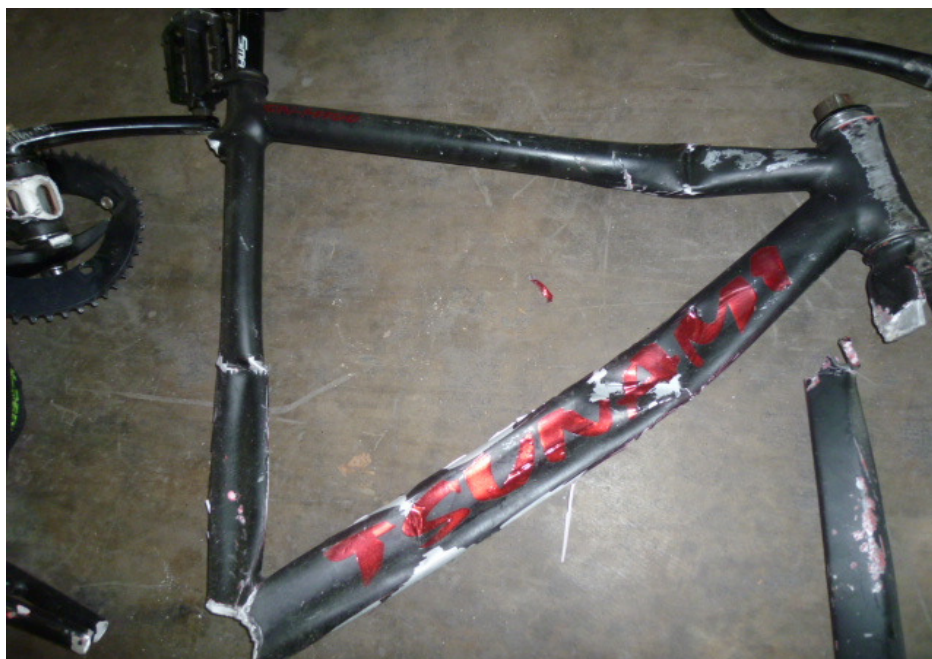
Photo 4 shows the bent frame of the Bicycle as a result of the accident.

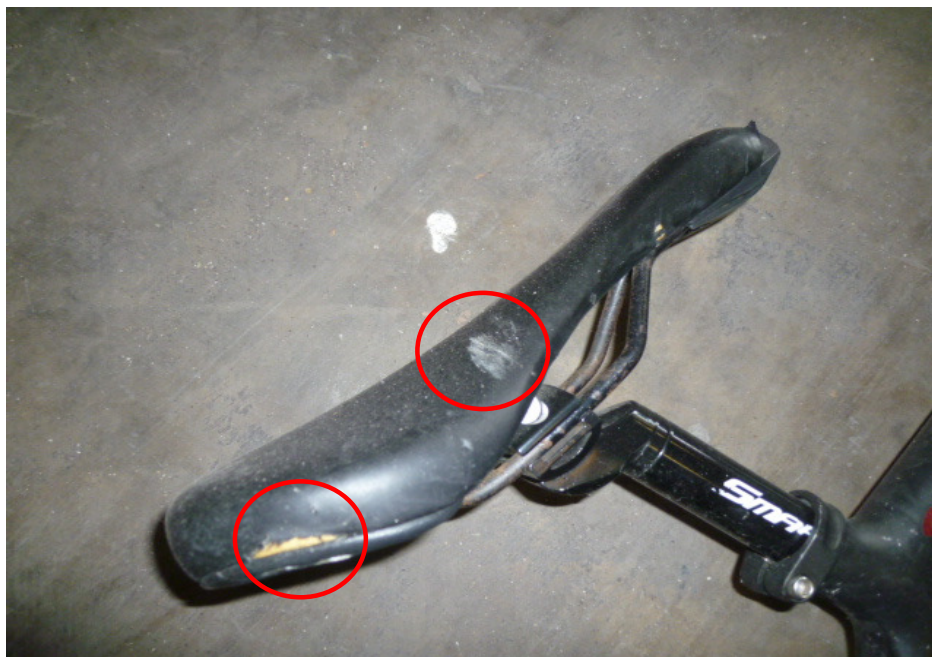
Photo 5 shows a close-up view of the torn seat of the Bicycle due to the accident.

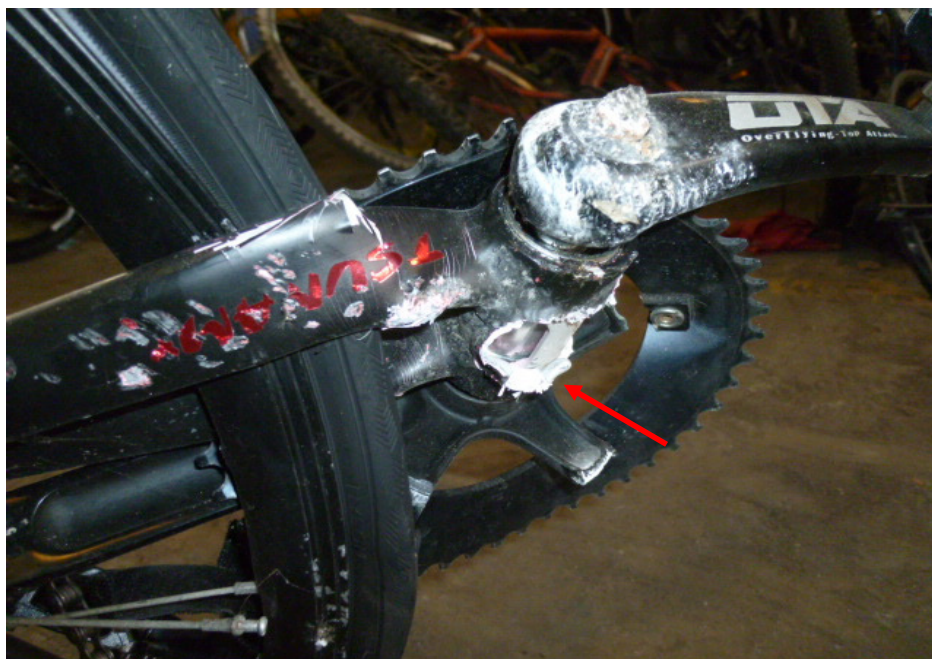
Photo 6 shows the broken left pedal of the Bicycle as a result of the accident (arrowed).

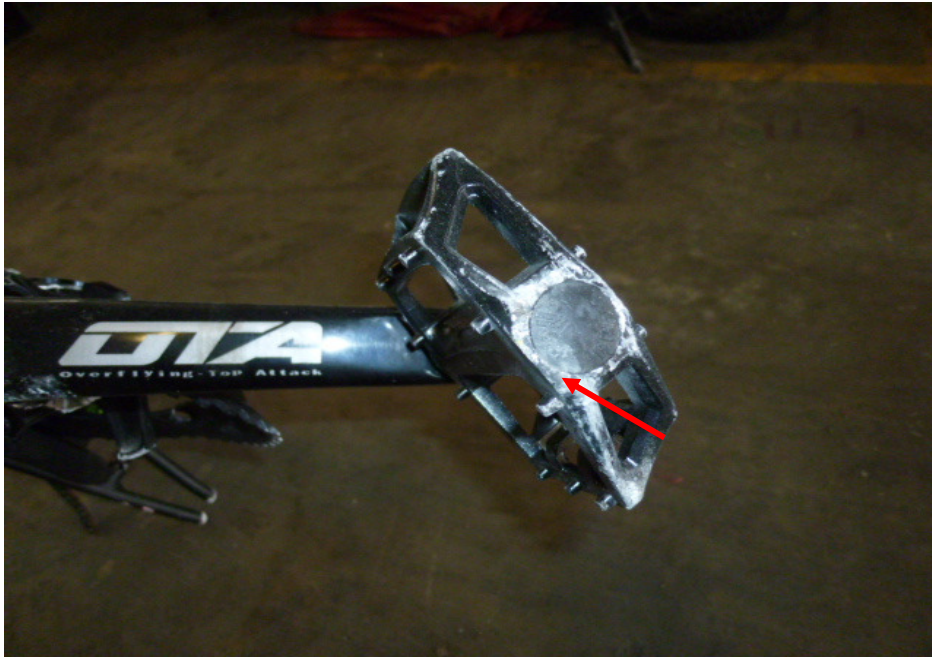
Photo 7 shows the broken left pedal of the Bicycle as a result of the accident (arrowed).

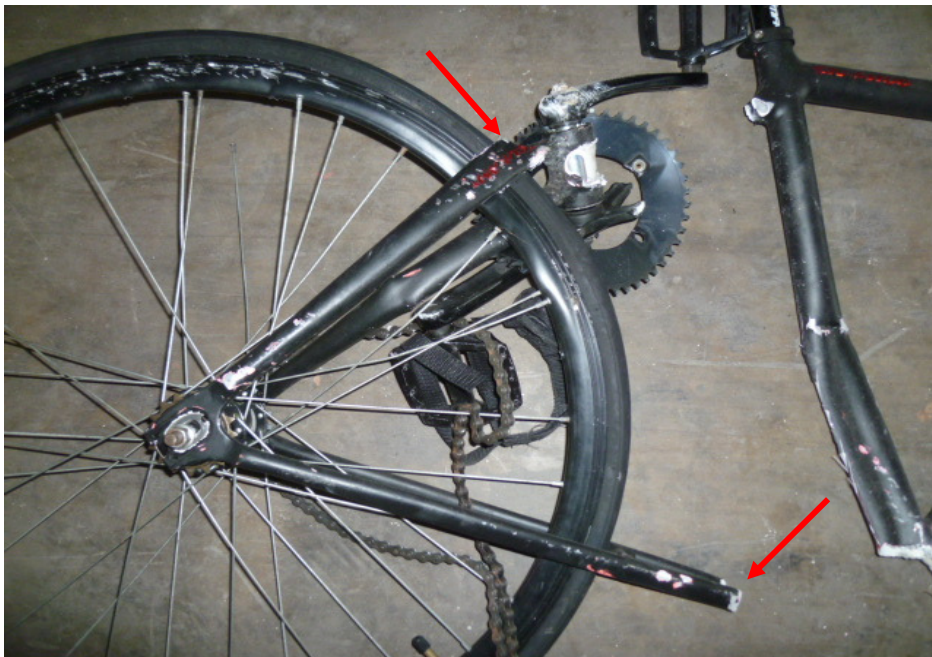
Photo 8 shows the dislodged rear frame of the Bicycle as a result of the accident (arrowed).

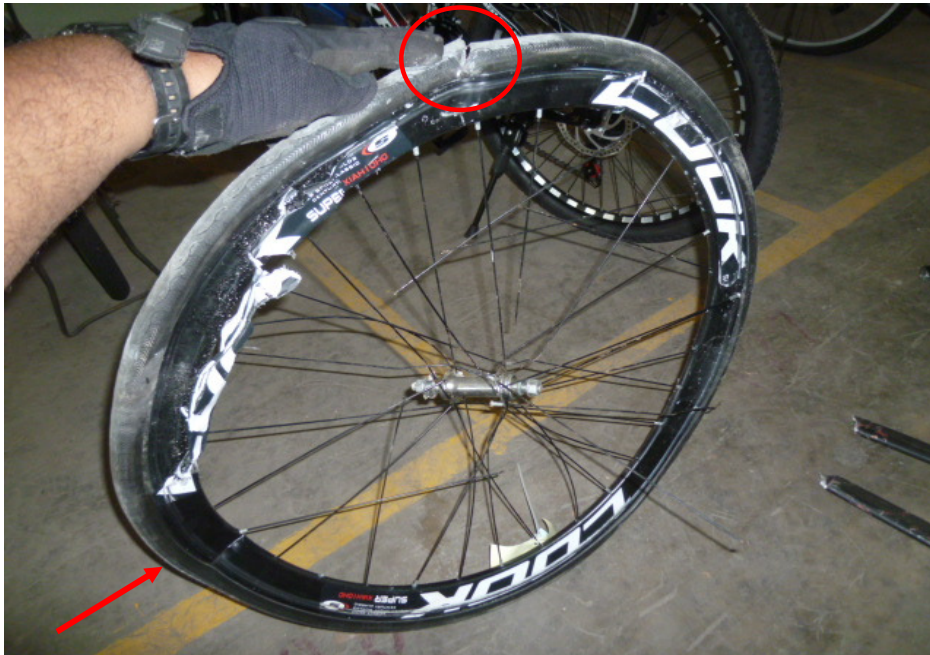
6. Both tyres were wrapped around alloy spoke wheel rims. At the time of our inspection, we observed that the front wheel rim was dislodged as a result of the accident. We also found both wheel rims were bent and the spokes on both wheel rims were bent as a result of the accident. See photos 9 - 12 below.

Photo 9 shows the bent front wheel rim and deflated front tyre of the Bicycle most likely as a result of the accident (arrowed). The pattern of the tread was clearly visible. However we also observed a cut/tear on the front tyre (circled).

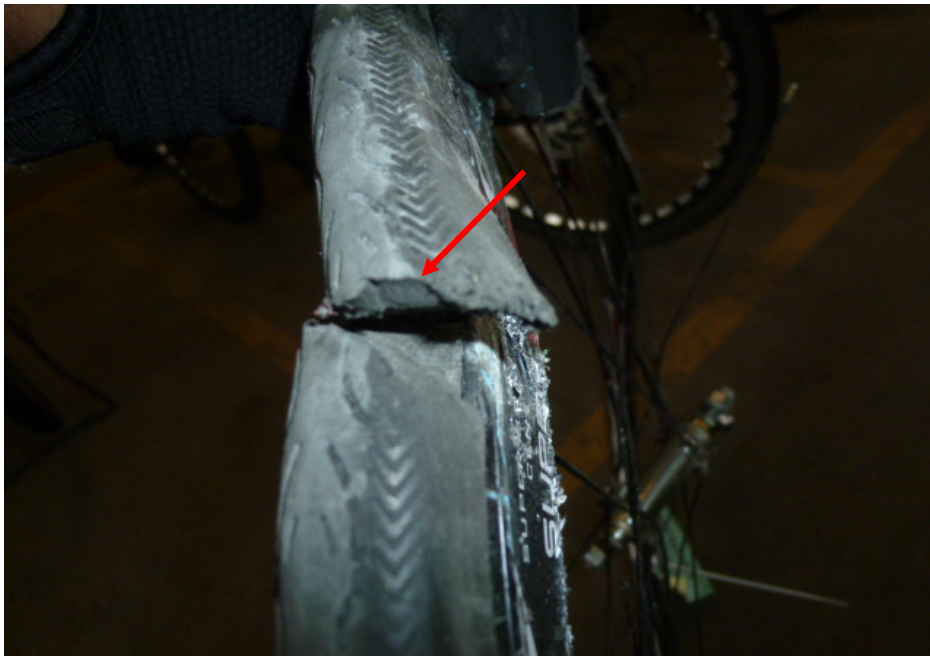
Photo 10 shows a close up view of the cut/tear on the front tyre of the Bicycle most likely as a result of the accident (arrowed).

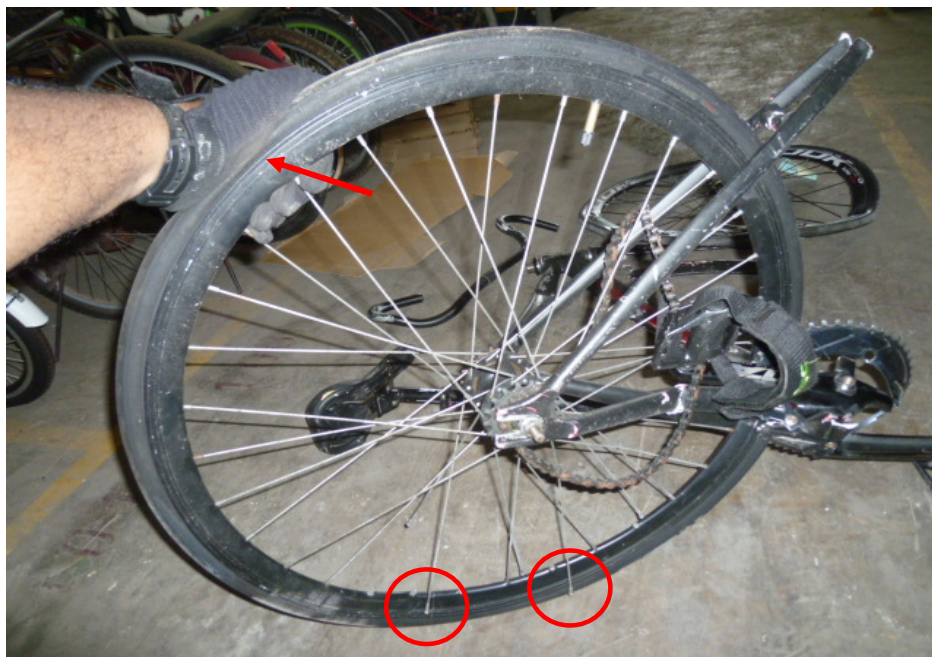
Photo 11 shows the bent rear wheel rim (circled) and deflated rear tyre of the Bicycle most likely as a result of the accident (arrowed). The pattern of the tread was clearly visible.

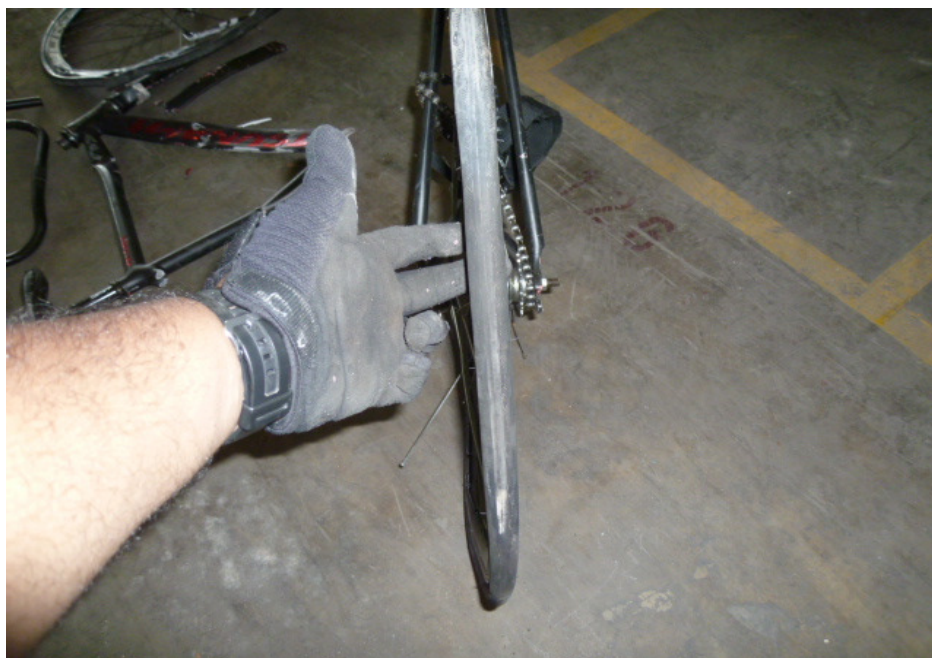
Photo 12 shows the deflated rear tyre of the Bicycle. The pattern of the tread was clearly visible. There was no tear, burst mark(s) and/or punctured hole(s) on the sidewalls as well as across the tread of the rear tyre.

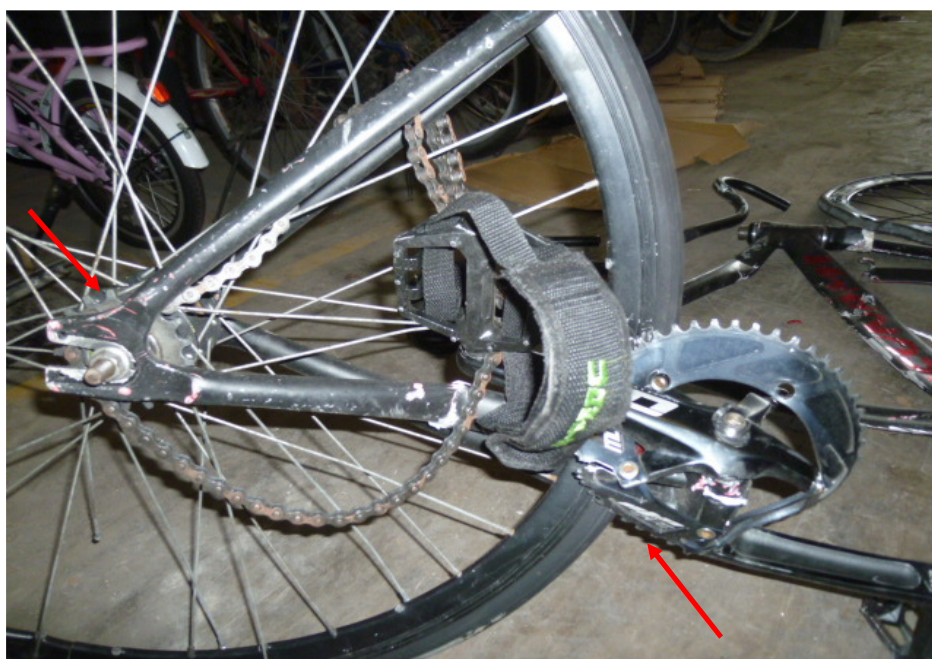
7. The gear train of the Bicycle was found to be severely damaged as a result of the accident. No free play tension test can be conducted due to the extensive damages. See photos 13 & 14 below.

Photo 13 shows the general view of the gear train of the Bicycle, which was observed to have sustained severe damages as a result of the accident. (arrowed).

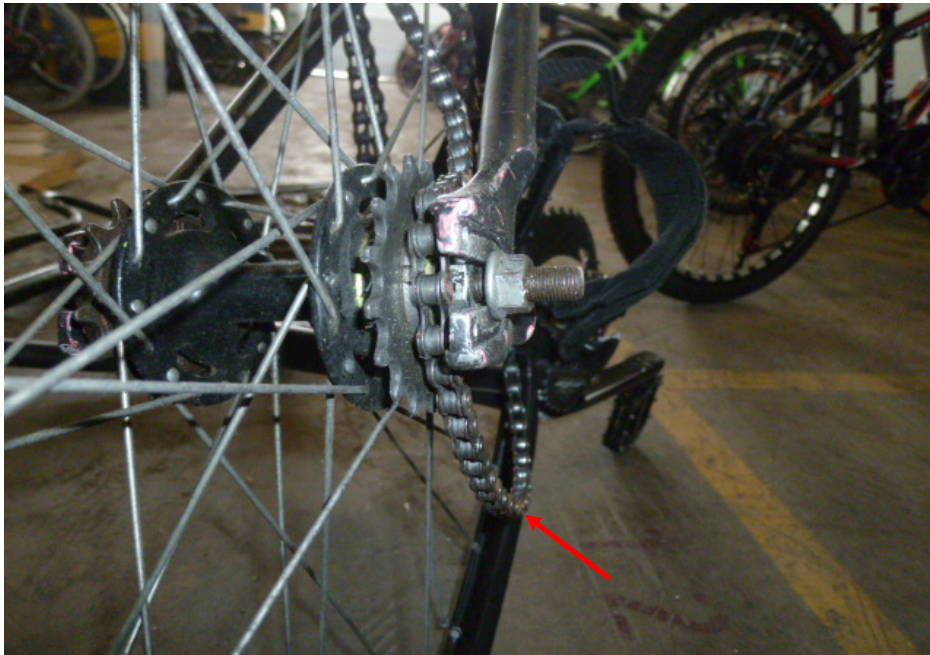
Photo 14 shows a close up view of the gear train of the Bicycle, which was observed to have sustained severe damages as a result of the accident (arrowed). No free play tension test can be conducted due to the extensive damages.

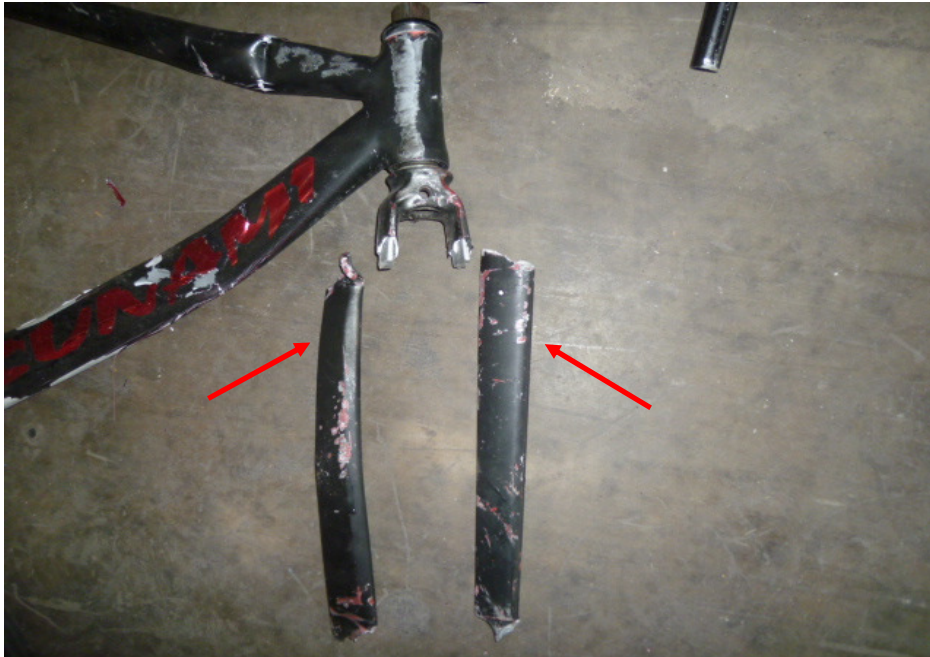
8. For this case, we were not able to conduct any test(s) on the steering system of the Bicycle due to the damages on its front fork. The front fork assembly was found to be broken and dislodged as a result of the accident, hence causing the whole steering system to be out of alignment and rendering the Bicycle immobile for any static or operational tests.
9. The Bicycle was found not to be fitted with a braking system. Hence we were unable to conduct any static or operational tests of the braking system. See photos 15 - 16 below.

Photo 15 shows the front fork assembly (arrowed) of the Bicycle. The front forks and fork bracket of the Bicycle were both found to be broken and dislodged as a result of the accident, hence causing the whole steering system to be out of alignment and rendering the Bicycle immobile for any static or operational tests.

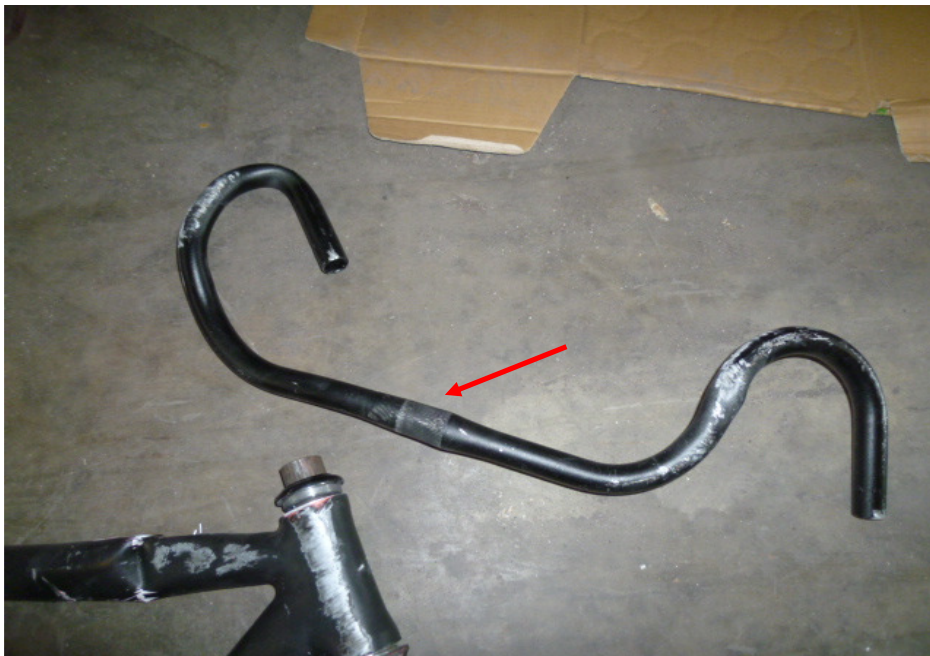
Photo 16 shows the dislodged handlebar (arrowed) of the Bicycle. The Bicycle was found not to be fitted with a braking system. Hence we were unable to conduct any static or operational tests of the braking system.
