Your Ref: TP/IP/29173/2021
Our Ref : CI/TPD21008011/N

Fatal Accident Investigation Team

**INSPECTION REPORT OF BICYCLE (ORANGE) - TRAFFIC POLICE POUND
REPORT NO. 2062/21**

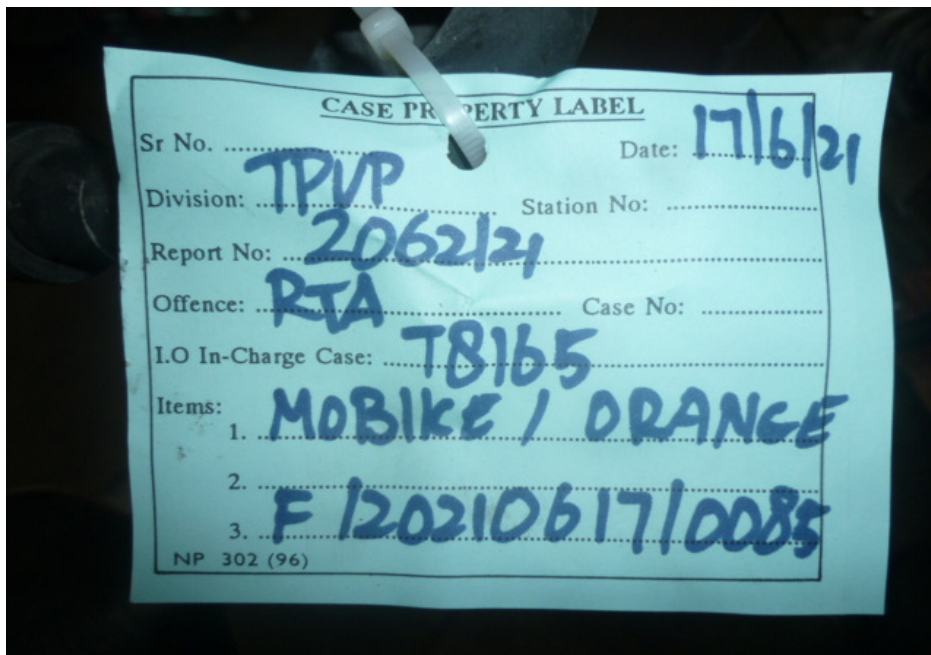
Photo 1 shows the identification of the Bicycle with reference to Traffic Police Pound Report No. 2062/21.

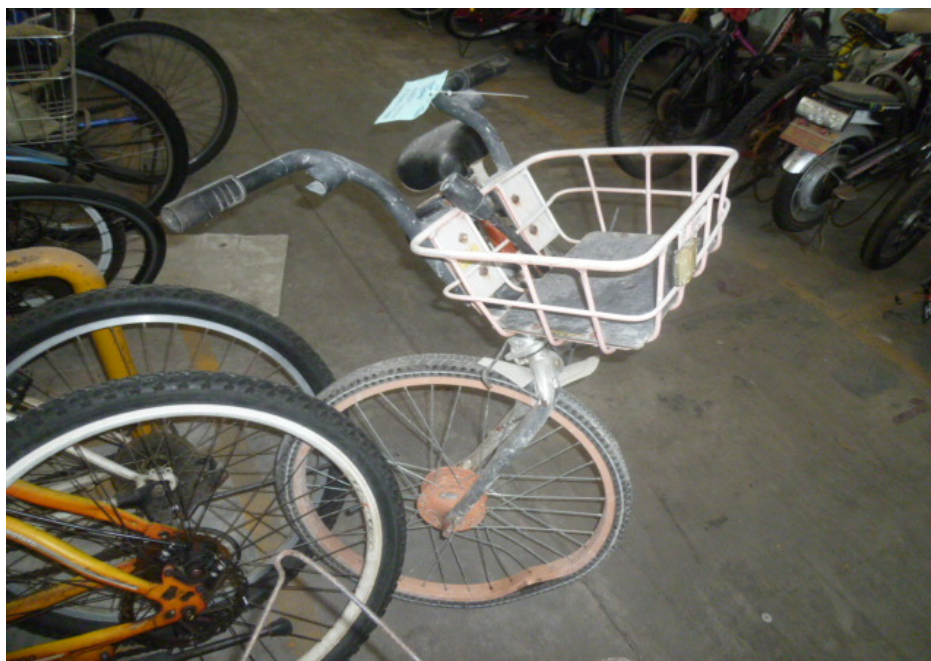
Photo 2 shows the frontal portion of the Bicycle at the time of our inspection. The Bicycle had sustained damages all around.

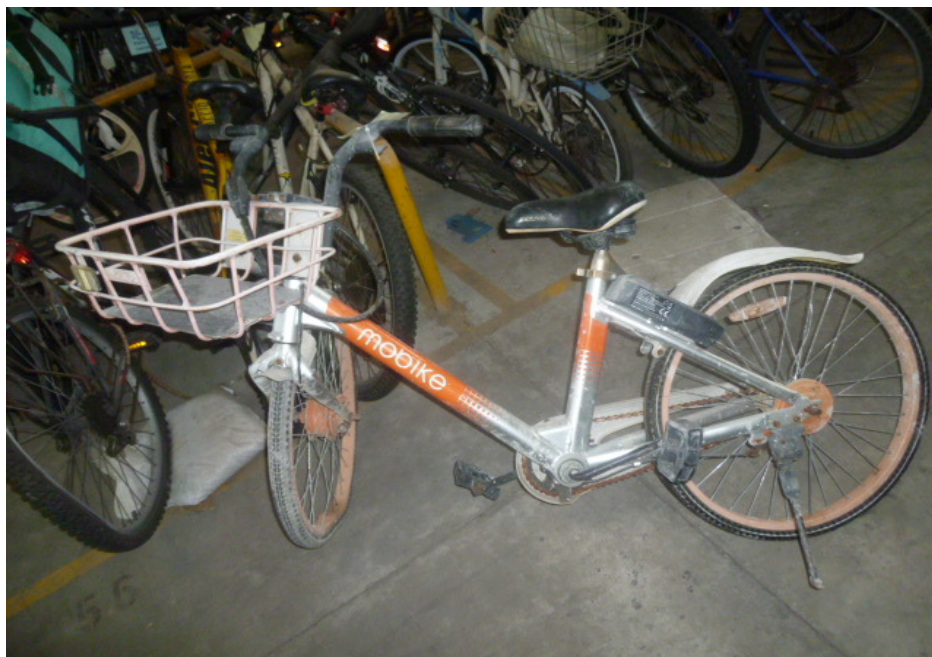
Photo 3 shows the left body of the Bicycle at the time of our inspection. The Bicycle had sustained damages all around.

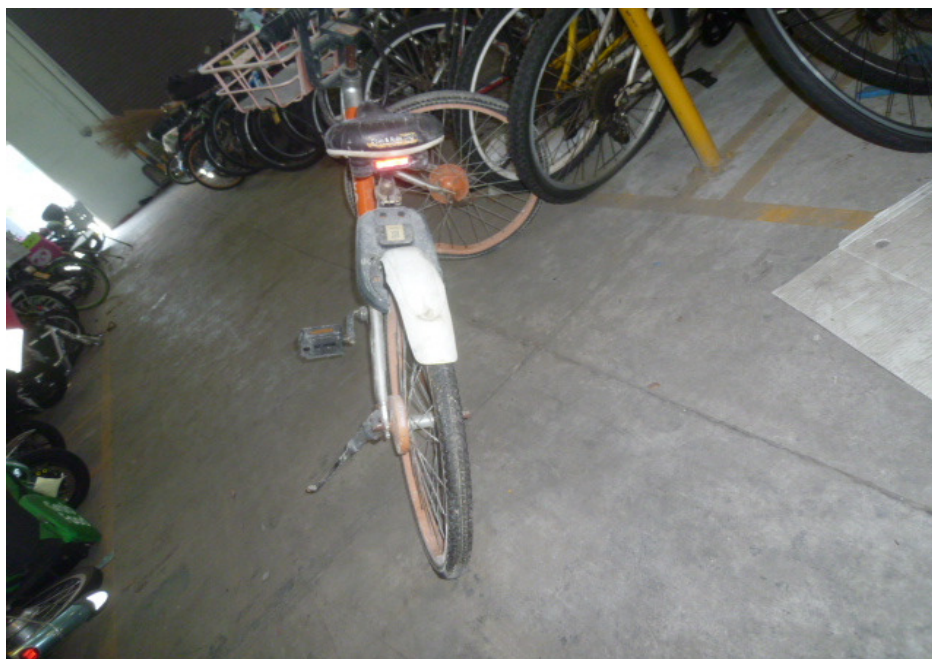
4. The Bicycle was observed to have sustained damages all around. The body parts that were found to have been damaged include its front basket, front fork assembly, front mudguard, left pedal and rear mudguard, amongst others as a result of the accident. See photos 1 – 9 below.

Photo 4 shows the rear portion of the Bicycle at the time of our inspection. The Bicycle had sustained damages all around. The body parts that were found to have been damaged include its front basket, front fork assembly, front mudguard, left pedal and rear mudguard, amongst others as a result of the accident.

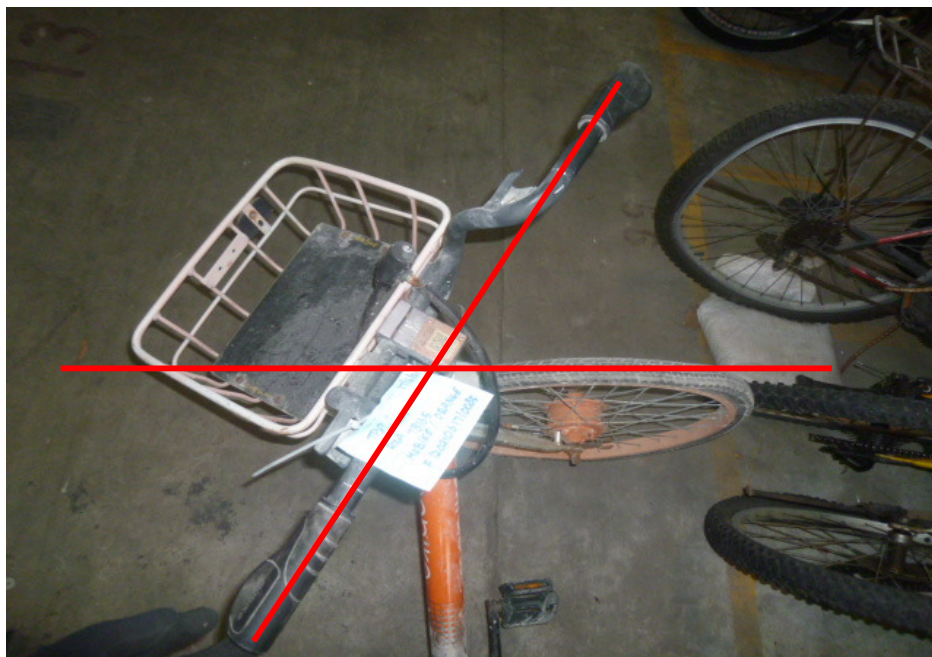
Photo 5 shows the frontal portion of the Bicycle (top view) at the time of our inspection. There was a misalignment of the handle bar & front tyre observed as a result of the accident.

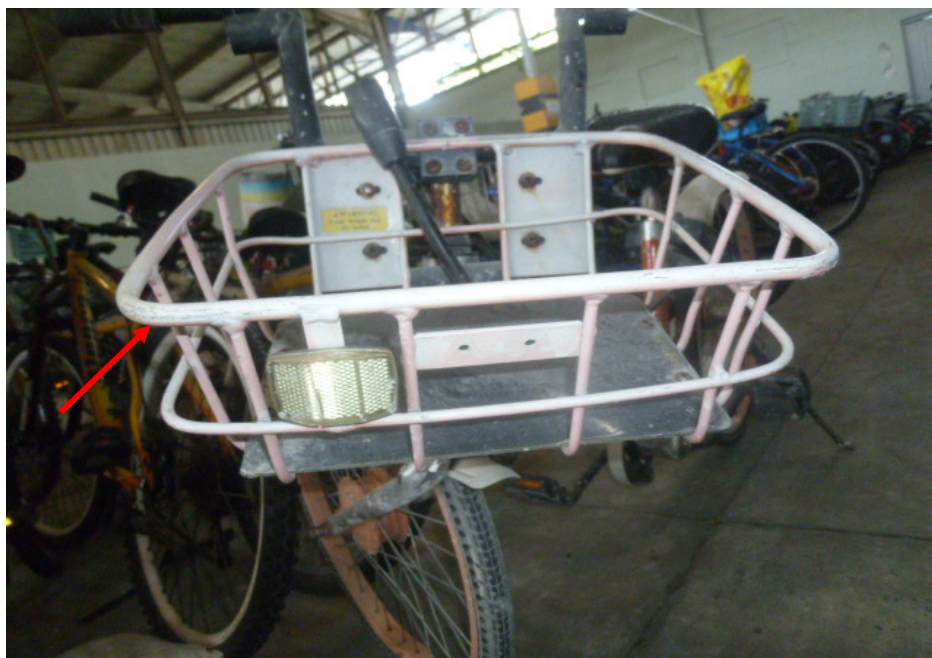
Photo 6 shows the damaged front basket (arrowed) of the Bicycle at the time of our inspection.

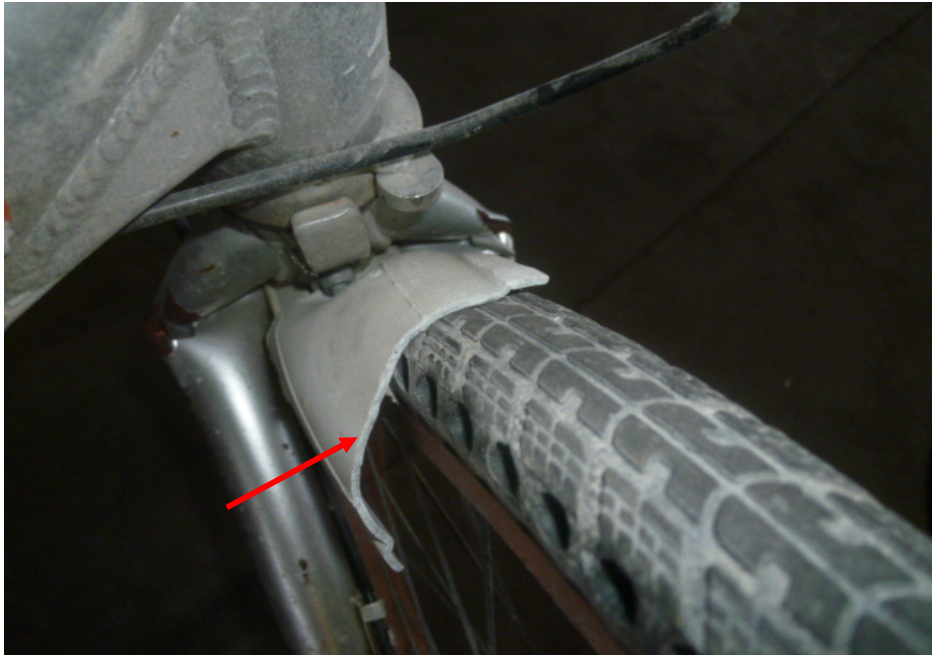
Photo 7 shows the broken front mudguard (arrowed) of the Bicycle at the time of our inspection.

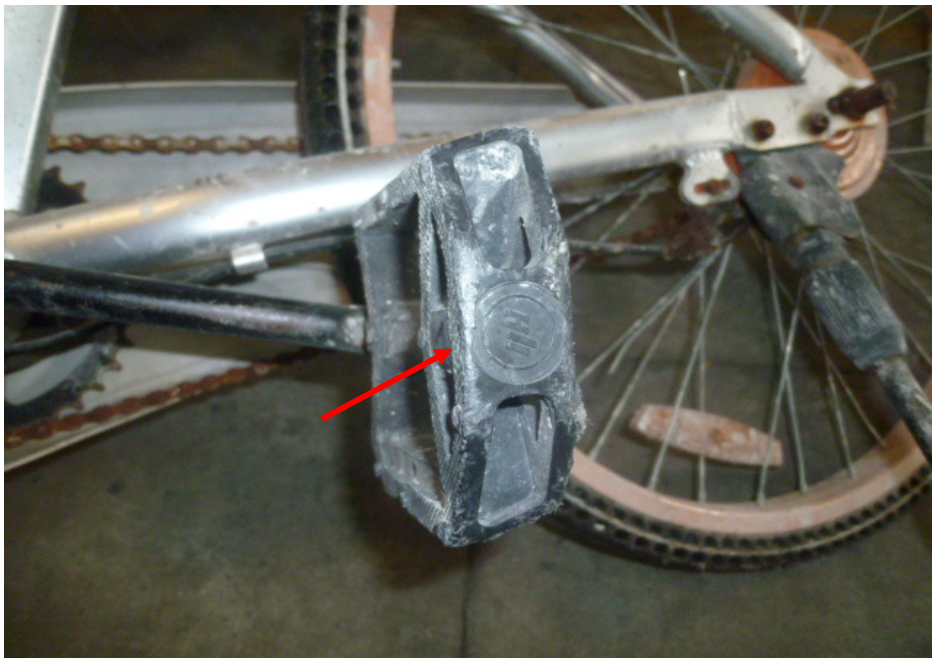
Photo 8 shows the damaged right pedal of the Bicycle (arrowed) at the time of our inspection.

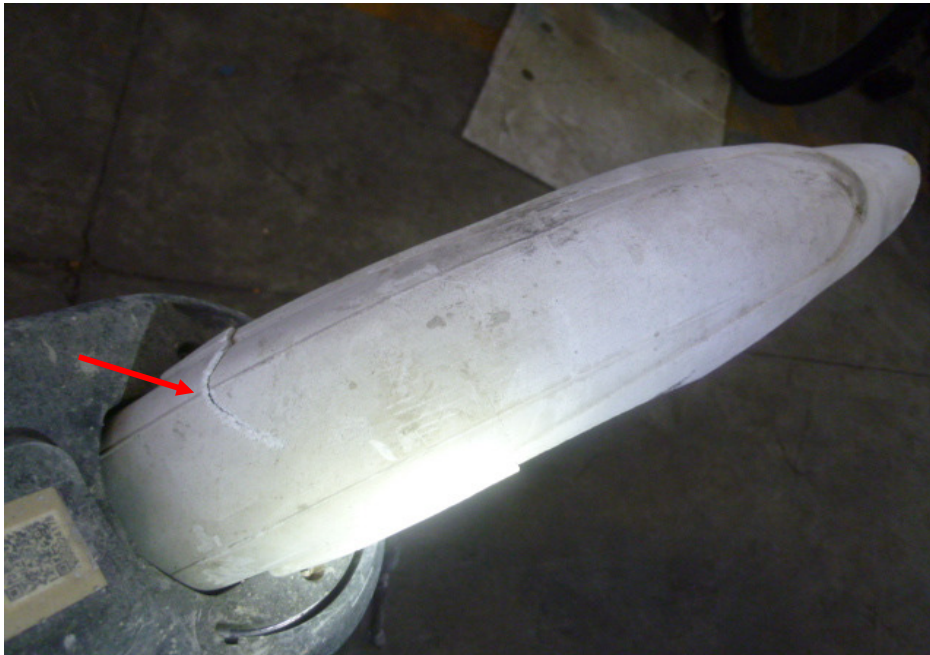
Photo 9 shows the cracked rear mudguard (arrowed) of the Bicycle at the time of our inspection.

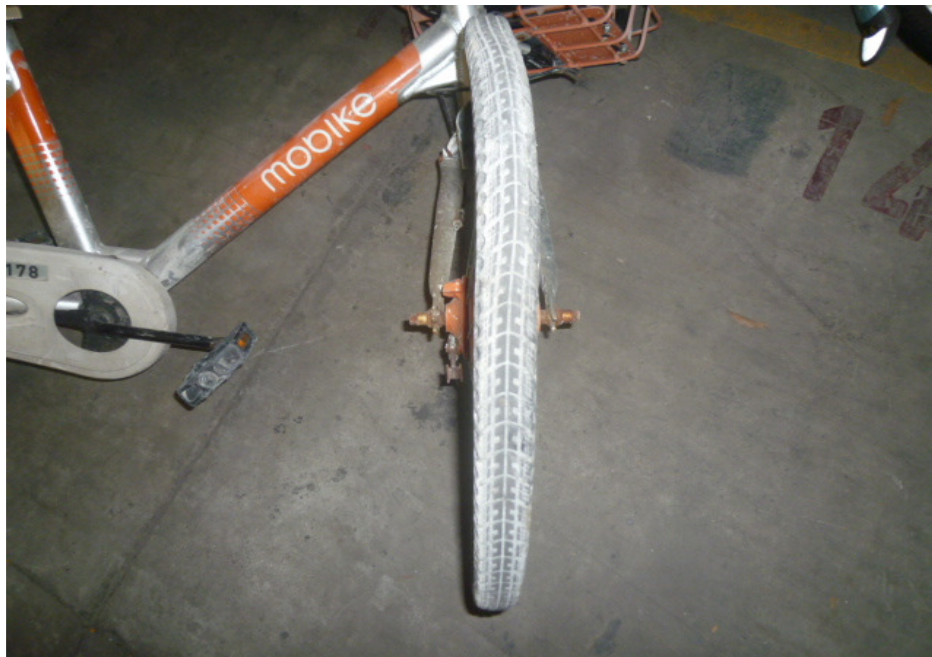
5. The condition of the Bicycle's front & rear tyres was observed to be in serviceable condition. The tread pattern of the 2 tyres was clearly visible. We did not observe any tear, burst mark(s) and/or punctured hole(s) on the sidewalls as well as across the tread of the 2 tyres. The 2 tyres were both observed to be sufficiently inflated for vehicular operation. The tyre brand, tyre size and remaining tread depth of the 2 tyres were recorded as follows:-

Photo 10 shows the front tyre of the Bicycle. The pattern of the tread was clearly visible. There was no tear, burst mark(s) and/or punctured hole(s) on the sidewalls as well as across the tread of the front tyre. The front tyre was also observed to be sufficiently inflated for vehicular operation.

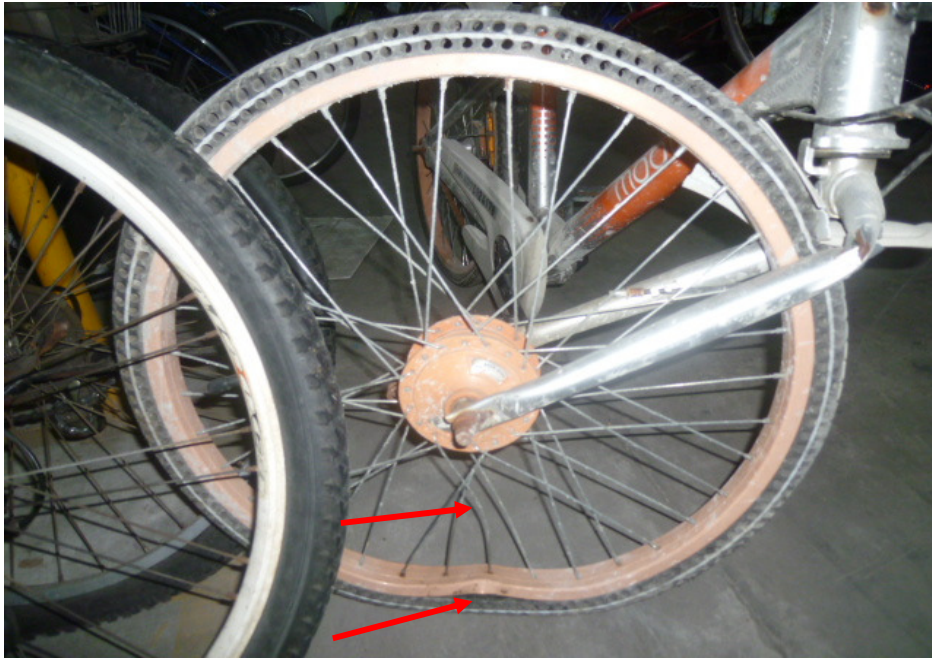
6. Both tyres were wrapped around alloy spoke wheel rims. At the time of our inspection, we did not observe any visible damage on the rear wheel rim of the Bicycle. However we did observe that the front wheel rim was bent and the spokes on the front wheel rim were bent as a result of the accident. See photos 10 - 12 below.

Photo 11 shows the bent spokes and front wheel rim of the Bicycle at the time of our inspection (arrowed).

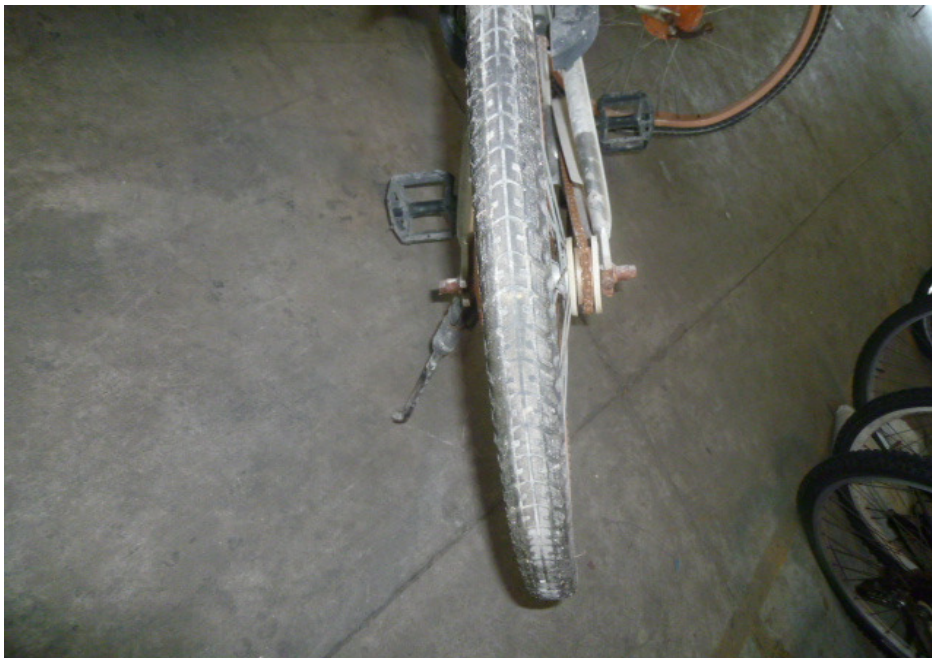
Photo 12 shows the rear tyre of the Bicycle. The pattern of the tread was clearly visible. There was no tear, burst mark(s) and/or punctured hole(s) on the sidewalls as well as across the tread of the front tyre. The rear tyre was also observed to be sufficiently inflated for vehicular operation.

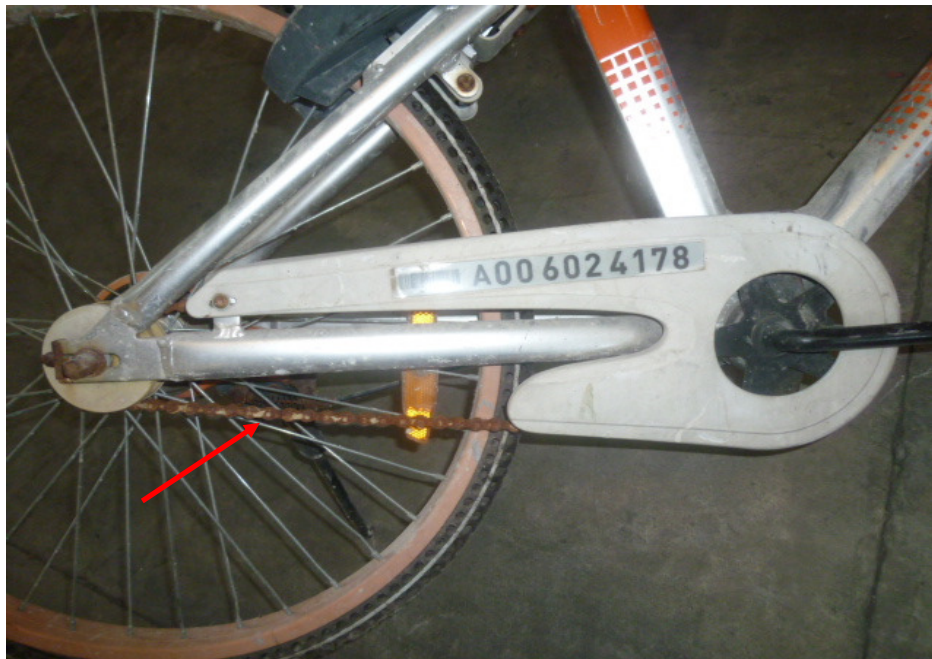
7. The gear train of the Bicycle was found to be intact without any misalignment. However it was observed not to be adequately lubricated for operating purposes. See photos 13 & 14 below.

Photo 13 shows the general view of the gear train of the Bicycle, which was observed to be intact with no misalignment. However it was observed not to be adequately lubricated for operating purposes (arrowed).

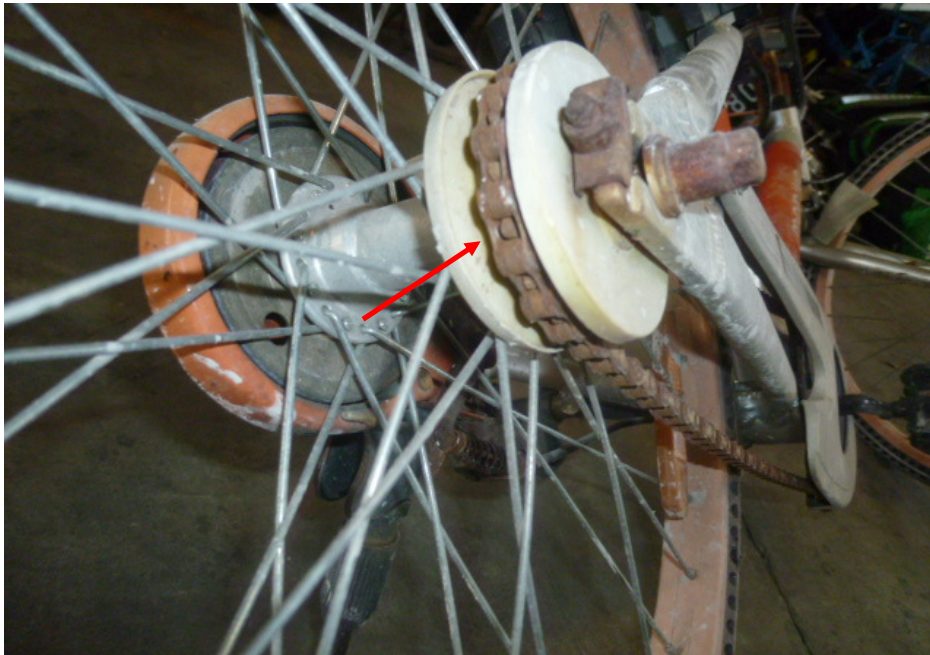
Photo 14 shows a closer view of the gear train (arrowed) of the Bicycle, which was observed to be intact with no misalignment. However it was observed not to be adequately lubricated for operating purposes.

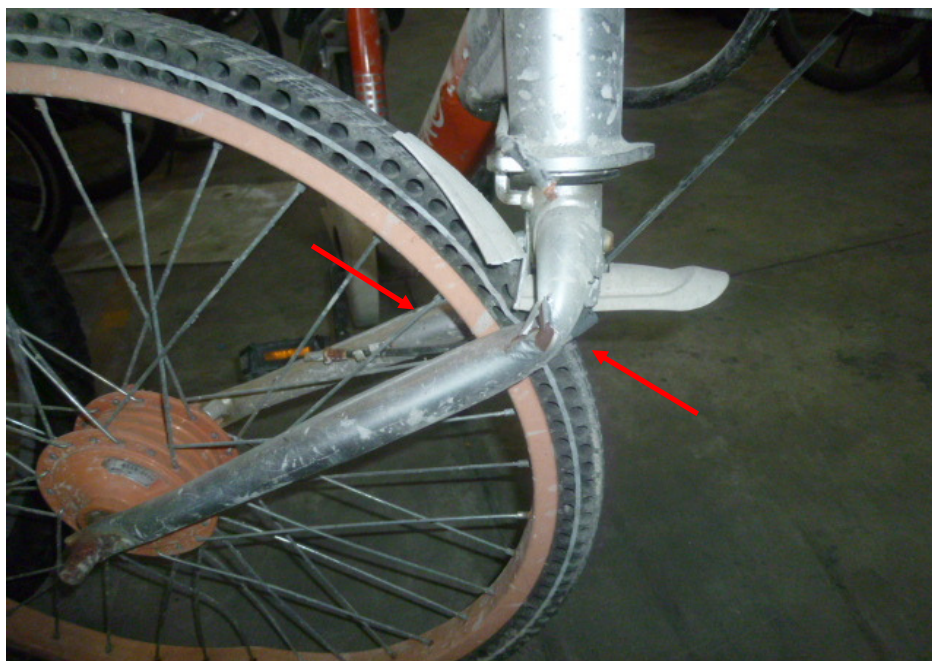
8. For this case, we were not able to conduct any test(s) on the steering system of the Bicycle due to the damages on its front fork. The front fork assembly was found to be bent as a result of the accident, hence causing the whole steering system to be out of alignment and rendering the Bicycle immobile for any static or operational tests.

Photo 15 shows the front fork assembly (arrowed) of the Bicycle. The front forks of the Bicycle were both found to be bent as a result of the accident, hence causing the whole steering system to be out of alignment and rendering the Bicycle immobile for any static or operational tests.

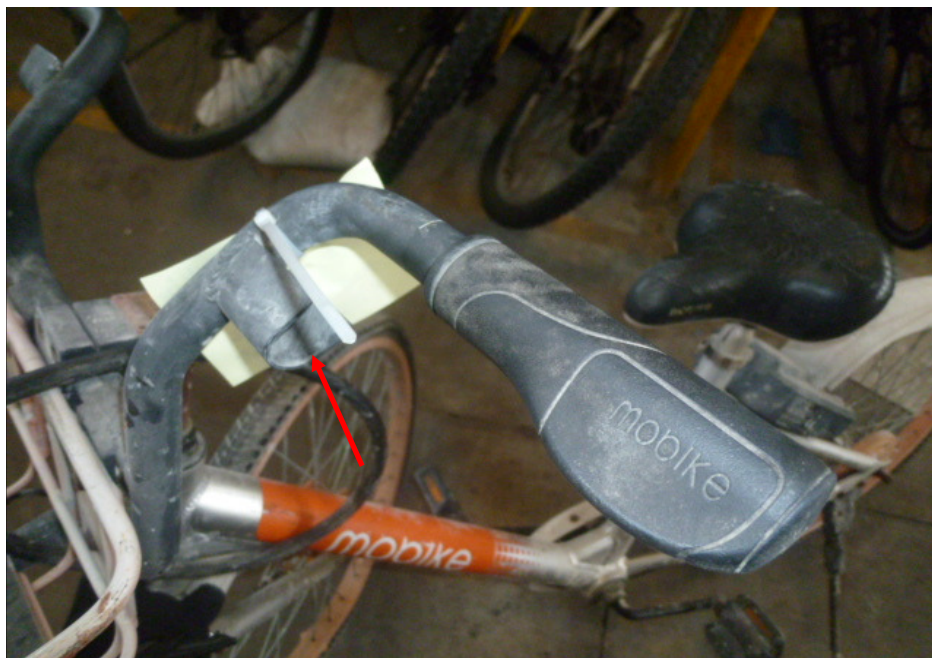
10. Upon closer inspection, we observed that there were no hand brake levers fitted onto the handlebar of the Bicycle. We also found that the brake cables for the front and rear braking system of the Bicycle were cut. Hence we were unable to conduct any static or operational tests on the braking system. See photos 15 - 20 below.

Photo 16 shows the left handlebar of the Bicycle. Upon closer inspection, we observed that there was no hand brake lever fitted on the left handlebar of the Bicycle (arrowed).

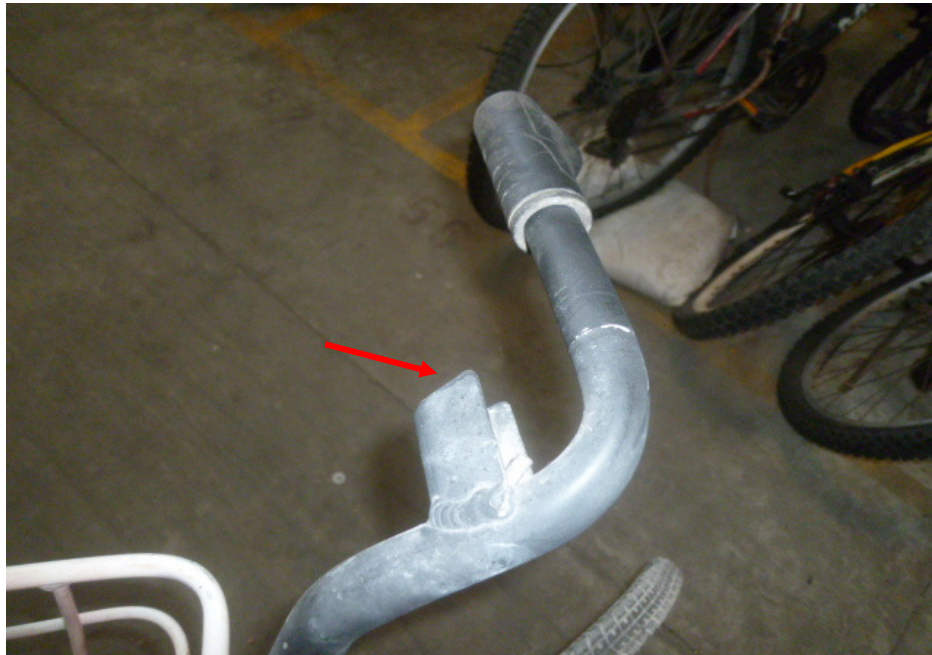
Photo 17 shows the right handlebar of the Bicycle. Upon closer inspection, we observed that there was no hand brake lever fitted on the right handlebar of the Bicycle (arrowed).

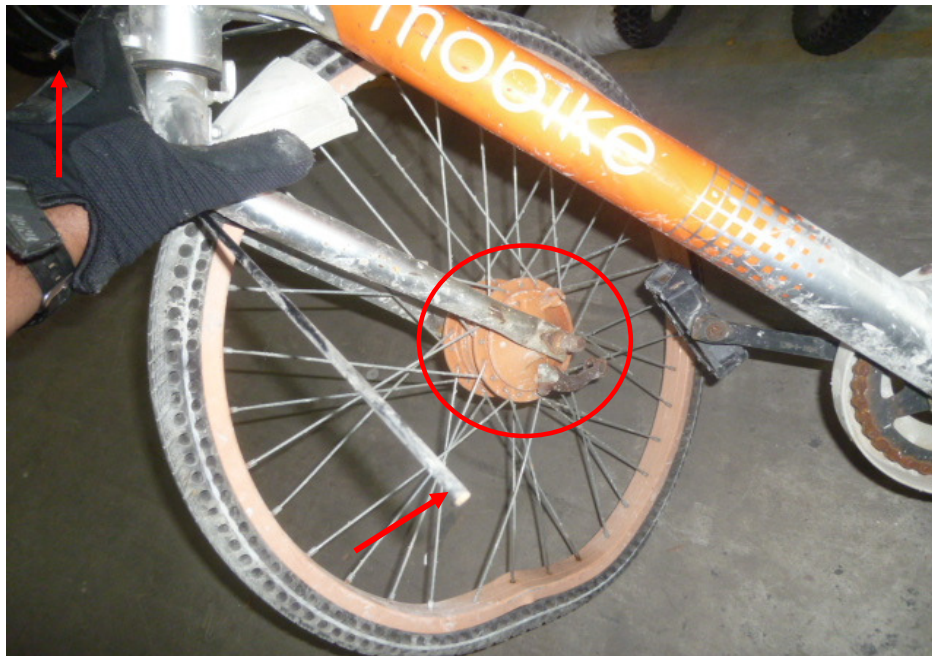
Photo 18 shows the front wheel of the Bicycle. The type of brake system for the front wheel was of a mechanical type, controlled by the left hand lever of the Bicycle. Our checks on the spring and drum (circled), which are all part of the components in the front brake system of the Bicycle reveal all to be intact and without damage. However we also found that the brake cables for the front and rear braking system of the Bicycle were cut (arrowed).

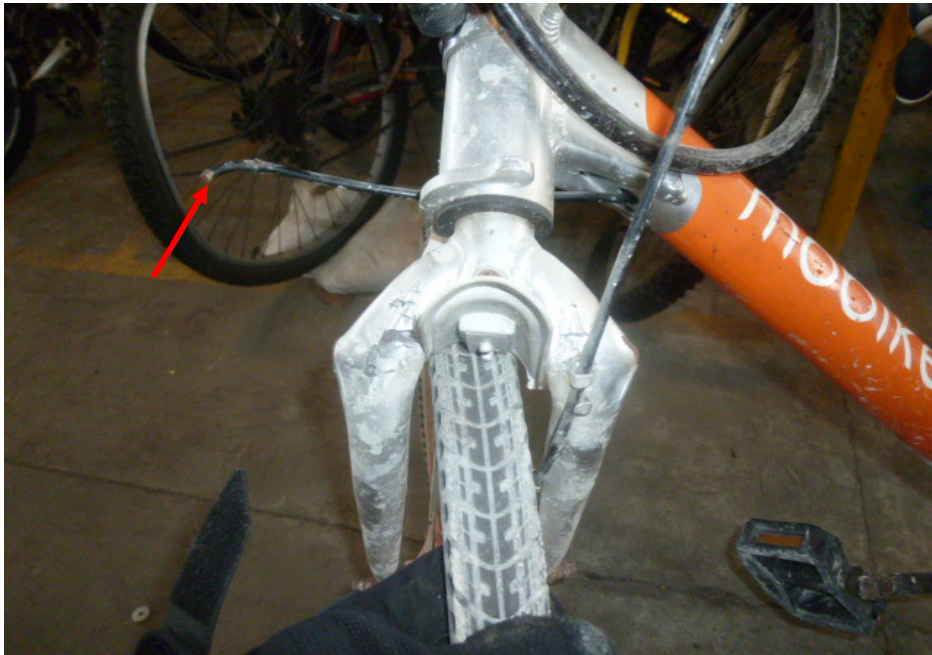
Photo 19 shows a closer view of the brake cable for the rear braking system of the Bicycle which was observed to be cut (arrowed).

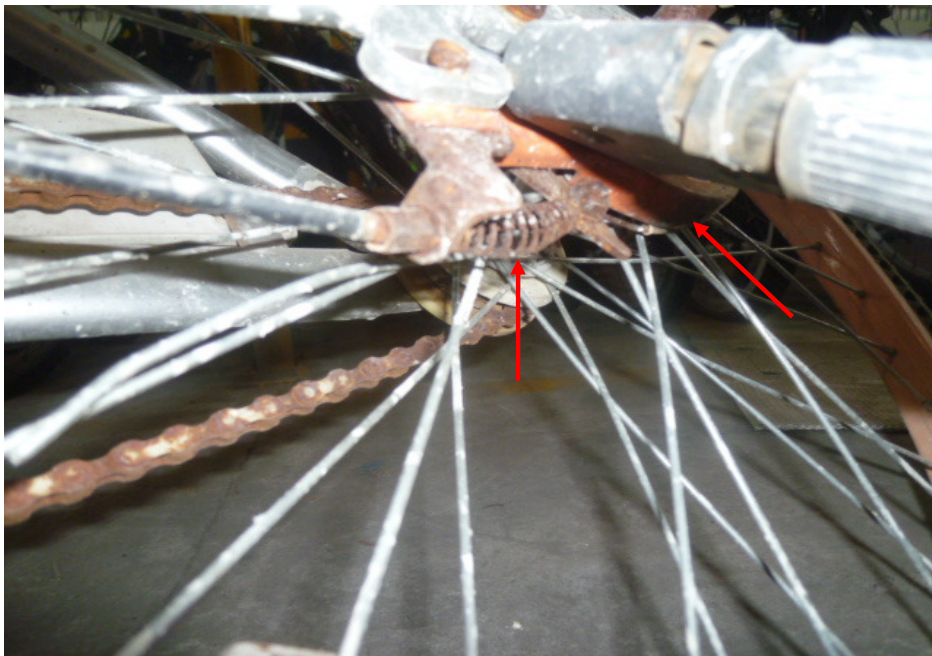
Photo 20 shows the rear wheel of the Bicycle. The type of brake system for the rear wheel was of a mechanical type, controlled by the right hand lever of the Bicycle. Our checks on the spring and drum (circled), which are all part of the components in the rear brake system of the Bicycle reveal all to be intact and without damage (arrowed).
