Your Ref : SNM21D204166/C02/TANCHC
Our Ref : CS/CTI21008037/P

M/s CHINA TAIPING INSURANCE (S) PTE LTD.

**AUTOMOBILE TECHNICAL INVESTIGATION REPORT OF ACCIDENT
INVOLVING GBD 3327T AND SLQ 8417Y ON 24 JULY 2021**

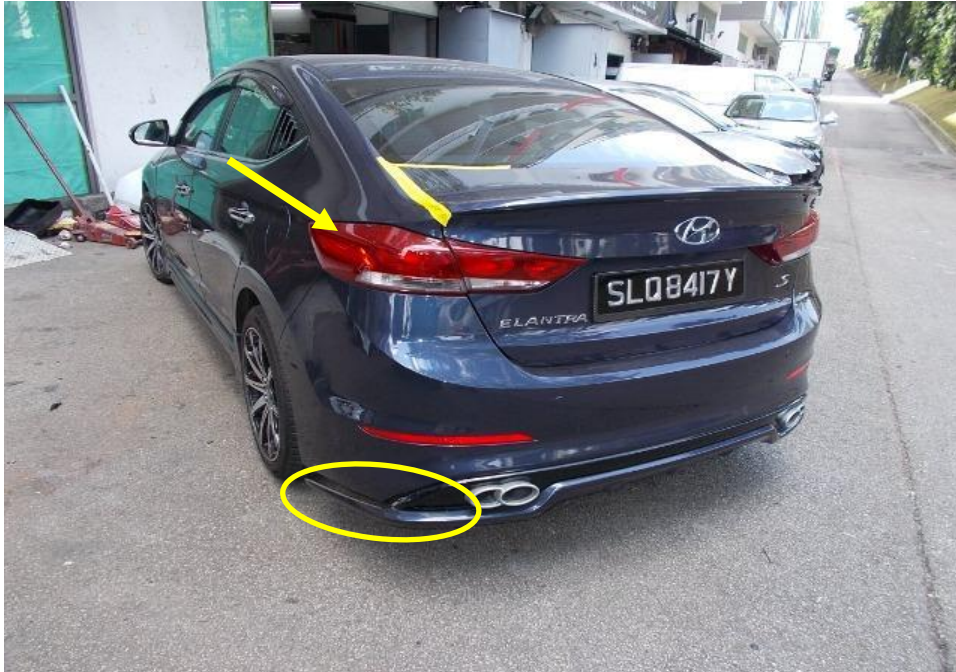
10. Examination of these photographs showed the rear bumper skirting had been damaged and dislodged from the Car. Further observed were rear left brake lamp both were observed misaligned from the rear portion of Car See photos 1 – 5 below.

Photo 1 shows the general view of the rear portion of Car at the time of inspection. The rear bumper skirting (yellow circle) had been damaged and dislodged. Also the rear left brake lamp (arrowed) was found to be misaligned.

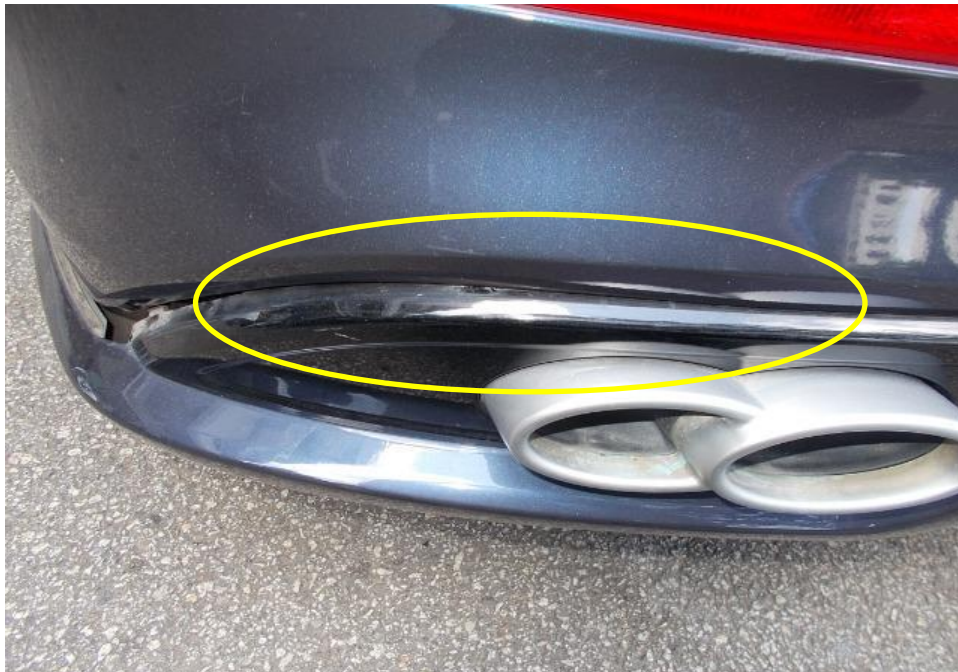
Photo 2 shows the close up view of the rear left portion of Car at the time of inspection. The rear bumper skirting had been damaged. It was also noted that it was dislodged (circled) from the rear bumper of Car.

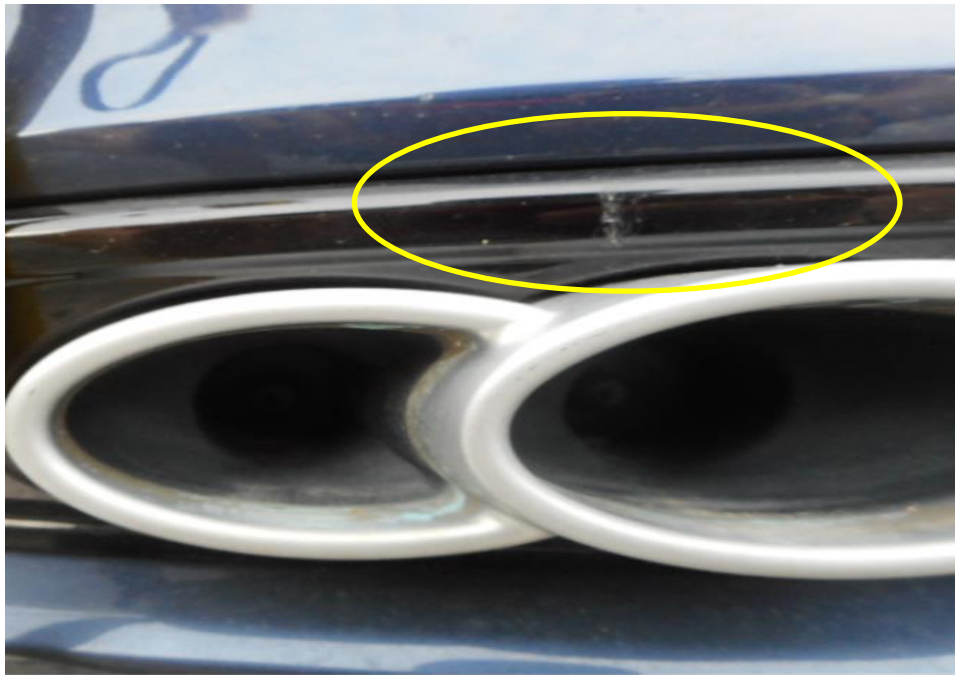
Photo 3 shows the close up view of the rear left portion of Car at the time of inspection. The rear bumper skirting had been damaged. It was also noted that it was dislodged (circled) from the rear bumper of Car.

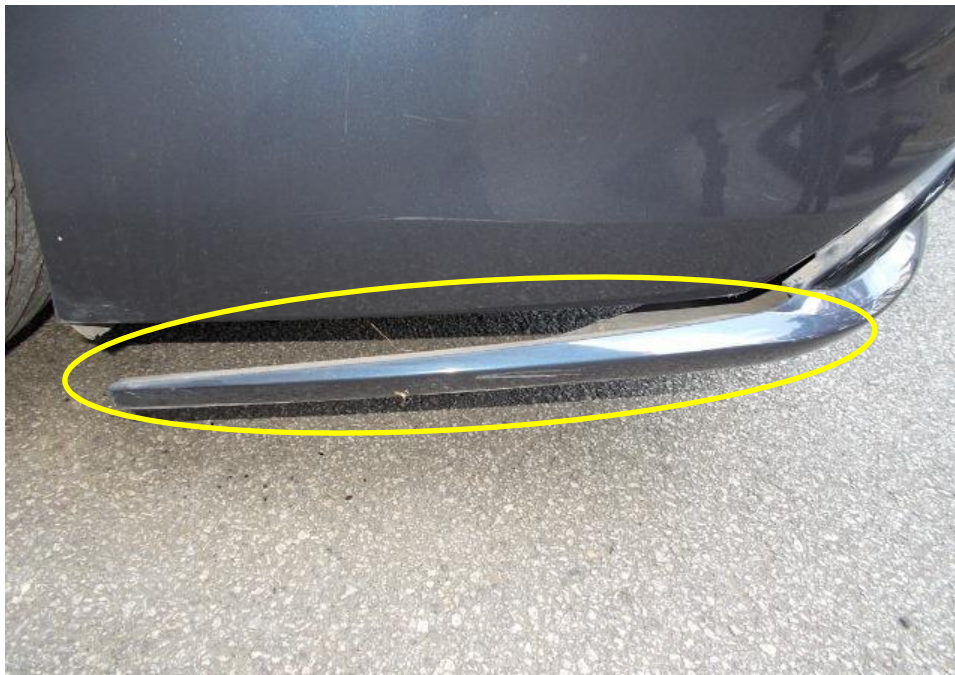
Photo 4 shows the close up view of the rear left portion of Car at the time of inspection. The rear bumper skirting had been damaged. It was also noted that it was dislodged (circled) from the rear bumper of Car.

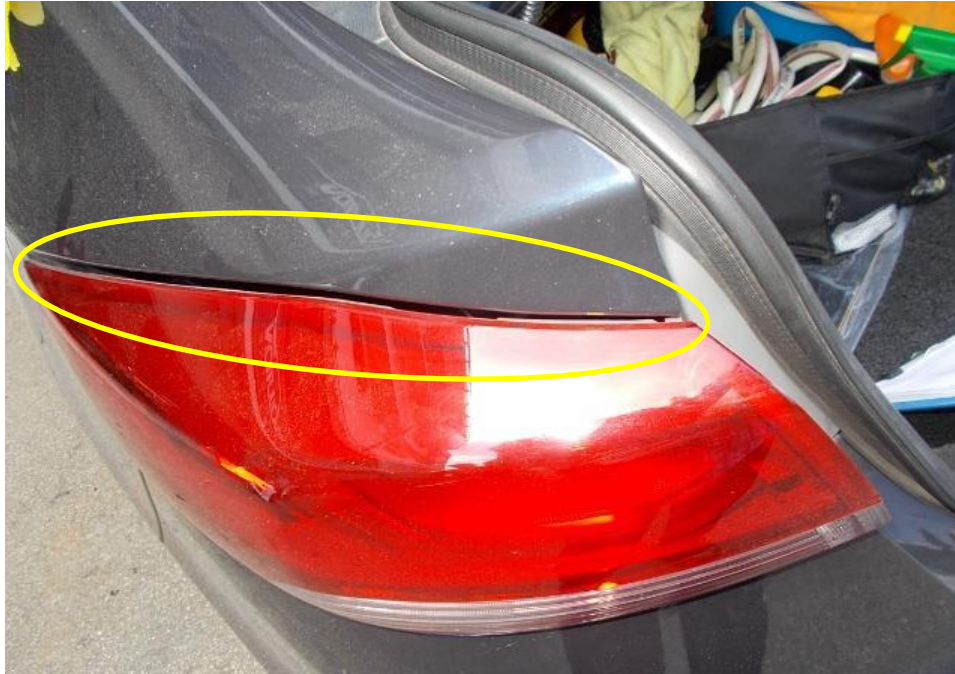
Photo 5 shows the close up view of the rear portion of Car at the time of inspection. The rear left brake lamp was observed to be misaligned (circled).

- d) For the other damages found on the front body panel, front emblem and grille sustained by the Lorry, the impact would have been quite heavy. However, the misalignments found on the rear left brake lamp of the Car, they were minor as compared to the ones on the Lorry. These damages observed on the rear portion of Car was not a result of this contact and does not correspond to the damage observed on the front portion of the Lorry.

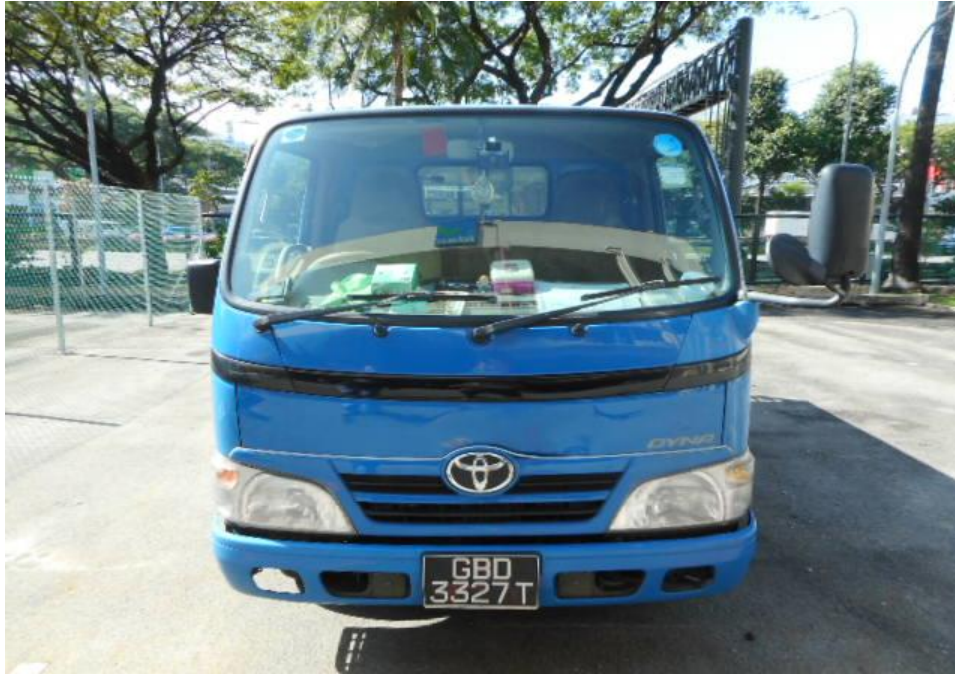
Photo 6 shows the general view of the front portion of Lorry at the time of our inspection.

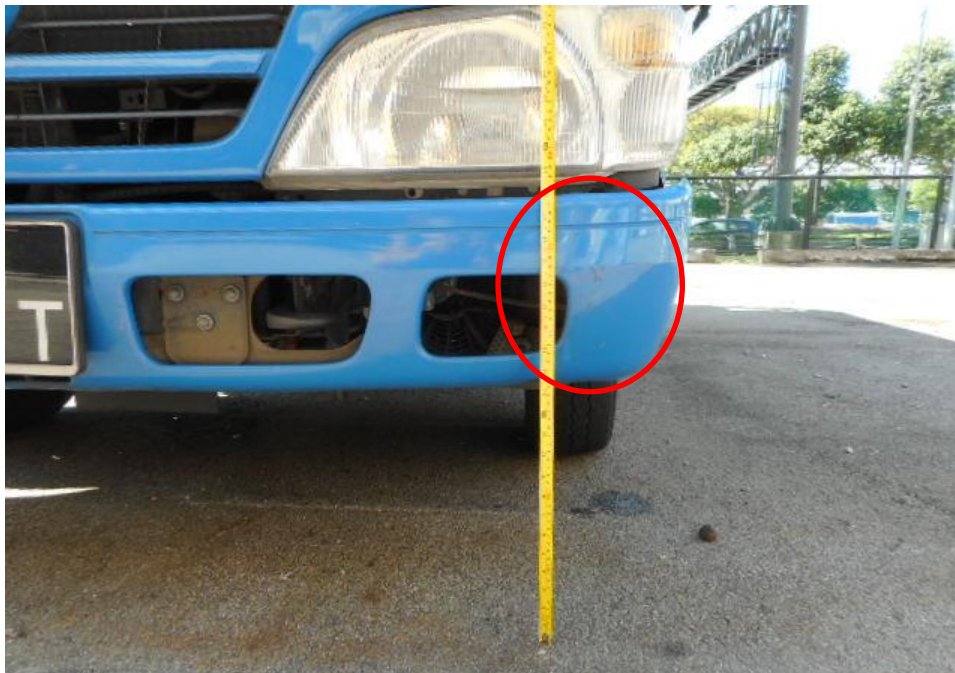
Photo 7 shows a close up view of the Lorry front left bumper portion. There were damages observed on the front bumper there when bent mark and scratch marks (circled).

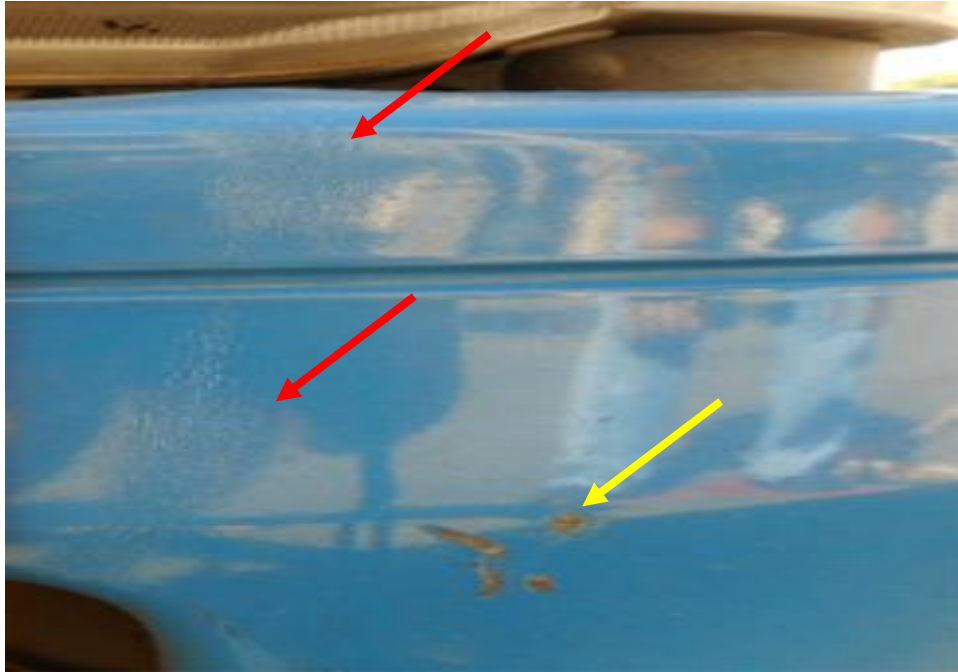
Photo 8 shows a close up view of the Lorry front left bumper portion. We observed bent (red arrow) and scratched marks (yellow arrow).

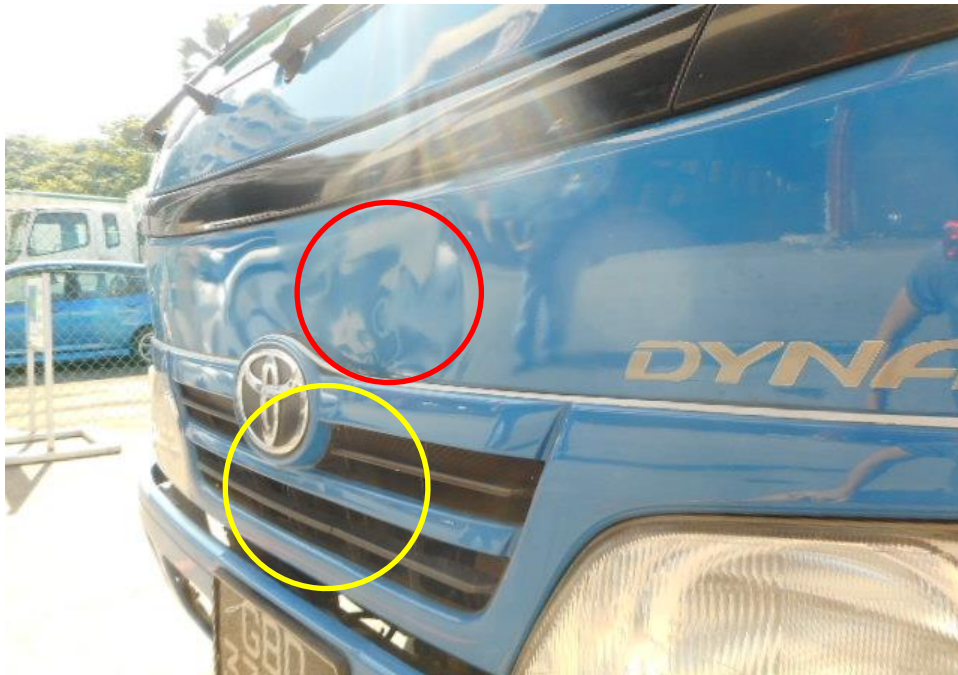
Photo 9 shows a close up view of the Lorry front portion. There were dents observed on the front body panel (red circle) and cracks (yellow circle) on the front emblem and grille of the Lorry.

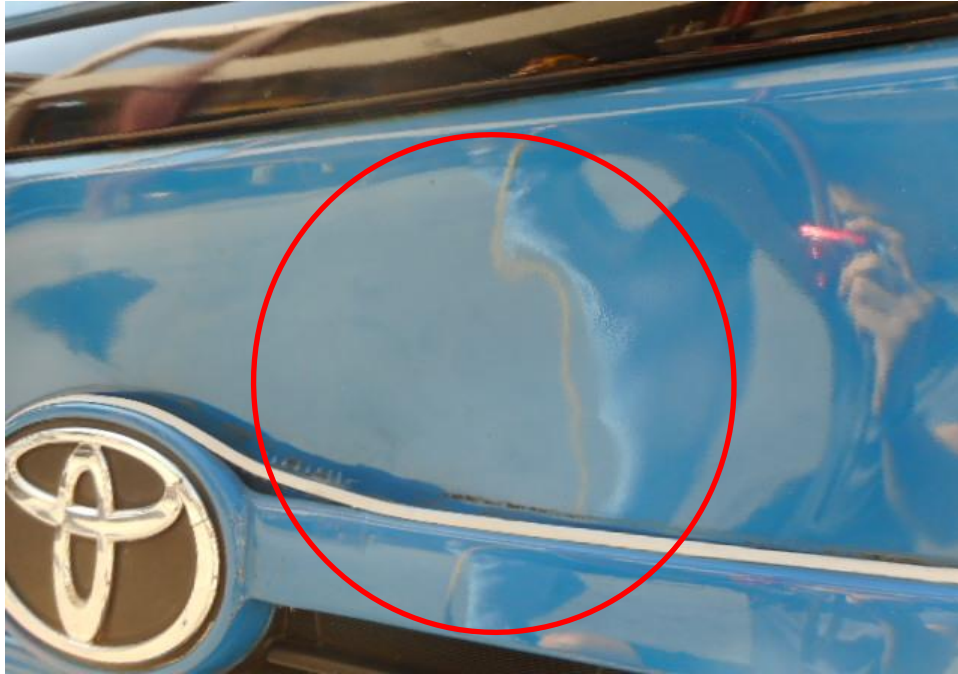
Photo 10 shows a close up view of the Lorry front portion. We observed dent on its front body panel (circled).

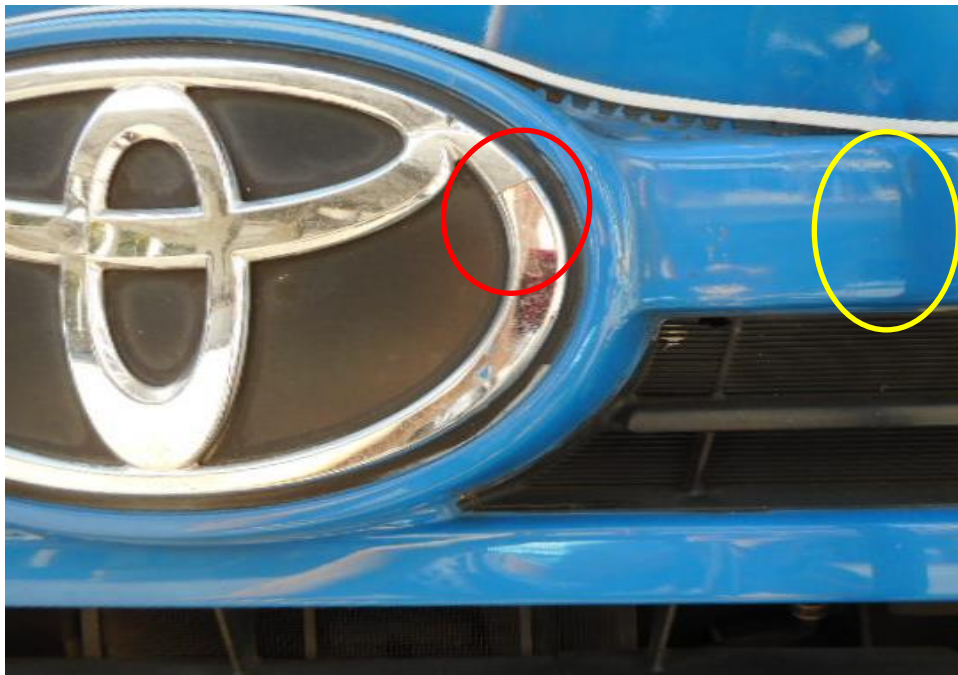
Photo 11 shows a close up view of the Lorry front portion. We observed crack marks on the emblem (red circle) and dent (yellow circle) on the front body panel of its front portion (circled).

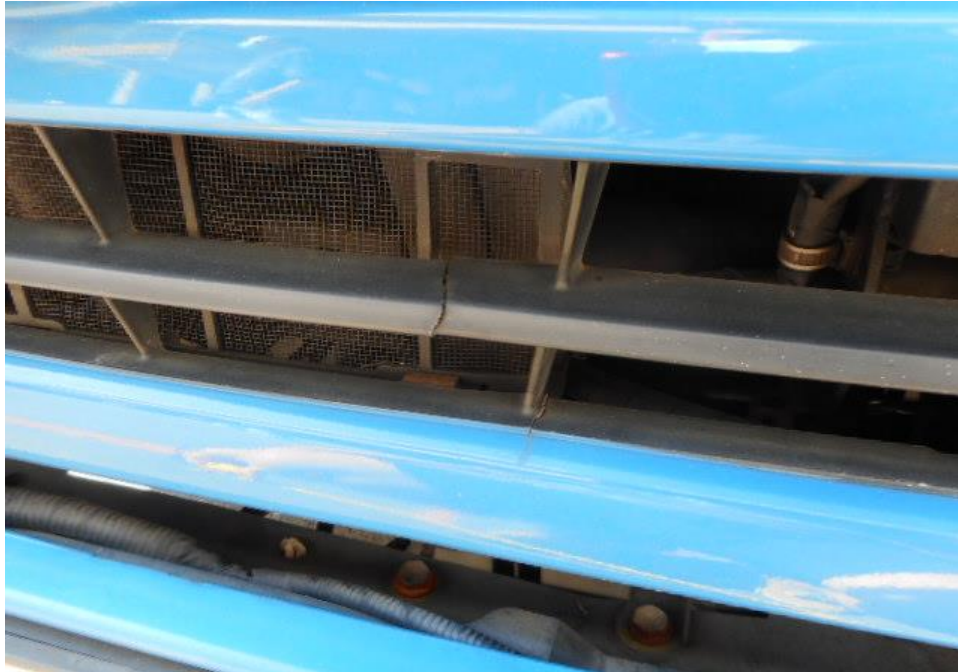
Photo 12 shows a general view of the Lorry front portion. We observed multiple groups of crack marks on the front grille.

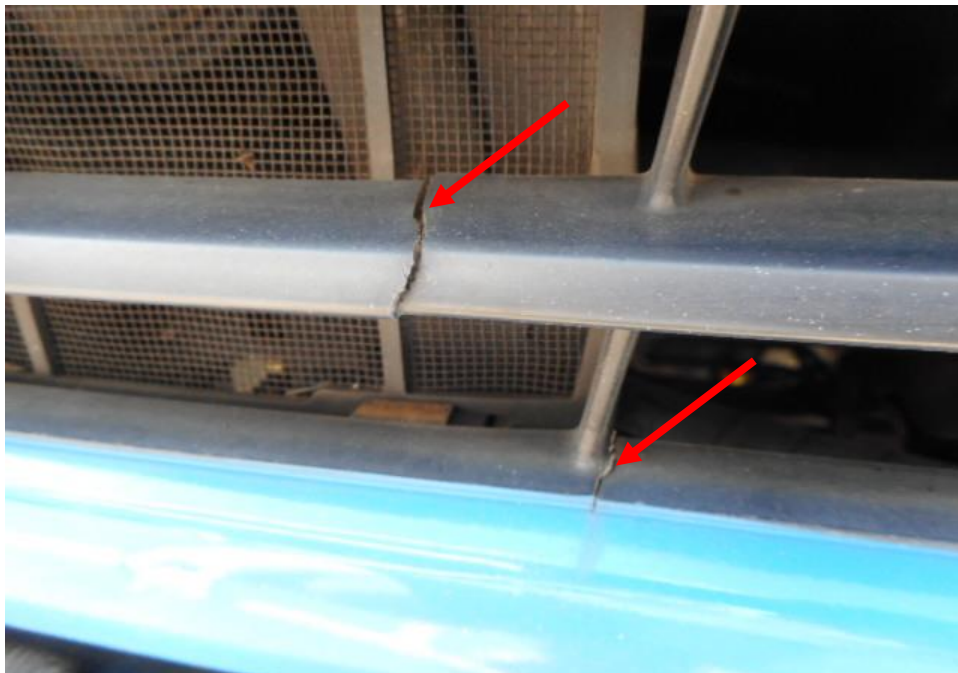
Photo 13 shows a close up view of the Lorry front portion. We observed multiple groups of crack marks on the front grille (arrowed).

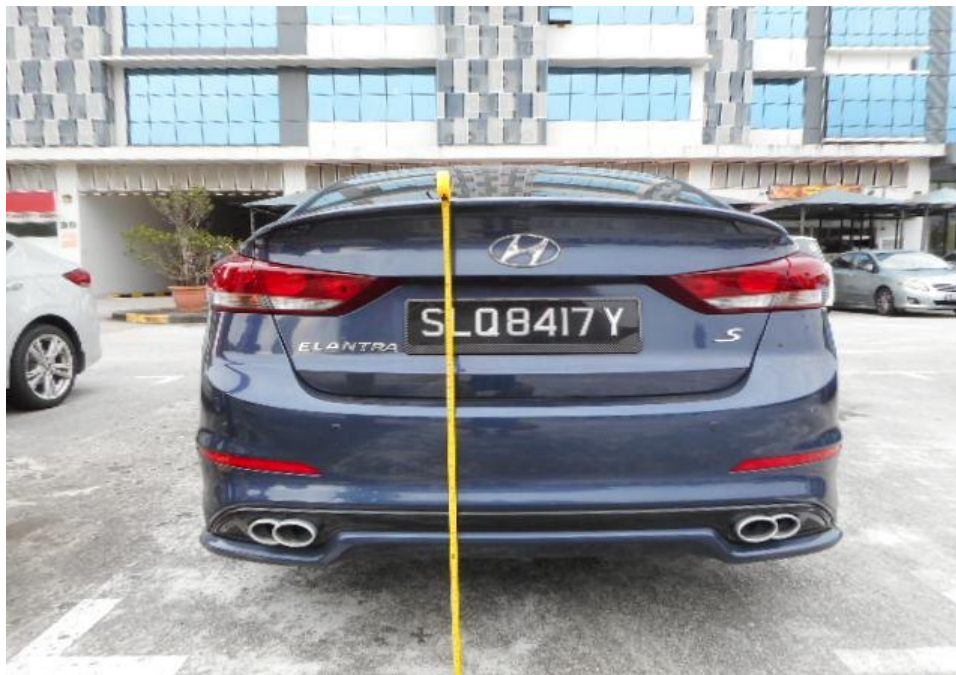
Photo 14 shows the general view of the height measurement being conducted on the rear portion of Car. The height above ground level of where the dislodgement and scratches of the rear bumper skirting, was at, 37cm to 27cm respectively.

- a) the height above ground level of the range of damages (which included the damage and dislodgement of the rear bumper skirting of the Car) was measured to be between 38cm to 27cm above ground level respectively.

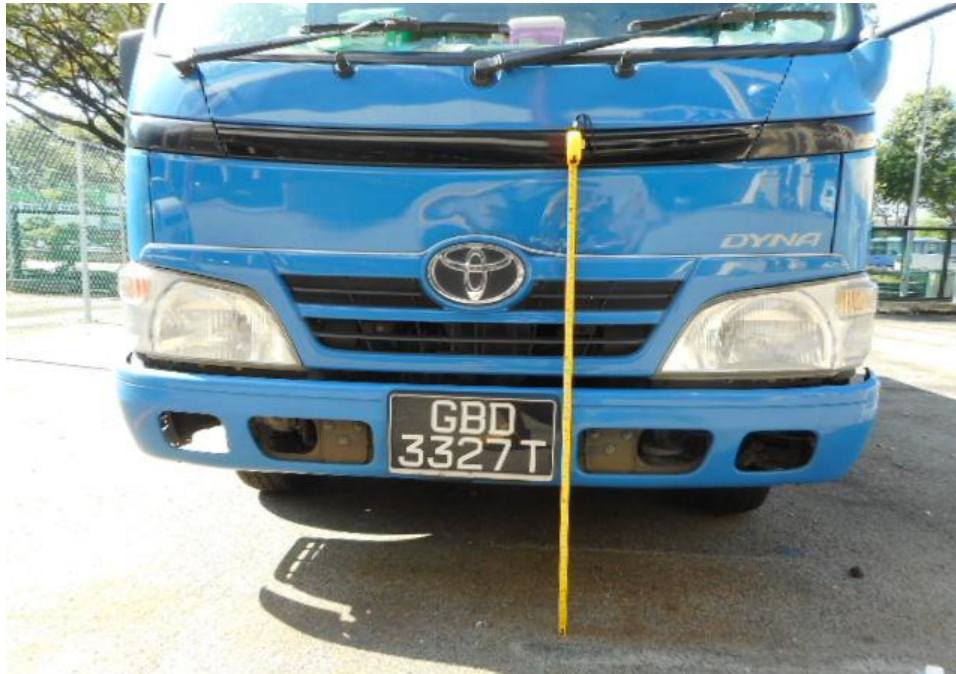
Photo 15 shows a general view of the height measurement being conducted on the front portion of Lorry. The bent and scratched marks on the front left bumper, was measured to be at 55cm to 43cm above ground level.

- b) the height measurements above ground level of the bent and scratched marks found on the front bumper of the Lorry was measured to be at 55cm to 43cm above ground level respectively;

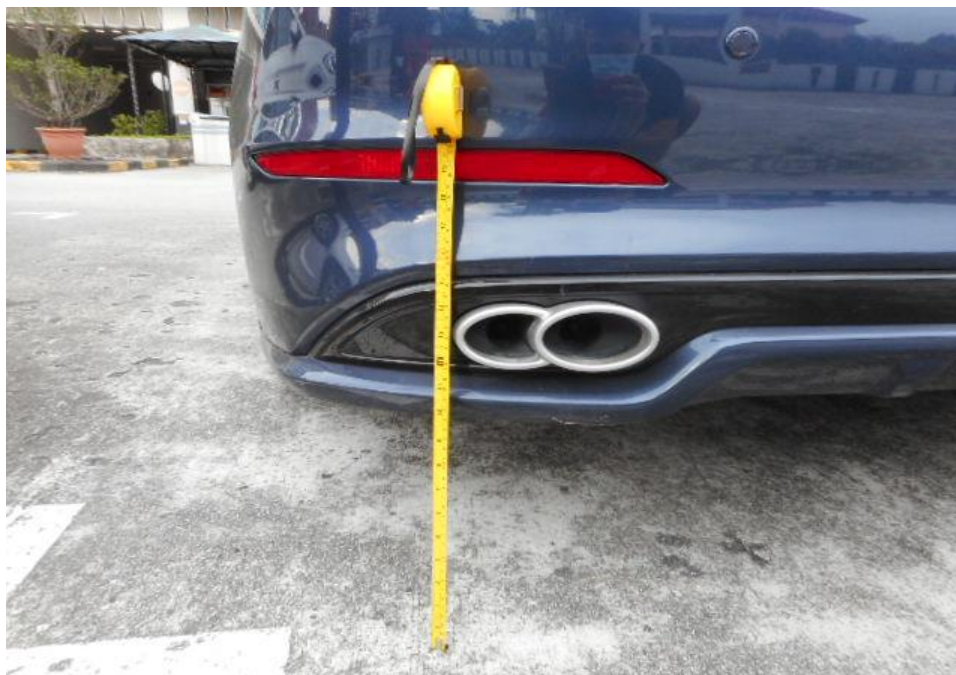
Photo 16 shows the general up view of the height measurement being conducted on the rear portion of Car. The height above ground level of where the damaged and dislodgment were found on the rear bumper skirting of the Car was at 37cm to 27cm.

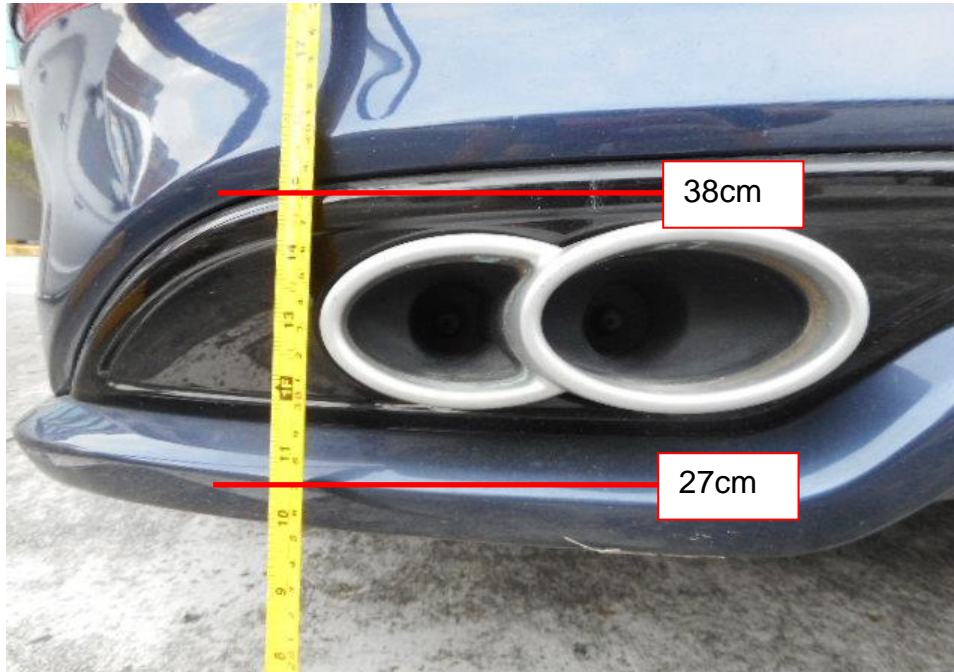
Photo 17 shows the close up view of the height measurement being conducted on the rear portion of Car. The height above ground level of where the damage were found on the rear bumper skirting of the Car was between 38cm to 27cm.

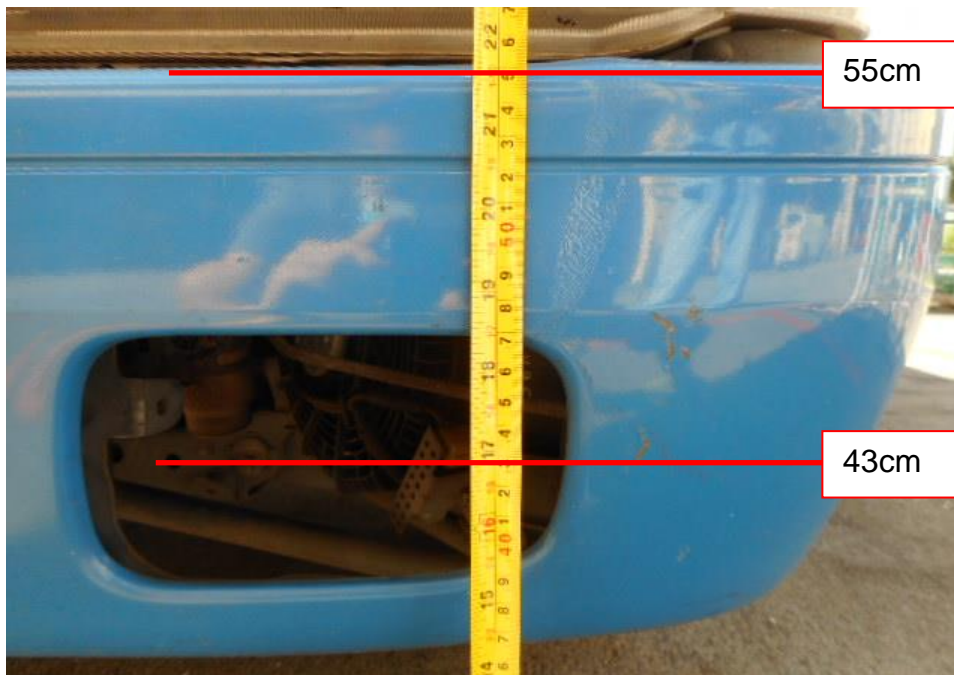
Photo 18 shows the close up view of the height measurement being conducted on the front portion of Lorry. The bent and scratched marks found on the front left bumper was measured to be between 55cm to 43cm above ground level.

- c) The height measurements appear to show that the measurements for possible contact point for the accident between the rear bumper skirting of the Car and the front bumper of the Lorry does not fall in between. From our understanding and observations of the contact points for these damaged portions we are in view that the mentioned points are not the results of this particular collision between both involved Vehicles and we suggest that there was no possible contact between the rear portion of Car and the front portion of Lorry.
