Your Ref: Mercedes Benz E53
(chassis number WDD2130612A731628)
Our Ref : CI/TP21008084/D

**INSPECTION REPORT OF AN UNREGISTERD MERCEDES BENZ E53
MOTOR CAR WITH CHASSIS NUMBER WDD2130612A731628**

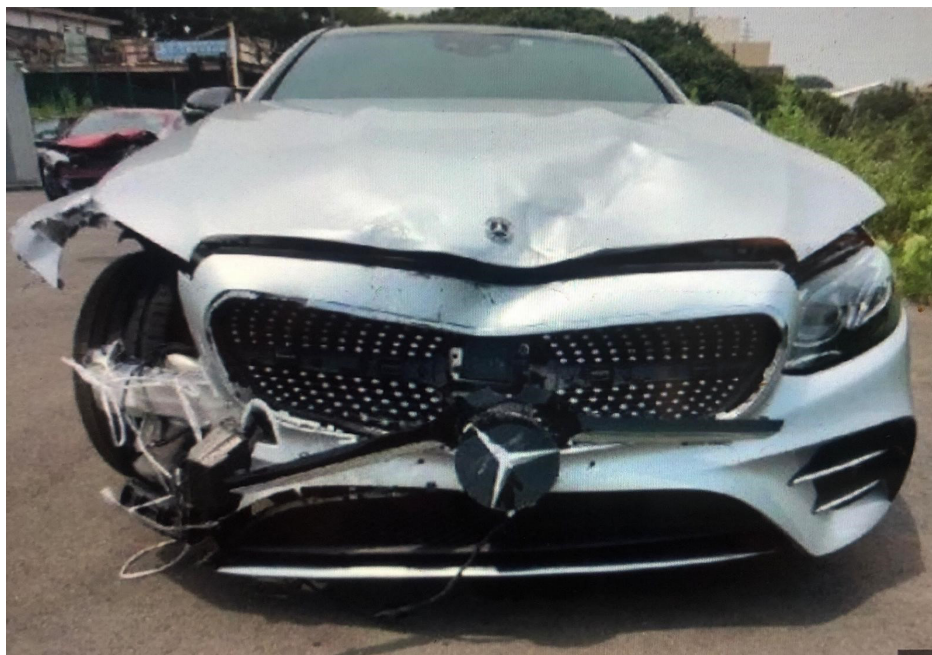
3. The photographs provided to me had showed damage to the Motor Car's frontal body. Body parts observed to have been damaged include the front bumper, front bumper centre garnish, front bumper centre lower grille, front bumper right lower grille, front bumper reinforcement, radiator grille, front emblem, front headlamps, front bonnet, front bonnet locks, front bonnet hinges, front right fender, front right fender inner shield, front top centre panel, front headlamp top right panel, front support panel and front top air duct amongst others.
4. No physical damage was observed to other areas of the Motor Car. The airbags were also not deployed as seen from the photographs that were provided to me. See photo 1 – 4 below.

Photo 1 shows the frontal body of the Motor Car prior to any repairs being carried out (photograph provided to me). The Motor Car was observed to have sustained damage at its frontal body. Body parts damaged include its front bumper, front bumper centre garnish, front bumper centre lower grille, radiator grille, front emblem and front bonnet amongst others.

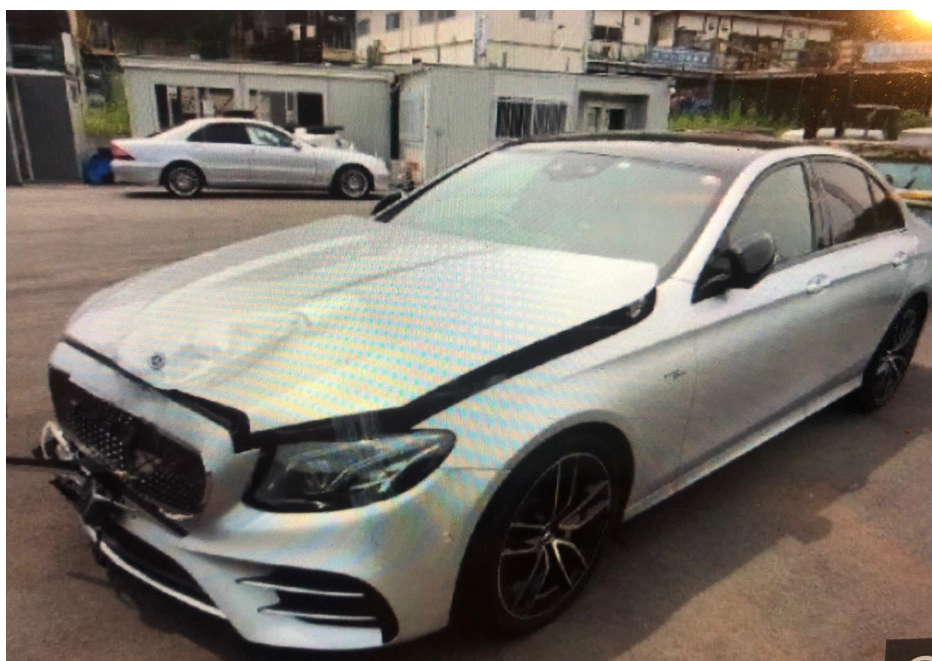
Photo 2 shows the front left body of the Motor Car prior to any repairs being carried out (photograph provided to me). The Motor Car was observed to have sustained damage at its frontal body. Body parts damaged include its front bumper, front bonnet, front bonnet hinges, front bonnet locks, front left headlamp and radiator grille amongst others.

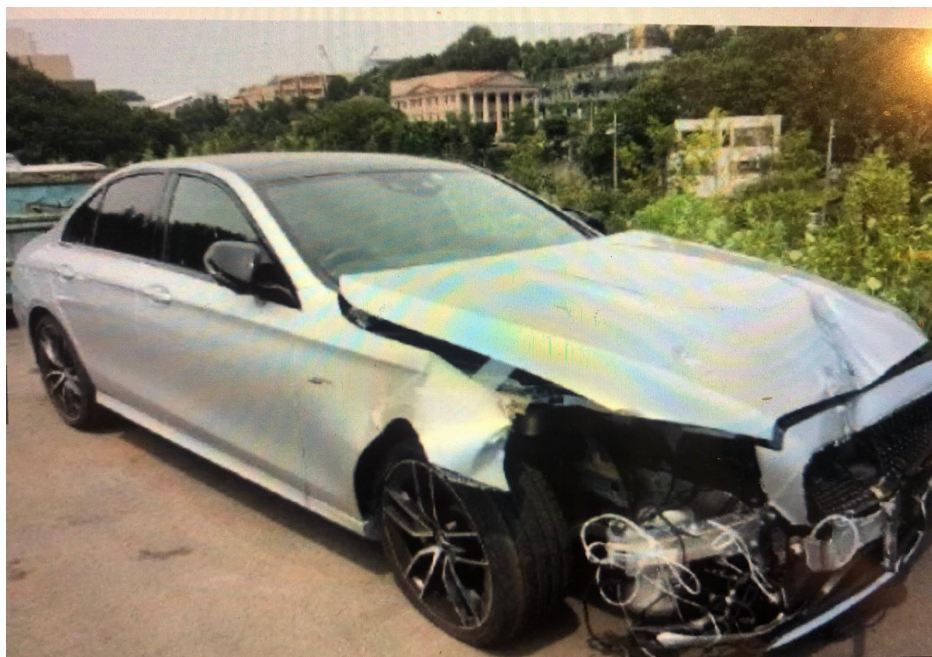
Photo 3 shows the front right body of the Motor Car prior to any repairs being carried out (photograph provided to me). The Motor Car was observed to have sustained damage at its frontal body. Body parts damaged include its front bumper, front bumper reinforcement, front bumper right lower grille, front right headlamp, front bonnet, front right fender and front right fender inner shield amongst others.

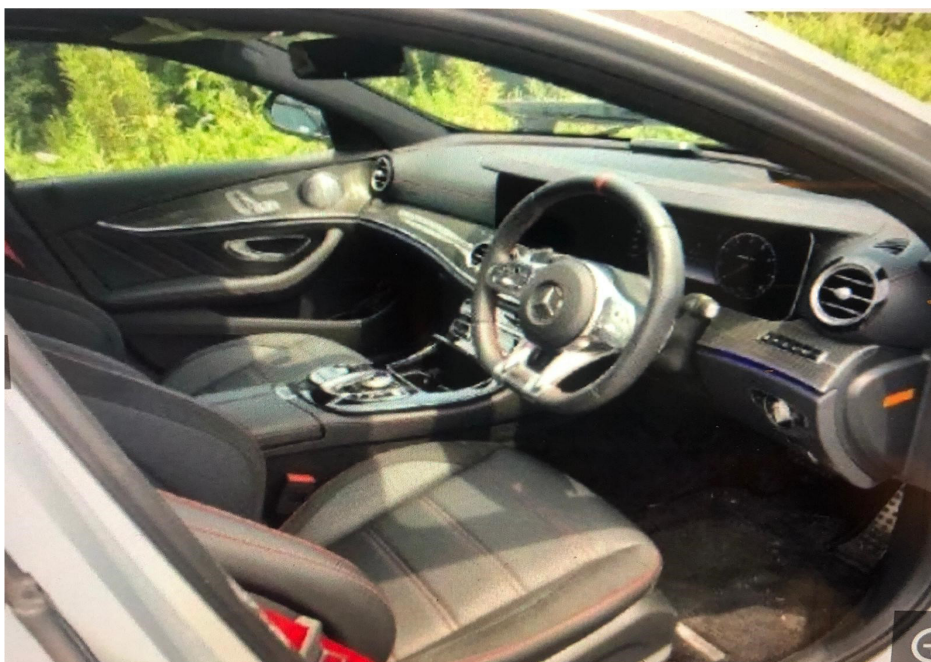
Photo 4 shows the interior compartment of the Motor Car prior to any repairs being carried out (photograph provided to me). The airbags of the Motor Car were not deployed.

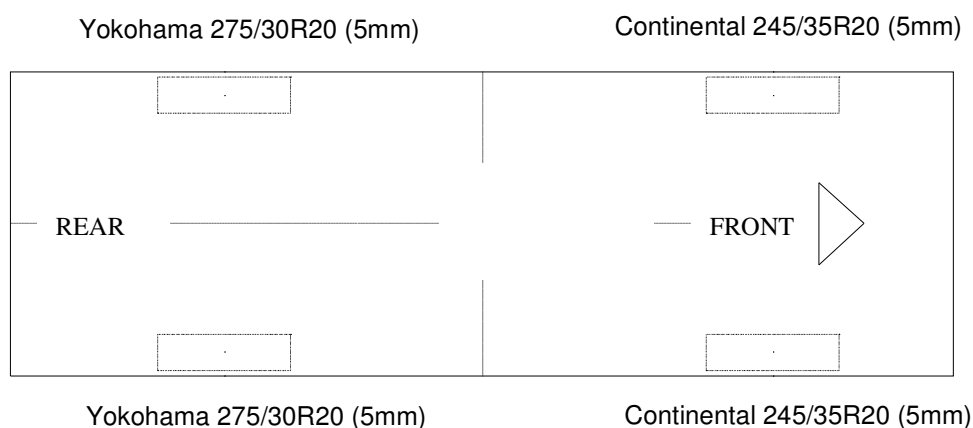
8. It was fitted with 20inch sport wheel rims that were wrapped with tyres that were observed to be of serviceable condition. The tyres were also sufficiently inflated for vehicular operation. The tyre brand, tyre size and approximate remaining tread depth of the 4 tyres of the Motor Car were recorded as follows: -

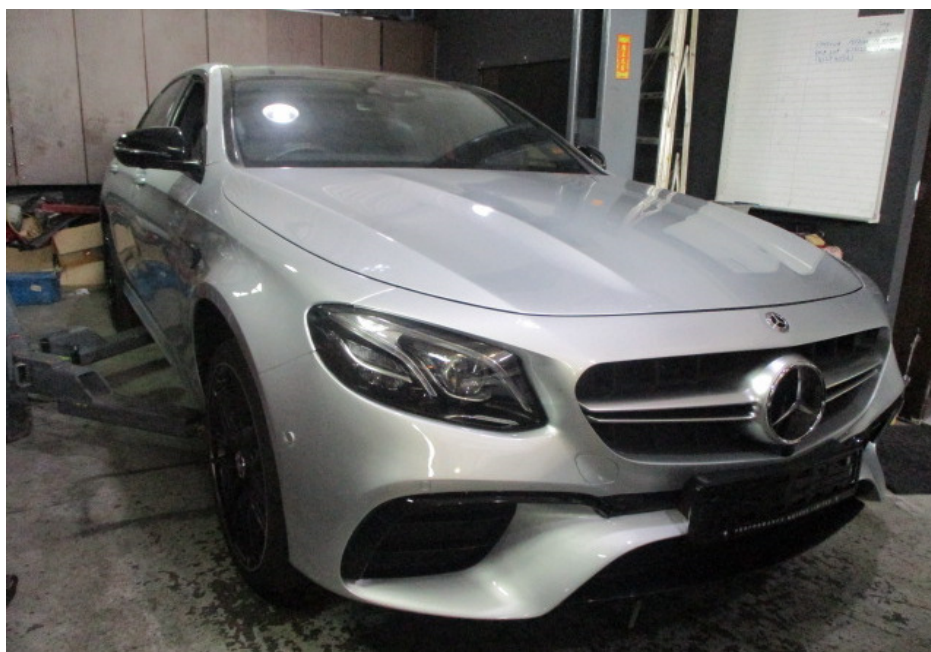
Photo 5 shows a general view of the front right body of the Motor Car at the time of my inspection. The Motor Car was observed to be in a relatively good general condition with no loose exterior fittings observed. The body parts at the frontal body portion of the Motor Car were visually examined and it was observed that the repair/restoration works carried out to the damaged area of the Motor Car (refer to photograph 1 – 3 above) were reasonably adequate and in order.

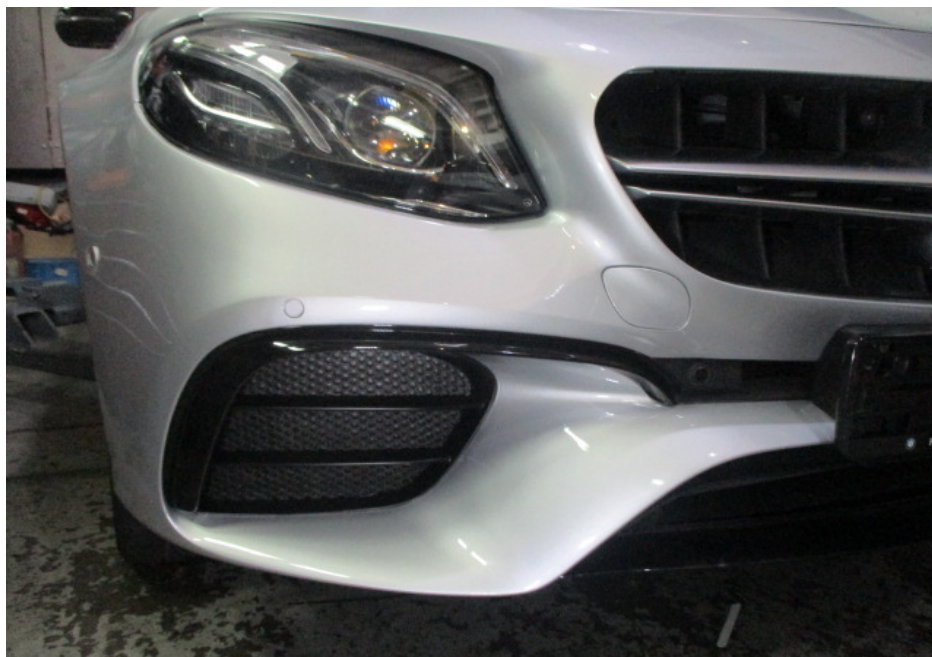
Photo 6 shows a closer view of the front bumper, front bumper centre garnish, front bumper right lower grille, front right headlamp and radiator grille of the Motor Car. The body parts at the frontal body of the Motor Car were visually examined and it was observed that the repair/restoration works carried out to the damaged area of the Motor Car (refer to photograph 1 & 3 above) were reasonably adequate and in order.

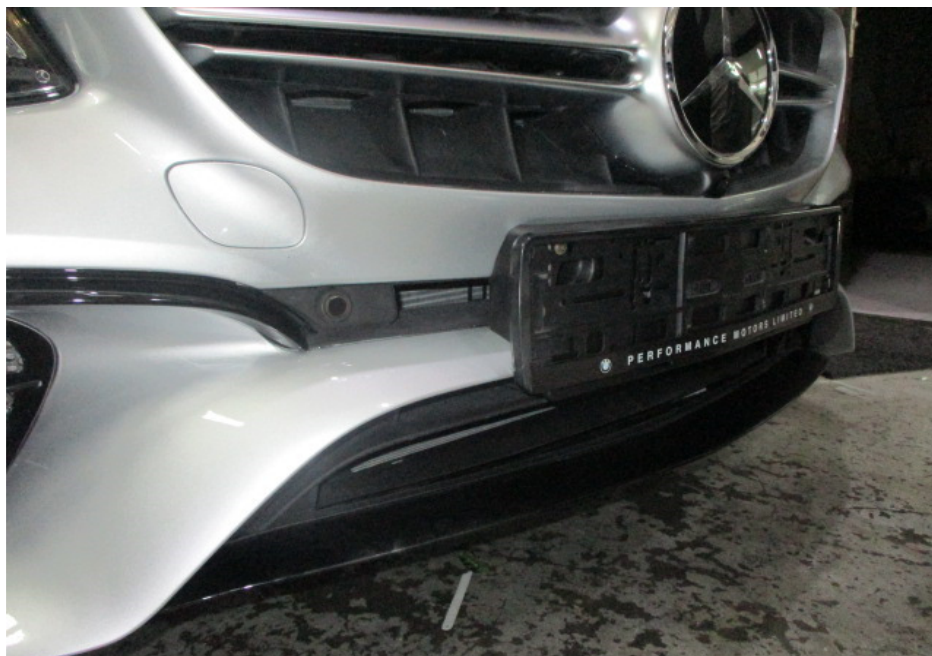
Photo 7 shows a closer view of the front bumper, front bumper centre lower grille, front emblem and radiator grille of the Motor Car. The body parts at the frontal body of the Motor Car were visually examined and it was observed that the repair/restoration works carried out to the damaged area of the Motor Car (refer to photograph 1 & 3 above) were reasonably adequate and in order.

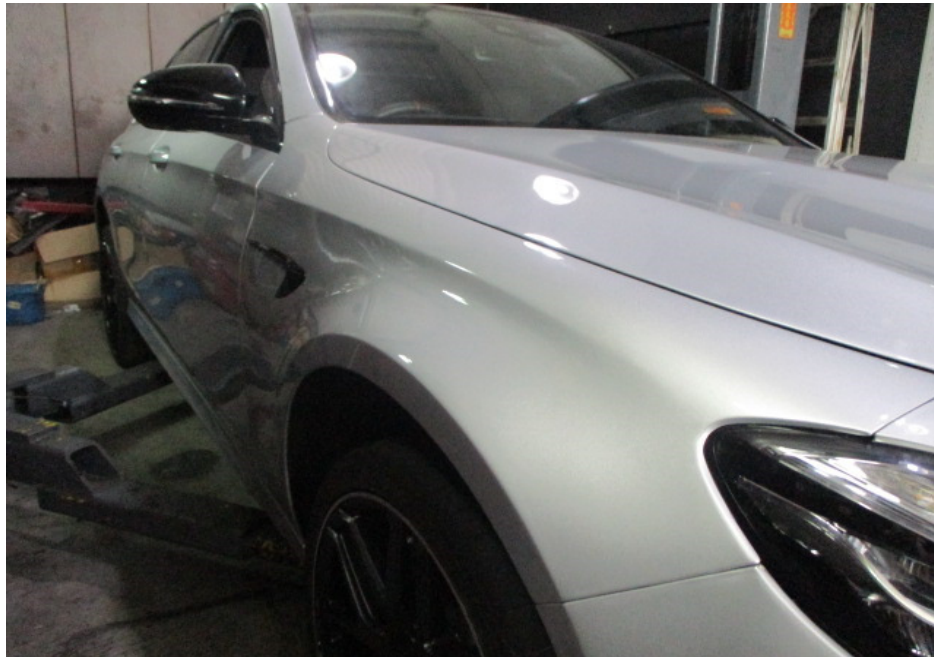
Photo 8 shows a closer view of the front right headlamp, front right fender and front bonnet of the Motor Car. The body parts at the frontal body of the Motor Car were visually examined and it was observed that the repair/restoration works carried out to the damaged area of the Motor Car (refer to photograph 3 above) were reasonably adequate and in order.

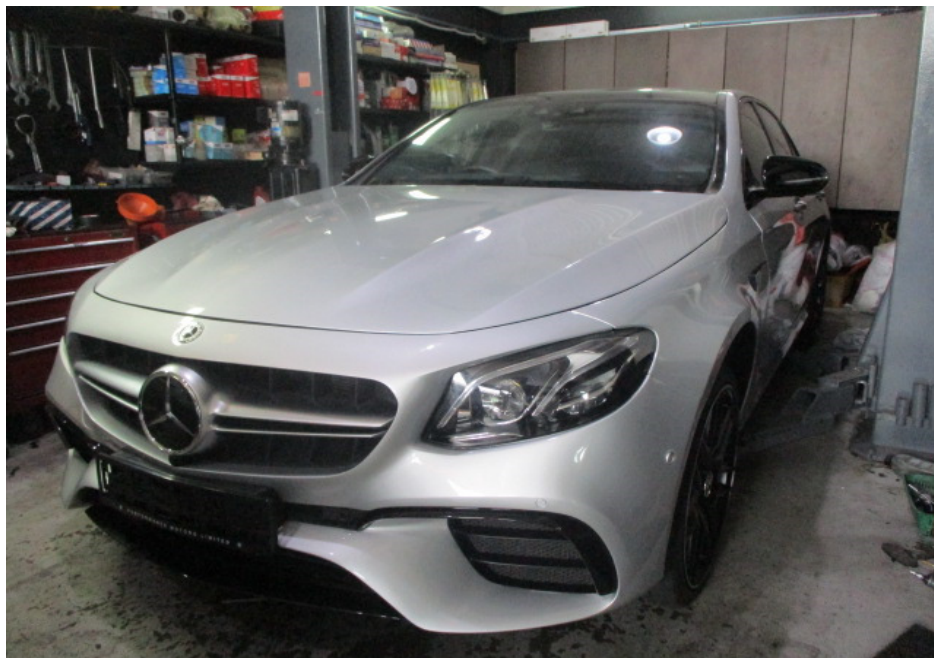
Photo 9 shows a general view of the front left body of the Motor Car at the time of my inspection. The Motor Car was observed to be in a relatively good general condition with no loose exterior fittings observed. The body parts at the frontal body portion of the Motor Car were visually examined and it was observed that the repair/restoration works carried out to the damaged area of the Motor Car (refer to photograph 1 – 3 above) were reasonably adequate and in order.

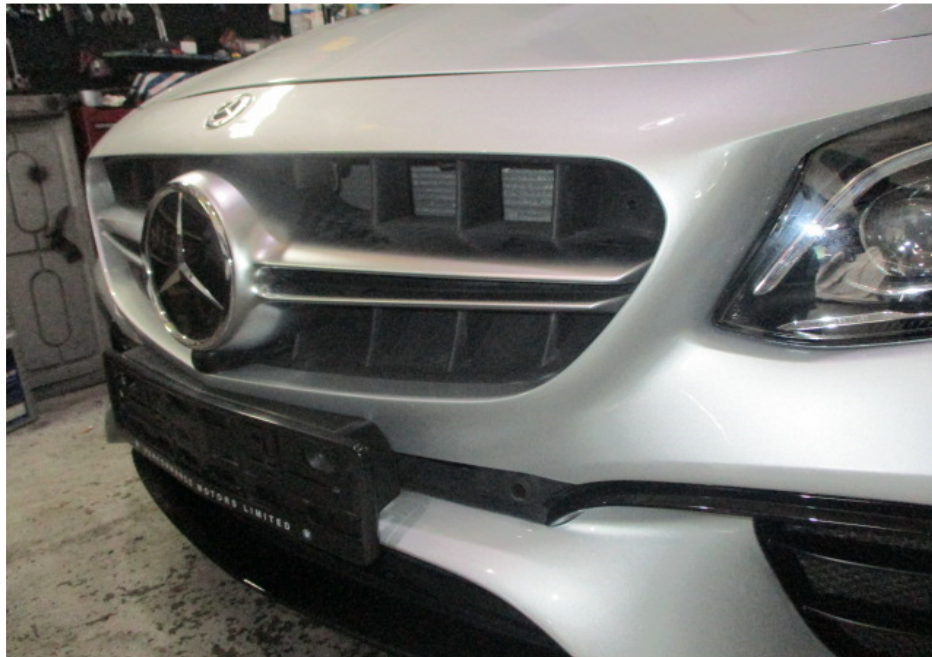
Photo 10 shows a closer view of the front bumper, front bumper centre garnish, front emblem, radiator grille and front left headlamp of the Motor Car. The body parts at the frontal body of the Motor Car were visually examined and it was observed that the repair/restoration works carried out to the damaged area of the Motor Car (refer to photograph 1 & 2 above) were reasonably adequate and in order.

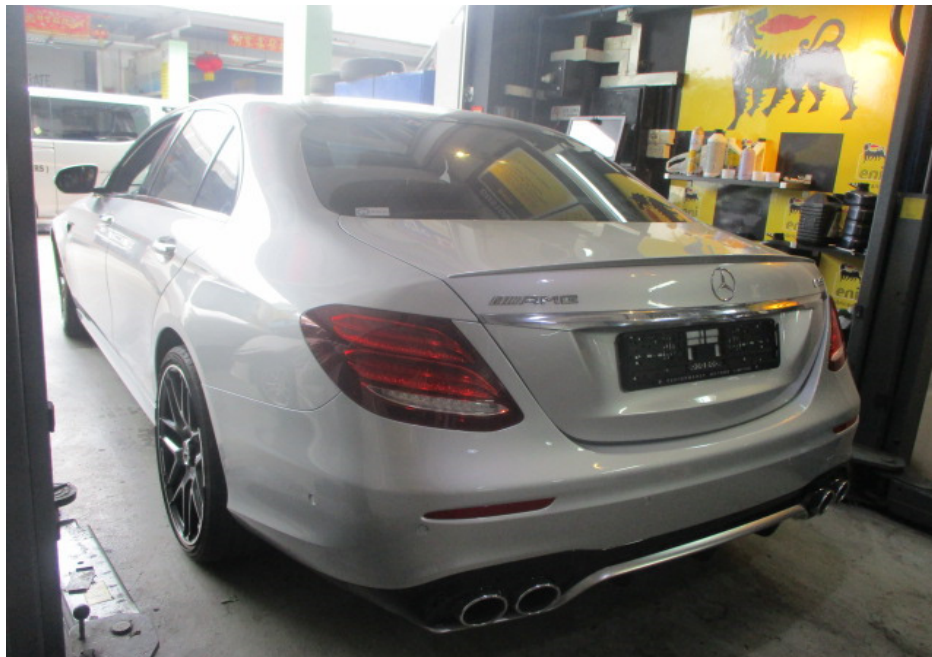
Photo 11 shows a general view of the rear left body of the Motor Car at the time of my inspection. The Motor Car was observed to be in a relatively good general condition with no loose exterior fittings observed. The mileage of the Motor Car recorded at the time of my inspection was 8,120km.

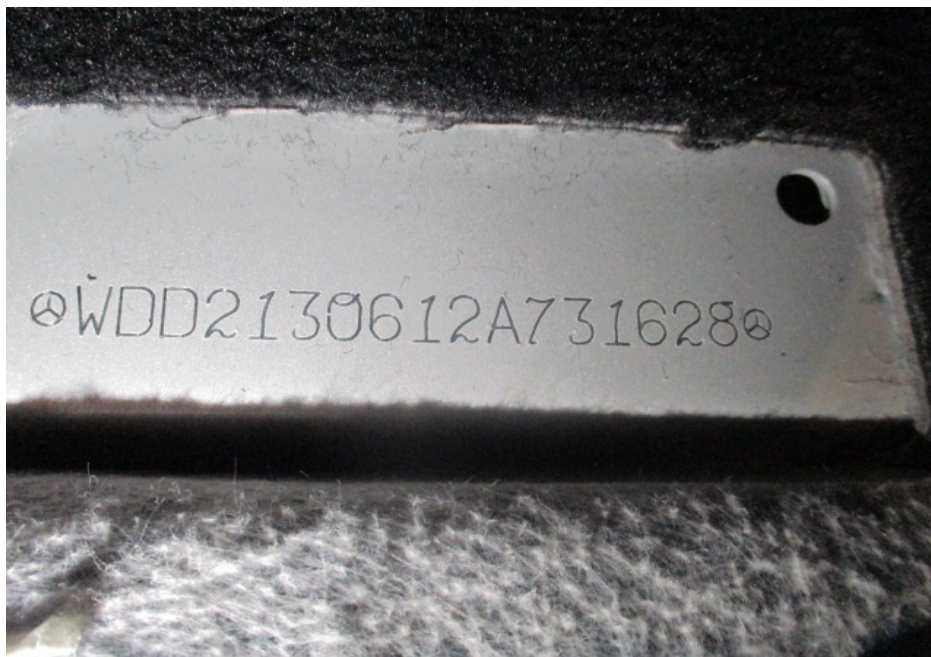
Photo 12 shows the chassis number of the Motor Car. The chassis number recorded was WDD2130612A731628.

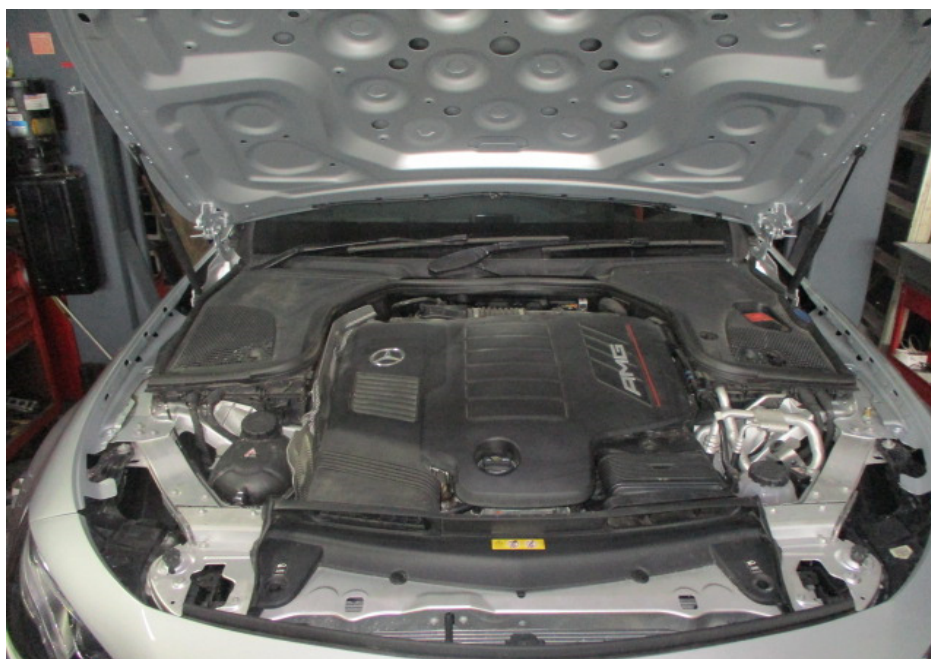
Photo 13 shows a general view of the engine compartment of the Motor Car at the time of my inspection. The various parts and components inside the engine compartment were all observed to be intact and properly fitted. There was also no sign(s) or indication(s) of fluid leak and/or fluid stain found inside the engine compartment. The repair/restoration works carried out to the various parts within the engine compartment like the front top centre panel, front headlamp top right panel, front support panel and front top air duct amongst others, were reasonably adequate and in order.

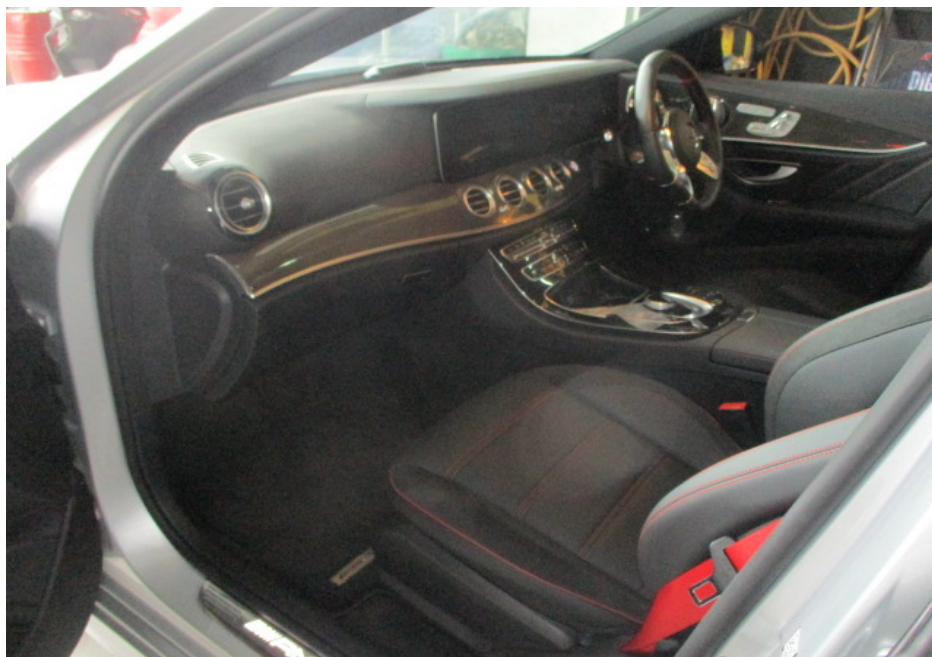
Photo 14 shows a general view of the interior compartment of the Motor Car at the time of my inspection. The various parts and components, trims, carpet and upholstery inside the interior compartment were all observed to be intact and properly fitted.

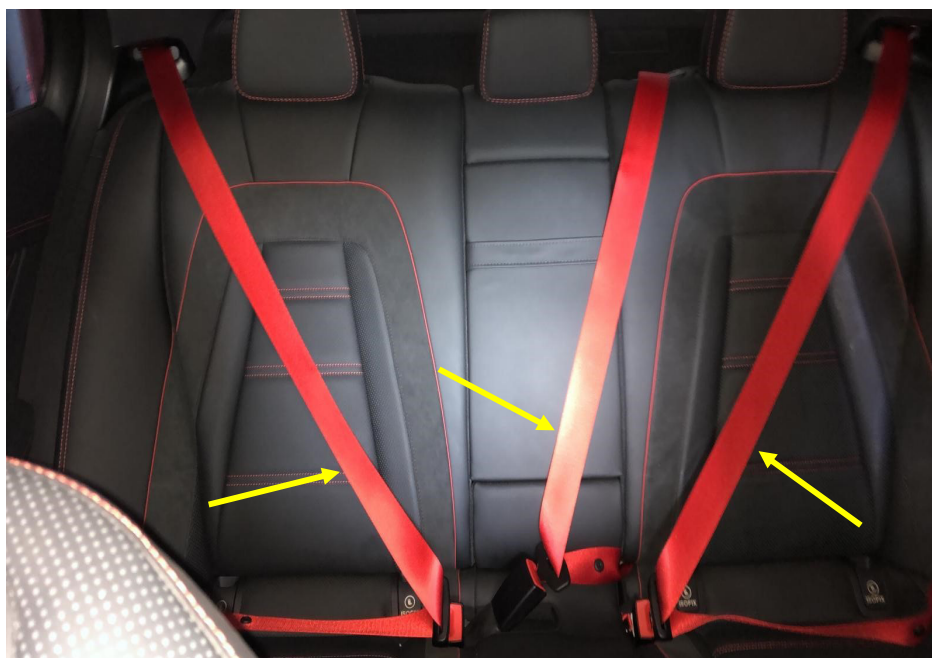
Photo 15 shows the rear seats of the Motor Car. All the seats of the Motor Car were secured via seat rails to the floorboard. They were also fitted with a retractable seat belt reel and a pre-tensioner. The seat belts (arrowed) of the Motor Car were tested and were able to be fastened into the respective pre-tensions that were fitted on the side of each individual seat.

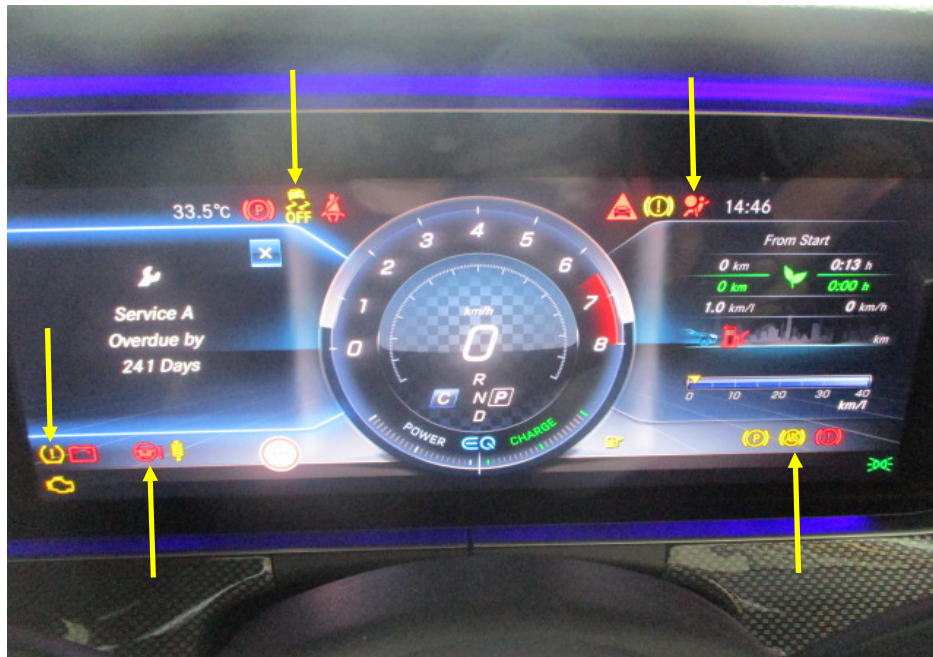
Photo 16 shows the warning lights for the various electronic safety features appearing on the instrument panel of the Motor Car during its self-test when the engine is cranked, in particular the ABS, SRS, EPS, TPM and TCS lights (arrowed).

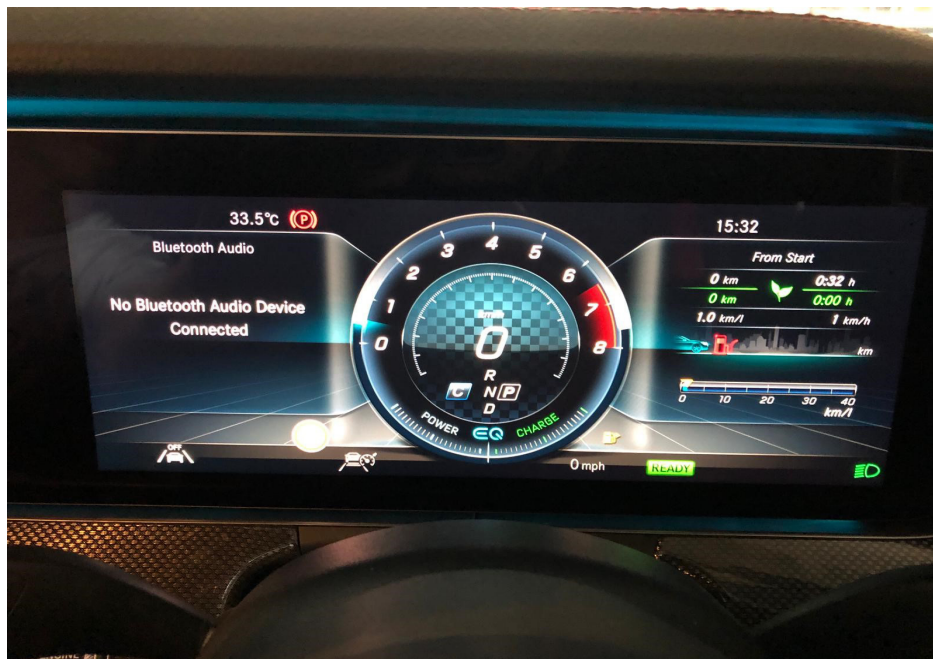
Photo 17 shows the respective warning lights no longer illuminated, indicating that there is no fault detected to the ABS, SRS, EPS, TPM and TCS systems of the Motor Car during the self-test. These electronic systems were hence in working condition at the time of my inspection.

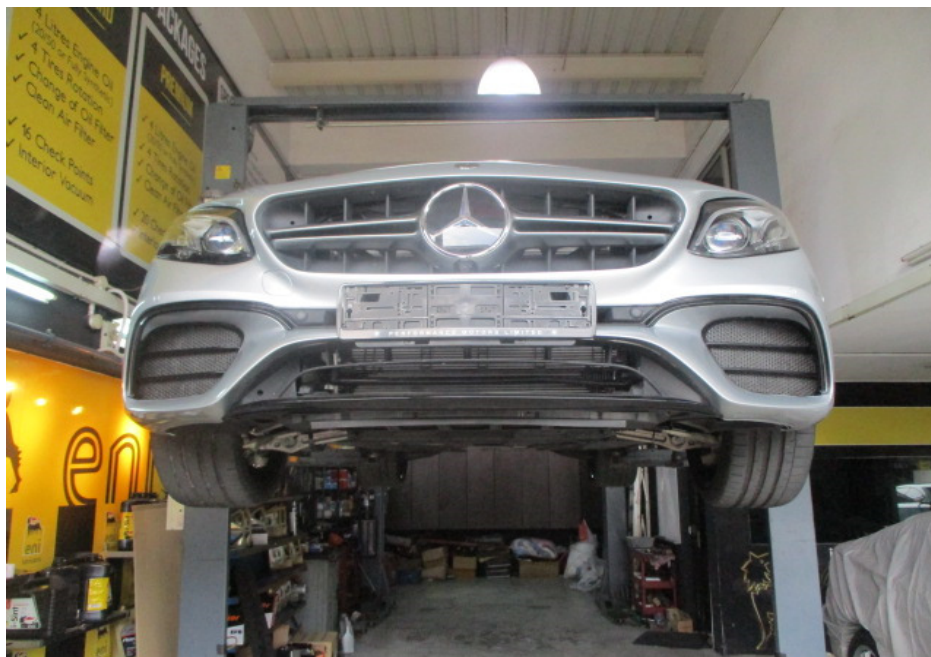
Photo 18 shows the Motor Car hoisted up for checks on its undercarriage. There was no sign(s) or indication(s) of fluid leakage and/or fluid stain(s) on the underside of the Motor Car. The undercarriage components of the Motor Car were also all observed to be intact and secured in an appropriate manner.

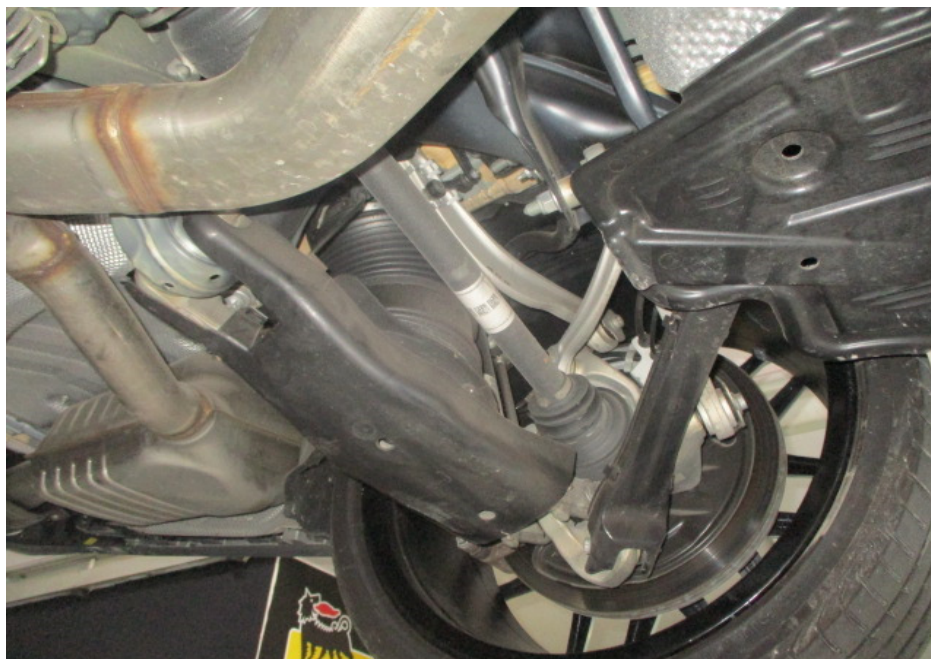
Photo 19 shows a general view of the control arms and linkages at the rear left wheel of the Motor Car. I did not observe any fluid leak and/or fluid stain on the underside of the Motor Car. All the Motor Car's undercarriage components were observed to be intact and secured in an appropriate manner.

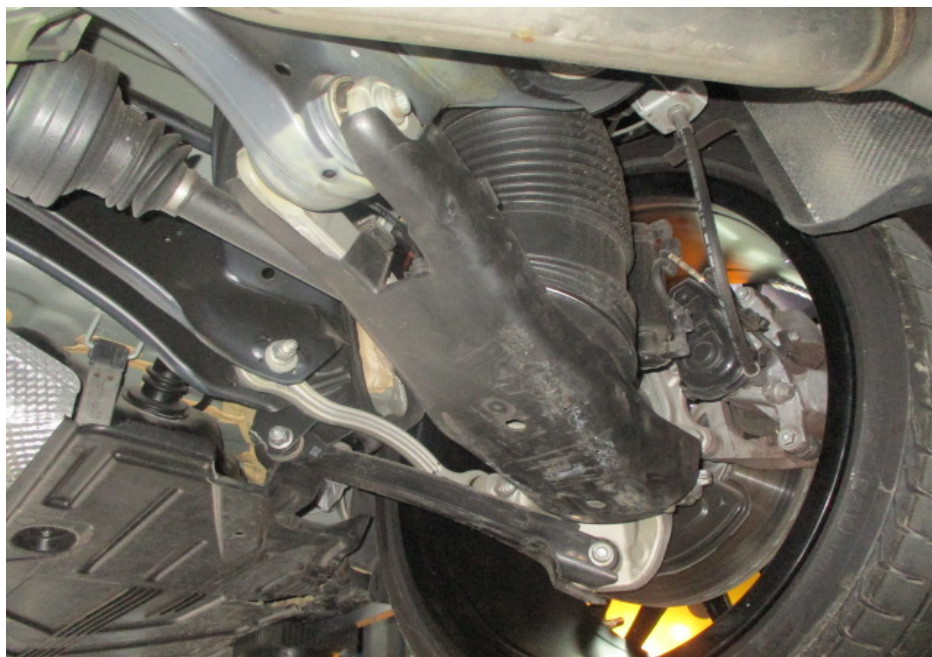
Photo 20 shows a general view of the control arms and linkages at the rear right wheel of the Motor Car. I did not observe any fluid leak and/or fluid stain on the underside of the Motor Car. All the Motor Car's undercarriage components were observed to be intact and secured in an appropriate manner.

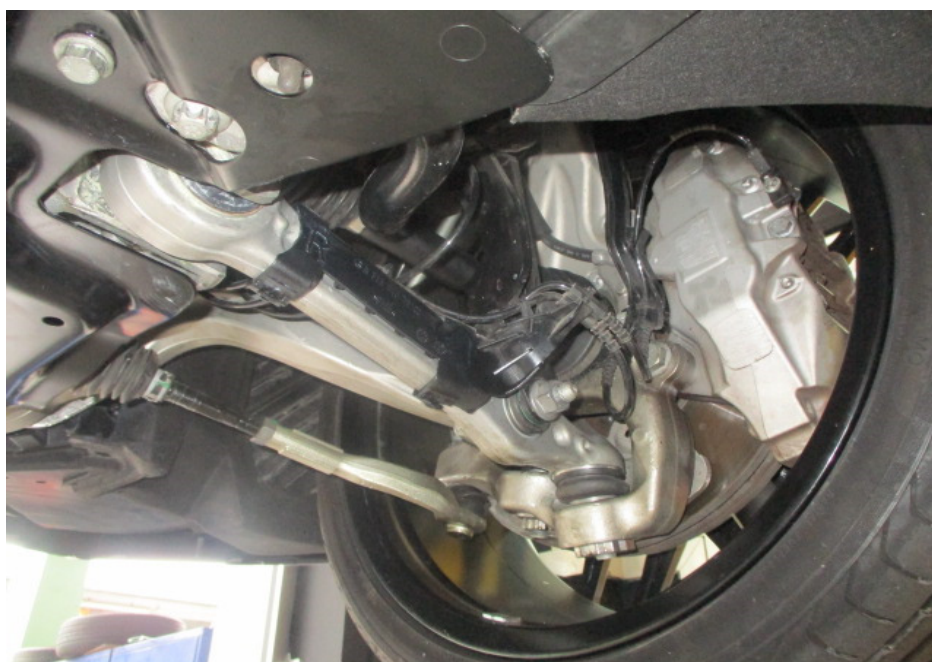
Photo 21 shows the various undercarriage components at the front right wheel of the Motor Car. The mechanical components, control arms and linkages were all found to be intact and secured in an appropriate manner.

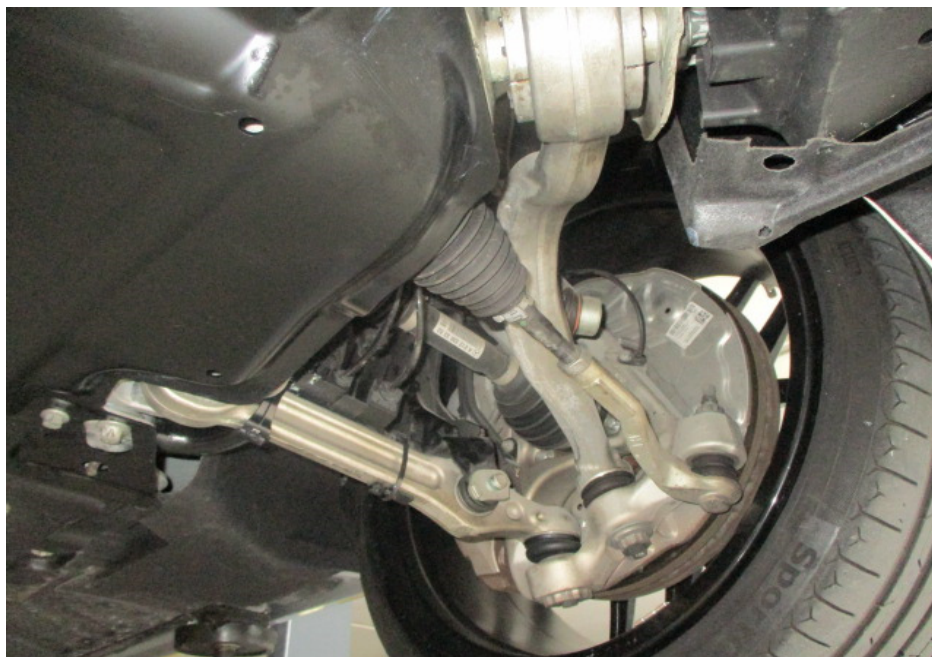
Photo 22 shows the various undercarriage components at the front left wheel of the Motor Car. The mechanical components, control arms and linkages were all found to be intact and secured in an appropriate manner. I also did not observe any fluid leak and/or fluid stain on the underside of the Motor Car.

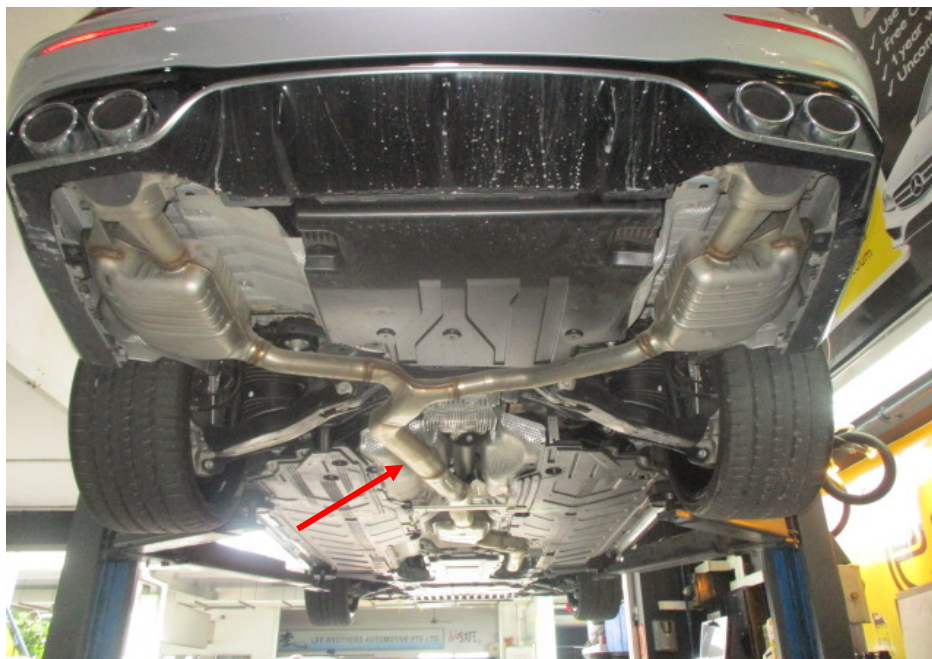
Photo 23 shows a general view of the rear section of the Motor Car's exhaust system. My examination of the Motor Car's exhaust system revealed no sign(s) or indication(s) of any cut or weld marks along its exhaust pipes (arrowed), on its catalytic converter, centre resonator box and on its rear mufflers.

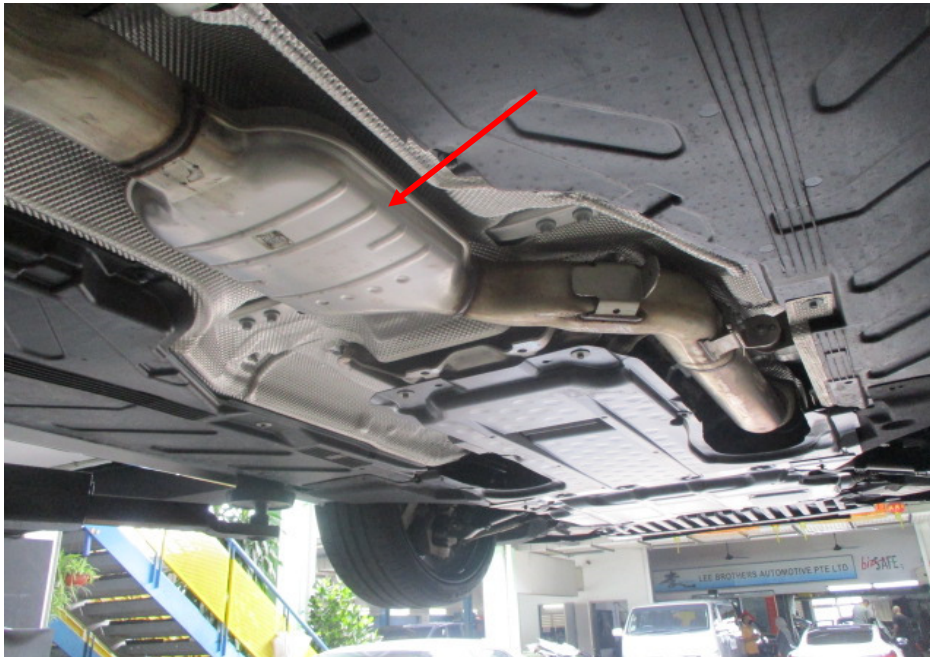
Photo 24 shows a general view of the front section of the Motor Car's exhaust system. My examination of the Motor Car's exhaust system revealed no sign(s) or indication(s) of any cut or weld marks along its exhaust pipes, on its catalytic converter, centre resonator box (arrowed) and on its rear mufflers.

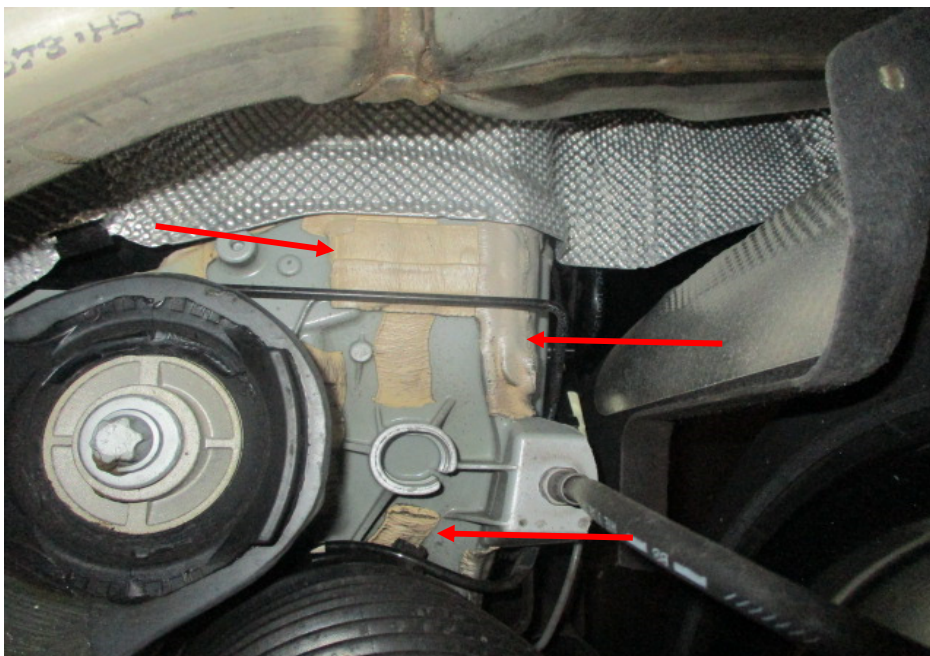
Photo 25 shows the chassis/structural body at the underside rear right of the Motor Car. The original factory sealant (arrowed) at the joints along the chassis/structural body was untouched. In general, I had found no work was carried out on the chassis/structural body of the Motor Car. The chassis/structural body of the Motor Car was originally fitted.

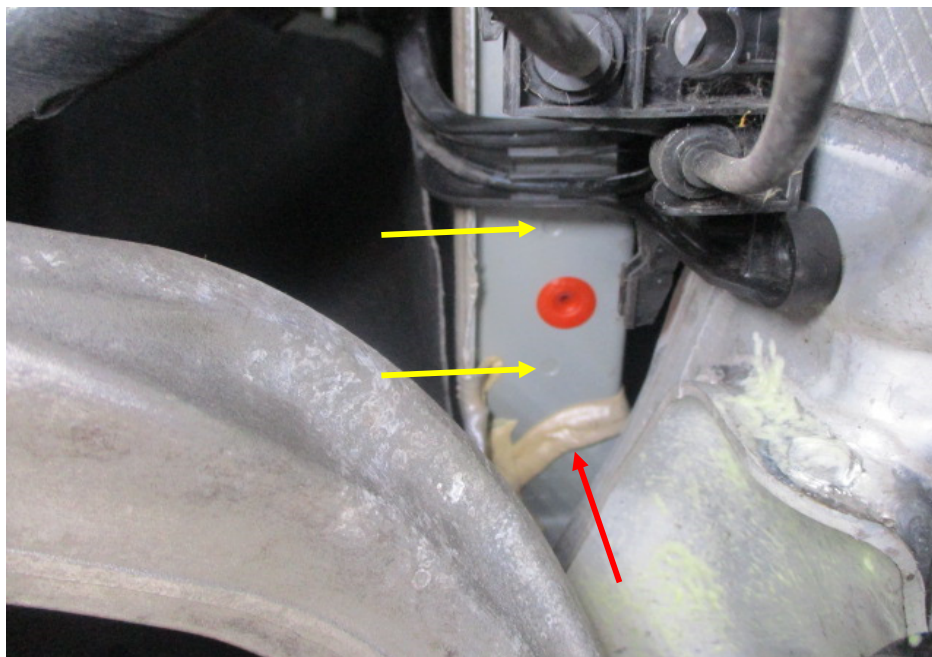
Photo 26 shows the chassis/structural body at the underside front left of the Motor Car. I did not find any weld marks other than original spot weld marks (yellow arrow) on the chassis/structural body of the Motor Car. The original factory sealant (red arrow) at the joints along the chassis/structural body was untouched, indicating no work was done on the chassis/structural body of the Motor Car and that the chassis/structural body was originally fitted.

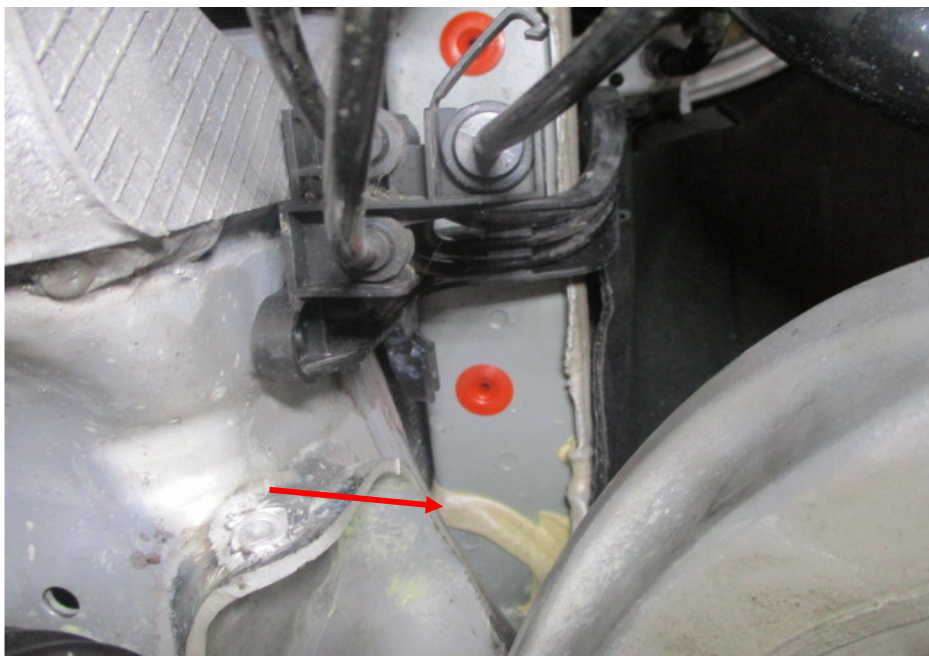
Photo 27 shows the chassis/structural body at the underside front right of the Motor Car. The original factory sealant (arrowed) at the joints along the chassis/structural body was observed to be untouched. In general, I had found no work was carried out on the chassis/structural body of the Motor Car. The chassis/structural body of the Motor Car was originally fitted.

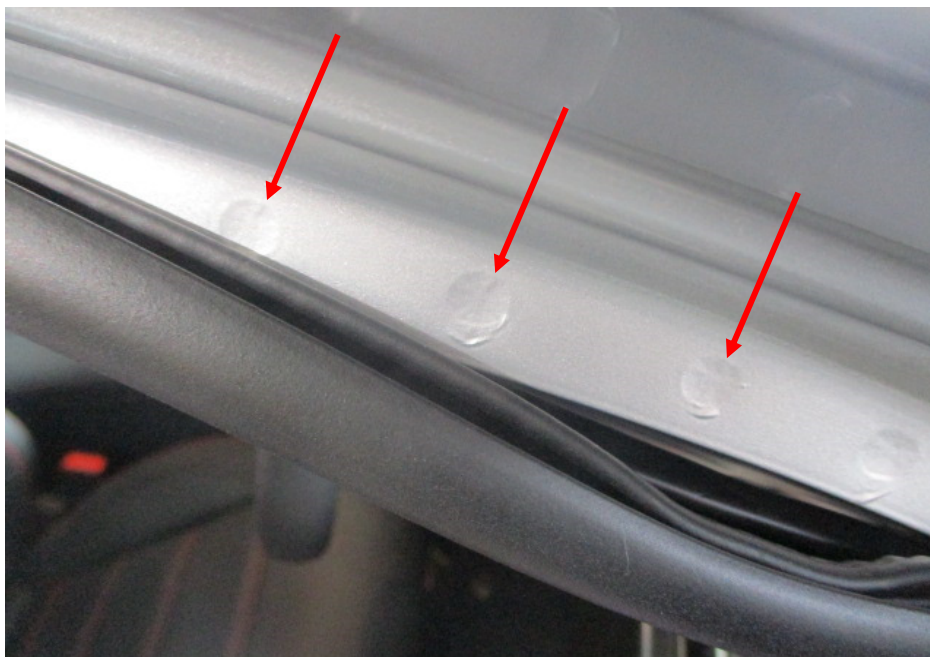
Photo 28 shows the right side "A" pillar of the Motor Car. I did not find any weld marks other than original spot weld marks (arrowed) on the right side "A" pillar of the Motor Car which, indicates that there was no re-welding works carried out. In general, I had found all the non-detachable body panels of the Motor Car to be originally fitted at the time of my inspection.

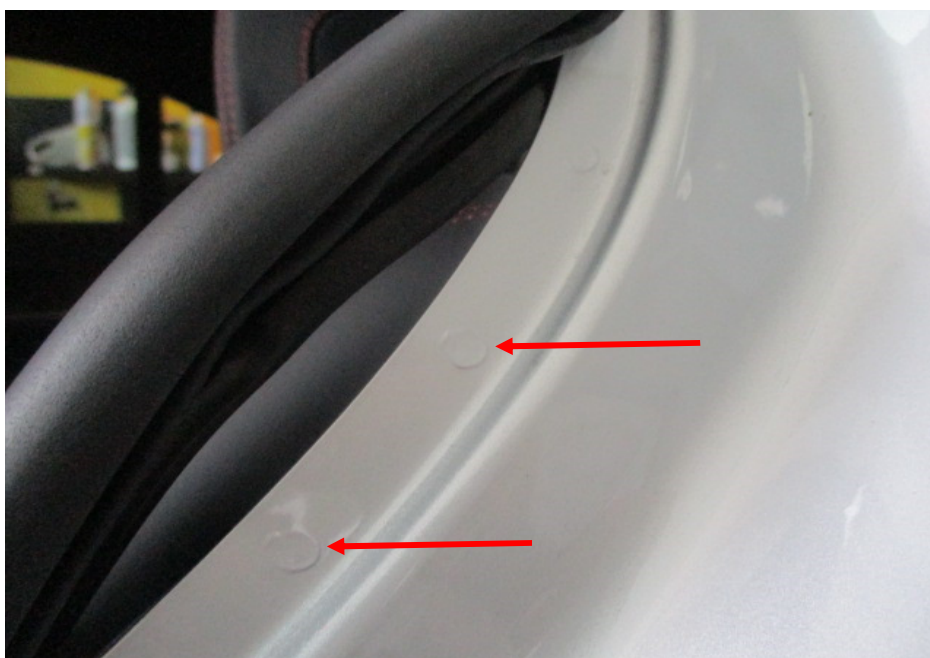
Photo 29 shows the left side "C" pillar of the Motor Car. I did not find any weld marks other than original spot weld marks (arrowed) on the left side "C" pillar of the Motor Car which, indicates that there was no re-welding works carried out. In general, I had found all the non-detachable body panels of the Motor Car to be originally fitted at the time of my inspection.

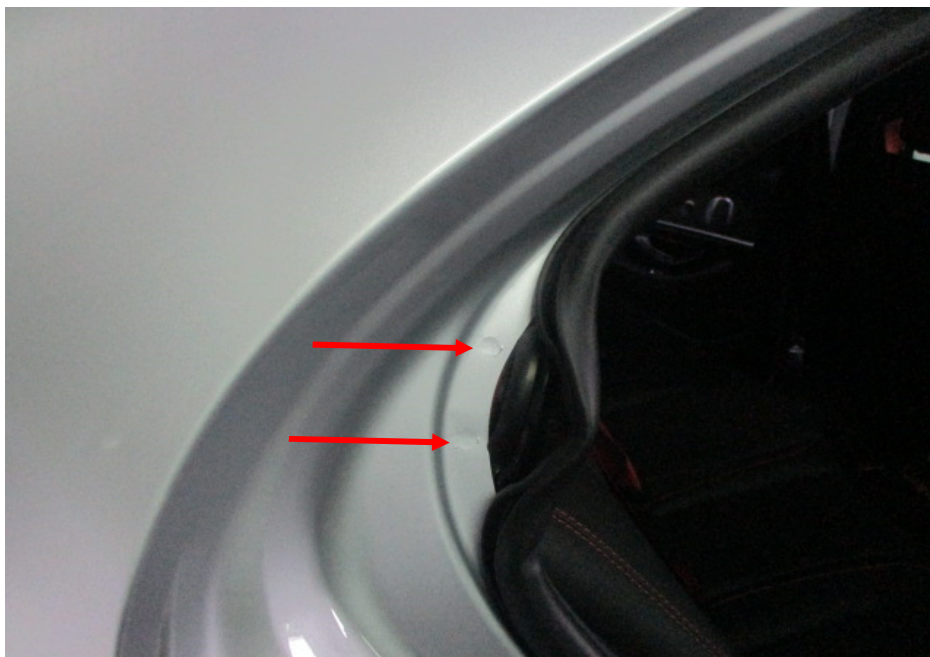
Photo 30 shows the right side "C" pillar of the Motor Car. I did not find any weld marks other than original spot weld marks (arrowed) on the right side "C" pillar of the Motor Car which, indicates that there was no re-welding works carried out. In general, I had found all the non-detachable body panels of the Motor Car to be originally fitted at the time of my inspection.
