Your Ref: BMW 850i  
(chassis number WBABC42010CE78995)  
Our Ref : CI/TP21008085/D

30 July 2021

**Focus Auto Pte Ltd**

**INSPECTION REPORT OF AN UNREGISTERD BMW 850i MOTOR CAR WITH CHASSIS NUMBER WBABC42010CE78995**

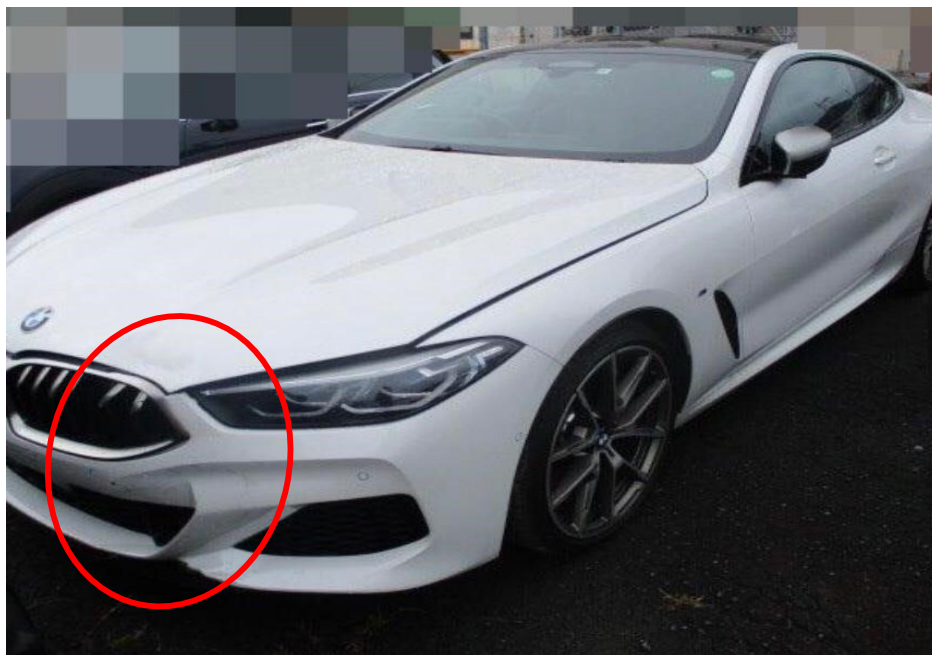
**Photo 1** shows the front left body of the Motor Car prior to any repairs being carried out (photograph provided to me). The Motor Car was observed to have sustained relatively minor damage at its frontal body (circled). Body parts damaged include its front bumper, front bumper centre lower grille, radiator grille and front bonnet.

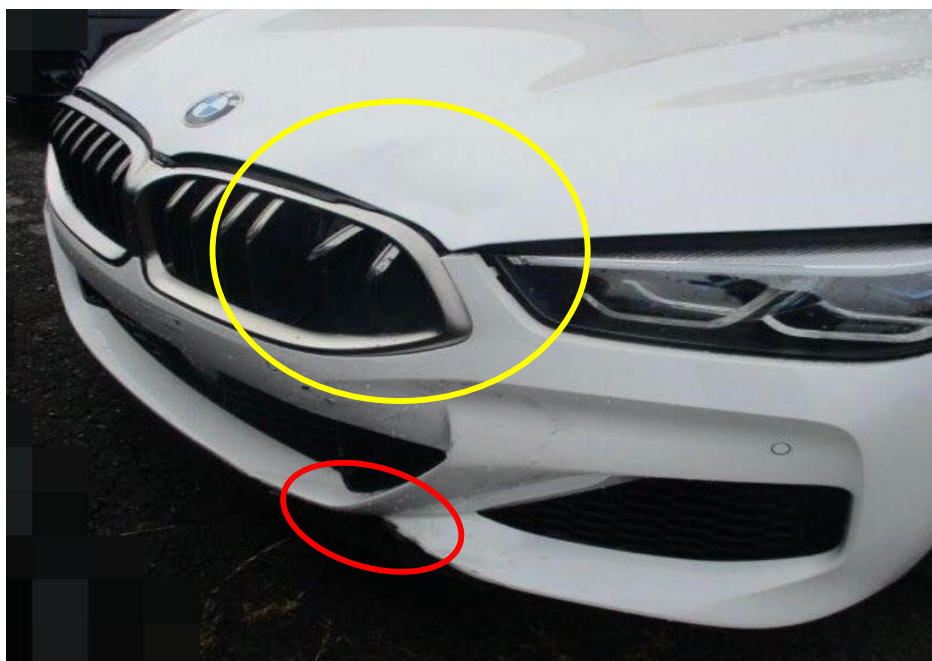
**Photo 2** shows a closer view of the damage at the frontal body of the Motor Car prior to any repairs being carried out (photograph provided to me). The front bumper (red circle), radiator grille and front bonnet (yellow circle) were observed to have been damaged.

22. The body parts at the frontal body of the Motor Car were all visually examined, and it was noted that the repair/restoration works carried out to the damaged area of the Motor Car (refer photograph 2 & 3 above) were reasonably adequate and in order.

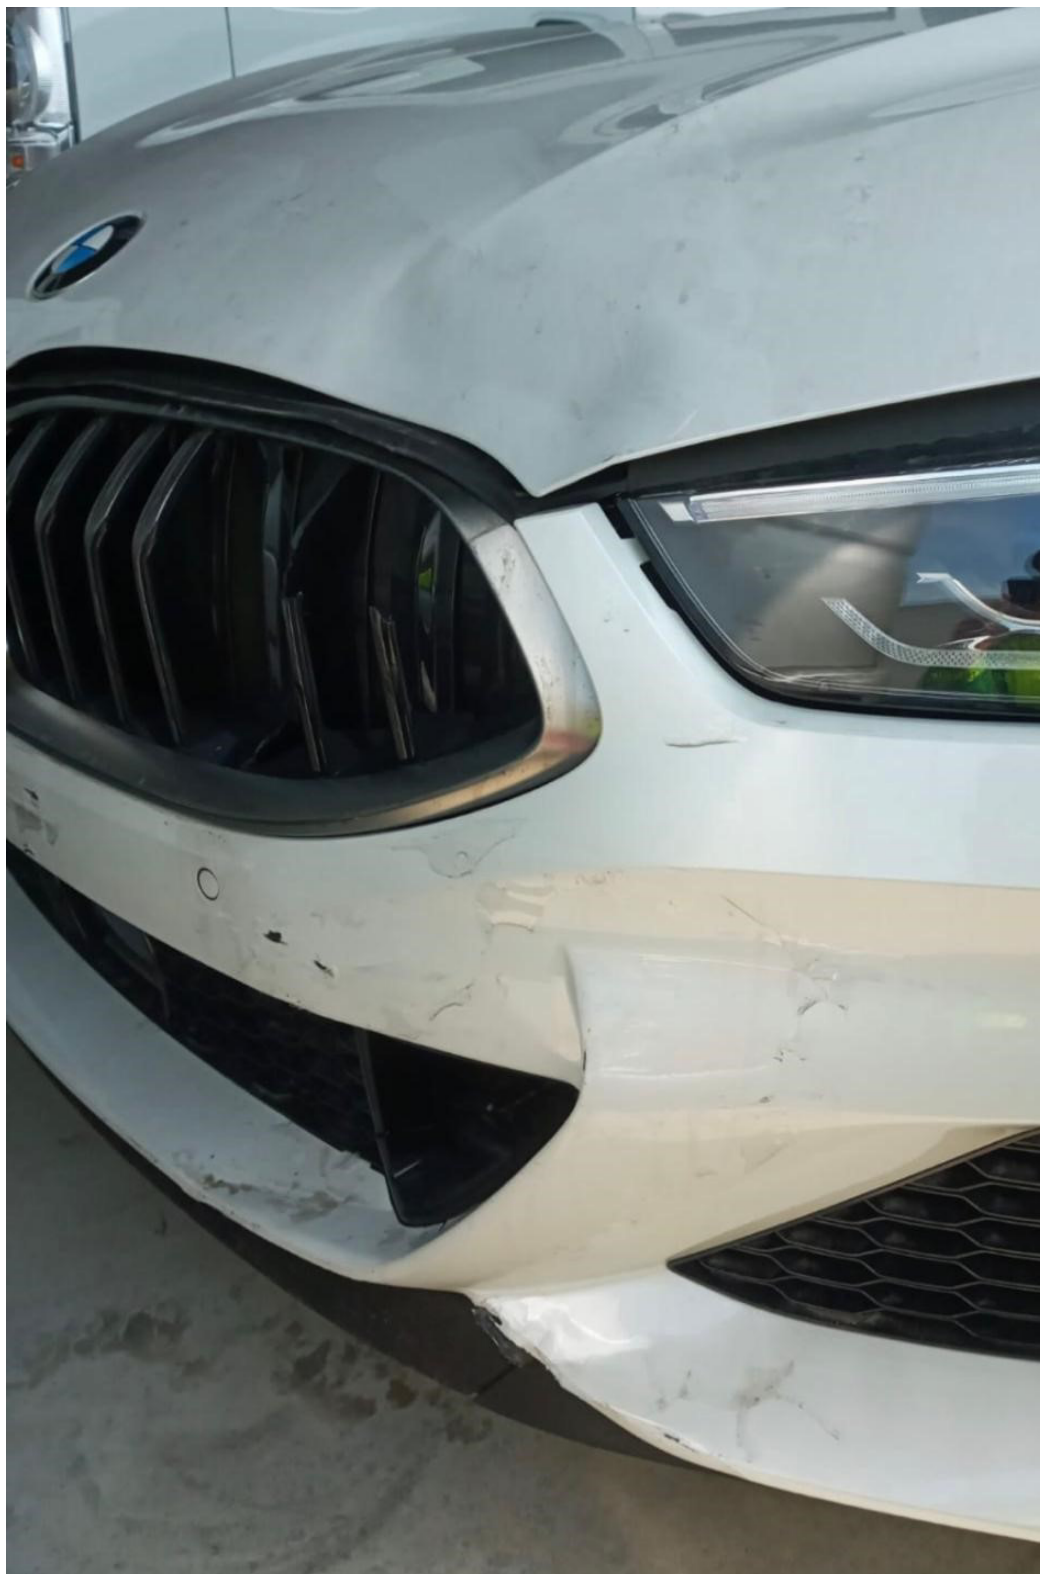
**Photo 3** shows a closer view of the damage at the frontal body of the Motor Car prior to any repairs being carried out (photograph provided to me). The front bumper, front bumper centre lower grille, radiator grille and front bonnet were observed to have been damaged.

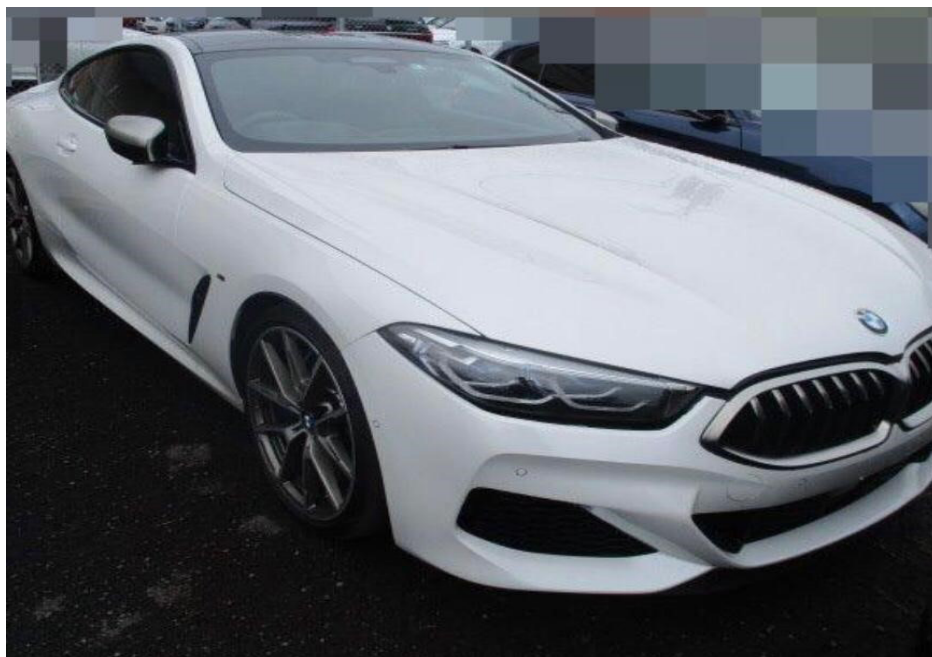
**Photo 4** shows the front right body of the Motor Car prior to any repairs being carried out (photograph provided to me). Apart for the frontal body, there was no physical damage observed to other areas of the Motor Car.

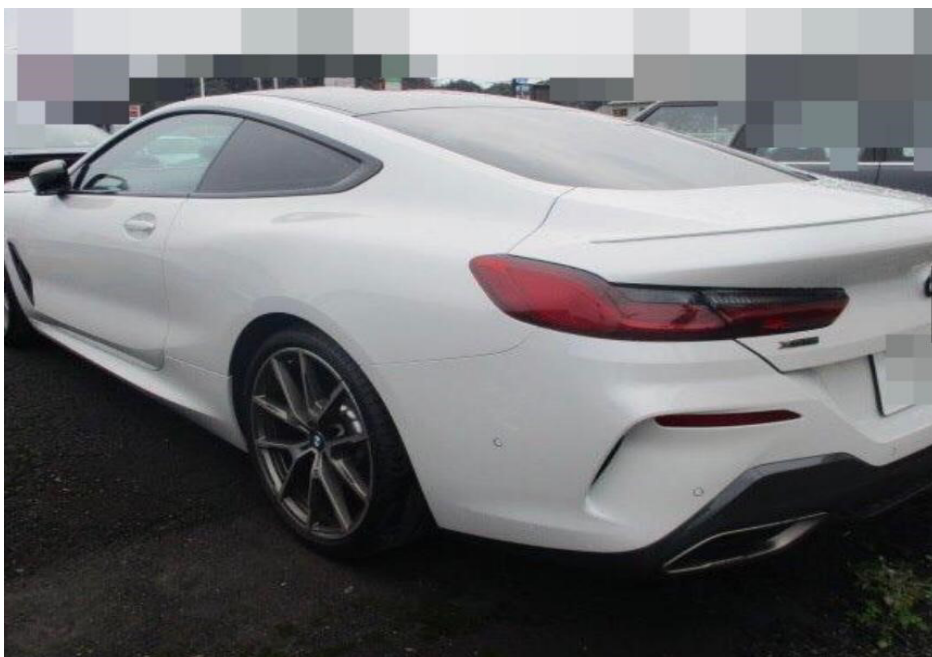
**Photo 5** shows the rear left body of the Motor Car prior to any repairs being carried out (photograph provided to me). Apart for the frontal body, there was no physical damage observed to other areas of the Motor Car.

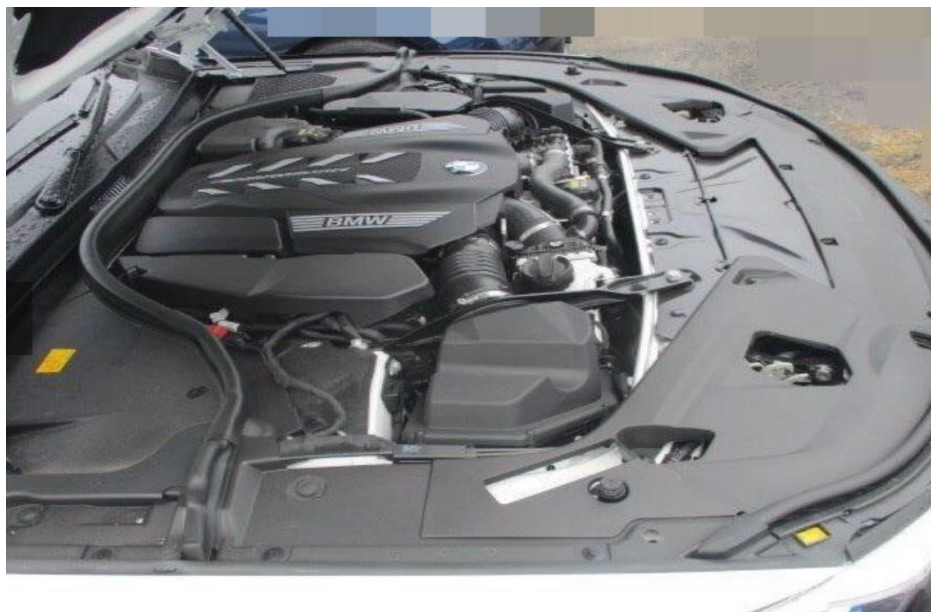
**Photo 6** shows the engine compartment of the Motor Car prior to any repairs being carried out (photograph provided to me). Parts within the engine compartment were intact and unaffected.

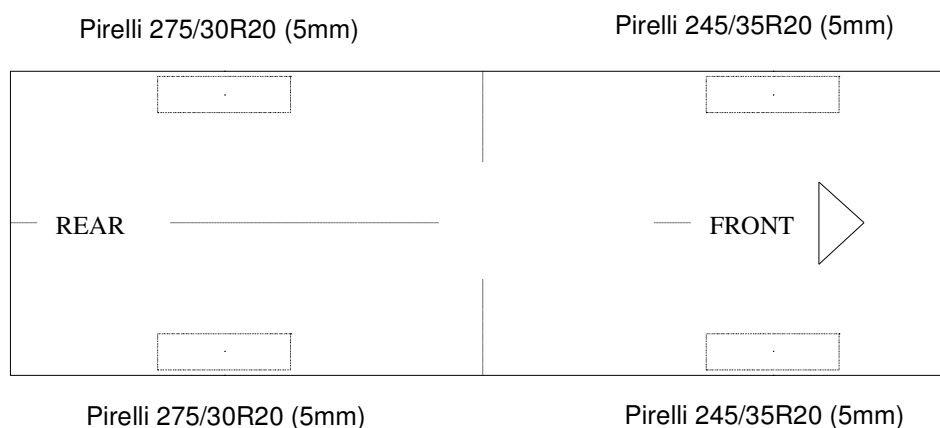
8. It was fitted with 20inch sport wheel rims that were wrapped with tyres that were observed to be of serviceable condition. The tyres were also sufficiently inflated for vehicular operation. The tyre brand, tyre size and approximate remaining tread depth of the 4 tyres of the Motor Car were recorded as follows: -

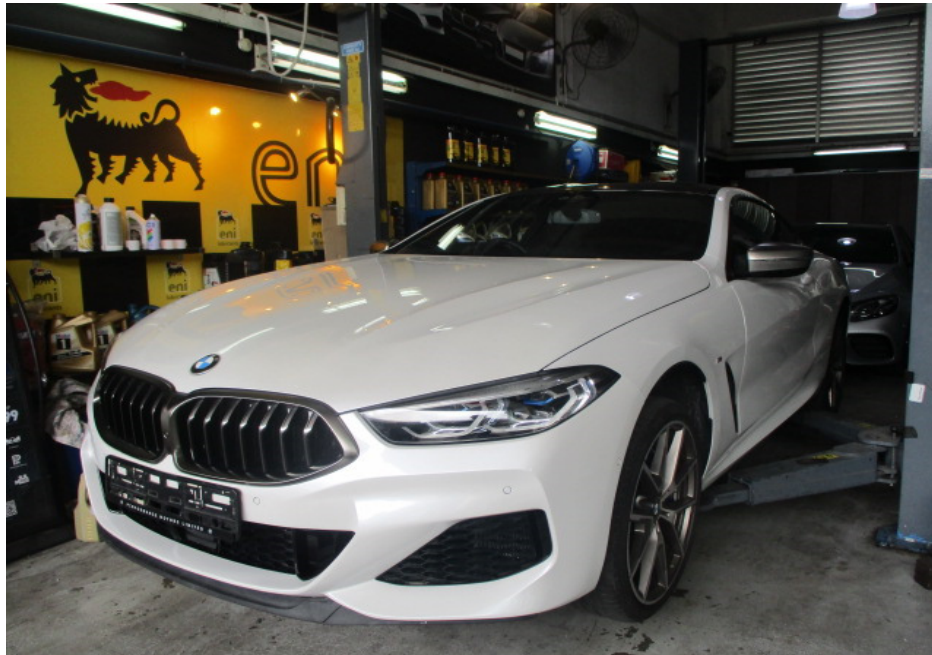
**Photo 7** shows a general view of the front left body of the Motor Car at the time of my inspection. The Motor Car was observed to be in a relatively good general condition with no loose exterior fittings observed. The body parts at the frontal body of the Motor Car were visually examined and it was observed that the repair/restoration works carried out to the damaged area of the Motor Car (refer to photograph 2 & 3) were reasonably adequate and in order.

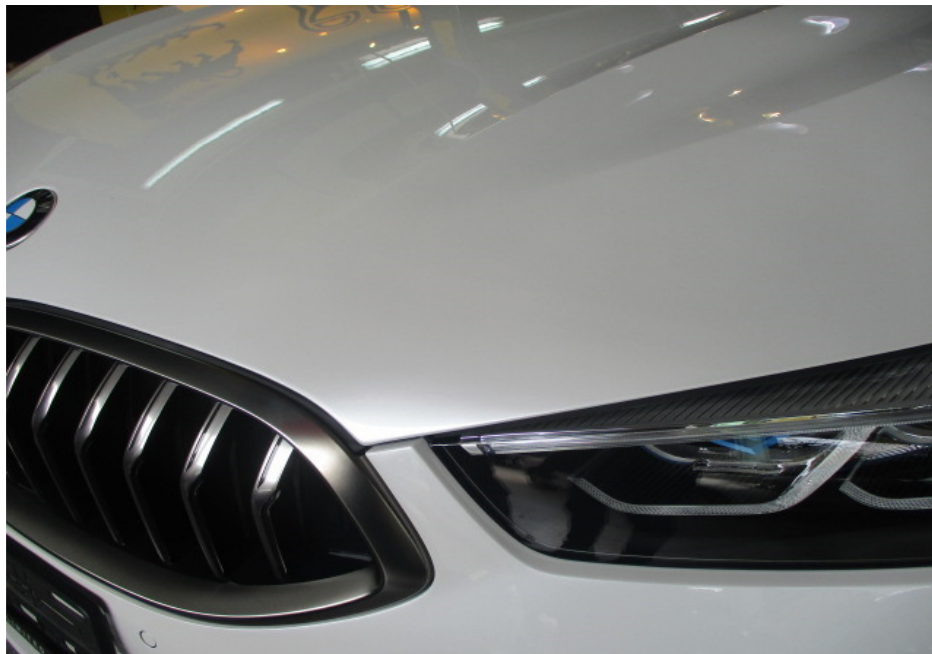
**Photo 8** shows a closer view of the front bonnet and radiator grille of the Motor Car. The body parts at the frontal body of the Motor Car were visually examined and it was observed that the repair/restoration works carried out to the damaged area of the Motor Car (refer to photograph 2 & 3 above) were reasonably adequate and in order.

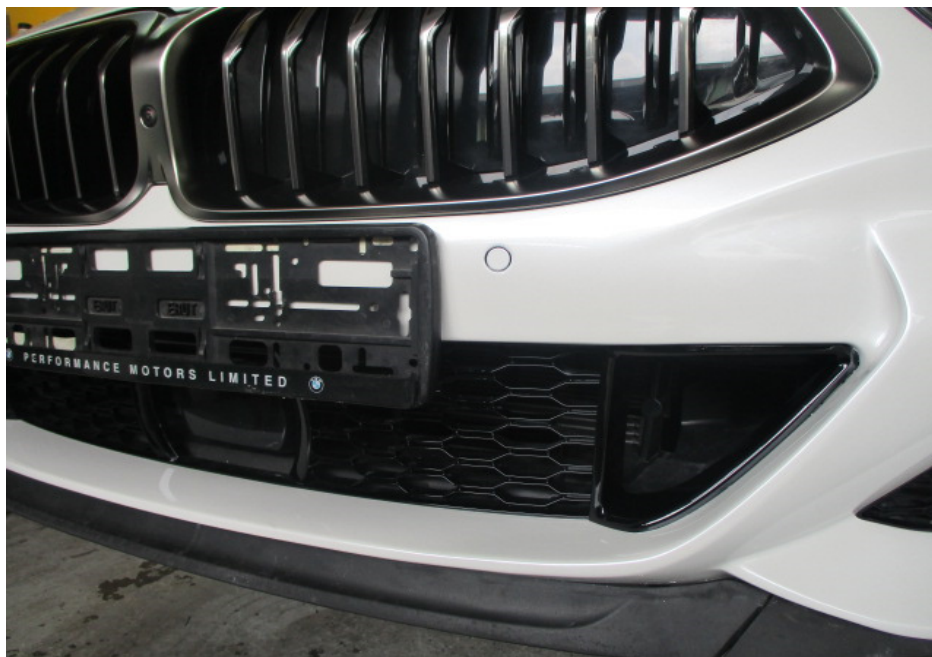
**Photo 9** shows a closer view of the front bumper, front bumper centre lower grille and radiator grille of the Motor Car. The body parts at the frontal body of the Motor Car were visually examined and it was observed that the repair/restoration works carried out to the damaged area of the Motor Car (refer to photograph 2 & 3 above) were reasonably adequate and in order.

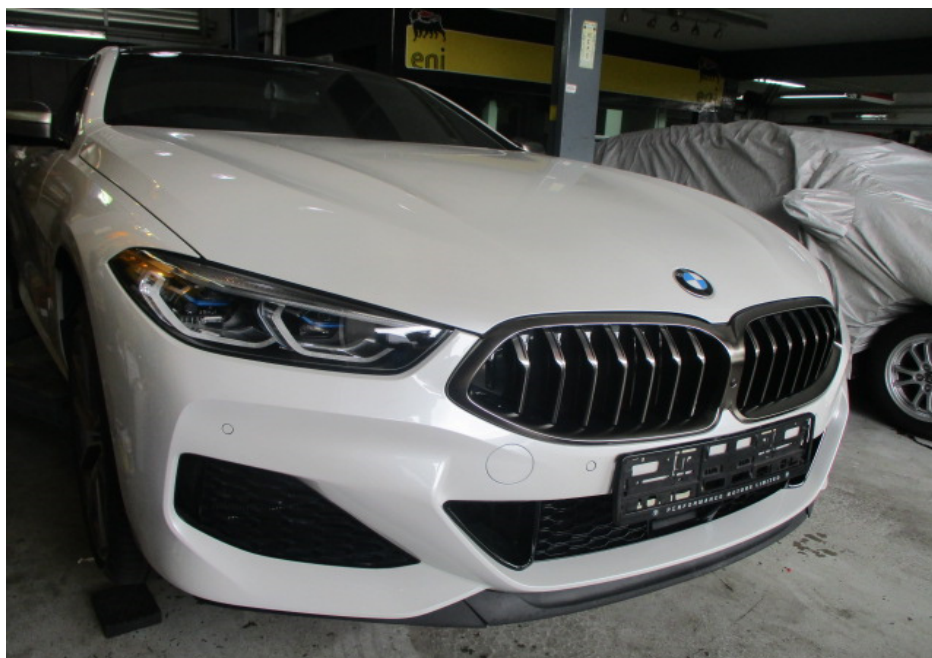
**Photo 10** shows a general view of the front right body of the Motor Car at the time of my inspection. The Motor Car was observed to be in a relatively good general condition with no loose exterior fittings observed. The body parts at the frontal body of the Motor Car were visually examined and it was observed that the repair/restoration works carried out to the damaged area of the Motor Car (refer to photograph 2 & 3) were reasonably adequate and in order.

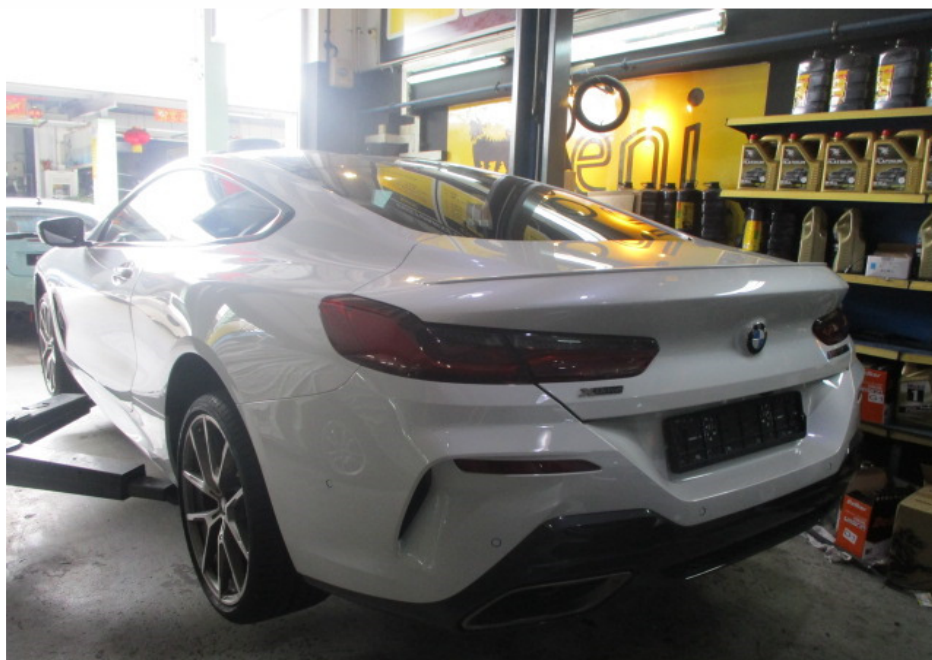
**Photo 11** shows a general view of the rear left body of the Motor Car at the time of my inspection. The Motor Car was observed to be in a relatively good general condition with no loose exterior fittings observed. The mileage of the Motor Car recorded at the time of my inspection was 2,219km.

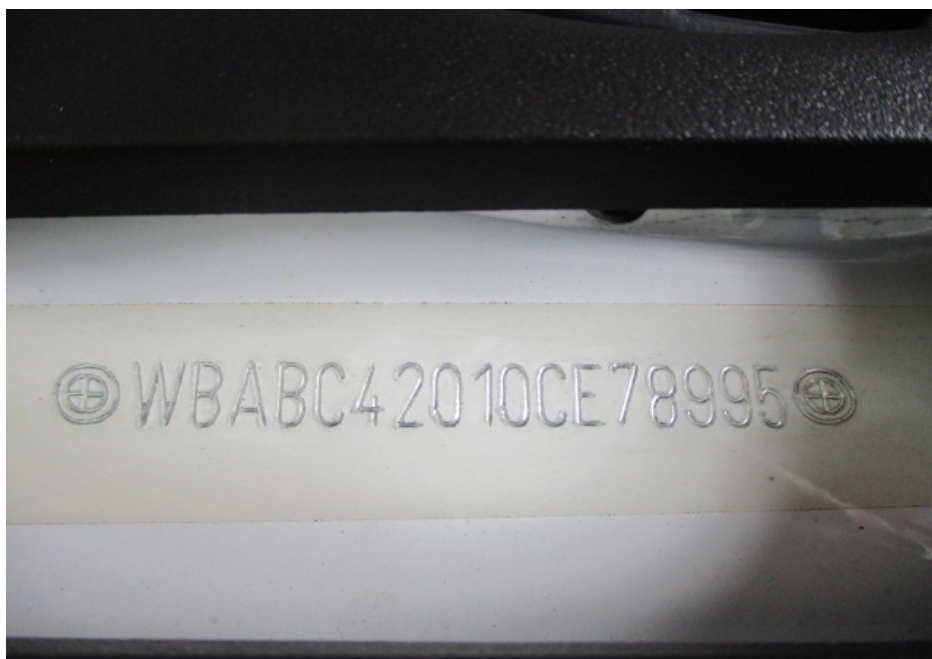
**Photo 12** shows the chassis number of the Motor Car. The chassis number recorded was WBABC42010CE78995.

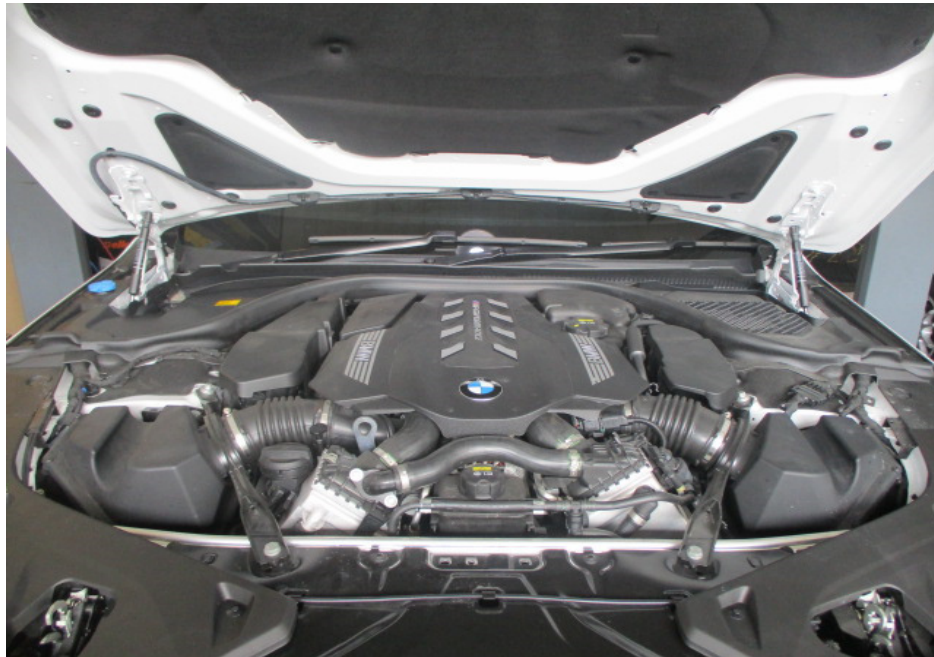
**Photo 13** shows a general view of the engine compartment of the Motor Car at the time of my inspection. The various parts and components inside the engine compartment were all observed to be intact and properly fitted. There was also no sign(s) or indication(s) of fluid leak and/or fluid stain found inside the engine compartment.

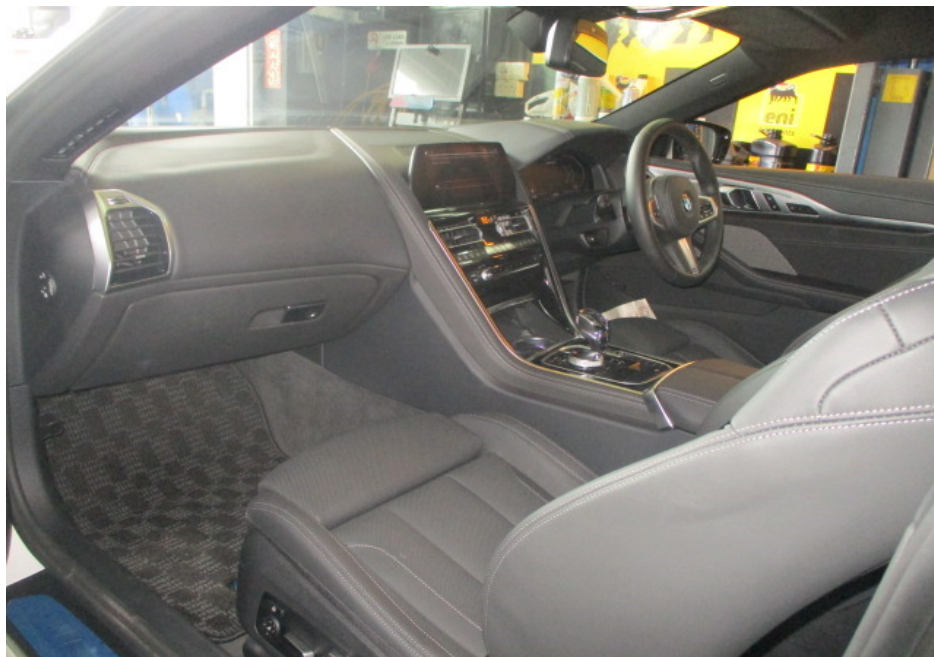
**Photo 14** shows a general view of the interior compartment of the Motor Car at the time of my inspection. The various parts and components, trims, carpet and upholstery inside the interior compartment were all observed to be intact and properly fitted.

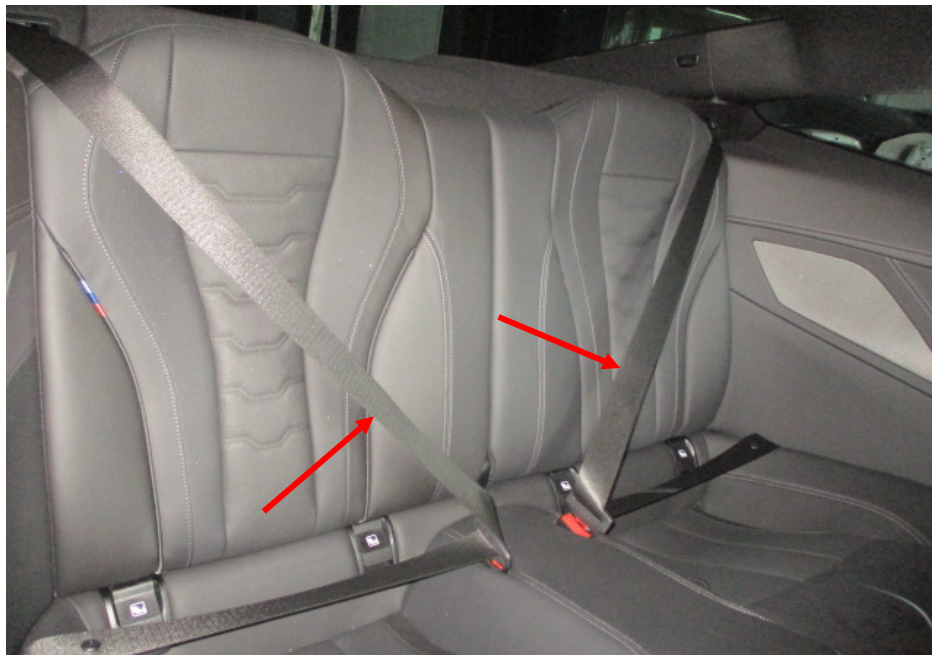
**Photo 15** shows the rear seats of the Motor Car. All the seats of the Motor Car were secured via seat rails to the floorboard. They were also fitted with a retractable seat belt reel and a pre-tensioner. The seat belts (arrowed) of the Motor Car were tested and were able to be fastened into the respective pre-tensions that were fitted on the side of each individual seat.

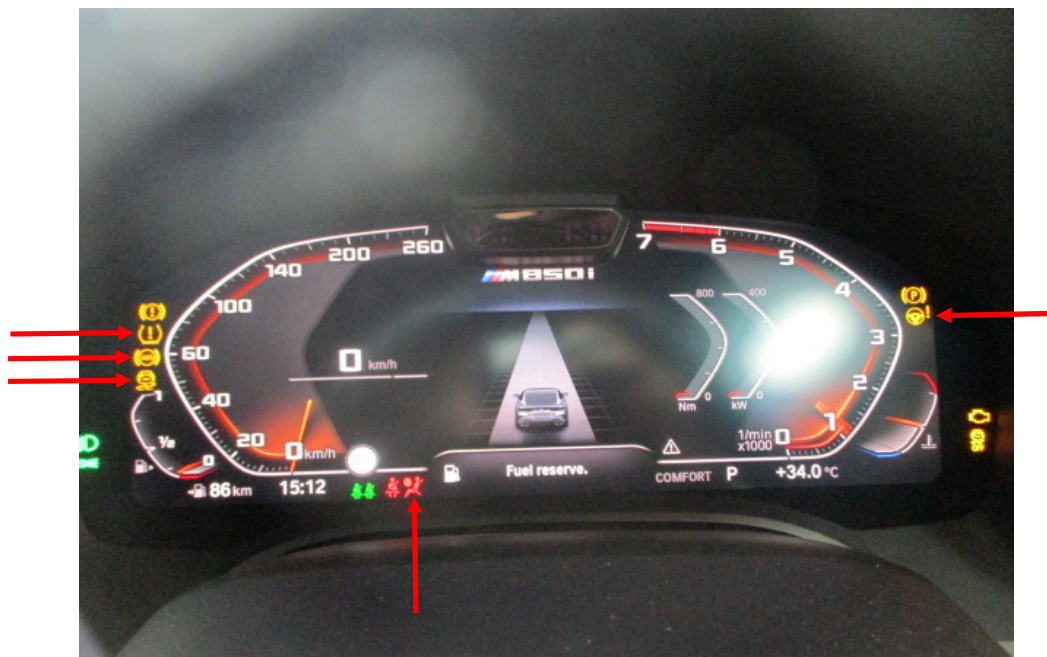
**Photo 16** shows the warning lights for the various electronic safety features appearing on the instrument panel of the Motor Car during its self-test when the engine is cranked, in particular the ABS, SRS, IAS, TPM and DSC lights (arrowed).

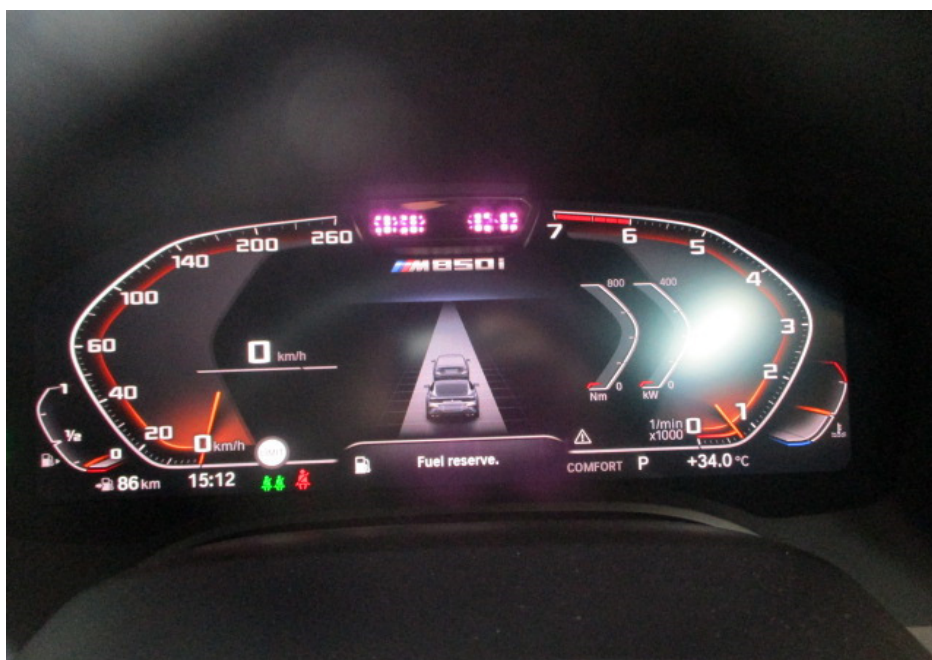
**Photo 17** shows the respective warning lights no longer illuminated, indicating that there is no fault detected to the ABS, SRS, IAS, TPM and DSC systems of the Motor Car during the self-test. These electronic systems were hence in working condition at the time of my inspection.

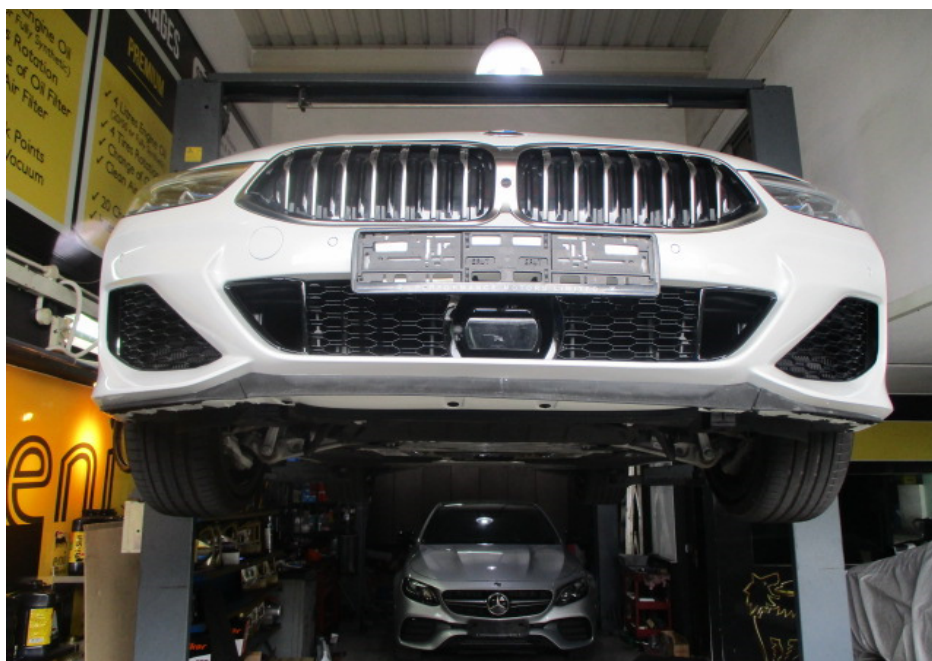
**Photo 18** shows the Motor Car hoisted up for checks on its undercarriage. There was no sign(s) or indication(s) of fluid leakage and/or fluid stain(s) on the underside of the Motor Car. The undercarriage components of the Motor Car were also all observed to be intact and secured in an appropriate manner.

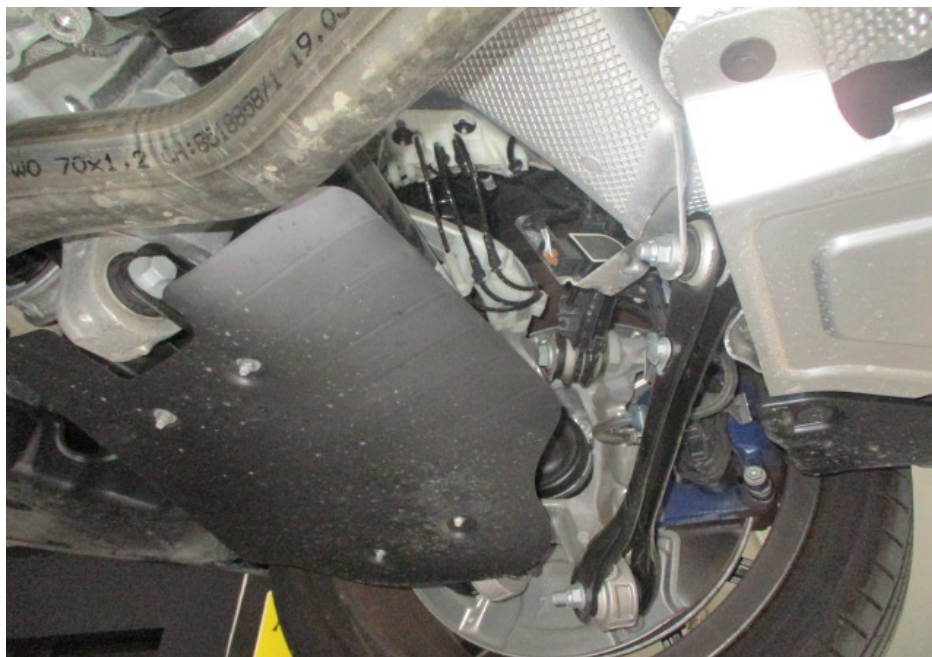
**Photo 19** shows a general view of the control arms and linkages at the rear left wheel of the Motor Car. I did not observe any fluid leak and/or fluid stain on the underside of the Motor Car. All the Motor Car's undercarriage components were observed to be intact and secured in an appropriate manner.

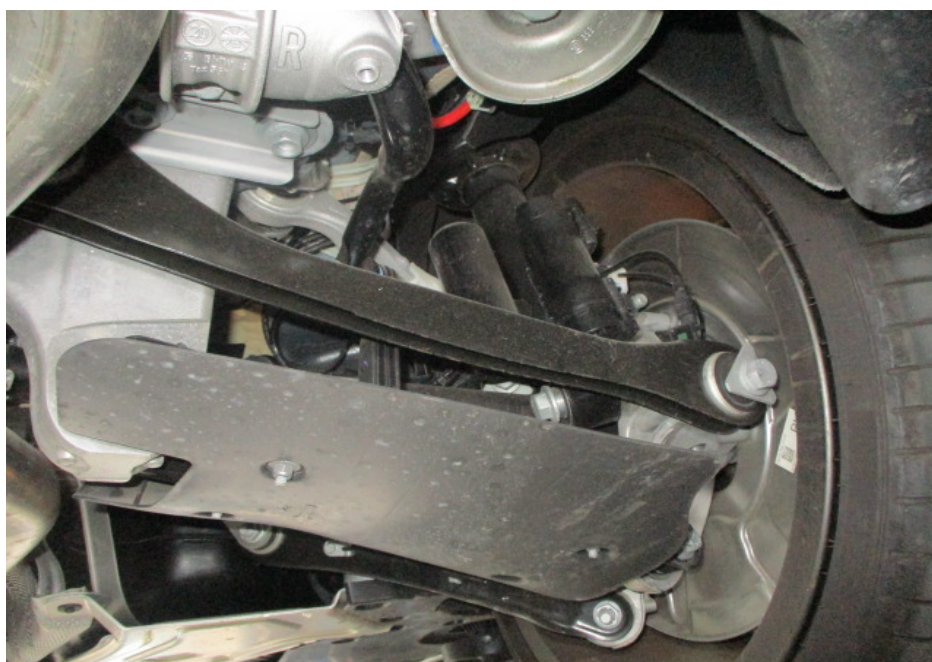
**Photo 20** shows the various undercarriage components at the rear right wheel of the Motor Car. The various mechanical components, control arms and linkages were all found to be intact and secured in an appropriate manner.

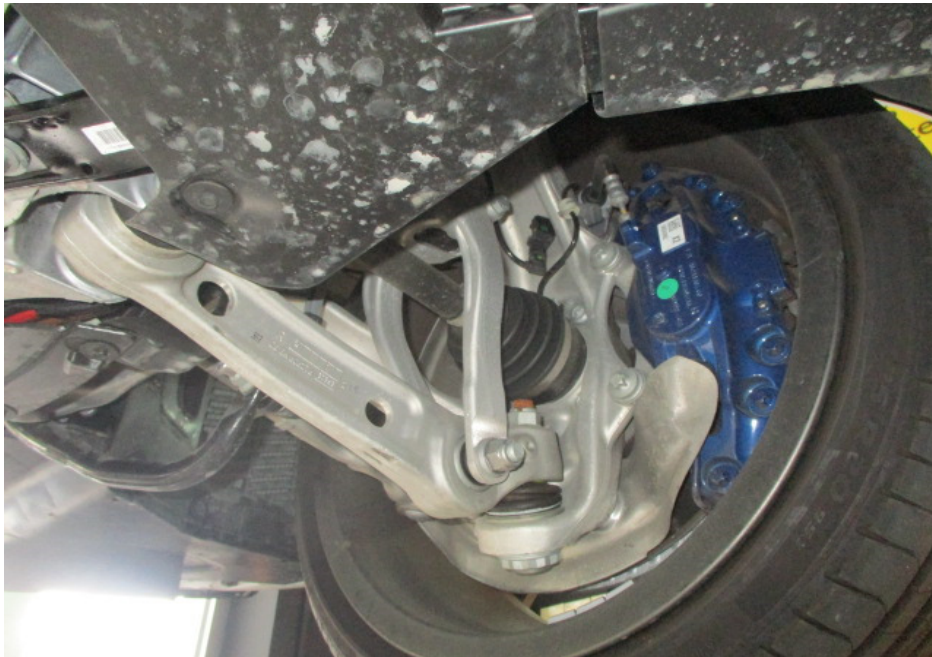
**Photo 21** shows the various undercarriage components at the front right wheel of the Motor Car. The mechanical components, control arms and linkages were all found to be intact and secured in an appropriate manner. I also did not observe any fluid leak and/or fluid stain on the underside of the Motor Car.

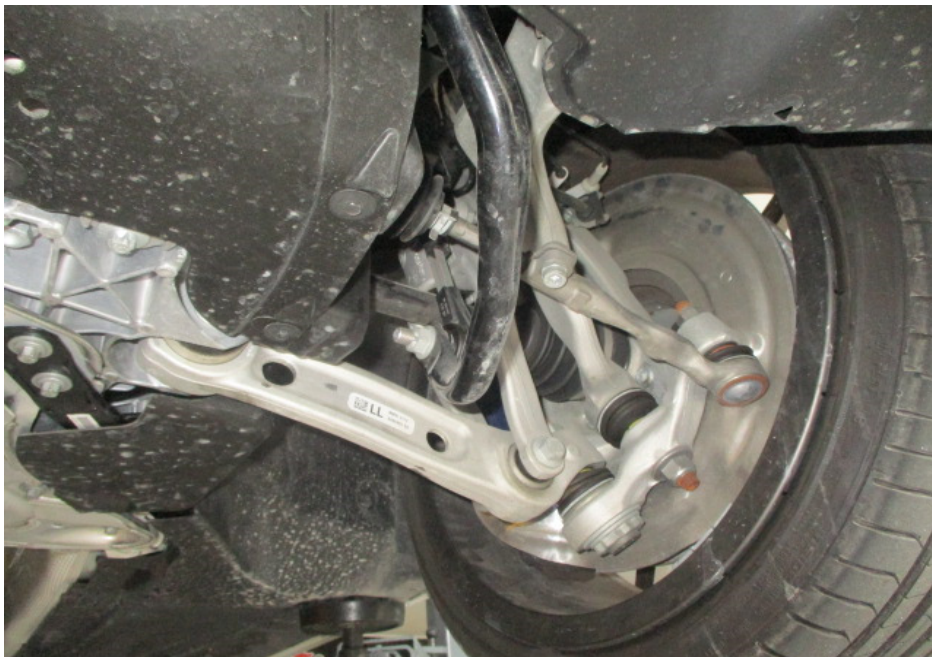
**Photo 22** shows the various undercarriage components at the front left wheel of the Motor Car. The mechanical components, control arms and linkages were all found to be intact and secured in an appropriate manner.

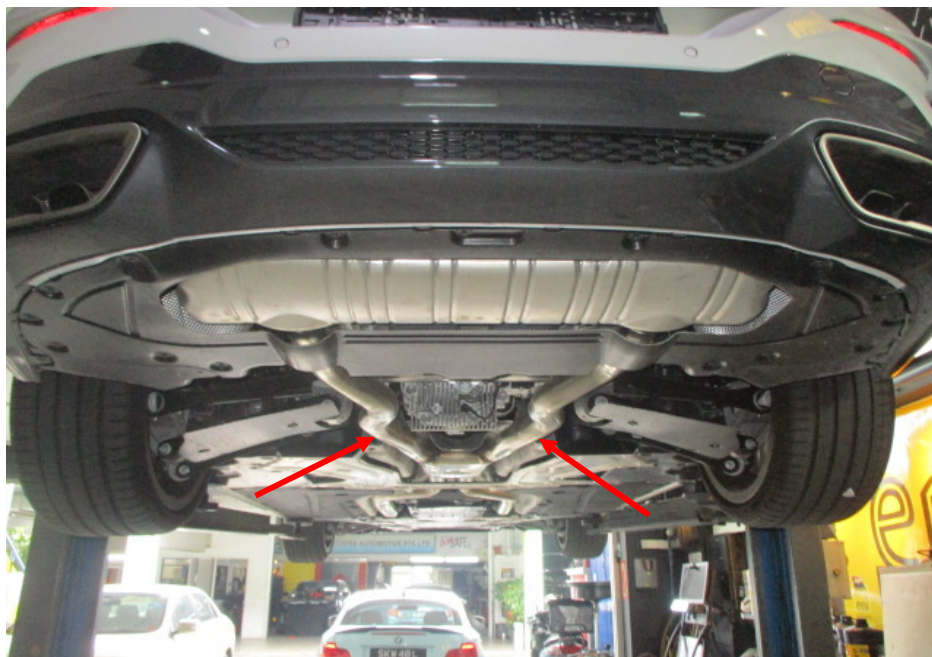
**Photo 23** shows a general view of the rear section of the Motor Car's exhaust system. My examination of the Motor Car's exhaust system revealed no sign(s) or indication(s) of any cut or weld marks along its exhaust pipes (arrowed), on its catalytic converters, centre resonator box and on its rear muffler.

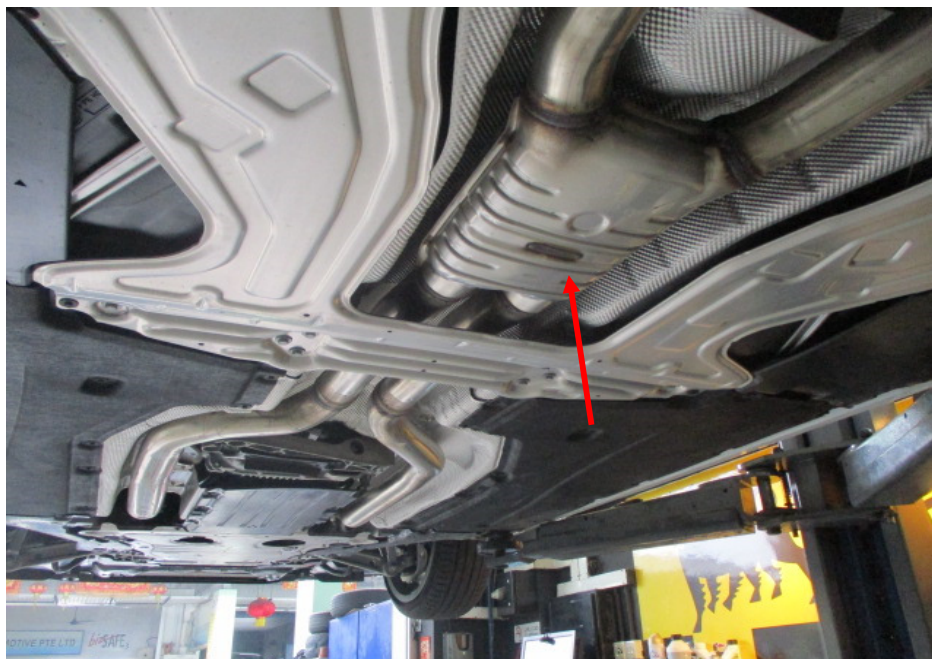
**Photo 24** shows a general view of the front section of the Motor Car's exhaust system. My examination of the Motor Car's exhaust system revealed no sign(s) or indication(s) of any cut or weld marks along its exhaust pipes, on its catalytic converters, centre resonator box (arrowed) and on its rear muffler.

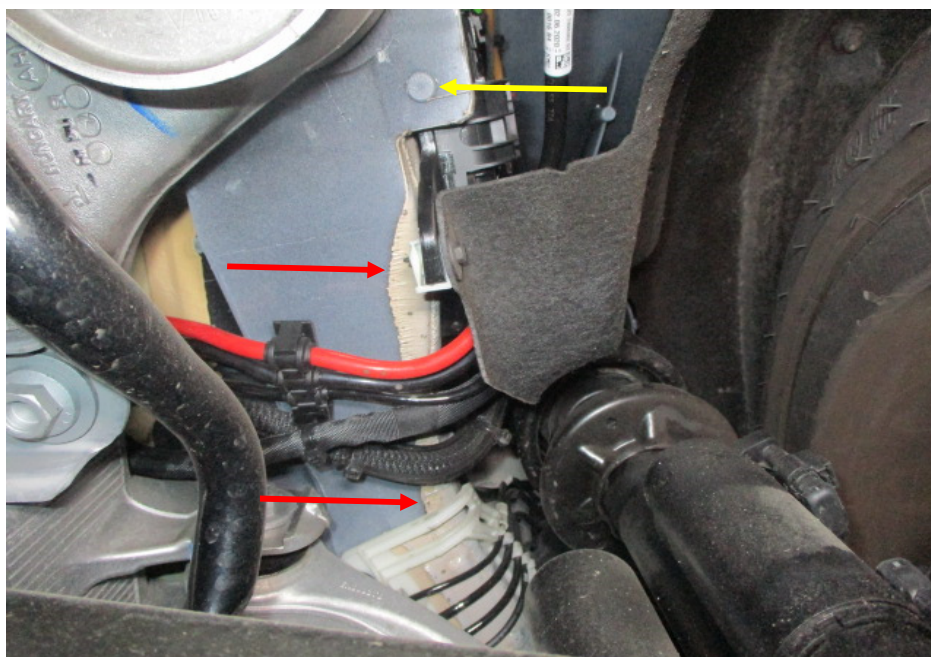
**Photo 25** shows the chassis/structural body at the underside rear right of the Motor Car. I did not find any weld marks other than original spot weld marks (yellow arrow) on the chassis/structural body of the Motor Car. The original factory sealant (red arrow) at the joints along the chassis/structural body was untouched, indicating no work was done on the chassis/structural body of the Motor Car and that the chassis/structural body was originally fitted.

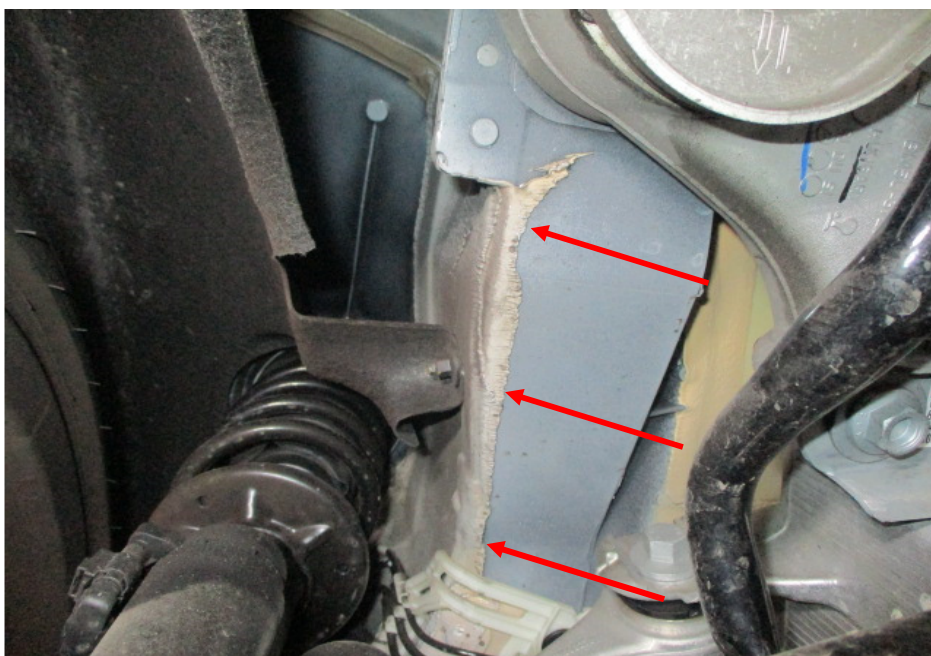
**Photo 26** shows the chassis/structural body at the underside rear left of the Motor Car. The original factory sealant (arrowed) at the joints along the chassis/structural body was untouched, indicating no work was done on the chassis/structural body of the Motor Car and that the chassis/structural body was originally fitted.

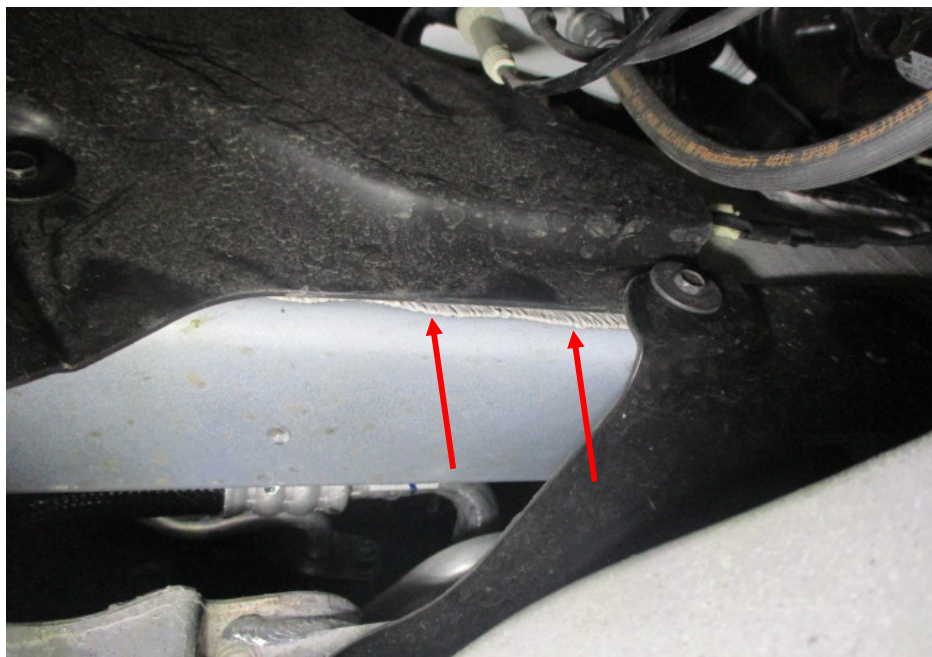
**Photo 27** shows the chassis/structural body at the underside front left of the Motor Car. The original factory sealant (arrowed) at the joints along the chassis/structural body was observed to be untouched. In general, I had found no work was carried out on the chassis/structural body of the Motor Car. The chassis/structural body of the Motor Car was originally fitted.

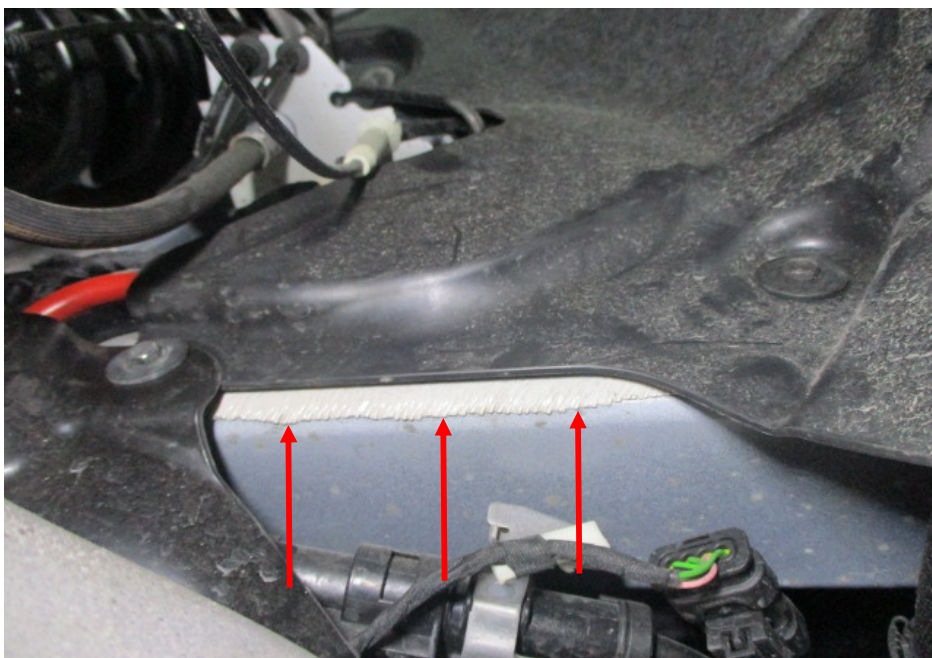
**Photo 28** shows the chassis/structural body at the underside front right of the Motor Car. I did not find any weld marks other than original spot weld marks on the chassis/structural body of the Motor Car. The original factory sealant (arrowed) at the joints along the chassis/structural body was untouched, indicating no work was done on the chassis/structural body of the Motor Car and that the chassis/structural body was originally fitted.

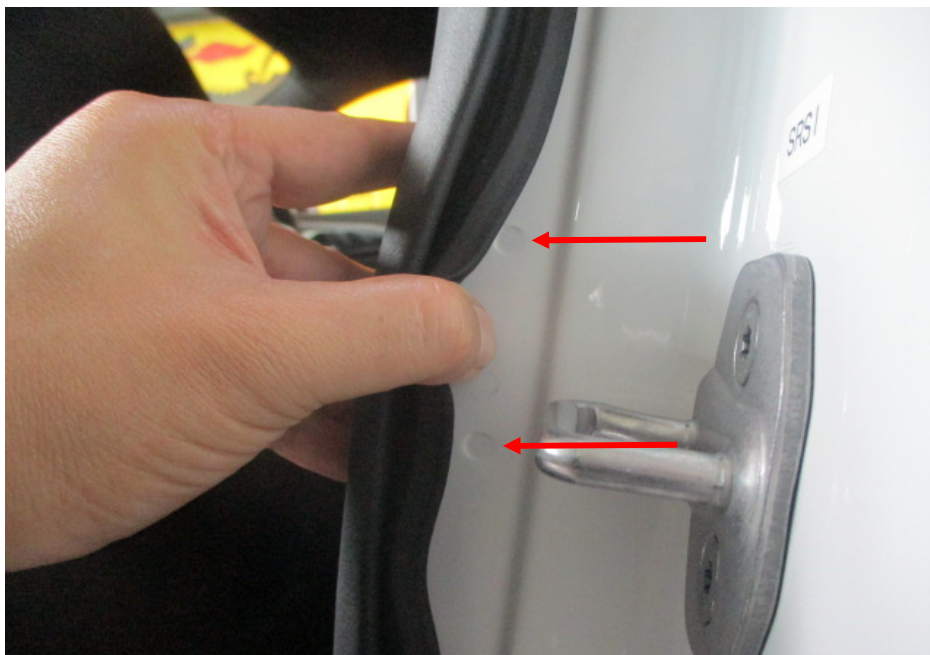
**Photo 29** shows the left side rear body panel of the Motor Car. I did not find any weld marks other than original spot weld marks (arrowed) on the left side rear body panel of the Motor Car which, indicates that there was no re-welding works carried out. In general, I had found all the non-detachable body panels of the Motor Car to be originally fitted at the time of my inspection.
