Your Ref: Porsche Cayenne
(chassis number WP1ZZZ9YZKDA05558)
Our Ref : CI/TP21008093/D

31 July 2021

INSPECTION REPORT OF AN UNREGISTERD PORSCHE CAYENNE MOTOR CAR WITH CHASSIS NUMBER WP1ZZZ9YZKDA05558

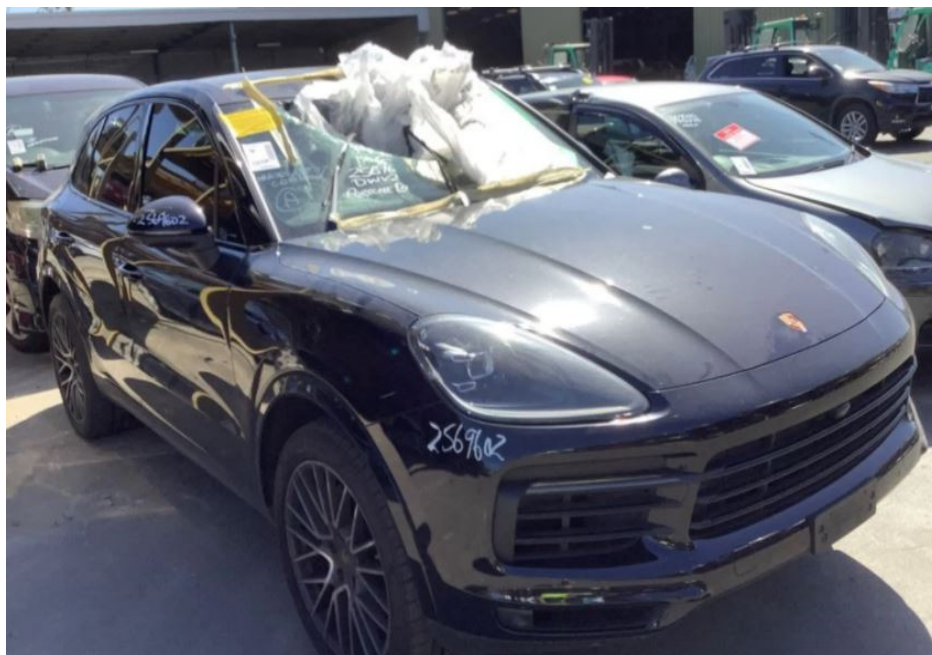
Photo 1 shows the front right body of the Motor Car prior to any repairs being carried out (photograph provided to me). The Motor Car did not appear to have sustain physical damage to its exterior body panels. Its front windscreen was however observed to be shattered.

21. The front windscreen and damaged parts within the interior compartment of the Motor Car were visually examined and it was noted that the repair/restoration works carried out to the damaged area of the Motor Car (refer to photograph 1 – 4 above) were reasonably adequate and in order.

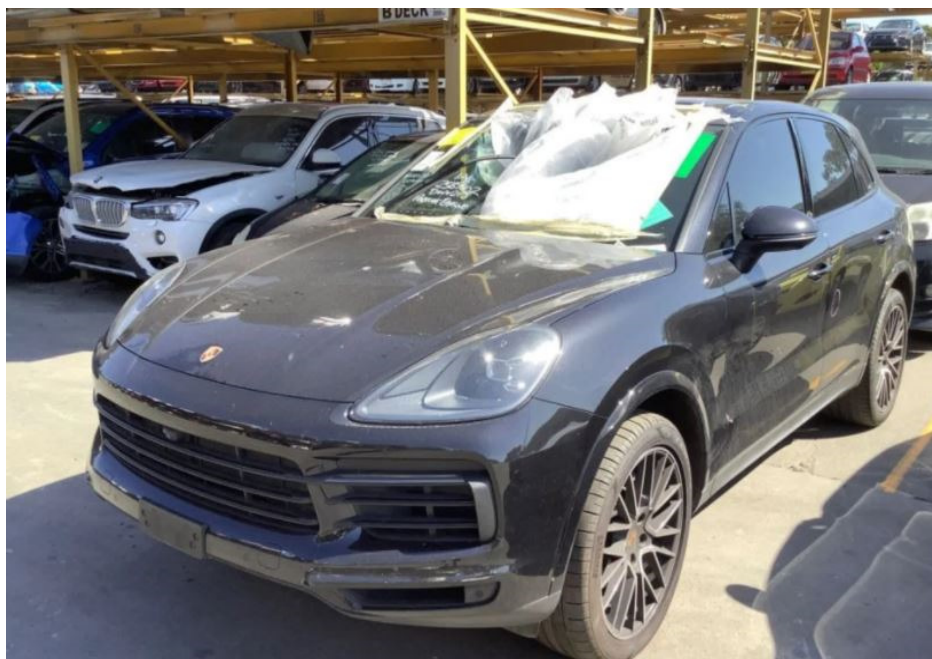
Photo 2 shows the front left body of the Motor Car prior to any repairs being carried out (photograph provided to me). The Motor Car did not appear to have sustain physical damage to its exterior body panels. Its front windscreen was however observed to be shattered.

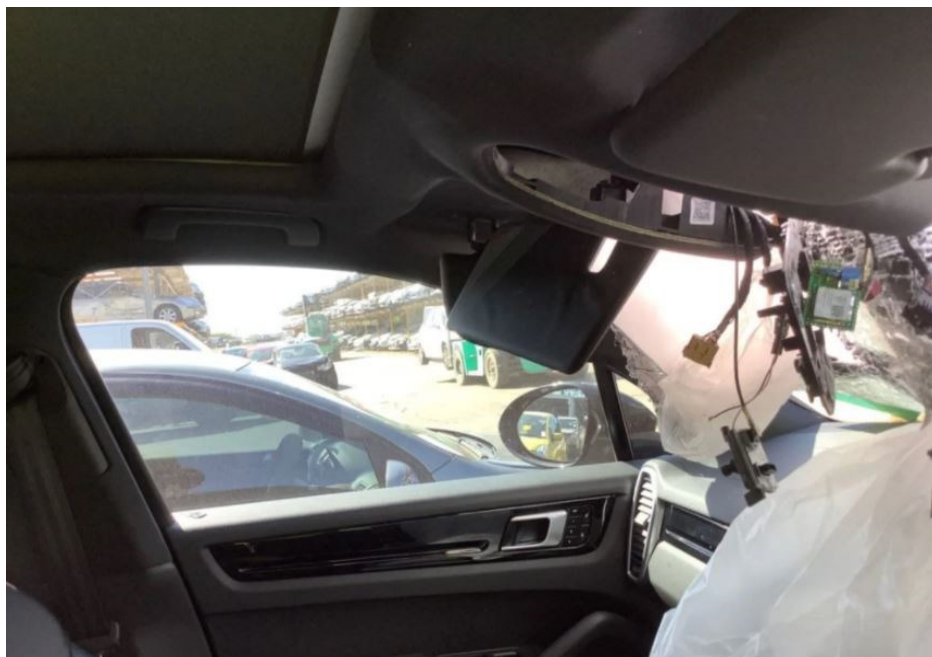
Photo 3 shows the interior compartment of the Motor Car prior to any repairs being carried out (photograph provided to me). The interior roof upholstery, interior sun visors, rear view mirror and interior top control panel were all observed to be damaged. The airbags of the Motor Car were not deployed as seen from the photographs that were provided to me.

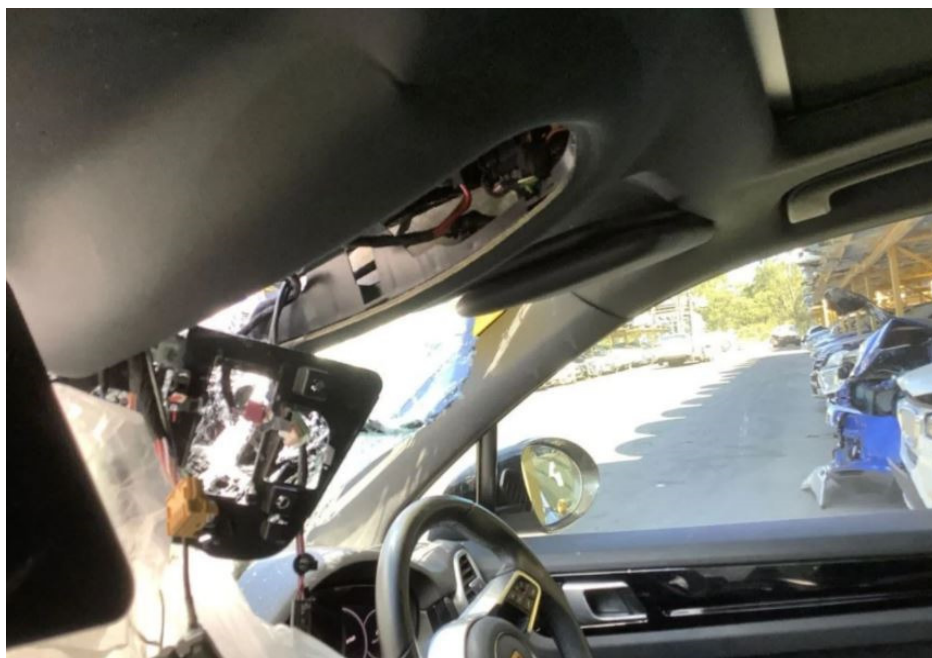
Photo 4 shows the interior compartment of the Motor Car prior to any repairs being carried out (photograph provided to me). The interior roof upholstery, interior sun visors, rear view mirror and interior top control panel were all observed to be damaged. The airbags of the Motor Car were not deployed as seen from the photographs that were provided to me.

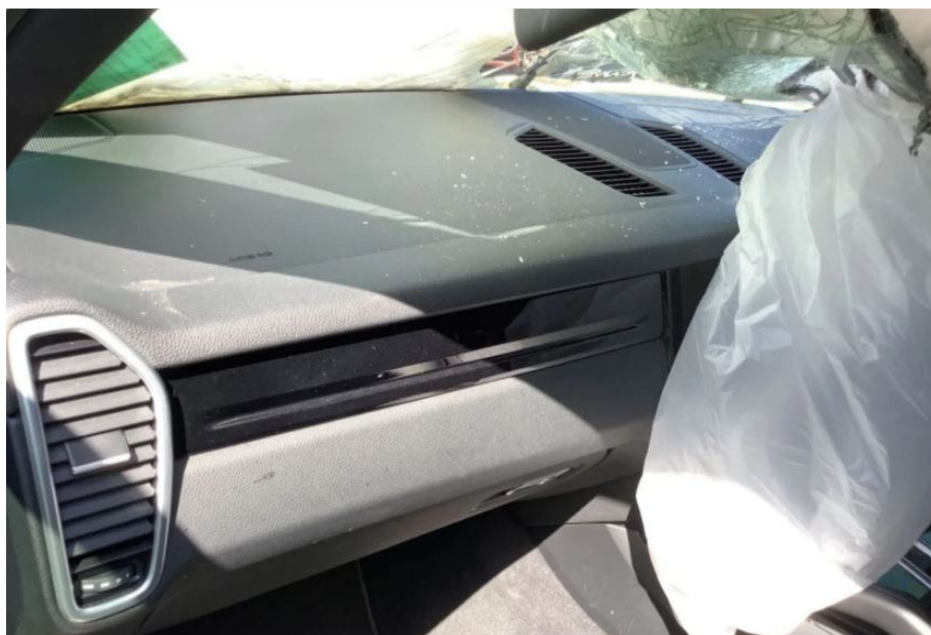
Photo 5 shows the front dashboard of the Motor Car prior to any repairs being carried out (photograph provided to me). The front dashboard did not appear to have sustain physical damage.

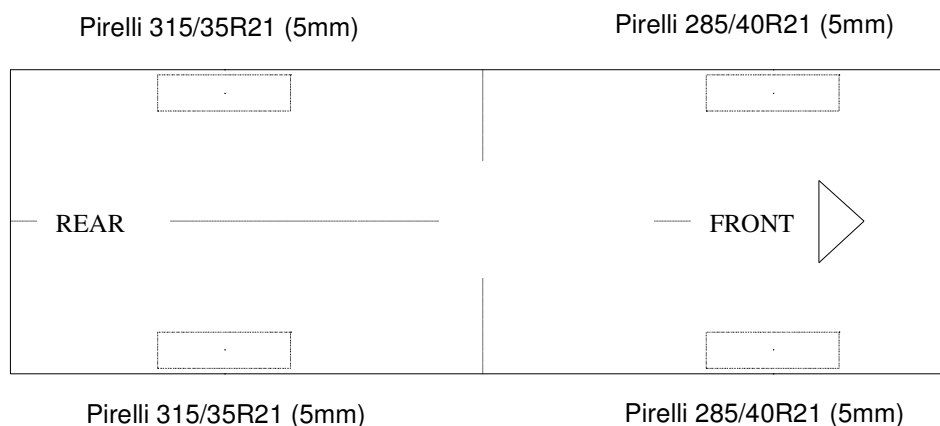
7. It was fitted with 21inch sport wheel rims that were wrapped with tyres that were observed to be of serviceable condition. The tyres were also sufficiently inflated for vehicular operation. The tyre brand, tyre size and approximate remaining tread depth of the 4 tyres of the Motor Car were recorded as follows: -

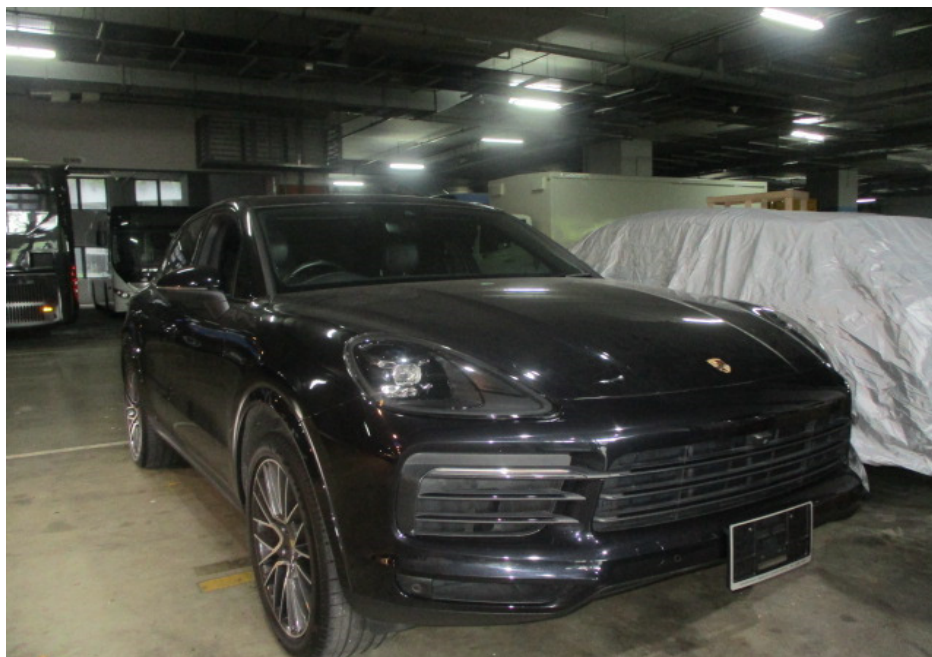
Photo 6 shows a general view of the front right body of the Motor Car at the time of my inspection. The Motor Car was observed to be in a relatively good general condition with no loose exterior fittings observed. The front windscreen of the Motor Car was visually examined, and it was observed that the repair/restoration works carried out to the damaged area of the Motor Car (refer to photograph 1 & 2 above) were reasonably adequate and in order.

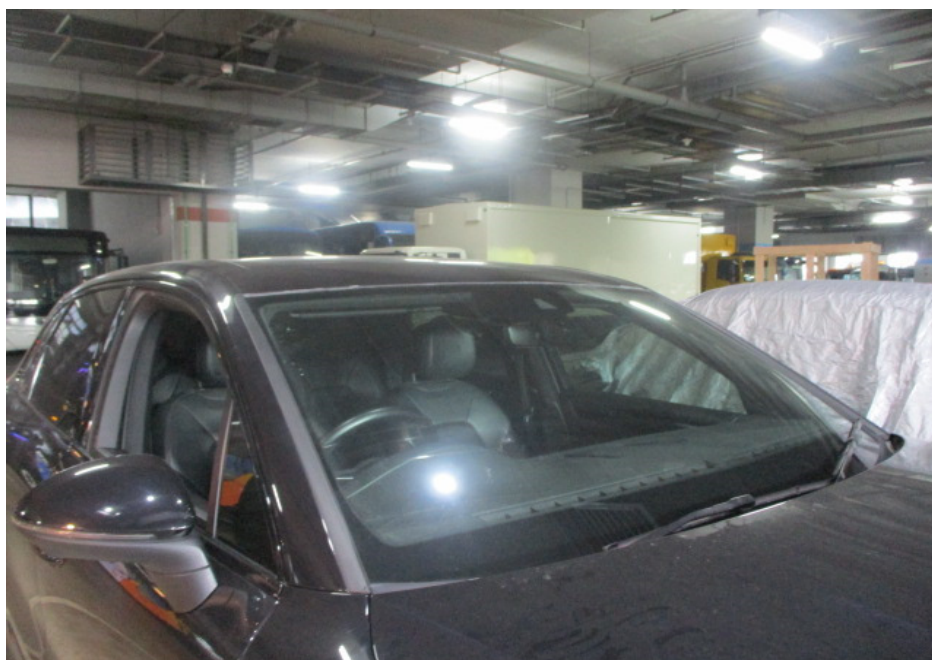
Photo 7 shows a closer view of the Motor Car's front windscreen. The repair/restoration works carried out to the damaged area of the Motor Car (refer to photograph 1 & 2 above) were reasonably adequate and in order.

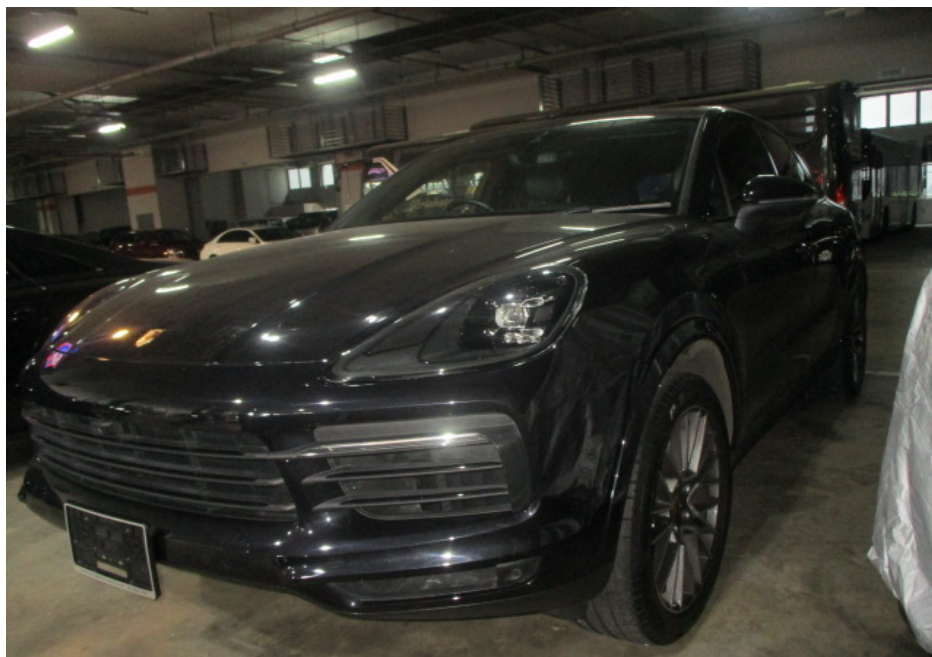
Photo 8 shows a general view of the front left body of the Motor Car at the time of my inspection. The Motor Car was observed to be in a relatively good general condition with no loose exterior fittings observed. The front windscreen of the Motor Car was visually examined, and it was observed that the repair/restoration works carried out to the damaged area of the Motor Car (refer to photograph 1 & 2 above) were reasonably adequate and in order.

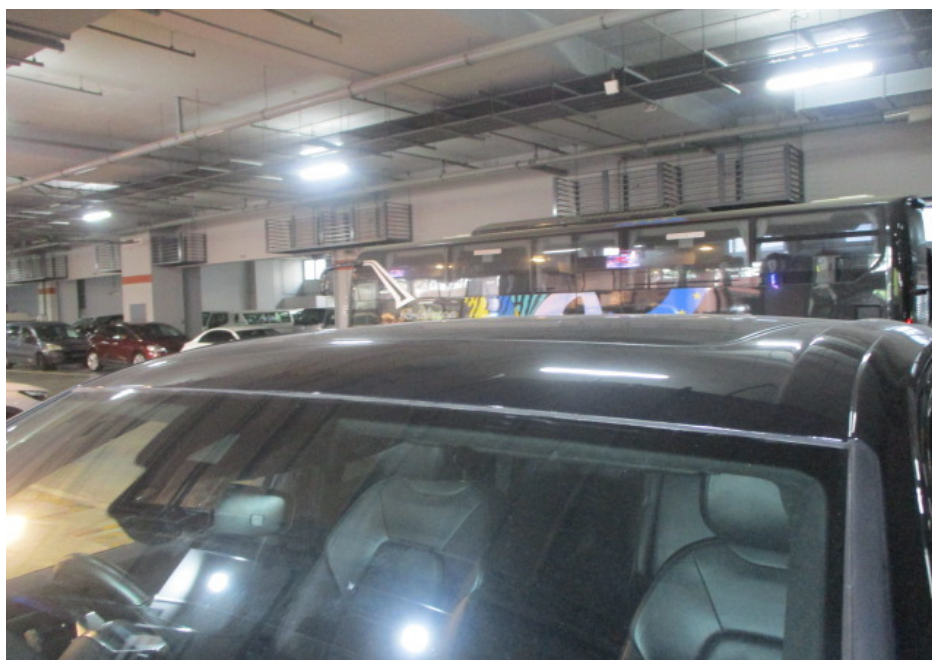
Photo 9 shows a closer view of the Motor Car's front windscreen. The repair/restoration works carried out to the damaged area of the Motor Car (refer to photograph 1 & 2 above) were reasonably adequate and in order.

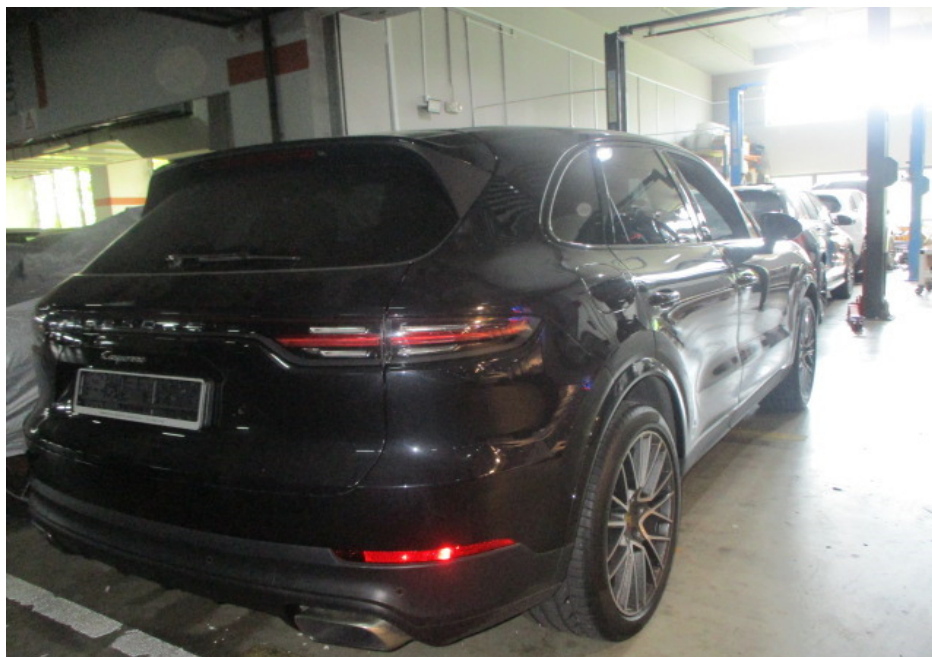
Photo 10 shows a general view of the rear right body of the Motor Car at the time of my inspection. The Motor Car was observed to be in a relatively good general condition with no loose exterior fittings observed. The mileage of the Motor Car recorded at the time of my inspection was 49,801km.

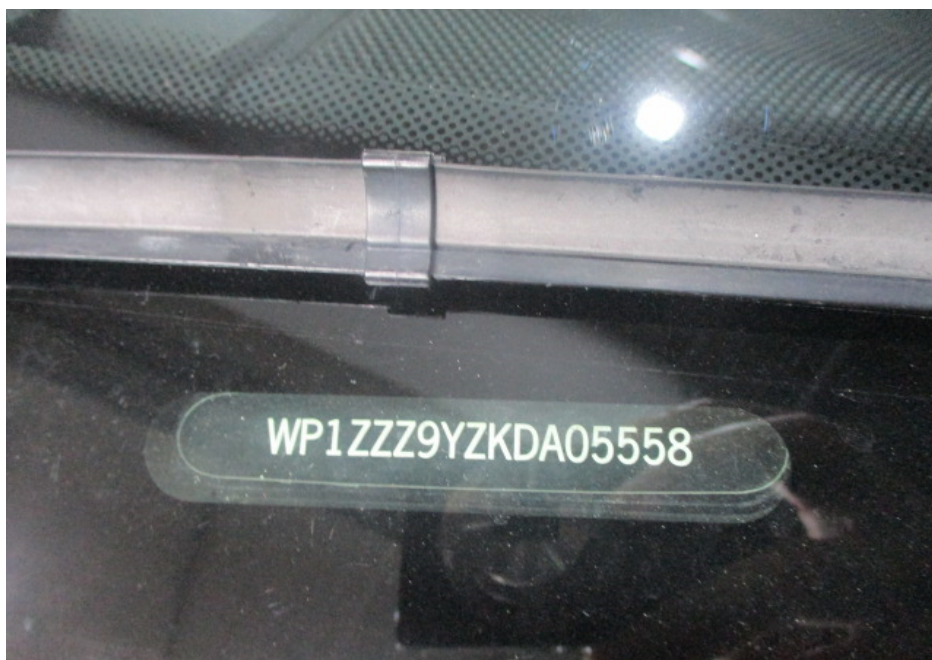
Photo 11 shows the chassis number of the Motor Car. The chassis number recorded was WP1ZZZ9YZKDA05558.

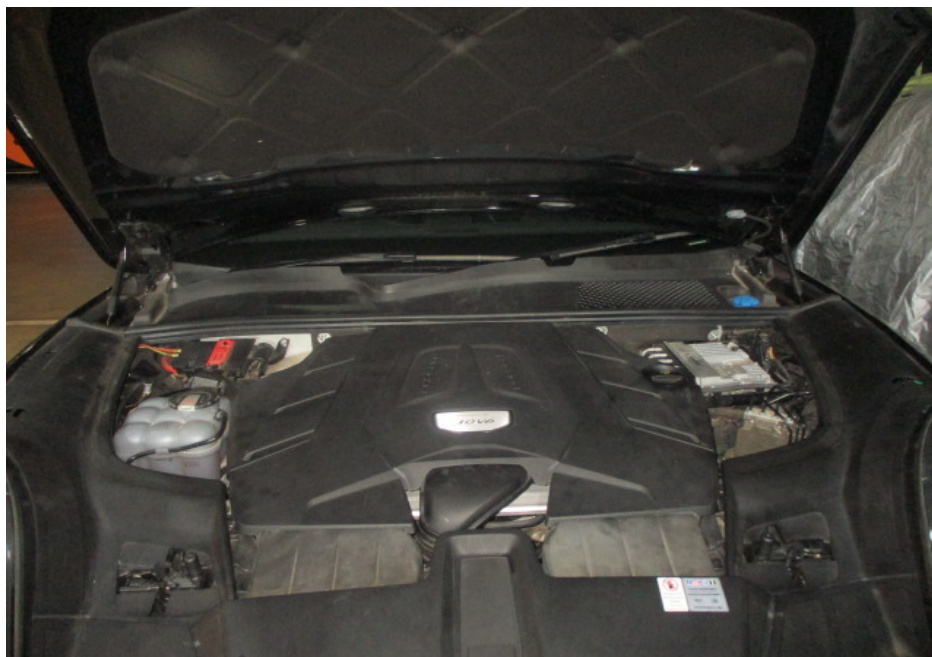
Photo 12 shows a general view of the engine compartment of the Motor Car at the time of my inspection. The various parts and components inside the engine compartment were all observed to be intact and properly fitted. There was also no sign(s) or indication(s) of fluid leak and/or fluid stain found inside the engine compartment.

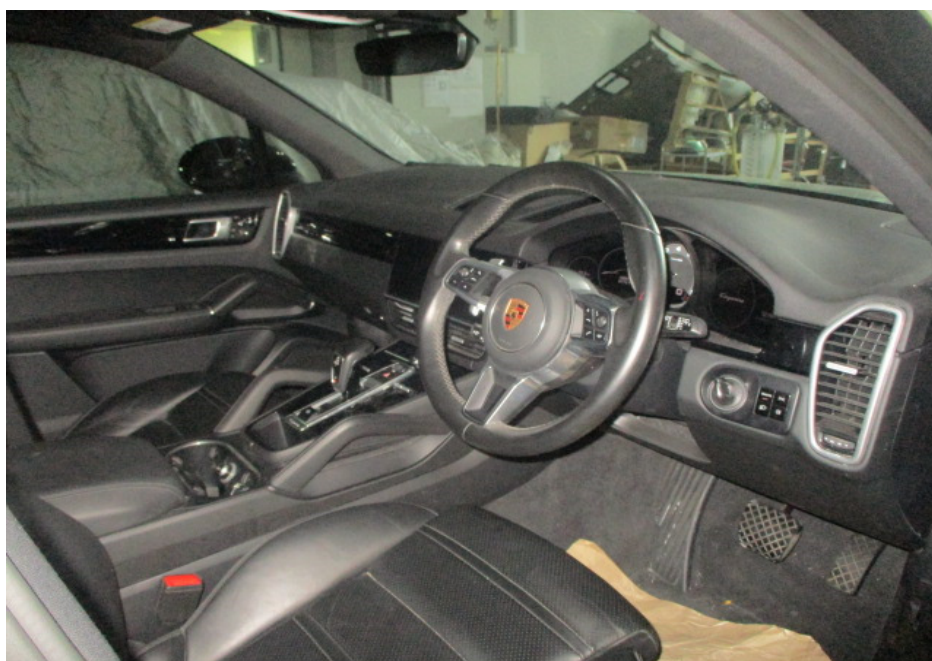
Photo 13 shows the interior compartment of the Motor Car at the time of my inspection. The various parts and components, trims, carpet and upholstery inside the interior compartment were all observed to be intact and properly fitted. The repair/restoration works carried out to the damaged area of the Motor Car (refer to photograph 3 & 4 above) were reasonably adequate and in order.

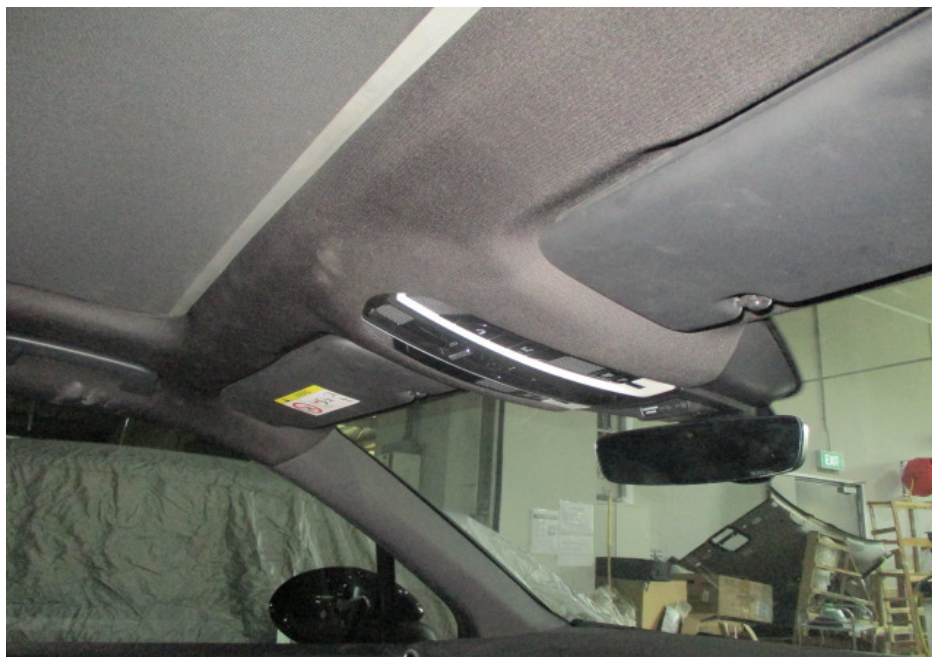
Photo 14 shows a closer view of the Motor Car's interior roof upholstery, interior sun visors, rear view mirror and interior top control panel. The repair/restoration works carried out to the damaged area of the Motor Car (refer to photograph 3 & 4 above) were reasonably adequate and in order.

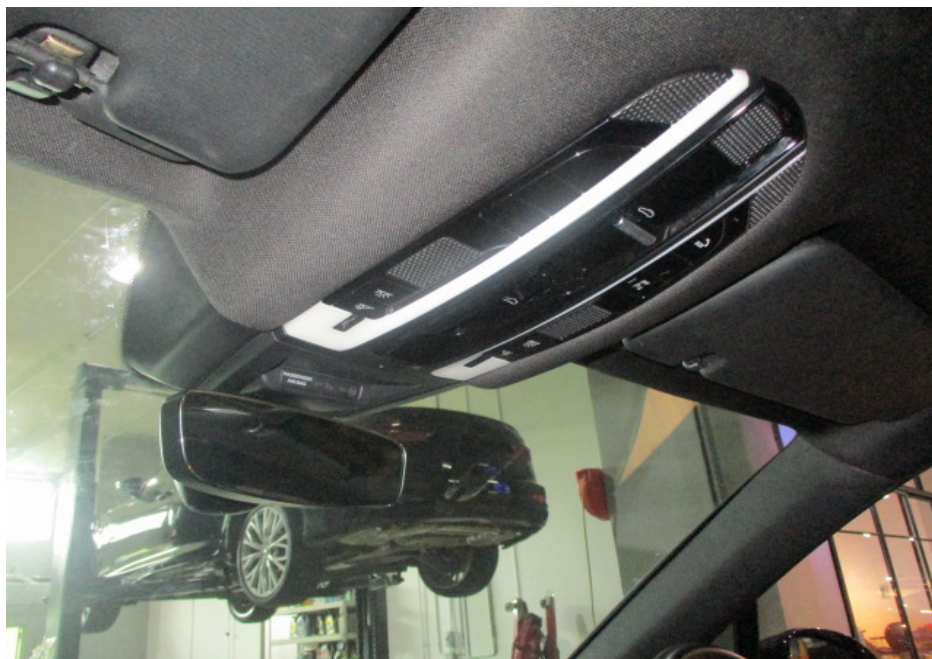
Photo 15 shows a closer view of the Motor Car's interior roof upholstery, interior sun visors, rear view mirror and interior top control panel. The repair/restoration works carried out to the damaged area of the Motor Car (refer to photograph 3 & 4 above) were reasonably adequate and in order.

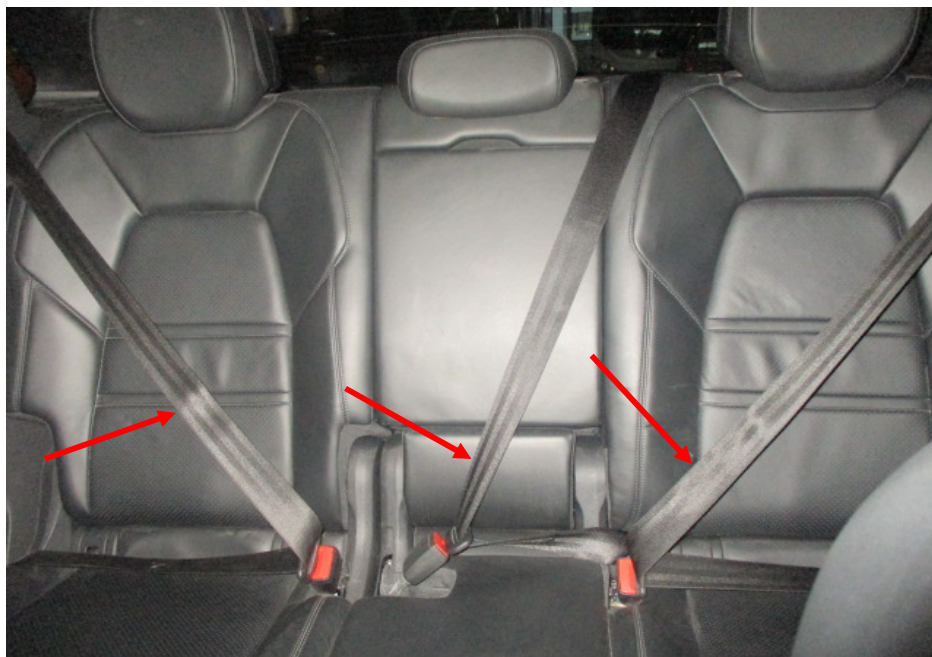
Photo 16 shows the rear seats of the Motor Car. All the seats of the Motor Car were secured via seat rails to the floorboard. They were also fitted with a retractable seat belt reel and a pre-tensioner. The seat belts (arrowed) were tested and were able to be fastened into the respective pre-tensions that were fitted on the side of each individual seat.

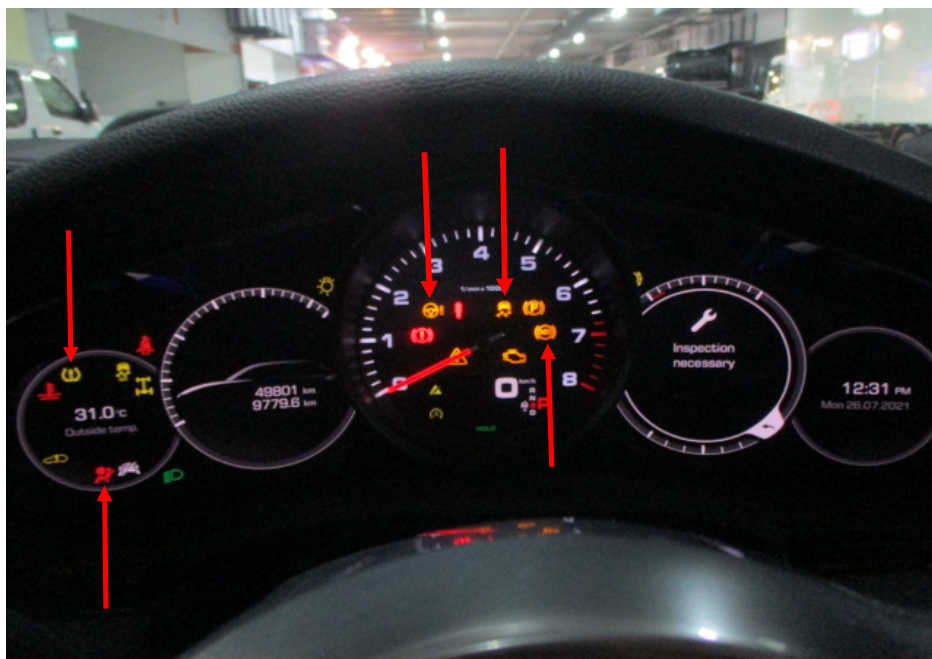
Photo 17 shows the warning lights for the various electronic safety features appearing on the instrument panel of the Motor Car during its self-test when the engine is cranked, in particular the ABS, SRS, PSS, TPM and PSM lights (arrowed).

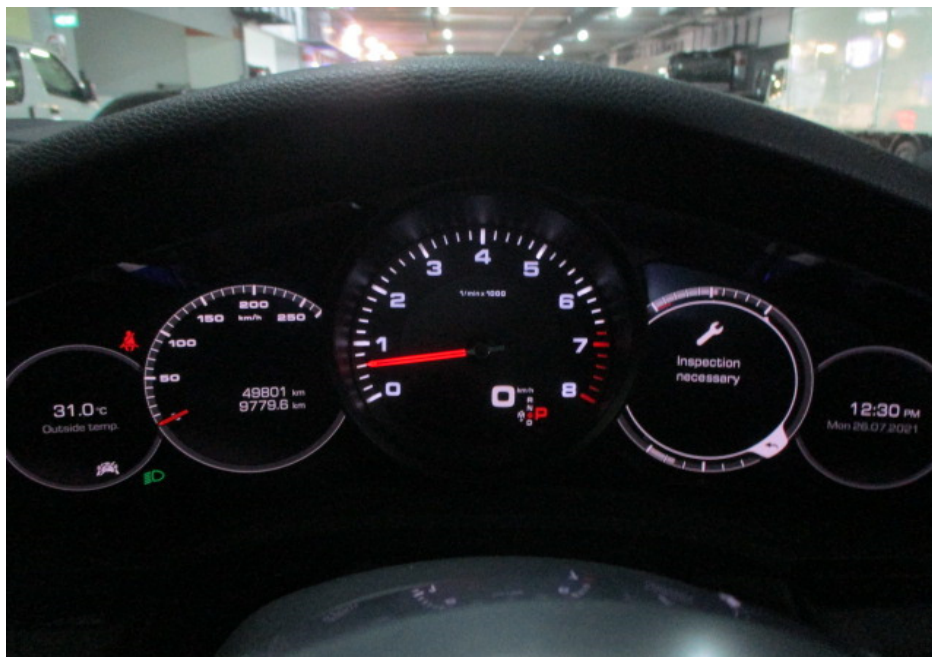
Photo 18 shows the respective warning lights no longer illuminated, indicating that there is no fault detected to the ABS, SRS, PSS, TPM and PSM systems of the Motor Car during the self-test. These electronic systems were hence in working condition at the time of my inspection.

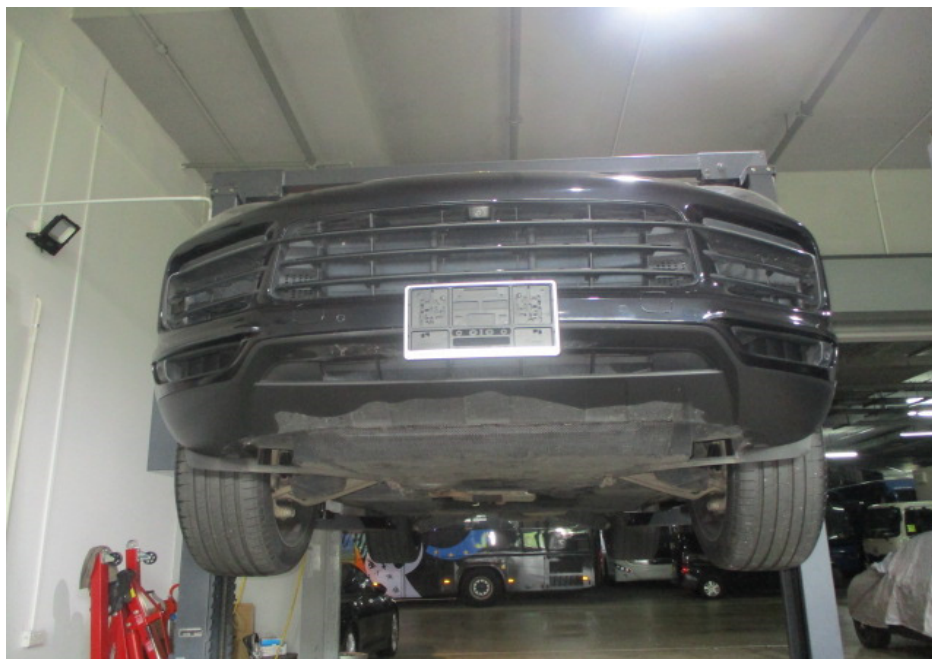
Photo 19 shows the Motor Car hoisted up for checks on its undercarriage. There was no sign(s) or indication(s) of fluid leakage and/or fluid stain(s) on the underside of the Motor Car. The undercarriage components of the Motor Car were also all observed to be intact and secured in an appropriate manner.

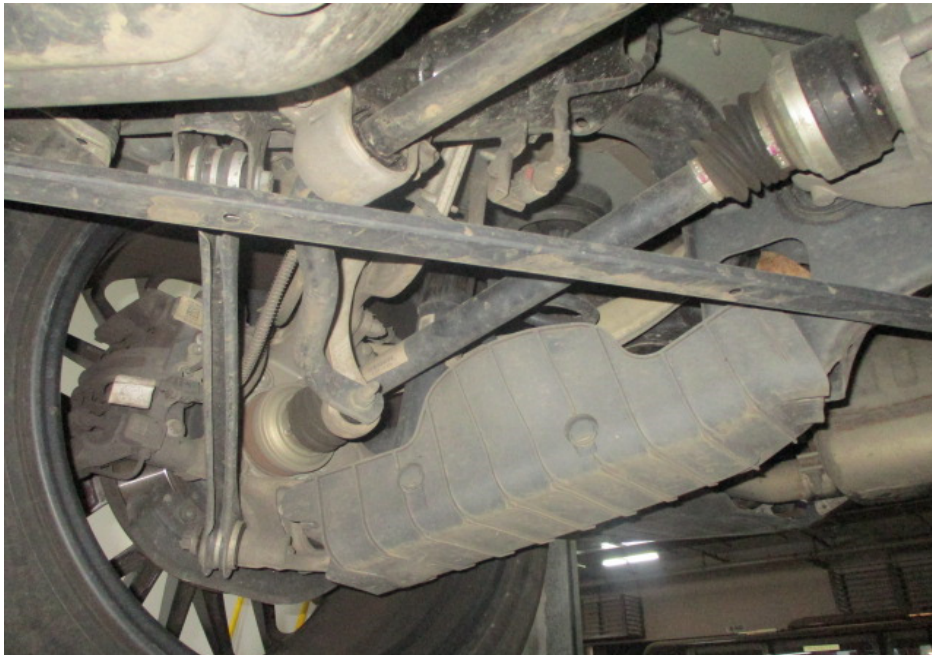
Photo 20 shows a general view of the control arms and linkages at the rear right wheel of the Motor Car. I did not observe any fluid leak and/or fluid stain on the underside of the Motor Car. All the Motor Car's undercarriage components were observed to be intact and secured in an appropriate manner.

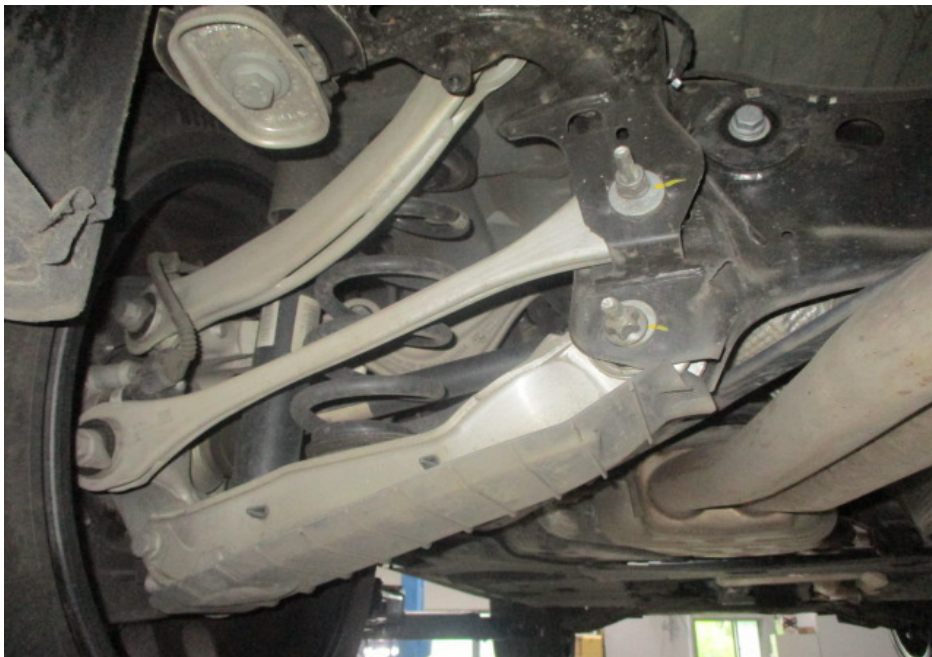
Photo 21 shows a general view of the control arms and linkages at the rear left wheel of the Motor Car. I did not observe any fluid leak and/or fluid stain on the underside of the Motor Car. All the Motor Car's undercarriage components were observed to be intact and secured in an appropriate manner.

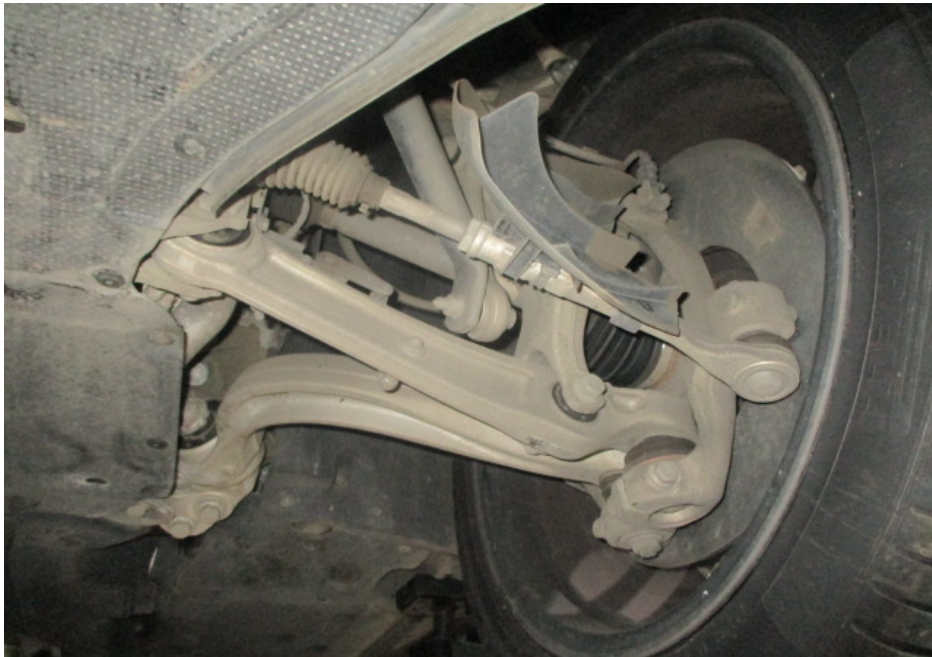
Photo 22 shows the various undercarriage components at the front left wheel of the Motor Car. The mechanical components, control arms and linkages were all found to be intact and secured in an appropriate manner.

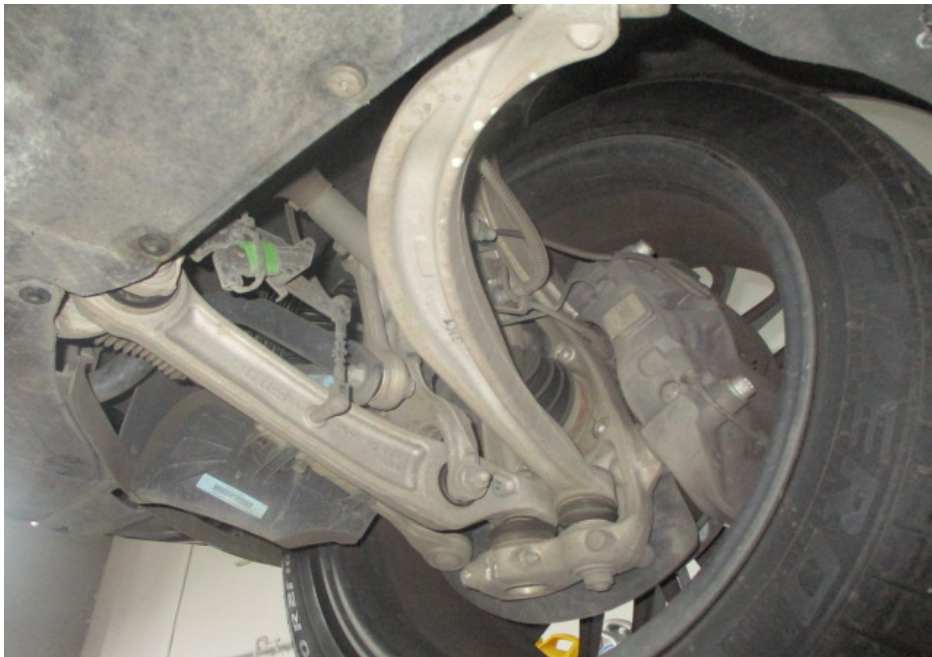
Photo 23 shows the various undercarriage components at the front right wheel of the Motor Car. The mechanical components, control arms and linkages were all found to be intact and secured in an appropriate manner. I also did not observe any fluid leak and/or fluid stain on the underside of the Motor Car.

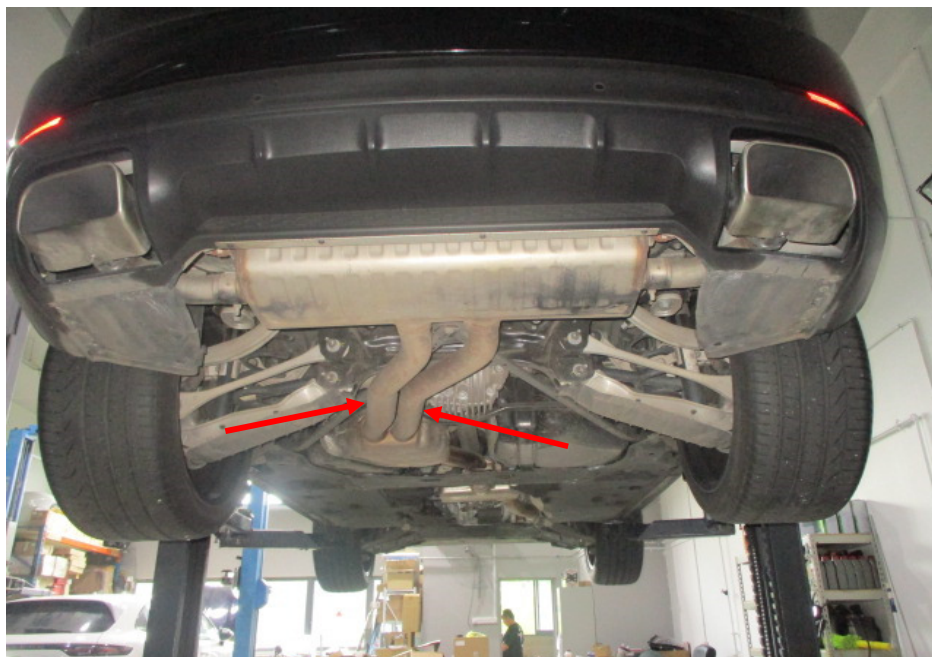
Photo 24 shows a general view of the rear section of the Motor Car's exhaust system. My examination of the Motor Car's exhaust system revealed no sign(s) or indication(s) of any cut or weld marks along its exhaust pipes (arrowed), on its catalytic converter, centre resonator boxes and on its rear muffler.

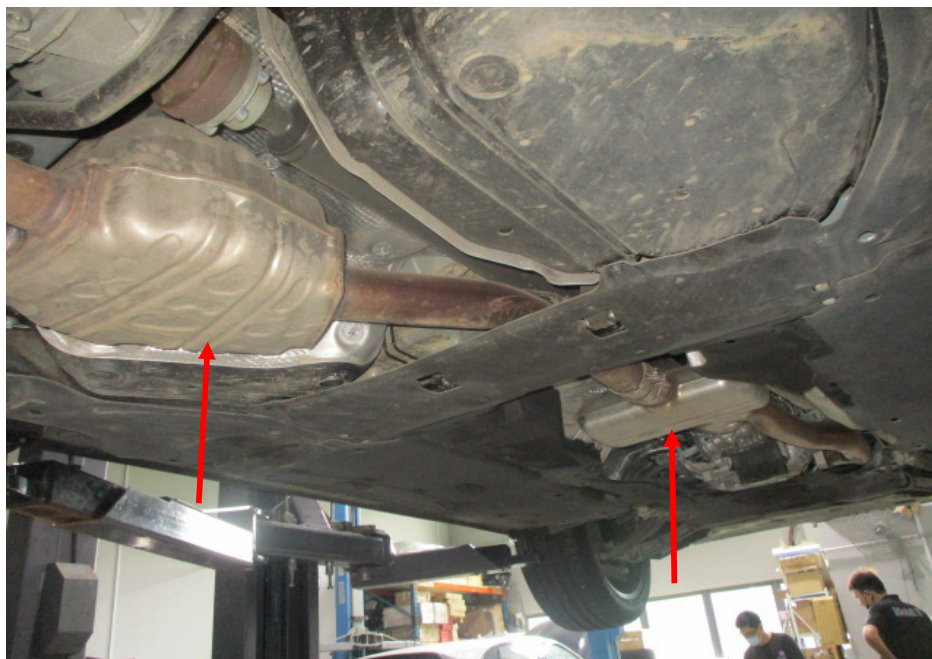
Photo 25 shows a general view of the front section of the Motor Car's exhaust system. My examination of the Motor Car's exhaust system revealed no sign(s) or indication(s) of any cut or weld marks along its exhaust pipes, on its catalytic converter, centre resonator boxes (arrowed) and on its rear muffler.

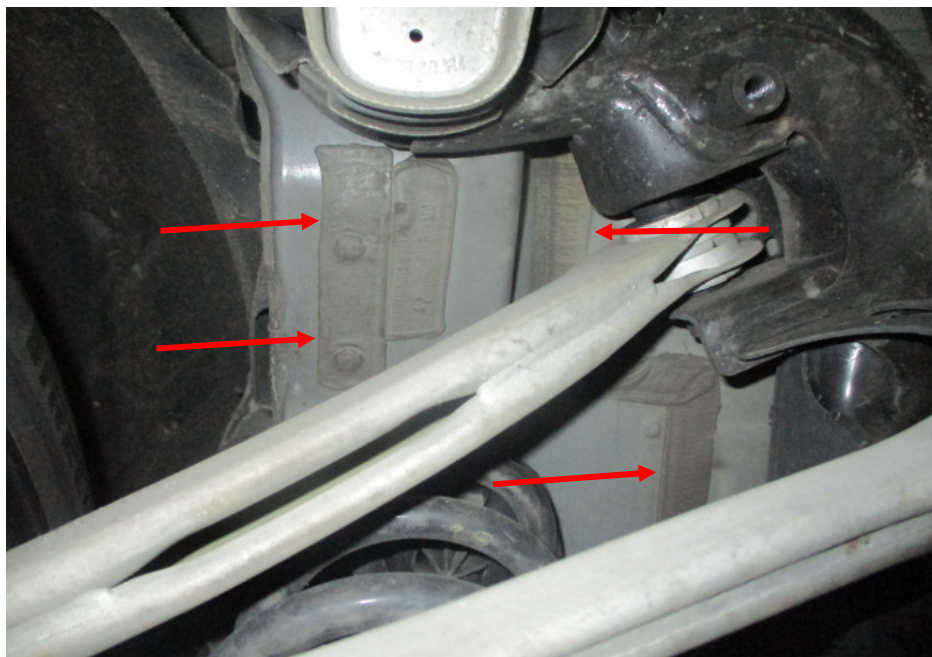
Photo 26 shows the chassis/structural body at the underside rear left of the Motor Car. I did not find any weld marks other than original spot weld marks on the chassis/structural body of the Motor Car. The original factory sealant (arrowed) at the joints along the chassis/structural body was untouched, indicating no work was done on the chassis/structural body of the Motor Car and that the chassis/structural body was originally fitted.

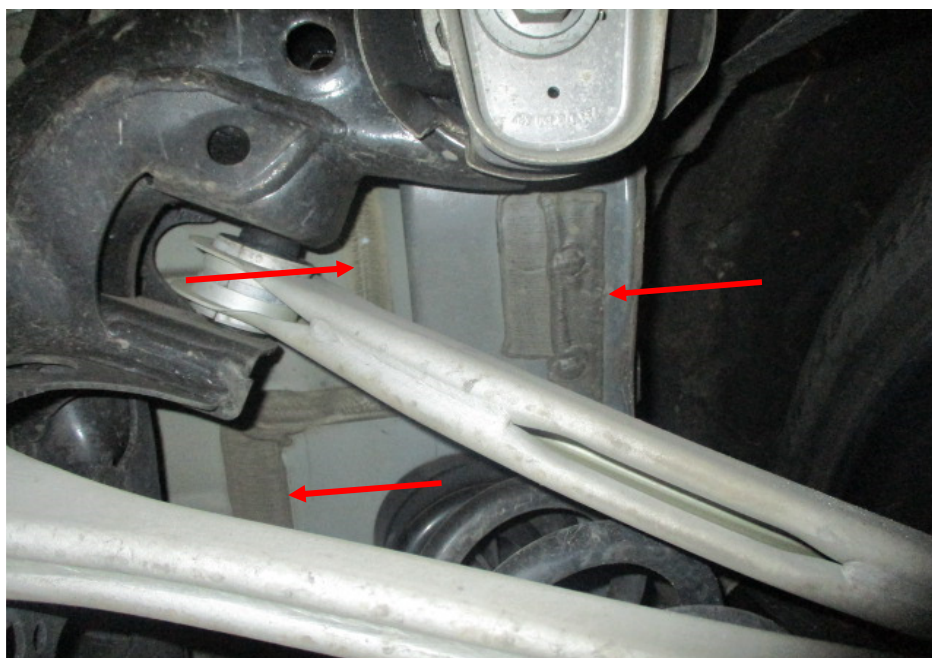
Photo 27 shows the chassis/structural body at the underside rear right of the Motor Car. The original factory sealant (arrowed) at the joints along the chassis/structural body was observed to be untouched. In general, I had found no work was carried out on the chassis/structural body of the Motor Car. The chassis/structural body of the Motor Car was originally fitted.

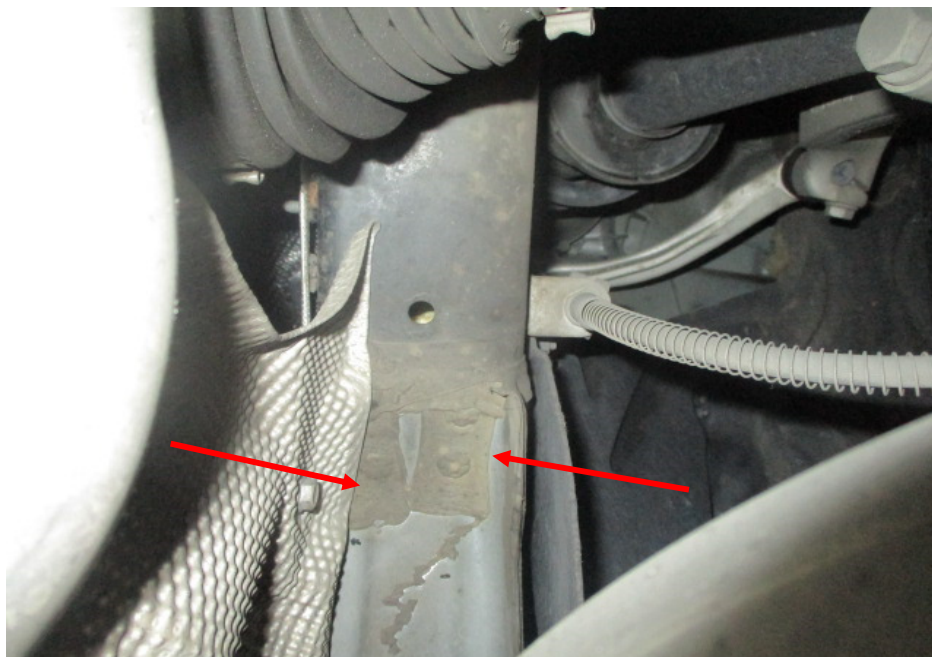
Photo 28 shows the chassis/structural body at the underside front left of the Motor Car. I did not find any weld marks other than original spot weld marks on the chassis/structural body of the Motor Car. The original factory sealant (arrowed) at the joints along the chassis/structural body was untouched, indicating no work was done on the chassis/structural body of the Motor Car and that the chassis/structural body was originally fitted.

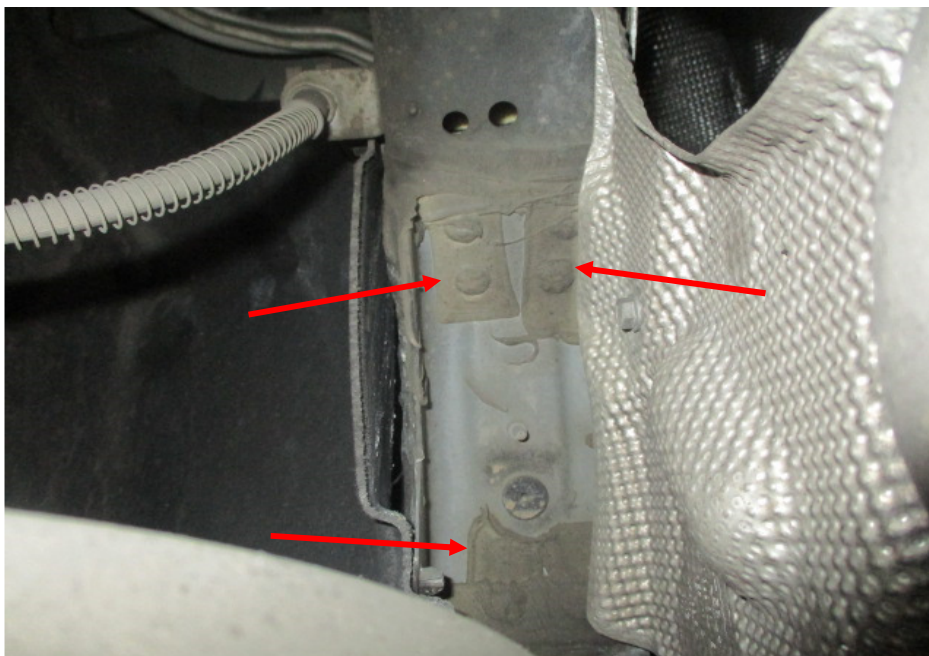
Photo 29 shows the chassis/structural body at the underside front right of the Motor Car. The original factory sealant (arrowed) at the joints along the chassis/structural body was observed to be untouched. In general, I had found no work was carried out on the chassis/structural body of the Motor Car. The chassis/structural body of the Motor Car was originally fitted.

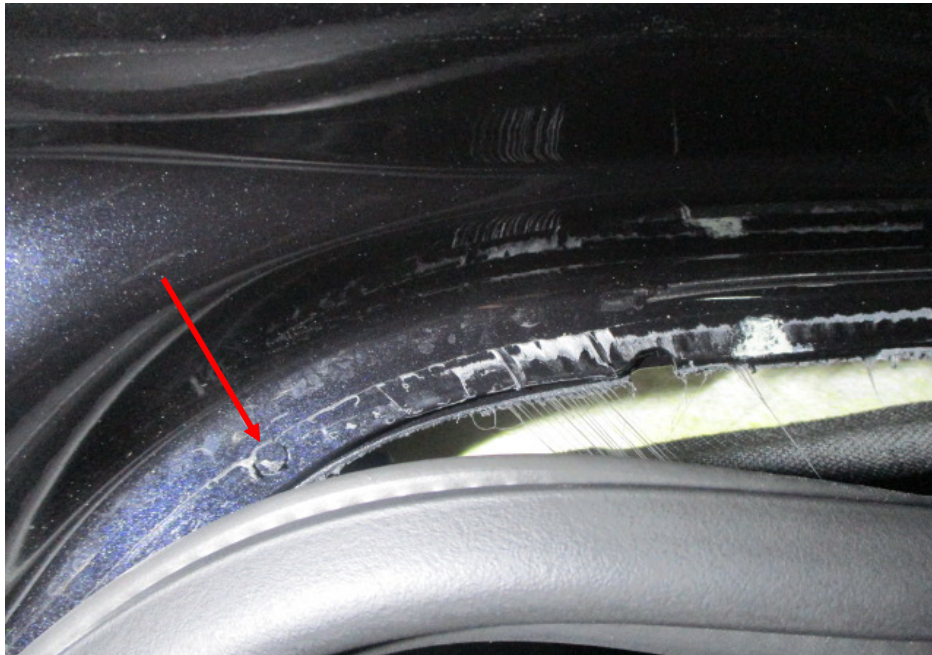
Photo 30 shows the right side "C" pillar of the Motor Car. I did not find any weld marks other than original spot weld marks (arrowed) on the right side "C" pillar of the Motor Car which, indicates that there was no re-welding works carried out. In general, I had found all the non-detachable body panels of the Motor Car to be originally fitted at the time of my inspection.
