(chassis number WAUZZZF23KN111901)

Our Ref : CI/TP21008094/D

INSPECTION REPORT OF AN UNREGISTERD AUDI A6 MOTOR CAR WITH CHASSIS NUMBER WAUZZZF23KN111901

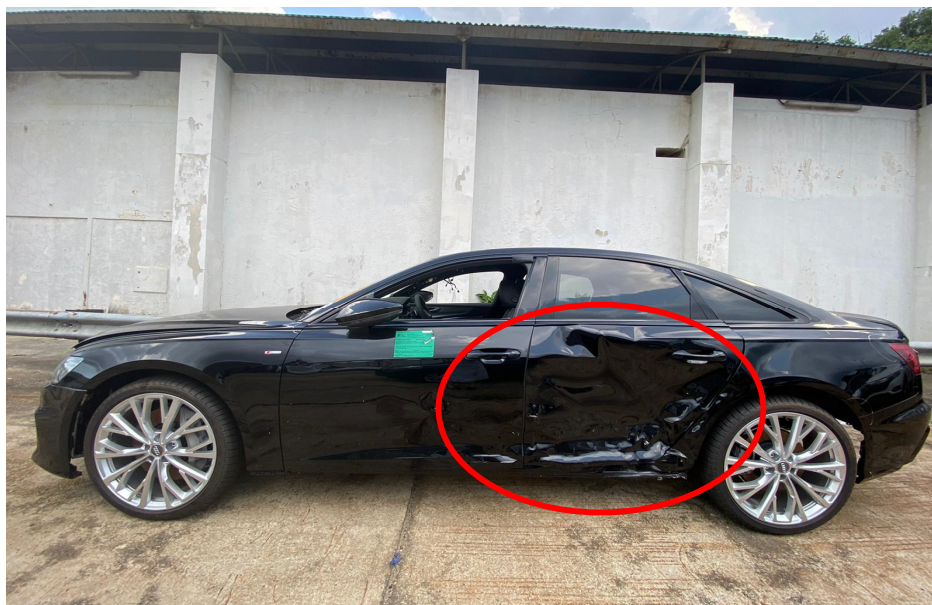
Photo 1 shows the left body of the Motor Car prior to any repairs being carried out (photograph provided to me). The Motor Car was observed to have sustained damage to its left body (circled). The left front door, left rear door, left rear fender and left side rocker panel garnish were amongst the body parts that were observed to have been damaged.

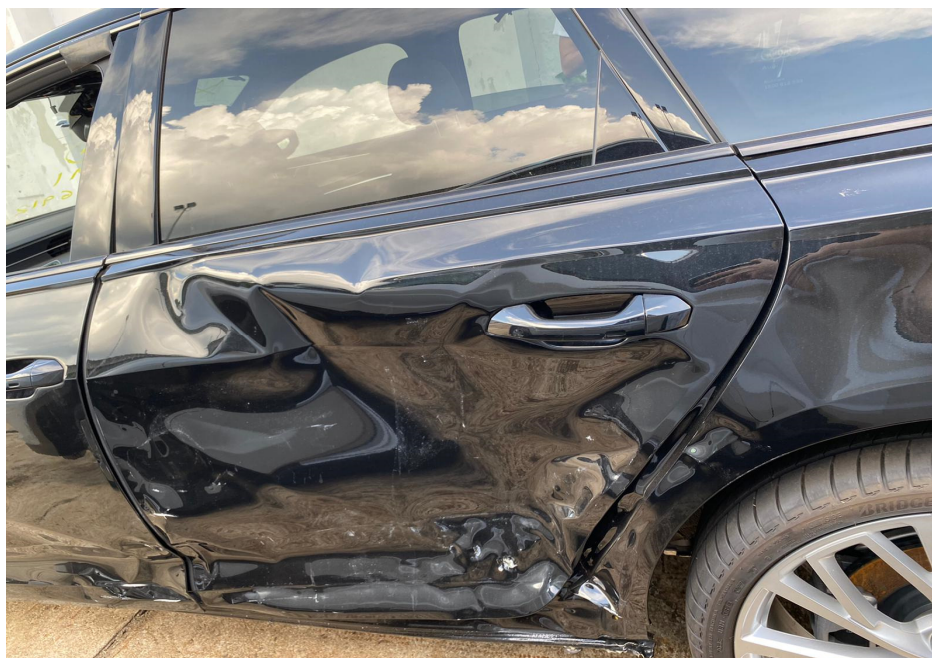
Photo 2 shows a closer view of the damage to the left body of the Motor Car prior to any repairs being carried out (photograph provided to me). The left front door, left rear door, left rear fender and left side rocker panel garnish were amongst the body parts that were observed to have been damaged. The extent of damage seen may have also resulted in damage to the left rear door lock, left rear door inner trimboard, left rear door window regulator and left rear door lower hinge amongst others.

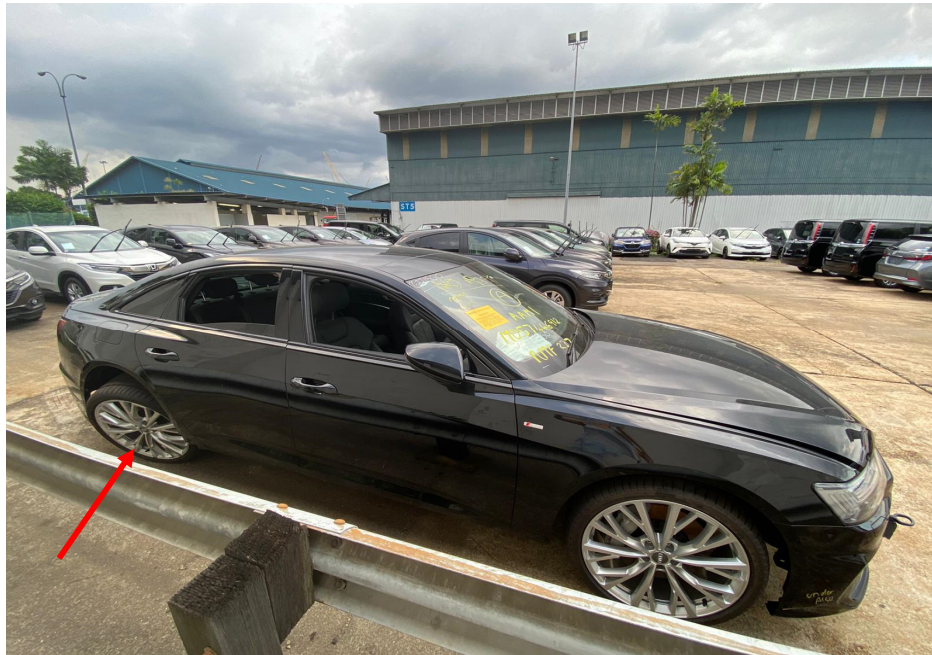
Photo 3 shows the right body of the Motor Car prior to any repairs being carried out (photograph provided to me). The rear right wheel (arrowed) of the Motor Car was observed to be tilted, which would indicate damage to the rear right undercarriage parts like the rear right shock absorber, rear right lower arms and linkages amongst others.

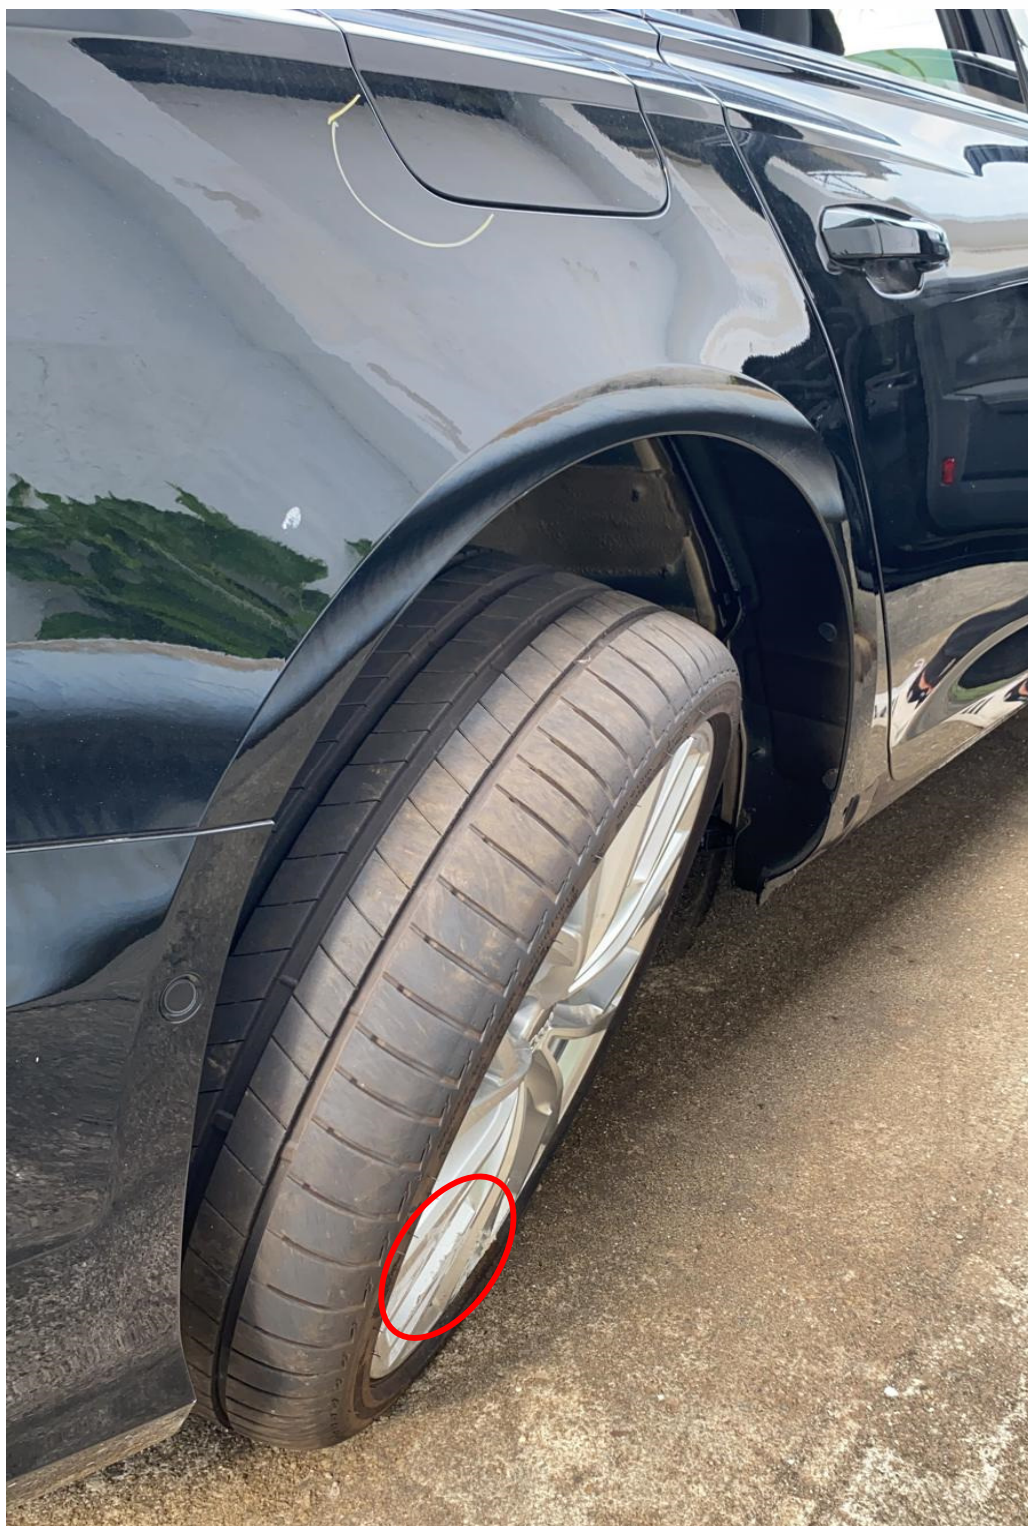
Photo 4 shows a closer view of the Motor Car's tilted rear right wheel prior to any repairs being carried out (photograph provided to me). The photographs had showed damage (circled) to the Motor Car's rear right wheel rim but not on the surrounding body parts. The tilting of the rear right wheel indicates damage to the rear right undercarriage parts like the rear right shock absorber, rear right lower arms and linkages amongst others.

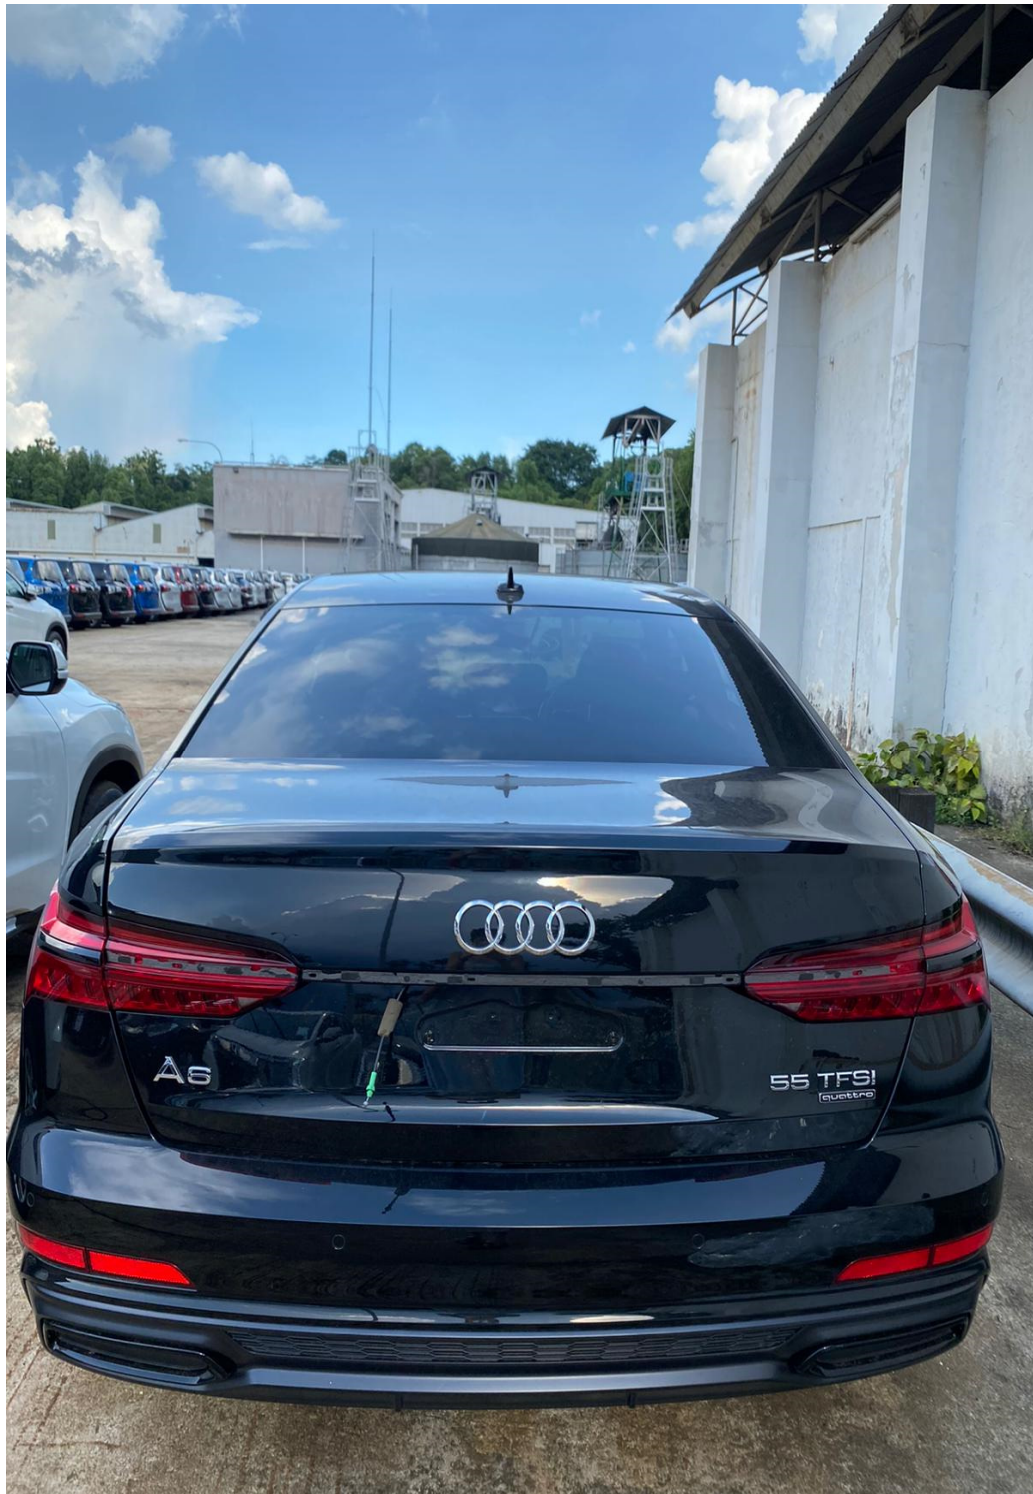
Photo 5 shows the rear body of the Motor Car prior to any repairs being carried out (photograph provided to me). No physical damage was seen to the rear body of the Motor Car.

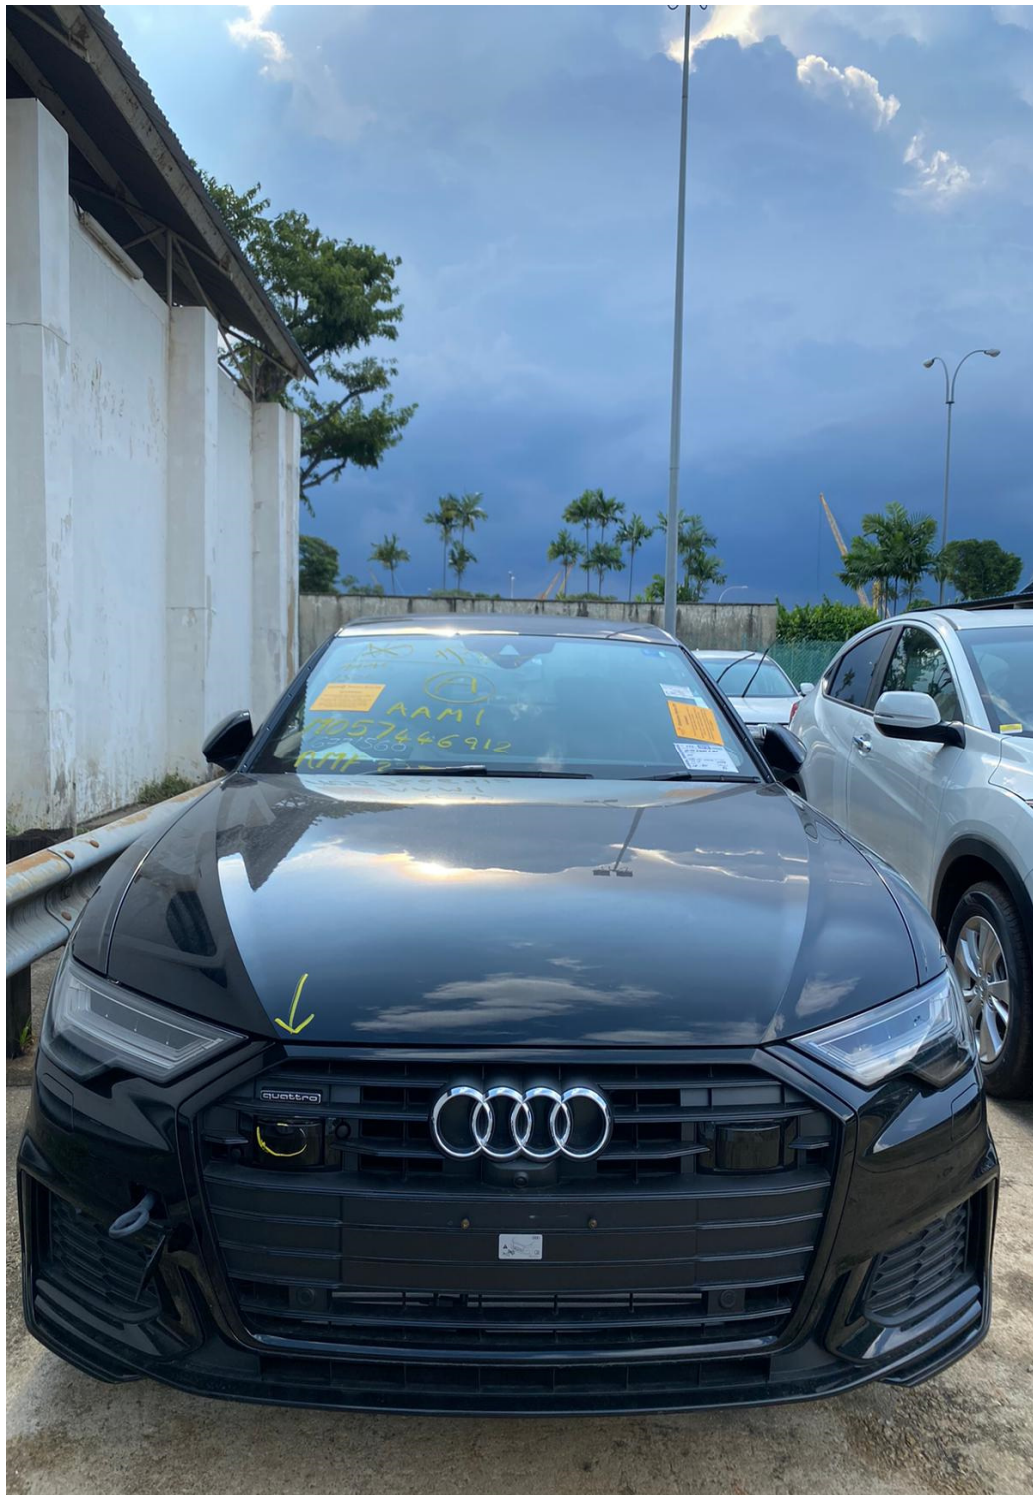
Photo 6 shows the front body of the Motor Car prior to any repairs being carried out (photograph provided to me). No physical damage was seen to the front body of the Motor Car.

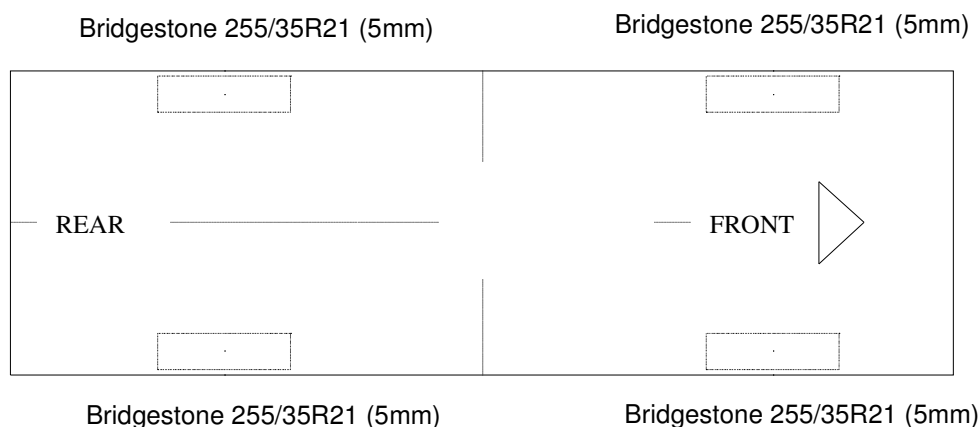
9. It was fitted with 21inch sport wheel rims that were wrapped with tyres that were observed to be of serviceable condition. The tyres were also sufficiently inflated for vehicular operation. The tyre brand, tyre size and approximate remaining tread depth of the 4 tyres of the Motor Car were recorded as follows: -

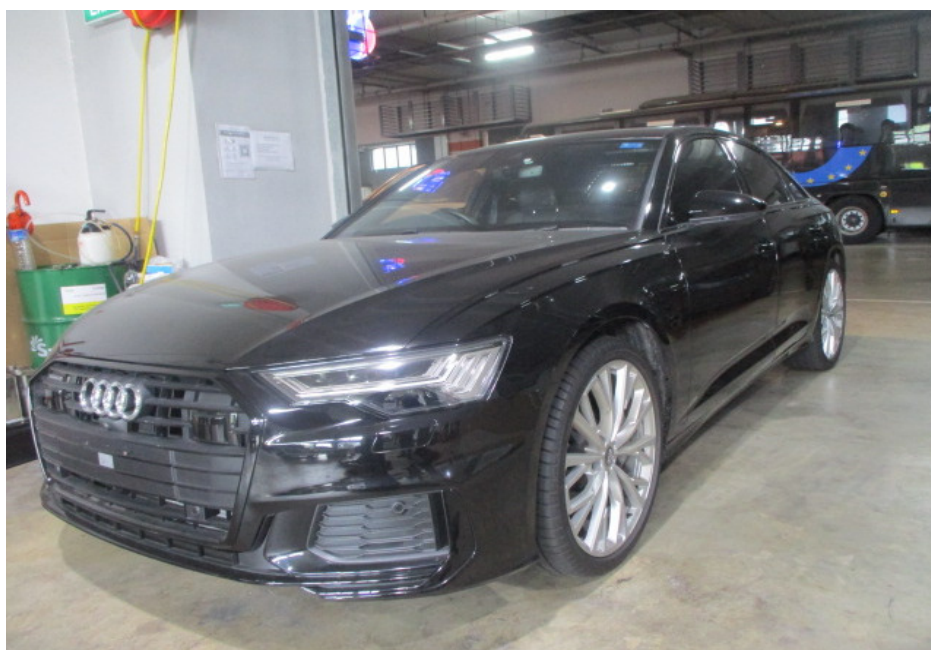
Photo 7 shows a general view of the front left body of the Motor Car at the time of my inspection. The Motor Car was observed to be in a relatively good general condition with no loose exterior fittings observed. The body parts at the left body of the Motor Car were visually examined and it was observed that the repair/restoration works carried out to the damaged area of the Motor Car (refer to photograph 1 & 2 above) were reasonably adequate and in order.

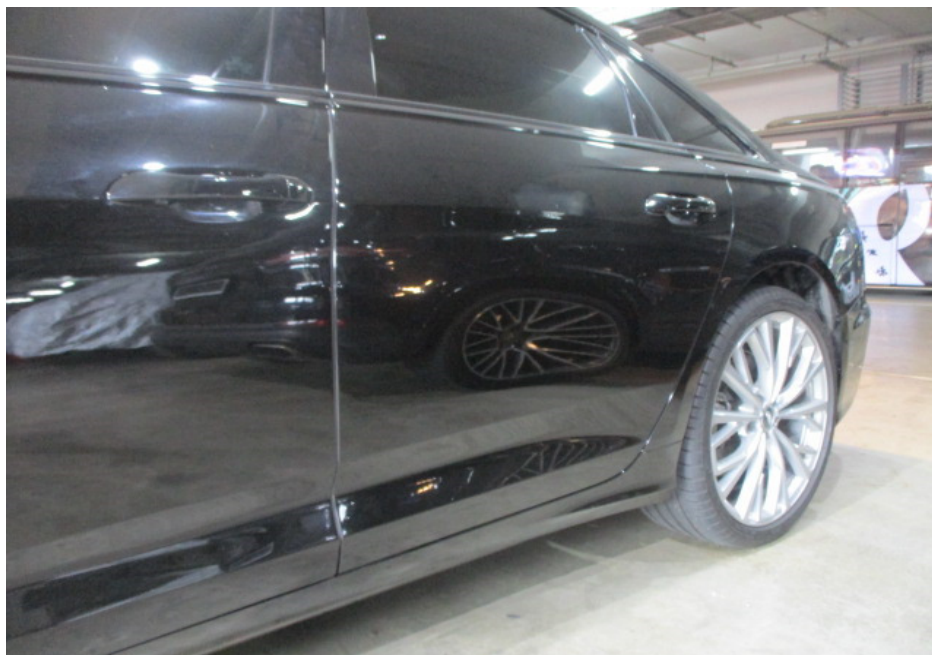
Photo 8 shows a closer view of the Motor Car's left front door, left rear door and left side rocker panel garnish. The repair/restoration works carried out to the damaged area of the Motor Car (refer to photograph 1 & 2 above) were reasonably adequate and in order.

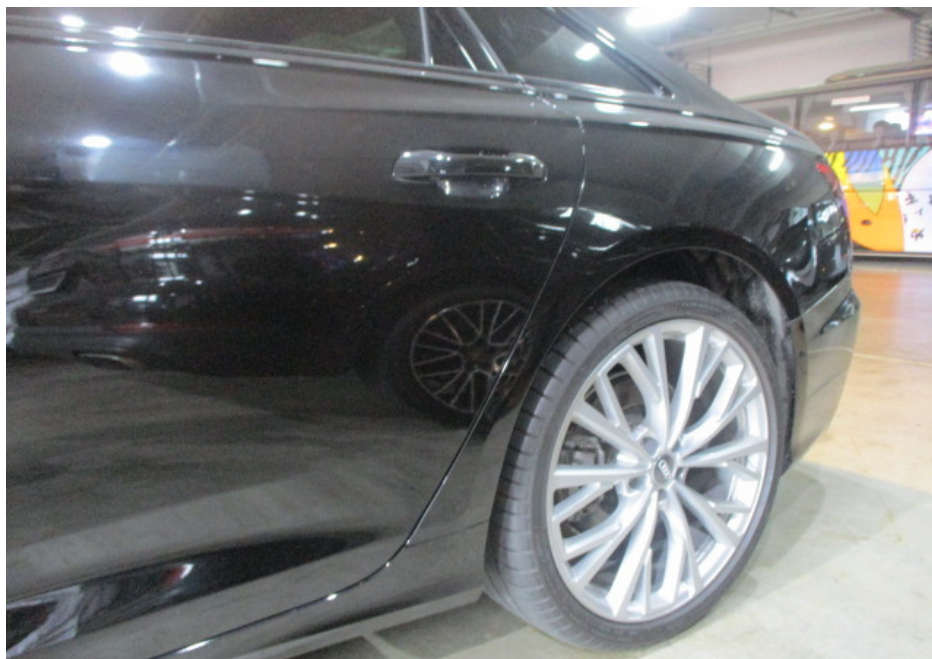
Photo 9 shows a closer view of the Motor Car's left rear door, left rear fender and left side rocker panel garnish. The repair/restoration works carried out to the damaged area of the Motor Car (refer to photograph 1 & 2 above) were reasonably adequate and in order.

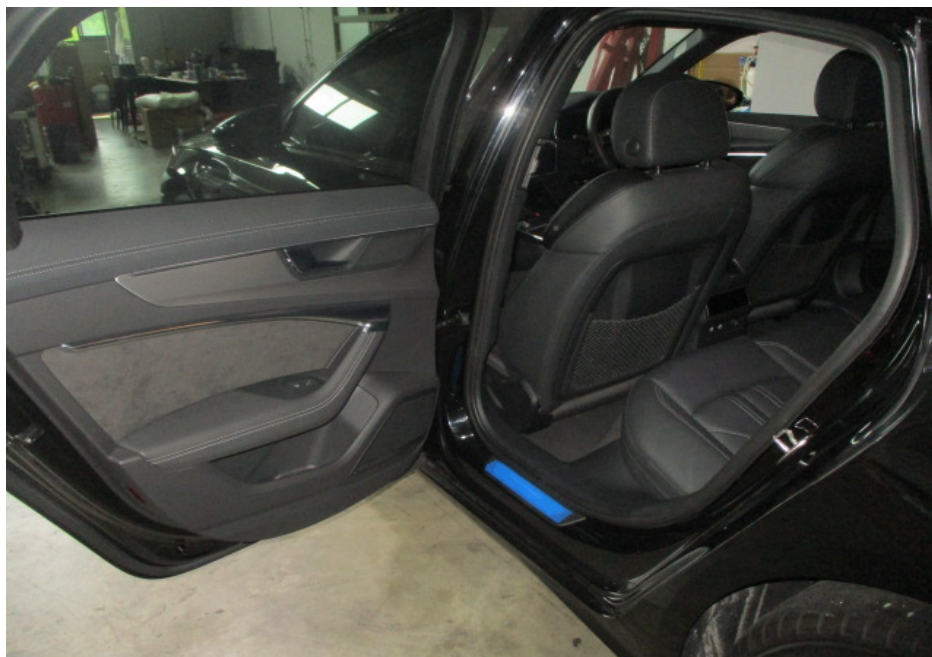
Photo 10 shows the Motor Car's left rear door inner trimboard, left rear fender and left side rocker panel. The repair/restoration works carried out to the damaged area of the Motor Car (refer to photograph 1 & 2 above) were reasonably adequate and in order.

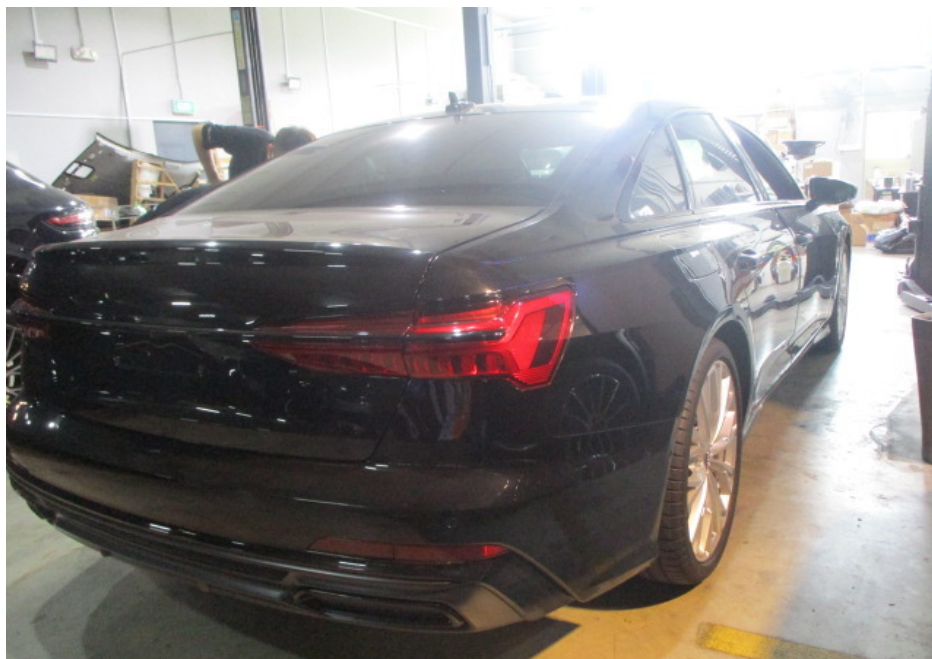
Photo 11 shows a general view of the rear right body of the Motor Car at the time of my inspection. The Motor Car was observed to be in a relatively good general condition with no loose exterior fittings observed. The mileage of the Motor Car recorded at the time of my inspection was 2,029km.

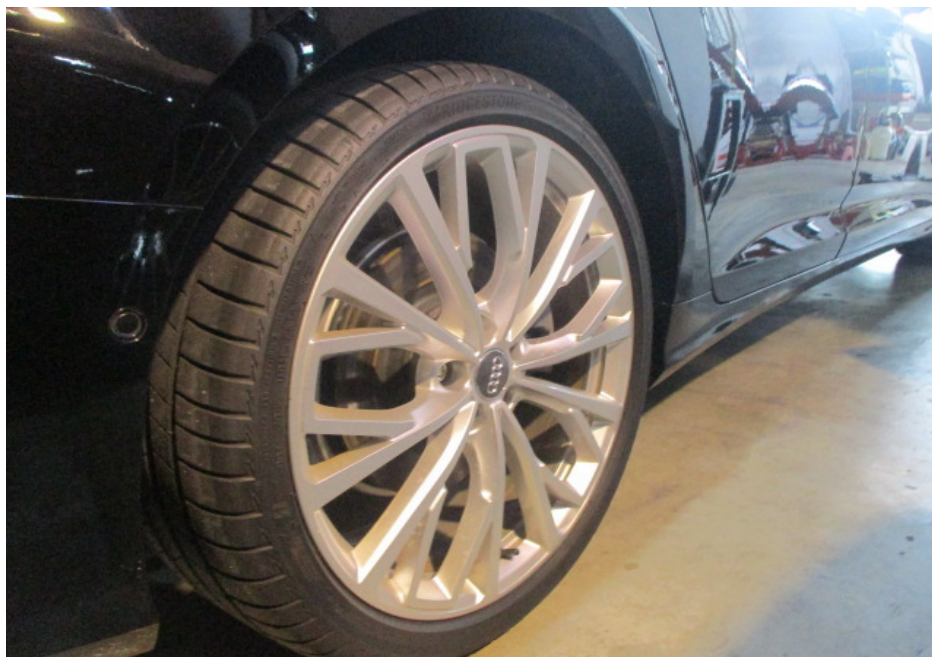
Photo 12 shows a closer view of the Motor Car's rear right wheel rim. The repair/restoration works carried out to the damaged area of the Motor Car (refer to photograph 3 & 4 above) were reasonably adequate and in order.

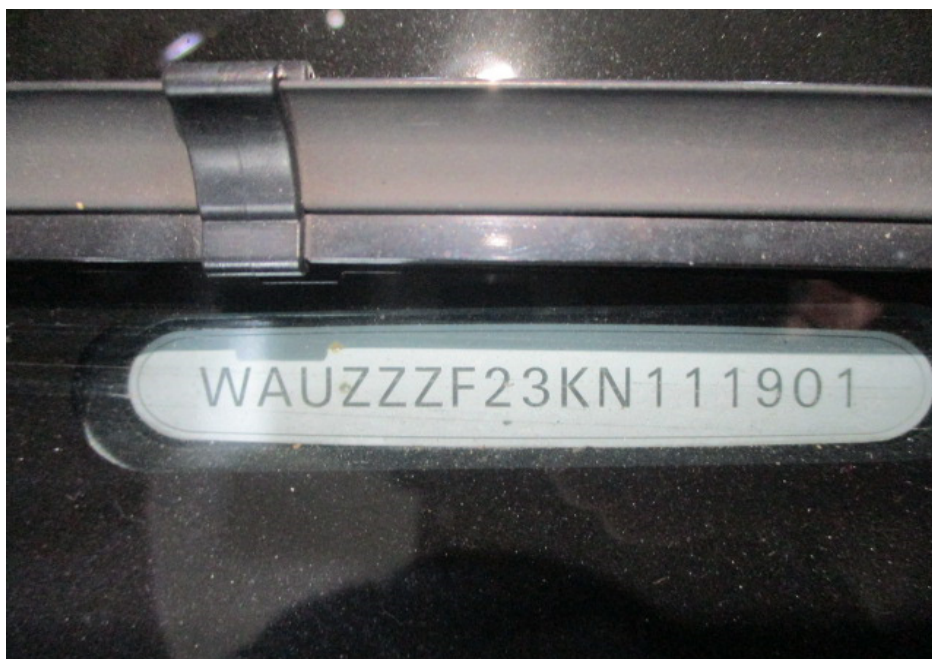
Photo 13 shows the chassis number of the Motor Car. The chassis number recorded was WAUZZZF23KN111901.

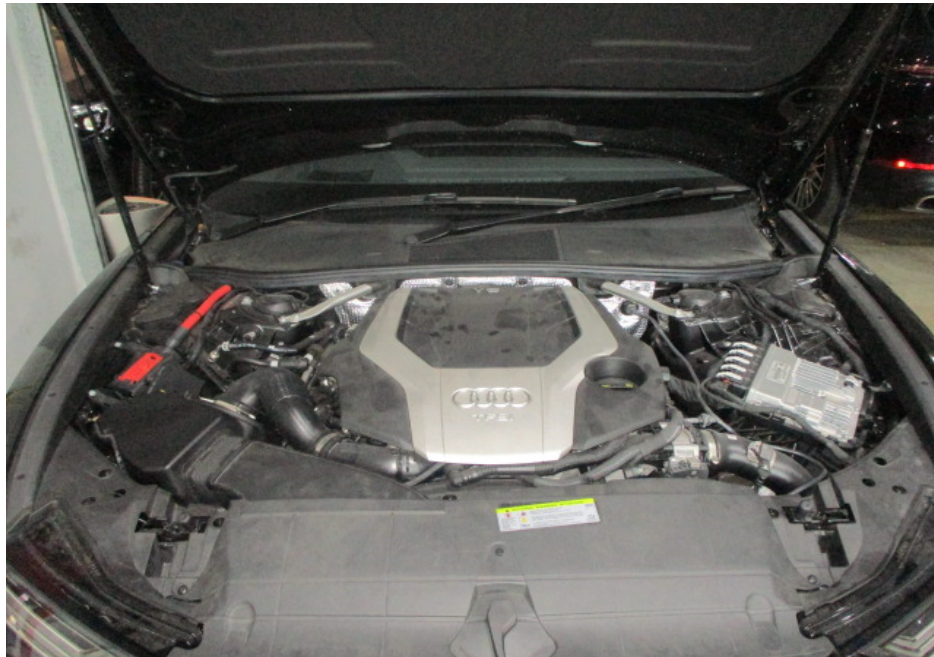
Photo 14 shows a general view of the engine compartment of the Motor Car at the time of my inspection. The various parts and components inside the engine compartment were all observed to be intact and properly fitted. There was also no sign(s) or indication(s) of fluid leak and/or fluid stain found inside the engine compartment.

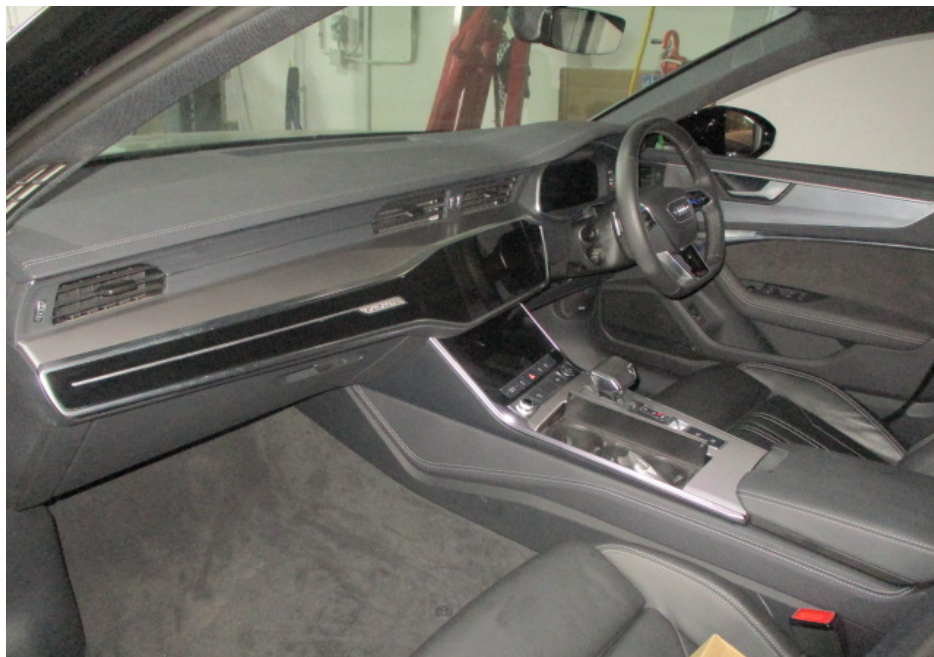
Photo 15 shows the interior compartment of the Motor Car at the time of my inspection. The various parts and components, trims, carpet and upholstery inside the interior compartment were all observed to be intact and properly fitted.

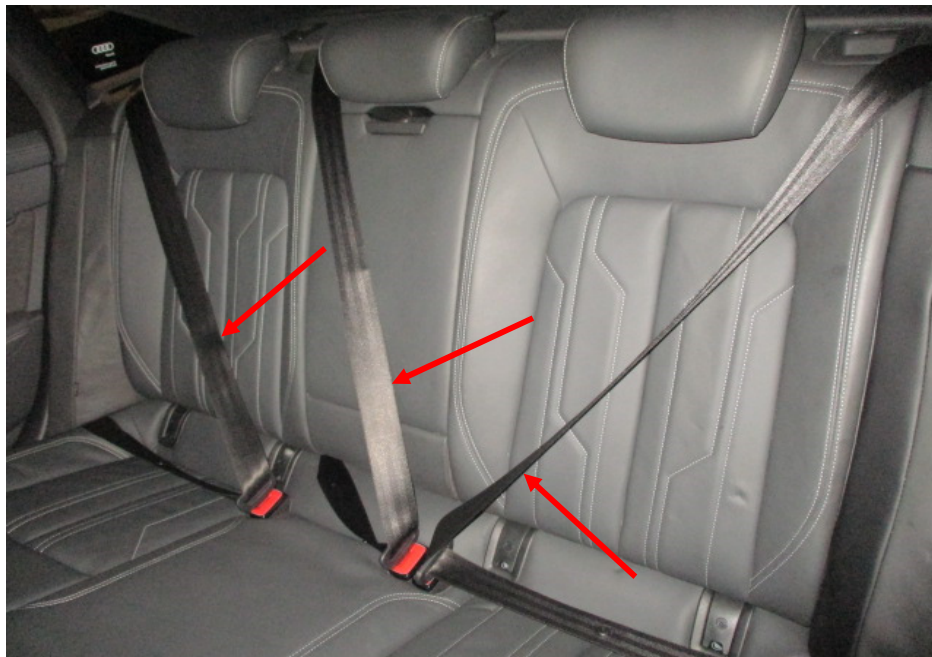
Photo 16 shows the rear seats of the Motor Car. All the seats of the Motor Car were secured via seat rails to the floorboard. They were also fitted with a retractable seat belt reel and a pre-tensioner. The seat belts (arrowed) were tested and were able to be fastened into the respective pre-tensions that were fitted on the side of each individual seat.

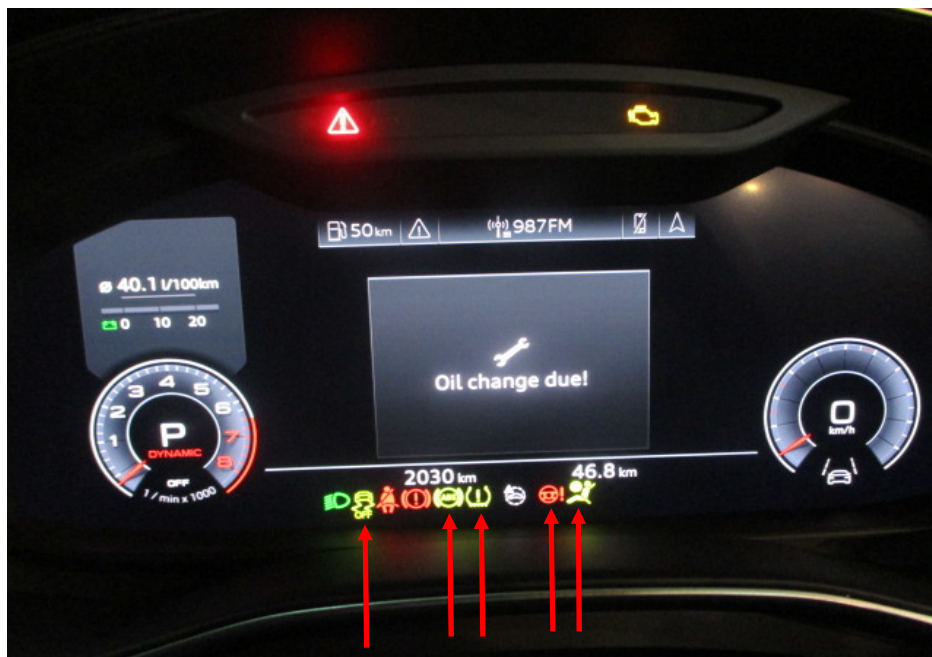
Photo 17 shows the warning lights for the various electronic safety features appearing on the instrument panel of the Motor Car during its self-test when the engine is cranked, in particular the ABS, SRS, EPS, TPM and ESC lights (arrowed).

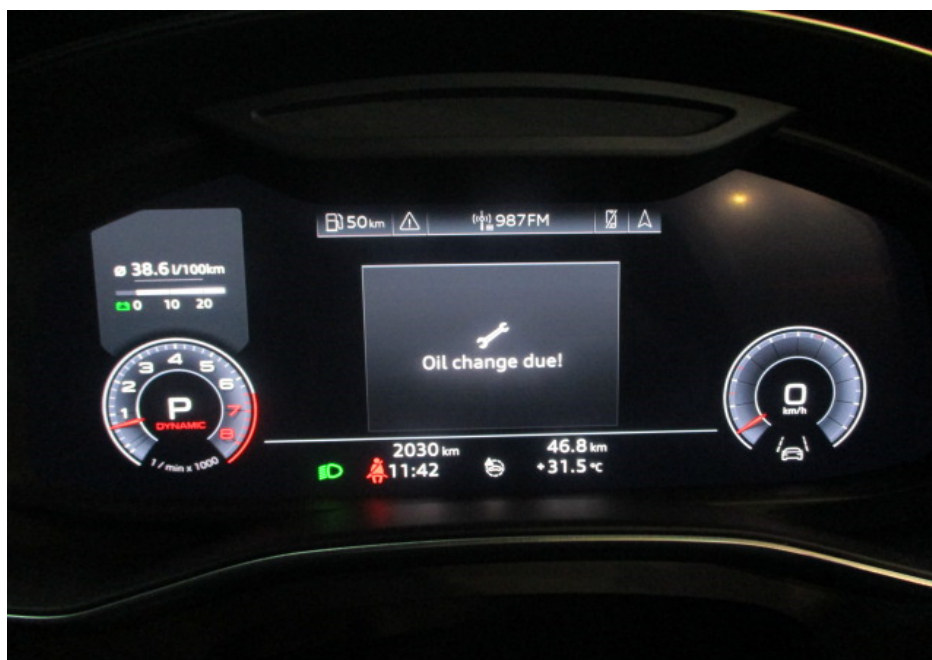
Photo 18 shows the respective warning lights no longer illuminated, indicating that there is no fault detected to the ABS, SRS, EPS, TPM and ESC systems of the Motor Car during the self-test. These electronic systems were hence in working condition at the time of my inspection.

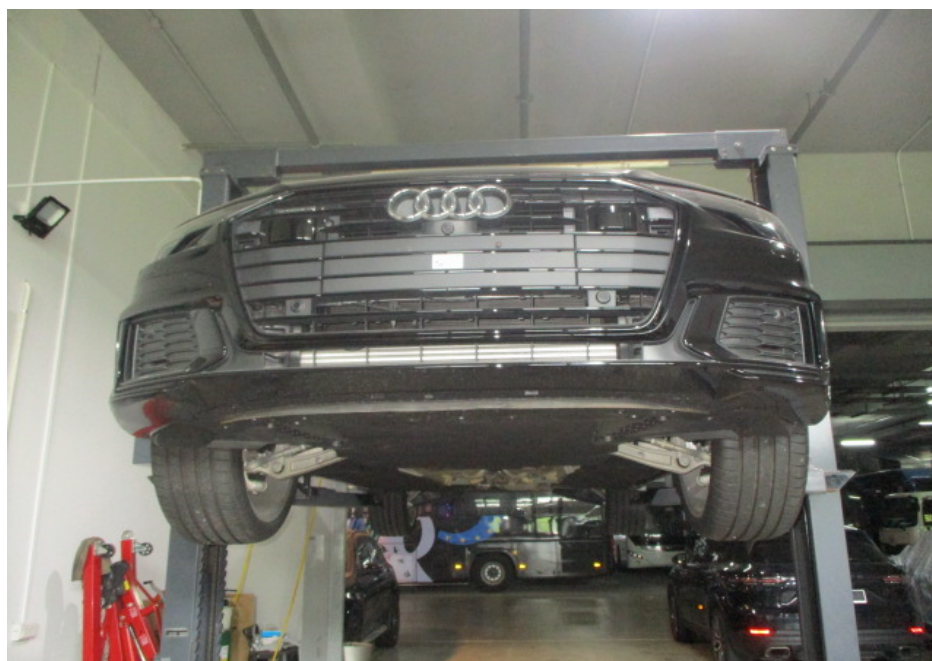
Photo 19 shows the Motor Car hoisted up for checks on its undercarriage. There was no sign(s) or indication(s) of fluid leakage and/or fluid stain(s) on the underside of the Motor Car. The undercarriage components of the Motor Car were also all observed to be intact and secured in an appropriate manner.

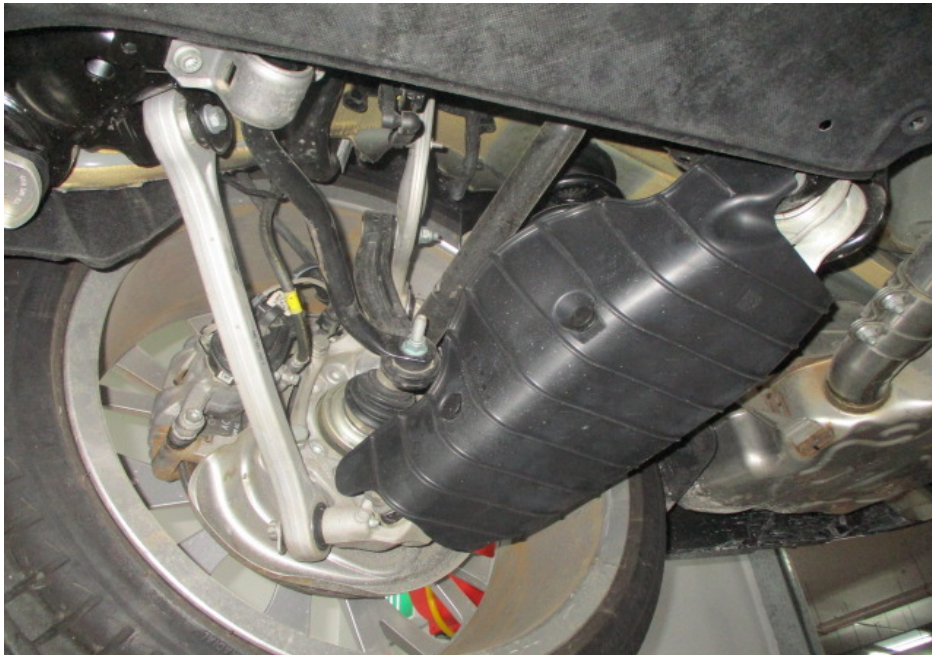
Photo 20 shows a general view of the control arms and linkages at the rear right wheel of the Motor Car. I did not observe any fluid leak and/or fluid stain on the underside of the Motor Car. All the Motor Car's undercarriage components were observed to be intact and secured in an appropriate manner.

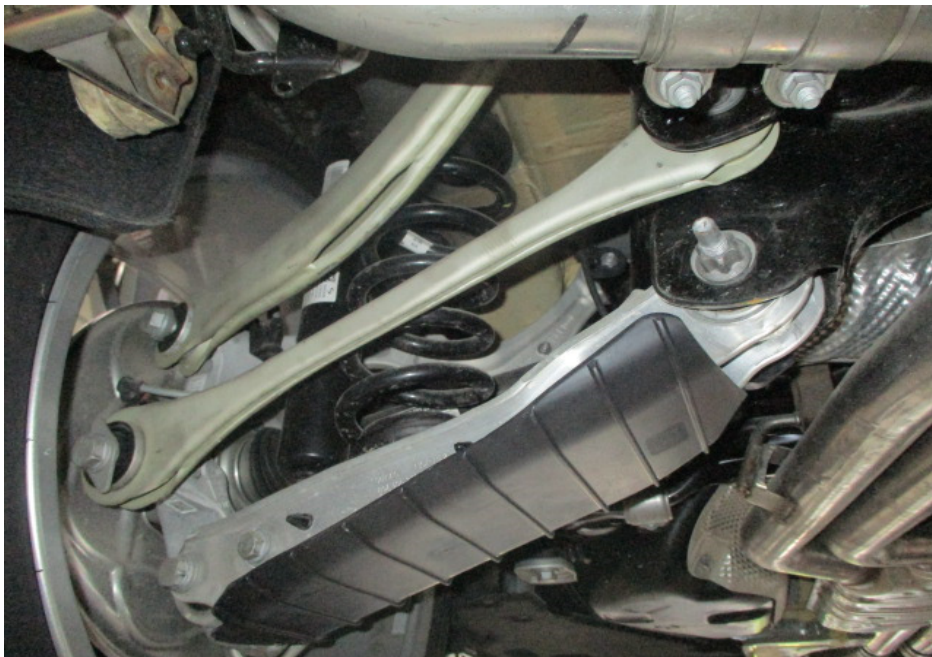
Photo 21 shows a general view of the control arms and linkages at the rear left wheel of the Motor Car. I did not observe any fluid leak and/or fluid stain on the underside of the Motor Car. All the Motor Car's undercarriage components were observed to be intact and secured in an appropriate manner.

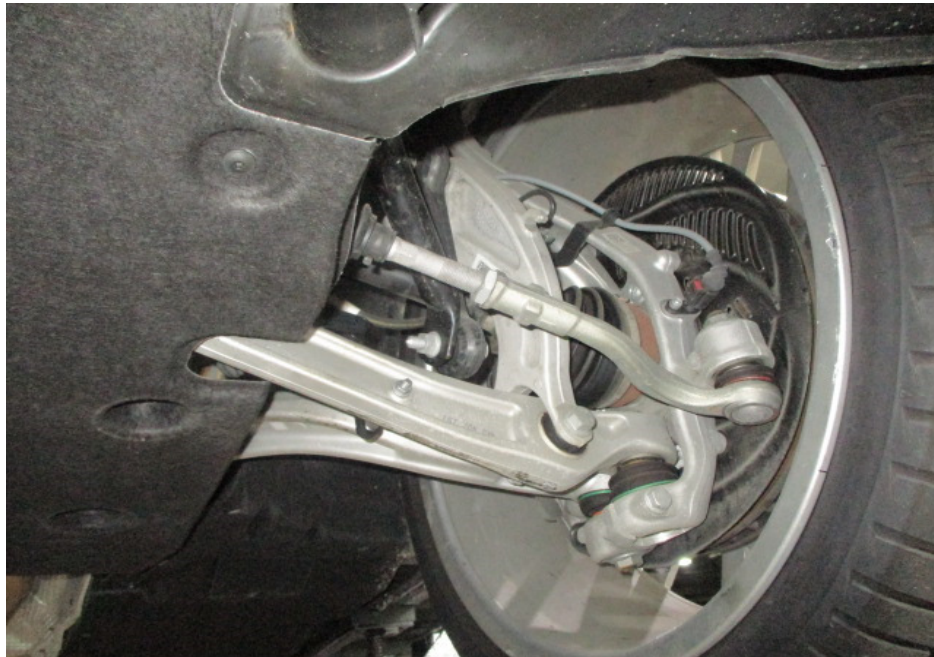
Photo 22 shows the various undercarriage components at the front left wheel of the Motor Car. The mechanical components, control arms and linkages were all found to be intact and secured in an appropriate manner.

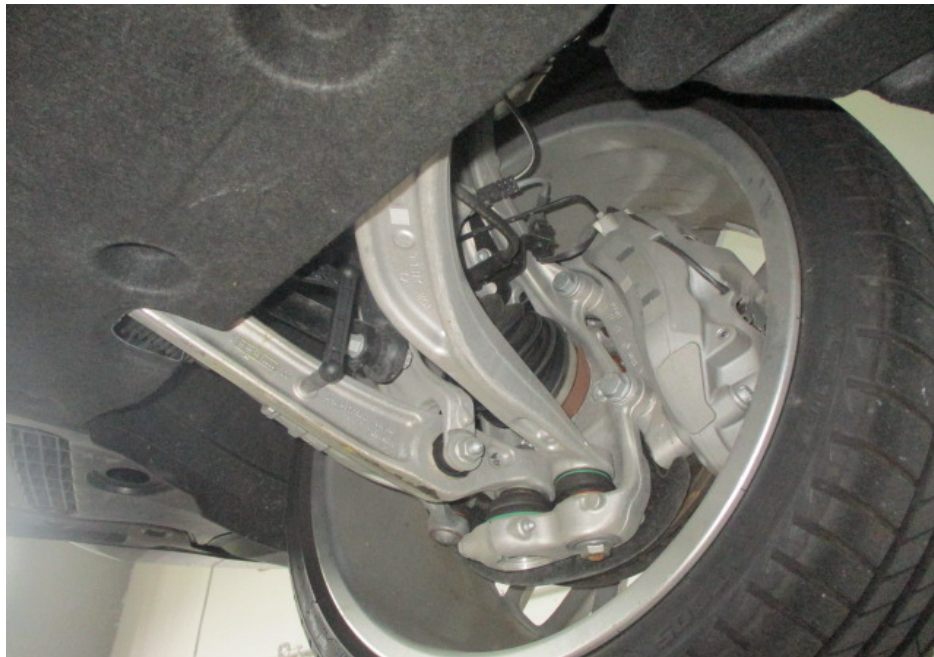
Photo 23 shows the various undercarriage components at the front right wheel of the Motor Car. The mechanical components, control arms and linkages were all found to be intact and secured in an appropriate manner. I also did not observe any fluid leak and/or fluid stain on the underside of the Motor Car.

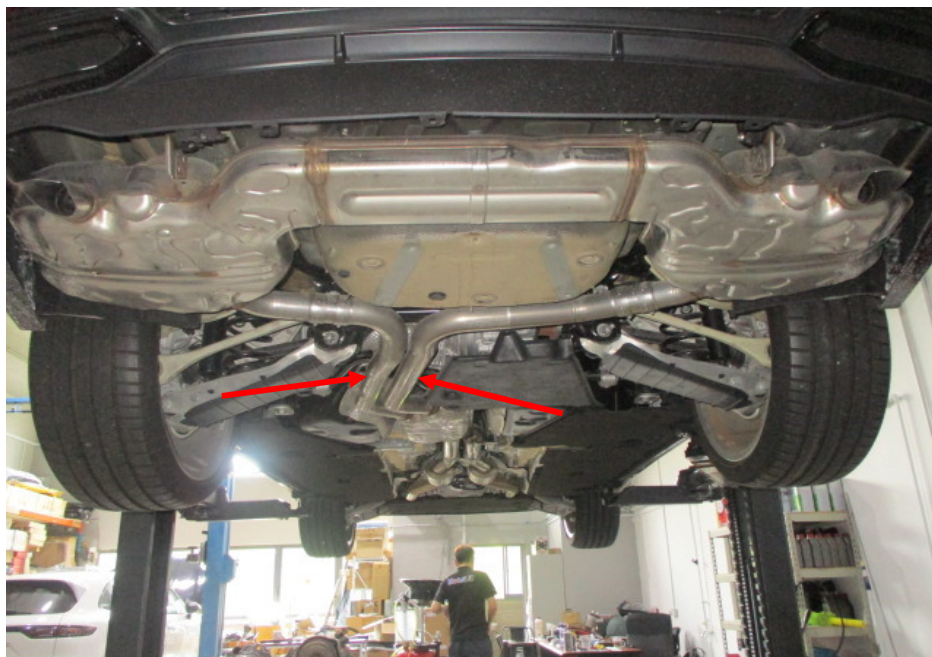
Photo 24 shows a general view of the rear section of the Motor Car's exhaust system. My examination of the Motor Car's exhaust system revealed no sign(s) or indication(s) of any cut or weld marks along its exhaust pipes (arrowed), on its catalytic converters, centre resonator boxes and on its rear mufflers.

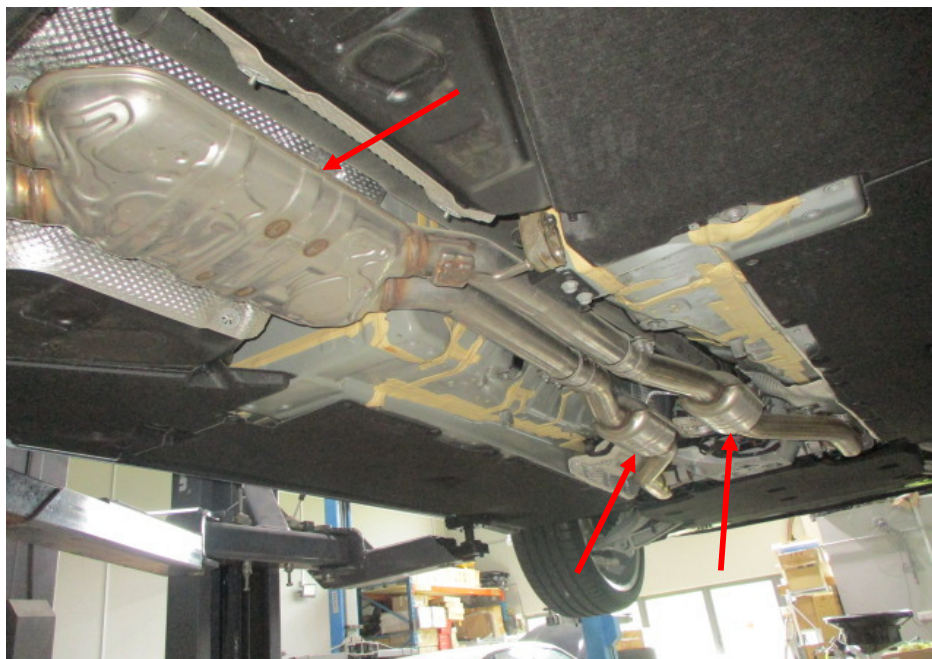
Photo 25 shows a general view of the front section of the Motor Car's exhaust system. My examination of the Motor Car's exhaust system revealed no sign(s) or indication(s) of any cut or weld marks along its exhaust pipes, on its catalytic converters, centre resonator boxes (arrowed) and on its rear mufflers.

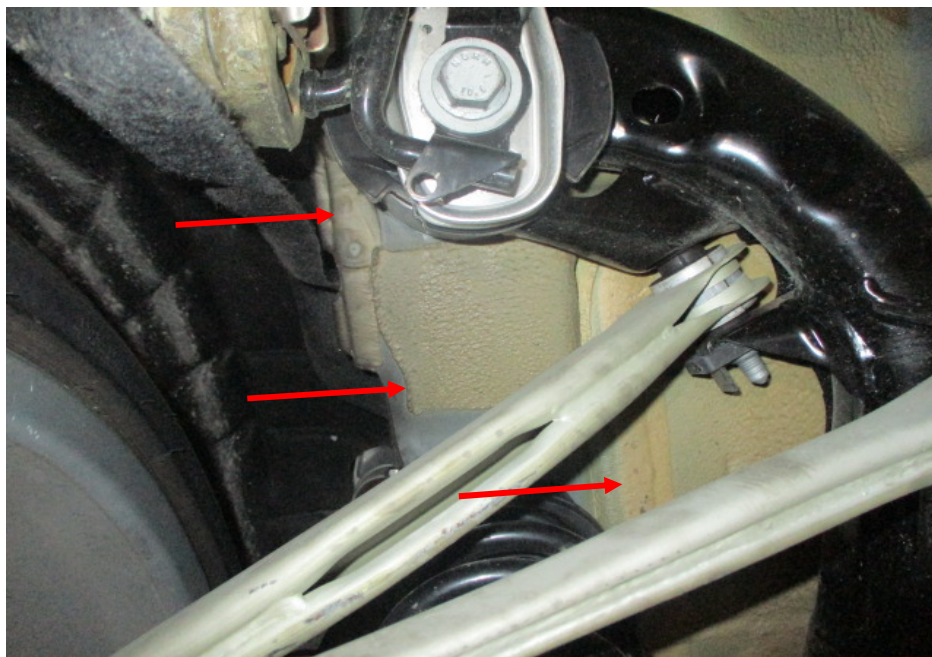
Photo 26 shows the chassis/structural body at the underside rear left of the Motor Car. I did not find any weld marks other than original spot weld marks on the chassis/structural body of the Motor Car. The original factory sealant (arrowed) at the joints along the chassis/structural body was untouched, indicating no work was done on the chassis/structural body of the Motor Car and that the chassis/structural body was originally fitted.

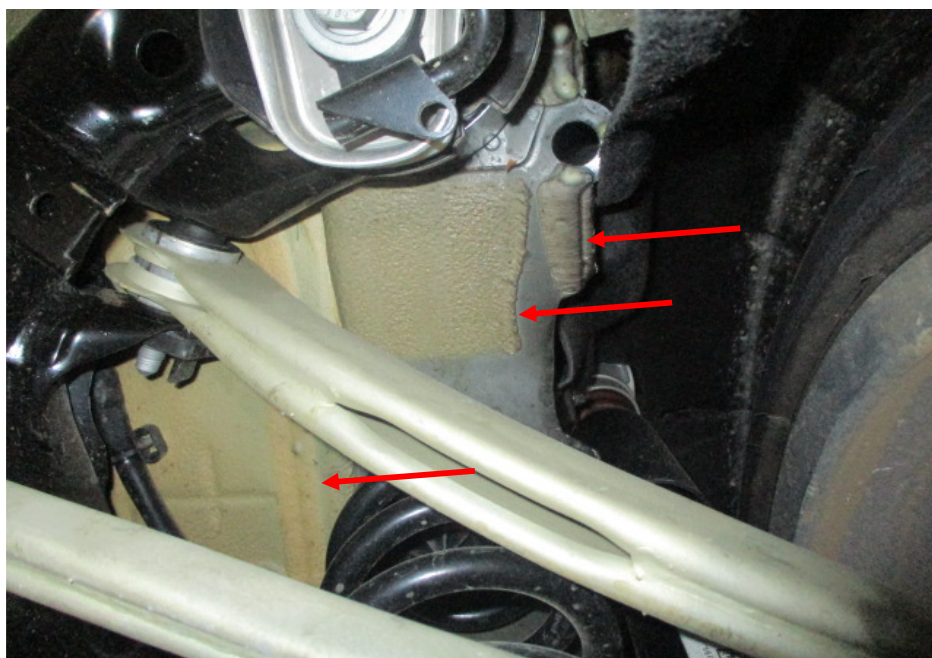
Photo 27 shows the chassis/structural body at the underside rear right of the Motor Car. The original factory sealant (arrowed) at the joints along the chassis/structural body was observed to be untouched. In general, I had found no work was carried out on the chassis/structural body of the Motor Car. The chassis/structural body of the Motor Car was originally fitted.

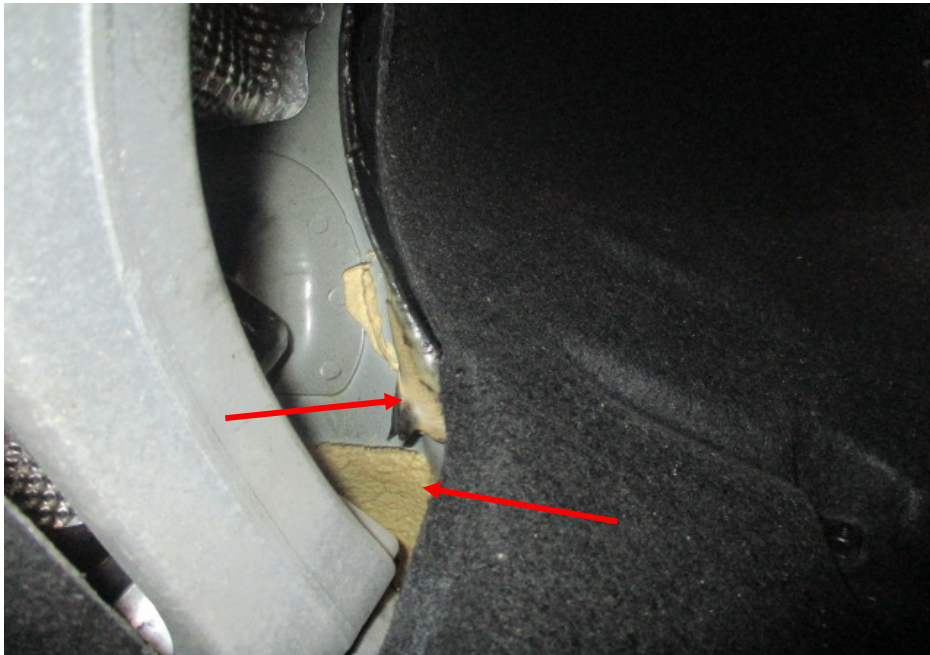
Photo 28 shows the chassis/structural body at the underside front left of the Motor Car. I did not find any weld marks other than original spot weld marks on the chassis/structural body of the Motor Car. The original factory sealant (arrowed) at the joints along the chassis/structural body was untouched, indicating no work was done on the chassis/structural body of the Motor Car and that the chassis/structural body was originally fitted.
