(chassis number WAUZZZF23KN111901)

Our Ref : CI/TP21008094/D

INSPECTION REPORT OF AN UNREGISTERD AUDI A6 MOTOR CAR WITH CHASSIS NUMBER WAUZZZF23KN111901

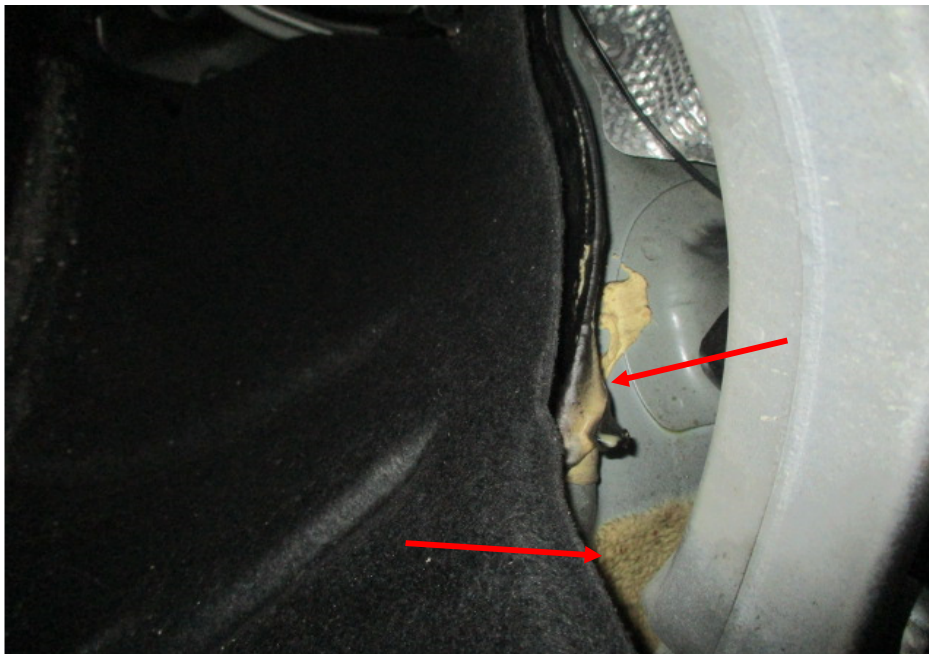
Photo 29 shows the chassis/structural body at the underside front right of the Motor Car. The original factory sealant (arrowed) at the joints along the chassis/structural body was observed to be untouched. In general, I had found no work was carried out on the chassis/structural body of the Motor Car. The chassis/structural body of the Motor Car was originally fitted.

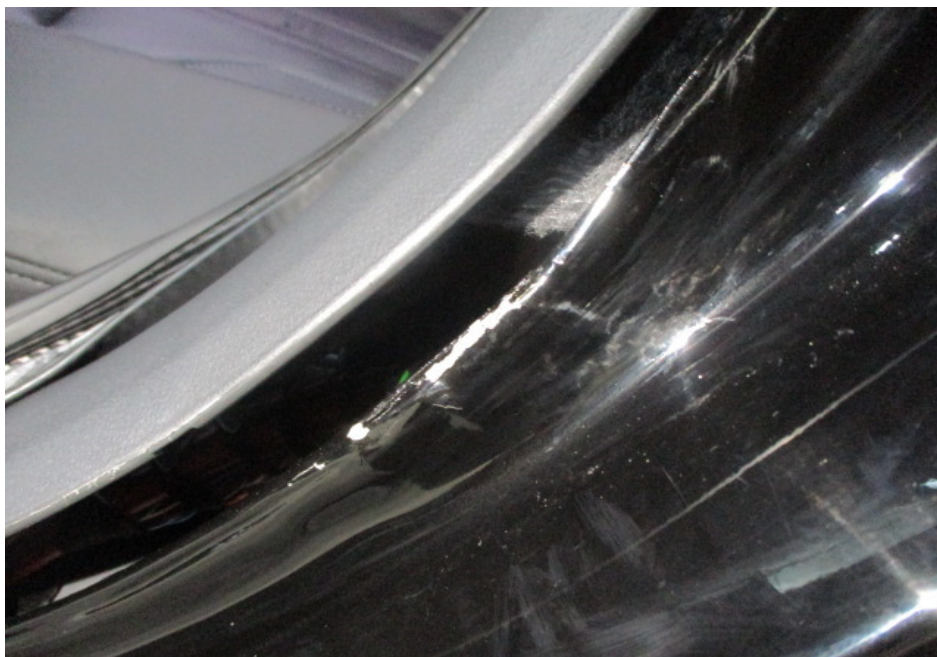
Photo 30 shows the lower section of the Motor Car's left side "C" pillar. I did not find any original weld marks at the lower section of the left side "C" pillar. Original weld marks were however found at the upper section of the left side "C" pillar (refer to photograph 31 below). The lack of original weld marks at the lower section was due to smoothening of the lower section for re-spraying work after the left rear fender was repaired.

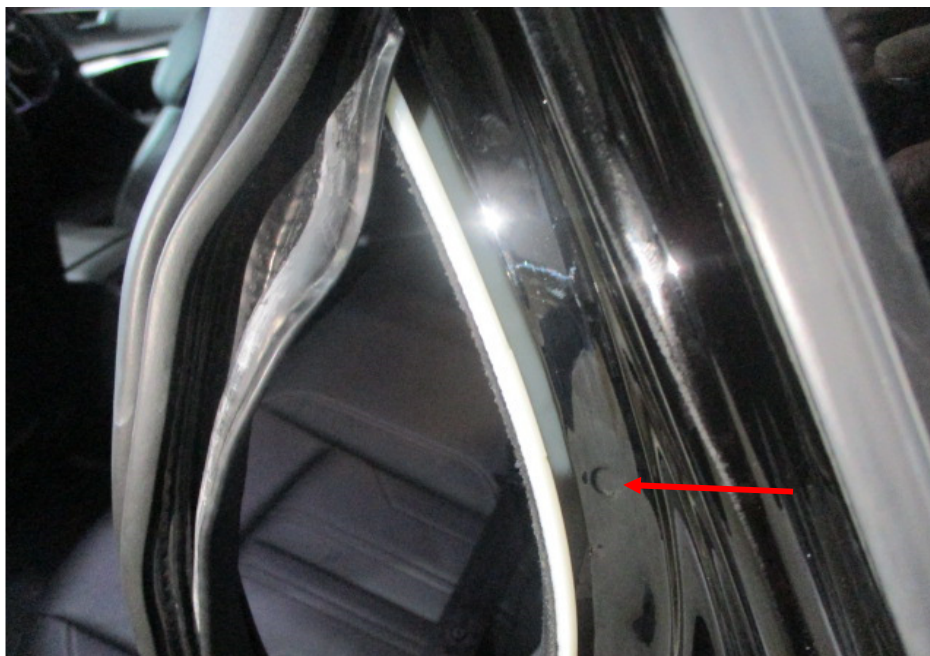
Photo 31 shows the upper section of the Motor Car's left side "C" pillar. Original weld marks (arrowed) were observed at the upper section. The lack of original weld marks at the lower section of the Motor Car's left side "C" pillar (refer to photograph 30) was due to smoothening of the lower section for re-spraying work after the left rear fender was repaired.

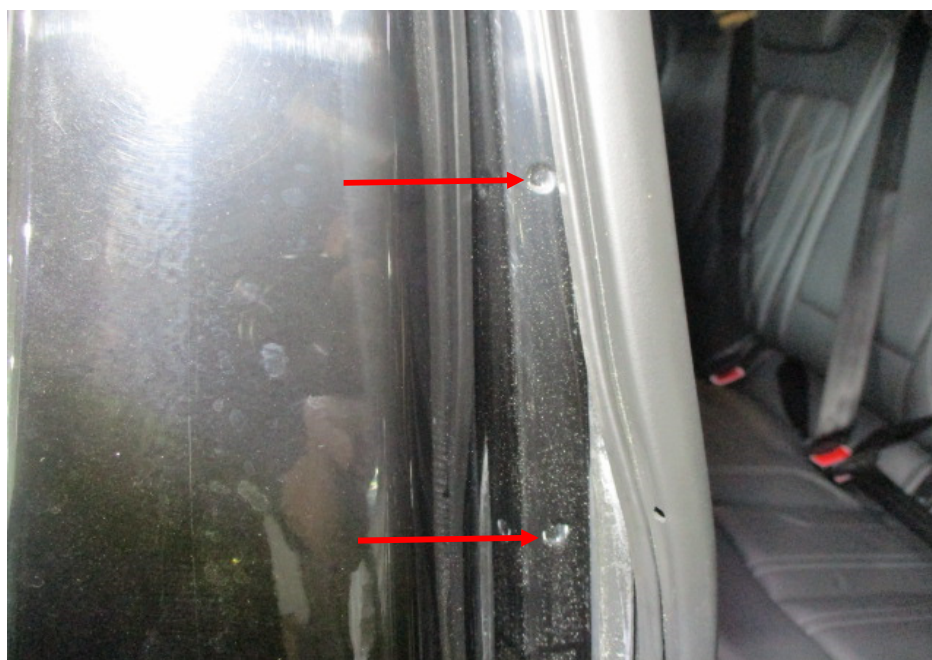
Photo 32 shows the left side "B" pillar of the Motor Car. I did not find any weld marks other than original spot weld marks (arrowed) on the left side "B" pillar of the Motor Car which, indicates that there was no re-welding works carried out. In general, I had found all the non-detachable body panels of the Motor Car to be originally fitted at the time of my inspection.
