Your Ref: Toyota Vellfire
(chassis number GGH300032119)
Our Ref : CI/TP21008096/D

INSPECTION REPORT OF AN UNREGISTERED TOYOTA VELLFIRE MOTOR CAR WITH CHASSIS NUMBER GGH300032119

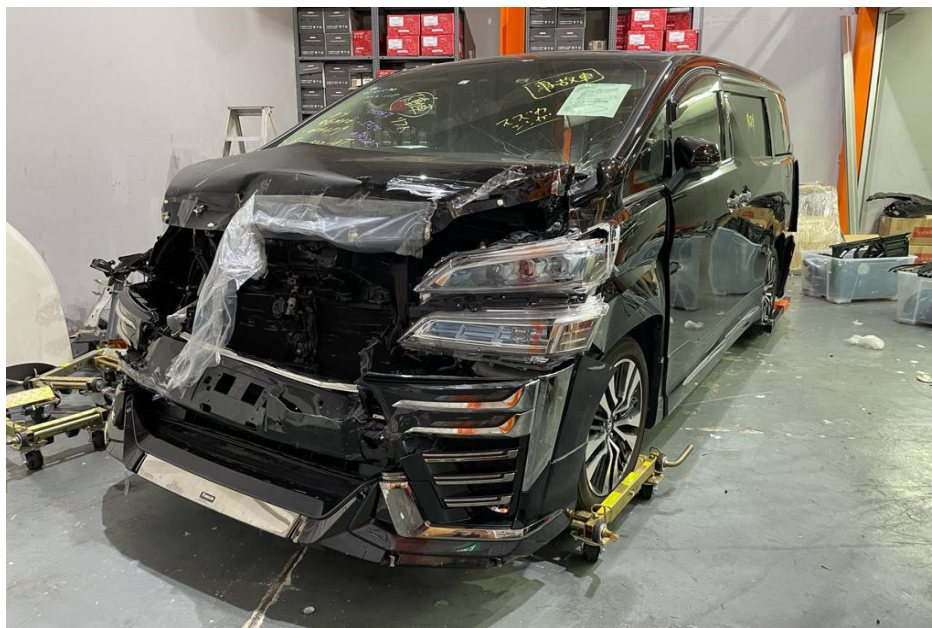
3. The photographs provided to me had showed damage to the frontal body and rear left body of the Motor Car. Body parts damaged at the frontal body include the front bumper, front bumper sponge, front bumper reinforcement, front bumper centre garnish, front bumper centre lower grille, front bumper lower chrome moulding, front bumper left lower grille, front bumper right lower grille, radiator grille, front emblem, front headlamps, front bonnet, front bonnet chrome moulding, front bonnet lock, front support panel, aircon condenser, radiator, front windscreen, front fenders and front doors amongst others.

Photo 1 shows the front left body of the Motor Car (photograph provided to me). The Motor Car was observed to have sustained damage at its frontal body. The front bumper, front bumper left lower grille, front bumper lower chrome moulding, front bumper reinforcement, front bonnet, front support panel, aircon condenser, radiator, front left headlamp, front left fender and front windscreen were amongst the body parts that were observed to have been damaged.

23. The body parts at the frontal body and rear left body of the Motor Car were visually examined and it was noted that the repair/restoration works carried out to the damaged area of the Motor Car (refer to photograph 1 - 3 above) were reasonably adequate and in order.

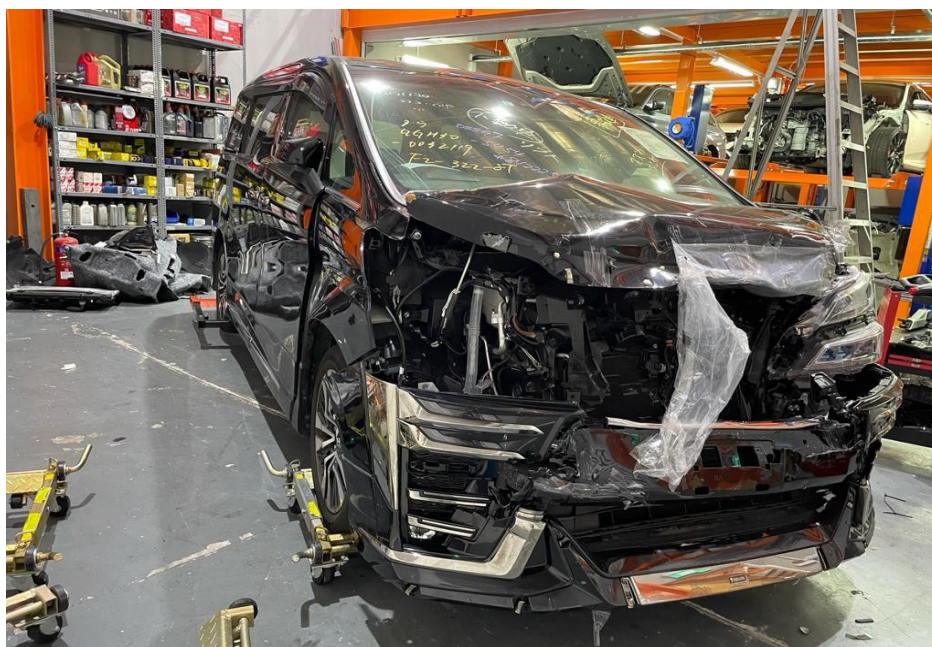
Photo 2 shows the front right body of the Motor Car (photograph provided to me). The Motor Car was observed to have sustained damage at its frontal body. The front bumper, front bumper centre lower grille, front bumper right lower grille, front bumper centre garnish, front bumper reinforcement, radiator grille, front emblem, front bonnet, front bonnet chrome moulding, front right headlamp and front right fender were amongst the body parts that were observed to have been damaged.

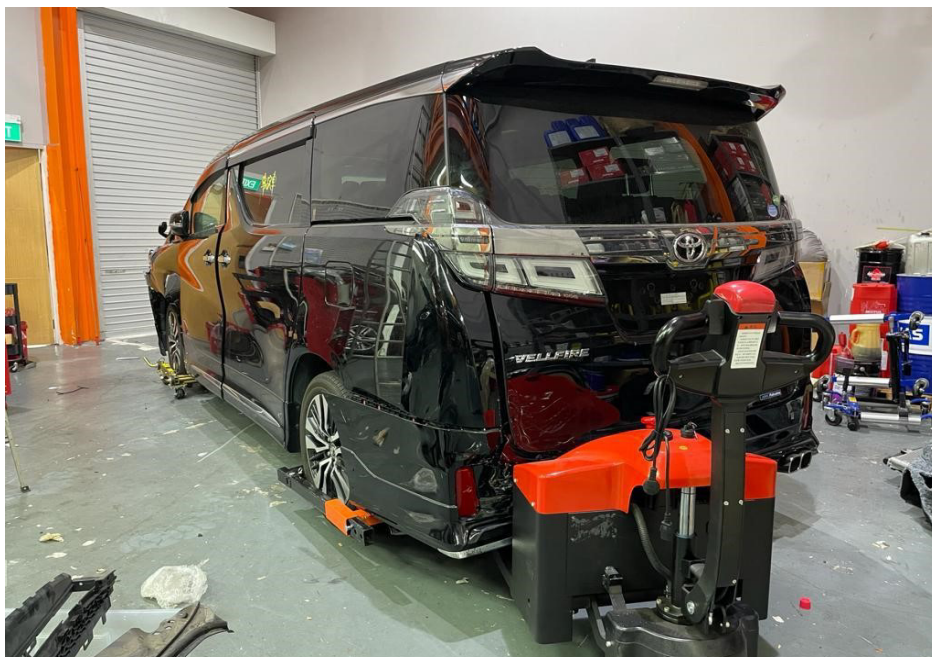
4. With regard to the rear left body, I had observed damage to the Motor Car's rear bumper, rear bumper lower cover, rear bumper left reflector, rear bumper left chrome moulding, rear bumper left top garnish and rear tailgate amongst others.

Photo 3 shows the rear left body of the Motor Car (photograph provided to me). Apart from the frontal body, the photographs provided had also showed damage to the rear left body of the Motor Car. The Motor Car's rear bumper, rear bumper lower cover, rear bumper left reflector, rear bumper left chrome moulding, rear bumper left top garnish and rear tailgate were amongst the body parts that were observed to have been damaged.

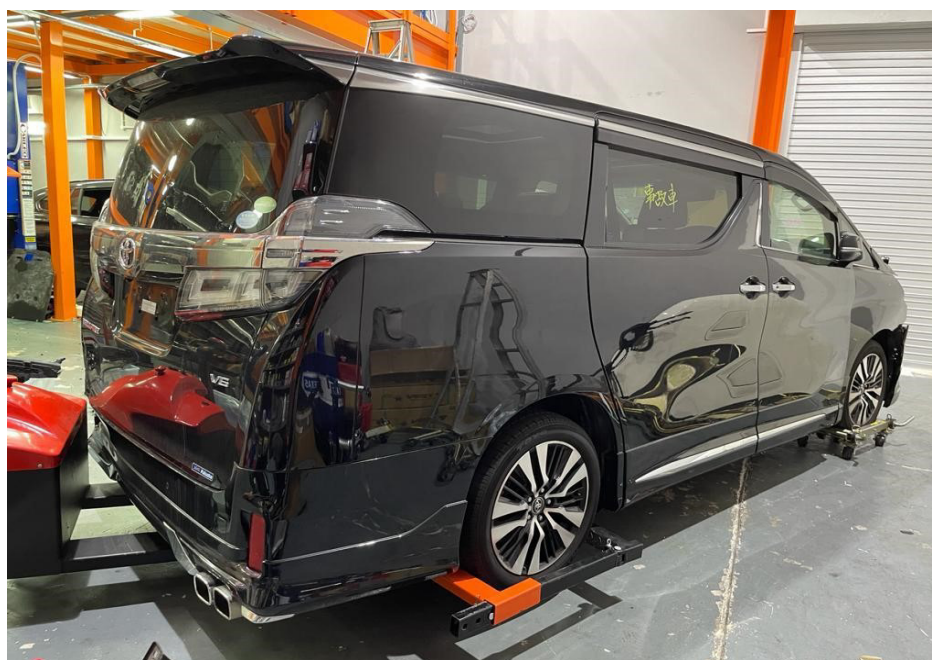
Photo 4 shows the rear right body of the Motor Car (photograph provided to me). The right body of the Motor Car appears to be without any physical damage. The airbags were also not deployed as seen from the photographs that were provided to me.

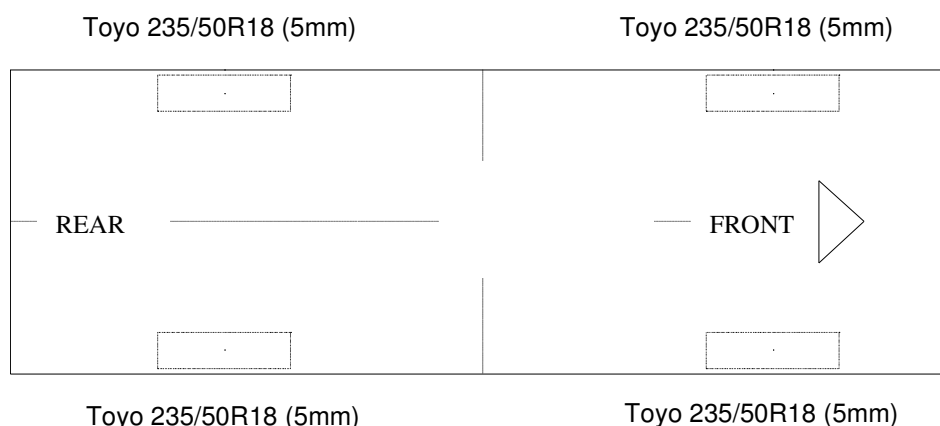
9. It was fitted with 18inch sport wheel rims that were wrapped with tyres that were observed to be of serviceable condition. The tyres were also sufficiently inflated for vehicular operation. The tyre brand, tyre size and approximate remaining tread depth of the 4 tyres of the Motor Car were recorded as follows: -

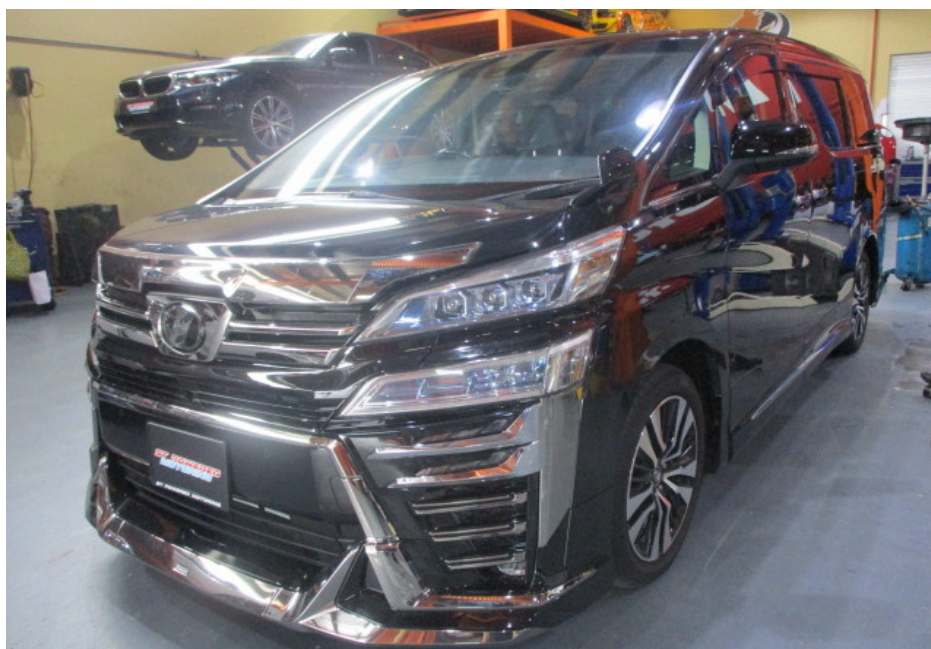
Photo 5 shows a general view of the front left body of the Motor Car at the time of my inspection. The Motor Car was observed to be in a relatively good general condition with no loose exterior fittings observed. The body parts at the frontal body of the Motor Car were visually examined and it was observed that the repair/restoration works carried out to the damaged area of the Motor Car (refer to photograph 1 & 2 above) were reasonably adequate and in order.

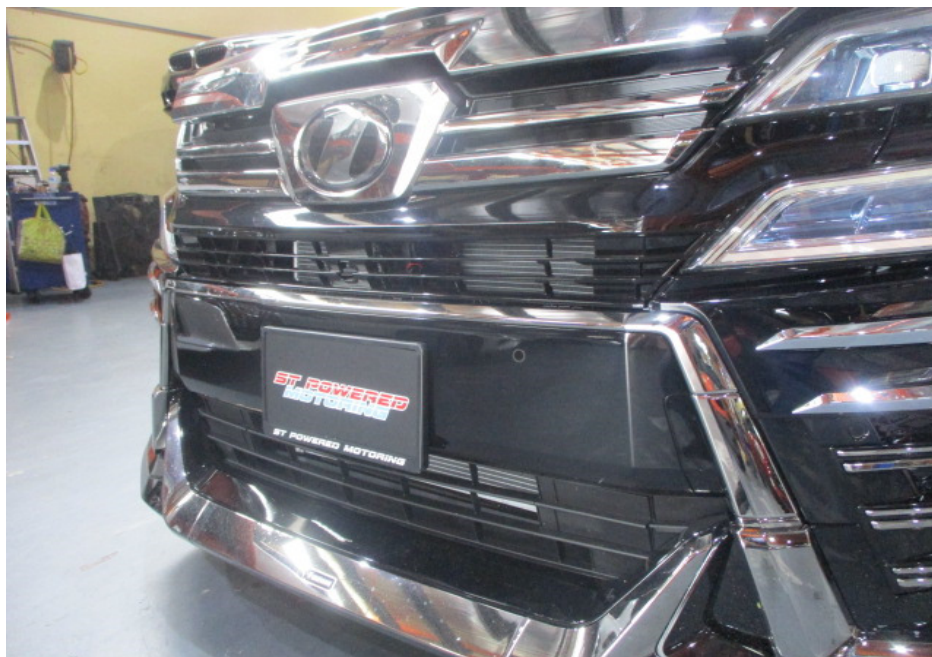
Photo 6 shows a closer view of the Motor Car's front bumper centre lower grille, front bumper centre garnish, front bumper lower chrome moulding, radiator grille and front emblem. The body parts at the frontal body of the Motor Car were visually examined and it was observed that the repair/restoration works carried out to the damaged area of the Motor Car (refer to photograph 1 & 2 above) were reasonably adequate and in order.

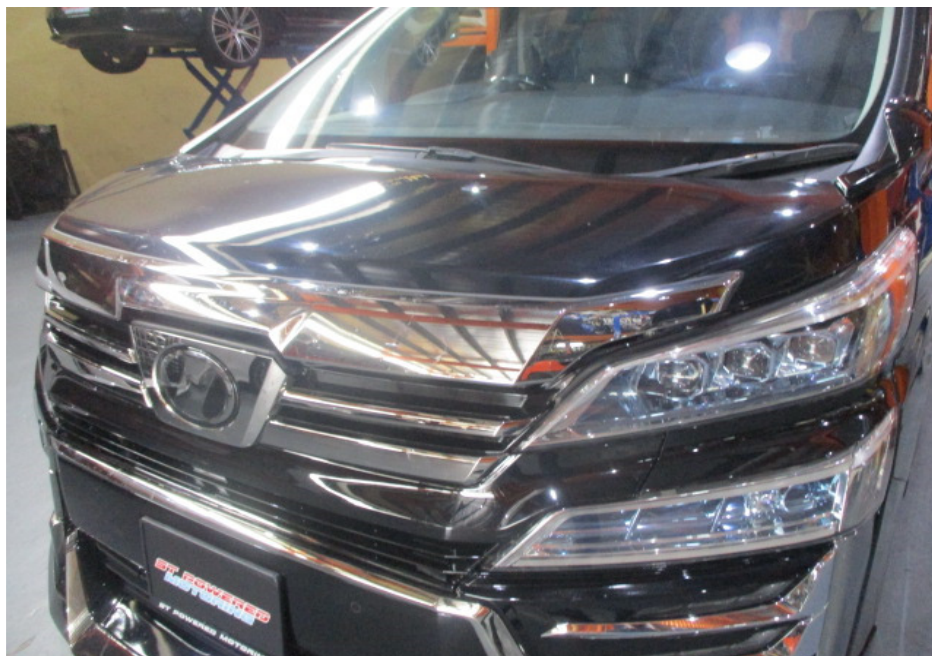
Photo 7 shows a closer view of the Motor Car's front left headlamp, front bonnet, front bonnet chrome moulding and front windscreen. The body parts at the frontal body of the Motor Car were visually examined and it was observed that the repair/restoration works carried out to the damaged area of the Motor Car (refer to photograph 1 & 2 above) were reasonably adequate and in order.

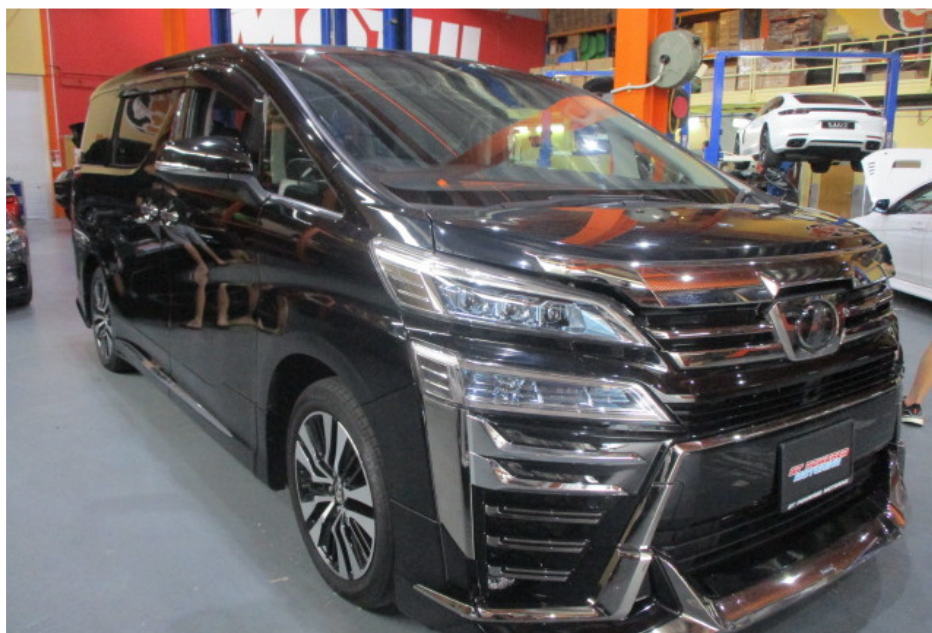
Photo 8 shows a general view of the front right body of the Motor Car at the time of my inspection. The Motor Car was observed to be in a relatively good general condition with no loose exterior fittings observed. The body parts at the frontal body of the Motor Car were visually examined and it was observed that the repair/restoration works carried out to the damaged area of the Motor Car (refer to photograph 1 & 2 above) were reasonably adequate and in order.

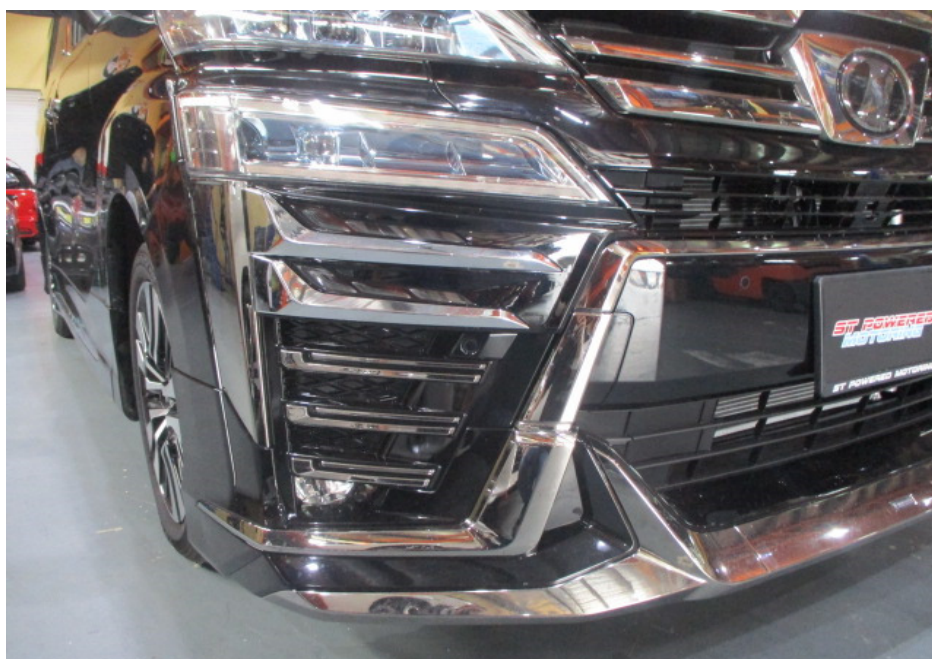
Photo 9 shows a closer view of the Motor Car's front bumper, front bumper right lower grille, front bumper centre lower grille, front bumper lower chrome moulding and front right headlamp. The body parts at the frontal body of the Motor Car were visually examined and it was observed that the repair/restoration works carried out to the damaged area of the Motor Car (refer to photograph 1 & 2 above) were reasonably adequate and in order.

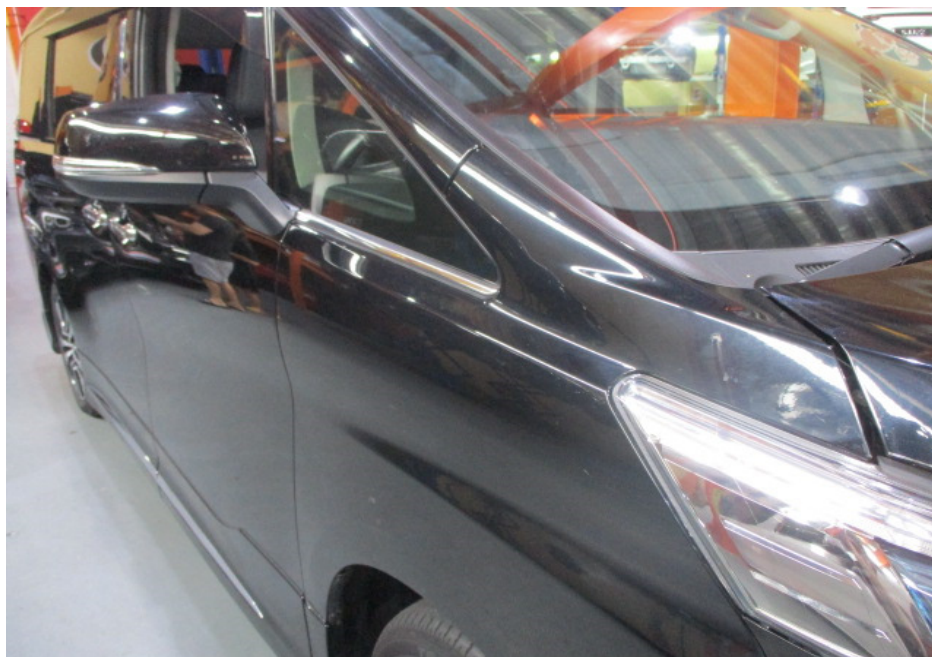
Photo 10 shows a closer view of the Motor Car's front right headlamp, front right fender and front windscreen. The body parts at the frontal body of the Motor Car were visually examined and it was observed that the repair/restoration works carried out to the damaged area of the Motor Car (refer to photograph 1 & 2 above) were reasonably adequate and in order.

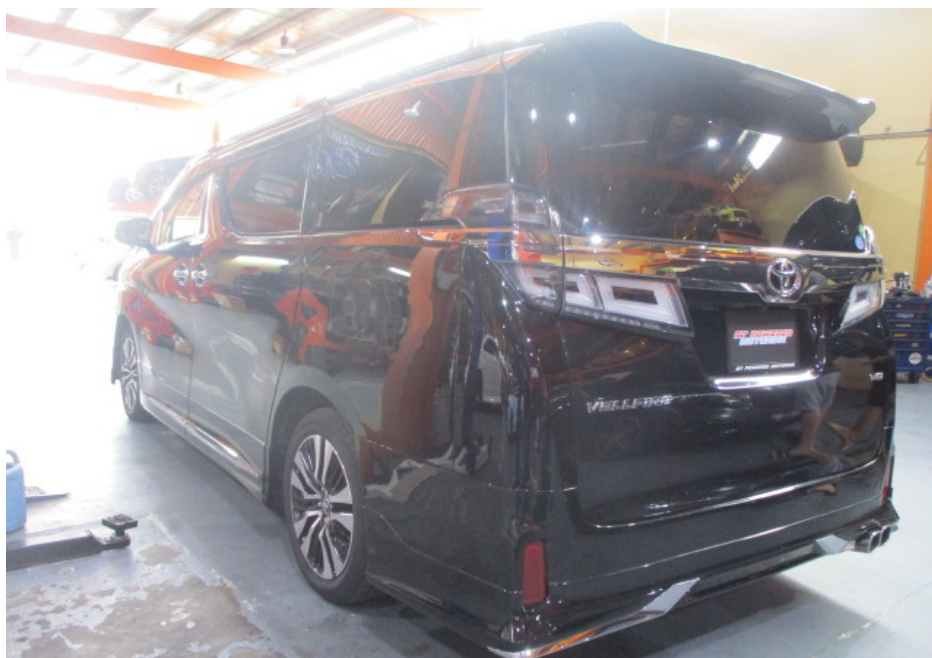
Photo 11 shows a general view of the rear left body of the Motor Car at the time of my inspection. The Motor Car was observed to be in a relatively good general condition with no loose exterior fittings observed. The body parts at the rear left body of the Motor Car were visually examined and it was observed that the repair/restoration works carried out to the damaged area of the Motor Car (refer to photograph 3 above) were reasonably adequate and in order.

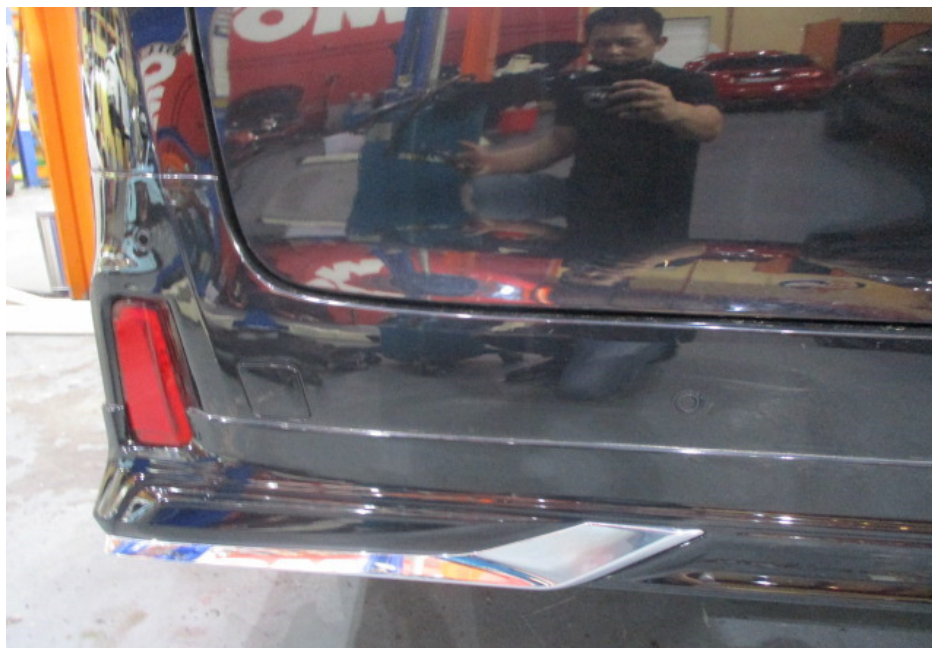
Photo 12 shows a closer view of the Motor Car's rear bumper, rear bumper lower cover, rear bumper left reflector, rear bumper left chrome moulding and rear tailgate. The body parts at the rear left body of the Motor Car were visually examined and it was observed that the repair/restoration works carried out to the damaged area of the Motor Car (refer to photograph 3 above) were reasonably adequate and in order.

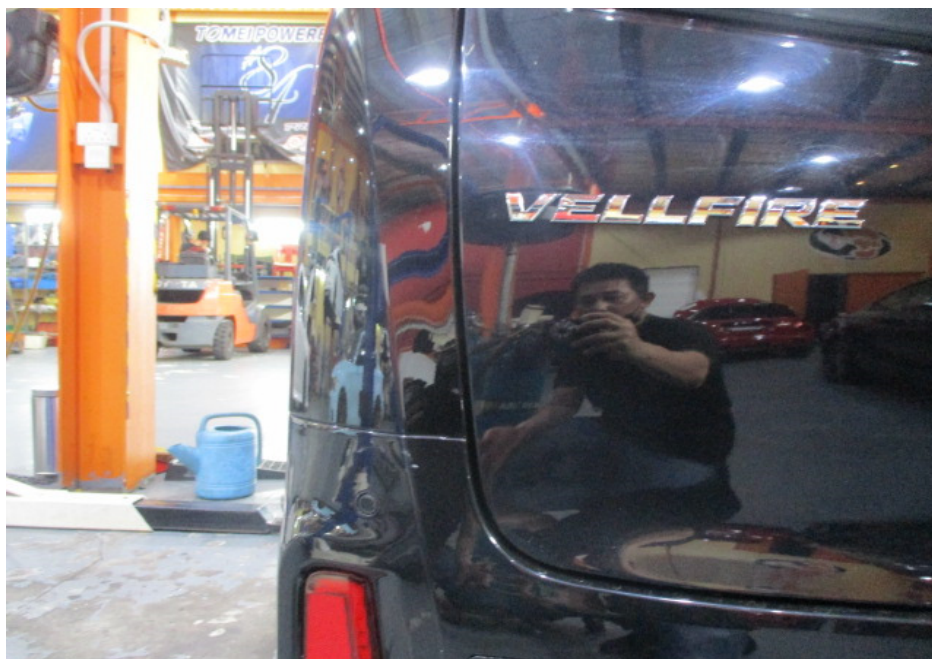
Photo 13 shows a closer view of the Motor Car's rear bumper, rear bumper left reflector, rear bumper left top garnish and rear tailgate. The body parts at the rear left body of the Motor Car were visually examined and it was observed that the repair/restoration works carried out to the damaged area of the Motor Car (refer to photograph 3 above) were reasonably adequate and in order.

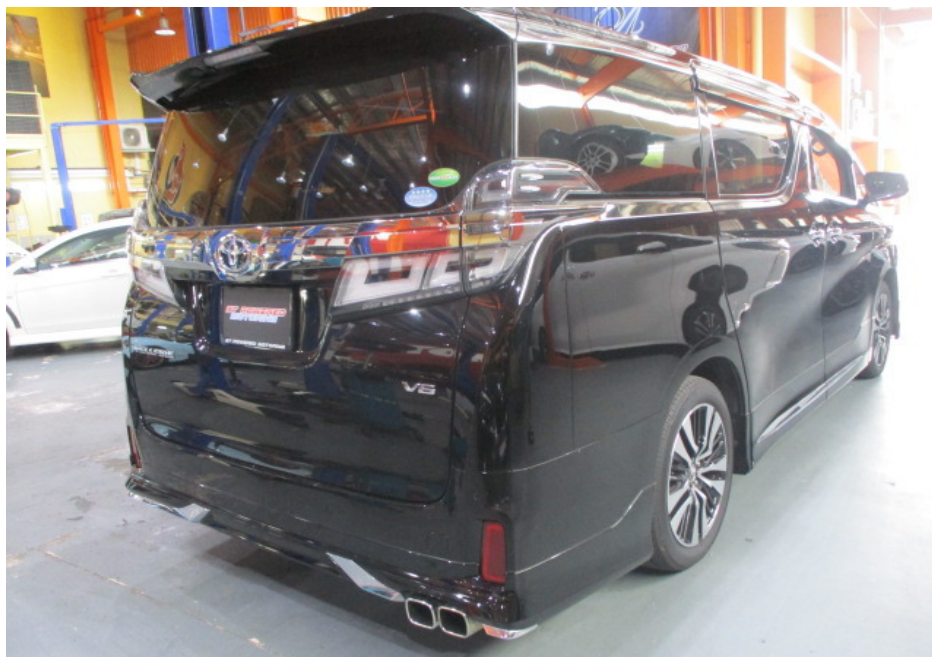
Photo 14 shows a general view of the rear right body of the Motor Car at the time of my inspection. The Motor Car was observed to be in a relatively good general condition with no loose exterior fittings observed. The mileage of the Motor Car recorded at the time of my inspection was 8,405km.

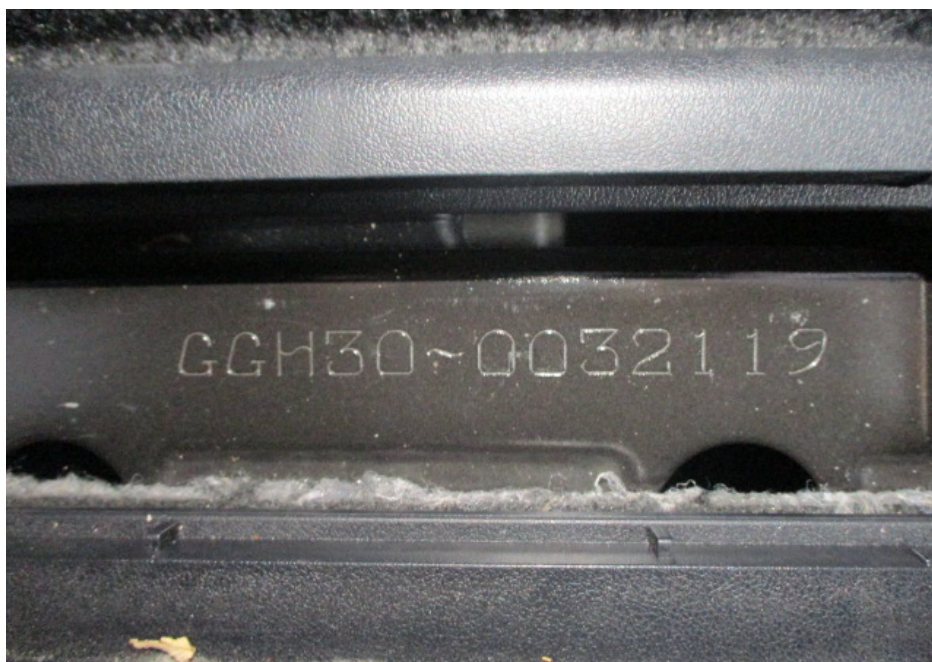
Photo 15 shows the chassis number of the Motor Car. The chassis number recorded was GGH300032119.

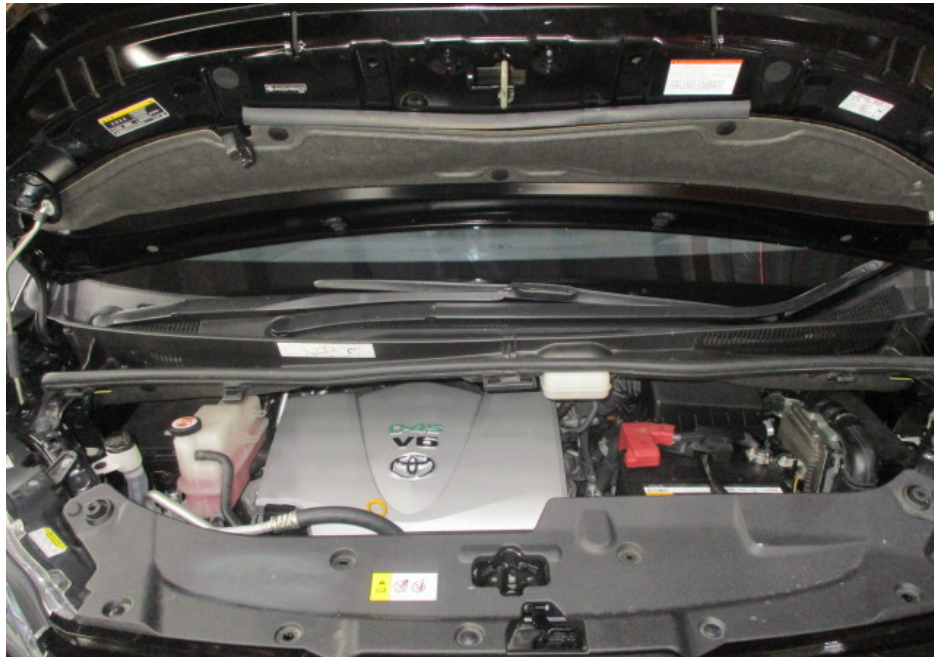
Photo 16 shows a general view of the engine compartment of the Motor Car at the time of my inspection. The various parts and components inside the engine compartment were all observed to be intact and properly fitted. There was also no sign(s) or indication(s) of fluid leak and/or fluid stain found inside the engine compartment.

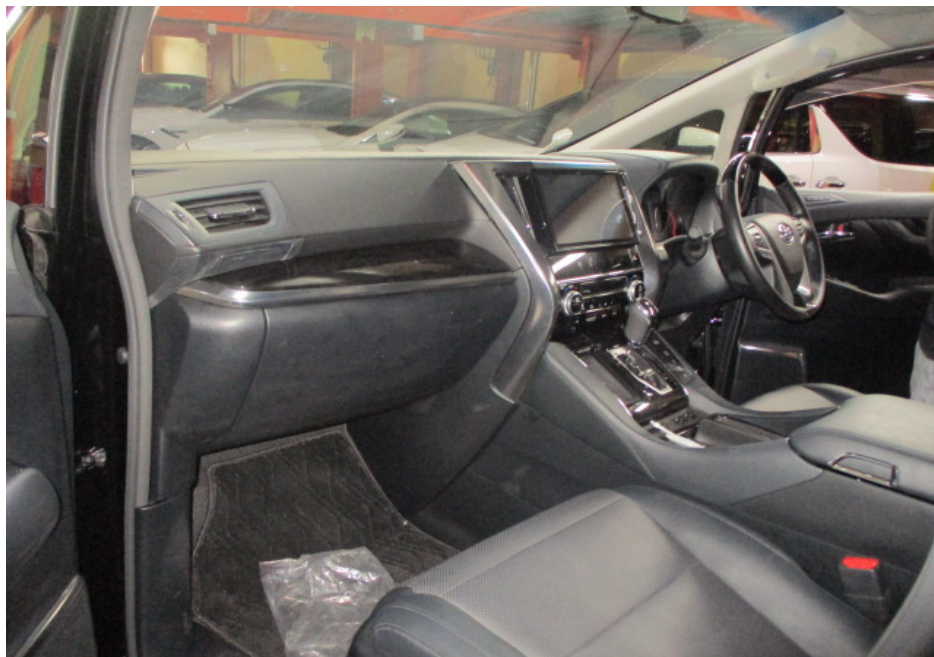
Photo 17 shows the interior compartment of the Motor Car at the time of my inspection. The various parts and components, trims, carpet and upholstery inside the interior compartment were all observed to be intact and properly fitted.

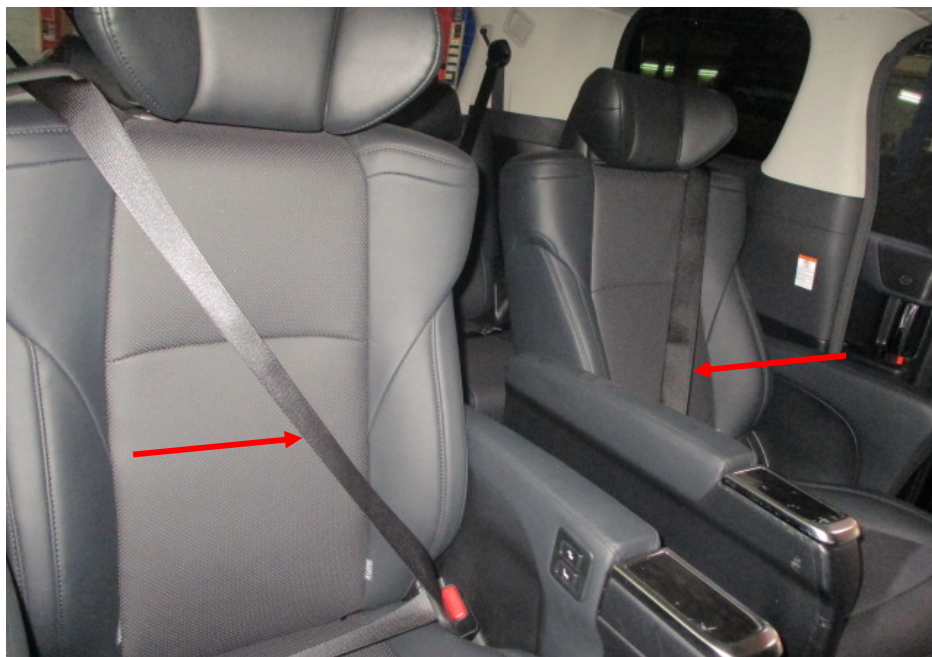
Photo 18 shows the rear seats at the 1st row of the Motor Car. All the seats of the Motor Car were secured via seat rails to the floorboard. They were also fitted with a retractable seat belt reel and a pre-tensioner. The seat belts (arrowed) were tested and were able to be fastened into the respective pre-tensions that were fitted on the side of each individual seat.

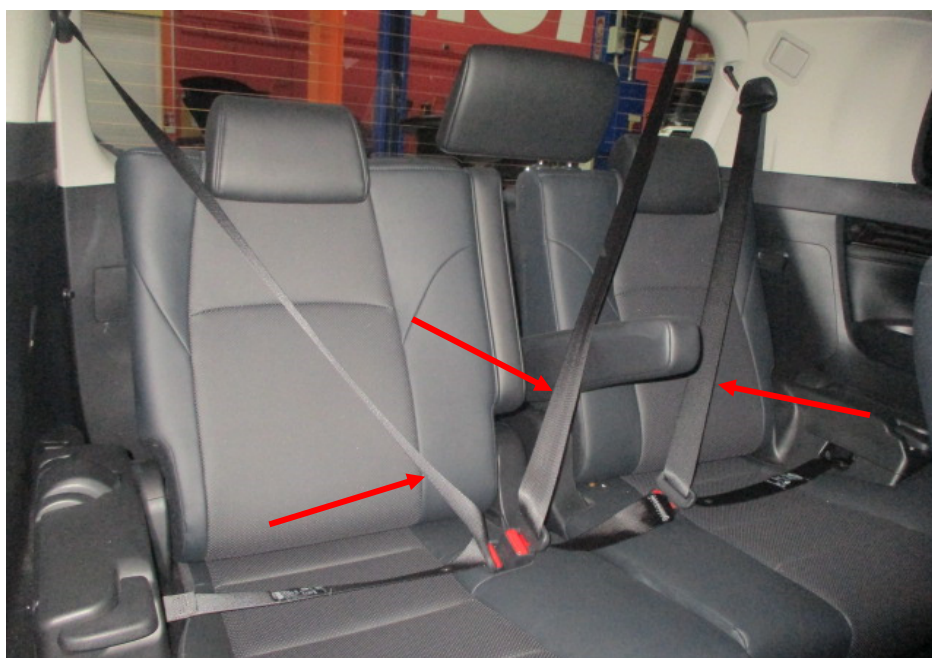
Photo 19 shows the rear seats at the 2nd row of the Motor Car. All the seats of the Motor Car were secured via seat rails to the floorboard. They were also fitted with a retractable seat belt reel and a pre-tensioner. The seat belts (arrowed) were tested and were able to be fastened into the respective pre-tensions that were fitted on the side of each individual seat.

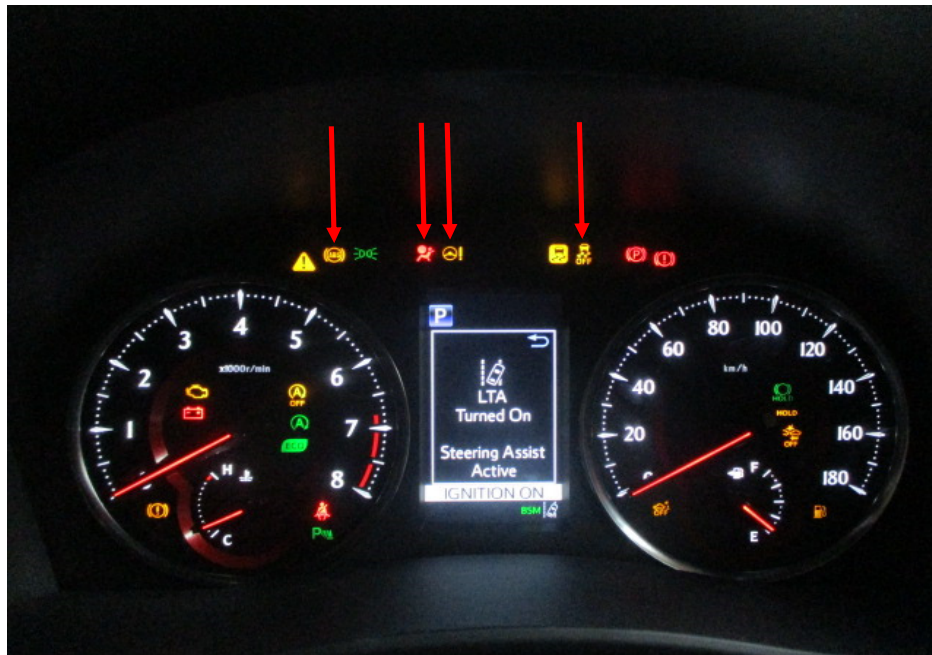
Photo 20 shows the warning lights for the various electronic safety features appearing on the instrument panel of the Motor Car during its self-test when the engine is cranked, in particular the lights for the ABS, SRS, EPS, VSC and various pre-collision systems (arrowed).

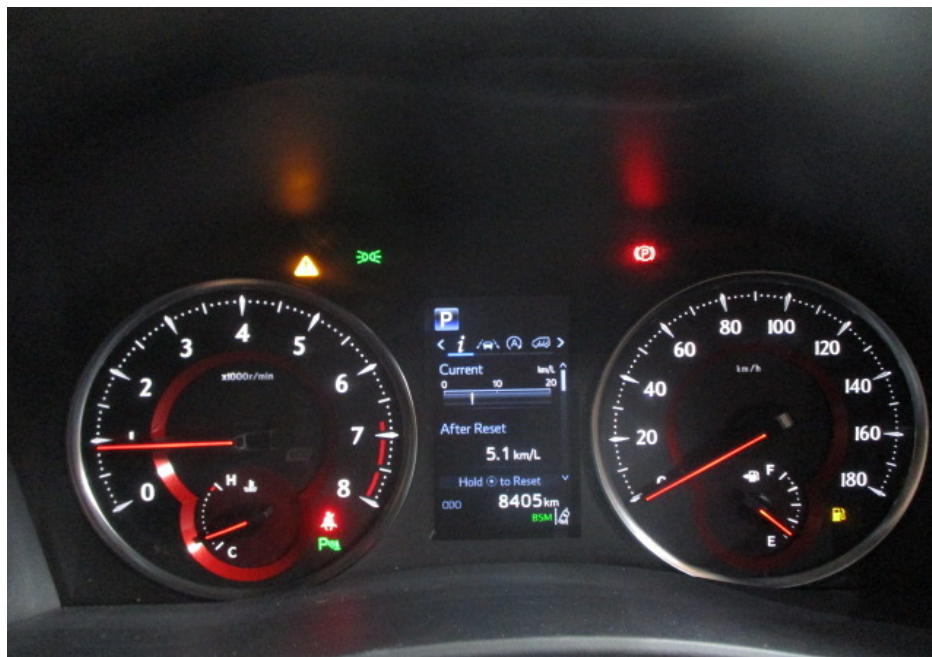
Photo 21 shows the respective warning lights no longer illuminated, indicating that there is no fault detected to the ABS, SRS, EPS, VSC and various pre-collision systems of the Motor Car during the self-test. These electronic systems were hence in working condition at the time of my inspection.

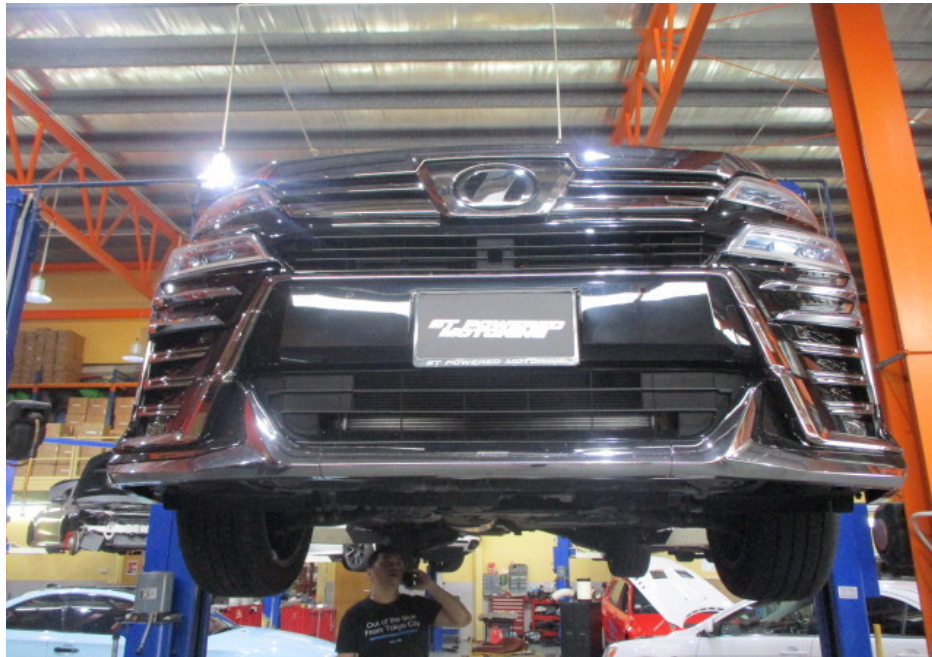
Photo 22 shows the Motor Car hoisted up for checks on its undercarriage. There was no sign(s) or indication(s) of fluid leakage and/or fluid stain(s) on the underside of the Motor Car. The undercarriage components of the Motor Car were also all observed to be intact and secured in an appropriate manner.

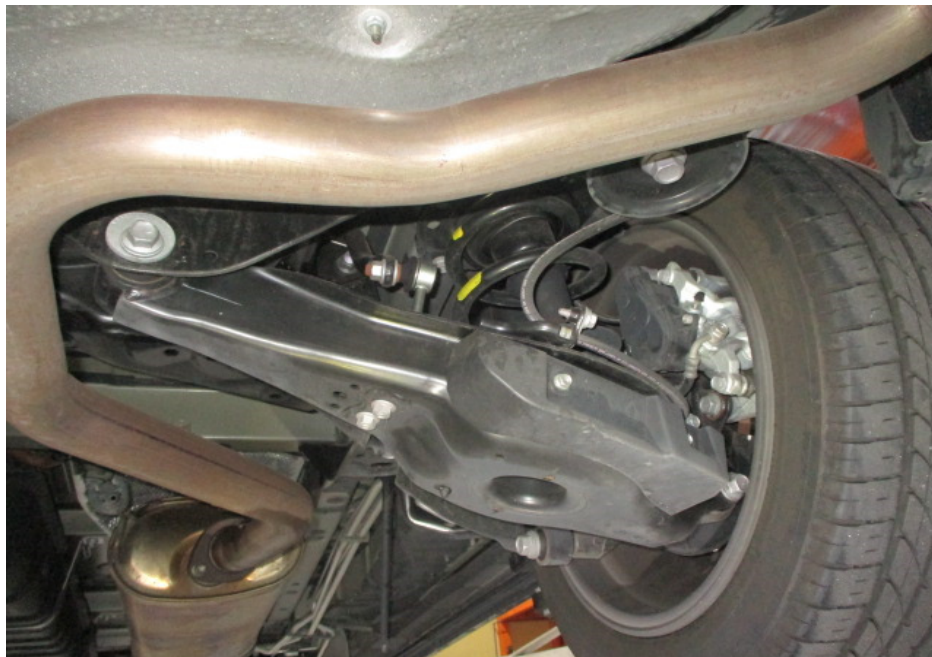
Photo 23 shows a general view of the control arms and linkages at the rear right wheel of the Motor Car. I did not observe any fluid leak and/or fluid stain on the underside of the Motor Car. All of the Motor Car's undercarriage components were observed to be intact and secured in an appropriate manner.

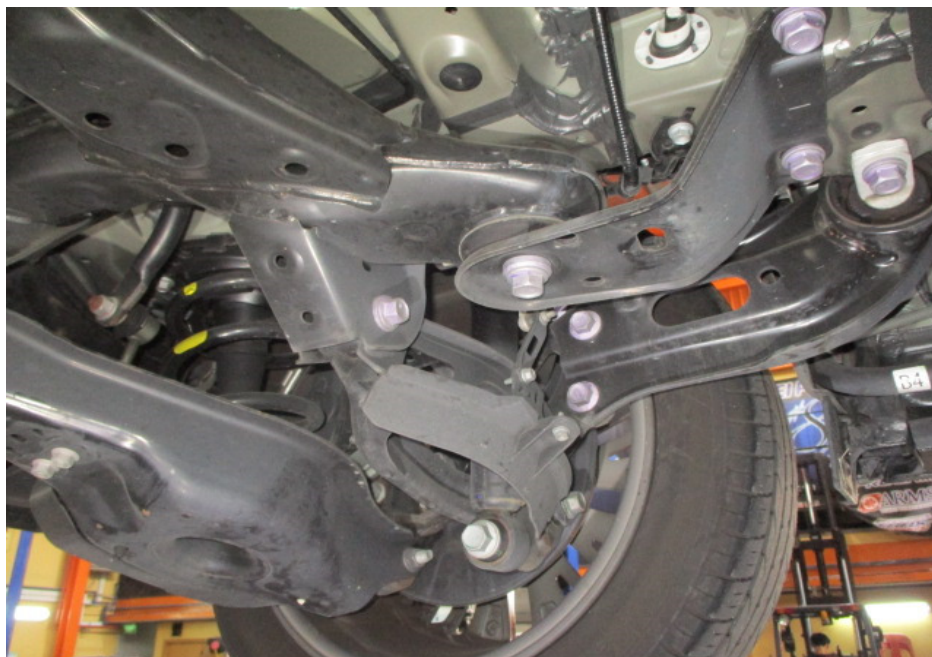
Photo 24 shows a general view of the control arms and linkages at the rear left wheel of the Motor Car. I did not observe any fluid leak and/or fluid stain on the underside of the Motor Car. All of the Motor Car's undercarriage components were observed to be intact and secured in an appropriate manner.

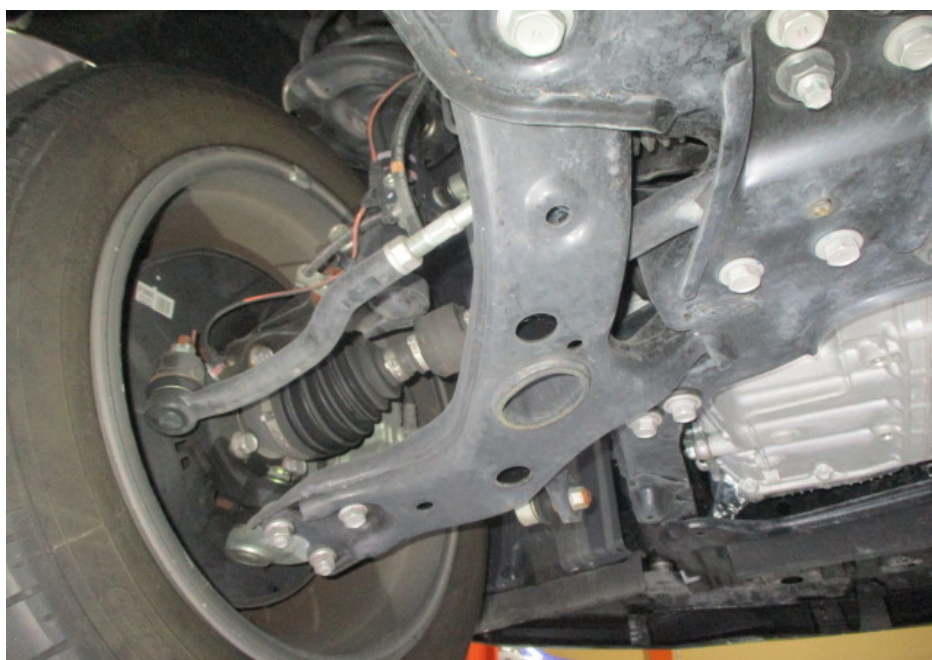
Photo 25 shows the various undercarriage components at the front left wheel of the Motor Car. The mechanical components, control arms and linkages were all found to be intact and secured in an appropriate manner.

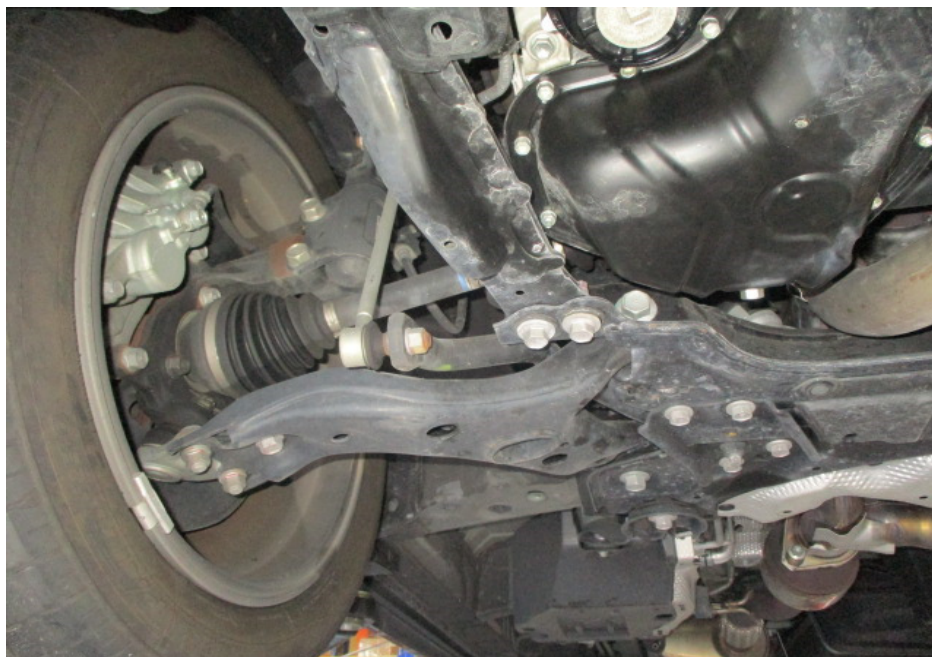
Photo 26 shows the various undercarriage components at the front right wheel of the Motor Car. The mechanical components, control arms and linkages were all found to be intact and secured in an appropriate manner. I also did not observe any fluid leak and/or fluid stain on the underside of the Motor Car.

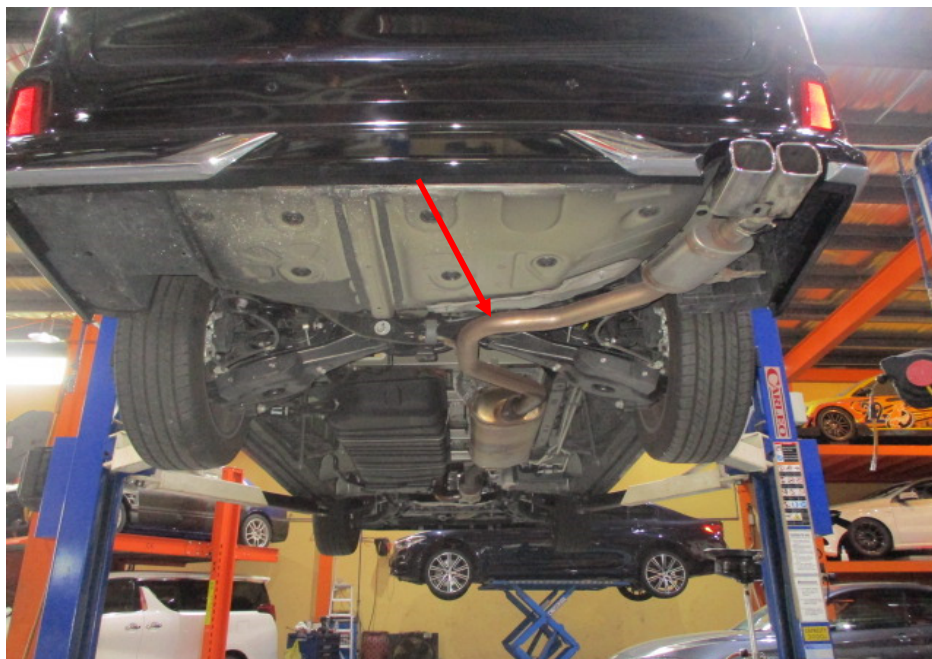
Photo 27 shows a general view of the rear section of the Motor Car's exhaust system. My examination of the Motor Car's exhaust system revealed no sign(s) or indication(s) of any cut or weld marks along its exhaust pipe (arrowed), on its catalytic converter, centre resonator box and on its rear muffler.

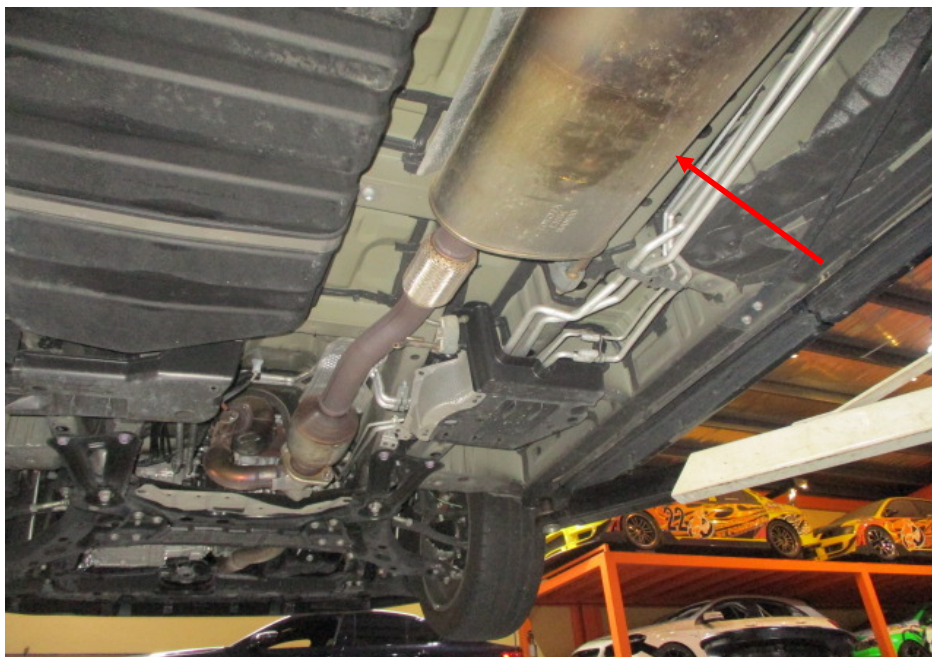
Photo 28 shows a general view of the front section of the Motor Car's exhaust system. My examination of the Motor Car's exhaust system revealed no sign(s) or indication(s) of any cut or weld marks along its exhaust pipe, on its catalytic converter, centre resonator box (arrowed) and on its rear muffler.

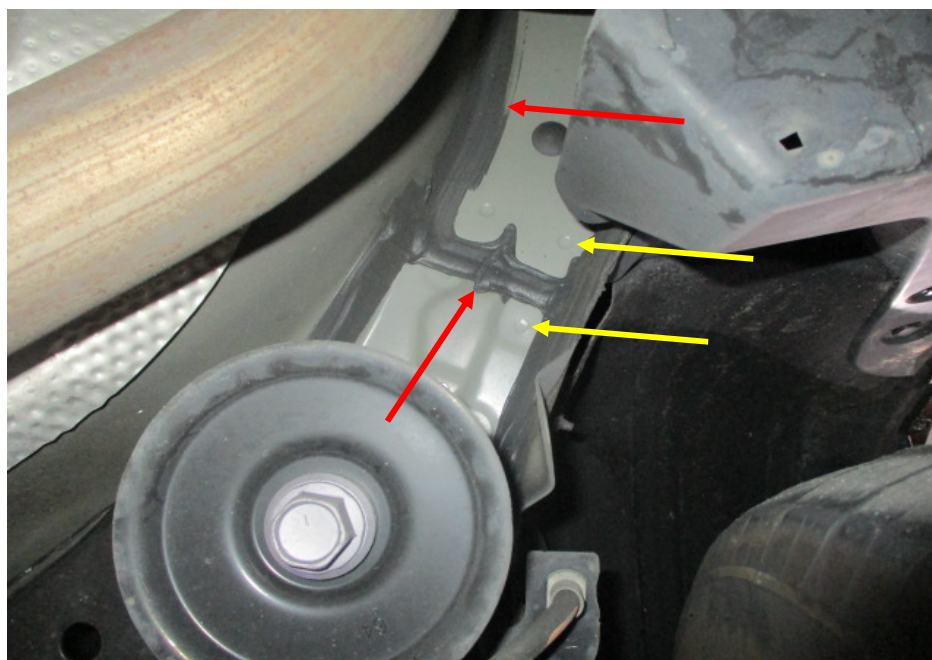
Photo 29 shows the chassis/structural body at the underside rear right of the Motor Car. I did not find any weld marks other than original spot weld marks (yellow arrow) on the chassis/structural body of the Motor Car. The original factory sealant (red arrow) at the joints along the chassis/structural body was untouched, indicating no work was done on the chassis/structural body of the Motor Car and that the chassis/structural body was originally fitted.

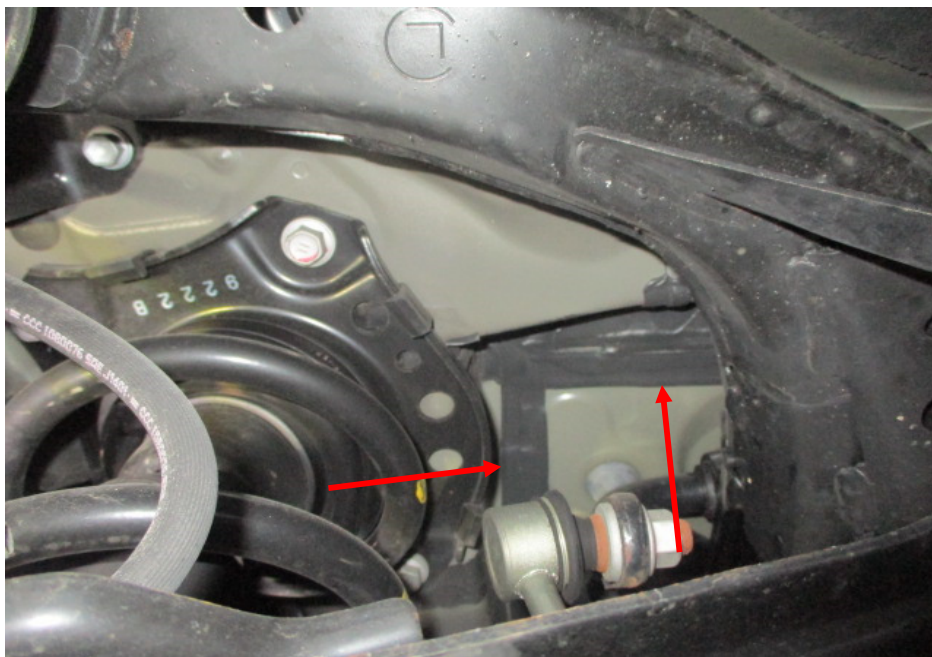
Photo 30 shows the floorboard and chassis/structural body at the underside rear left of the Motor Car. The original factory sealant (arrowed) at the joints along the floorboard was observed to be untouched. In general, I had found all the non-detachable body panels of the Motor Car to be originally fitted at the time of my inspection.

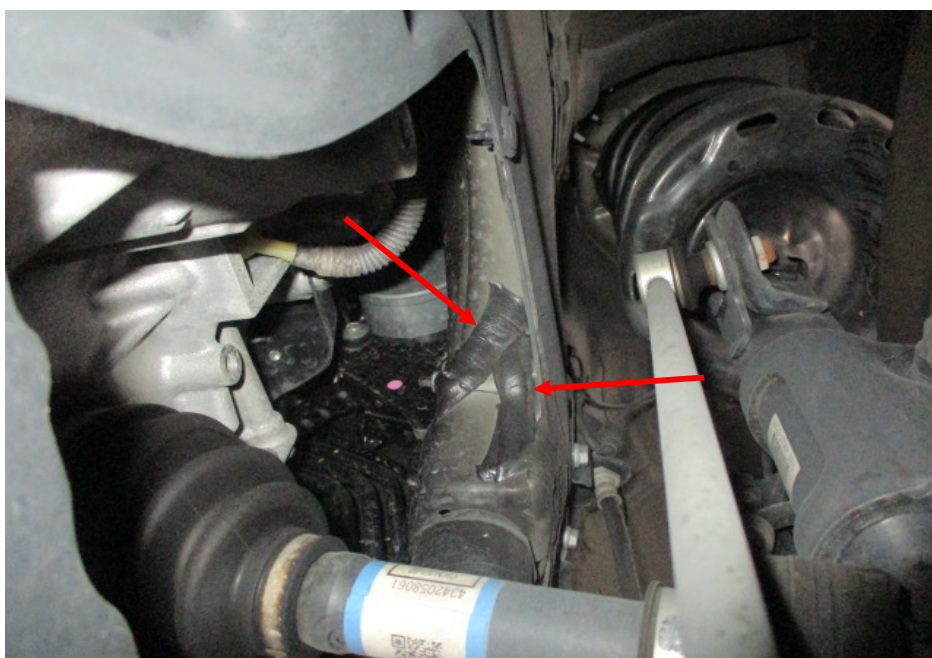
Photo 31 shows the chassis/structural body at the underside front left of the Motor Car. The original factory sealant (arrowed) at the joints along the chassis/structural body was observed to be untouched. In general, I had found no work was carried out on the chassis/structural body of the Motor Car. The chassis/structural body of the Motor Car was originally fitted.
