Your Ref: Toyota Vellfire
(chassis number GGH300032119)
Our Ref : CI/TP21008096/D

INSPECTION REPORT OF AN UNREGISTERED TOYOTA VELLFIRE MOTOR CAR WITH CHASSIS NUMBER GGH300032119

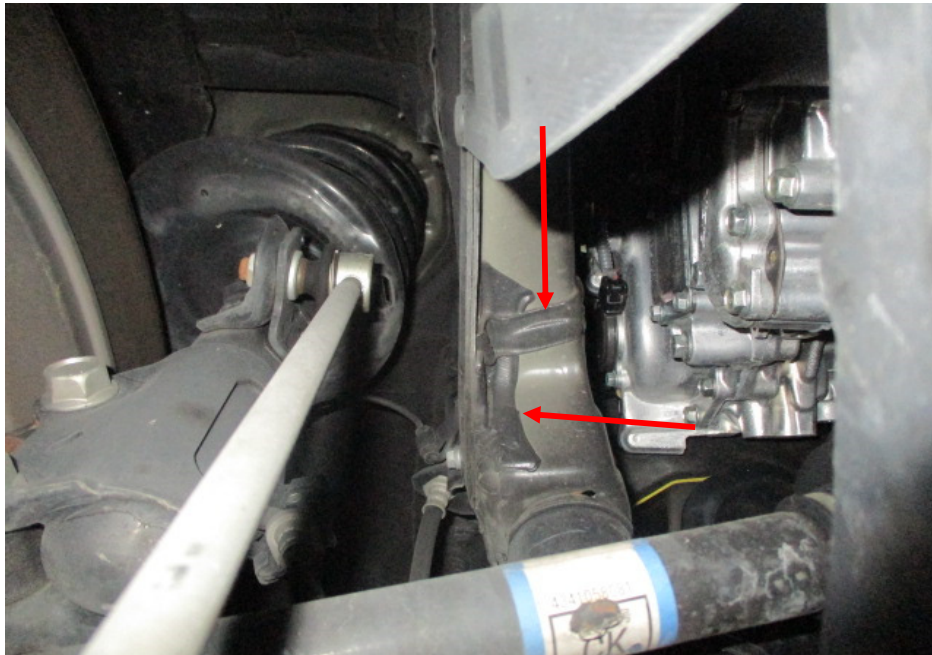
Photo 32 shows the chassis/structural body at the underside front right of the Motor Car. The original factory sealant (arrowed) at the joints along the chassis/structural body was observed to be untouched. In general, I had found no work was carried out on the chassis/structural body of the Motor Car. The chassis/structural body of the Motor Car was originally fitted.

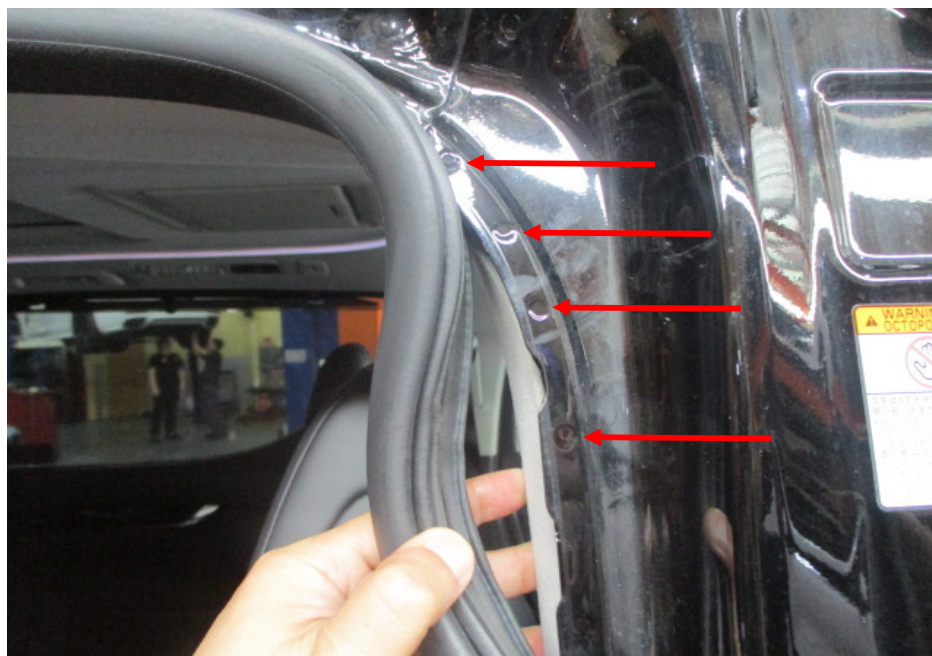
Photo 33 shows the right side centre pillar of the Motor Car. I did not find any weld marks other than original spot weld marks (arrowed) on the right side centre pillar of the Motor Car, which indicates that there was no re-welding works carried out. In general, I had found all the non-detachable body panels of the Motor Car to be originally fitted at the time of my inspection.

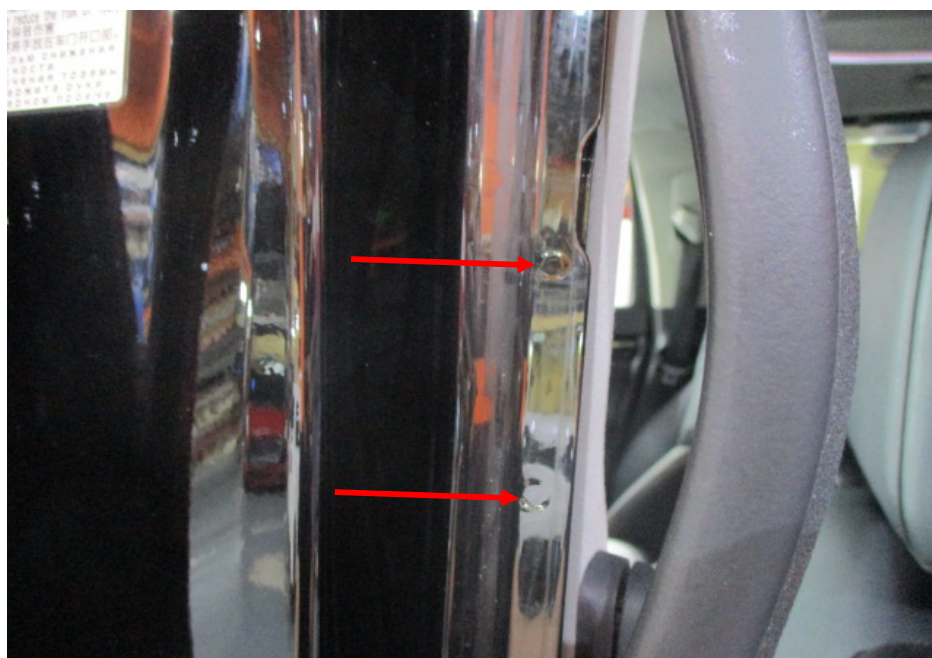
Photo 34 shows the left side centre pillar of the Motor Car. I did not find any weld marks other than original spot weld marks (arrowed) on the left side centre pillar of the Motor Car, which indicates that there was no re-welding works carried out. In general, I had found all the non-detachable body panels of the Motor Car to be originally fitted at the time of my inspection.
