Our Reference : KAAS/TA/5920/3525/TP/02.20  
Date : 15 March 2020

## VEHICLE APPRAISAL REPORT

Name of Workshop : Lush Automotive Pte Ltd  
Place of inspection : 8 Kaki Bukit Ave 4 #03-47, Premier @ Kaki Bukit, Singapore 415875  
Date of Assignment : 03 March 2020  
Date of Accident : 22 February 2020  
Date of Inspection : 03 March 2020

| Registration No. | : SGP 3525R | Chassis Frame No. | : ACR50-7033925 |

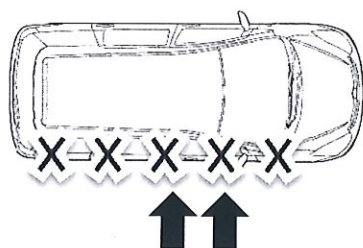
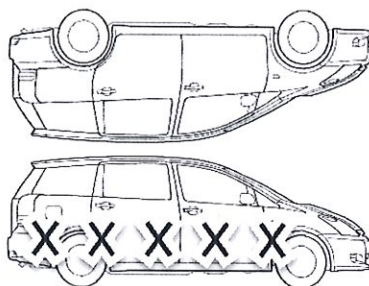
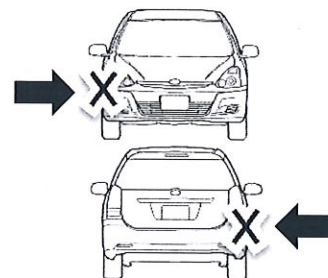
Damages sustained were consistent with the subject vehicle being involved in a collision with another vehicle and the impact was delivered

Squarely to the RH Side

portion of the vehicle.

The general area of damages is at the

RH Side portion
