Our Reference : KAAS/TA/5920/3525/TP/02.20  
Date : 15 March 2020

## VEHICLE APPRAISAL REPORT

Registration No.	: SGP 3525R	Chassis Frame No.	: ACR50-7033925
Make / Model	: Toyota Estima 2.4A	Engine No. ( Logcard )	: 2AZC060615
Year of Manufacture/Reg	: 2006	Odometer Reading	: 199,672 KM
Colour	: Black		
Class / Type	: MPV

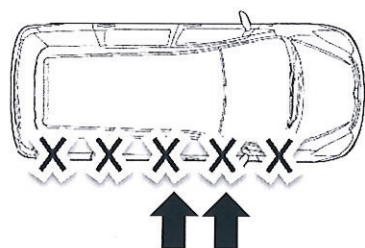
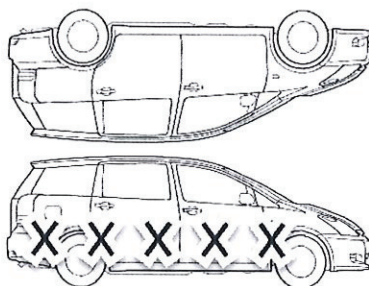
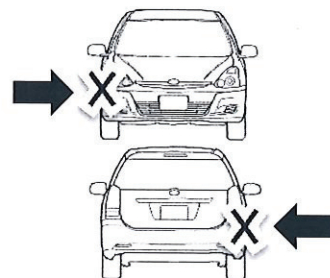
Damages sustained were consistent with the subject vehicle being involved in a collision with another vehicle and the impact was delivered

**Squarely to the RH Side**

portion of the vehicle.

The general area of damages is at the

**RH Side portion**

The estimated repair costs submitted by Messrs **Lush Automotive Pte Ltd** is \$ 18,388.00 .  
We have adjusted the cost to \$ 13,152.50 and the repairer has agreed to undertake the repairs at a  
**Contract Lump Sum of \$ 10,500.00** to a acceptable quality and standards.  
However, we have not given authorization and instruction to the repairer to proceed with the repairs.
