Your Ref: BMW 840i  
(chassis number WBAGV22010CD34061)  
Our Ref : CI/TP21008224/D

**INSPECTION REPORT OF AN UNREGISTERED BMW 840i MOTOR CAR  
WITH CHASSIS NUMBER WBAGV22010CD34061**

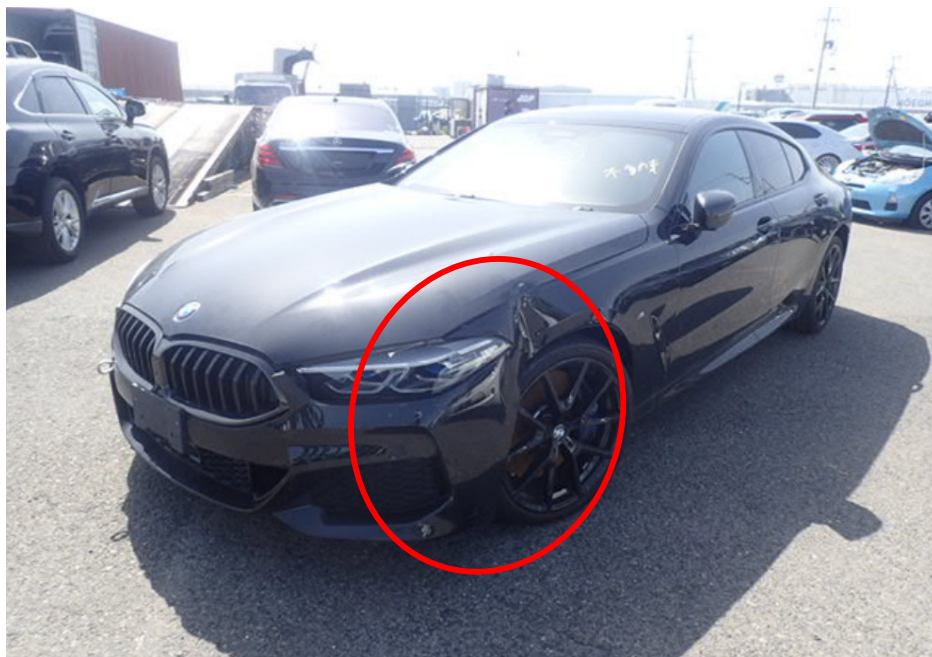
**Photo 1** shows a general view of the front left body of the Motor Car (photograph provided to me). The Motor Car was observed to have sustained damage at its front left body (circled). The front bumper, front left headlamp, front bonnet and front left fender were amongst the body parts that were observed to have been damaged. The front left wheel and front right wheel (refer to photograph 4 below) were orientated in different directions, which suggests to me that there was damage to the front right undercarriage parts of the Motor Car given that the front right wheel rim was damaged (refer to photograph 6 below).

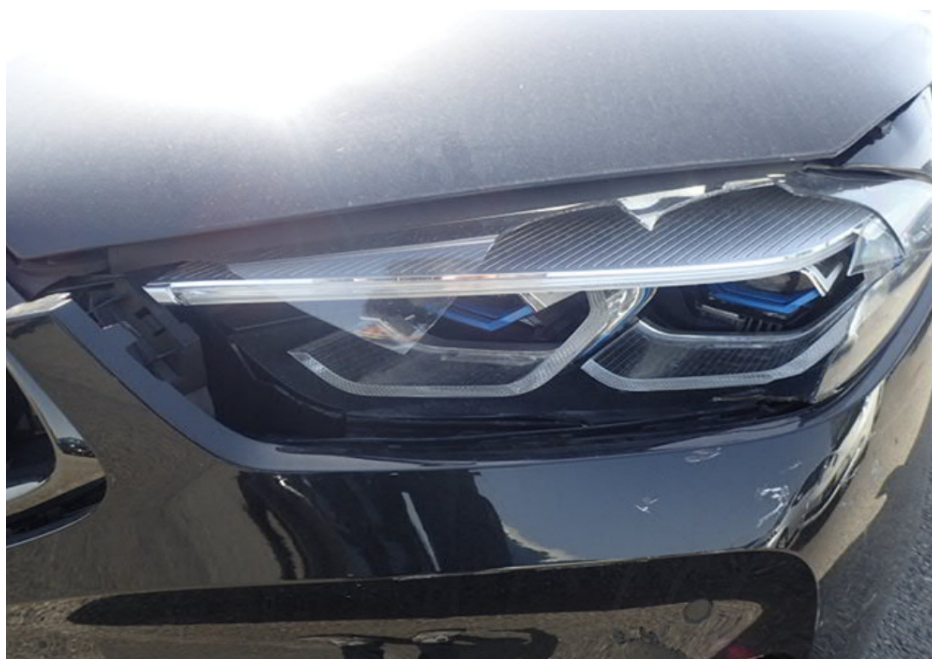
**Photo 2** shows a closer view of the damage to the front left headlamp and front bumper of the Motor Car (photograph provided to me).

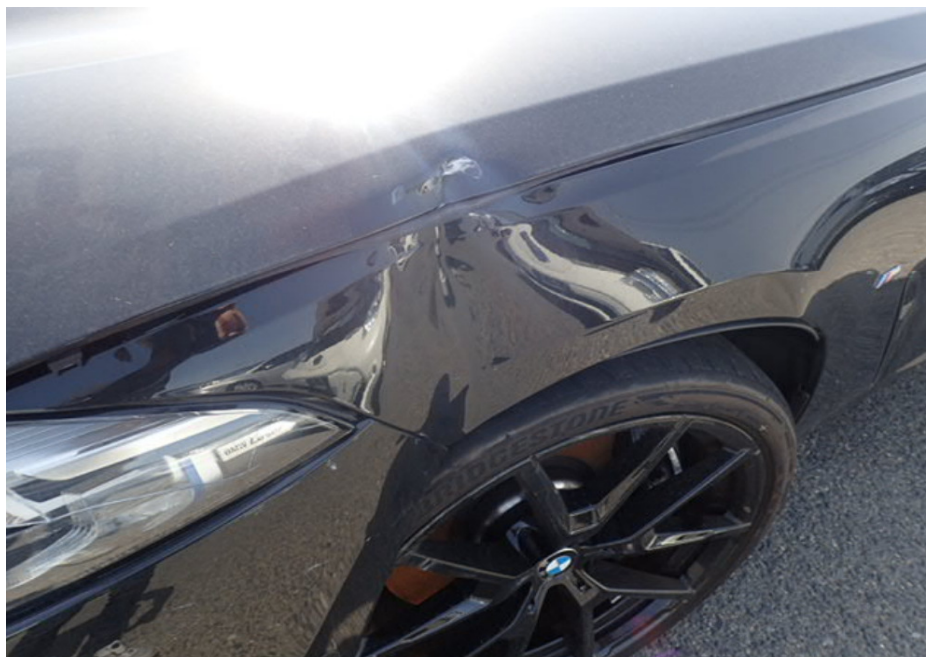
**Photo 3** shows a closer view of the damage to the front left fender and front bonnet of the Motor Car (photograph provided to me).

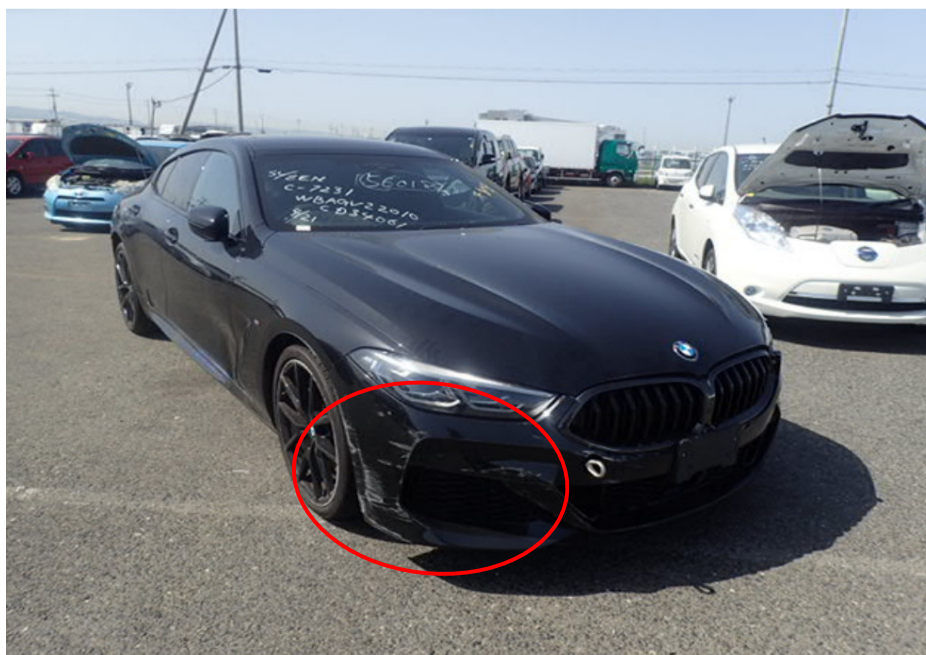
**Photo 4** shows a general view of the front right body of the Motor Car (photograph provided to me). Apart for the front left body, the Motor Car had also sustained damage at its front right body (circled). The front bumper and front right wheel rim were amongst the body parts that were observed to have been damaged. The front right wheel and front left wheel (refer to photograph 1 above) were orientated in different directions, which suggests to me that there was damage to the front right undercarriage parts of the Motor Car given that the front right wheel rim was damaged (refer to photograph 6 below).

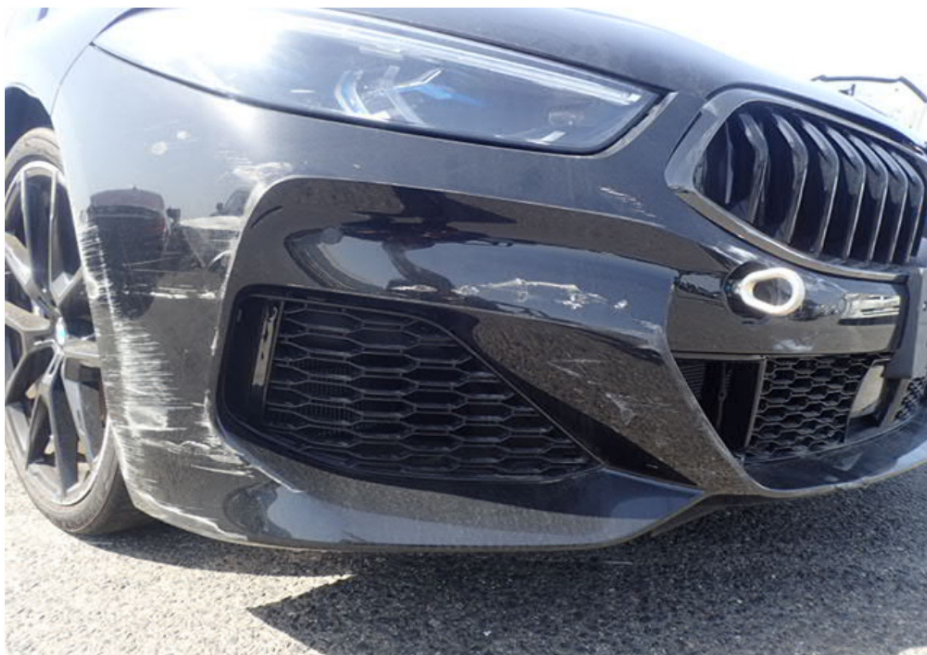
**Photo 5** shows a closer view of the damage to the front bumper at the front right body of the Motor Car (photograph provided to me).

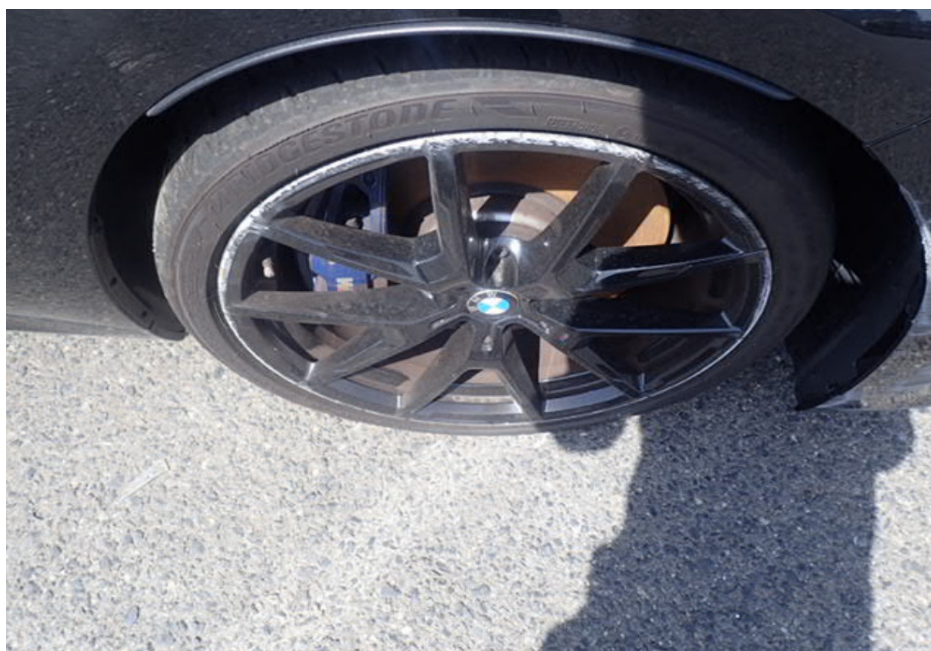
**Photo 6** shows a closer view of the damage to the front right wheel rim of the Motor Car (photograph provided to me). Grazed marks were seen to the edges at the outer circumference of the front right wheel rim. The front right undercarriage parts of the Motor Car were likely to be affected as the orientation of the Motor Car's front wheels were not in the same direction (refer to photograph 1 and 4 above). Parts that may possibly have been affected include the front right lower arm, front right upper arm, front right knuckle arm, front right shock absorber and front right steering tie rod amongst others.

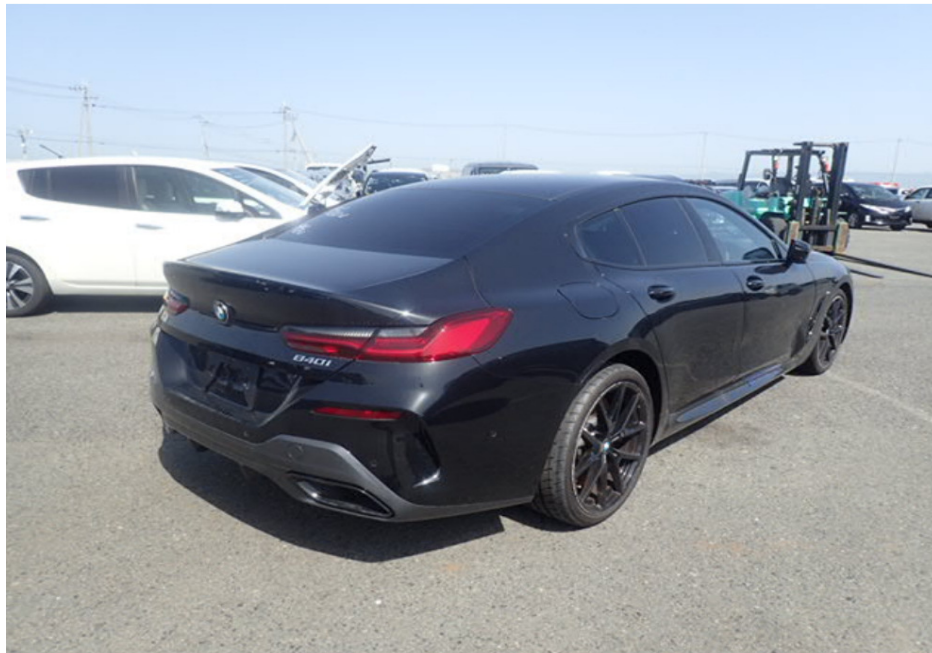
**Photo 7** shows the rear right body of the Motor Car (photograph provided to me). Apart for the front left body and front right body, there was no physical damage observed to other areas of the Motor Car.

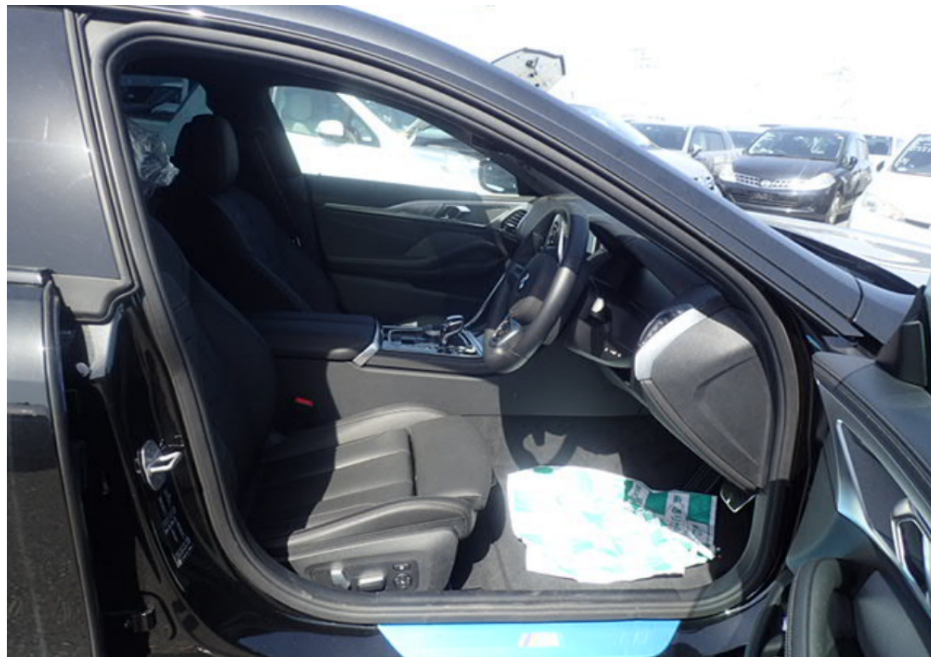
**Photo 8** shows the interior compartment of the Motor Car (photograph provided to me). Parts and components within the interior compartment were observed to be unaffected. The airbags of the Motor Car were also not deployed as seen from the photographs that were provided to me.

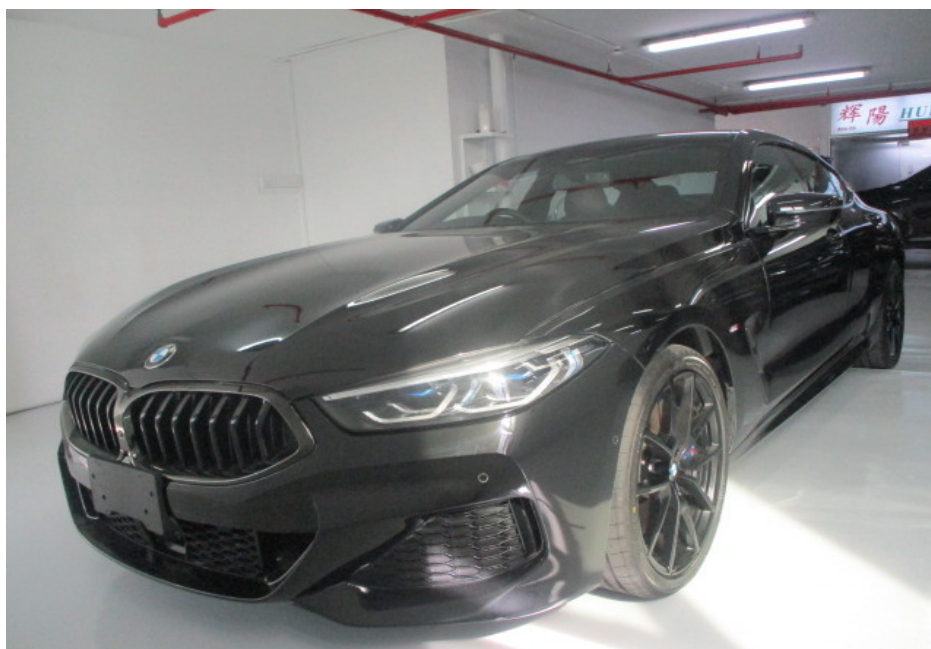
**Photo 9** shows a general view of the front left body of the Motor Car at the time of my inspection. The Motor Car was observed to be in a relatively good general condition with no loose exterior fittings observed. The body parts at the front left body of the Motor Car were visually examined and it was observed that the repair/restoration works carried out to the damaged area of the Motor Car (refer to photograph 1 - 3 above) were reasonably adequate and in order.

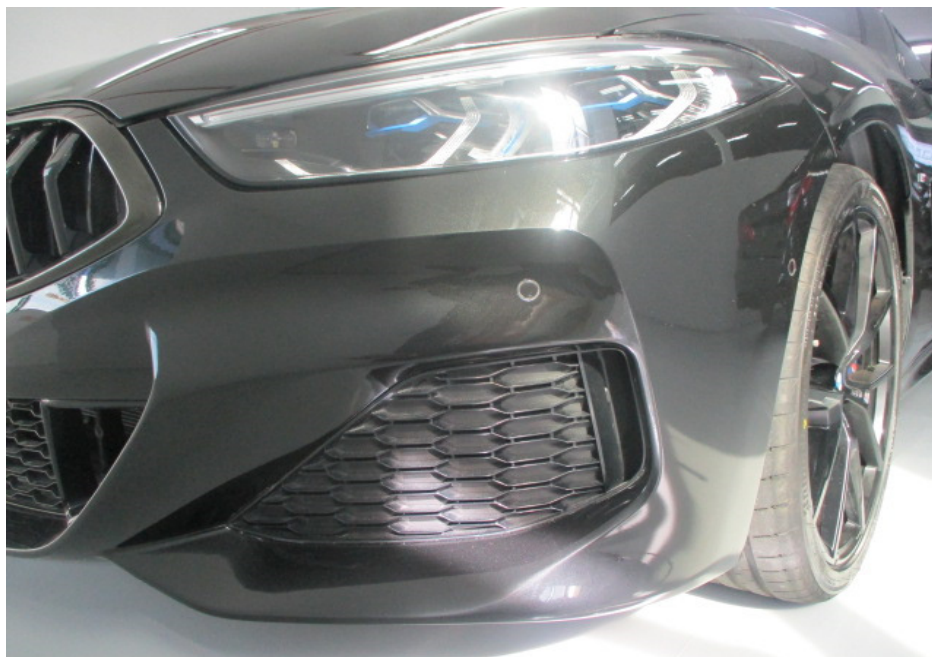
**Photo 10** shows a closer view of the front bumper and front left headlamp of the Motor Car at the time of my inspection. The body parts at the front left body of the Motor Car were visually examined and it was observed that the repair/restoration works carried out to the damaged area of the Motor Car (refer to photograph 2 above) were reasonably adequate and in order.

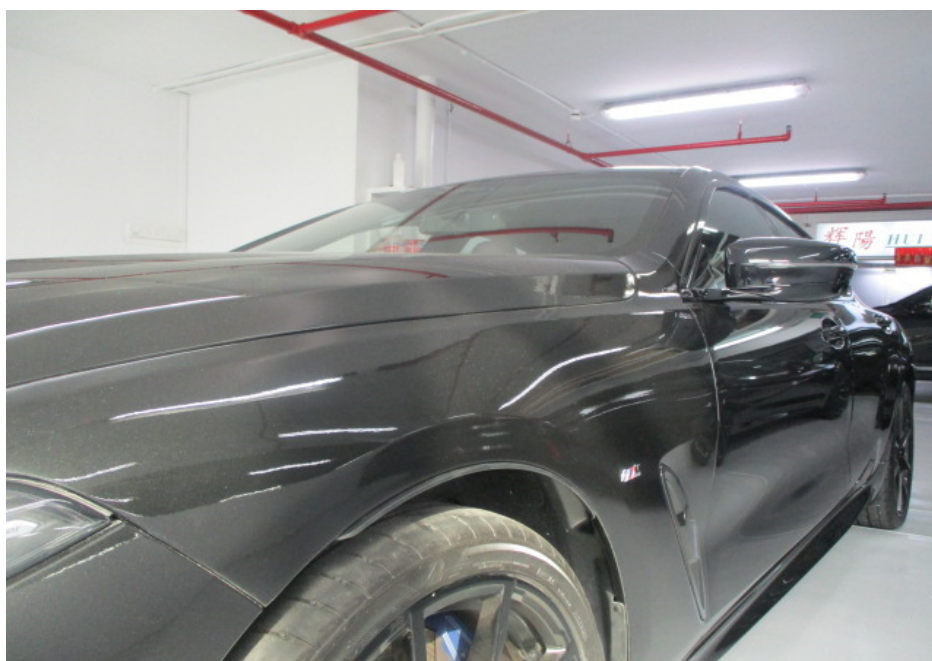
**Photo 11** shows a closer view of the front bonnet and front left fender of the Motor Car at the time of my inspection. The body parts at the front left body of the Motor Car were visually examined and it was observed that the repair/restoration works carried out to the damaged area of the Motor Car (refer to photograph 3 above) were reasonably adequate and in order.

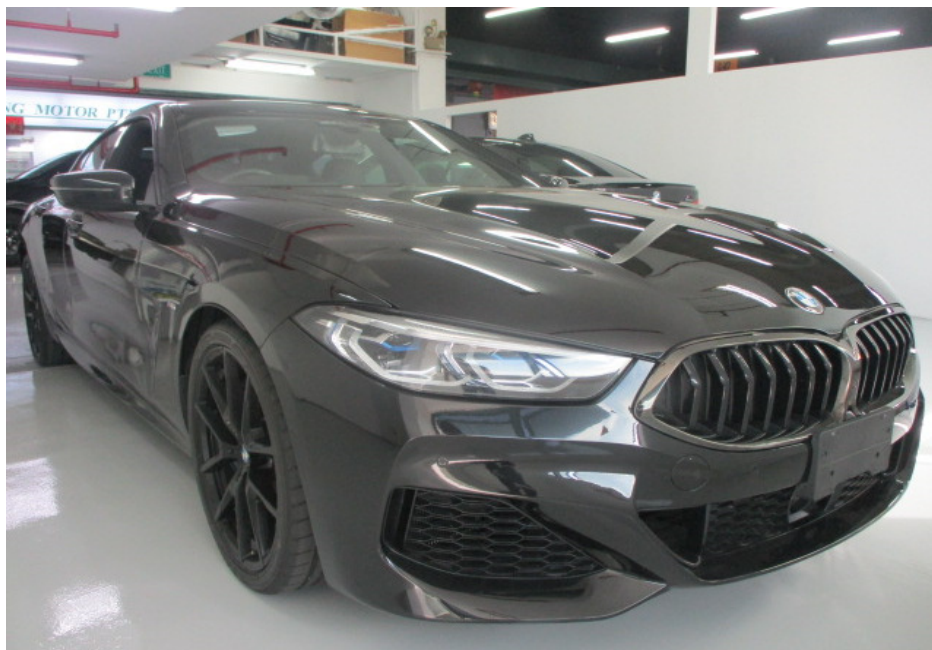
**Photo 12** shows a general view of the front right body of the Motor Car at the time of my inspection. The Motor Car was observed to be in a relatively good general condition with no loose exterior fittings observed. The body parts at the front right body of the Motor Car were visually examined and it was observed that the repair/restoration works carried out to the damaged area of the Motor Car (refer to photograph 4 - 6 above) were reasonably adequate and in order.

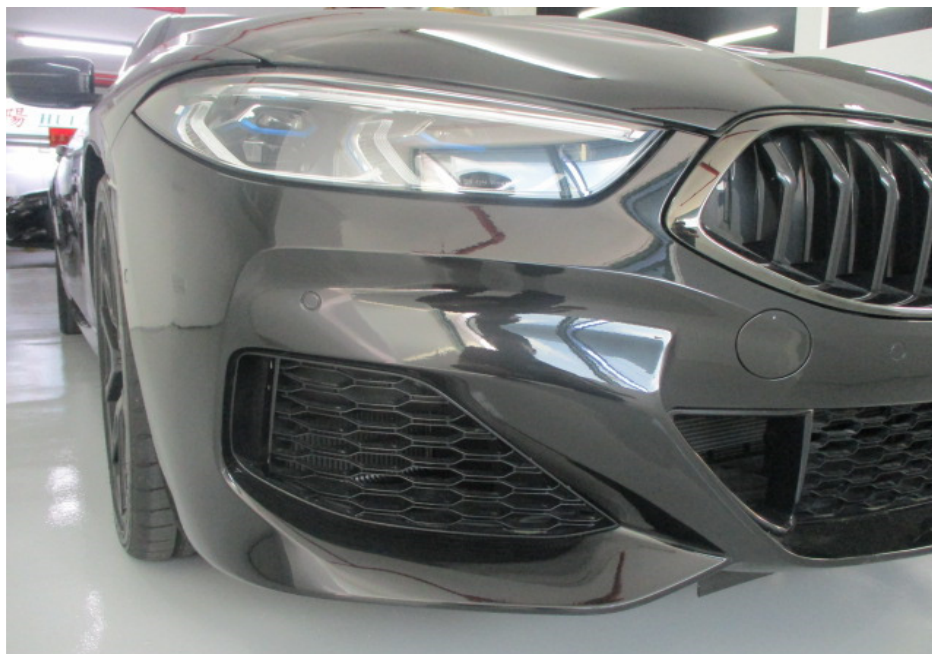
**Photo 13** shows a closer view of the Motor Car's front bumper at the time of my inspection. The body parts at the front right body of the Motor Car were visually examined and it was observed that the repair/restoration works carried out to the damaged area of the Motor Car (refer to photograph 5 above) were reasonably adequate and in order.

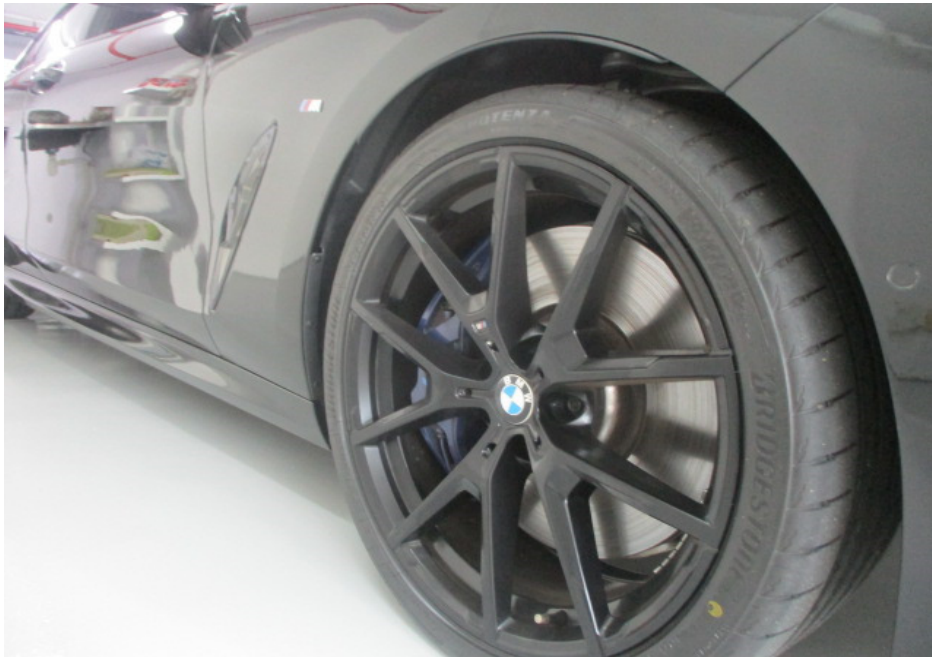
**Photo 14** shows a closer view of the front right wheel rim of the Motor Car at the time of my inspection. The body parts at the front right body of the Motor Car were visually examined and it was observed that the repair/restoration works carried out to the damaged area of the Motor Car (refer to photograph 6 above) were reasonably adequate and in order.

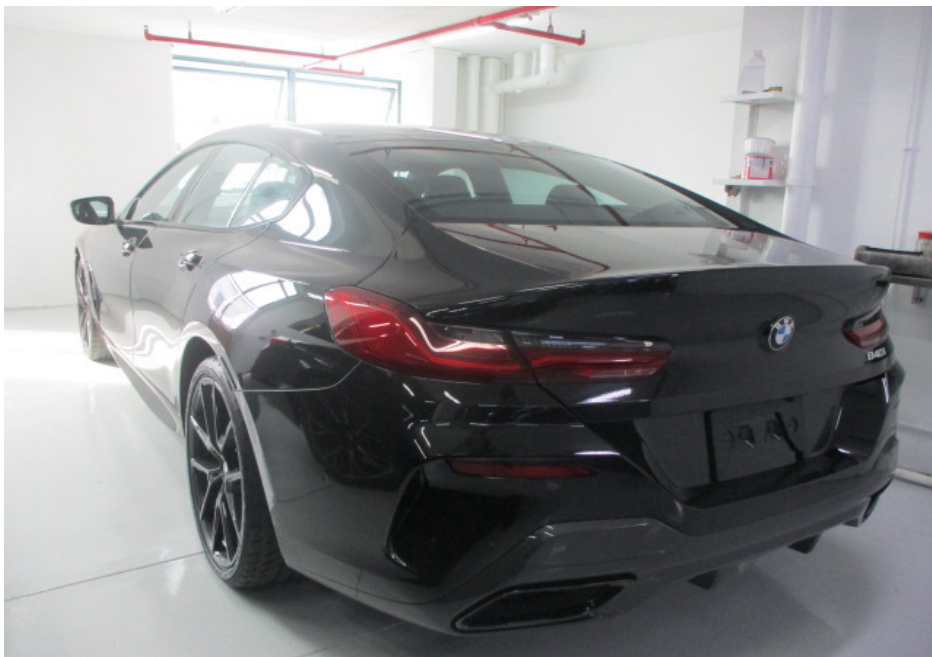
**Photo 15** shows a general view of the rear left body of the Motor Car at the time of my inspection. The Motor Car was observed to be in a relatively good general condition with no loose exterior fittings observed. The mileage of the Motor Car recorded at the time of my inspection was 2,966km.

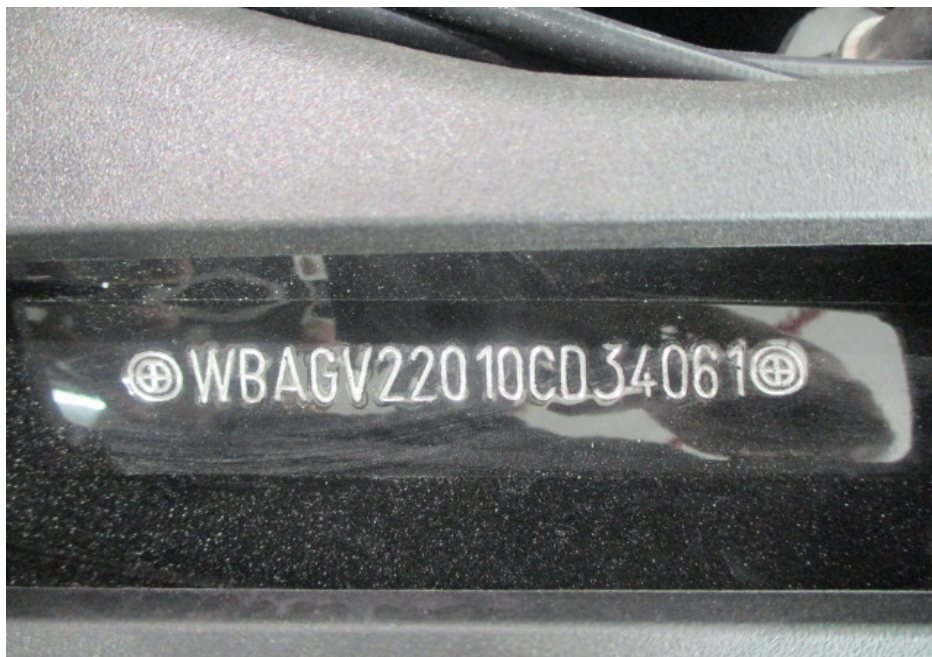
**Photo 16** shows the chassis number of the Motor Car. The chassis number recorded was WBAGV22010CD34061.

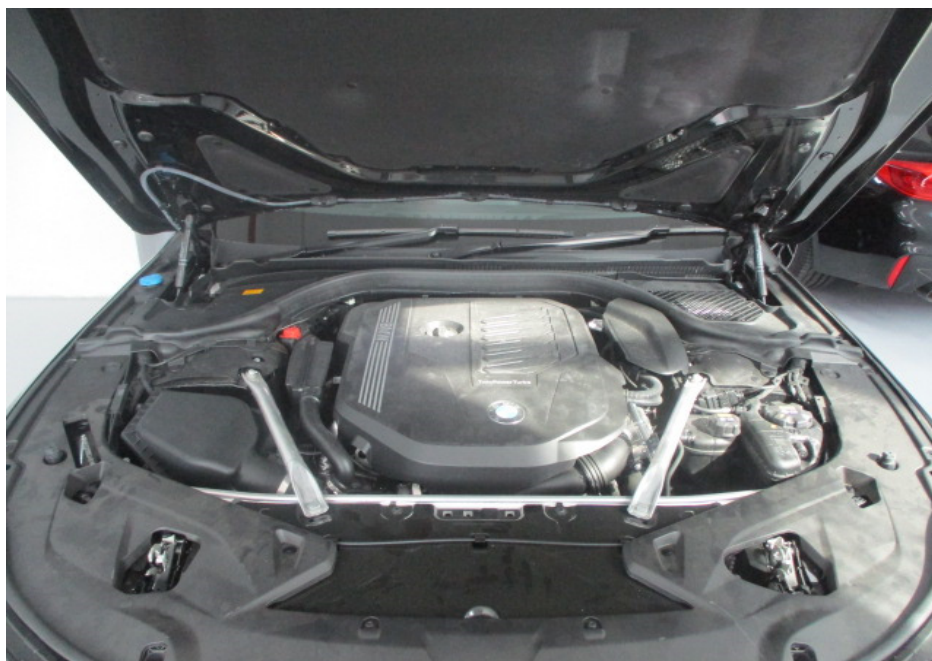
**Photo 17** shows a general view of the engine compartment of the Motor Car at the time of my inspection. The various parts and components inside the engine compartment were all observed to be intact and properly fitted. There was also no sign(s) or indication(s) of fluid leak and/or fluid stain found inside the engine compartment.

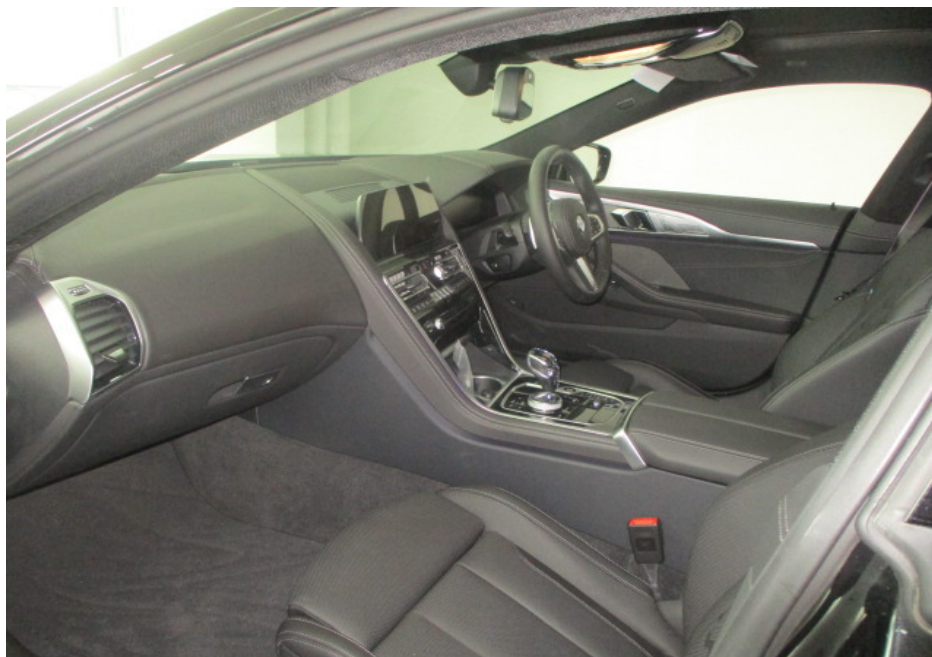
**Photo 18** shows the interior compartment of the Motor Car at the time of my inspection. The various parts and components, trims, carpet, and upholstery inside the interior compartment were all observed to be intact and properly fitted.

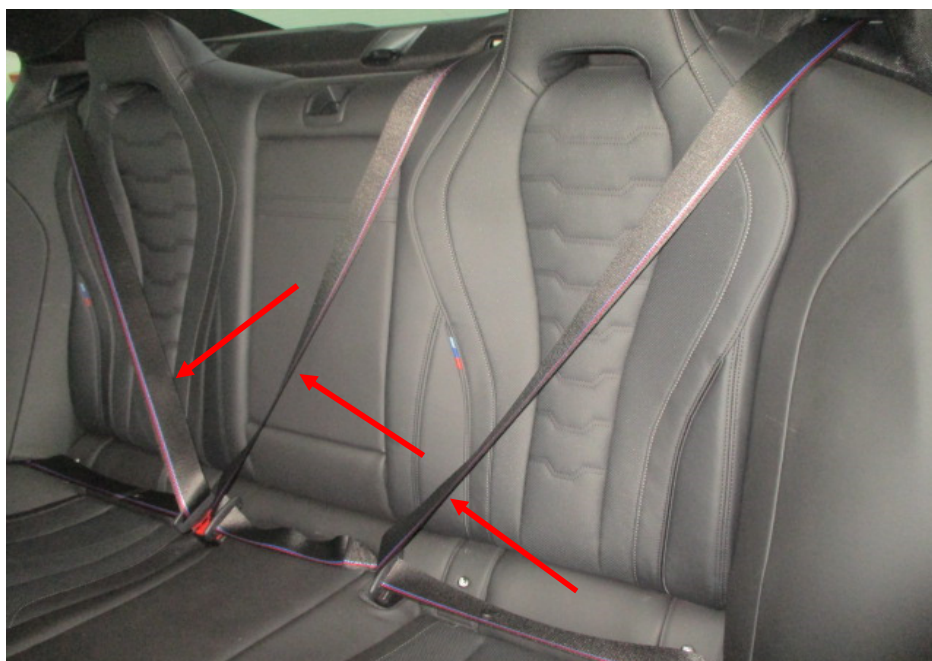
**Photo 19** shows the rear seats of the Motor Car. All the seats of the Motor Car were secured via seat rails to the floorboard. They were also fitted with a retractable seat belt reel and a pre-tensioner. The seat belts (arrowed) were tested and were able to be fastened into the respective pre-tensions that were fitted on the side of each individual seat.

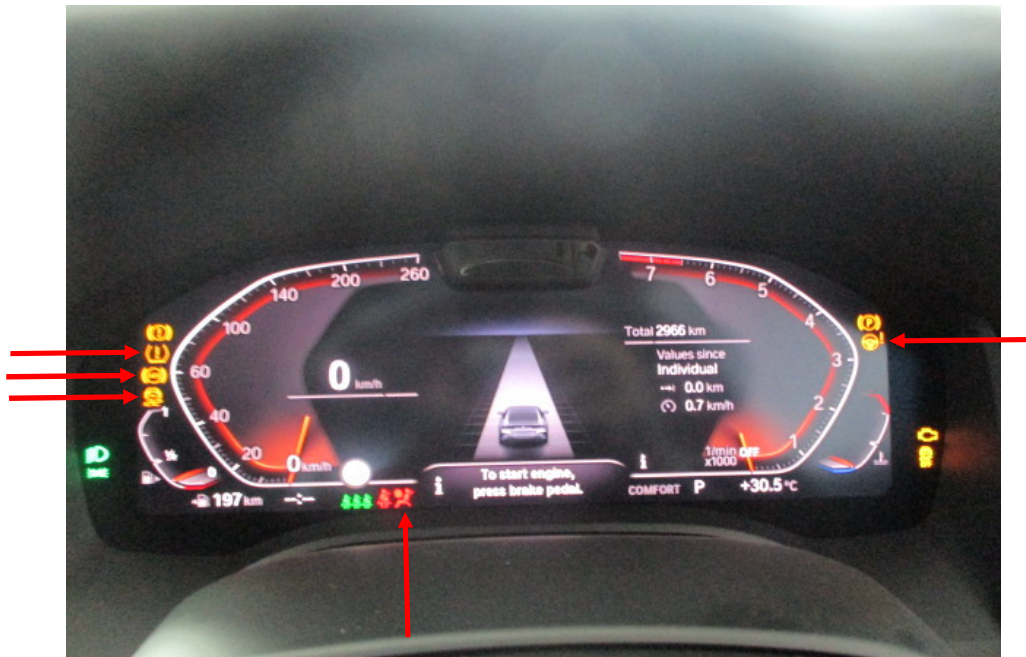
**Photo 20** shows the warning lights for the various electronic safety features appearing on the instrument panel of the Motor Car during its self-test when the engine is cranked, in particular the ABS, SRS, IAS, TPM and DSC lights (arrowed).

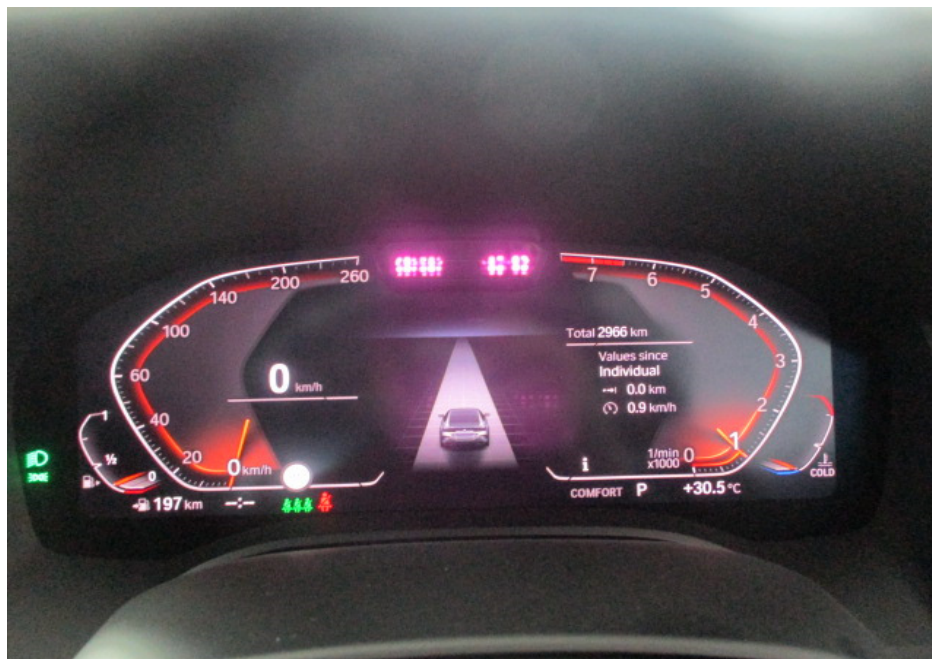
**Photo 21** shows the respective warning lights no longer illuminated, indicating that there is no fault detected to the ABS, SRS, IAS, TPM and DSC systems of the Motor Car during the self-test. These electronic systems were hence in working condition at the time of my inspection.

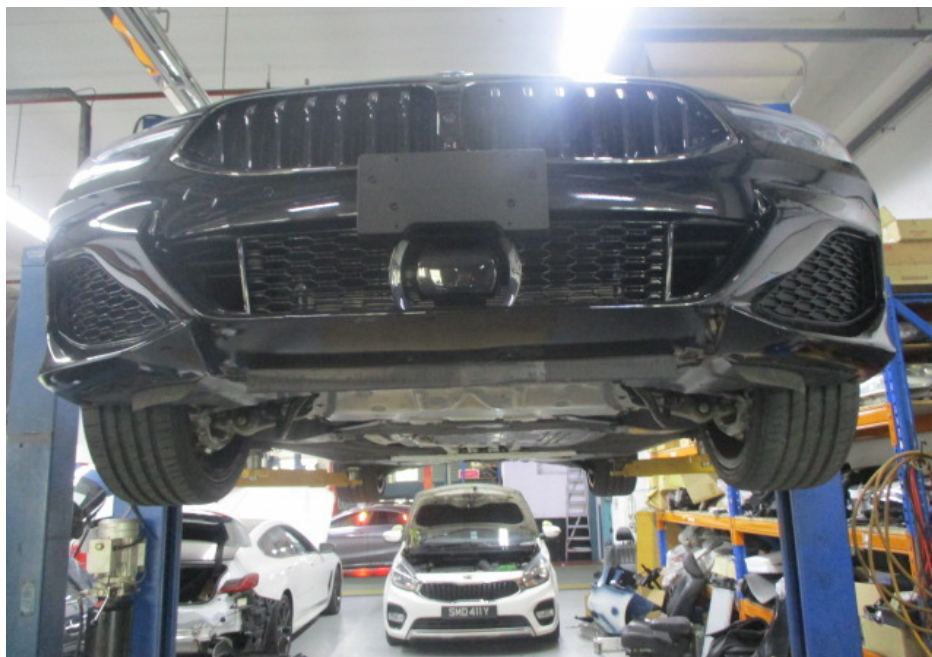
**Photo 22** shows the Motor Car hoisted up for checks on its undercarriage. There was no sign(s) or indication(s) of fluid leakage and/or fluid stain(s) on the underside of the Motor Car. The undercarriage components of the Motor Car were also all observed to be intact and secured in an appropriate manner.

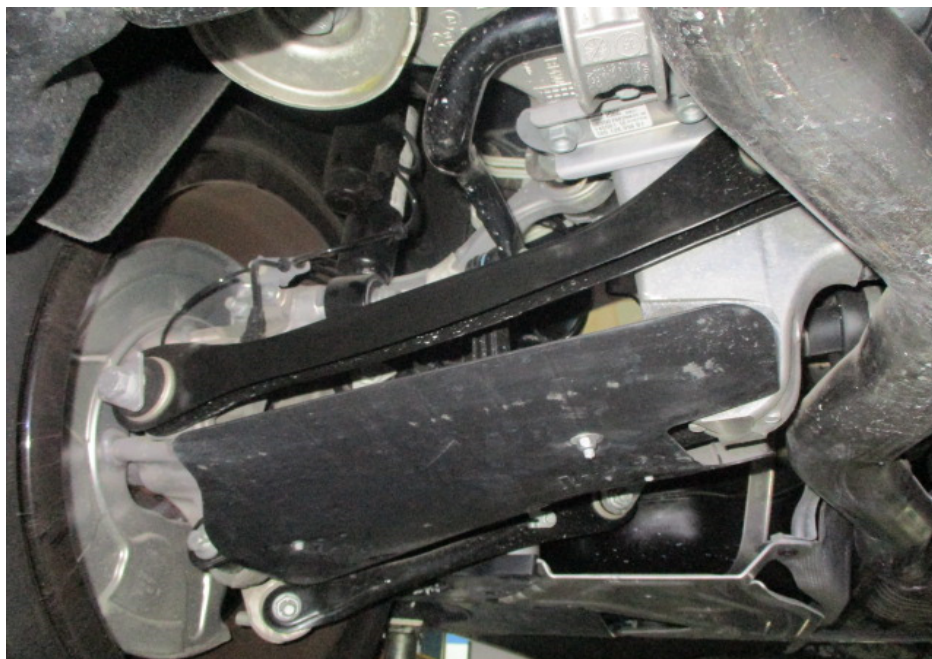
**Photo 23** shows a general view of the control arms and linkages at the rear left wheel of the Motor Car. I did not observe any fluid leak and/or fluid stain on the underside of the Motor Car. All of the Motor Car's undercarriage components were observed to be intact and secured in an appropriate manner.

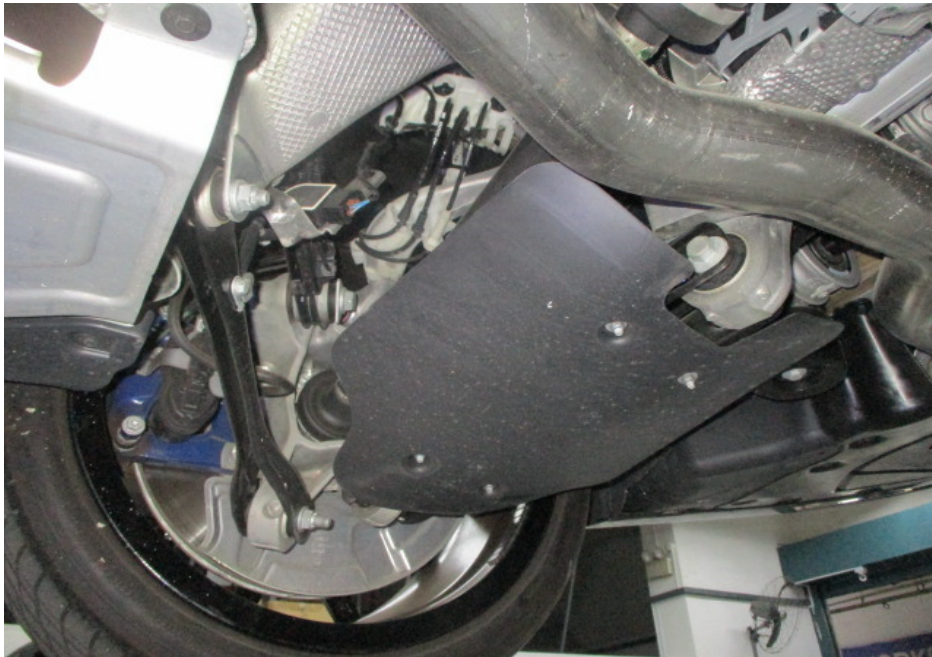
**Photo 24** shows a general view of the control arms and linkages at the rear right wheel of the Motor Car. I did not observe any fluid leak and/or fluid stain on the underside of the Motor Car. All of the Motor Car's undercarriage components were observed to be intact and secured in an appropriate manner.

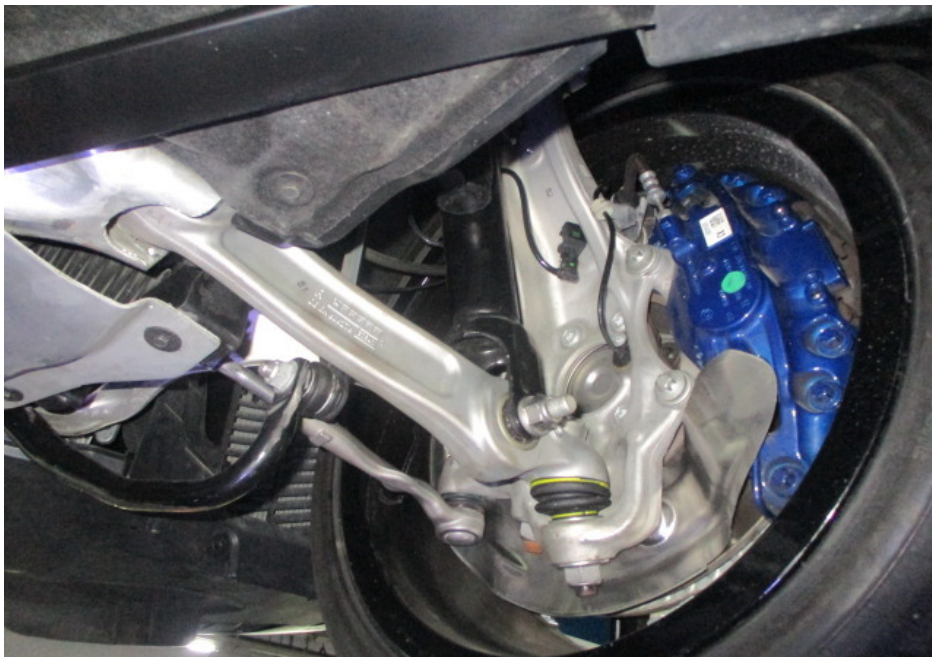
**Photo 25** shows the various undercarriage components at the front right wheel of the Motor Car. The mechanical components, control arms and linkages were all found to be intact and secured in an appropriate manner.

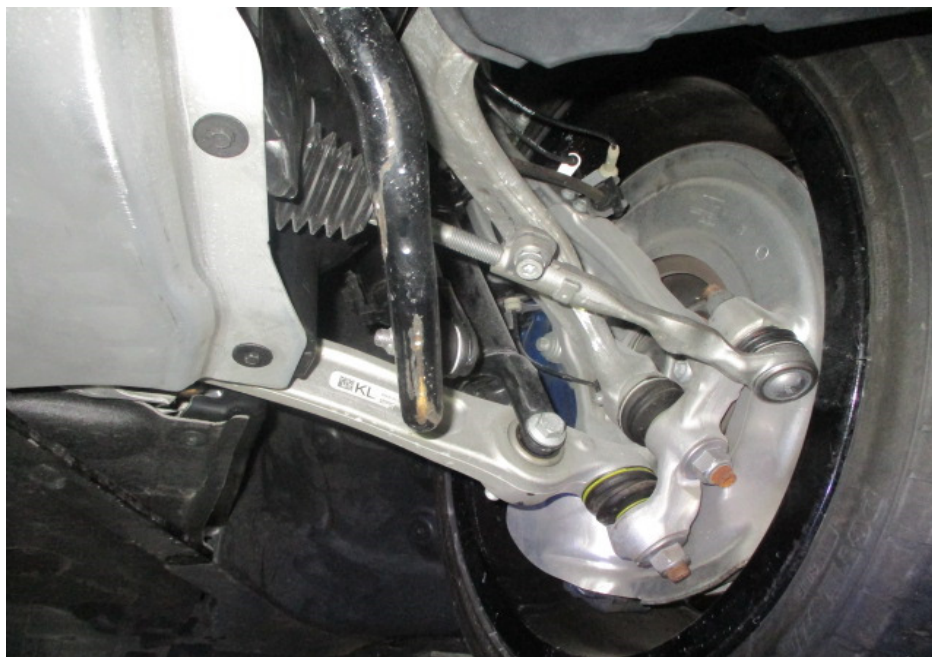
**Photo 26** shows the various undercarriage components at the front left wheel of the Motor Car. The mechanical components, control arms and linkages were all found to be intact and secured in an appropriate manner. I also did not observe any fluid leak and/or fluid stain on the underside of the Motor Car.

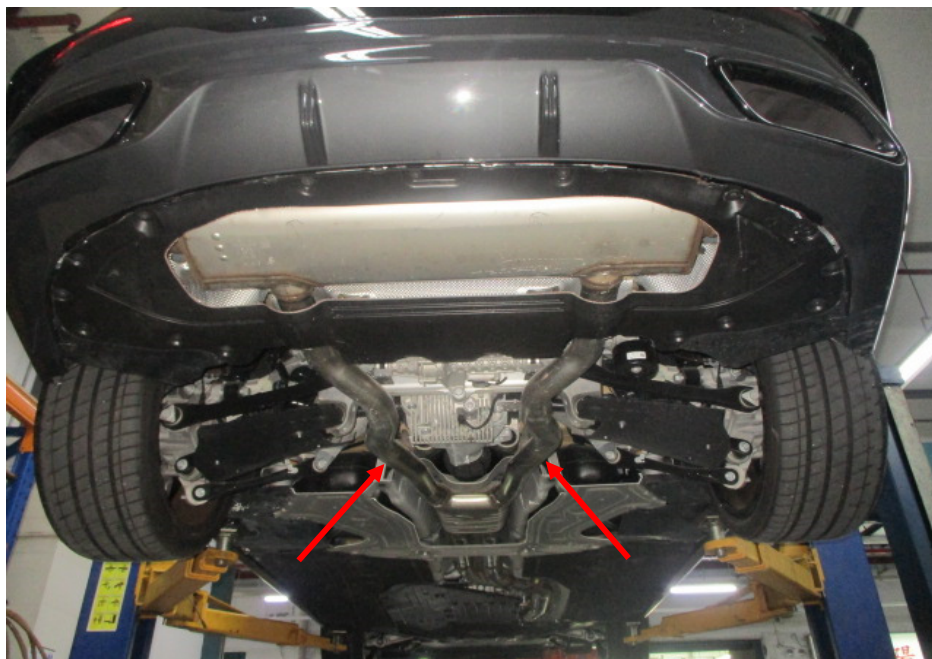
**Photo 27** shows the rear section of the Motor Car's exhaust system. My examination of the Motor Car's exhaust system revealed no sign(s) or indication(s) of any cut or weld marks along its exhaust pipes (arrowed), centre resonator box, rear muffler and on its catalytic converter.

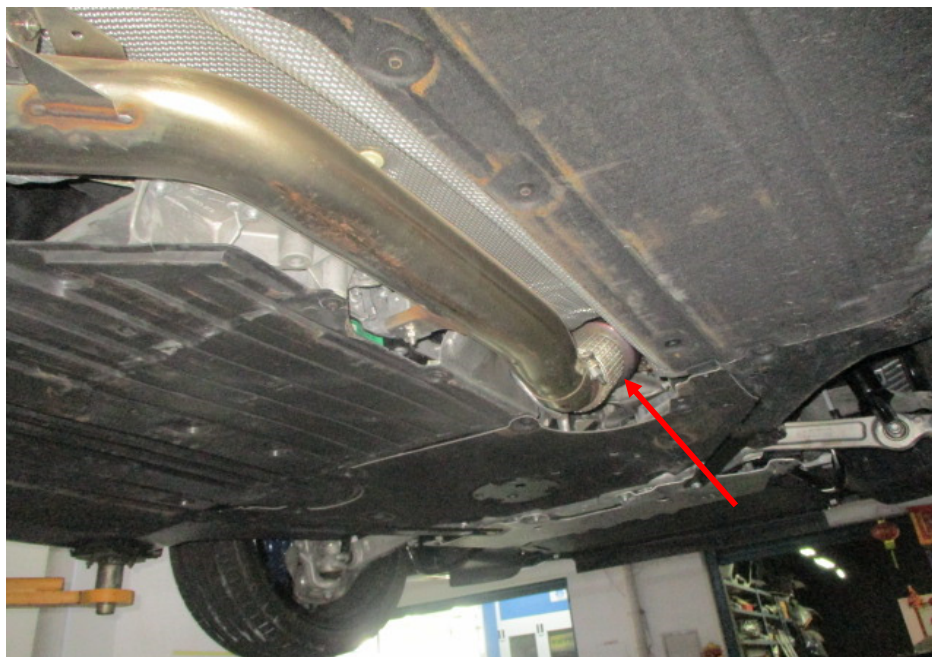
**Photo 28** shows the front section of the Motor Car's exhaust system. My examination of the Motor Car's exhaust system revealed no sign(s) or indication(s) of any cut or weld marks along its exhaust pipes, centre resonator box, rear muffler and on its catalytic converter (arrowed).

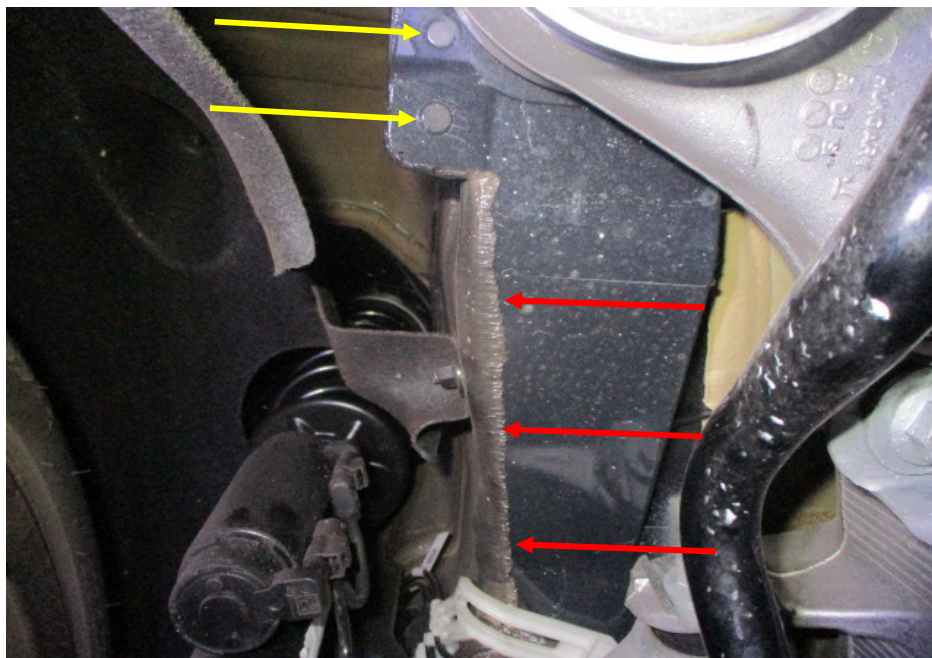
**Photo 29** shows the chassis/structural body at the underside rear left of the Motor Car. I did not find any weld marks other than original spot weld marks (yellow arrow) on the chassis/structural body of the Motor Car. The original factory sealant (red arrow) at the joints along the chassis/structural body was also untouched, indicating no work was done on the chassis/structural body of the Motor Car and that the chassis/structural body was originally fitted.

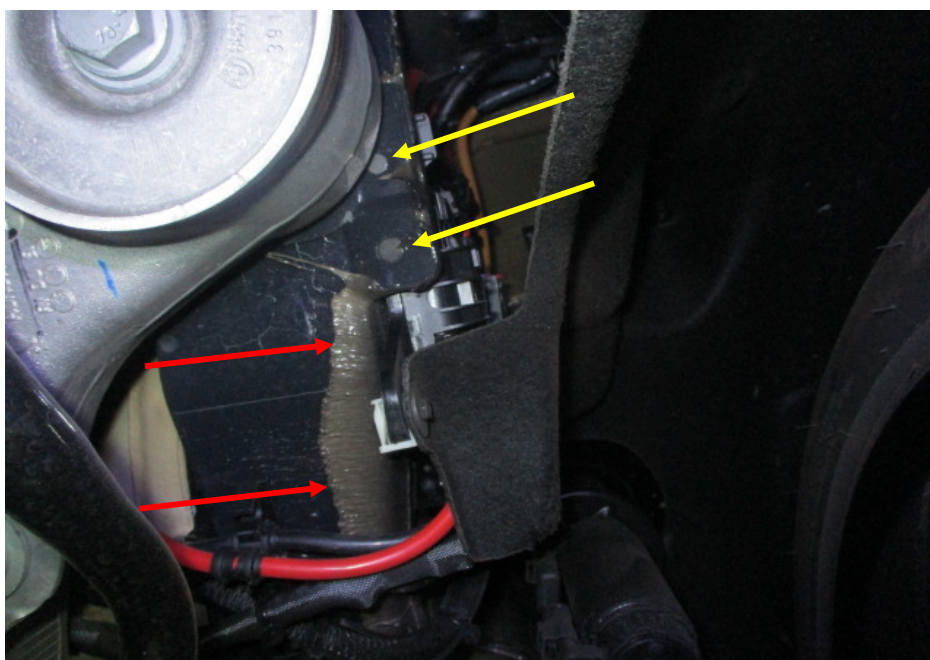
**Photo 30** shows the chassis/structural body at the underside rear right of the Motor Car. I did not find any weld marks other than original spot weld marks (yellow arrow) on the chassis/structural body of the Motor Car. The original factory sealant (red arrow) at the joints along the chassis/structural body was also untouched, indicating no work was done on the chassis/structural body of the Motor Car and that the chassis/structural body was originally fitted.

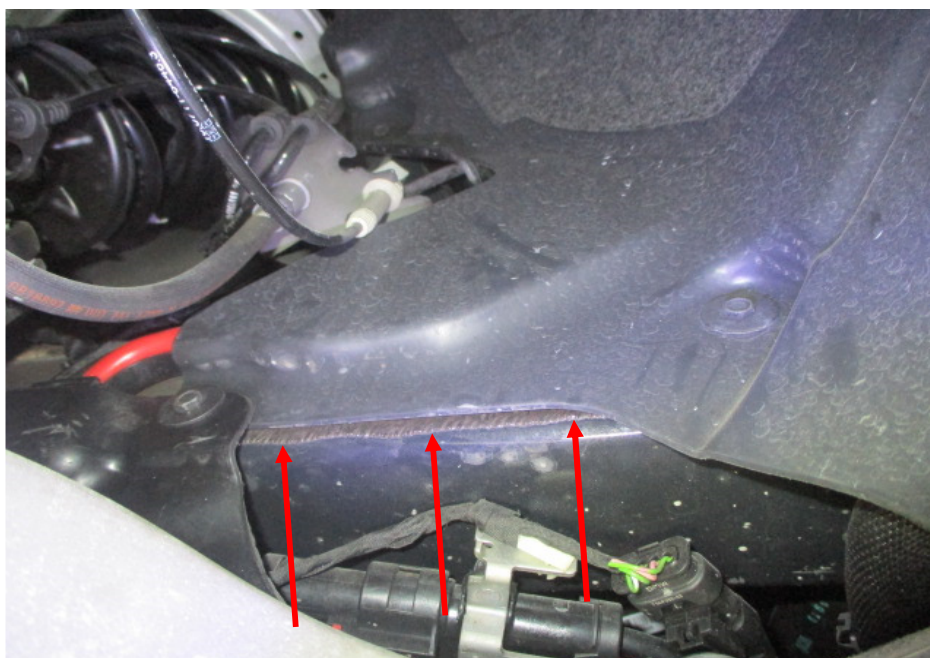
**Photo 31** shows the chassis/structural body at the underside front right of the Motor Car. The original factory sealant (arrowed) at the joints along the chassis/structural body was observed to be untouched. In general, I had found no work was carried out on the chassis/structural body of the Motor Car. The chassis/structural body of the Motor Car was originally fitted.

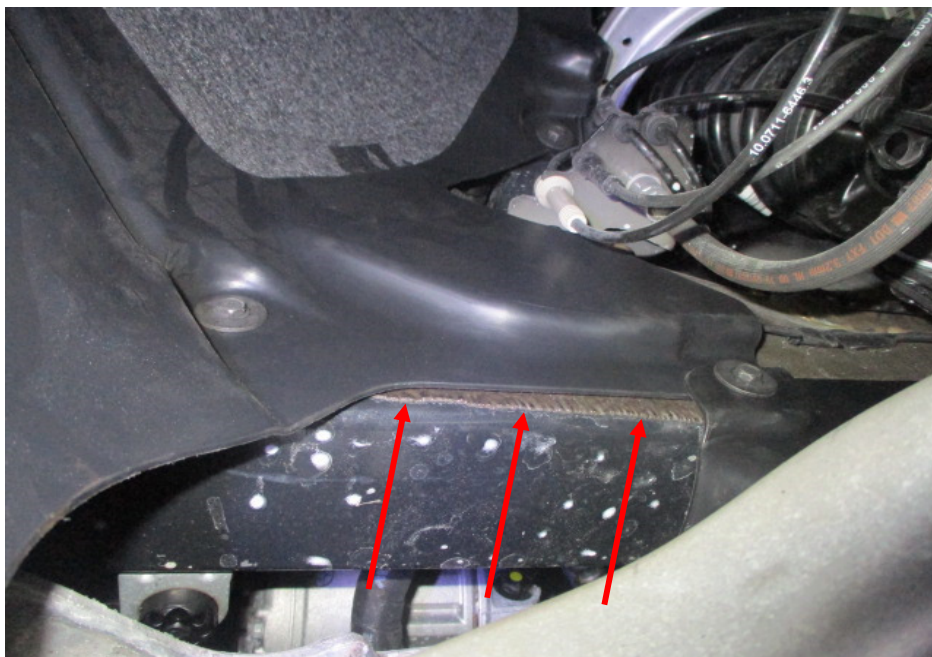
**Photo 32** shows the chassis/structural body at the underside front left of the Motor Car. The original factory sealant (arrowed) at the joints along the chassis/structural body was observed to be untouched. In general, I had found no work was carried out on the chassis/structural body of the Motor Car. The chassis/structural body of the Motor Car was originally fitted.
