Your Ref: BMW 840i  
(chassis number WBAGV22010CD34061)  
Our Ref : CI/TP21008224/D

**INSPECTION REPORT OF AN UNREGISTERED BMW 840i MOTOR CAR  
WITH CHASSIS NUMBER WBAGV22010CD34061**

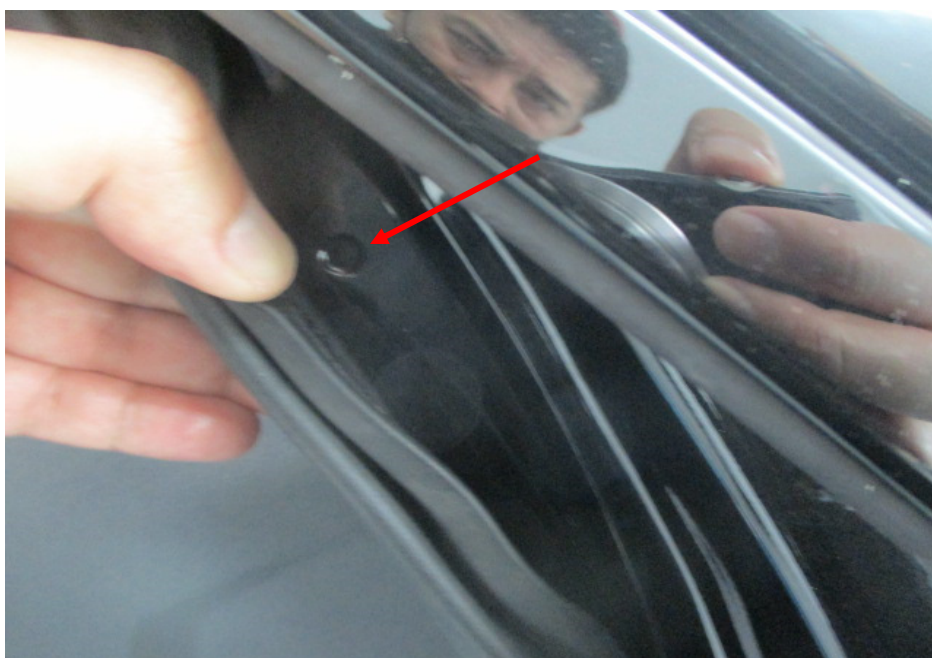
**Photo 33** shows the right side "A" pillar of the Motor Car. I did not find any weld marks other than original spot weld marks (arrowed) on the right side "A" pillar of the Motor Car which, indicates that there was no re-welding works carried out. In general, I had found all the non-detachable body panels of the Motor Car to be originally fitted at the time of my inspection.

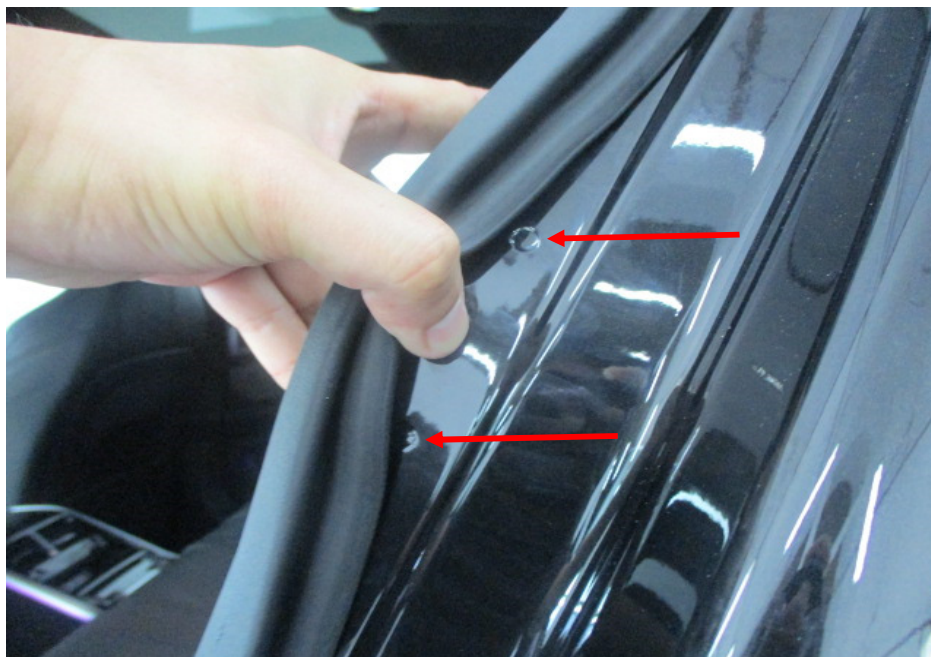
**Photo 34** shows the left side "C" pillar of the Motor Car. I did not find any weld marks other than original spot weld marks (arrowed) on the left side "C" pillar of the Motor Car which, indicates that there was no re-welding works carried out. In general, I had found all the non-detachable body panels of the Motor Car to be originally fitted at the time of my inspection.
