Your Ref: BMW M5  
(chassis number WBSJF02040GA04880)  
Our Ref : CI/TP21008225/D

03 August 2021

**INSPECTION REPORT OF AN UNREGISTERED BMW M5 MOTOR CAR WITH CHASSIS NUMBER WBSJF02040GA04880**

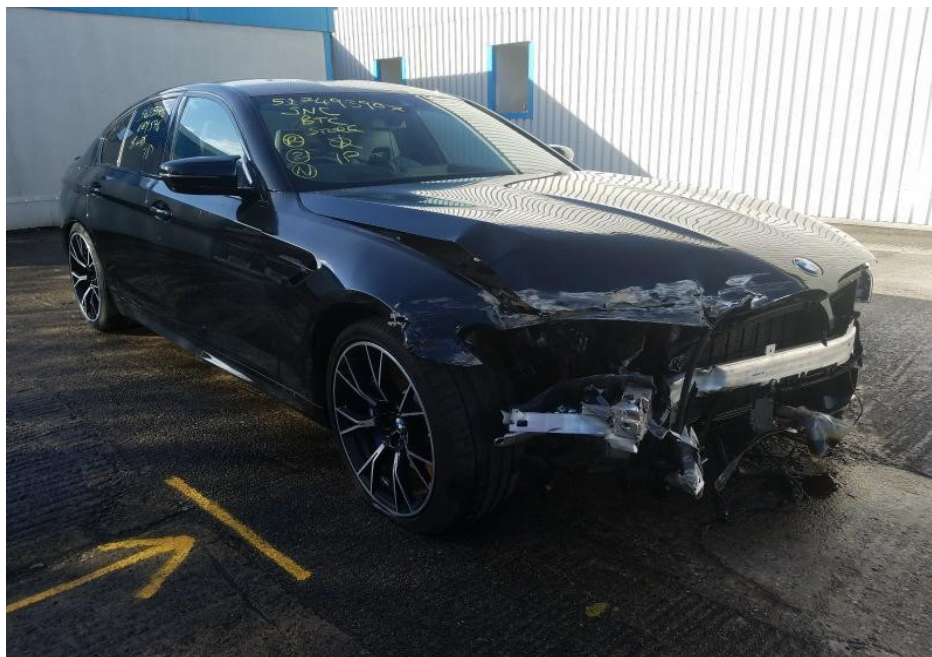
**Photo 1** shows a general view of the front right body of the Motor Car (photograph provided to me). The Motor Car was observed to have sustained damage at its front right body. The front bumper and all its related parts and attachments, front bumper reinforcement, front bumper sponge, front parking sensors, radar unit, radiator grilles, front undercover, front right headlamp, front bonnet, front right fender and front right fender inner shield amongst others were observed to be damaged

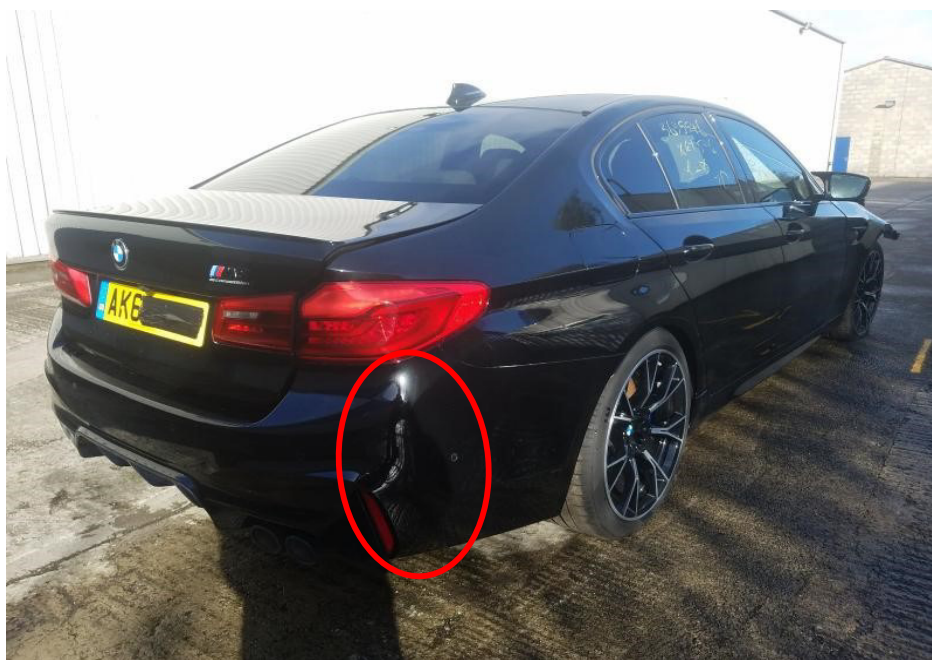
**Photo 2** shows the rear right body of the Motor Car (photograph provided to me). The rear bumper of the Motor Car was also observed to be dented at its right corner area (circled).

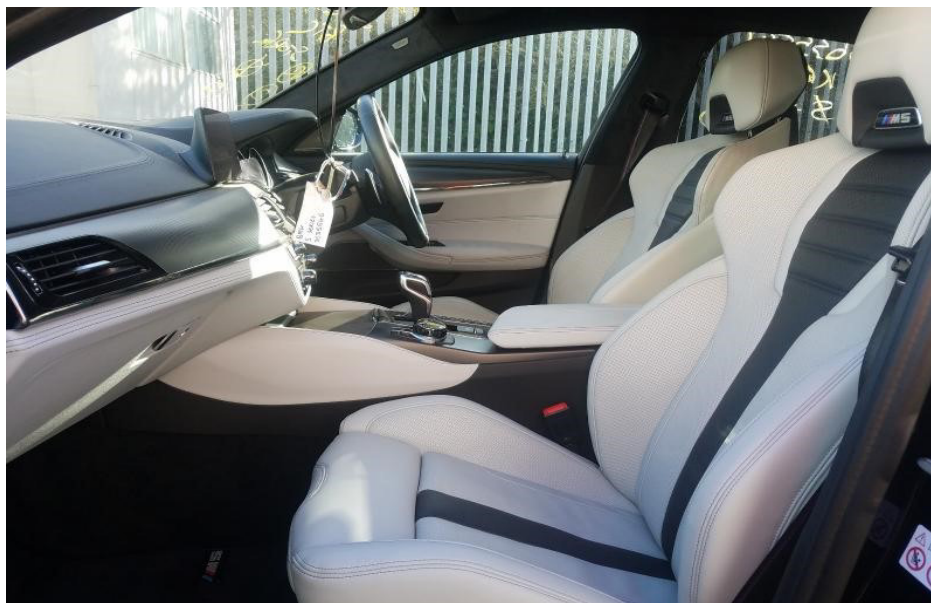
**Photo 3** shows the interior compartment of the Motor Car (photograph provided to me). Parts and components within the interior compartment were observed to be unaffected. The airbags were also not deployed.

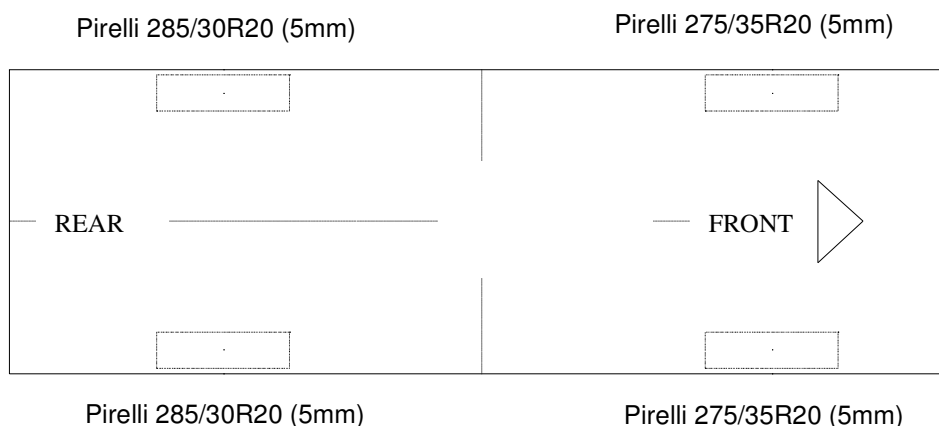
8. It was fitted with 20inch sport wheel rims that were wrapped with tyres that were observed to be of serviceable condition. The tyres were also sufficiently inflated for vehicular operation. The tyre brand, tyre size and approximate remaining tread depth of the 4 tyres of the Motor Car were recorded as follows: -

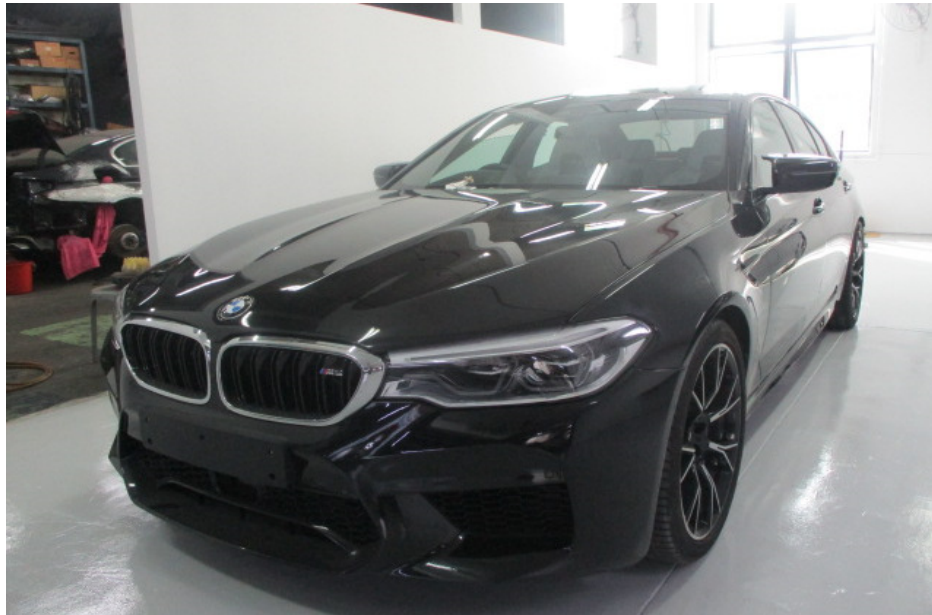
**Photo 4** shows a general view of the front left body of the Motor Car at the time of my inspection. The Motor Car was observed to be in a relatively good general condition with no loose exterior fittings observed. The body parts at the frontal body of the Motor Car were visually examined and it was observed that the repair/restoration works carried out to the damaged area of the Motor Car (refer to photograph 1 above) were reasonably adequate and in order.

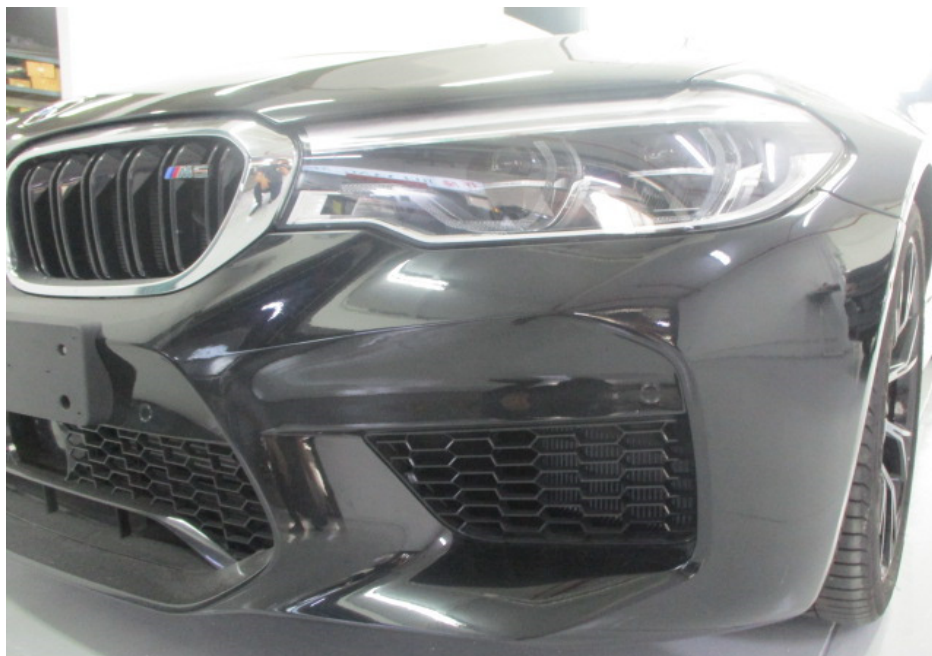
**Photo 5** shows a closer view of the front bumper, front bumper left lower grille, radiator grille and front left headlamp of the Motor Car at the time of my inspection. The body parts at the frontal body of the Motor Car were visually examined and it was observed that the repair/restoration works carried out to the damaged area of the Motor Car (refer to photograph 1 above) were reasonably adequate and in order.

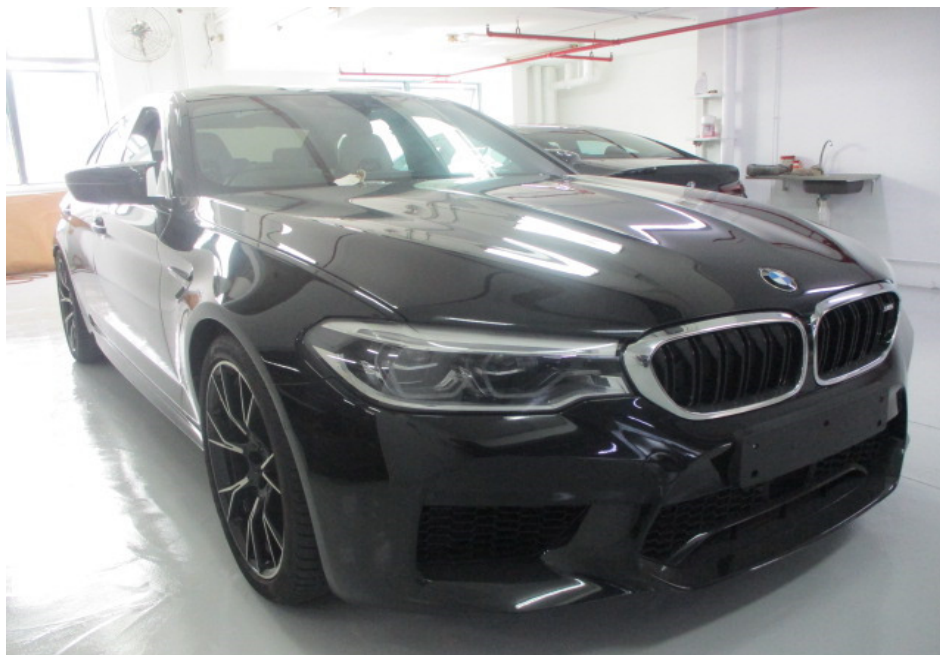
**Photo 6** shows a general view of the front right body of the Motor Car at the time of my inspection. The Motor Car was observed to be in a relatively good general condition with no loose exterior fittings observed. The body parts at the front right body of the Motor Car were visually examined and it was observed that the repair/restoration works carried out to the damaged area of the Motor Car (refer to photograph 1 above) were reasonably adequate and in order.

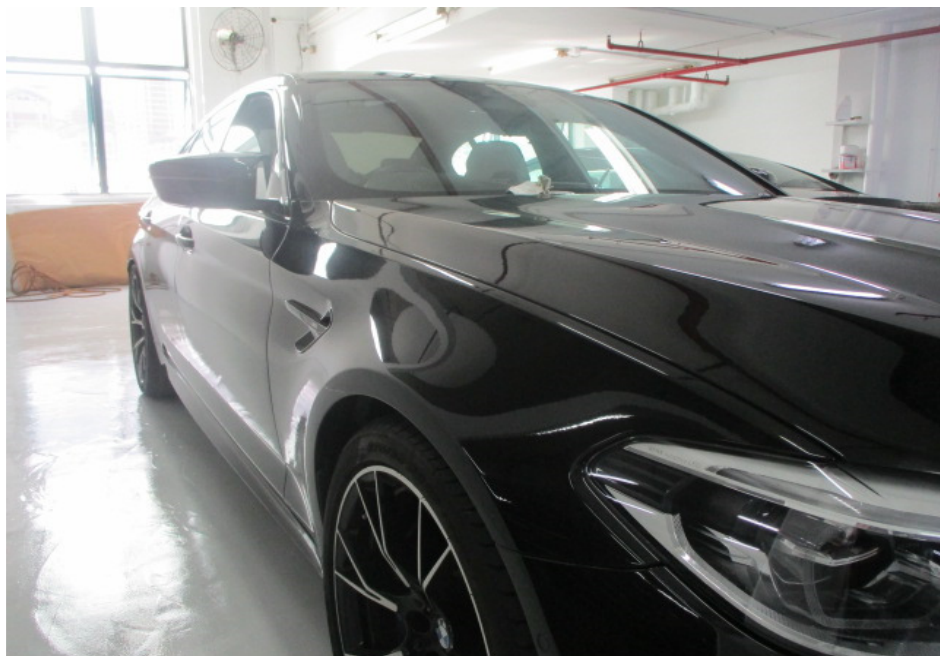
**Photo 7** shows a closer view of the front bonnet, front right headlamp and front right fender of the Motor Car at the time of my inspection. The body parts at the front right body of the Motor Car were visually examined and it was observed that the repair/restoration works carried out to the damaged area of the Motor Car (refer to photograph 1 above) were reasonably adequate and in order.

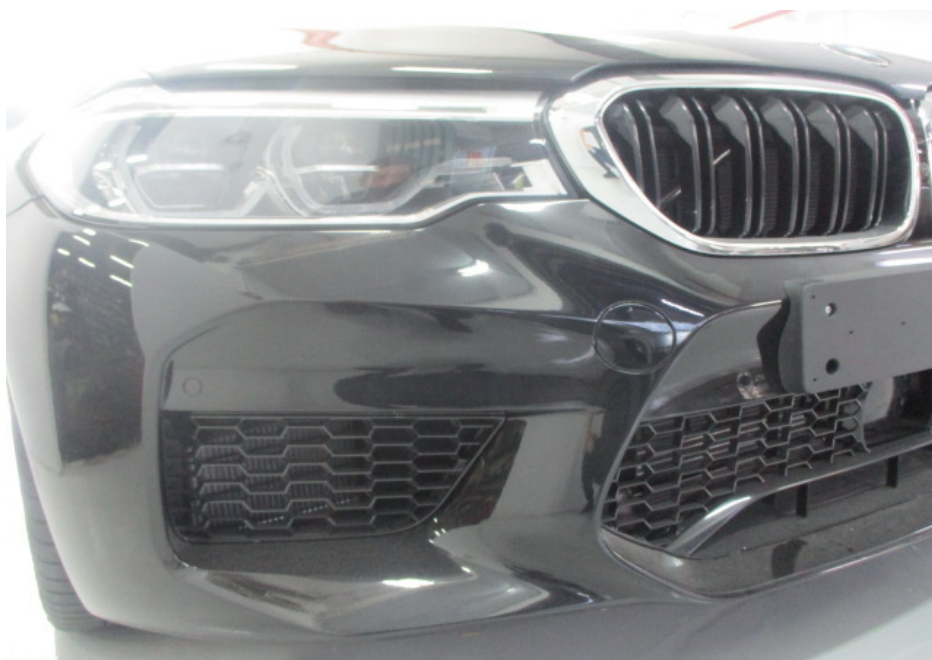
**Photo 8** shows a closer view of the Motor Car's front bumper, front bumper right lower grille, front right headlamp, radiator grille and front bonnet at the time of my inspection. The body parts at the front right body of the Motor Car were visually examined and it was observed that the repair/restoration works carried out to the damaged area of the Motor Car (refer to photograph 1 above) were reasonably adequate and in order.

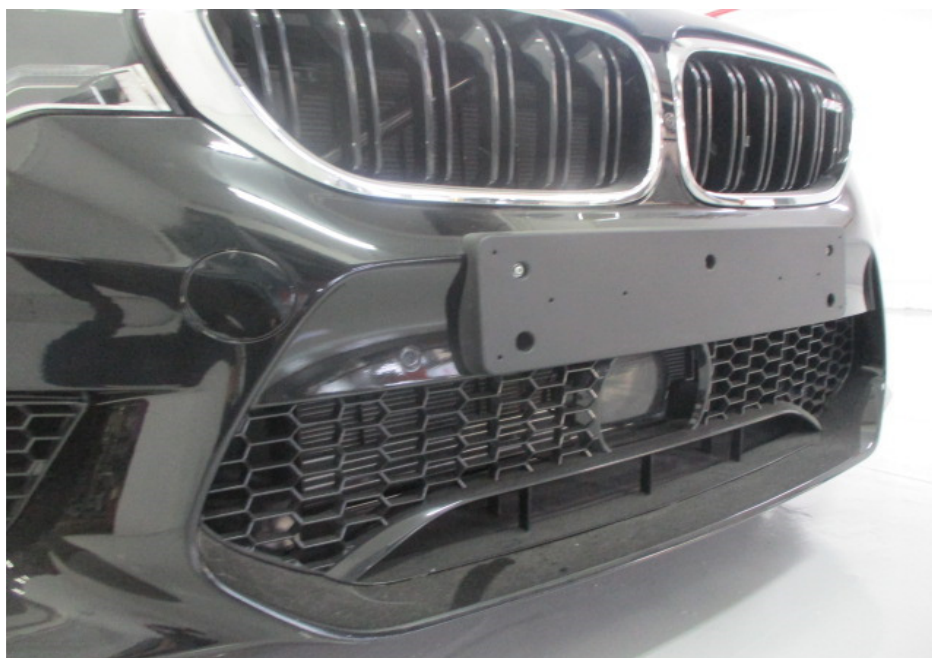
**Photo 9** shows a closer view of the front bumper centre lower grille, radar unit and radiator grilles of the Motor Car at the time of my inspection. The body parts at the frontal body of the Motor Car were visually examined and it was observed that the repair/restoration works carried out to the damaged area of the Motor Car (refer to photograph 1 above) were reasonably adequate and in order.

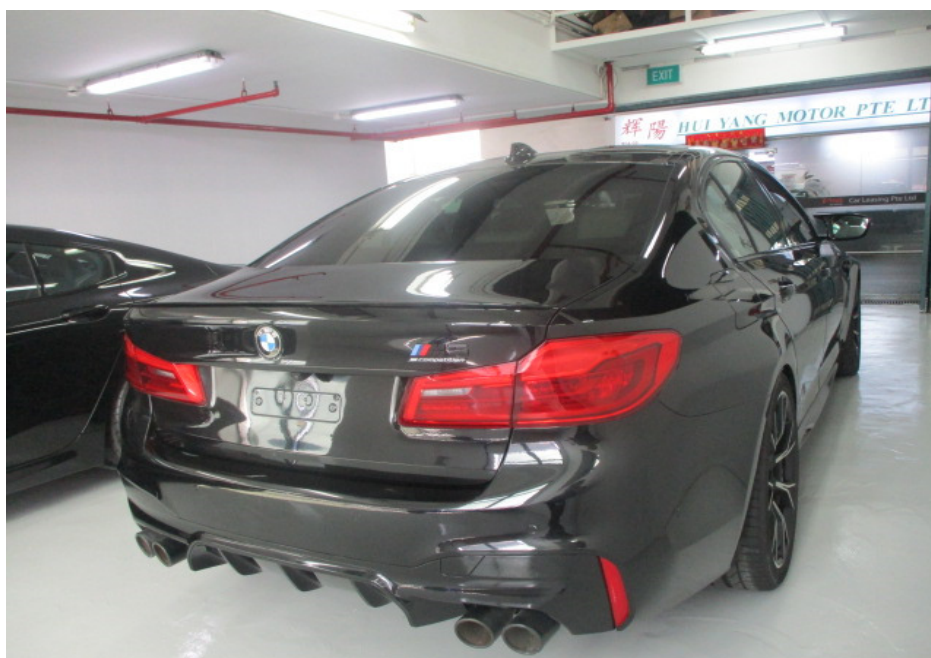
**Photo 10** shows a general view of the rear right body of the Motor Car at the time of my inspection. The body parts at the rear right body of the Motor Car, in particular the rear bumper, were visually examined and it was observed that the repair/restoration works carried out to the damaged area of the Motor Car (refer to photograph 2 above) were reasonably adequate and in order.

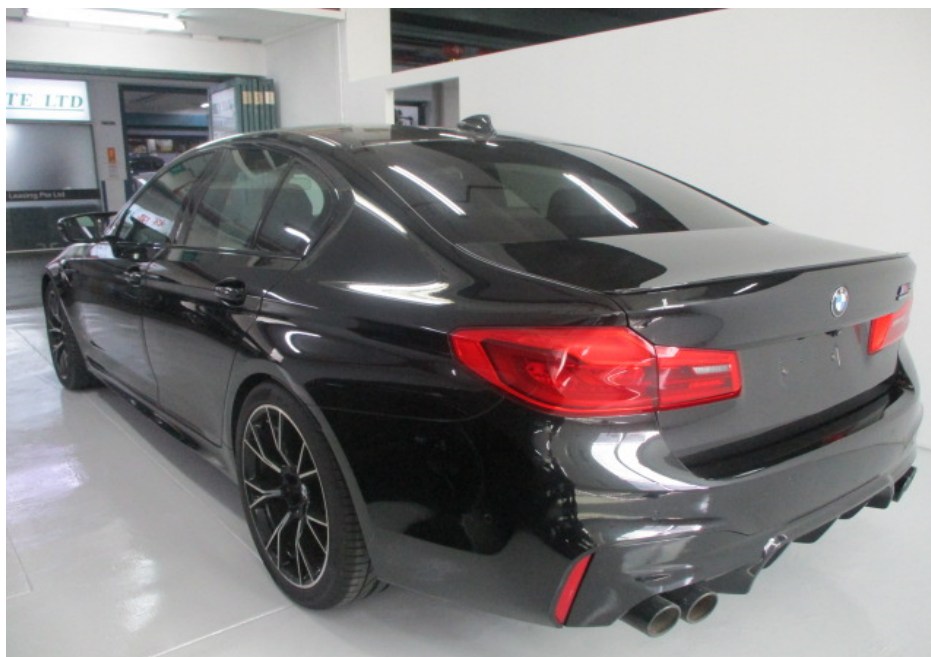
**Photo 11** shows a general view of the rear left body of the Motor Car at the time of my inspection. The Motor Car was observed to be in a relatively good general condition with no loose exterior fittings observed. The mileage of the Motor Car recorded at the time of my inspection was 10,402km.

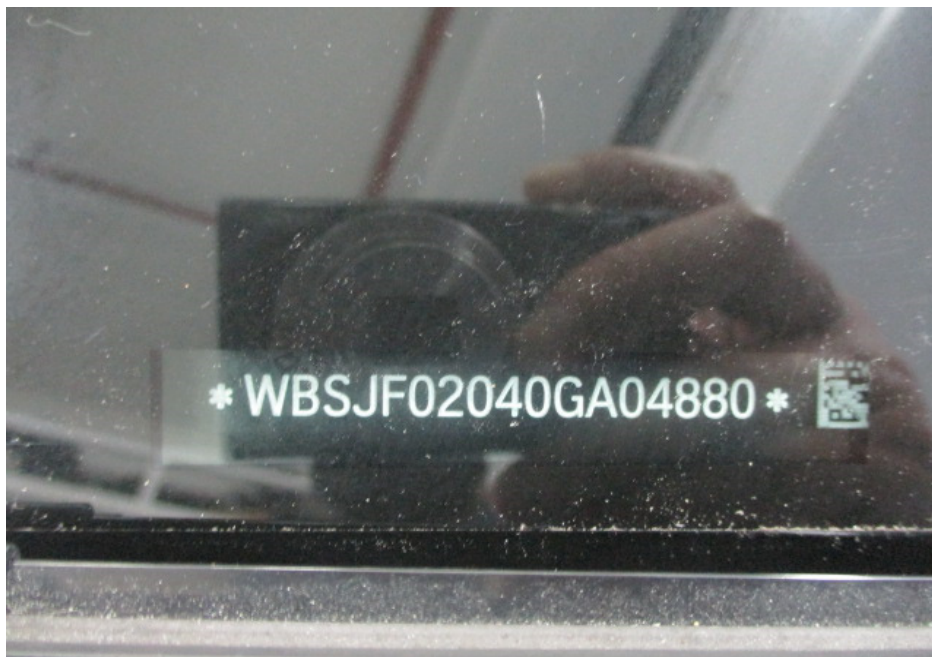
**Photo 12** shows the chassis number of the Motor Car. The chassis number recorded was WBSJF02040GA04880.

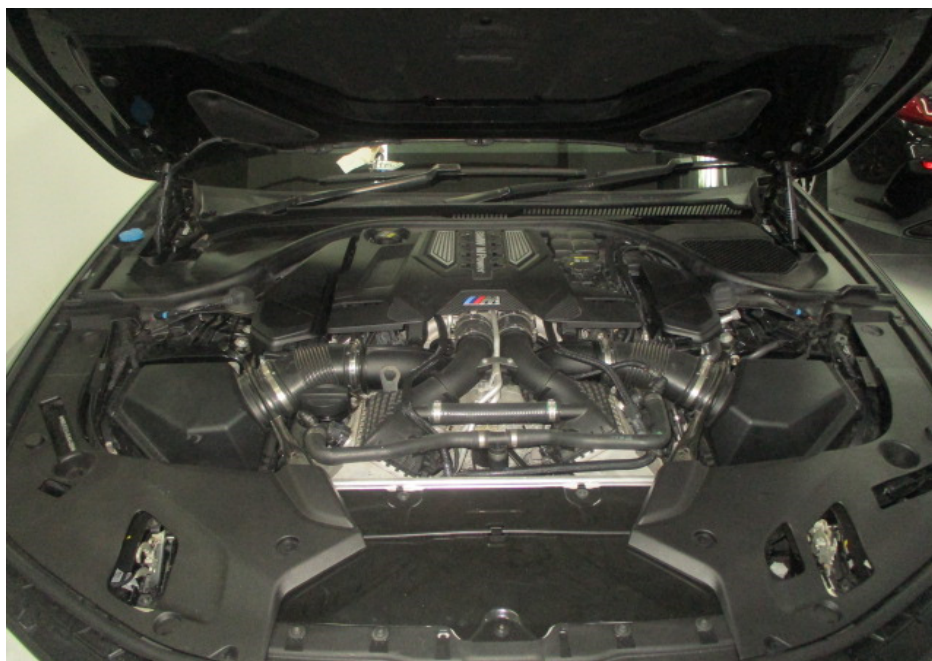
**Photo 13** shows a general view of the engine compartment of the Motor Car at the time of my inspection. The various parts and components inside the engine compartment were all observed to be intact and properly fitted. There was also no sign(s) or indication(s) of fluid leak and/or fluid stain found inside the engine compartment.

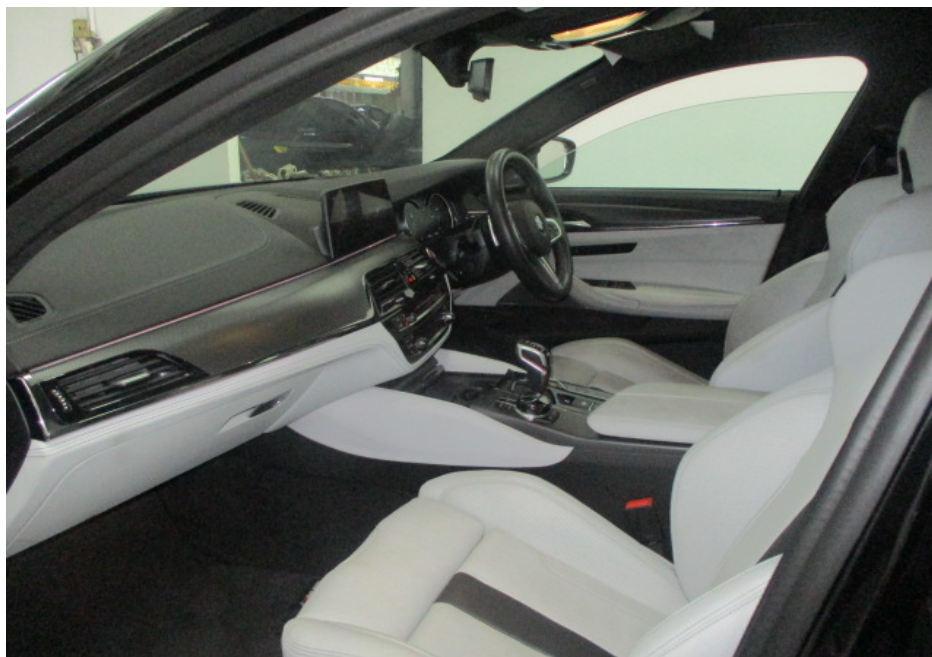
**Photo 14** shows the interior compartment of the Motor Car at the time of my inspection. The various parts and components, trims, carpet and upholstery inside the interior compartment were all observed to be intact and properly fitted.

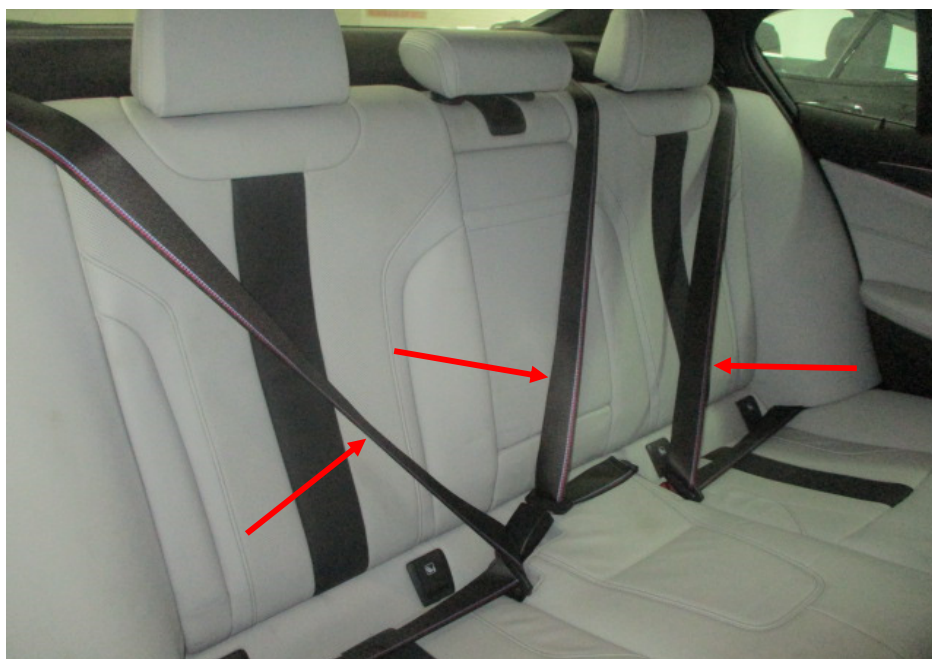
**Photo 15** shows the rear seats of the Motor Car. All the seats of the Motor Car were secured via seat rails to the floorboard. They were also fitted with a retractable seat belt reel and a pre-tensioner. The seat belts (arrowed) were tested and were able to be fastened into the respective pre-tensions that were fitted on the side of each individual seat.

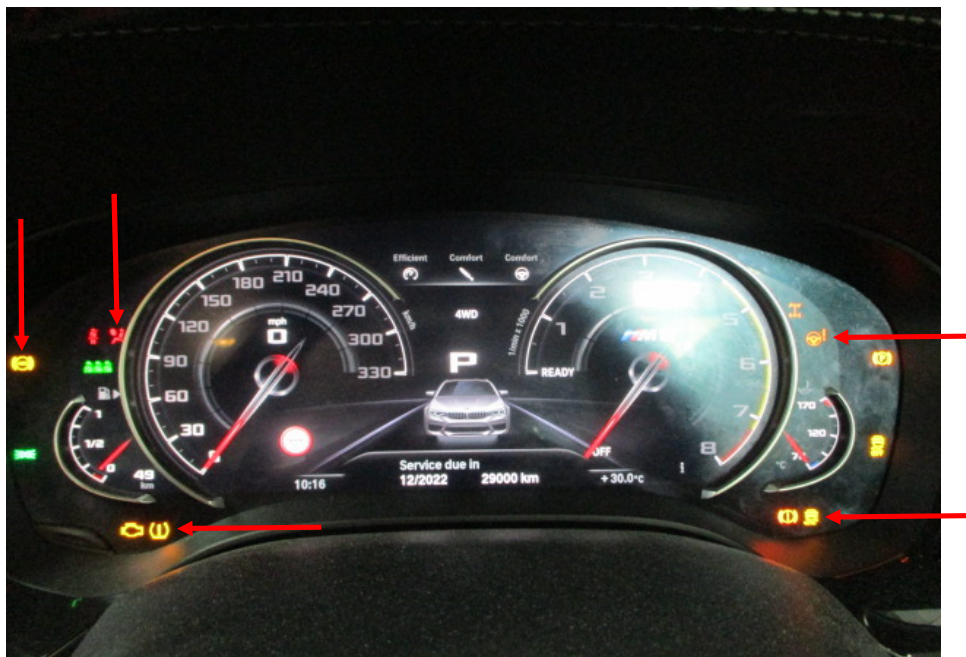
**Photo 16** shows the warning lights for the various electronic safety features appearing on the instrument panel of the Motor Car during its self-test when the engine is cranked, in particular the ABS, SRS, IAS, TPM and DSC lights (arrowed).

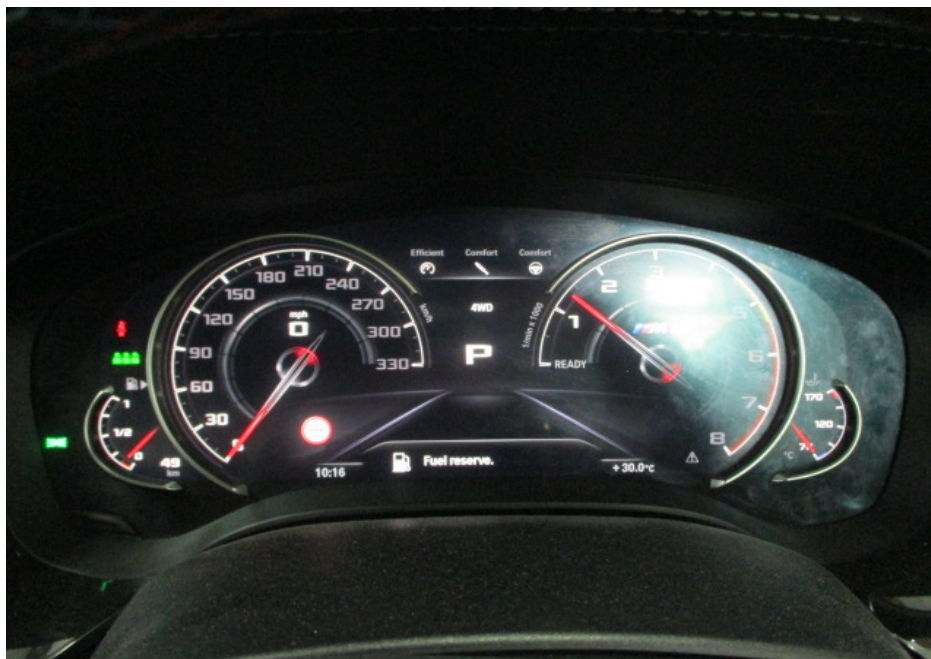
**Photo 17** shows the respective warning lights no longer illuminated, indicating that there is no fault detected to the ABS, SRS, IAS, TPM and DSC systems of the Motor Car during the self-test. These electronic systems were hence in working condition at the time of my inspection.

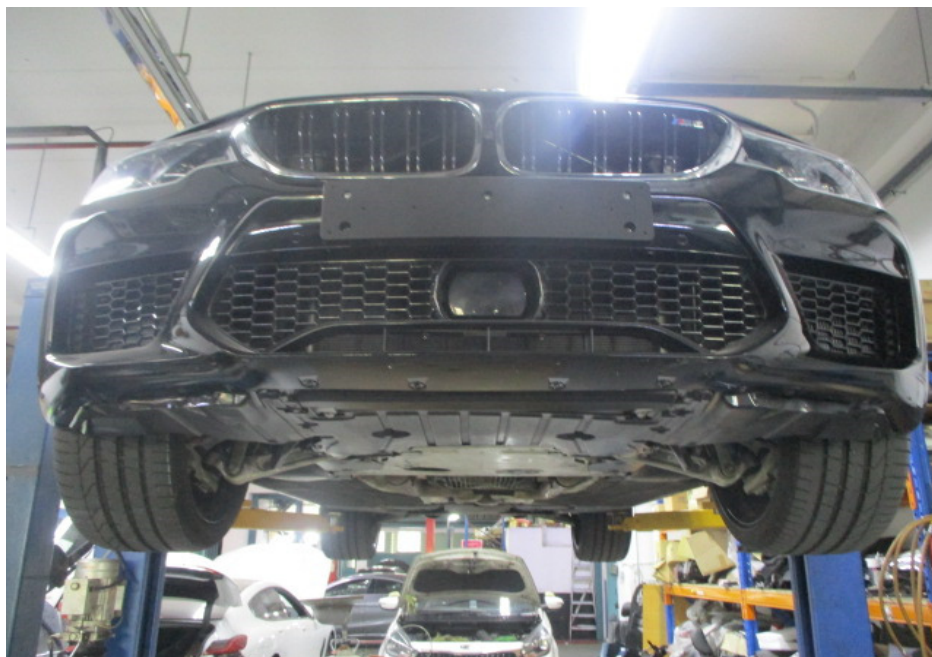
**Photo 18** shows the Motor Car hoisted up for checks on its undercarriage. There was no sign(s) or indication(s) of fluid leakage and/or fluid stain(s) on the underside of the Motor Car. The undercarriage components of the Motor Car were also all observed to be intact and secured in an appropriate manner.

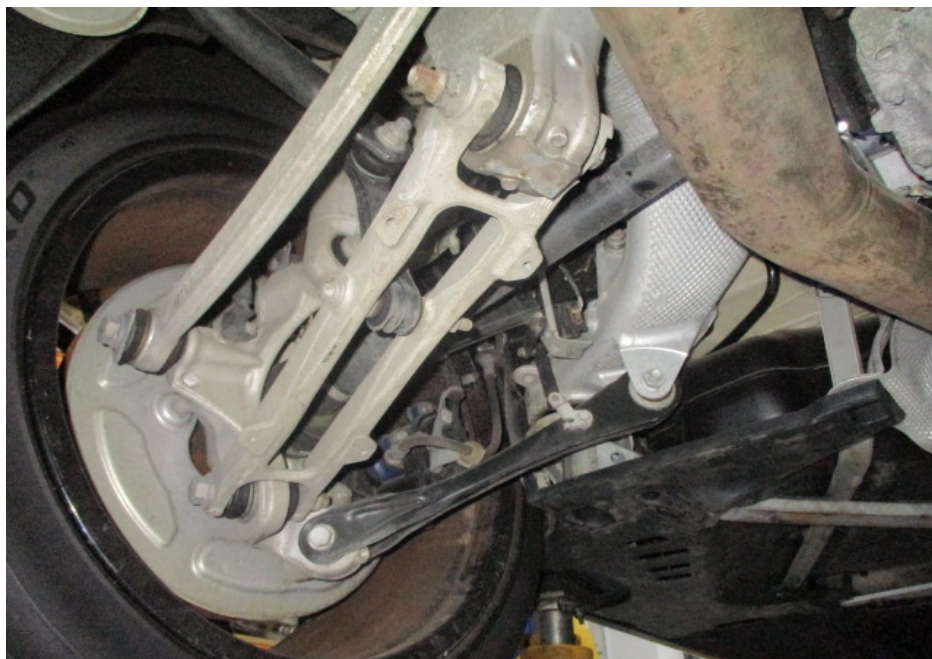
**Photo 19** shows a general view of the control arms and linkages at the rear left wheel of the Motor Car. I did not observe any fluid leak and/or fluid stain on the underside of the Motor Car. All of the Motor Car's undercarriage components were observed to be intact and secured in an appropriate manner.

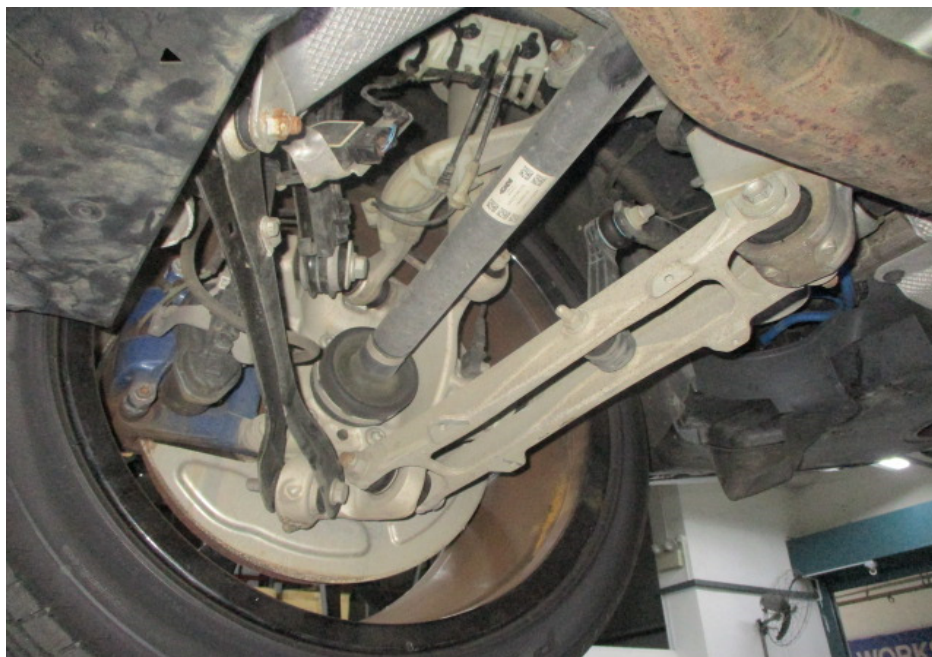
**Photo 20** shows a general view of the control arms and linkages at the rear right wheel of the Motor Car. I did not observe any fluid leak and/or fluid stain on the underside of the Motor Car. All of the Motor Car's undercarriage components were observed to be intact and secured in an appropriate manner.

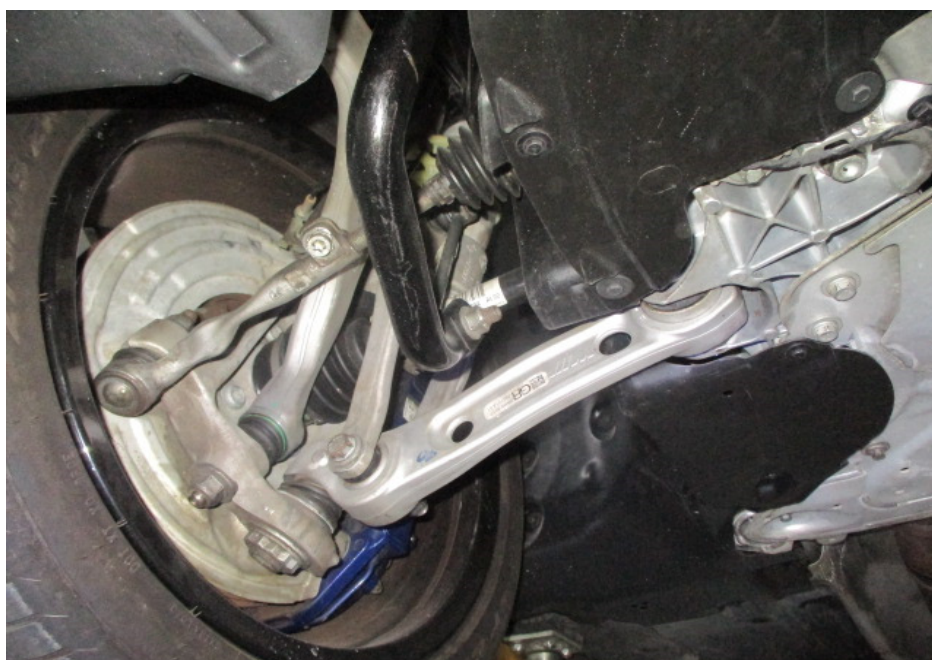
**Photo 21** shows the various undercarriage components at the front right wheel of the Motor Car. The mechanical components, control arms and linkages were all found to be intact and secured in an appropriate manner.

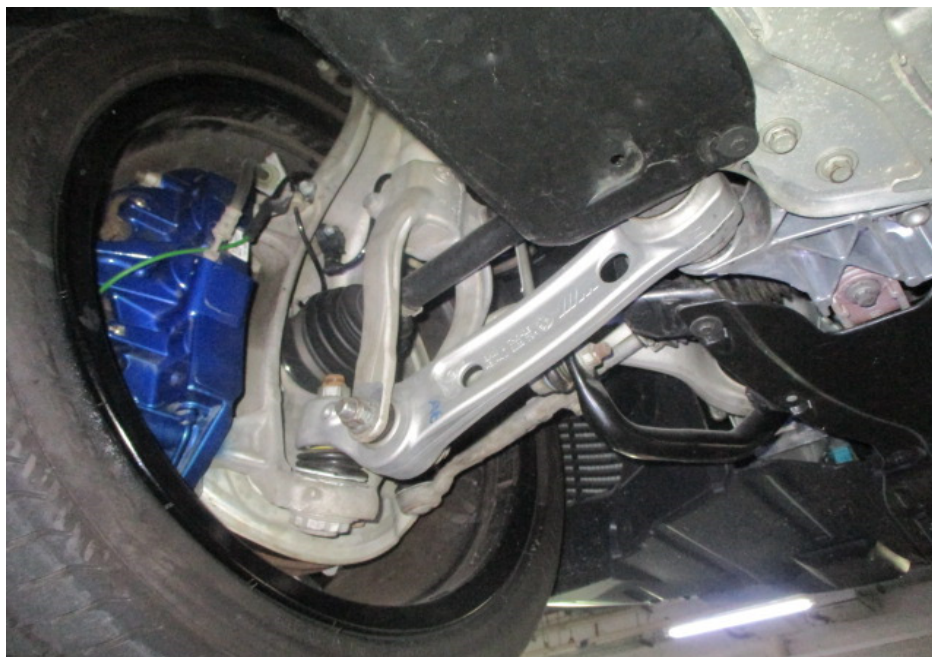
**Photo 22** shows the various undercarriage components at the front left wheel of the Motor Car. The mechanical components, control arms and linkages were all found to be intact and secured in an appropriate manner. I also did not observe any fluid leak and/or fluid stain on the underside of the Motor Car.

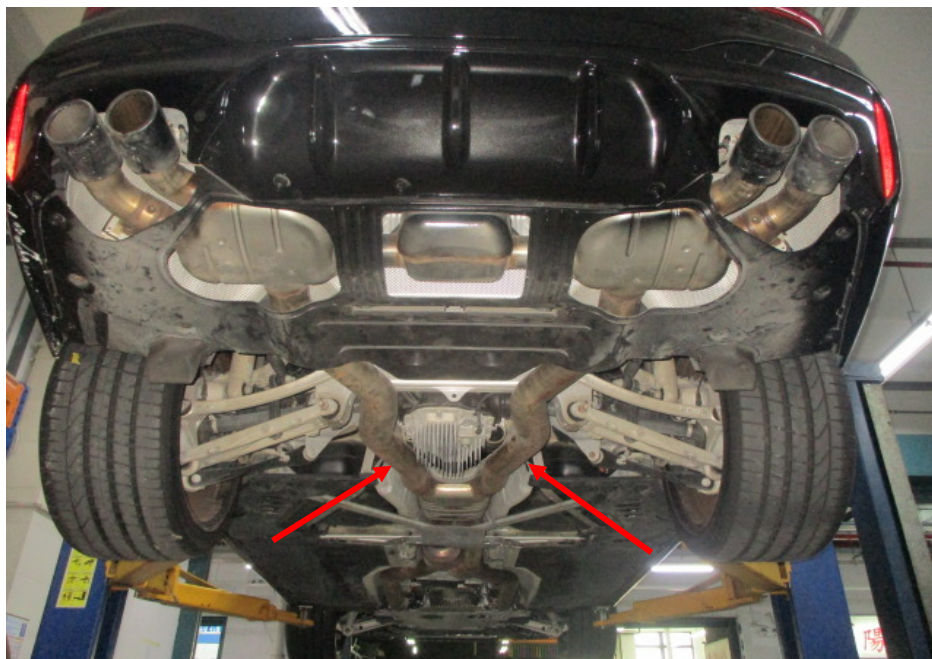
**Photo 23** shows the rear section of the Motor Car's exhaust system. My examination of the Motor Car's exhaust system revealed no sign(s) or indication(s) of any cut or weld marks along its exhaust pipes (arrowed), centre resonator boxes, rear mufflers and on its catalytic converters.

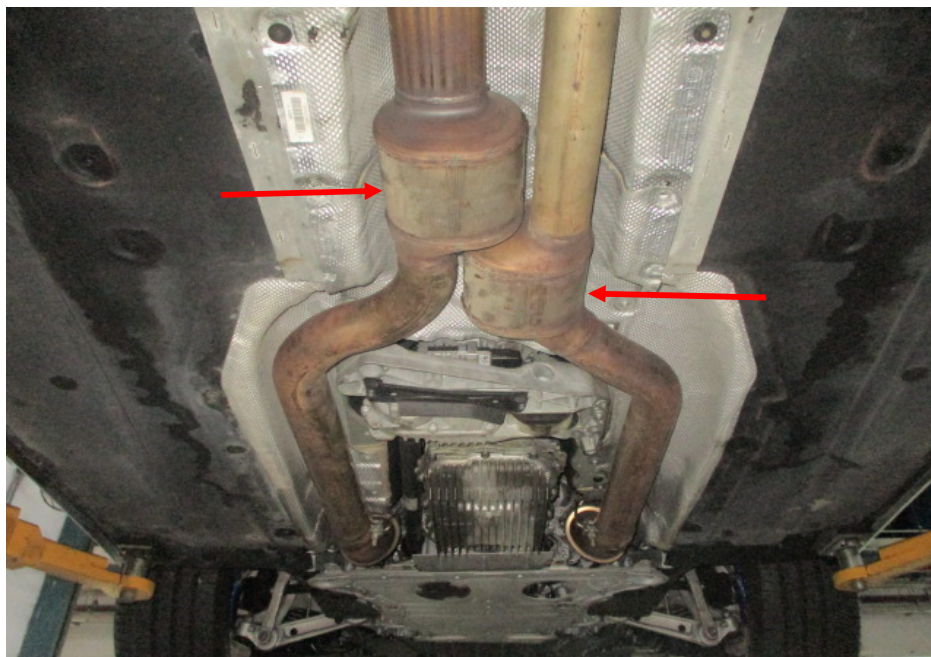
**Photo 24** shows the front section of the Motor Car's exhaust system. My examination of the Motor Car's exhaust system revealed no sign(s) or indication(s) of any cut or weld marks along its exhaust pipes, centre resonator boxes (arrowed), rear mufflers and on its catalytic converters.

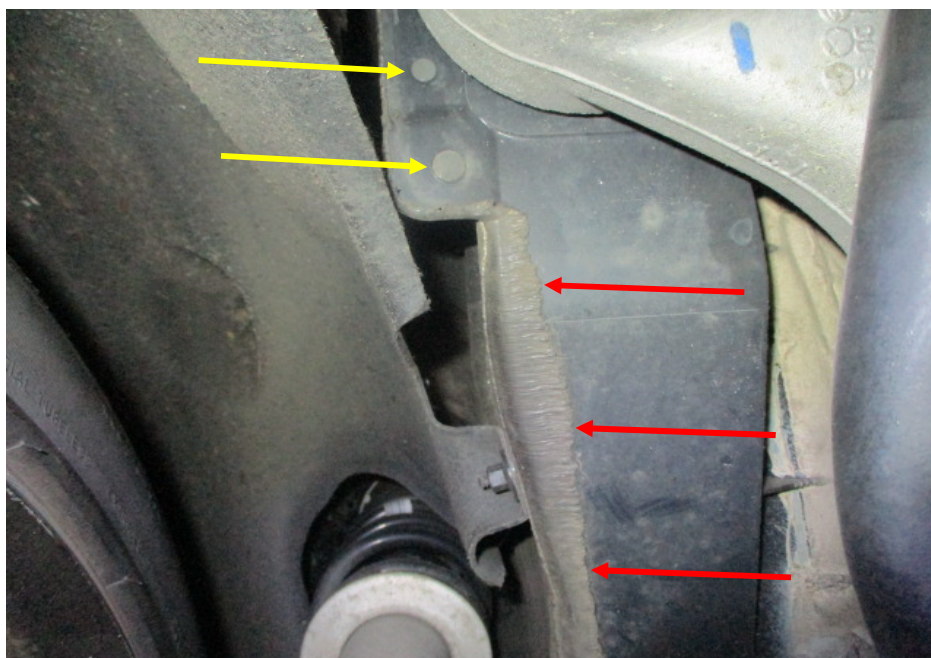
**Photo 25** shows the chassis/structural body at the underside rear left of the Motor Car. I did not find any weld marks other than original spot weld marks (yellow arrow) on the chassis/structural body of the Motor Car. The original factory sealant (red arrow) at the joints along the chassis/structural body was also untouched, indicating no work was done on the chassis/structural body of the Motor Car and that the chassis/structural body was originally fitted.

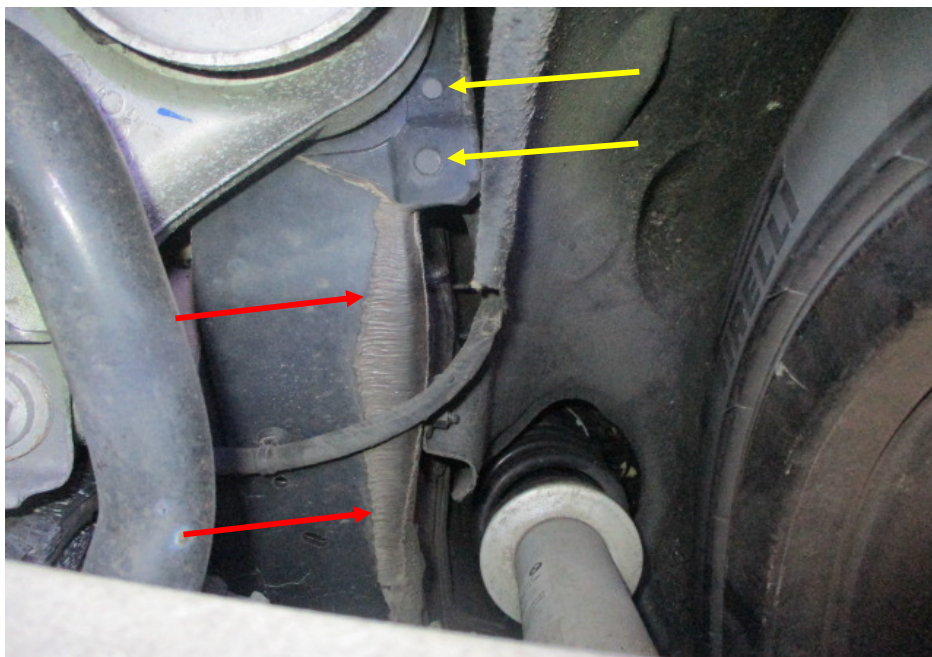
**Photo 26** shows the chassis/structural body at the underside rear right of the Motor Car. I did not find any weld marks other than original spot weld marks (yellow arrow) on the chassis/structural body of the Motor Car. The original factory sealant (red arrow) at the joints along the chassis/structural body was also untouched, indicating no work was done on the chassis/structural body of the Motor Car and that the chassis/structural body was originally fitted.

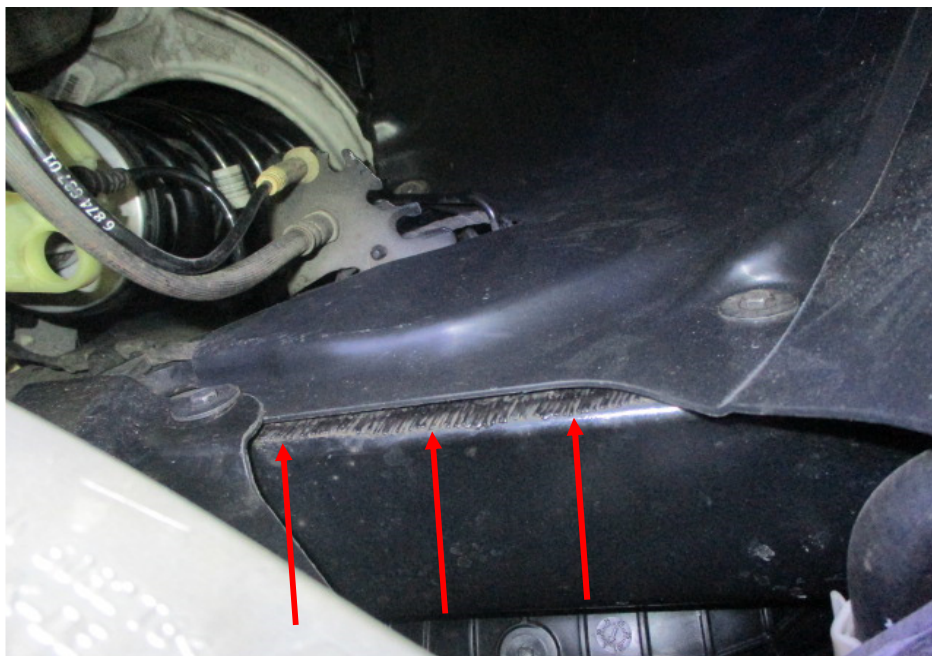
**Photo 27** shows the chassis/structural body at the underside front right of the Motor Car. The original factory sealant (arrowed) at the joints along the chassis/structural body was observed to be untouched. In general, I had found no work was carried out on the chassis/structural body of the Motor Car. The chassis/structural body of the Motor Car was originally fitted.

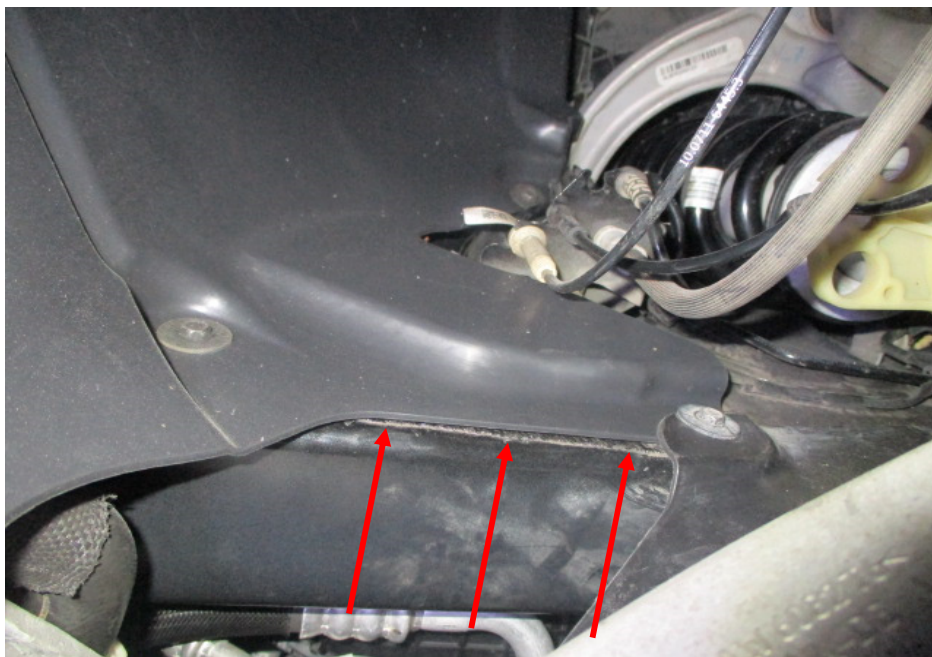
**Photo 28** shows the chassis/structural body at the underside front left of the Motor Car. The original factory sealant (arrowed) at the joints along the chassis/structural body was observed to be untouched. In general, I had found no work was carried out on the chassis/structural body of the Motor Car. The chassis/structural body of the Motor Car was originally fitted.

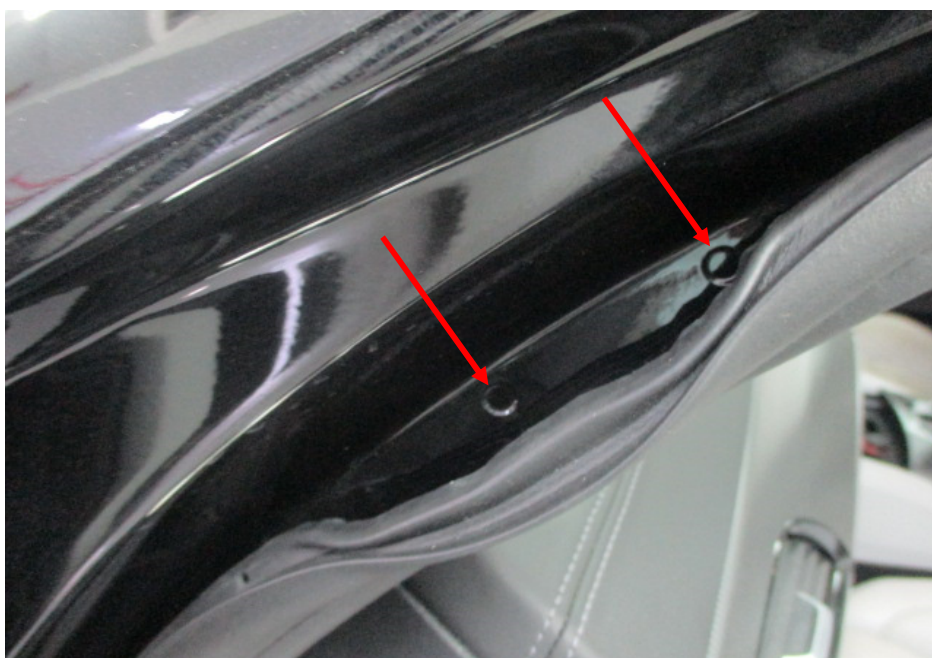
**Photo 29** shows the left side "A" pillar of the Motor Car. I did not find any weld marks other than original spot weld marks (arrowed) on the left side "A" pillar of the Motor Car which, indicates that there was no re-welding works carried out. In general, I had found all the non-detachable body panels of the Motor Car to be originally fitted at the time of my inspection.

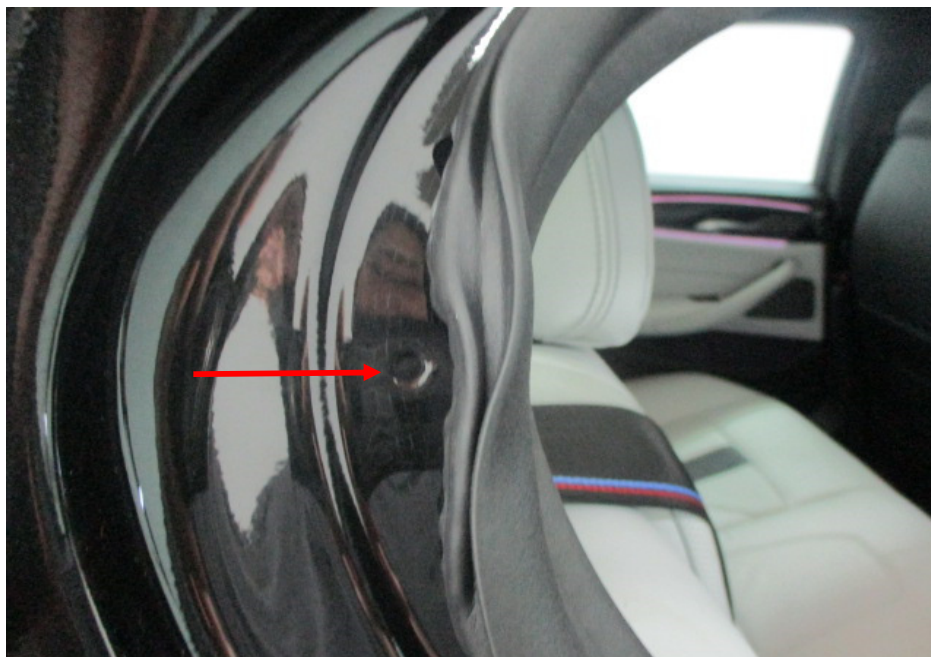
**Photo 30** shows the right side “C” pillar of the Motor Car. I did not find any weld marks other than original spot weld marks (arrowed) on the right side “C” pillar of the Motor Car which, indicates that there was no re-welding works carried out. In general, I had found all the non-detachable body panels of the Motor Car to be originally fitted at the time of my inspection.
