Your Ref: TP/IP/10545/2021  
Our Ref : CI/TPD21008290/N

5 August 2021

**Fatal Accident Investigation Team**

**INSPECTION REPORT OF MOTORCYCLE JSY 91**

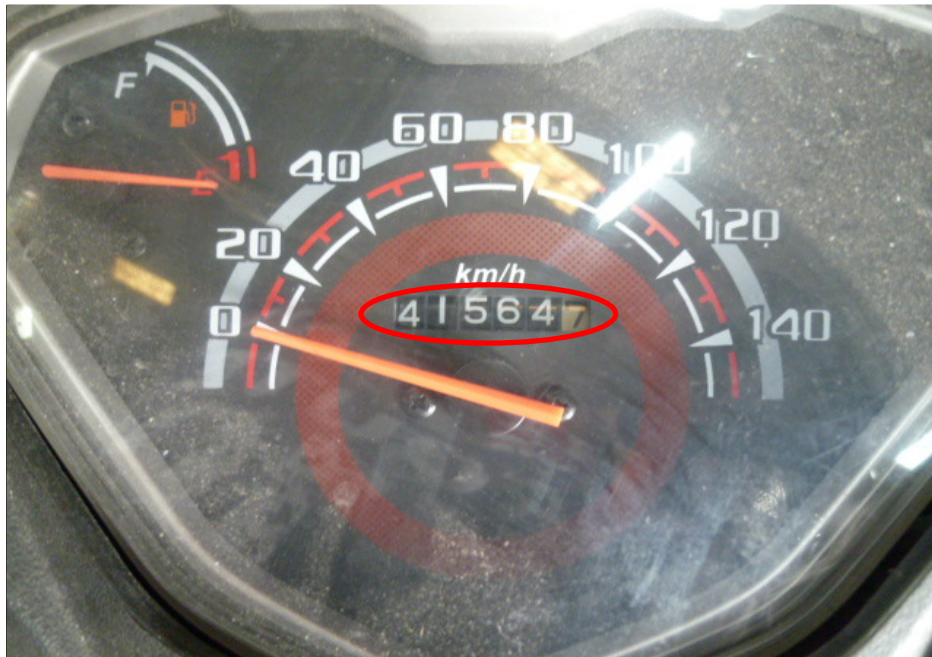
**Photo 1** shows the speedometer gauge of the Motorcycle. The mileage of the Motorcycle at the time of our inspection was 41, 564km (circled).

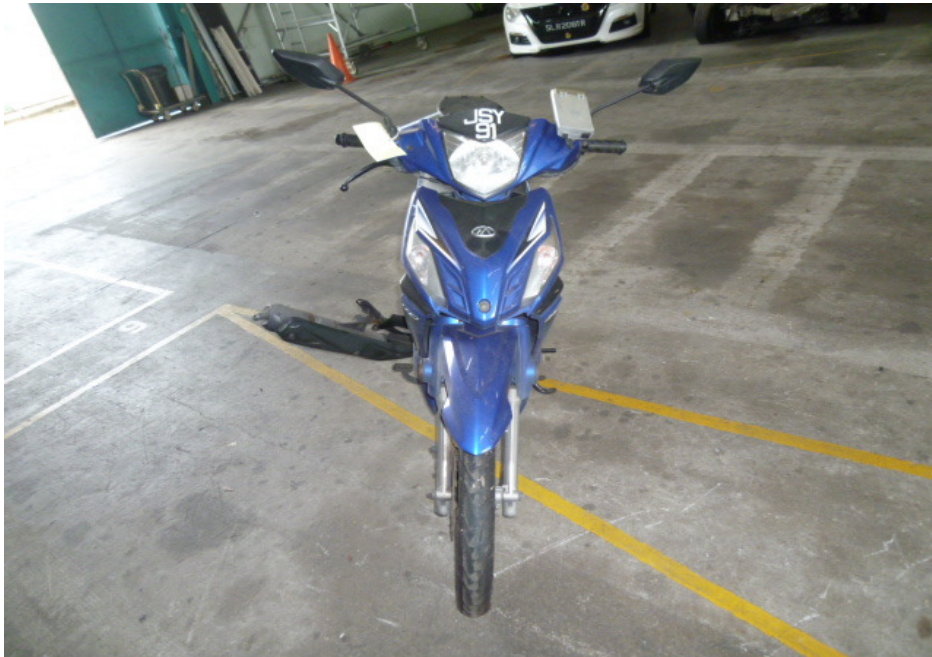
**Photo 2** shows a general view of the frontal portion of the Motorcycle at the time of our inspection. The Motorcycle was observed to have sustained damages all around.

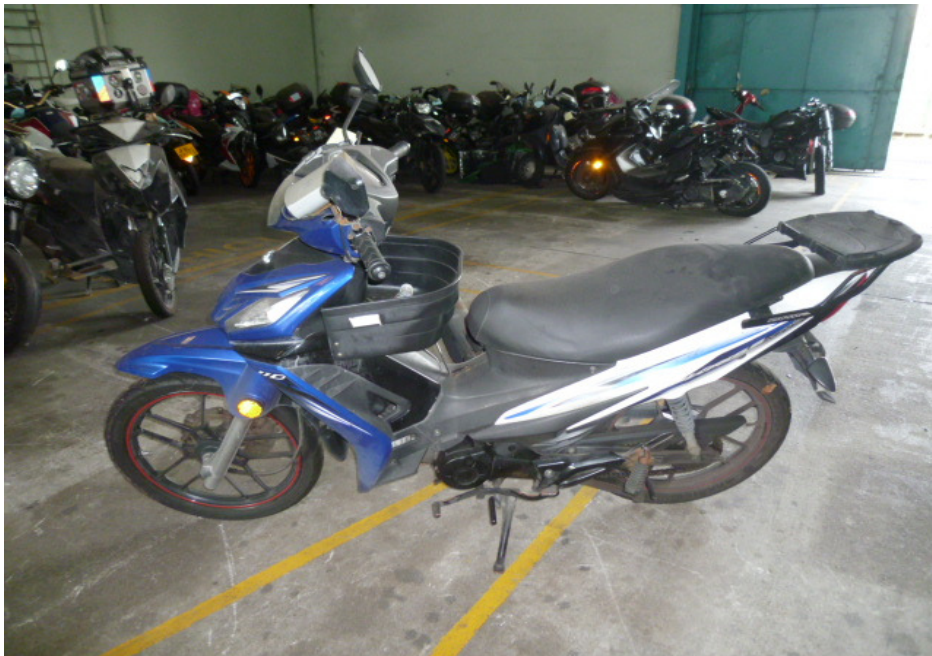
**Photo 3** shows a general view of the left body of the Motorcycle at the time of our inspection. The Motorcycle was observed to have sustained damages all around.

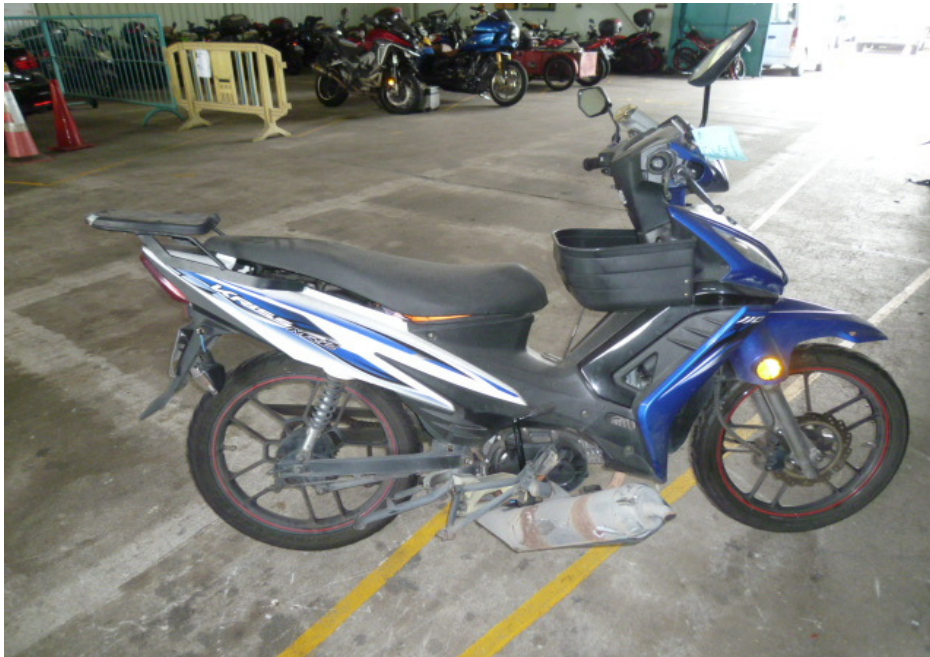
**Photo 4** shows a general view of the right body of the Motorcycle at the time of our inspection. The Motorcycle was observed to have sustained damages all around.

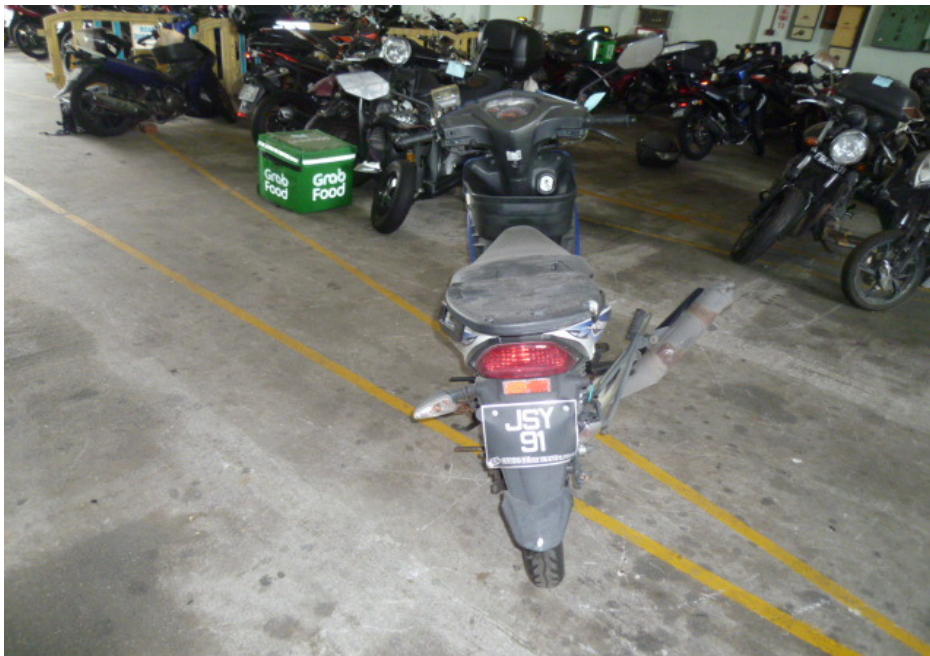
**Photo 5** shows a general view of the right body of the Motorcycle at the time of our inspection. The Motorcycle was observed to have sustained damages all around. Amongst the body parts that were found to have been damaged include its front brake lever, right side mirror, right handlebar end, right pillion footpeg bracket, left pillion footpeg, left rear side cover, right rear signal lamp, top box rack, rear number plate and exhaust muffler, amongst others..

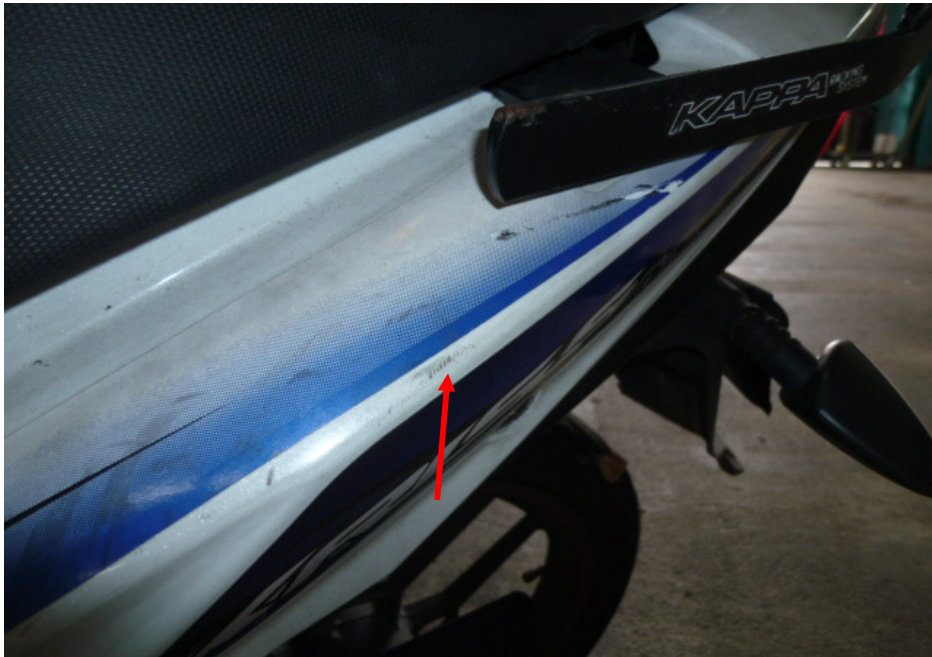
**Photo 6** shows a closer view of the left rear side cover which was amongst the body parts of the Motorcycle that had sustained damage as a result of the accident (arrowed).

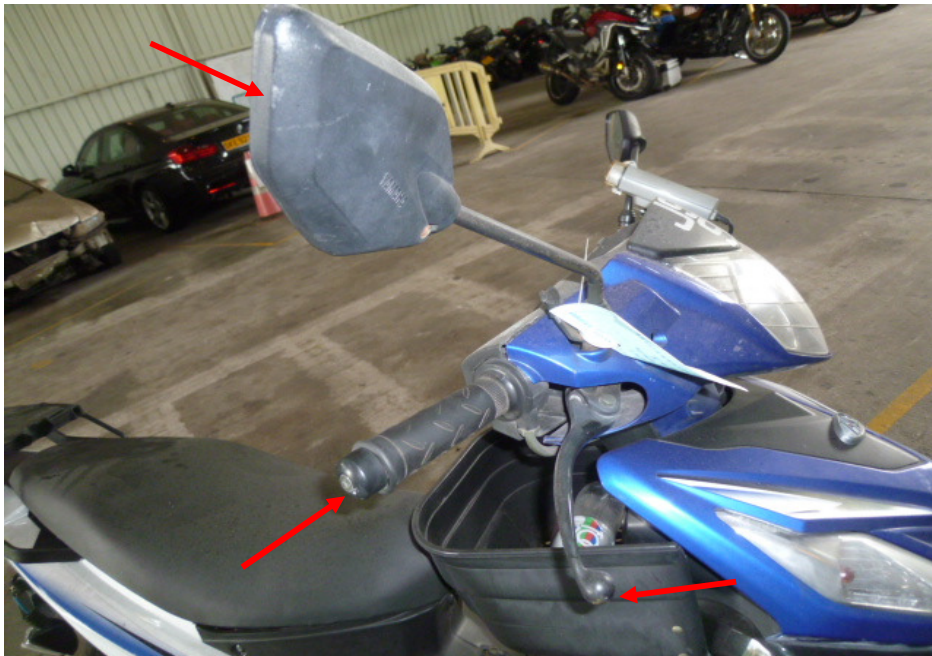
**Photo 7** shows the right handlebar end, right side mirror and front brake lever (arrowed), which were amongst the body parts of the Motorcycle that had sustained damage as a result of the accident.

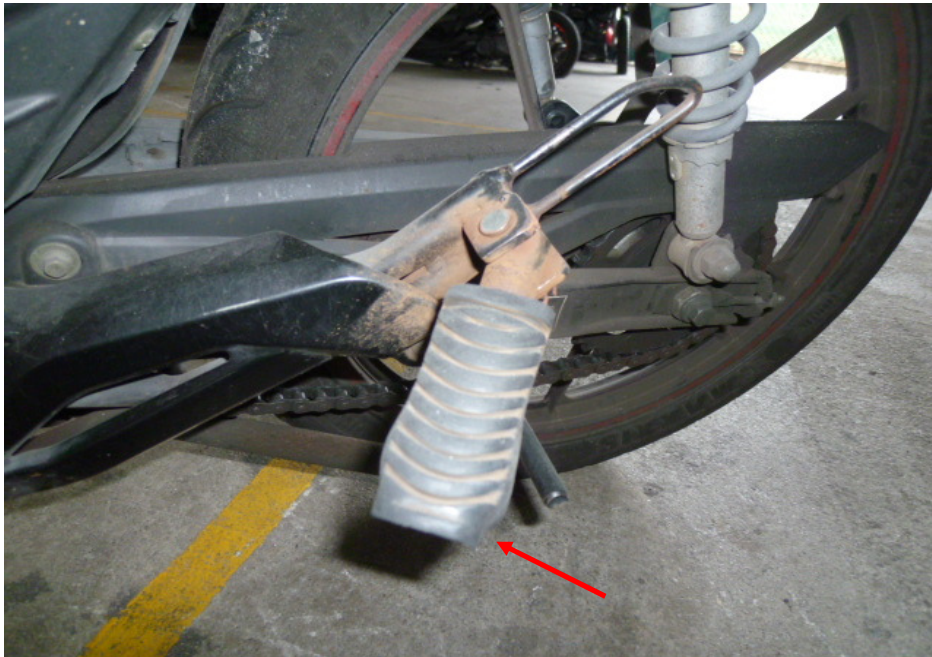
**Photo 8** shows a closer view of the left pillion footpeg which was amongst the body parts of the Motorcycle that had sustained damage as a result of the accident (arrowed).

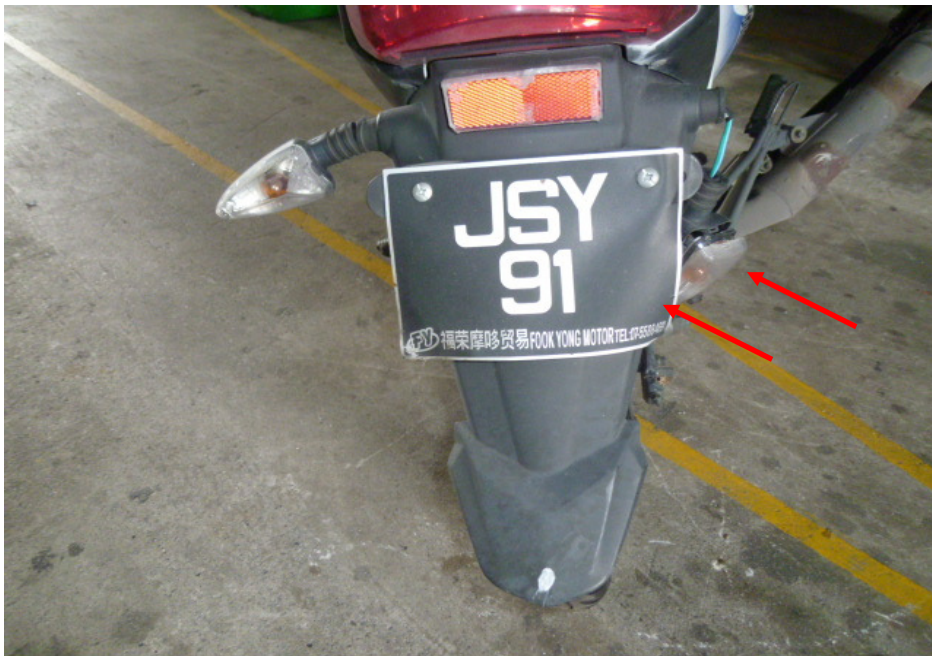
**Photo 9** shows a closer view of the dented rear number plate and broken right rear signal lamp of the Motorcycle as a result of the accident (arrowed).

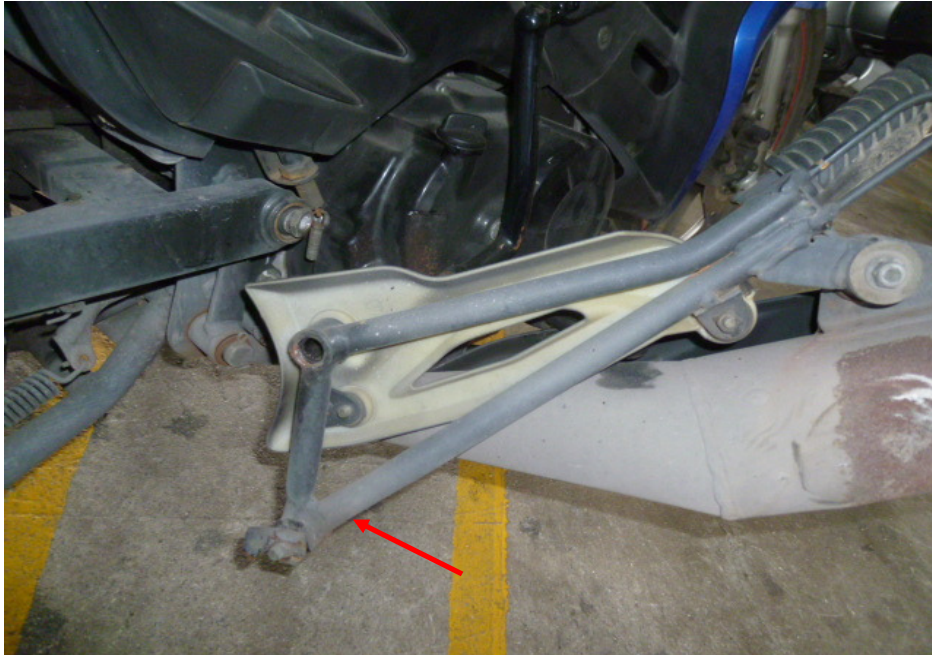
**Photo 10** shows a closer view of the broken right pillion footpeg bracket (arrowed) which was amongst the body parts of the Motorcycle that had sustained damages as a result of the accident.

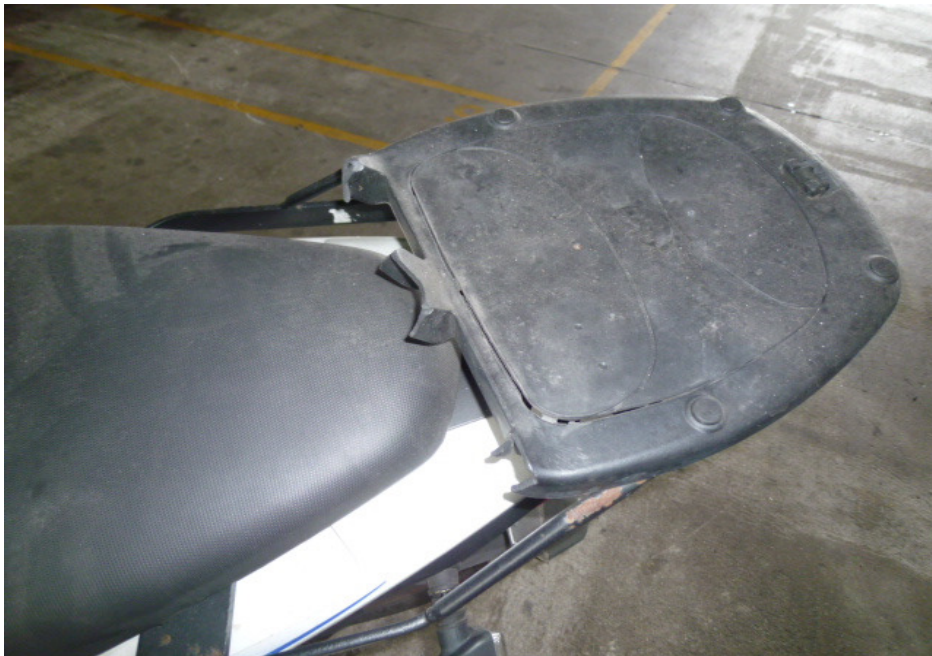
**Photo 11** shows the broken top box rack of the Motorcycle as a result of the accident.

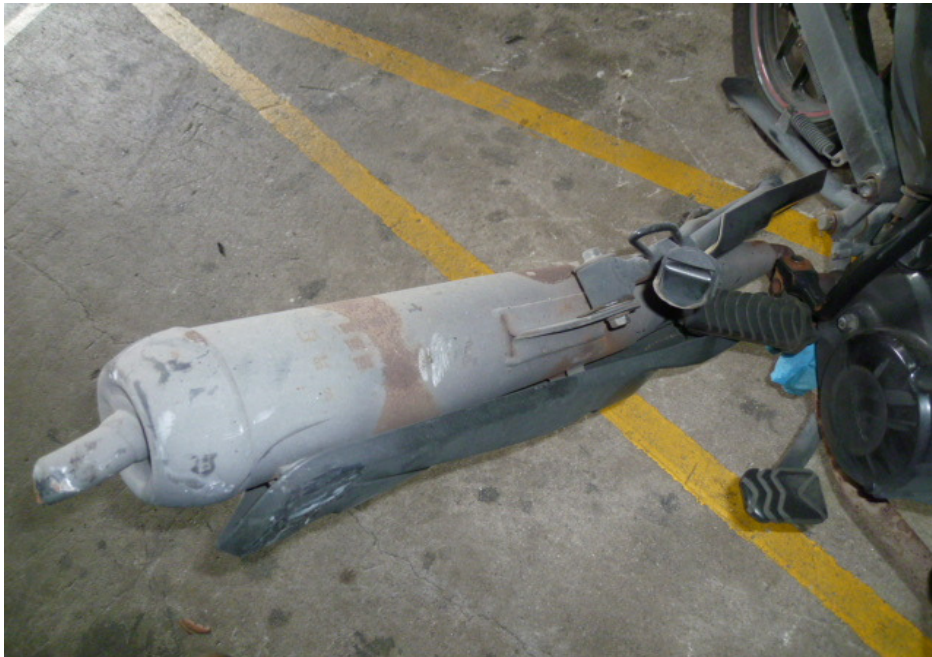
**Photo 12** shows the bent exhaust muffler of the Motorcycle as a result of the accident.

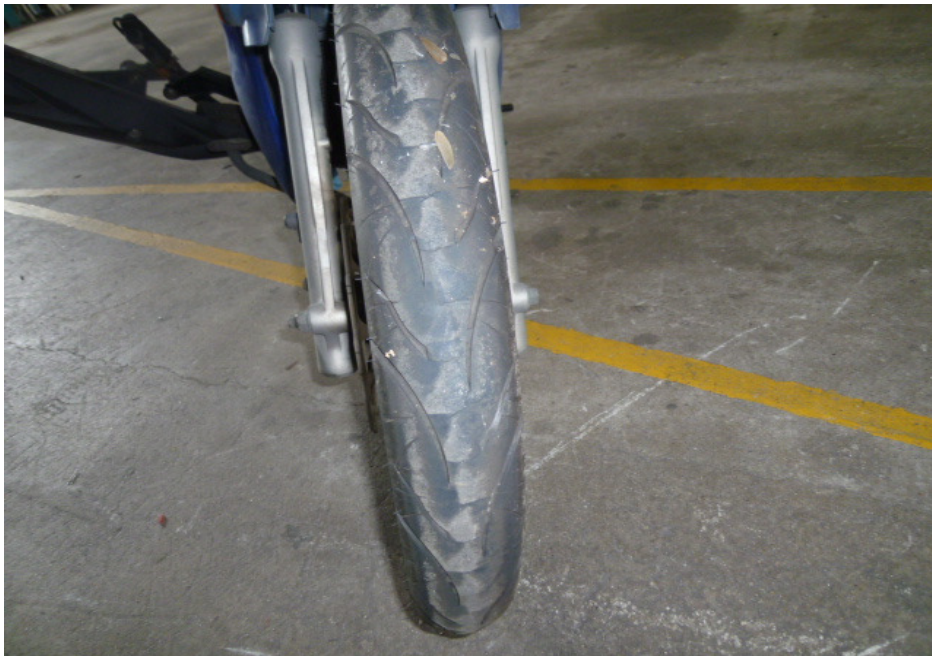
**Photo 13** shows the front tyre of the Motorcycle at the time of our inspection. The front tyre was observed to be in serviceable condition with remaining tread depth of approximately 3mm. The pattern of the tread was also clearly visible. There was no tear, burst mark(s) and/or punctured hole(s) on the sidewalls as well as across the tread of the front tyre.

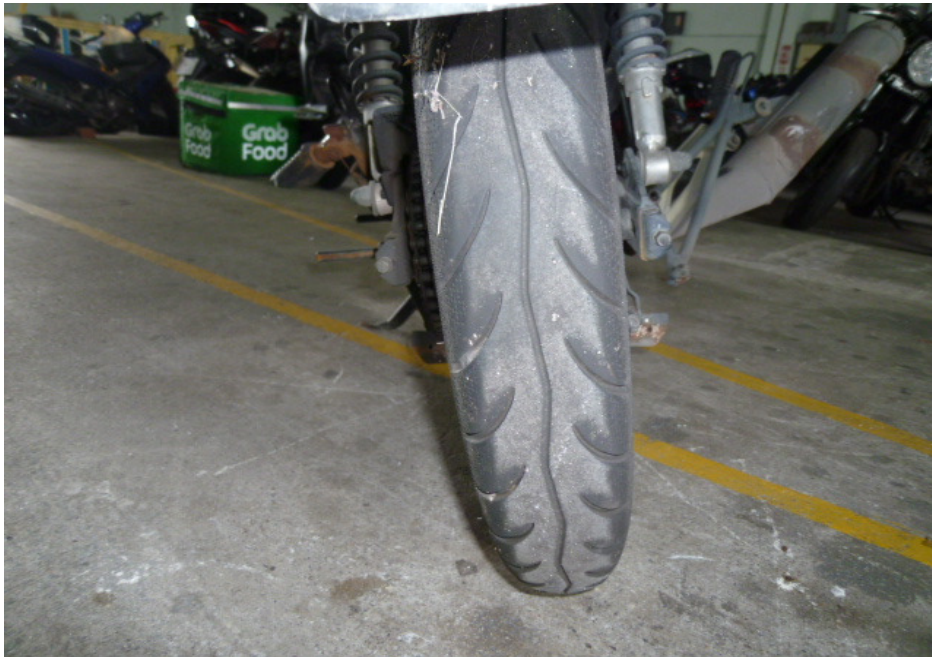
**Photo 14** shows the condition of the Motorcycle's rear tyre. The rear tyre was observed to be in serviceable condition with remaining tread depth of approximately 3mm. The tyre was also observed to be sufficiently inflated for vehicular operation. We did not observe any tear, burst mark(s) and/or punctured hole(s) on the sidewalls as well as across the tread of the rear tyre.

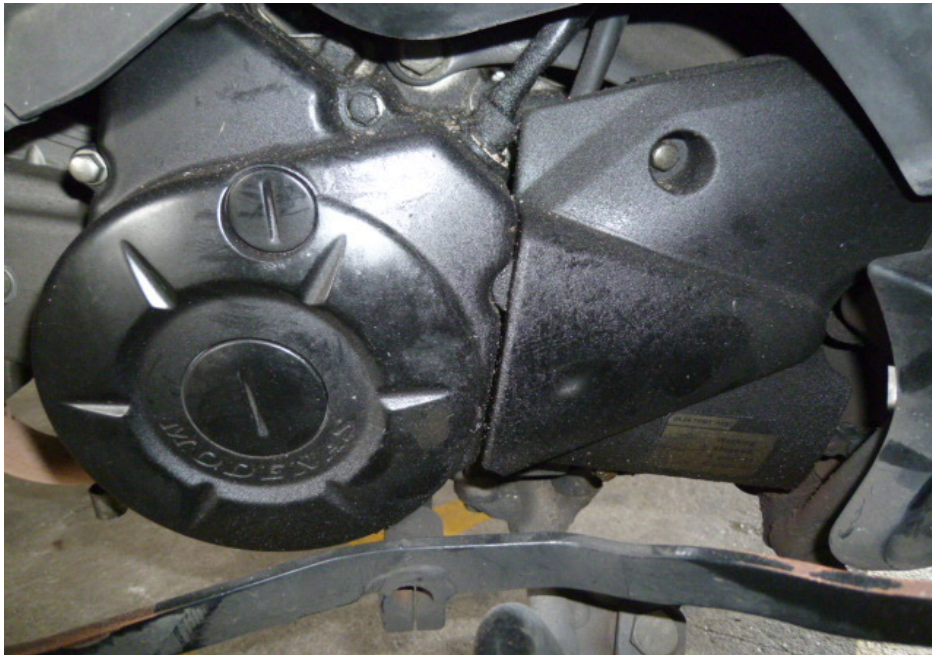
**Photo 15** shows the left side of the engine of the Motorcycle at the time of our inspection. The various engine related parts and components were found to be intact with no visible damage. There was also no sign(s) or indication(s) of fluid leak observed around the left engine area of the Motorcycle.

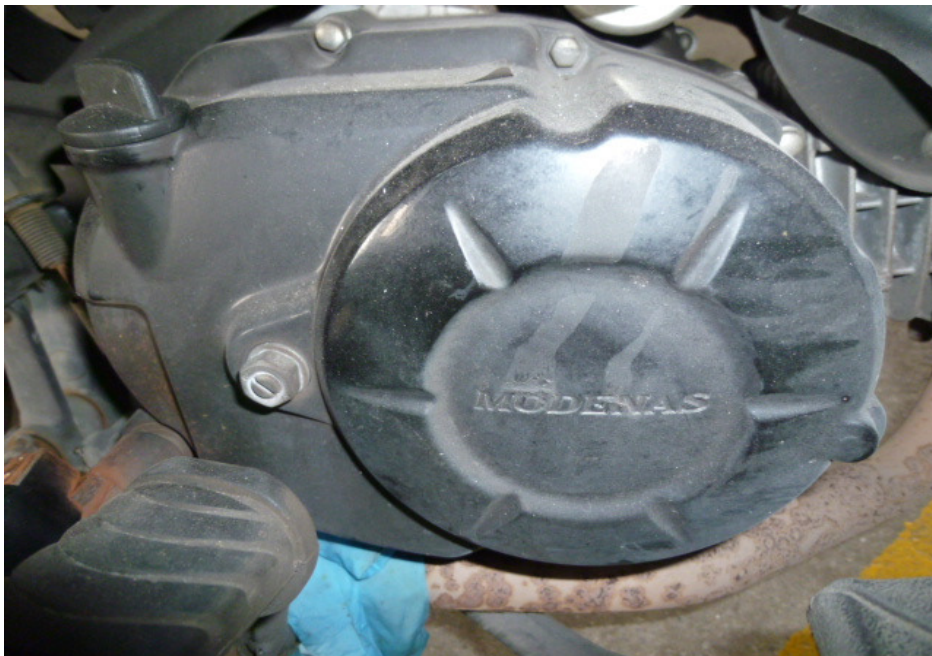
**Photo 16** shows the right side of the engine of the Motorcycle at the time of our inspection. The various engine related parts and components were found to be intact with no visible damage. There was also no sign(s) or indication(s) of fluid leak observed around the right engine area of the Motorcycle.

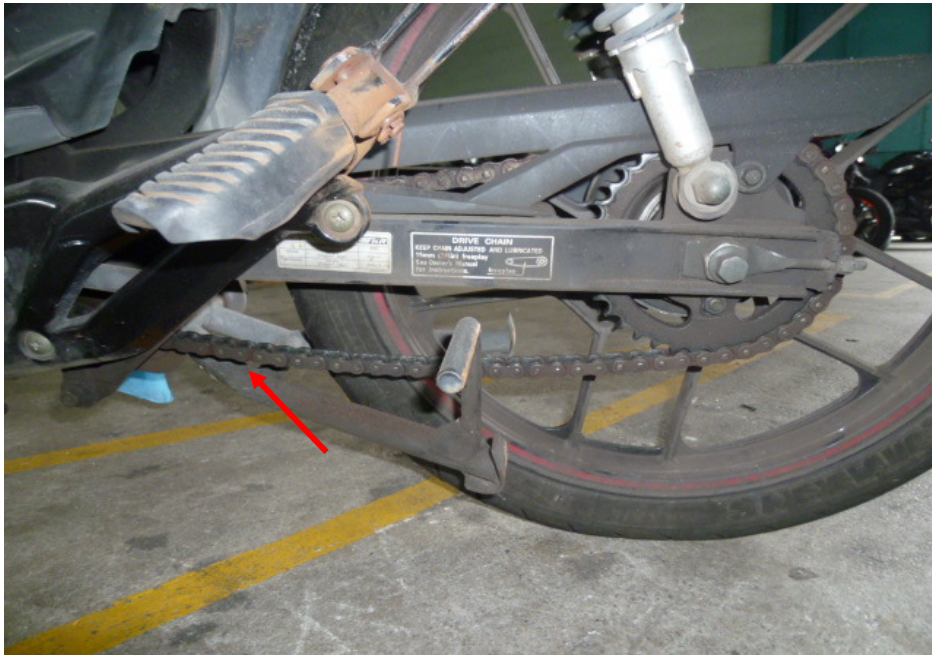
**Photo 17** shows the general view of the gear train (arrowed) of the Motorcycle, which was observed to be intact with no misalignment. It was also adequately lubricated for operating purposes.

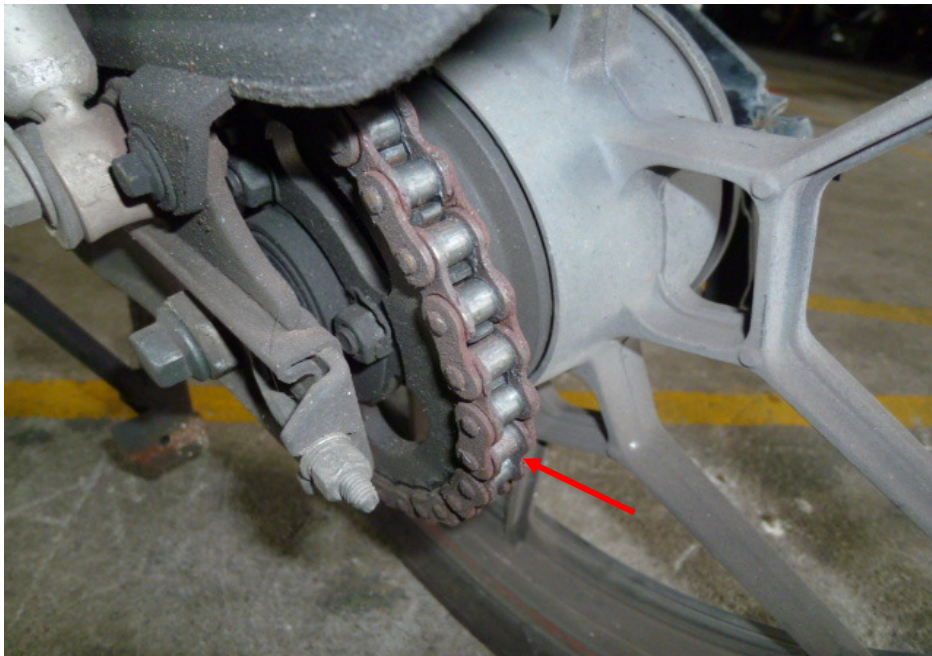
**Photo 18** shows a closer view of the gear train (arrowed) of the Motorcycle, which was observed to be intact with no misalignment. It was also adequately lubricated for operating purposes.

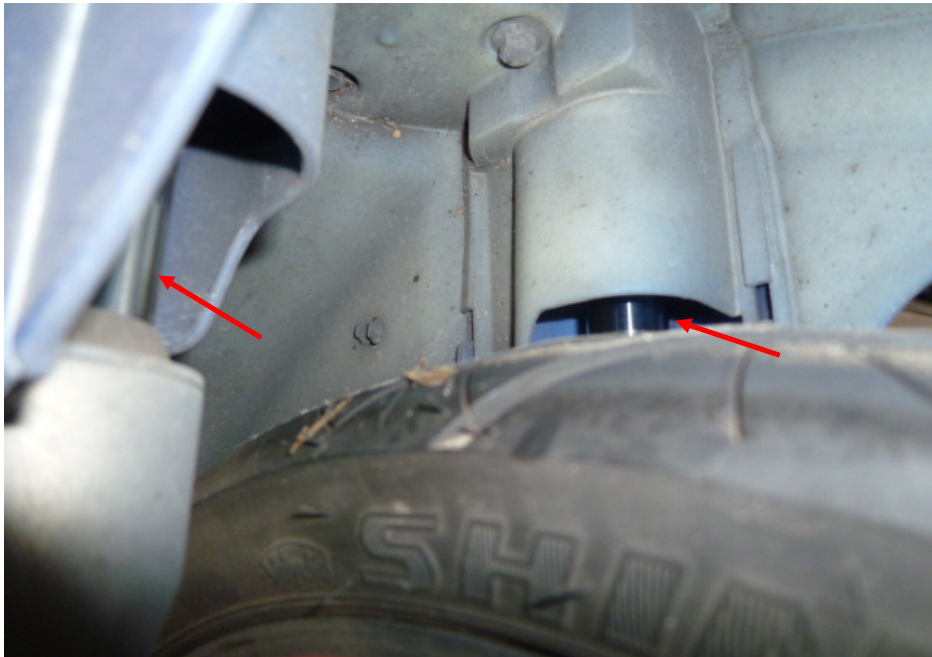
11. Our checks on the various steering components of the Motorcycle revealed that its steering system was not in serviceable condition. Its front fork was found to be intact. Turning the handle bar towards the right did not produce any abnormal free play and/or resistance. However we were unable to turn the handle bar towards the left due to resistance most probably as a result of damages sustained during the accident.

**Photo 19** shows the front fork (arrowed) of the Motorcycle. Its front fork was found to be intact. Turning the handle bar towards the right did not produce any abnormal free play and/or resistance. However we were unable to turn the handle bar towards the left due to resistance most probably as a result of damages sustained during the accident.

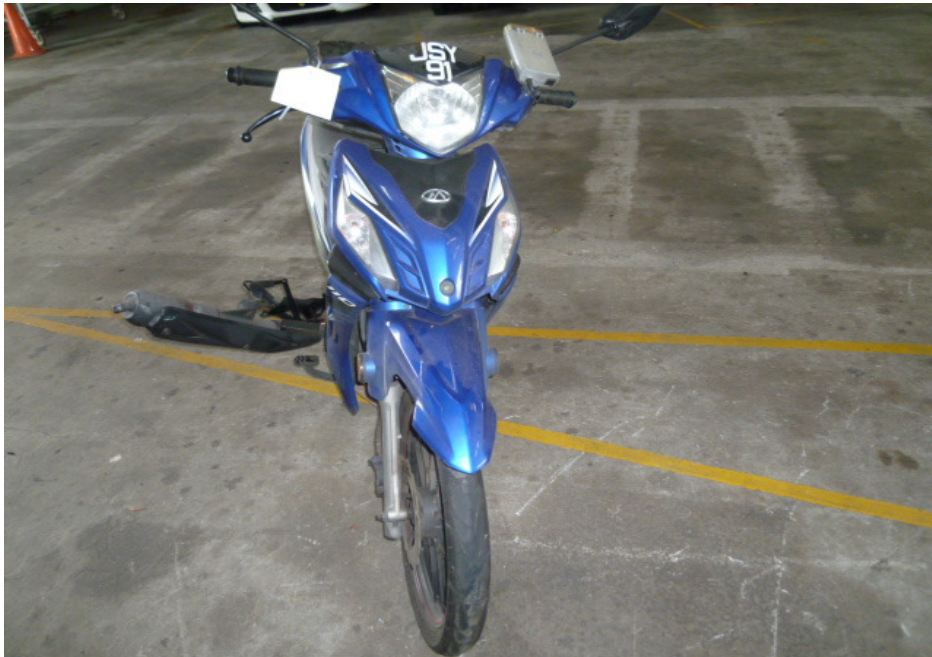
**Photo 20** shows the front wheel of the Motorcycle turned towards its left. We were unable to turn the handle bar fully towards the left due to resistance most probably as a result of damages sustained during the accident.

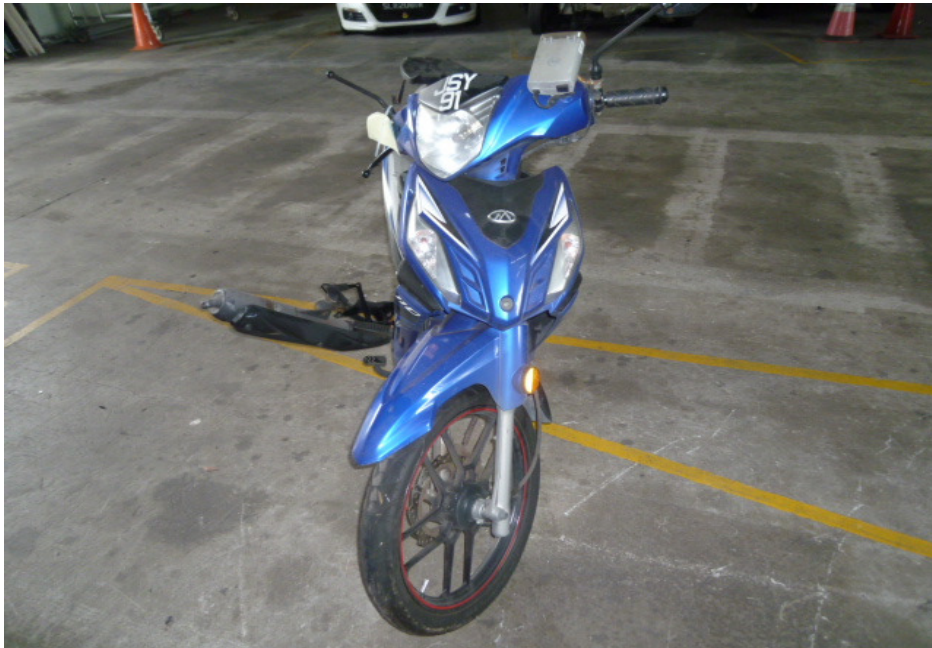
**Photo 21** shows the front wheel of the Motorcycle turned towards its full right. Turning the Motorcycle's handle bar towards the right did not produce any abnormal free play and/or resistance. This would indicate that the steering system of the Motorcycle was in serviceable condition at the time of our inspection.

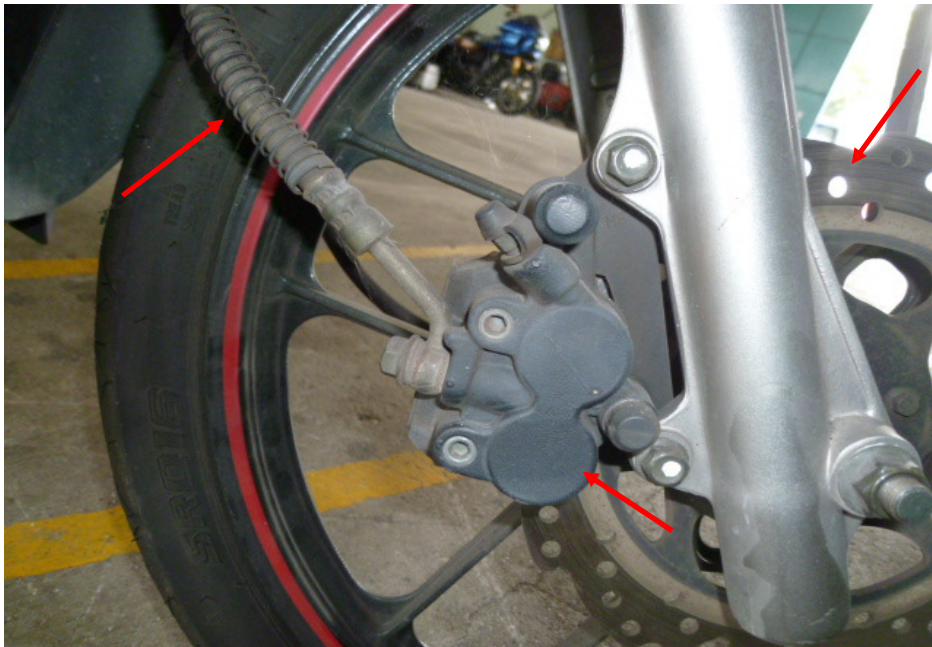
**Photo 22** shows a close up view of the front brake caliper, front brake disc and front brake hose (arrowed) of the Motorcycle, which are all part of the components in the hydraulic front brake system of the Motorcycle. Our visual checks of these various components had revealed all to be intact with no visible damage. No leakage of brake fluid was also observed.

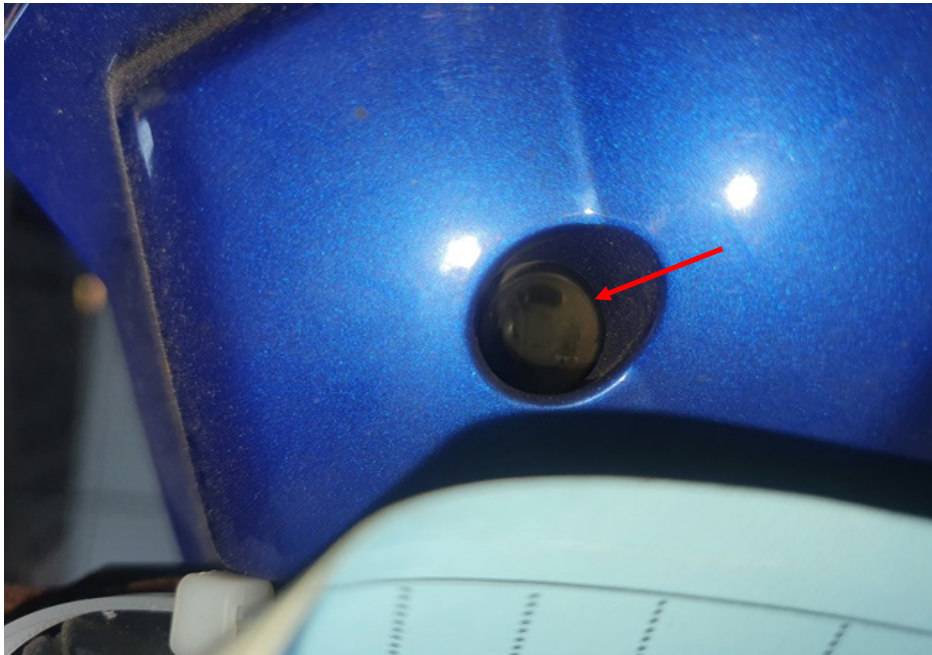
**Photo 23** shows the brake fluid reservoir for the front brake of the Motorcycle. The brake fluid was found to be of sufficient level for operating purposes. However the brake fluid was found to be slightly contaminated (arrowed).

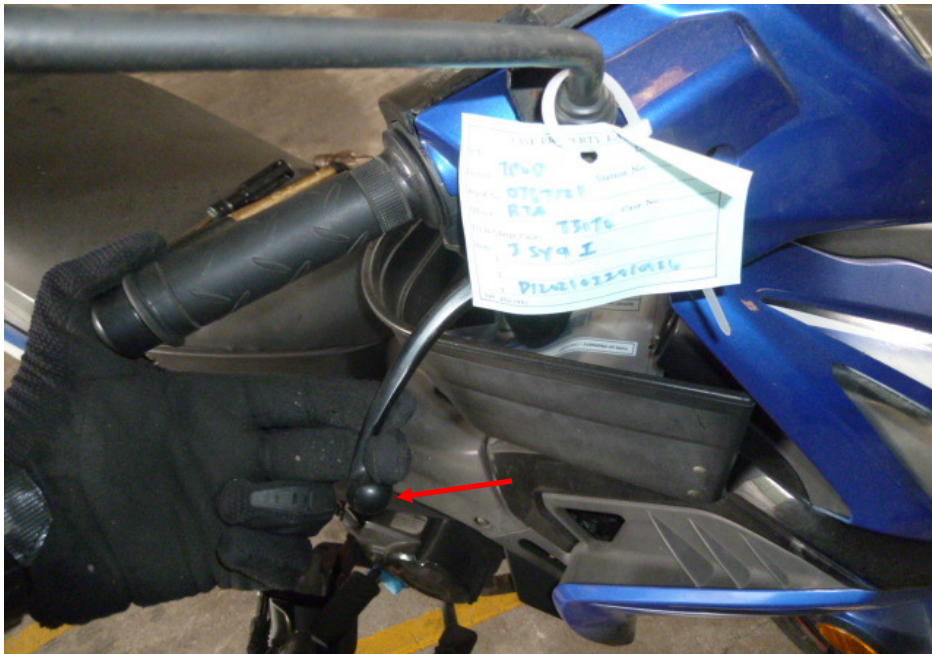
**Photo 24** shows the front brake lever being depressed. There was some resistance felt (spongy like feel) upon pressing the front brake lever (arrowed). This would indicate that there is no leakage of pressure/vacuum in the brake system.

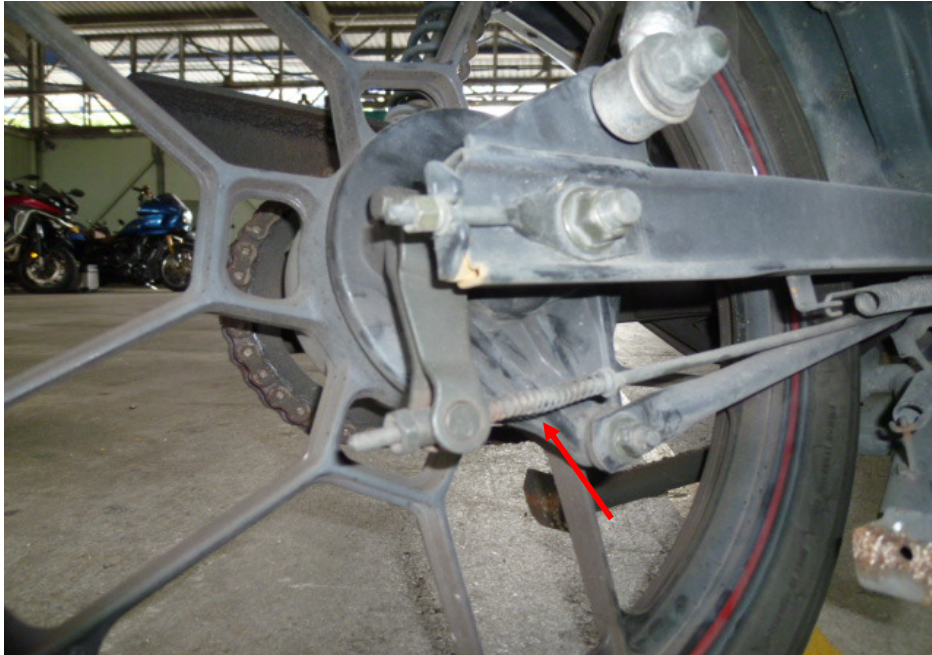
**Photo 25** shows the rear wheel of the Motorcycle. The type of brake system for the rear wheel was of a mechanical type, controlled by the brake foot pedal of the Motorcycle. Our checks of the cable (arrowed), spring and drum which are all part of the components in the rear brake system of the Motorcycle reveal all to be intact and without damage.
