Your Ref: TP/IP/10473/2021
Our Ref : CI/TPD21008295/N

Fatal Accident Investigation Team

MECHANICAL INSPECTION REPORT OF MOTORCYCLE FBN 2822J

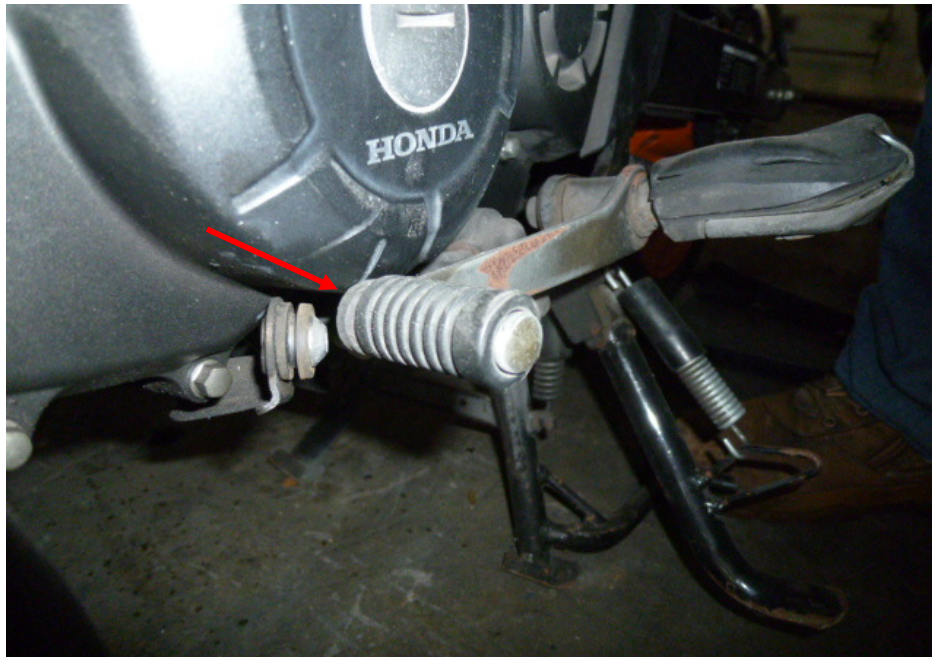
4. The mileage of the Motorcycle could not be recorded at the time of our inspection as the engine could not be started due to a jammed gear shift pedal.
5. The Motorcycle had sustained damages all around. Body parts that were found to have been damaged include its headlight assembly, front cowling, front fork assembly, front wheel rim, front mudguard, left side mirror, clutch lever, side cowlings, gear shift pedal and left front footrest, amongst others.

Photo 1 shows the mileage of the Motorcycle which could not be recorded at the time of our inspection as the engine could not be started due to a jammed gear shift pedal (arrowed).

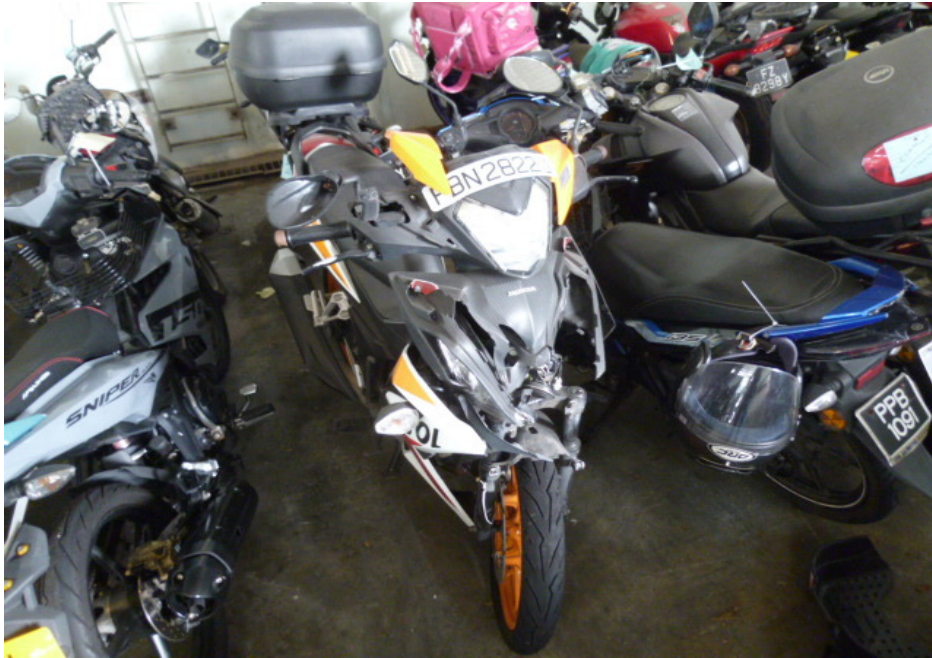
Photo 2 shows a general view of the frontal portion of the Motorcycle at the time of our inspection. The Motorcycle had sustained damages all around.

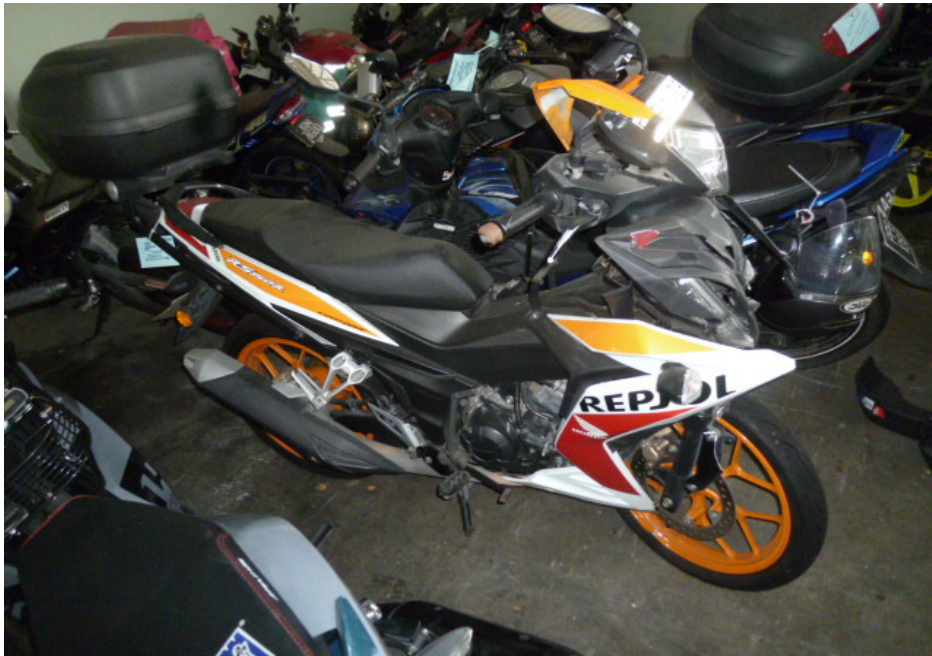
Photo 3 shows a general view of the right body of the Motorcycle at the time of our inspection. The Motorcycle had sustained damages all around. Body parts that were found to have been damaged include its headlight assembly, front cowling, front fork assembly, front wheel rim, front mudguard, left side mirror, clutch lever, side cowlings, gear shift pedal and left front footrest, amongst others.

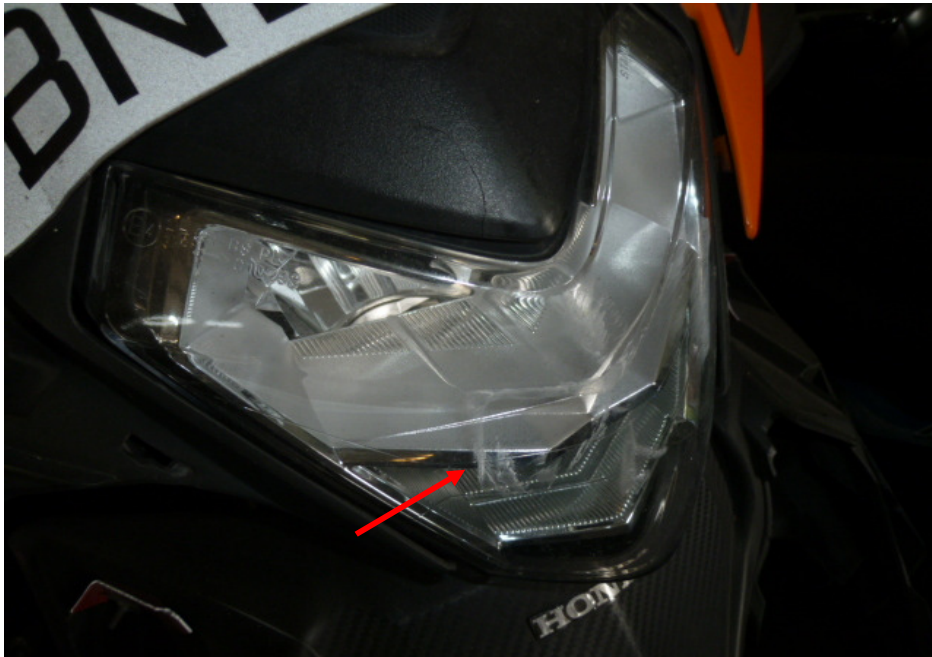
Photo 4 shows a closer view of the headlight assembly which was amongst the body parts at the front body of the Motorcycle that had sustained damage as a result of the accident (arrowed).

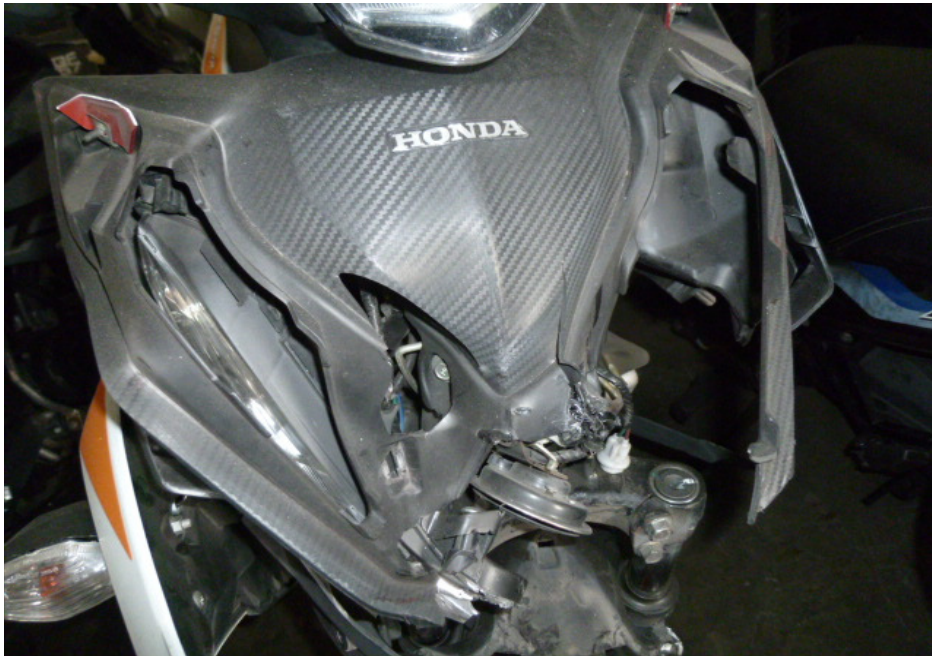
Photo 5 shows a closer view of the front cowling which was amongst the body parts at the front body of the Motorcycle that had sustained damage as a result of the accident.

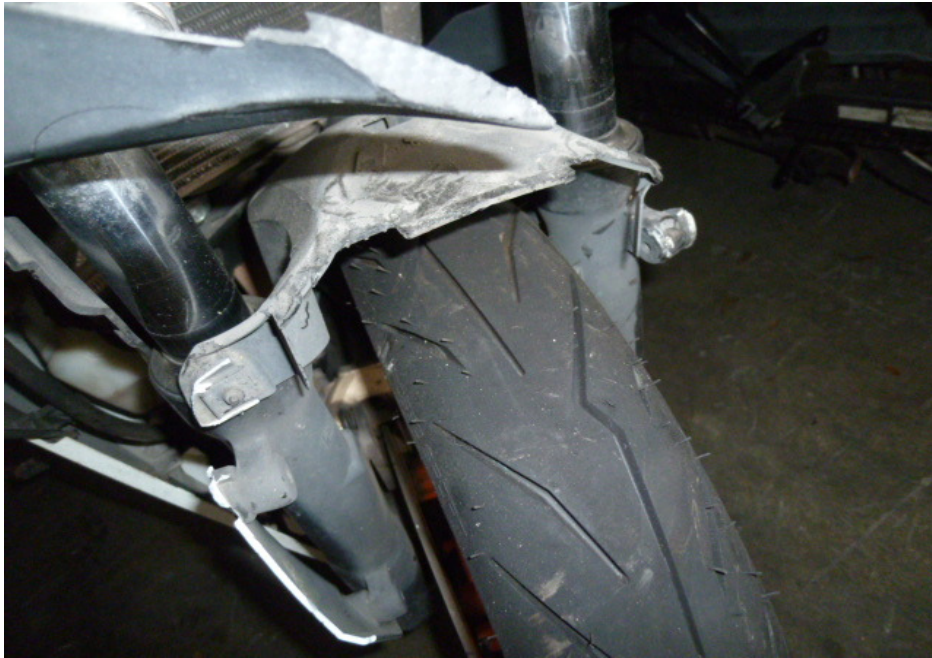
Photo 6 shows a closer view of the front mudguard which was amongst the body parts at the front body of the Motorcycle that had sustained damage as a result of the accident.

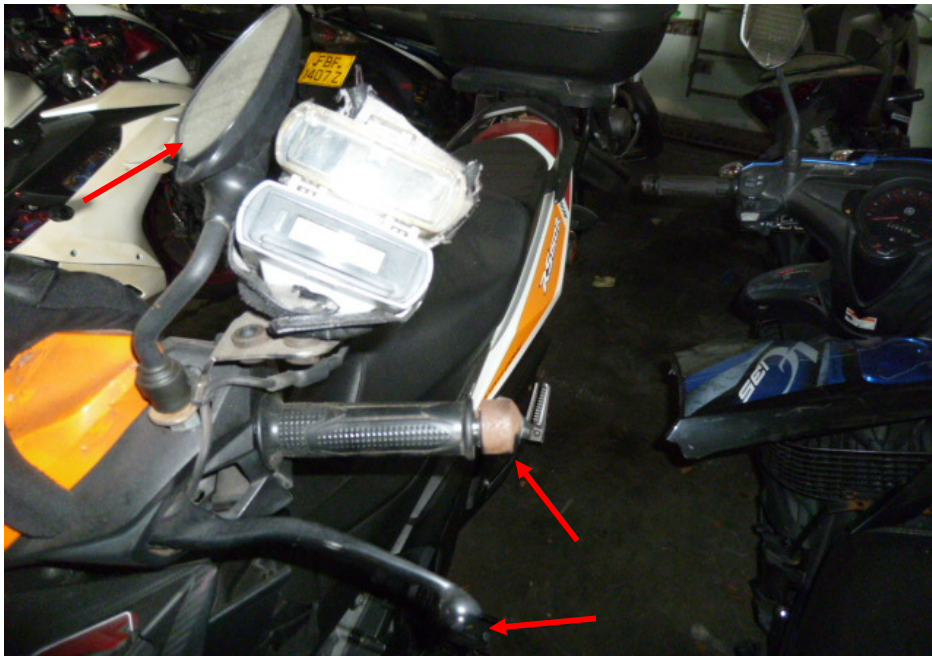
Photo 7 shows a closer view of the left side mirror, clutch lever and left handlebar end of the Motorcycle (arrowed). These parts were amongst the body parts of the Motorcycle which were damaged as a result of the accident.

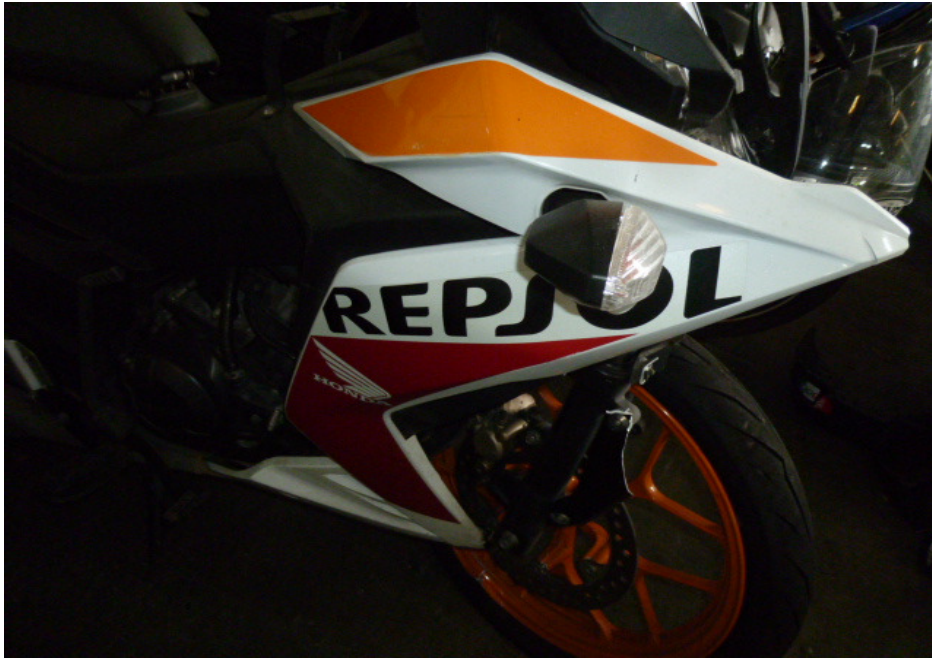
Photo 8 shows a closer view of the right cowling which was amongst the body parts of the Motorcycle that had sustained damage as a result of the accident.

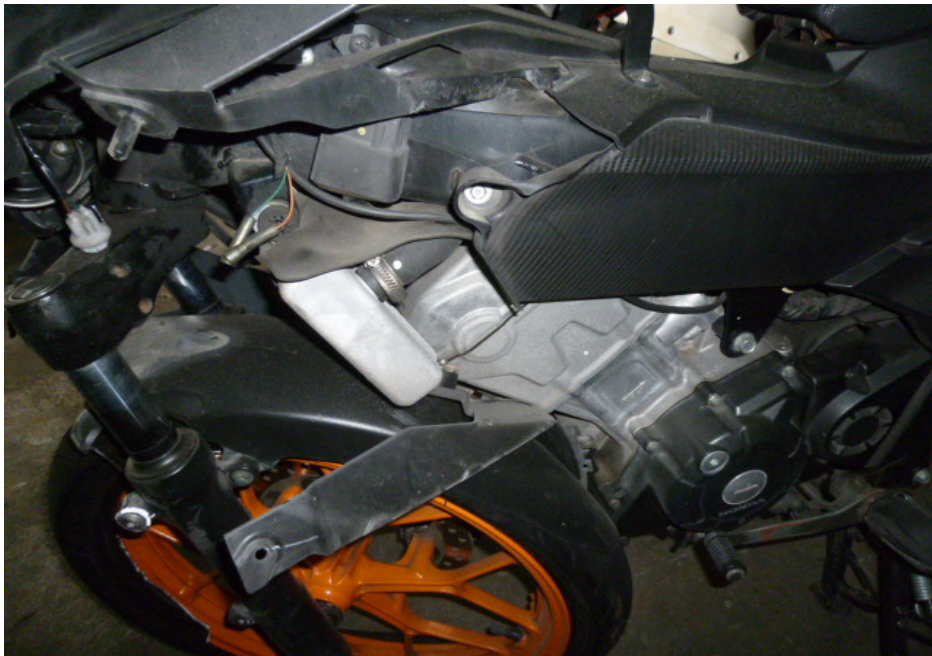
Photo 9 shows a closer view of the missing left cowling of the Motorcycle that as a result of the accident.

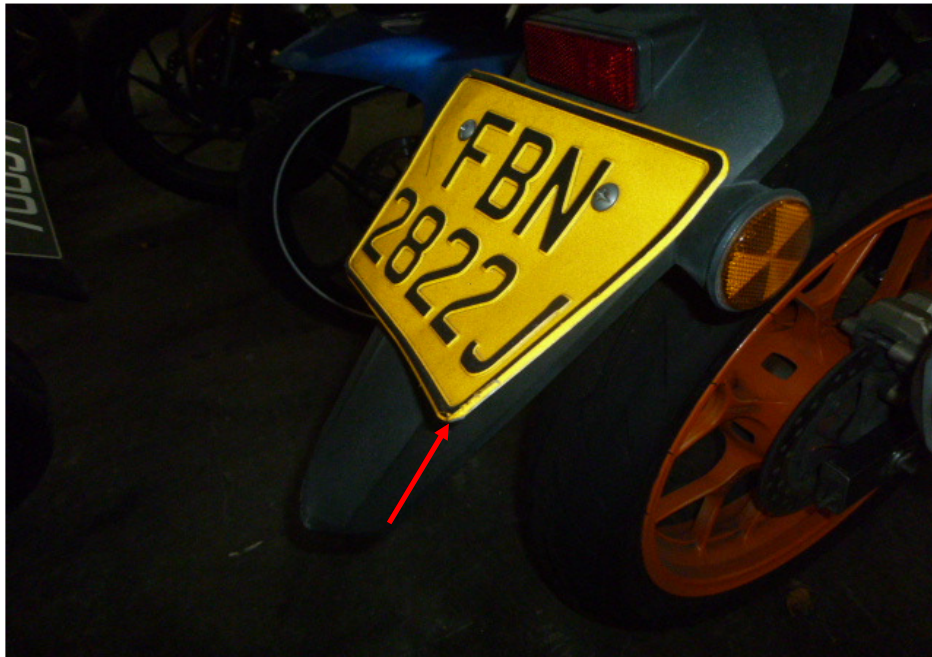
Photo 10 shows the dented rear number plate of the Motorcycle as a result of the accident (arrowed).

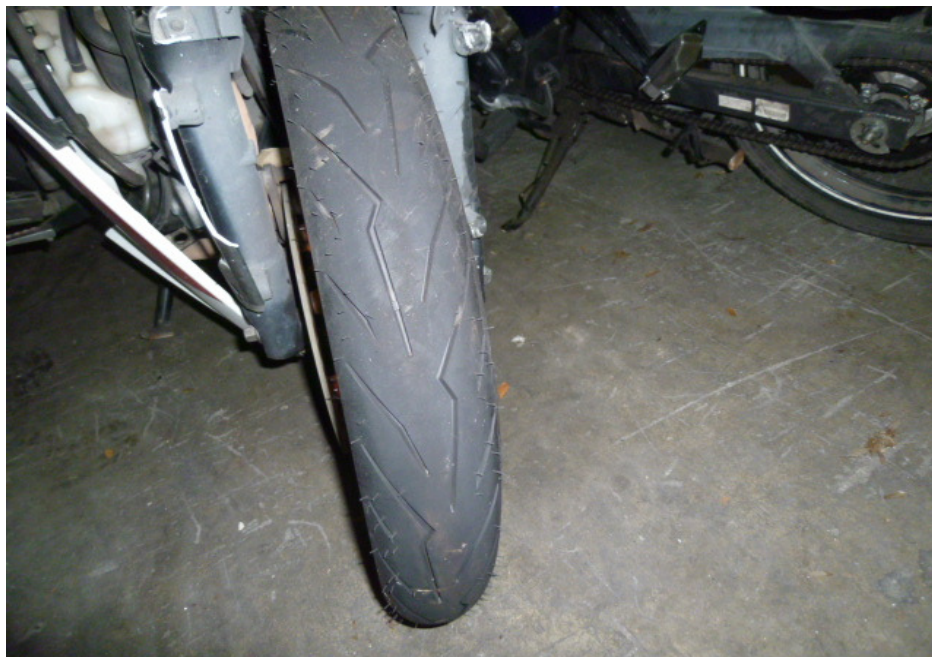
8. The 2 tyres were wrapped around alloy wheel rims. At the time of our inspection, we observed that front wheel rim was broken. See photos 1 – 13 below.

Photo 11 shows the front tyre of the Motorcycle at the time of our inspection. The pattern of the tread was clearly visible with remaining tread depth of approximately 4mm. We did not observe any tear, burst mark(s) and/or punctured hole(s) on the sidewalls as well as across the tread of the front tyre. However we did observe that the front tyre was deflated due to the broken front wheel rim.

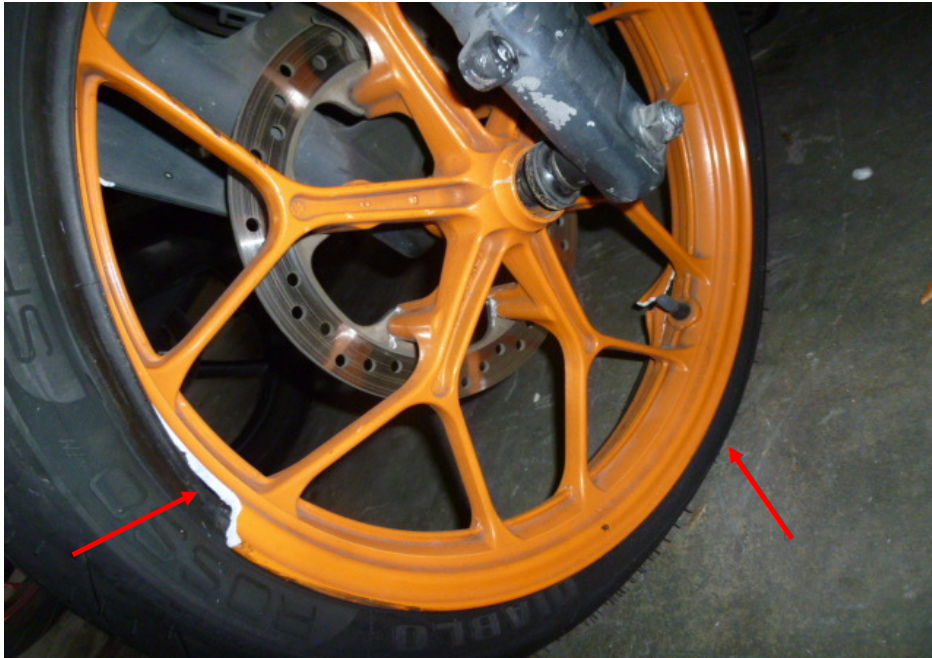
Photo 12 shows a close up view of the deflated front tyre due to the broken front wheel rim of the Motorcycle at the time of our inspection (arrowed).

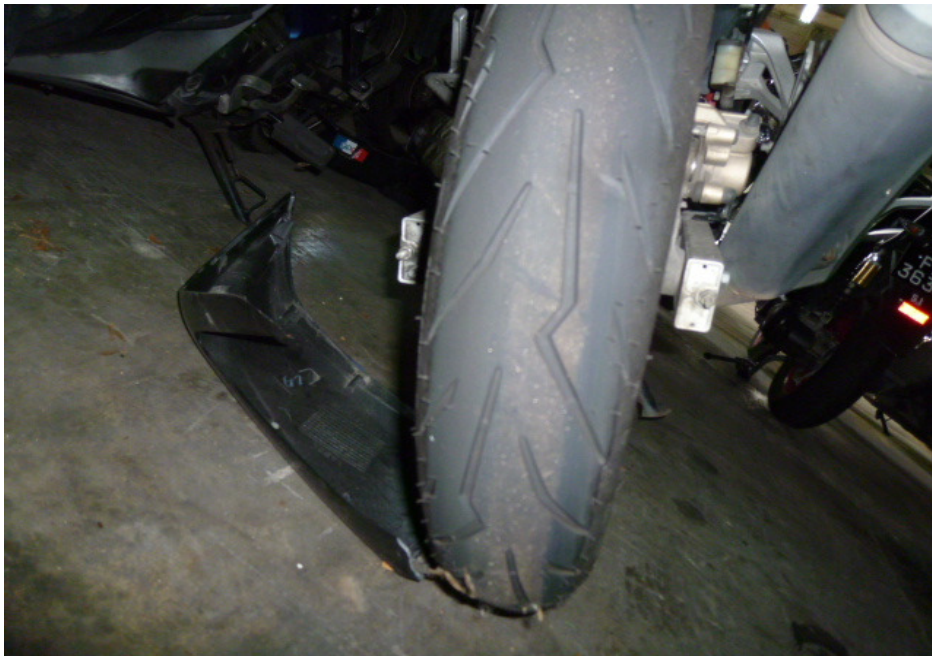
Photo 13 shows the condition of the Motorcycle's rear tyre. The pattern of the tread was clearly visible with remaining tread depth of approximately 3mm. We did not observe any tear, burst mark(s) and/or punctured hole(s) on the sidewalls as well as across the tread of the rear tyre.

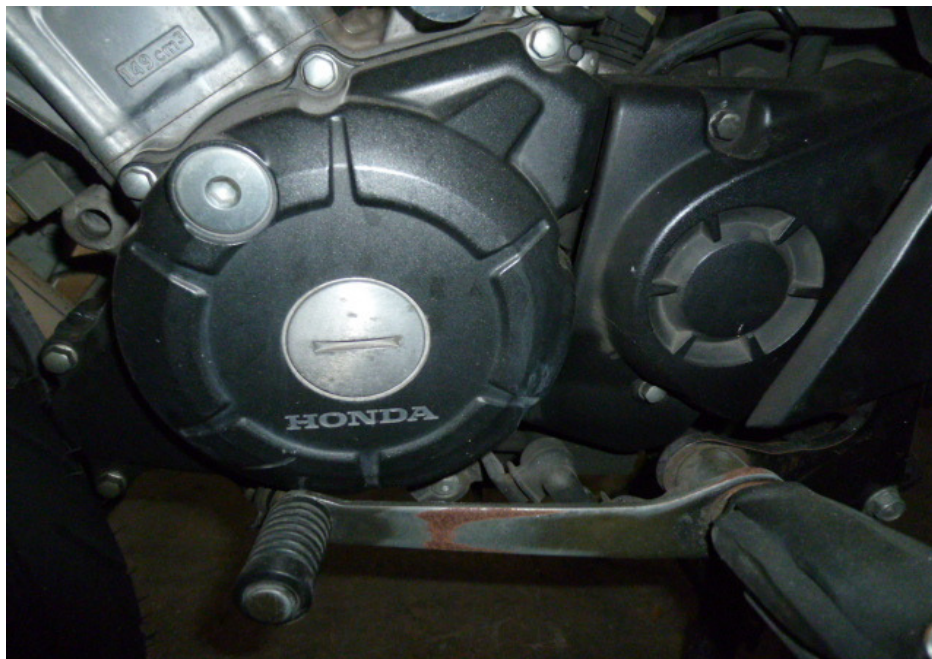
Photo 14 shows the left side of the engine of the Motorcycle at the time of our inspection. The various engine related parts and components were found to be intact with no visible damage. There was also no sign(s) or indication(s) of fluid leak observed around the left engine area of the Motorcycle.

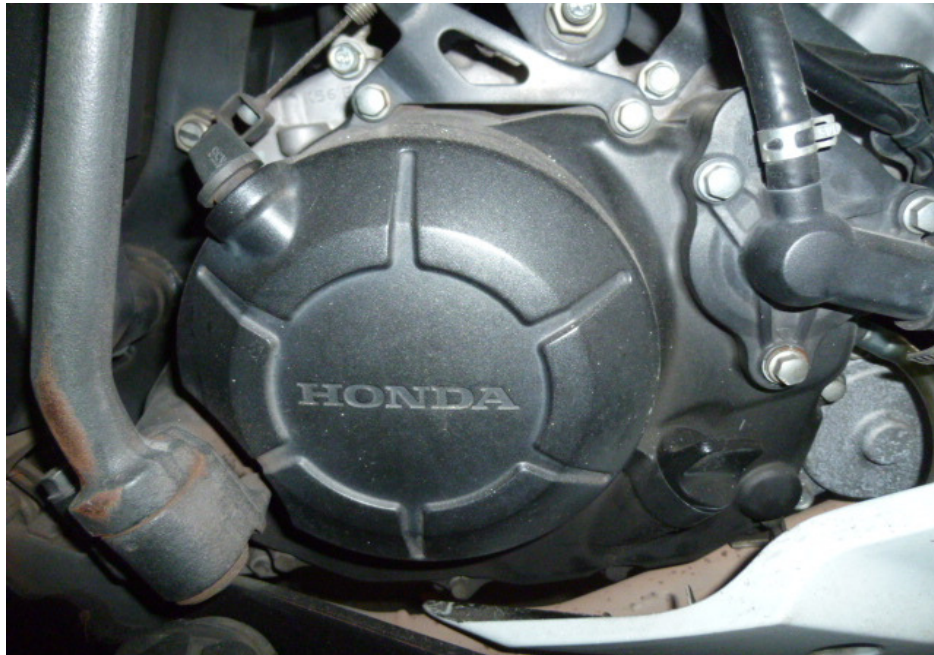
Photo 15 shows the right side of the engine of the Motorcycle at the time of our inspection. The various engine related parts and components were found to be intact with no visible damage. There was also no sign(s) or indication(s) of fluid leak observed around the right engine area of the Motorcycle.

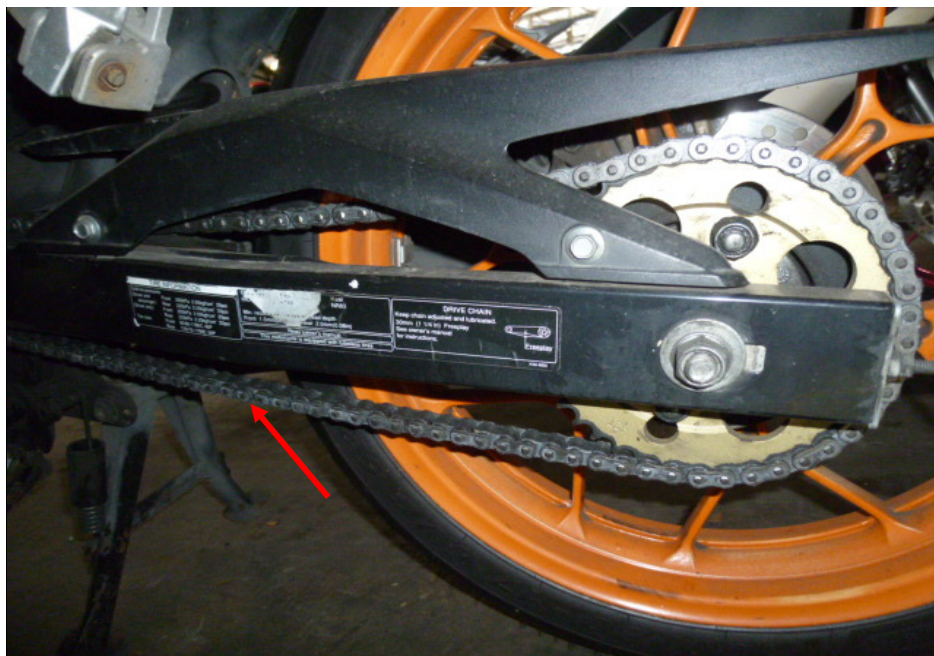
Photo 16 shows the gear chain (arrowed) of the Motorcycle, which was observed to be intact with no misalignment. It was also adequately lubricated for operating purposes. The gear chain rotates the rear wheel of the Motorcycle.

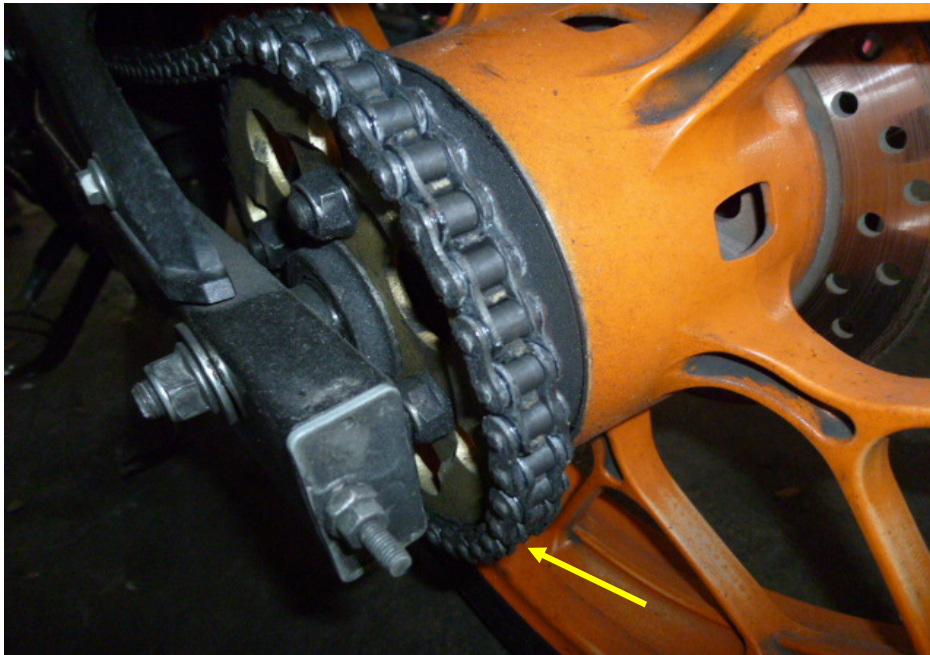
Photo 17 shows the closer view of the gear chain (arrowed) of the Motorcycle, which was observed to be intact with no misalignment. It was also adequately lubricated for operating purposes.

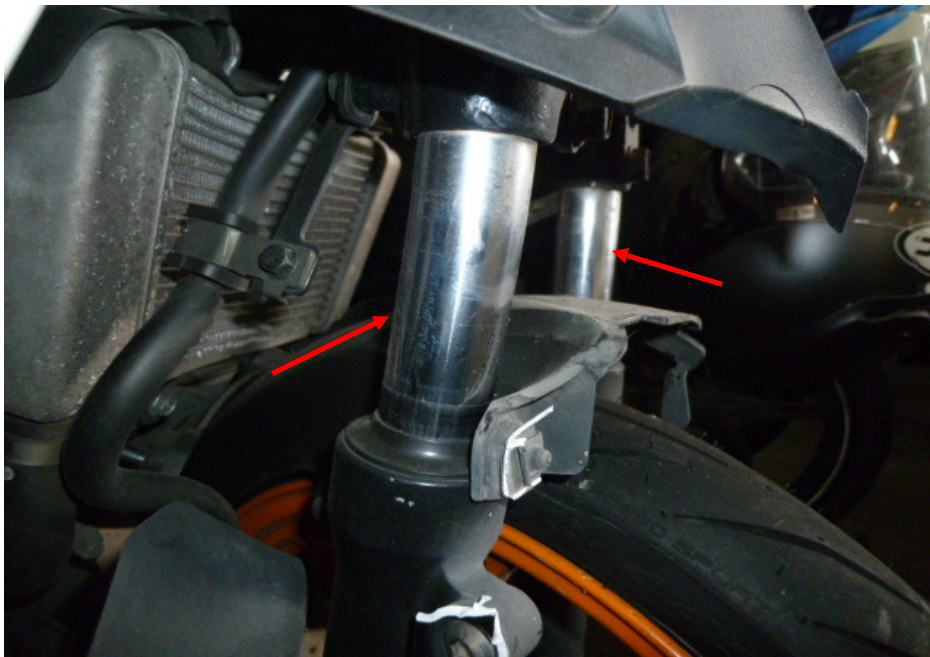
11. For this case, we were not able to conduct any test(s) on the steering system of the Motorcycle due to the damage of its fork assembly. The front forks were found to be bent inwards as a result of the accident.

Photo 18 shows the front forks of the Motorcycle. The front forks were observed to be bent inwards as a result of the accident (arrowed). We were hence not able to conduct any tests on the steering system of the Motorcycle.

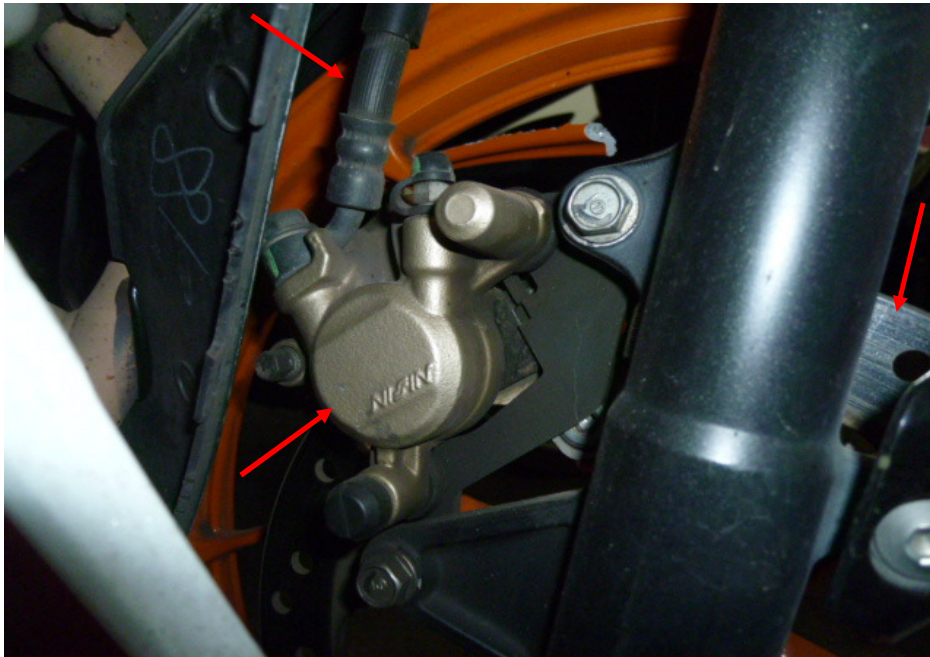
Photo 19 shows a close up view of the front brake caliper, front brake disc and front brake hose (arrowed) of the Motorcycle, which are all part of the components in the hydraulic front brake system of the Motorcycle. Our visual checks of these various components had revealed all to be intact with no visible damage. No leakage of brake fluid was also observed.

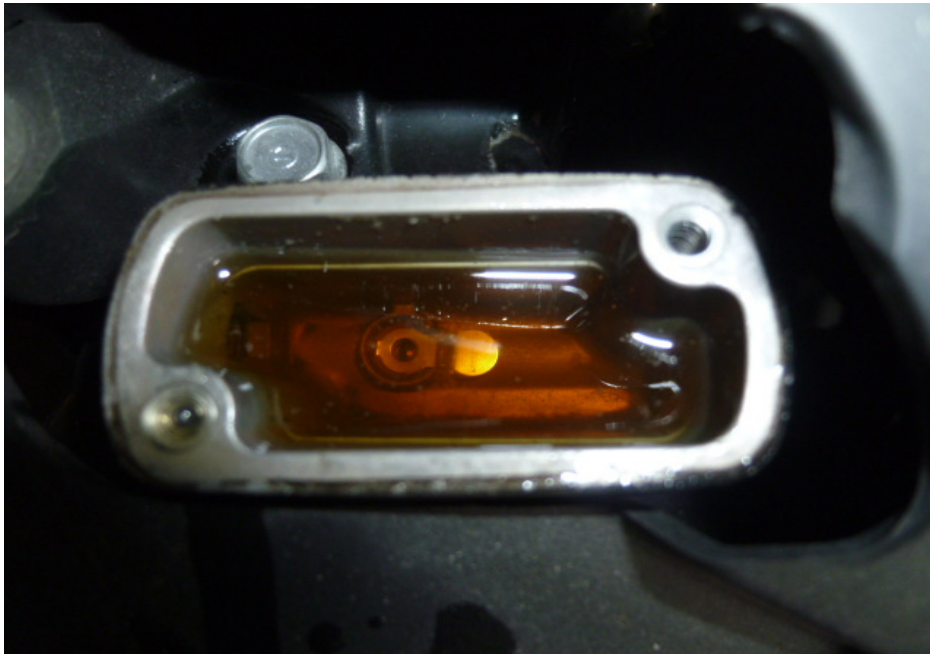
Photo 20 shows the brake fluid reservoir for the front brake of the Motorcycle. The brake fluid was observed to be of sufficient level for operational purposes and without contamination.

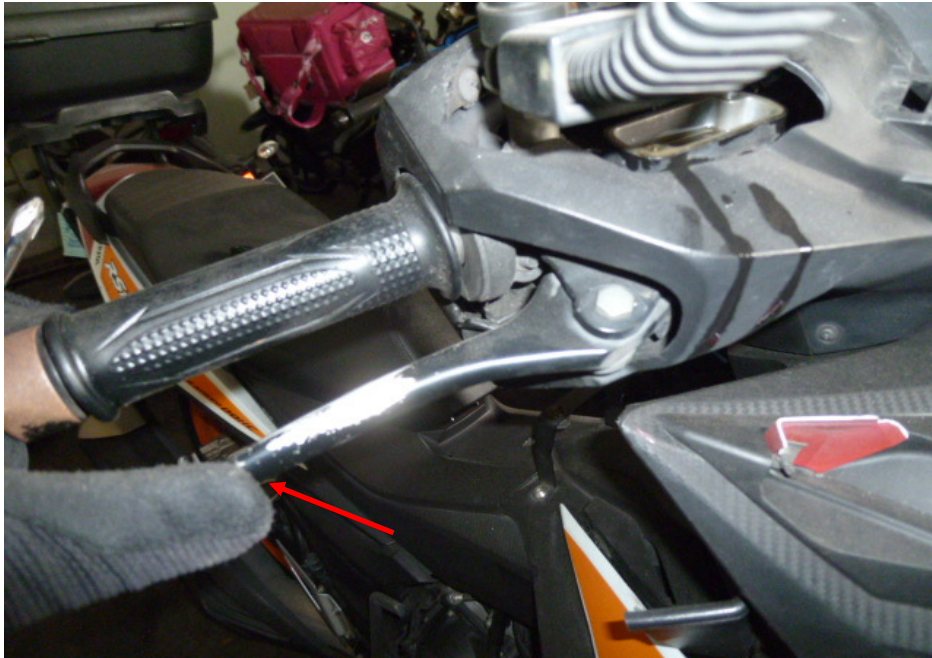
Photo 21 shows the front brake lever being depressed. There was some resistance felt (spongy like feel) upon pressing the front brake lever (arrowed). This would indicate that there is no leakage of pressure/vacuum in the brake system.

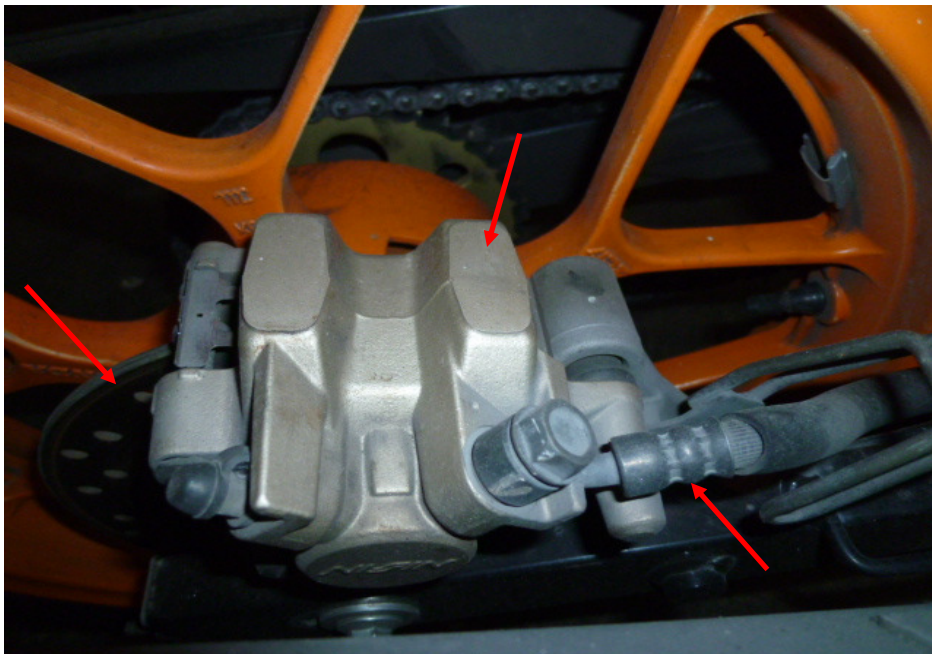
Photo 22 shows a close up view of the rear brake caliper, rear brake disc and rear brake hose (arrowed) of the Motorcycle, which are all part of the components in the hydraulic rear brake system of the Motorcycle. Our visual checks of these various components had revealed all to be intact with no visible damage. No leakage of brake fluid was also observed.

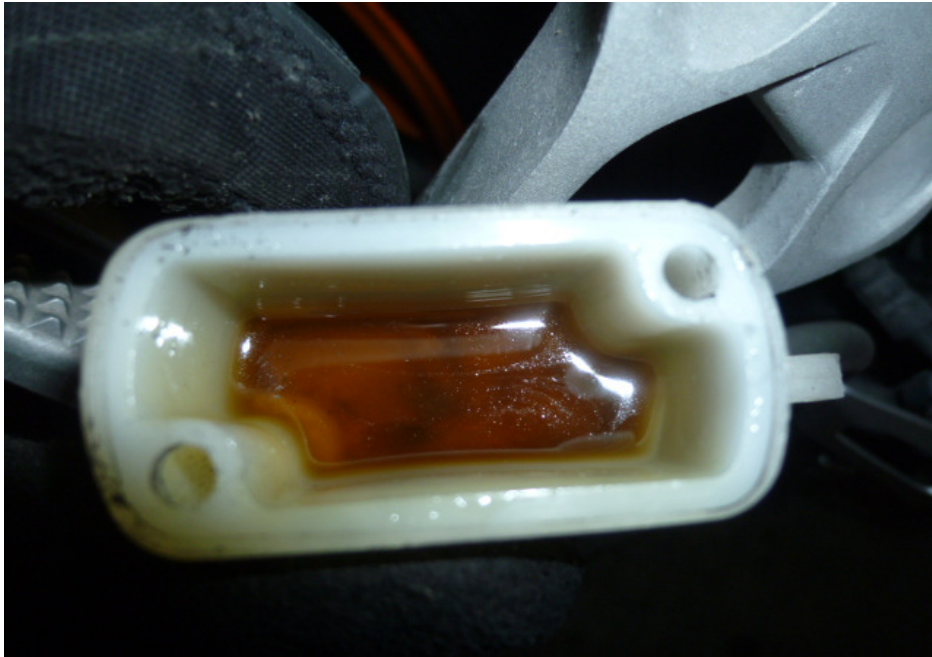
Photo 23 shows the brake fluid reservoir for the rear brake of the Motorcycle. The brake fluid was observed to be of sufficient level for operational purposes and without contamination.
