Your Ref: TP/IP/16299/2021  
Our Ref : CI/TPD21008296/N

5 August 2021

**Fatal Accident Investigation Team**

**INSPECTION REPORT OF MOTORCYCLE FBH 9173J**

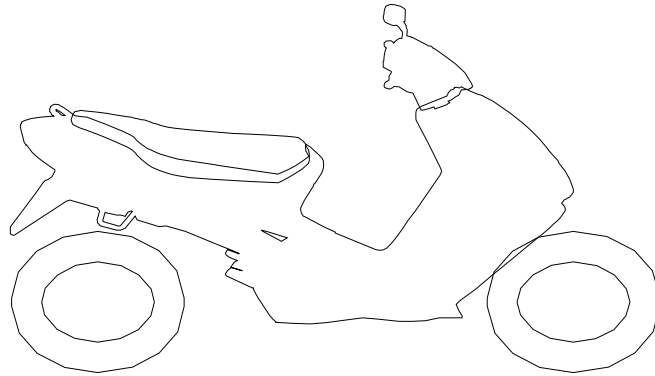
7. The tyre brand, tyre size and remaining tread depth of the 2 tyres were recorded as follows:-

Michelin 3.50 - 10 (3mm)

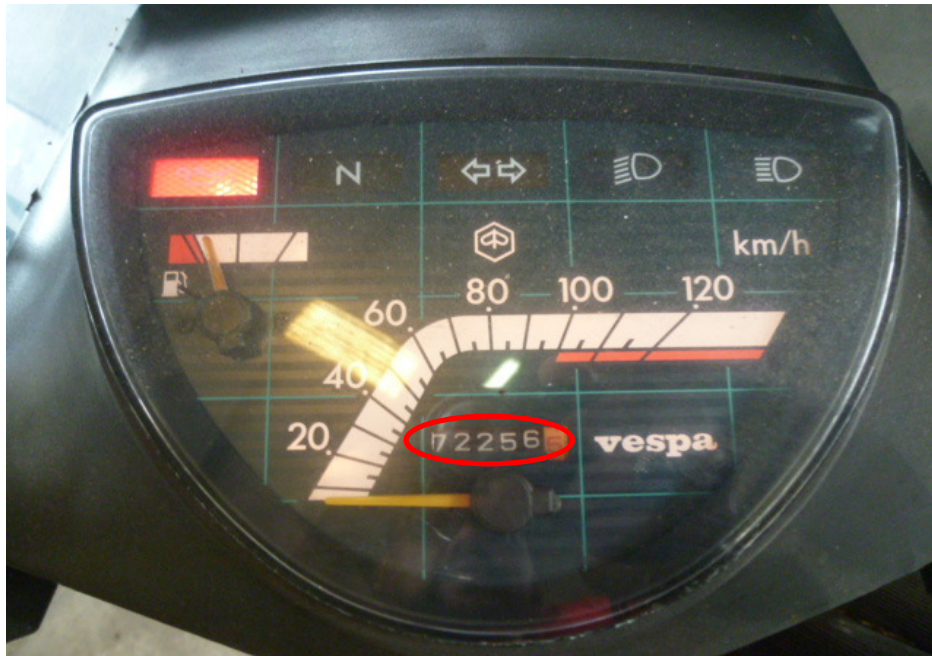
**Photo 1** shows the speedometer gauge of the Motorcycle where the mileage recorded at the time of our inspection was 72, 256km (circled).

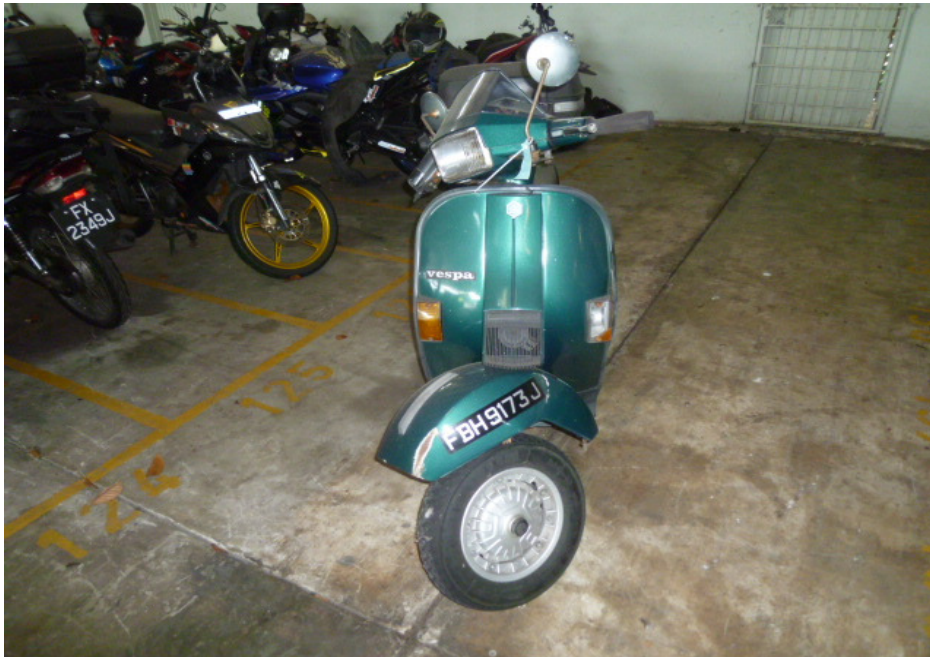
**Photo 2** shows a general view of the frontal portion of the Motorcycle at the time of our inspection. The Motorcycle was observed to have sustained damages at its left body.

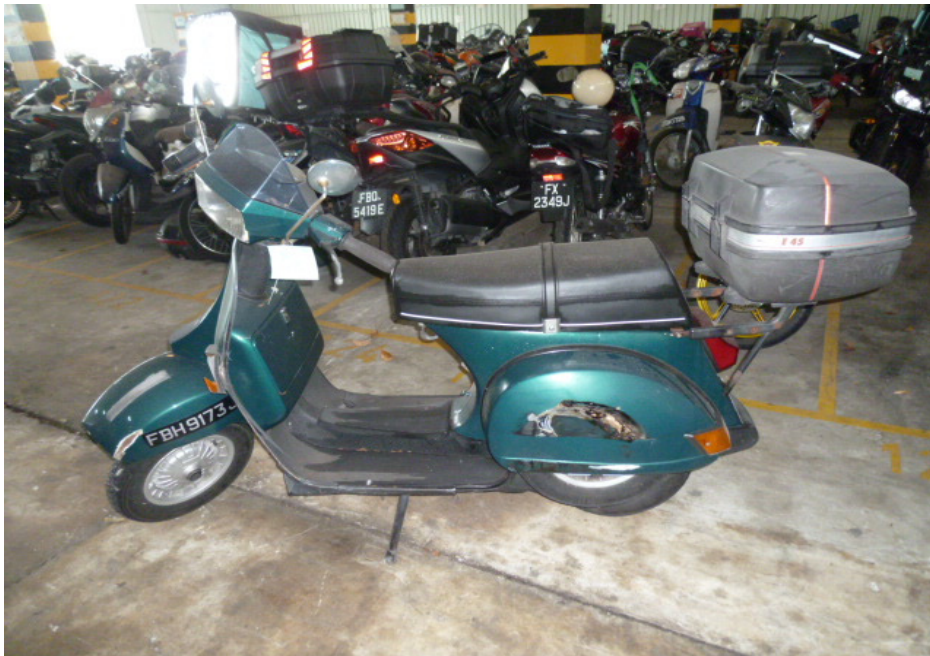
4. The mileage of the Motorcycle at the time of our inspection was 72,256km.
5. The Motorcycle was observed to have sustained damages along its left body. The body parts that were found to have been damaged include its front mudguard, left front signal lamp, left side mirror, clutch lever, left rear side cover, left bottom cowl and top box, amongst others.

**Photo 3** shows a general view of the left body of the Motorcycle at the time of our inspection. The Motorcycle was observed to have sustained damages at its left body. Amongst the body parts that were found to have been damaged include its front mudguard, left front signal lamp, left side mirror, clutch lever, left rear side cover, left bottom cowling and top box, amongst others.

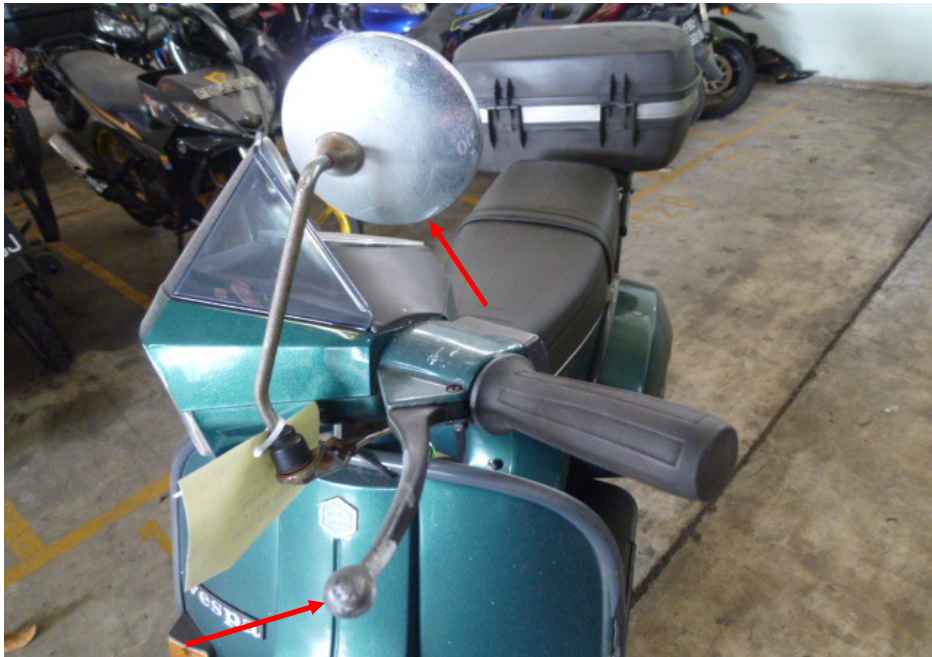
**Photo 4** shows a closer view of the clutch lever and left side mirror (arrowed) which were amongst the body parts of the Motorcycle that had sustained damage as a result of the accident.

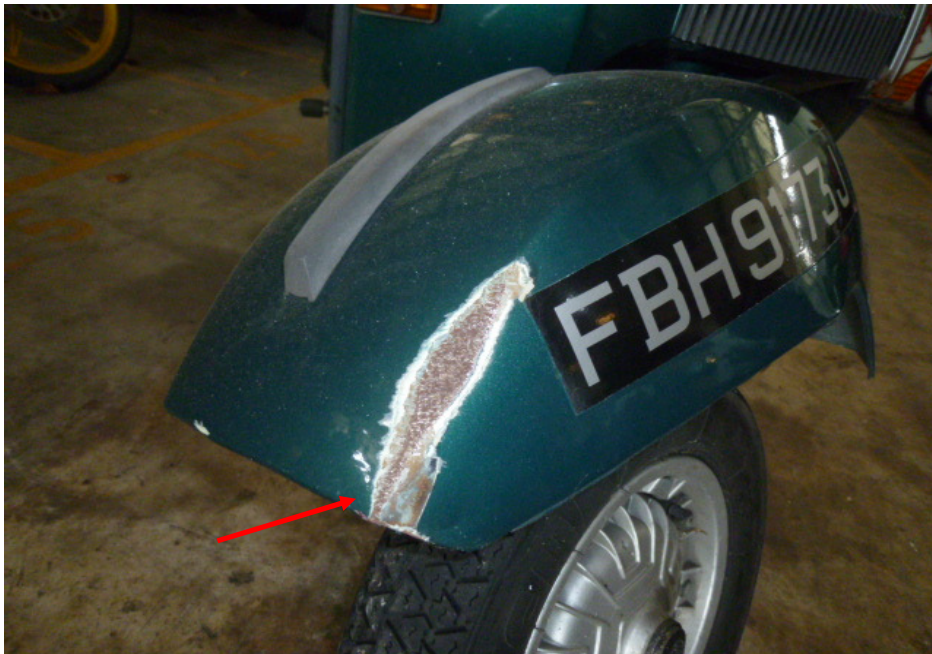
**Photo 5** shows the damaged front mudguard (arrowed) of the Motorcycle. The damage sustained was again mainly of grazing nature.

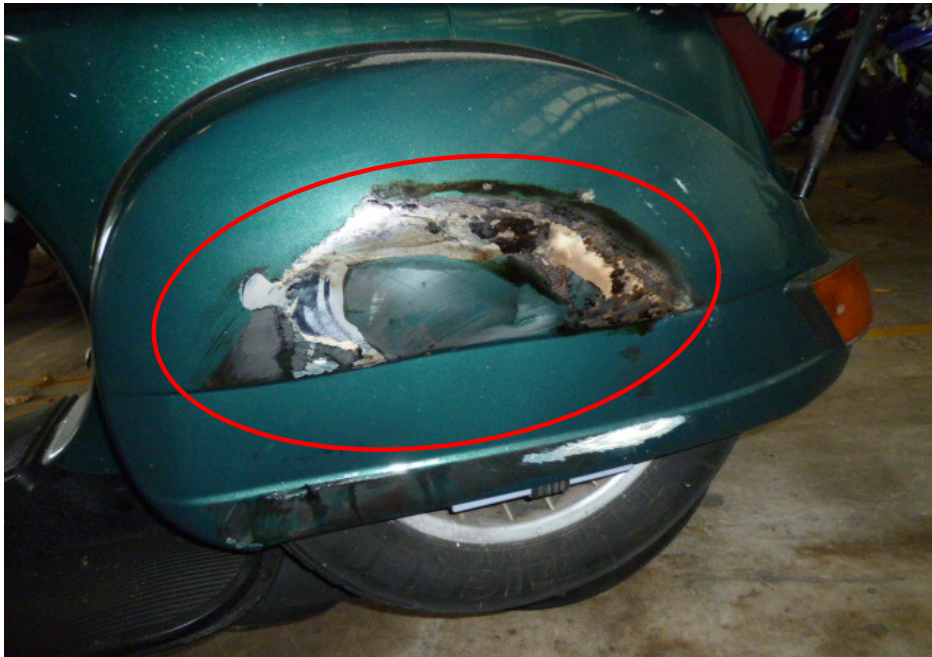
**Photo 6** shows the dented left rear side cover (circled) of the Motorcycle as a result of the accident.

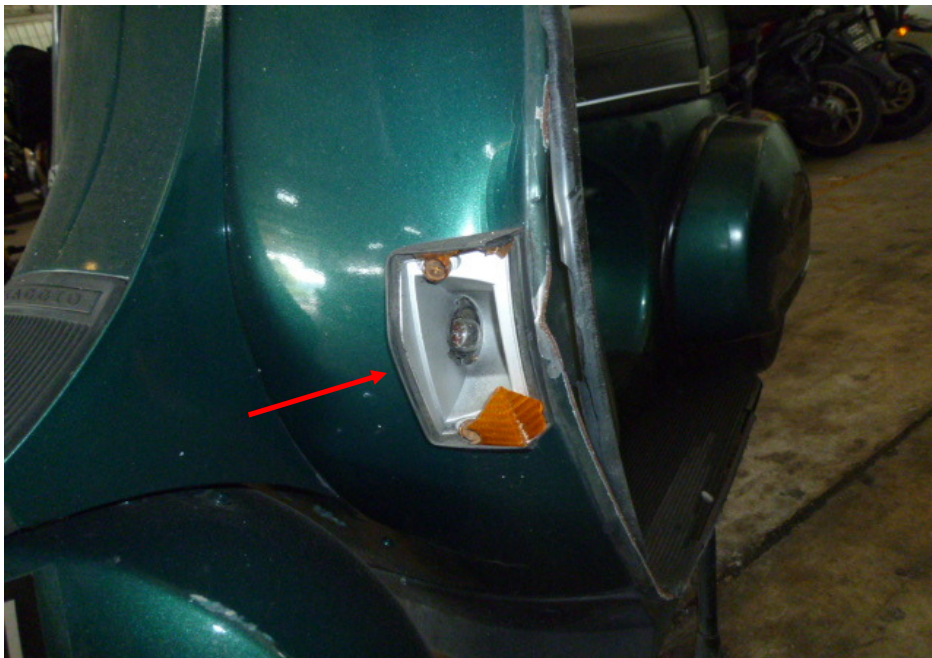
**Photo 7** shows the cracked left front signal lamp (arrowed) of the Motorcycle as a result of the accident.

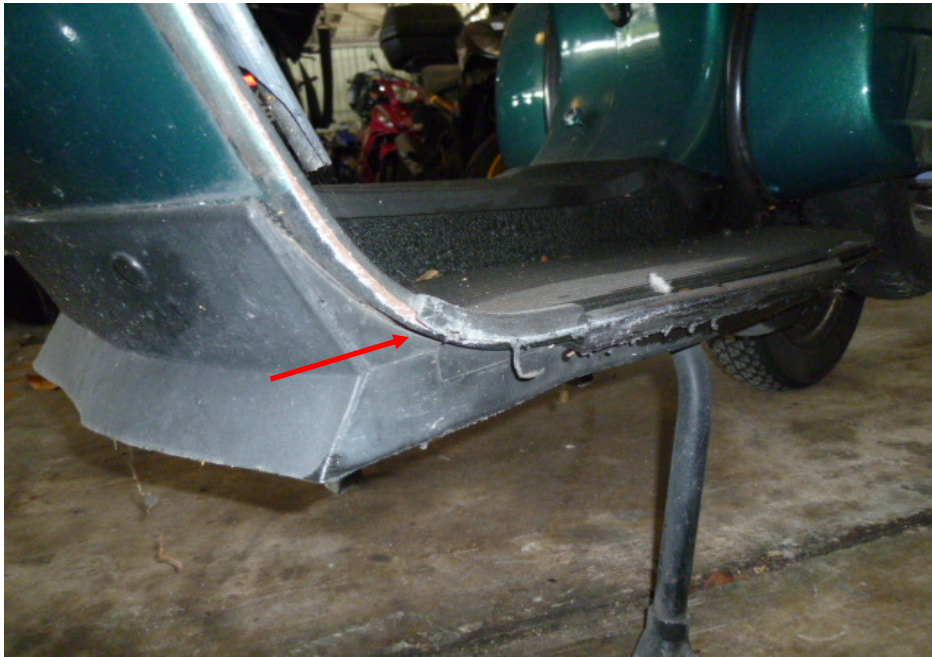
**Photo 8** shows the grazed left bottom cowling (arrowed) of the Motorcycle as a result of the accident.

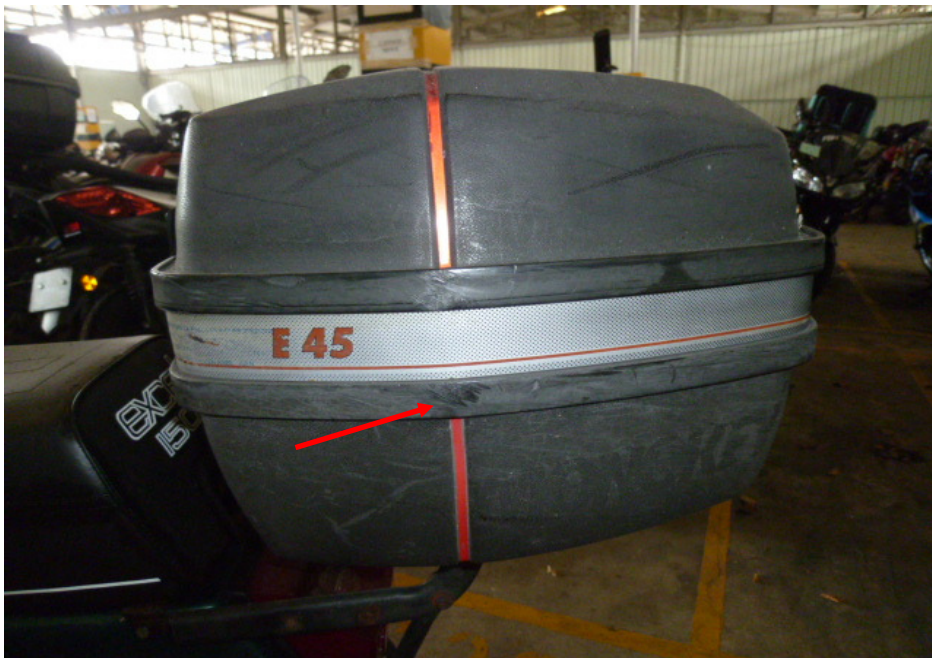
**Photo 9** shows the grazed top box (arrowed) of the Motorcycle as a result of the accident.

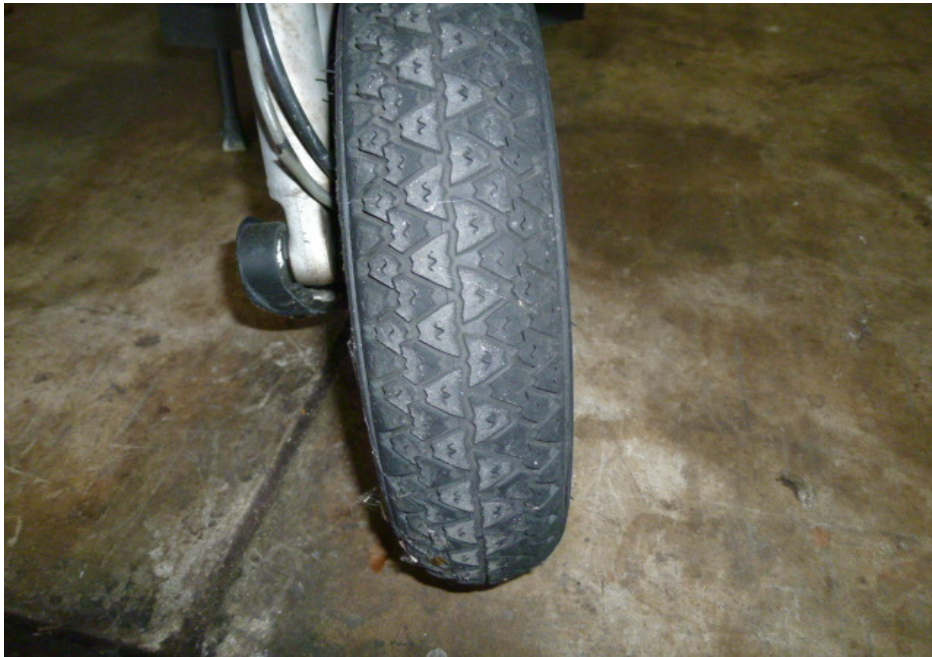
**Photo 10** shows the condition of the Motorcycle's front tyre. The front tyre was observed to be in serviceable condition with remaining tread depth of approximately 3mm. There was no tear, burst mark(s) and/or punctured hole(s) on the sidewalls as well as across the tread of the front tyre.

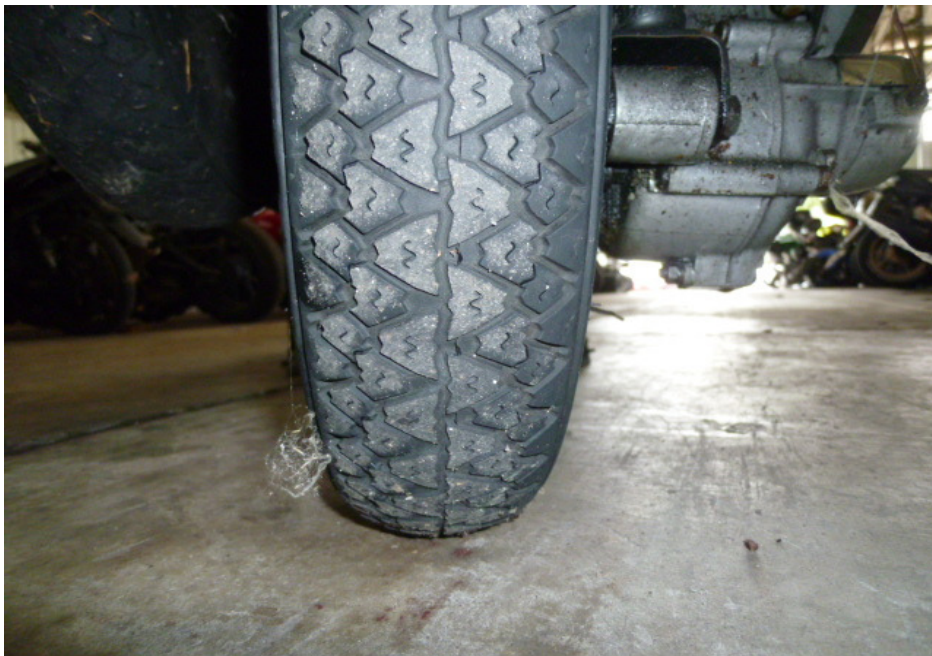
**Photo 11** shows the condition of the Motorcycle's rear tyre. The rear tyre was observed to be in serviceable condition with remaining tread depth of approximately 3mm. The tyre was also observed to be sufficiently inflated for vehicular operation. We did not observe any tear, burst mark(s) and/or punctured hole(s) on the sidewalls as well as across the tread of the rear tyre.

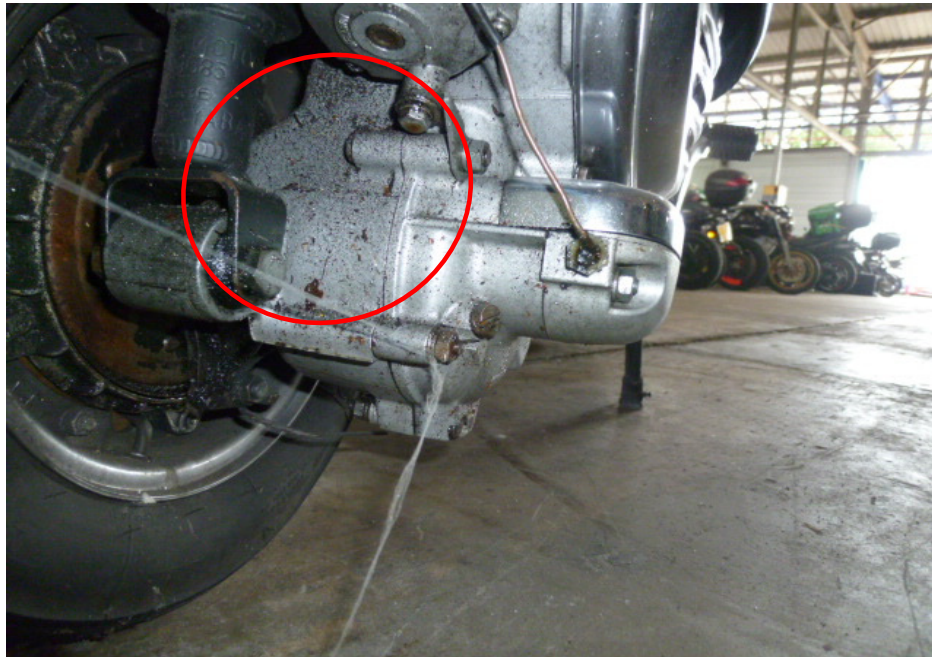
9. Upon examination of the Motorcycle's engine area, we had observed that the various engine related parts and components were intact with no visible damage. Fluid stains were however observed on the underside of the engine area. The presence of dust and dirt particles accumulated around the stained areas indicates that the fluid leak had occurred sometime before the accident.
10. The drive train of the Motorcycle was found to be intact without any misalignment. There was also no visible tear or cut observed on the connecting hoses and cables. See photos 12 – 14 below.

**Photo 12** shows the bottom of the Motorcycle's engine area where fluid stains were observed to have been formed. The presence of dust and/or dirt particles accumulated at the areas where the fluid stains had formed (circled), indicates that the fluid leak had occurred sometime before the accident.

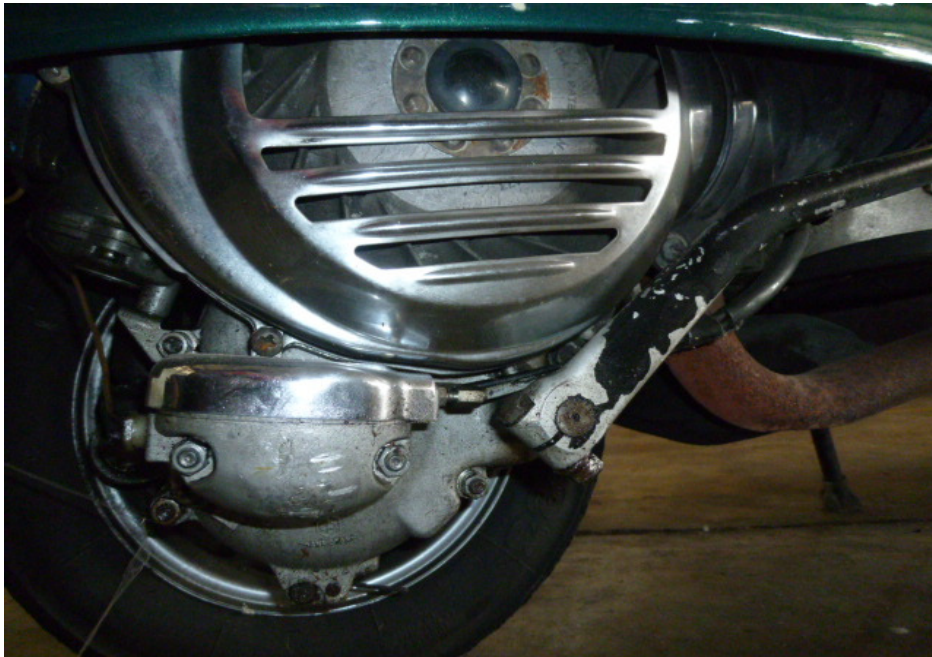
**Photo 13** shows the engine of the Motorcycle at the time of our inspection. The various engine related parts and components were found to be intact with no visible damage. There was also no sign(s) or indication(s) of fluid leak observed around the engine area of the Motorcycle.

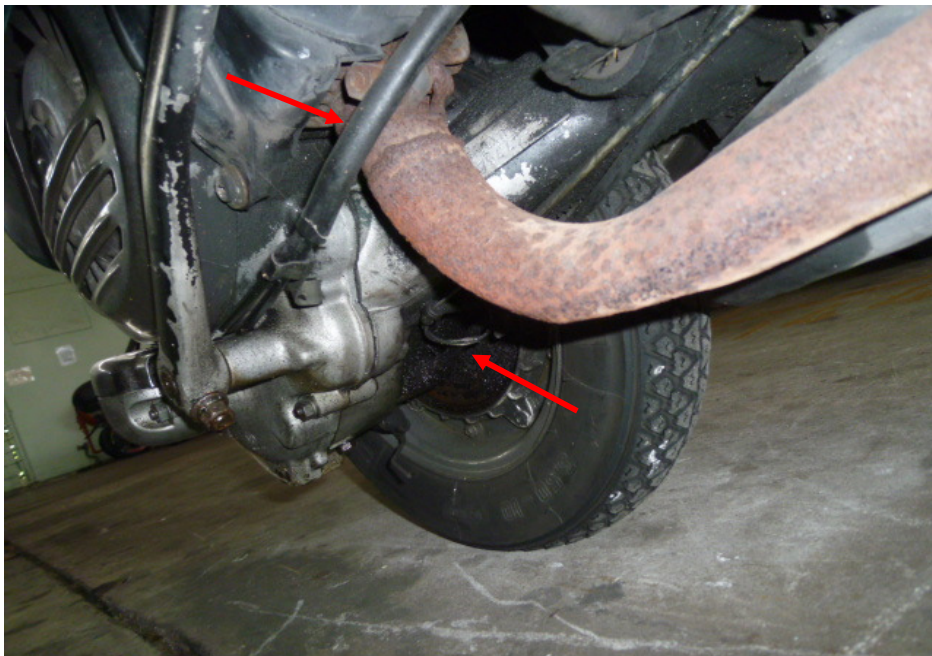
**Photo 14** shows the general view of the drive train of the Motorcycle, which was observed to be intact with no misalignment. There was also no visible tear or cut observed on the connecting hoses and cables (arrowed).

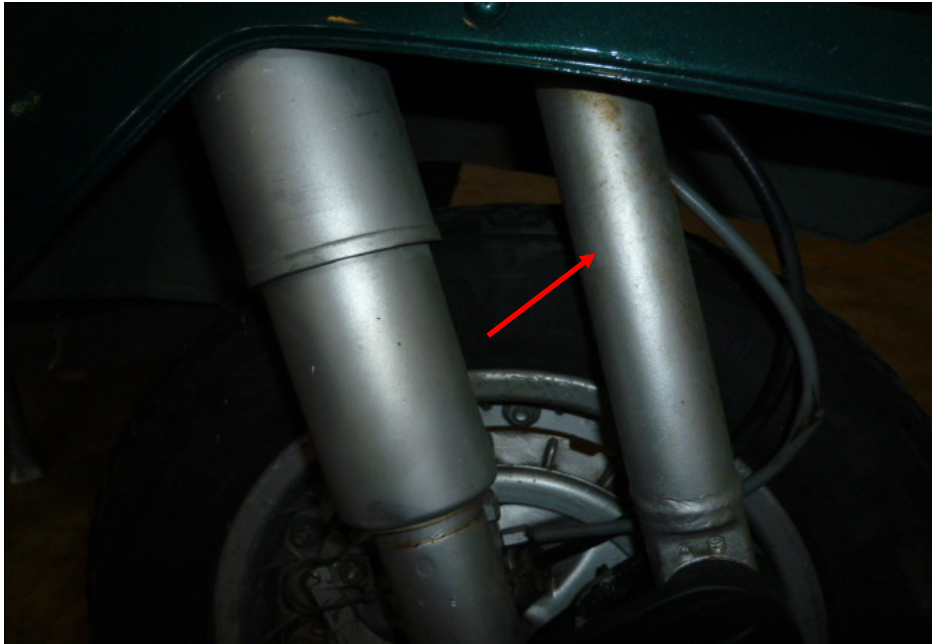
11. Our checks on the various steering components of the Motorcycle revealed that its steering system was in serviceable condition. Its steering stem and front fork was found to be intact and undamaged. Turning the handle bar towards the left and right also did not produce any abnormal free play and/or resistance.

**Photo 15** shows the front fork (arrowed) of the Motorcycle. The front fork of the Motorcycle was both found to be intact and undamaged. Turning the Motorcycle's handle bar towards the left and right did not produce any abnormal free play and/or resistance. The steering system of the Motorcycle was in serviceable condition at the time of our inspection.

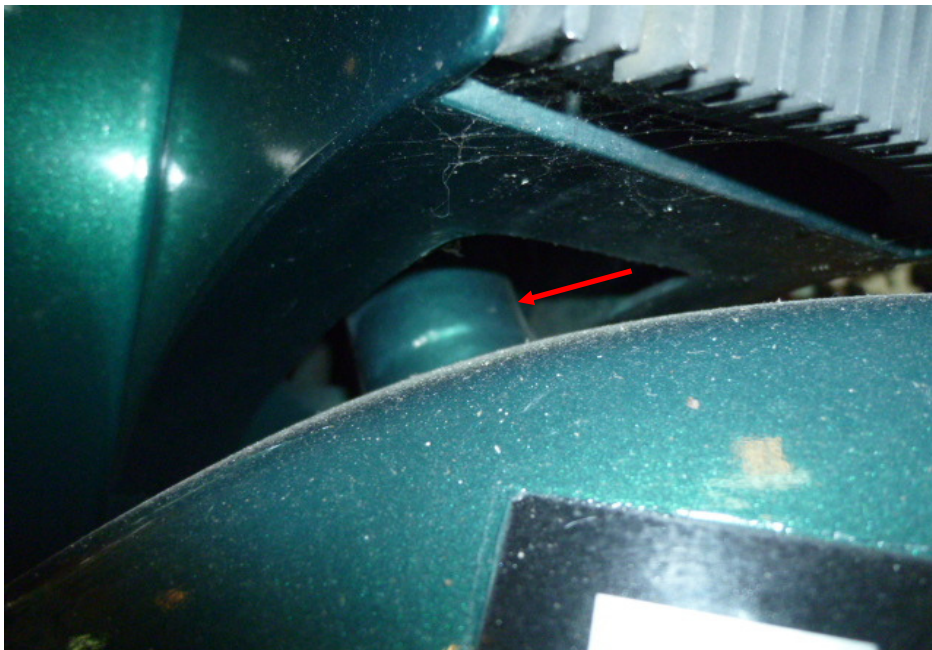
**Photo 16** shows the steering stem (arrowed) of the Motorcycle. The steering stem of the Motorcycle was both found to be intact and undamaged. Turning the Motorcycle's handle bar towards the left and right did not produce any abnormal free play and/or resistance. The steering system of the Motorcycle was in serviceable condition at the time of our inspection.

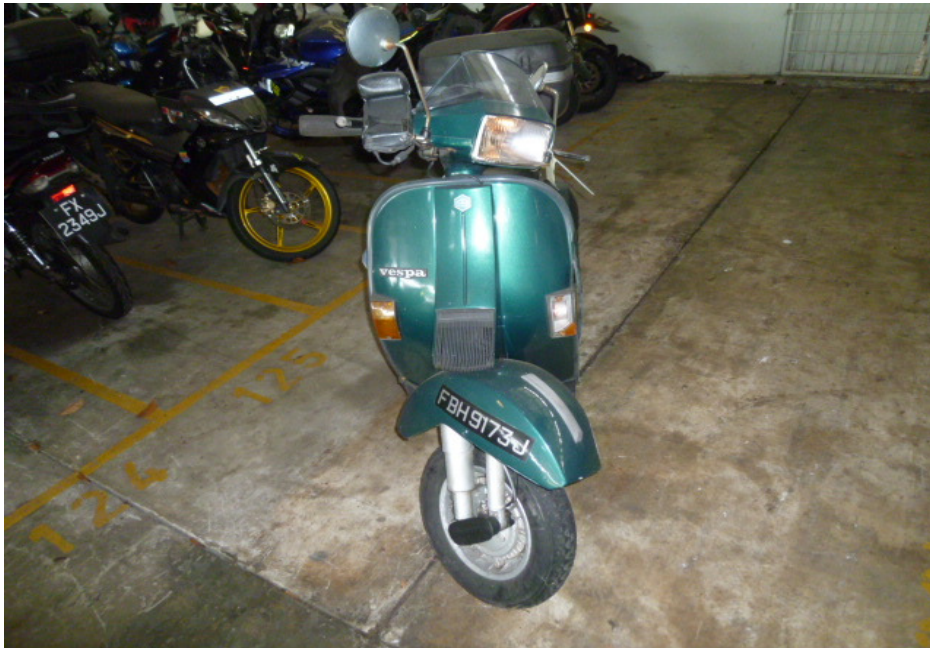
**Photo 17** shows the front wheel of the Motorcycle turned towards its full left. Turning the Motorcycle's handle bar towards the left and right did not produce any abnormal free play and/or resistance. This would indicate that the steering system of the Motorcycle was in serviceable condition at the time of our inspection.

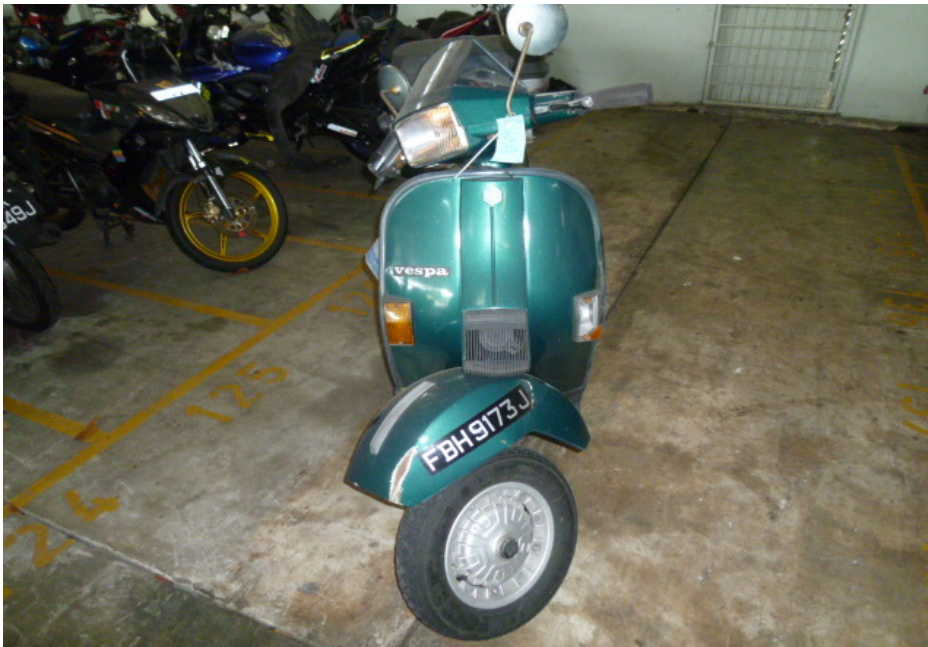
**Photo 18** shows the front wheel of the Motorcycle turned towards its full right. Turning the Motorcycle's handle bar towards the left and right did not produce any abnormal free play and/or resistance. This would indicate that the steering system of the Motorcycle was in serviceable condition at the time of our inspection.

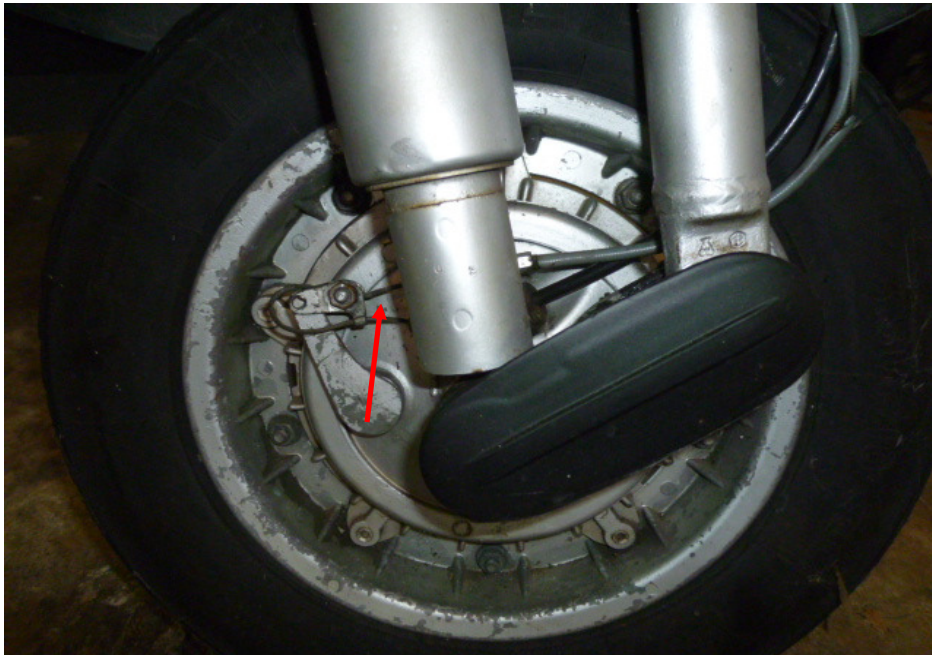
12. The braking system of the Motorcycle was observed to be controlled by mechanical means (cables and springs). Our visual examination of the various components in the Motorcycle's braking system like the brake cables, springs, drums, brake lever and brake pedal reveal all to be intact and without damage. The brake for the front wheel is engaged by pressing the brake lever at the right side of the Motorcycle's handle bar while the brake for the rear wheel is engaged by stepping on the brake pedal at the right side panel of the Motorcycle. There was also no visible tear or cut observed on the connecting hoses and cables.

13. We subsequently carried out an operational test of the Motorcycle's braking system. This was done by manually pushing the Motorcycle forward and backward, simulating the Motorcycle in motion, and thereafter engaging the front brake and rear brake of the Motorcycle. At the end of the short operational test, we did not observe any abnormal behaviour of the Motorcycle's braking system. The front wheel and rear wheel of the Motorcycle were able to stop rotating immediately upon depressing the brake lever and stepping on the brake pedal. See photos 15 – 20 below.

**Photo 19** shows the front wheel of the Motorcycle. The type of brake system for the front wheel was of a mechanical type, controlled by the front brake lever of the Motorcycle. Our checks of the cable (arrowed), spring and drum which are all part of the components in the front brake system of the Motorcycle reveal all to be intact and without damage.

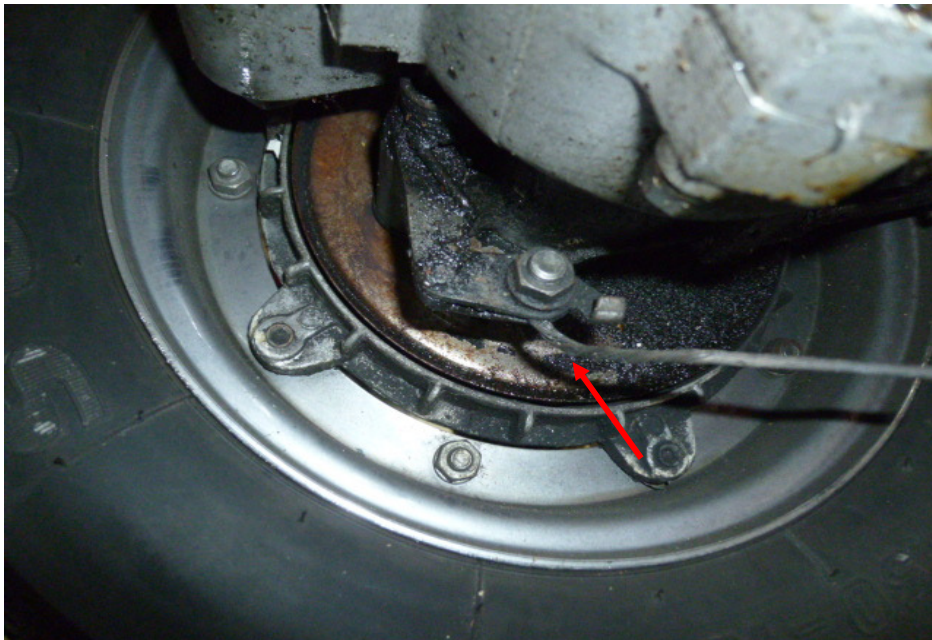
**Photo 20** shows the rear wheel of the Motorcycle. The type of brake system for the rear wheel was of a mechanical type, controlled by the brake foot pedal of the Motorcycle. Our checks of the cable (arrowed), spring and drum which are all part of the components in the rear brake system of the Motorcycle reveal all to be intact and without damage.
