Your Ref: TP/IP/19205/2021
Our Ref : CI/TPD21008297/N

Fatal Accident Investigation Team

**INSPECTION REPORT OF BICYCLE (BLUE) - TRAFFIC POLICE POUND
REPORT NO. PR 1344/21**

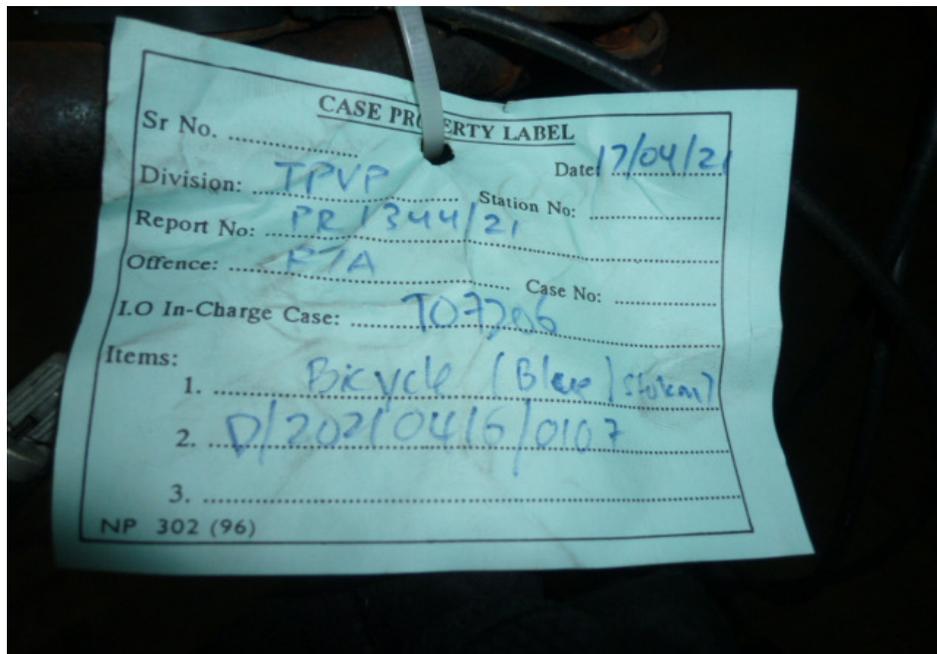
Photo 1 shows the identification of the Bicycle with reference to Traffic Police Pound Report No. PR 1344/21.

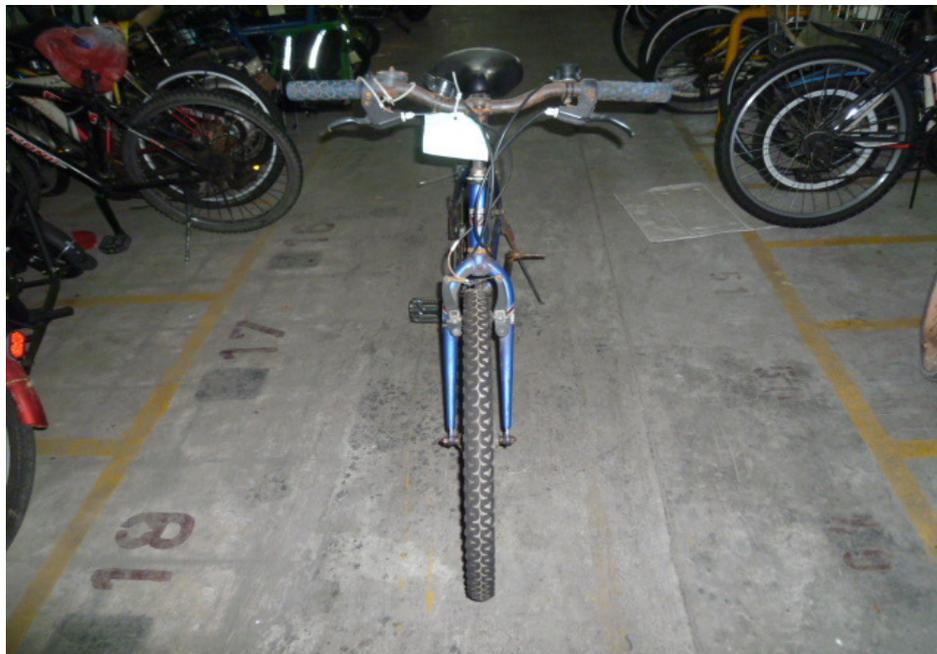
Photo 2 shows the frontal portion of the Bicycle at the time of our inspection. The Bicycle had sustained damages all around.

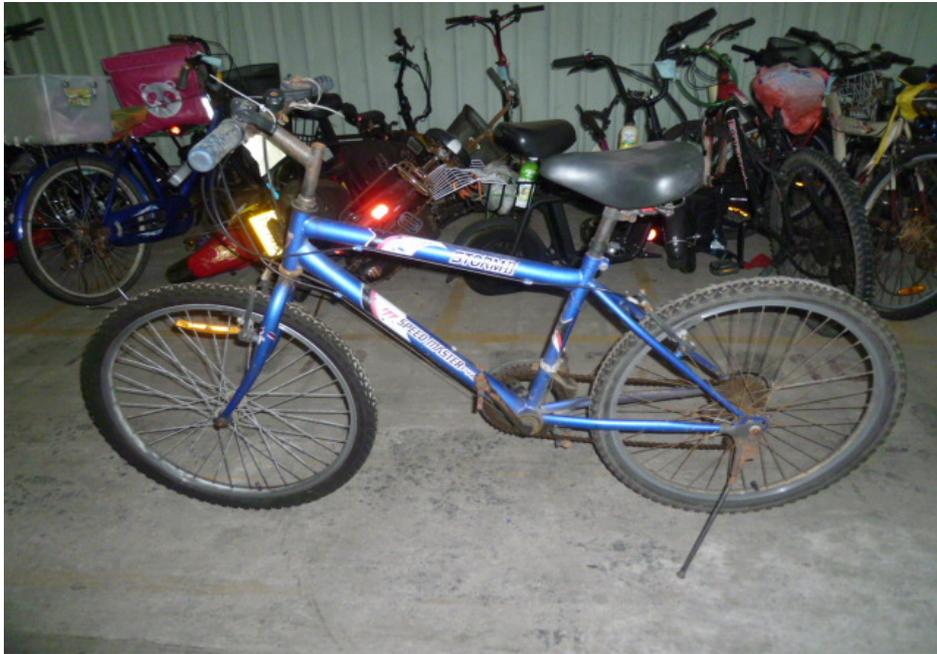
Photo 3 shows the left body of the Bicycle at the time of our inspection. The Bicycle had sustained damages all around.

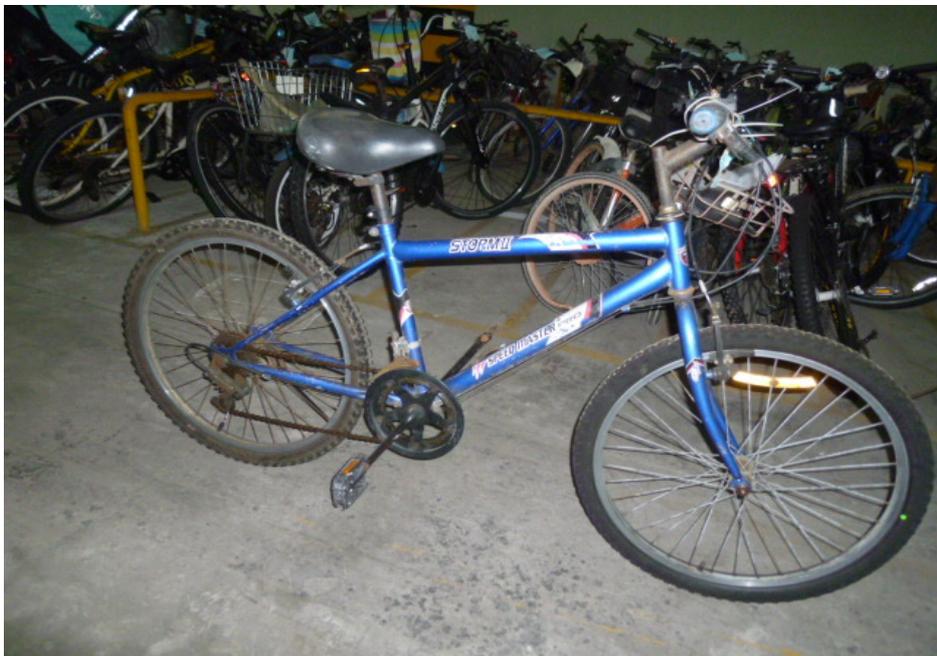
4. The Bicycle was observed to have sustained damages all around. The body parts that were found to have been damaged include its bell, right hand brake lever, pedals and seat, amongst others as a result of the accident. See photos 1 – 9 below.

Photo 4 shows the right body of the Bicycle at the time of our inspection. The Bicycle had sustained damages all around. The body parts that were found to have been damaged include its bell, right hand brake lever, pedals and seat, amongst others as a result of the accident.

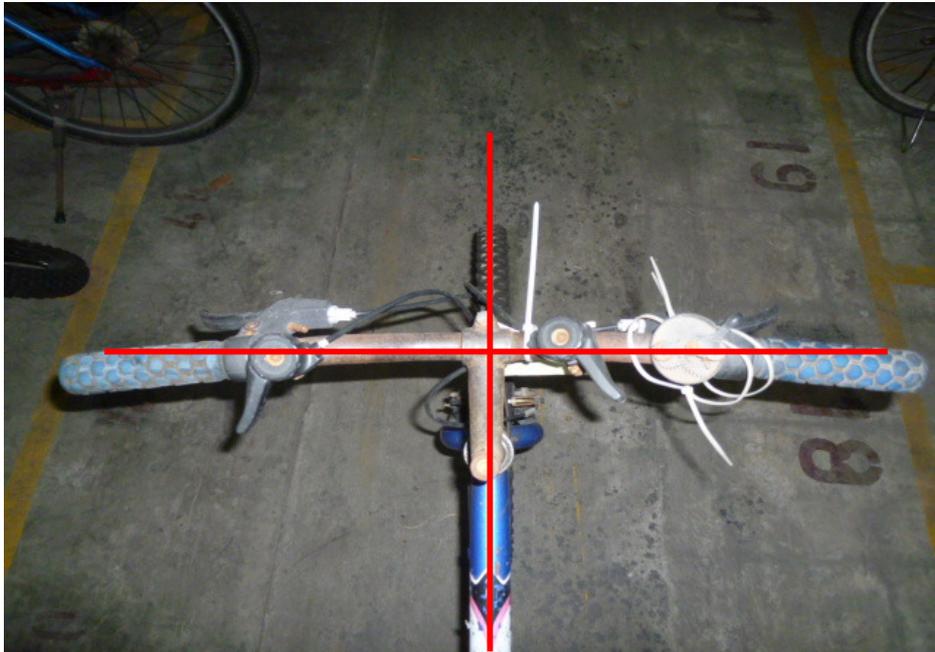
Photo 5 shows the frontal portion of the Bicycle (top view) at the time of our inspection. There was no misalignment of the handle bar & front tyre observed as a result of the accident.

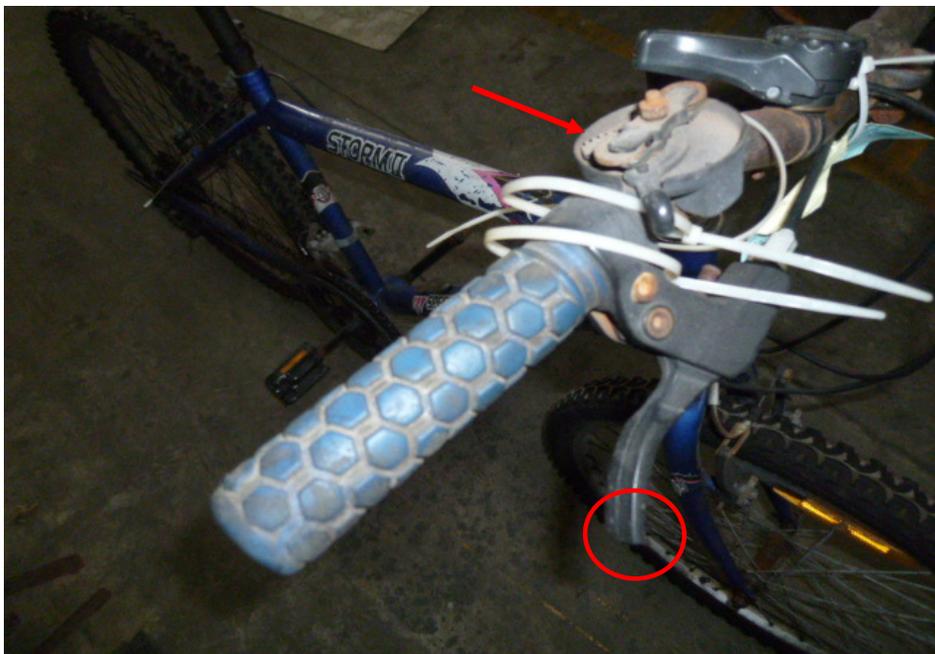
Photo 6 shows the broken bell (arrowed) and broken right hand brake lever (circled) of the Bicycle at the time of our inspection.

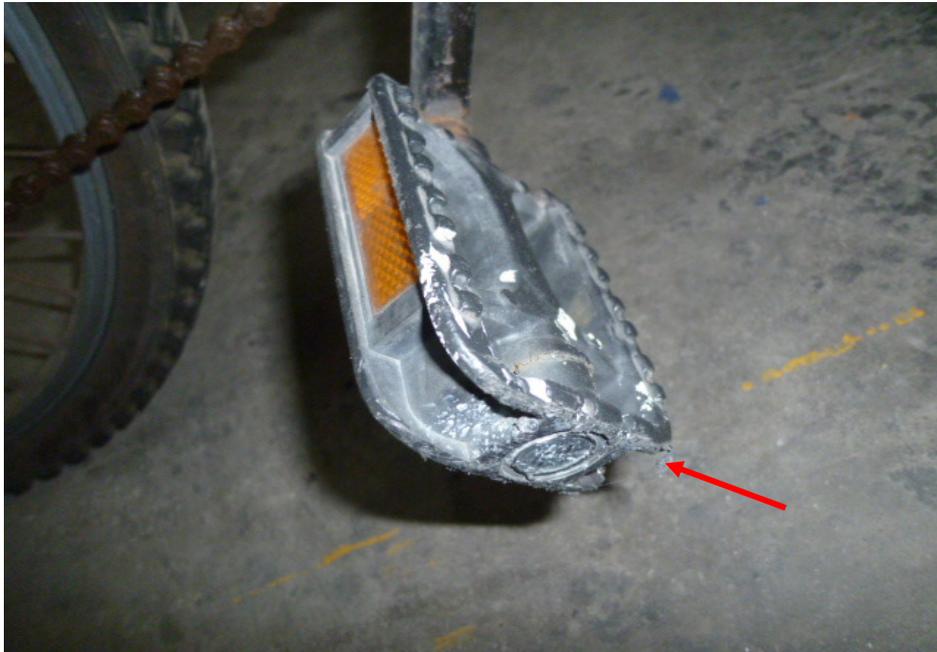
Photo 7 shows the damages of grazing nature on the right pedal of the Bicycle at the time of our inspection (arrowed).

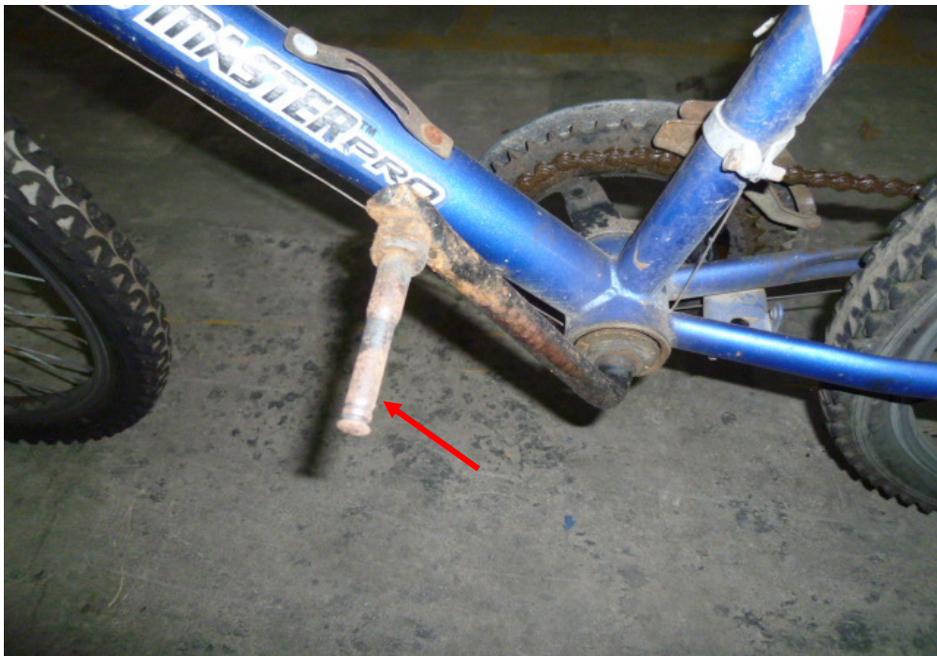
Photo 8 shows the missing left pedal of the Bicycle at the time of our inspection (arrowed).

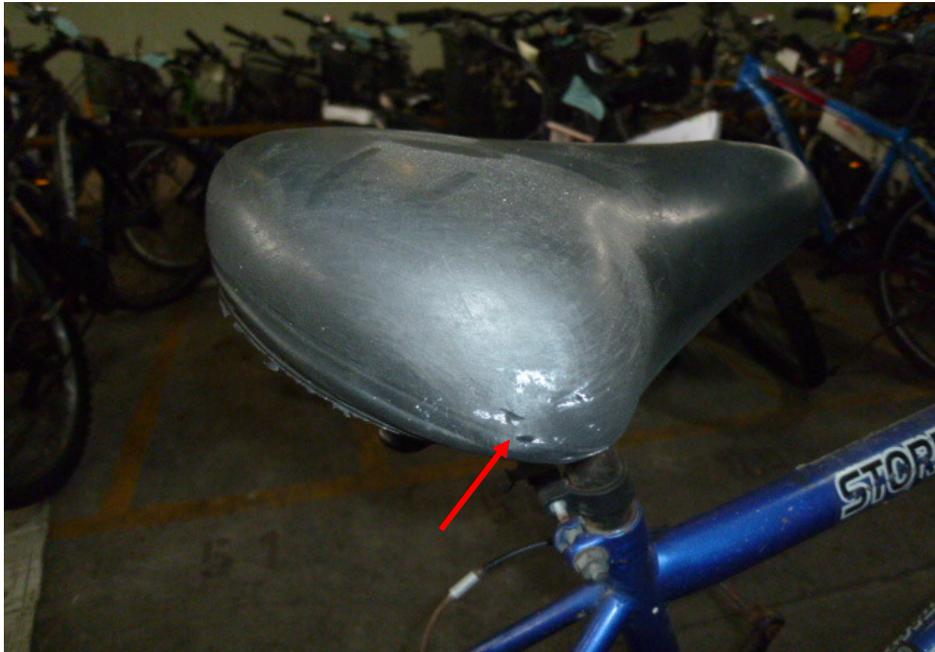
Photo 9 shows a close-up view of the damaged seat (arrowed) of the Bicycle as a result of the accident.

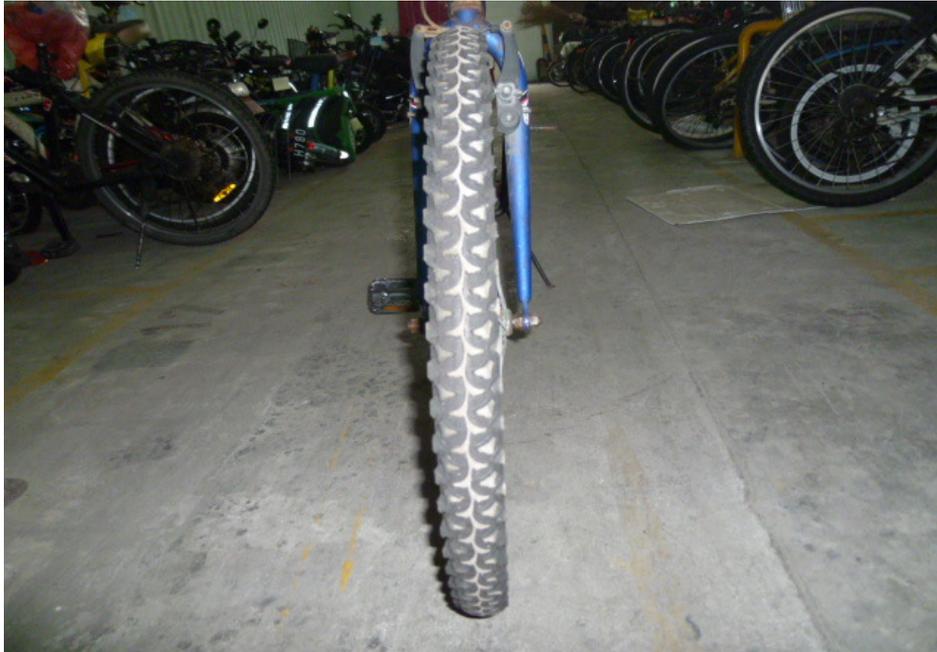
5. The condition of the Bicycle's front & rear tyres was observed to be in serviceable condition. The tread pattern of the 2 tyres was clearly visible. We did not observe any tear, burst mark(s) and/or punctured hole(s) on the sidewalls as well as across the tread of the 2 tyres. The rear tyre was observed to be sufficiently inflated for vehicular operation. However the front tyre was observed to be deflated at the time of our inspection. The tyre brand, tyre size and remaining tread depth of the 2 tyres were recorded as follows:-

Photo 10 shows the front tyre of the Bicycle. The pattern of the tread was clearly visible. There was no tear, burst mark(s) and/or punctured hole(s) on the sidewalls as well as across the tread of the front tyre. However the front tyre was observed to be deflated.

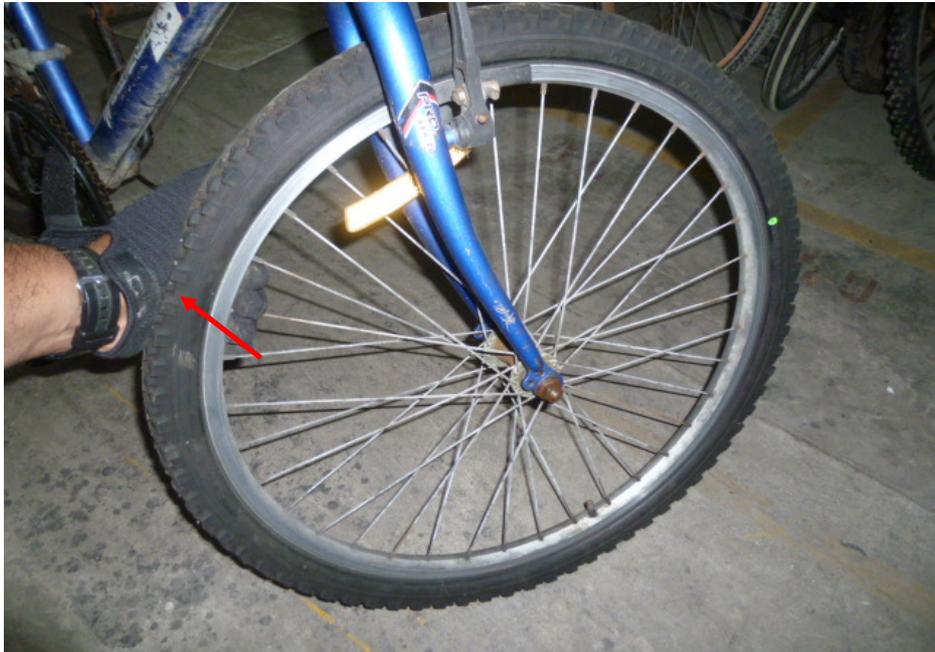
Photo 11 shows the deflated front tyre of the Bicycle (arrowed).

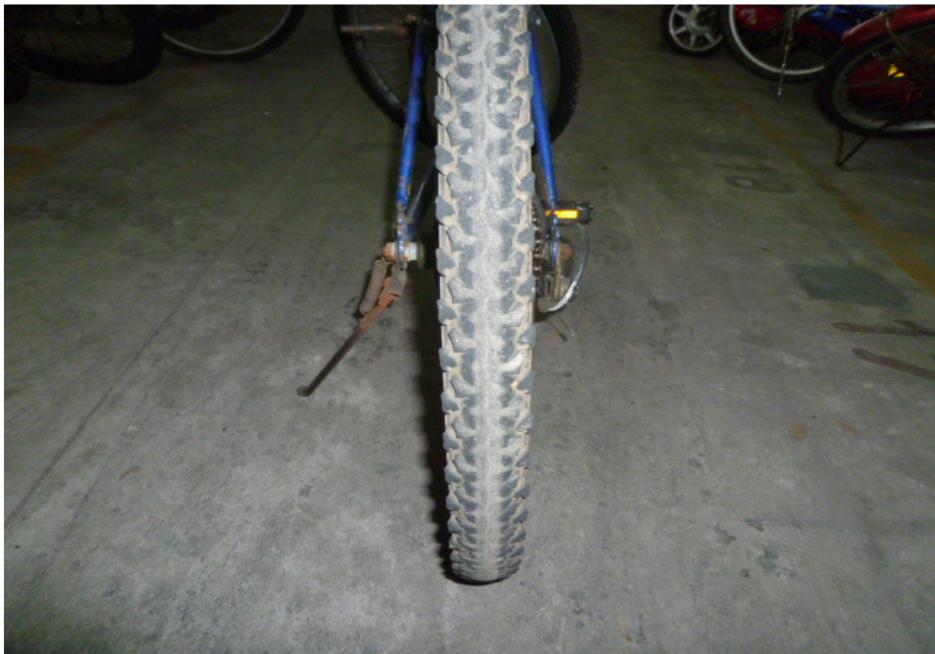
Photo 12 shows the rear tyre of the Bicycle. The pattern of the tread was clearly visible. There was no tear, burst mark(s) and/or punctured hole(s) on the sidewalls as well as across the tread of the front tyre. The rear tyre was also observed to be sufficiently inflated for vehicular operation.

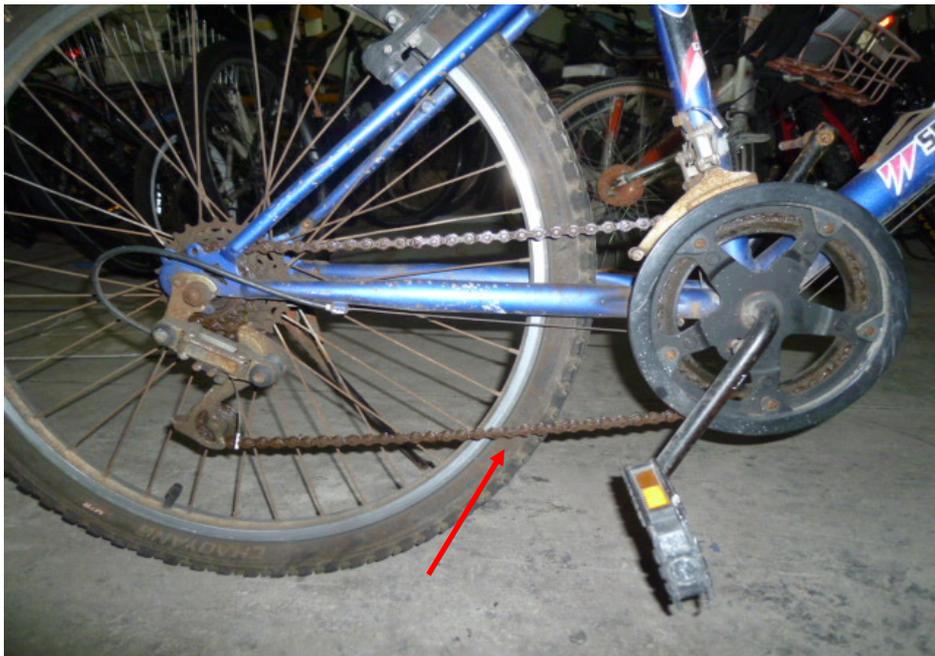
7. The gear train of the Bicycle was found to be intact without any misalignment. It was also adequately lubricated for operating purposes. See photos 13 & 14 below.

Photo 13 shows the general view of the gear train of the Bicycle, which was observed to be intact with no misalignment (arrowed). It was also adequately lubricated for operating purposes.

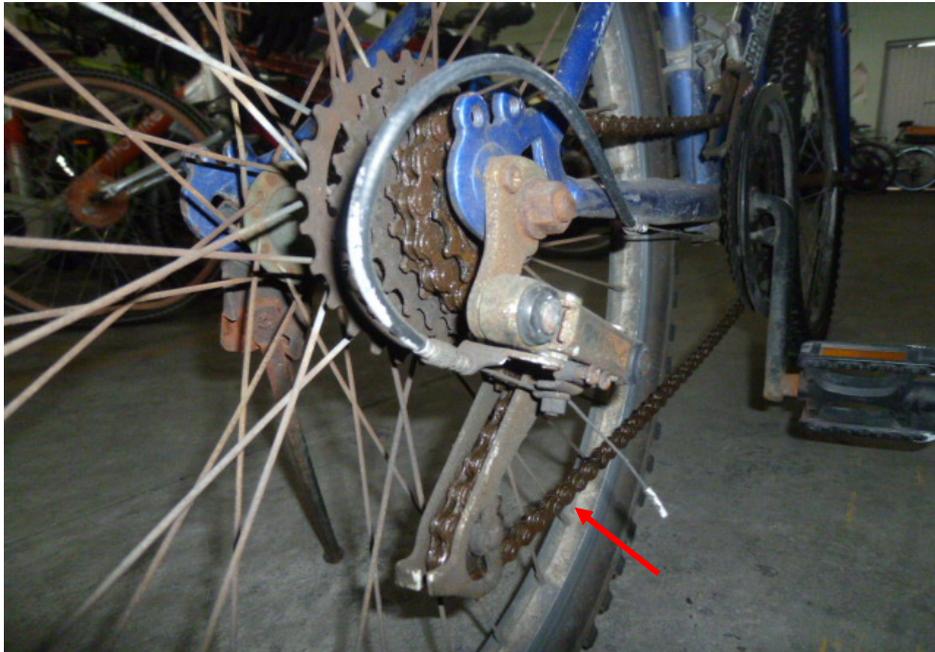
Photo 14 shows a closer view of the gear train of the Bicycle, which was observed to be intact with no misalignment (arrowed). It was also adequately lubricated for operating purposes.

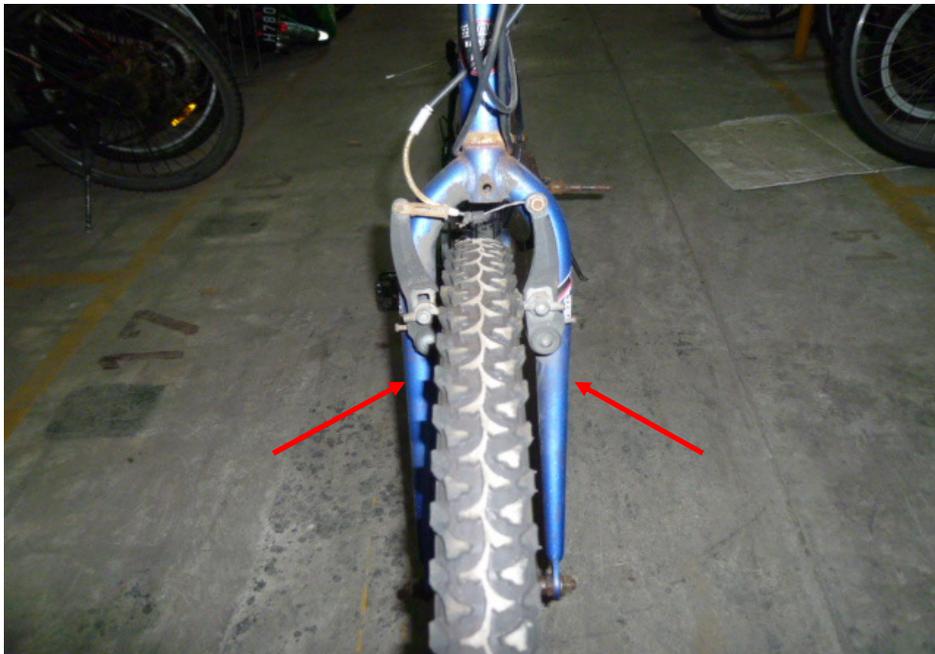
8. Our checks on the various steering components of the Bicycle revealed that its steering system was in serviceable condition. Its front fork was found to be intact and undamaged. Turning the handle bar towards the left and right did not produce any abnormal free play and/or resistance.

Photo 15 shows the front forks (arrowed) of the Bicycle. The front forks and fork bracket of the Bicycle were both found to be intact and undamaged. Turning the Bicycle's handle bar towards the left and right did not produce any abnormal free play. The steering system of the Bicycle was in serviceable condition at the time of our inspection.

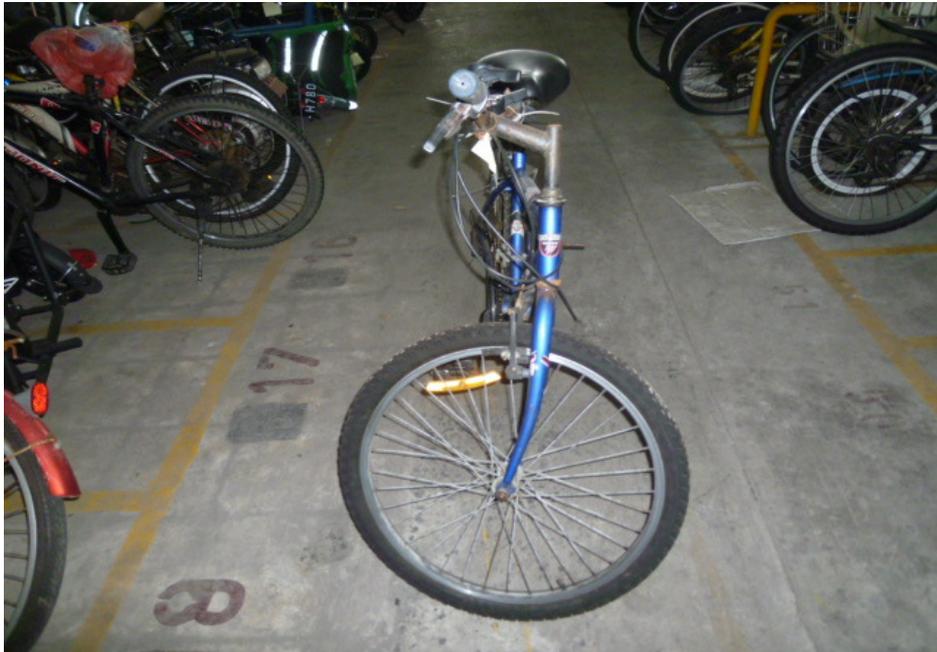
Photo 16 shows the front wheel of the Bicycle turned towards its full right. Turning the Bicycle's handle bar towards the right did not produce any abnormal free play and/or resistance. This would indicate that the steering system of the Bicycle was in serviceable condition at the time of our inspection.

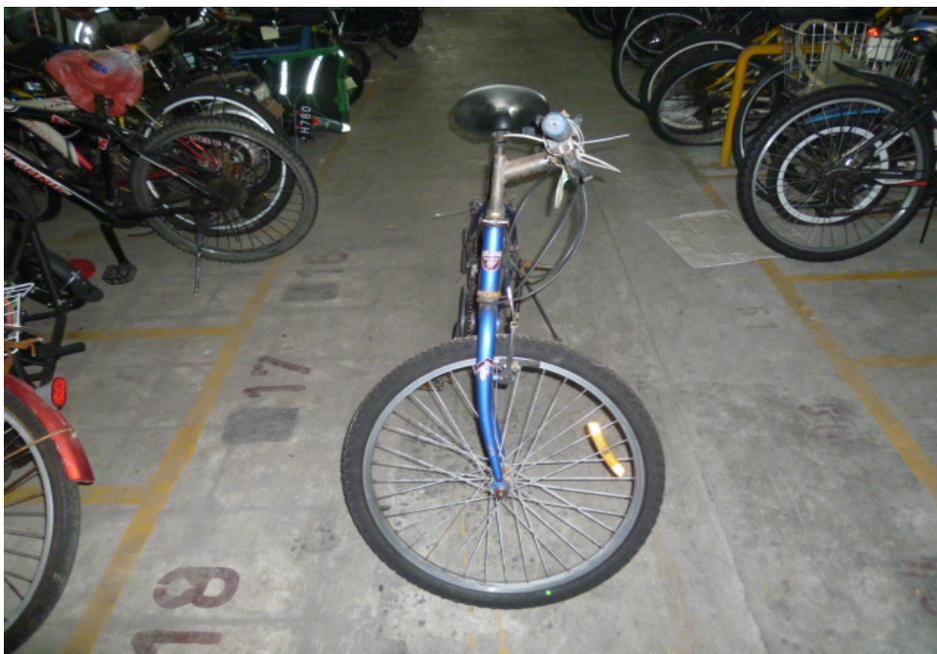
Photo 17 shows the front wheel of the Bicycle turned towards its full left. Turning the Bicycle's handle bar towards the left did not produce any abnormal free play and/or resistance. This would indicate that the steering system of the Bicycle was in serviceable condition at the time of our inspection.

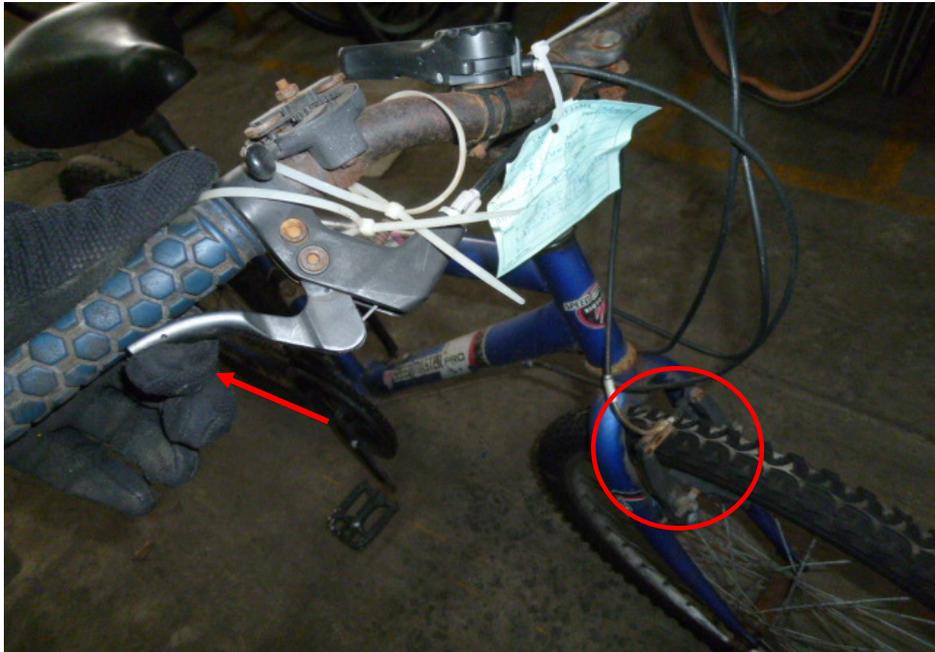
10. A static brake test was conducted on the front brake of the Bicycle. There was some resistance felt upon pressing the right hand brake lever. This was further confirmed by looking at the front brake clamps while we pressed the left hand brake lever. It shows that the front brake clamps responded to the gripping action. The rubber brake blocks pressed against the front wheel rim.

Photo 18 shows a static brake test conducted on the Bicycle's front brake. There was some resistance felt upon pressing the right hand brake lever (arrowed). It also shows that the front brake clamps responded to the gripping action (circled) after depressing the right hand brake lever.

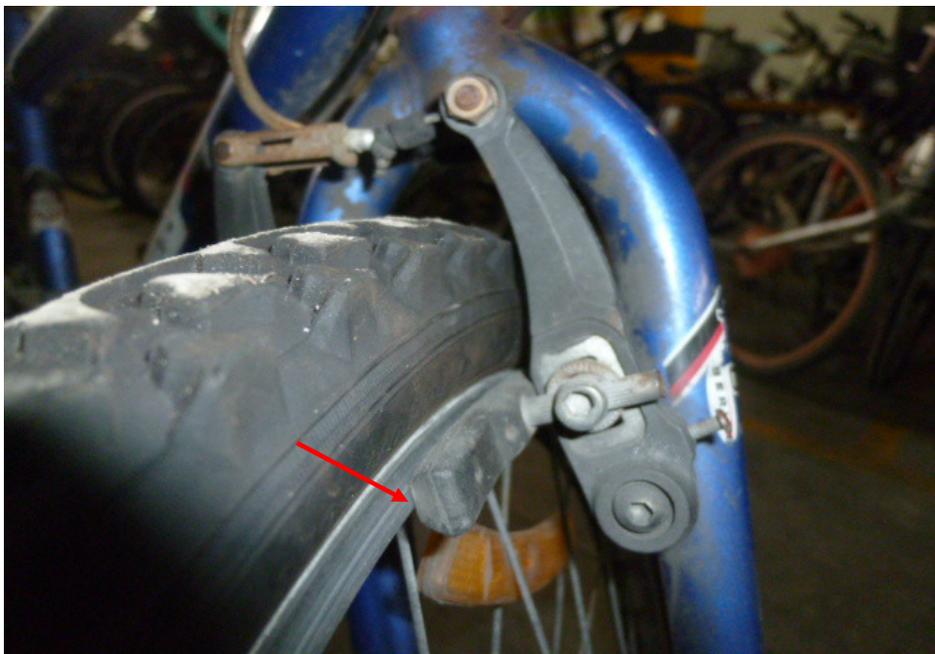
Photo 19 shows a close up view of the front brake clamps responding to the gripping action. The rubber brake blocks pressed against the front wheel rim upon depressing the right hand brake lever (arrowed).

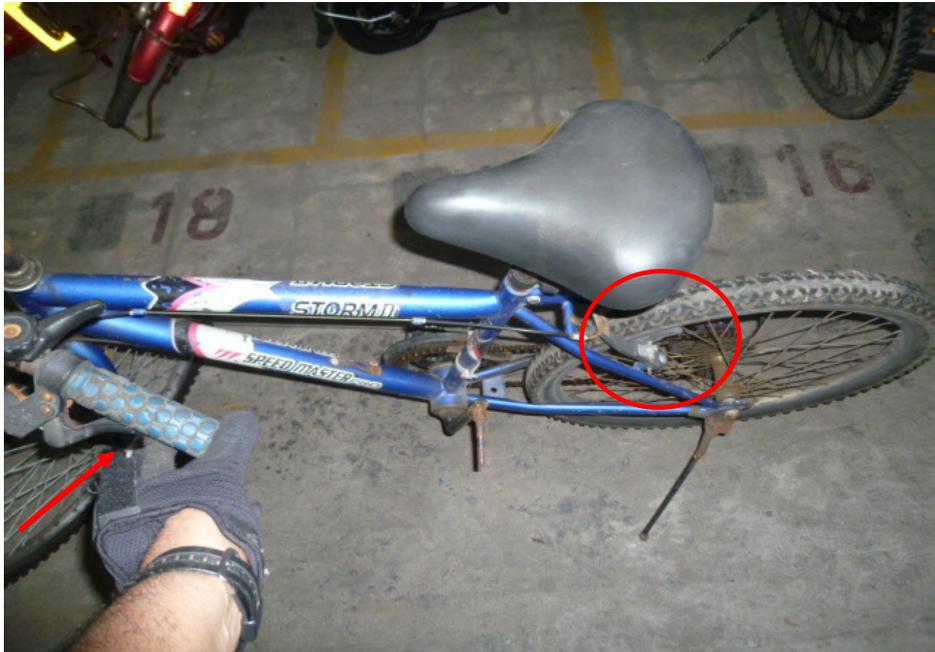
11. A static brake test was conducted on the rear brake of the Bicycle. There was some resistance felt upon pressing the left hand brake lever. This was further confirmed by looking at the rear brake clamps while we pressed the left hand brake lever. It shows that the rear brake clamps responded to the gripping action. The rubber brake blocks pressed against the rear wheel rim.

Photo 20 shows a static brake test conducted on the Bicycle's rear brake. There was some resistance felt upon pressing the left hand brake lever (arrowed). It also shows that the rear brake clamps responded to the gripping action (circled) after depressing the left hand brake lever.

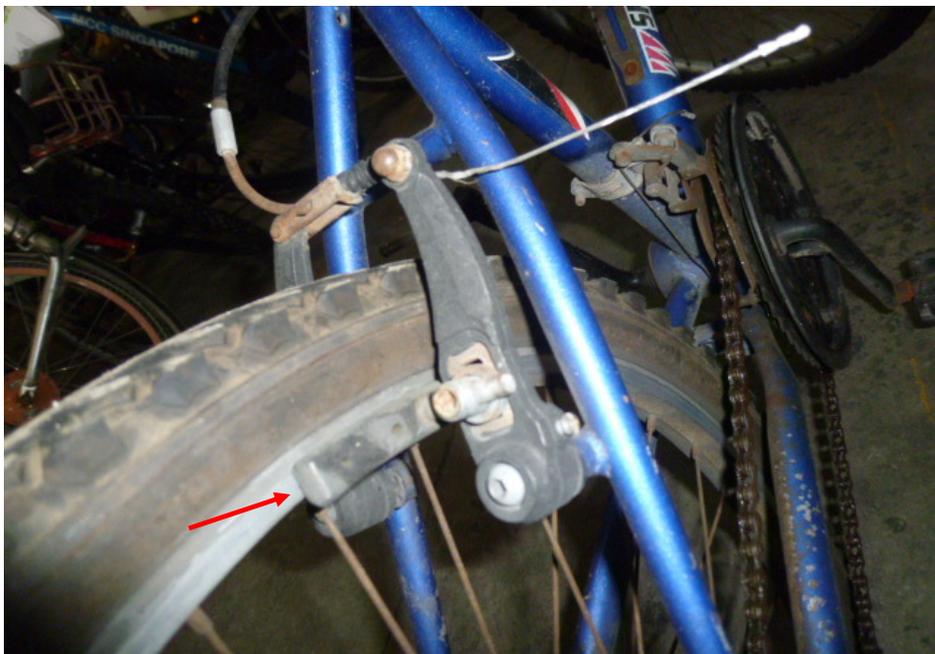
Photo 21 shows a close up view of the rear brake clamps responding to the gripping action. The rubber brake blocks pressed against the rear wheel rim upon depressing the left hand brake lever (arrowed).
